Campbelltown Hospital Redevelopment

AIR MONITORING REPORT MAY 2020

Prepared For CPB

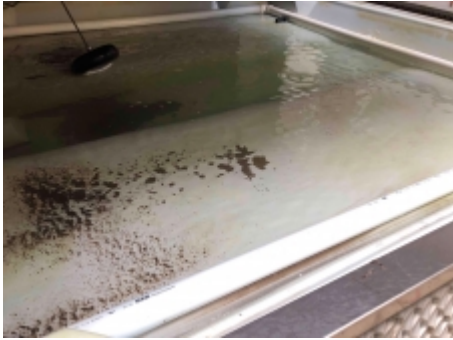
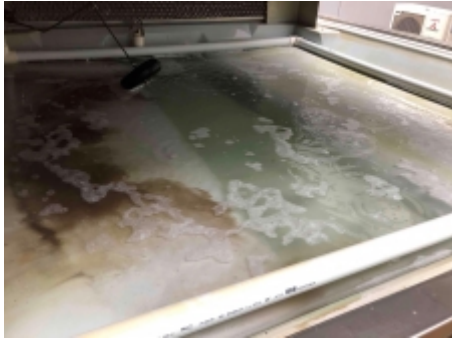
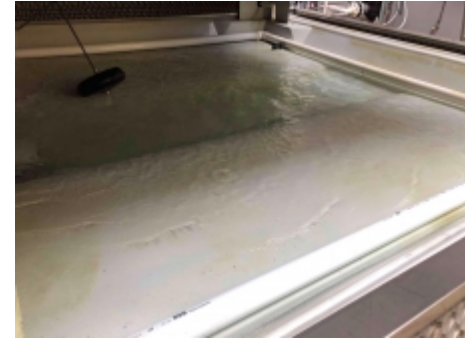
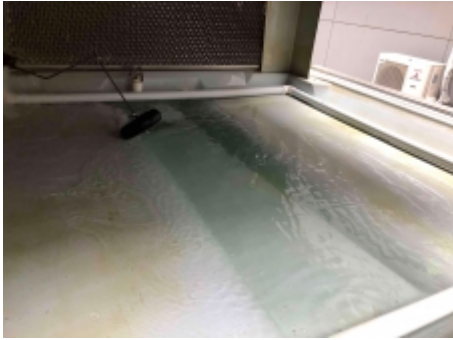
4476	✓	✓	✓	X			
ASSET		TOWER CONDITION		ADDITIONAL SERVICES PERFORMED		REMARKS	
CTC-1041-01		Mildly Dirty				Pressure washed all wetted areas	
Non Conformance	System conforms				BAR Activities Performed		
SAS REPRESENTATIVE					CUSTOMER REPRESENTATIVE		
Signature

Before and after tower basins

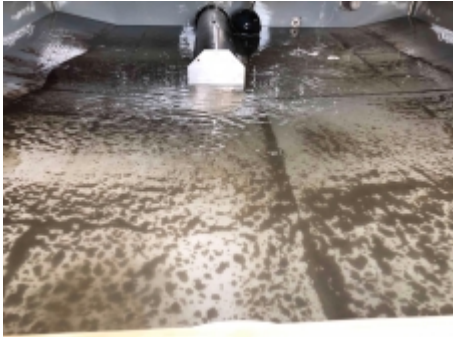
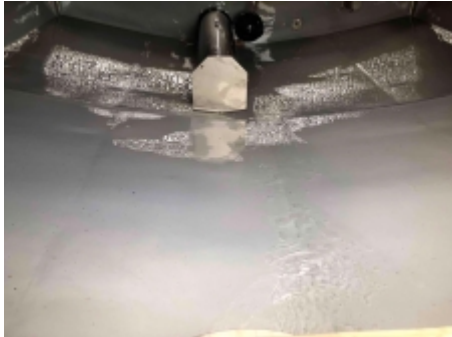
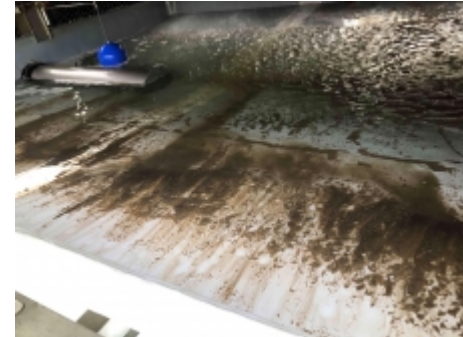
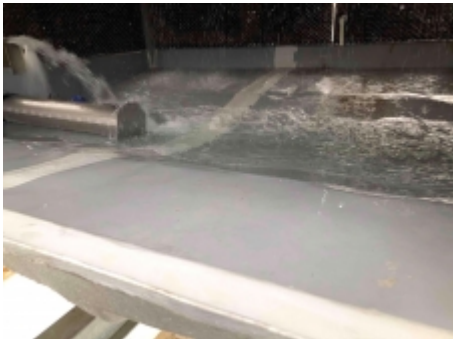
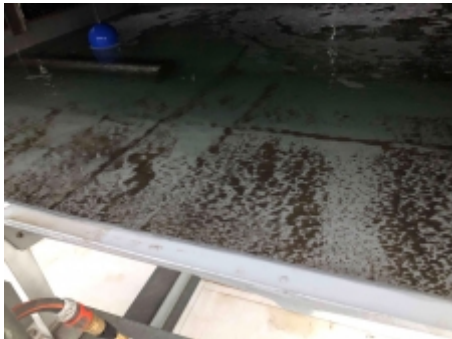
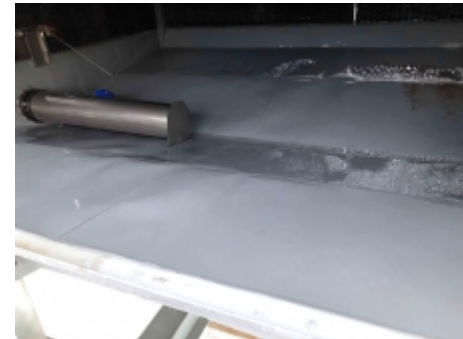
4478	✓	✓	✓	X			
ASSET		TOWER CONDITION		ADDITIONAL SERVICES PERFORMED		REMARKS	
CTC-1042-01		Dirty				Flushed balance line pipe, checked fans, pressure washed all wetted areas. Returned valves to marked positions.	
Non Conformance	System conforms				BAR Activities Performed		
SAS REPRESENTATIVE					CUSTOMER REPRESENTATIVE		
Signature

Before and after tower basins

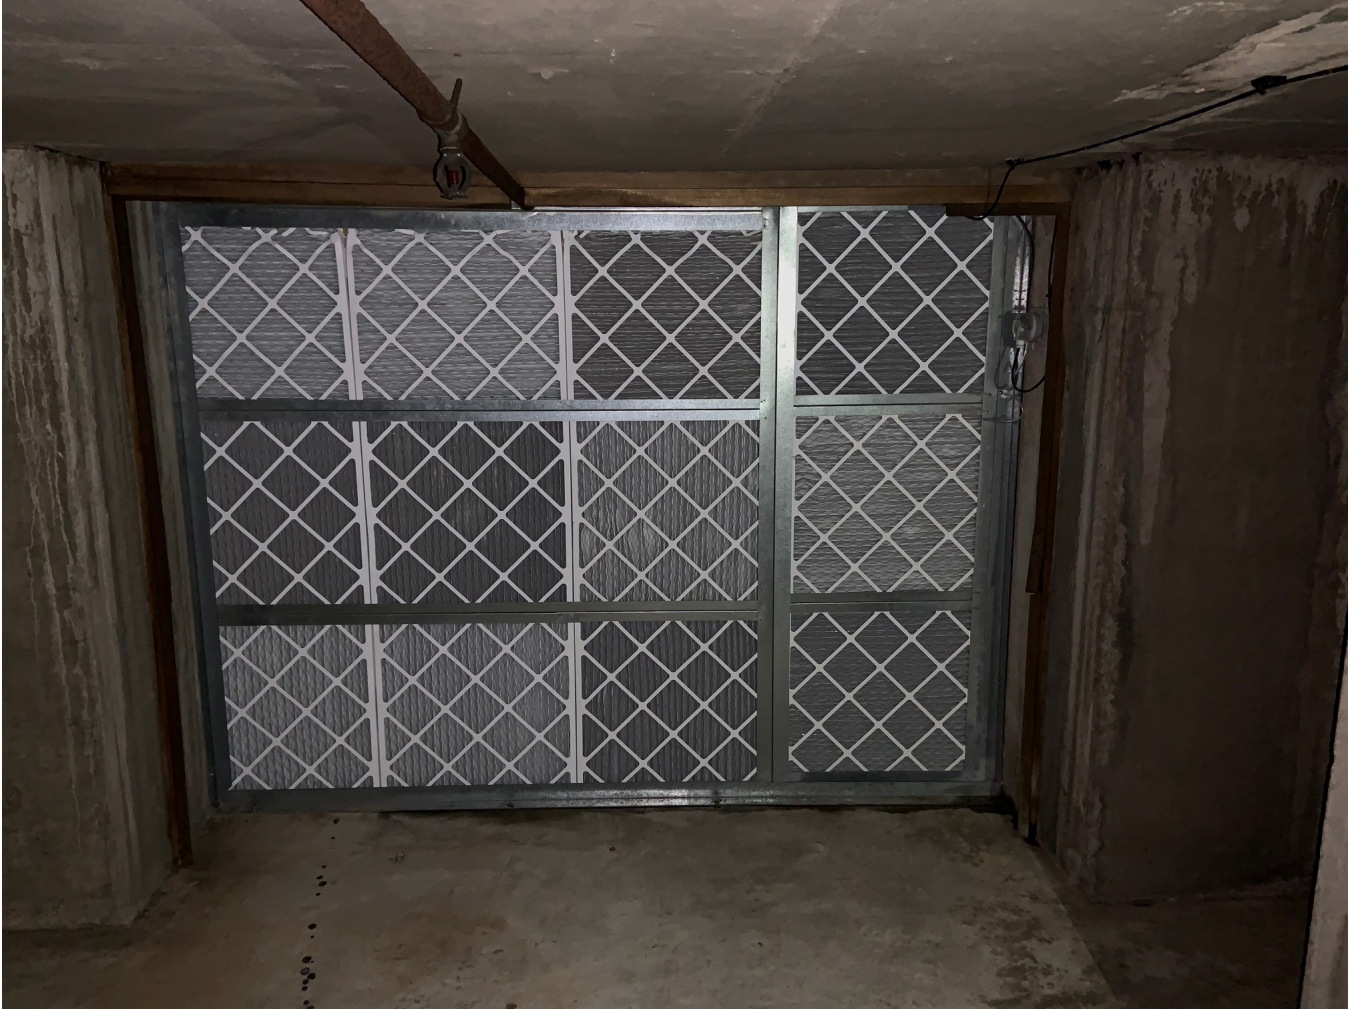
Building B - OA Filters - (Changed 10th June 2020 ,Following AHU Install)
