PROPERTY CONDITION SURVEY - COMMERCIAL/INDUSTRIAL

AD2696A

Mears and Church Street
MUDGEES NSW 2850

145 Church Street
MUDGEES NSW 2850

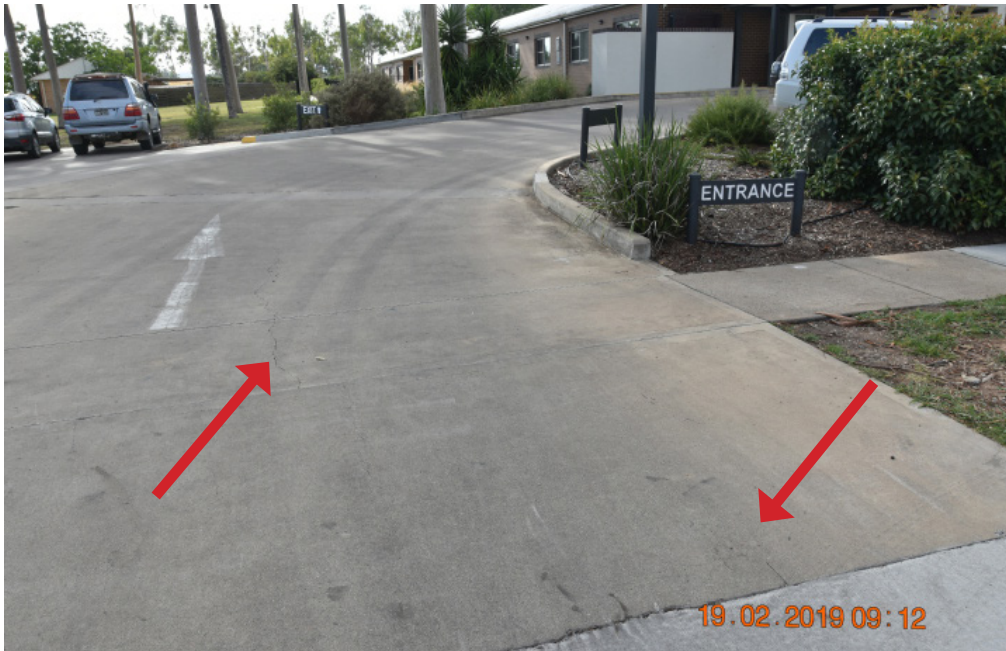
Figure: 0003

- Cracking in the entrance driveway to the medical centre. See photo 3-5, 8-10
- Cracking in the exit driveway. See photo 69, 70
- Chipping in the exit driveway. See photo 175
- Chipping in the crossover and cracking in the exit driveway. See photo 176
- Cracking in the driveway to 30 Meares Street. See photo 250
- Cracking in the south driveway to the hospital. See photo 270-276, 285
- Cracking the south driveway to the hospital, looking north. See photo 278, 291, 292
- Poor condition in the south driveway to the hospital. See photo 288
- Cracking the south driveway to the hospital, looking north. See photo 289, 290

1. Cracking in the entrance driveway to the medical centre. See photo 3-5, 8-10
2. Cracking in the north carpark. See photo 13-16, 18
3. Cracking in the west carpark. See photo 21, 22, 58-60

General view of the entrance driveway to the medical centre. Showing cracking.

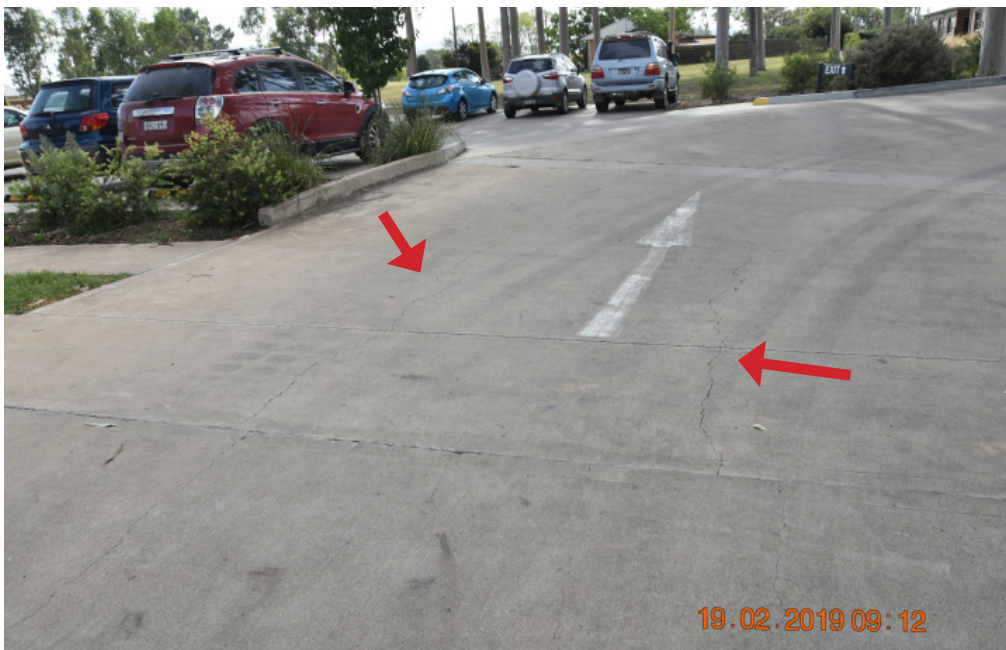
Figure: 0004

General view of the entrance driveway to the medical centre. Showing cracking.

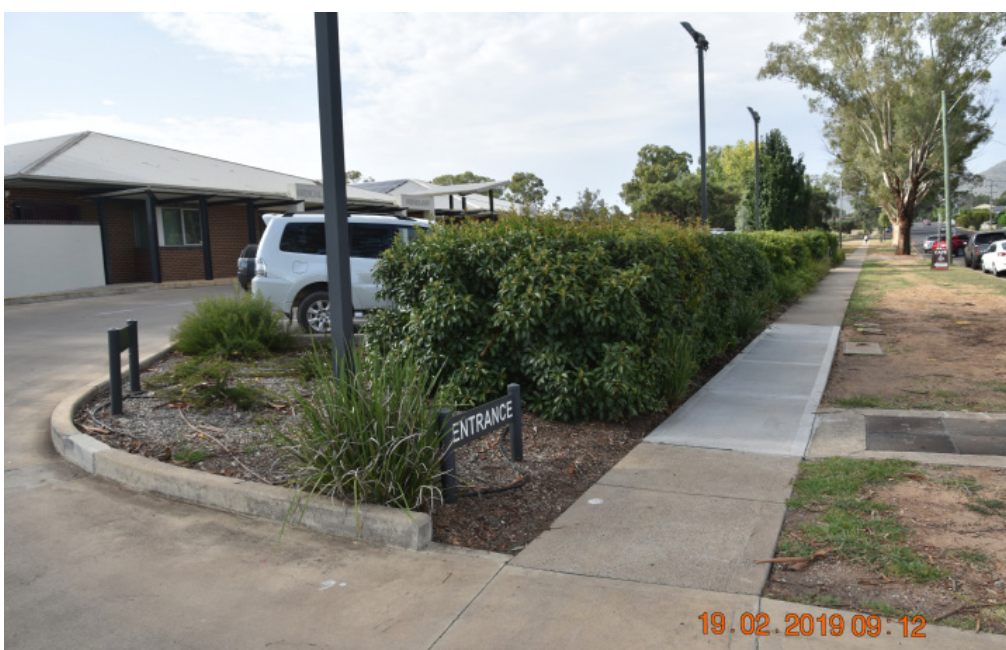
Figure: 0005

General view of the entrance driveway to the medical centre. Showing cracking.

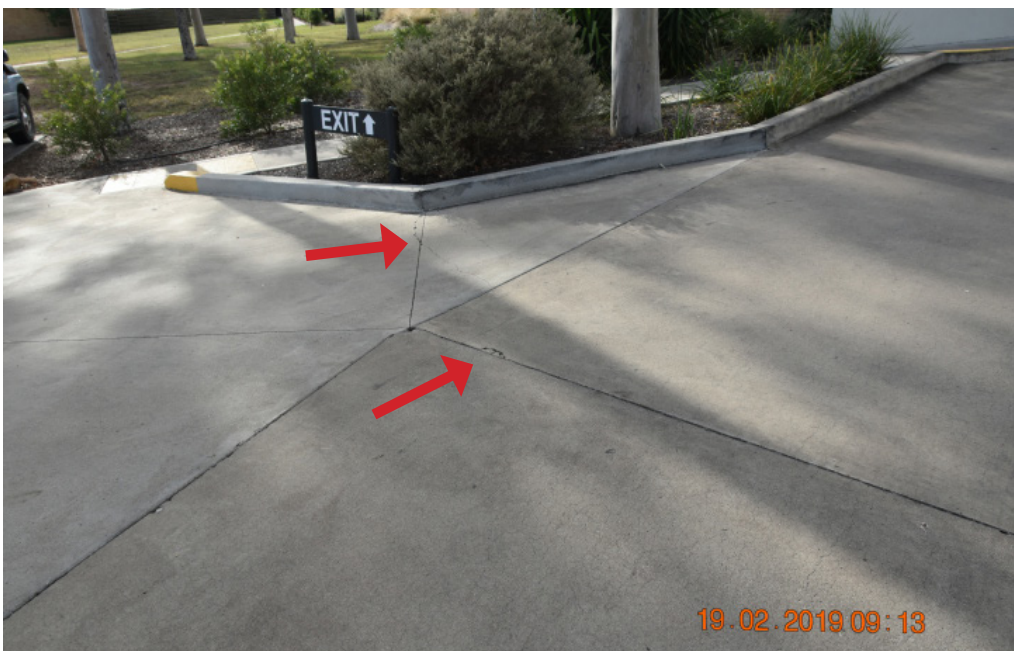
Figure: 0009

General view of the entrance driveway. Showing cracking.

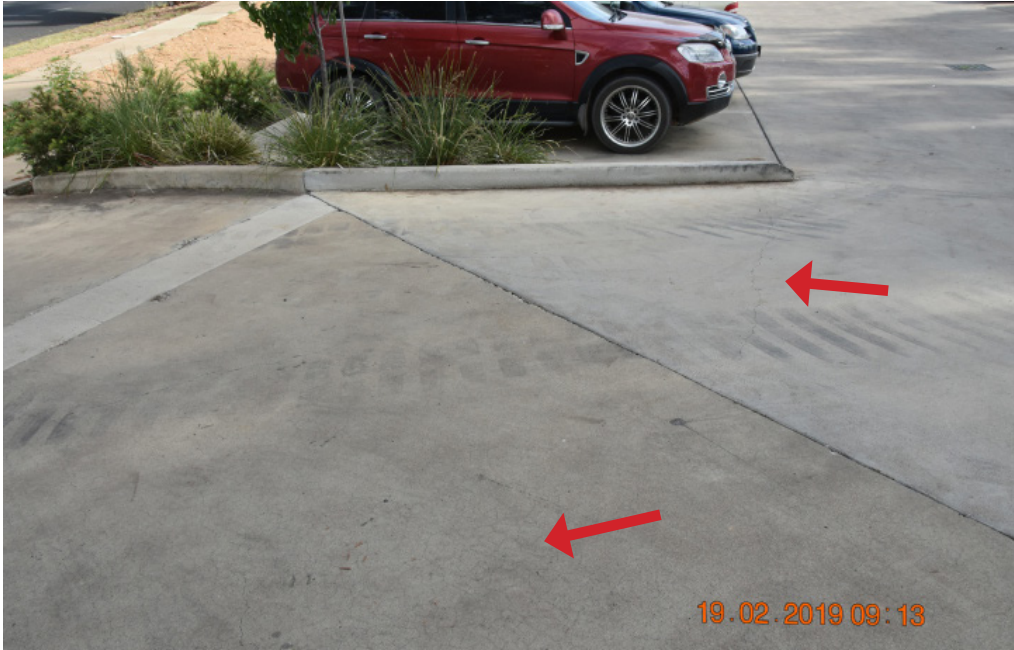
Figure: 0010

General view of the entrance driveway. Showing cracking.

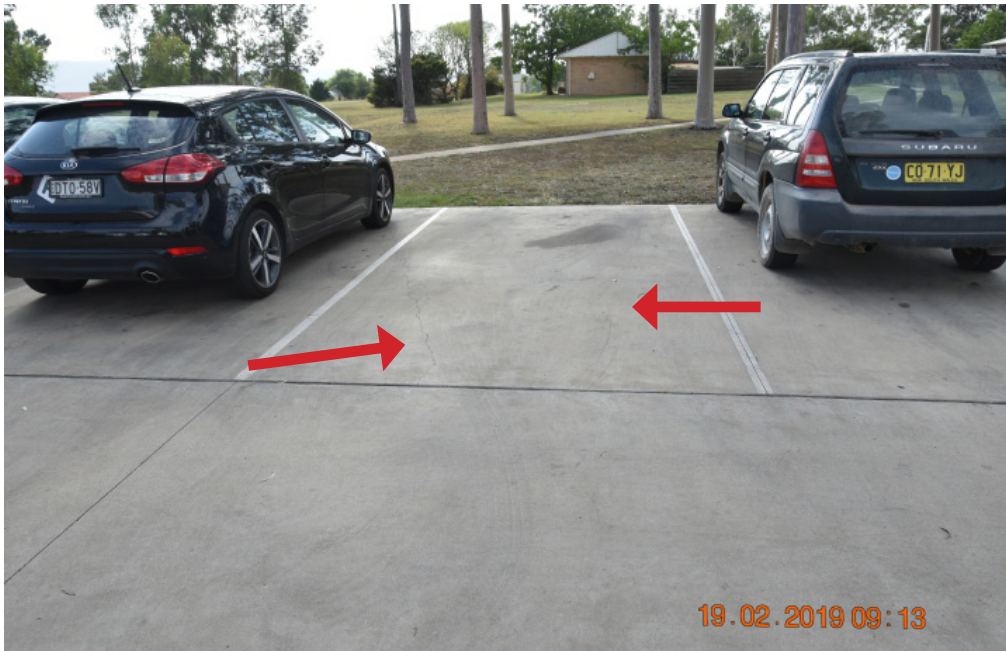
Figure: 0016

- Cracking in the north carpark. See photo 13-16, 18
- Cracking in the west carpark. See photo 21, 22, 58-60
- Cracking in the west carpark, looking south from the pedestrian crosswalk. See photo 23

General view of the north carpark. Showing cracking.

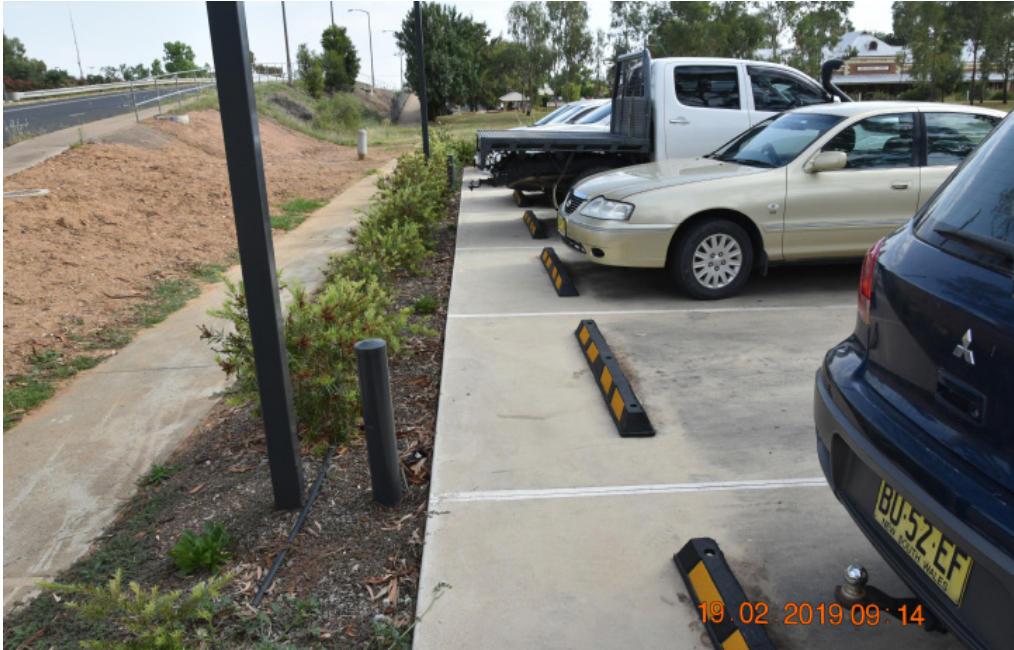
Figure: 0018

General view of the north carpark. Showing cracking.

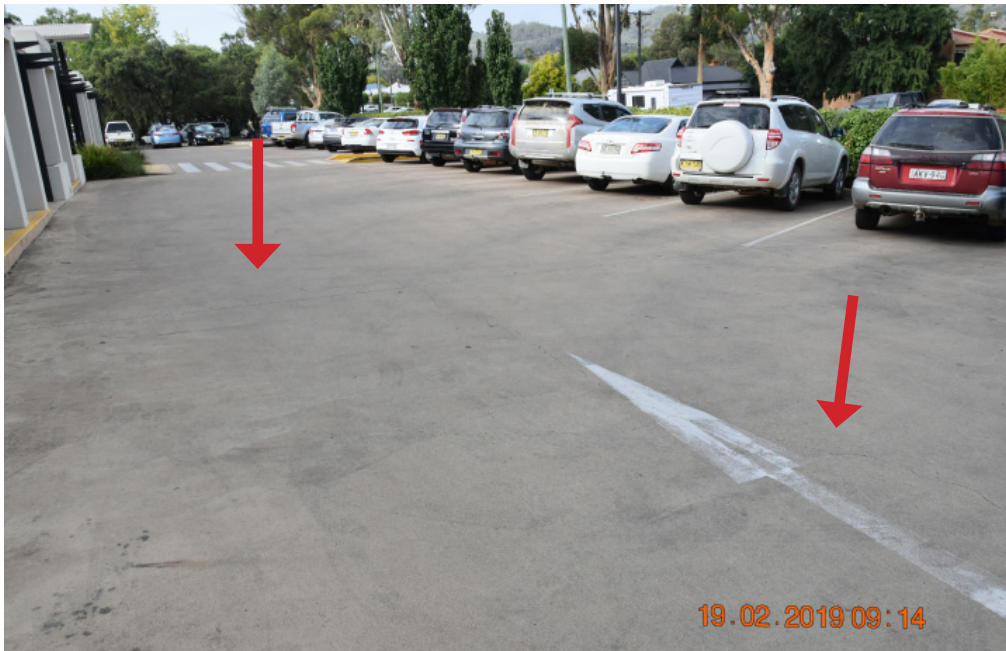
Figure: 0022

General view of the west carpark. Showing cracking.

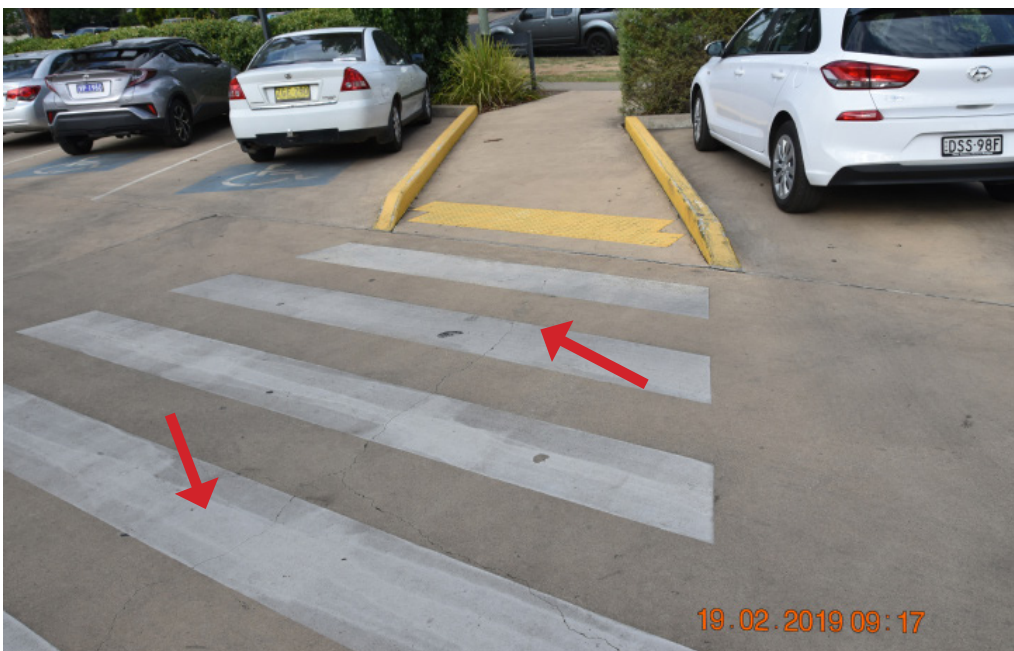
Figure: 0038

- Chipping in the paving on the west side of the medical centre. See photo 38
- Cracking in the paving near the southwest corner of the medical centre. See photo 71

10. Chipping in the paving on the west side of the medical centre. See photo 38
11. Cracking in the pedestrian crosswalk on the west side of the medical centre. See photo 39, 40

Chipping in the paving on the west side of the medical centre.

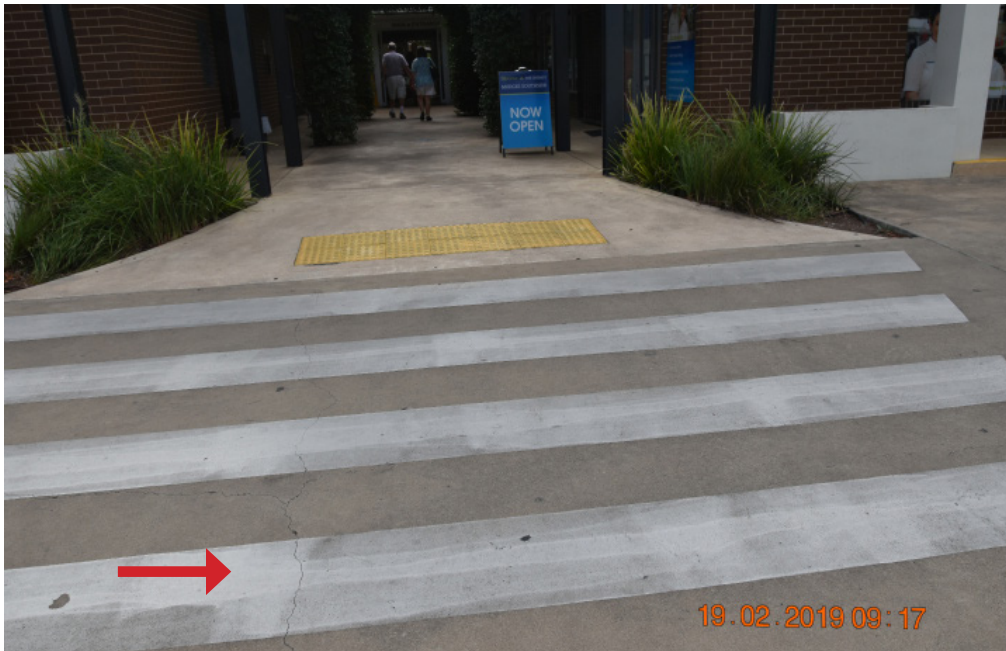
Figure: 0040

- Cracking in the pedestrian crosswalk on the west side of the medical centre. See photo 39, 40

Pedestrian crosswalk on the west side of the medical centre. Showing cracking.

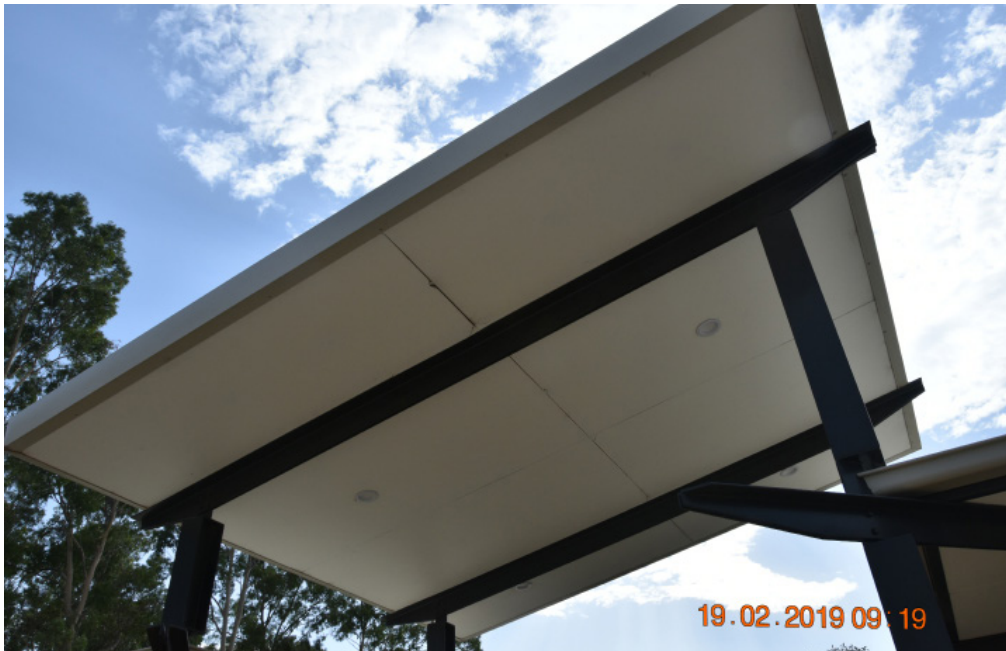
Figure: 0051

12. Cracking in the underside of the awning on the north side of the pharmacy. See photo 51
13. Cracking in the underside of the sail shade outside the main entrance to the medical centre. See photo 43

Cracking in the underside of the awning on the north side of the pharmacy.

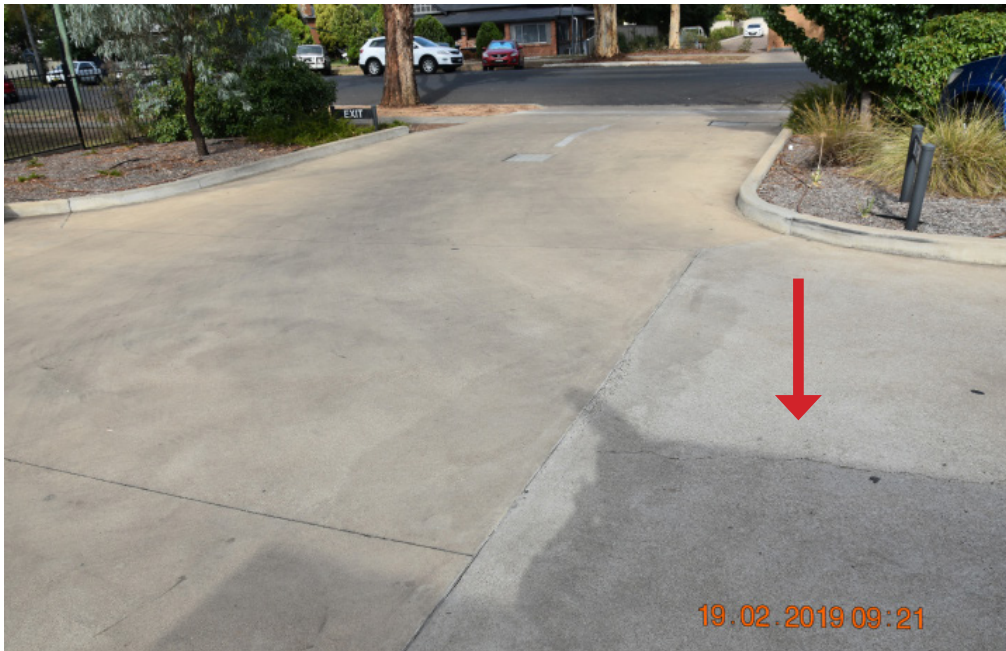
Figure: 0070

16. Cracking in the exit driveway. See photo 69, 70
17. Cracking in the paving near the southwest corner of the medical centre. See photo 71
18. Cracking in the south carpark. See photo 78-80

General view of the exit driveway. Showing cracking.

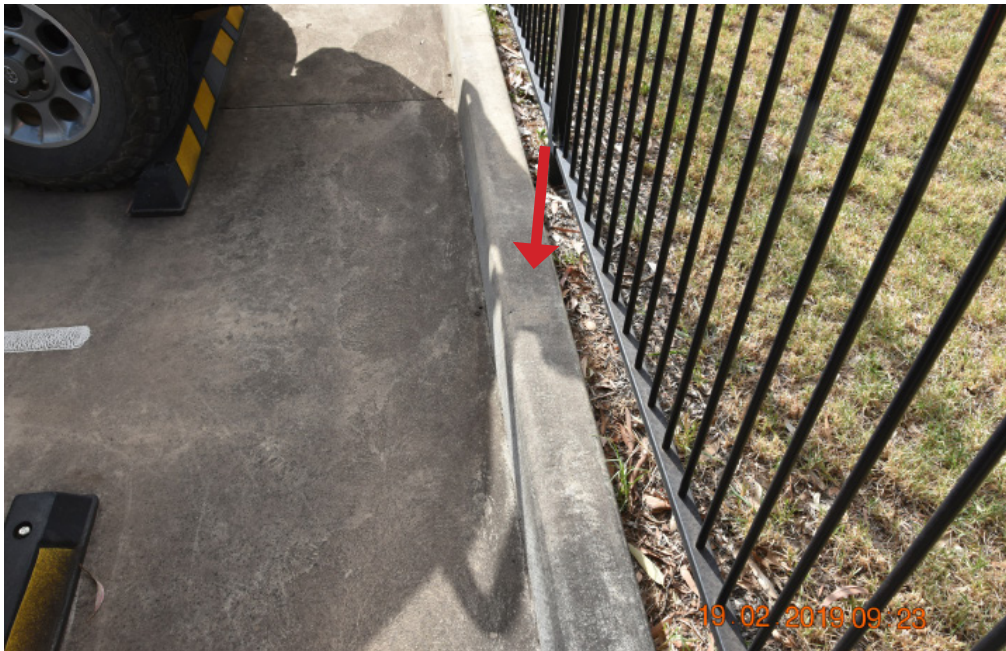
Figure: 0088

- Cracking in the kerb on the south side of the south carpark, adjacent to the west parking space. See photo 86
- Cracking in the kerb on the south side of the south carpark, adjacent to the third parking space from the west. See photo 87, 88
- Cracking in the kerb on the south side of the south carpark, adjacent to the fourth parking space from the west. See photo 89
- Cracking in the kerb on the south side of the south carpark, adjacent to the fifth parking space from the west. See photo 90

19. Cracking in the kerb on the south side of the south carpark, adjacent to the west parking space. See photo 86
20. Cracking in the kerb on the south side of the south carpark, adjacent to the third parking space from the west. See photo 87, 88

Cracking in the kerb on the south side of the south carpark, adjacent to the third parking space from the west.

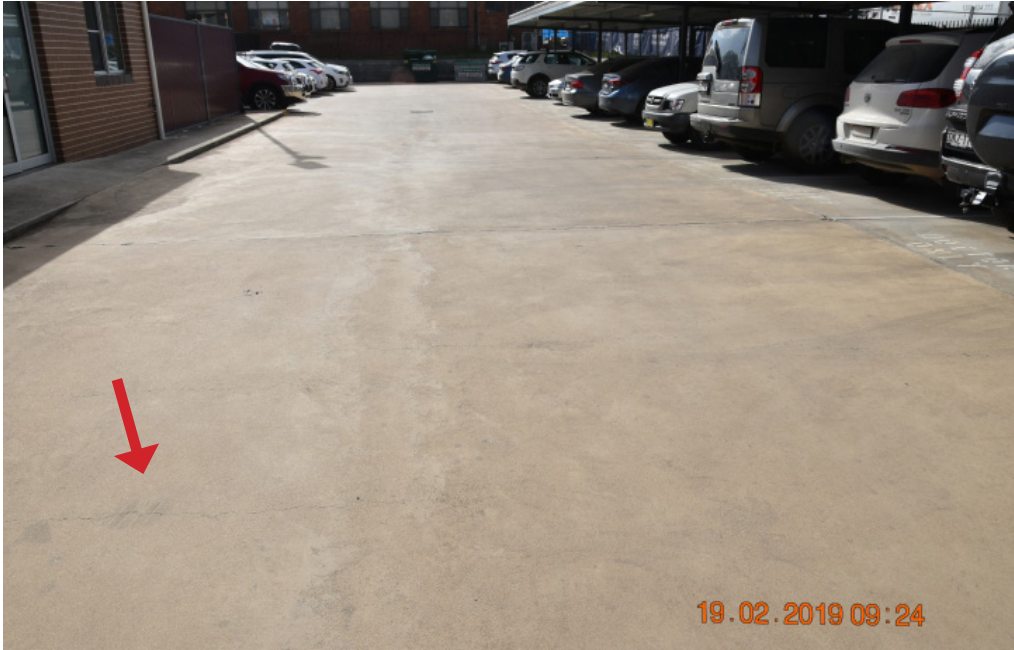
Figure: 0093

- Cracking in the south carpark. See photo 78-80
- Cracking in the south carpark, looking west. See photo 93
- Cracking in the south carpark, looking east. See photo 94

General view of the south carpark, looking west. Showing cracking.

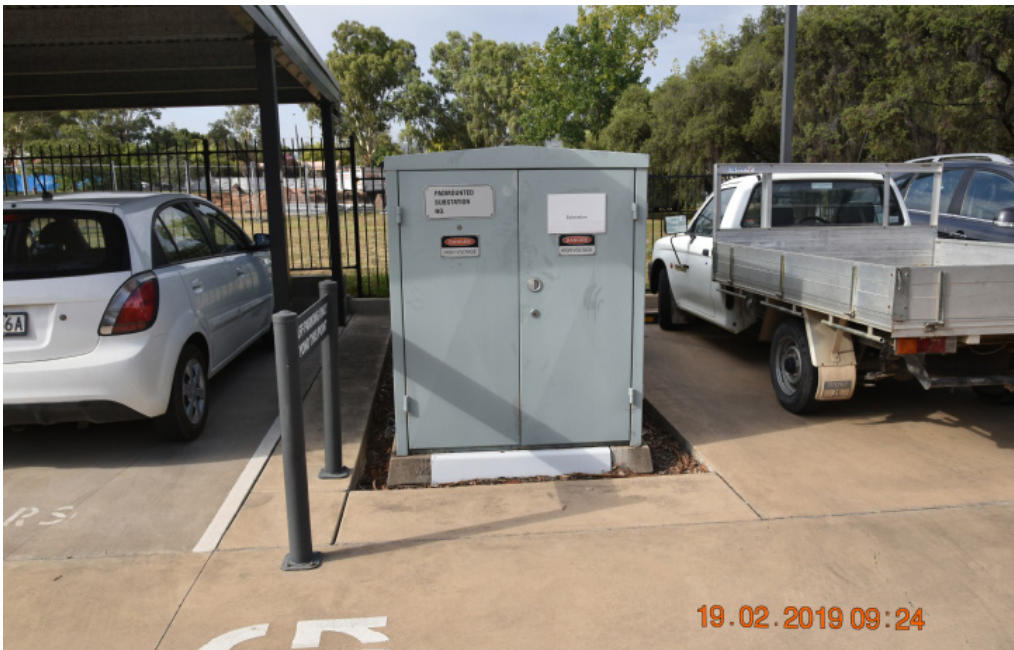
Figure: 0094

General view of the south carpark, looking east. Showing cracking.

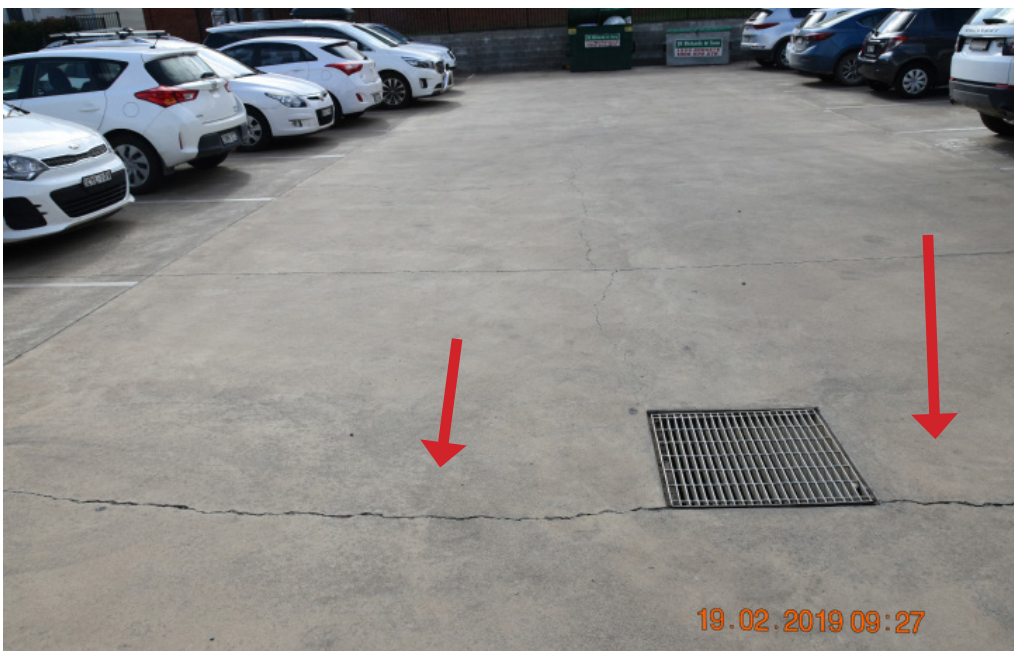
Figure: 0122

- Wide cracking in the south carpark, near the southeast corner of the medical centre. See photo 122, 123
- Cracking in the south carpark, east side. See photo 131-134

Wide cracking in the south carpark, near the southeast corner of the medical centre.

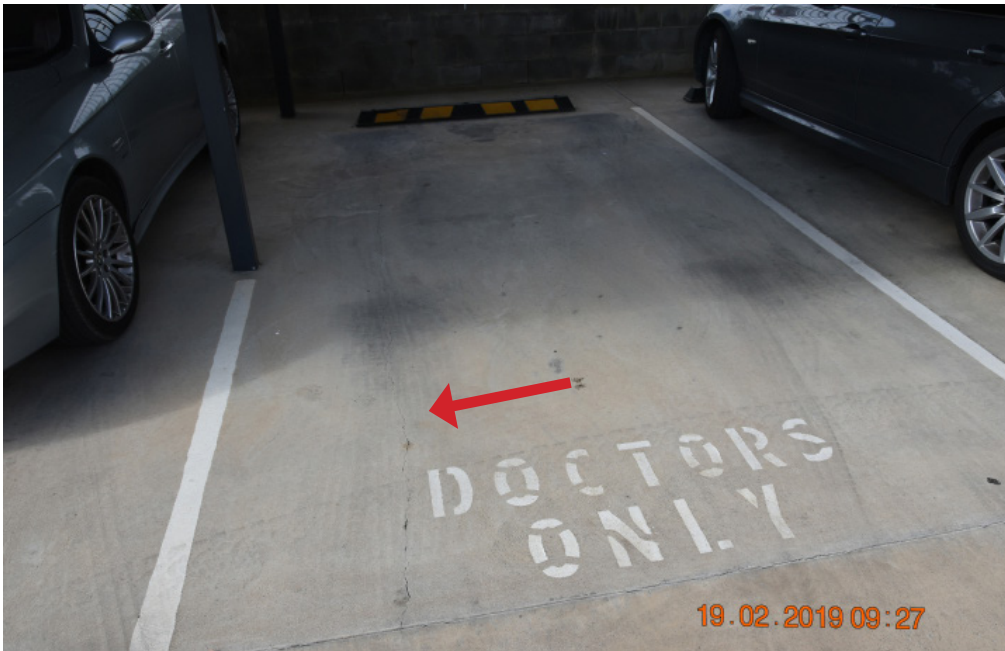
Figure: 0124

- Cracking in the south carpark, looking east from the doctors only parking spaces. See photo 111
- Cracking in the doctors only parking spaces. See photo 112, 113, 124, 125

Cracking in the doctors only parking spaces.

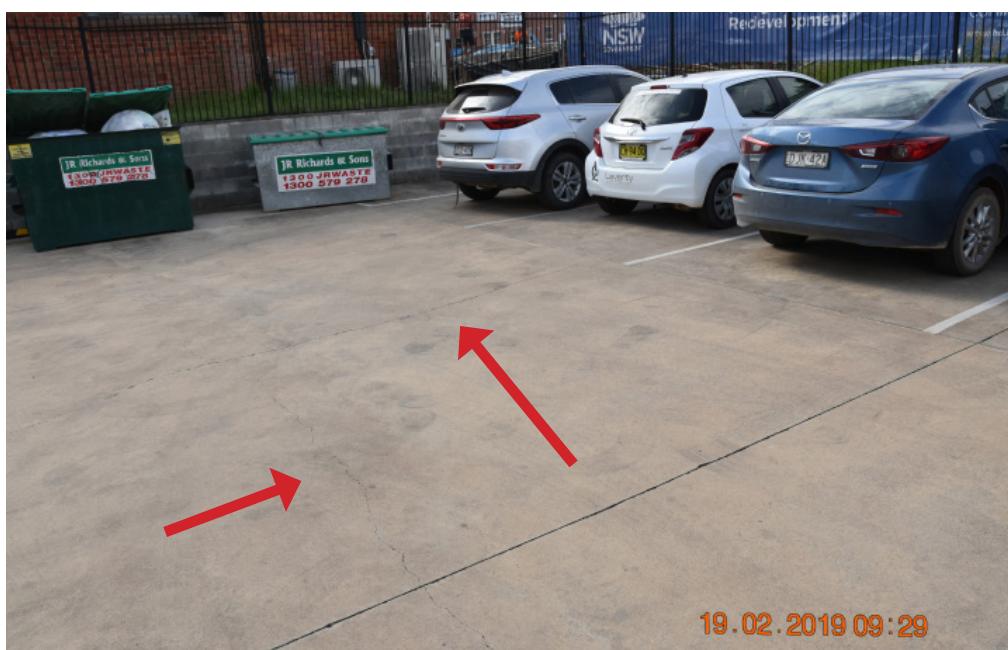
Figure: 0131

General view of the south carpark, east side. Showing cracking.

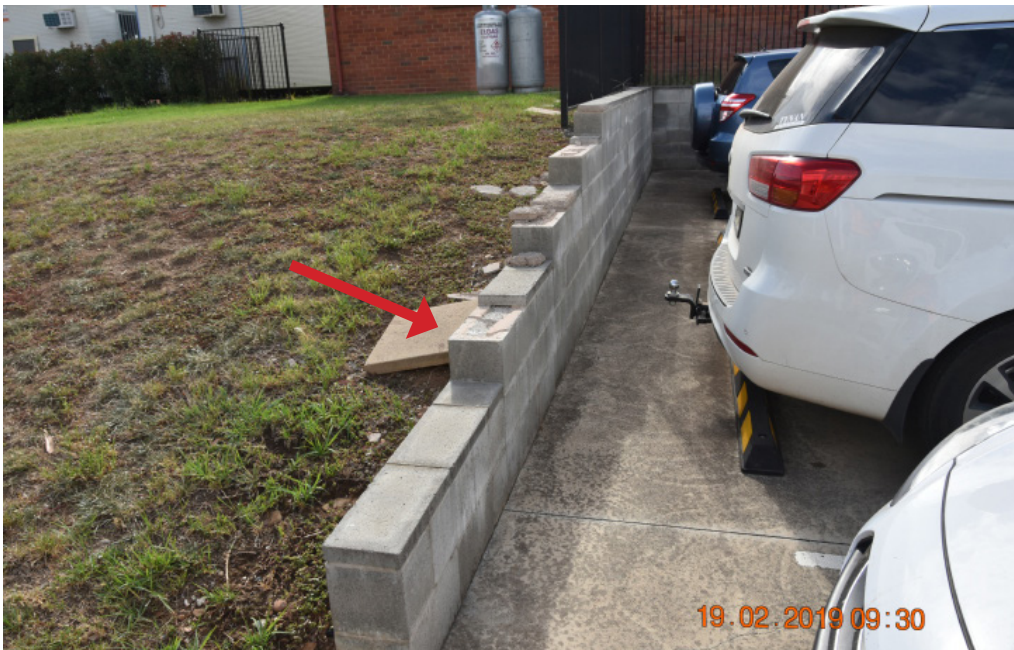
Figure: 0139

- Damage in the retaining wall on the north side of the doctors only parking spaces on the south carpark. See photo 139, 140
- Leaning in the power pole on the north side of the helipad. See photo 247, 248
- Damage in the pit lid adjacent to the south driveway to the hospital. See photo 286, 287
- Damage in the drainage pit outside the east hospital building. See photo 298, 299
- Damage in the pit lid in the pathway near the southeast corner of the helipad. See photo 305
- Missing brick in the retaining wall on the south side of the helipad. See photo 314

Retaining wall on the north side of the doctors only parking spaces on the south carpark. Showing damage.

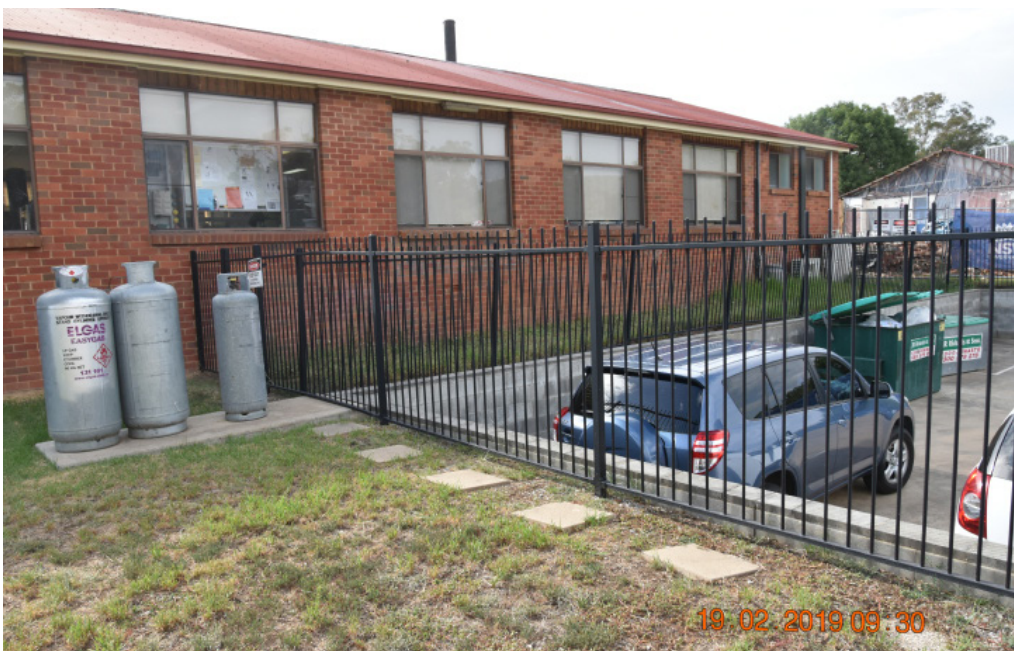
Figure: 0140

Retaining wall on the north side of the doctors only parking spaces on the south carpark. Showing damage.

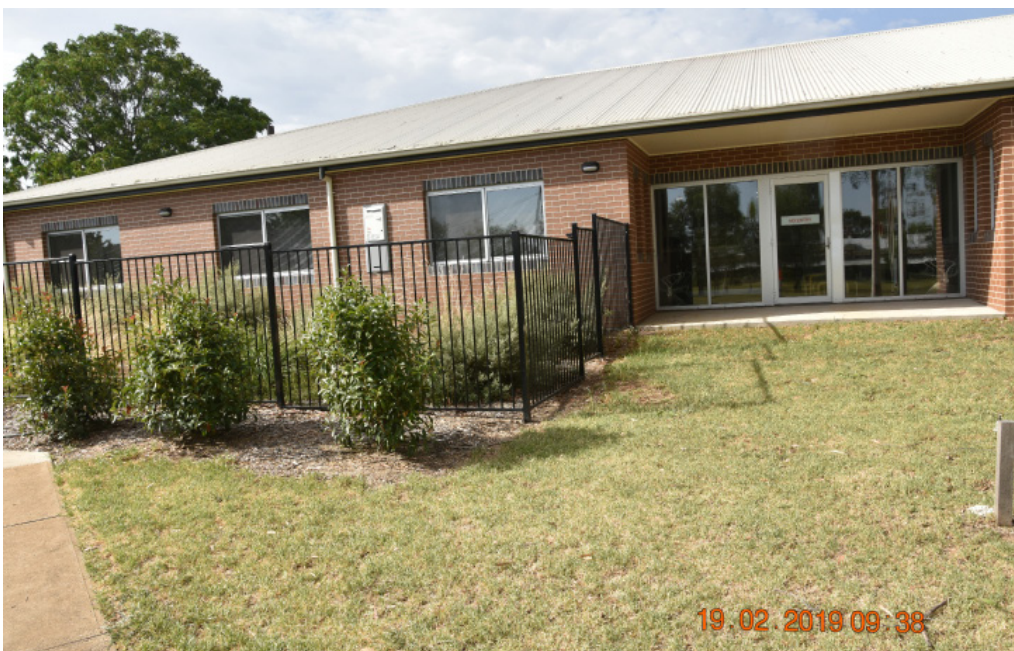
Figure: 0200

- Chipping in the paving on the east side of the medical centre, opposite the courtyard. See photo 168
- Cracking and chipping in the pathway on the north side of the medical centre, near the east corner. See photo 200

Pathway on the north side of the medical centre, near the east corner. Showing cracking and chipping.

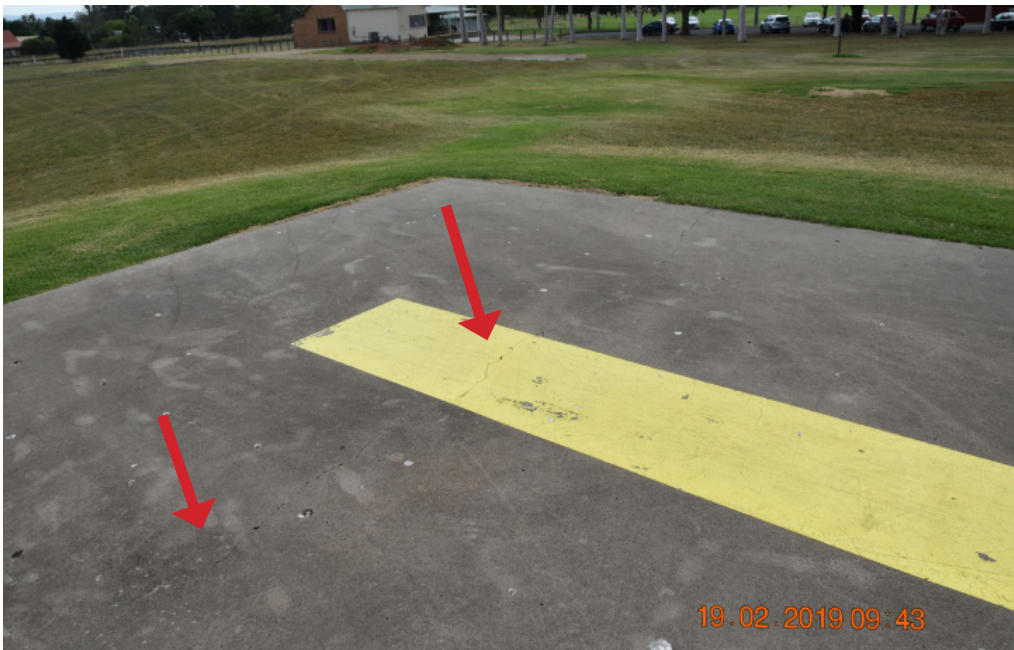
Figure: 0211

- Cracking in the helipad. See photo 211-214
- Fine cracking in the concrete slab on the north side of the helipad. See photo 226-228
- Cracking in the second concrete slab from the east on the north side of the helipad. See photo 233-235

General view of the helipad. Showing cracking.

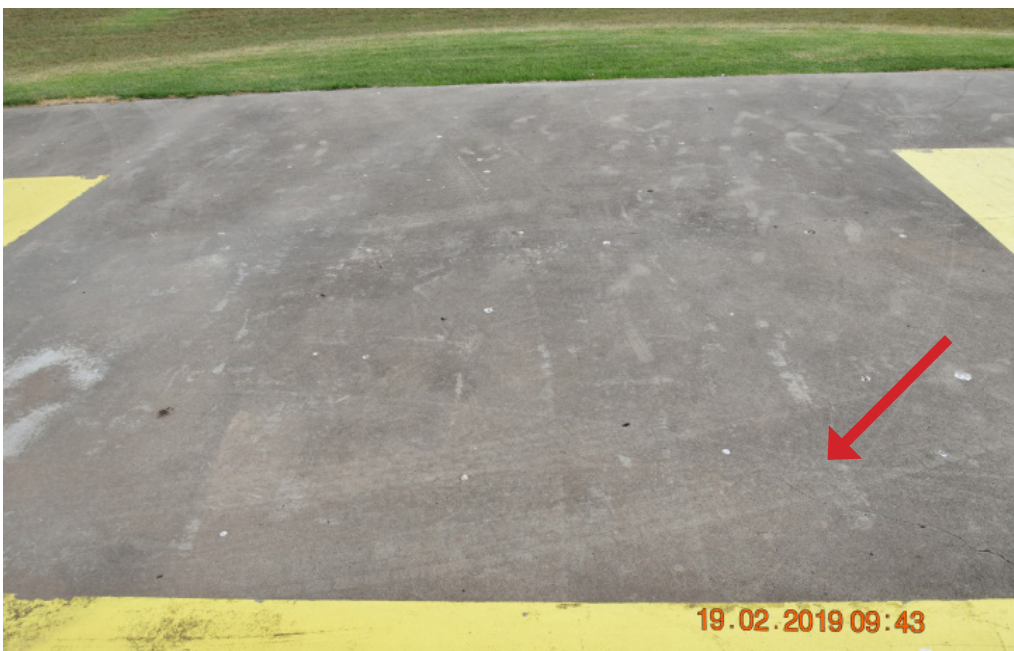
Figure: 0212

General view of the helipad. Showing cracking.

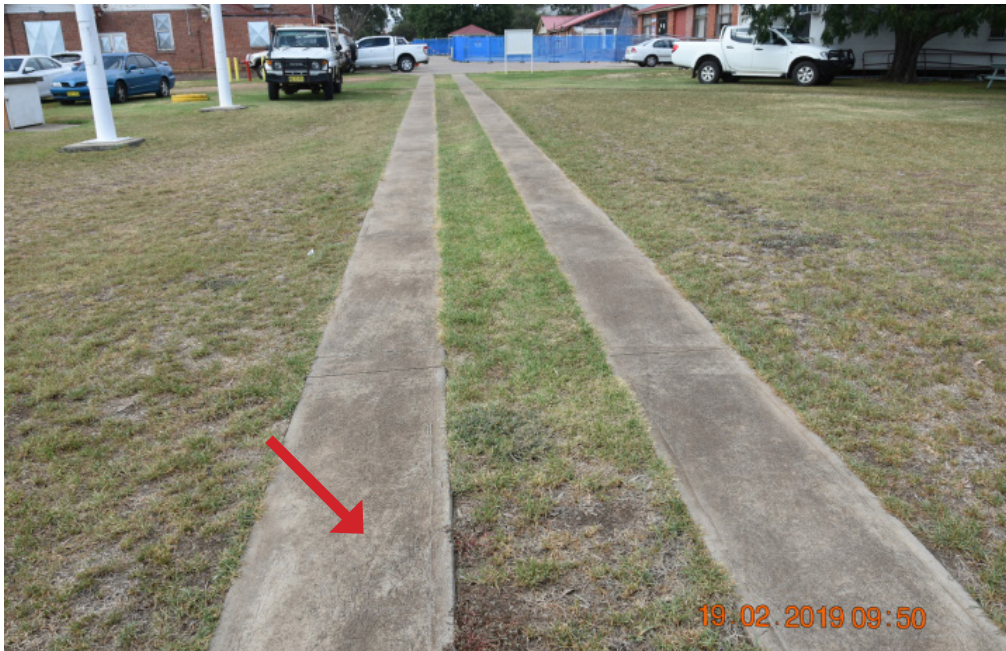
Figure: 0249

- Cracking in the paving at 30 Meares Street. See photo 249
- Chipping in the concrete slab of the fuel storage adjacent to the helipad. See photo 253
- Cracking in the paving outside the east hospital building. See photo 297

General view of the paving at 30 Meares Street. Showing cracking.

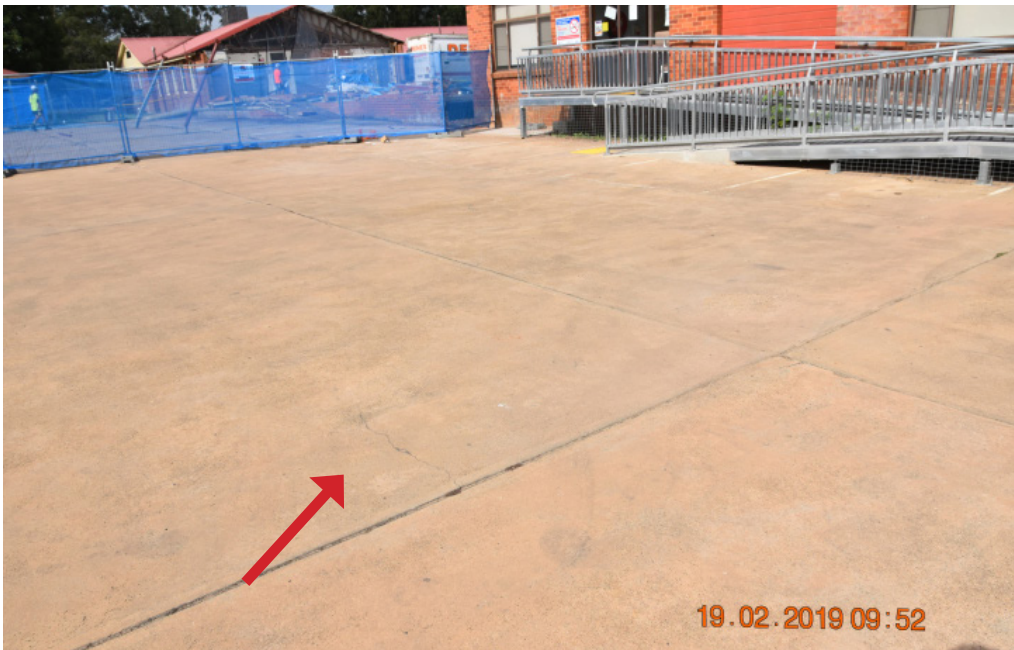
Figure: 0262

- Cracking in the carpark at the southwest corner of the helipad. See photo 262, 263, 268, 269
- Cracking in the branch carpark, adjacent to the hospital. See photo 279-284

General view of the carpark at the south-west corner of the helipad. Showing cracking.

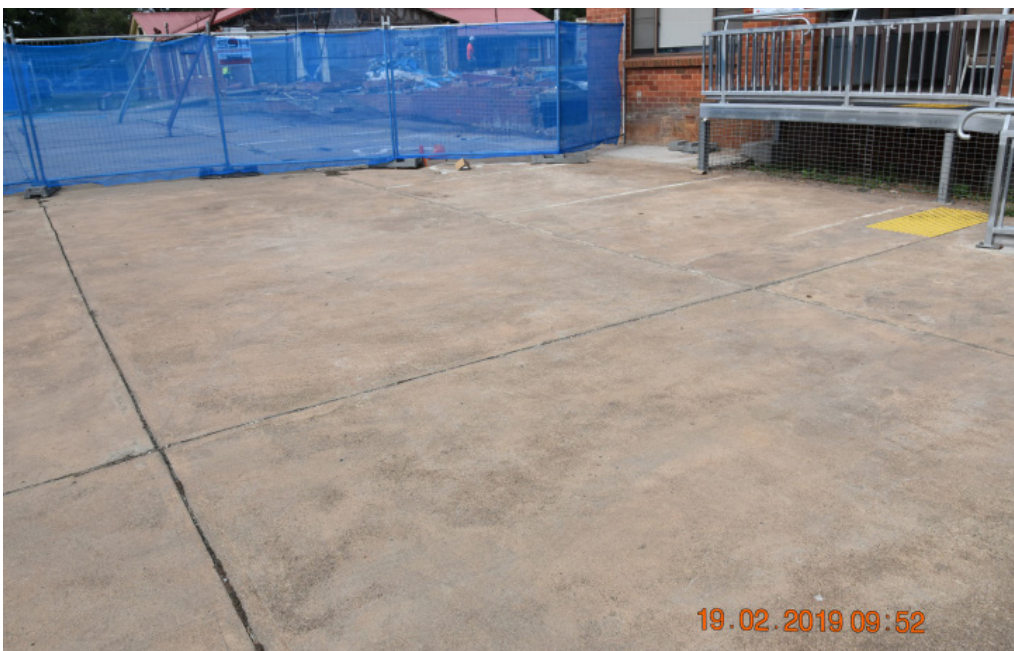
Figure: 0263

General view of the carpark at the south-west corner of the helipad. Showing cracking.

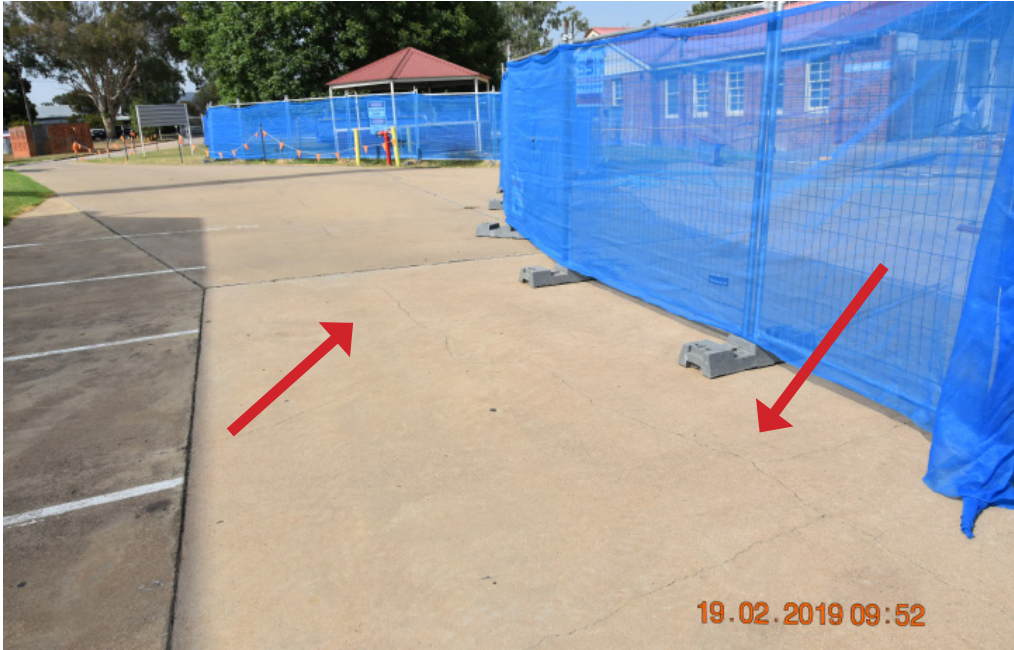
Figure: 0270

General view of the south driveway to the hospital. Showing cracking.

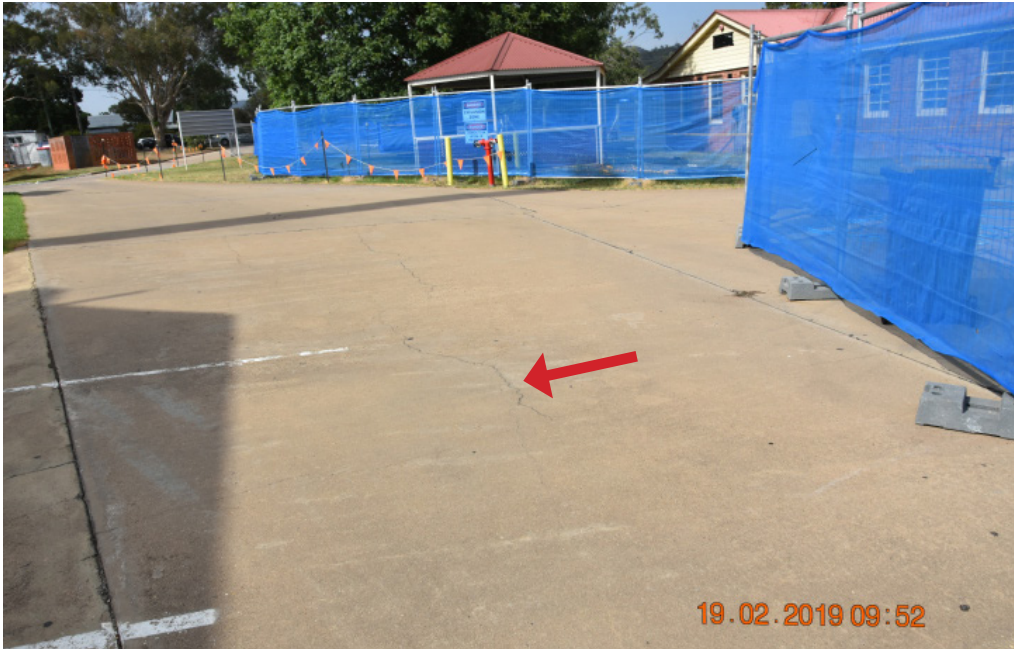
Figure: 0271

General view of the south driveway to the hospital. Showing cracking.

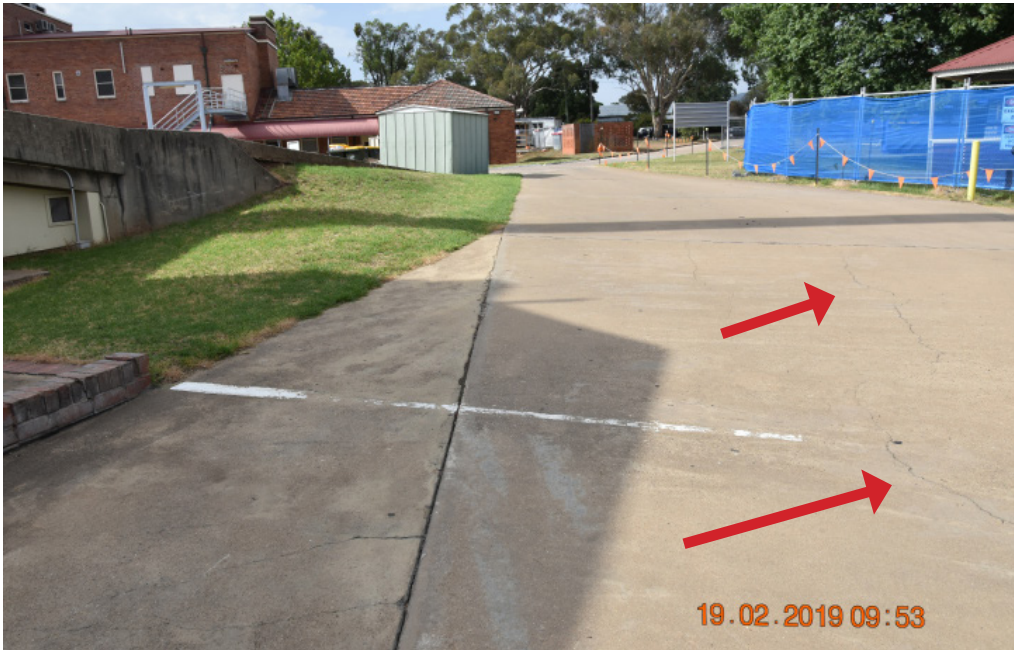
Figure: 0272

General view of the south driveway to the hospital. Showing cracking.

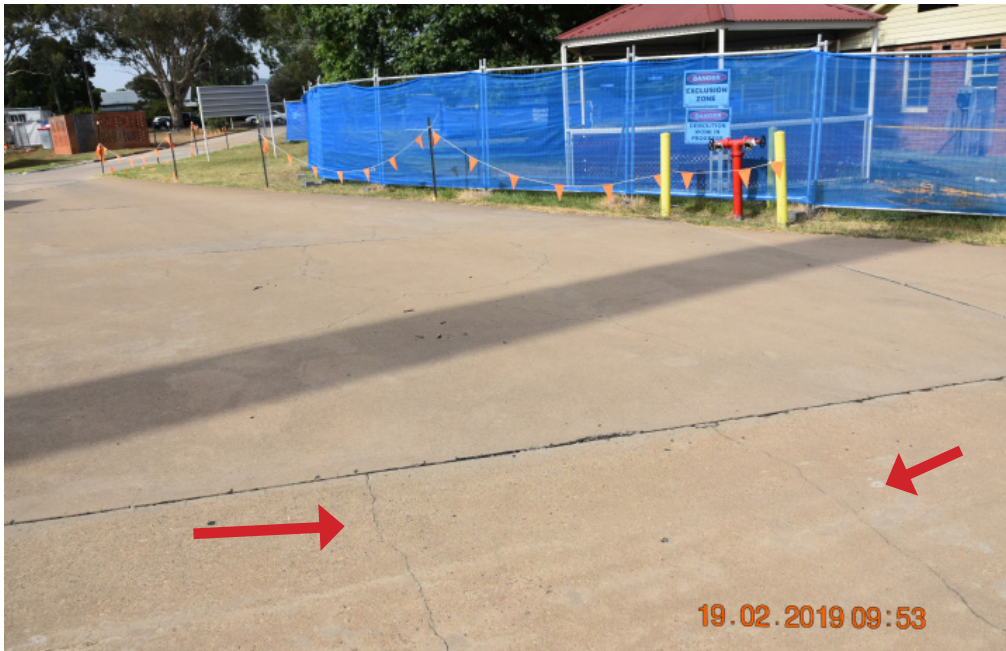
Figure: 0273

General view of the south driveway to the hospital. Showing cracking.

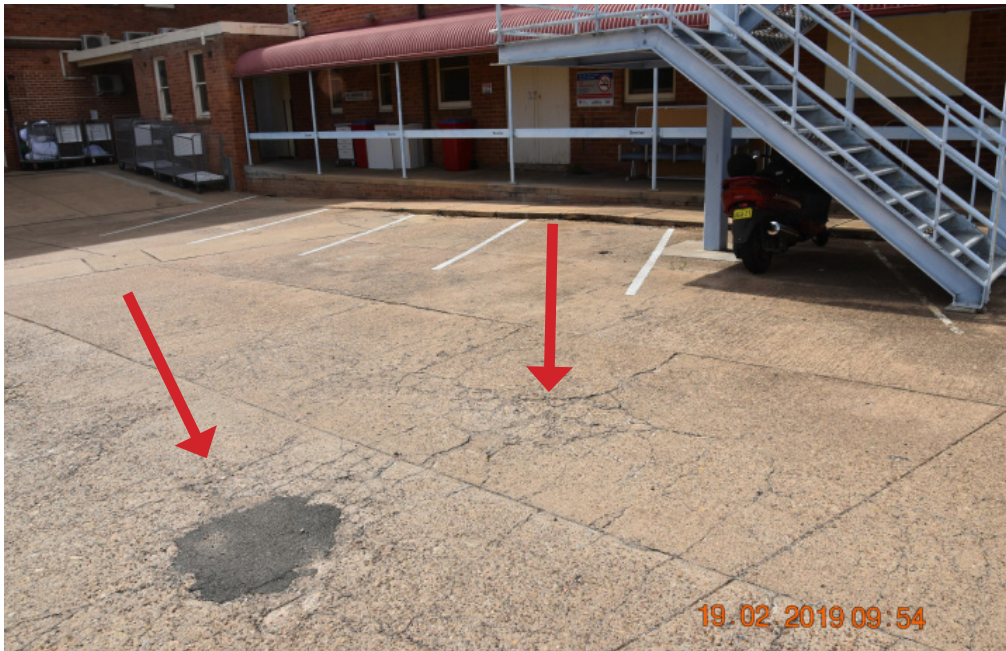
Figure: 0279

General view of the branch carpark, adjacent to the hospital. Showing cracking. Typical throughout.

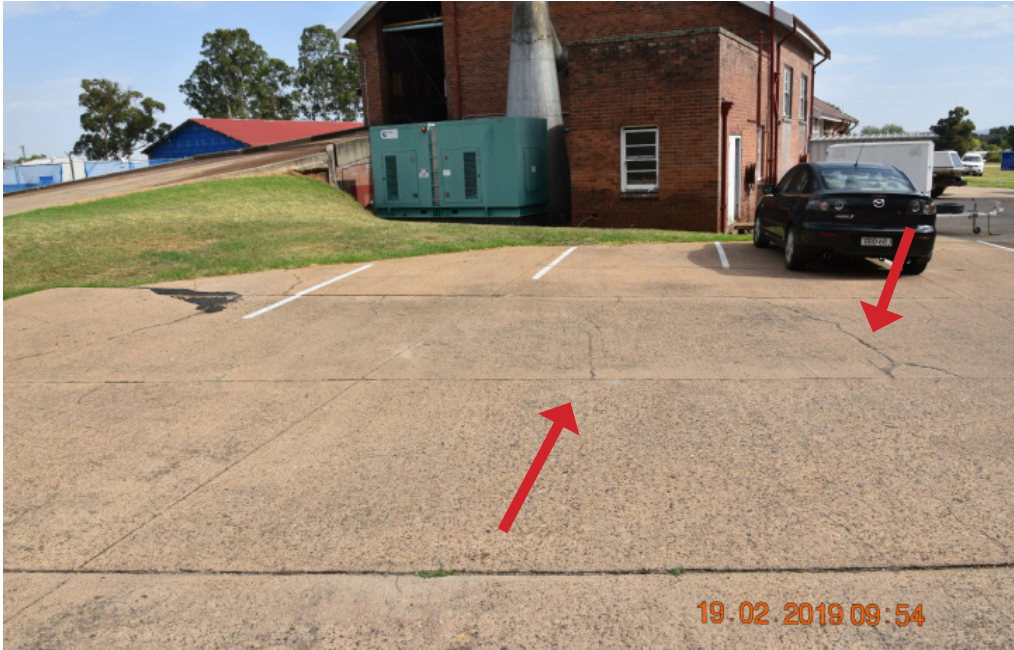
Figure: 0282

General view of the branch carpark, adjacent to the hospital. Showing cracking. Typical throughout.
