PROPERTY CONDITION SURVEY - COMMERCIAL/INDUSTRIAL

AD2696A

Mears and Church Street
MUDGEES NSW 2850

145 Church Street
MUDGEES NSW 2850

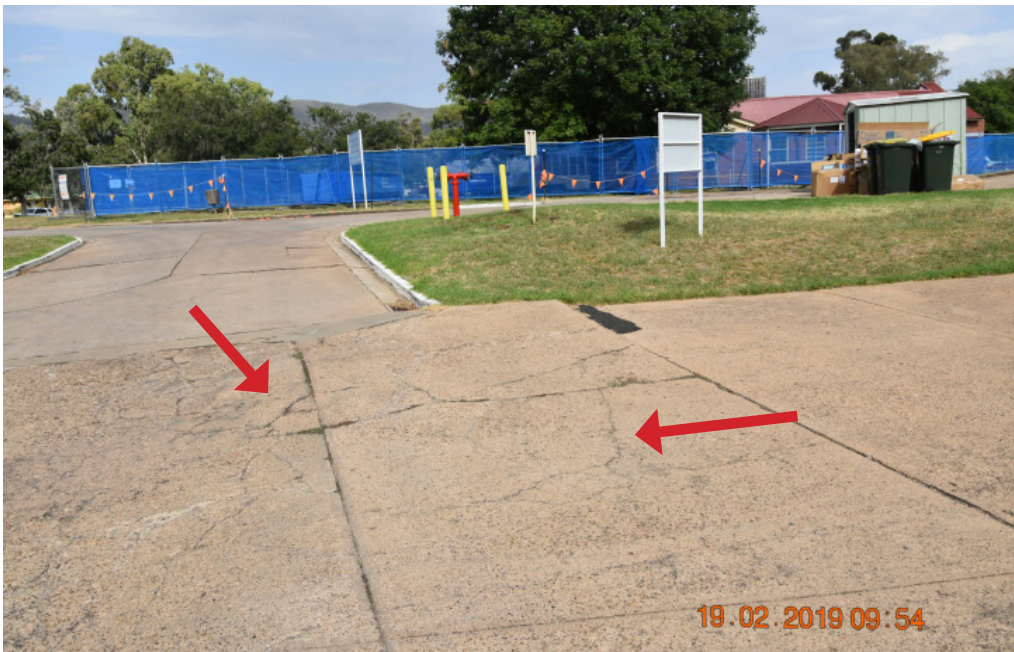
Figure: 0283

- Cracking in the carpark at the southwest corner of the helipad. See photo 262, 263, 268, 269
- Cracking in the branch carpark, adjacent to the hospital. See photo 279-284

General view of the branch carpark, adjacent to the hospital. Showing cracking. Typical throughout.

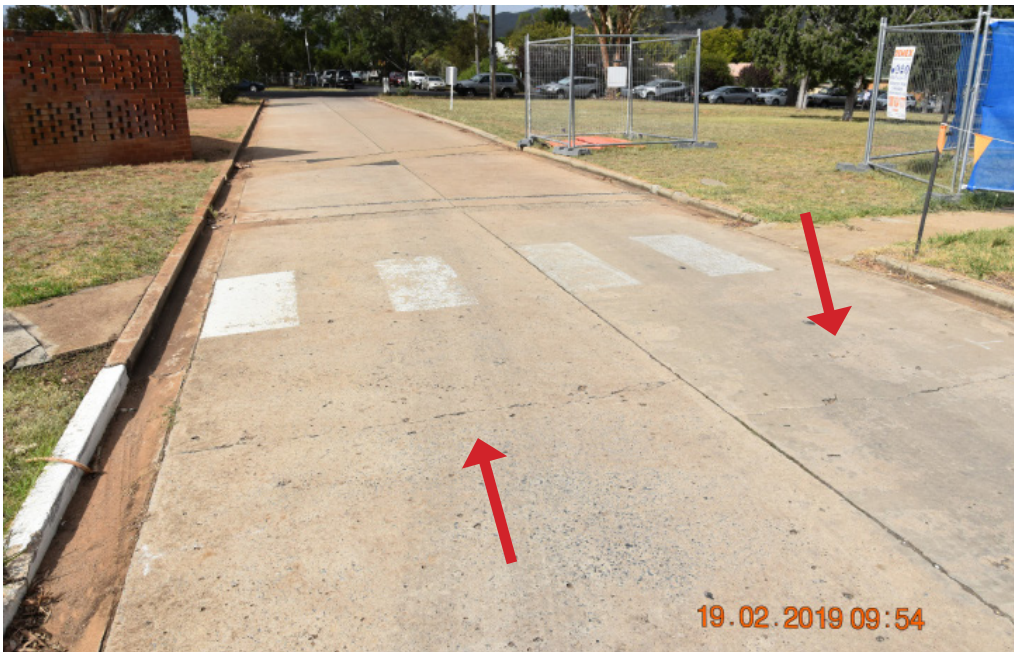
Figure: 0284

General view of the branch carpark, adjacent to the hospital. Showing cracking. Typical throughout.

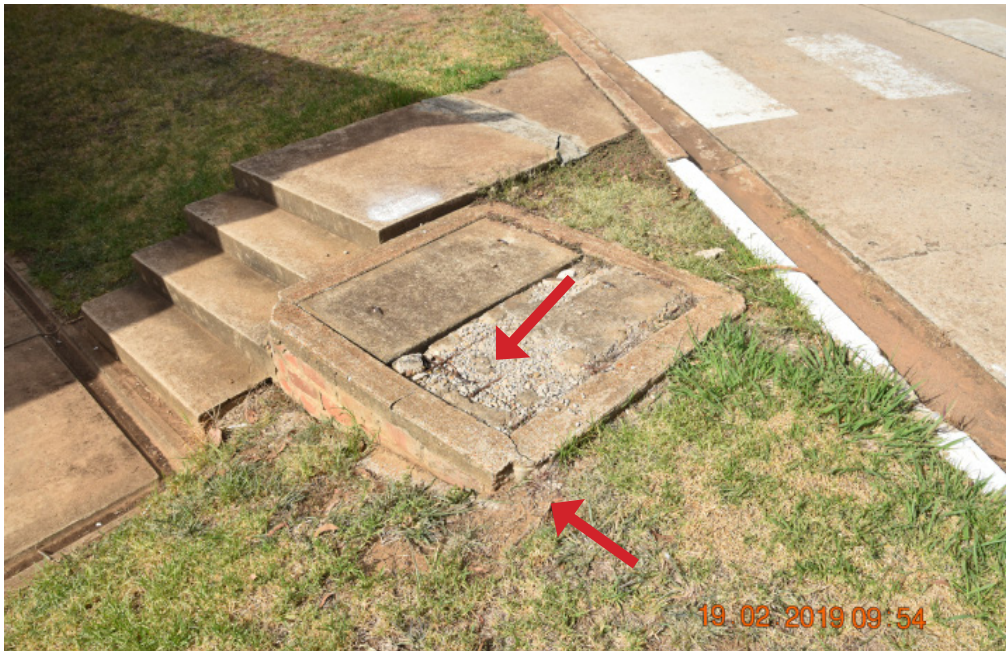
Figure: 0285

General view of the south driveway to the hospital. Showing cracking.

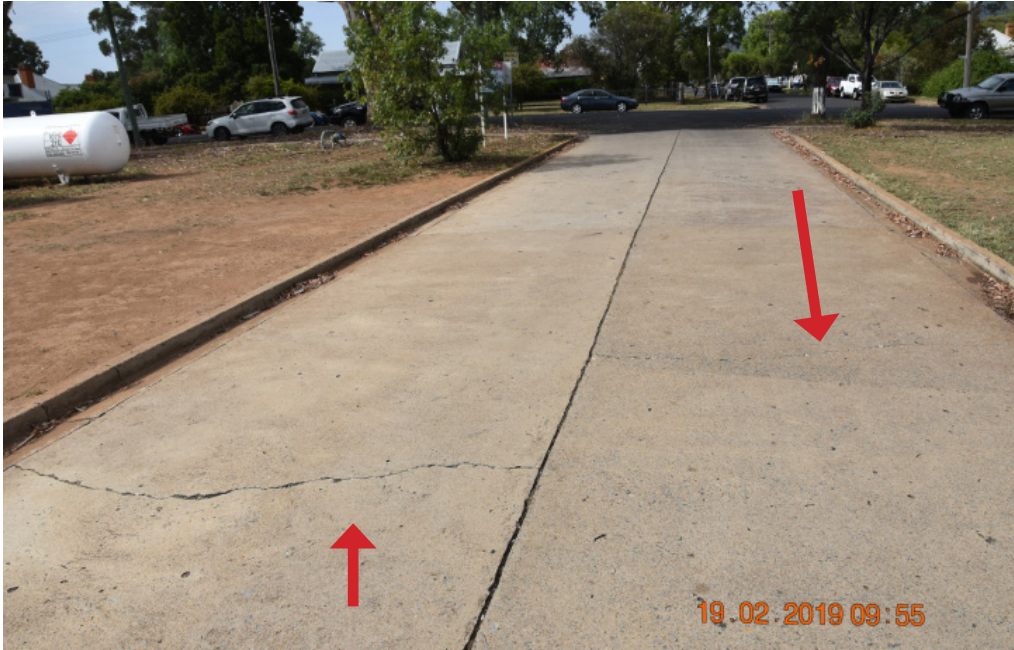
Figure: 0288

General view of the south driveway to the hospital. Showing poor condition.

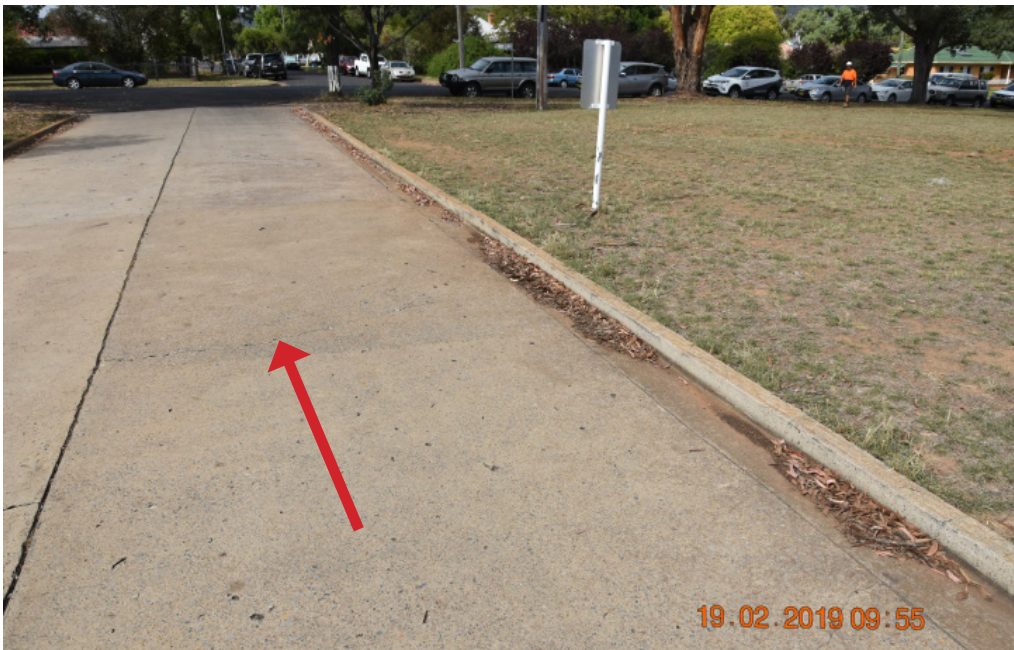
Figure: 0289

- Cracking in the entrance driveway to the medical centre. See photo 3-5, 8-10
- Cracking in the exit driveway. See photo 69, 70
- Chipping in the exit driveway. See photo 175
- Chipping in the crossover and cracking in the exit driveway. See photo 176
- Cracking in the driveway to 30 Meares Street. See photo 250
- Cracking in the south driveway to the hospital. See photo 270-276, 285
- Cracking the south driveway to the hospital, looking north. See photo 278, 291, 292
- Poor condition in the south driveway to the hospital. See photo 288
- Cracking the south driveway to the hospital, looking north. See photo 289, 290

General view of the south driveway to the hospital, looking south. Showing cracking.

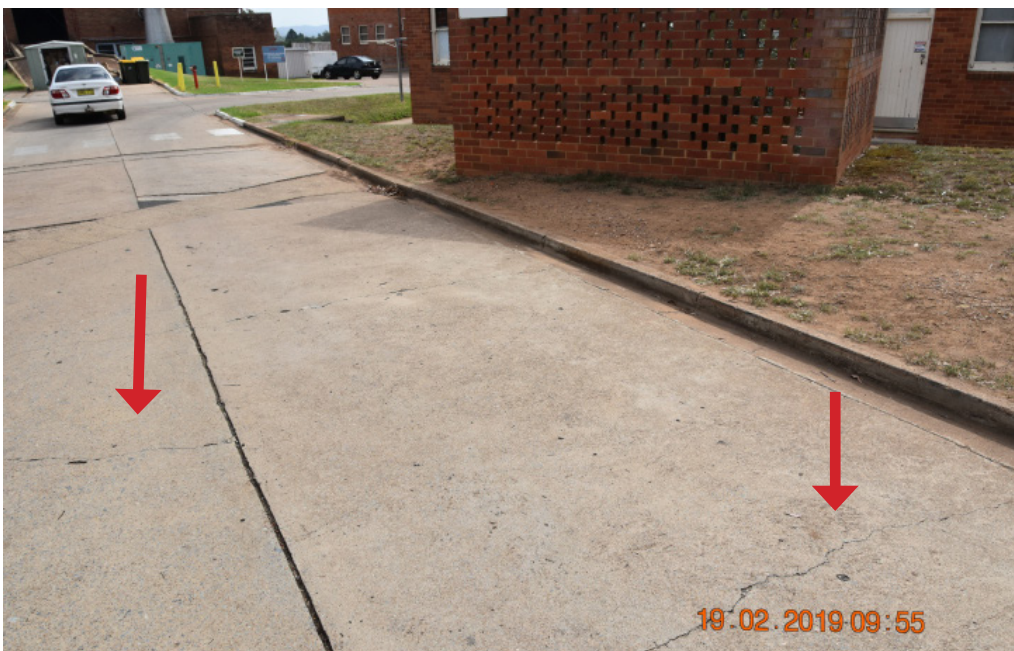
Figure: 0290

General view of the south driveway to the hospital, looking south. Showing cracking.

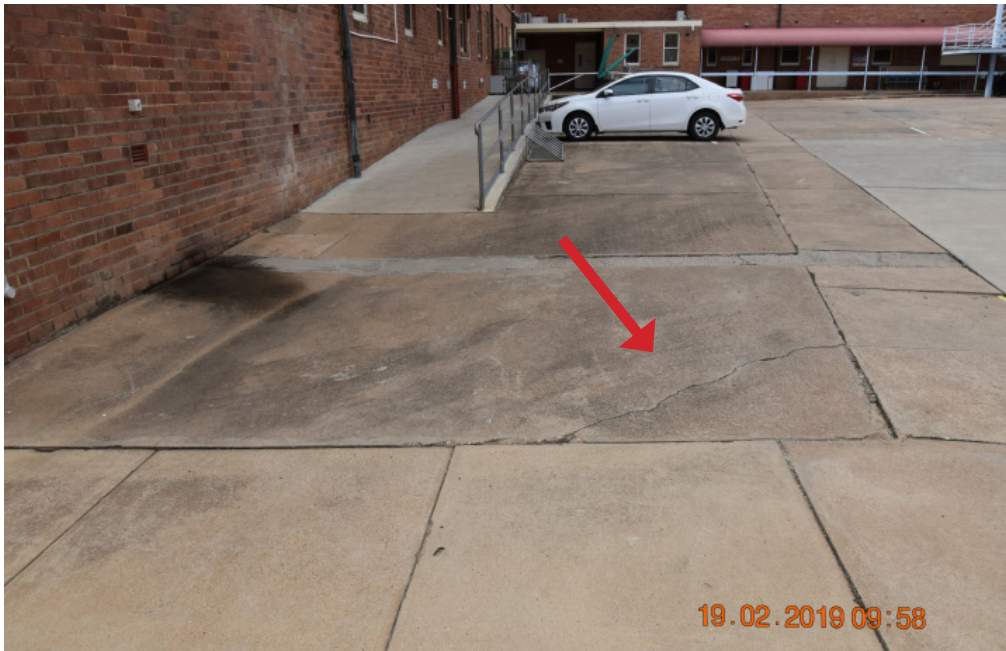
Figure: 0300

- Cracking in the carpark outside the oral health building. See photo 300-302

General view of the carpark outside the oral health building. Showing cracking.

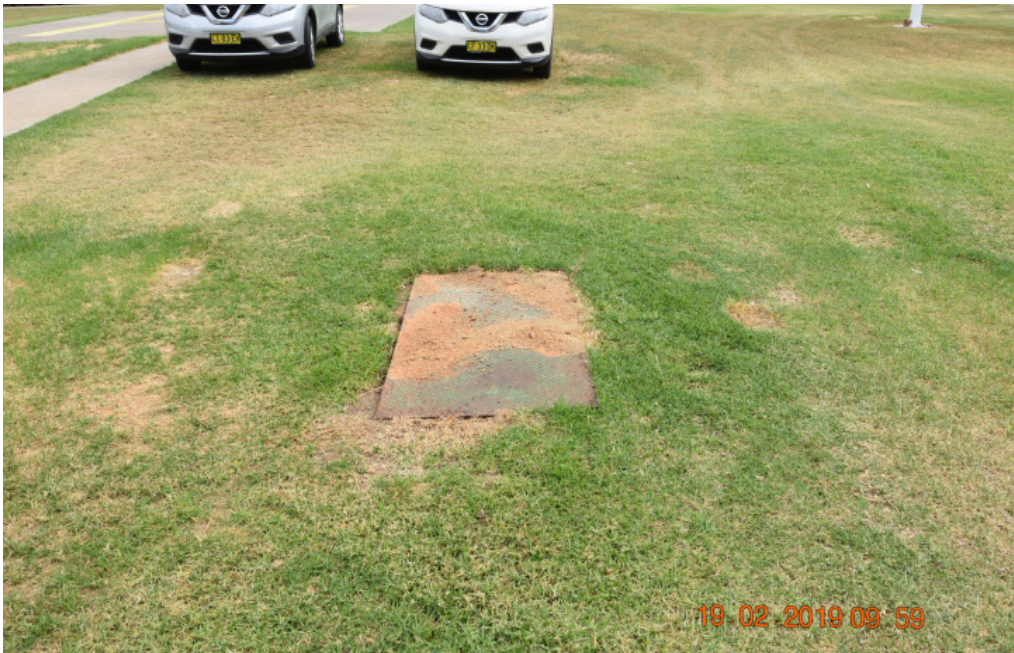
Figure: 0309

- Cracking in the pathway near the southeast corner of the helipad. See photo 303, 304, 307-309, 311, 312

General view of the pathway near the southeast corner of the helipad. Showing cracking.

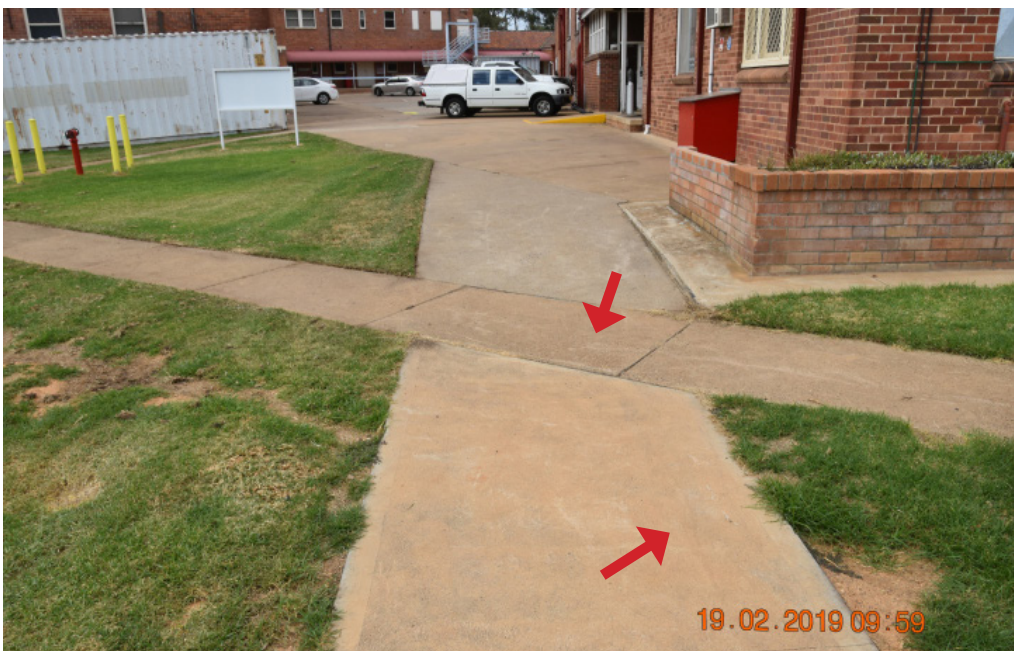
Figure: 0311

General view of the pathway near the southeast corner of the helipad. Showing cracking.

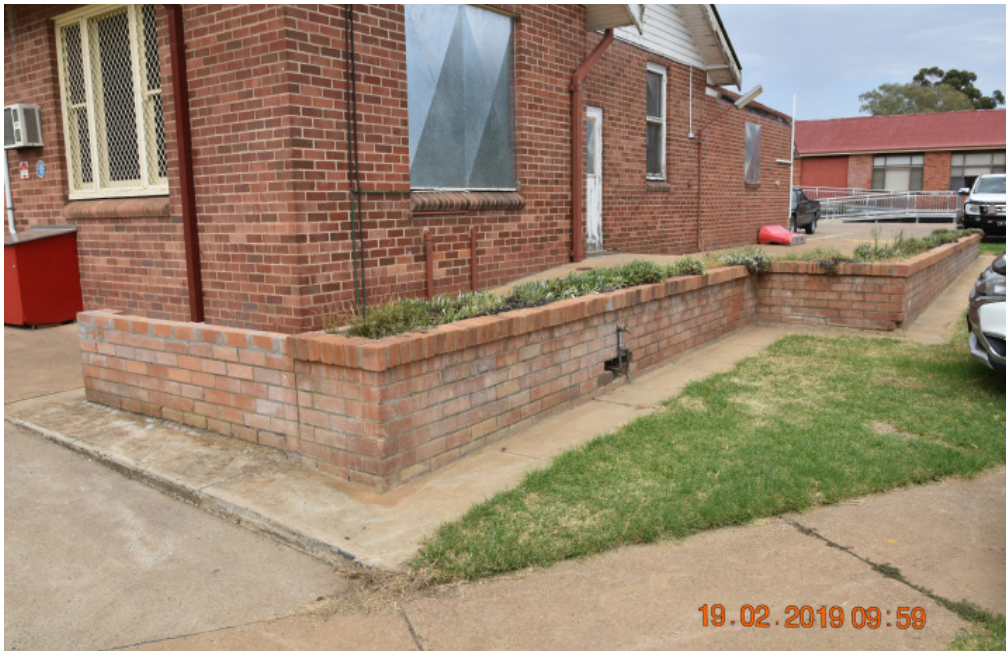
Figure: 0312

General view of the pathway near the southeast corner of the helipad. Showing cracking.
