Council Assets Surrounding Hornsby Hospital

Dilapidation Report
80818469

Prepared for	Watpac Construction Pty Ltd
Project Name	Dilapidation Report
File Reference	Dilapidation Report - Hornsby Hospital Council Assets-2018-06-28.docx
Job Reference	80818469
Date	June 2018

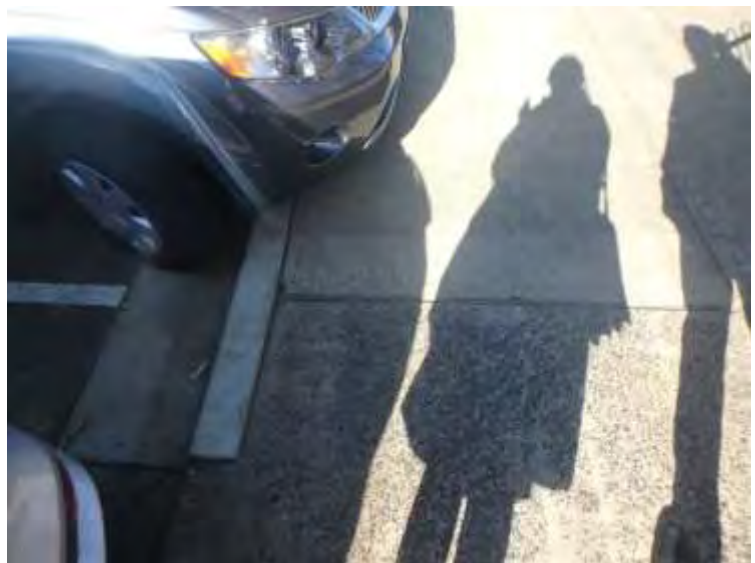
Defect ID 014
Area Type External
Location Derby Road, Hornsby
Element Road
Defect Type Cracking
Length (mm) Approx. 15,000mm
Width (mm) Approx. 1mm
General Comments:
 Cracking to asphalt road around the previous repair

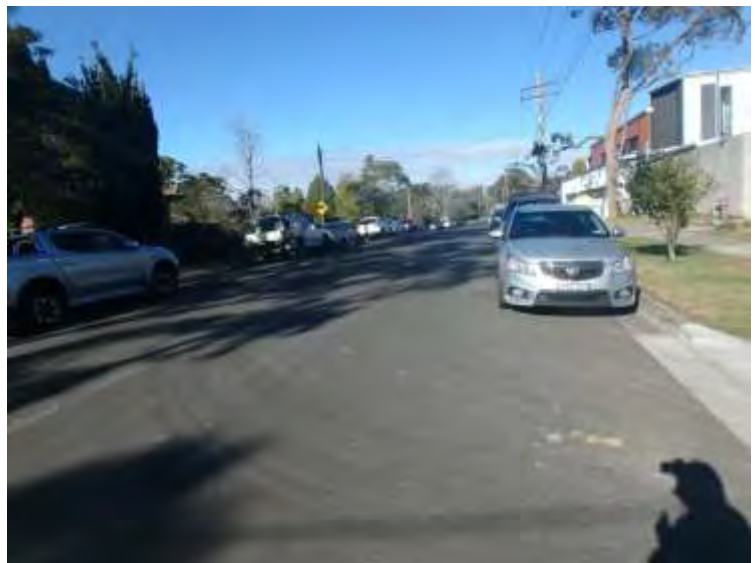
Defect ID 017
Area Type External
Location Derby Road, Hornsby
Element General Shot
Defect Type N/A
Length (mm) N/A
Width (mm) N/A

General Comments:
 General shot to Derby Road, in a southerly direction.

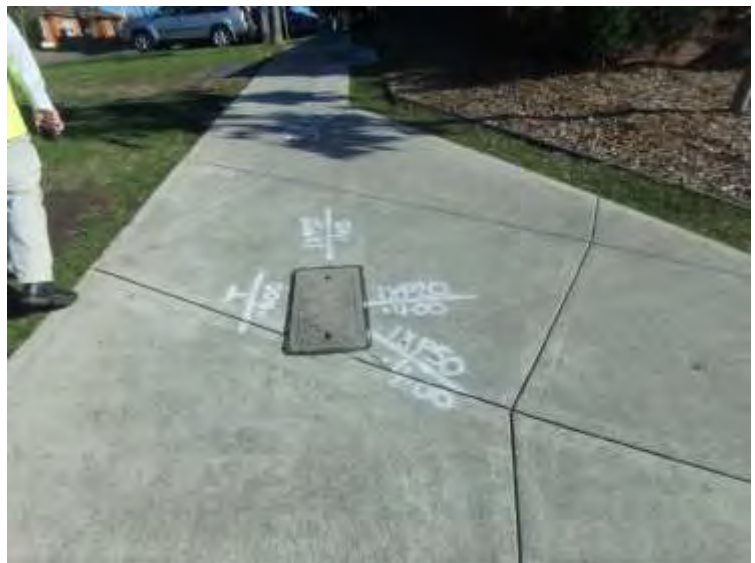
Defect ID 023
Area Type External
Location Burdett Street, Hornsby
Element Footpath
Defect Type Cracking
Length (mm) Approx. 500mm
Width (mm) Varying
General Comments:
 Cracking to pit surround

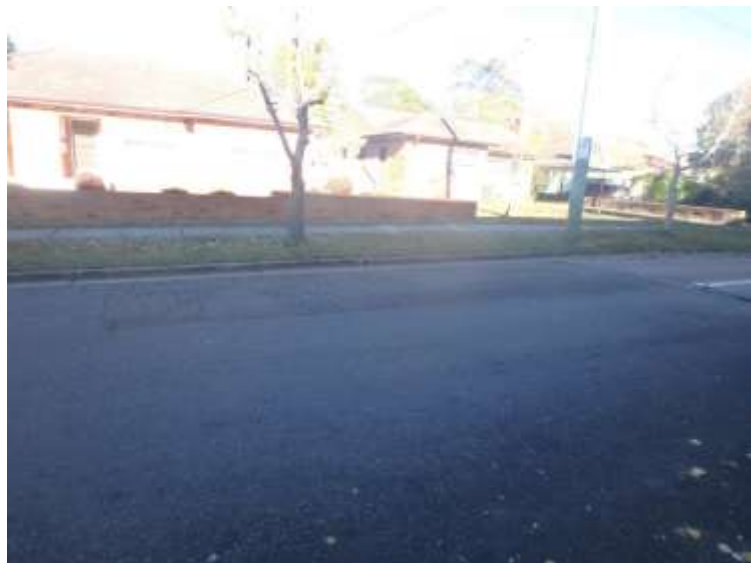
Defect ID 026
Area Type External
Location Burdett Street, Hornsby
Element Road
Defect Type Cracking
Length (mm) N/A
Width (mm) Varying
General Comments:
 Multiple cracking to asphalt road

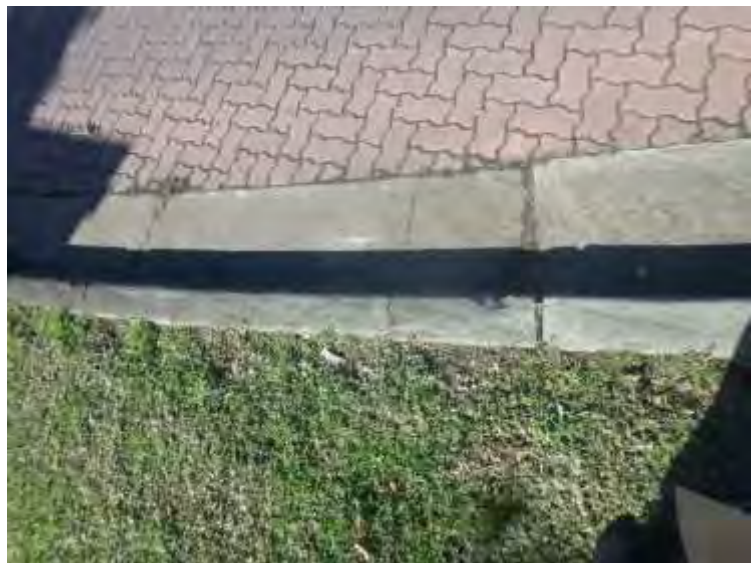
Defect ID 029
Area Type External
Location Burdett Street, Hornsby
Element Kerb
Defect Type Cracking
Length (mm) Approx. 150mm
Width (mm) Approx. 1mm
General Comments:
 Cracking to concrete kerb

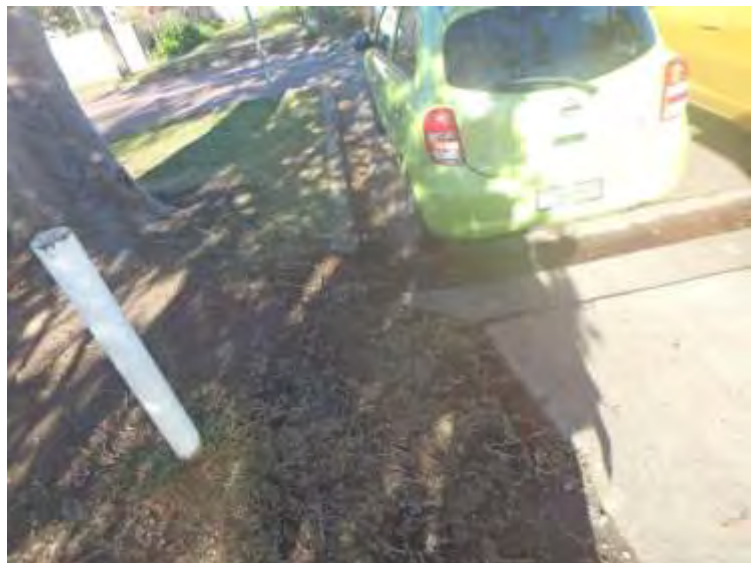
Defect ID 032
Area Type External
Location Burdett Street, Hornsby
Element Kerb
Defect Type Missing
Length (mm) Approx. 500mm
Width (mm) Approx. 150mm
General Comments:
 Missing section of concrete kerb

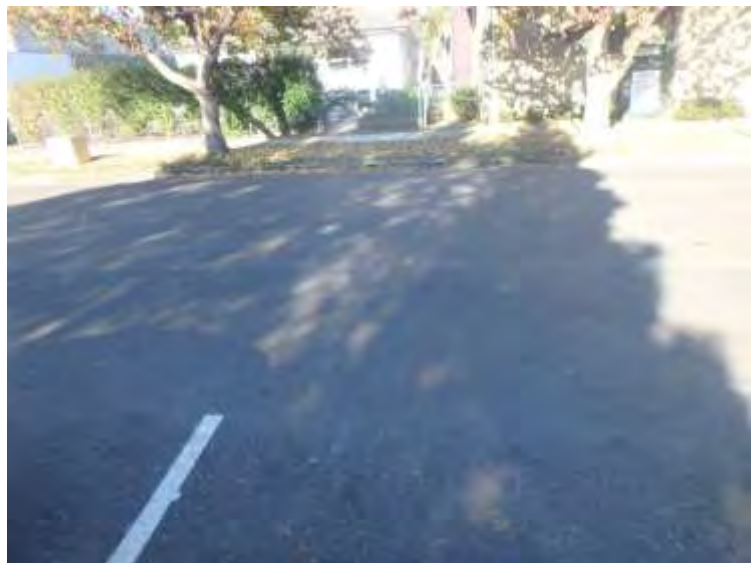
Defect ID 035
Area Type External
Location Burdett Street, Hornsby
Element Road
Defect Type Cracking
Length (mm) N/A
Width (mm) Approx. 2mm
General Comments:
 Multiple cracking to asphalt road

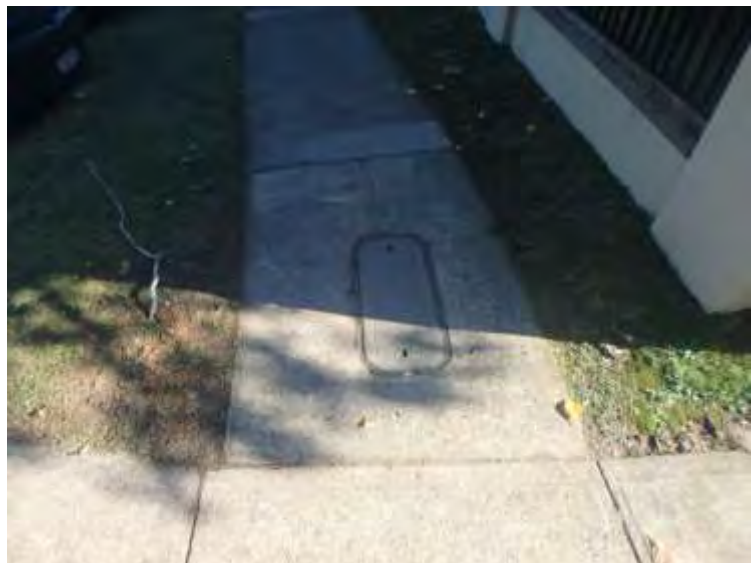
Defect ID 038
Area Type External
Location Burdett Street, Hornsby
Element Footpath
Defect Type Cracking
Length (mm) Approx. 500mm
Width (mm) Approx. 2mm
General Comments:
 Cracking to concrete footpath surround pit

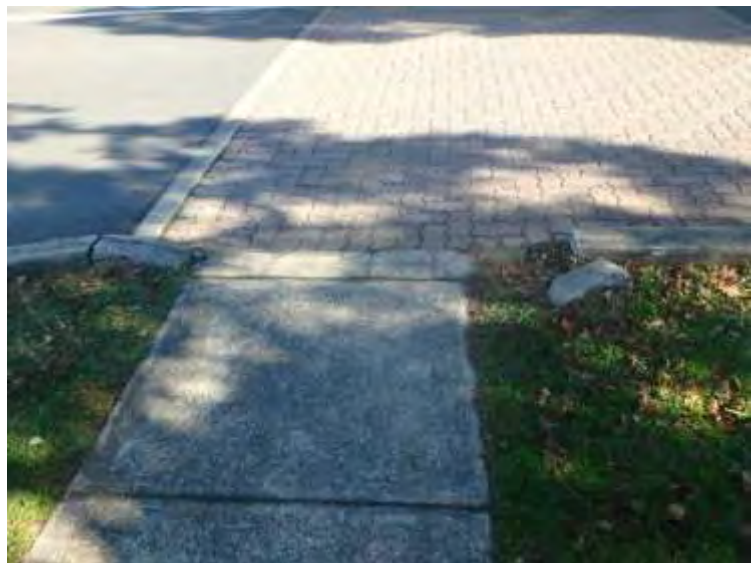
Defect ID 041
Area Type External
Location Palmerston Road, Hornsby
Element Kerb
Defect Type Cracking
Length (mm) 150mm each
Width (mm) Approx. 1mm
General Comments:
 Multiple cracking to concrete kerb

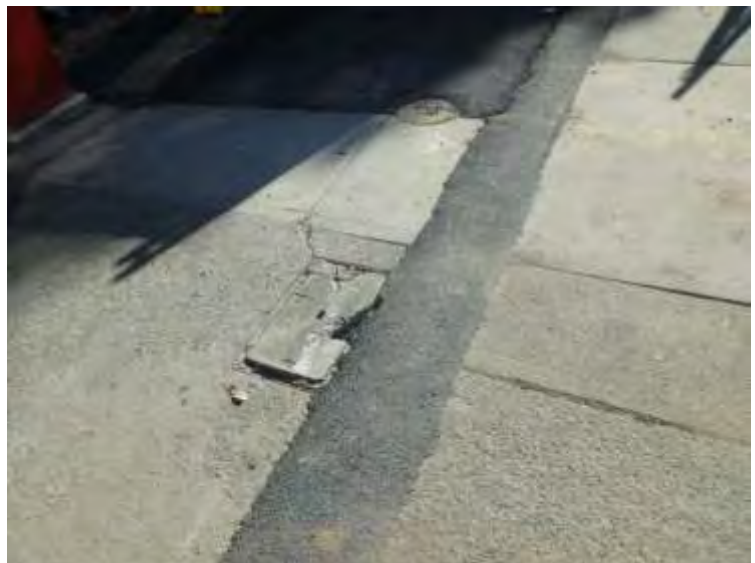
Defect ID 053
Area Type External
Location Palmerston Road, Hornsby
Element Footpath
Defect Type Cracking
Length (mm) N/A
Width (mm) Varying
General Comments:
 Cracking to concrete footpath surround pit, damaged pit

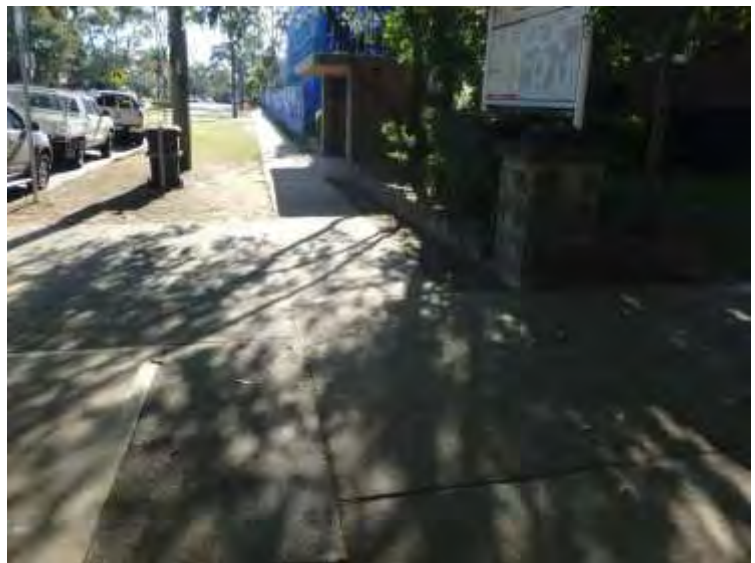
Defect ID 056
Area Type External
Location Palmerston Road, Hornsby
Element Driveway
Defect Type Cracking
Length (mm) Approx. 1,000mm
Width (mm) Approx. 3mm
General Comments:
 Cracking to concrete driveway

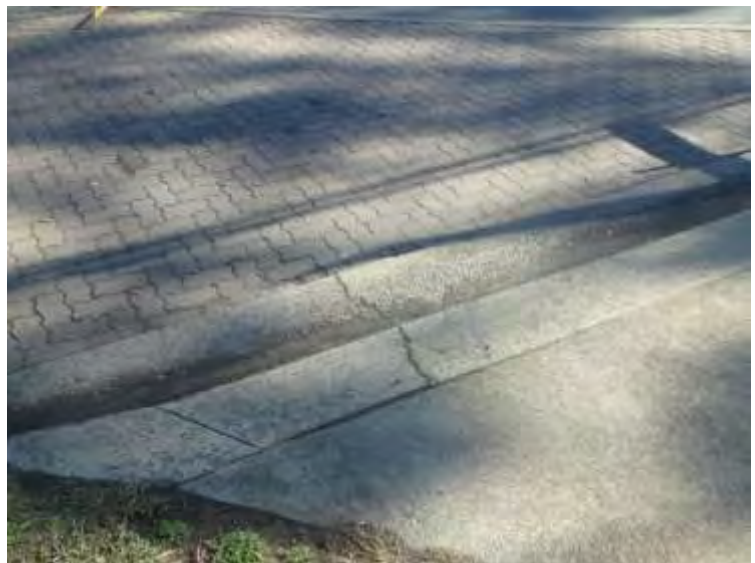
Defect ID 062
Area Type External
Location Palmerston Road, Hornsby
Element Driveway
Defect Type Cracking
Length (mm) Approx. 300mm
Width (mm) Approx. 2mm
General Comments:
 Cracking to concrete driveway

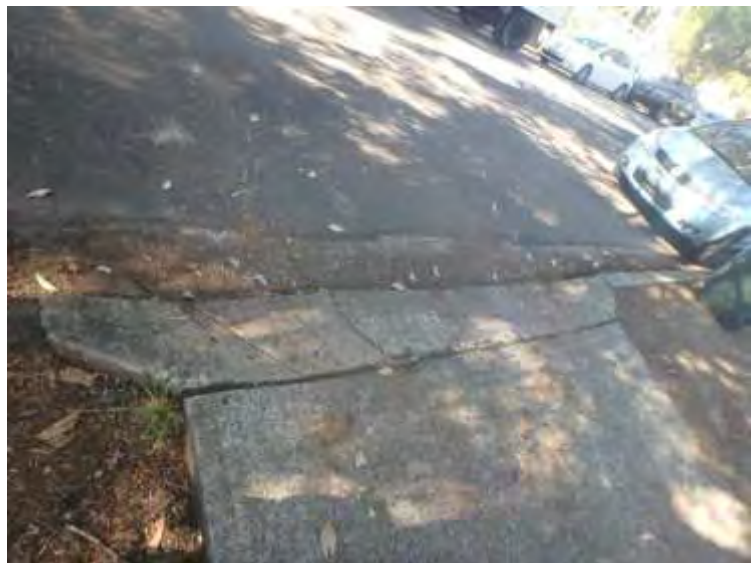
Defect ID 068
Area Type External
Location Palmerston Road, Hornsby
Element Driveway
Defect Type Cracking
Length (mm) N/A
Width (mm) Varying
General Comments:
 Cracking to concrete driveway

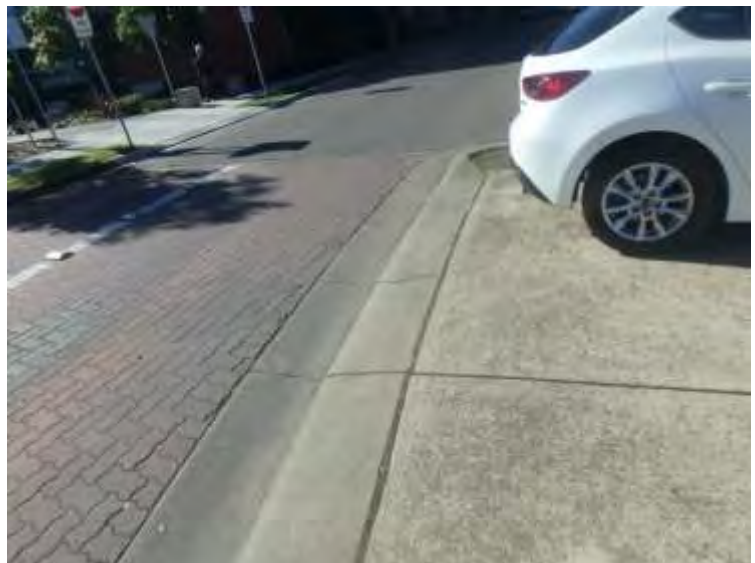
Defect ID 071
Area Type External
Location Palmerston Road, Hornsby
Element Driveway
Defect Type Cracking
Length (mm) Approx. 1,000mm
Width (mm) Approx. 2mm
General Comments:
 Cracking to concrete driveway

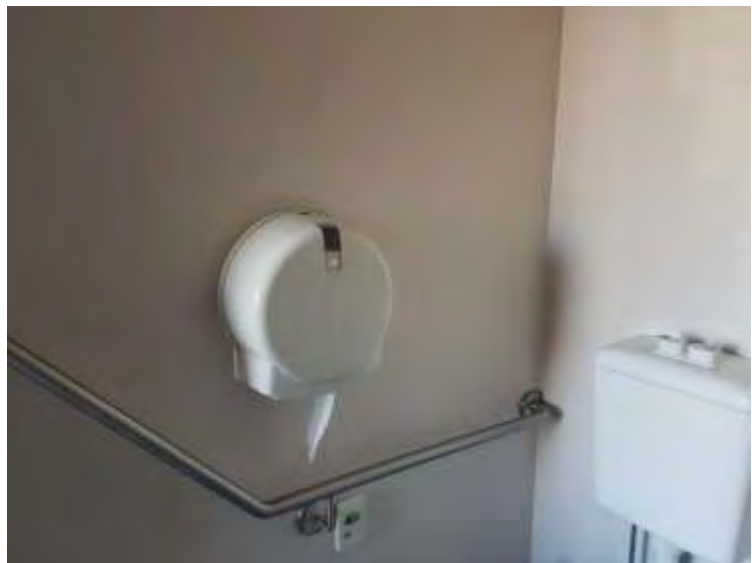
Defect ID A46
Area Type Internal
Location Hope Building Level 2
 Maternity Room 9
Element Plasterboard
Defect Type Crack
Length (mm) 4000
Width (mm) 0.5
General Comments:
 Horizontal cracking on wall

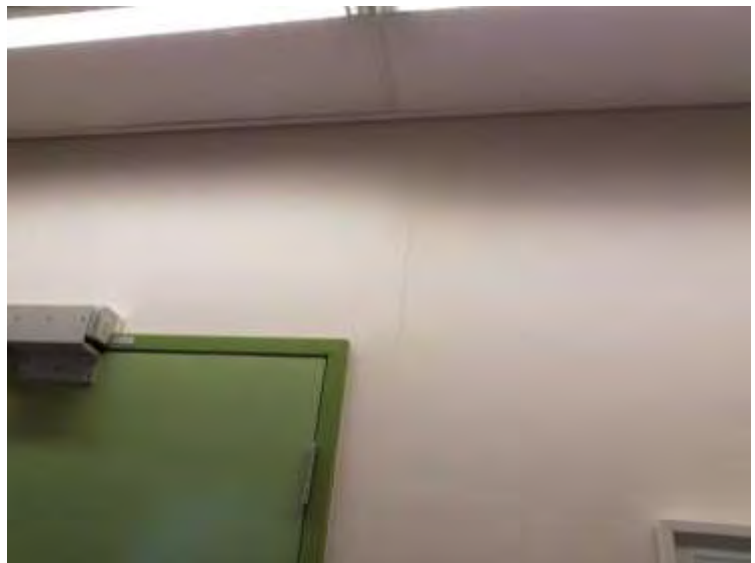
Defect ID A103
Area Type Internal
Location Hope Building Level 2
 Maternity Hallway
Element Plasterboard
Defect Type Crack
Length (mm) 500
Width (mm) 0.5
General Comments:
 Vertical cracking on wall

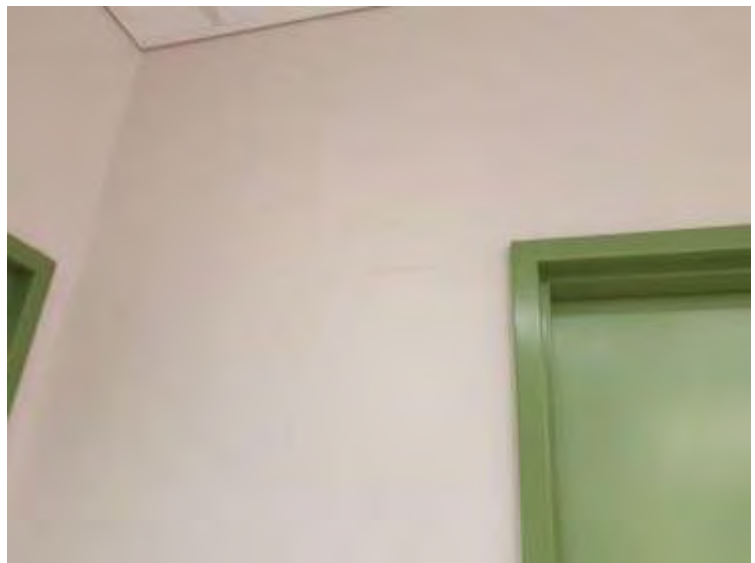
Defect ID A107
Area Type Internal
Location Hope Building Level 2
 Maternity Hallway
Element Plasterboard
Defect Type Crack
Length (mm) 1000
Width (mm) 0.5
General Comments:
 Horizontal cracking adjacent to door

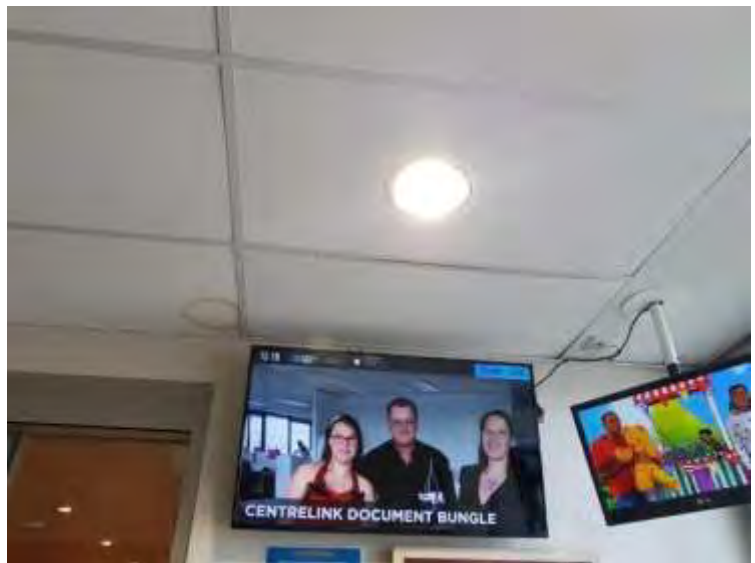
Defect ID A119
Area Type Internal
Location Hope Building Level 2
 Maternity Waiting room
Element Ceiling Tile
Defect Type Staining & loose tile
Length (mm) NA
Width (mm) NA
General Comments:
 Staining on ceiling tile and loose ceiling tile

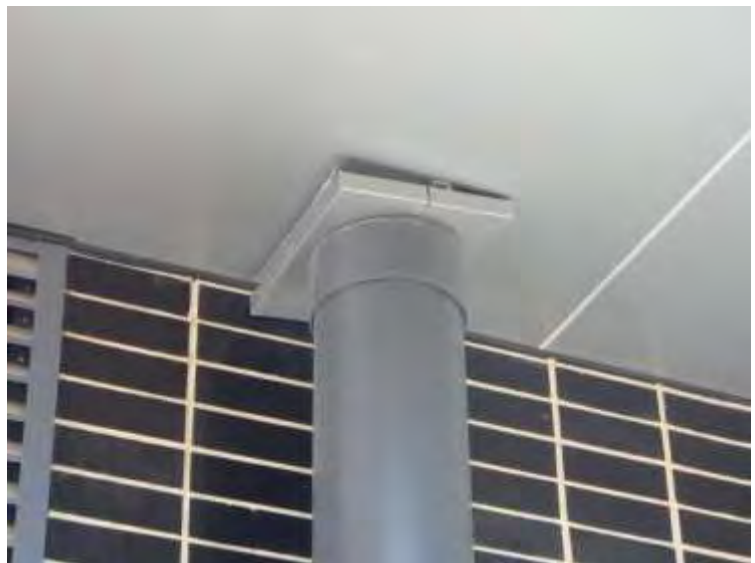
General Comments:
Loose metal panel at top of column
