KANE

WASTE MANAGEMENT PLAN

CHILDRENS HOSPITAL WESTMEAD STAGE 2 –PROJECT: CHW & VVMF REFURBISHMENT
CONTRACT NUMBER: HI 22029

Health Infrastructure NSW
Hazardous Building Materials Survey

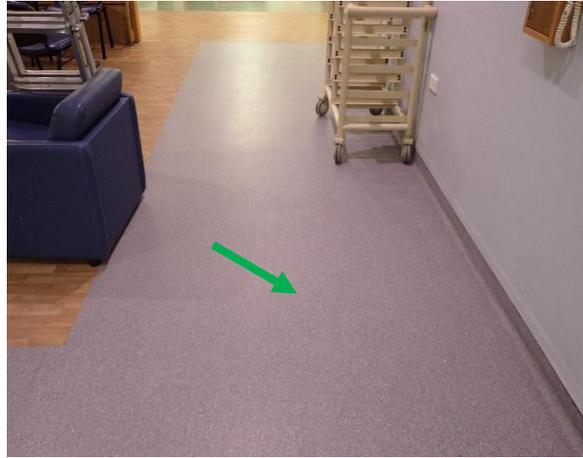
Photo 2: Level 1 Gait lab, staff kitchen area, top of floor – Non-asbestos blue vinyl flooring

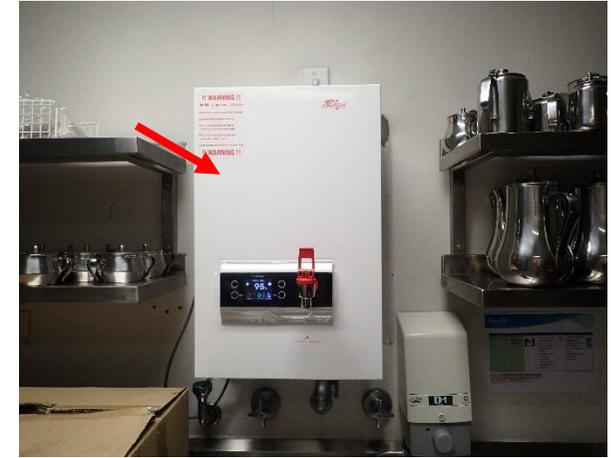
Photo 3: Level 1 Gait lab, staff kitchen and meeting room – hot water unit assumed to contain internal SMF insulation

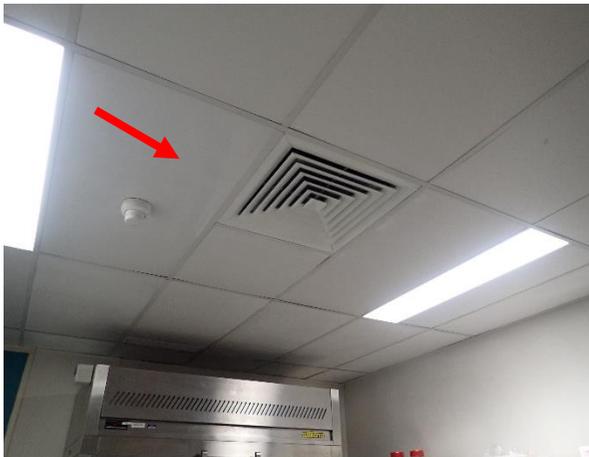
Photo 4: Level 1 Gait lab, kitchen, false ceilings throughout – false ceiling tiles assumed to contain SMF

-	False ceilings throughout – suspended ceiling tiles	Ceiling tiles	-	Yes	Bonded	Assumed SMF	Good	200 m ²	Remove in accordance with NOHSC:2006 (1990)	13/12/2021 JBS&G ML	Prior to refurbishment

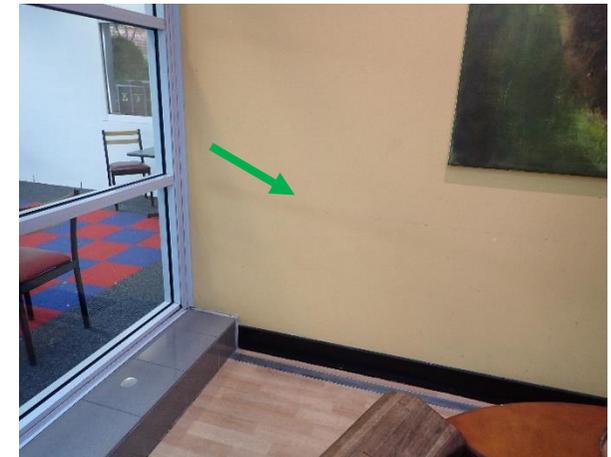
Photo 6: Level 1 Galleria entrance, cement rendered walls – non-lead based yellow paint

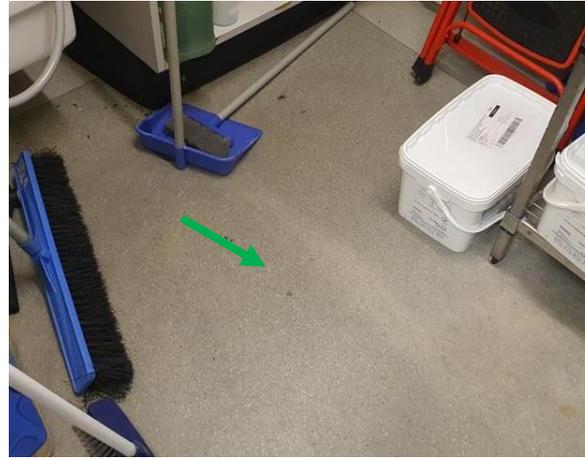
Photo 8: Level 1 Kitchen, chemical storage room, top of floor – non-asbestos grey vinyl flooring

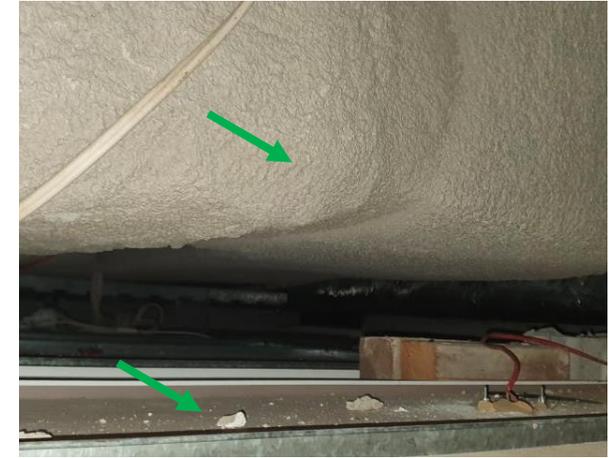
- Non-asbestos containing vermiculite (KIT-A2) was identified to the ducting in the ceiling cavity adjacent to the Chef room.
- Lead concentrations within settled dust below the adopted site criteria (KIT-LD1, 130 mg/kg) was identified to the ceiling cavity above the kitchen. This dust was also found not to contain asbestos (KIT-AD1).

Photo 9: Level 1 Kitchen, ceiling space, adjacent Chefs Room, vent – non-asbestos vermiculate. Lead concentration in settled dust was below the adopted criteria and settled dust does not contain asbestos

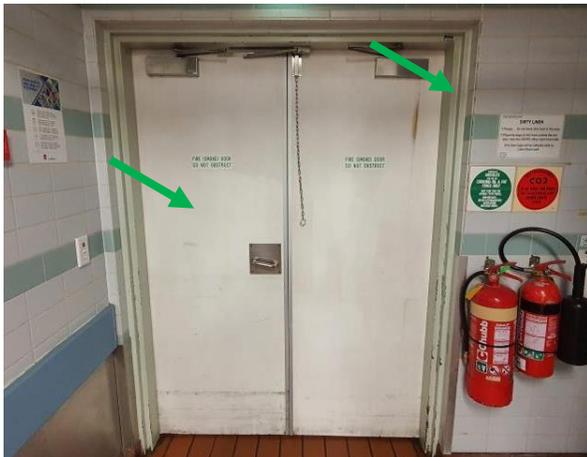
Photo 10: Level 1 Kitchen, north entry fire doors – assumed non-asbestos fire doors as doors were identified to be manufactured in 1990's or 2000's. Non-lead based light green paint on door frames

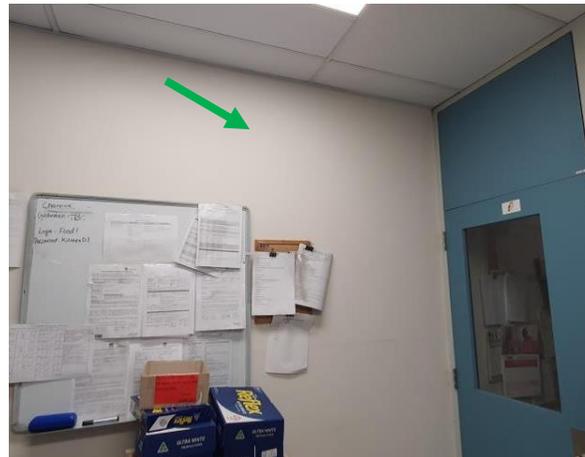
Photo 11: Level 1 Kitchen, cement rendered walls – non-lead based white paint

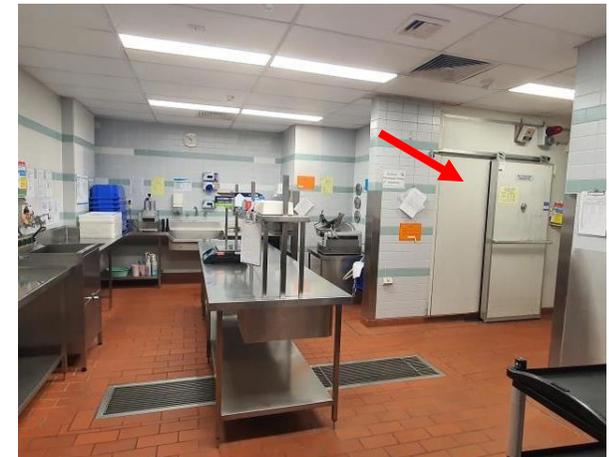
Photo 12: Level 1 Kitchen, north area of kitchen – cool rooms assumed to contain internal SMF insulation

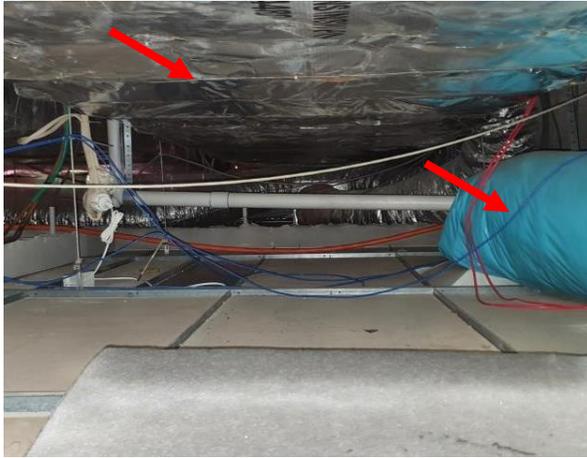
Photo 13: Level 1 Kitchen, ceiling space – ducting assumed to contain SMF

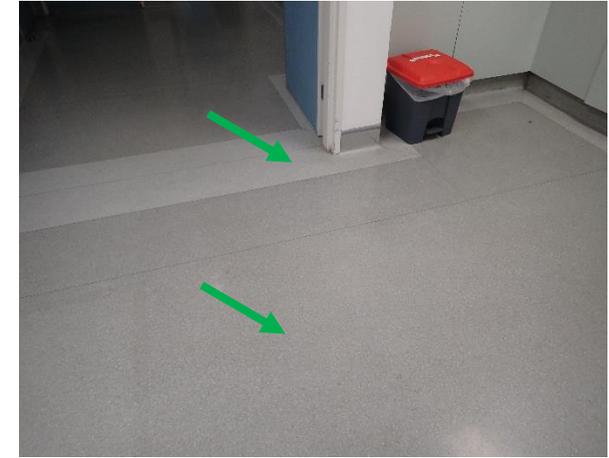
Photo 15: Level 2 Old Emergency Department, throughout emergency department, flooring – grey and light grey non-asbestos vinyl flooring

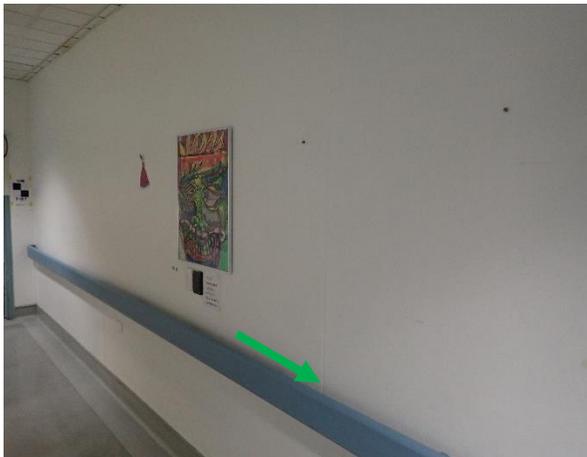
Photo 16: Level 2 Old Emergency Department - cement rendered walls, between walls – non-asbestos expansion joint

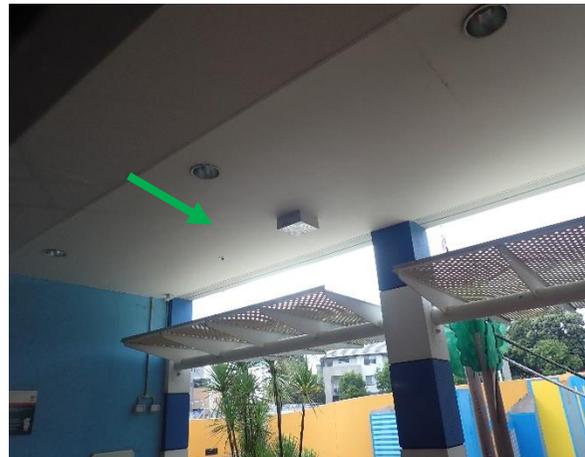
Photo 17: Level 2 Old Emergency Department - external smurf garden, soffit lining – non-asbestos fibre cement

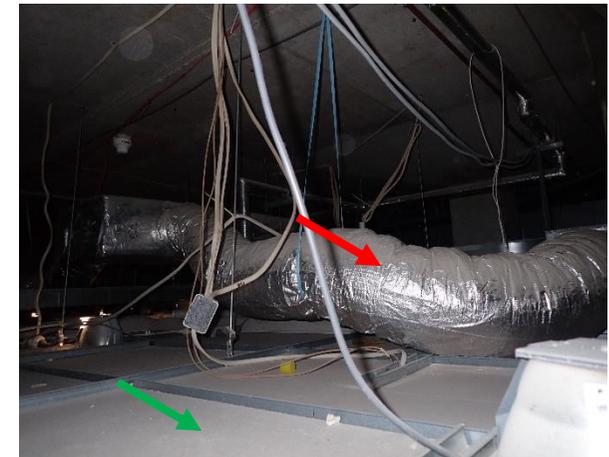
- Lead concentrations within settled dust below the adopted site criteria (ED-LD01, 23 mg/kg) was identified within the ceiling cavity. This dust was also found not to contain asbestos (ED-AD01).

Photo 18: Level 2 Old Emergency Department, ceiling cavity – settled dust was below the adopted site criteria and settled dust does not contain asbestos. Ducting assumed to contain SMF.

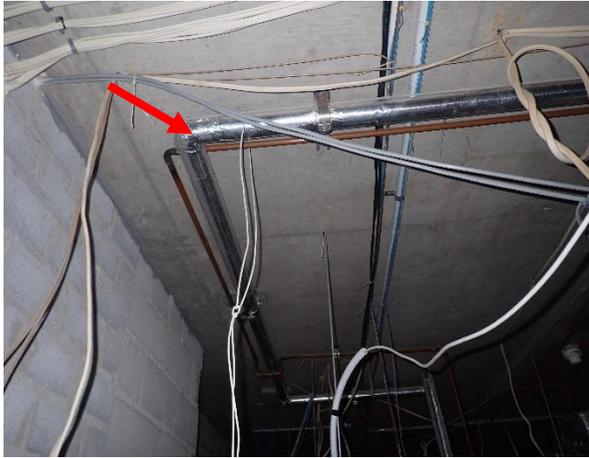
Photo 19: Level 2 Old Emergency Department, ceiling cavity – pipework, insulation assumed to contain SMF

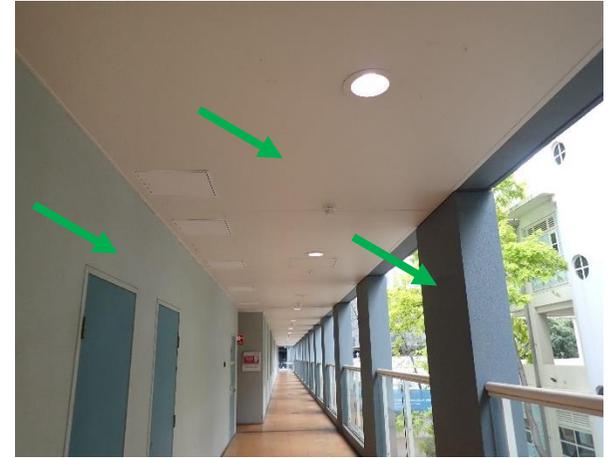
Photo 21: Level 2 Linkway and Pathway, external area, ceiling– non-asbestos fibre cement. Non-lead based light blue paint on cement rendered walls and non-lead based dark blue paint on pillars

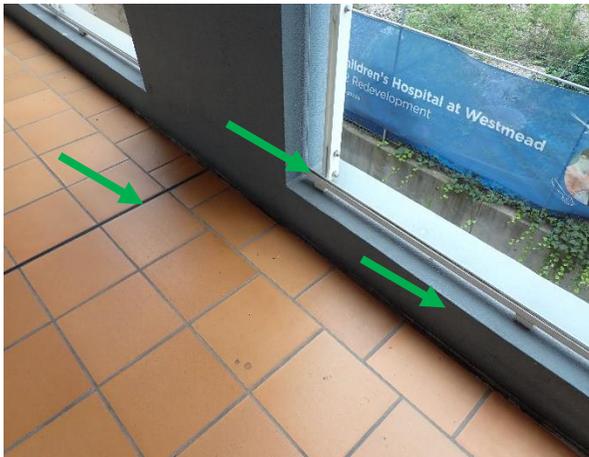
Photo 22: Level 2 Linkway and Pathway, external area, glass balustrade and between tile flooring – non-asbestos black mastic sealant.

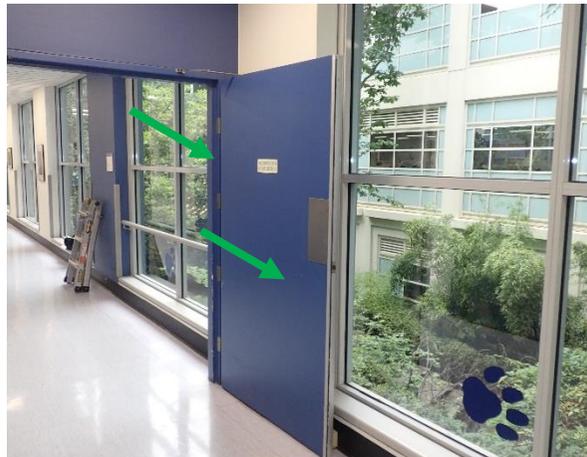
Photo 23: Level 2 Linkway and Pathway, fire doors and door jambs – Non-lead based blue paint. Fire doors observed to be manufactured in 1990s and is assumed to not contain asbestos

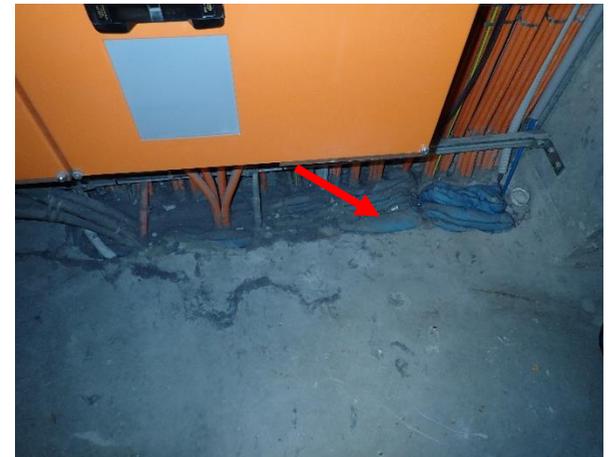
Photo 24: Level 2, Linkway and Pathway, electrical cupboard, cable penetrations – insulation pillows assumed to contain SMF

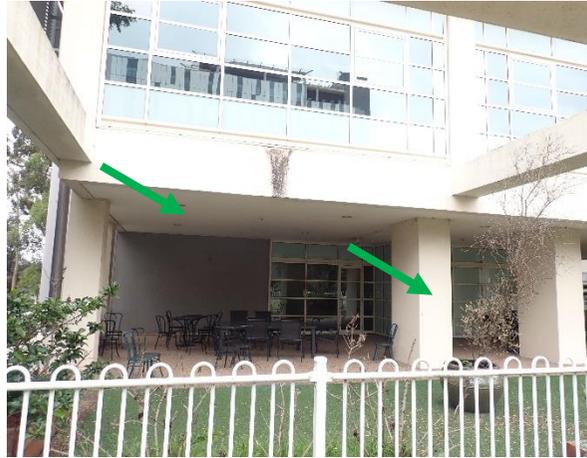
Photo 26: Level 2 Pathology Expansion area, external area, soffit lining – non-asbestos fibre cement. Non-lead based white paint on concrete pillars

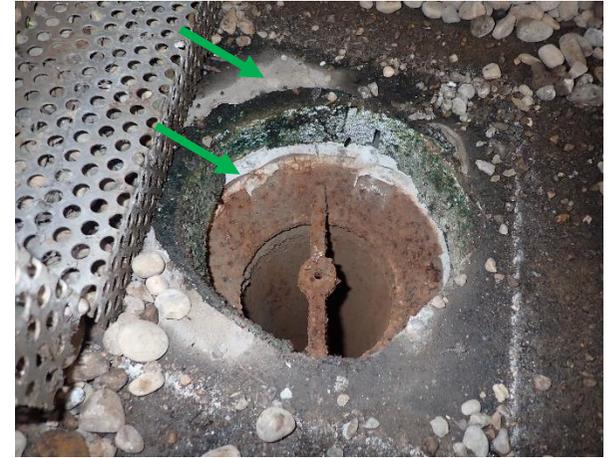
- Non-asbestos containing fibre cement sheeting (PE-A01) was identified to the soffit lining.
- Non-asbestos containing pebblecrete pavers (PE-A02) was identified to the flooring within the northern courtyard portion.
- The waterproofing membrane within the exposed roof portion comprised a combination of plastic and foam layers, with a gravel surface covering. No suspected ACM were observed.
- Non-lead based white paint (PE-LP01, < 0.01% w/w) was identified to the concrete pillars.
- No other hazardous materials were identified at the time of inspection.

Photo 27: Level 2 Pathology Expansion Area, northern courtyard portion, flooring – non-asbestos fibre cement. Non-asbestos waterproofing material observed

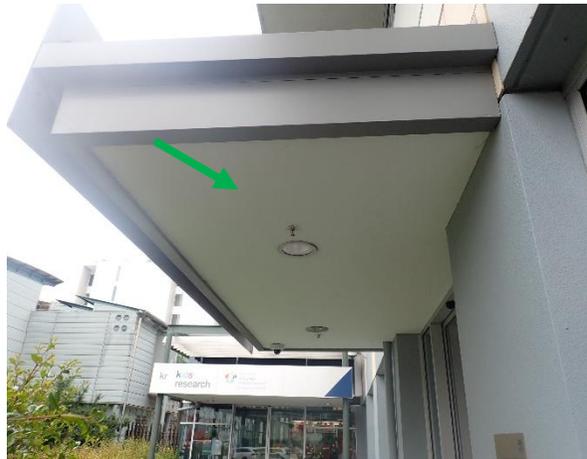
Photo 29: Level 2 Clinical Research Centre (CRC), soffit lining – non-asbestos fibre cement

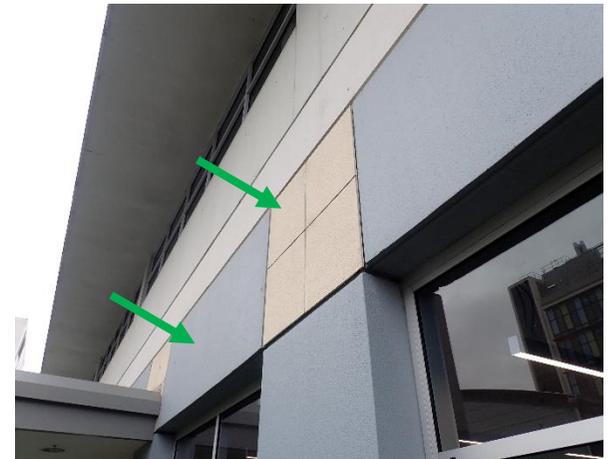
Photo 30: Level 2, Clinical Research Centre (CRC) façade– non-asbestos compressed fibre cement. Walls, non-lead based blue paint

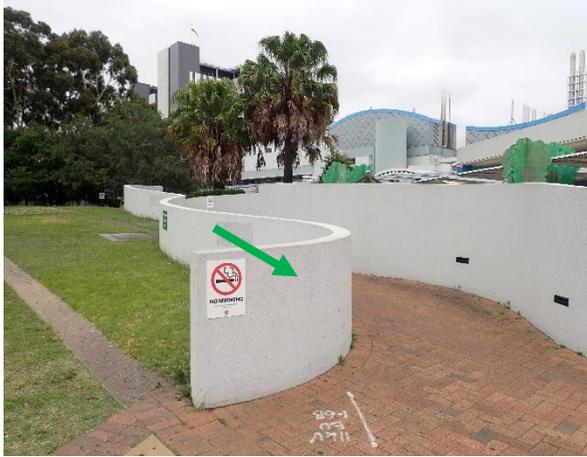
Photo 31: Level 2 external forecourt, curved walkway walls– non-lead based grey paint

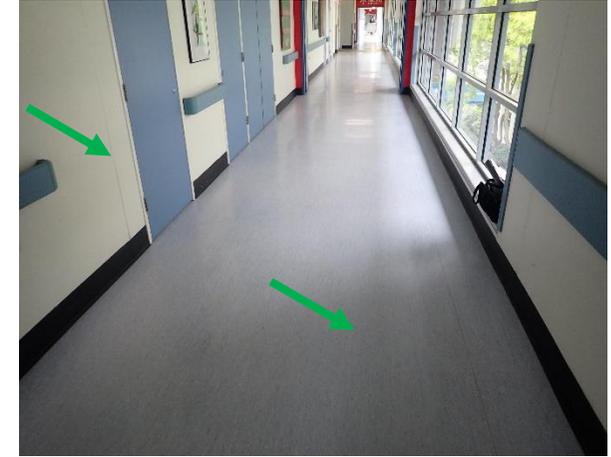
Photo 33: Level 3 Linkway and pathway, internal area throughout, flooring – assumed non-asbestos blue vinyl flooring. Walls and door jambs – non-lead based white paint
