**Royal Prince Alfred Hospital Redevelopment (RPAH  
Redevelopment)**

**Construction Noise and Vibration Monitoring Report 2**

| Document Title | Construction Noise and Vibration Monitoring |

| Revision | Date | Document Reference | Prepared By | Checked By | Approved By |
|---|---|---|---|---|---|
| 0 | 30/01/2024 | 20230239.17/3001A/R0/LA | LA | | AW |

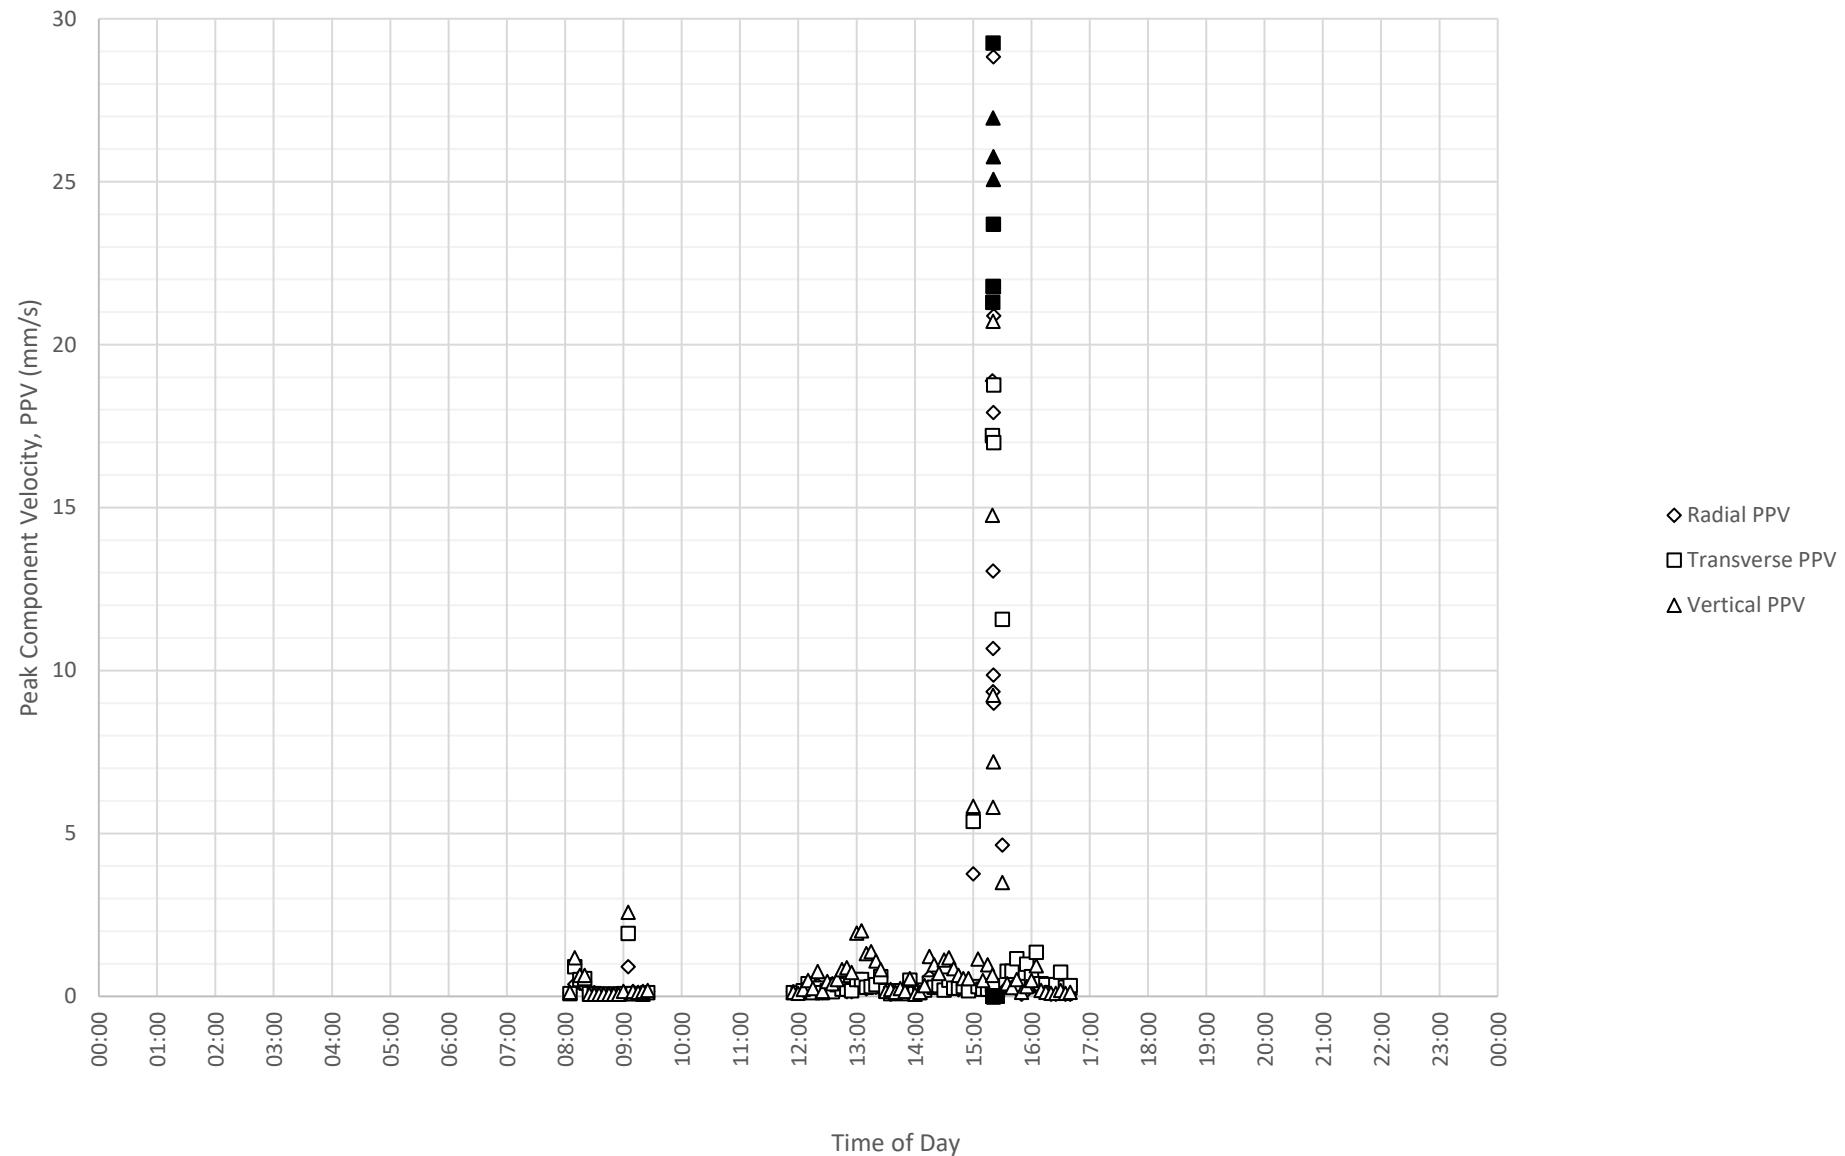
### Daily Monitored Vibration Levels at Susan Wakil Health Building on 12-12-2023

- Exceedances were observed on 12/12/2023 and 13/12/2023.
  - Exceedances were limited to short periods, noting these only occurred for one period on the 12/12 and two periods on the 13/12 of less than 10 minutes at a given time before returning to compliant levels.
