REPORT TO
HEALTH INFRASTRUCTURE

ON
HAZARDOUS BUILDING MATERIALS SURVEY

FOR
MOREE HOSPITAL REDEVELOPMENT

AT
MOREE HOSPITAL, ALICE STREET, MOREE, NSW

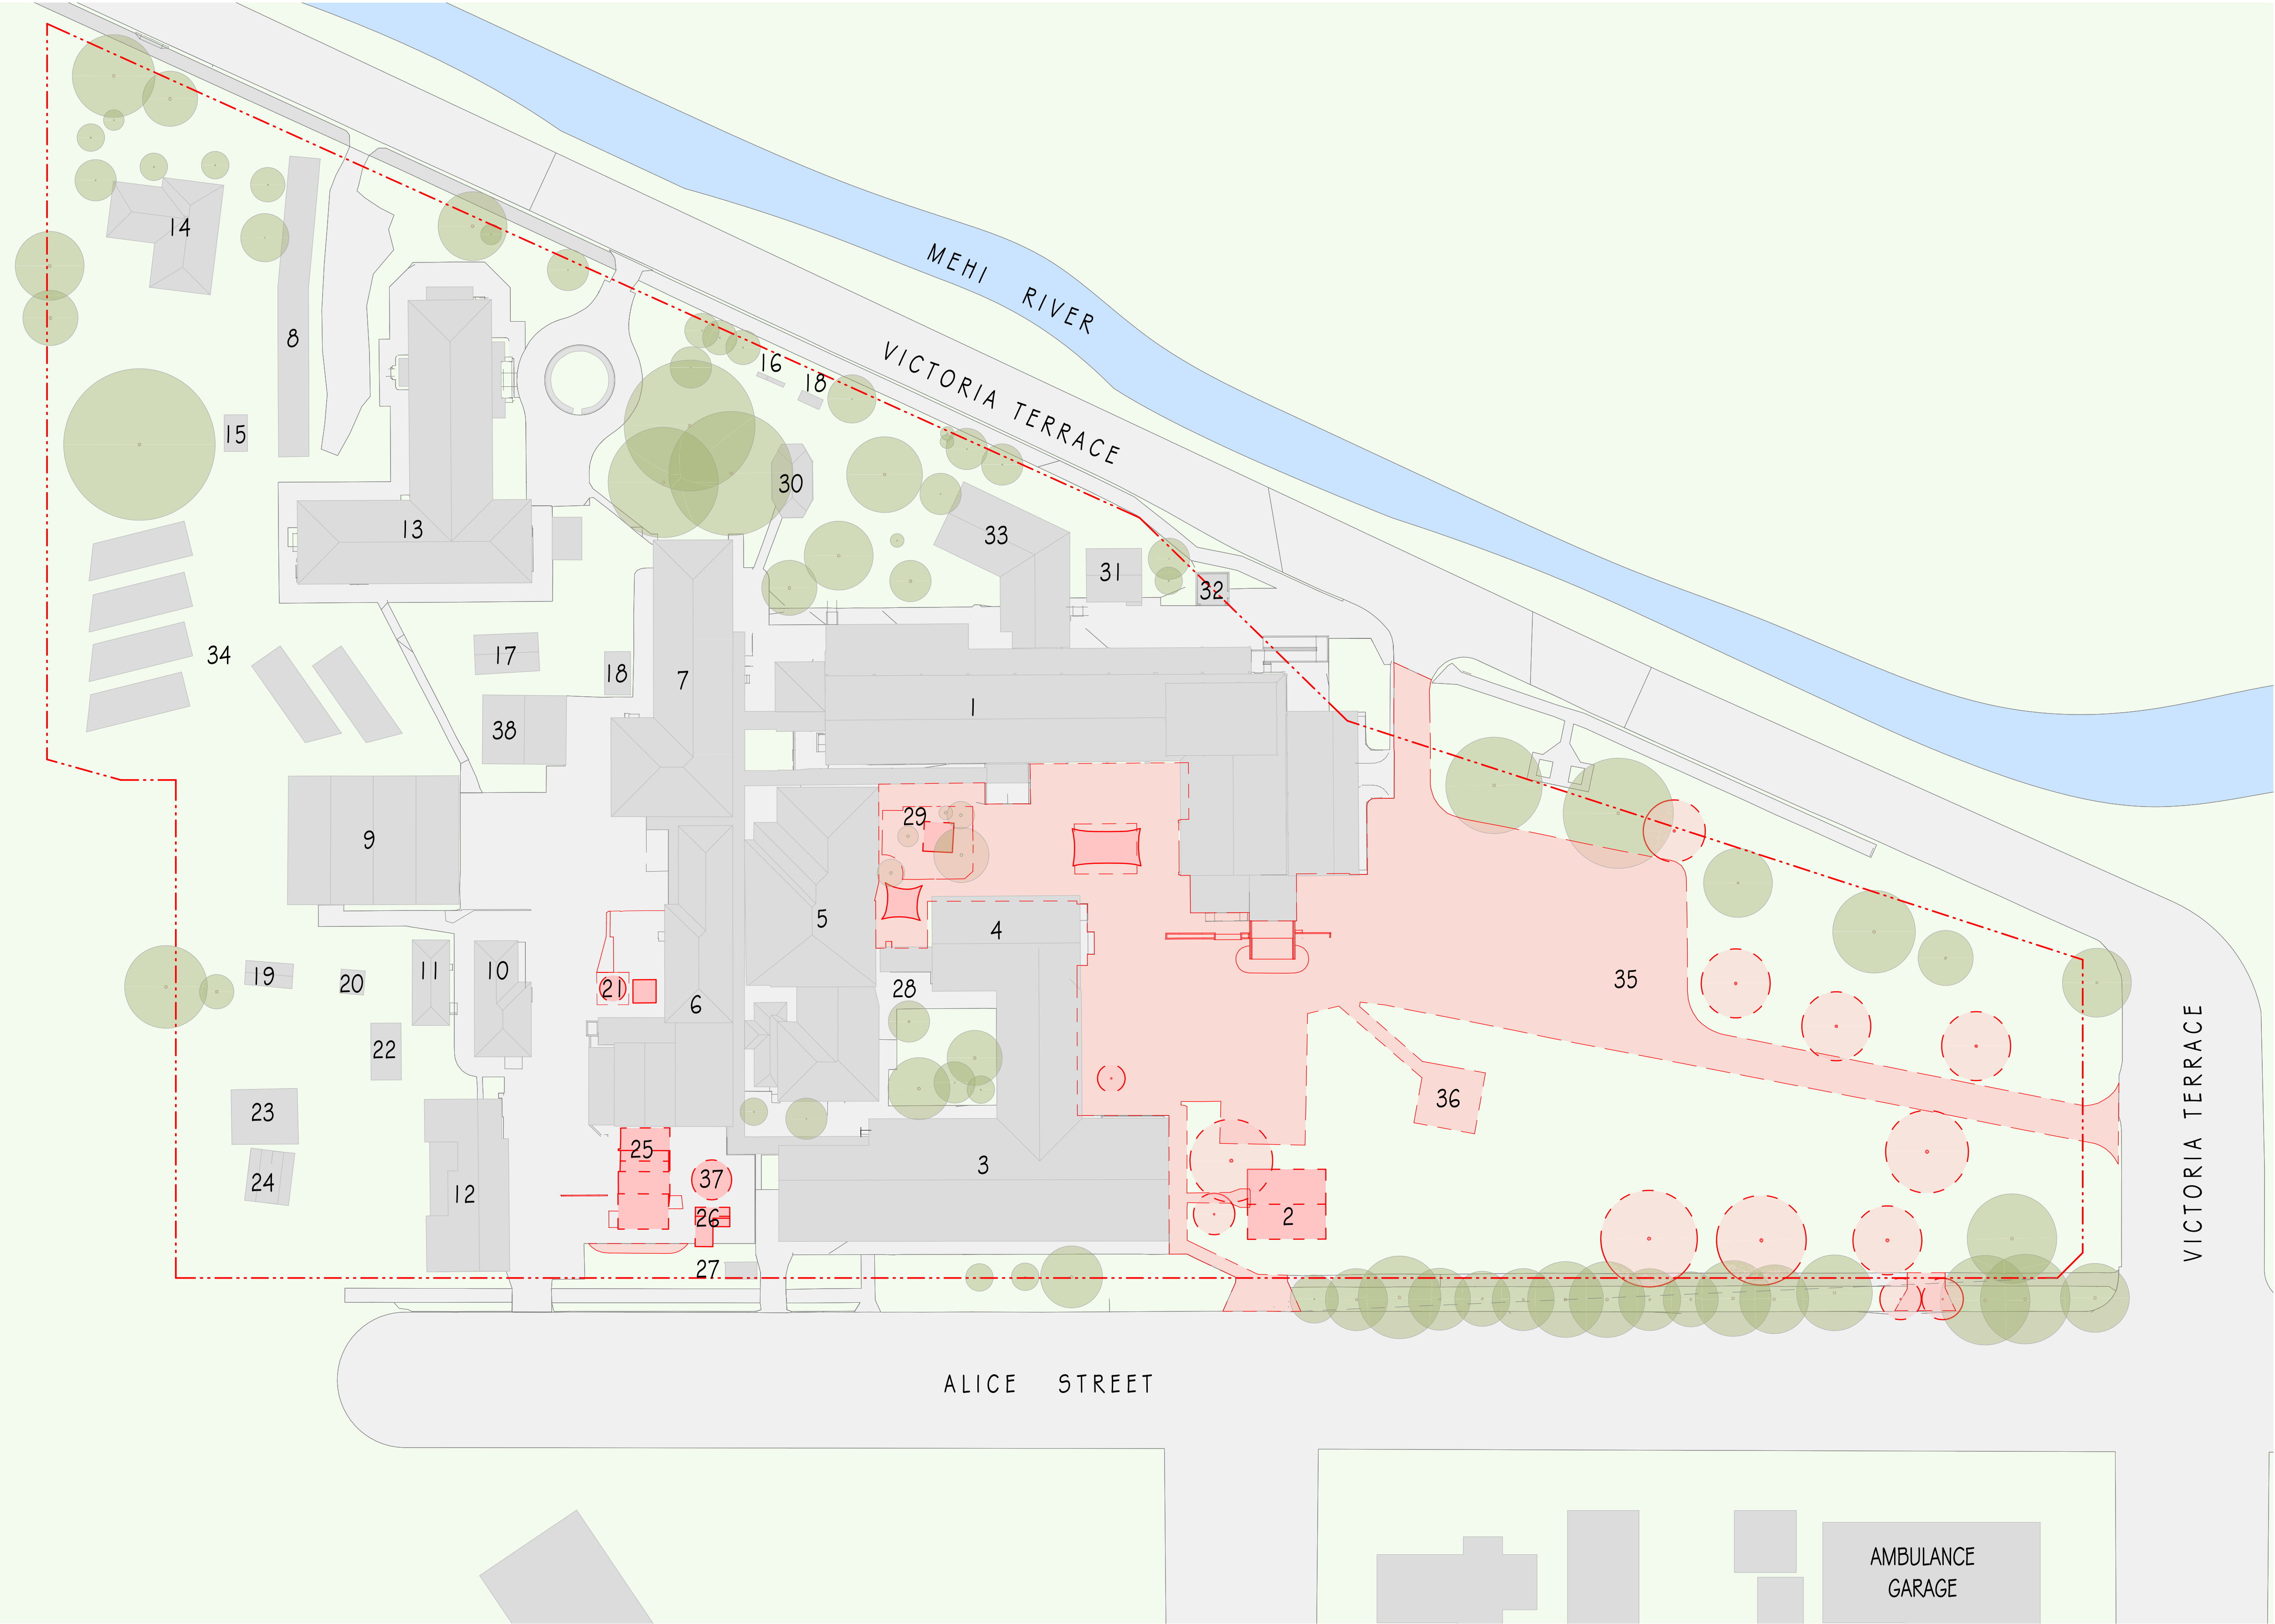
EXISTING BUILDINGS	
No.	Name
1	HOSPITAL BUILDING
2	ADMINISTRATION BUILDING
3	PICONE BUILDING
4	MENTAL HEALTH
5	CRANE & GLENNIE
6	HOLLINGWORTH BLOCK
7	KITCHEN
8	CARPORT
9	STORE BUILDING
10	MORTUARY
11	ENGINEER'S OFFICE
12	WORKSHOP
13	STAFF ACCOMODATION
14	AG HEALTH HOUSE
15	BARBECUE SHED
16	MSB
17	EMERGENCY GENERATOR
18	SUB STATION
19	PUMP HOUSE
20	FLAMMABLE LIQUID STORE
21	PORTABLE COLD WATER
22	BUS PORT
23	LPG TANKS
24	MAINTENANCE CAR PORT
25	MAINTENANCE SUB AREA
26	FIRE BOOSTED PUMP SHED
27	BACK FLOW SHED
28	KIOSK
29	ABORIGINAL SHADE SHELTER
30	STAFF SHADE SHELTER
31	CHILLER SHED
32	BULK OXYGEN VESSEL
33	RENAL BUILDING
34	DOCTOR'S ACCOMODATION
35	PARKING
36	HELIPAD
37	FIRE WATER STORAGE
38	SHED
