Project ID	20230239.17	
Document Title	Construction Noise and Vibration Monitoring Report	
Attention To	CPB Contractors Pty Limited

1 INTRODUCTION

This report covers the twenty-fifth fortnight since the beginning of construction monitoring, being between Monday 11th November, 2024 and Sunday 24th November, 2024.

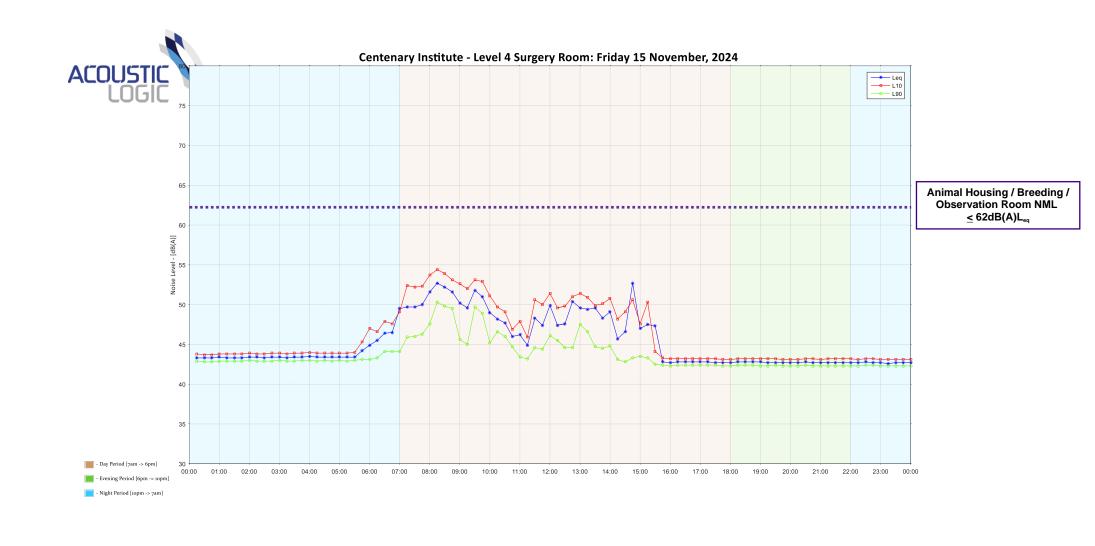
CENTENARY INSTITUTE – LEVEL 4 SURGERY ROOM (SOUTHERN FAÇADE)

Noise monitoring conducted throughout the monitoring period shows general adherence to the noise management levels provided within Section 3 of this letter.
