**RE: Noise & Vibration Monitoring Reporting – October 2023**

## CONSTRUCTION NOISE AND VIBRATION REPORT

**Stage 3 St. George Hospital,  
16 Kensington Street,  
Kogarah**

Monitoring Period:  
29 September 2023 to 05 October 2023

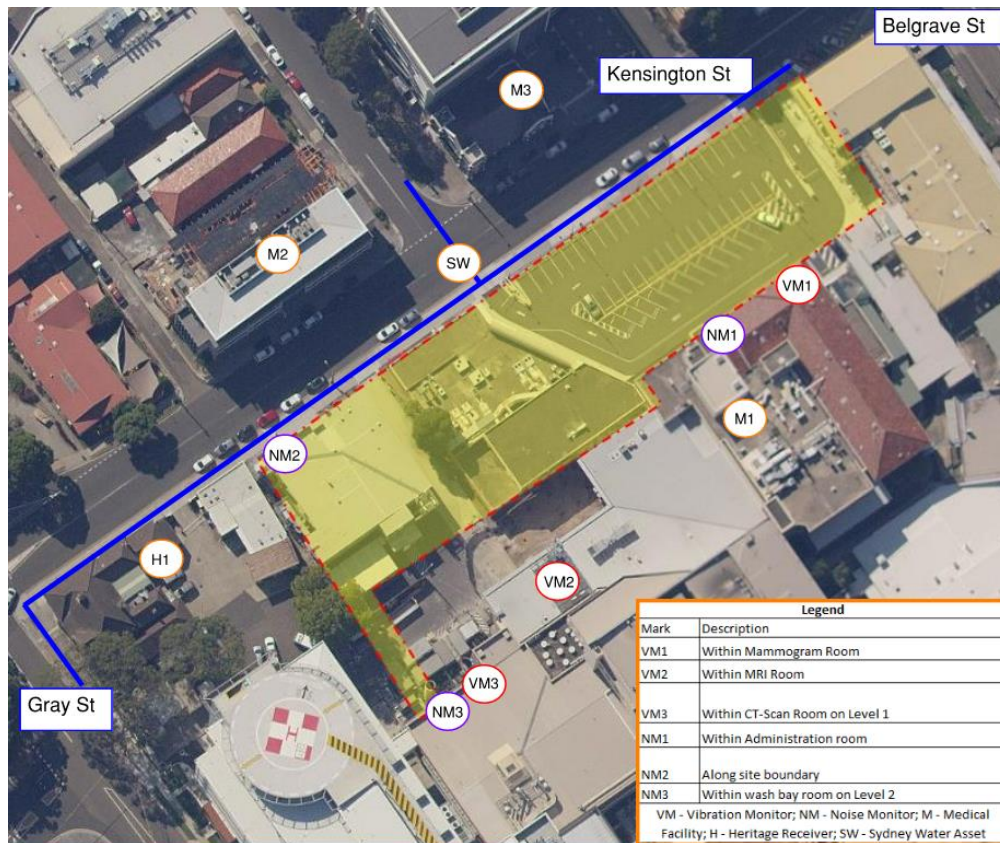
Figure 4 Site setup

In accordance with the recommendations from the Construction Noise & Vibration Monitoring Plan, Ref # VIB-23661-NVMP[B] dated 31 May 2023 prepared by Paragon Engineering, the criteria “Structures that, because of their particular sensitivity to vibration, cannot be classified under lines 1 and 2)” has been considered for the heritage building and Medical facility with sensitive equipment where the criteria/trigger is set to **3mm/s**. Figure 4 shows the location of each vibration monitor.

The noise monitor was mounted on a solar stand in accordance with the manufacturer's recommendations. The monitor is oriented with the camera facing the direction of the noise source as per the recommendation of the manufacturer. The monitor was located to be as close to the sensitive noise receiver as possible as shown in *Figure 4* below. Each device was set to continuous daily monitoring at 15-minute intervals recording  $L_{Aeq(15min)}$ .
