Royal Prince Alfred Hospital Redevelopment (RPAH  
Redevelopment)

Construction Noise and Vibration Monitoring Report 6

Client Doc. No. RPA-ACO-ACL-RPT-MW-000009 - Rev A

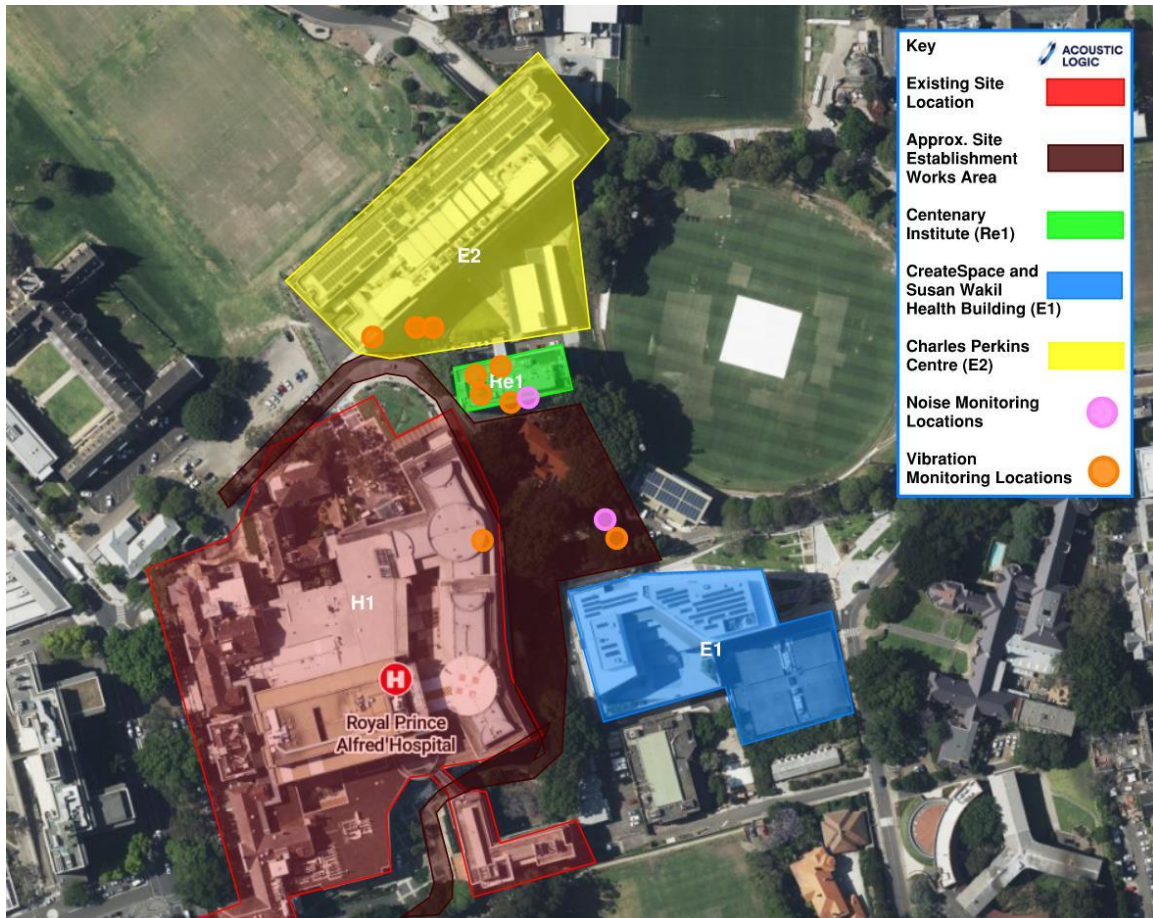
**Figure 1: Aerial Site Map with Nearest Sensitive Receivers (Sourced from Sixmaps)**

See an aerial photo in Figure 1 below for detailed receiver locations.

Please refer to Figure 1 for detailed monitoring locations. Appendix C provides photos of the monitors installed at the project site.

Please refer to Figure 1 for detailed monitoring locations.

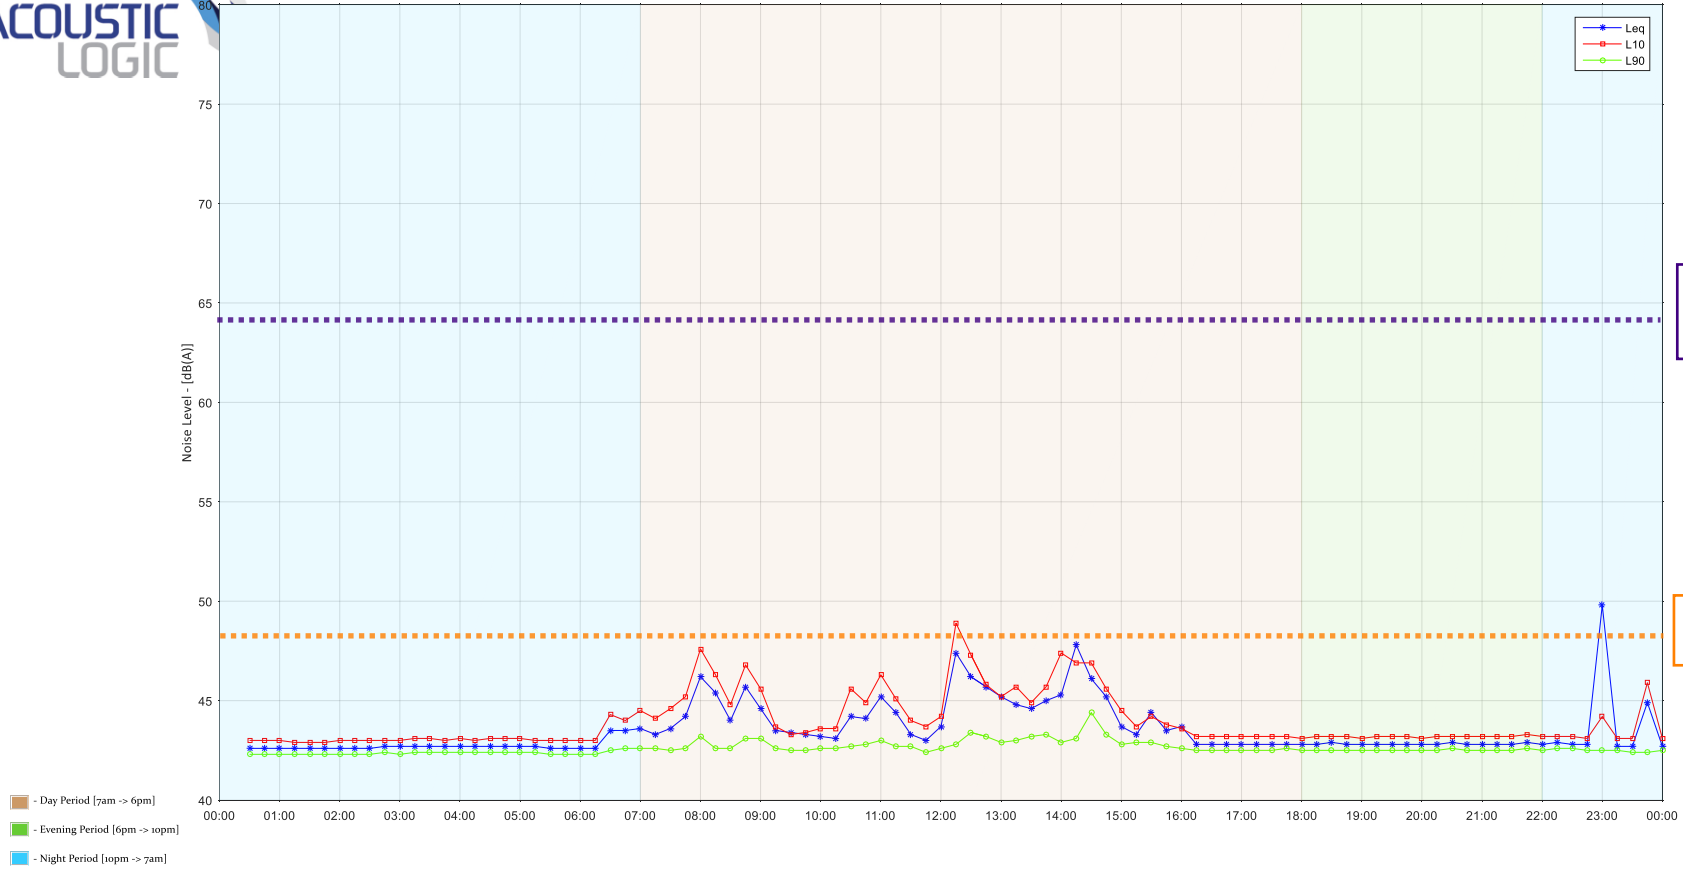
### Centenary Institute - L4 Surgery: Monday 19 February, 2024

Animal Housing / Breeding /  
Observation Room NML  
 $\leq 64\text{dB(A)}L_{eq}$

Animal Operating Room NML  
 $\leq 48\text{dB(A)}L_{eq}$

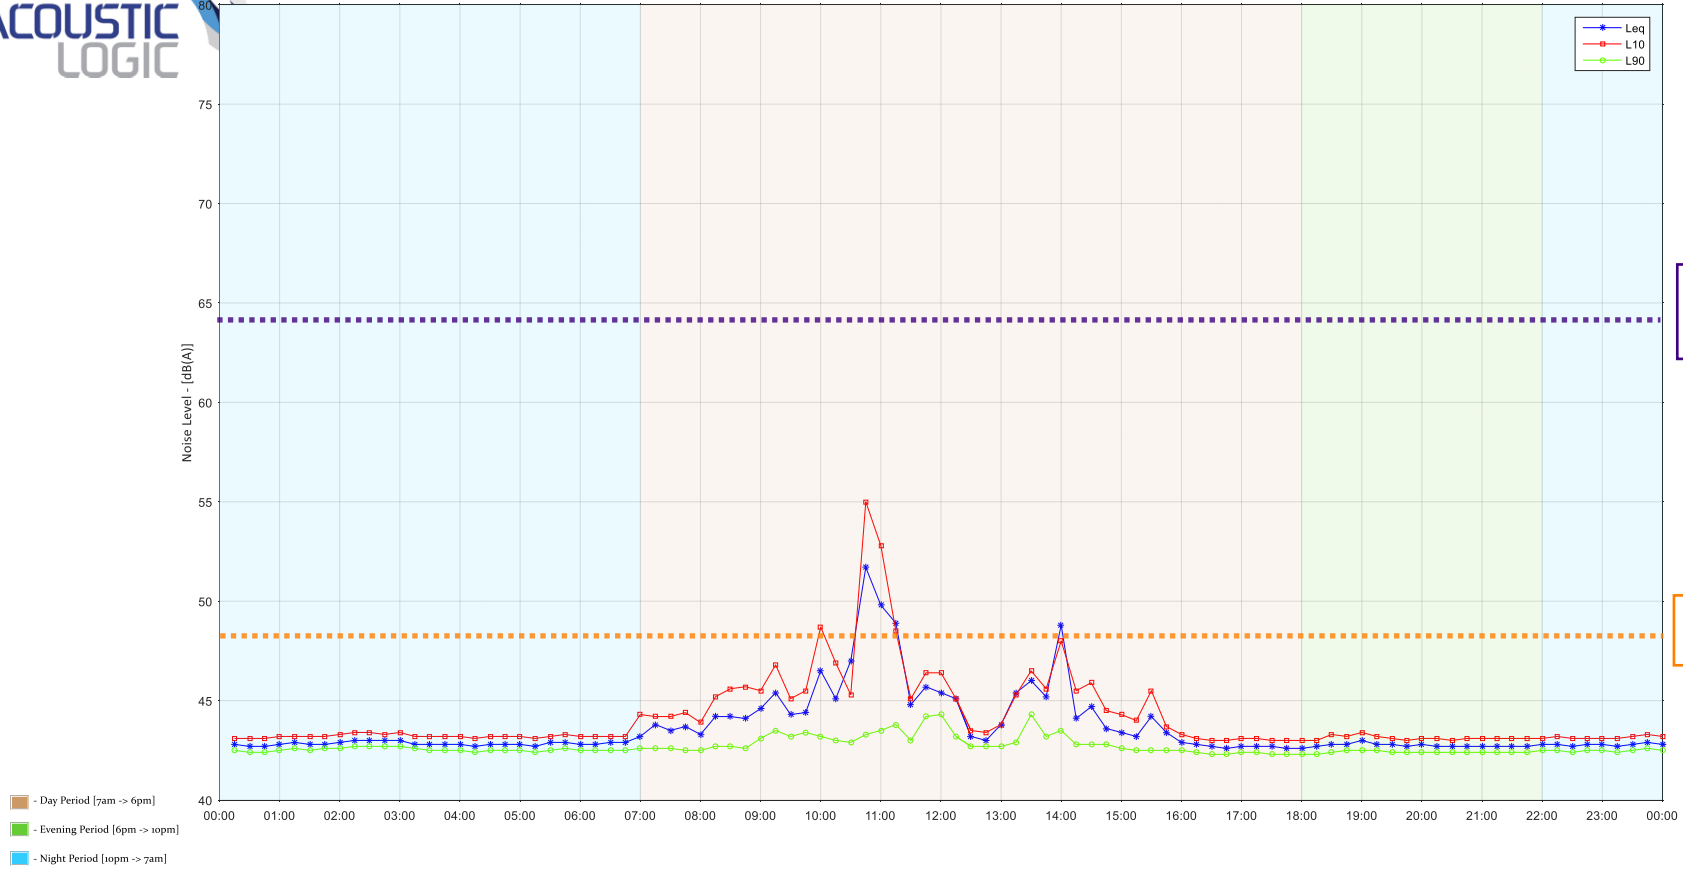
### Centenary Institute - L4 Surgery: Tuesday 20 February, 2024

- Measured noise levels were observed to be above the surgery room noise management level on the following dates during periods of construction:
  - 20/02/2024.
  - 21/02/2024.
  - 23/02/2024.
  - 27/02/2024.
  - 28/02/2024.
  - 29/02/2024.
  - 01/03/2024.
- Generally, measured noise levels above the noise management levels within the operating room were observed for short periods of time before returning to below the noise management level ( $\leq$  30 min). Within the monitoring period, there are three sustained periods of noise above the NML for longer than this that may have been caused by construction activity (two periods of 45 mins and one period of 1 hour consecutively).
- Noise levels are continuing to be observed and monitored to ensure ongoing adherence with the requirements of Section 3.1.

**Animal Housing / Breeding / Observation Room NML**  
 $\leq 64\text{dB(A)}L_{\text{eq}}$

**Animal Operating Room NML**  
 $\leq 48\text{dB(A)}L_{\text{eq}}$

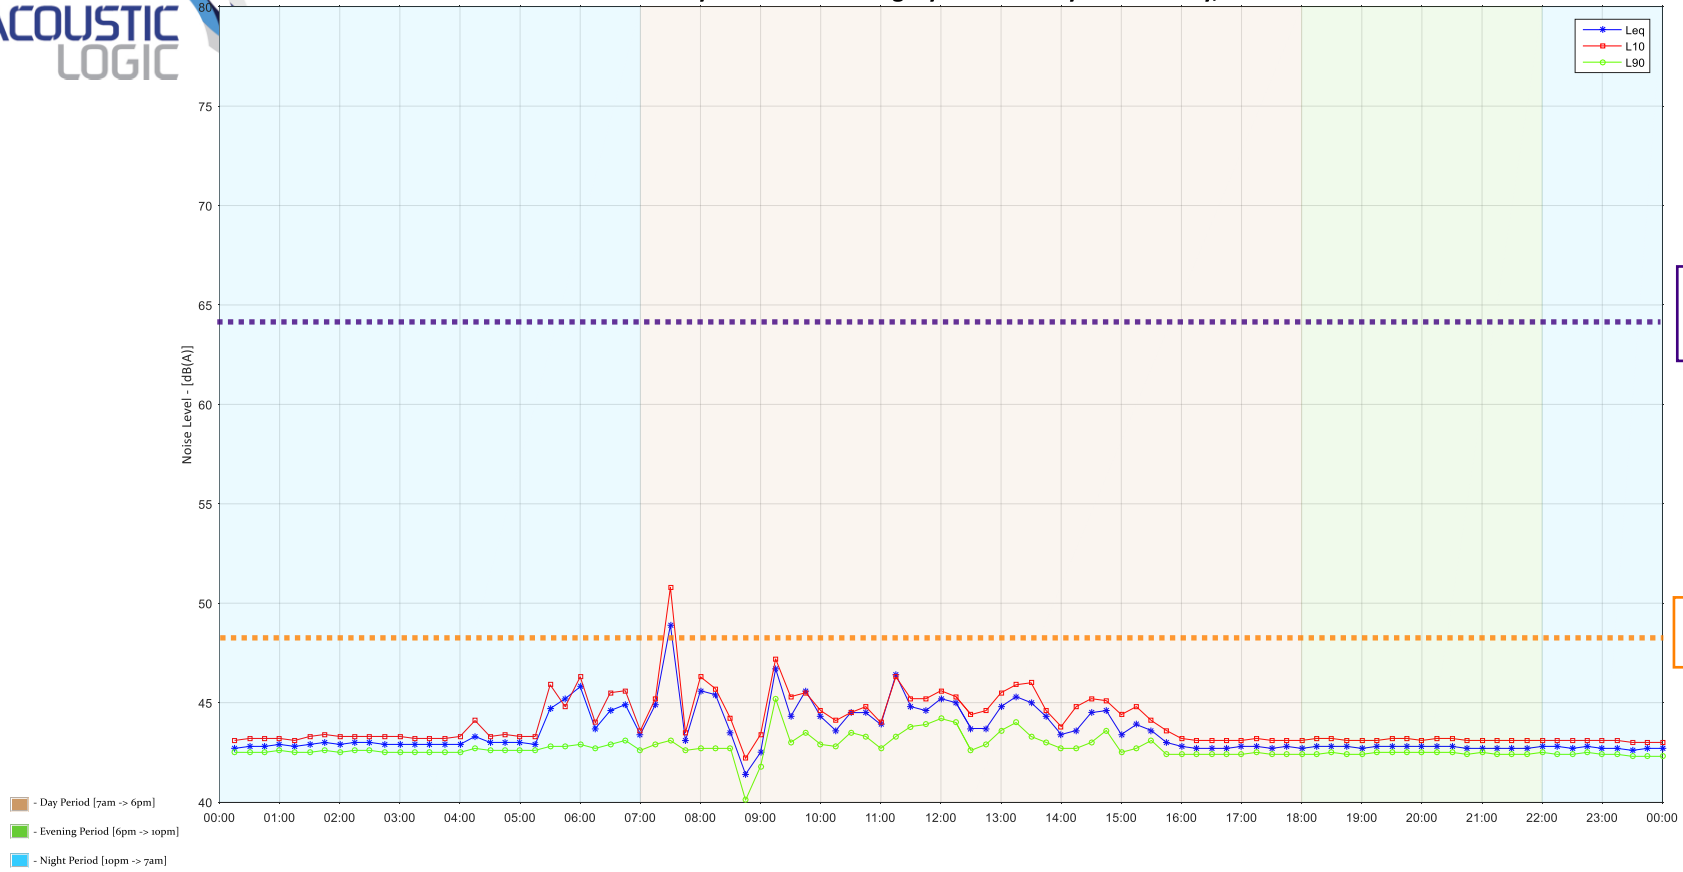
### Centenary Institute - L4 Surgery: Wednesday 21 February, 2024

**Animal Housing / Breeding / Observation Room NML**  
 $\leq 64\text{dB(A)}L_{eq}$

**Animal Operating Room NML**  
 $\leq 48\text{dB(A)}L_{eq}$

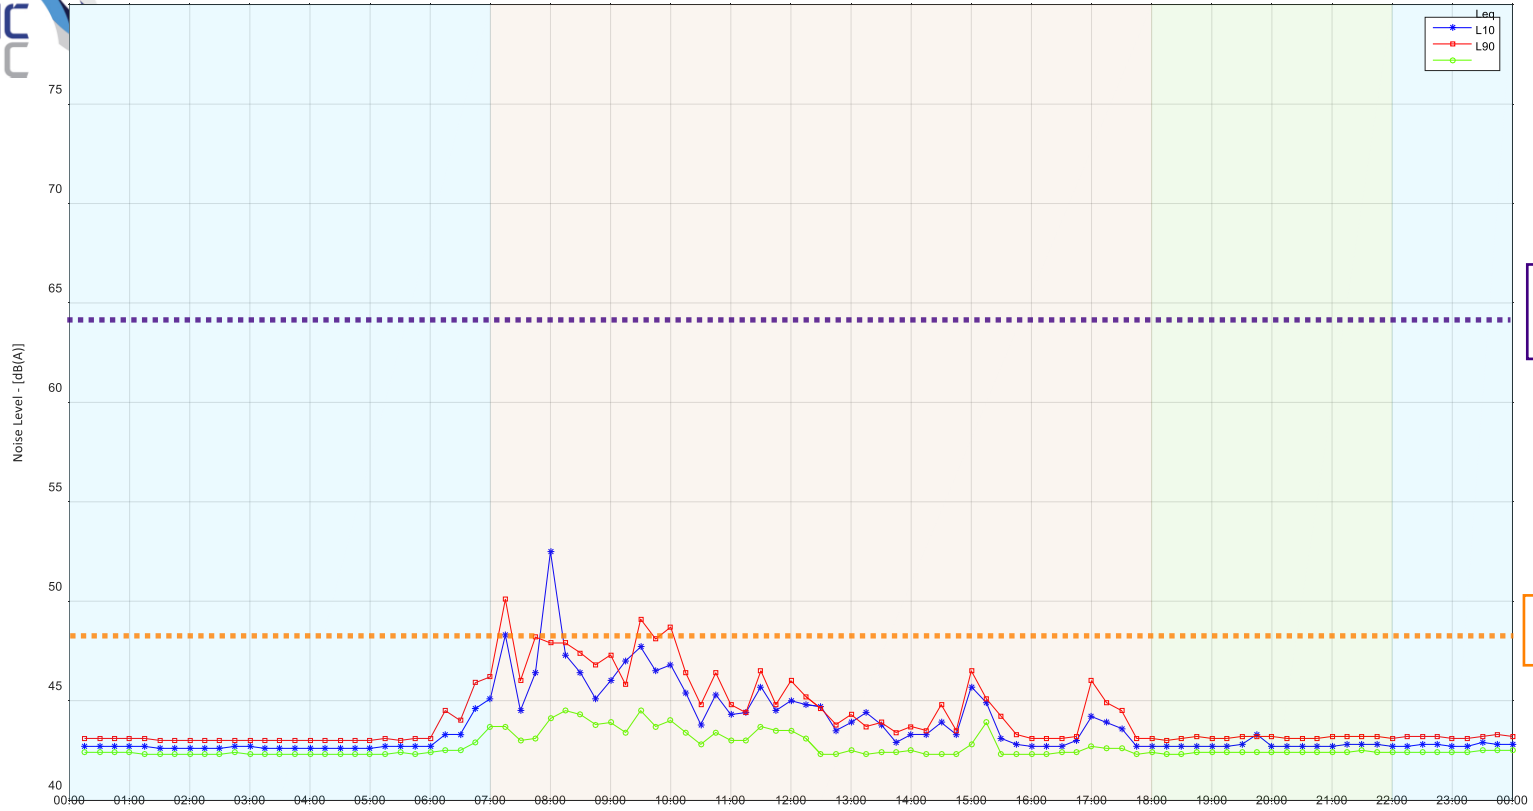
### Centenary Institute - L4 Surgery: Friday 23 February, 2024

**Animal Housing / Breeding /  
Observation Room NML  
≤ 64dB(A)<sub>L<sub>eq</sub></sub>**

**Animal Operating Room NML  
≤ 48dB(A)<sub>L<sub>eq</sub></sub>**

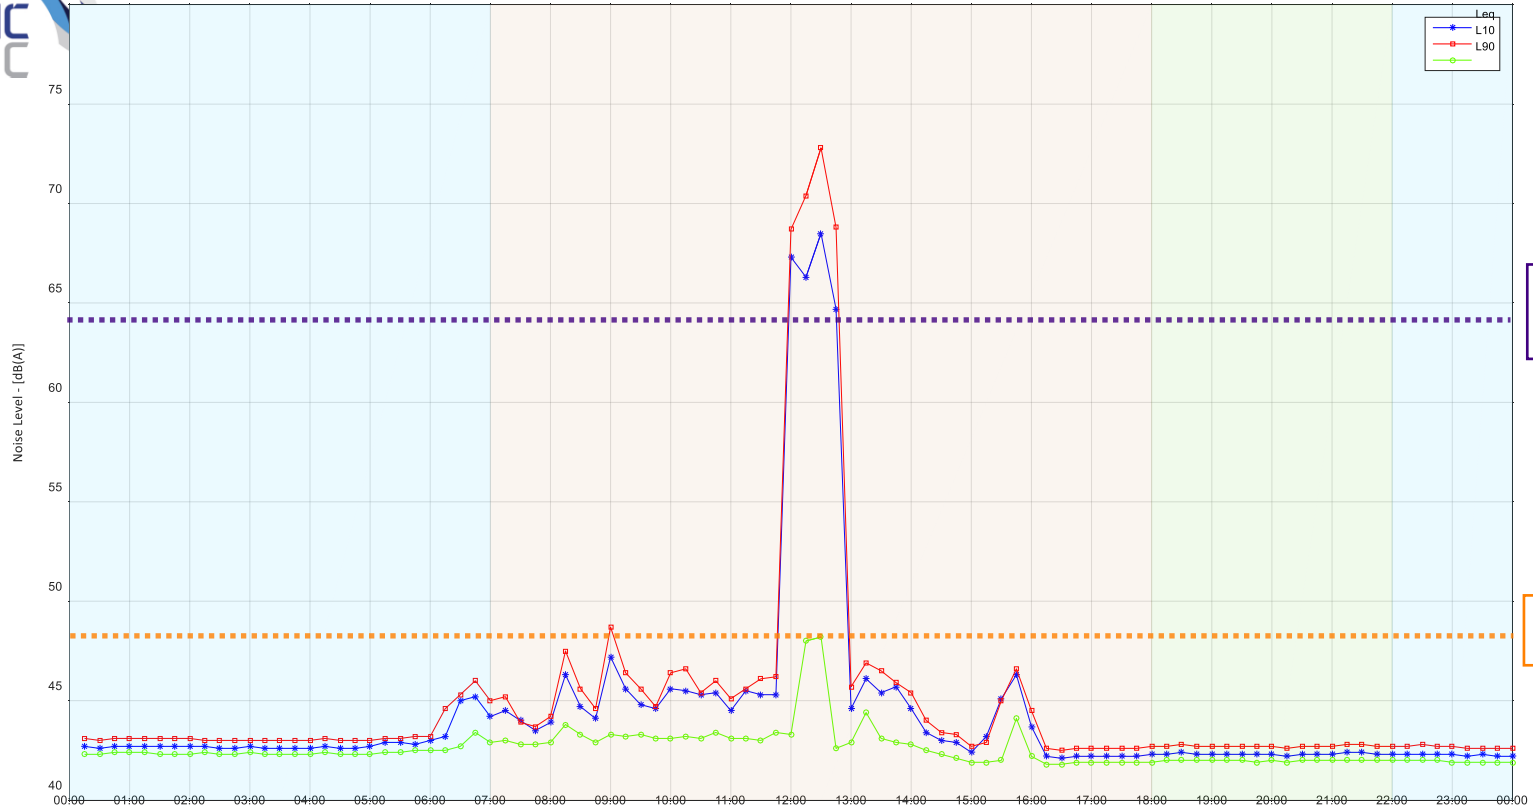
### Centenary Institute - L4 Surgery: Friday 01 March, 2024

- Measured noise levels were observed to be above the holding, breeding, and observation rooms noise management level on 01/03/2024.
- Noise levels were measured for a period of 1 hour before returning to being below the noise management level.
- Acoustic Logic note that it is unlikely that these measured noise levels are indicative of construction activity, due to the resultant noise levels when compared with the levels that were measured within the periods surrounding this hour period, noting that measured noise levels were significantly below the Surgery Room NML for the remainder of the day.
- Measured noise levels are maintained below the noise management levels for the remainder of the monitoring period.

Animal Housing / Breeding /  
Observation Room NML  
 $\leq 64\text{dB(A)}L_{\text{eq}}$

Animal Operating Room NML  
 $\leq 48\text{dB(A)}L_{\text{eq}}$

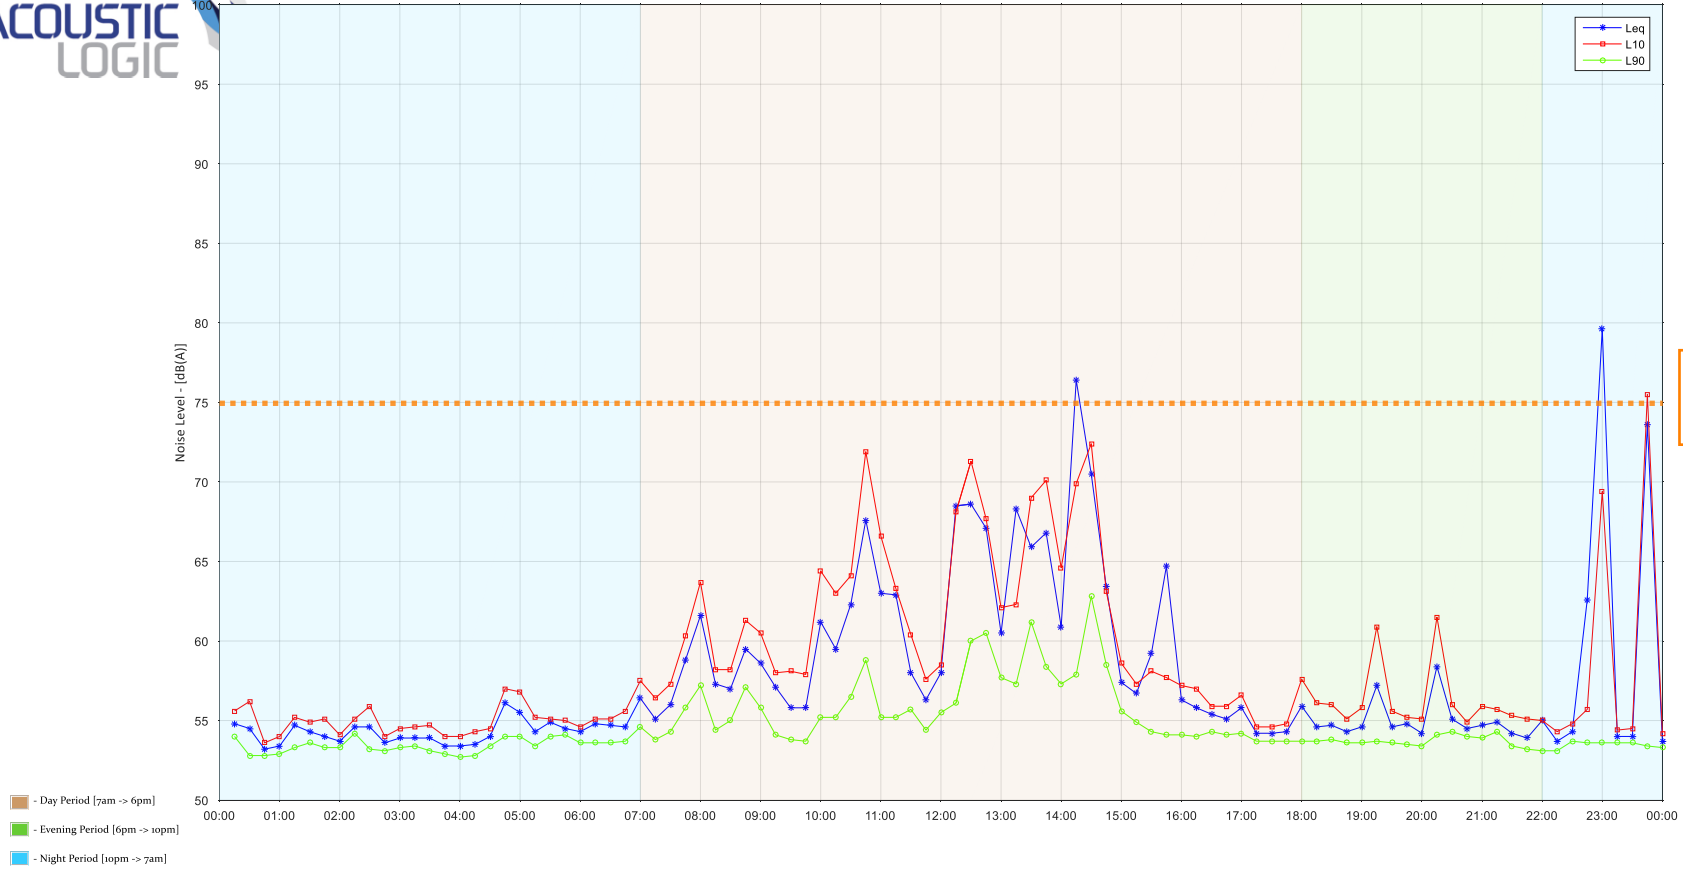
### Outside Susan Wakil Health Building: Monday 19 February, 2024

- Notwithstanding, and based on this reduction, measured noise levels which have been attributed to construction activity were observed to be above the noise management level on the following dates:

Education NML  
(Including correction)  
 $\leq 75\text{dB(A)}L_{\text{eq}}$

- Noise levels impacting Susan Wakil will be continued to be monitored throughout the early works construction to assess the impact of this receiver.

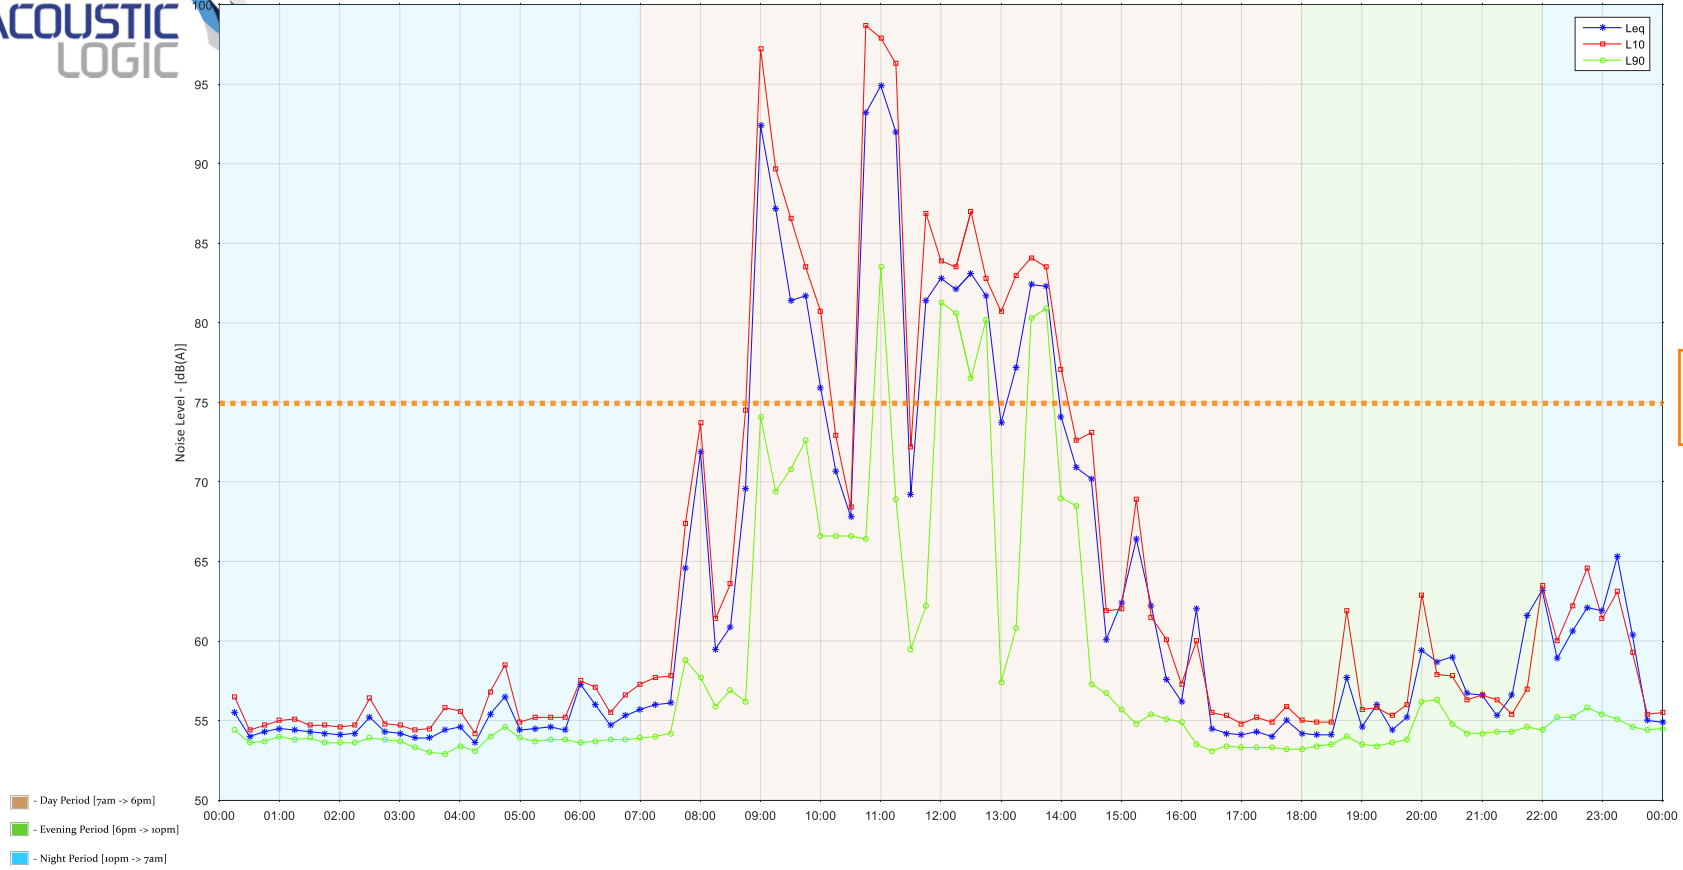
### Outside Susan Wakil Health Building: Wednesday 21 February, 2024

Education NML  
(Including correction)  
 $\leq 75\text{dB(A)}L_{\text{eq}}$

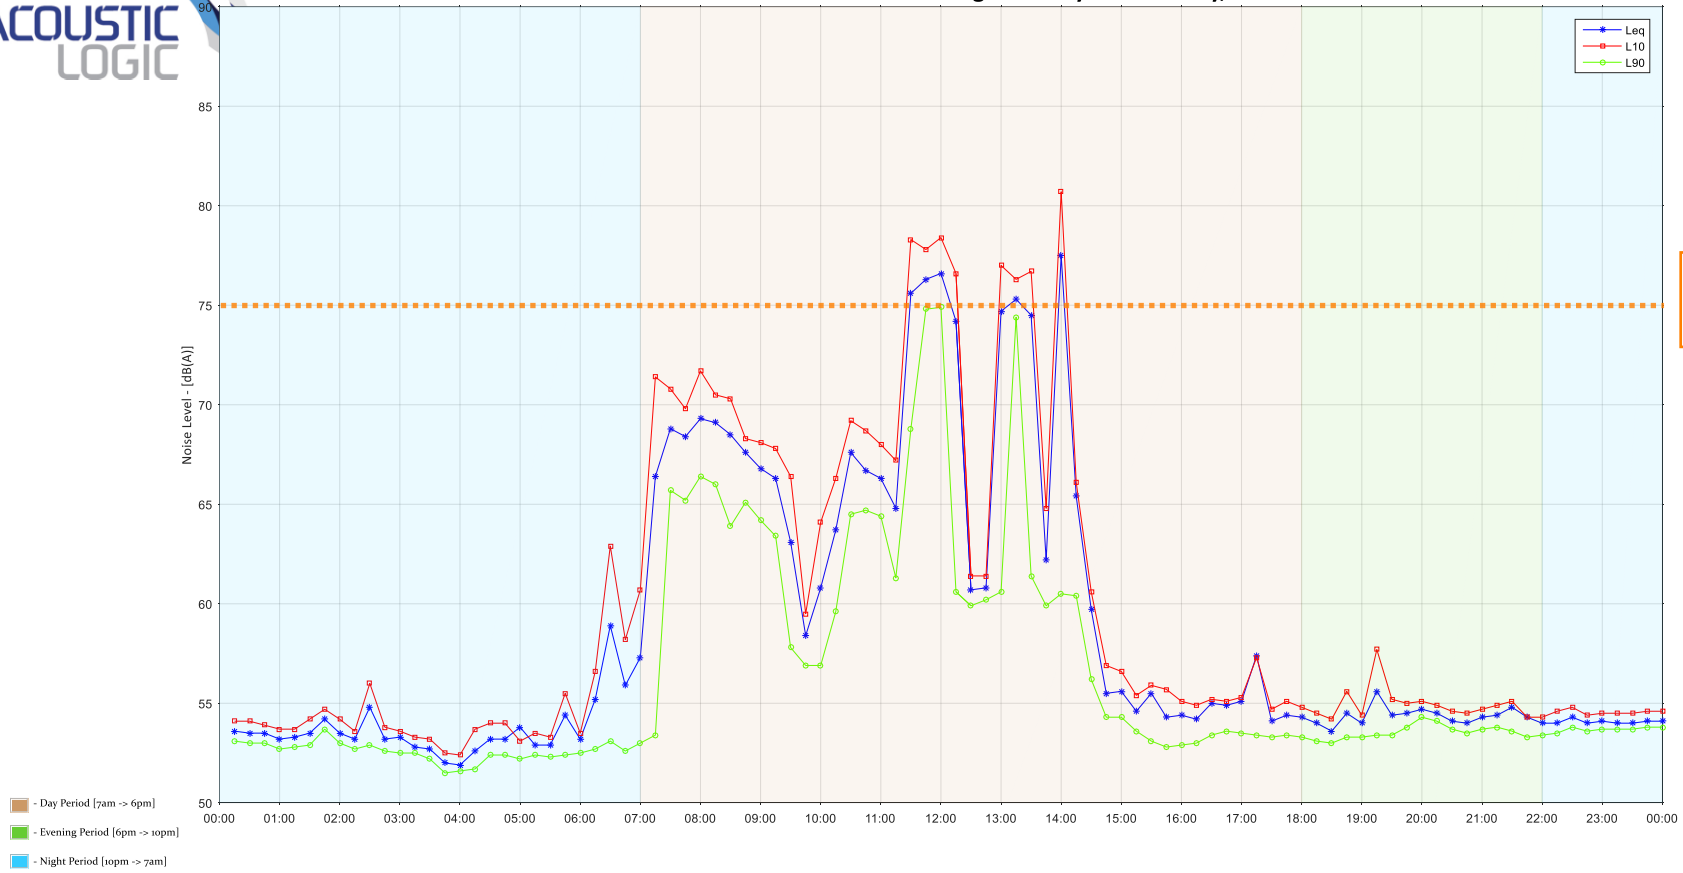
### Outside Susan Wakil Health Building: Tuesday 27 February, 2024

**Education NML  
(Including correction)  
≤ 75dB(A)<sub>L<sub>eq</sub></sub>**
