RE: Noise & Vibration Monitoring Reporting – December 2023

CONSTRUCTION NOISE AND VIBRATION REPORT

**Stage 3 St. George Hospital,
16 Kensington Street,
Kogarah**

8 December 2023
Ref: PAR-23661-NVR-W30 [A]

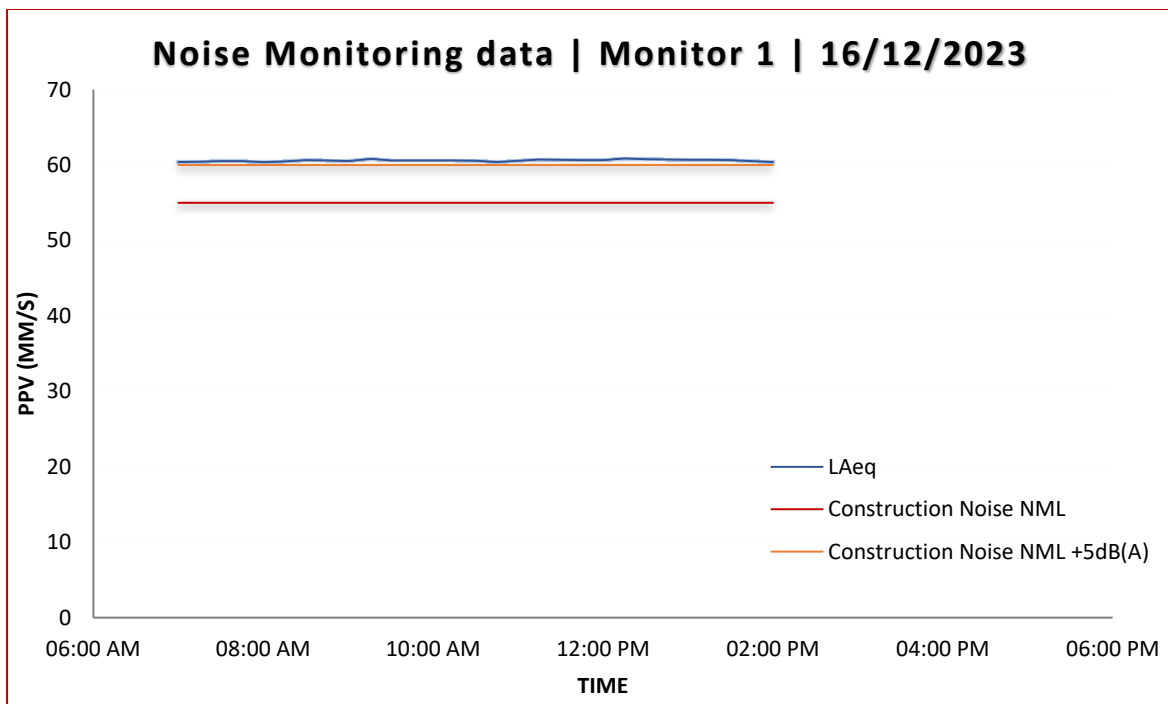
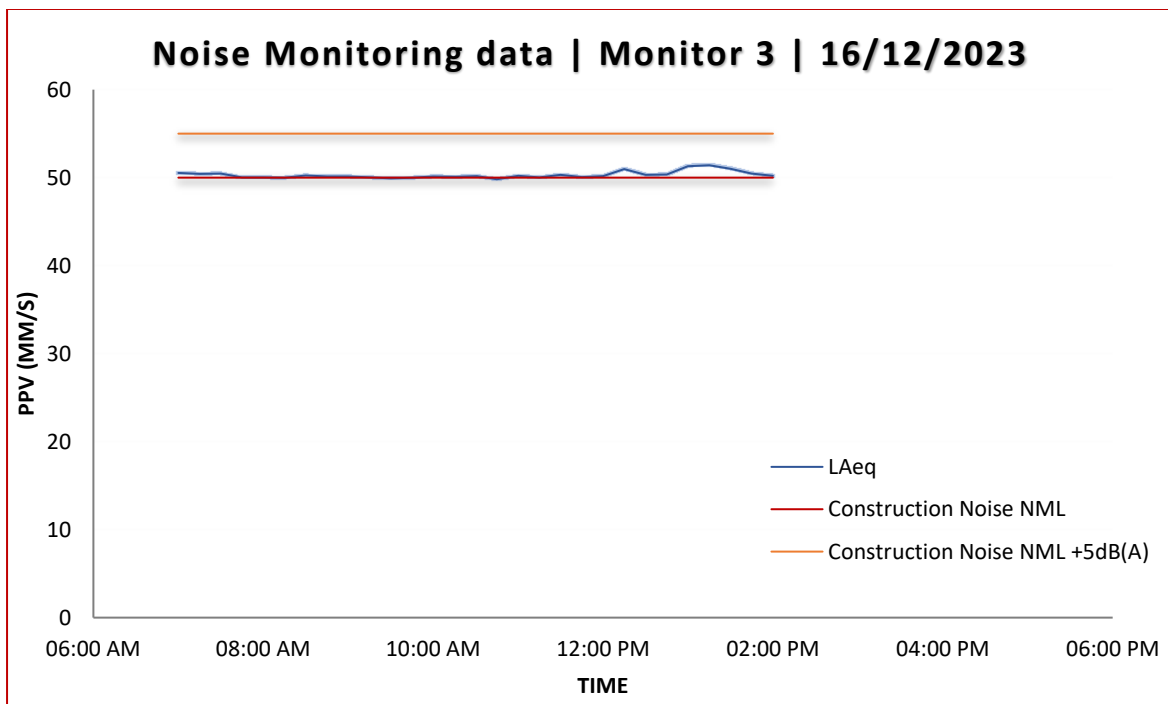
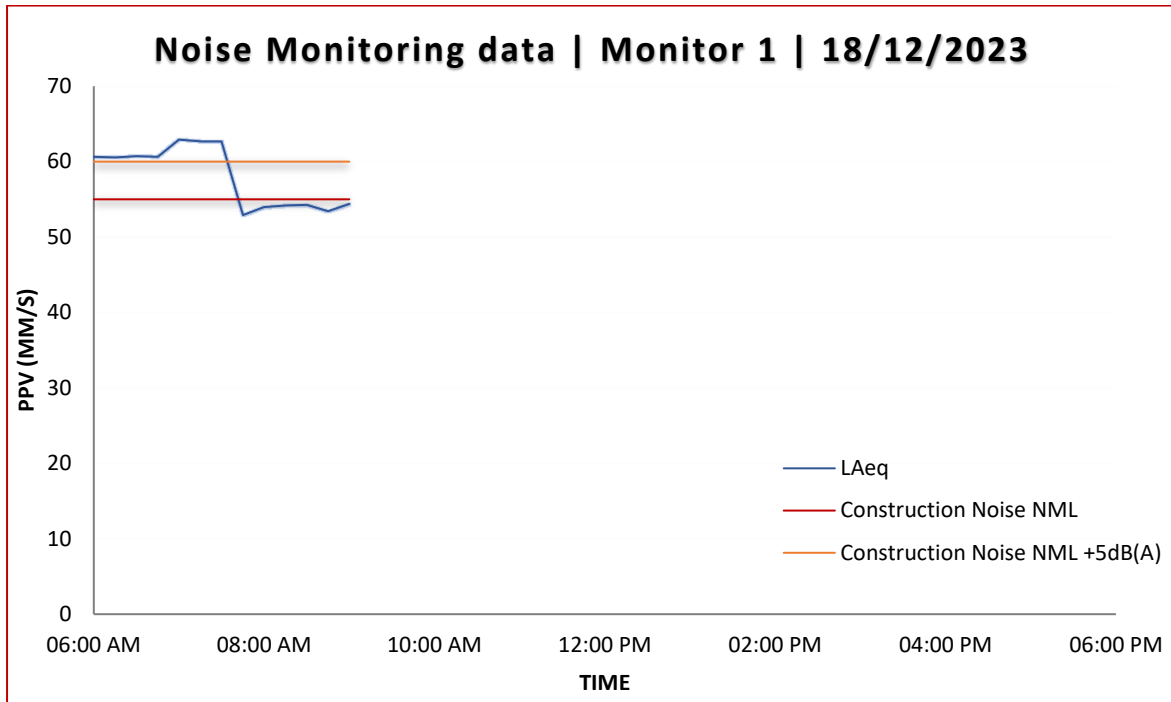
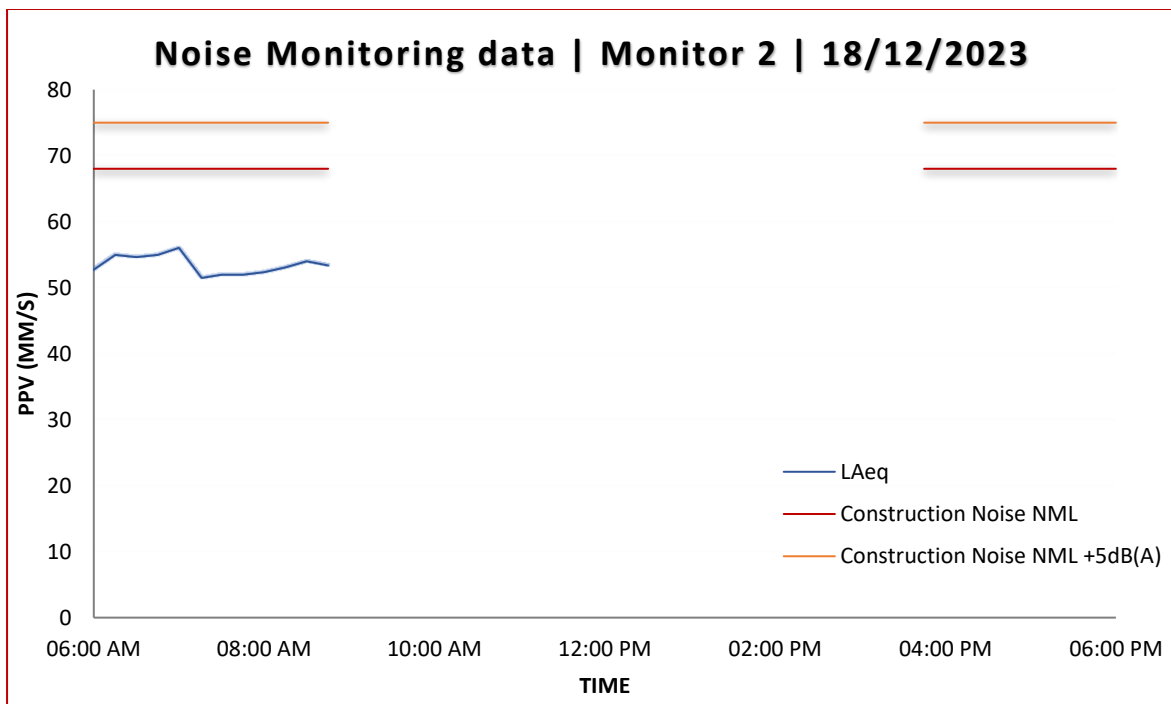
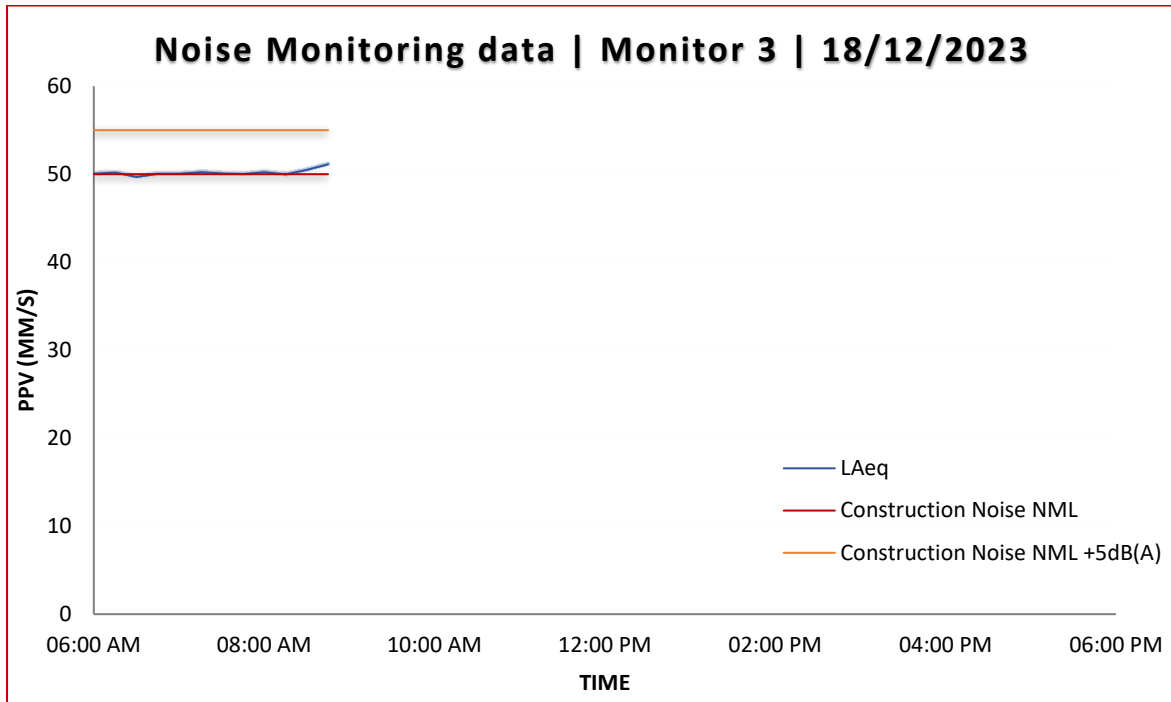
Appendix 2 – Noise Monitoring Date

The results found in *Table 7* summarises the noise level recorded for this project. During the monitoring period, noise monitor at Location 1 have exceeded the criteria by up to 04 dB(A) for the Noise Affected NML and up to 01 dB(A) for Highly Noise affected level set for this site. For Location 2 and Location 3, the NML were within the criteria set for this site. It should be noted that the exceedance at Location 2 are from trucks idling adjacent to the noise monitor. Further monitoring is recommended, and vibration and noise controls should be implemented to maintain the structural integrity of surrounding structures and avoid discomfort to surrounding residents. As per client's request, the vibration monitor 3 was off-hired on 07/11/2023 and no further data was collected for this monitor.
