Royal Prince Alfred Hospital Redevelopment (RPAH Redevelopment)

Construction Noise and Vibration Monitoring Report 23

Client Doc. No. RPA-ACO-ACL-RPT-MW-000026 - Rev A

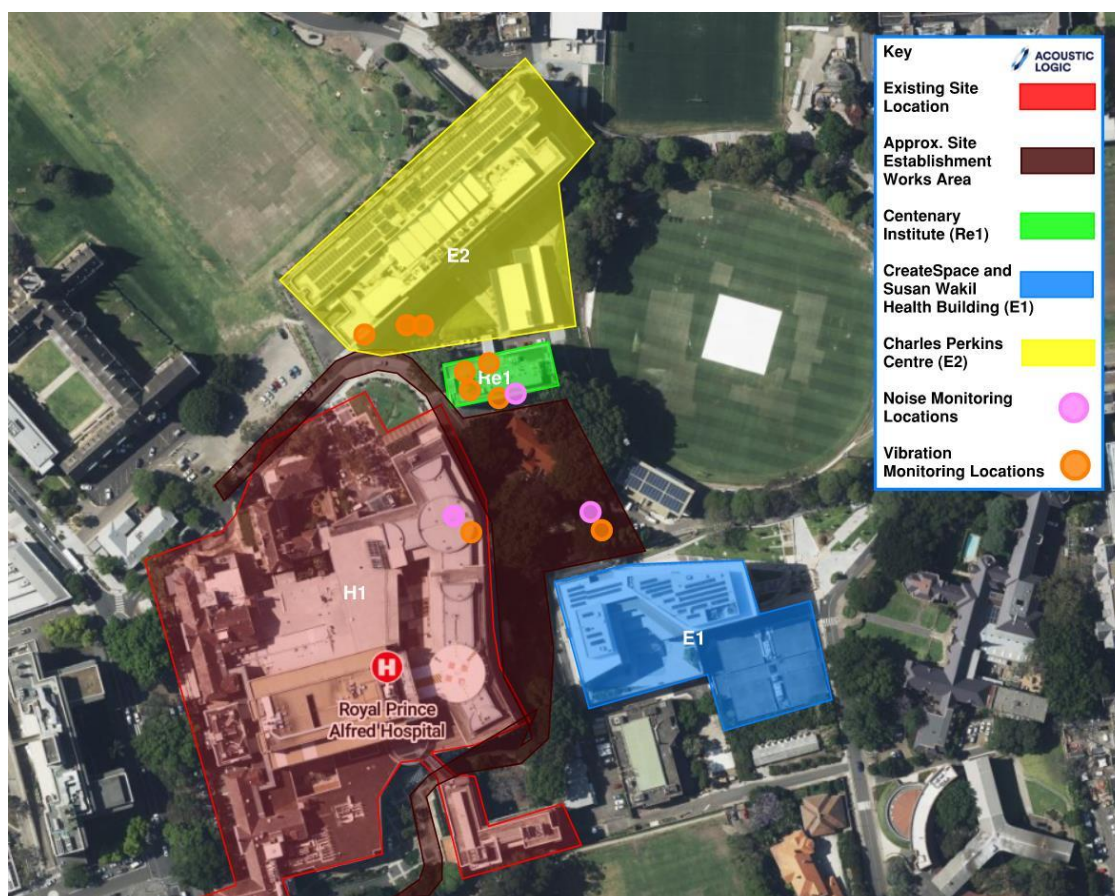
Figure 1: Aerial Site Map with Nearest Sensitive Receivers (Sourced from Sixmaps)

See an aerial photo in Figure 1 below for detailed receiver locations.

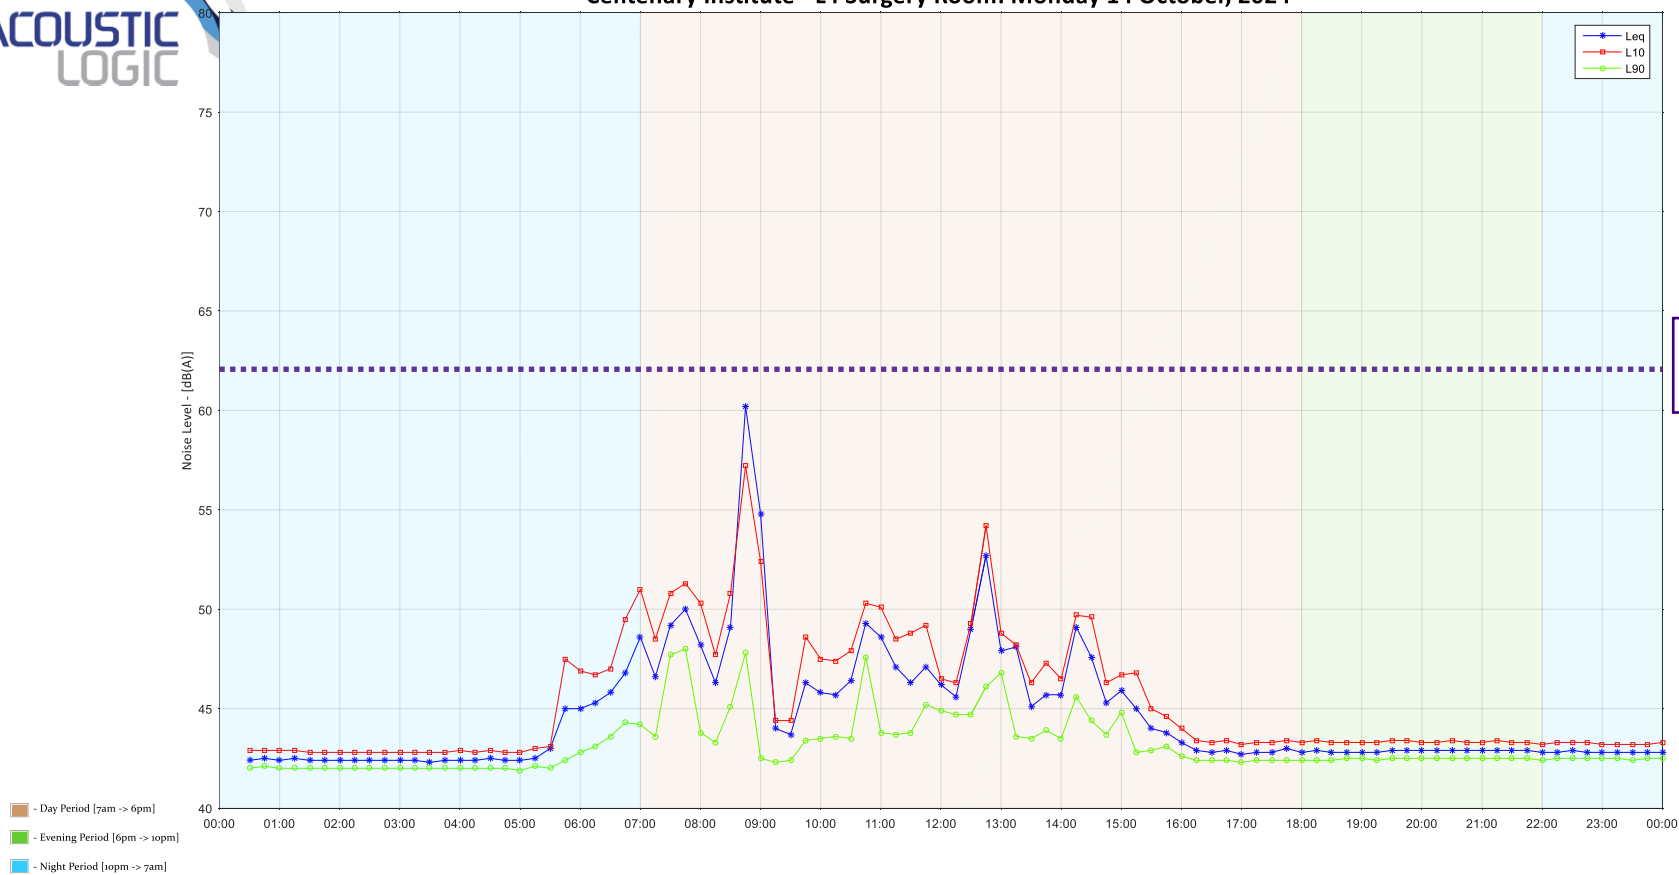
Centenary Institute - L4 Surgery Room: Monday 14 October, 2024

Animal Housing / Breeding /
Observation Room NML
 $\leq 62\text{dB(A)}_{\text{Leq}}$

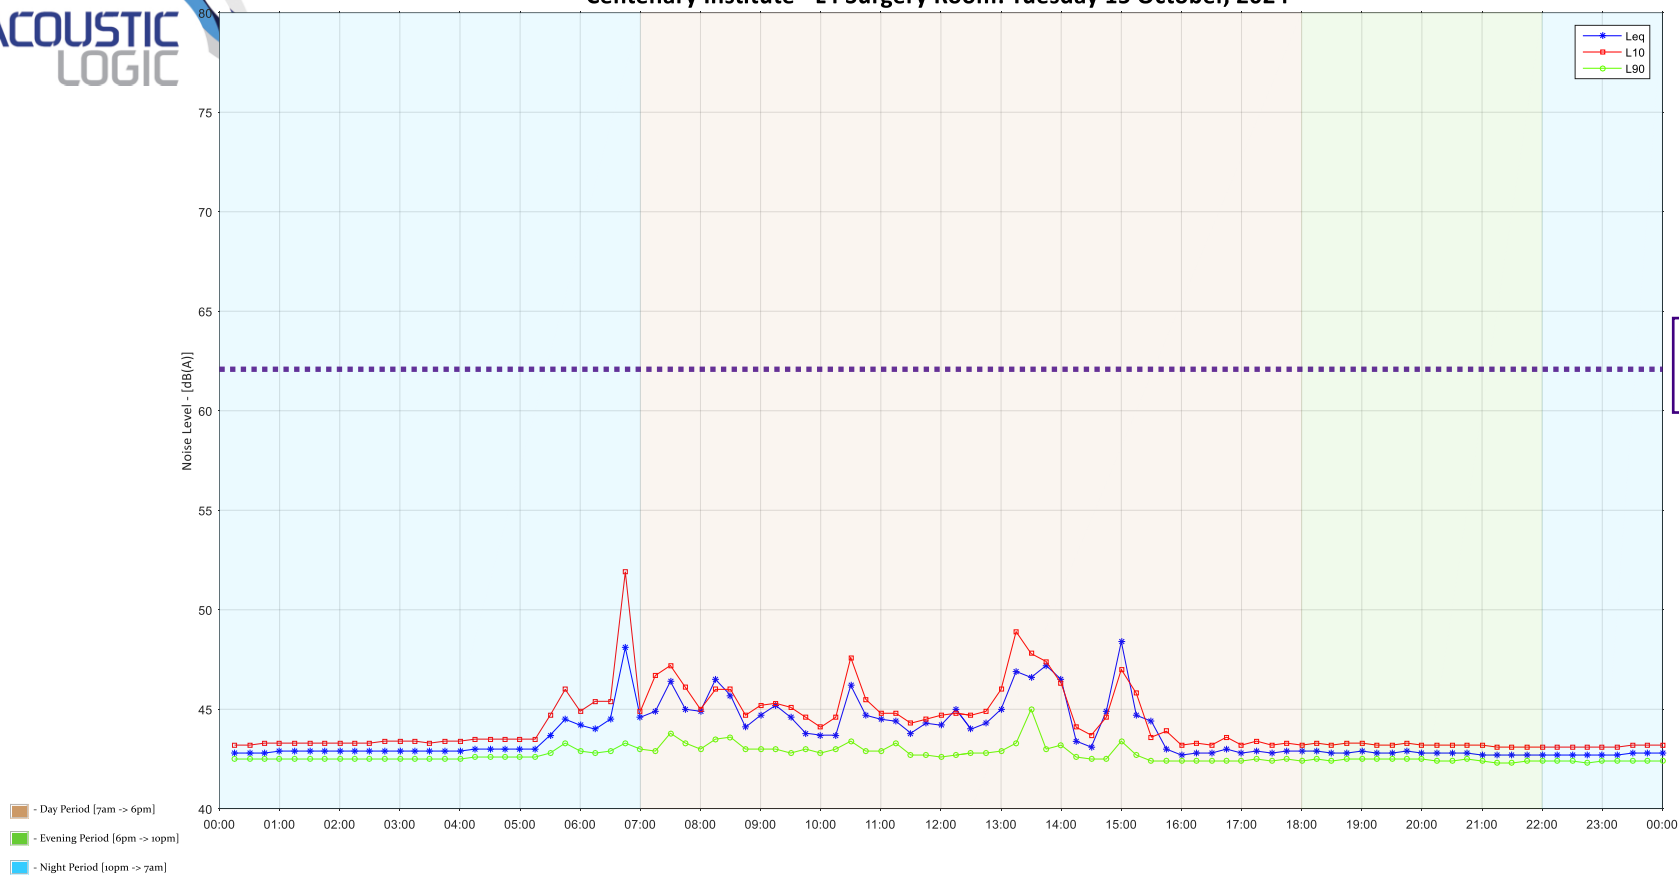
Centenary Institute - L4 Surgery Room: Tuesday 15 October, 2024

Animal Housing / Breeding /
Observation Room NML
 $\leq 62\text{dB(A)}_{\text{Leq}}$

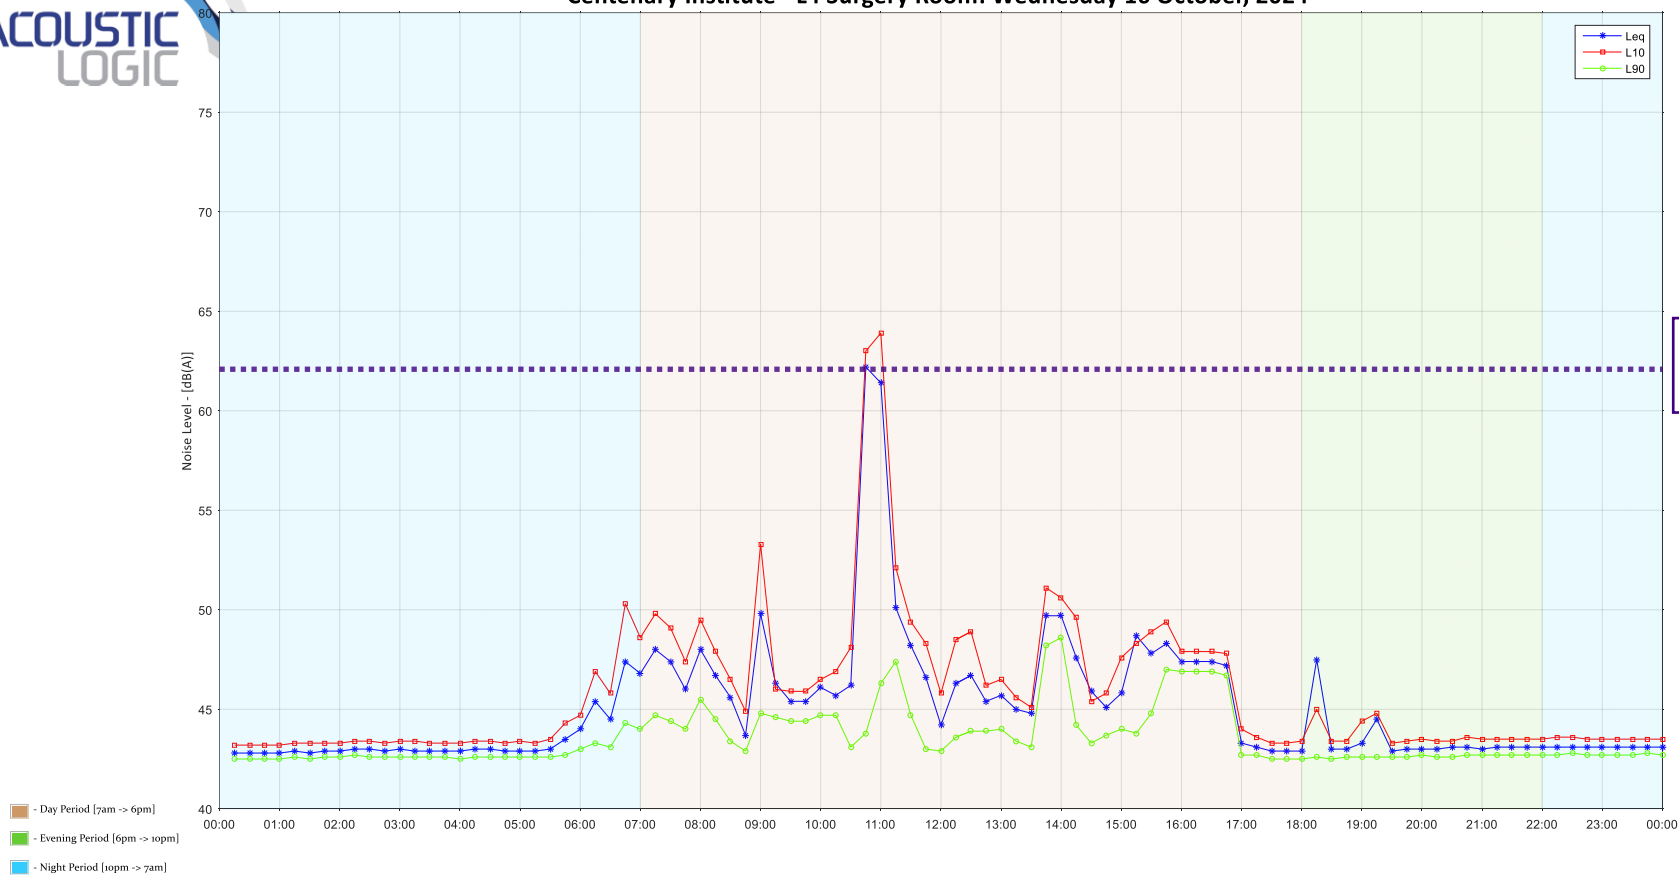
Centenary Institute - L4 Surgery Room: Wednesday 16 October, 2024

Animal Housing / Breeding /
Observation Room NML
 $\leq 62\text{dB(A)}_{\text{Leq}}$

- One 15-minute period on 16/10/2024 was recorded at an internal noise level of 62.2dB(A) within the surgery room, or 0.2dB(A) above the NML within the space.

- Reviewing the results measured at the monitoring station, Acoustic Logic conclude that the result is unlikely to be caused by construction activity, noting that noise levels within surrounding periods to the 30-minute period of elevated internal noise levels are significantly lower than this.

- Further, significant L_{max} measurements during the periods of elevated levels indicate the monitor was impacted by activity close to the microphone, as opposed to the construction site.

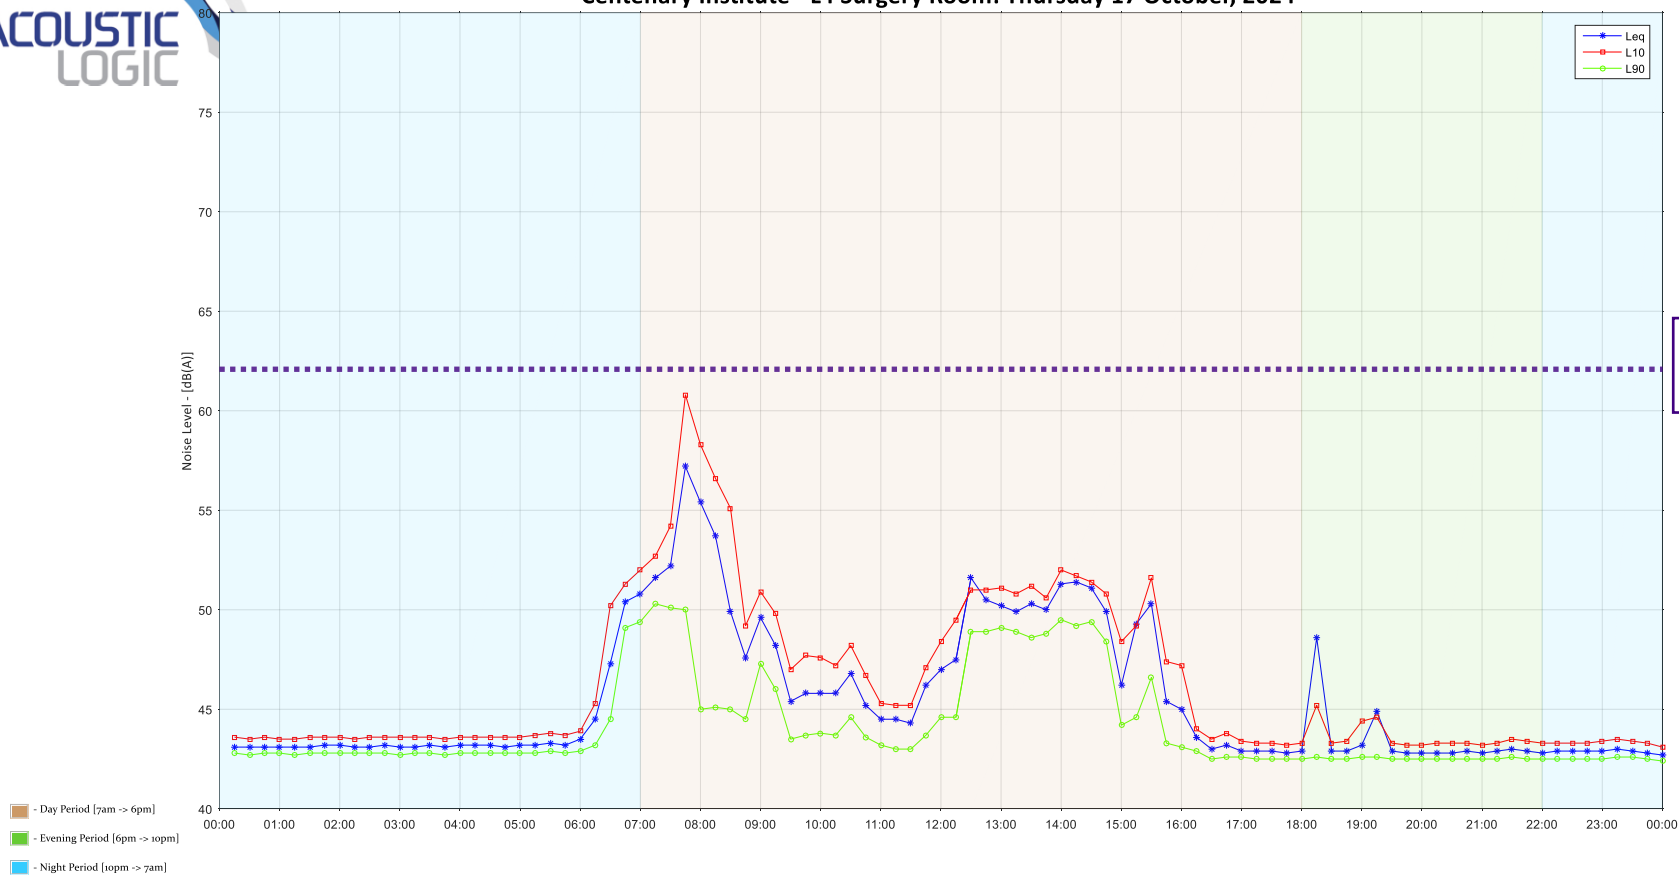
Centenary Institute - L4 Surgery Room: Thursday 17 October, 2024

Animal Housing / Breeding /
Observation Room NML
 $\leq 62\text{dB(A)}_{\text{Leq}}$

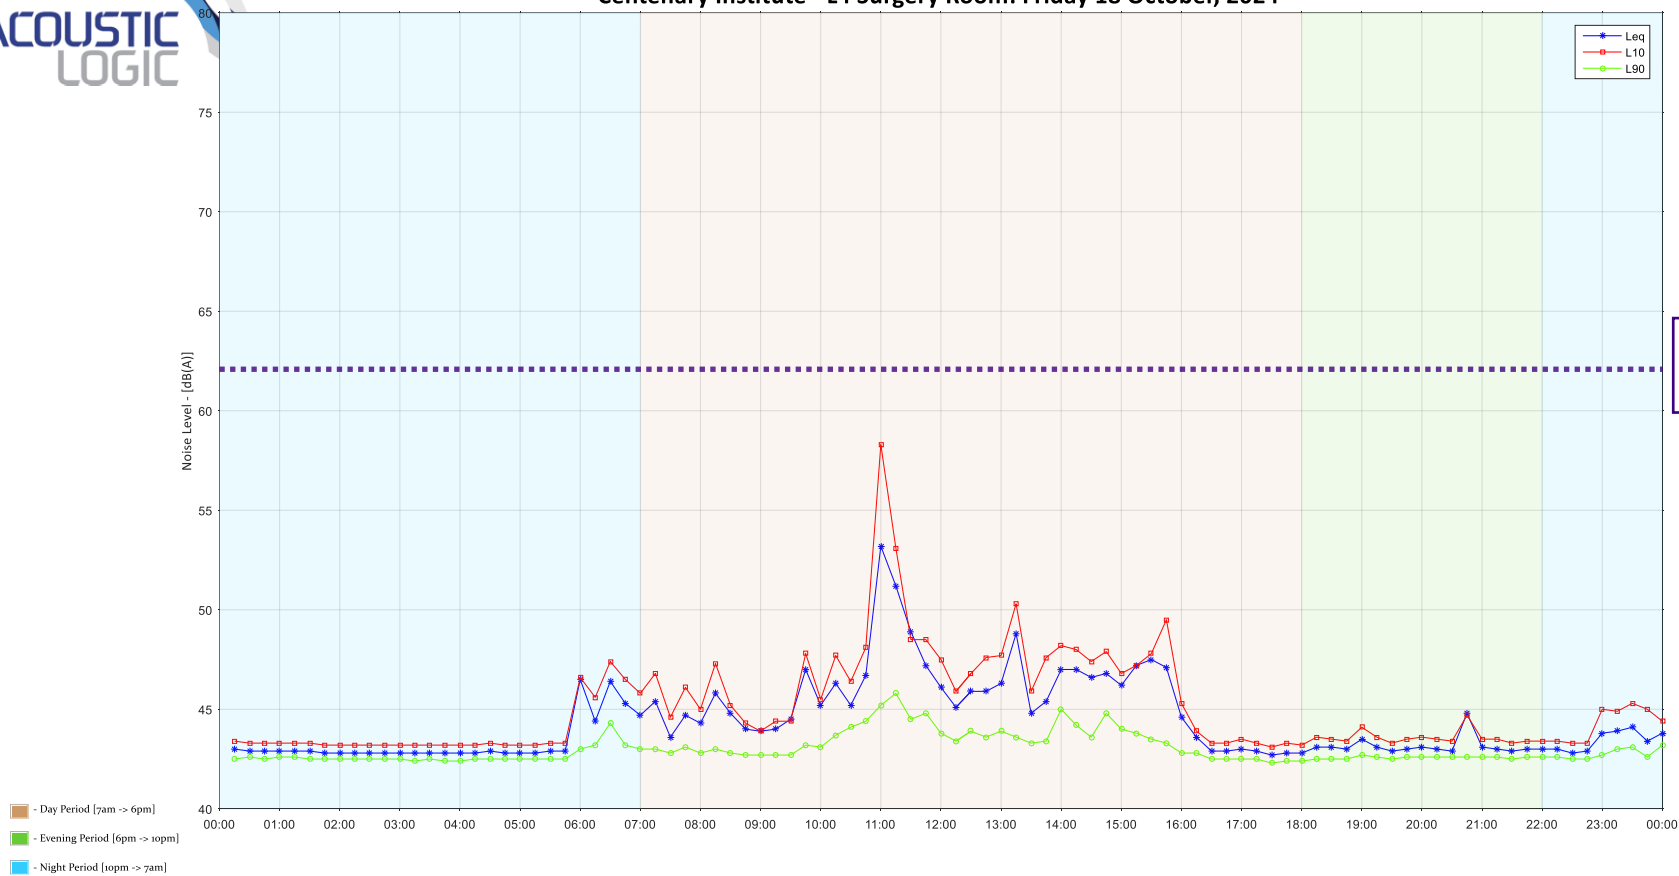
Centenary Institute - L4 Surgery Room: Friday 18 October, 2024

Animal Housing / Breeding /
Observation Room NML
 $\leq 62\text{dB(A)}_{\text{Leq}}$

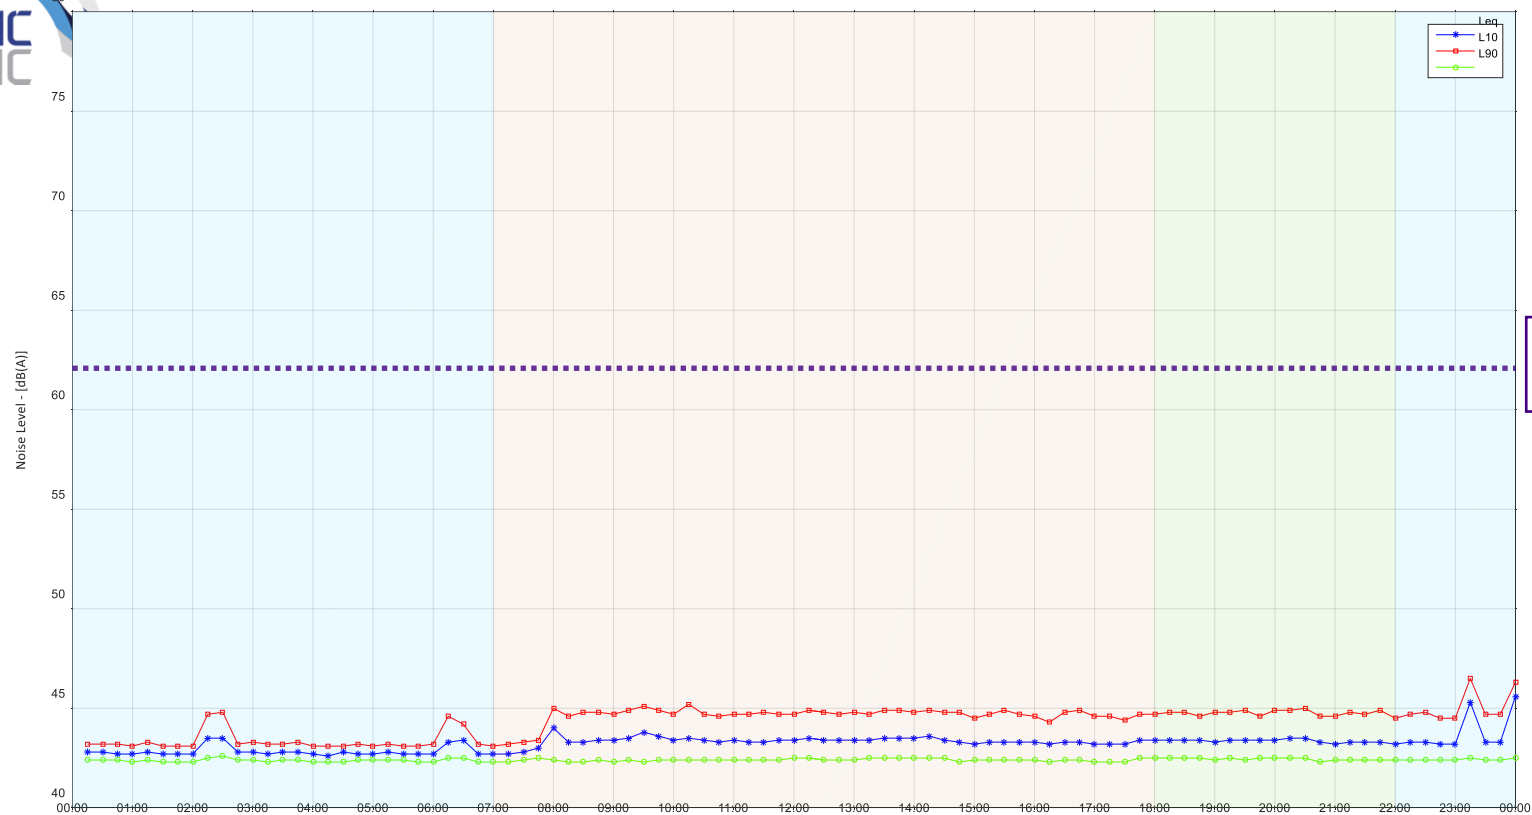
Centenary Institute - L4 Surgery Room: Saturday 19 October, 2024

Animal Housing / Breeding /
Observation Room NML
 $\leq 62\text{dB(A)}L_{\text{eq}}$

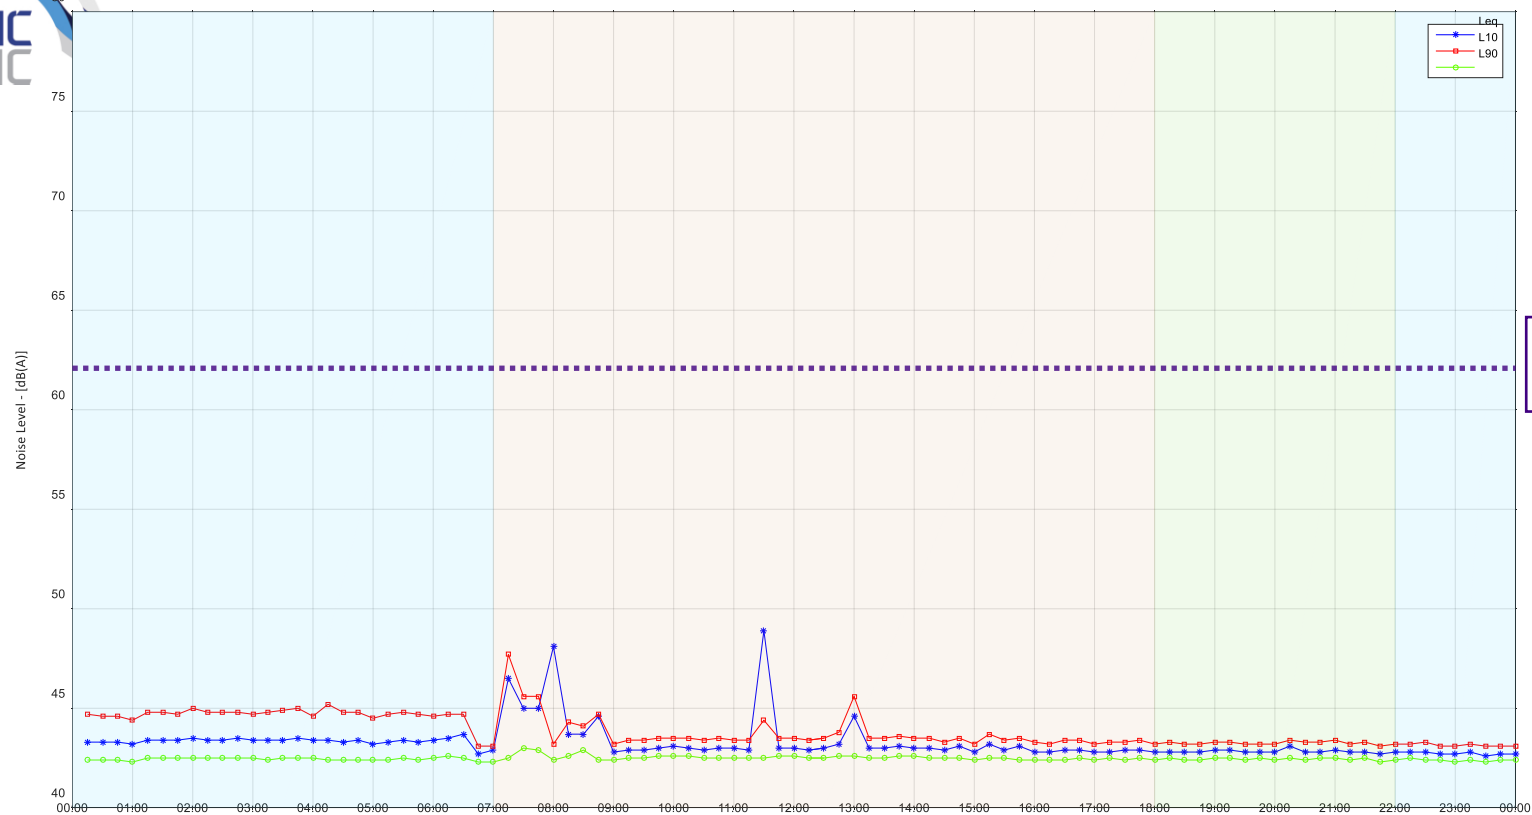
Centenary Institute - L4 Surgery Room: Sunday 20 October, 2024

Animal Housing / Breeding /
Observation Room NML
 $\leq 62\text{dB(A)}_{\text{Leq}}$

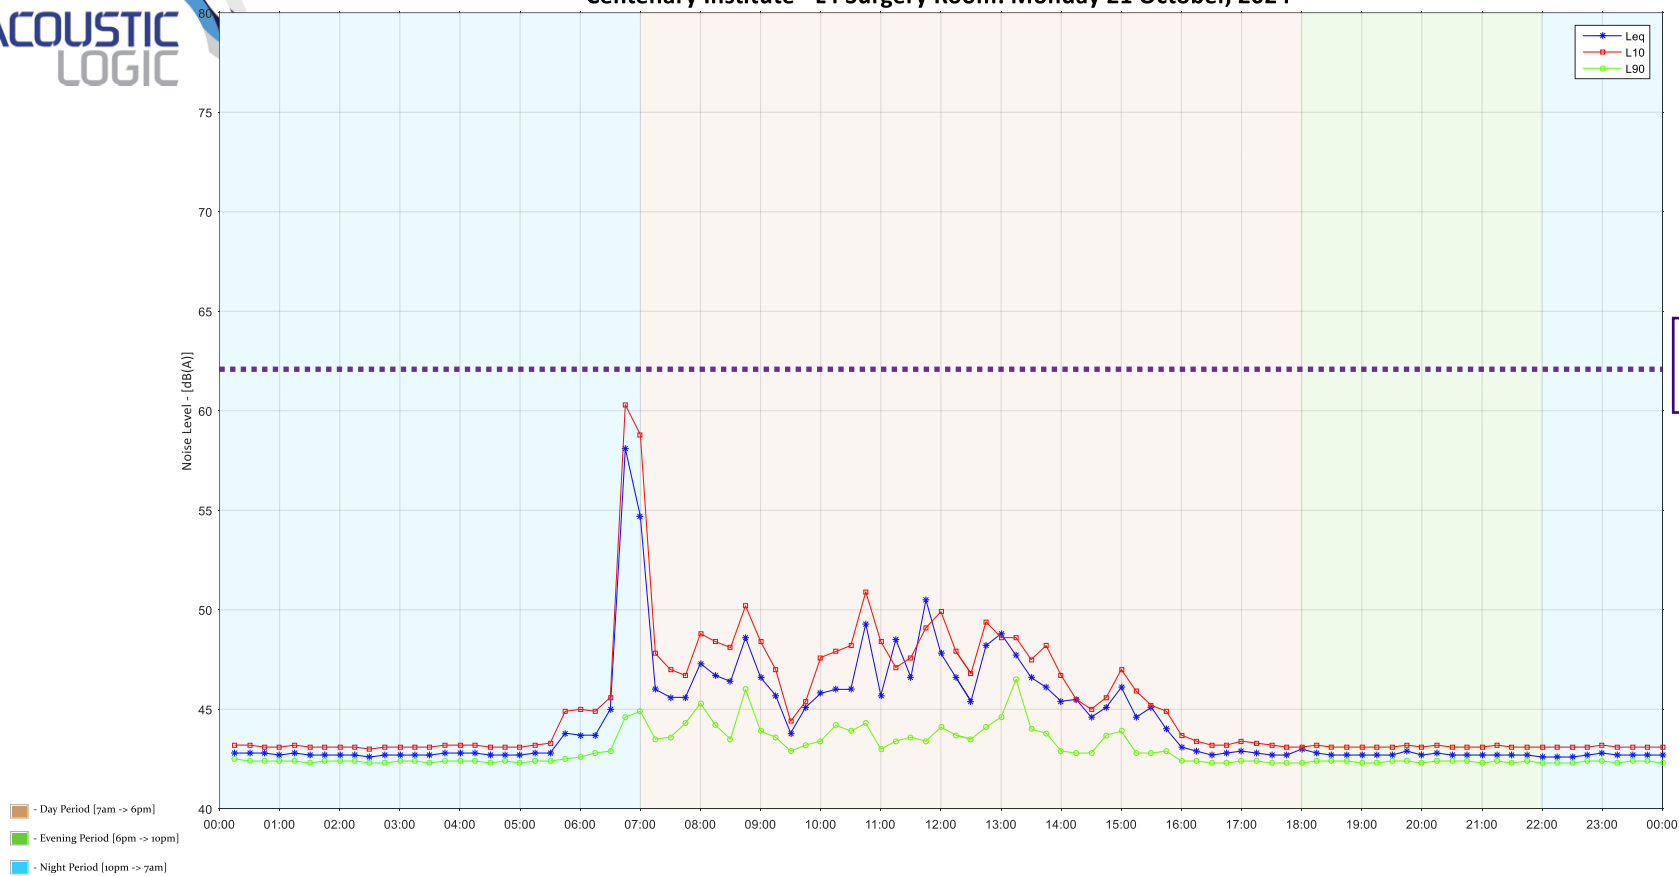
Centenary Institute - L4 Surgery Room: Monday 21 October, 2024

Animal Housing / Breeding /
Observation Room NML
 $\leq 62\text{dB(A)}_{\text{Leq}}$

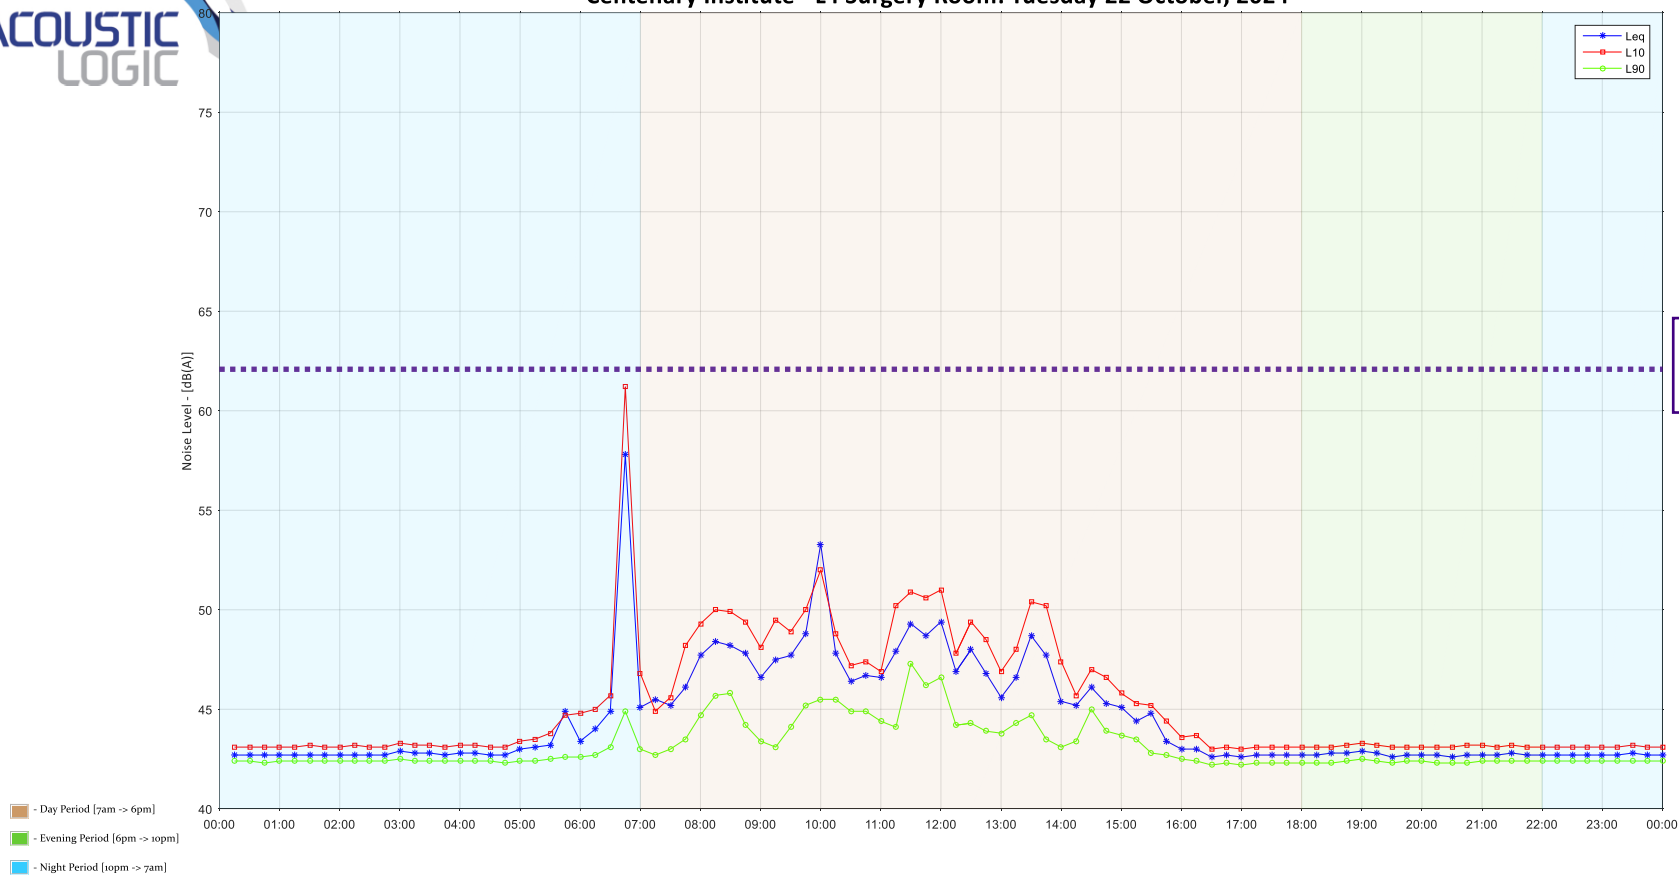
Centenary Institute - L4 Surgery Room: Tuesday 22 October, 2024

Animal Housing / Breeding /
Observation Room NML
 $\leq 62\text{dB(A)}_{\text{Leq}}$

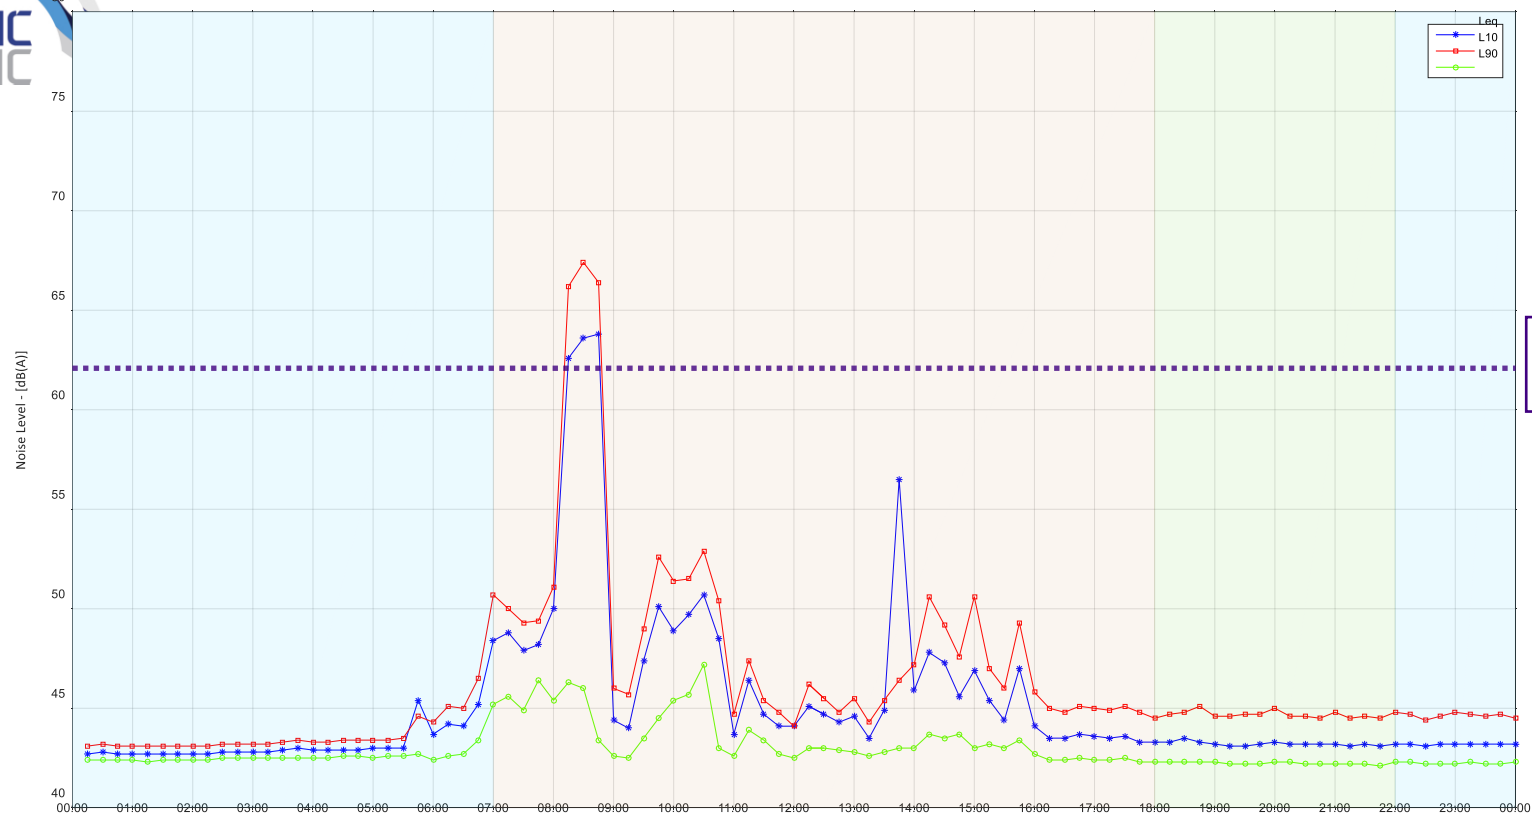
Centenary Institute - L4 Surgery Room: Wednesday 23 October, 2024

Animal Housing / Breeding /
Observation Room NML
 $\leq 62\text{dB(A)}_{\text{Leq}}$

- 24/10/2024.
- CI confirmed via correspondence that observed levels on the 23rd and 24th October were related to internal operational activity, and were not related to construction activity on site.

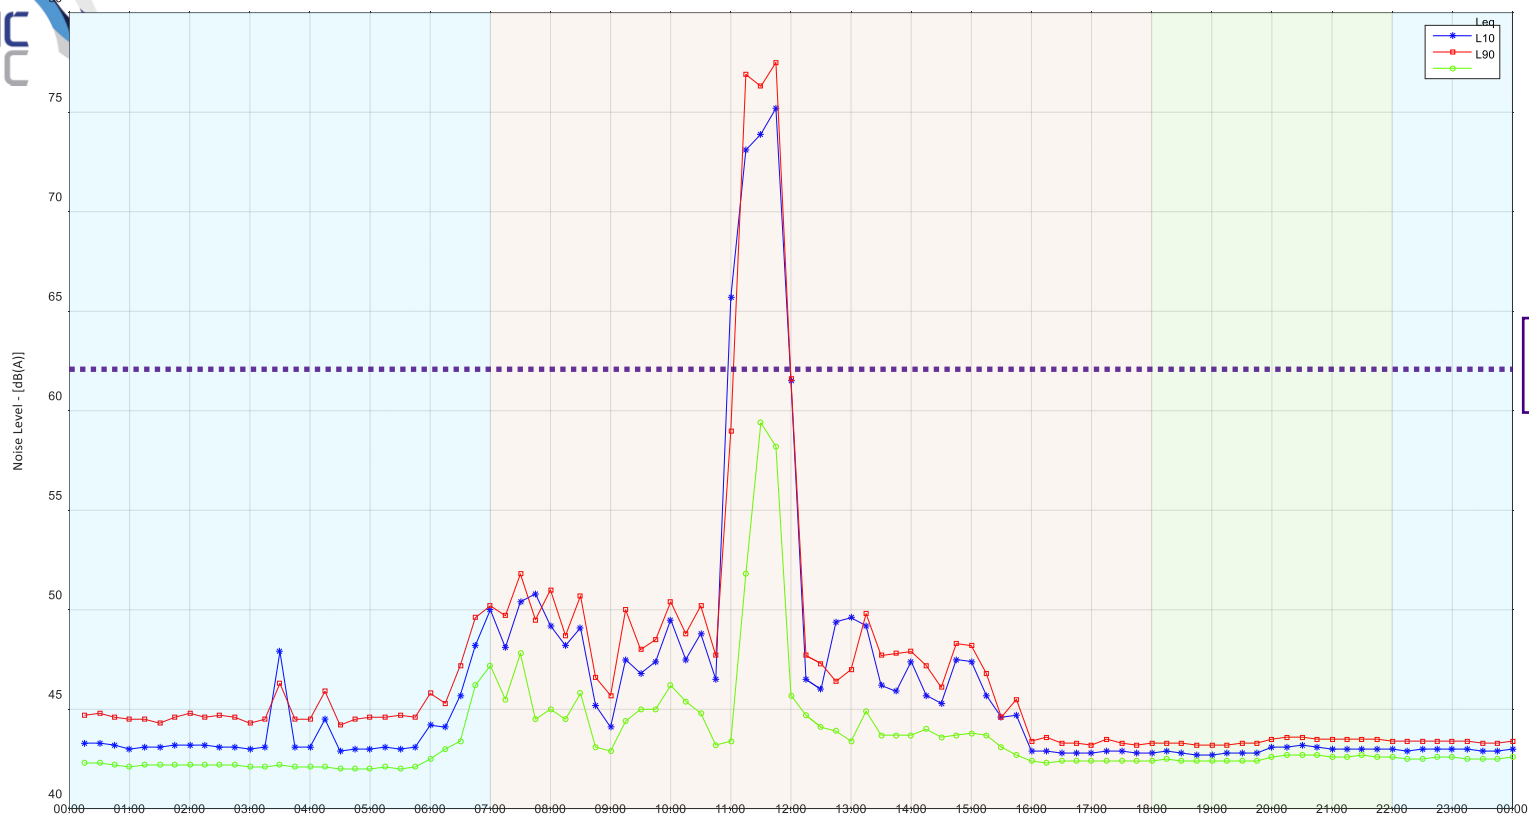
Centenary Institute - L4 Surgery Room: Thursday 24 October, 2024

Animal Housing / Breeding /
Observation Room NML
 $\leq 62\text{dB(A)}L_{\text{eq}}$

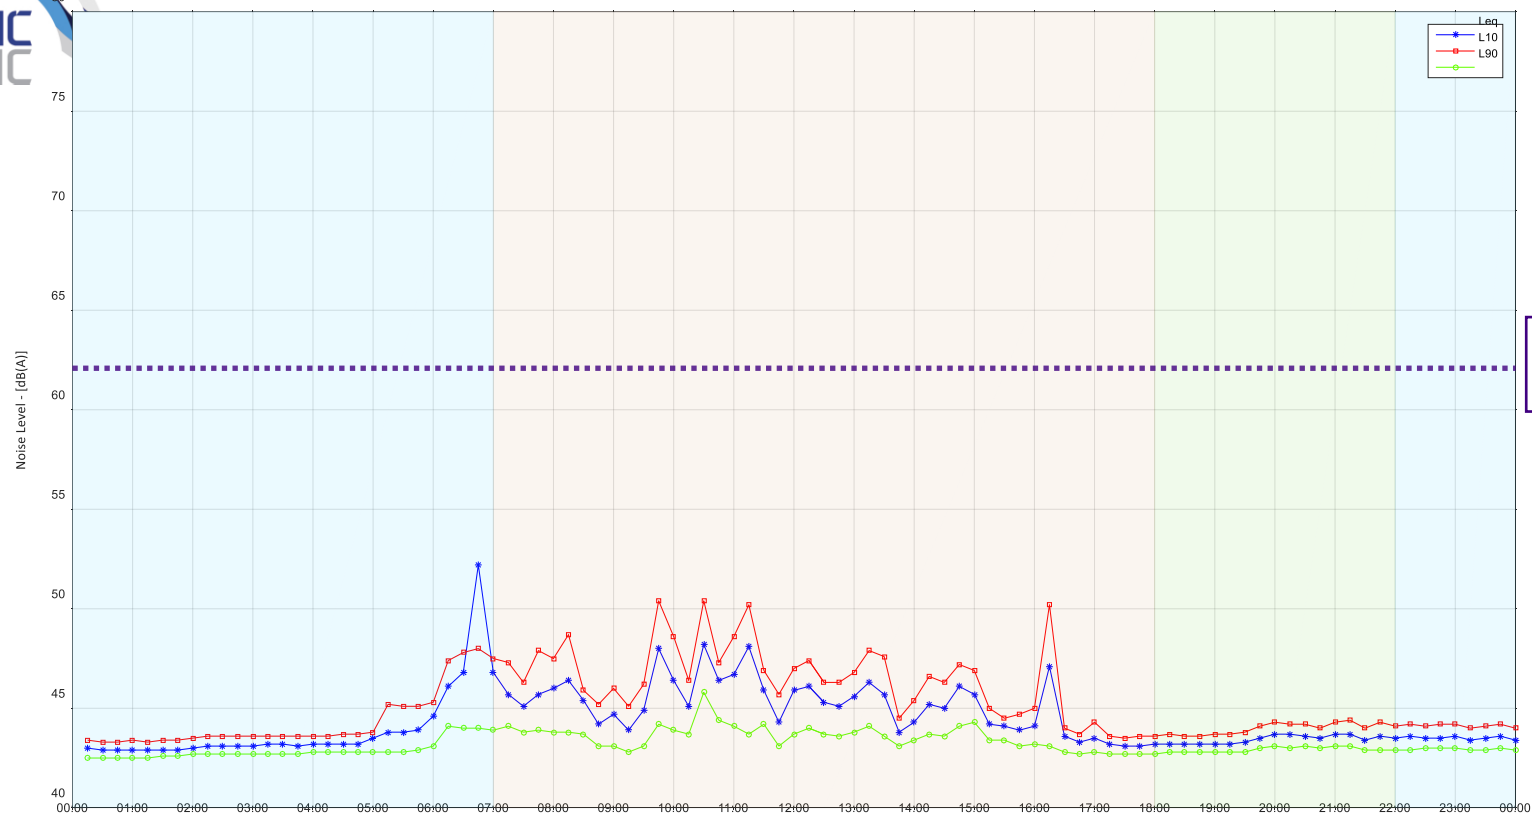
Centenary Institute - L4 Surgery Room: Friday 25 October, 2024

Animal Housing / Breeding /
Observation Room NML
 $\leq 62\text{dB(A)}_{\text{Leq}}$

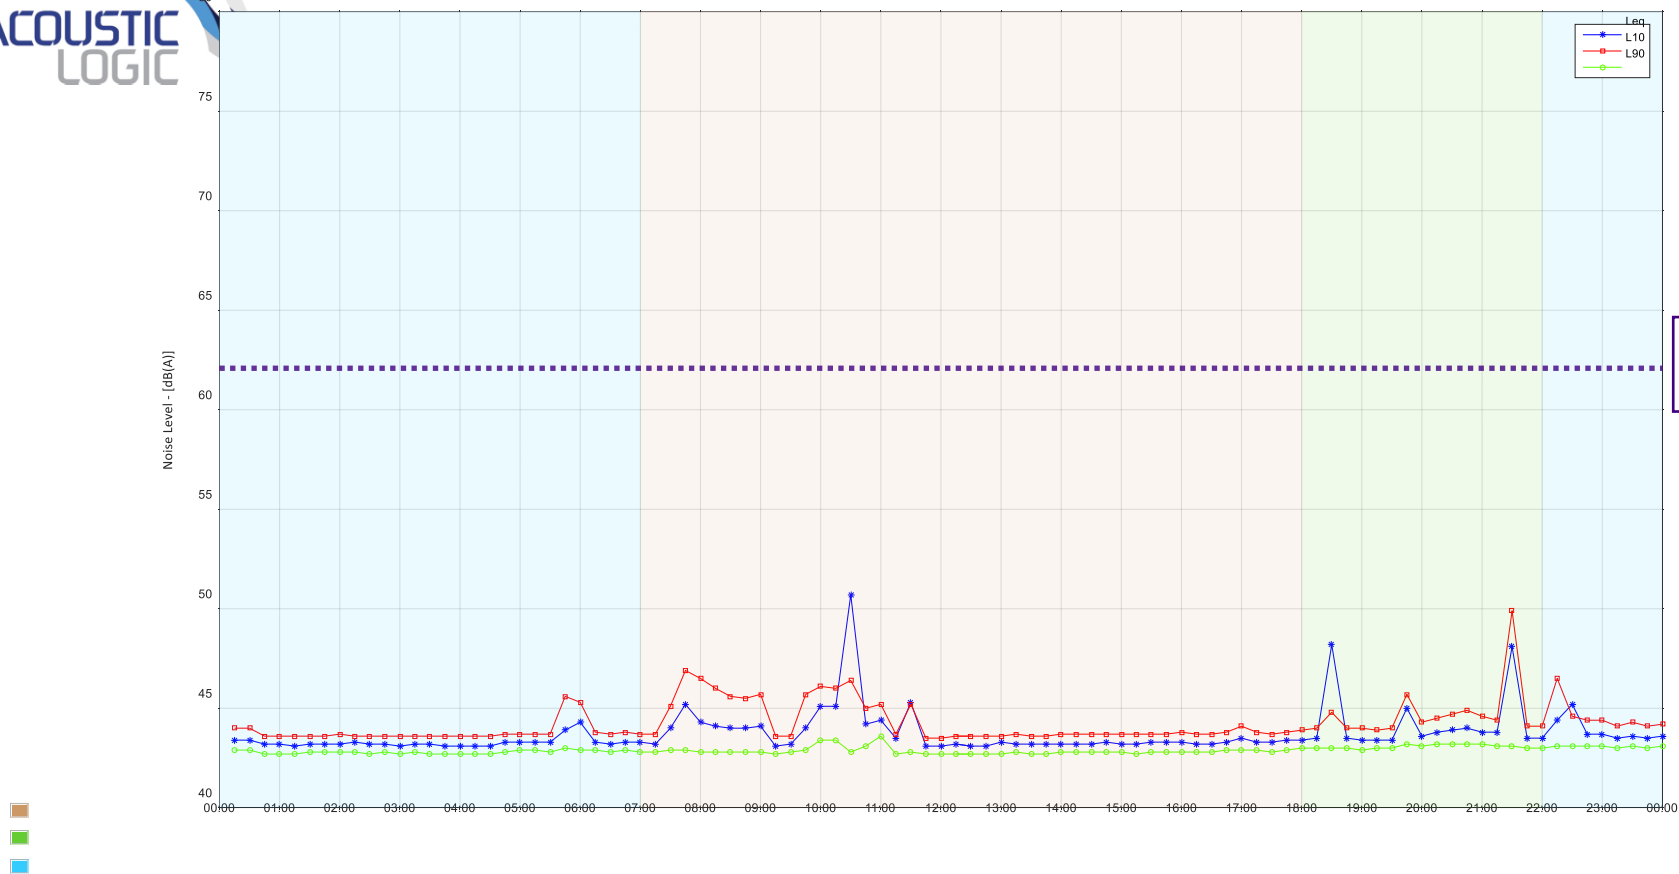
Centenary Institute - L4 Surgery Room: Saturday 26 October, 2024

Animal Housing / Breeding /
Observation Room NML
 $\leq 62\text{dB(A)}L_{\text{eq}}$

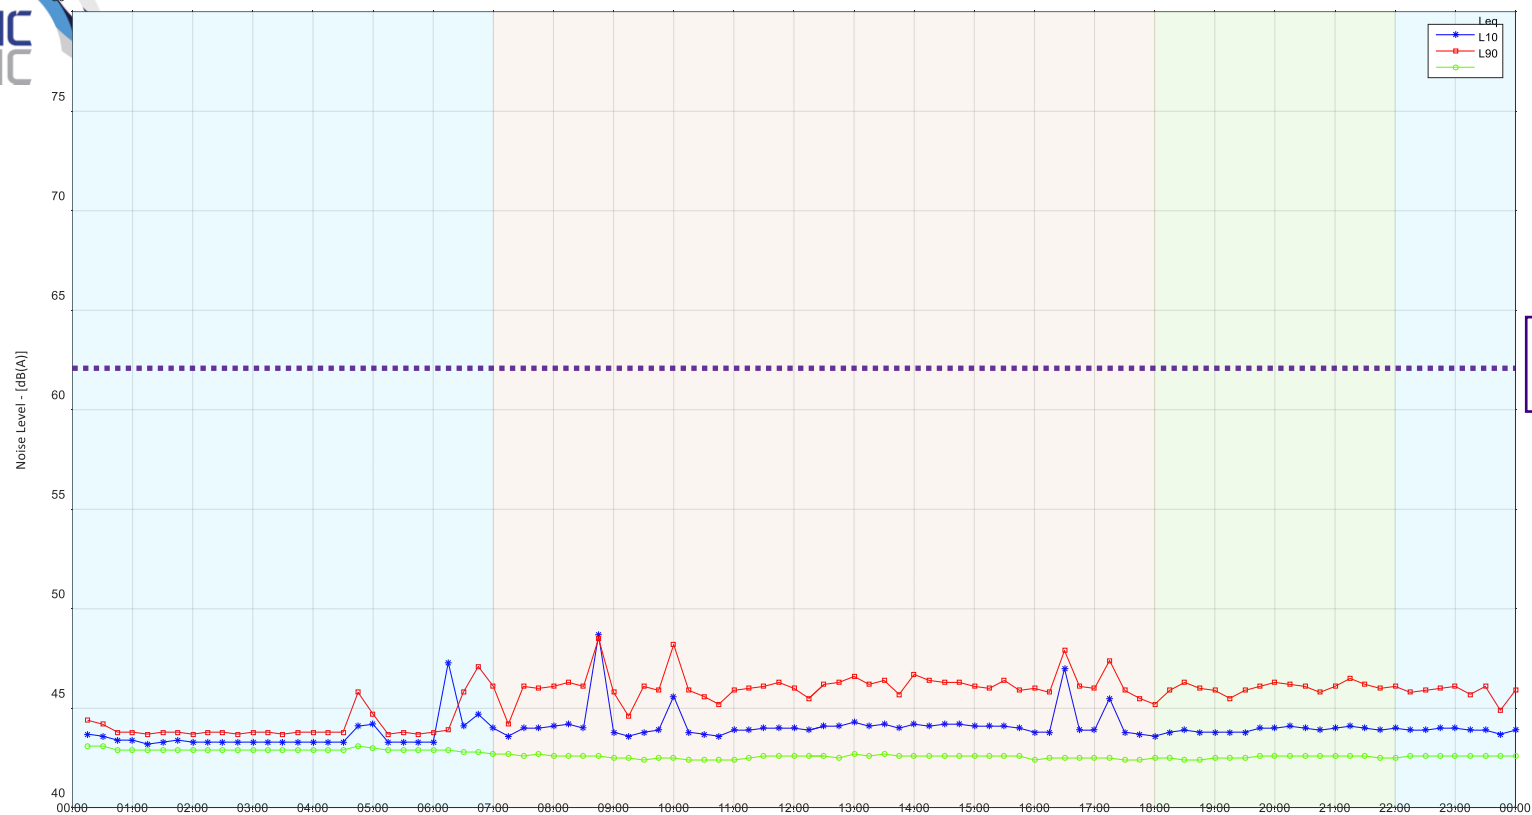
Centenary Institute - L4 Surgery Room: Sunday 27 October, 2024

Animal Housing / Breeding /
Observation Room NML
 $\leq 62\text{dB(A)}_{L_{eq}}$

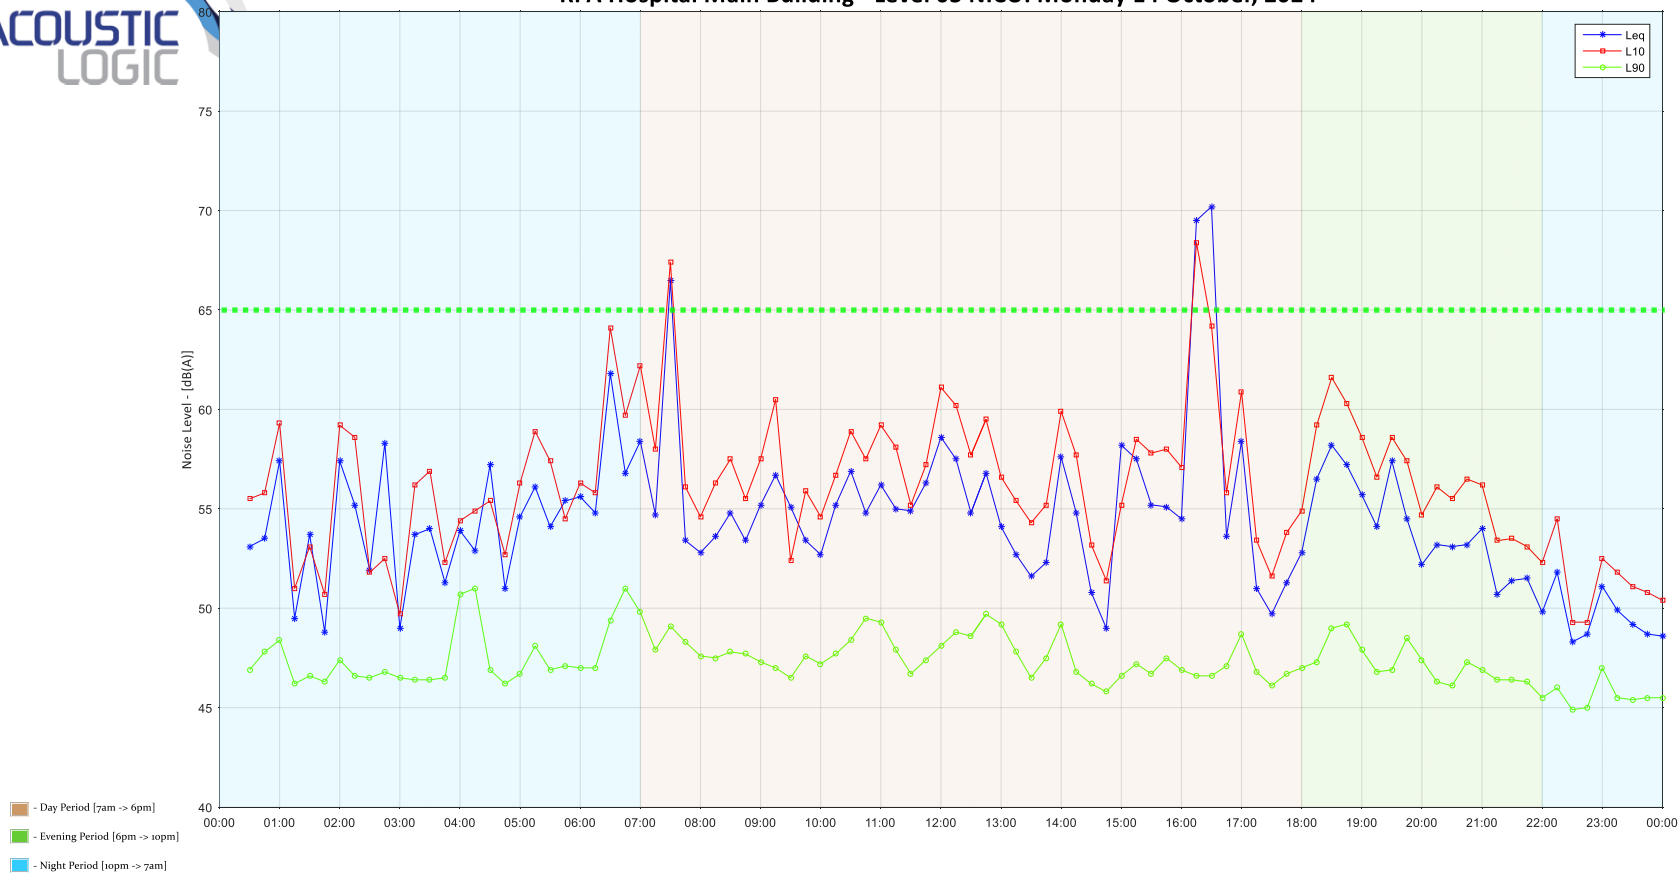
RPA Hospital Main Building - Level 03 NICU: Monday 14 October, 2024

NICU NML
 (Including correction)
 $\leq 65\text{dB(A)}_{L_{eq}}$

- The monitor is located underneath a benchtop and against two individual walls within the NICU area on Level 03 of the hospital main building. Due to the reflections experienced at the monitoring location due to this, a 5dB correction has been conservatively applied to the noise levels measured at the monitoring station.
- Noise levels were observed to be measured above the NML within the NICU space on the following dates:
 - 14/10/2024.
 - 16/10/2024.
 - 22/10/2024.

- Noise levels during construction hours were never observed to be above the NML for longer than one 15-minute period at a time, and hence it is likely that these events were caused by internal operational activity within the space, as opposed to construction works, noting that construction works are typically continuous in nature.
- We also note that there are 15 minute periods outside of construction hours where recorded levels are above the area's NML.
- Ongoing monitoring to continue within the NICU space.
