Royal Prince Alfred Hospital Redevelopment (RPAH Redevelopment)

Construction Noise and Vibration Monitoring Report 23

Client Doc. No. RPA-ACO-ACL-RPT-MW-000026 - Rev A

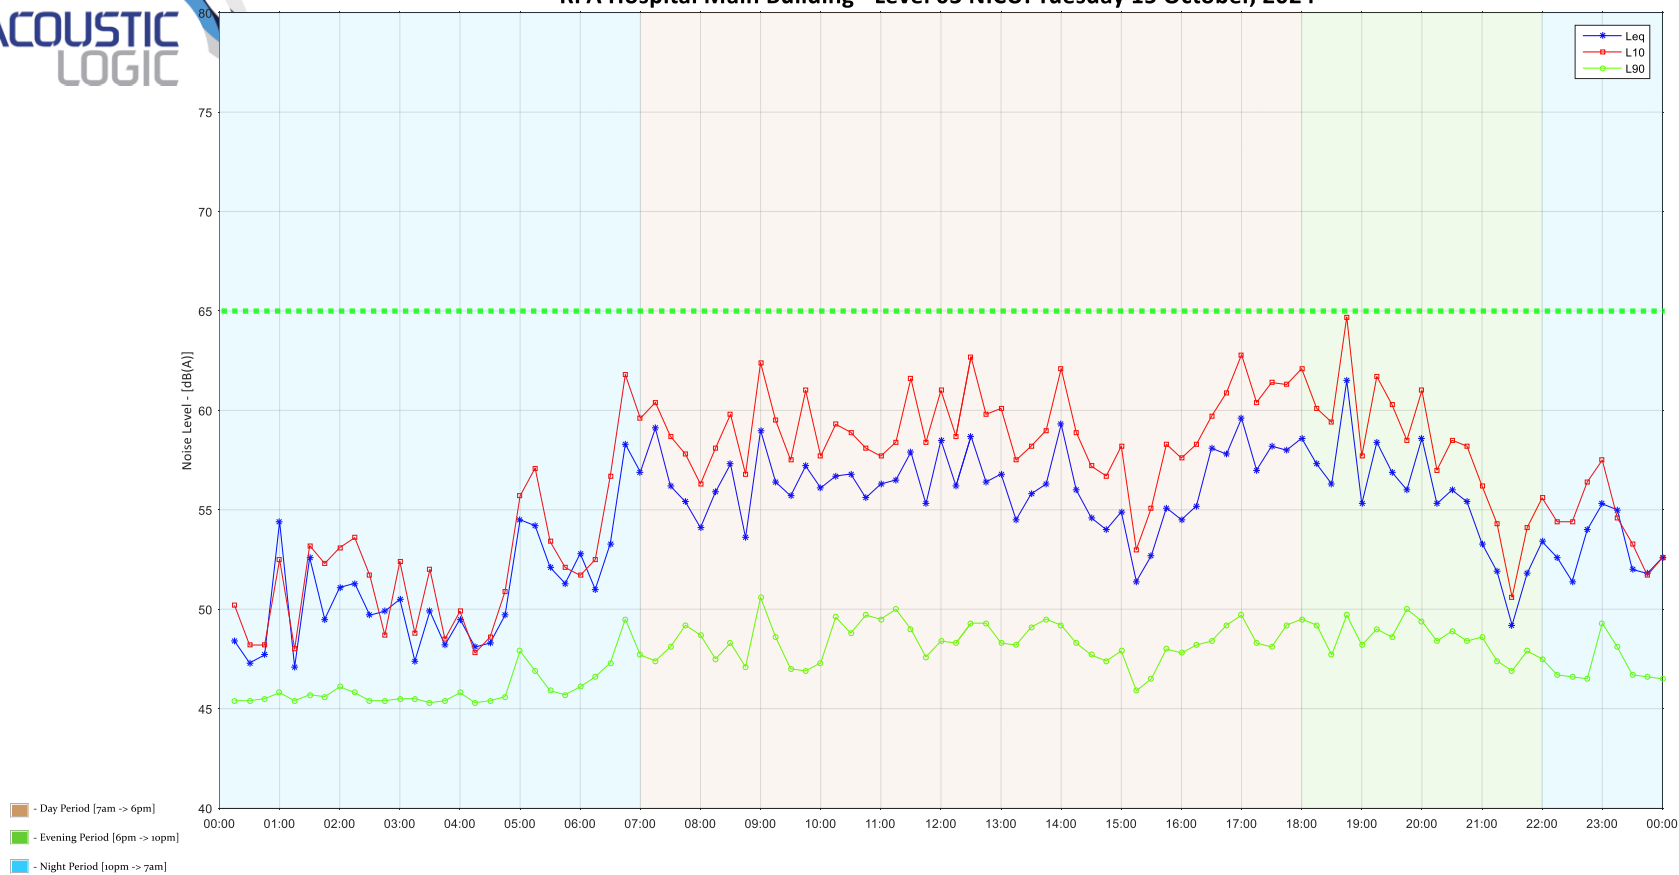
RPA Hospital Main Building - Level 03 NICU: Tuesday 15 October, 2024

NICU NML
(Including correction)
 $\leq 65\text{dB(A)}L_{eq}$

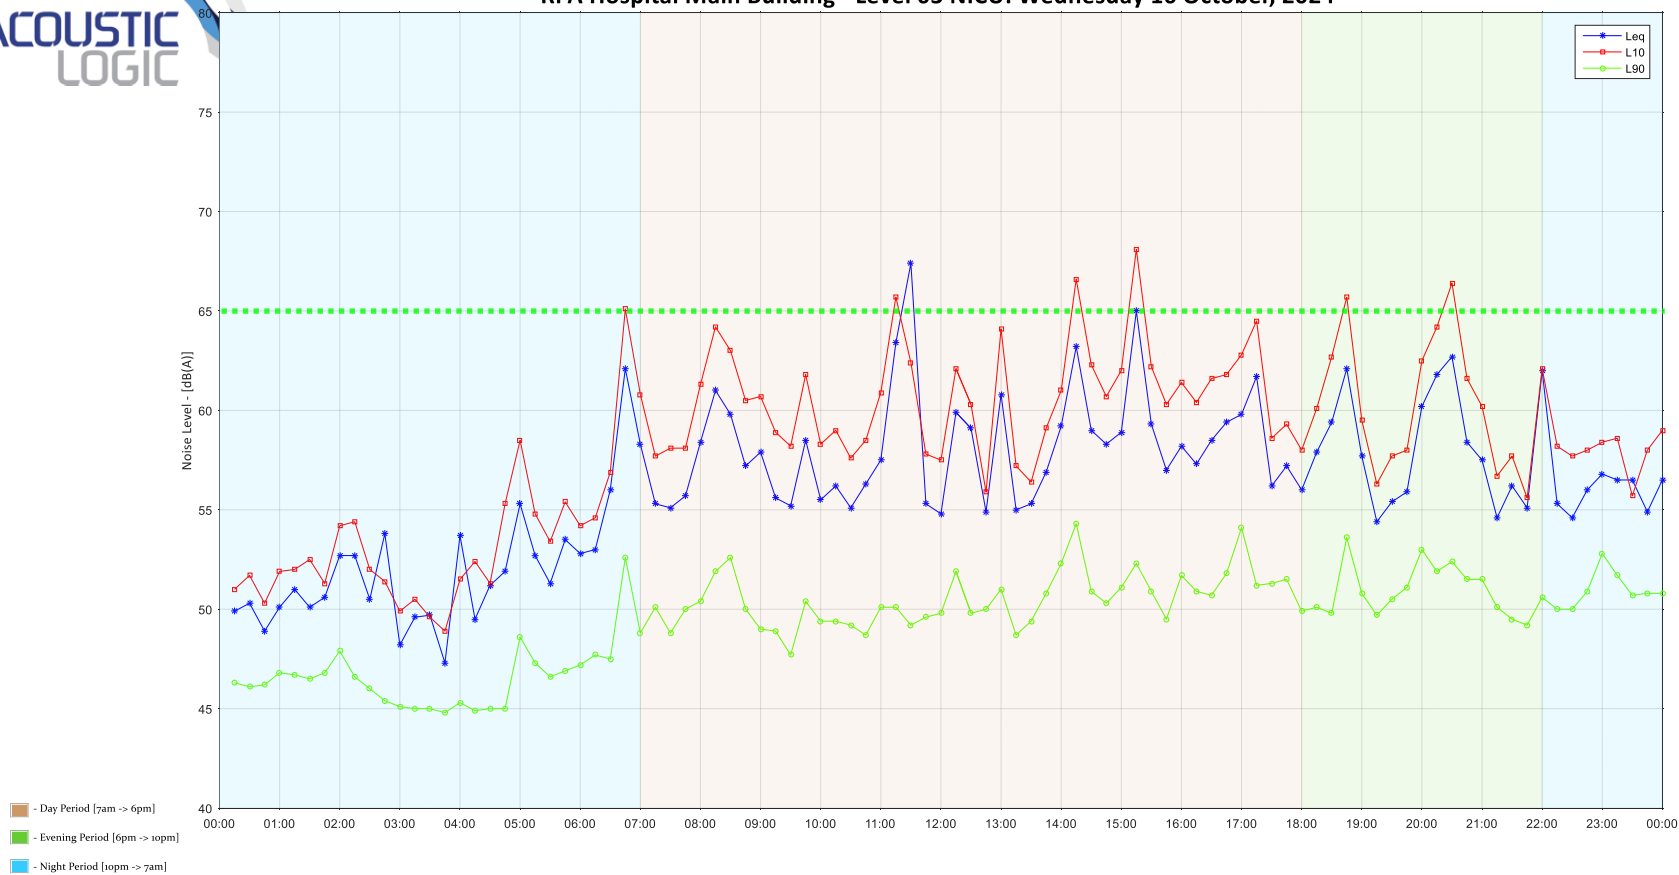
RPA Hospital Main Building - Level 03 NICU: Wednesday 16 October, 2024

NICU NML
(Including correction)
 $\leq 65\text{dB(A)}L_{eq}$

- The monitor is located underneath a benchtop and against two individual walls within the NICU area on Level 03 of the hospital main building. Due to the reflections experienced at the monitoring location due to this, a 5dB correction has been conservatively applied to the noise levels measured at the monitoring station.
- Noise levels were observed to be measured above the NML within the NICU space on the following dates:
 - 14/10/2024.
 - 16/10/2024.
 - 22/10/2024.

- Noise levels during construction hours were never observed to be above the NML for longer than one 15-minute period at a time, and hence it is likely that these events were caused by internal operational activity within the space, as opposed to construction works, noting that construction works are typically continuous in nature.
- We also note that there are 15 minute periods outside of construction hours where recorded levels are above the area's NML.
- Ongoing monitoring to continue within the NICU space.

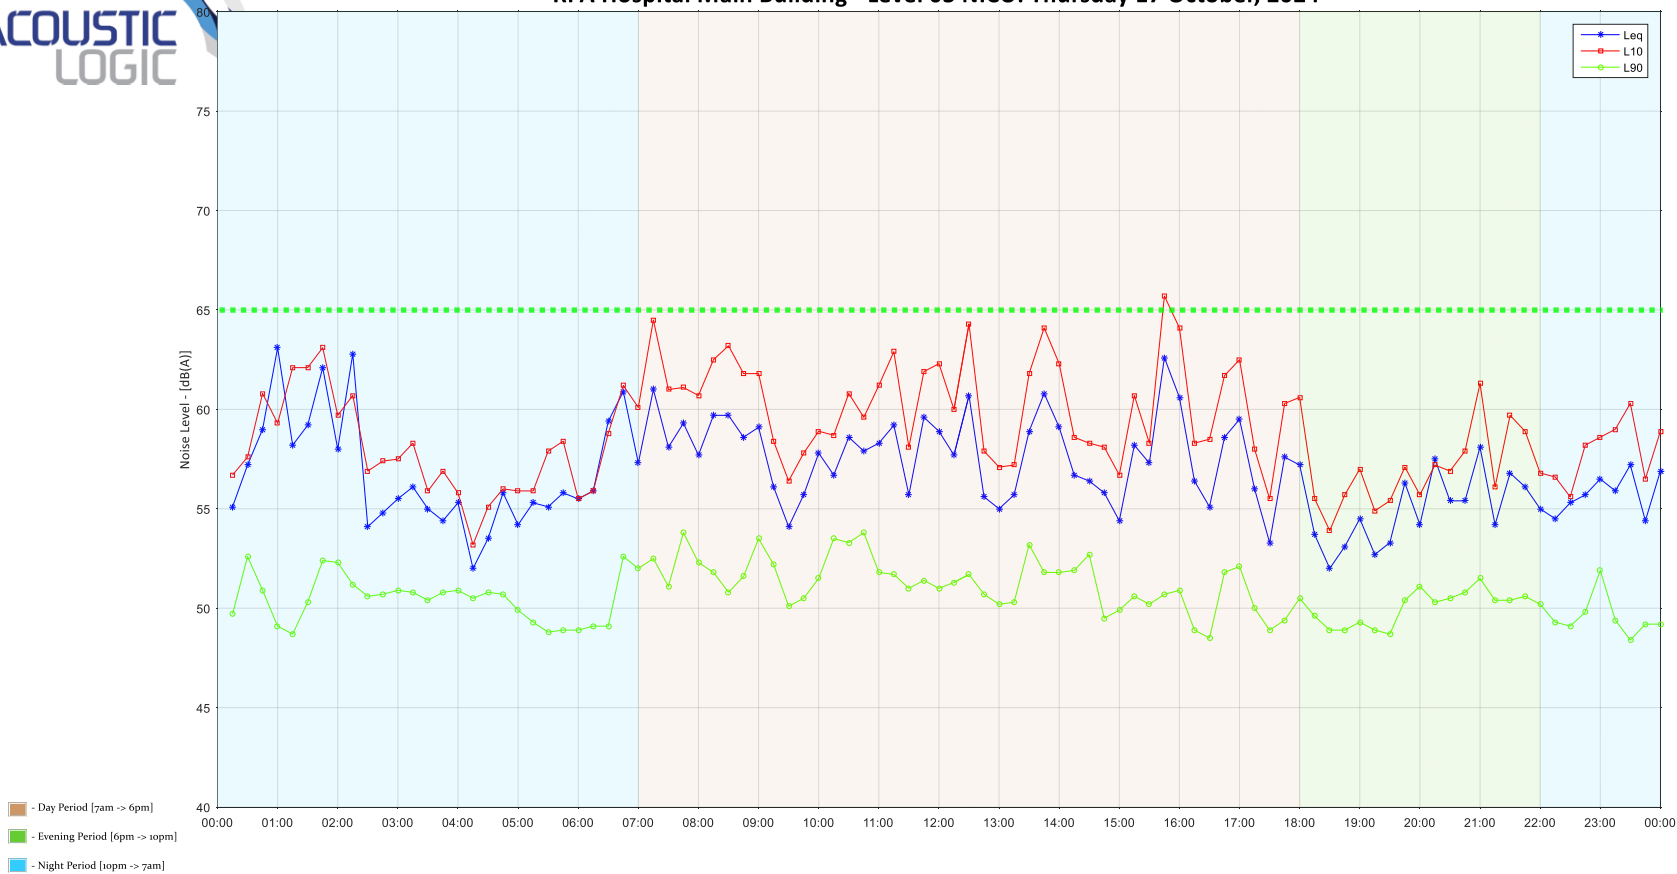
RPA Hospital Main Building - Level 03 NICU: Thursday 17 October, 2024

NICU NML
(Including correction)
 $\leq 65\text{dB(A)}_{L_{eq}}$

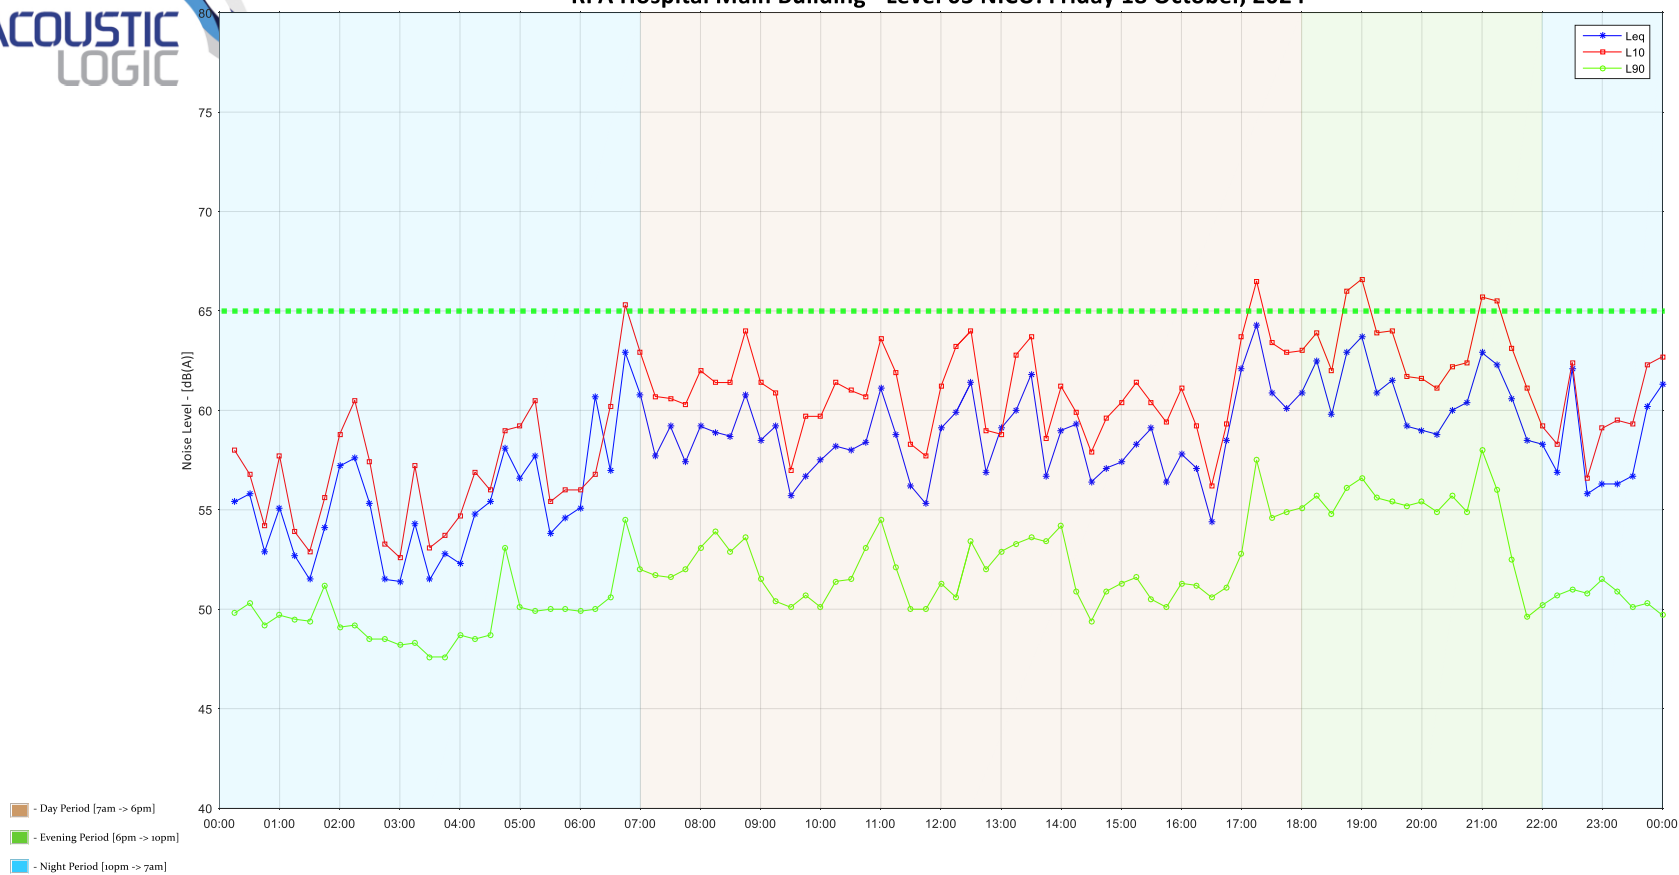
RPA Hospital Main Building - Level 03 NICU: Friday 18 October, 2024

NICU NML
 (Including correction)
 $\leq 65\text{dB(A)}_{L_{eq}}$

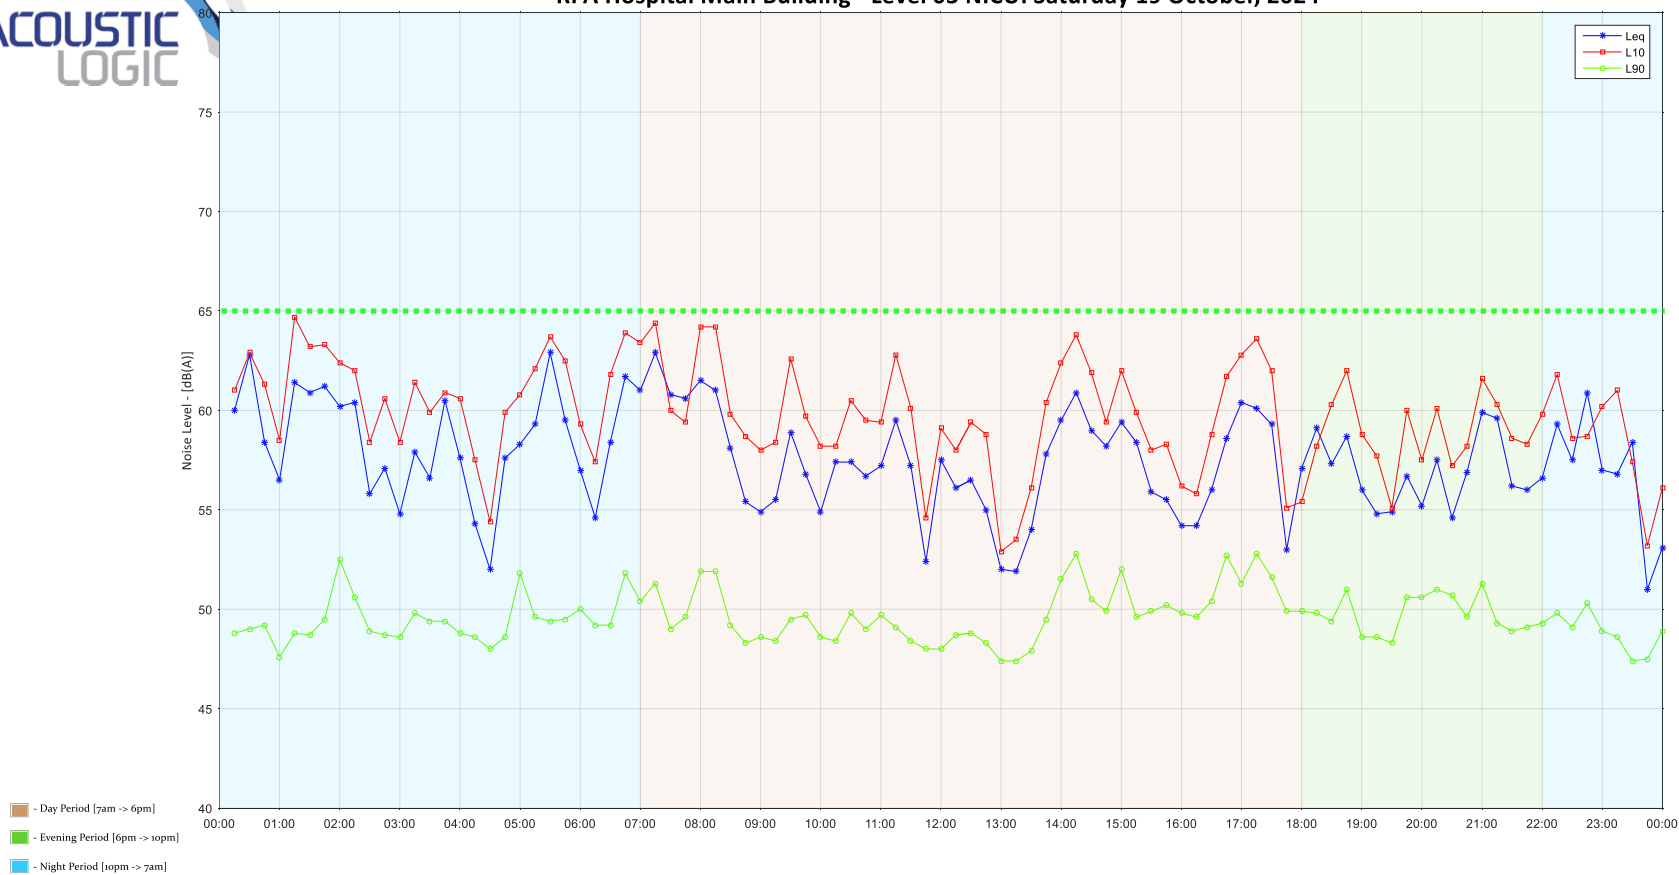
RPA Hospital Main Building - Level 03 NICU: Saturday 19 October, 2024

NICU NML
(Including correction)
 $\leq 65\text{dB(A)}_{L_{eq}}$

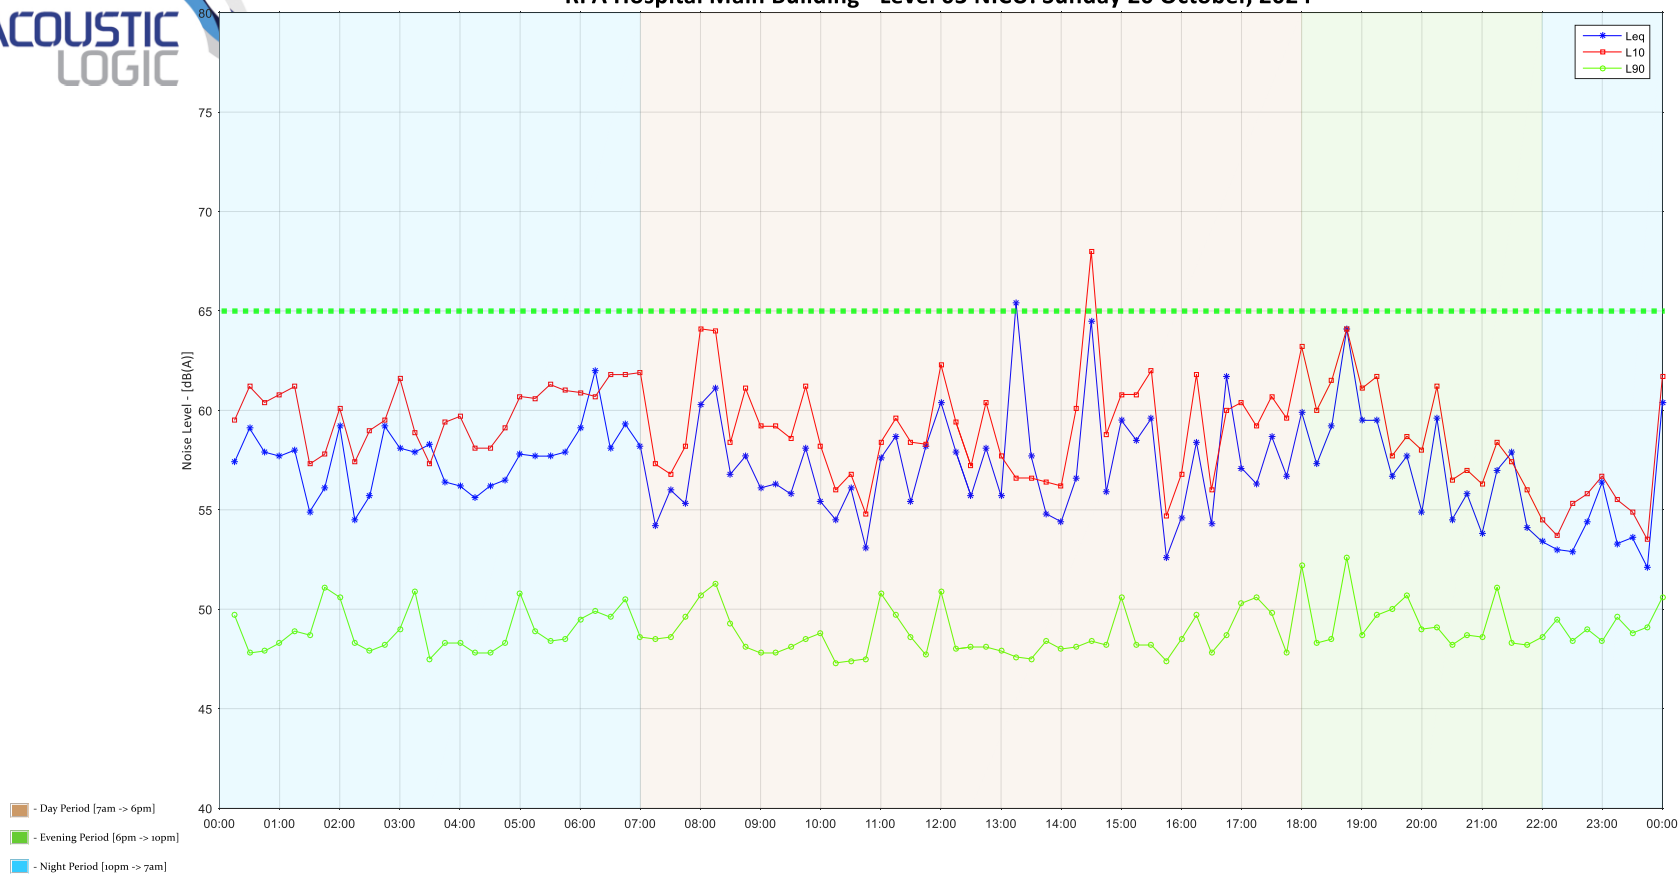
RPA Hospital Main Building - Level 03 NICU: Sunday 20 October, 2024

NICU NML
(Including correction)
 $\leq 65\text{dB(A)}L_{eq}$

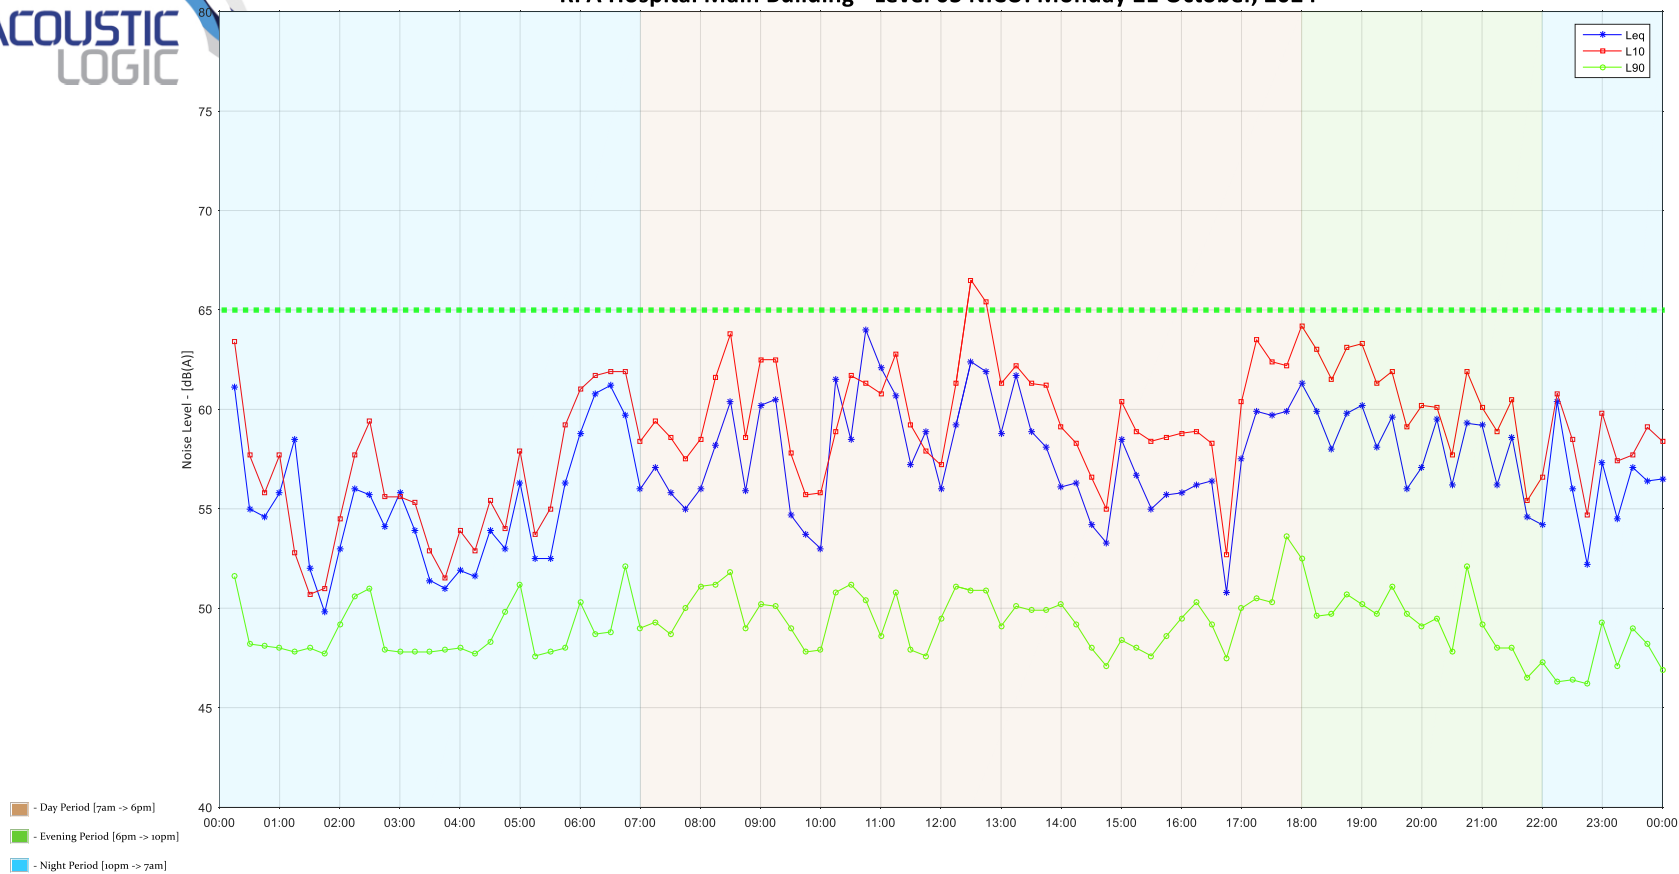
RPA Hospital Main Building - Level 03 NICU: Monday 21 October, 2024

NICU NML
(Including correction)
 $\leq 65\text{dB(A)}_{L_{eq}}$

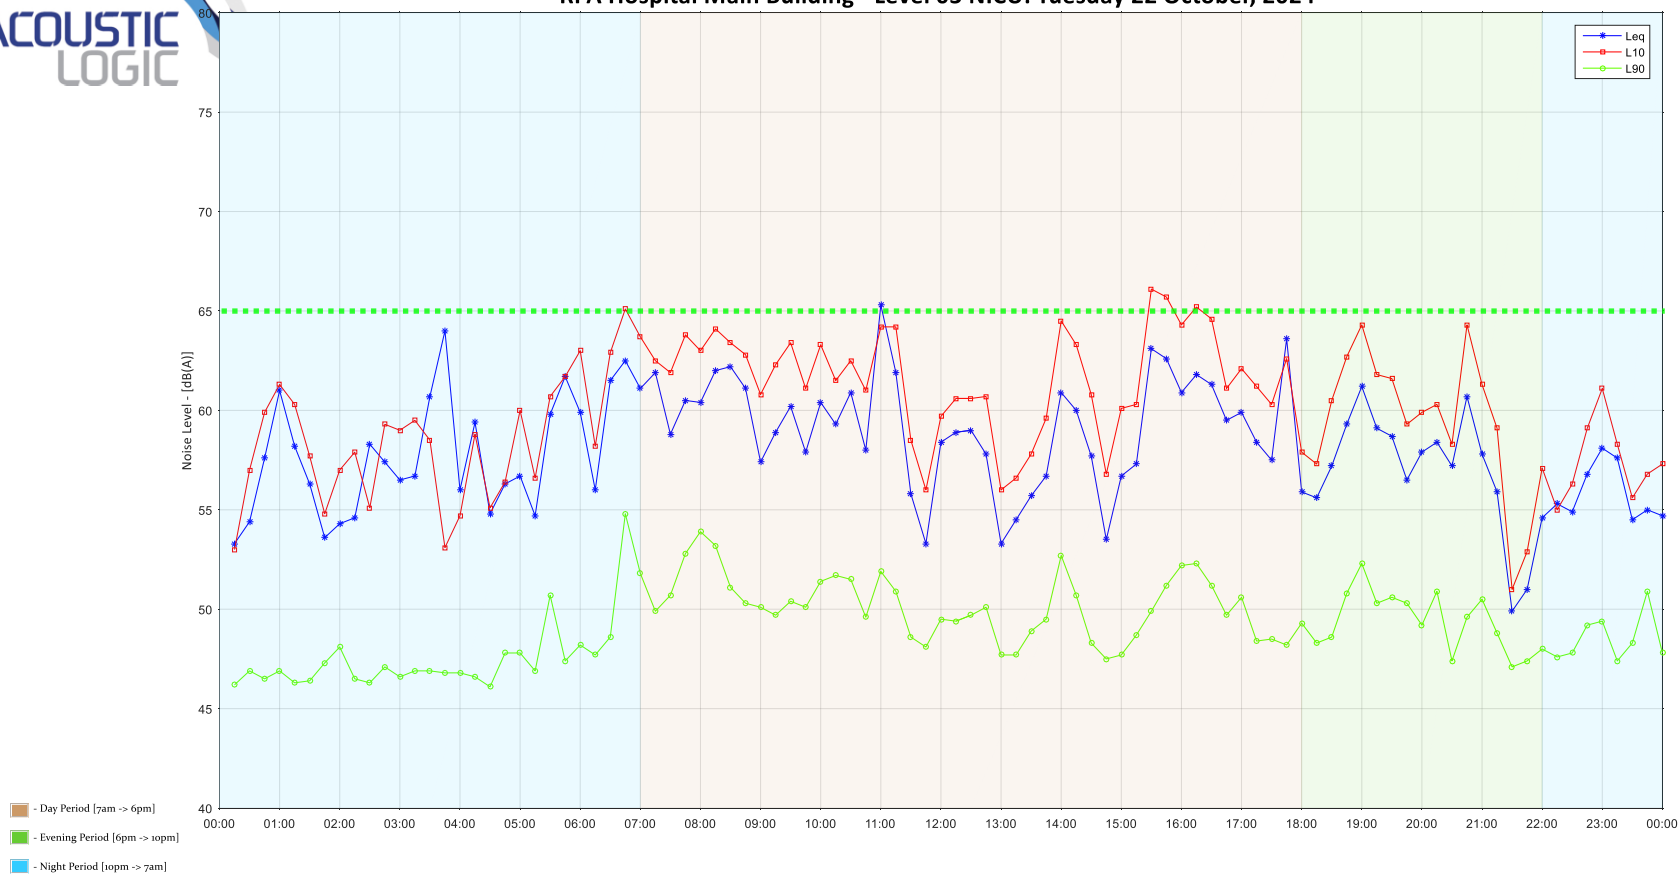
RPA Hospital Main Building - Level 03 NICU: Tuesday 22 October, 2024

NICU NML
(Including correction)
 $\leq 65\text{dB(A)}_{L_{eq}}$

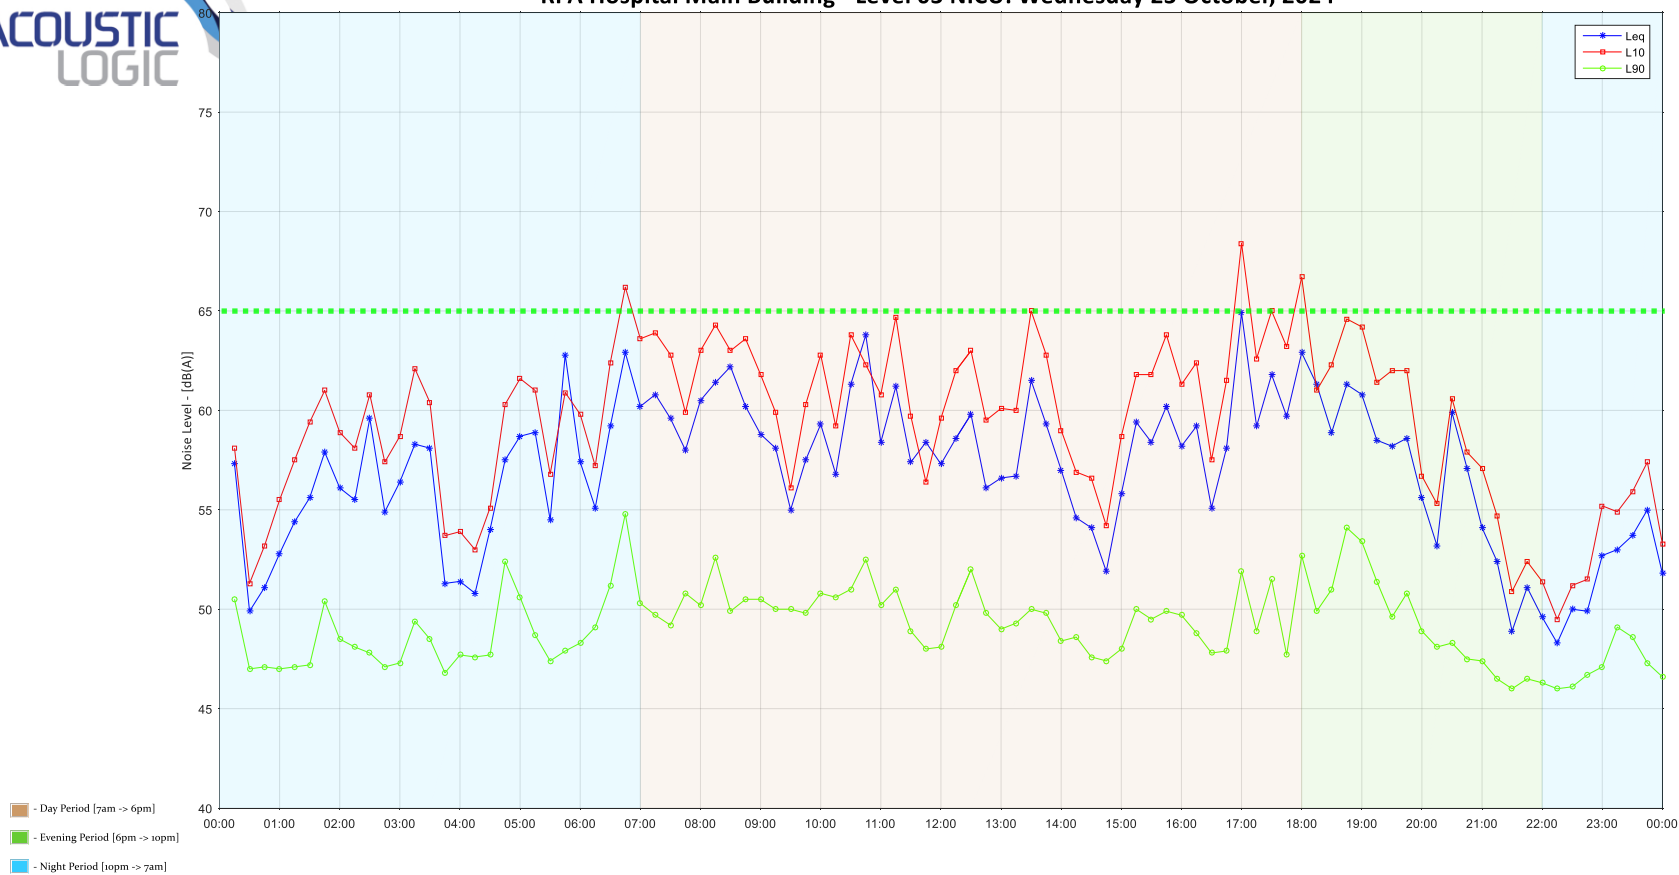
RPA Hospital Main Building - Level 03 NICU: Wednesday 23 October, 2024

NICU NML
(Including correction)
 $\leq 65\text{dB(A)}_{L_{eq}}$

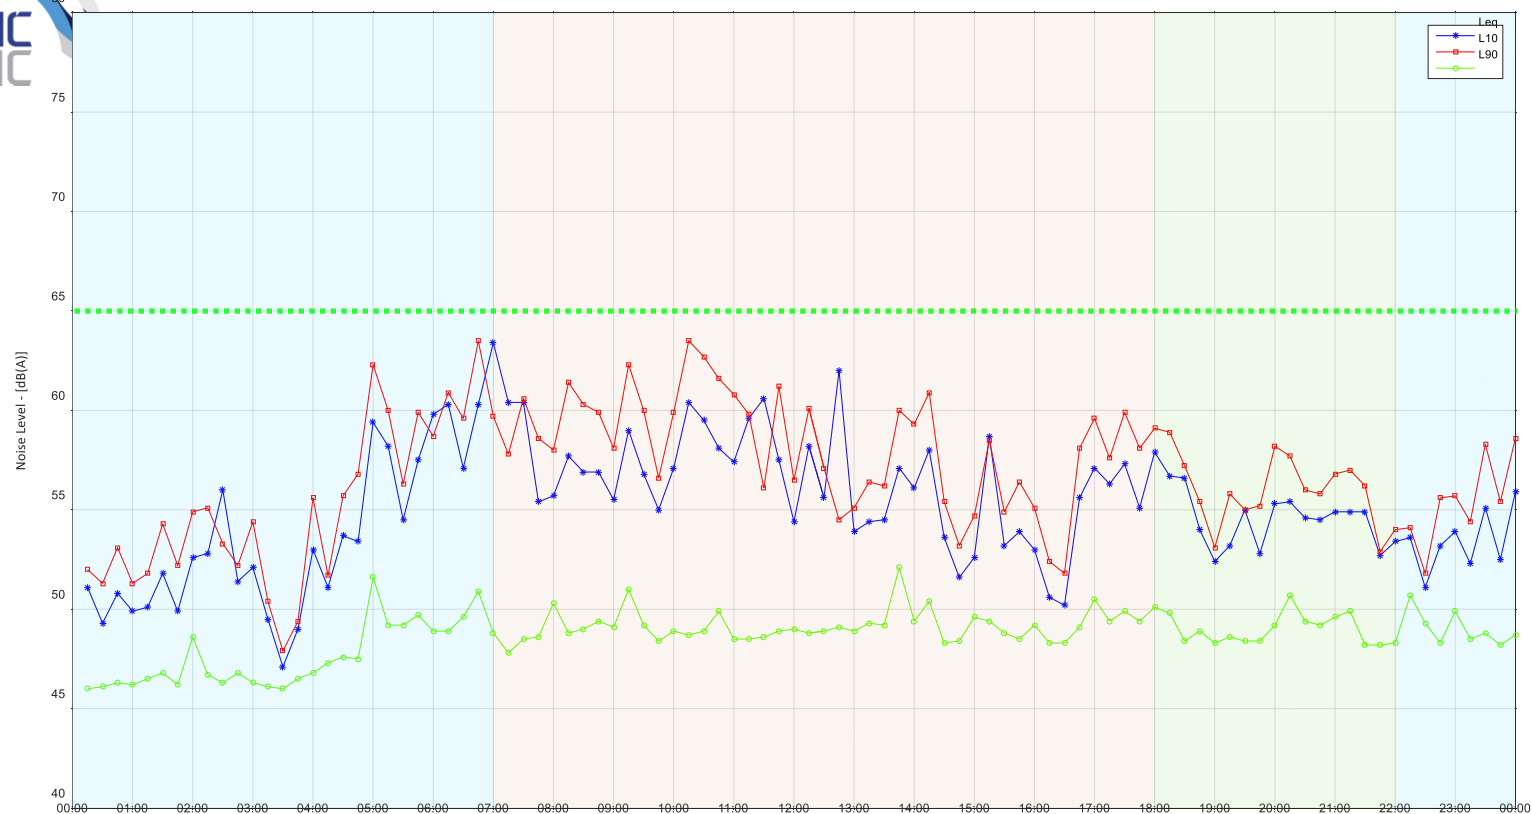
RPA Hospital Main Building - Level 03 NICU: Thursday 24 October, 2024

NICU NML
(Including correction)
 $\leq 65\text{dB(A)}_{L_{eq}}$

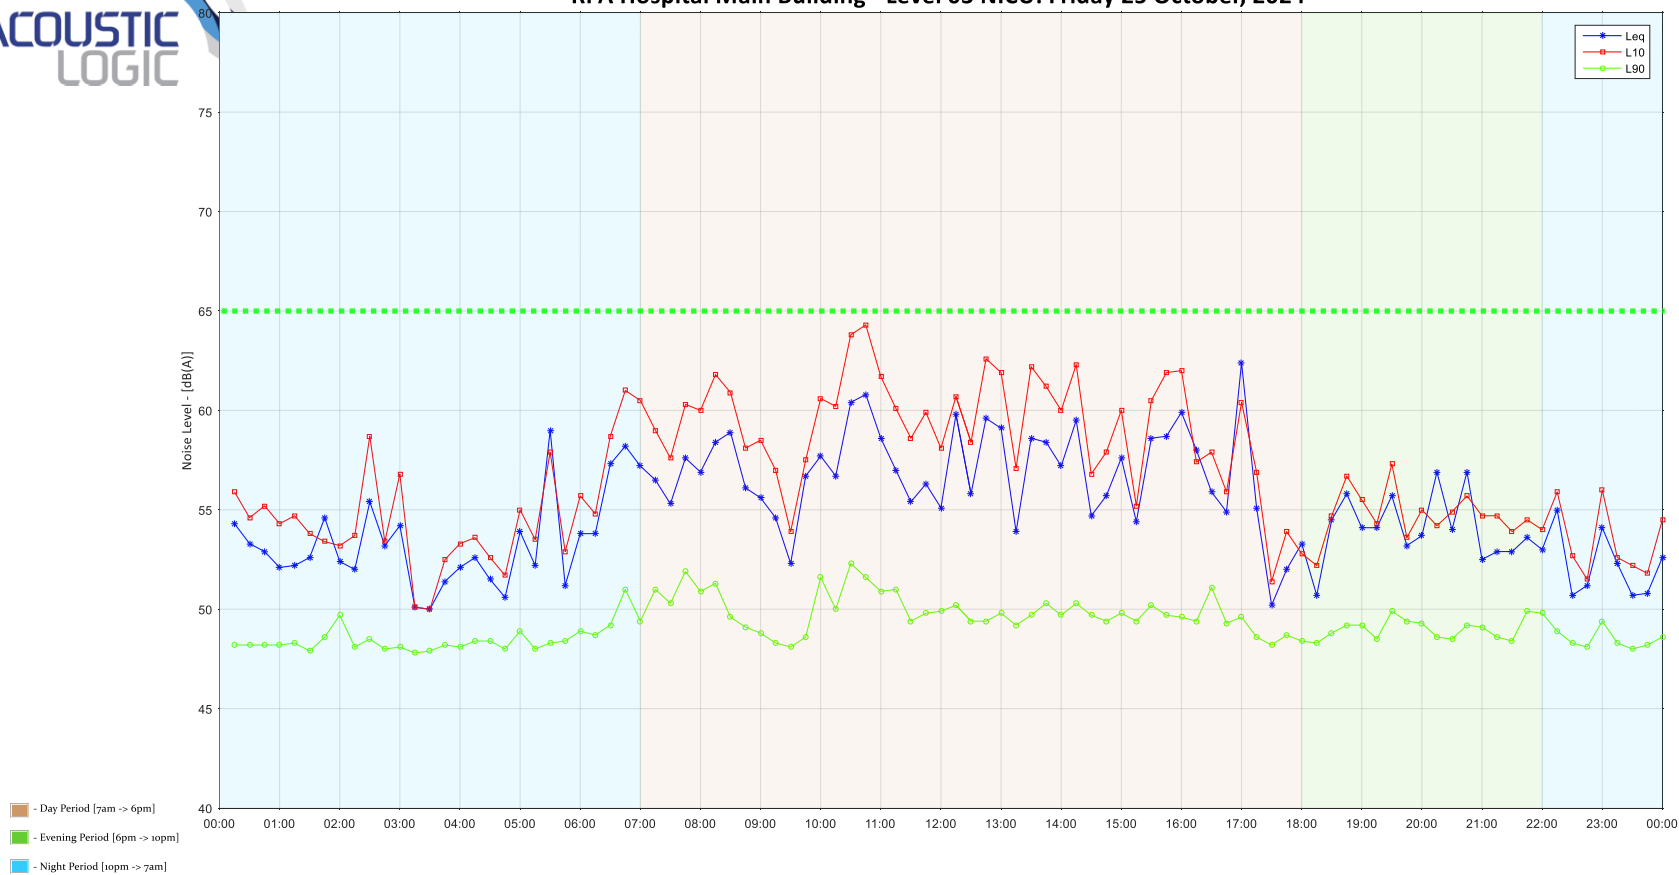
RPA Hospital Main Building - Level 03 NICU: Friday 25 October, 2024

NICU NML
(Including correction)
 $\leq 65\text{dB(A)}_{L_{eq}}$

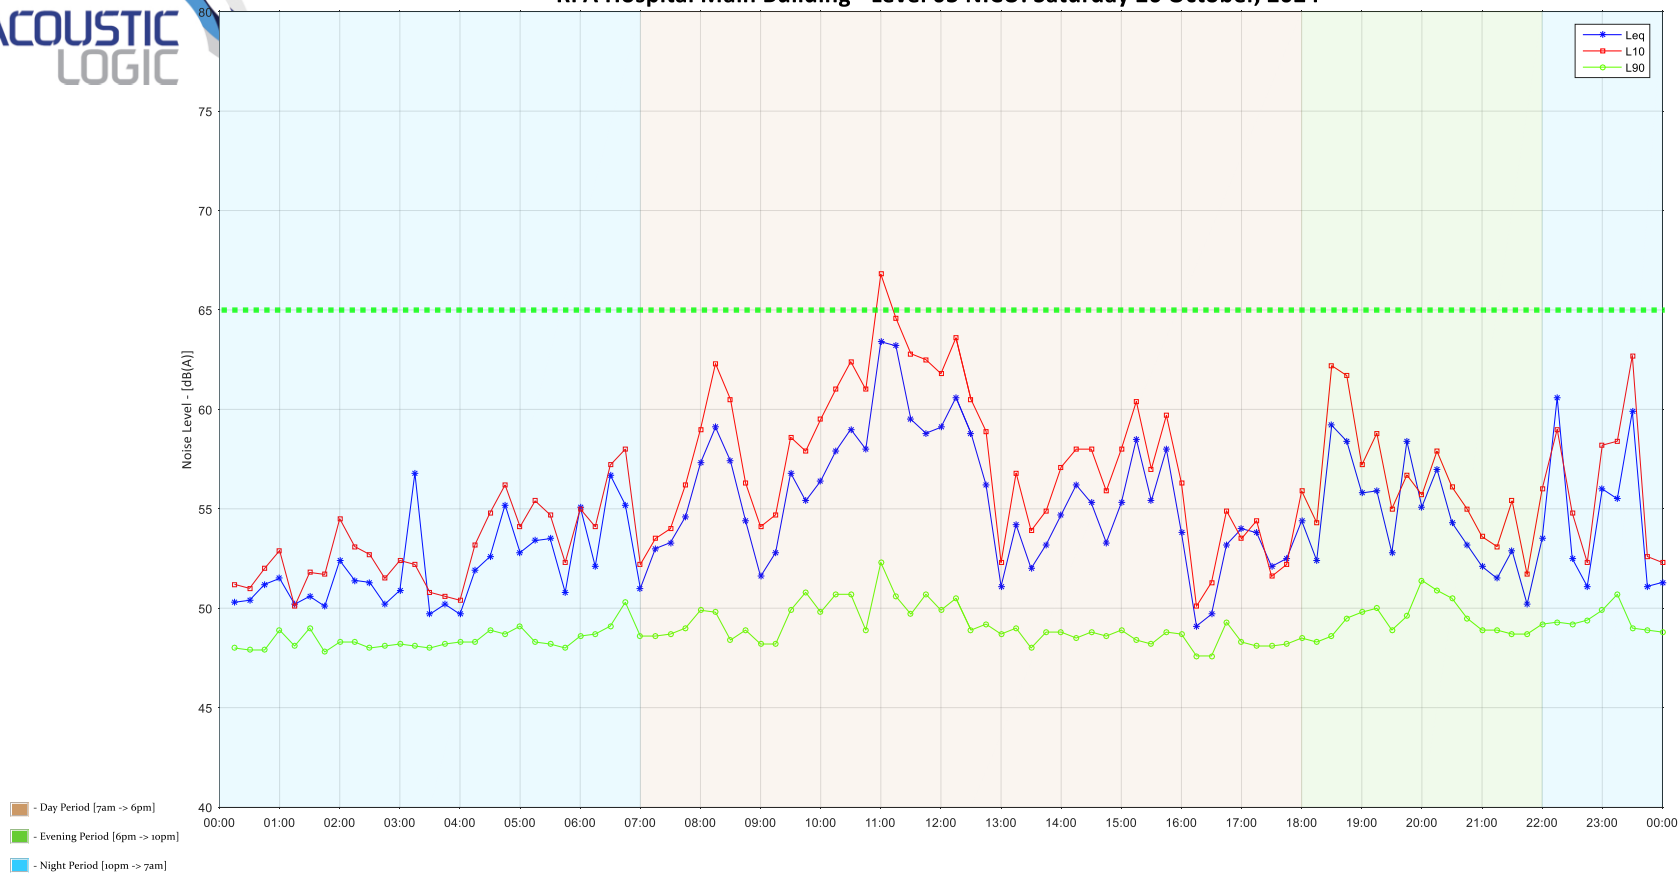
RPA Hospital Main Building - Level 03 NICU: Saturday 26 October, 2024

NICU NML
(Including correction)
 $\leq 65\text{dB(A)}_{L_{eq}}$

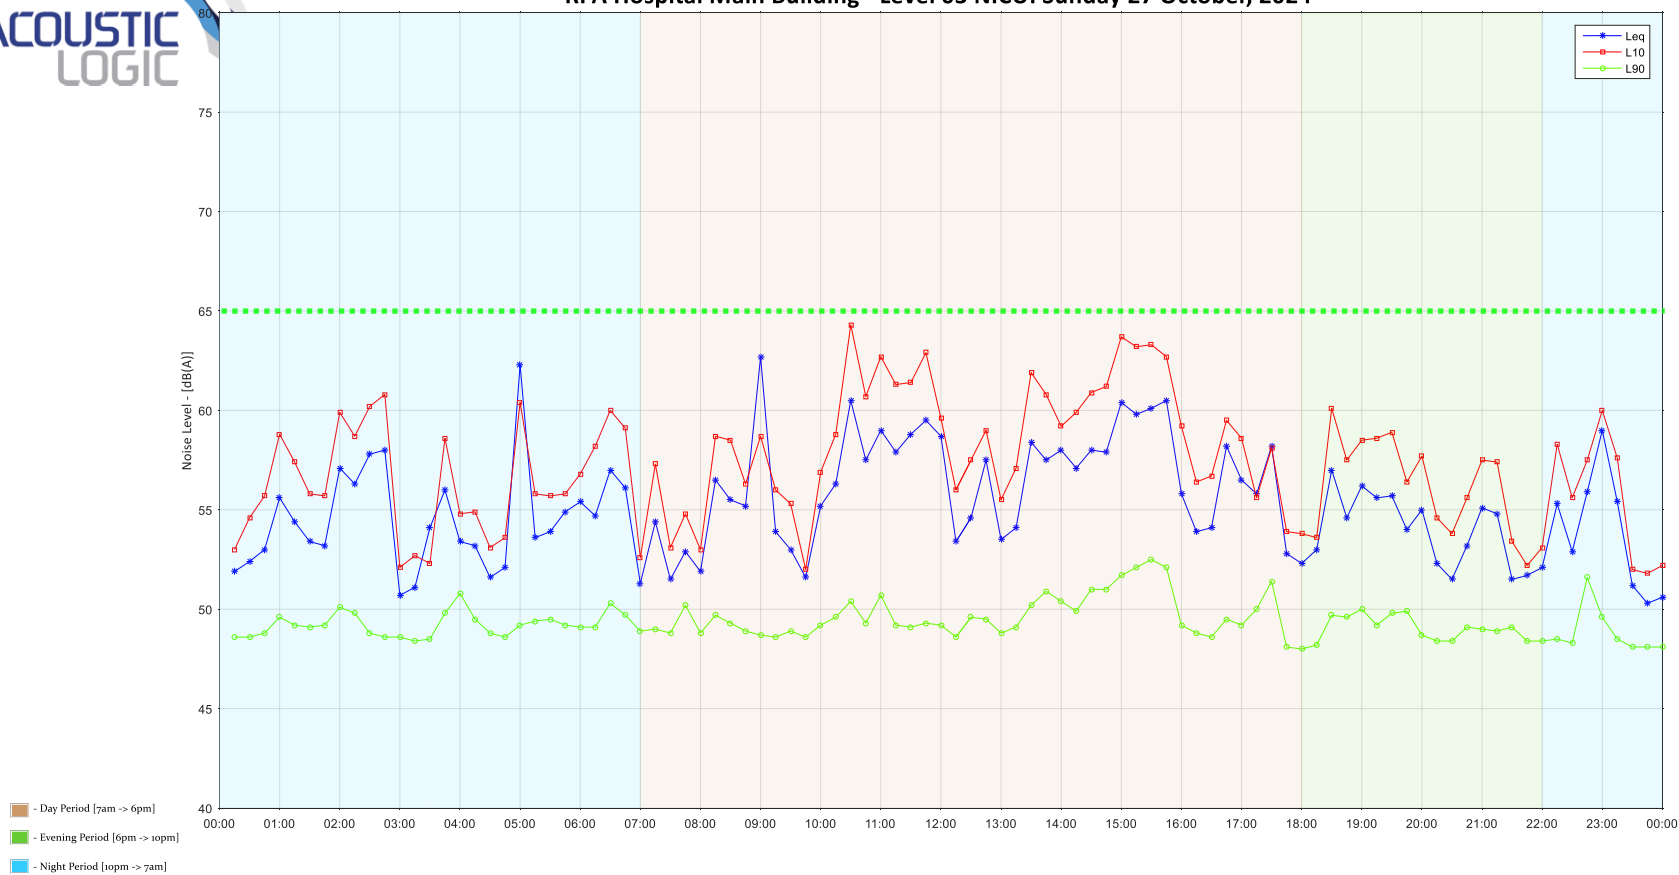
RPA Hospital Main Building - Level 03 NICU: Sunday 27 October, 2024

NICU NML
(Including correction)
 $\leq 65\text{dB(A)}_{L_{eq}}$

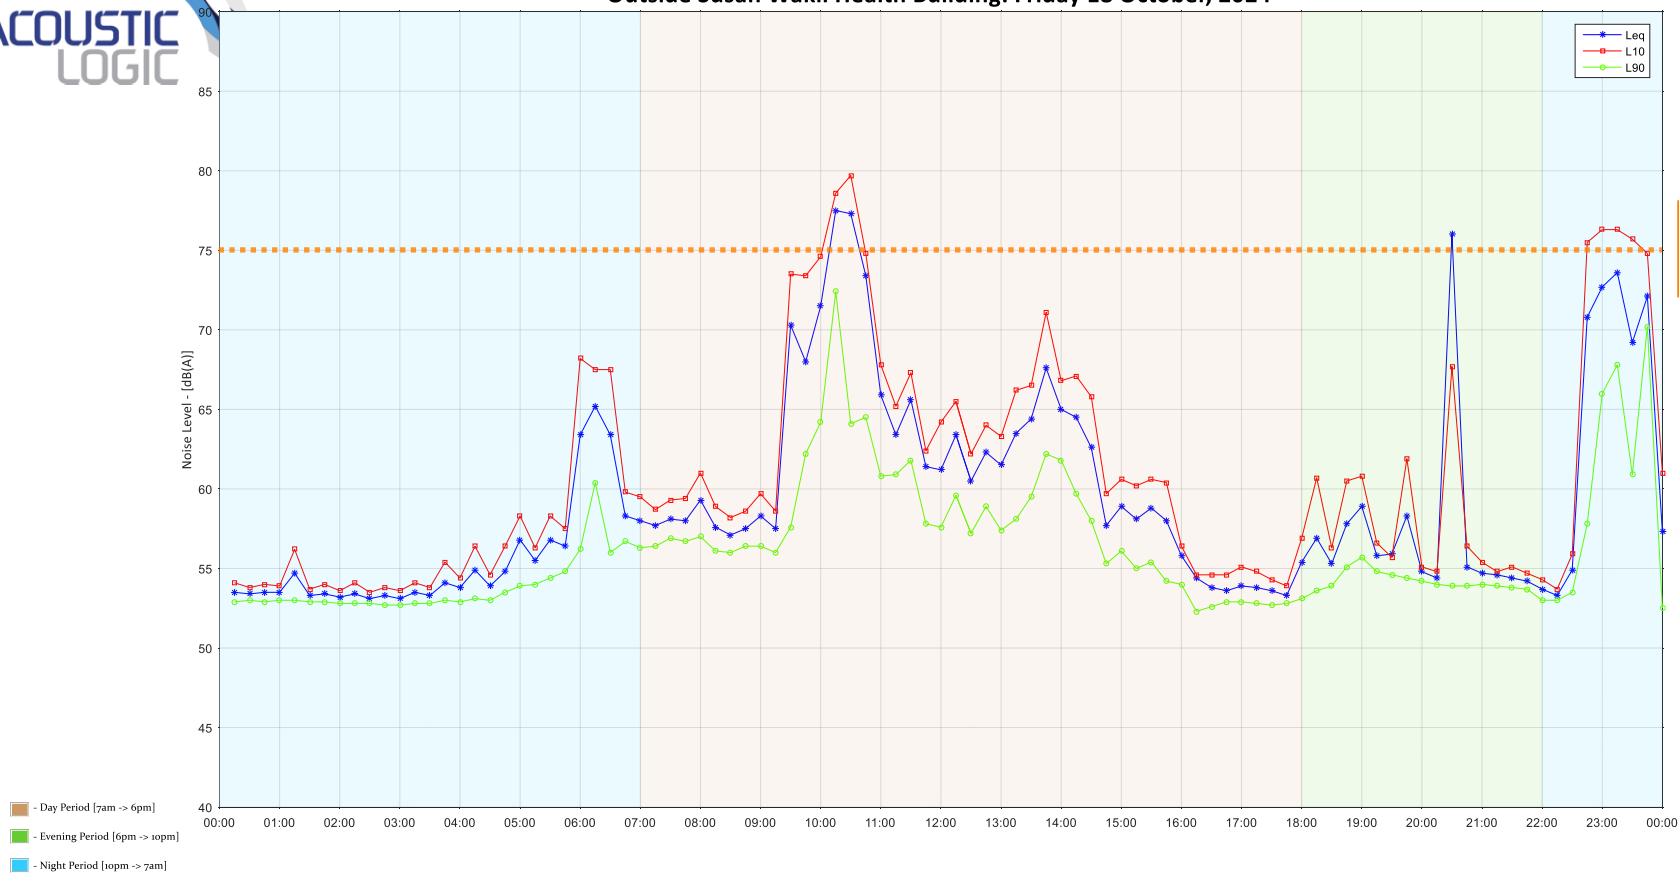
Outside Susan Wakil Health Building: Friday 18 October, 2024

Education NML
(Including correction)
≤ 75dB(A)_{Leq}

- With respect to the monitoring data, the noise monitor located outside of the Susan Wakil Health Building is within the demolition site boundary and approximately 15m closer to the area of the works than the façade of the Susan Wakil Health Building.

- Noting this increased distance attenuation, in conjunction with the transmission loss experienced through the inoperable façade of the Susan Wakil Health Building when comparing internal and external noise levels, Acoustic Logic expect that, at minimum, there is a 30dB reduction between the measured noise levels by the monitor, when compared with the resultant internal noise levels within the receiver.

- This reduction is considered conservative due to the distance between the monitor and the building, and hence, the noise impacts would be further reduced than what is outlined below in reality.

- Notwithstanding, noise levels have been measured to be above the NML at the monitoring location on the following dates during the monitoring period:
 - 18/10/2024.

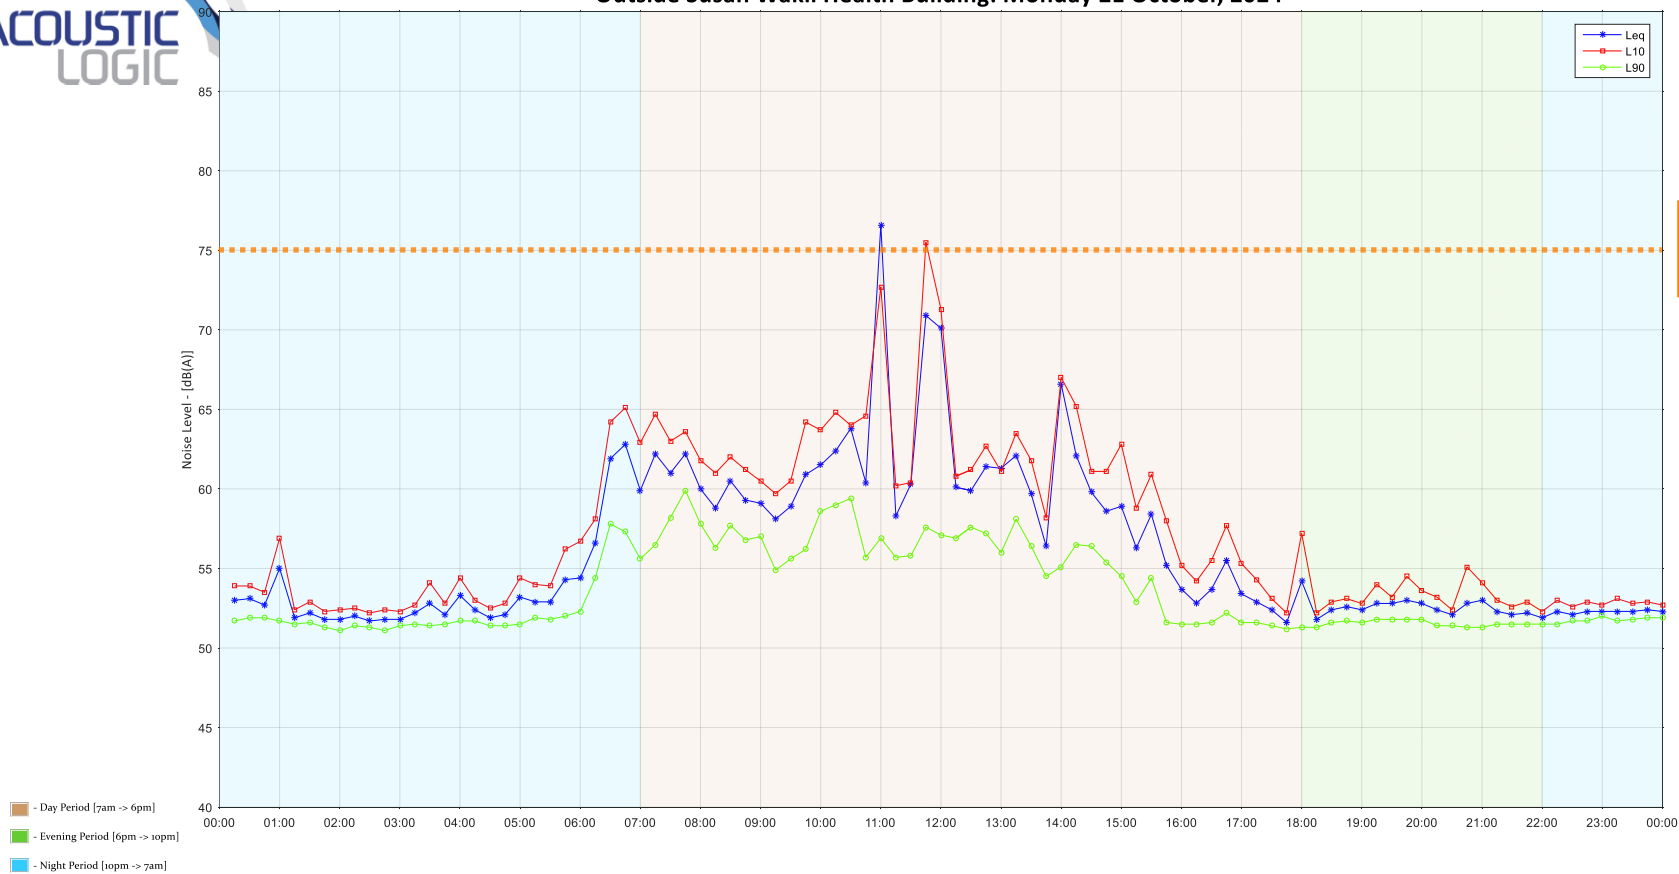
Outside Susan Wakil Health Building: Monday 21 October, 2024

Education NML
(Including correction)
 $\leq 75\text{dB(A)}_{\text{Leq}}$

- 21/10/2024.
 - 25/10/2024.
- Noise levels impacting Susan Wakil will be continued to be monitored throughout the early works construction to assess the impact of this receiver.
