Royal Prince Alfred Hospital Redevelopment (RPAH Redevelopment)

Construction Noise and Vibration Monitoring Report 23

Client Doc. No. RPA-ACO-ACL-RPT-MW-000026 - Rev A

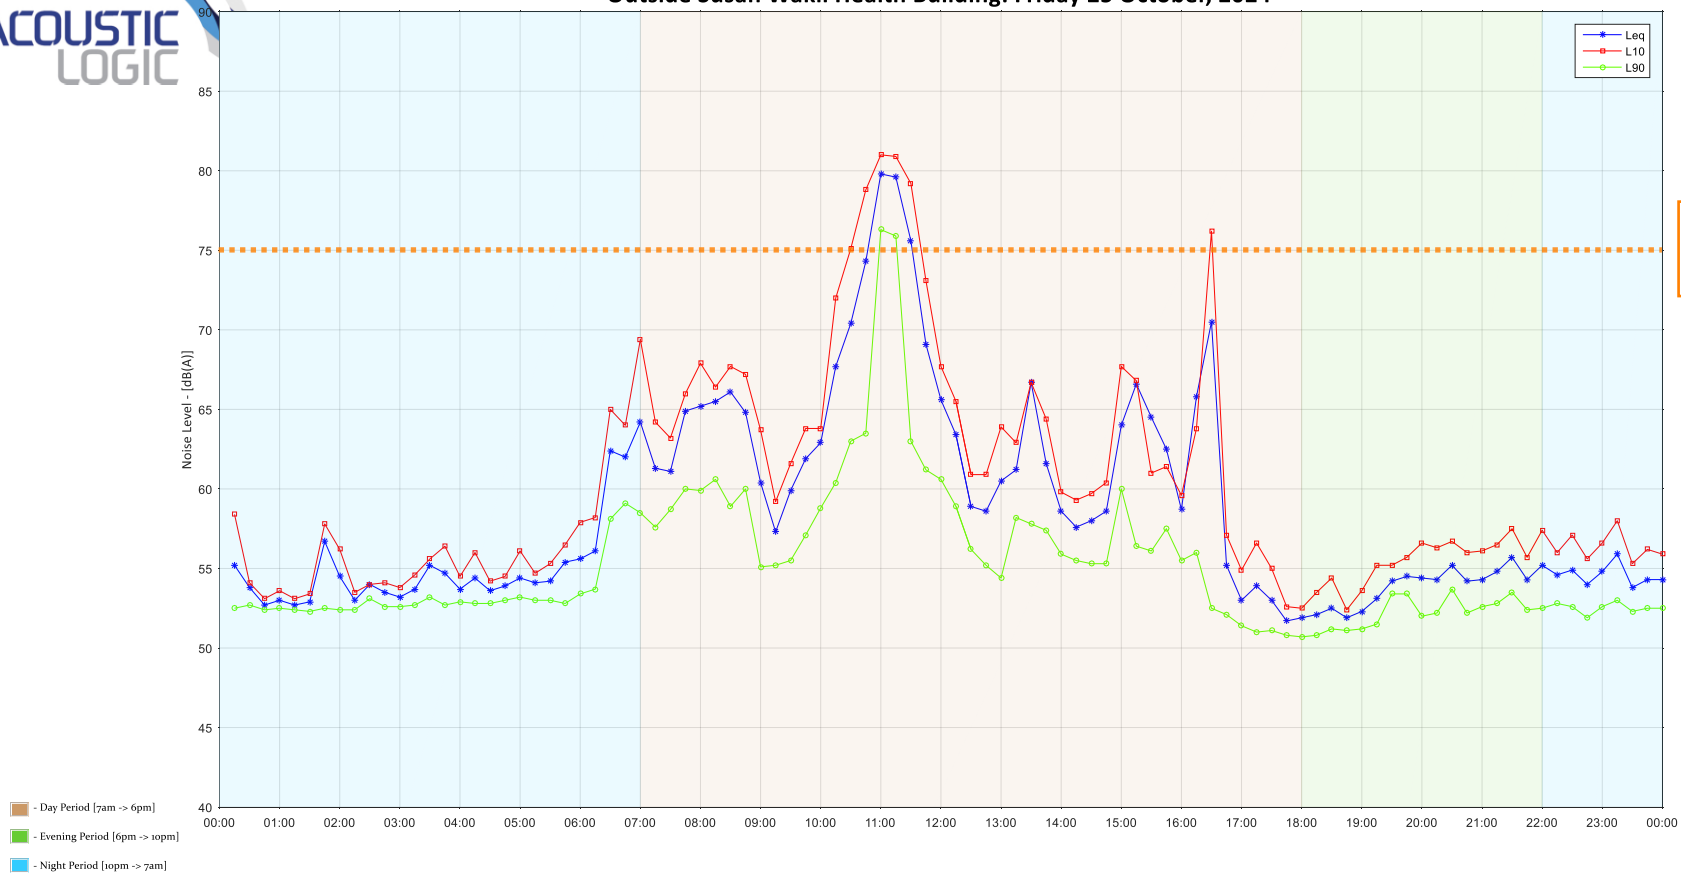
Outside Susan Wakil Health Building: Friday 25 October, 2024

Education NML
(Including correction)
 $\leq 75\text{dB(A)}_{\text{Leq}}$

- 21/10/2024.
 - 25/10/2024.
- Noise levels impacting Susan Wakil will be continued to be monitored throughout the early works construction to assess the impact of this receiver.

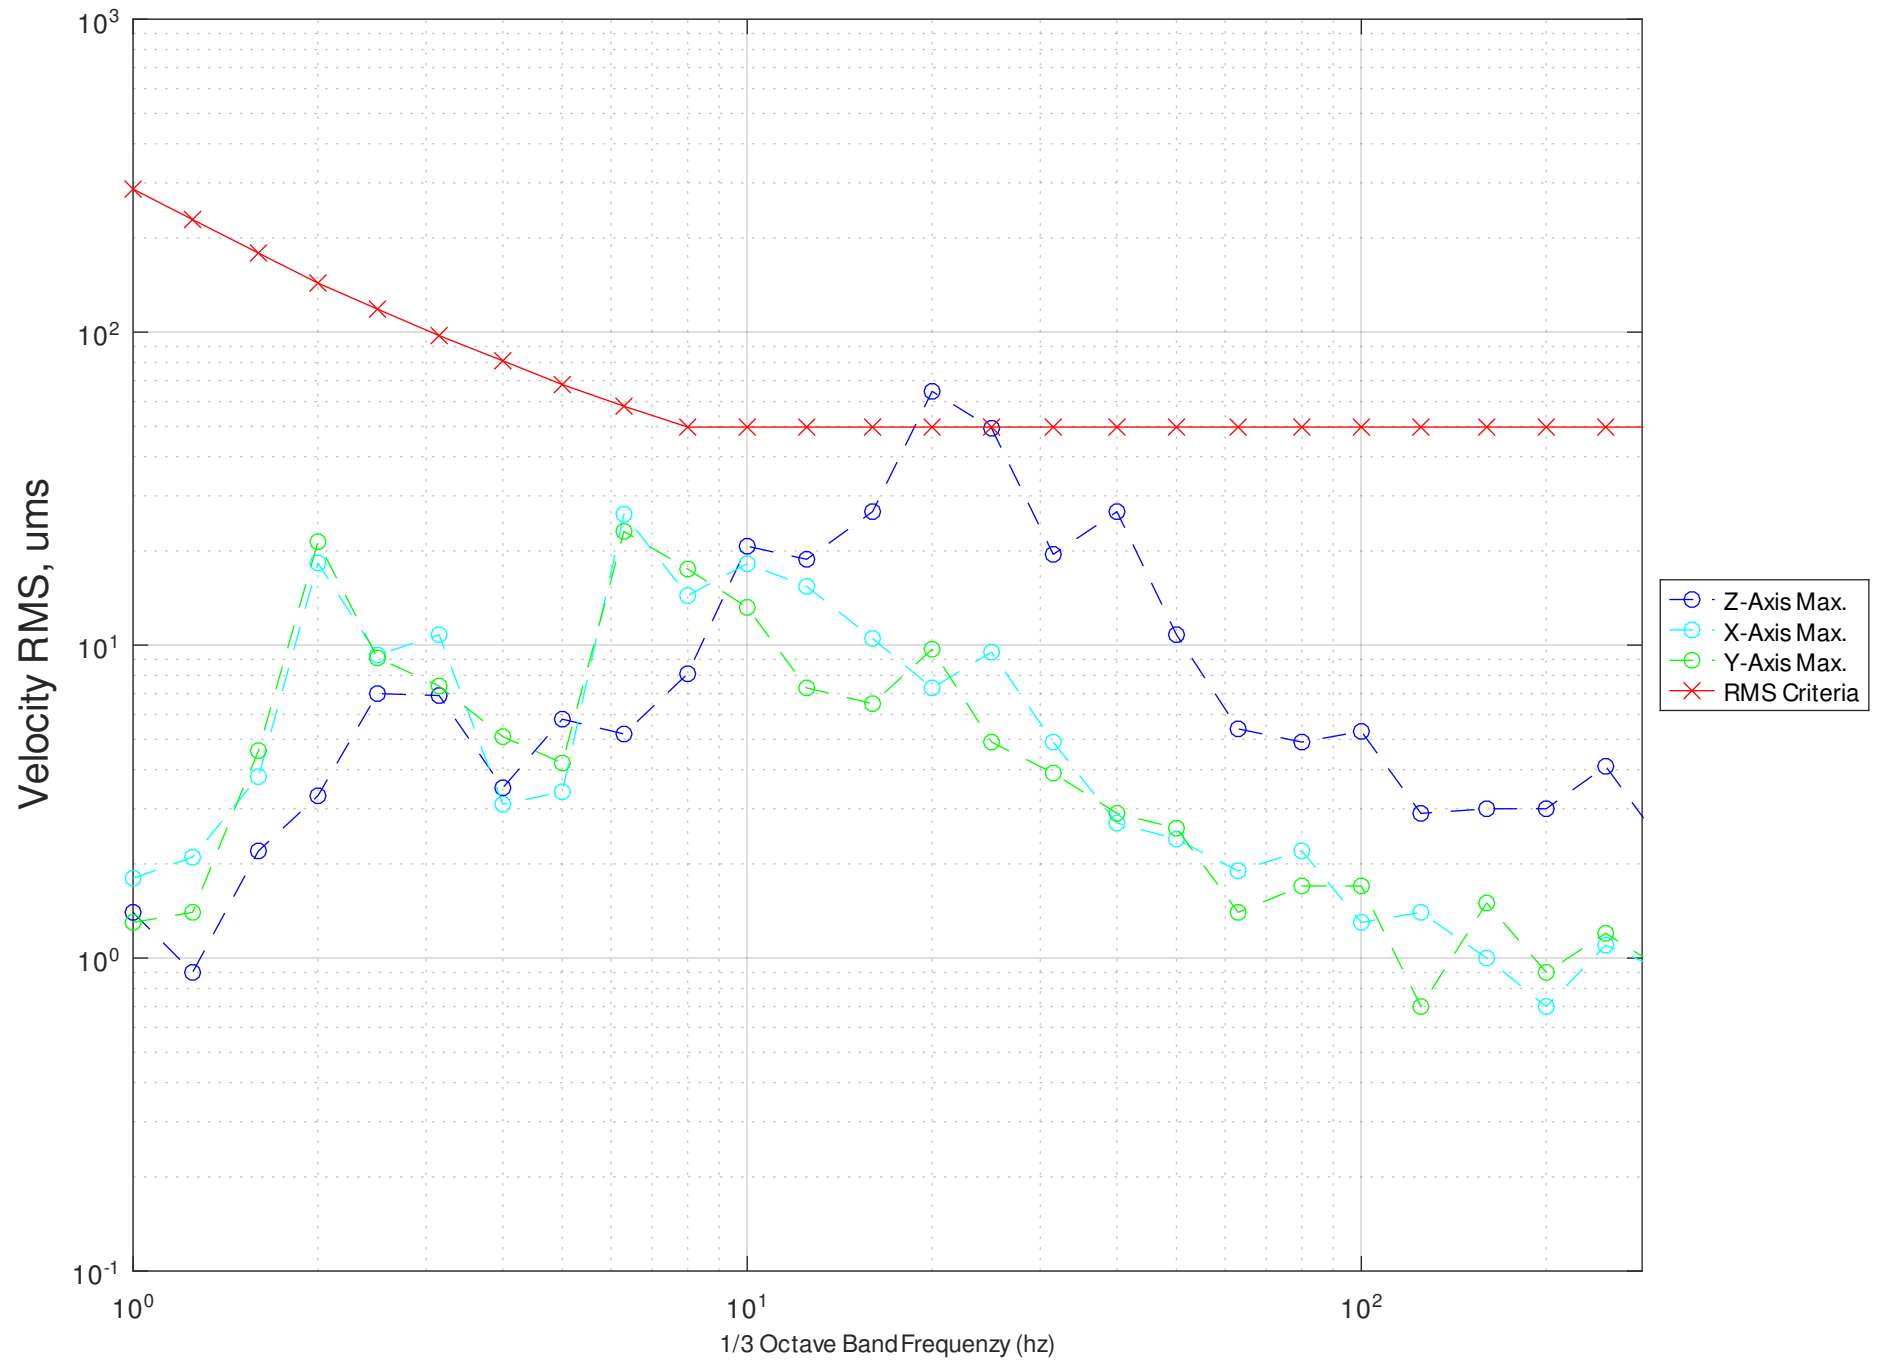
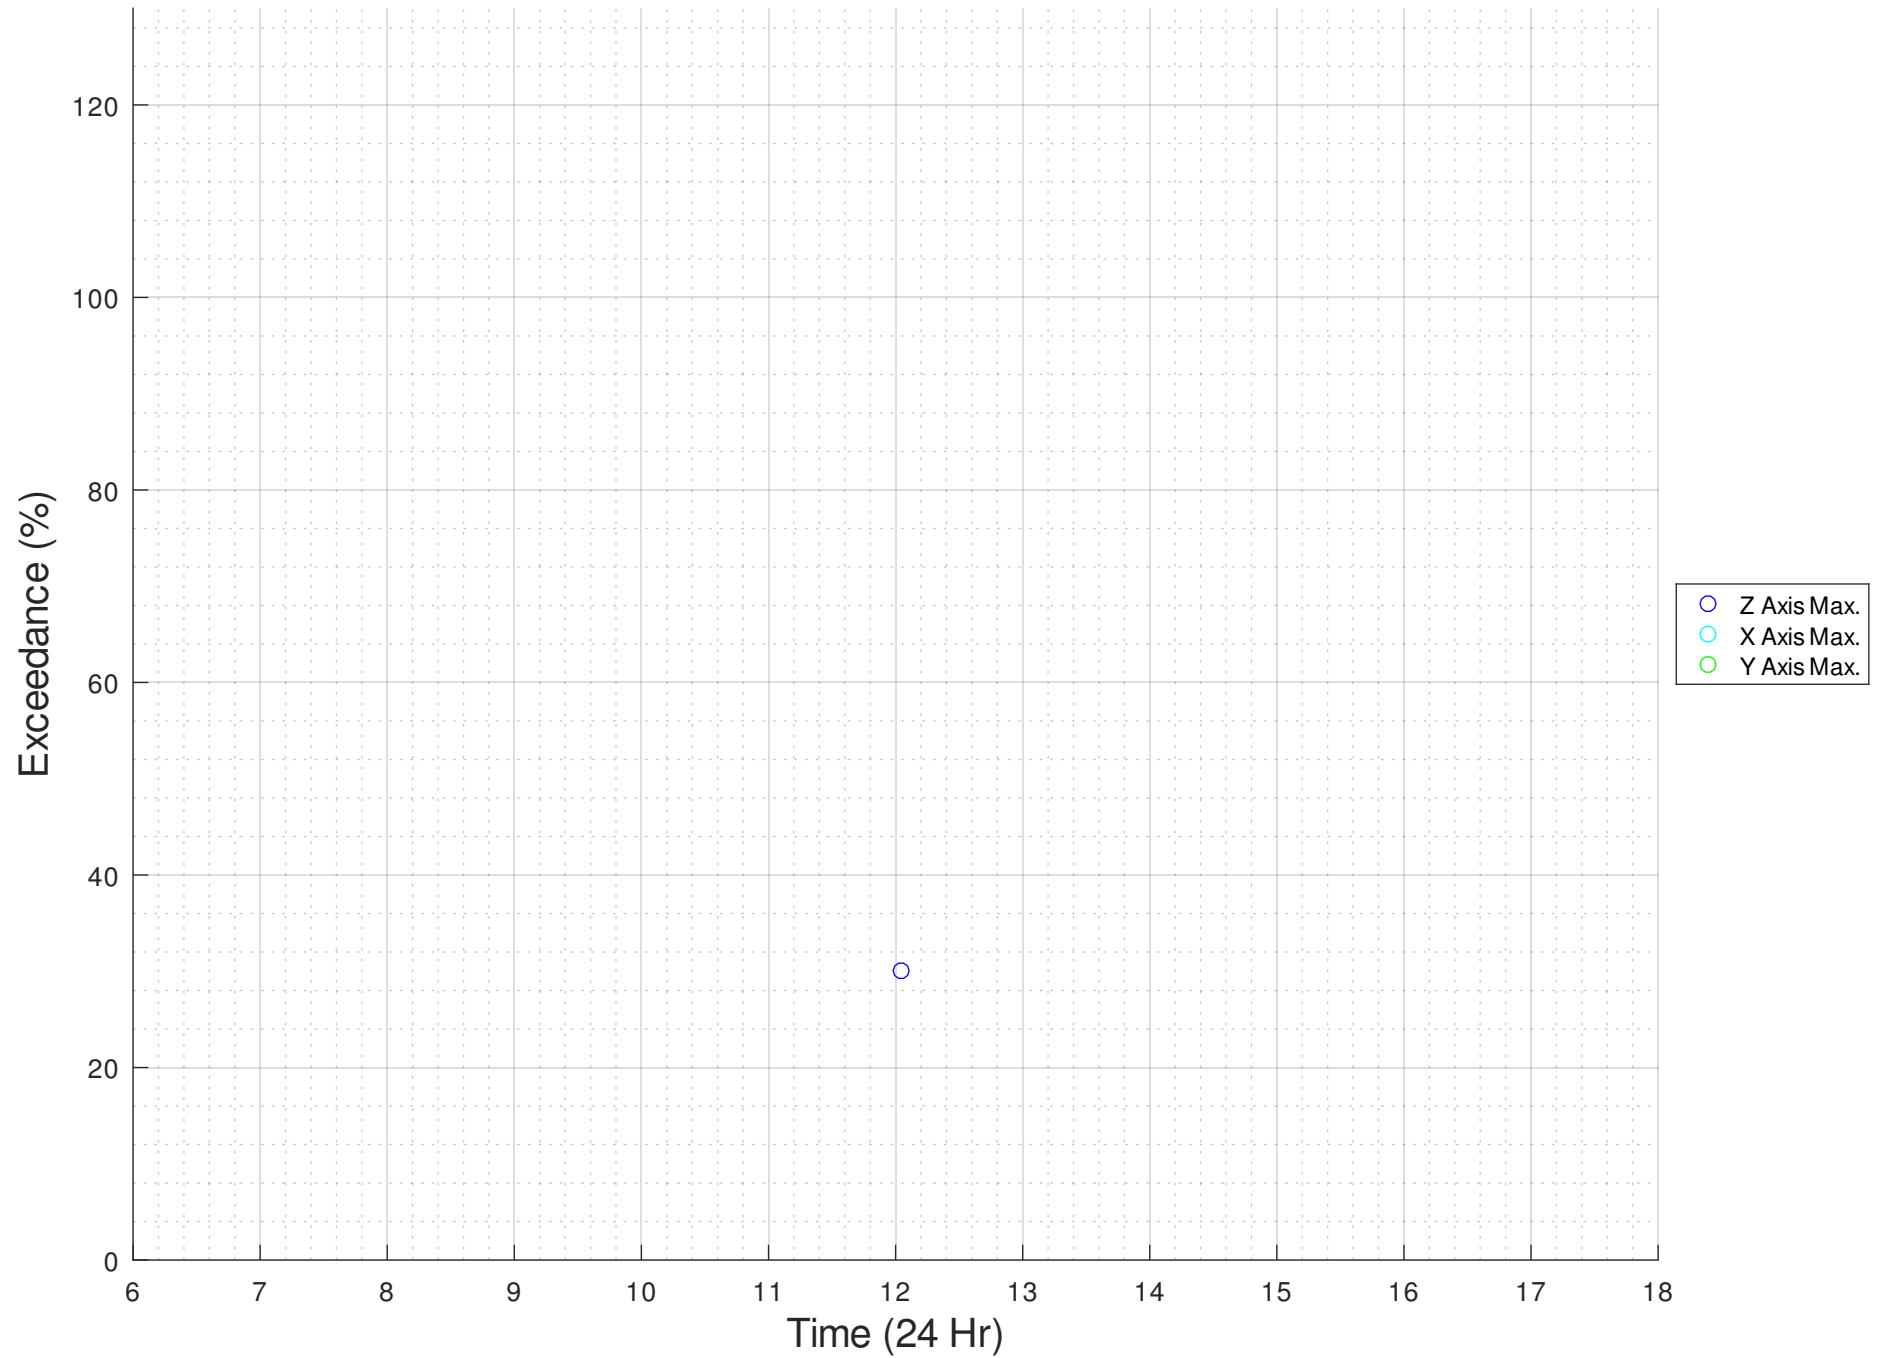
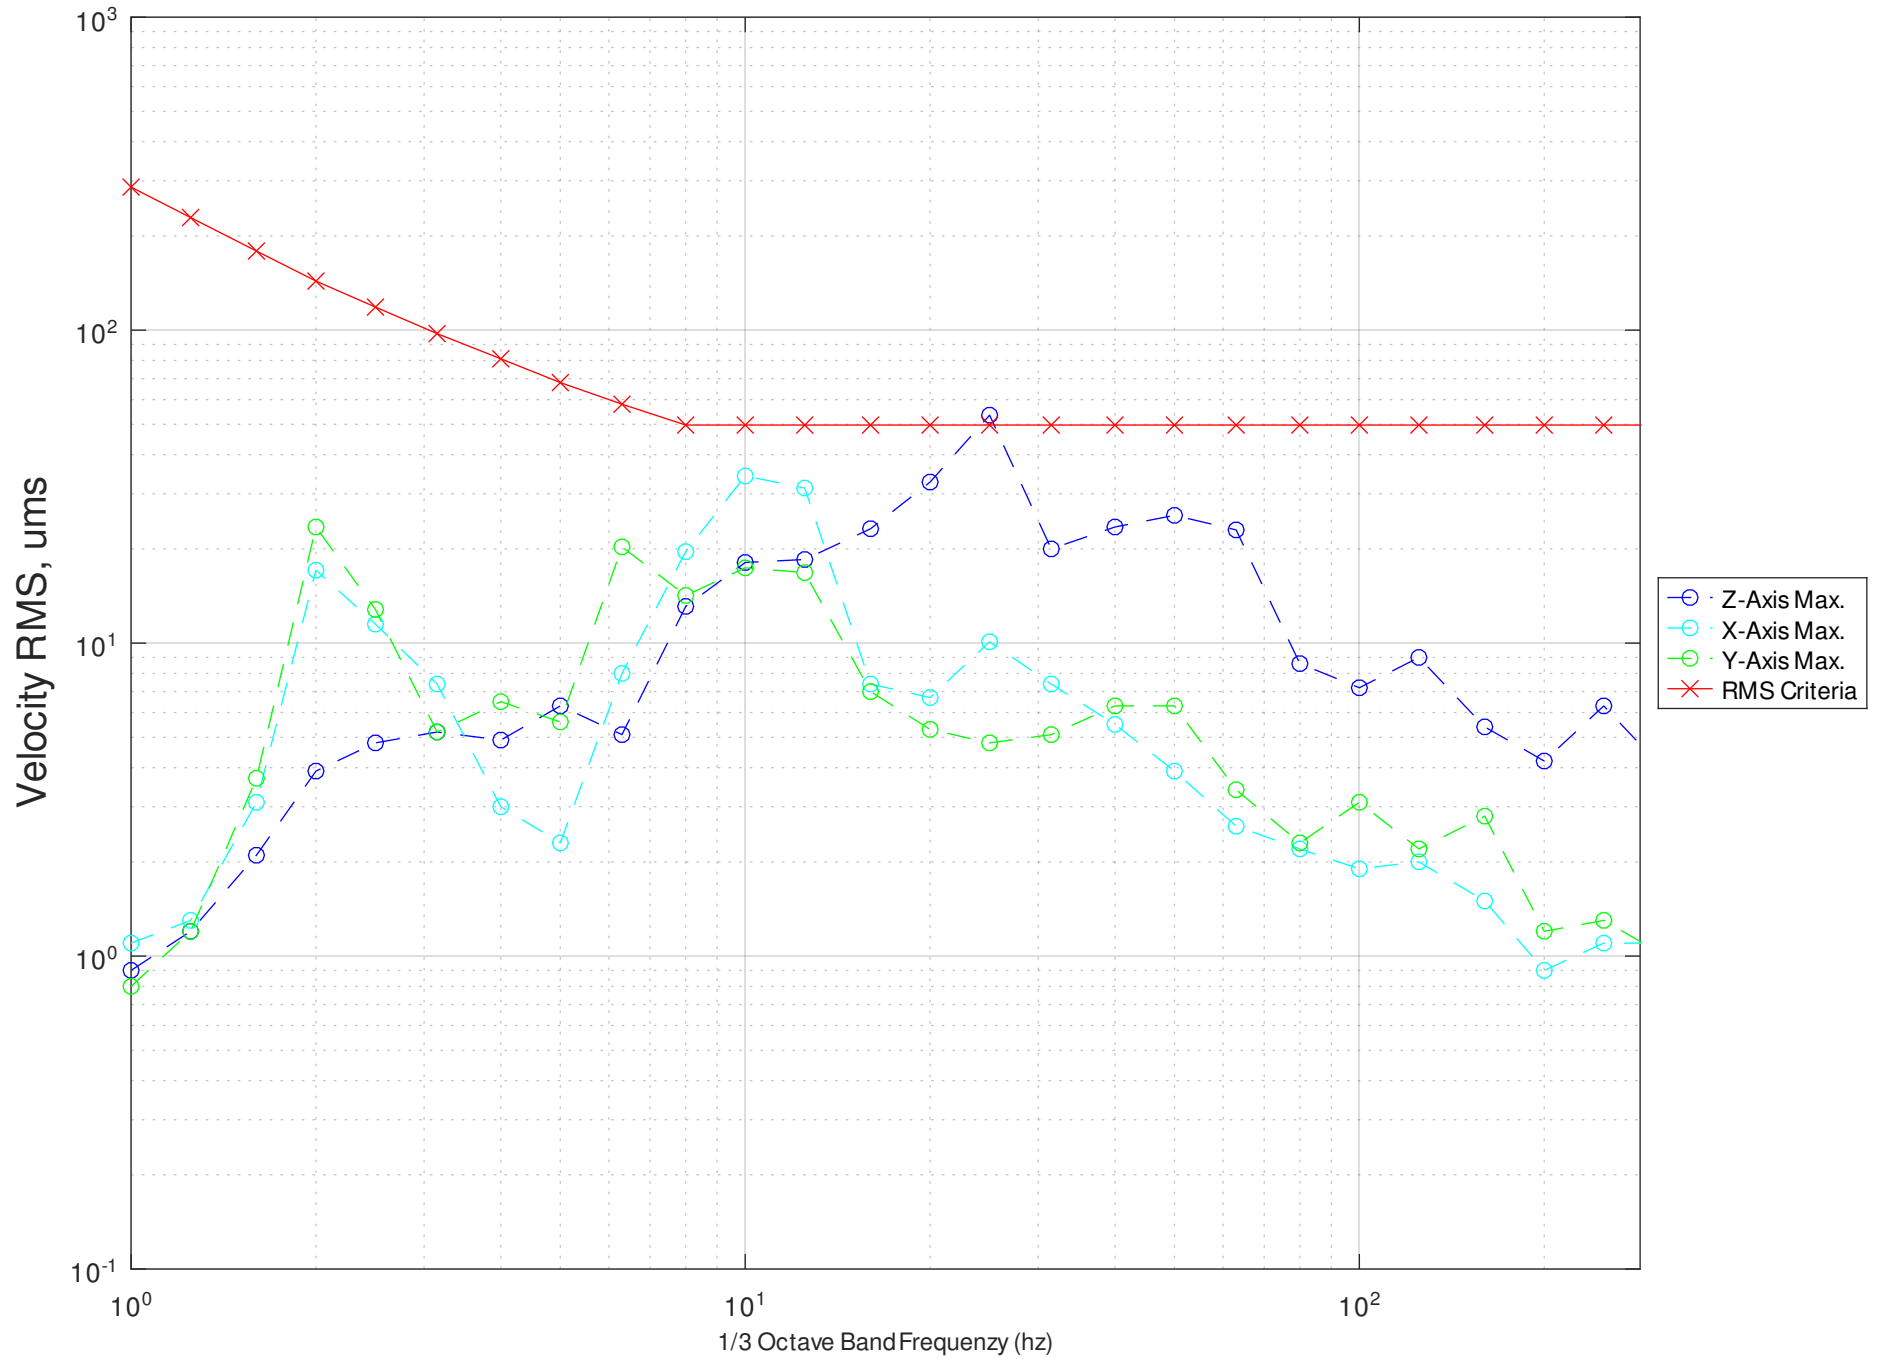
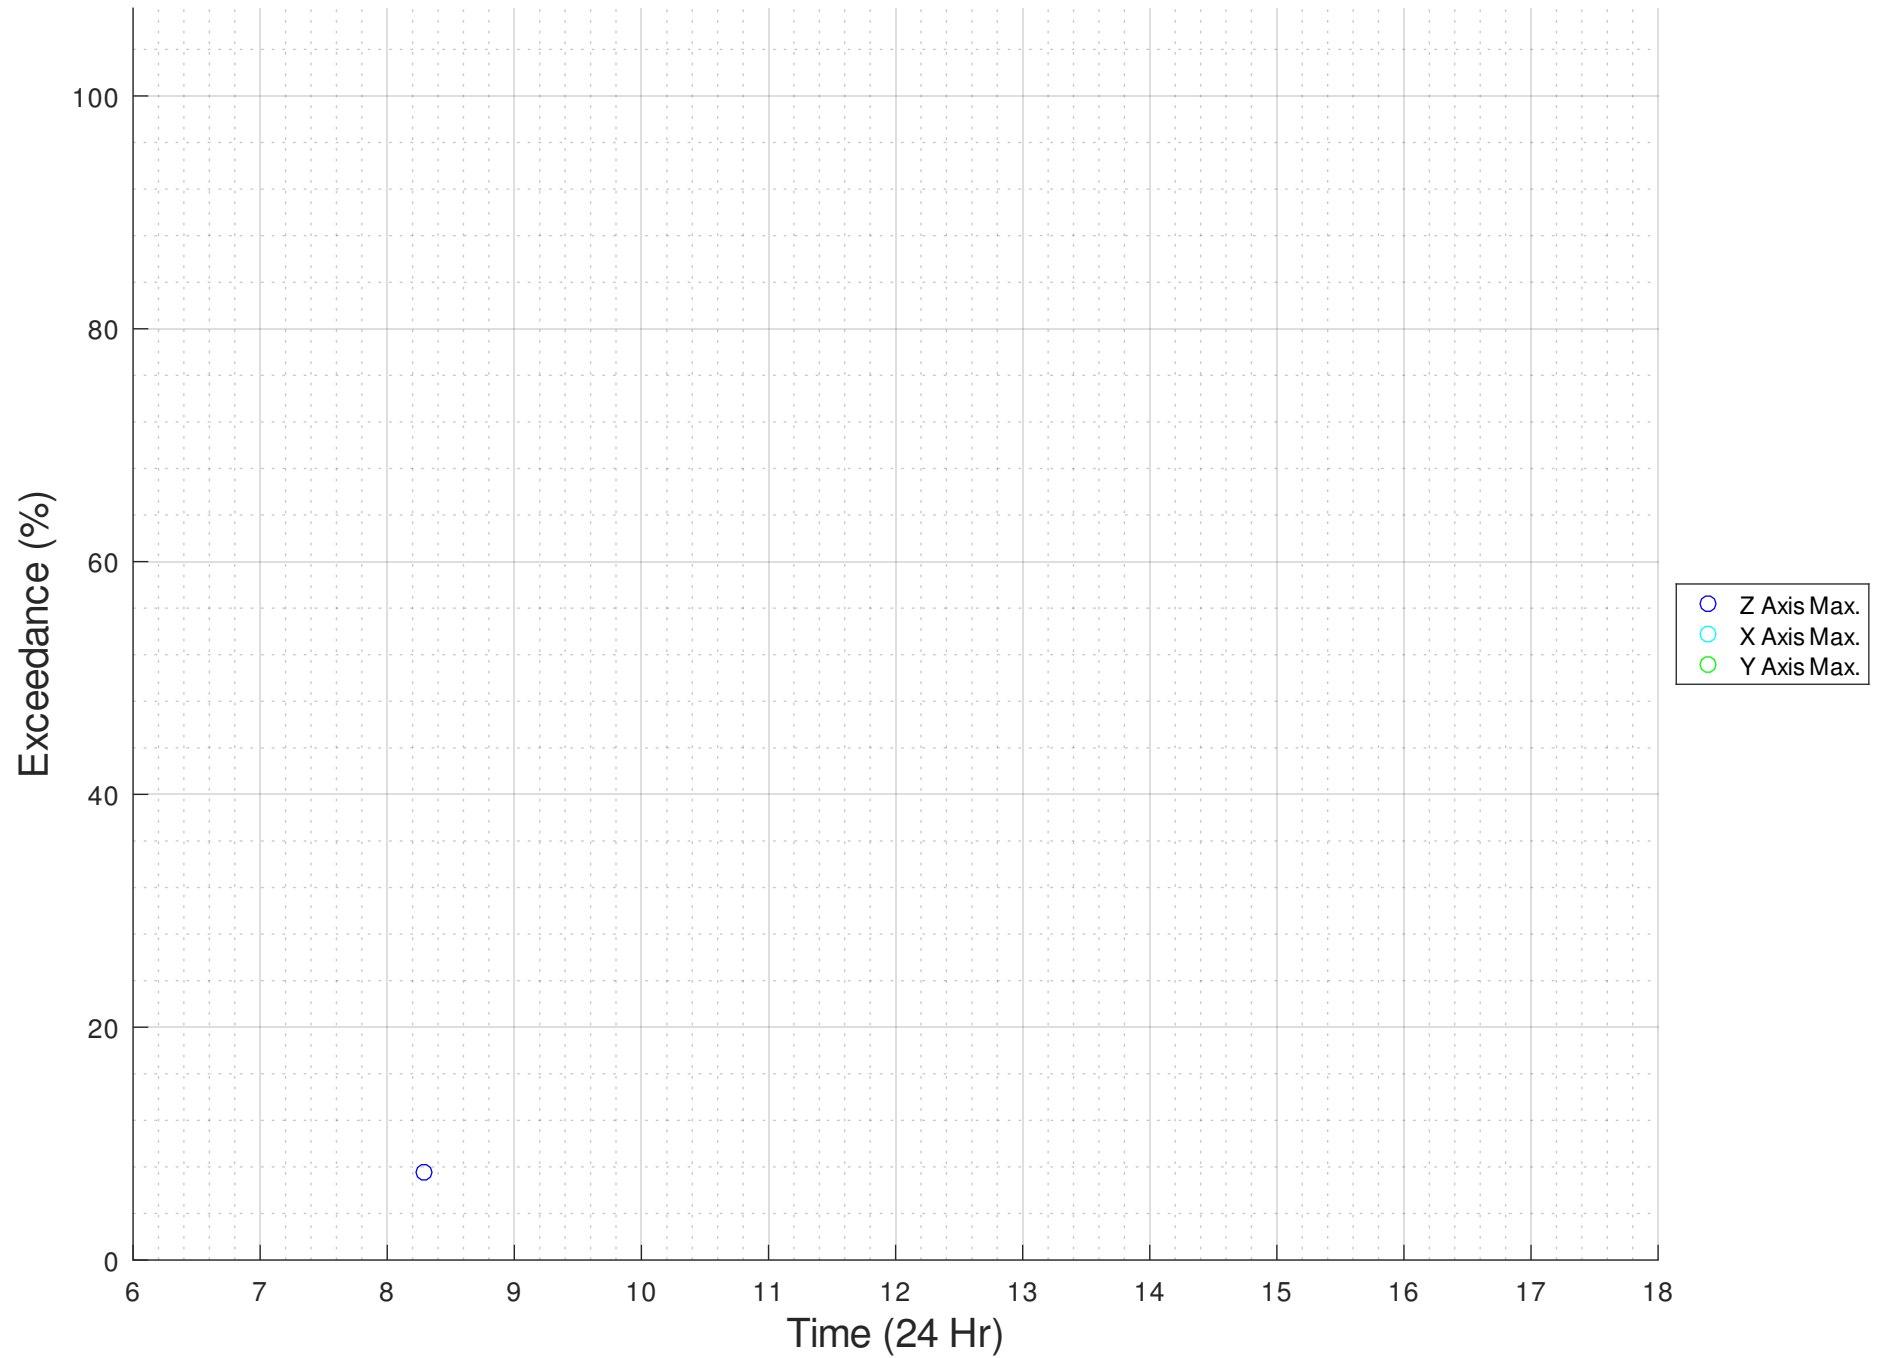
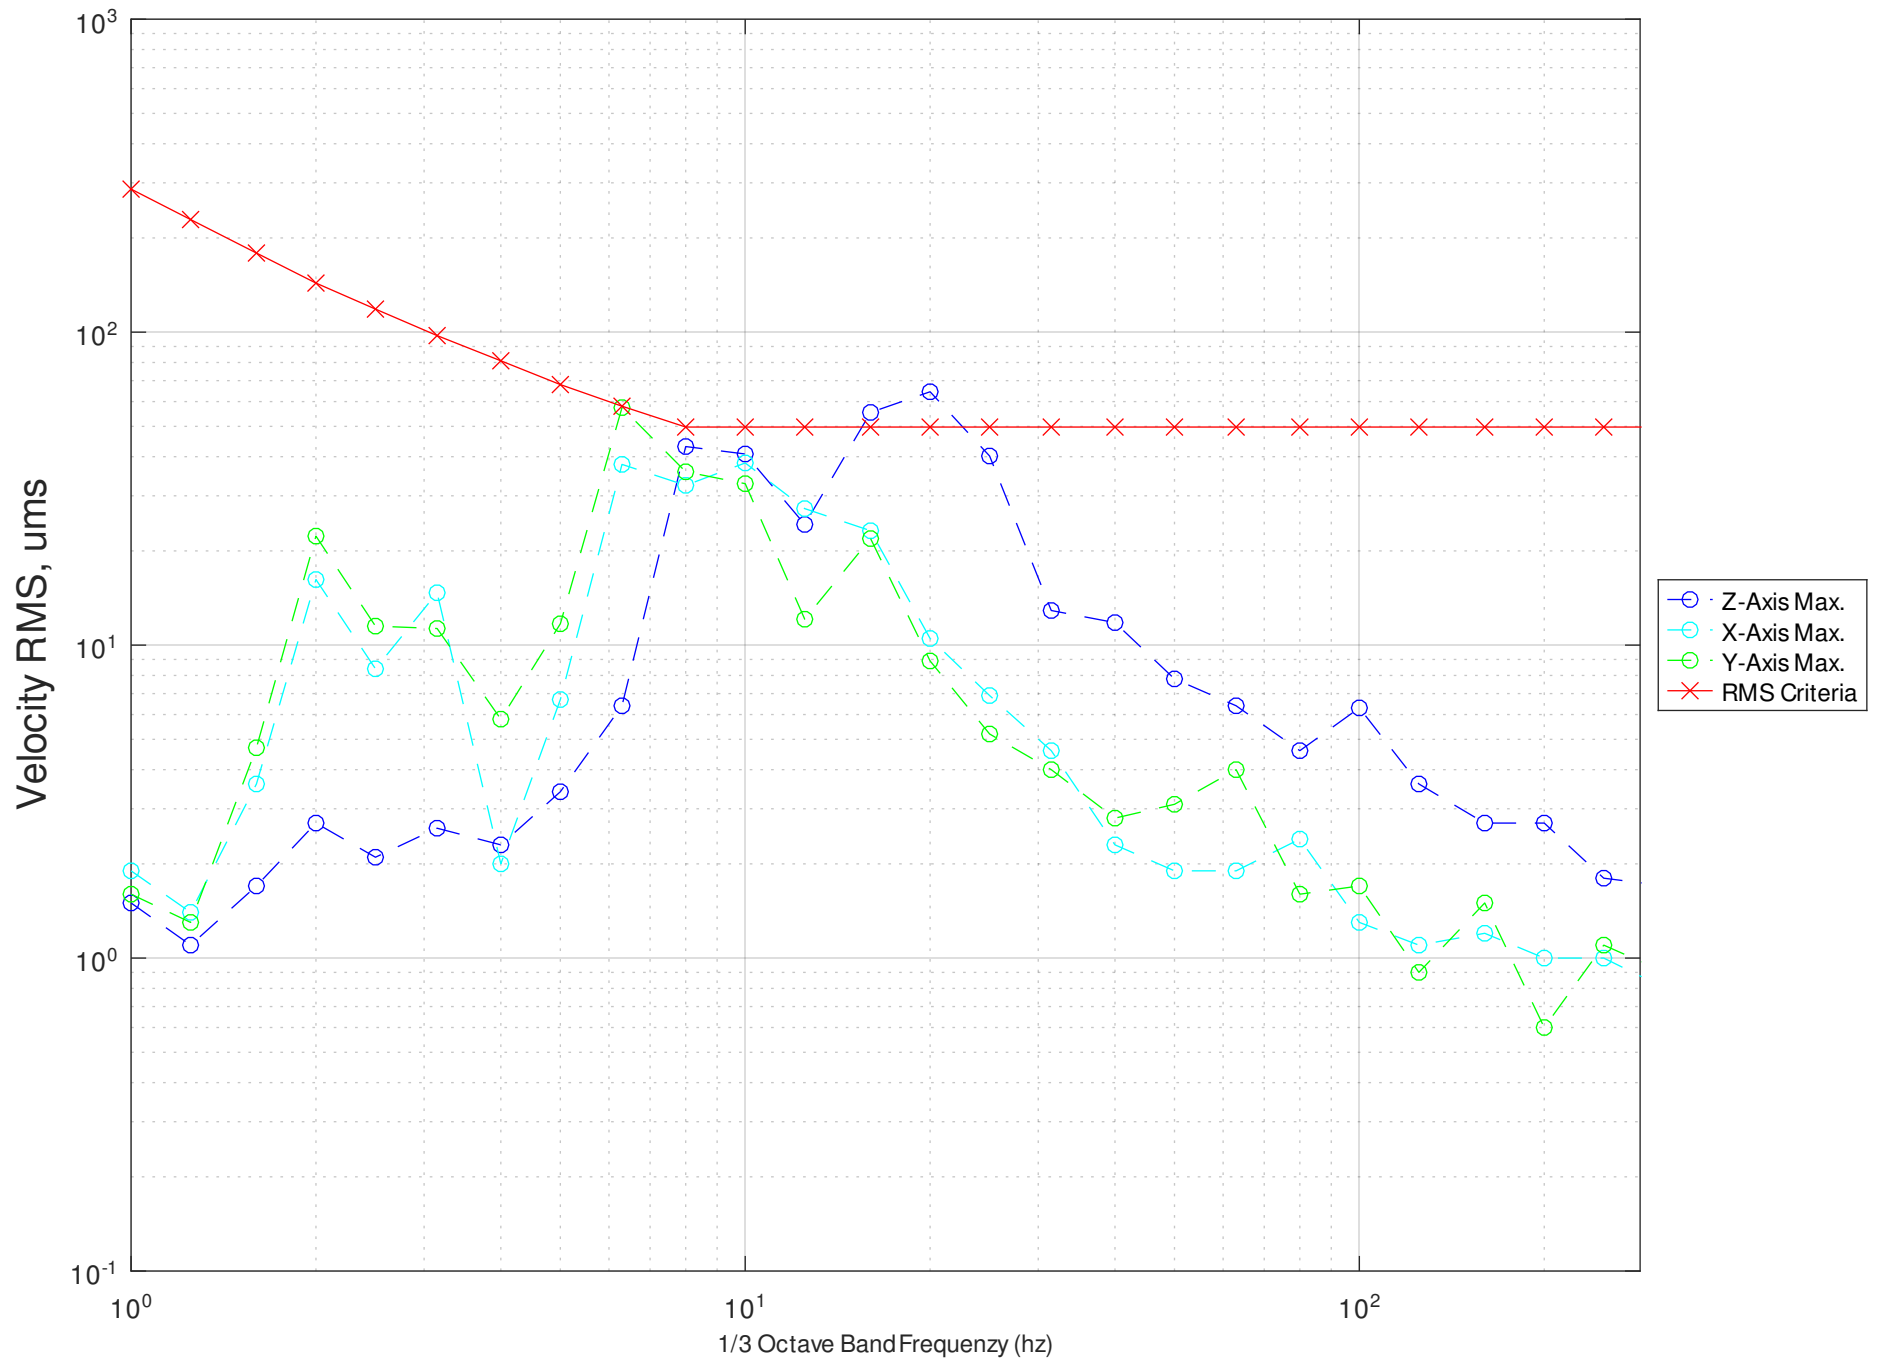
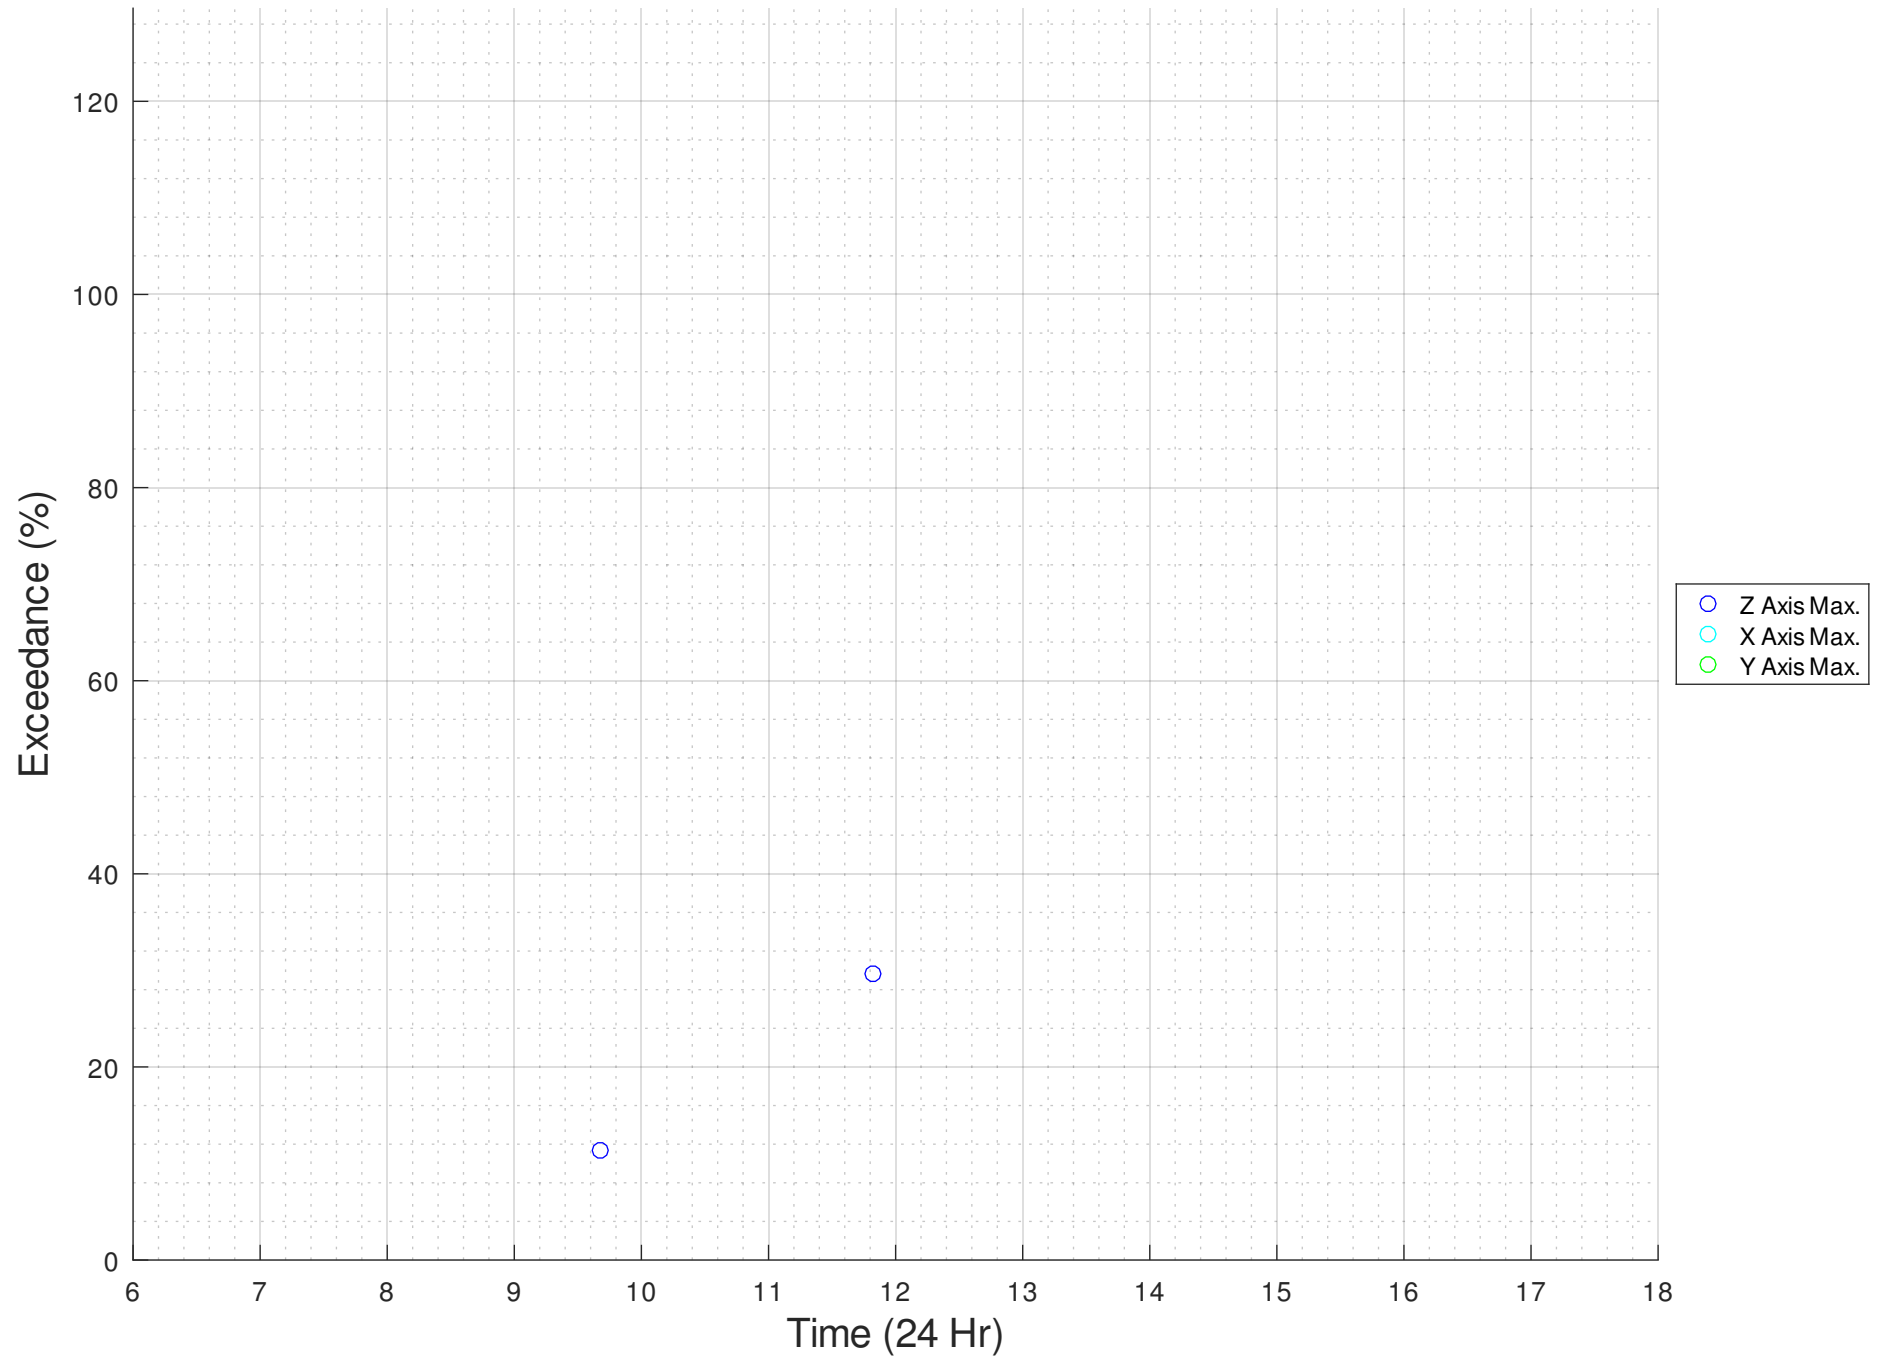
CENTENARY INSTITUTE – LEVEL 4 SURGERY ROOM (SOUTHERN FAÇADE)

- Level 3 – Fish Tanks:
 - No exceedances of vibration criteria were observed throughout this monitoring period.
- Level 4 – Surgery Room (Southern Façade), Clean Changeroom (Southern Façade) and Bathroom (Northern Façade):

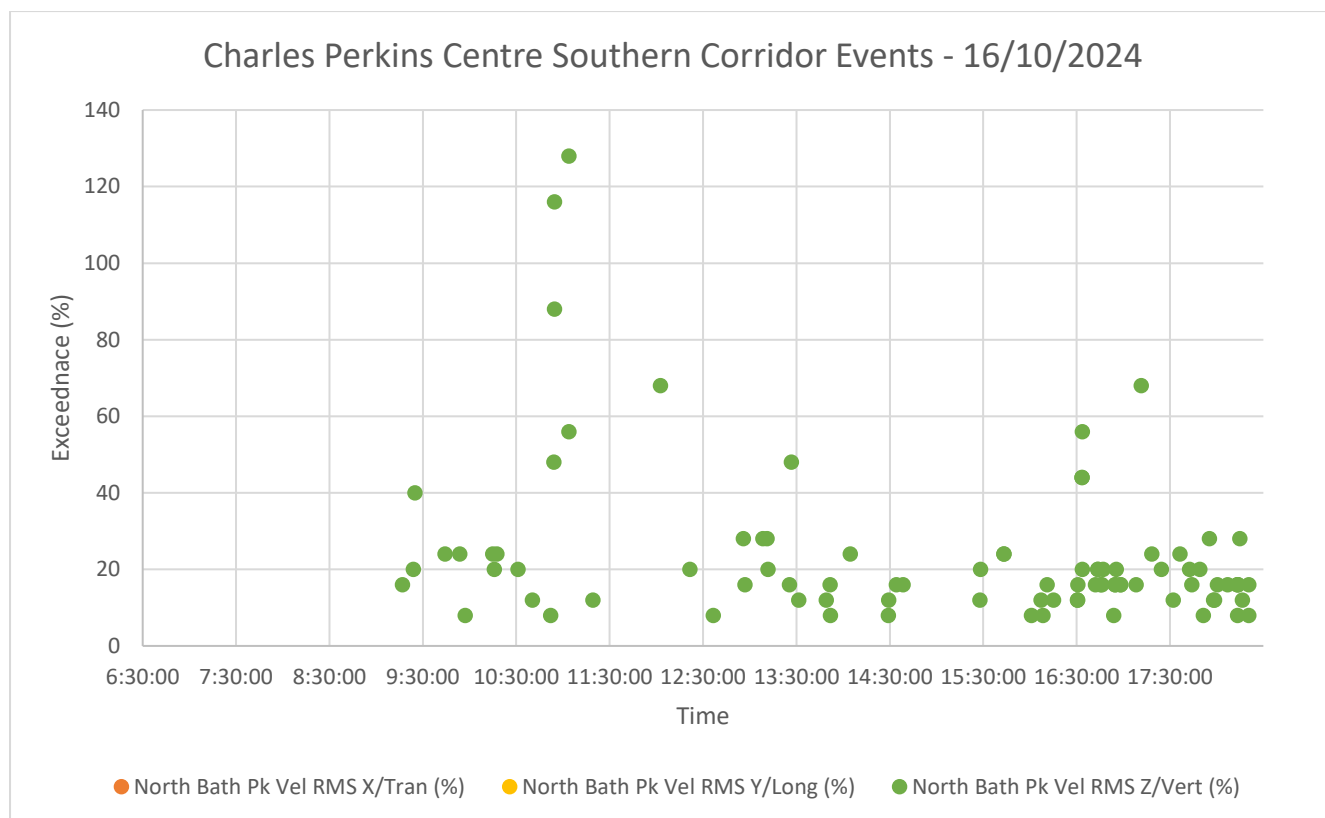
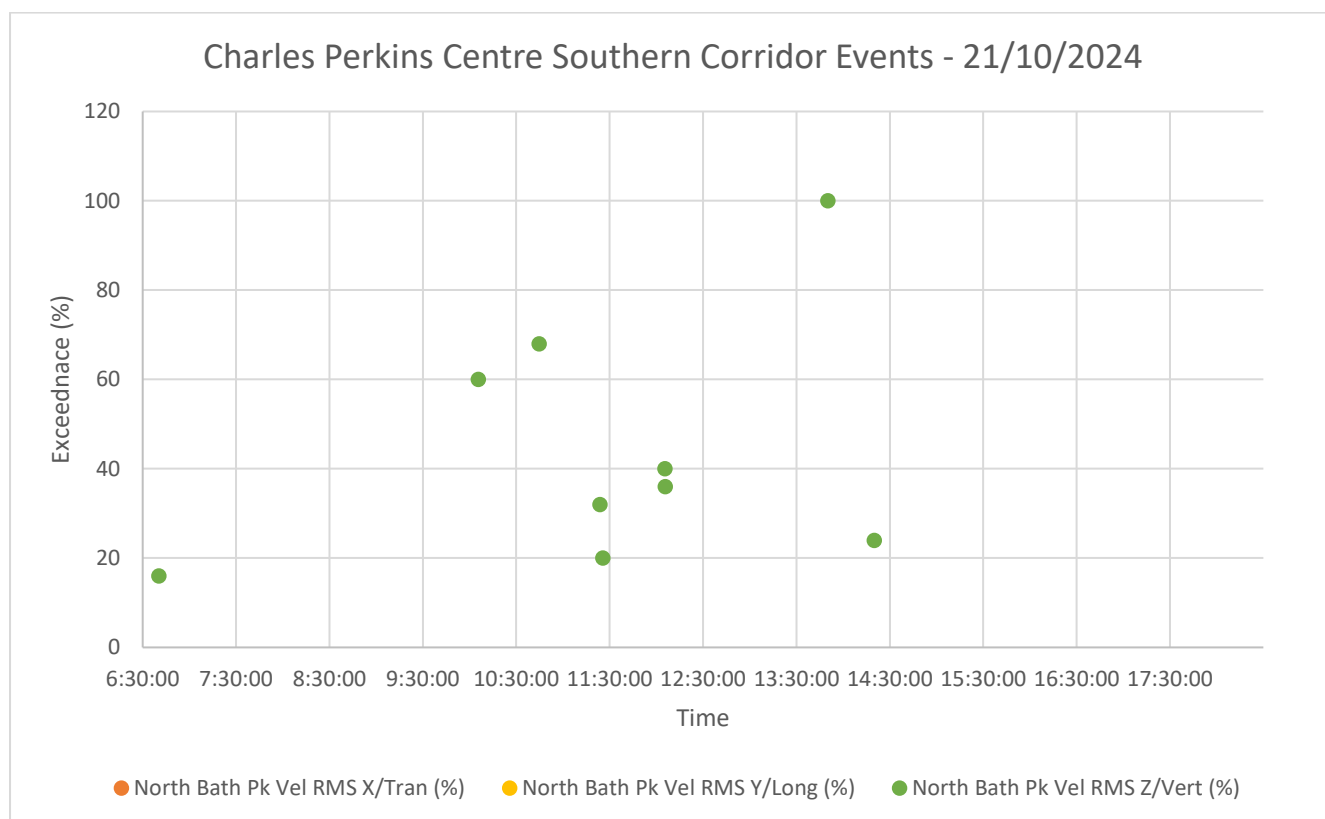
CHARLES PERKINS CENTRE – LEVEL B1 SOUTHERN CORRIDOR

- Southern Corridor (Imaging):
 - Exceedances of B2 VC-B criteria which display characteristics consistent with construction activity were observed at the monitoring station during construction hours on the following dates during the monitoring period:

- Exceedances are generally observed at 12.5Hz, likely to be the natural frequency of the CPC suspended slab. Exceedances at frequencies exclusive of 12.5Hz, 16Hz and 20Hz are rarely observed.

Charles Perkins Centre Southern Corridor Events - 22/10/2024

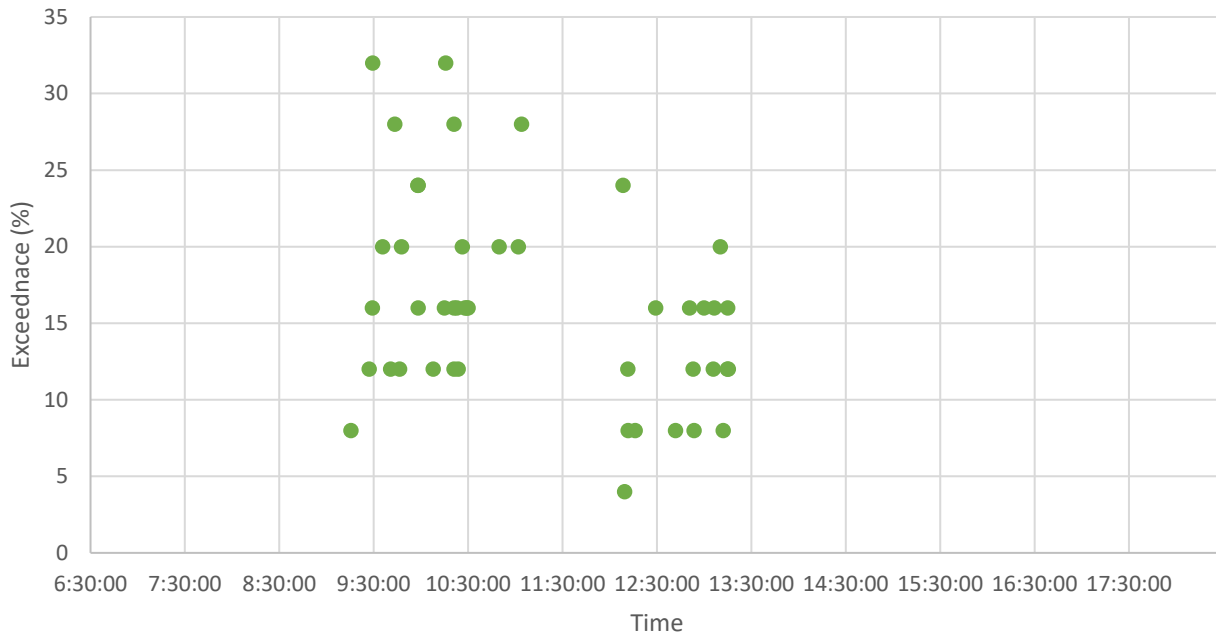
● North Bath Pk Vel RMS X/Tran (%) ● North Bath Pk Vel RMS Y/Long (%) ● North Bath Pk Vel RMS Z/Vert (%)

- For many of the measured exceedances there is a lack of correlation between the southern corridor monitor and the other monitoring stations surrounding the project site. Therefore, it is likely that some or most of these spikes have been caused by factors exclusive of the construction activity within the RPA Hospital project area.

- It is prudent to note that there were significant exceedances observed within the monitoring period which were outside of hours of works throughout the period, noting that various repeated exceedances were observed before 7am and after 5.00pm and on weekend days during the period. These events have not been attributed to the impacts of the construction.

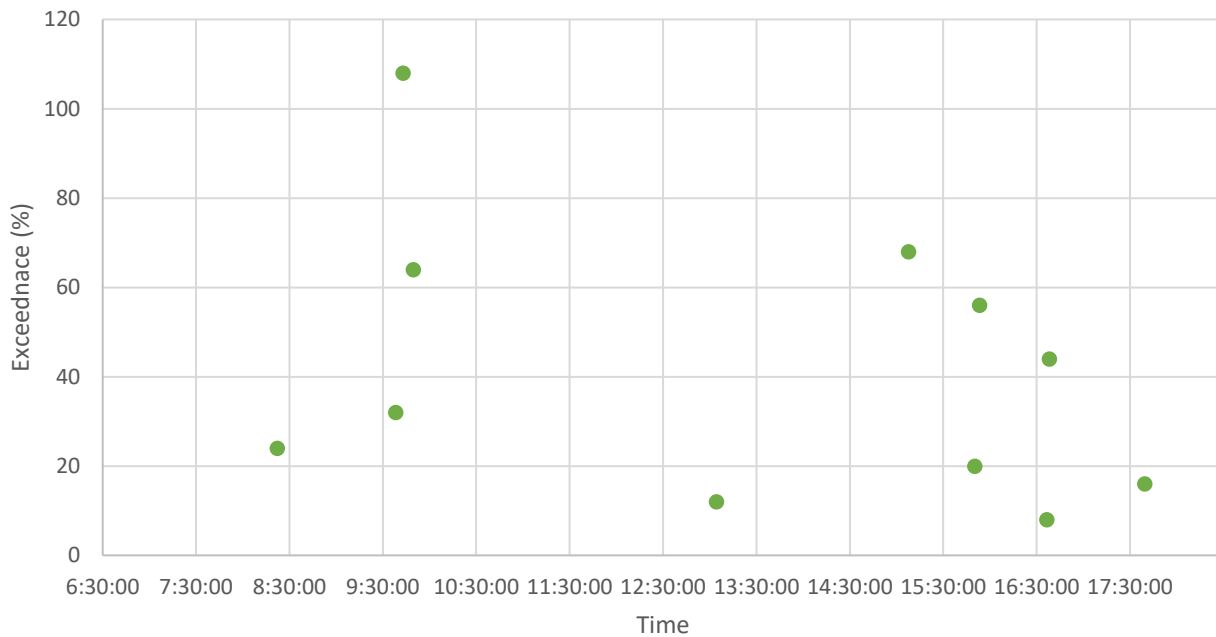
Charles Perkins Centre Southern Corridor Events - 23/10/2024

● North Bath Pk Vel RMS X/Tran (%) ● North Bath Pk Vel RMS Y/Long (%) ● North Bath Pk Vel RMS Z/Vert (%)
