Royal Prince Alfred Hospital Redevelopment (RPAH Redevelopment)

Construction Noise and Vibration Monitoring Report 23

Client Doc. No. RPA-ACO-ACL-RPT-MW-000026 - Rev A

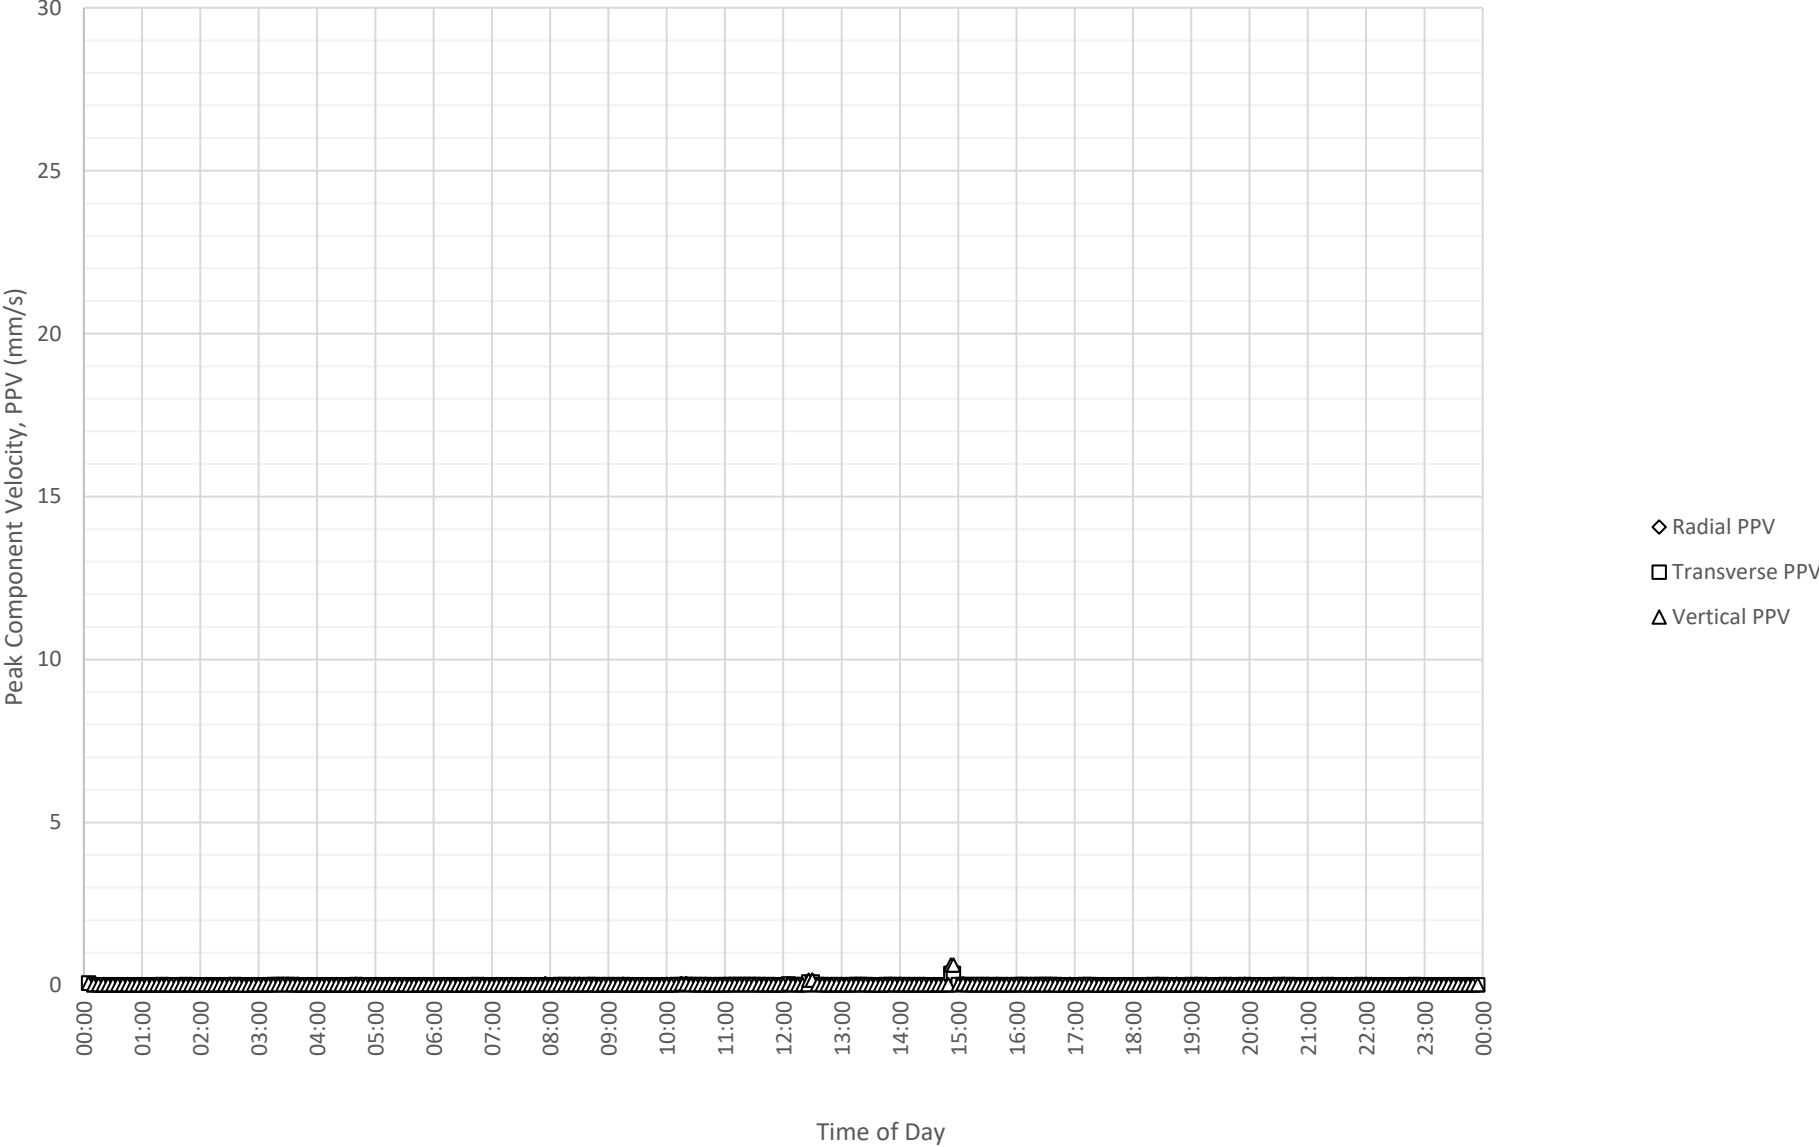
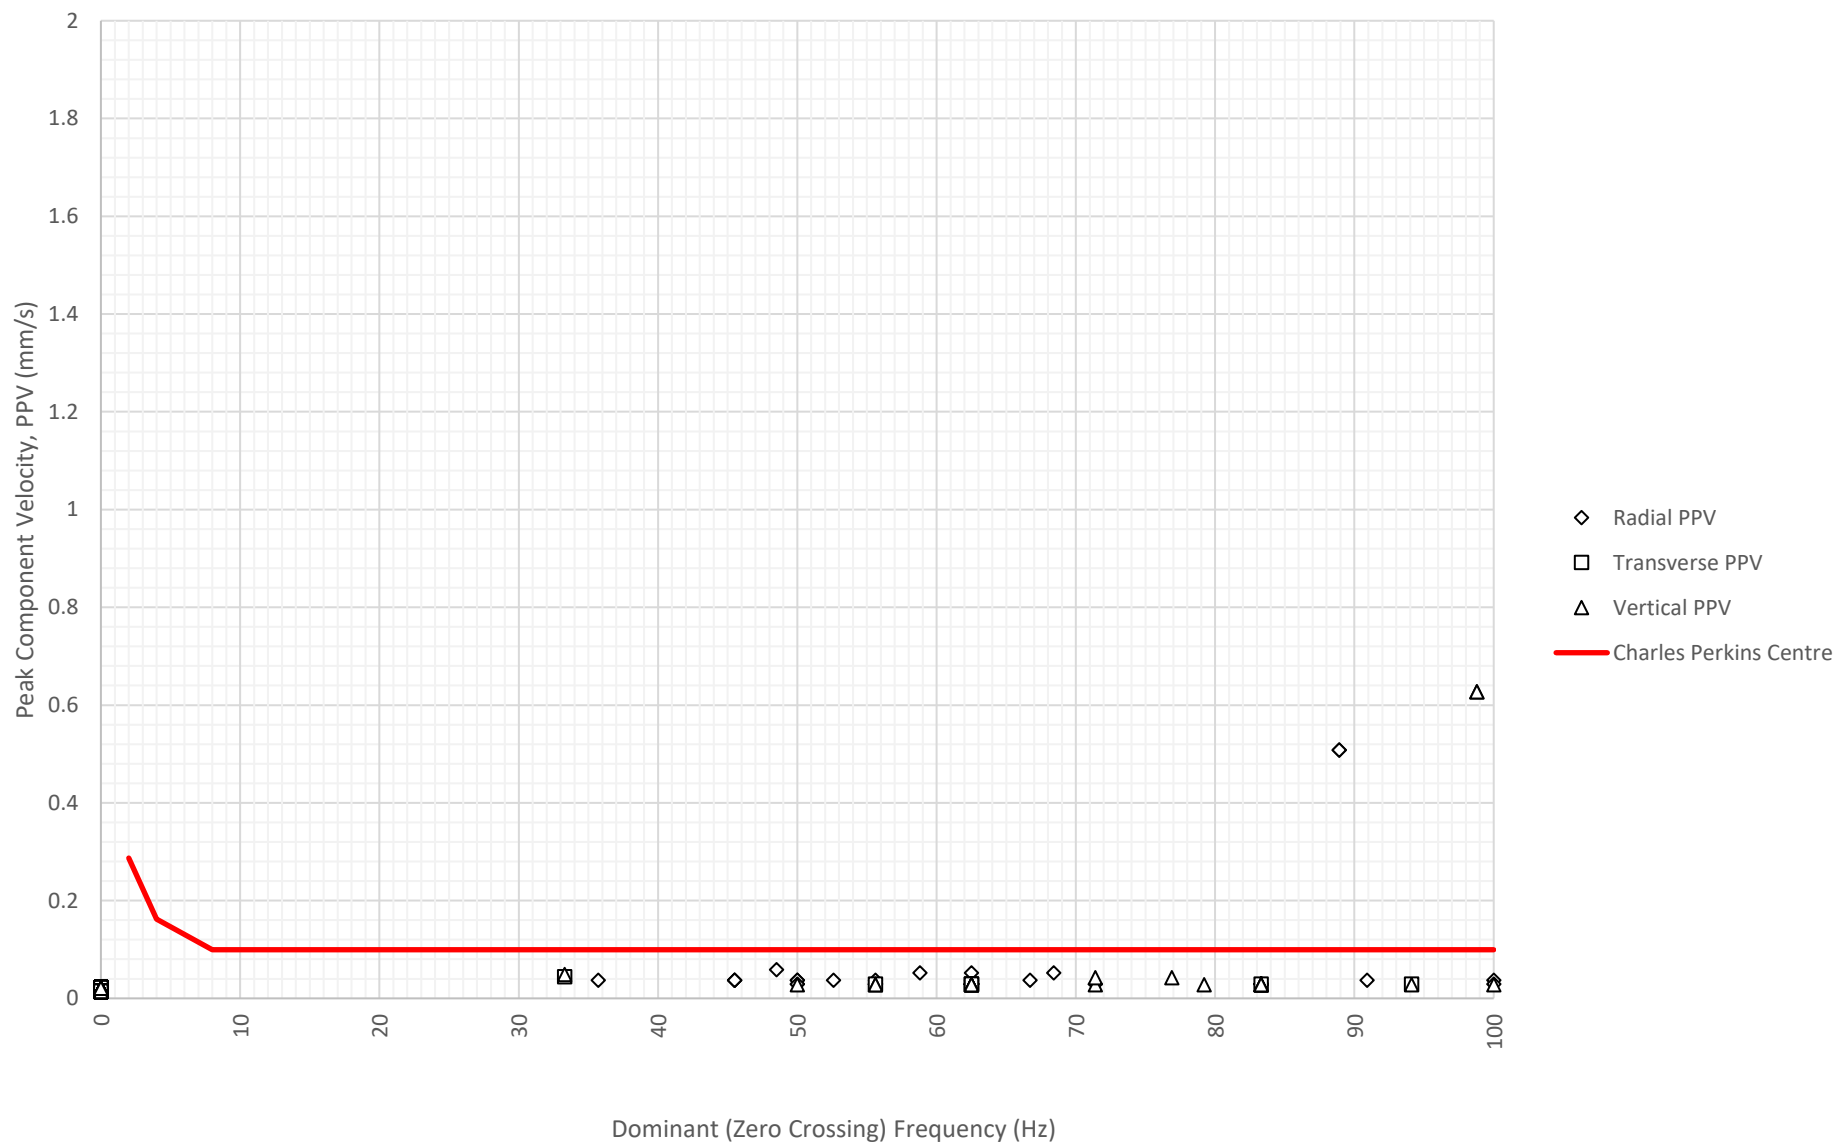
Daily Monitored Vibration Levels at Charles Perkins Centre - B1 Observation Room Corridor on 16-10-2024

Frequency Content of Vibration Levels at Charles Perkins Centre - B1 Observation Room Corridor on 16-10-2024

- Observation Room (Adjoining corridor):
 - An exceedance of the PPV trigger level of the Texcel monitor within the animal testing facility was observed on the following dates:

- 16/10/2024.
 - 21/10/2024.
 - 23/10/2024.
 - 25/10/2024.

- Alternatively, this may have been caused by operational activity within the facility such as a step or a trolley movement, which occurred closer to the texcel monitor however did not register an exceedance at the B & K monitor.

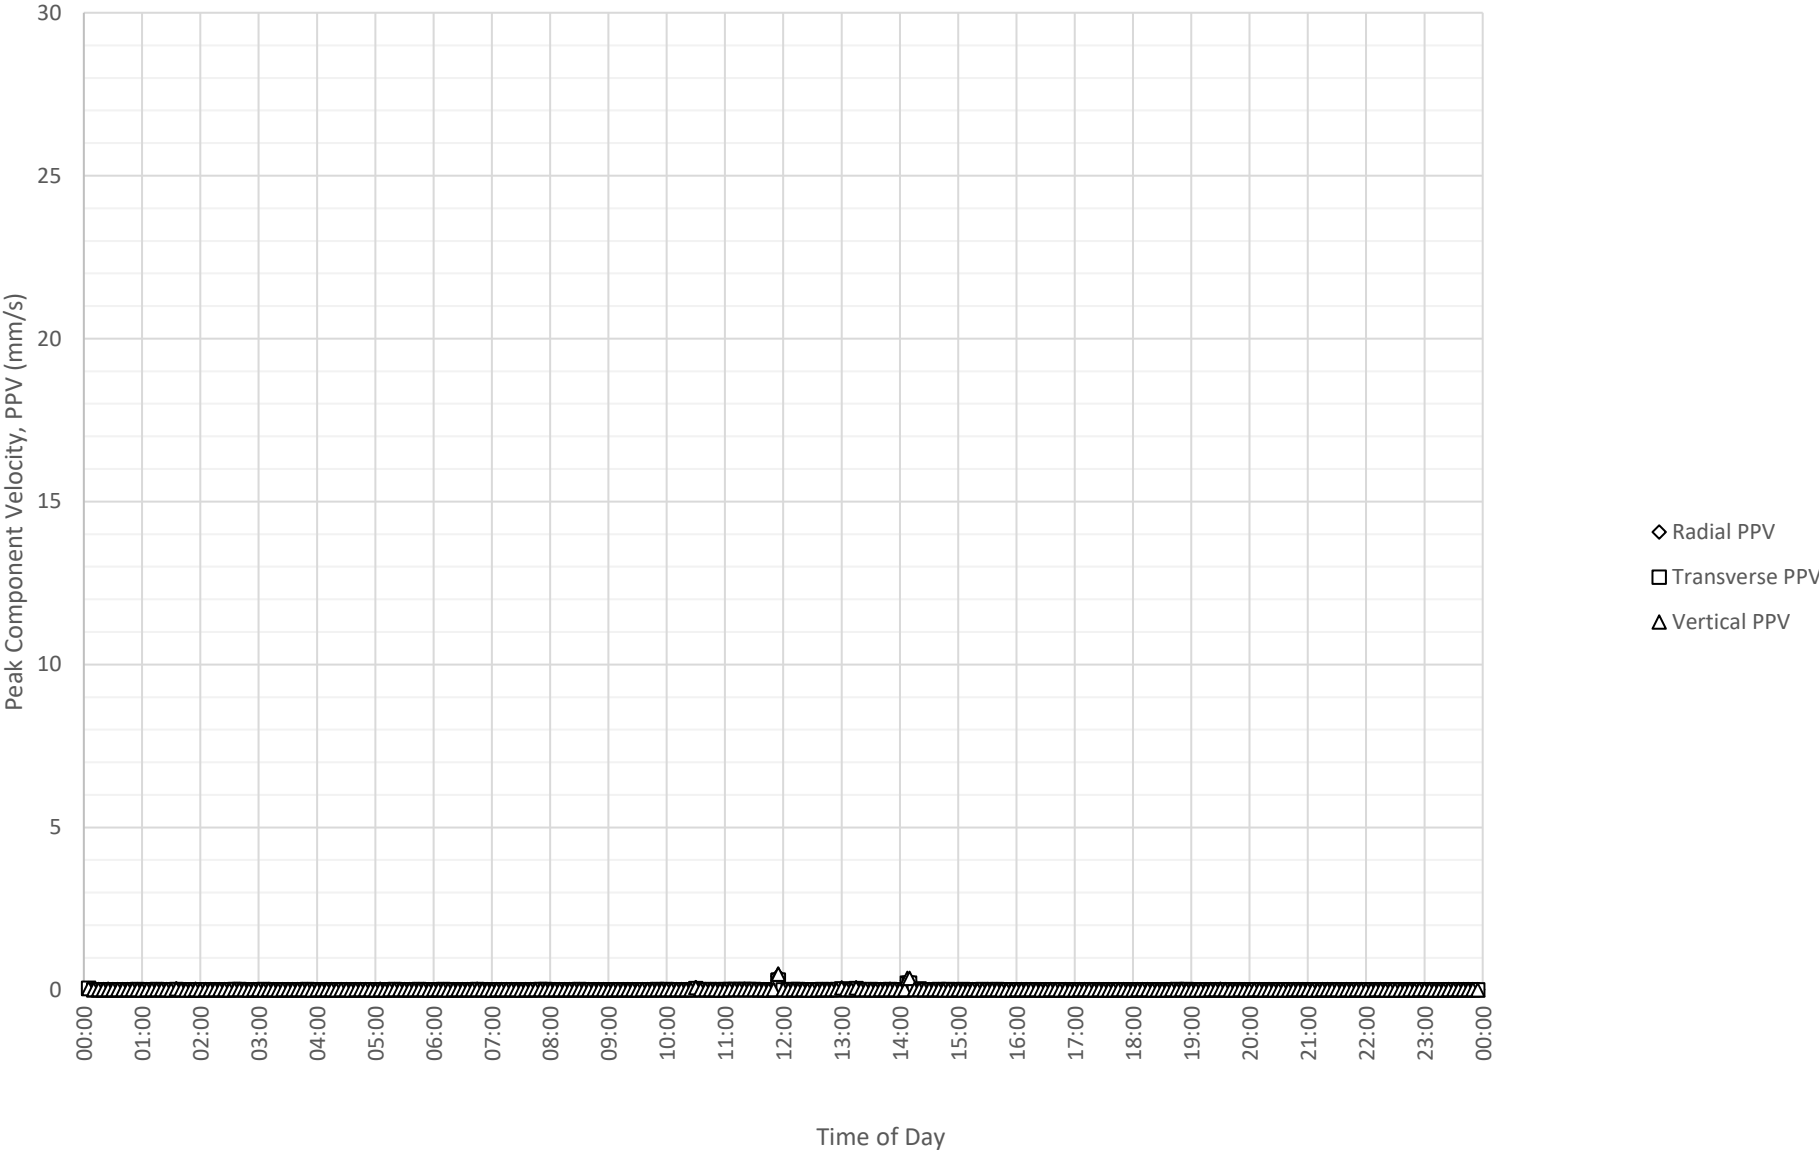
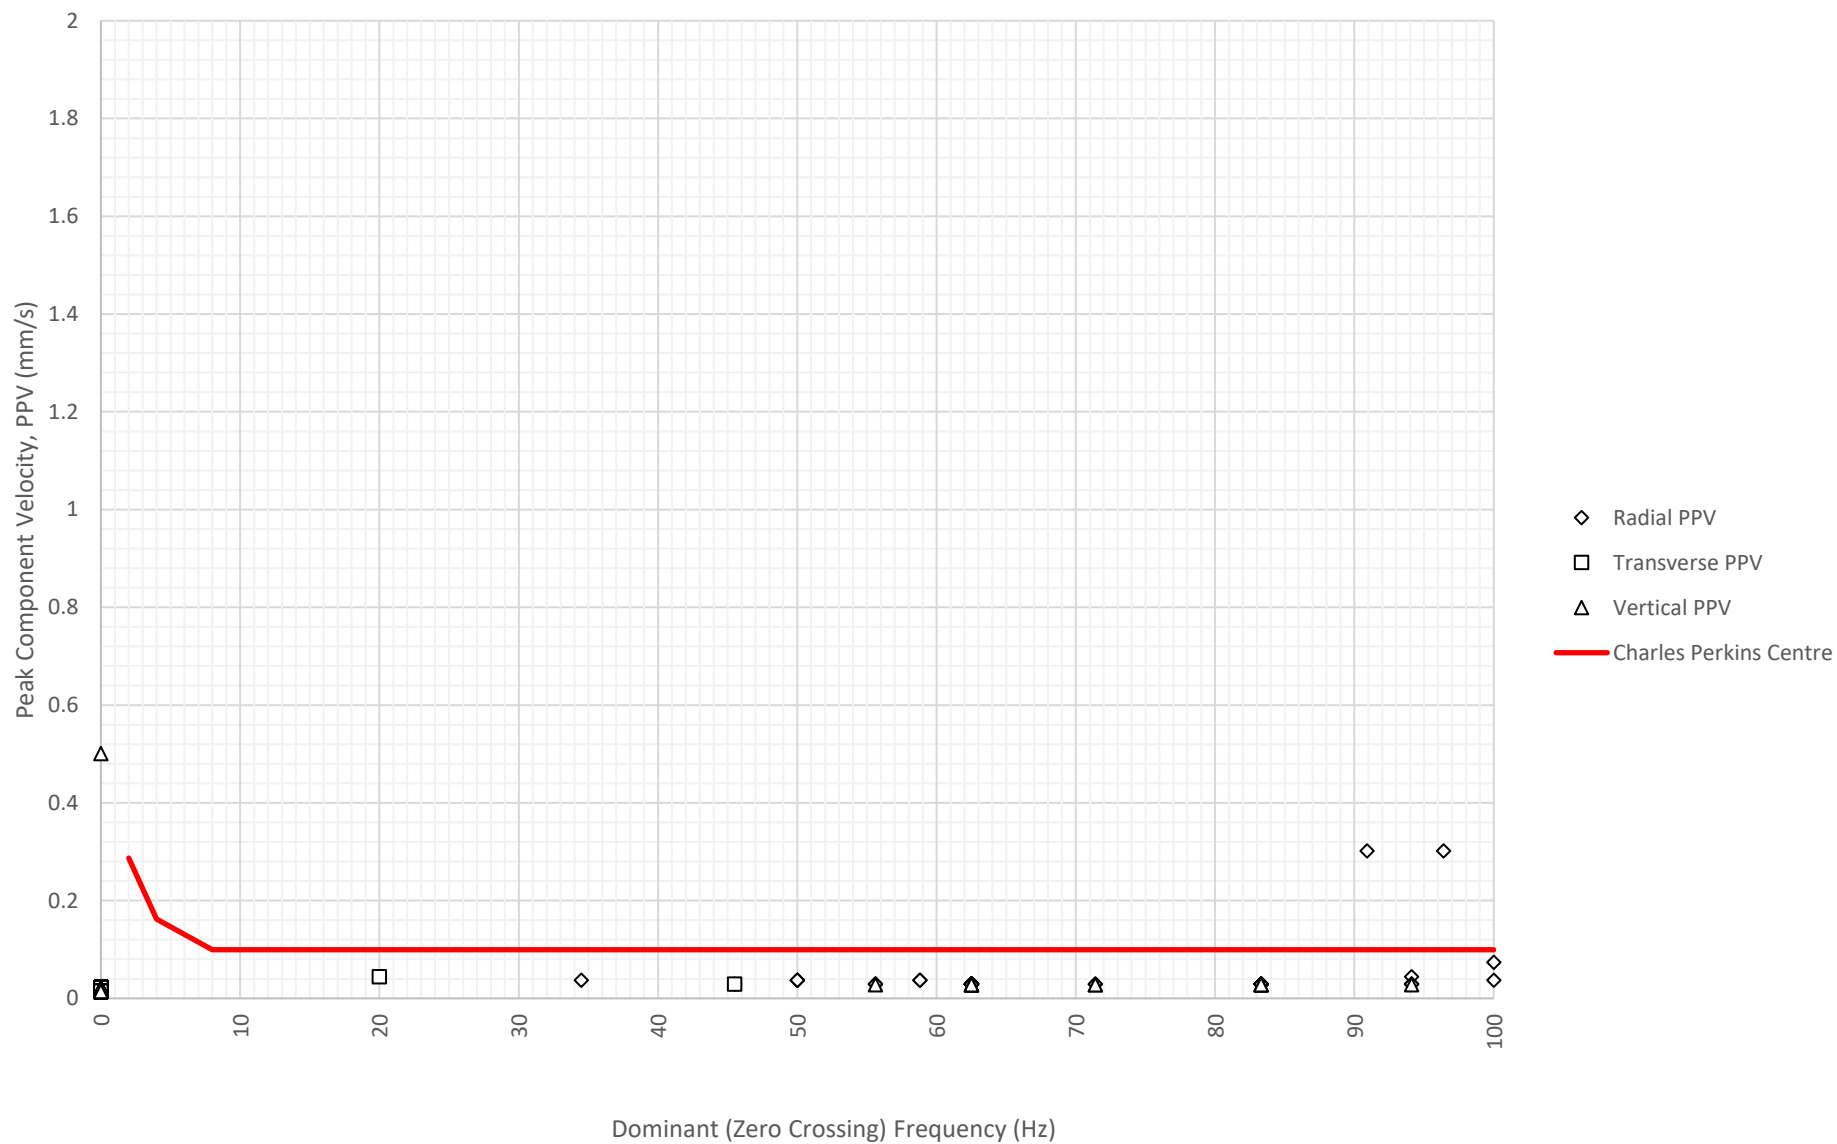
Daily Monitored Vibration Levels at Charles Perkins Centre - B1 Observation Room Corridor on 21-10-2024

Frequency Content of Vibration Levels at Charles Perkins Centre - B1 Observation Room Corridor on 21-10-2024

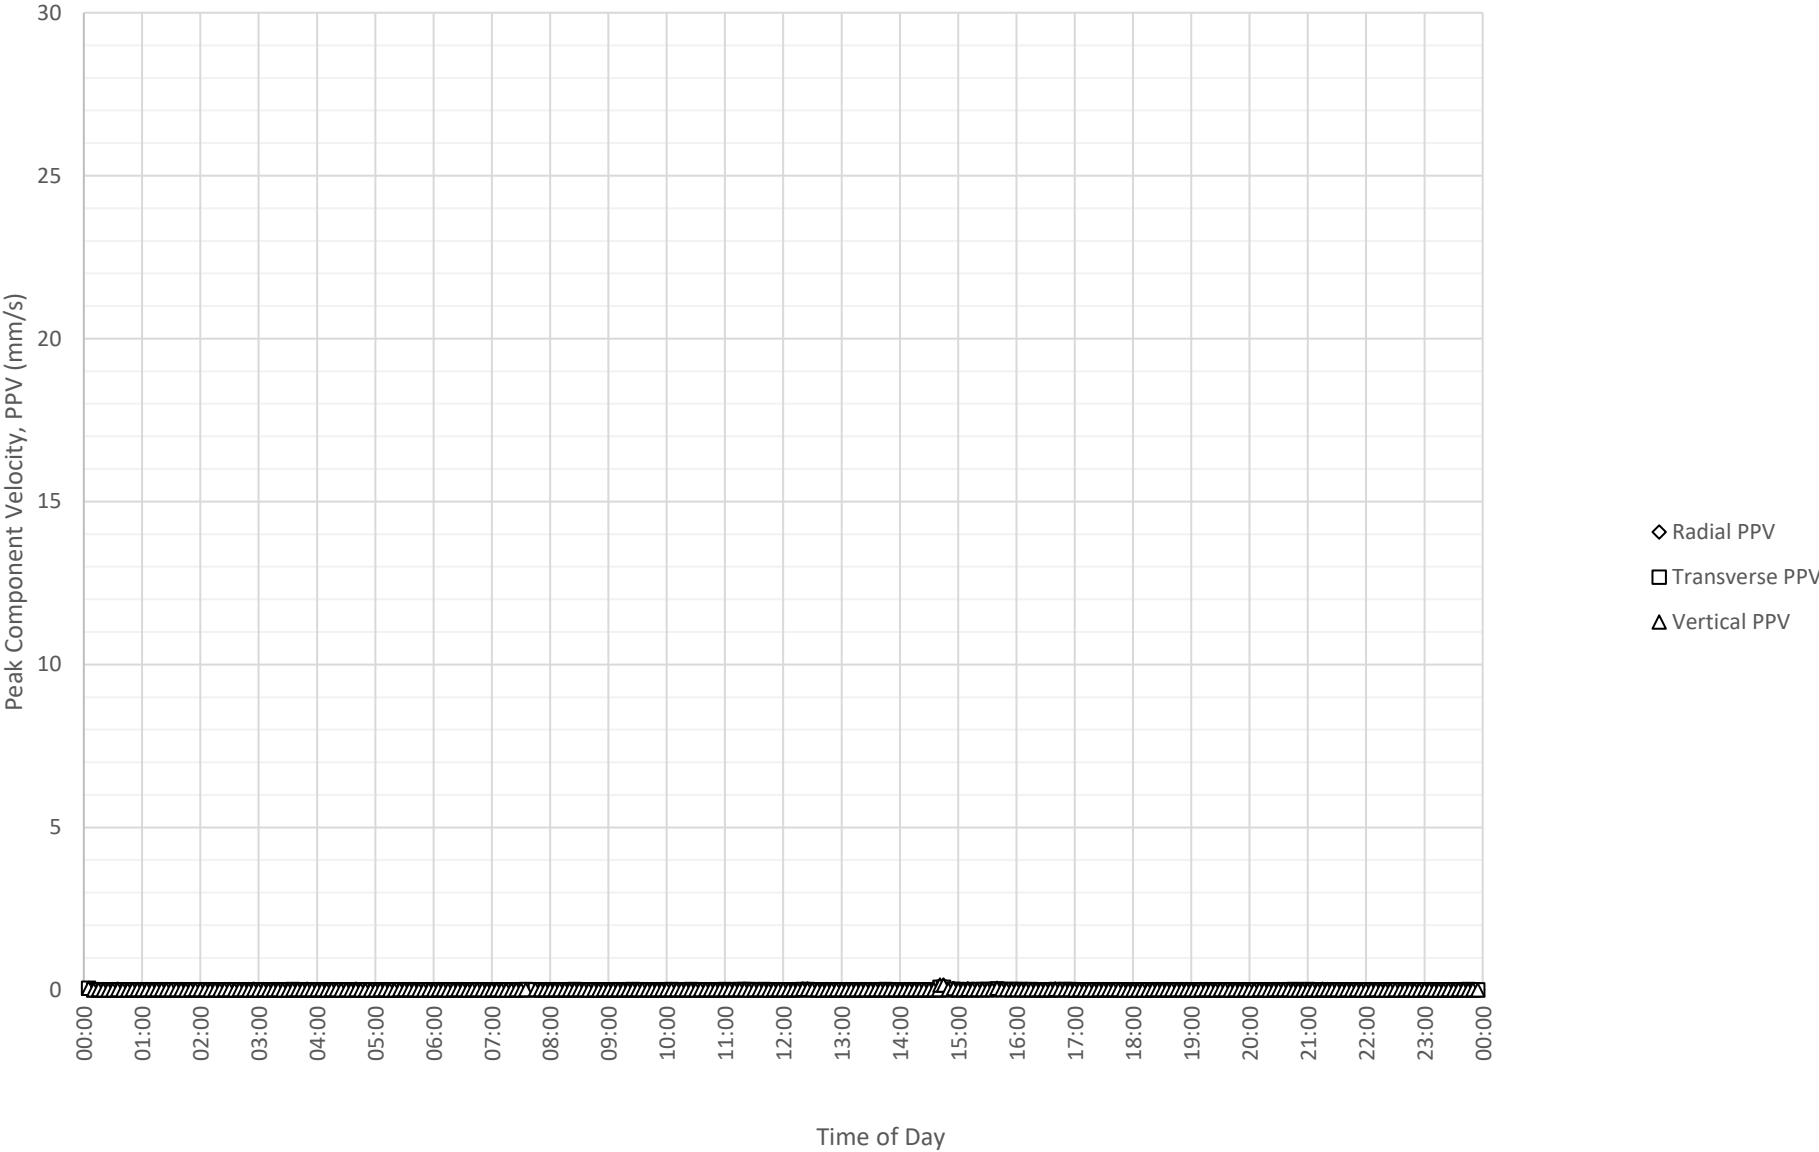
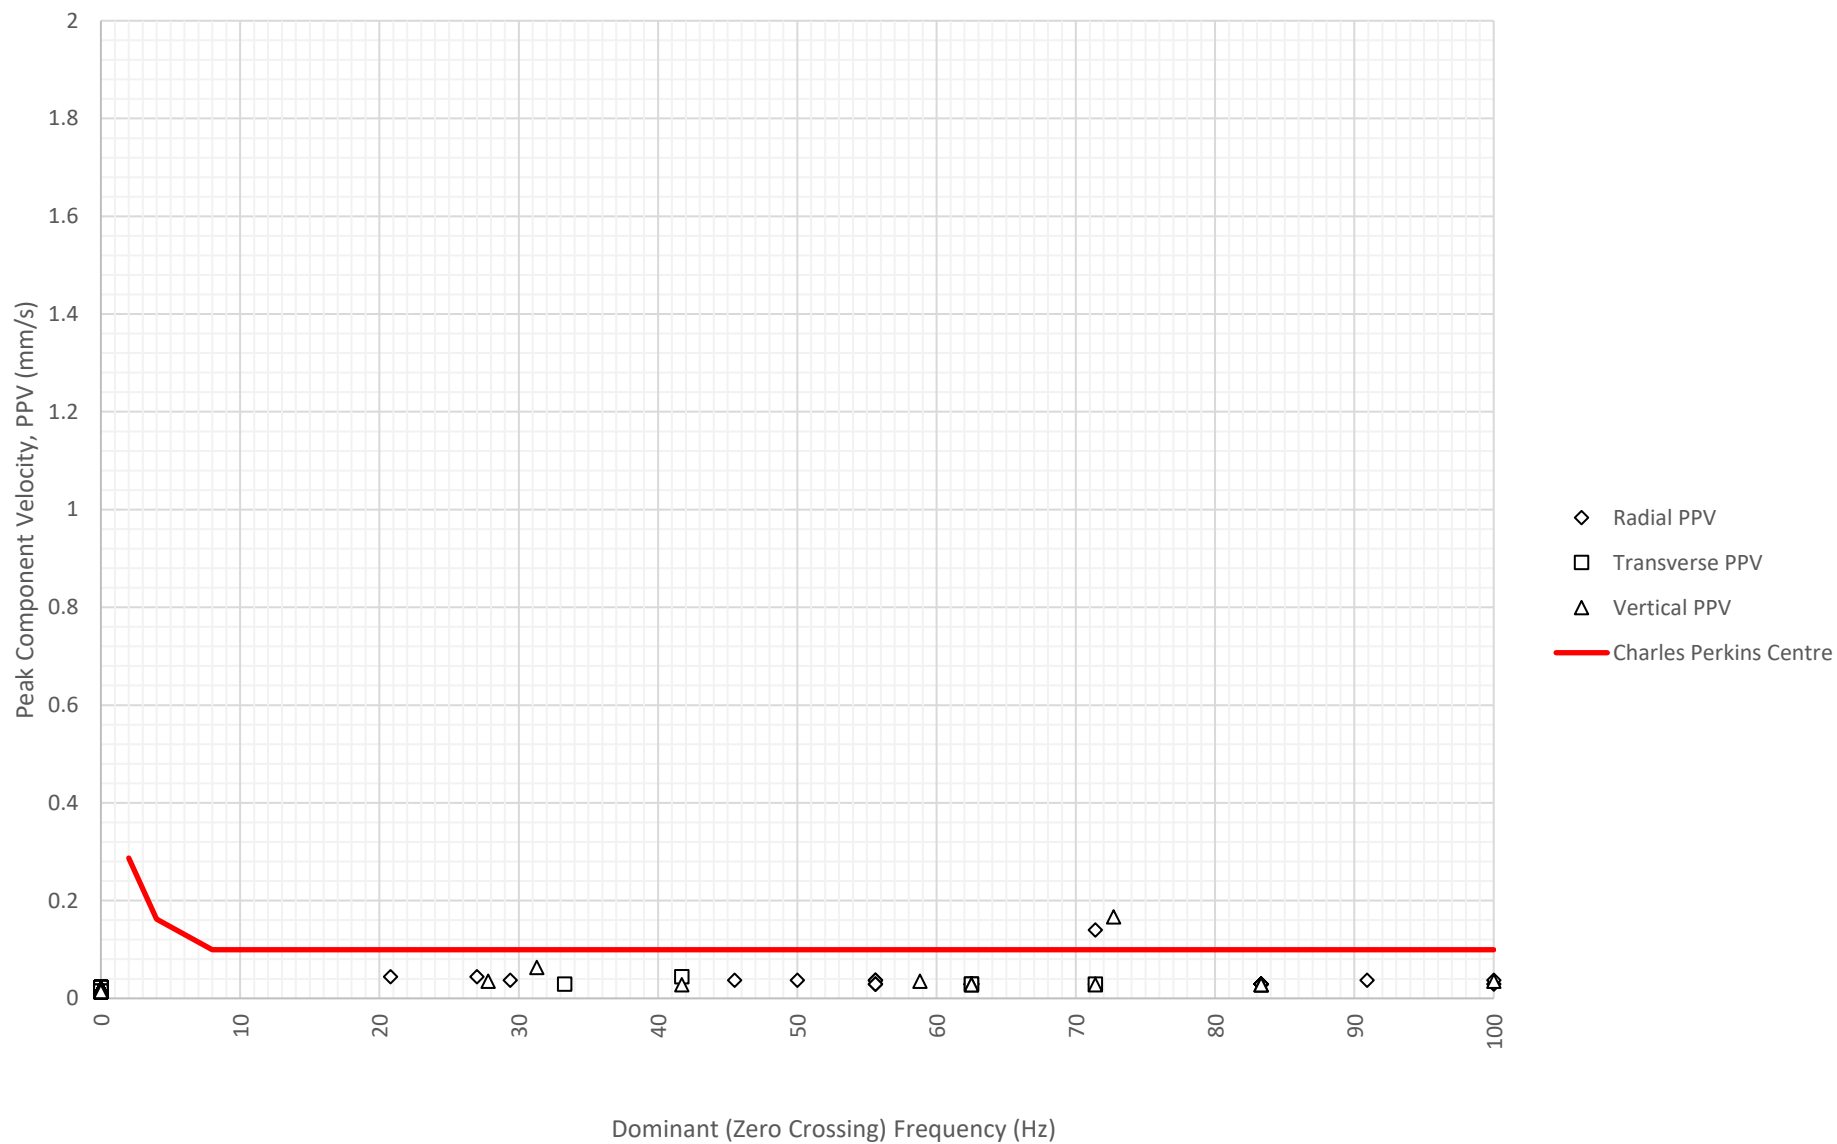
Daily Monitored Vibration Levels at Charles Perkins Centre - B1 Observation Room Corridor on 23-10-2024

Frequency Content of Vibration Levels at Charles Perkins Centre - B1 Observation Room Corridor on 23-10-2024

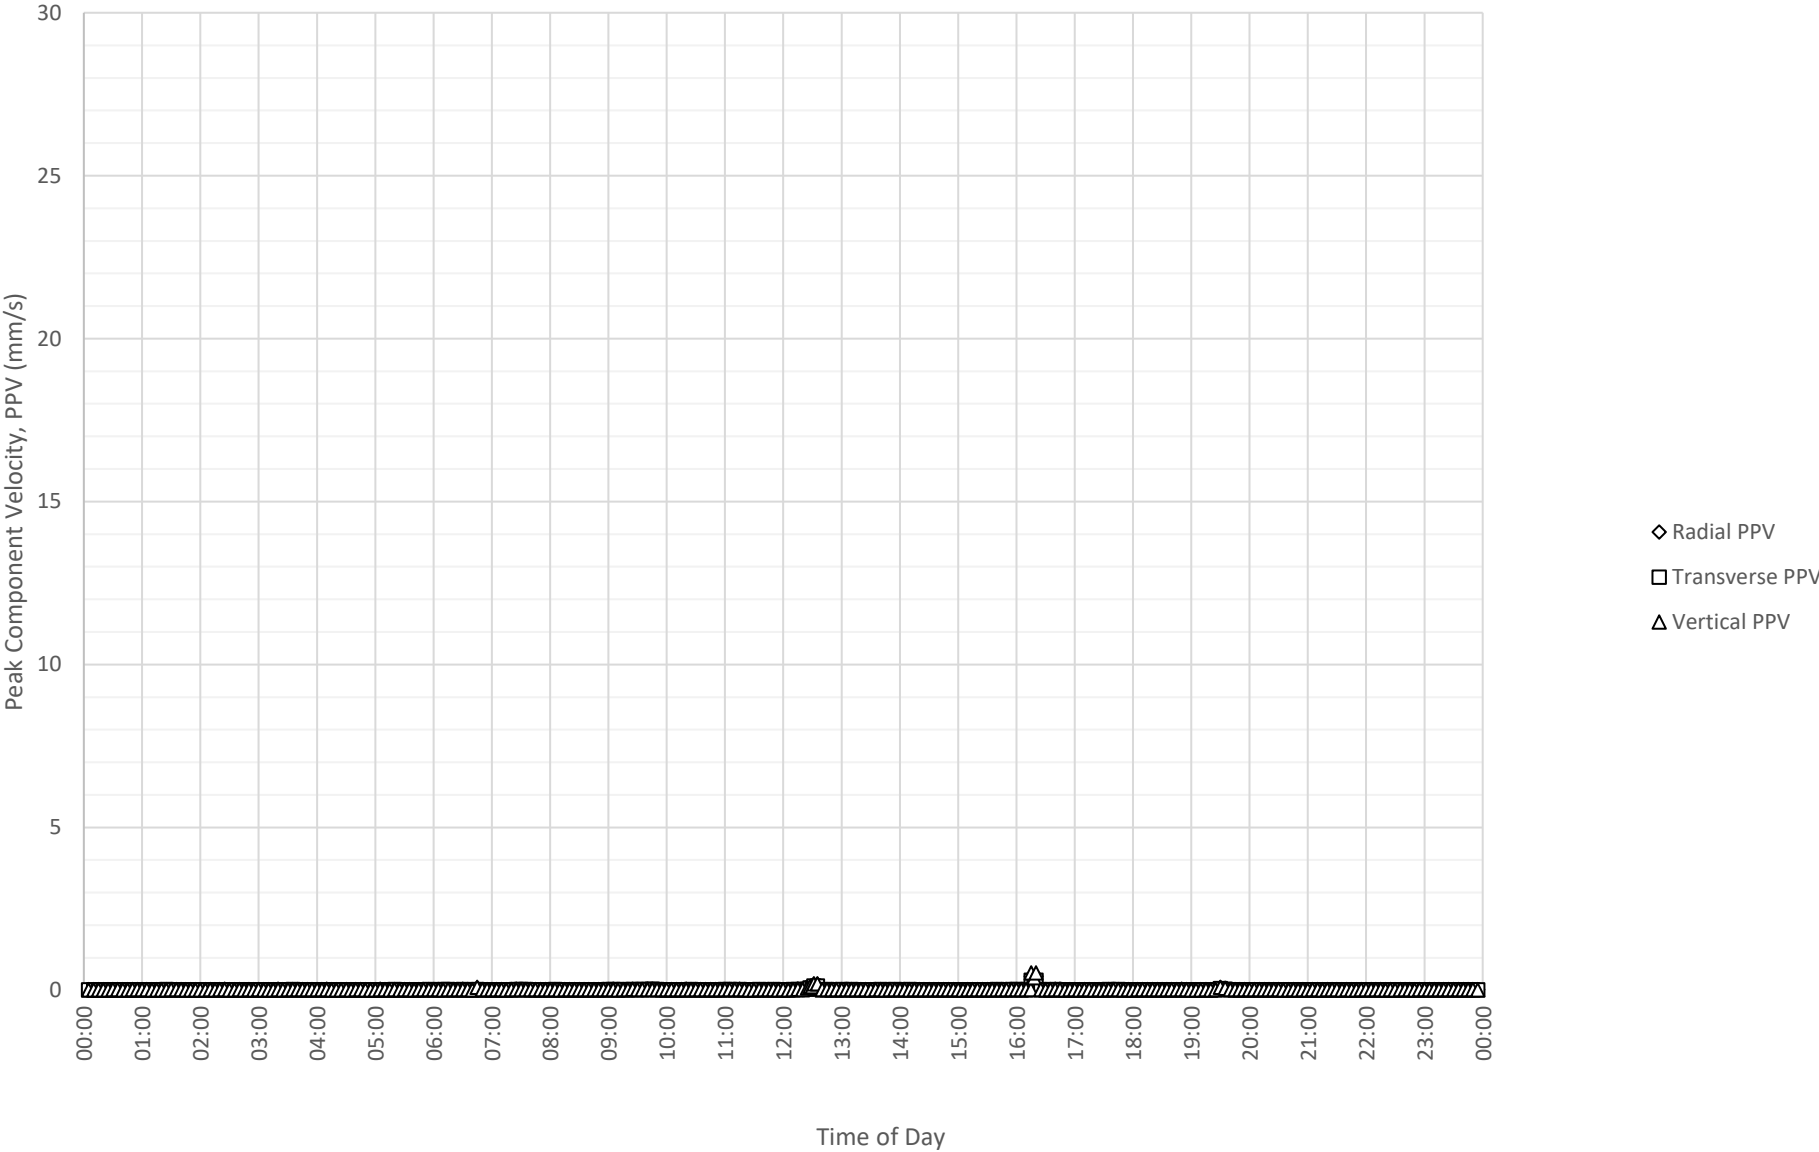
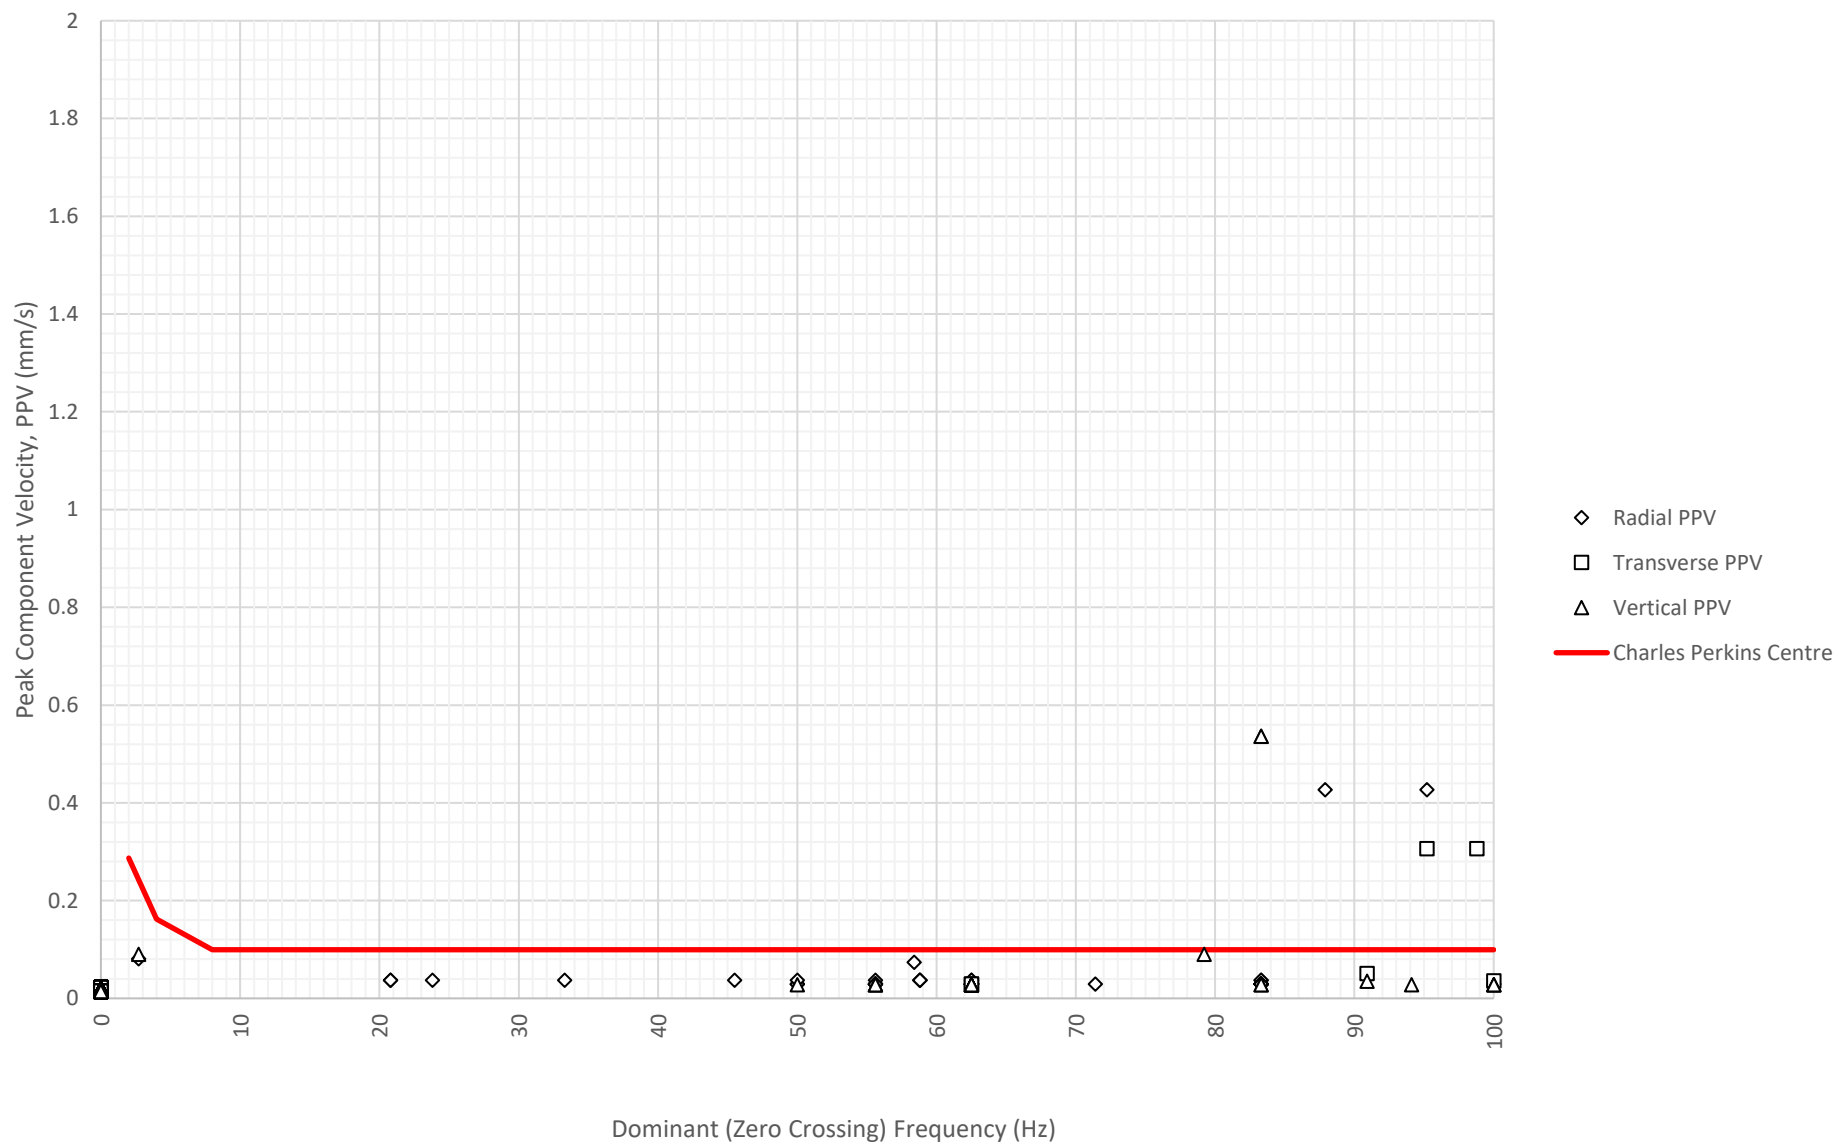
Daily Monitored Vibration Levels at Charles Perkins Centre - B1 Observation Room Corridor on 25-10-2024

Frequency Content of Vibration Levels at Charles Perkins Centre - B1 Observation Room Corridor on 25-10-2024
