Royal Prince Alfred Hospital Redevelopment (RPAH Redevelopment)

Construction Noise and Vibration Monitoring Report 29

Client Doc. No. RPA-ACO-ACL-RPT-MW-000032 - Rev B

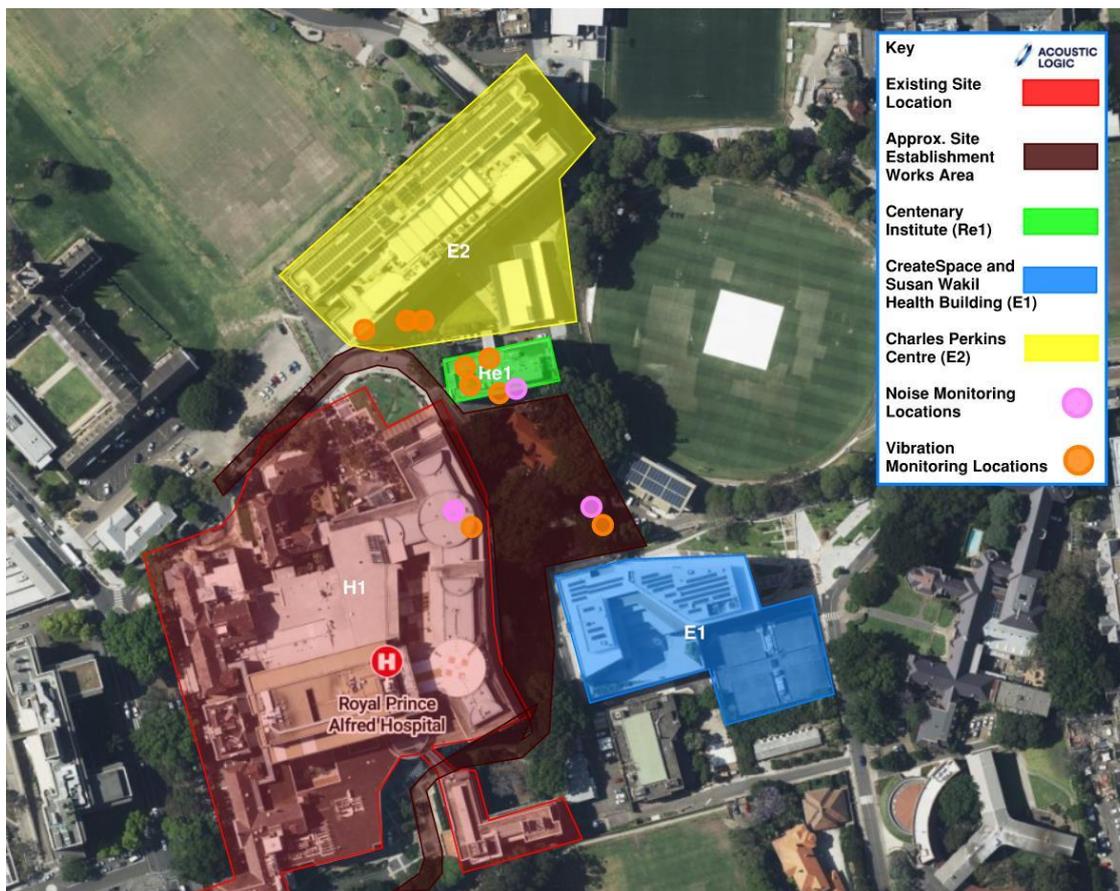
**Figure 1: Aerial Site Map with Nearest Sensitive Receivers (Sourced from Sixmaps)**

See an aerial photo in Figure 1 below for detailed receiver locations.

Please refer to Figure 1 for detailed monitoring locations.

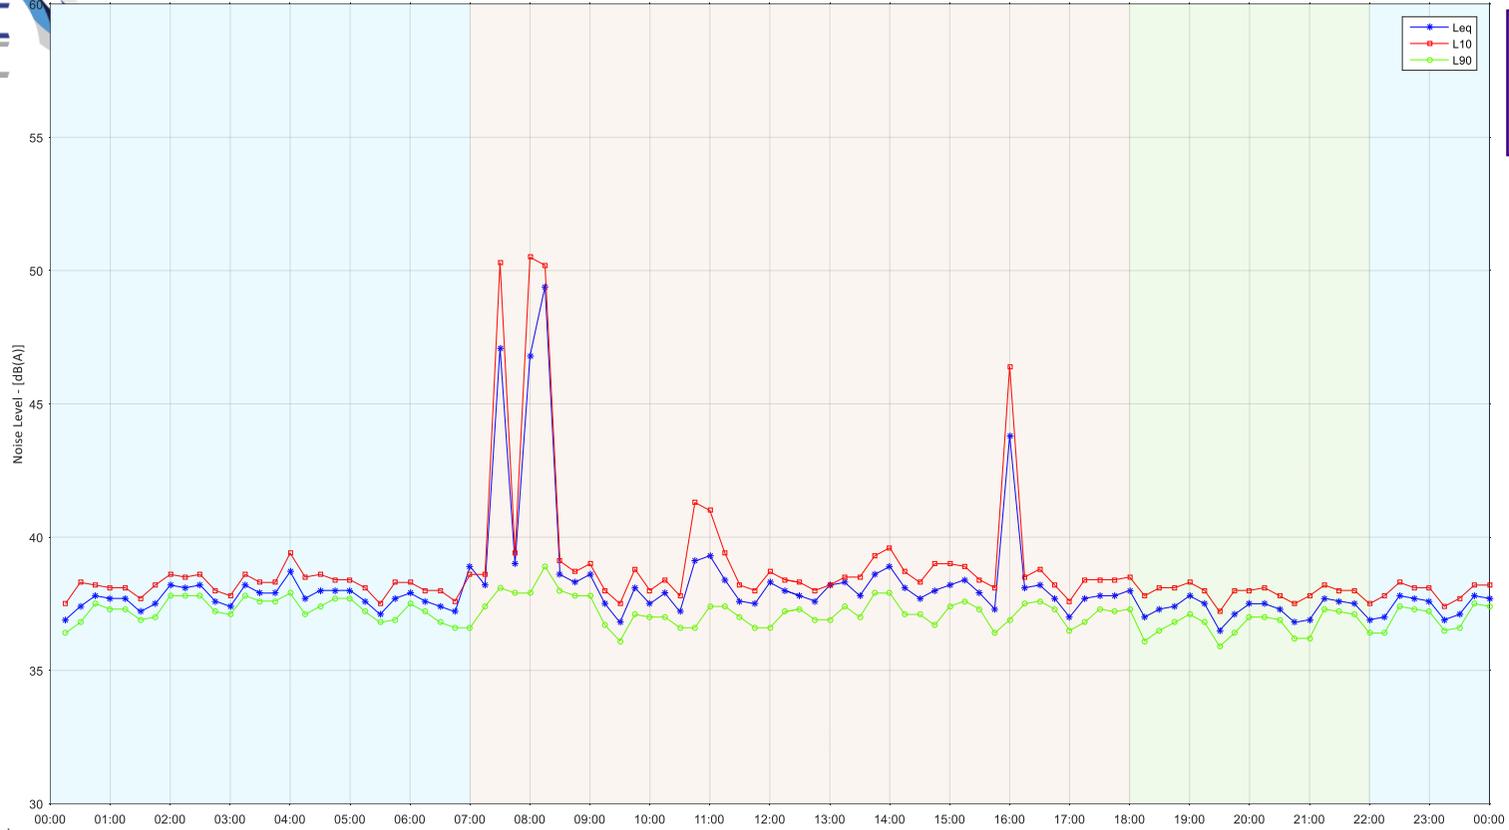
### Centenary Institute - Level 02 Office: Monday 20 January, 2025

All measured levels are below Animal Housing / Breeding / Observation Room NML  $\leq 62\text{dB(A)}L_{eq}$

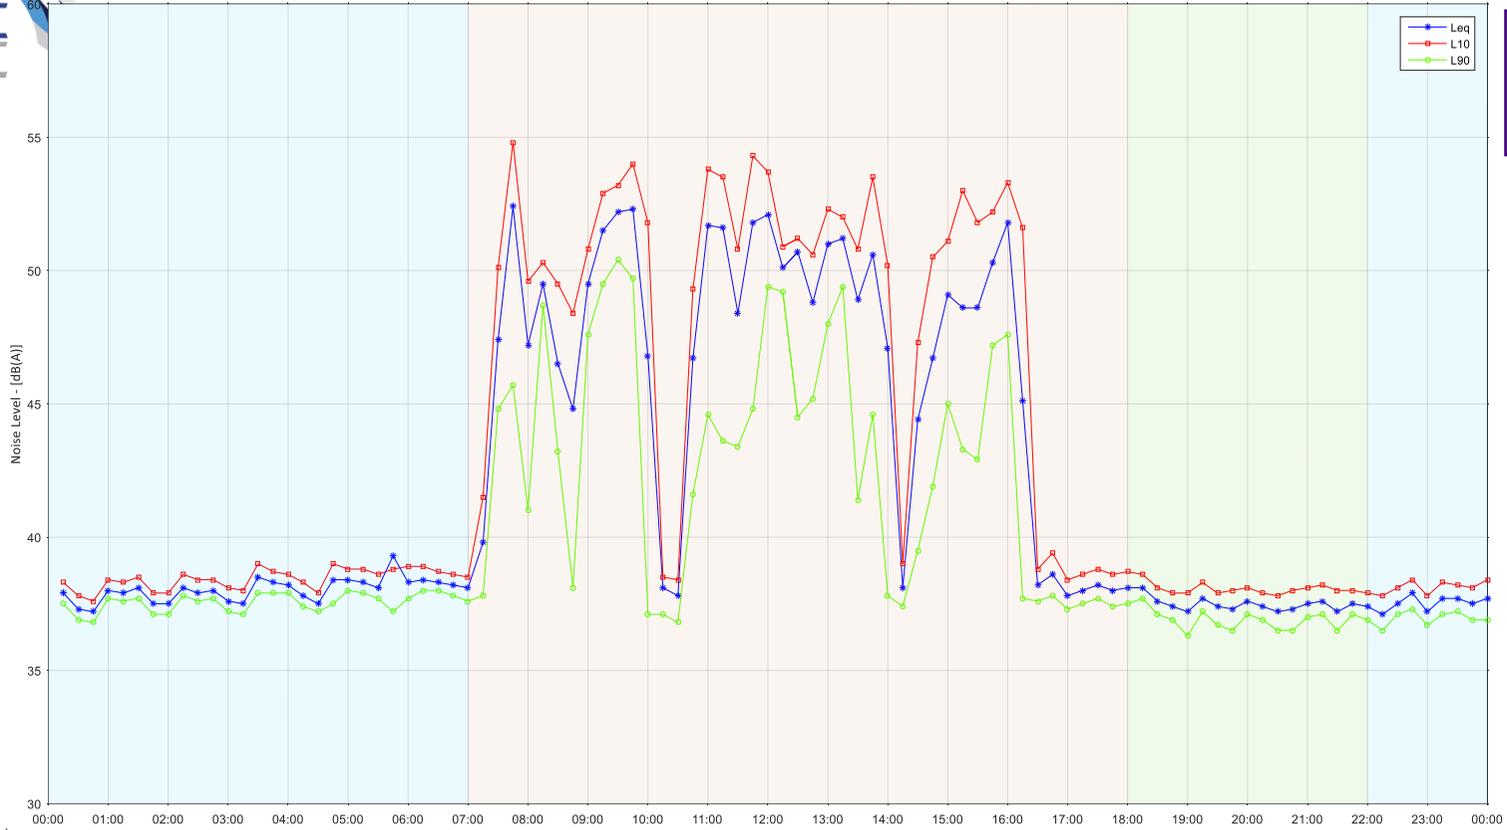
### Centenary Institute - Level 02 Office: Tuesday 21 January, 2025

All measured levels are below Animal Housing / Breeding / Observation Room NML  $\leq 62\text{dB(A)}_{L_{eq}}$

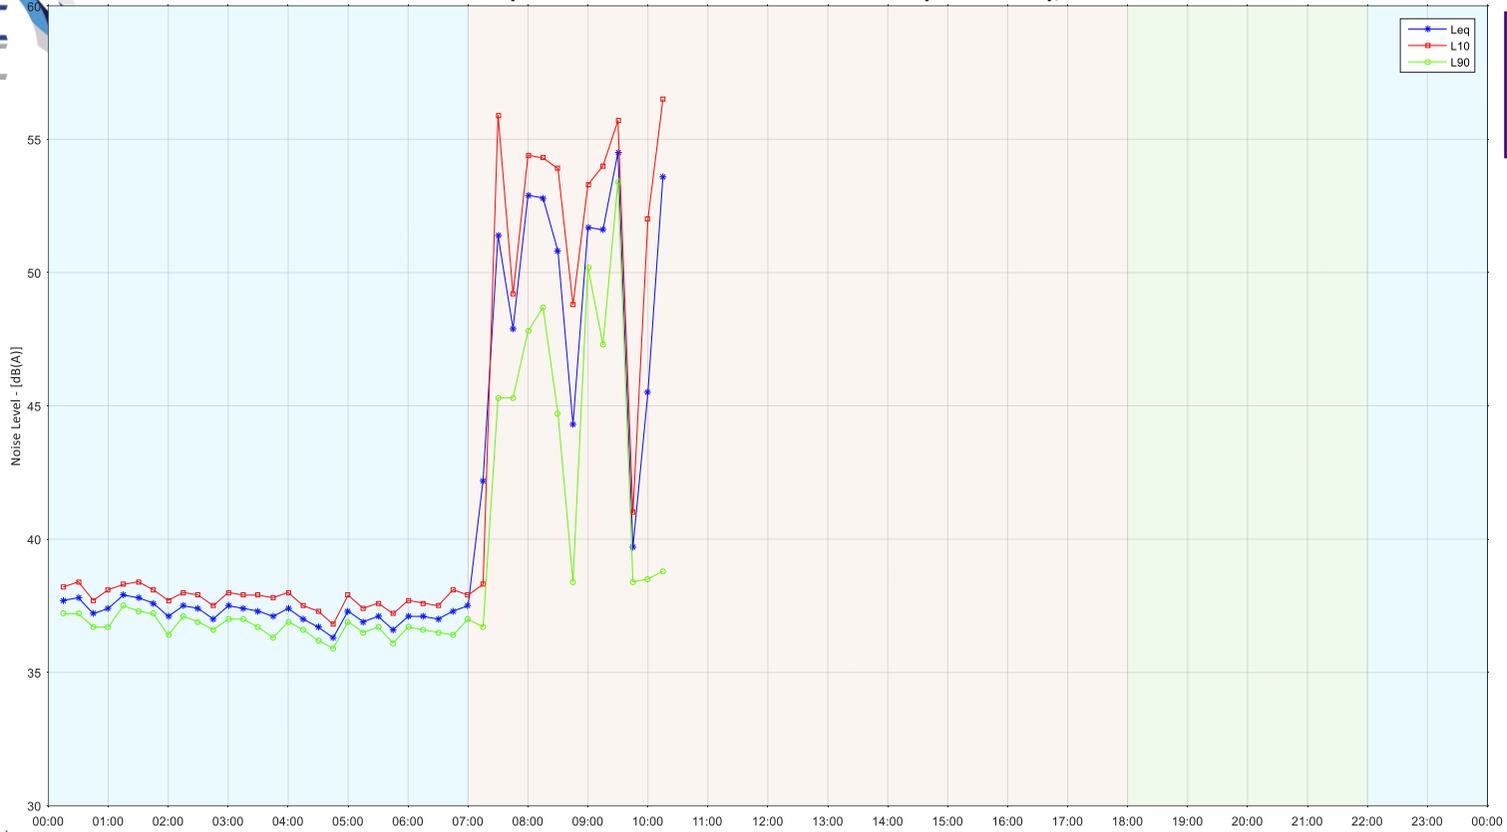
### Centenary Institute - Level 02 Office: Wednesday 22 January, 2025

All measured levels are below Animal Housing / Breeding / Observation Room NML  $\leq 62\text{dB(A)}L_{\text{eq}}$

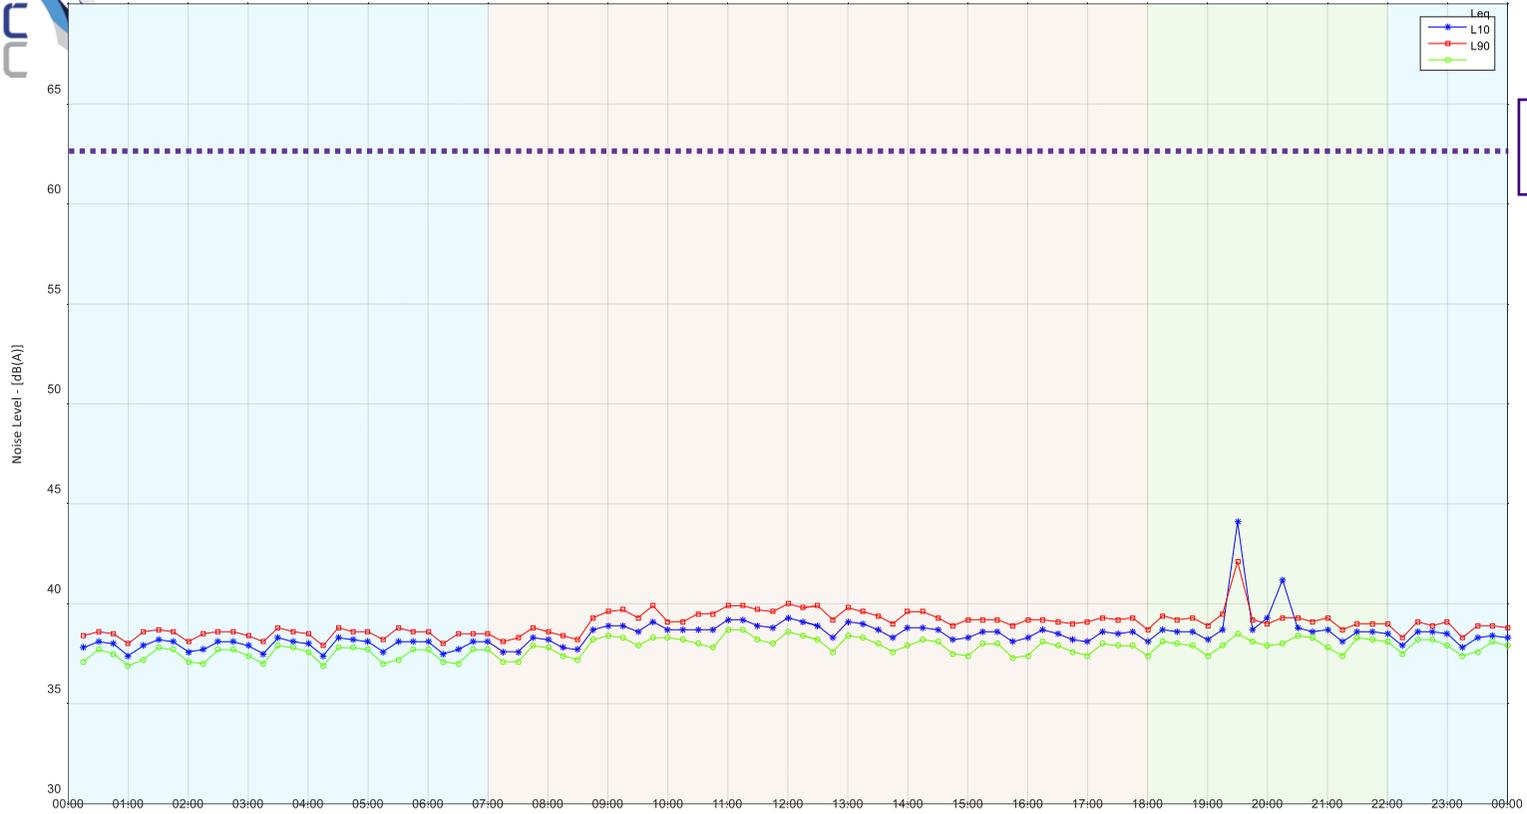
Centenary Institute - Level 02 Office: Monday 27 January, 2025

Animal Housing / Breeding /  
Observation Room NML  
 $\leq 62\text{dB(A)}L_{\text{eq}}$

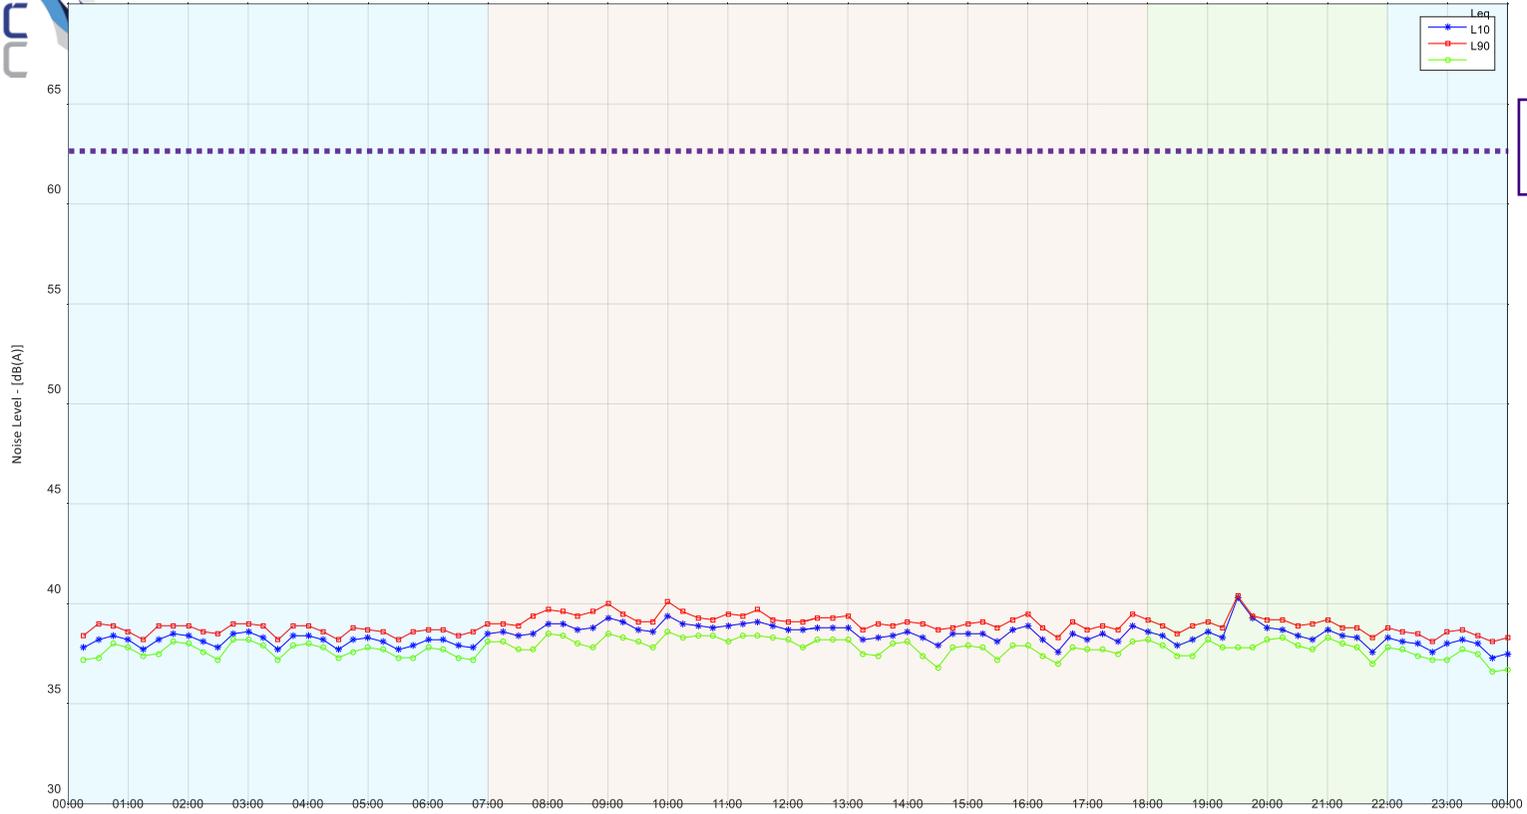
Centenary Institute - Level 02 Office: Tuesday 28 January, 2025

Animal Housing / Breeding /  
Observation Room NML  
 $\leq 62\text{dB(A)}L_{eq}$

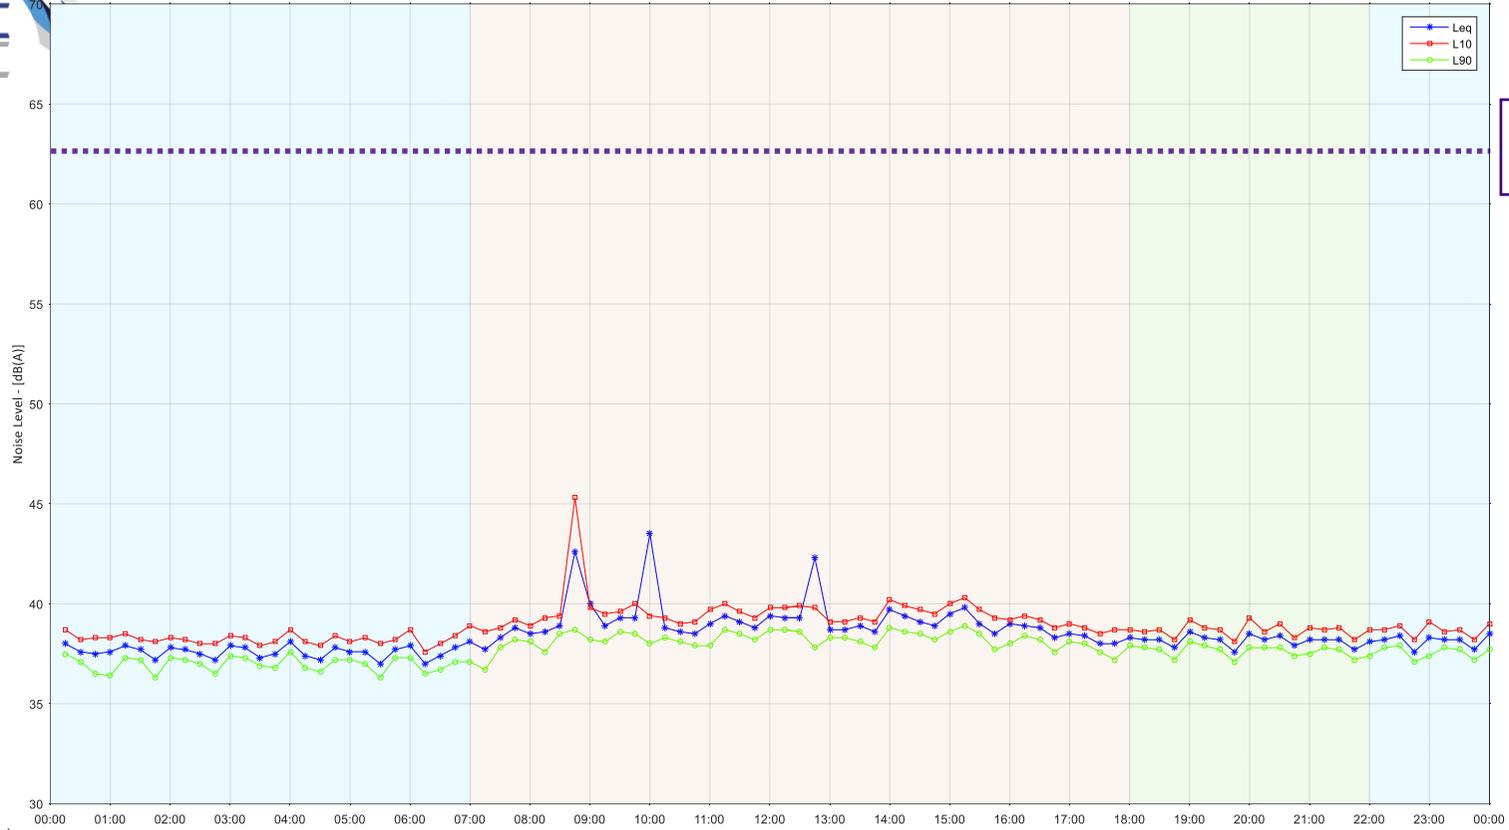
### Centenary Institute - Level 02 Office: Thursday 30 January, 2025

Animal Housing / Breeding /  
Observation Room NML  
 $\leq 62\text{dB(A)}L_{eq}$

- Day Period [7am -> 6pm]
- Evening Period [6pm -> 10pm]
- Night Period [10pm -> 7am]

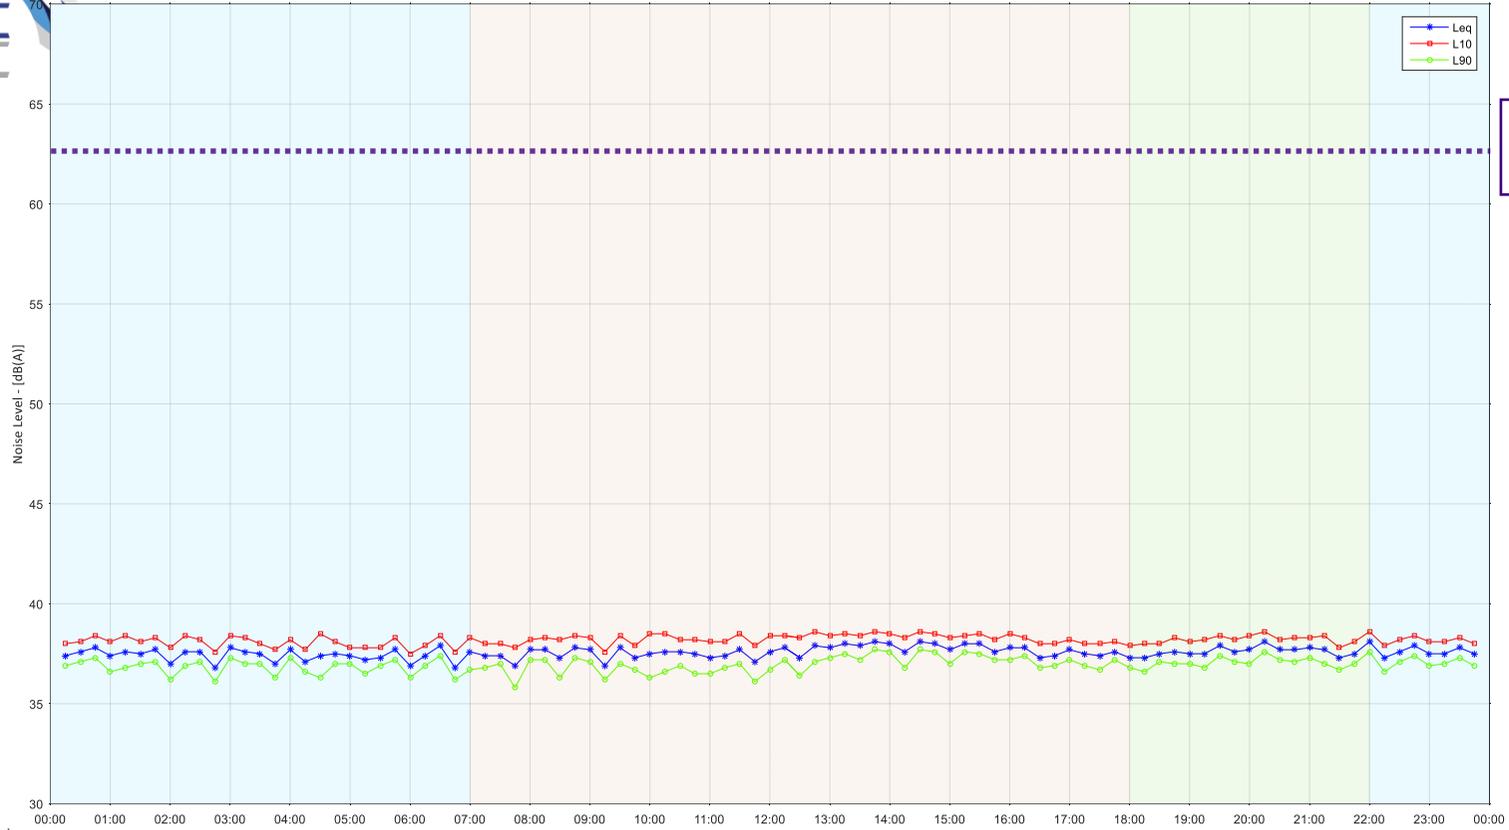
### Centenary Institute - Level 02 Office: Sunday 02 February, 2025

Animal Housing / Breeding /  
Observation Room NML  
 $\leq 62\text{dB(A)}L_{eq}$

- Day Period [7am -> 6pm]
- Evening Period [6pm -> 10pm]
- Night Period [10pm -> 7am]

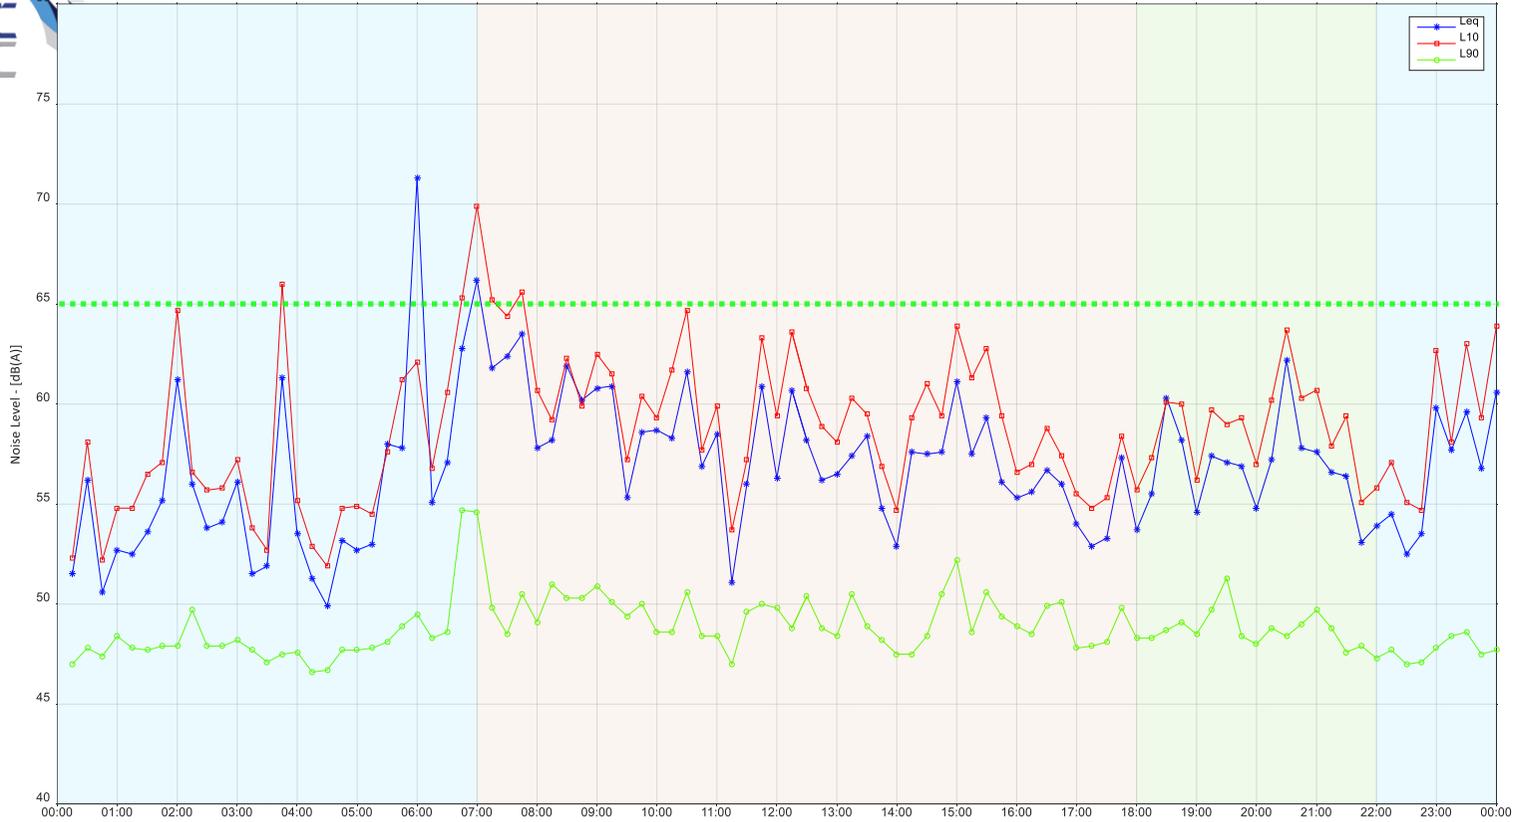
### RPA Hospital Main Building - Level 03 NICU: Tuesday 21 January, 2025

**NICU NML  
(Including correction)  
≤ 65dB(A)<sub>L<sub>eq</sub></sub>**

- Noise levels were observed to be measured above the NML within the NICU space on the following dates:
  - 21/01/2025.
  - 22/01/2025.
  - 24/01/2025.
  - 30/01/2025.

- 31/01/2025.
- Noise levels during construction hours were not observed to be above the NML for longer than one 15-minute period at a time, and hence it is likely that the large majority of these events were caused by internal operational activity within the space, as opposed to construction works, noting that construction works are typically continuous in nature.

- Generally, noise levels were measured to be marginally above the NML (Within 3dB).
- We also note that there are many 15-minute periods outside of construction hours where recorded levels are above the area's NML observed throughout the monitoring period.

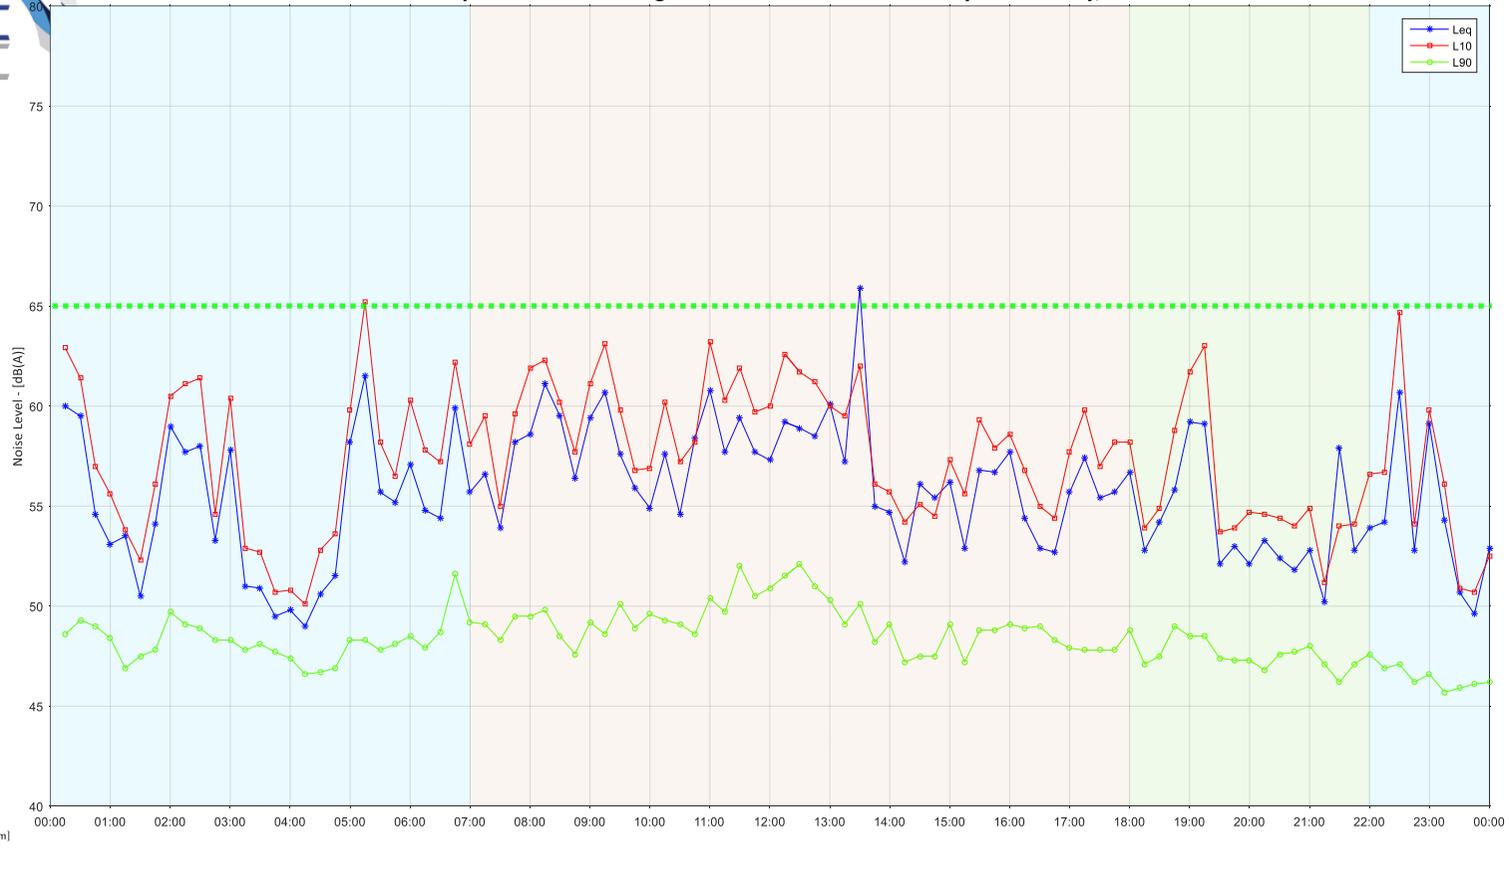
### RPA Hospital Main Building - Level 03 NICU: Wednesday 22 January, 2025

**NICU NML  
(Including correction)  
≤ 65dB(A)L<sub>eq</sub>**

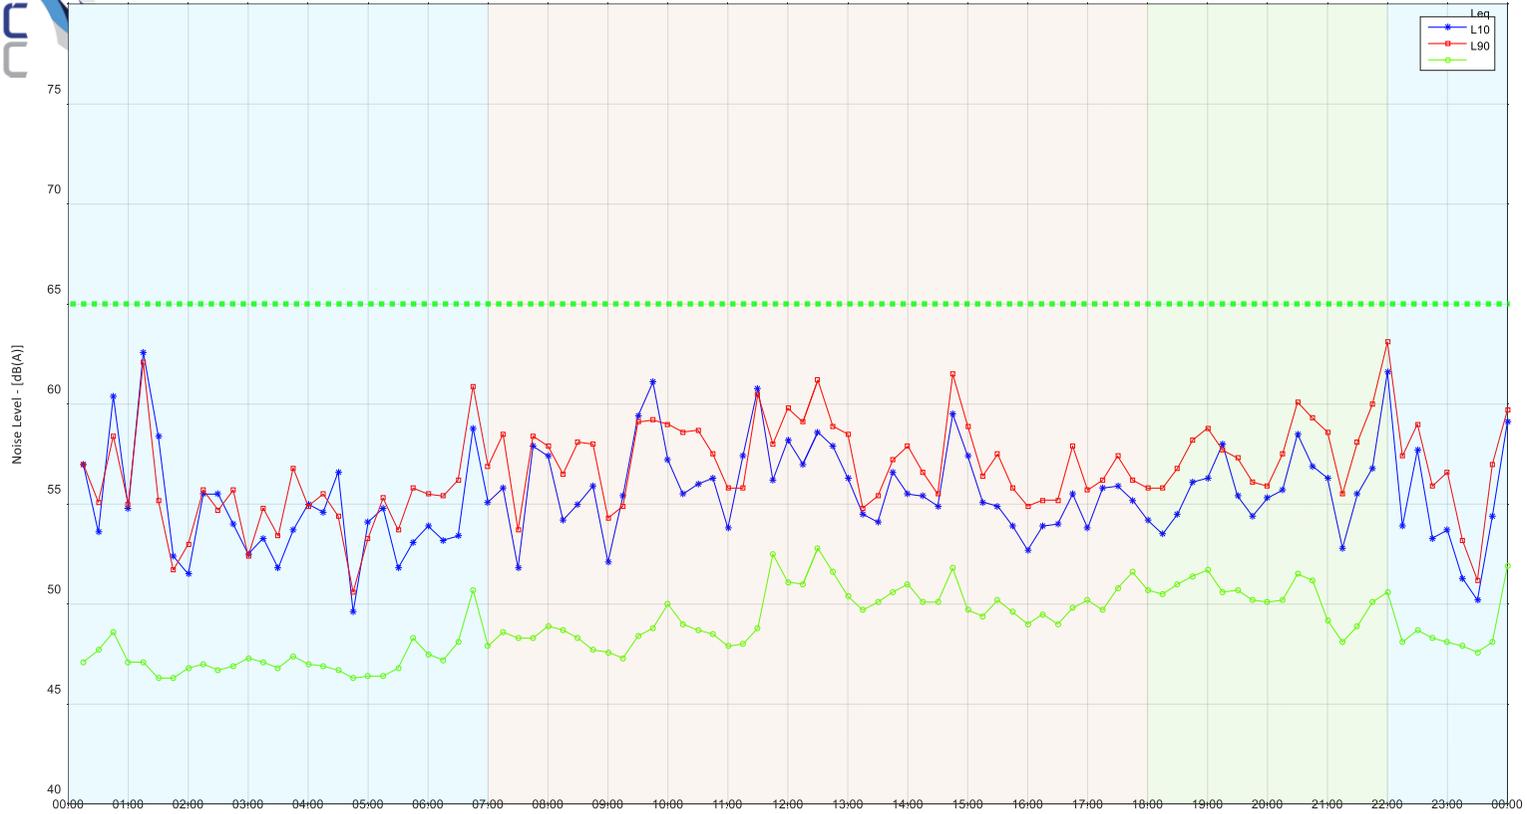
### RPA Hospital Main Building - Level 03 NICU: Saturday 25 January, 2025

**NICU NML  
(Including correction)  
≤ 65dB(A)<sub>L<sub>eq</sub></sub>**

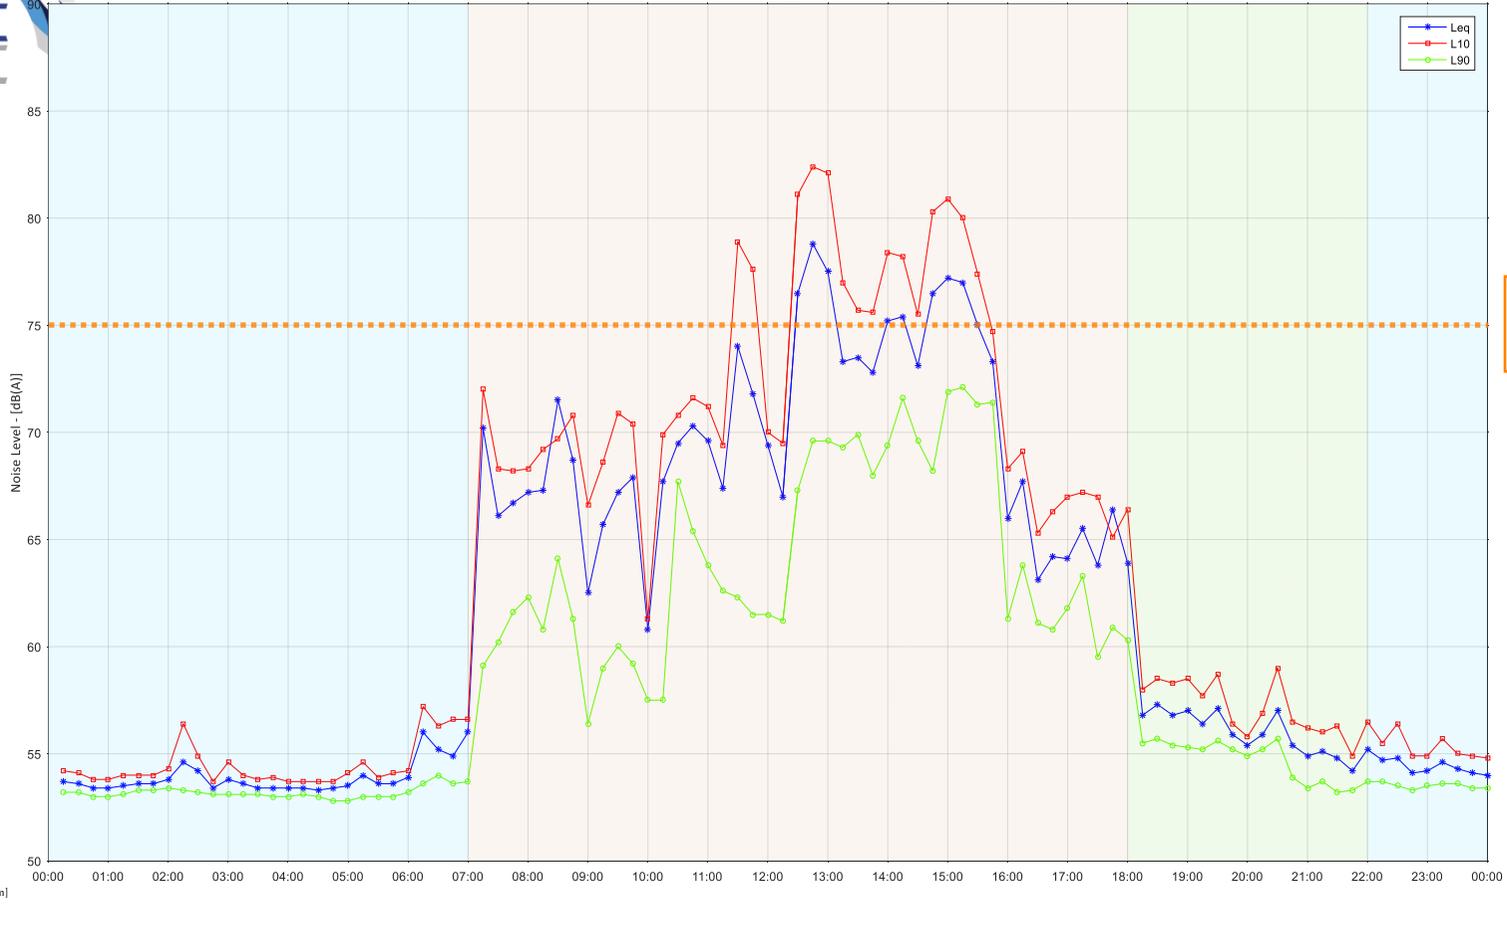
### Outside Susan Wakil Health Building: Wednesday 22 January, 2025

**Education NML  
(Including correction)  
≤ 75dB(A)<sub>L<sub>eq</sub></sub>**

- Notwithstanding and of the data available, noise levels have been measured to be above the NML at the monitoring location on the following dates:
  - 22/01/2025.

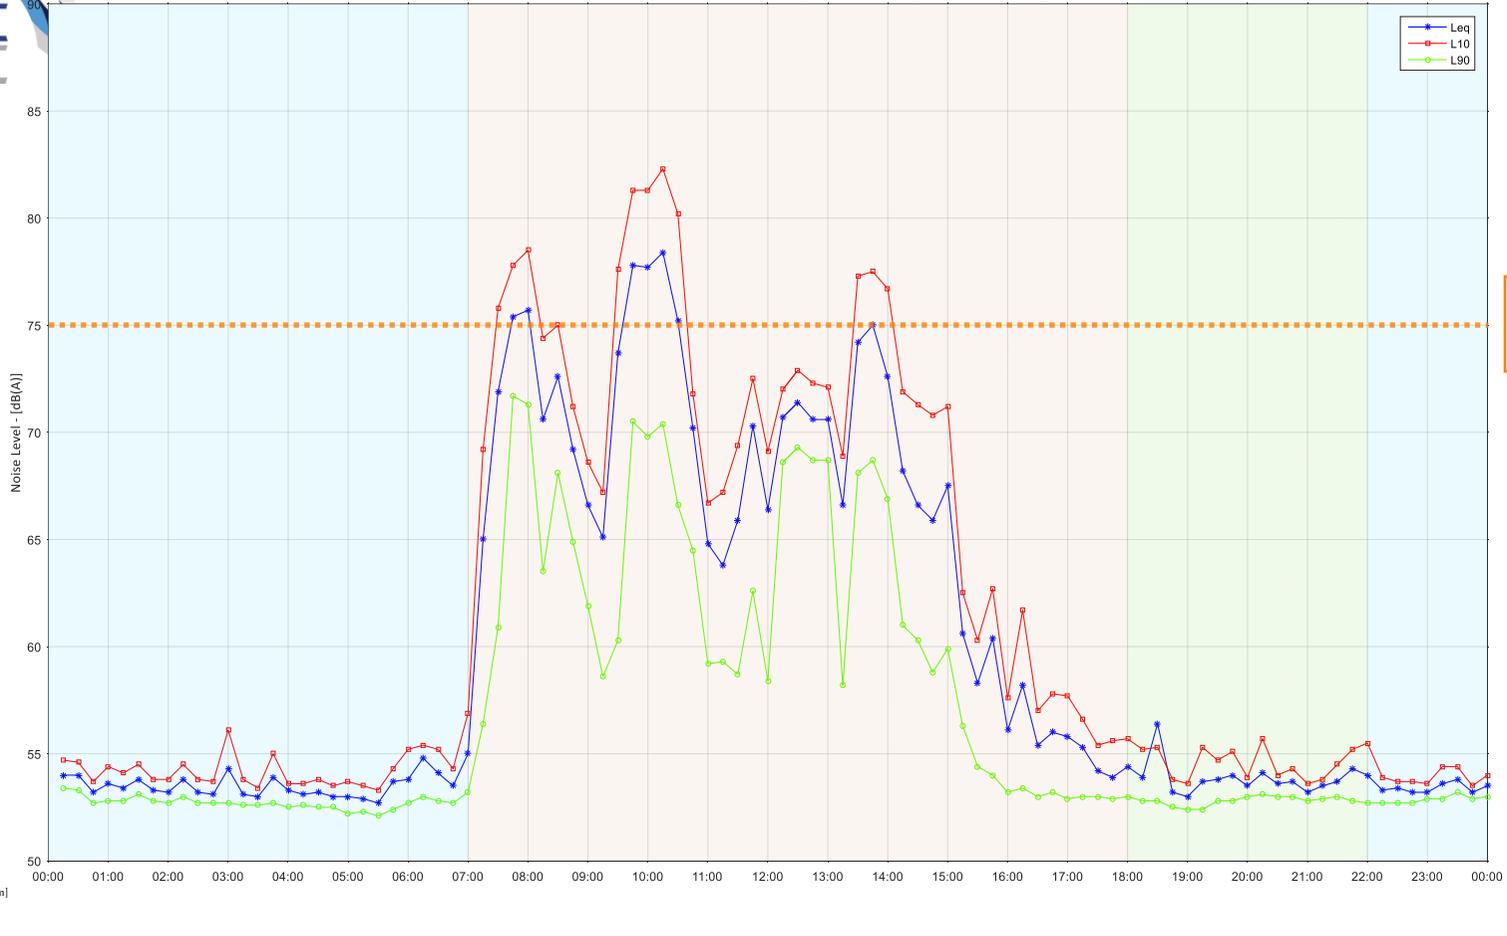
### Outside Susan Wakil Health Building: Thursday 23 January, 2025

**Education NML  
(Including correction)  
≤ 75dB(A)<sub>L<sub>eq</sub></sub>**

- 23/01/2025.
- Noise levels impacting Susan Wakil will be continued to be monitored throughout the early works construction to assess the impact of this receiver.

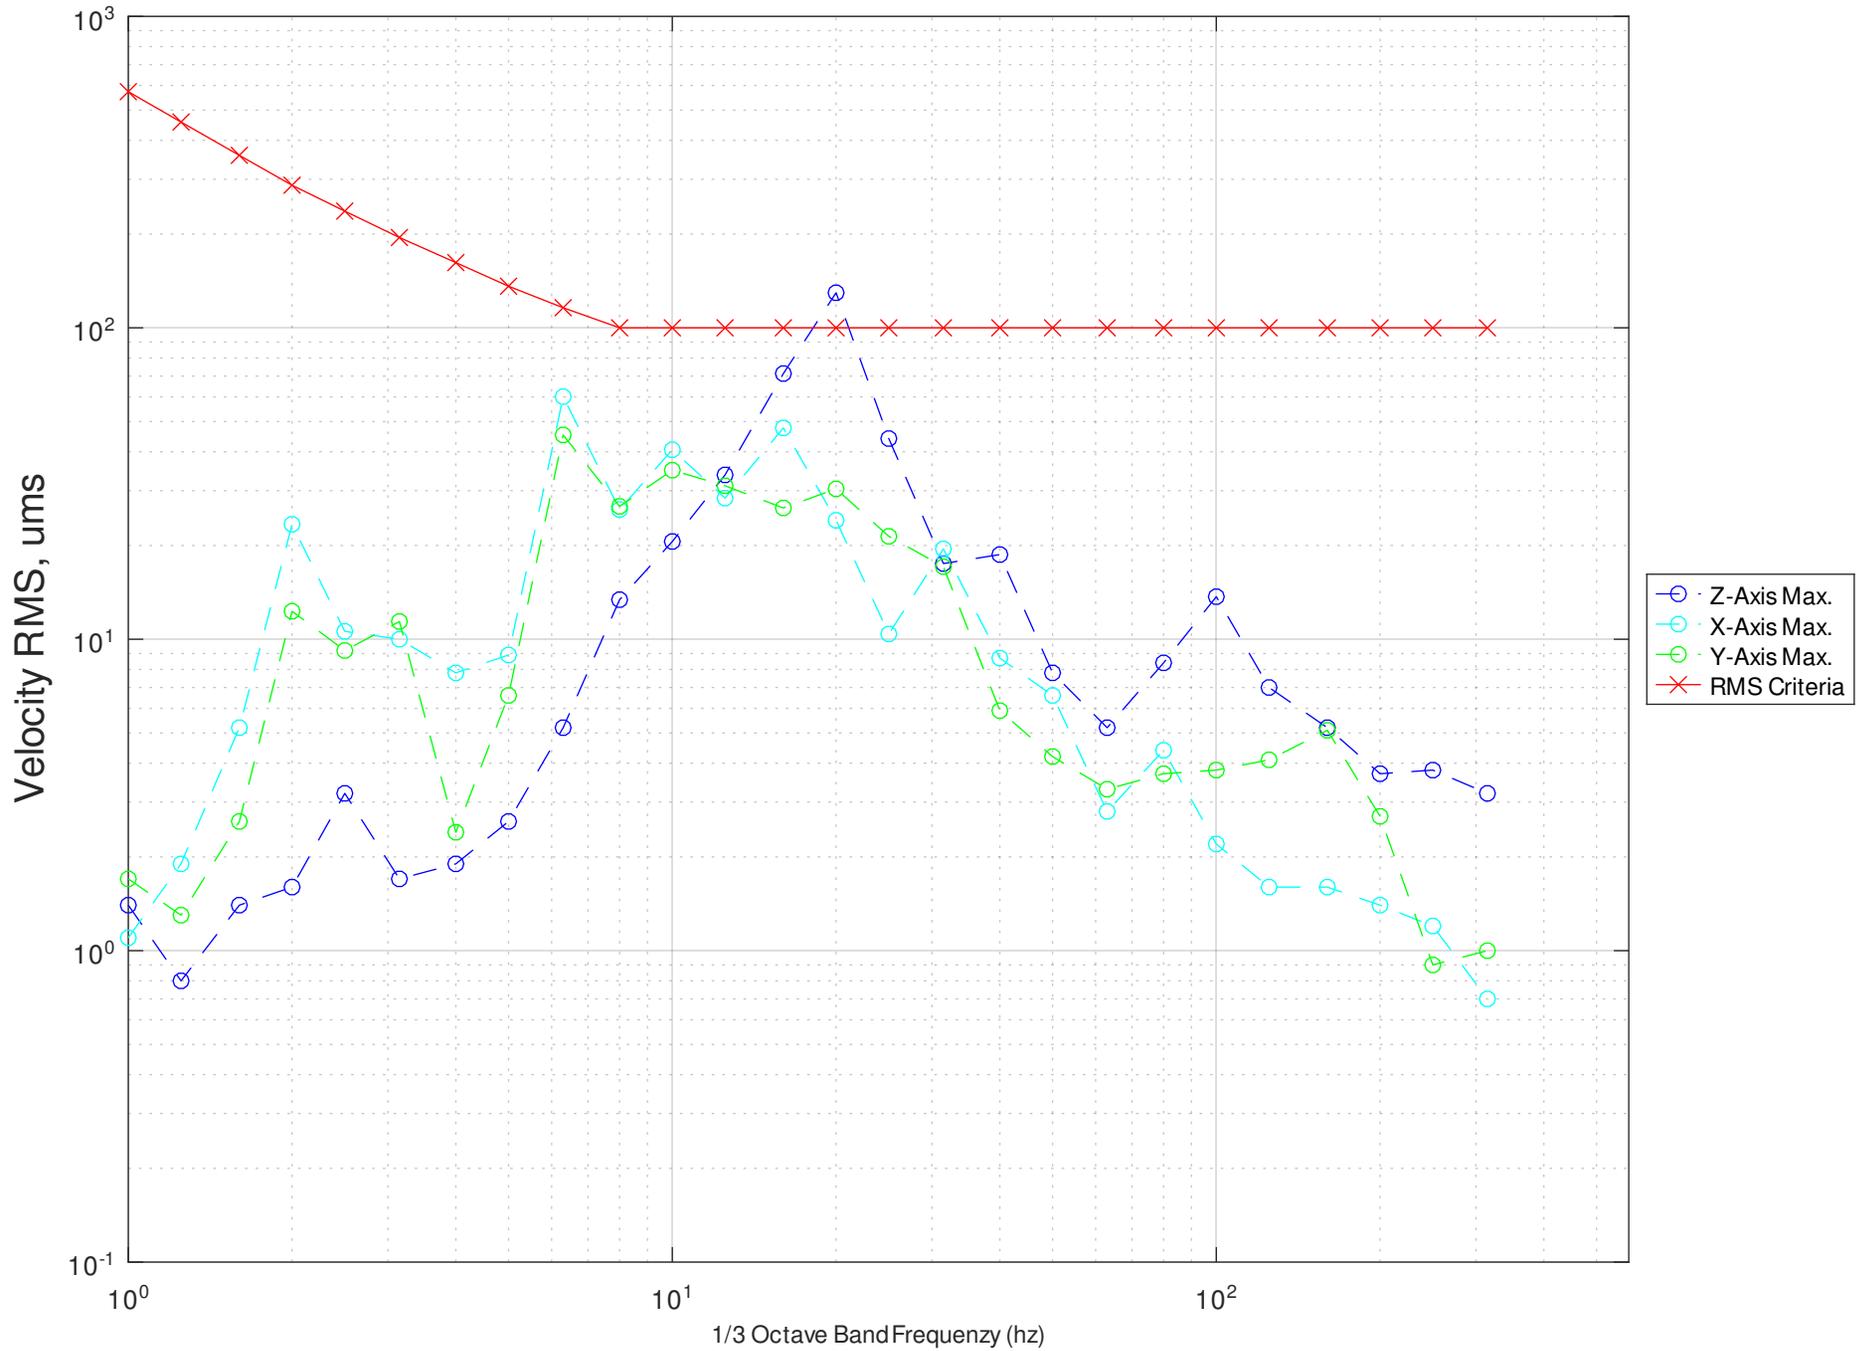
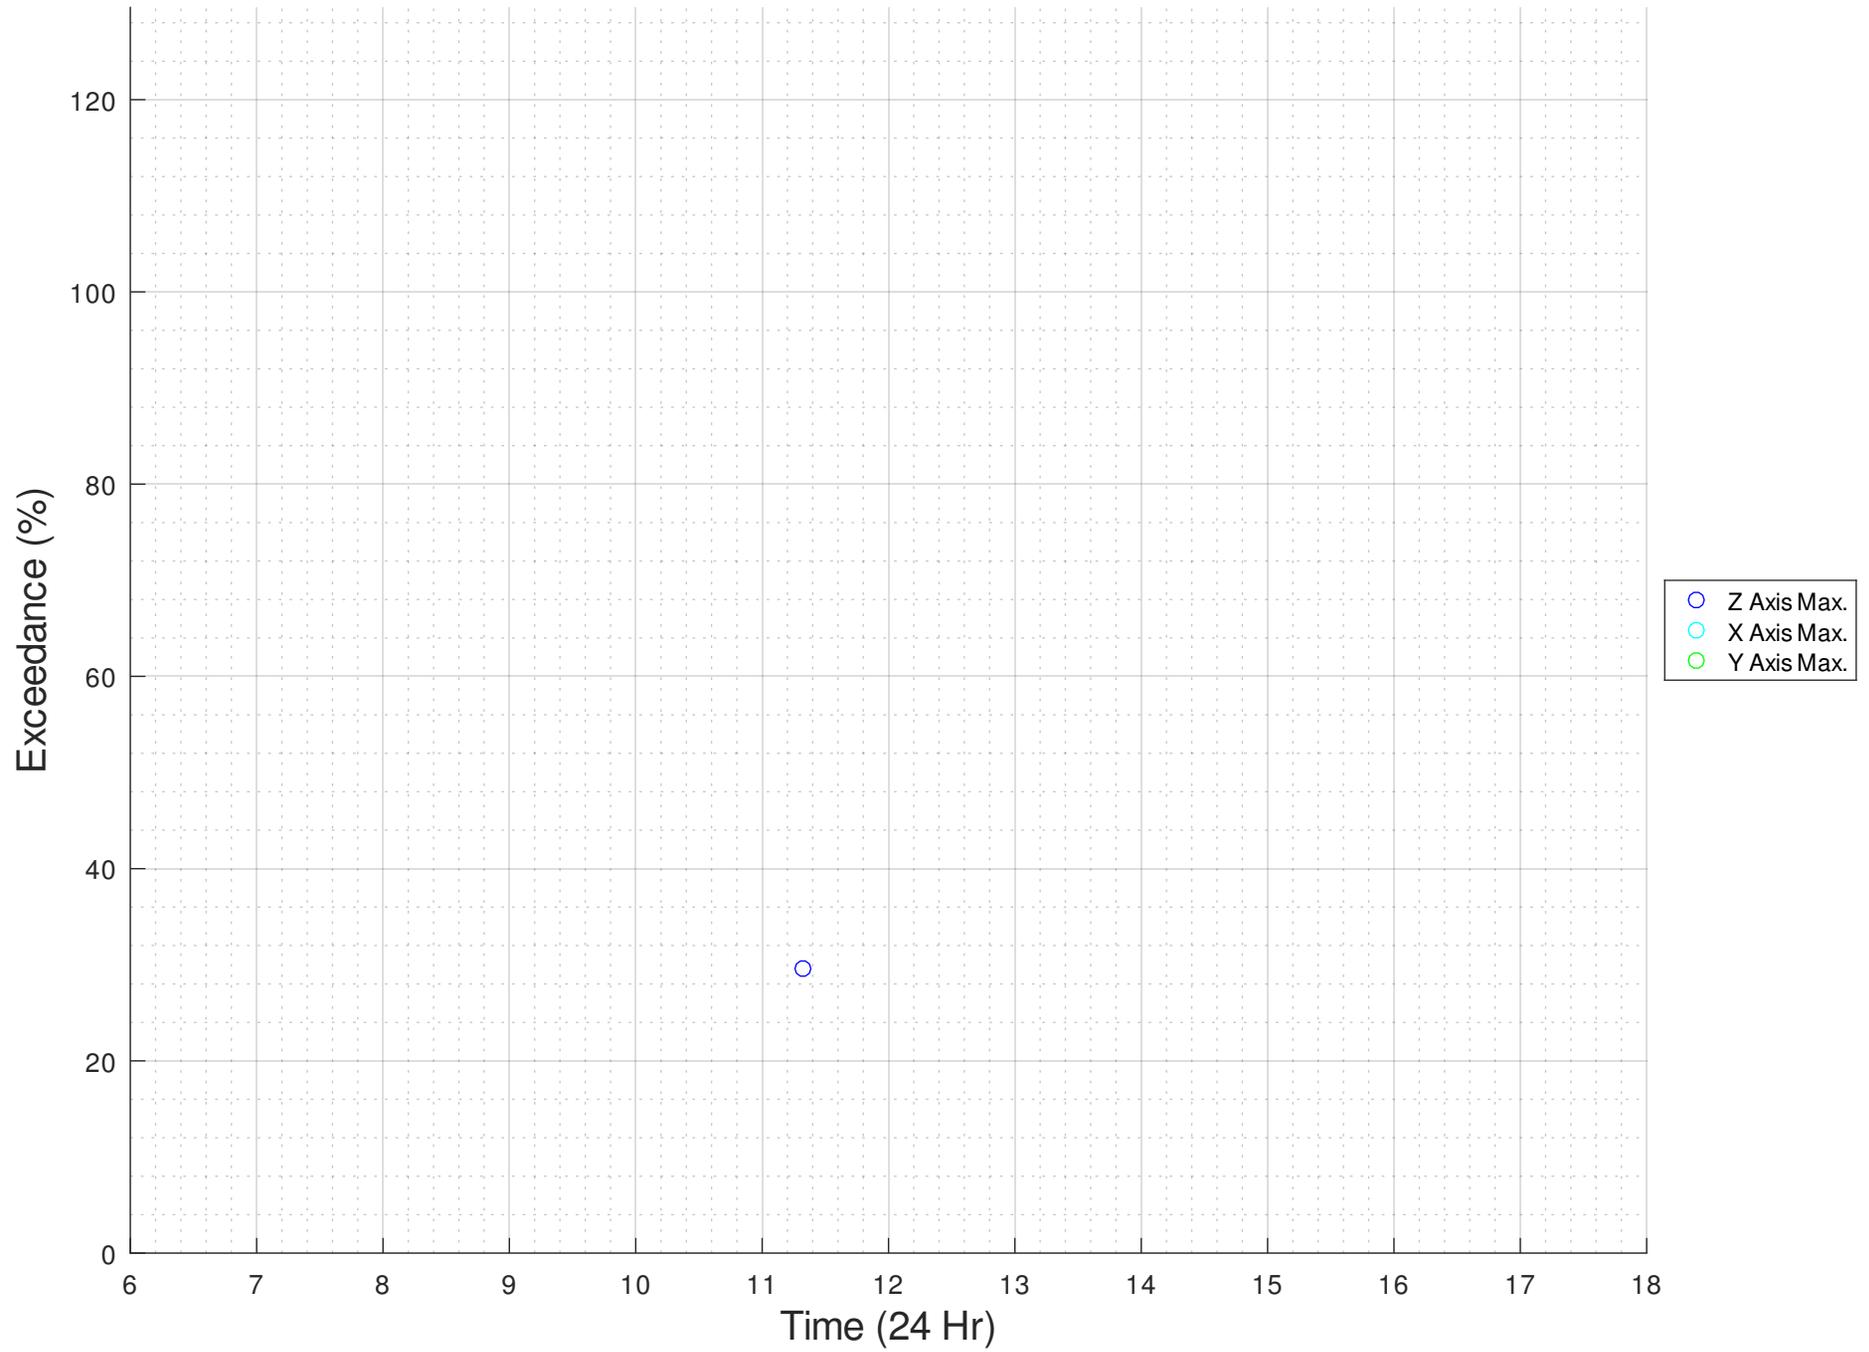
CI L4 Northern Bathroom - RMS Vibration Levels, Z,X&Y

- Individual exceedance events were recorded by the northern façade monitoring stations on the following dates:
    - Northern Bathroom - 21/01/2025 – Approx.. 30% exceedance.

- No exceedances observed during monitoring period.
- Vibration exceedances throughout the monitoring period have been attributed to piling works in the northern laneway adjacent to the CI facade. Due to the relatively short timeframe of works associated with the northern piling area, alternative construction methodology was not explored.
