Royal Prince Alfred Hospital Redevelopment (RPAH Redevelopment)

Construction Noise and Vibration Monitoring Report 29

Client Doc. No. RPA-ACO-ACL-RPT-MW-000032 - Rev B

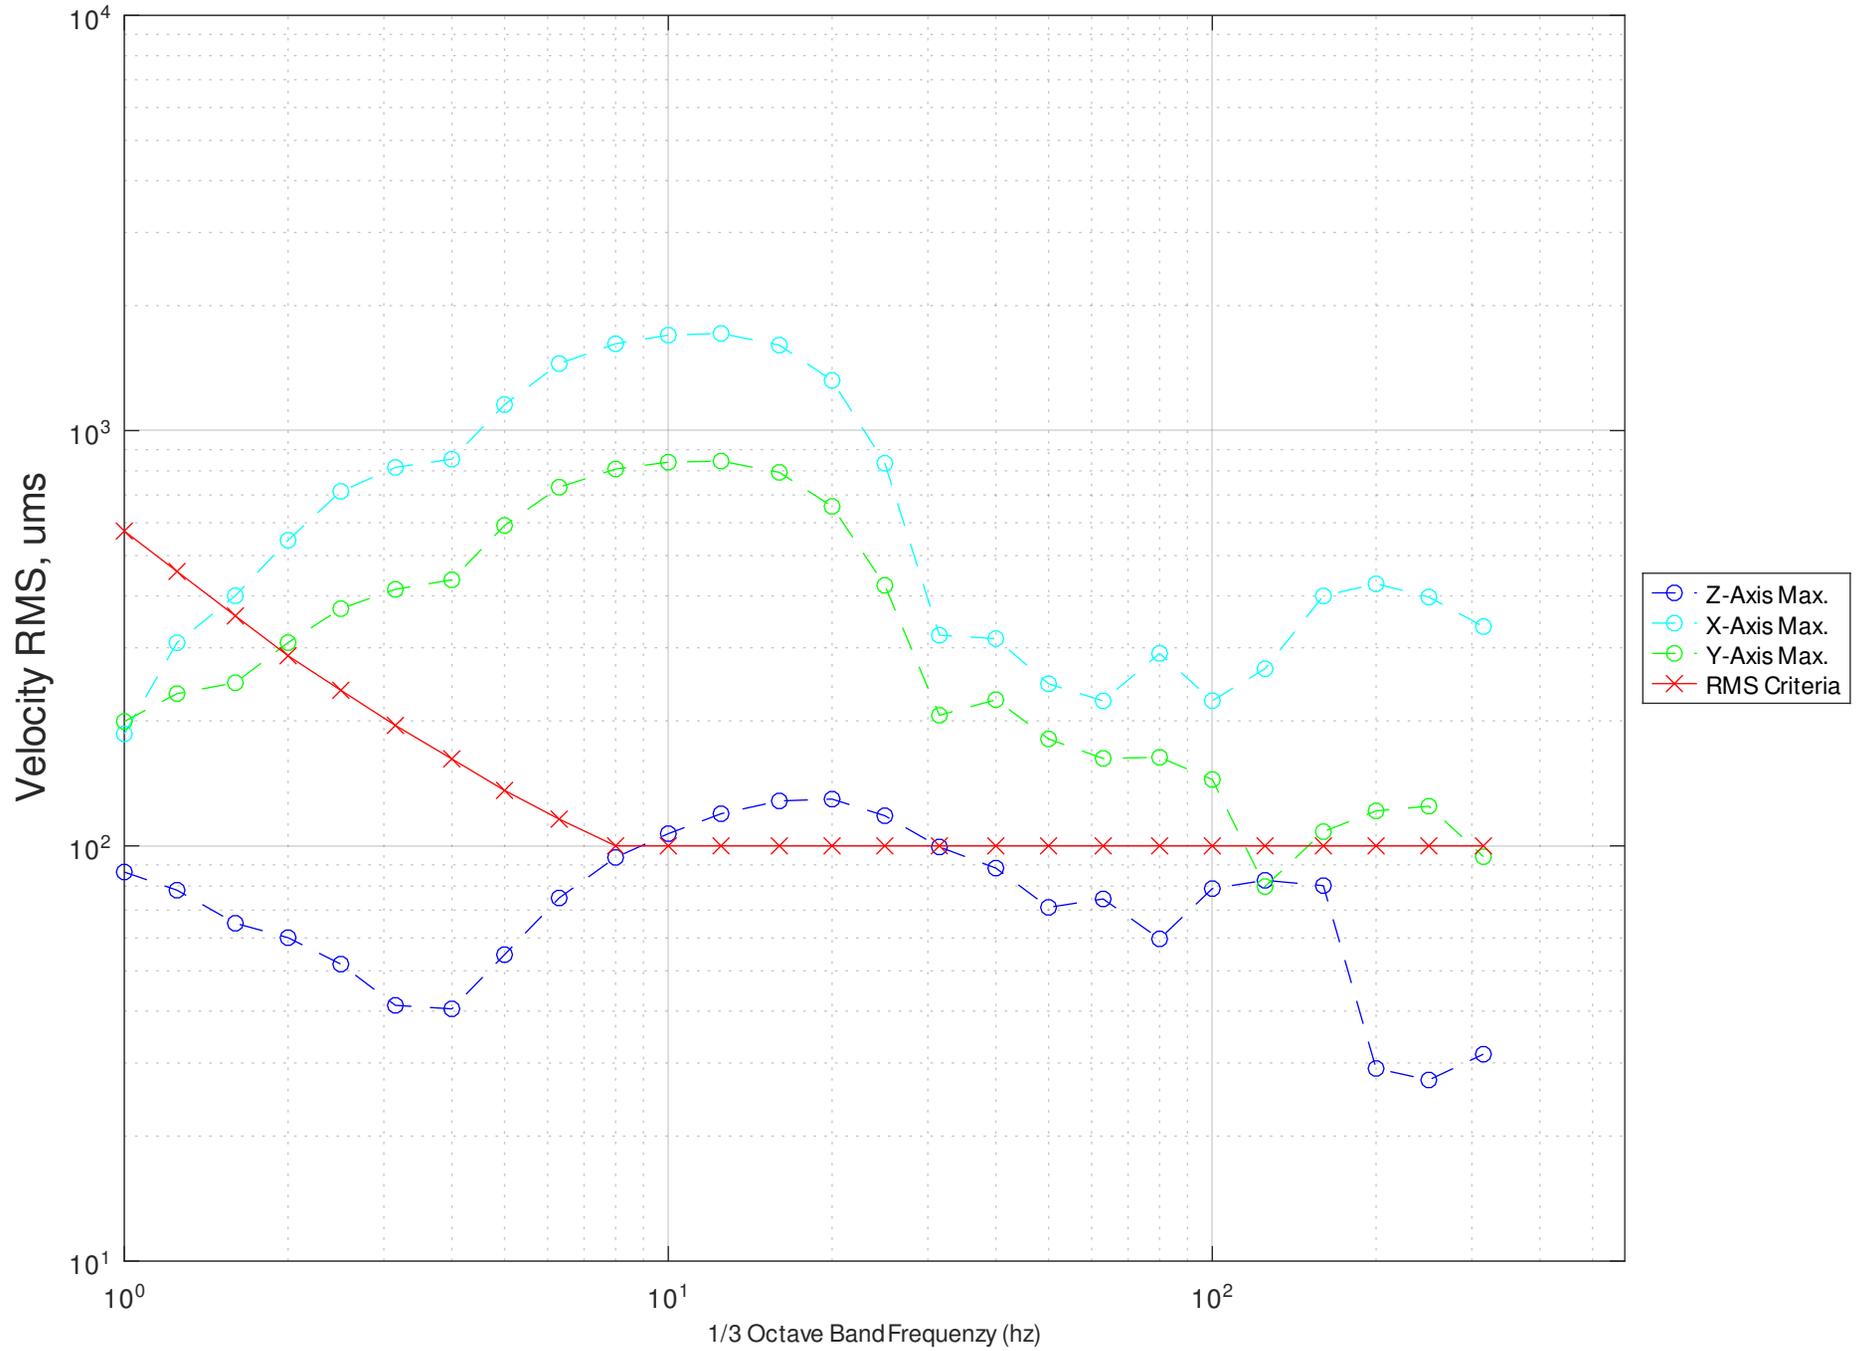
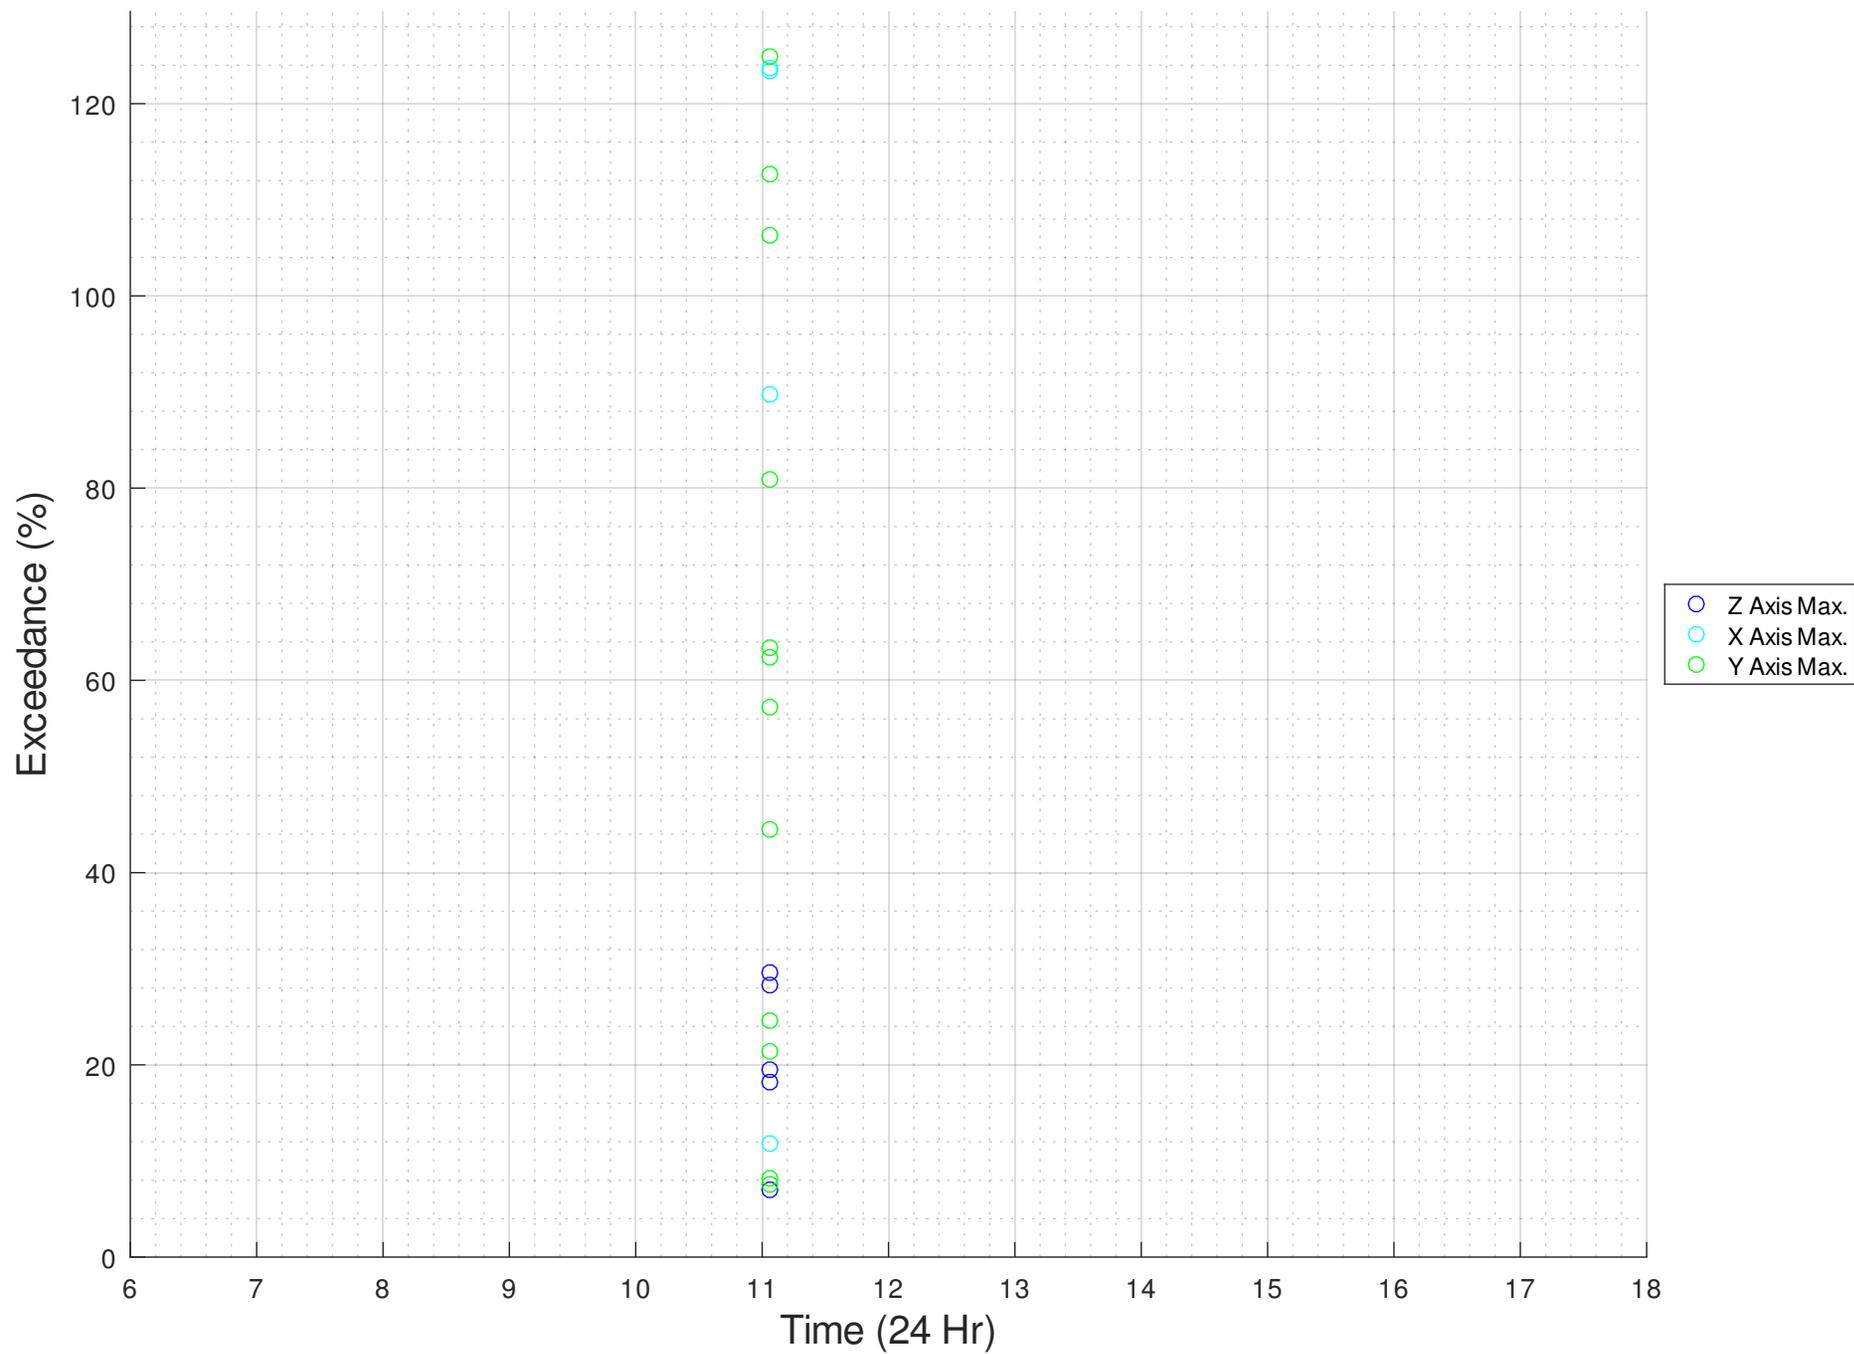
## CENTENARY INSTITUTE – LEVEL 4 NORTHERN EXPERIMENTATION ROOM

- Experimentation Room - 23/01/2025 – Approx.. 1600% exceedance – It is unlikely that the events measured on this date were related to construction activity, noting that there is significant exceedance observed in the translational directions that, if impacting the L4 slab, would have also been recorded by the other monitors on this floorplate. It is likely this was the result of a collision with the geophone.

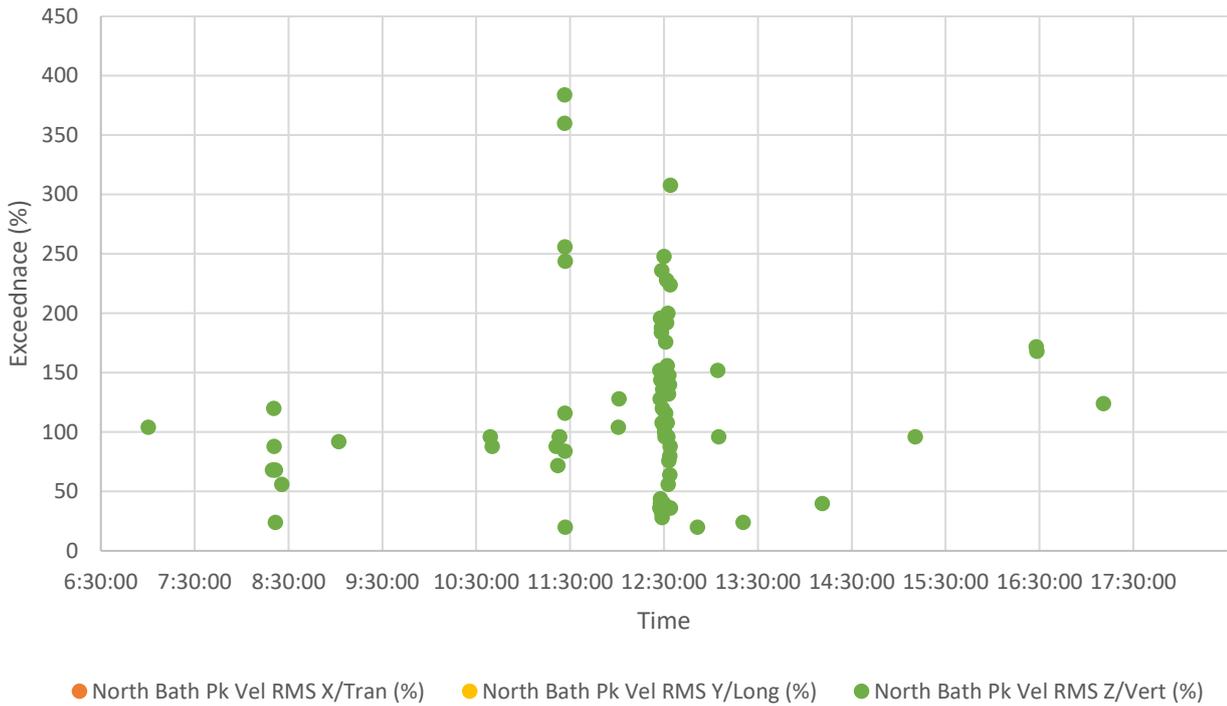
### Charles Perkins Centre Southern Corridor Events - 23/01/2025

- The maximum level measured during the monitoring period was  $121\mu\text{ms}^{-1}$  on 23/01/2025.
  - Exceedances are generally observed at 12.5Hz, likely to be the natural frequency of the CPC suspended slab. Exceedances at frequencies exclusive of 12.5Hz, 16Hz and 20Hz are rarely observed.

- For many of the measured exceedances there is a lack of correlation between the southern corridor monitor and the other monitoring stations surrounding the project site. Therefore, it is likely that some or most of these spikes have been caused by factors exclusive of the construction activity within the RPA Hospital project area.

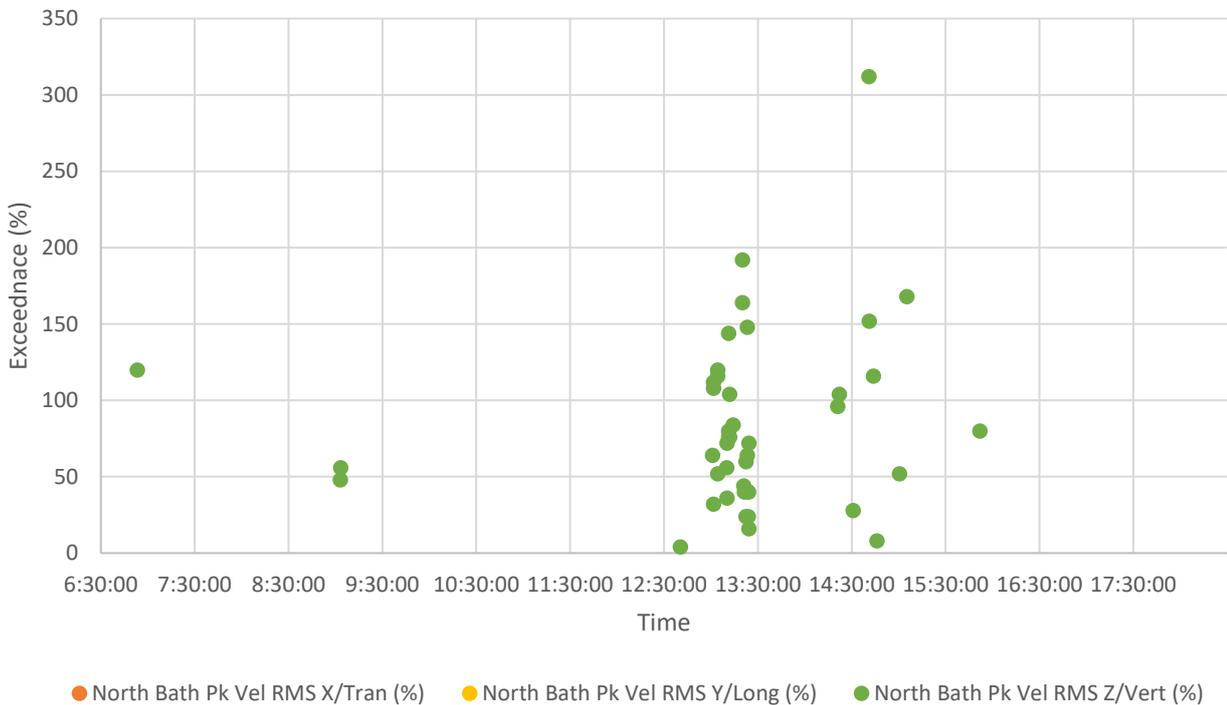
### Charles Perkins Centre Southern Corridor Events - 24/01/2025

- 21/01/2025.
    - 22/01/2025.
    - 23/01/2025.
    - 24/01/2025.
    - 29/01/2025.
    - 31/01/2025.
  - Exceedances are generally within 200% of the conservative VC-B criteria ( $75. \mu\text{ms}^{-1}$ )
