**RE: Noise & Vibration Monitoring Reporting – September 2023**

## CONSTRUCTION NOISE AND VIBRATION REPORT

**Stage 3 St. George Hospital,  
16 Kensington Street,  
Kogarah**

# NOISE & VIBRATION MONITORING REPORT

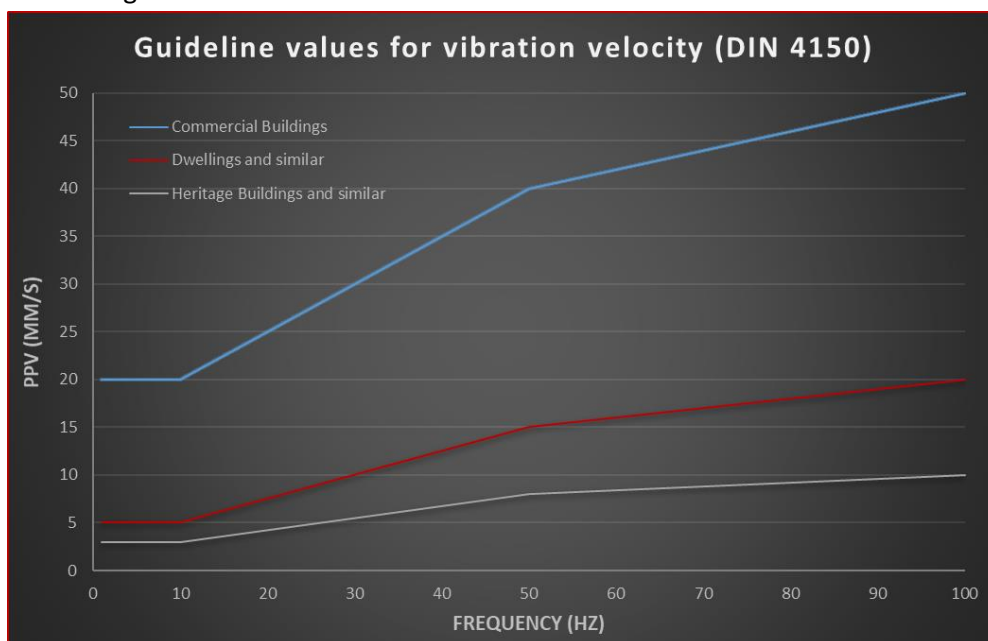
Figure 3 Guideline values for PPV as per DIN-4150

The DIN 4150, *Vibrations in buildings - Part 3: Effects on structures* is used to assess the likelihood of structural damage to nearby structures. Figure 3 below outline the frequency-dependent vibration criteria for Heritage, residential and commercial buildings. These levels have been established such that no damage would occur up to the limits. The levels are generally considered conservative, i.e. vibration levels that exceed the limits would not necessarily translate into structural damage.

The DIN standard defines 'damage' to include cracks forming in plastered surfaces of walls, existing cracks in a building becoming enlarged, and separation of lightweight walls from load bearing walls. Most commonly specified "safe" structural vibration limits are designed to minimise the risk of threshold or cosmetic surface cracks, and are set well below the levels that have potential to cause damage to the main structure. The *DIN 4150* states that buildings exposed to higher levels of vibration than recommended limits would not necessarily result in damage as these limits are generally recognised as being conservative.
