**RE: Noise & Vibration Monitoring Reporting – July 2023**

## CONSTRUCTION NOISE AND VIBRATION REPORT

**Stage 3 St. George Hospital,  
16 Kensington Street,  
Kogarah**

12 July 2023  
Ref: PAR-23661-NVR-W08[A]

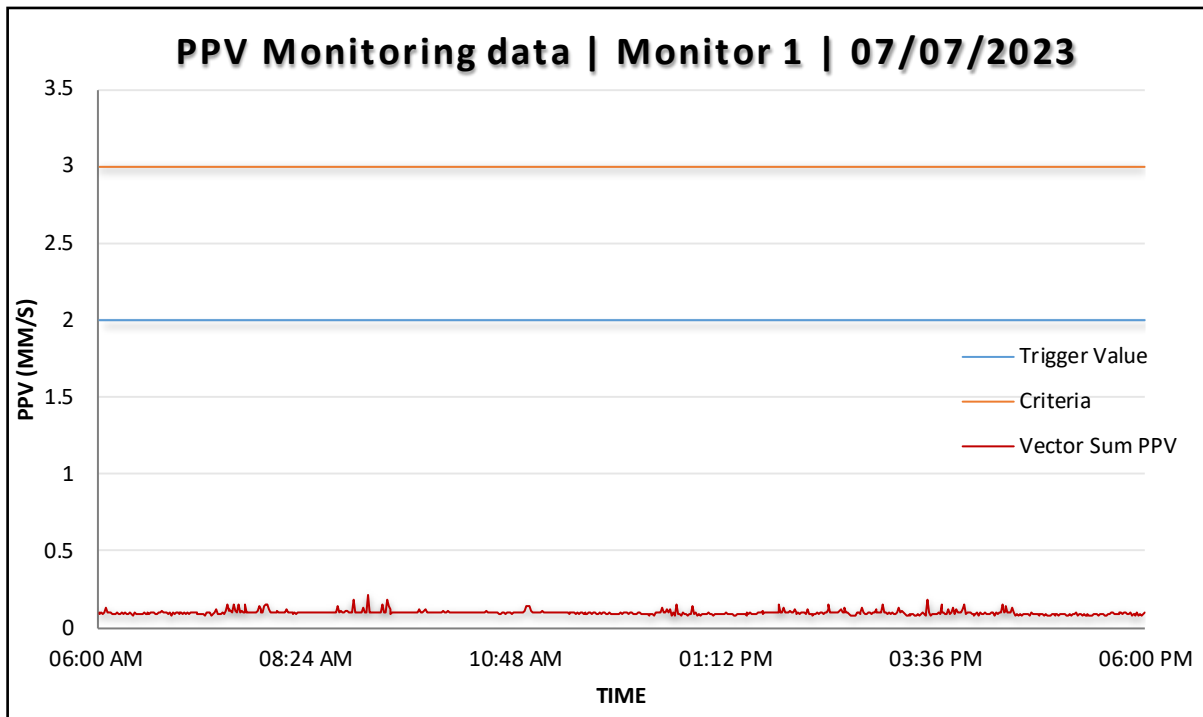
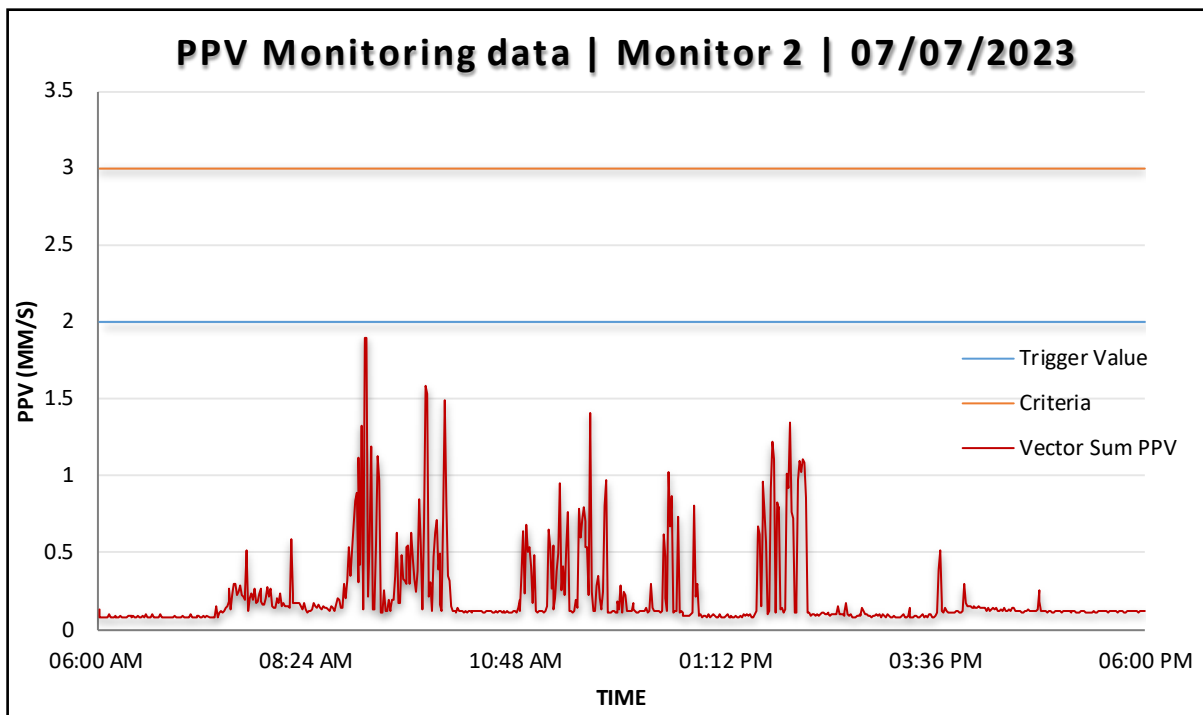
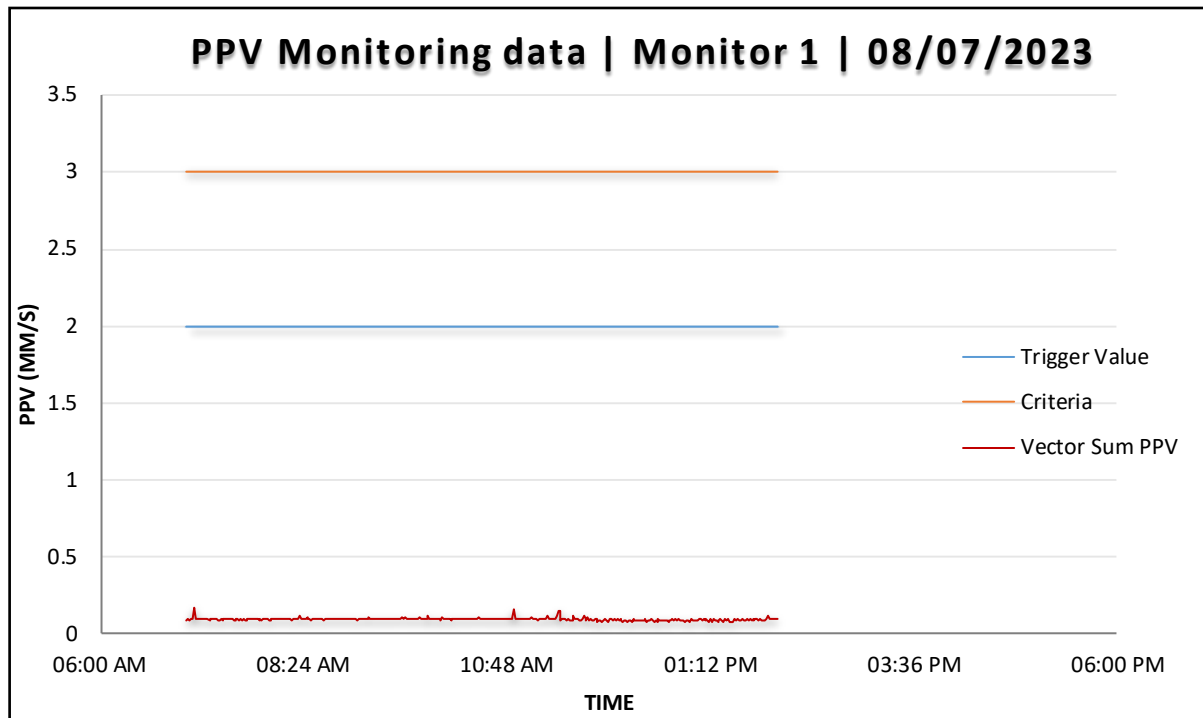
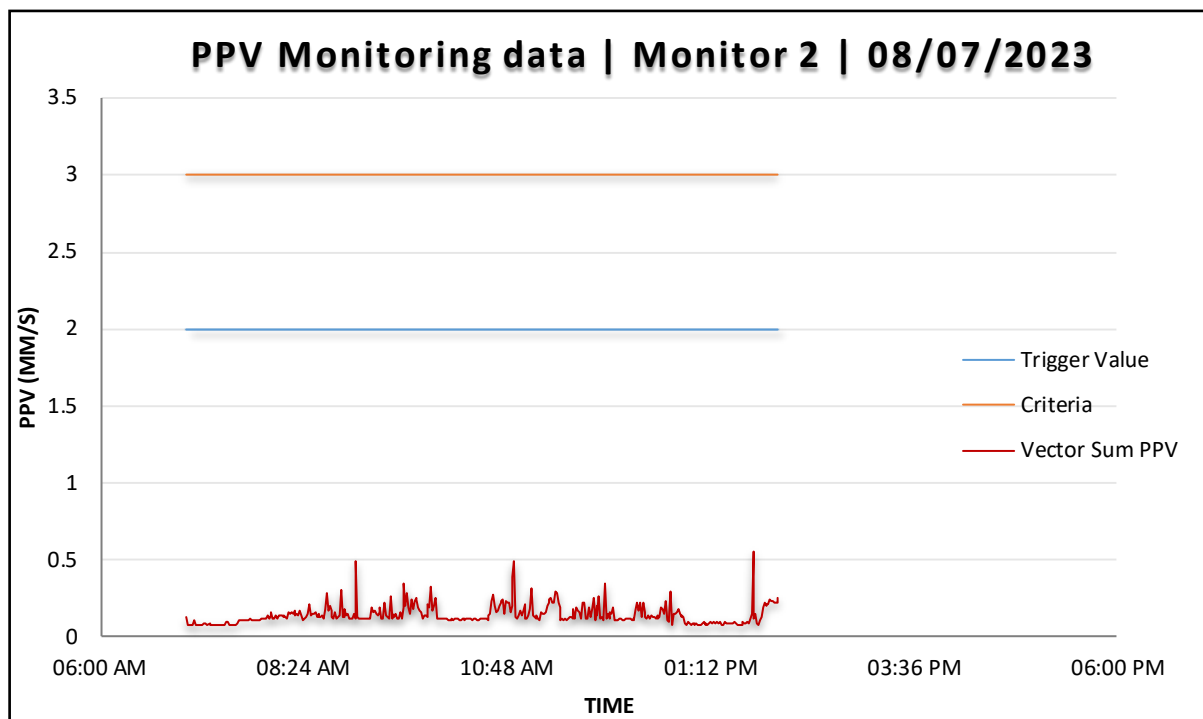
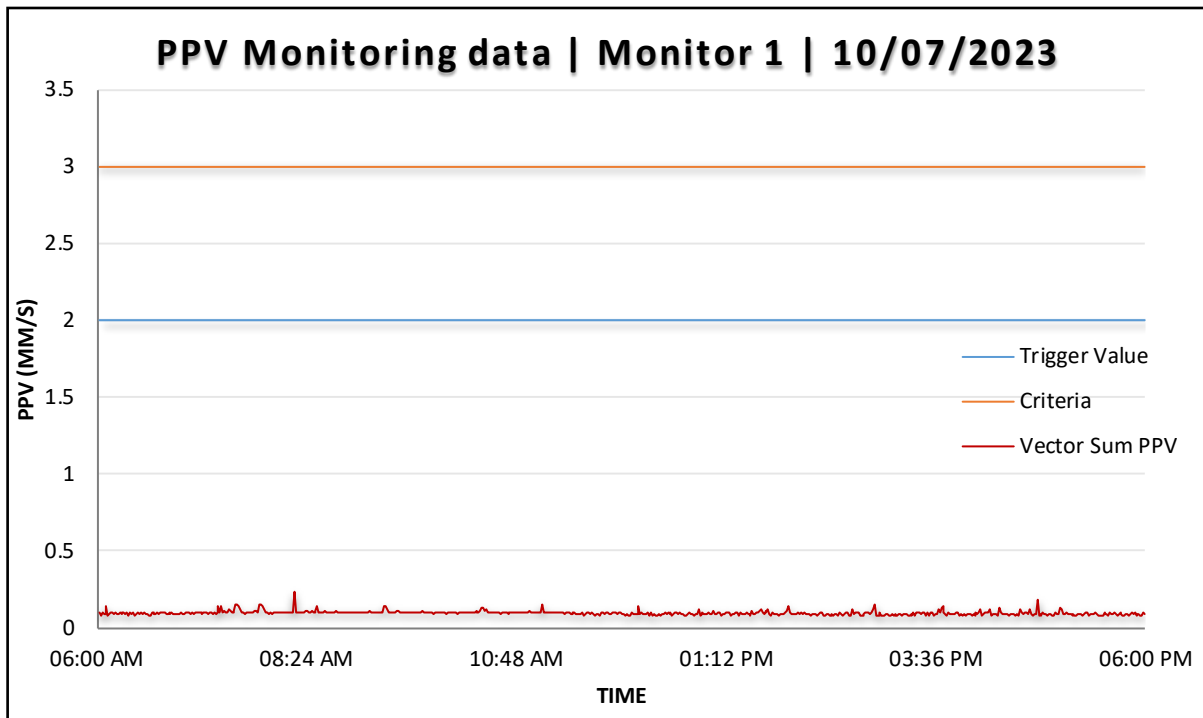
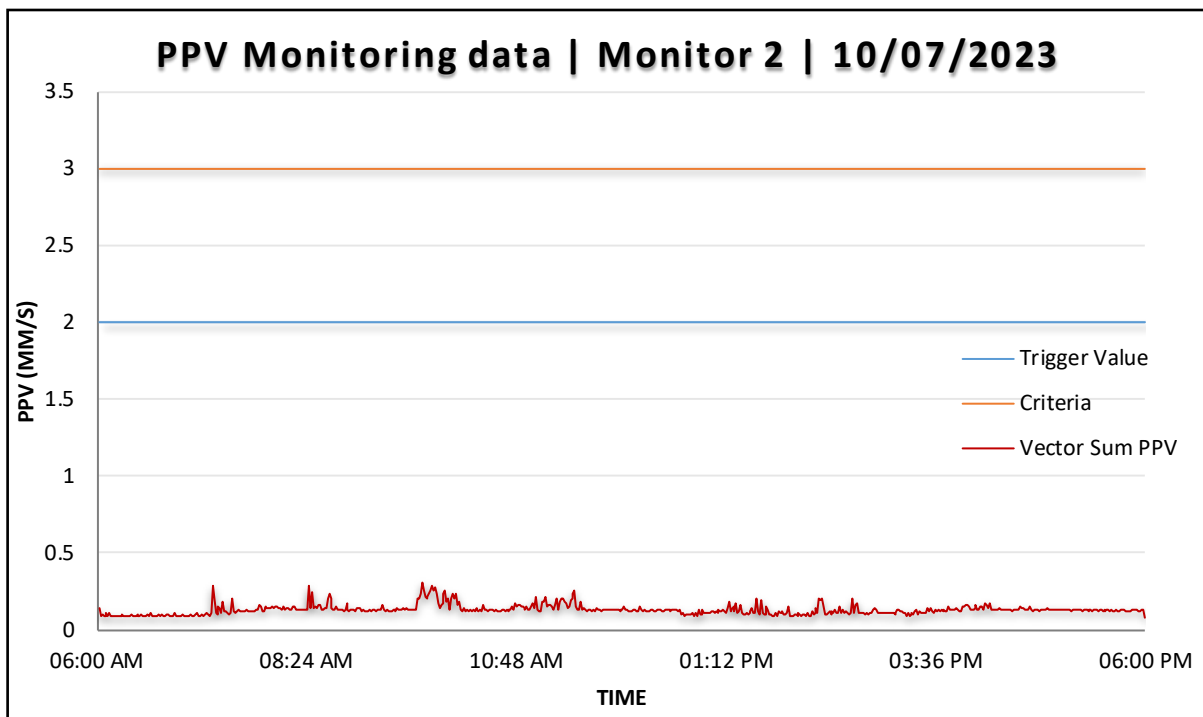
## Appendix 1 – Vibration Monitoring Data

The vibration results found in *Table 6* summarise the maximum daily peak particle velocity (PPV) recorded and compared to the criteria set for this project. The PPV was within the criteria during the monitoring period. It should also be noted that the vibration amplitudes recorded by Paragon to date are relatively marginal. It is understood that Acoustic Logic (AL) is undertaking vibration monitoring for the MRI and Mammogram equipment, we understand that their reporting criteria has been specifically set for the monitoring of these equipment. Based on the above, and although the vibration measurement output and reporting methodologies of Paragon and AL are not directly comparable, both reports are in line and indicating compliance with the criterion set for structural damage and equipment tolerances, respectively.

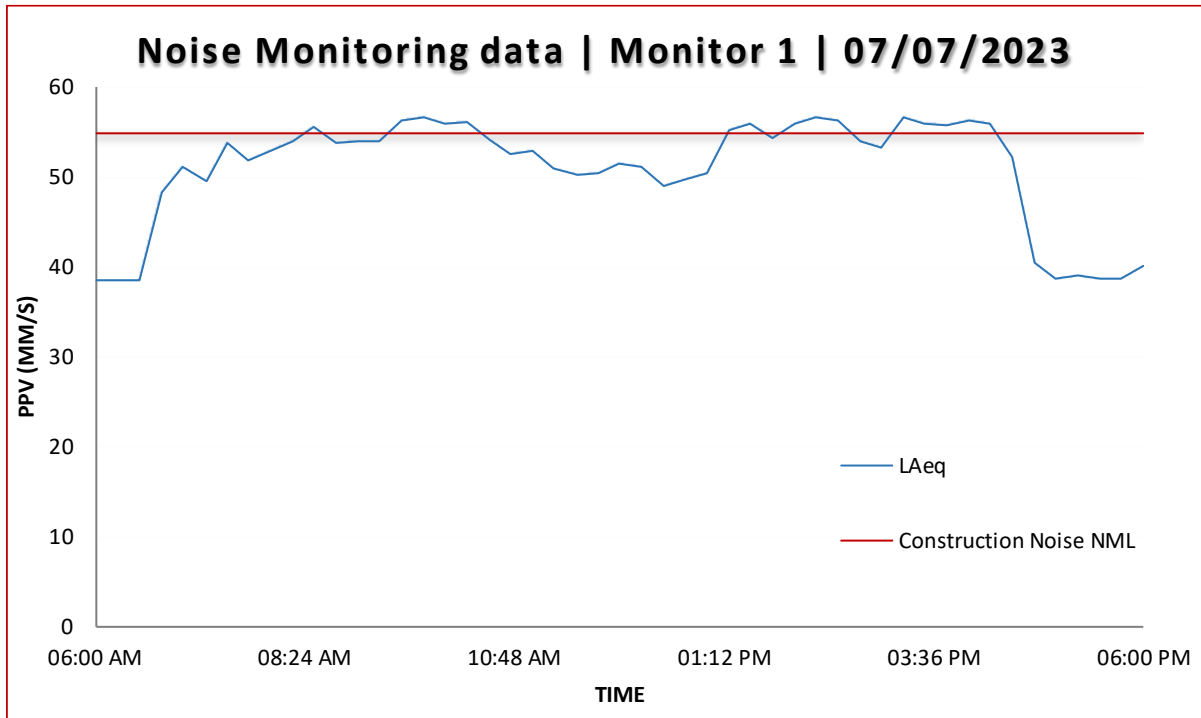
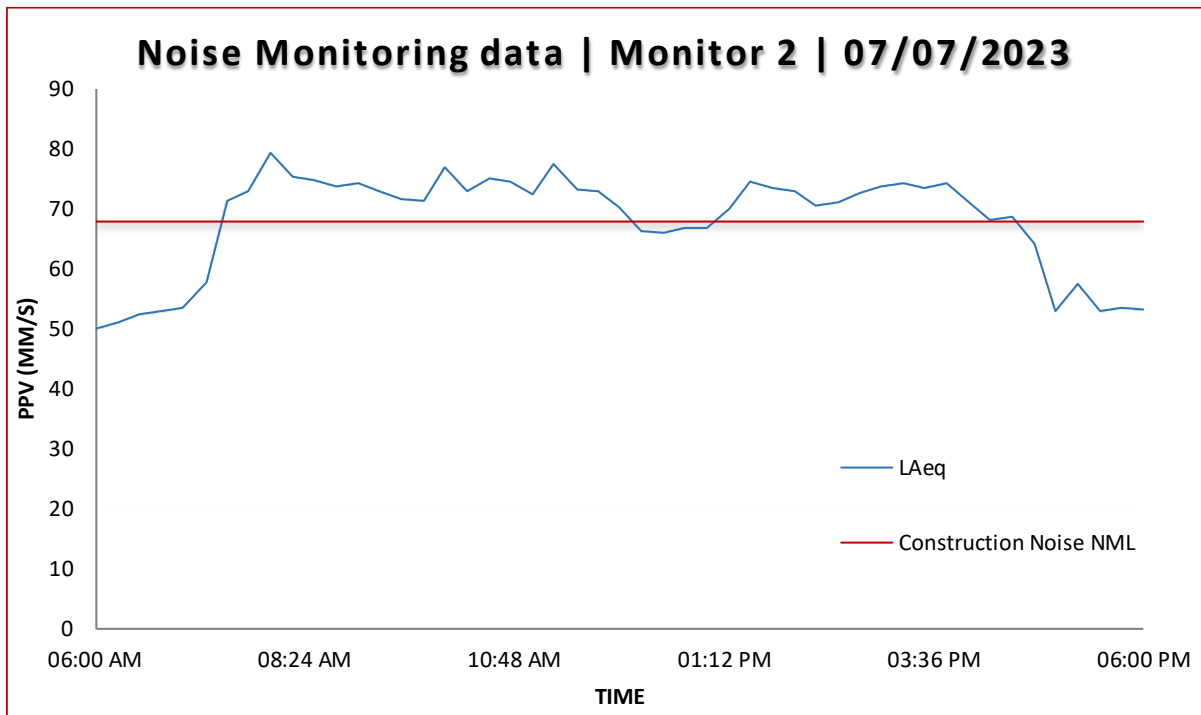
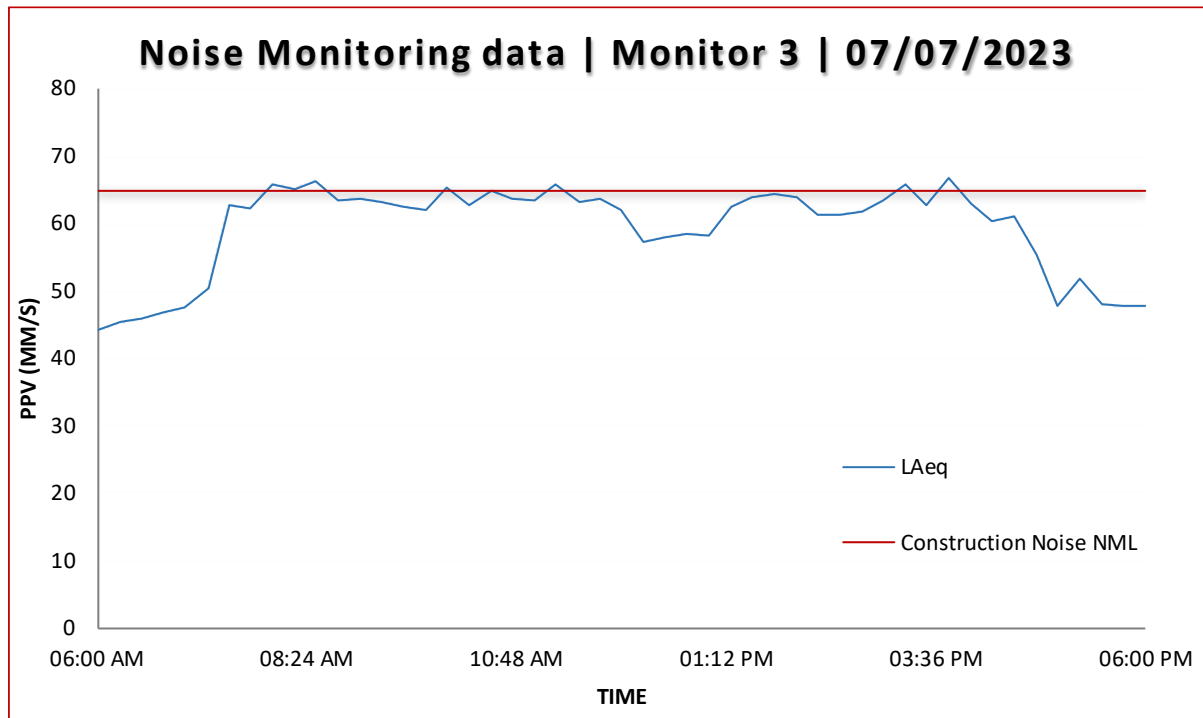
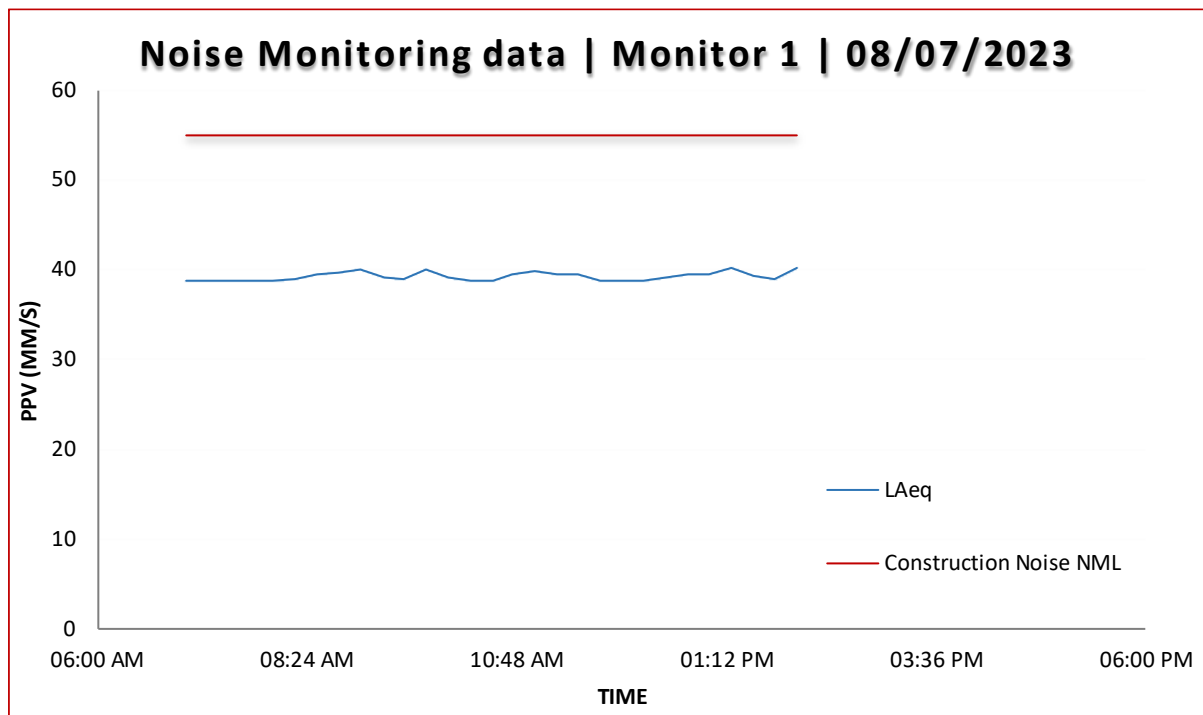
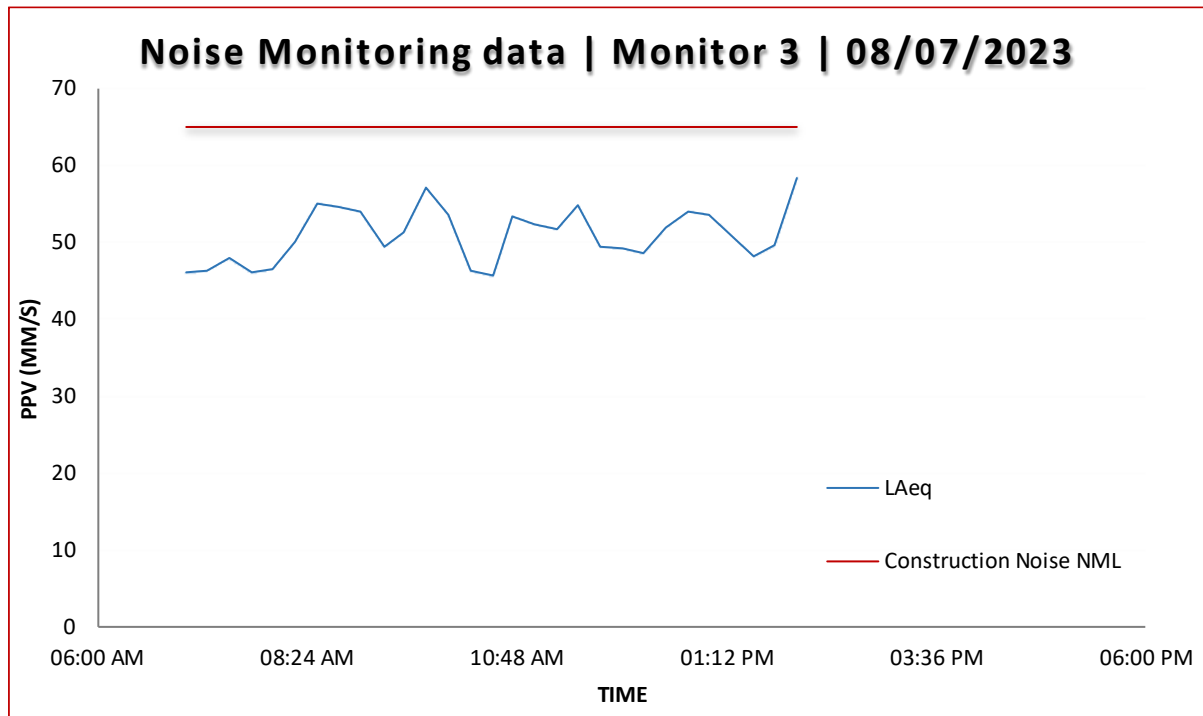
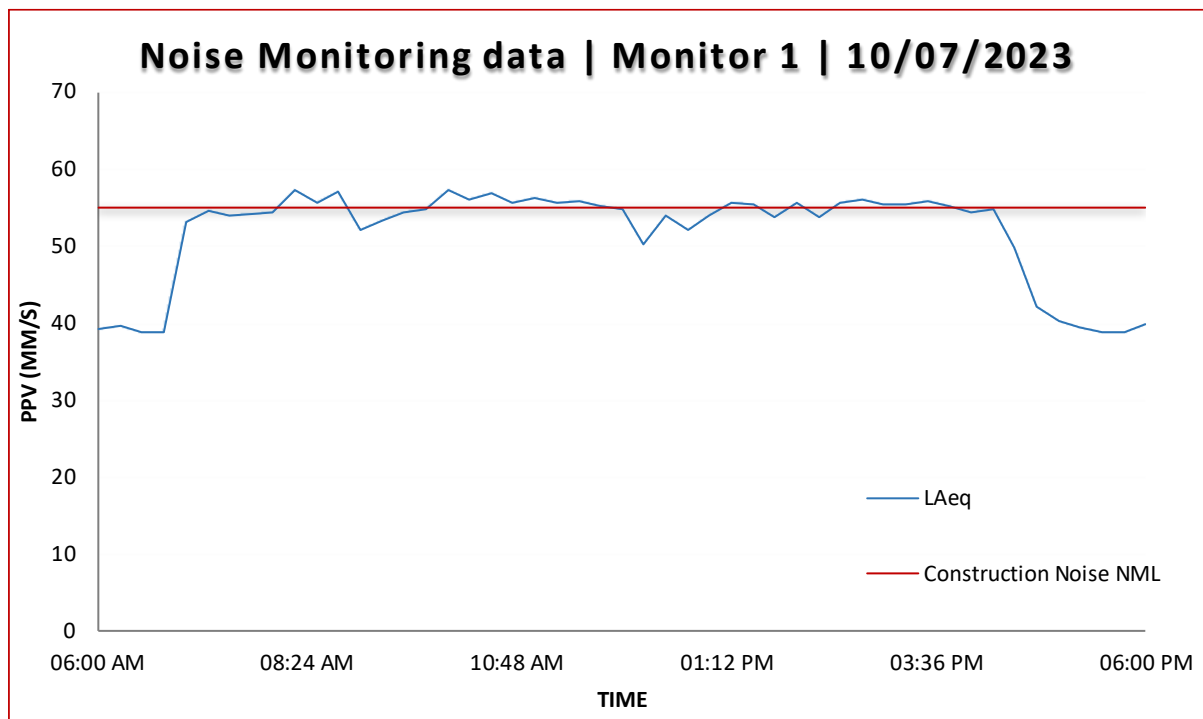
## Appendix 2 – Noise Monitoring Date

The results found in *Table 7* summarises the noise level recorded for this project. During the monitoring period, noise monitor at Location 2 have exceeded the criteria by up to 11 dB(A) for the Noise Affected NML and 04 dB(A) for highly noise affected. Location 1 and Location 3 have exceeded the criteria by up to 04 dB(A) and 06 dB(A) respectively during the monitoring period. It is found that many of the triggers from Location 1 are caused by workers and patient within the same room and therefore, it is recommended that the monitor is placed in a room away from work spaces and rooms with operating equipment to avoid these false triggers.

Further monitoring is recommended, and vibration and noise controls should be implemented to maintain the structural integrity of surrounding structures and avoid discomfort to surrounding residents.

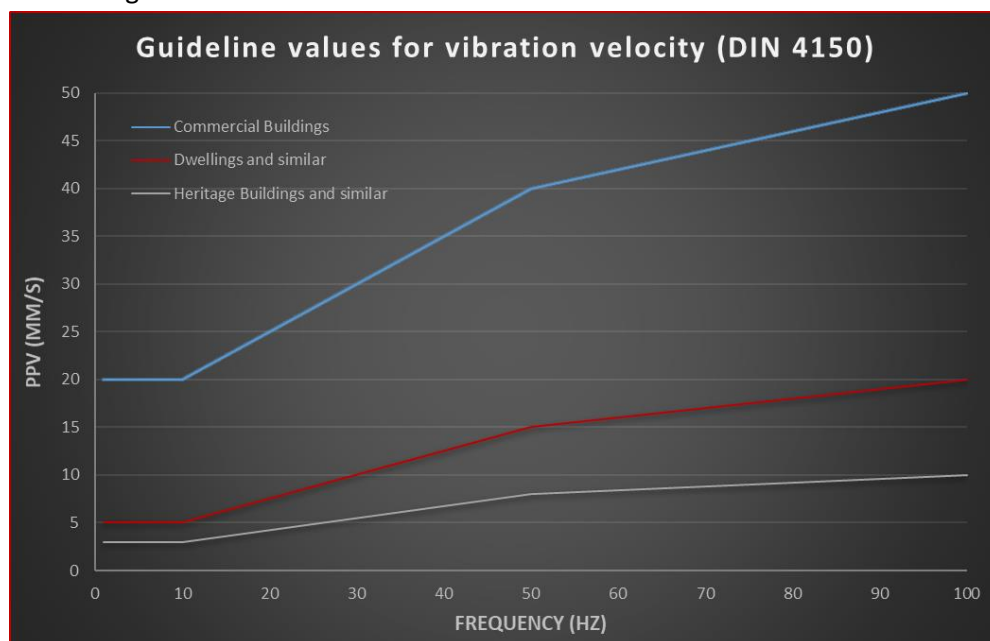
Figure 3 Guideline values for PPV as per DIN-4150

The DIN standard defines 'damage' to include cracks forming in plastered surfaces of walls, existing cracks in a building becoming enlarged, and separation of lightweight walls from load bearing walls. Most commonly specified "safe" structural vibration limits are designed to minimise the risk of threshold or cosmetic surface cracks, and are set well below the levels that have potential to cause damage to the main structure. The *DIN 4150* states that buildings exposed to higher levels of vibration than recommended limits would not necessarily result in damage as these limits are generally recognised as being conservative.

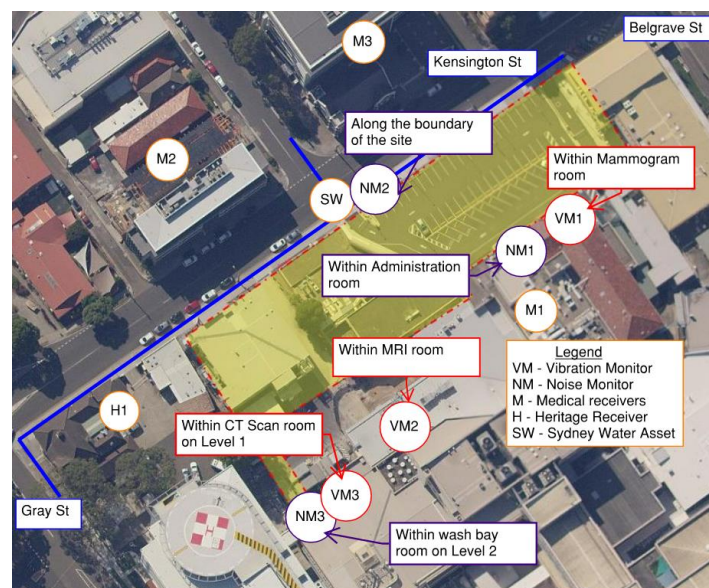
*Figure 4 Site setup*

In accordance with the recommendations from the Construction Noise & Vibration Monitoring Plan, Ref # VIB-23661-NVMP[B] dated 31 May 2023 prepared by Paragon Engineering, the criteria “Structures that, because of their particular sensitivity to vibration, cannot be classified under lines 1 and 2)” has been considered for the heritage building and Medical facility with sensitive equipment where the criteria/trigger is set to **3mm/s**. Figure 4 shows the location of each vibration monitor.

The noise monitor was mounted on a solar stand in accordance with the manufacturer's recommendations. The monitor is oriented with the camera facing the direction of the noise source as per the recommendation of the manufacturer. The monitor was located to be as close to the sensitive noise receiver as possible as shown in *Figure 4* below. Each device was set to continuous daily monitoring at 15-minute intervals recording  $L_{Aeq}(15min)$ .

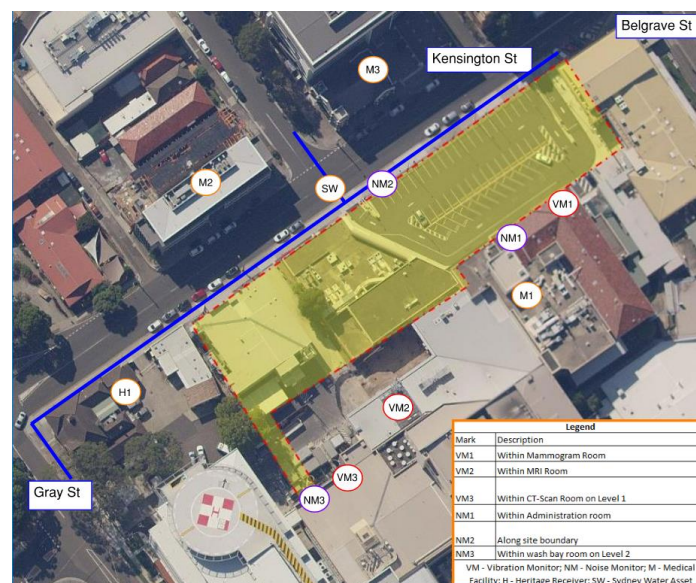
Figure 4 Site setup

In accordance with the recommendations from the Construction Noise & Vibration Monitoring Plan, Ref # VIB-23661-NVMP[B] dated 31 May 2023 prepared by Paragon Engineering, the criteria “Structures that, because of their particular sensitivity to vibration, cannot be classified under lines 1 and 2)” has been considered for the heritage building and Medical facility with sensitive equipment where the criteria/trigger is set to **3mm/s**. Figure 4 shows the location of each vibration monitor.

The noise monitor was mounted on a solar stand in accordance with the manufacturer's recommendations. The monitor is oriented with the camera facing the direction of the noise source as per the recommendation of the manufacturer. The monitor was located to be as close to the sensitive noise receiver as possible as shown in *Figure 4* below. Each device was set to continuous daily monitoring at 15-minute intervals recording  $L_{Aeq(15min)}$ .
