**RE: Noise & Vibration Monitoring Reporting – November 2023**

## CONSTRUCTION NOISE AND VIBRATION REPORT

**Stage 3 St. George Hospital,  
16 Kensington Street,  
Kogarah**

Monitoring Period:  
03 November 2023 to 09 November 2023

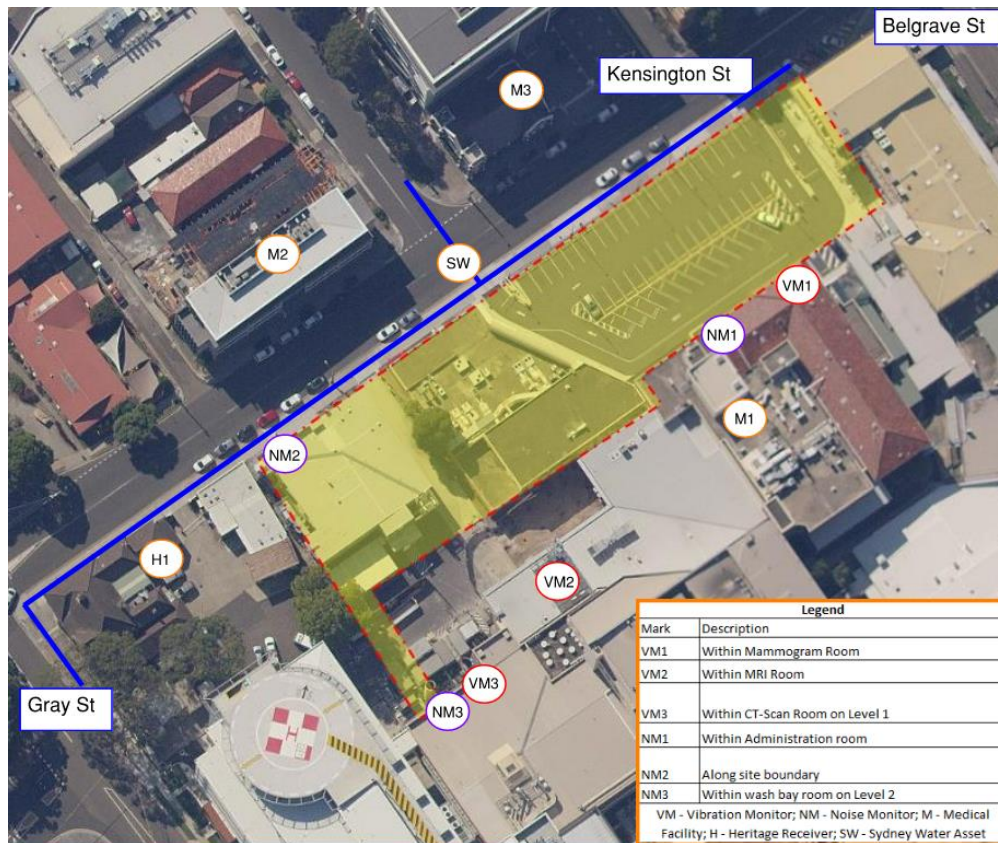
Figure 4 Site setup

In accordance with the recommendations from the Construction Noise & Vibration Monitoring Plan, Ref # VIB-23661-NVMP[B] dated 31 May 2023 prepared by Paragon Engineering, the criteria “Structures that, because of their particular sensitivity to vibration, cannot be classified under lines 1 and 2)” has been considered for the heritage building and Medical facility with sensitive equipment where the criteria/trigger is set to **3mm/s**. Figure 4 shows the location of each vibration monitor.

The geophone was firmly mounted in the ground in accordance with the manufacturer's recommendations & the Australian Standards AS 2775–2004 Mechanical vibration and shock – Mechanical mounting of accelerometers / the ISEE Field practice guidelines for blasting seismographs 2020 as applicable, the geophone was orientated as recommended by the manufacturer in the direction of the vibration source. Vibration Monitor 1 was installed on the wall within the mammogram waiting room and Vibration Monitor 2 was installed on the ground adjacent to the MRI room as can be seen in *Figure 4*. Each device was set to continuous daily monitoring mode at one-minute intervals recording velocities along the three orthogonal axes, i.e. x-axis / radial (back to chest), y-axis / transverse (right side to left side) or z-axis / vertical (foot to head) along with their corresponding frequencies.

The noise monitor was mounted on a solar stand in accordance with the manufacturer's recommendations. The monitor is oriented with the camera facing the direction of the noise source as per the recommendation of the manufacturer. The monitor was located to be as close to the sensitive noise receiver as possible as shown in *Figure 4* below. Each device was set to continuous daily monitoring at 15-minute intervals recording  $L_{Aeq(15min)}$ .

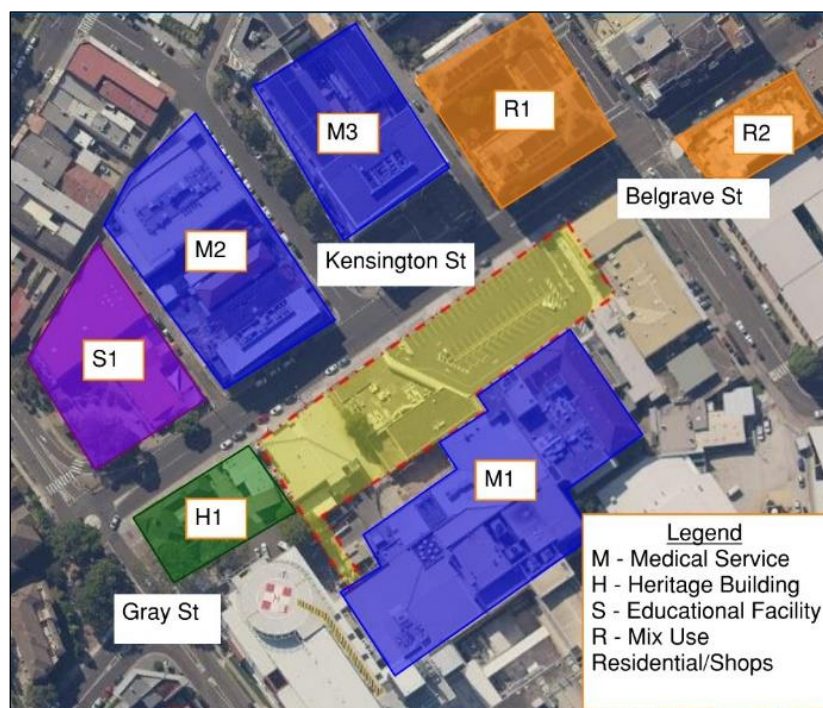
*Figure 2 Sensitive Noise Receiver*

The nearest noise sensitive receivers are identified in *Figure 2* and listed below:

- ❖ R1, Residential buildings on the Northern boundary of the site along Kensington St.
- ❖ R2, Residential buildings on the Eastern boundary of the site along Belgrave St.
- ❖ M1, Medical Facility on the Southern boundary of the site.
- ❖ M2, Medical Facility on the Northern boundary of the site along Kensington St.
- ❖ M3, Medical Facility on the Northern boundary of the site along Kensington St.
- ❖ S1, Educational Facility on the North-western boundary of the site along Kensington St.
- ❖ H1, Fire Station (heritage) on the Western side of the boundary.
