**RE: Noise & Vibration Monitoring Reporting – June 2023**

## CONSTRUCTION NOISE AND VIBRATION REPORT

**Stage 3 St. George Hospital,  
16 Kensington Street,  
Kogarah**

20 June 2023  
Ref: PAR-23661-NVR-W04[A]

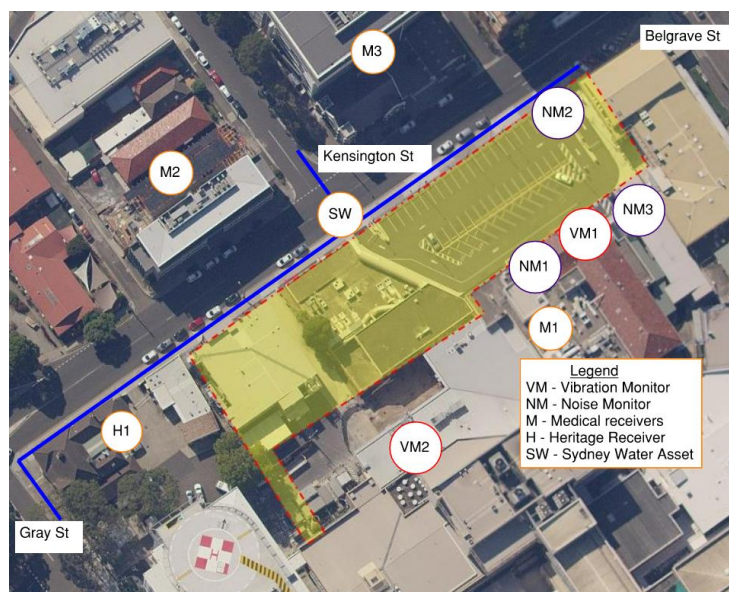
*Figure 4 Site setup*

In accordance with the recommendations from the Construction Noise & Vibration Monitoring Plan, Ref # VIB-23661-NVMP[B] dated 31 May 2023 prepared by Paragon Engineering, the criteria “Structures that, because of their particular sensitivity to vibration, cannot be classified under lines 1 and 2)” has been considered for the heritage building and Medical facility with sensitive equipment where the criteria/trigger is set to **3mm/s**. Figure 4 shows the location of each vibration monitor.

The geophone was firmly mounted in the ground in accordance with the manufacturer's recommendations & the Australian Standards AS 2775–2004 Mechanical vibration and shock – Mechanical mounting of accelerometers / the ISEE Field practice guidelines for blasting seismographs 2020 as applicable, the geophone was orientated as recommended by the manufacturer in the direction of the vibration source. Vibration Monitor 1 was installed on the wall within the mammogram waiting room and Vibration Monitor 2 was installed on the ground adjacent to the MRI room as can be seen in *Figure 4*. Each device was set to continuous daily monitoring mode at one-minute intervals recording velocities along the three orthogonal axes, i.e. x-axis / radial (back to chest), y-axis / transverse (right side to left side) or z-axis / vertical (foot to head) along with their corresponding frequencies.

The noise monitor was mounted on a solar stand in accordance with the manufacturer's recommendations. The monitor is oriented with the camera facing the direction of the noise source as per the recommendation of the manufacturer. The monitor was located to be as close to the sensitive noise receiver as possible as shown in *Figure 4* below. Each device was set to continuous daily monitoring at 15-minute intervals recording  $L_{Aeq(15min)}$ .

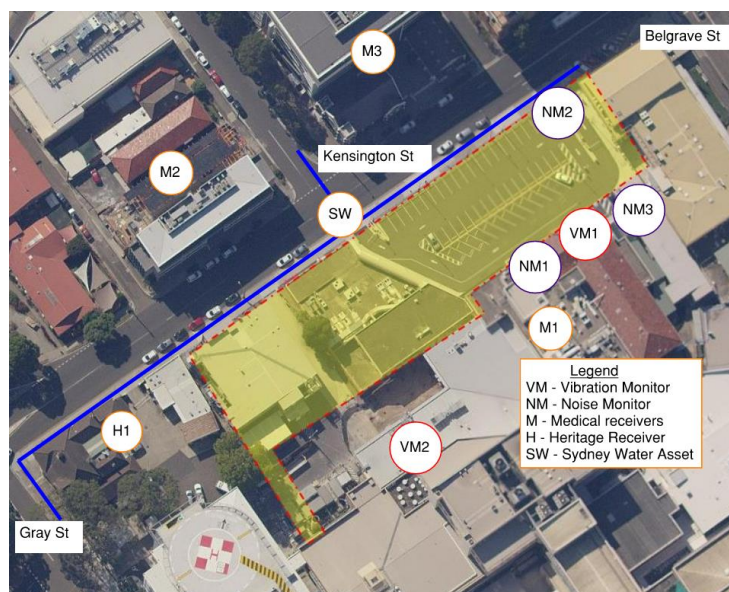
*Figure 4 Site setup*

In accordance with the recommendations from the Construction Noise & Vibration Monitoring Plan, Ref # VIB-23661-NVMP[B] dated 31 May 2023 prepared by Paragon Engineering, the criteria “Structures that, because of their particular sensitivity to vibration, cannot be classified under lines 1 and 2)” has been considered for the heritage building and Medical facility with sensitive equipment where the criteria/trigger is set to **3mm/s**. Figure 4 shows the location of each vibration monitor.

The noise monitor was mounted on a solar stand in accordance with the manufacturer's recommendations. The monitor is oriented with the camera facing the direction of the noise source as per the recommendation of the manufacturer. The monitor was located to be as close to the sensitive noise receiver as possible as shown in *Figure 4* below. Each device was set to continuous daily monitoring at 15-minute intervals recording  $L_{Aeq(15min)}$ .

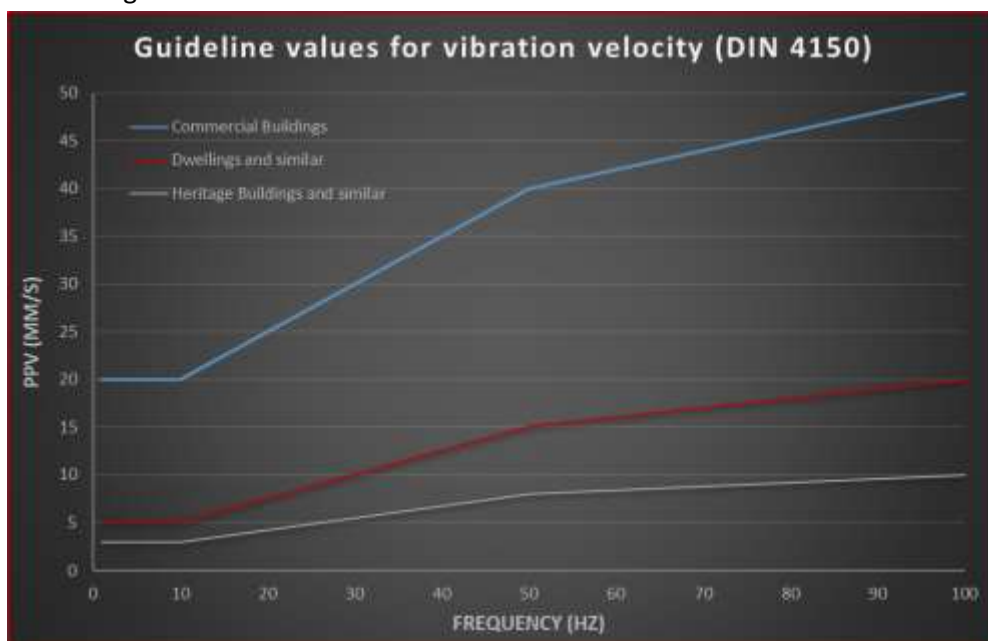
Figure 3 Guideline values for PPV as per DIN-4150

The DIN standard defines ‘damage’ to include cracks forming in plastered surfaces of walls, existing cracks in a building becoming enlarged, and separation of lightweight walls from load bearing walls. Most commonly specified “safe” structural vibration limits are designed to minimise the risk of threshold or cosmetic surface cracks, and are set well below the levels that have potential to cause damage to the main structure. The *DIN 4150* states that buildings exposed to higher levels of vibration than recommended limits would not necessarily result in damage as these limits are generally recognised as being conservative.

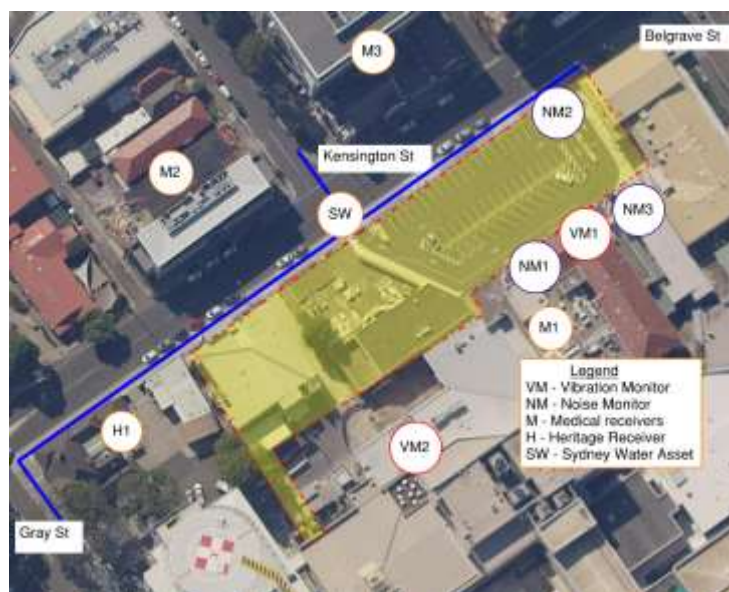
*Figure 4 Site setup*

In accordance with the recommendations from the Construction Noise & Vibration Monitoring Plan, Ref # VIB-23661-NVMP[B] dated 31 May 2023 prepared by Paragon Engineering, the criteria “Structures that, because of their particular sensitivity to vibration, cannot be classified under lines 1 and 2)” has been considered for the heritage building and Medical facility with sensitive equipment where the criteria/trigger is set to **3mm/s**. Figure 4 shows the location of each vibration monitor.

The noise monitor was mounted on a solar stand in accordance with the manufacturer's recommendations. The monitor is oriented with the camera facing the direction of the noise source as per the recommendation of the manufacturer. The monitor was located to be as close to the sensitive noise receiver as possible as shown in *Figure 4* below. Each device was set to continuous daily monitoring at 15-minute intervals recording  $L_{Aeq}(15min)$ .
