KANE

ENVIRONMENTAL MANAGEMENT PLAN

Children's Hospital Westmead (CHW) Stage 2 & VVMF – Refurbishment Works

30/11/2023

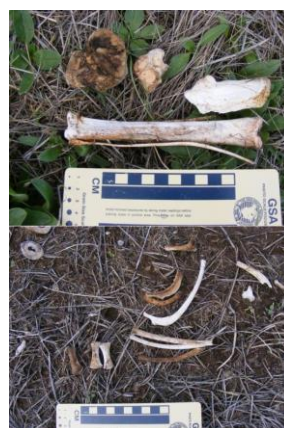
Figure 3: Disarticulated bones that require assessment to determine species.

Where it is not 'obvious' that the bones are human (in the majority of cases, illustrated by Figure 3), specialist assessment is required to establish the species of the bones. Photographs of the bones can assist this assessment if they are clear and taken in accordance with guidance provided in photo above. Good photographs often result in the bones being identified by a specialist without requiring a site visit; noting they are nearly always non-human. In these cases, non-human skeletal remains must be treated like any other unexpected archaeological find.

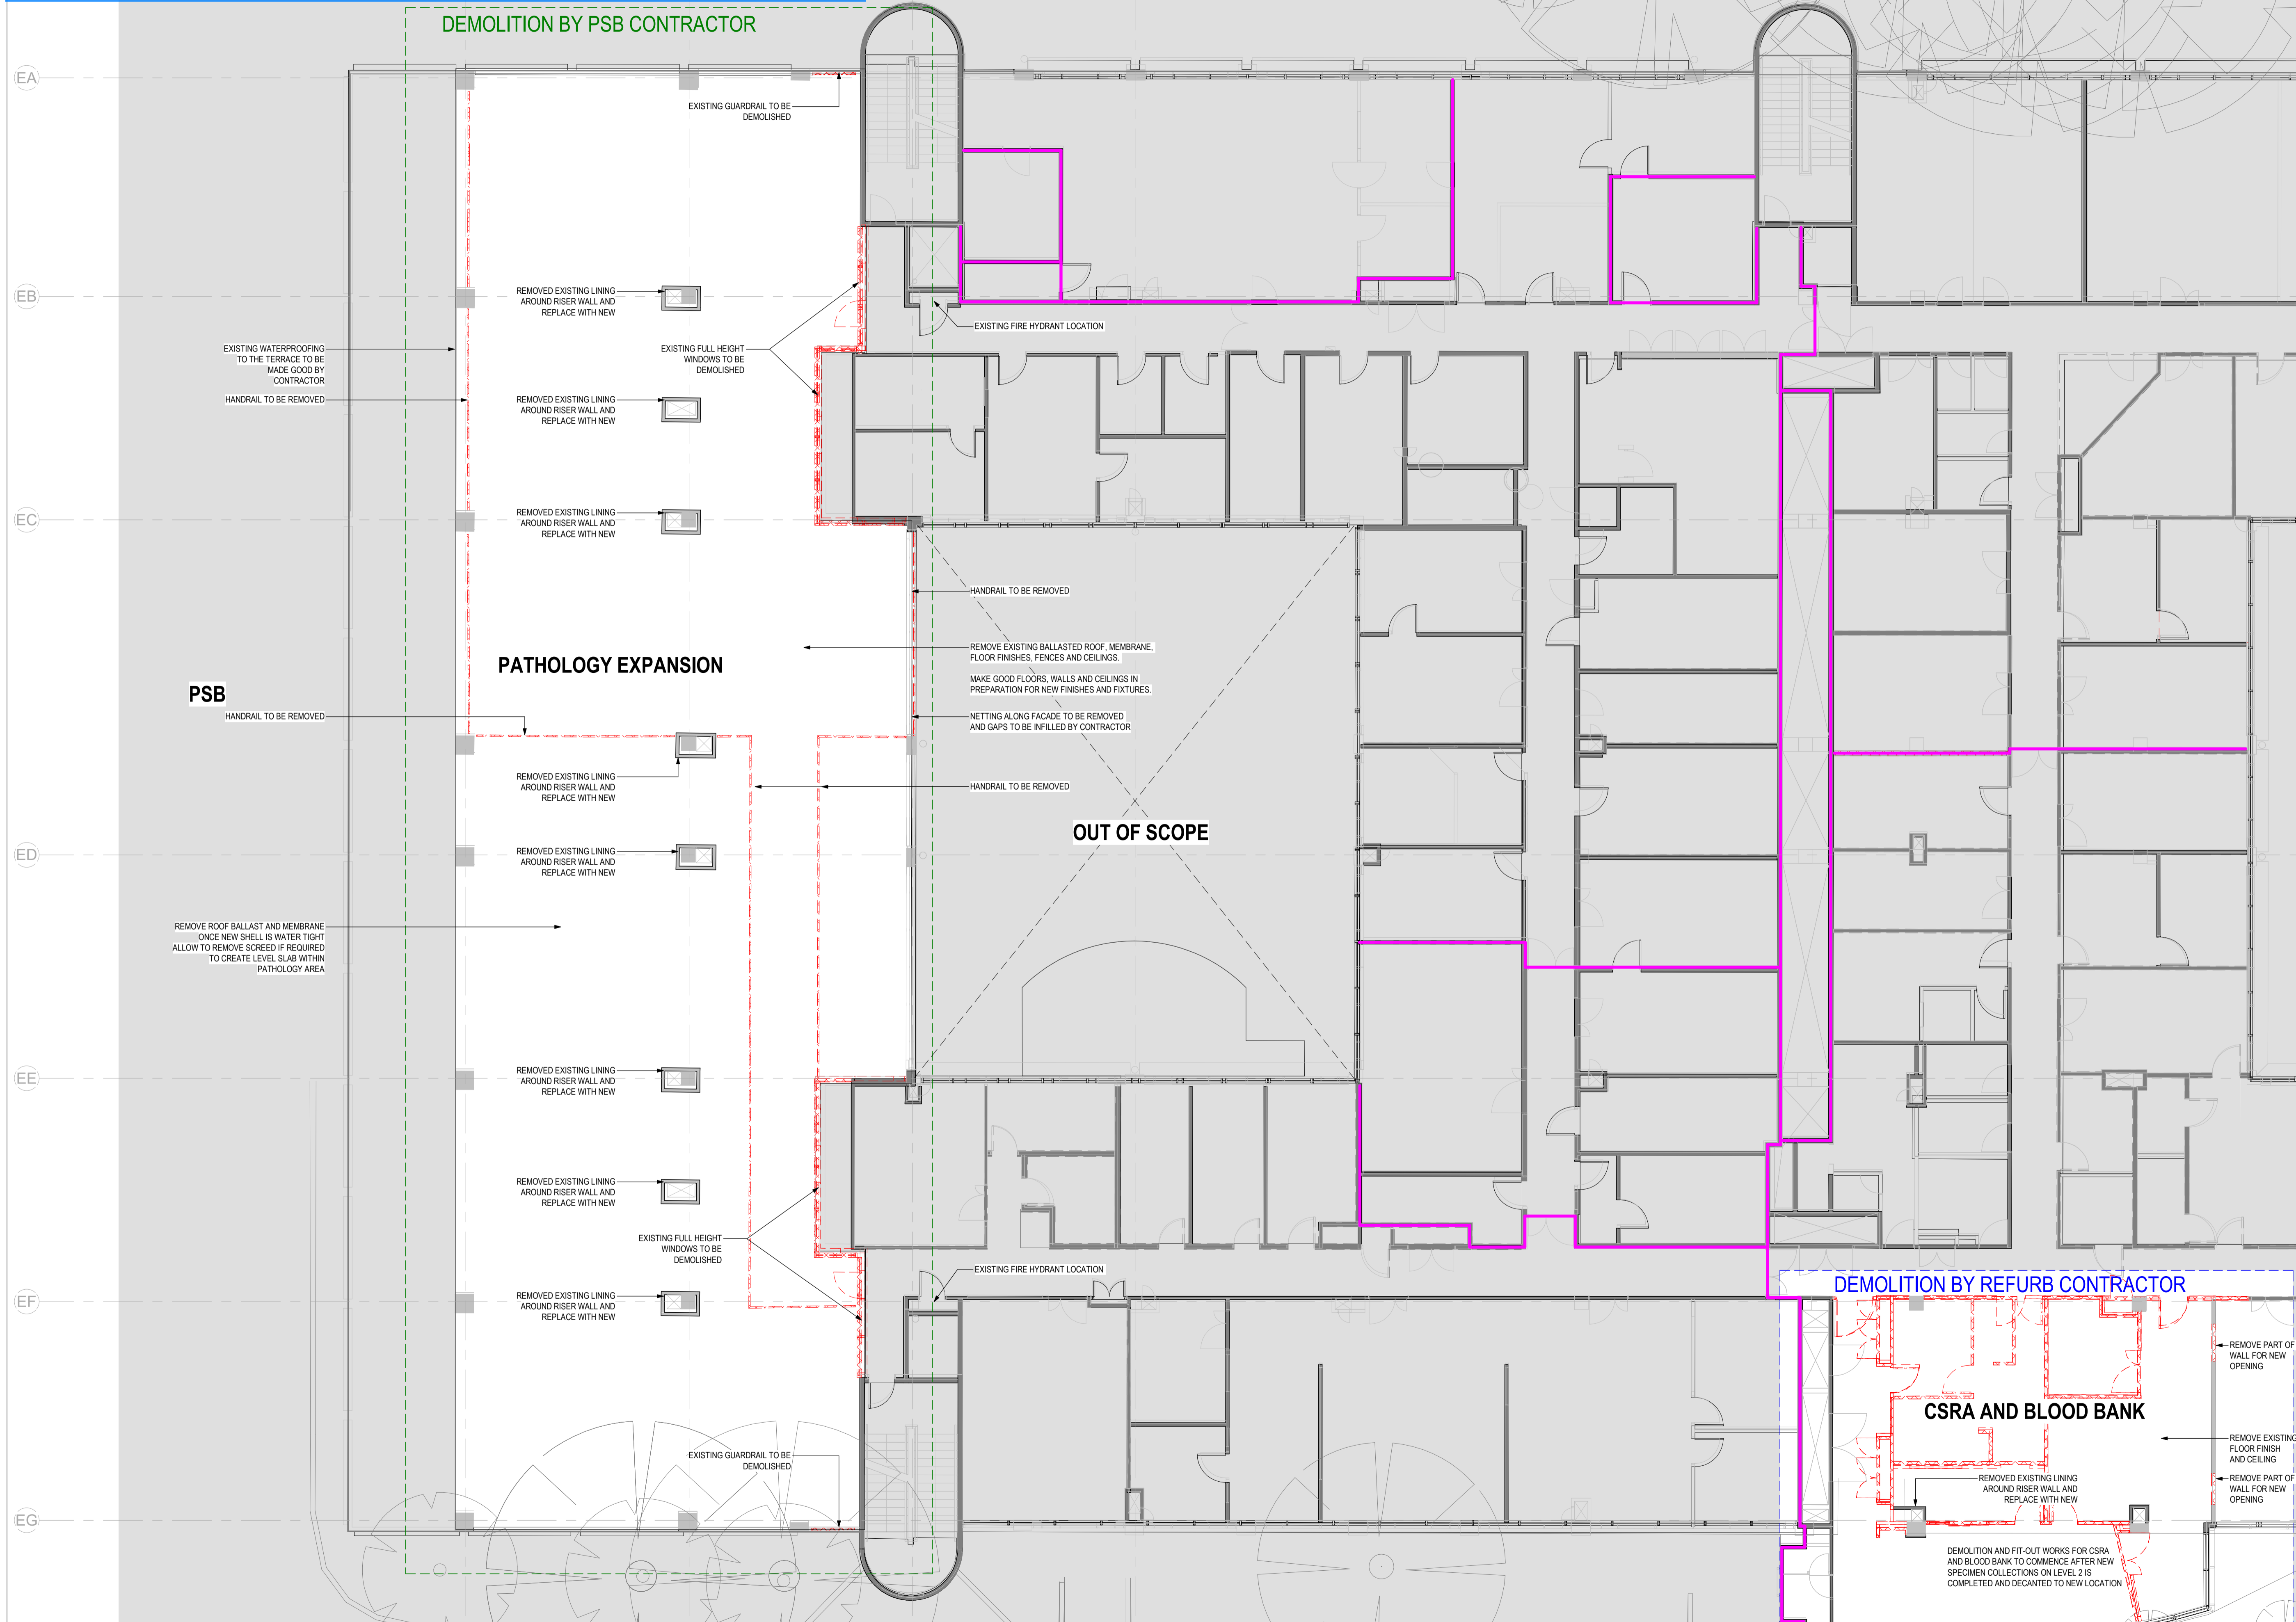
DEMOLITION PLAN

- KEY:**
- - - - - WALLS/DOORS TO BE DEMOLISHED
 - EXISTING TO BE RETAINED
 - PRESUMED EXISTING FIRE RATED WALL BASED ON ENGINEER'S DESKTOP STUDY 29/11/21 & 01/12/21 - CONTRACTORS TO VERIFY ON SITE

NOTE:
COMPLIANCE IS REQUIRED FOR ALL FIRE WALLS BOTH NEW AND EXISTING. EXISTING CONSTRUCTION AND SERVICE PENETRATIONS WILL BE REQUIRED TO BE INSPECTED TO DETERMINE COMPLIANCE. WHERE EXISTING WALLS ARE DEFICIENT, WALLS WILL BE REQUIRED TO BE UPGRADED TO ENSURE ADEQUATE FIRE (SMOKE) SEPARATION.

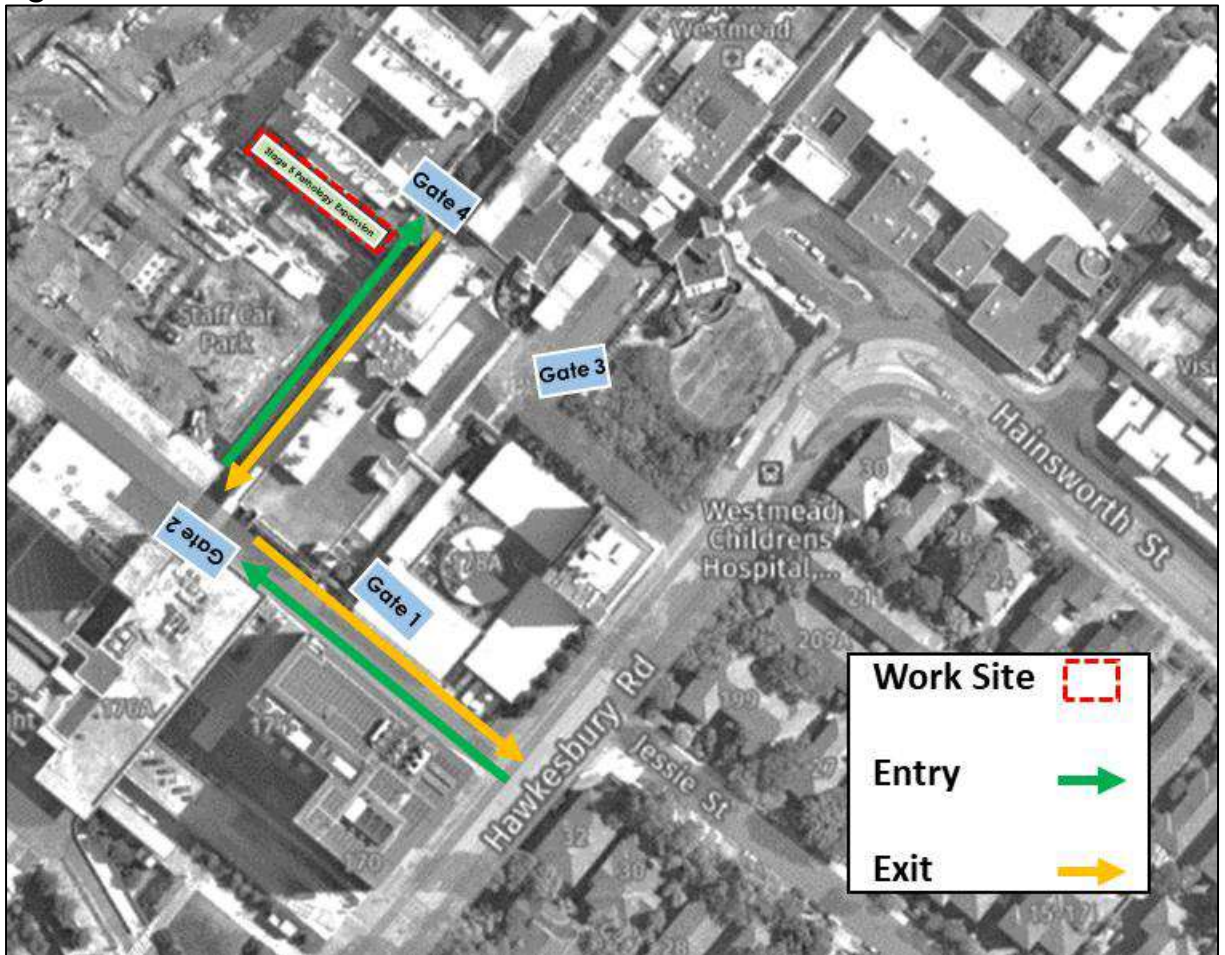
Figure 4.1: Site accesses

Truck access to the construction site is proposed via 3 gates (Gates 1, 2 and 4) off Research Lane. Separate access off Hawkesbury Road is also provided for B99 vehicles/utes/vans via Gate 3. These accesses are shown in Figure 4.1.

All vehicles will enter left-in from Hawkesbury Road (south) and exit left-out onto Hawkesbury Road (north).

Sufficient manoeuvring area will be provided on-site and on Research Lane to ensure construction vehicles can enter and exit in a forward direction via Hawkesbury Road for up to 8.8m medium rigid vehicles.

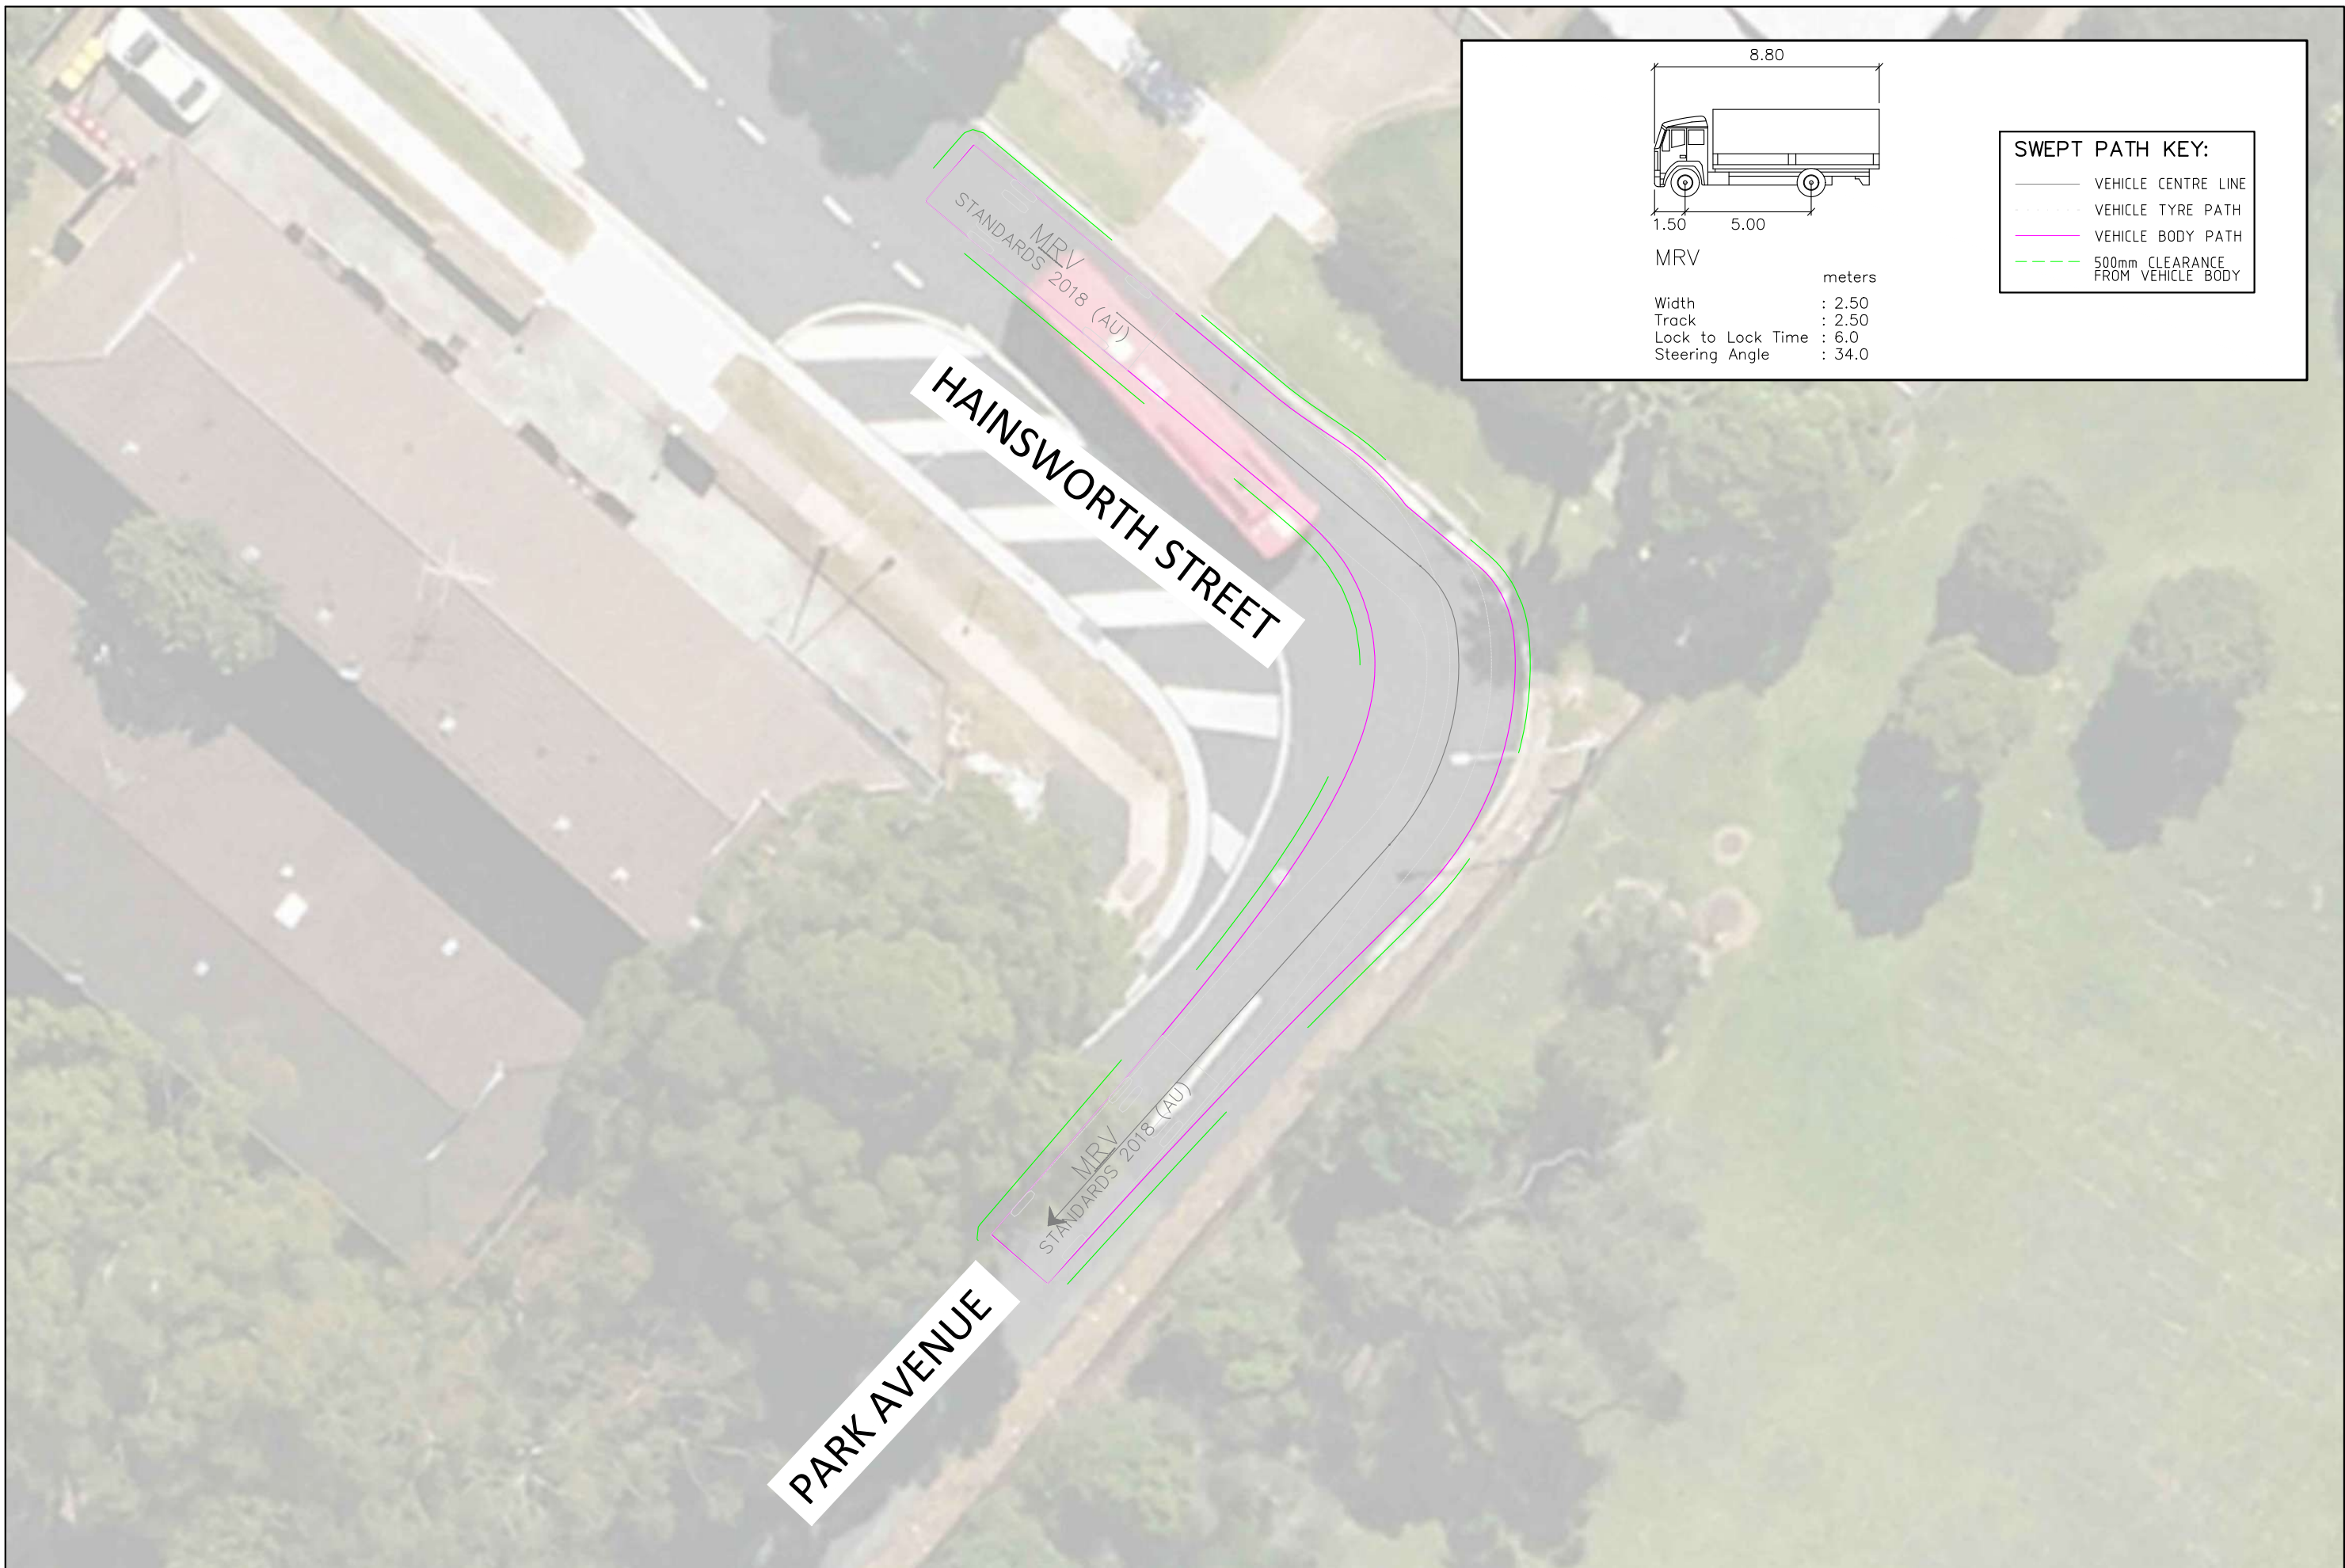
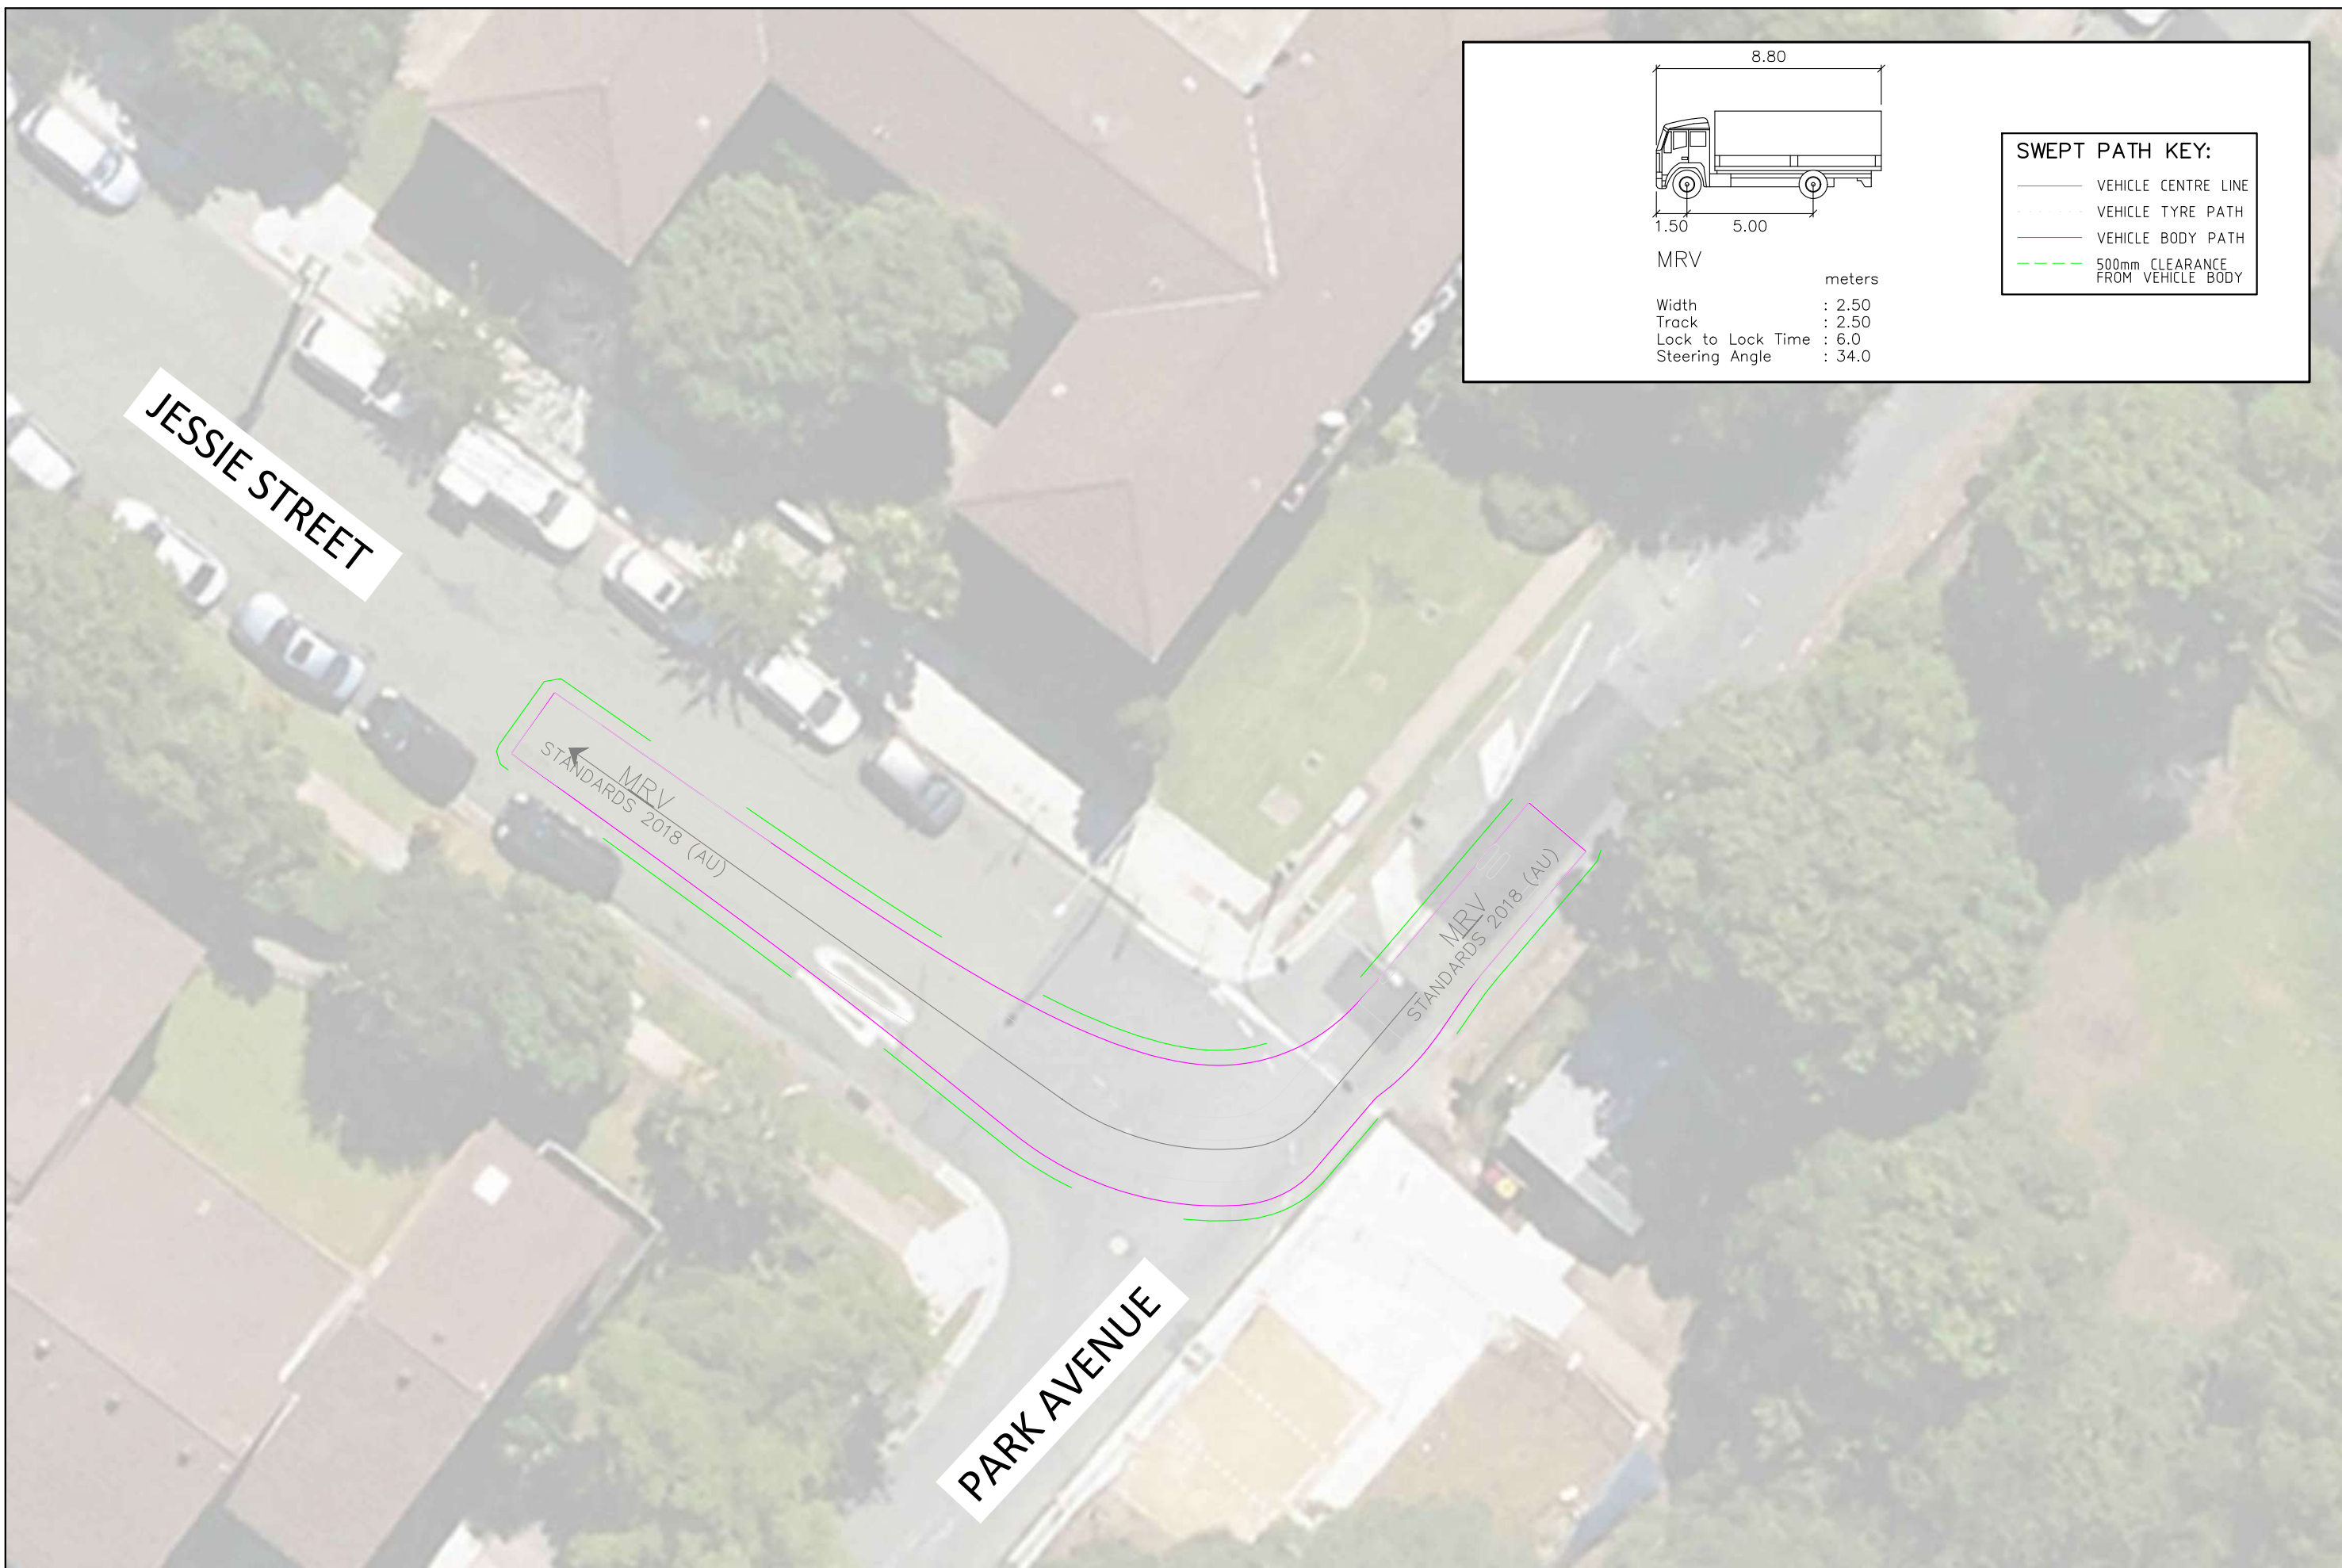
WESTMEAD CHILDREN'S HOSPITAL
CONSTRUCTION TRAFFIC MANAGEMENT PLAN
SWEEP PATH ASSESSMENT

- SWEPT PATH KEY:**
- VEHICLE CENTRE LINE
 - - - VEHICLE TYRE PATH
 - VEHICLE BODY PATH
 - - - 500mm CLEARANCE FROM VEHICLE BODY

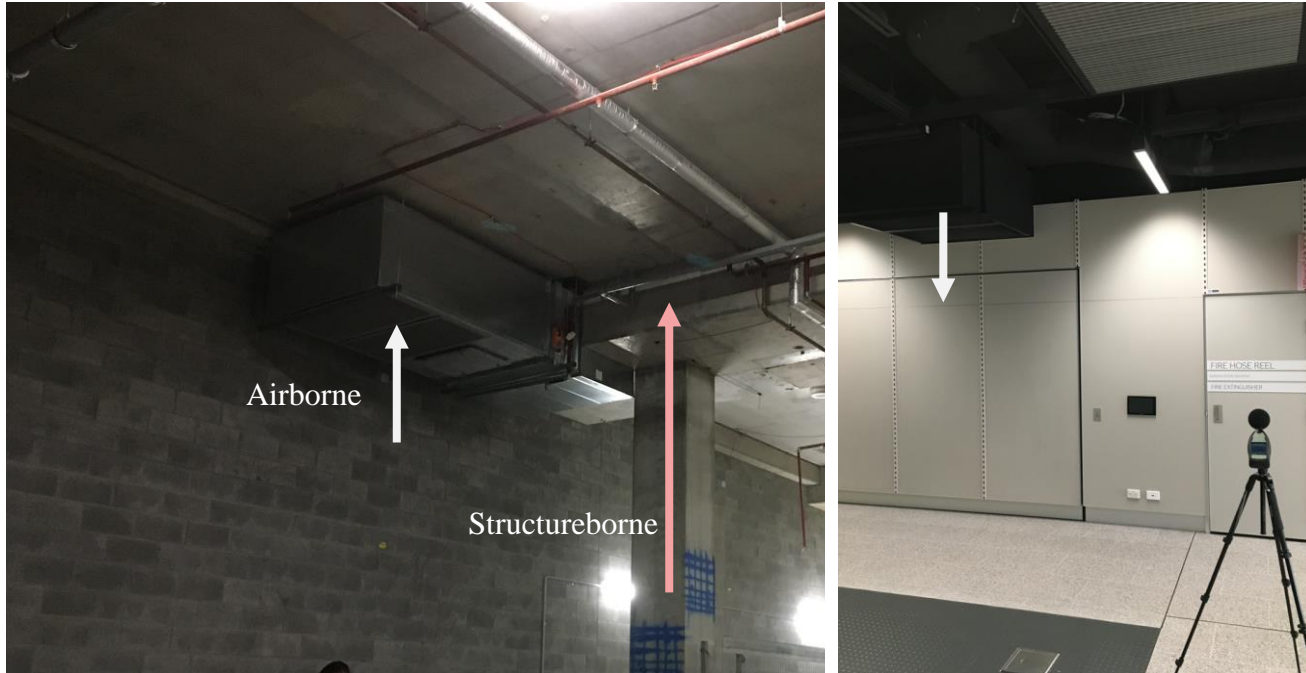
Figure 2: L1 and L2 airborne and structureborne noise transfer paths (Left: L1 VVMF site, Right: L2 Exposition)

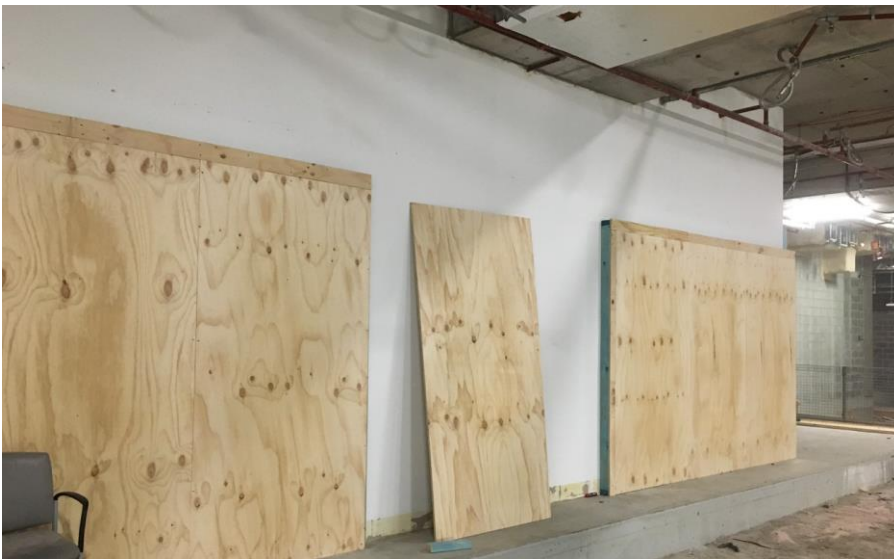
Figure 3: Temporary acoustic barrier - VVMF site

A temporary construction hoarding packed with mineral wool insulation was built in front of the glazed sections of the partition between the VVMF site and the lift lobby/corridor on L1. Measurements indicate this provides an approximate 9dB improvement in measured noise levels within corridor INVC.TE.011. It is expected that this will translate to a beneficial reduction in airborne noise transfer within the ED reception, however this was not tested during the survey.

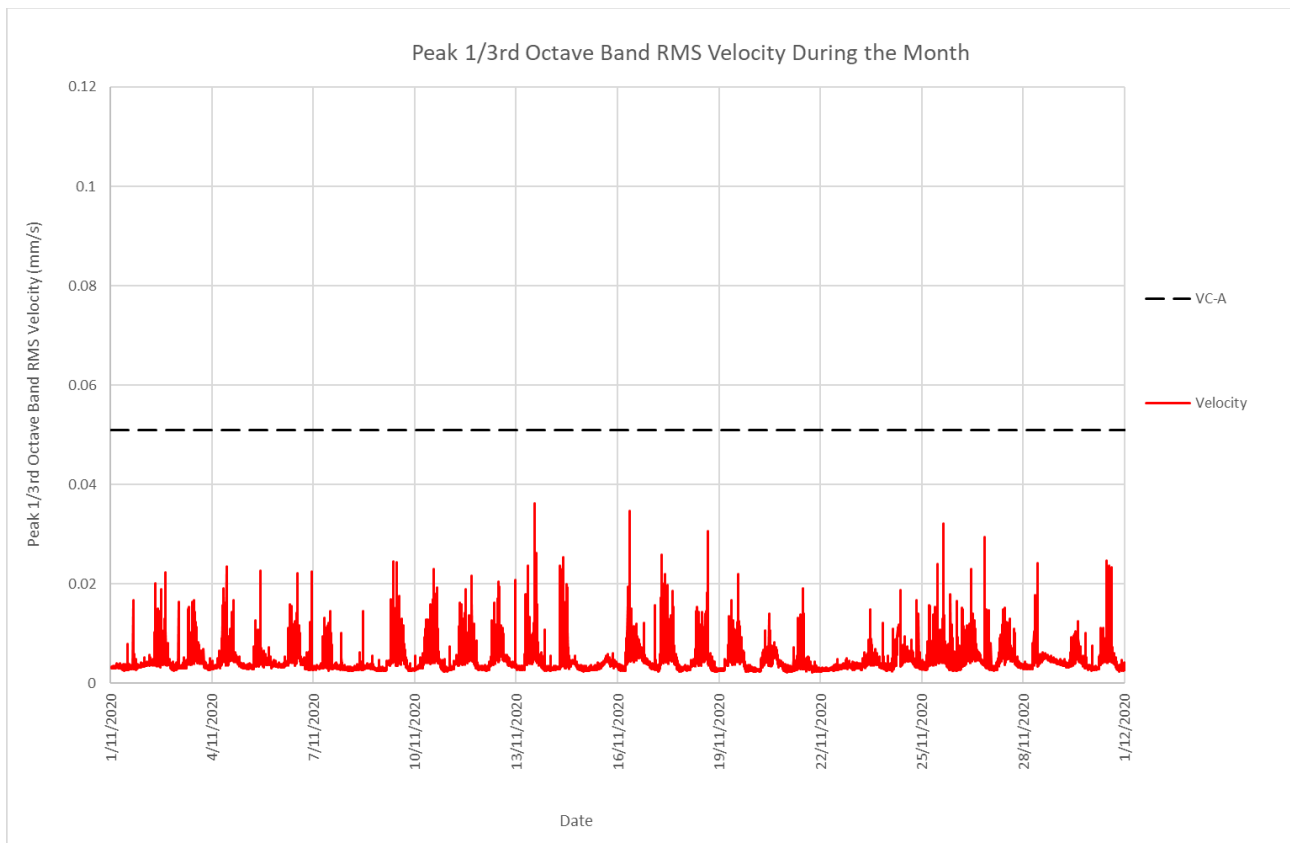
Figure 5: L3 laboratory - P17 demolition monitored levels (month 1)

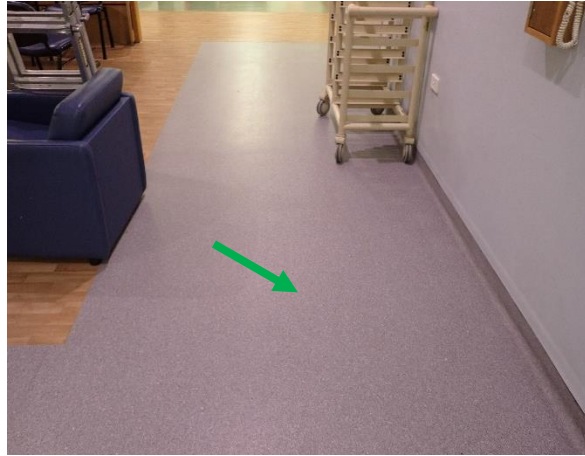
Photo 2: Level 1 Gait lab, staff kitchen area, top of floor – Non-asbestos blue vinyl flooring

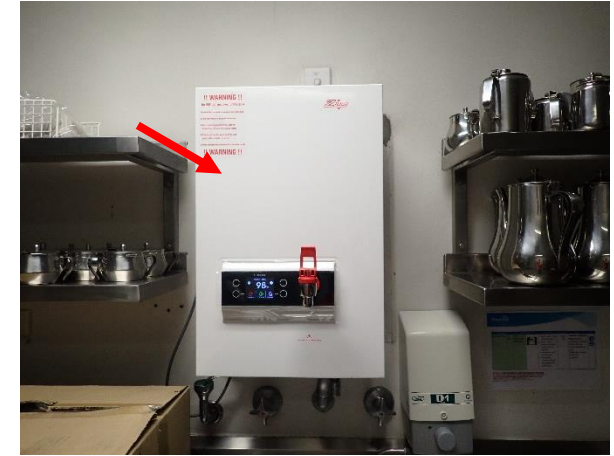
Photo 3: Level 1 Gait lab, staff kitchen and meeting room – hot water unit assumed to contain internal SMF insulation

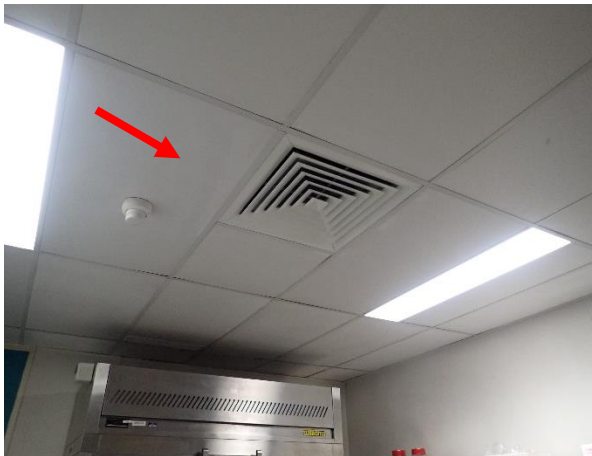
Photo 4: Level 1 Gait lab, kitchen, false ceilings throughout – false ceiling tiles assumed to contain SMF

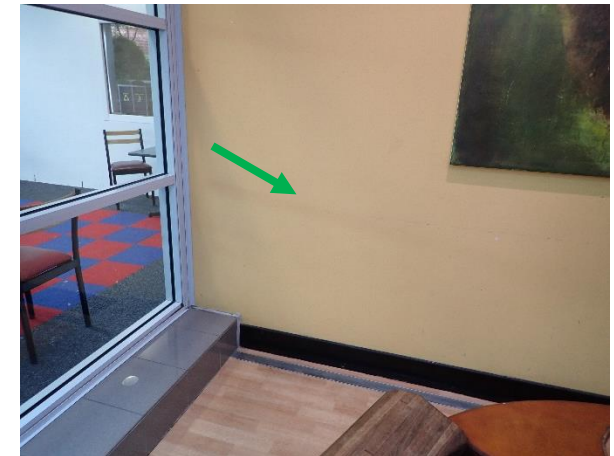
Photo 6: Level 1 Galleria entrance, cement rendered walls – non-lead based yellow paint

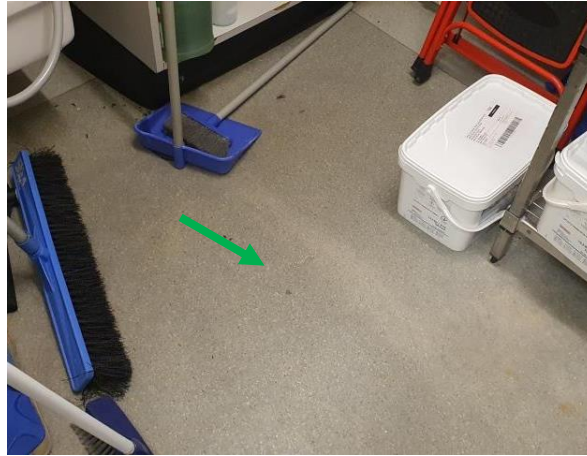
Photo 8: Level 1 Kitchen, chemical storage room, top of floor – non-asbestos grey vinyl flooring

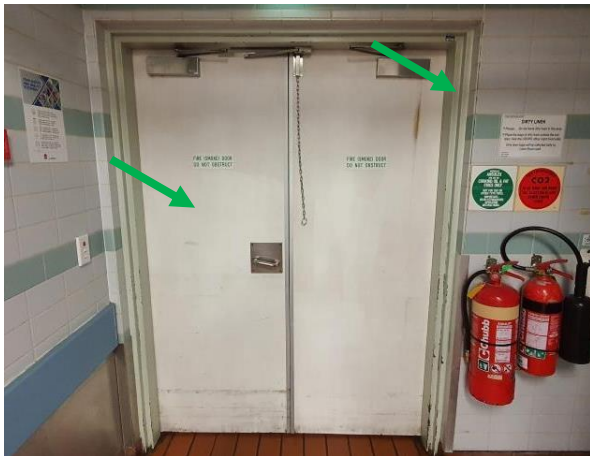
Photo 10: Level 1 Kitchen, north entry fire doors – assumed non-asbestos fire doors as doors were identified to be manufactured in 1990's or 2000's. Non-lead based light green paint on door frames

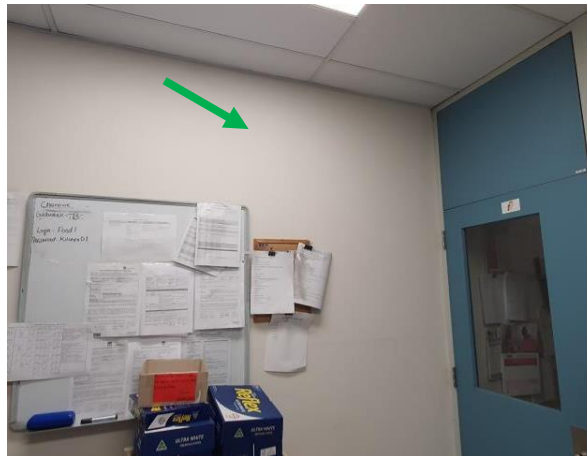
Photo 11: Level 1 Kitchen, cement rendered walls – non-lead based white paint

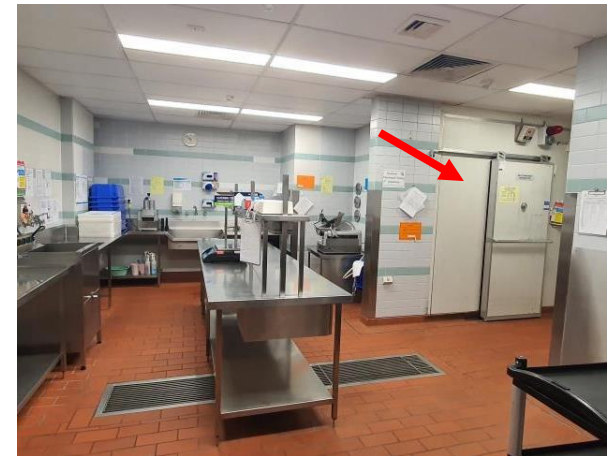
Photo 12: Level 1 Kitchen, north area of kitchen – cool rooms assumed to contain internal SMF insulation

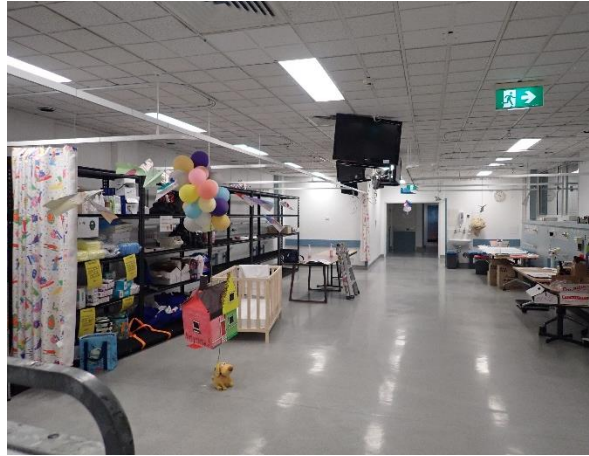
Photo 14: Level 2 Overview of Old Emergency Department

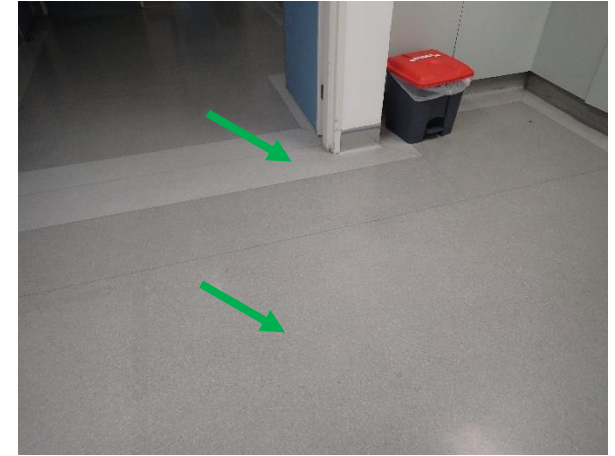
Photo 15: Level 2 Old Emergency Department, throughout emergency department, flooring – grey and light grey non-asbestos vinyl flooring

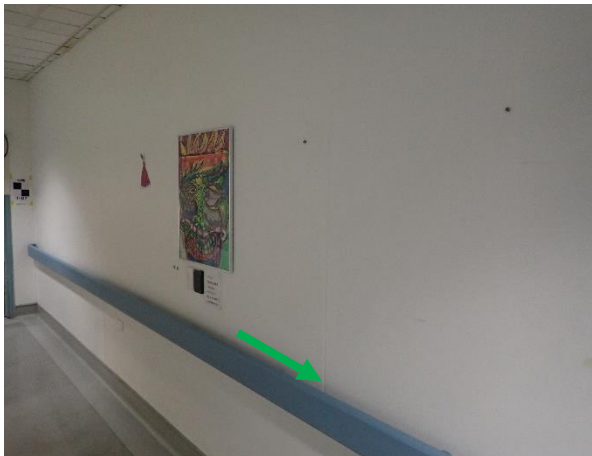
Photo 16: Level 2 Old Emergency Department - cement rendered walls, between walls – non-asbestos expansion joint

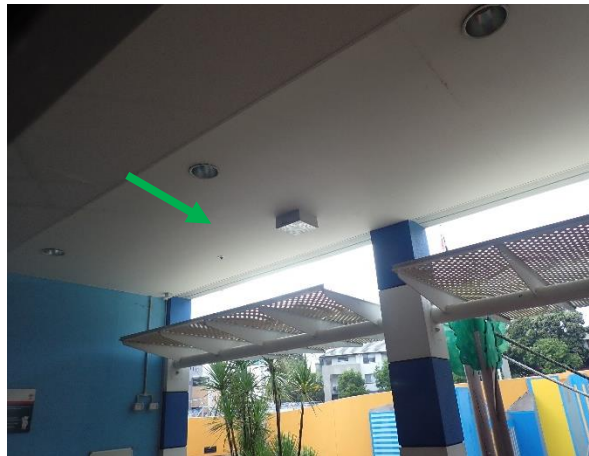
Photo 17: Level 2 Old Emergency Department - external smurf garden, soffit lining – non-asbestos fibre cement

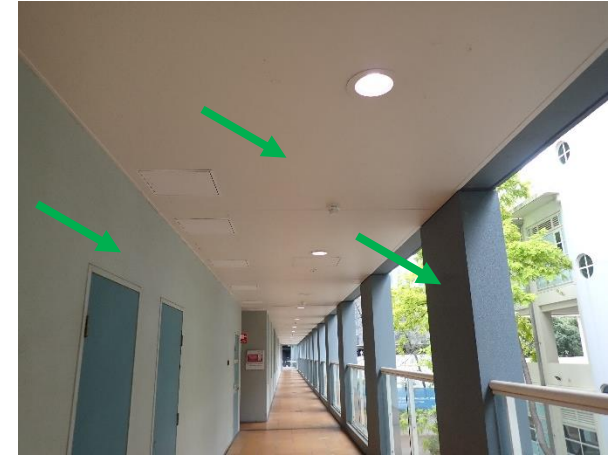
Photo 21: Level 2 Linkway and Pathway, external area, ceiling– non-asbestos fibre cement. Non-lead based light blue paint on cement rendered walls and non-lead based dark blue paint on pillars

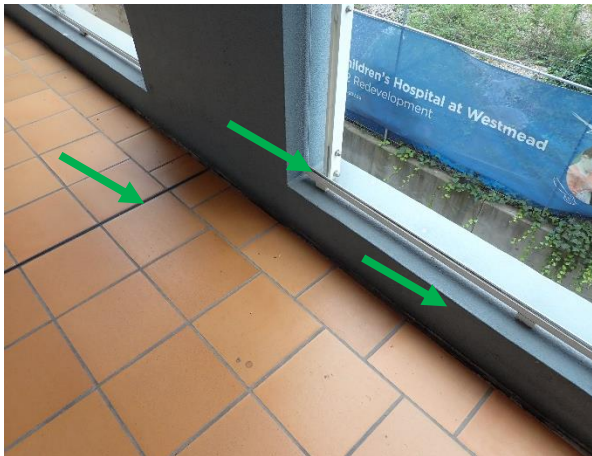
Photo 22: Level 2 Linkway and Pathway, external area, glass balustrade and between tile flooring – non-asbestos black mastic sealant.

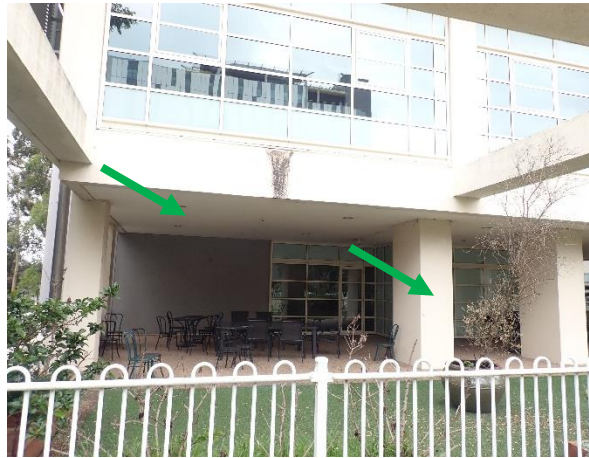
Photo 26: Level 2 Pathology Expansion area, external area, soffit lining – non-asbestos fibre cement. Non-lead based white paint on concrete pillars

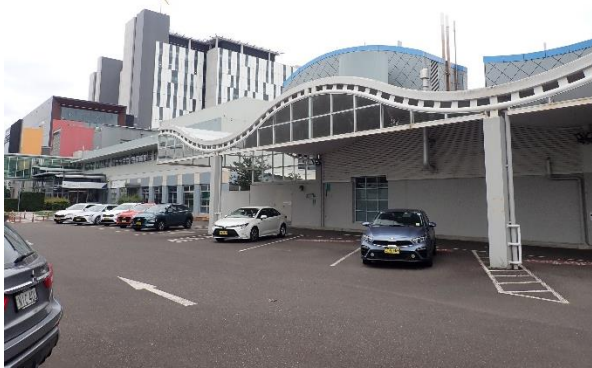
Photo 27: Level 2 Pathology Expansion Area, northern courtyard portion, flooring – non-asbestos fibre cement. Non-asbestos waterproofing material observed

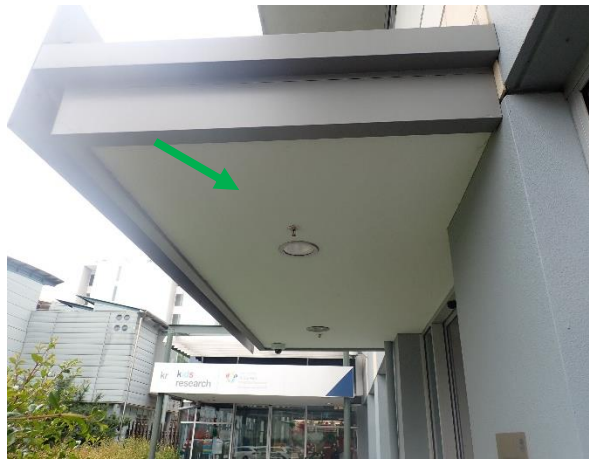
Photo 29: Level 2 Clinical Research Centre (CRC), soffit lining – non-asbestos fibre cement

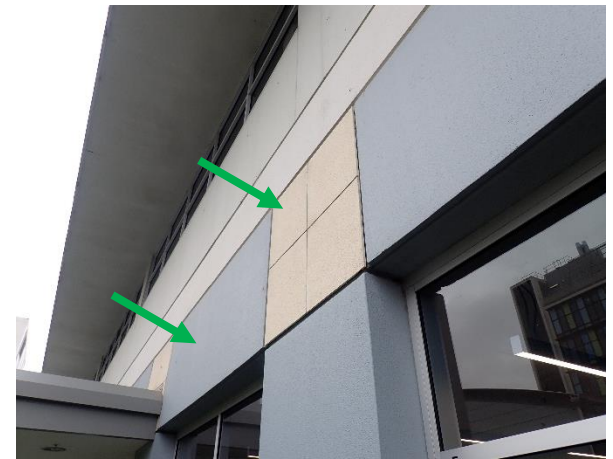
Photo 30: Level 2, Clinical Research Centre (CRC) façade– non-asbestos compressed fibre cement. Walls, non-lead based blue paint

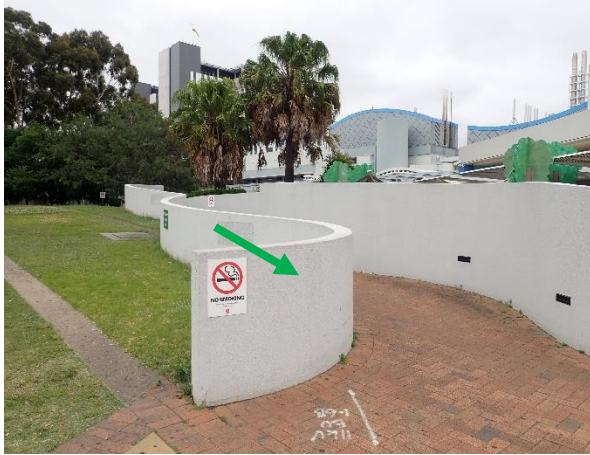
Photo 31: Level 2 external forecourt, curved walkway walls– non-lead based grey paint

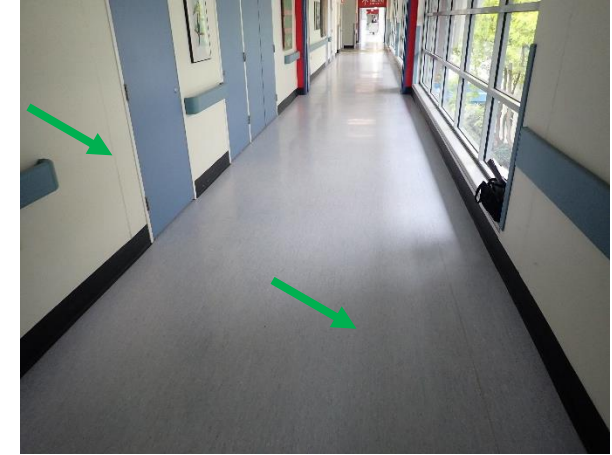
Photo 33: Level 3 Linkway and pathway, internal area throughout, flooring – assumed non-asbestos blue vinyl flooring. Walls and door jambs – non-lead based white paint
