Health Infrastructure NSW

Westmead PSB and MSCP Construction Noise Monitoring

Noise monitoring report 2022-03-01 to 2022-03-31

Vibration Monitoring - KR - Animal House - March 2022

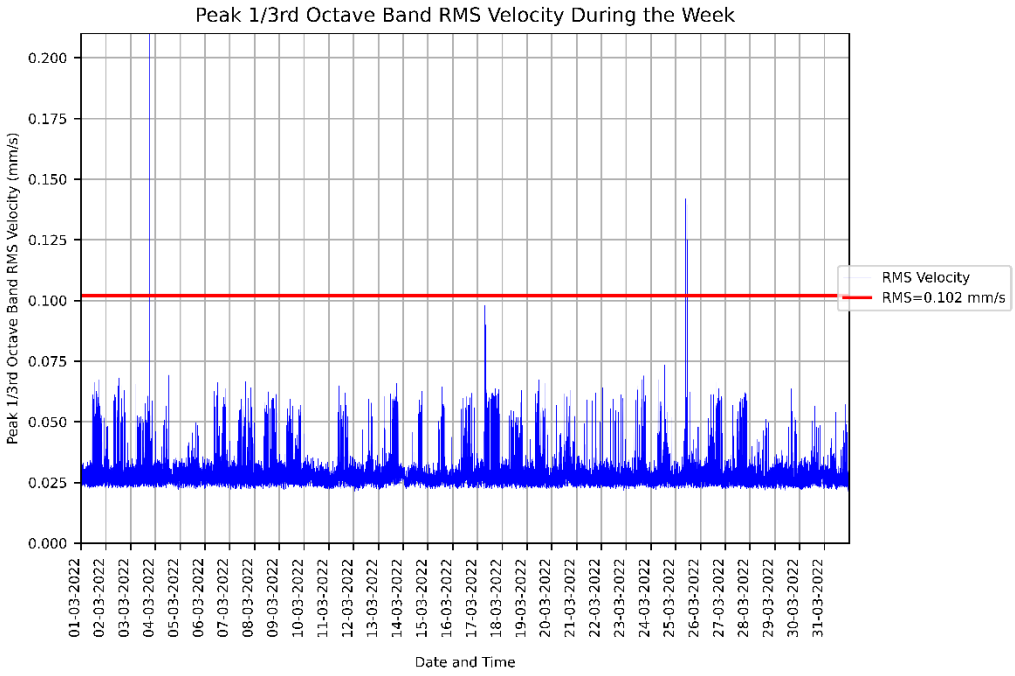
Figure 1: Measured RMSV vibration levels for 01/03/2022 to 31/03/2022 at the CHW - L1 Lab.

During Construction Hours	Outside of Construction Hours
0	4

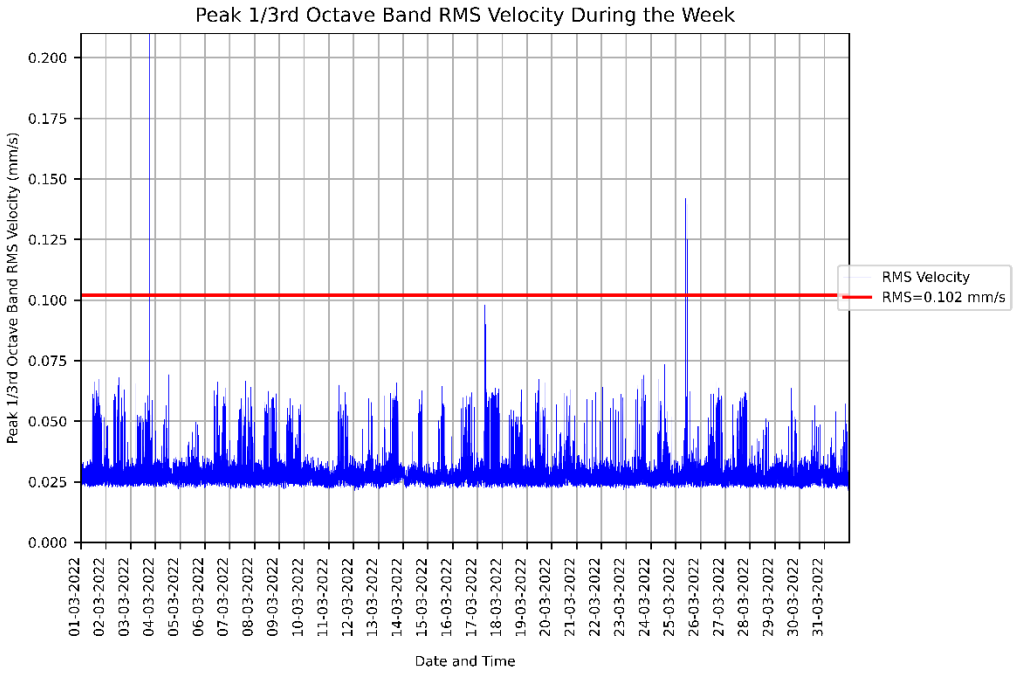
Figure 3: Measured RMSV vibration levels for 01/03/2022 to 31/03/2022 at the CHW - L1 Lab.

Figure 3 below shows the vibration levels (RMS velocity) recorded between 01/03/2022 and 31/03/2022. The recorded data is shown in blue, while the limit of 0.102mm/s (V_{RMS}) is shown in red.

During Construction Hours	Outside of Construction Hours
0	4

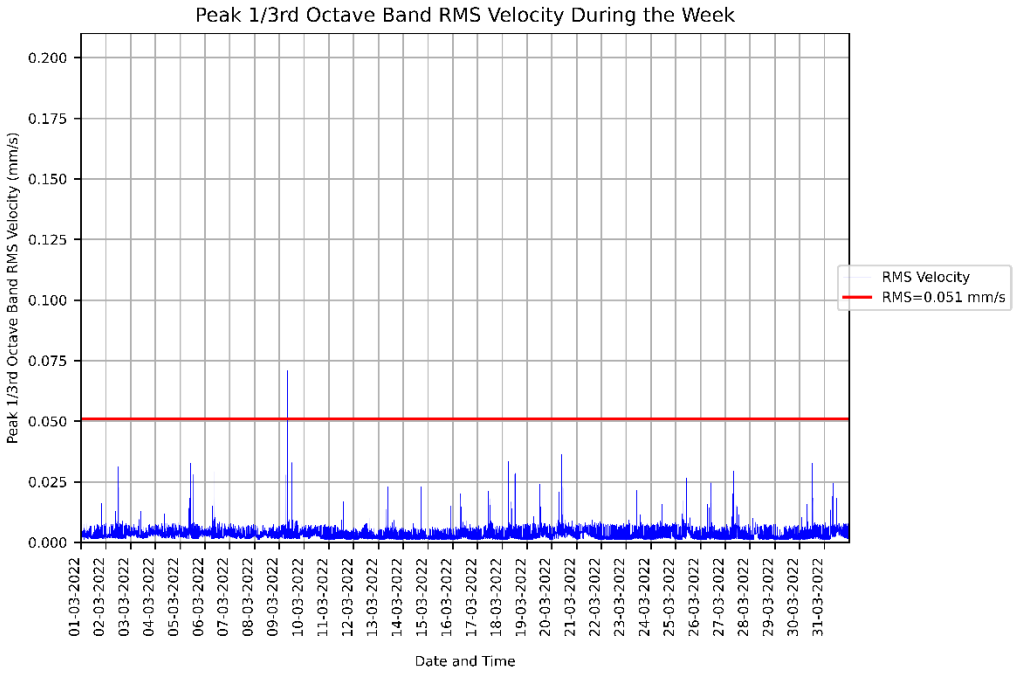
Figure 3: Measured RMSV vibration levels for 01/03/2022 to 31/03/2022 at the CASB Level 2 MRI.

Figure 3 below shows the vibration levels (RMS velocity) recorded between 01/03/2022 and 31/03/2022. The recorded data is shown in blue, while the limit of 0.051mm/s (V_{RMS}) is shown in red.

During Construction Hours	Outside of Construction Hours
1	0

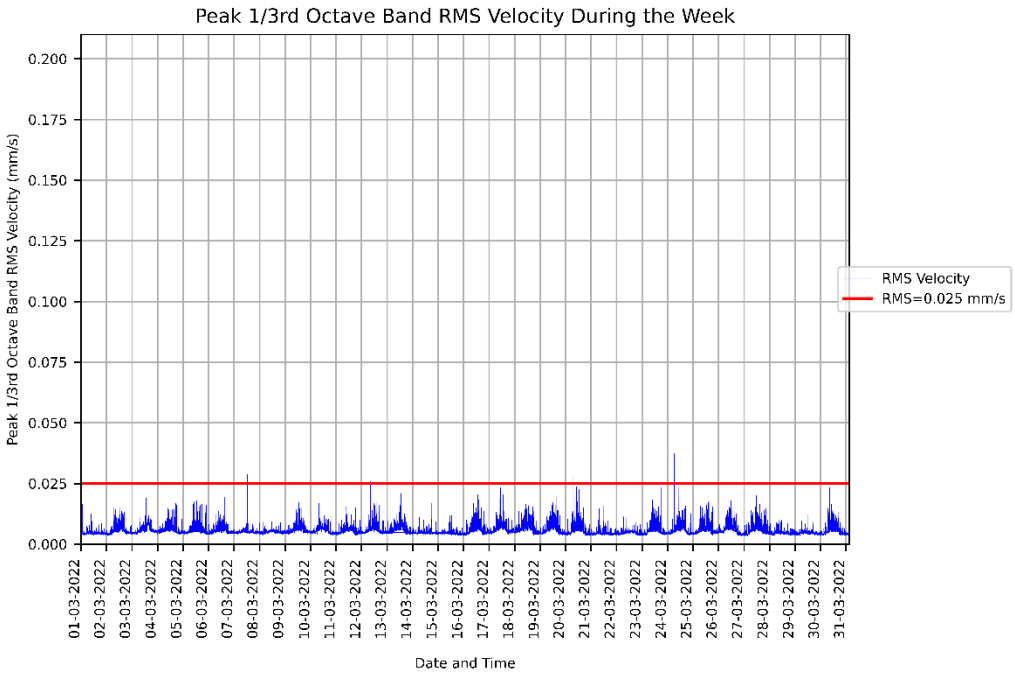
Figure 3: Measured RMSV vibration levels for 01/03/2022 to 31/03/2022 at the KR - L4 Lab 9.

Figure 3 below shows the vibration levels (RMS velocity) recorded between 01/03/2022 and 31/03/2022. The recorded data is shown in blue, while the limit of 0.025mm/s (V_{RMS}) is shown in red.

During Construction Hours	Outside of Construction Hours
3	2
