Council Assets Surrounding Hornsby Hospital

Dilapidation Report
80818469

Prepared for	Watpac Construction Pty Ltd
Project Name	Dilapidation Report
File Reference	Dilapidation Report - Hornsby Hospital Council Assets-2018-06-28.docx
Job Reference	80818469
Date	June 2018

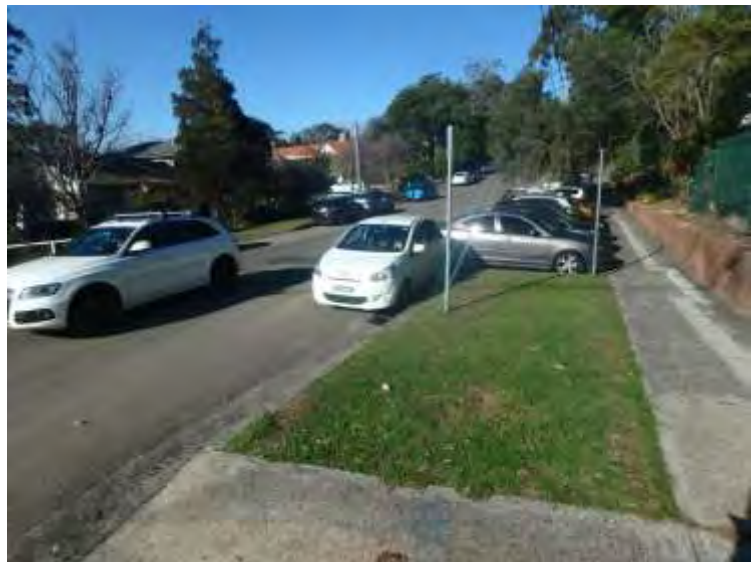
Defect ID 001
Area Type External
Location Derby Road, Hornsby
Element General shot
Defect Type N/A
Length (mm) N/A
Width (mm) N/A

General Comments:
 General shot to Derby Road, in a southerly direction.

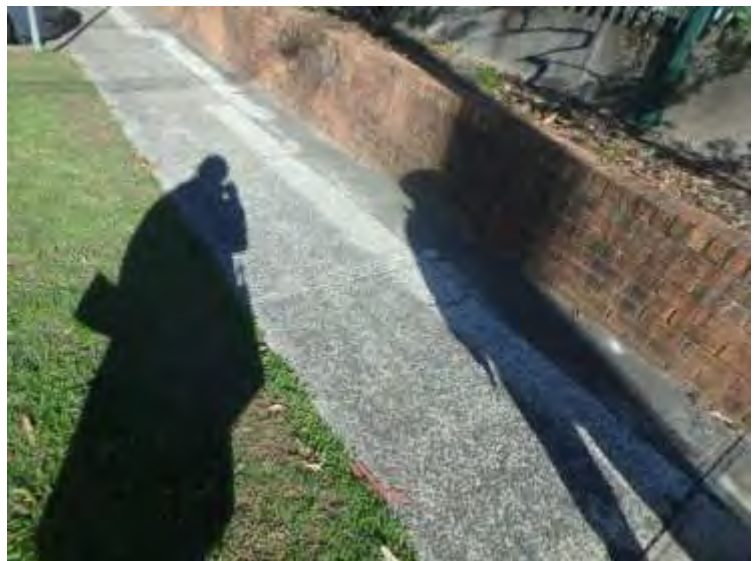
Defect ID 002
Area Type External
Location Derby Road, Hornsby
Element Footpath
Defect Type Cracking
Length (mm) Approx. 1,200mm
Width (mm) Varying

General Comments:
 Cracking to concrete footpath

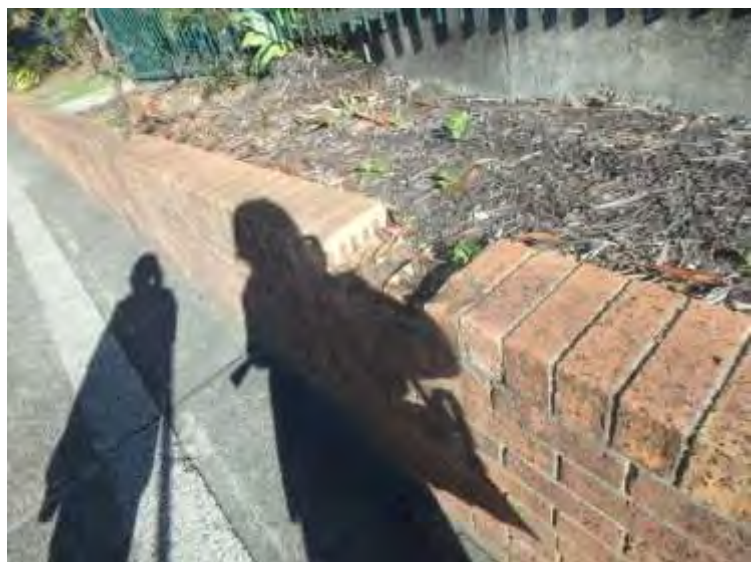
Defect ID 003
Area Type External
Location Derby Road, Hornsby
Element Brick Retaining Wall
Defect Type Missing Brick
Length (mm) N/A
Width (mm) N/A

General Comments:
 2 bricks missing from the brick retaining wall

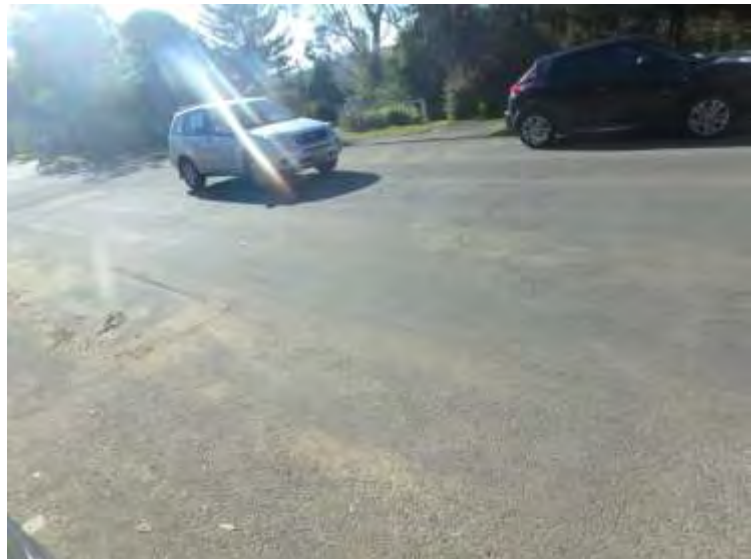
Defect ID 004
Area Type External
Location Derby Road, Hornsby
Element Road
Defect Type Cracking and Settlement
Length (mm) N/A
Width (mm) Approx. 2mm

Multiple cracking and partial settlement noted to the asphalt road

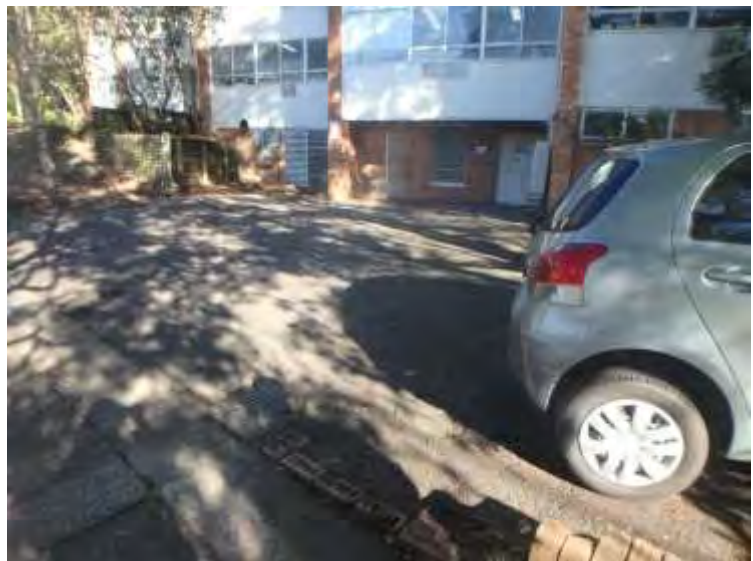
Defect ID 005
Area Type External
Location Derby Road, Hornsby
Element Driveway
Defect Type Cracking and Settlement
Length (mm) N/A
Width (mm) Approx. 1.5mm

Cracking to driveway

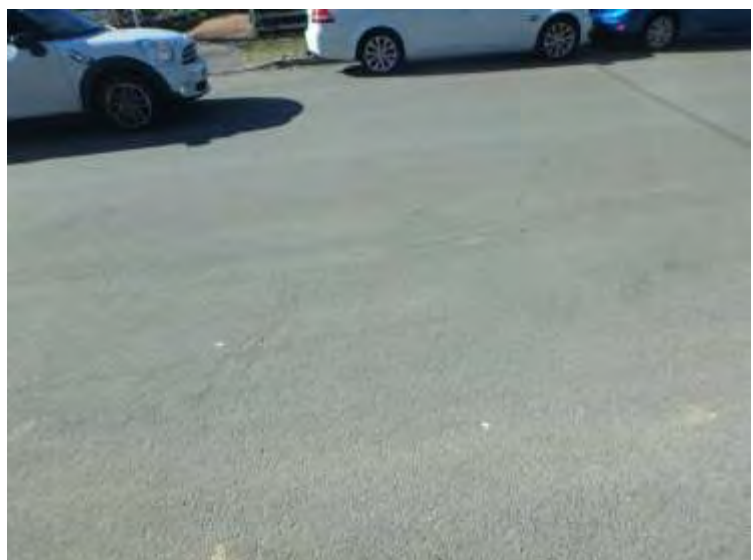
Defect ID 006
Area Type External
Location Derby Road, Hornsby
Element Driveway
Defect Type Cracking
Length (mm) Approx. 2,000mm
Width (mm) Approx. 1mm

Multiple cracking to the asphalt road

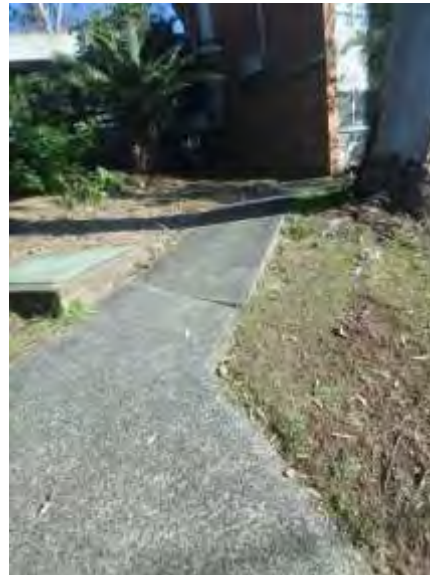
Defect ID 007
Area Type External
Location Derby Road, Hornsby
Element Footpath
Defect Type Settlement
Length (mm) Approx. 1,200mm
Width (mm) Approx. 10mm
General Comments:
 Settlement to concrete footpath

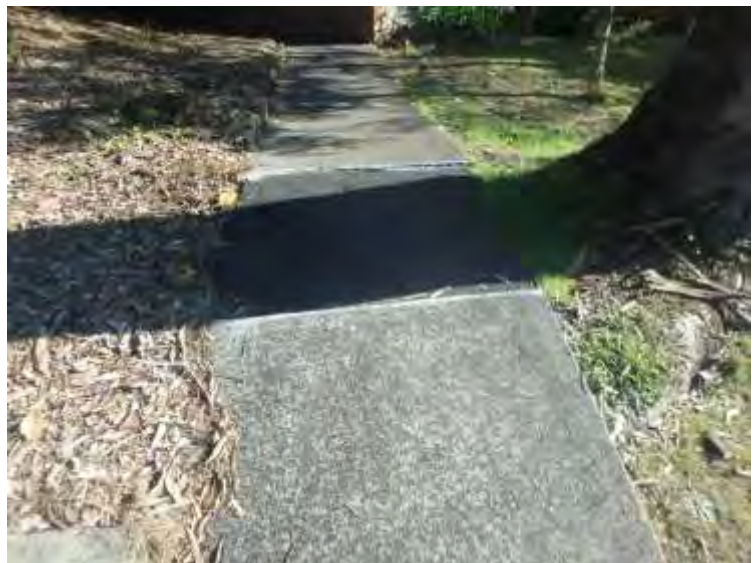
Defect ID 008
Area Type External
Location Derby Road, Hornsby
Element Footpath
Defect Type Settlement
Length (mm) Approx. 1,200mm
Width (mm) Approx. 10mm
General Comments:
 Settlement to concrete footpath

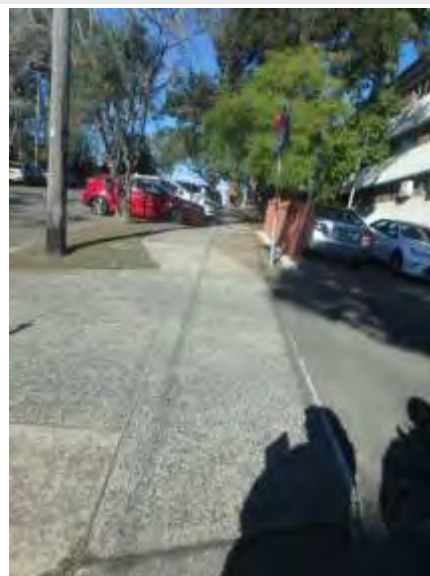
Defect ID 009
Area Type External
Location Derby Road, Hornsby
Element General shot
Defect Type N/A
Length (mm) N/A
Width (mm) N/A
General Comments:
 General shot to Derby Road, in a southerly direction.

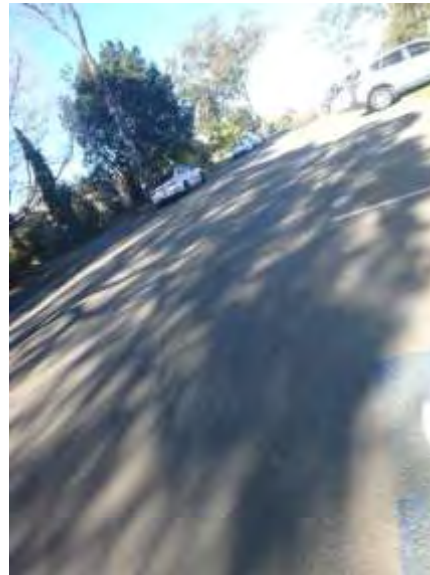
Defect ID 010
Area Type External
Location Derby Road, Hornsby
Element Road
Defect Type Cracking
Length (mm) N/A
Width (mm) Approx. 2mm
General Comments:
 Multiple cracking to the asphalt road

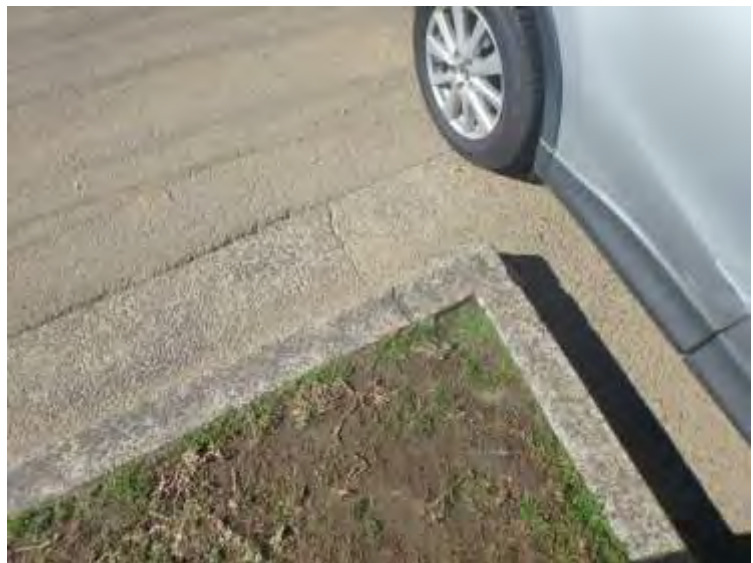
Defect ID 011
Area Type External
Location Derby Road, Hornsby
Element Road and kerb
Defect Type Cracking
Length (mm) Approx. 300mm
Width (mm) Approx. 1mm
General Comments:
 Cracking to asphalt road and concrete kerb

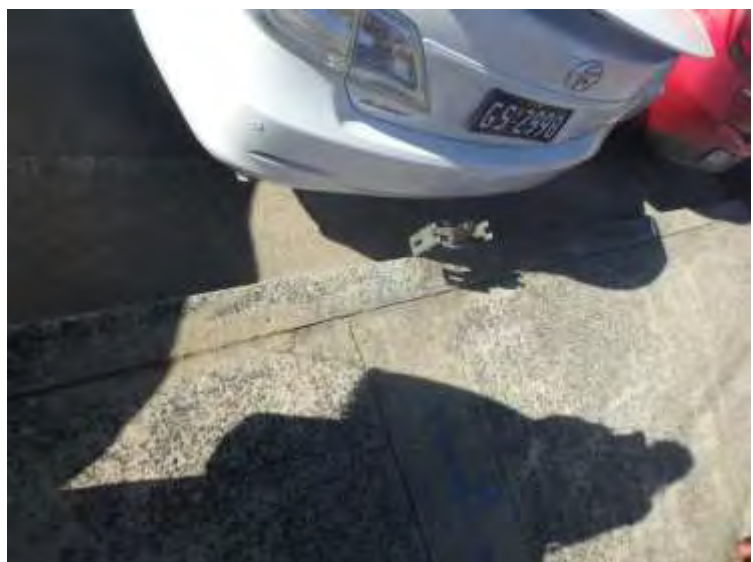
Defect ID 012
Area Type External
Location Derby Road, Hornsby
Element Footpath
Defect Type Cracking
Length (mm) Approx. 150mm
Width (mm) Approx. 70mm
General Comments:
 Broken concrete footpath

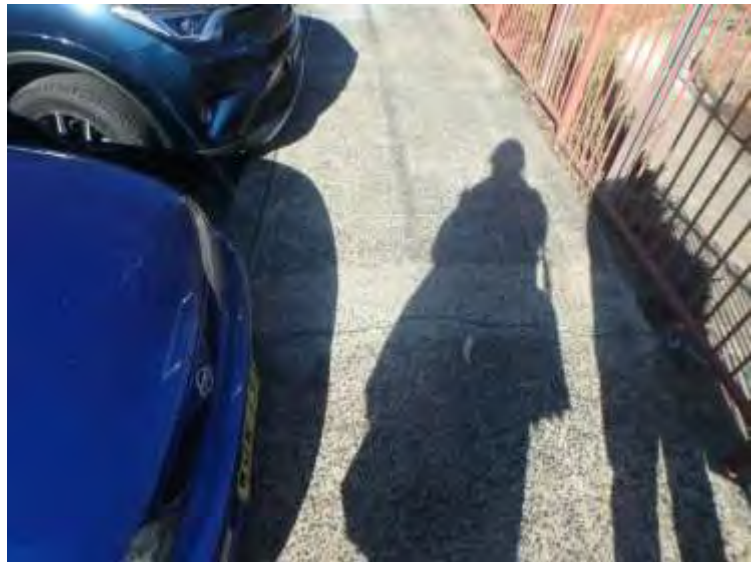
Defect ID 013
Area Type External
Location Derby Road, Hornsby
Element Footpath
Defect Type Cracking
Length (mm) Approx. 1,200mm
Width (mm) Approx. 2mm
General Comments:
 Cracking to concrete footpath

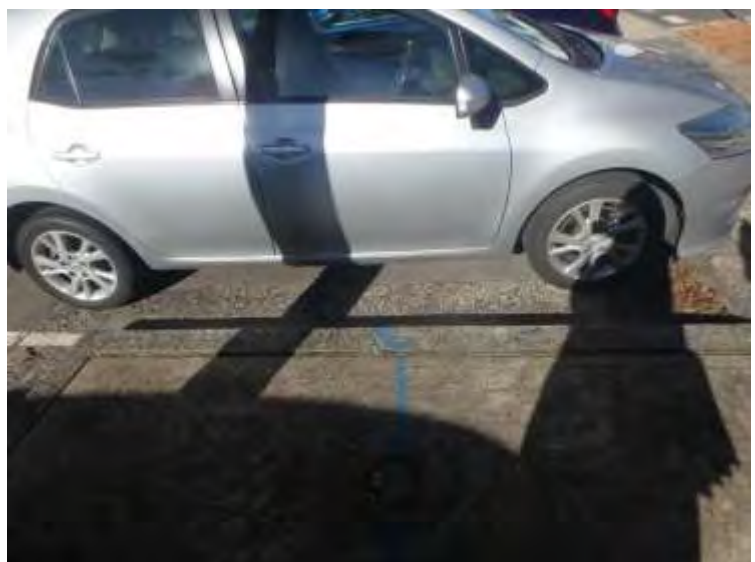
Defect ID 015
Area Type External
Location Derby Road, Hornsby
Element Kerb
Defect Type Cracking
Length (mm) Approx. 150mm
Width (mm) Approx. 1mm
General Comments:
 Cracking to concrete kerb

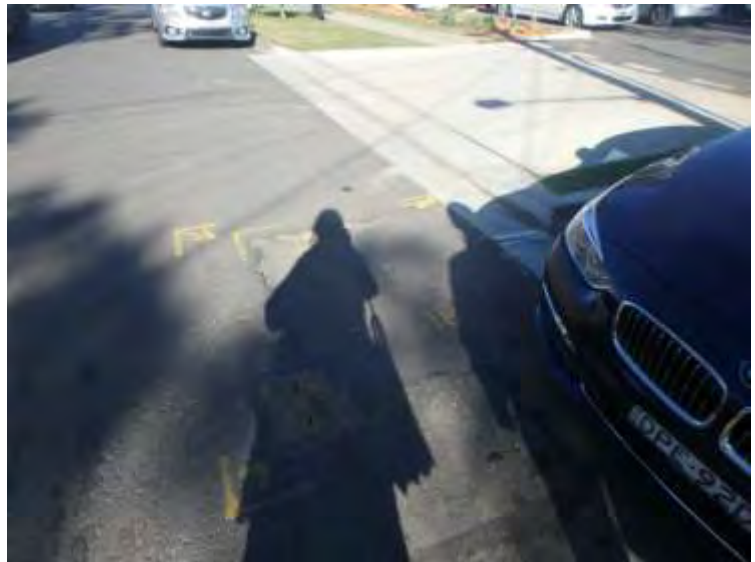
Defect ID 016
Area Type External
Location Derby Road, Hornsby
Element Road
Defect Type Cracking and Settlement
Length (mm) Approx. 1,500mm
Width (mm) Approx. 1,500mm

General Comments:
 Cracking and partial settlement to the asphalt road

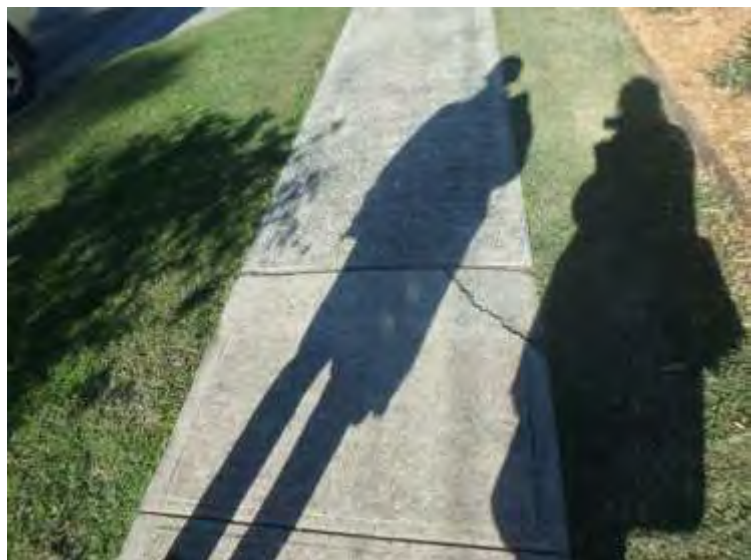
Defect ID 018
Area Type External
Location Derby Road, Hornsby
Element Footpath
Defect Type Cracking
Length (mm) Approx. 300mm
Width (mm) Approx. 3.5mm

General Comments:
 Cracking to concrete footpath

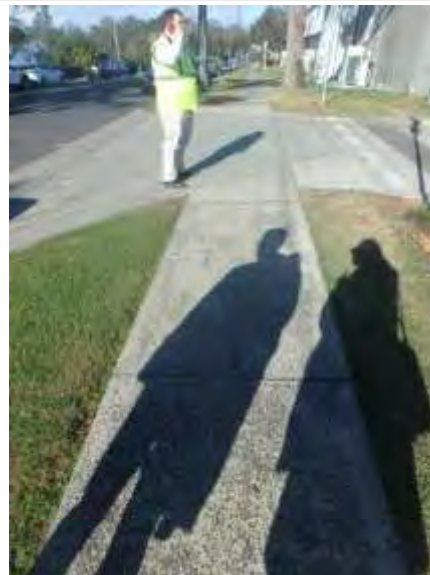
Defect ID 019
Area Type External
Location Derby Road, Hornsby
Element Footpath
Defect Type Cracking
Length (mm) Approx. 2,000mm
Width (mm) Varying
General Comments:
 Cracking to concrete footpath

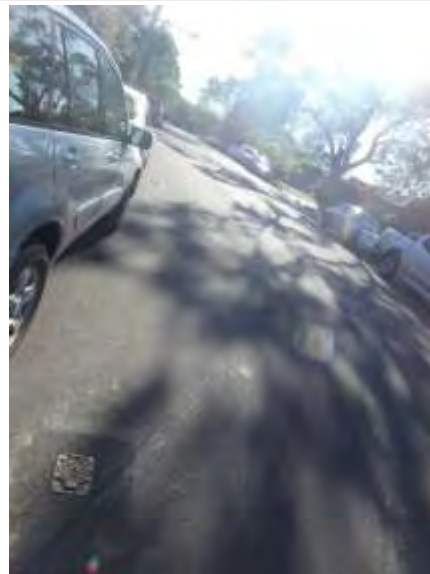
Defect ID 020
Area Type External
Location Derby Road, Hornsby
Element Footpath
Defect Type Cracking
Length (mm) N/A
Width (mm) Varying
General Comments:
 Multiple cracking to concrete footpath

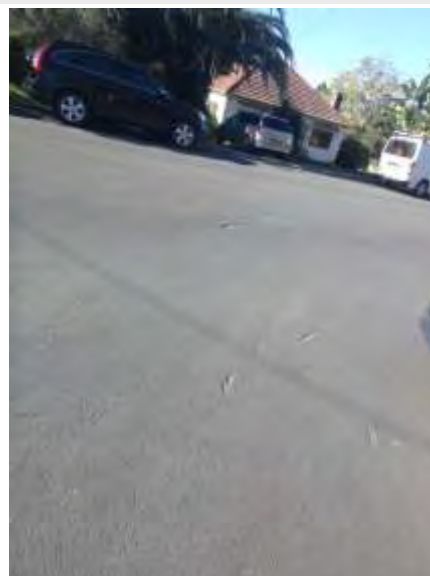
Defect ID 021
Area Type External
Location Derby Road, Hornsby
Element Road
Defect Type Chipped
Length (mm) N/A
Width (mm) Varying
General Comments:
 Chipped paver

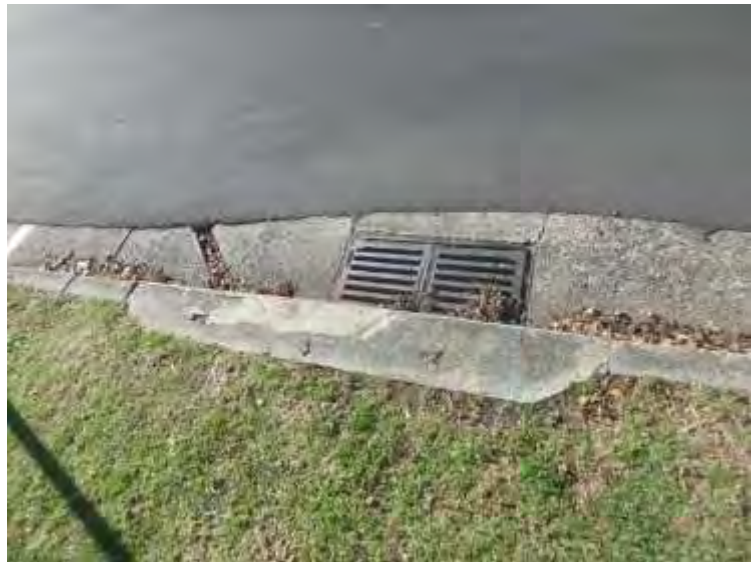
Defect ID 022
Area Type External
Location Derby Road, Hornsby
Element Road
Defect Type Cracking
Length (mm) Approx. 150mm
Width (mm) Approx. 1.5mm
General Comments:
 Cracking to pit surround

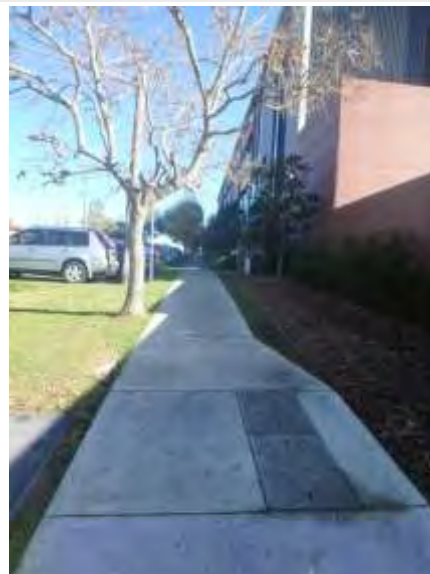
Defect ID 024
Area Type External
Location Burdett Street, Hornsby
Element General shot
Defect Type N/A
Length (mm) N/A
Width (mm) N/A
General Comments:
 N/A

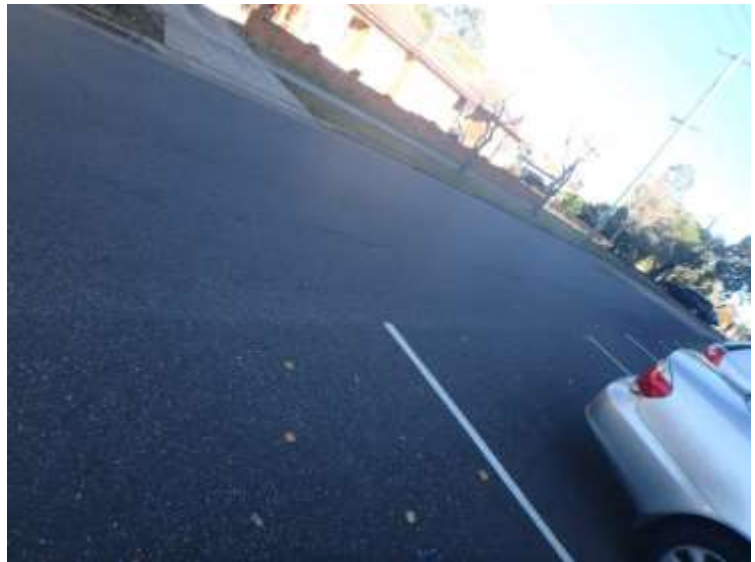
Defect ID 025
Area Type External
Location Burdett Street, Hornsby
Element Road
Defect Type Cracking
Length (mm) Approx. 10,000mm
Width (mm) Varying
General Comments:
 Multiple cracking to asphalt road

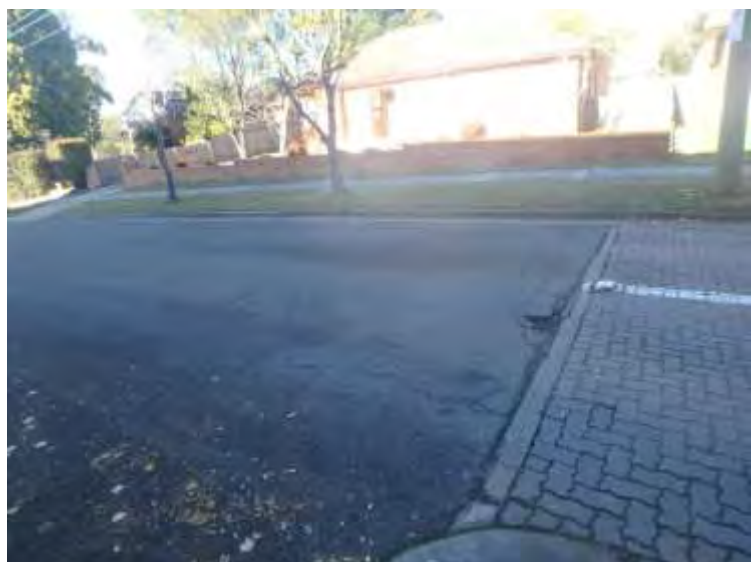
Defect ID 027
Area Type External
Location Burdett Street, Hornsby
Element Road
Defect Type Damaged
Length (mm) Approx. 500mm
Width (mm) Varying
General Comments:
 Damaged asphalt road

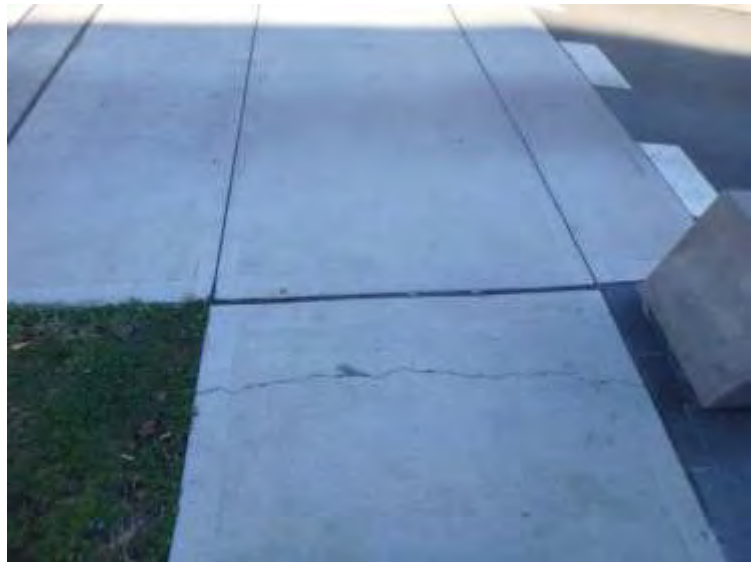
Defect ID 028
Area Type External
Location Burdett Street, Hornsby
Element Footpath
Defect Type Cracking
Length (mm) Approx. 1,200mm
Width (mm) Approx. 1.5mm
General Comments:
 Cracking to concrete footpath

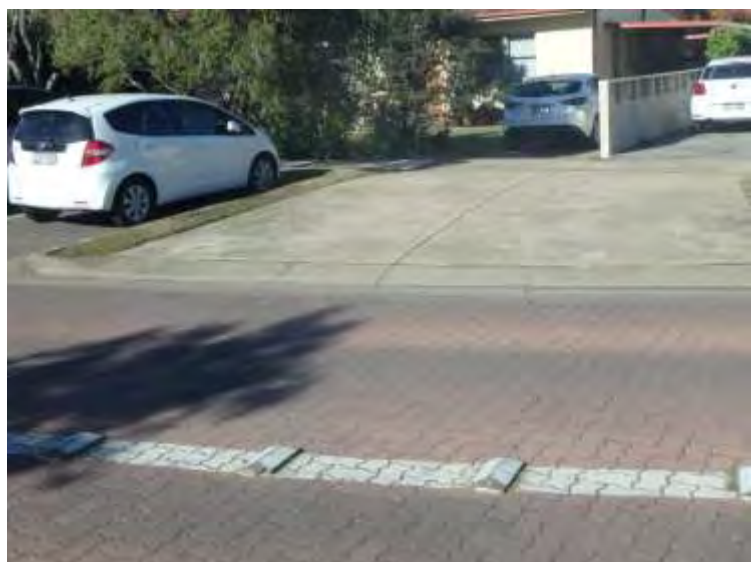
Defect ID 030
Area Type External
Location Burdett Street, Hornsby
Element Driveway
Defect Type Cracking
Length (mm) Approx. 1,000mm
Width (mm) Approx. 1.5mm
General Comments:
 Multiple cracking to concrete driveway

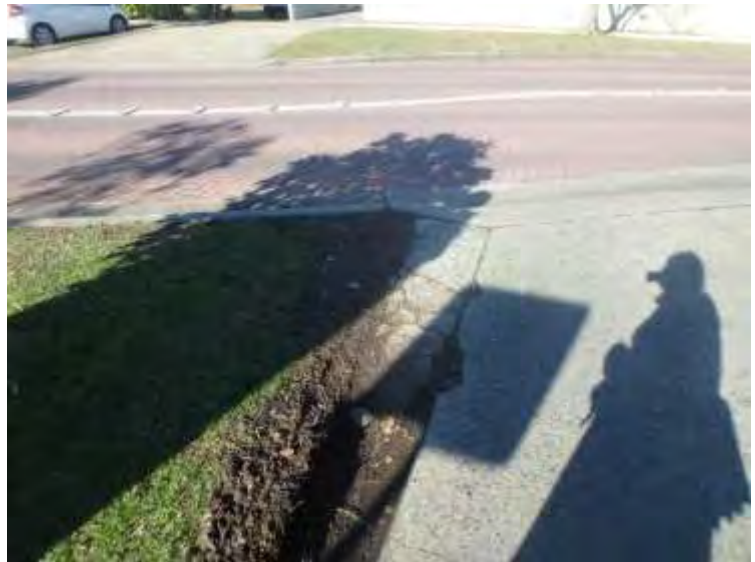
Defect ID 031
Area Type External
Location Burdett Street, Hornsby
Element Driveway
Defect Type Crumbling
Length (mm) N/A
Width (mm) Varying
General Comments:
 Crumbling concrete driveway

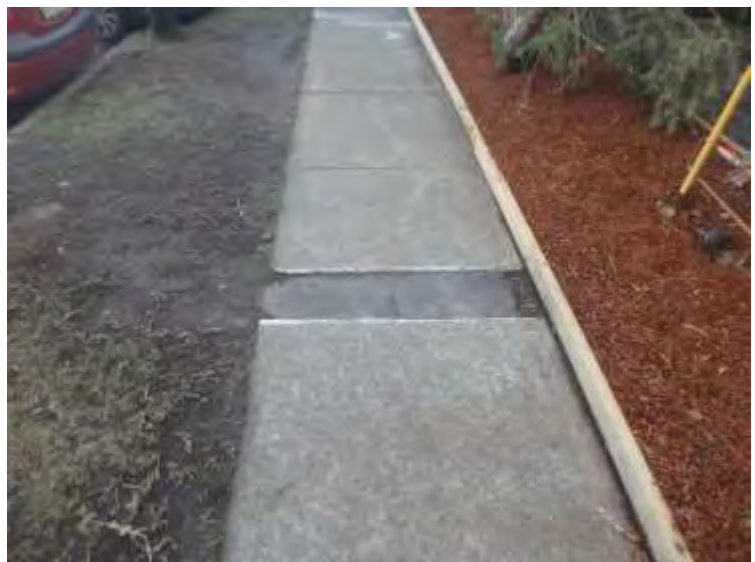
Defect ID 033
Area Type External
Location Burdett Street, Hornsby
Element Footpath
Defect Type Missing
Length (mm) Approx. 1,200mm
Width (mm) Approx. 500mm
General Comments:
 Missing concrete footpath

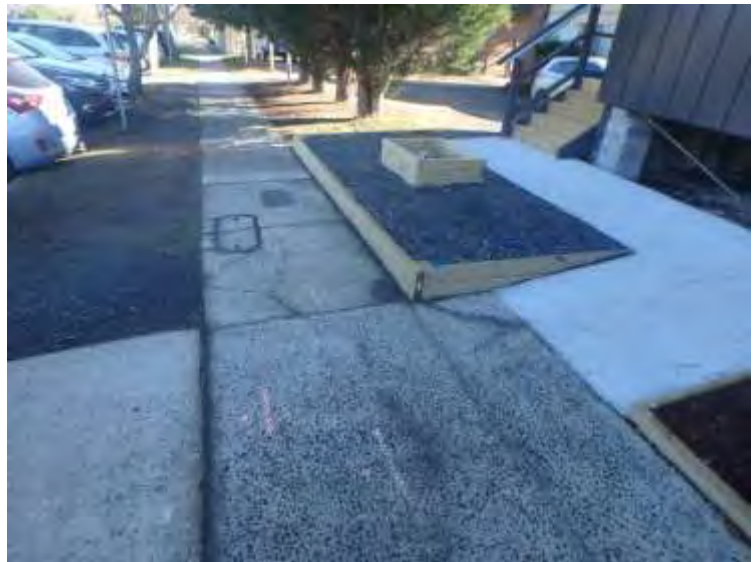
Defect ID 034
Area Type External
Location Burdett Street, Hornsby
Element Footpath
Defect Type Cracking
Length (mm) N/A
Width (mm) Varying
General Comments:
 Cracking to concrete footpath around pit

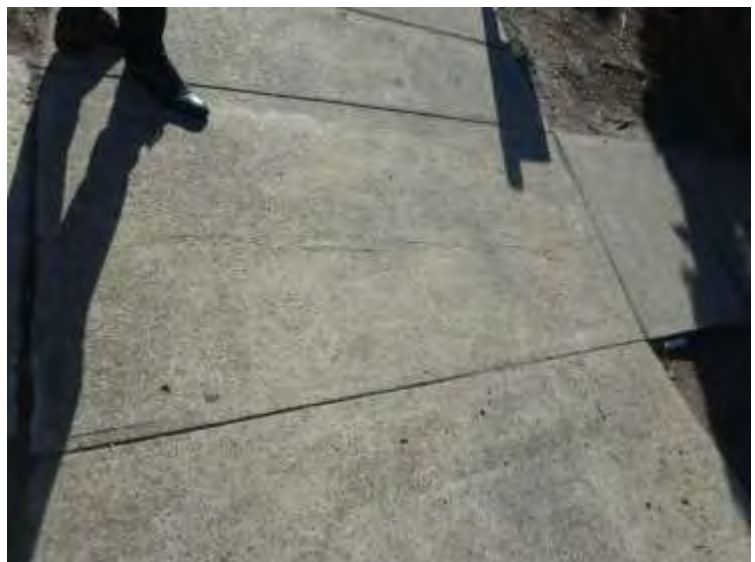
Defect ID 036
Area Type External
Location Burdett Street, Hornsby
Element Footpath
Defect Type Cracking
Length (mm) Approx. 2,000mm
Width (mm) Approx. 1mm
General Comments:
 Cracking to concrete footpath

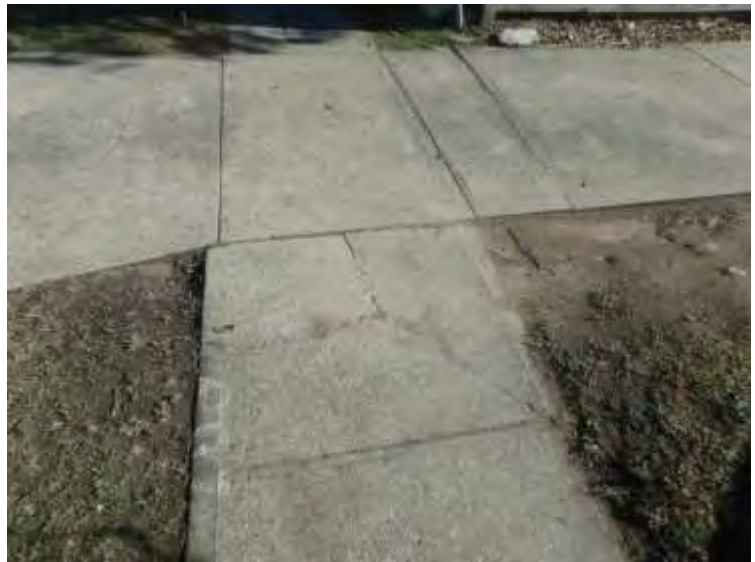
Defect ID 037
Area Type External
Location Burdett Street, Hornsby
Element Footpath
Defect Type Cracking
Length (mm) N/A
Width (mm) Varying
General Comments:
 Multiple cracking to concrete footpath

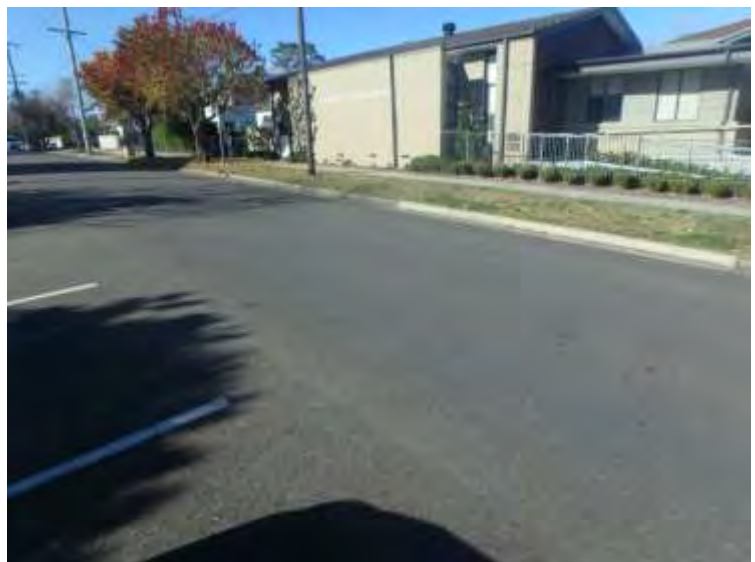
Defect ID 039
Area Type External
Location Burdett Street, Hornsby
Element Road
Defect Type Cracking
Length (mm) N/A
Width (mm) Approx. 1.5mm
General Comments:
 Multiple cracking to asphalt road

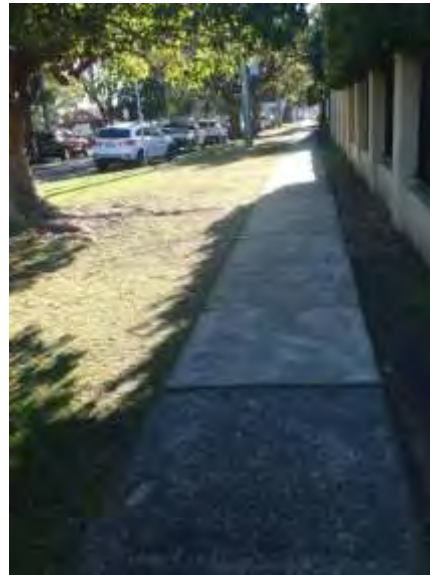
Defect ID 040
Area Type External
Location Palmerston Road, Hornsby
Element General Shot
Defect Type N/A
Length (mm) N/A
Width (mm) N/A
General Comments:
 General shot to Palmerston road

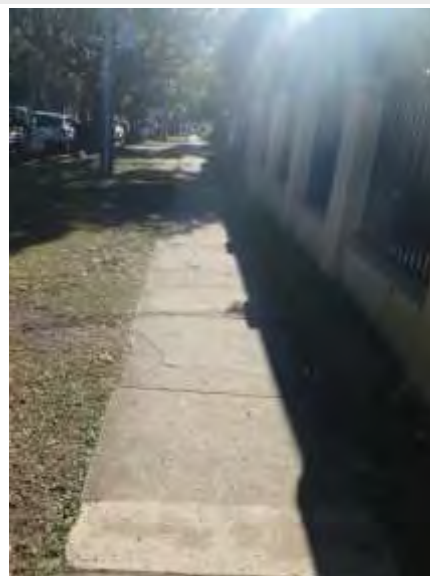
Defect ID 042
Area Type External
Location Palmerston Road, Hornsby
Element Footpath
Defect Type Cracking
Length (mm) N/A
Width (mm) Varying
General Comments:
 Multiple cracking to concrete footpath

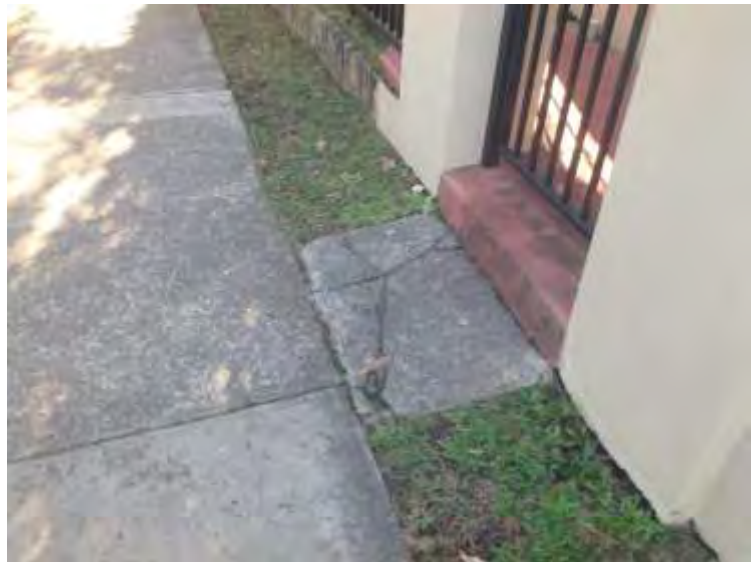
Defect ID 043
Area Type External
Location Palmerston Road, Hornsby
Element Footpath
Defect Type Cracking
Length (mm) N/A
Width (mm) Approx. 2mm

General Comments:
 Multiple cracking to concrete footpath

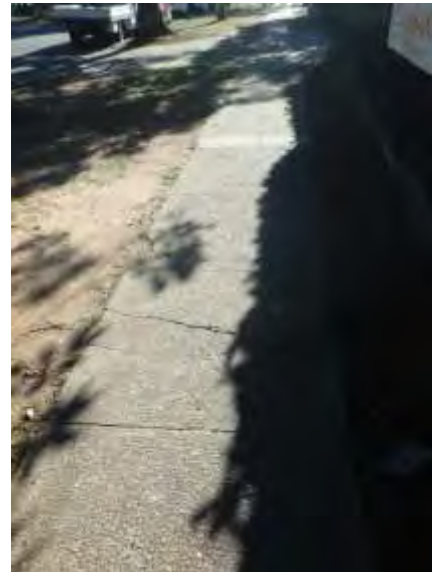
Defect ID 044
Area Type External
Location Palmerston Road, Hornsby
Element Footpath
Defect Type Cracking
Length (mm) N/A
Width (mm) Varying

General Comments:
 Multiple cracking to concrete footpath

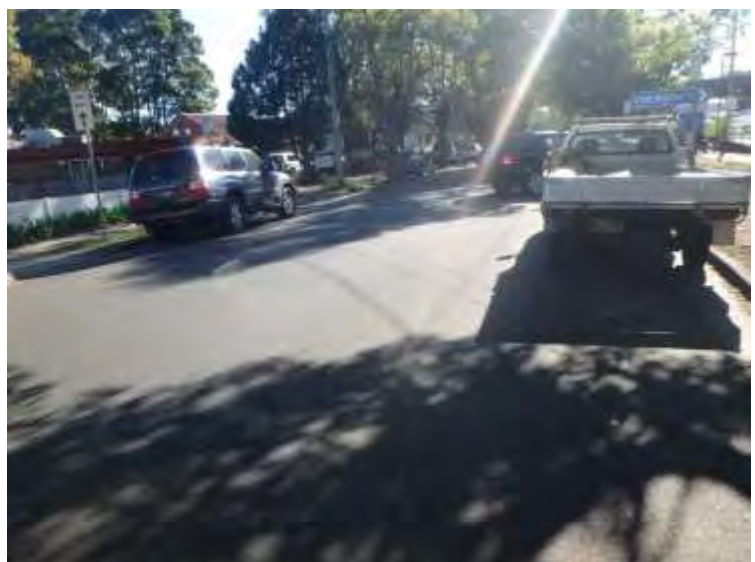
Defect ID 045
Area Type External
Location Palmerston Road, Hornsby
Element General Shot
Defect Type N/A
Length (mm) N/A
Width (mm) N/A

General Comments:
 General shot to Palmerston road

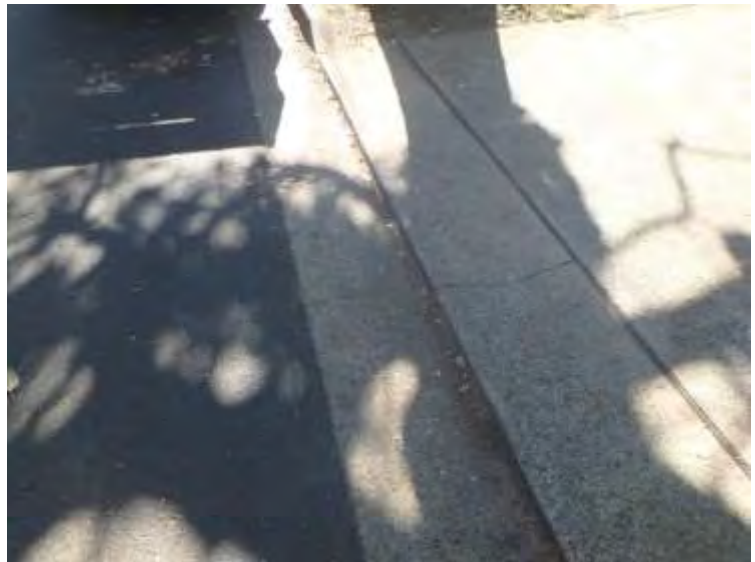
Defect ID 046
Area Type External
Location Palmerston Road, Hornsby
Element Driveway
Defect Type Cracking
Length (mm) Approx. 500mm
Width (mm) Approx. 1mm
General Comments:
 Cracking to concrete driveway

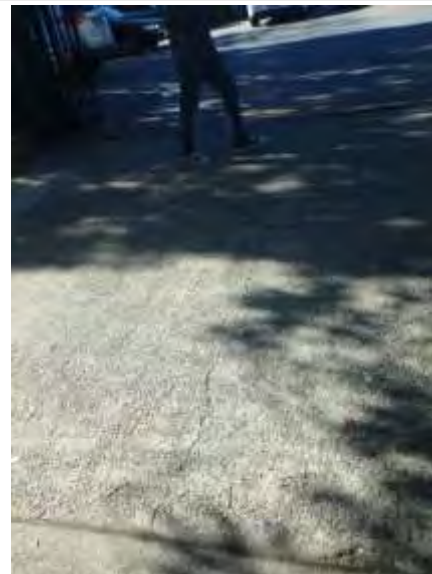
Defect ID 047
Area Type External
Location Palmerston Road, Hornsby
Element Driveway
Defect Type Cracking
Length (mm) Approx. 2,000mm
Width (mm) Approx. 1mm
General Comments:
 Cracking to concrete driveway

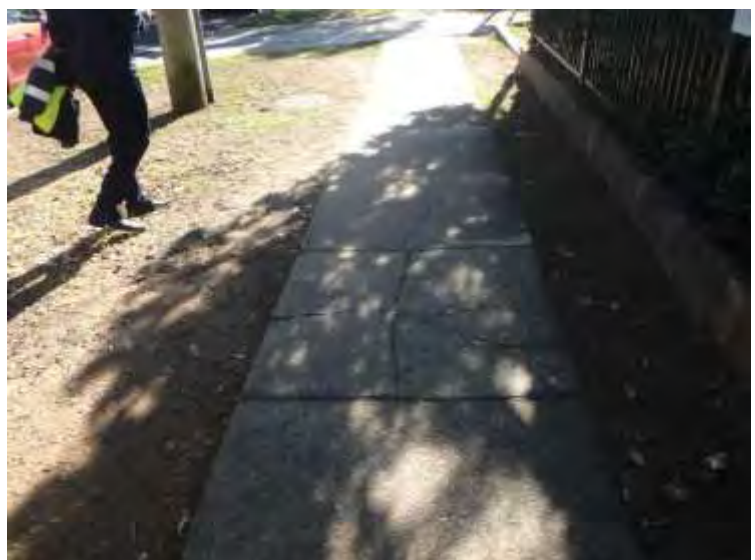
Defect ID 048
Area Type External
Location Palmerston Road, Hornsby
Element Footpath
Defect Type Cracking
Length (mm) N/A
Width (mm) Approx. 4mm
General Comments:
 Cracking to concrete footpath

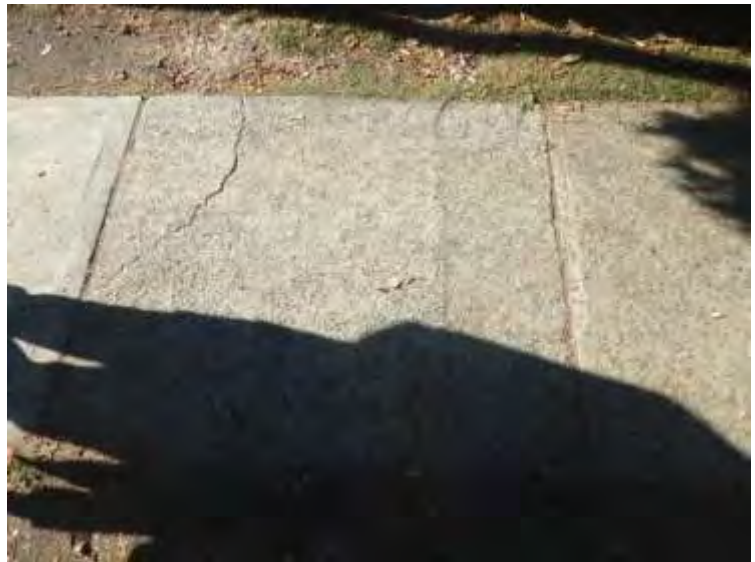
Defect ID 049
Area Type External
Location Palmerston Road, Hornsby
Element Footpath
Defect Type Cracking
Length (mm) Approx. 500mm
Width (mm) Approx. 3mm
General Comments:
 Cracking to concrete footpath

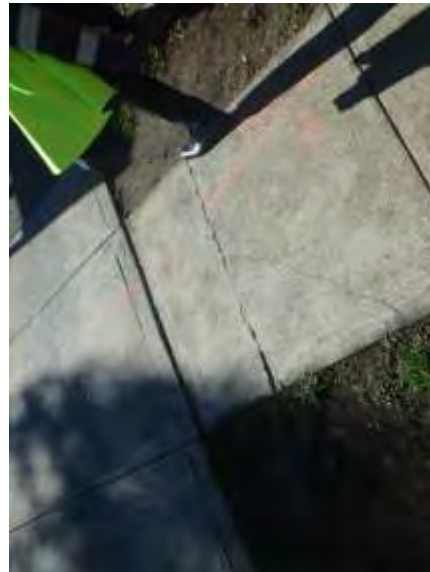
Defect ID 050
Area Type External
Location Palmerston Road, Hornsby
Element Footpath
Defect Type Cracking
Length (mm) Approx. 1,800mm in total
Width (mm) Varying
General Comments:
 Multiple cracking to concrete footpath

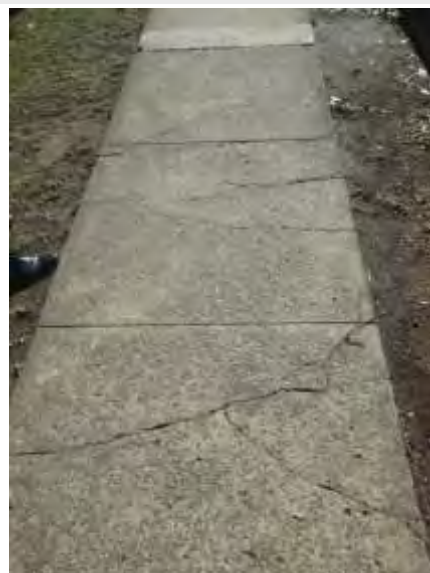
Defect ID 051
Area Type External
Location Palmerston Road, Hornsby
Element Footpath
Defect Type Cracking
Length (mm) N/A
Width (mm) Varying
General Comments:
 Typical cracking to concrete driveway

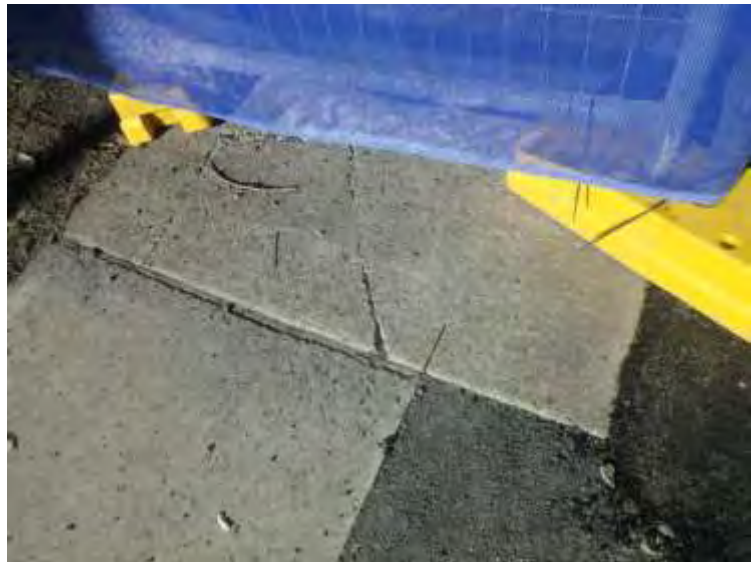
Defect ID 052
Area Type External
Location Palmerston Road, Hornsby
Element Footpath
Defect Type Cracking
Length (mm) Approx. 1,000mm
Width (mm) Approx. 2mm
General Comments:
 Cracking to concrete footpath

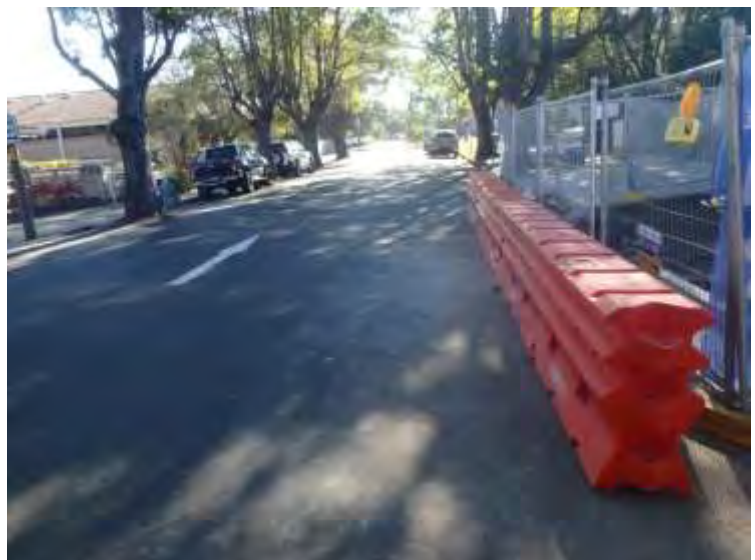
Defect ID 054
Area Type External
Location Palmerston Road, Hornsby
Element General Shot
Defect Type N/A
Length (mm) N/A
Width (mm) N/A
General Comments:
 General shot to Palmerston road

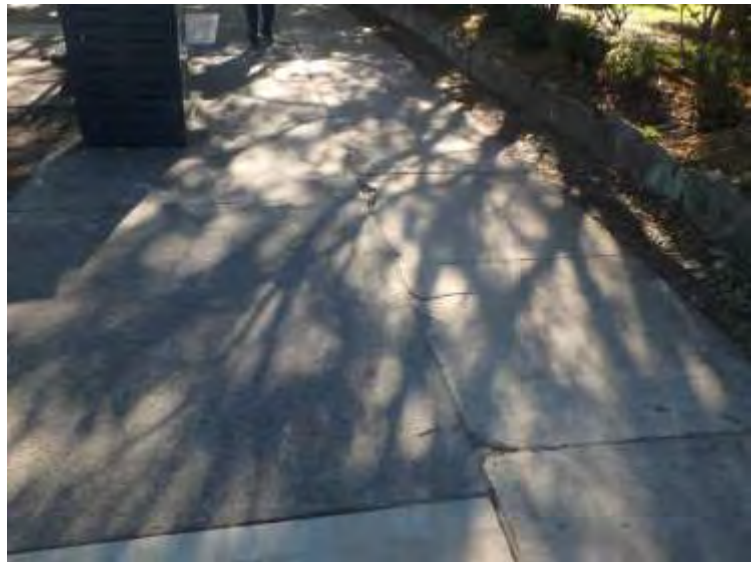
Defect ID 055
Area Type External
Location Palmerston Road, Hornsby
Element Footpath
Defect Type Chipped
Length (mm) N/A
Width (mm) N/A
General Comments:
 Chipped paver

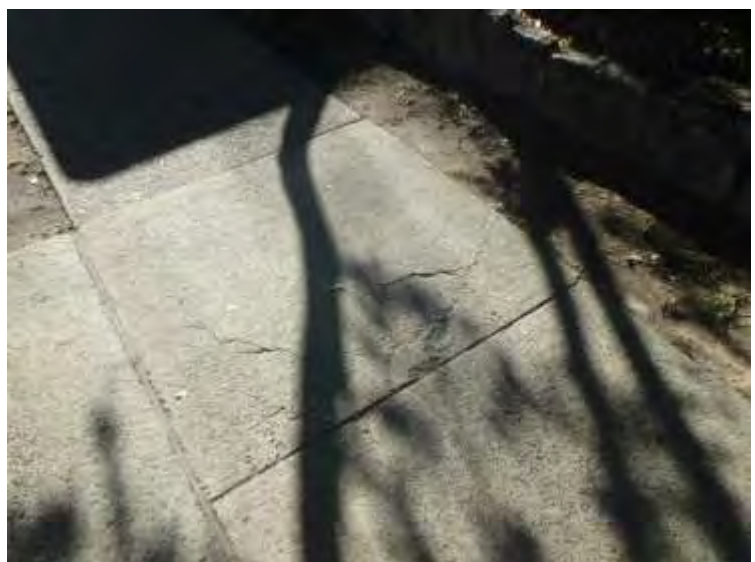
Defect ID 057
Area Type External
Location Palmerston Road, Hornsby
Element Footpath
Defect Type Cracking
Length (mm) N/A
Width (mm) Varying
General Comments:
 Cracking to concrete footpath

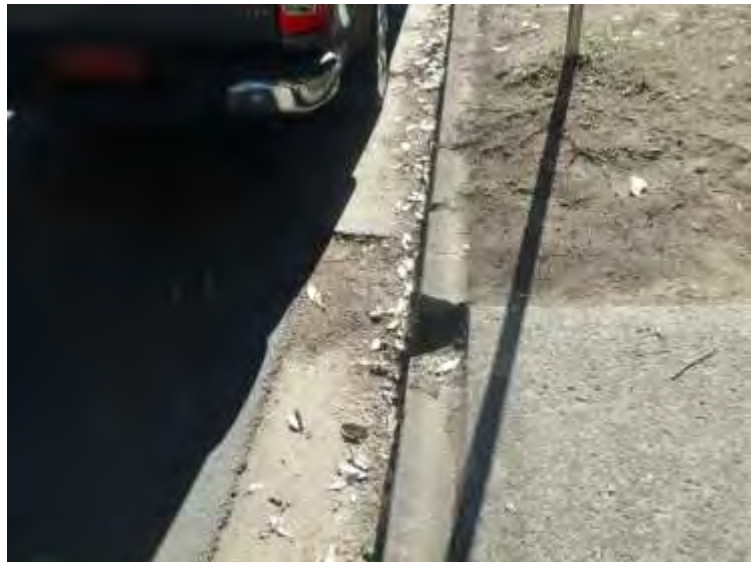
Defect ID 058
Area Type External
Location Palmerston Road, Hornsby
Element Kerb
Defect Type Chipped
Length (mm) N/A
Width (mm) N/A
General Comments:
 Chipped concrete kerb

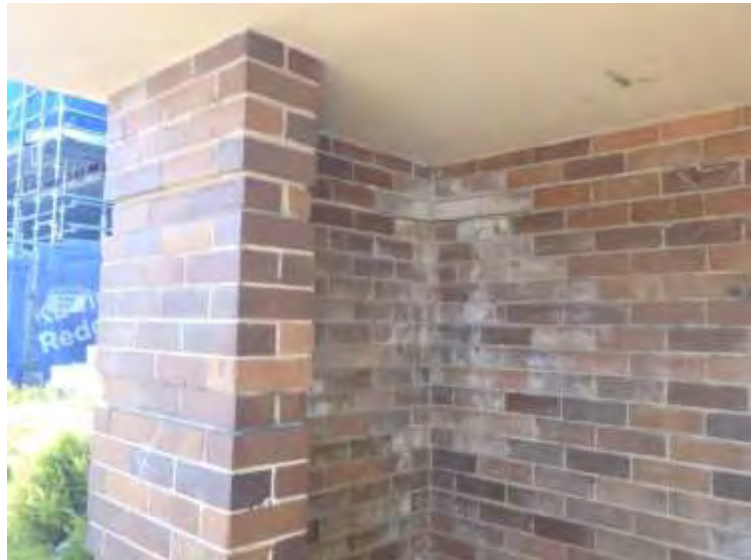
Defect ID 059
Area Type External
Location Palmerston Road, Hornsby
Element Brick Structure
Defect Type Cracking
Length (mm) Approx. 500mm
Width (mm) 10mm
General Comments:
 Vertical cracking to the brick structure, along mortar joint

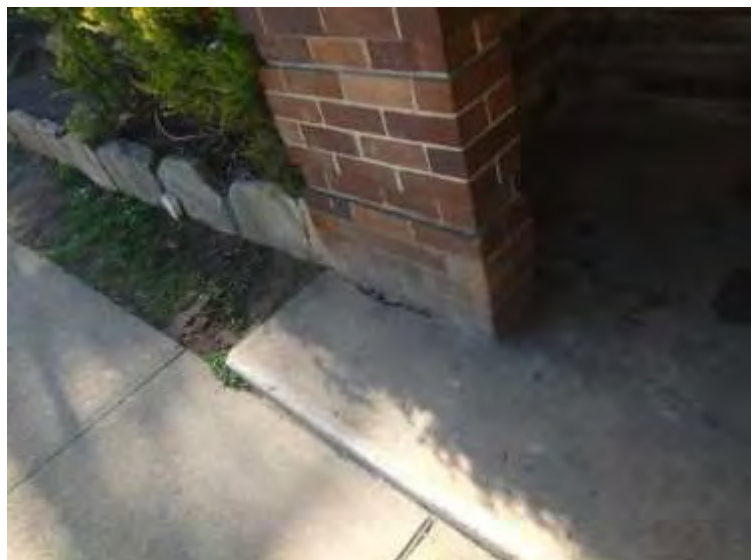
Defect ID 060
Area Type External
Location Palmerston Road, Hornsby
Element Footpath
Defect Type Cracking
Length (mm) Approx. 500mm
Width (mm) Varying
General Comments:
 Cracking to concrete footpath, adjoining the brick structure

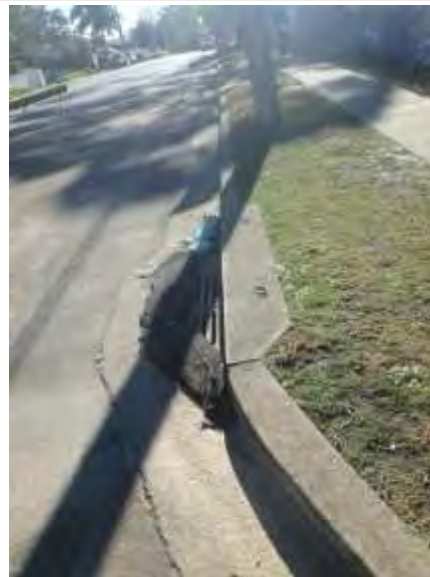
Defect ID 061
Area Type External
Location Palmerston Road, Hornsby
Element Pit
Defect Type N/A
Length (mm) N/A
Width (mm) N/A
General Comments:
 General shot of stormwater pit

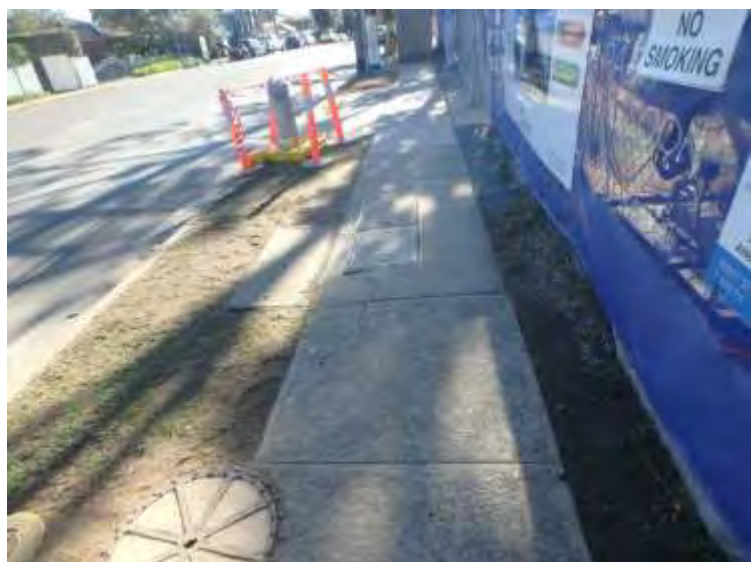
Defect ID 063
Area Type External
Location Palmerston Road, Hornsby
Element Footpath
Defect Type Cracking
Length (mm) N/A
Width (mm) Approx. 2mm
General Comments:
 Multiple cracking to concrete footpath

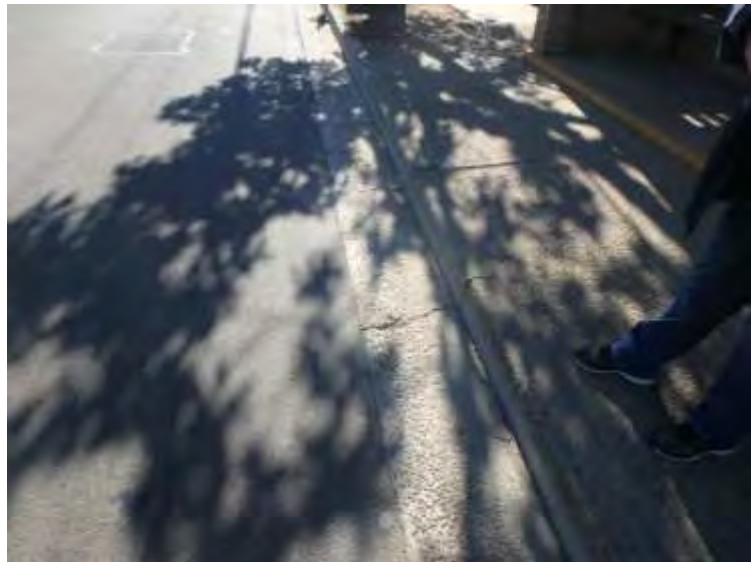
Defect ID 064
Area Type External
Location Palmerston Road, Hornsby
Element Kerb
Defect Type Cracking
Length (mm) Approx. 500mm
Width (mm) Approx. 3mm
General Comments:
 Cracking to concrete kerb

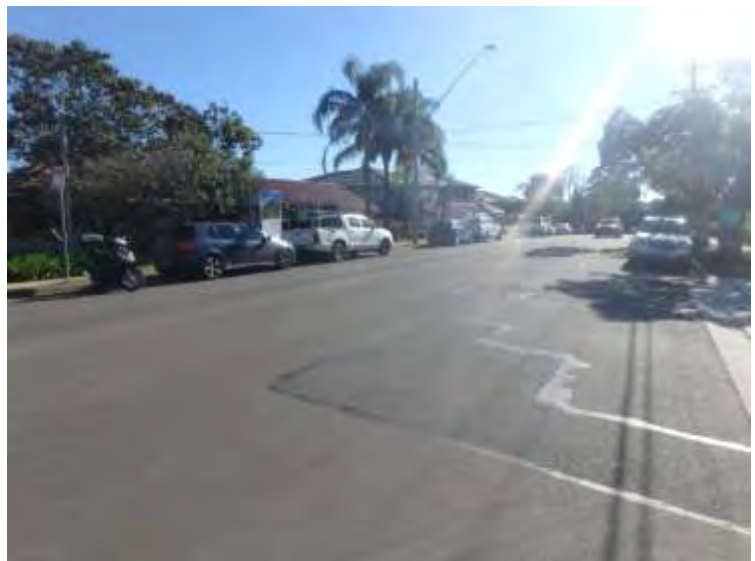
Defect ID 065
Area Type External
Location Palmerston Road, Hornsby
Element Road
Defect Type Previous Repair
Length (mm) N/A
Width (mm) N/A
General Comments:
 Previous repair on the road was noted
