Council Assets Surrounding Hornsby Hospital

Dilapidation Report
80818469

Prepared for	Watpac Construction Pty Ltd
Project Name	Dilapidation Report
File Reference	Dilapidation Report - Hornsby Hospital Council Assets-2018-06-28.docx
Job Reference	80818469
Date	June 2018

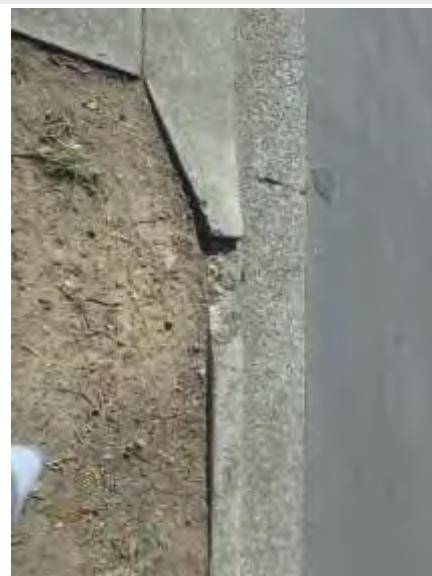
Defect ID 066
Area Type External
Location Palmerston Road, Hornsby
Element Kerb
Defect Type Chipped
Length (mm) Approx. 30mm
Width (mm) 150mm
General Comments:
 Chipped kerb

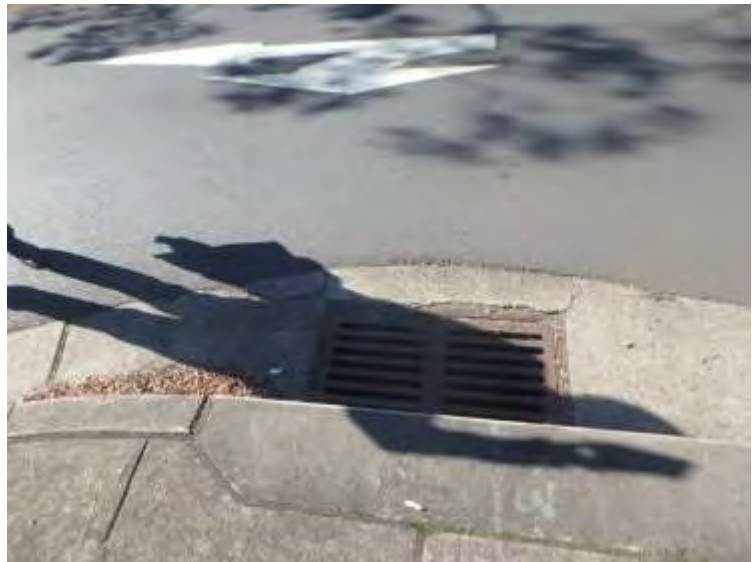
Defect ID 067
Area Type External
Location Palmerston Road, Hornsby
Element Road
Defect Type Cracking
Length (mm) N/A
Width (mm) Varying
General Comments:
 Cracking to road surround pit

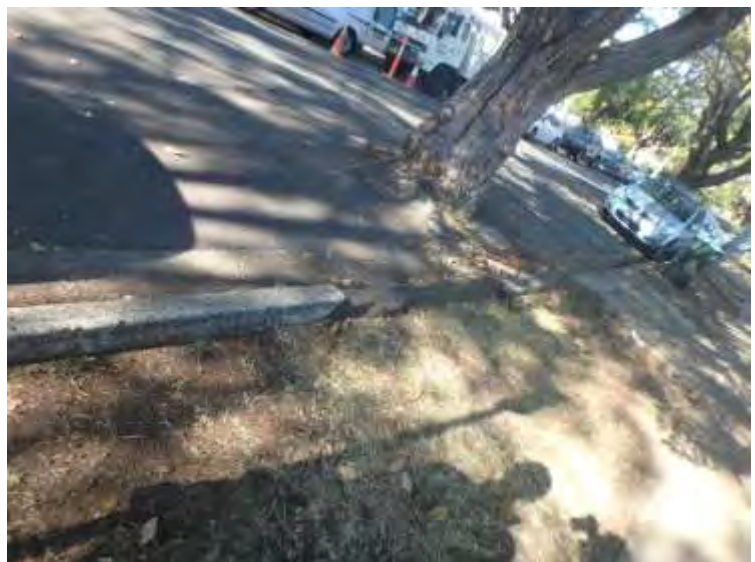
Defect ID 069
Area Type External
Location Palmerston Road, Hornsby
Element Kerb
Defect Type Damaged
Length (mm) Approx. 1,000mm
Width (mm) 150mm
General Comments:
 Damaged concrete kerb

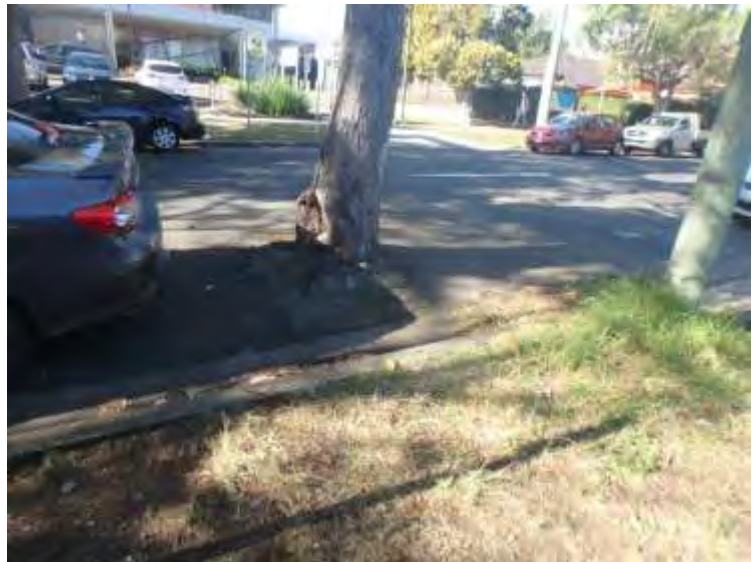
Defect ID 070
Area Type External
Location Palmerston Road, Hornsby
Element Tree
Defect Type N/A
Length (mm) N/A
Width (mm) N/A
General Comments:
 General shot of tree on site

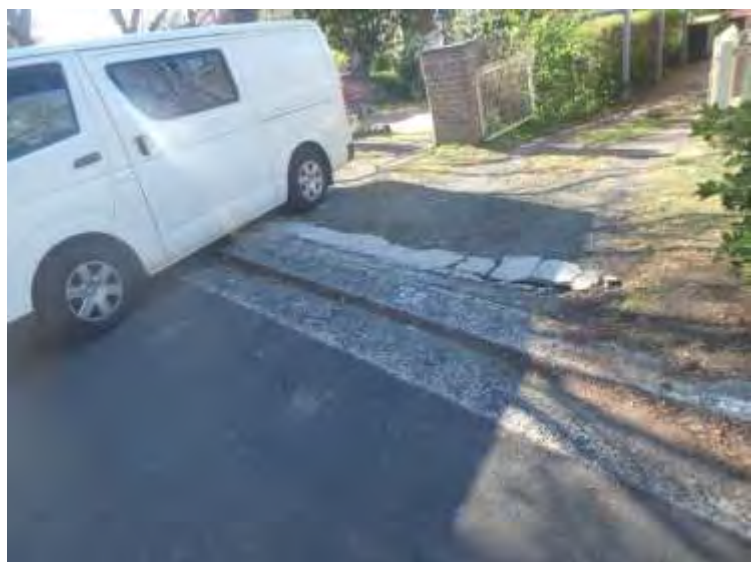
Defect ID 072
Area Type External
Location Burdett Street, Hornsby
Element Driveway
Defect Type Crumbling
Length (mm) N/A
Width (mm) N/A
General Comments:
 Crumbling concrete driveway

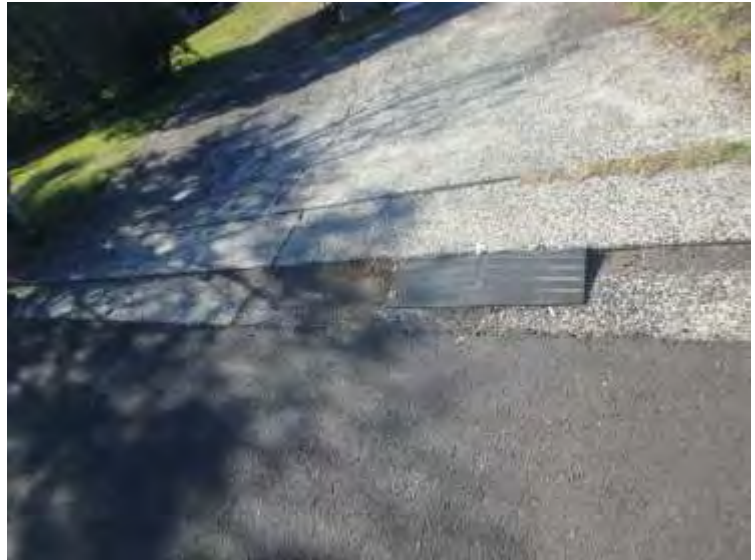
Defect ID 073
Area Type External
Location Burdett Street, Hornsby
Element Driveway
Defect Type Cracking
Length (mm) Approx. 2,000mm
Width (mm) Approx. 2mm
General Comments:
Cracking to concrete driveway

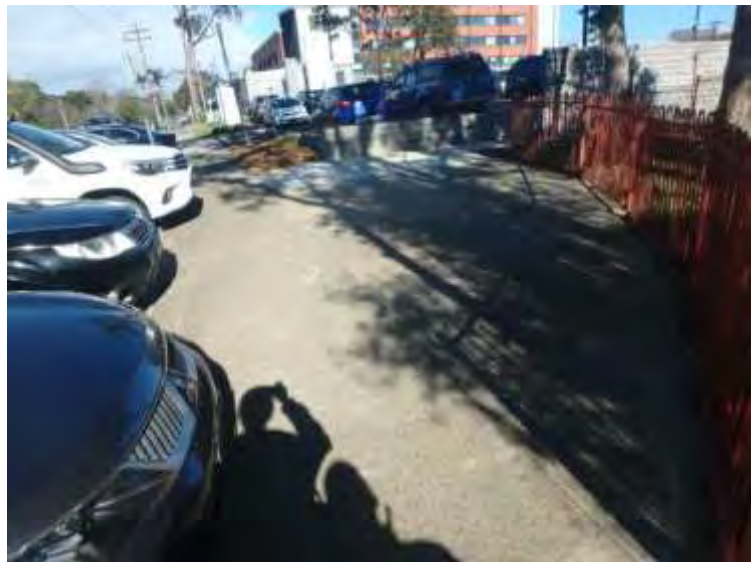
Defect ID A198
Area Type External
Location Building 14 Pavement
Element General Shot
Defect Type NA
Length (mm) NA
Width (mm) NA
General Comments:
 In reasonable condition

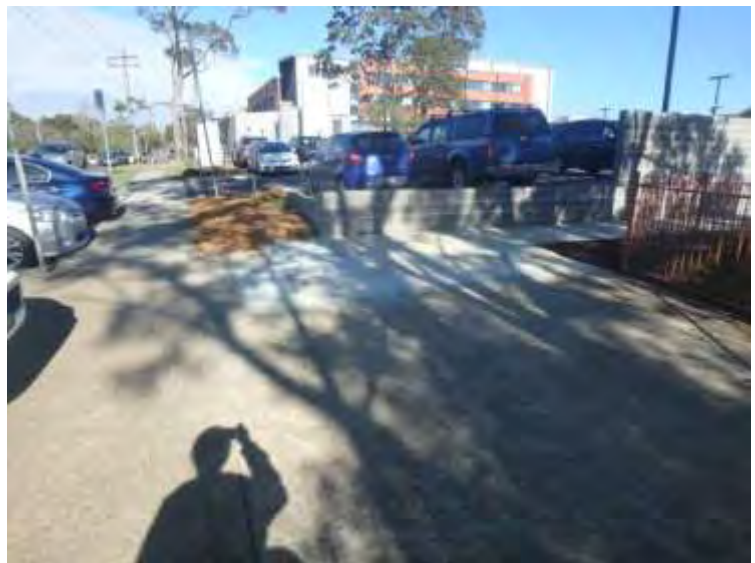
Defect ID A199
Area Type External
Location Building 14 Pavement
Element General Shot
Defect Type NA
Length (mm) NA
Width (mm) NA
General Comments:
 In reasonable condition

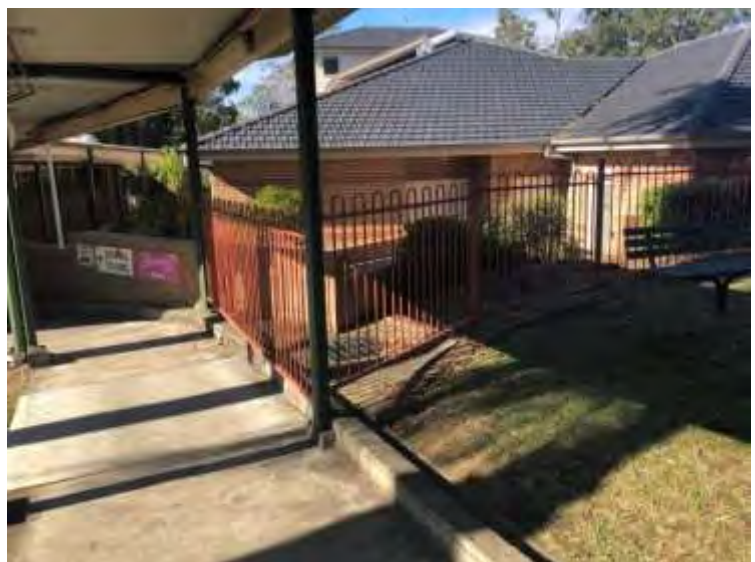
Defect ID A200
Area Type External
Location Building 14 Entry footpath
Element General Shot
Defect Type NA
Length (mm) NA
Width (mm) NA
General Comments:
 In reasonable condition

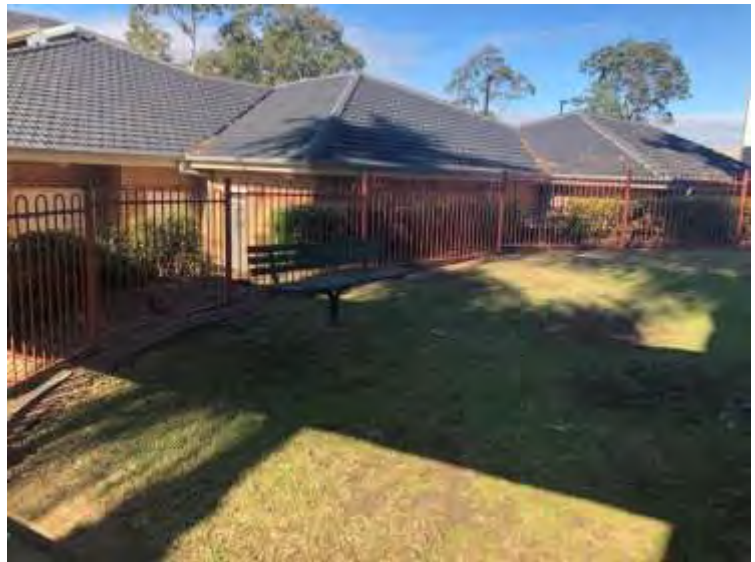
Defect ID A201
Area Type External
Location Building 14 Fencing
Element General Shot
Defect Type NA
Length (mm) NA
Width (mm) NA
General Comments:
 In reasonable condition

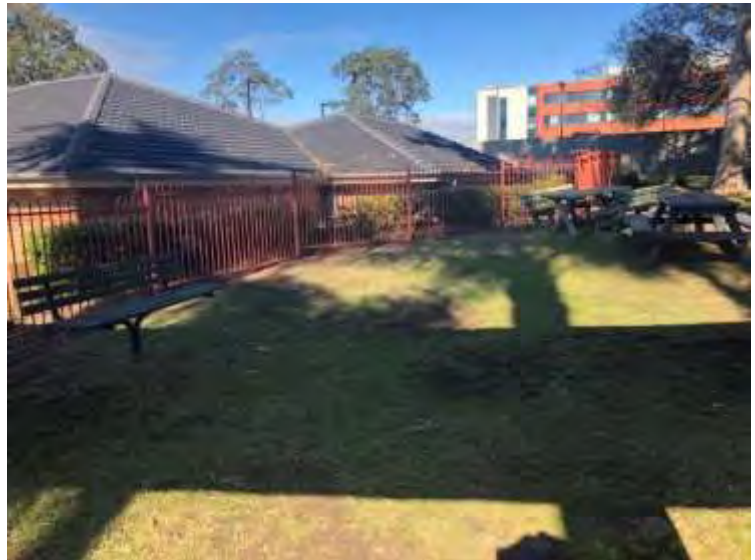
Defect ID A202
Area Type External
Location Building 14 Fencing
Element General Shot
Defect Type NA
Length (mm) NA
Width (mm) NA
General Comments:
 In reasonable condition

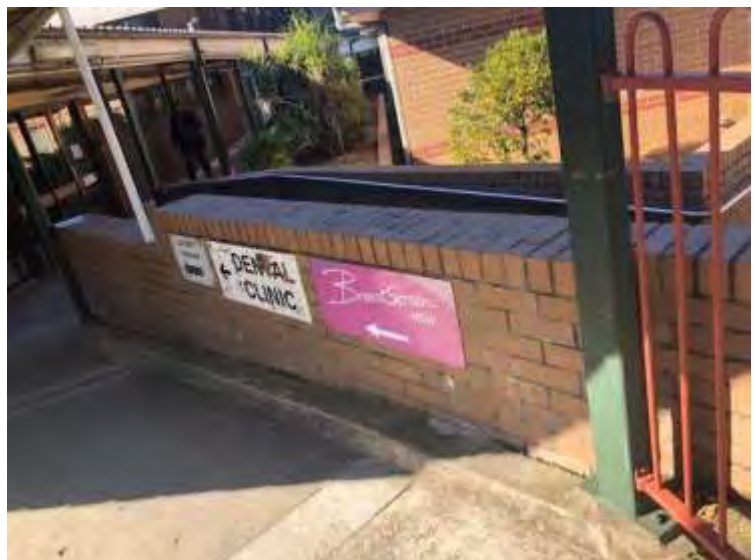
Defect ID A203
Area Type External
Location Building 14 Brick balustrade
Element General Shot
Defect Type NA
Length (mm) NA
Width (mm) NA
General Comments:
 In reasonable condition

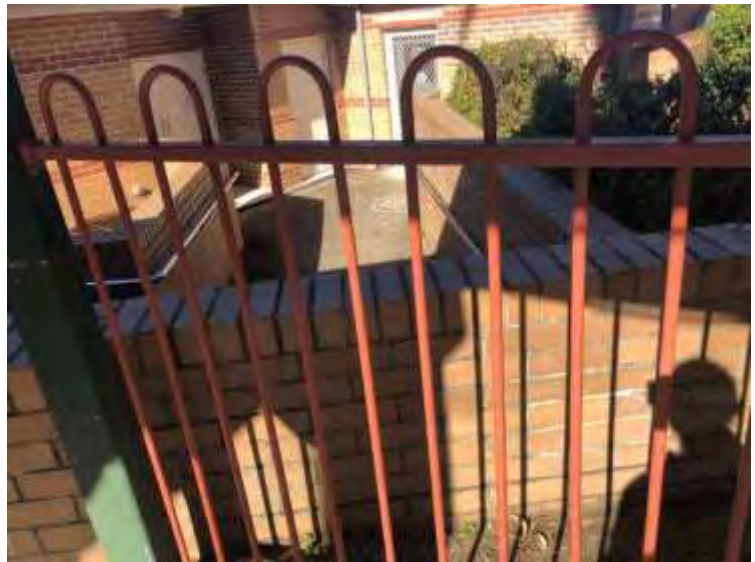
Defect ID A204

General Comments:
In reasonable condition

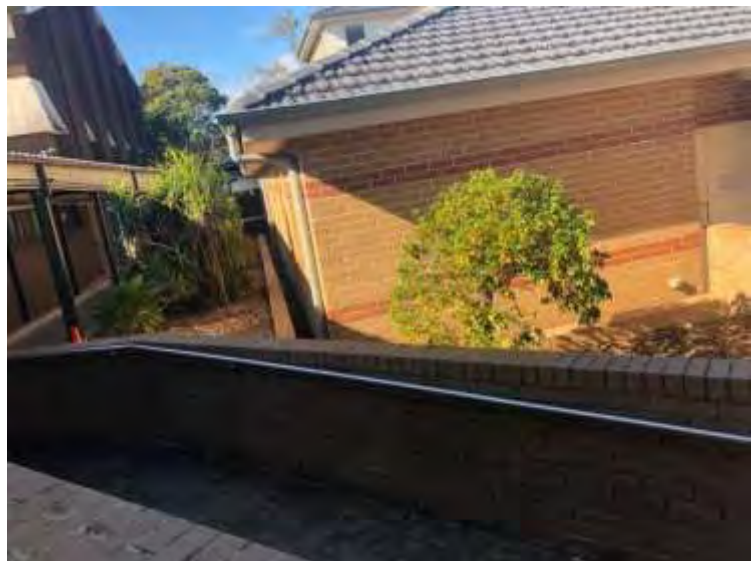
Defect ID A205

General Comments:
In reasonable condition

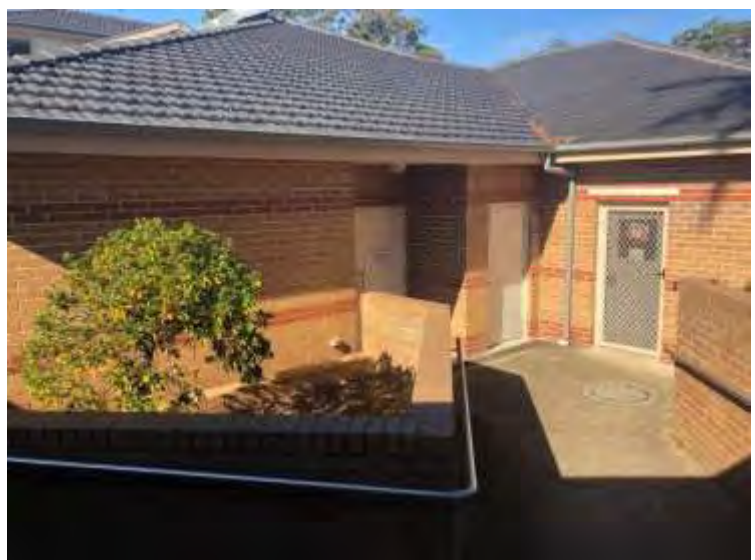
Defect ID A206

General Comments:
In reasonable condition

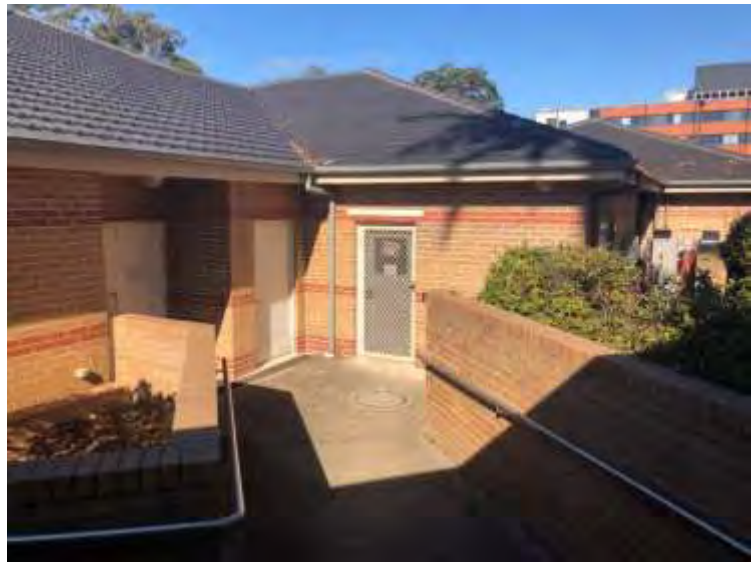
Defect ID A207
Area Type External
Location Building 14 General façade
Element General Shot
Defect Type NA
Length (mm) NA
Width (mm) NA
General Comments:
 In reasonable condition

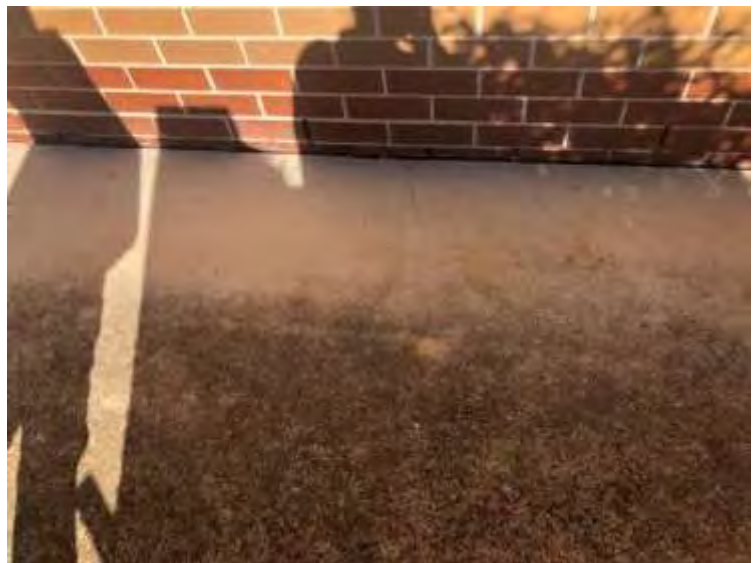
Defect ID A208
Area Type External
Location Building 14 General façade
Element General Shot
Defect Type NA
Length (mm) NA
Width (mm) NA
General Comments:
 In reasonable condition

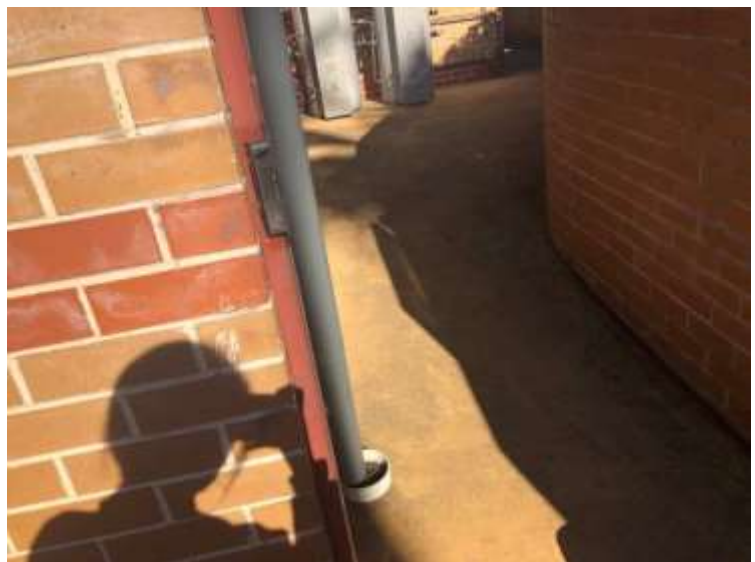
Defect ID A209
Area Type External
Location Building 14 Footpath
Element Concrete
Defect Type Crack
Length (mm) 500
Width (mm) 0.5
General Comments:
 Hairline cracking on concrete footpath

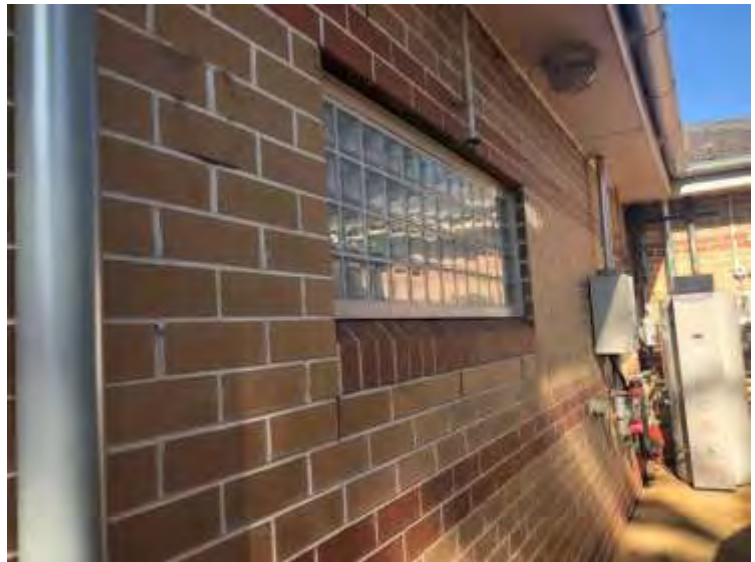
Defect ID A210
Area Type External
Location Building 14 Footpath
Element General Shot
Defect Type NA
Length (mm) NA
Width (mm) NA
General Comments:
 In reasonable condition

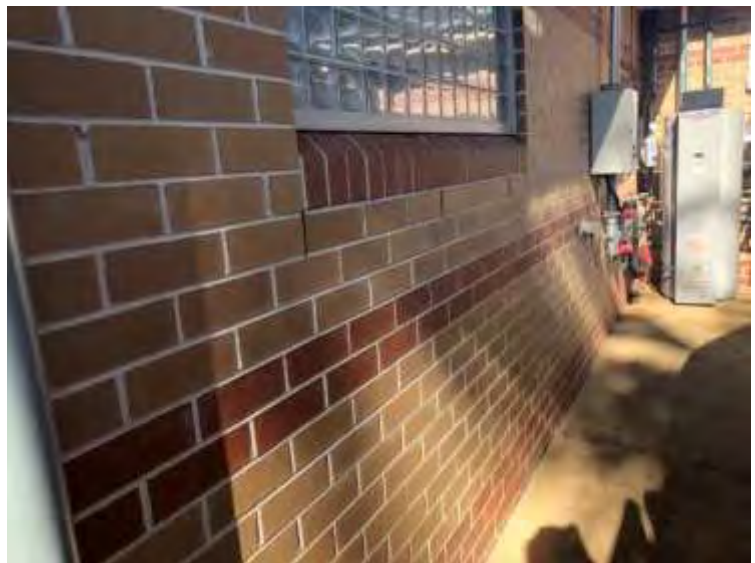
Defect ID A211
Area Type External
Location Building 14 General façade
Element General Shot
Defect Type NA
Length (mm) NA
Width (mm) NA
General Comments:
 In reasonable condition

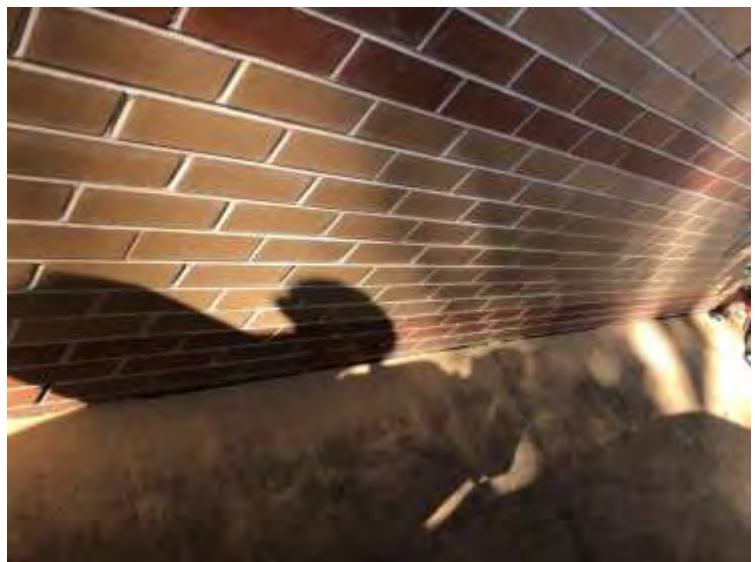
Defect ID A212
Area Type External
Location Building 14 General façade
Element General Shot
Defect Type NA
Length (mm) NA
Width (mm) NA
General Comments:
 In reasonable condition

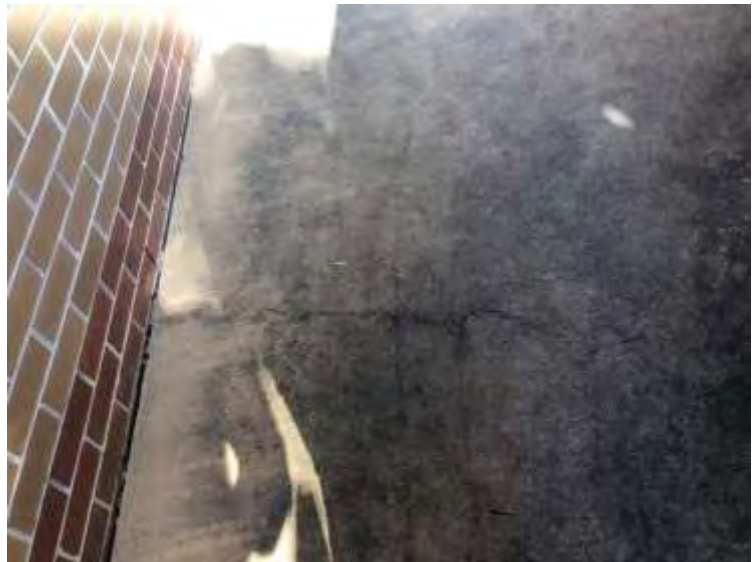
Defect ID A213
Area Type External
Location Building 14 Footpath
Element Concrete
Defect Type Crack
Length (mm) 500
Width (mm) 0.5
General Comments:
 Hairline cracking on concrete footpath

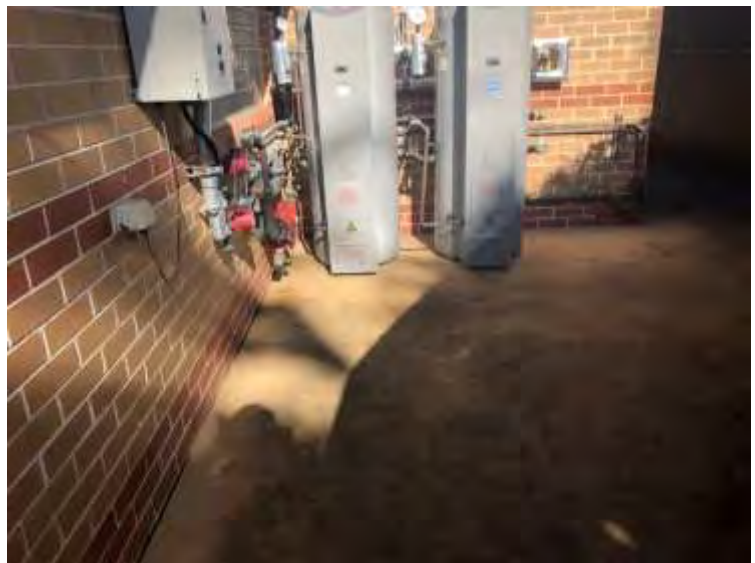
Defect ID A214
Area Type External
Location Building 14 General façade
Element General Shot
Defect Type NA
Length (mm) NA
Width (mm) NA
General Comments:
 In reasonable condition

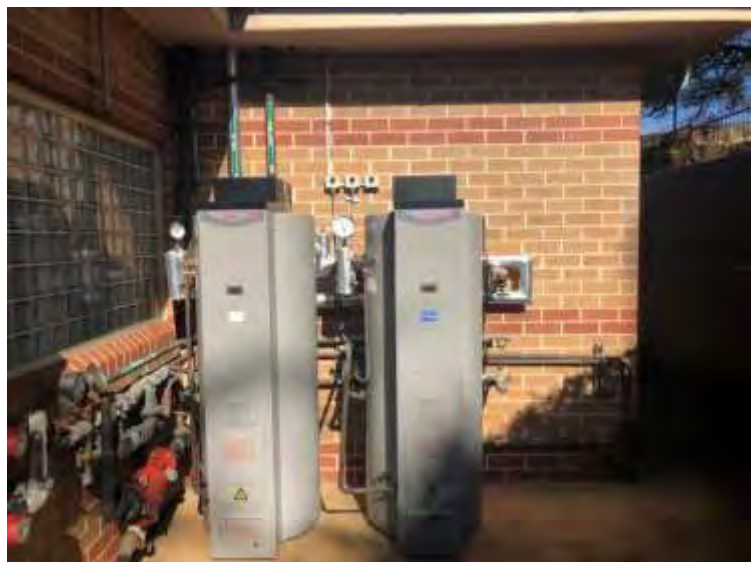
Defect ID A215
Area Type External
Location Building 14 General façade
Element General Shot
Defect Type NA
Length (mm) NA
Width (mm) NA
General Comments:
 In reasonable condition

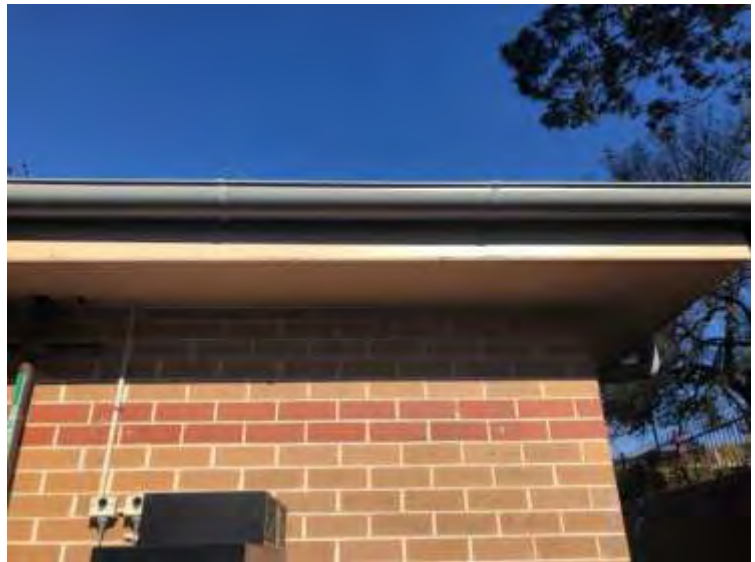
Defect ID A216
Area Type External
Location Building 14 Roof eave
Element General Shot
Defect Type NA
Length (mm) NA
Width (mm) NA
General Comments:
 In reasonable condition

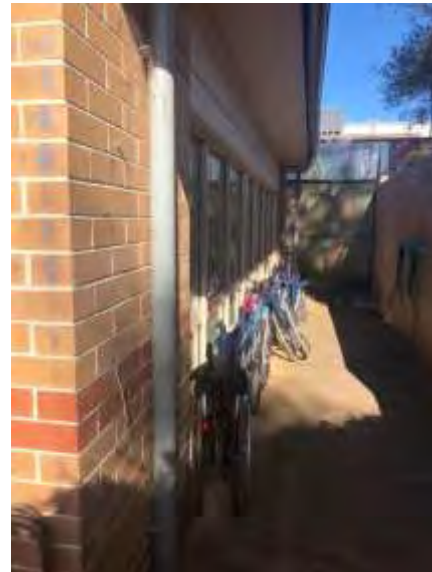
Defect ID A217
Area Type External
Location Building 14 General façade
Element General Shot
Defect Type NA
Length (mm) NA
Width (mm) NA
General Comments:
 In reasonable condition

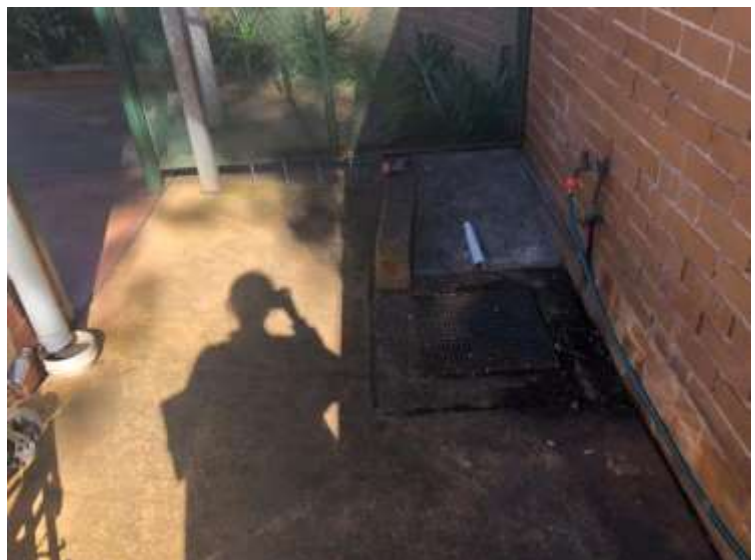
Defect ID A218
Area Type External
Location Building 14 Footpath
Element General Shot
Defect Type NA
Length (mm) NA
Width (mm) NA
General Comments:
 In reasonable condition

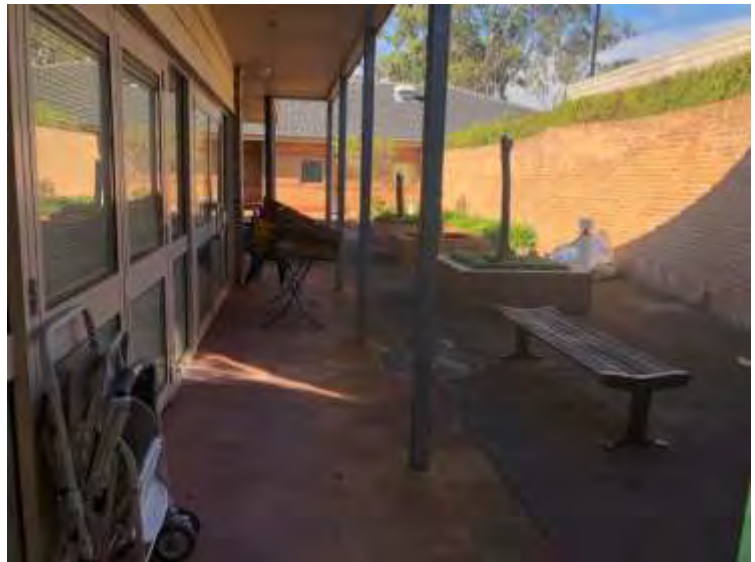
Defect ID A219
Area Type External
Location Building 14 Footpath
Element General Shot
Defect Type NA
Length (mm) NA
Width (mm) NA
General Comments:
 In reasonable condition

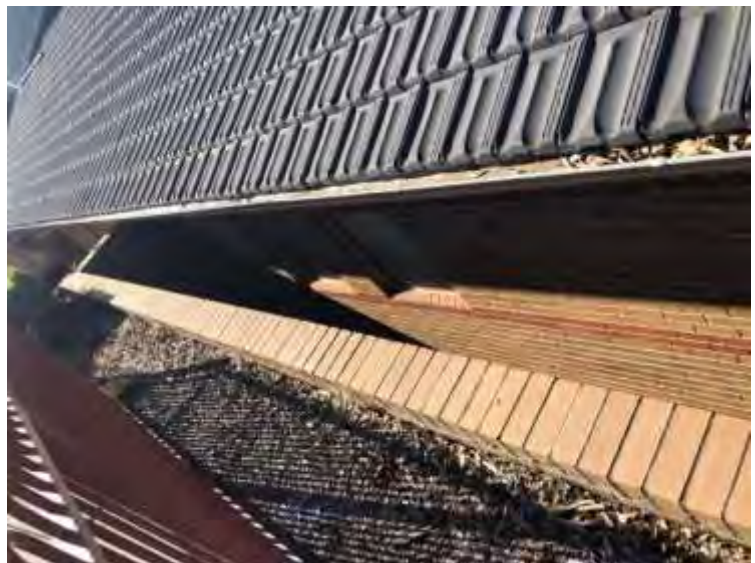
Defect ID A220
Area Type External
Location Building 14 Roof gutter
Element General Shot
Defect Type NA
Length (mm) NA
Width (mm) NA
General Comments:
 In reasonable condition

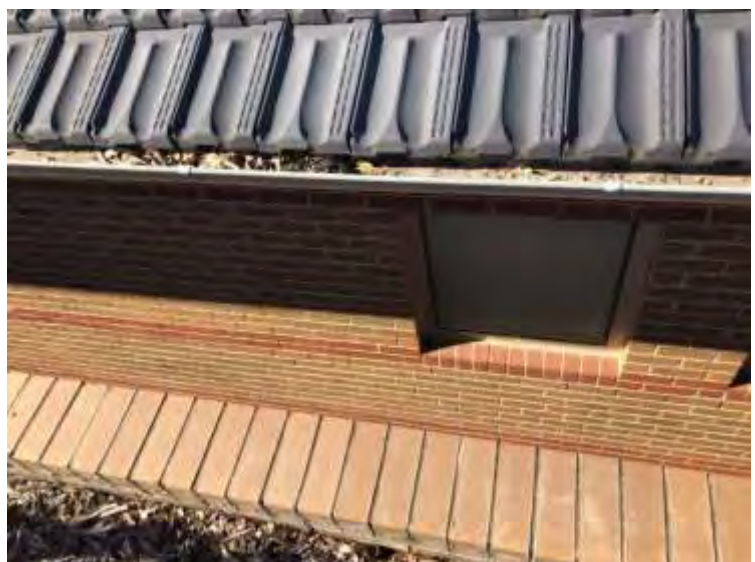
Defect ID A221
Area Type External
Location Building 14 Roof gutter
Element General Shot
Defect Type NA
Length (mm) NA
Width (mm) NA
General Comments:
 In reasonable condition

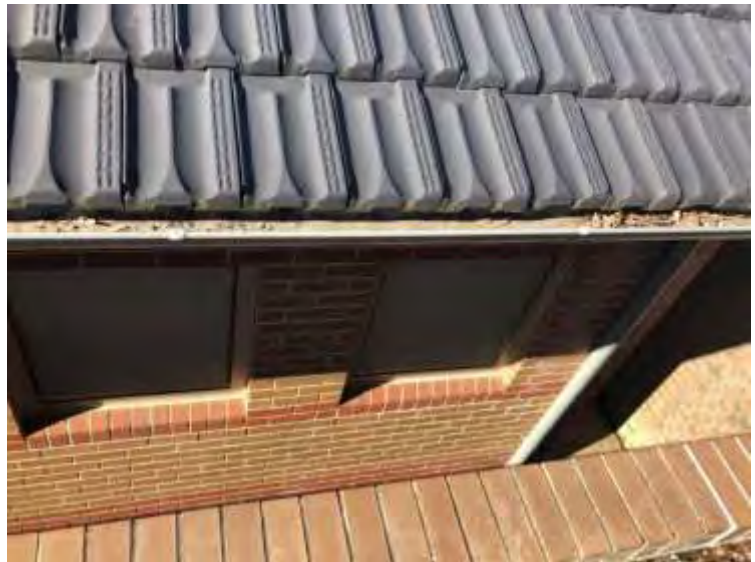
Defect ID A222
Area Type External
Location Building 14 Roof gutter
Element General Shot
Defect Type NA
Length (mm) NA
Width (mm) NA
General Comments:
 In reasonable condition

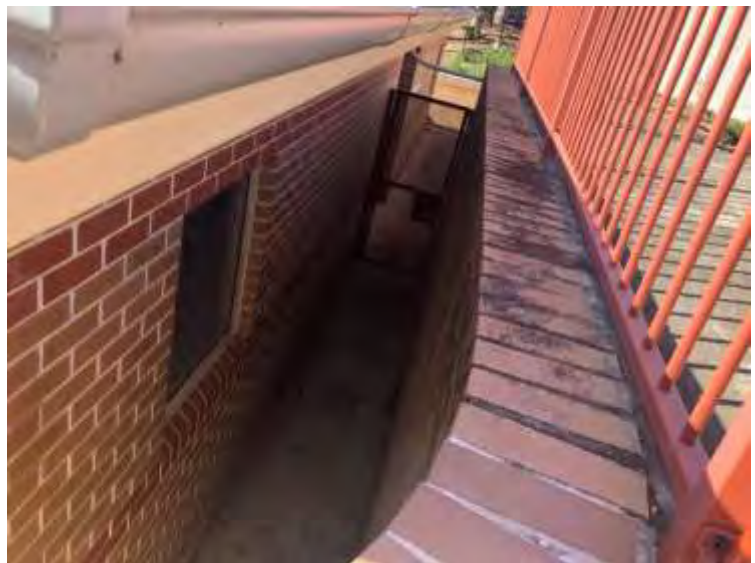
Defect ID A223
Area Type External
Location Building 14 Footpath
Element General Shot
Defect Type NA
Length (mm) NA
Width (mm) NA
General Comments:
 In reasonable condition

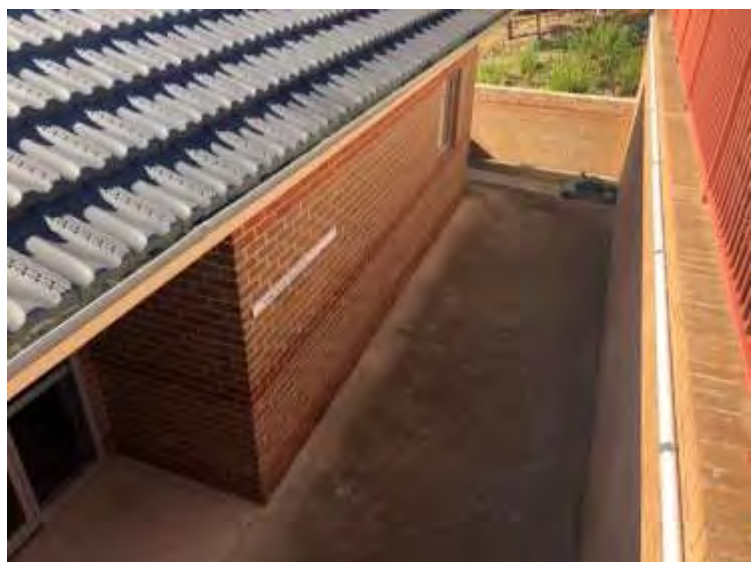
Defect ID A224
Area Type External
Location Building 14 Footpath
Element General Shot
Defect Type NA
Length (mm) NA
Width (mm) NA
General Comments:
 In reasonable condition

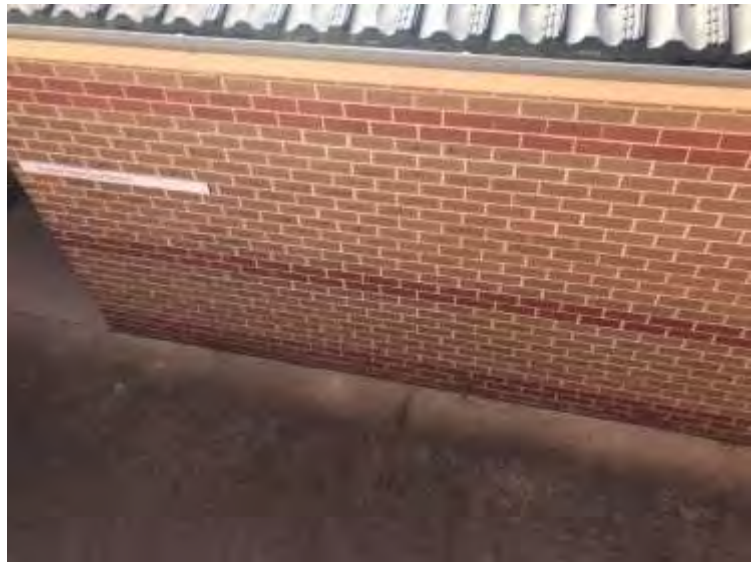
Defect ID A225
Area Type External
Location Building 14 General façade
Element General Shot
Defect Type NA
Length (mm) NA
Width (mm) NA
General Comments:
 In reasonable condition

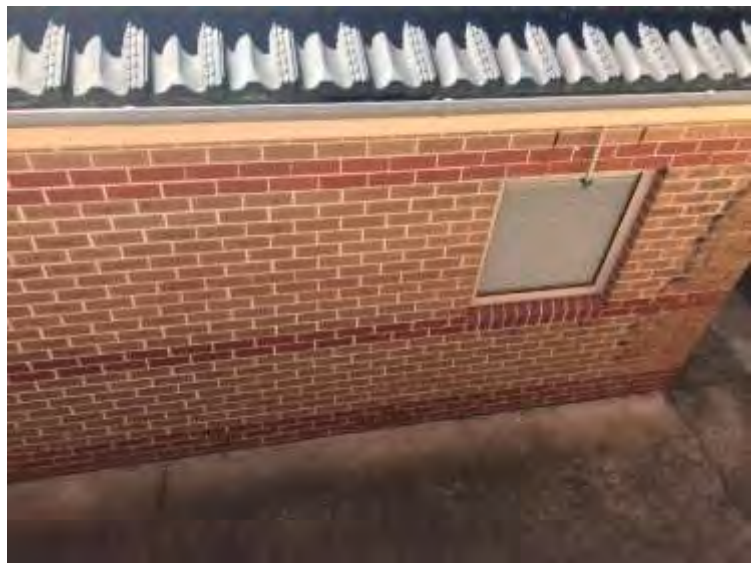
Defect ID A226
Area Type External
Location Building 14 General façade
Element General Shot
Defect Type NA
Length (mm) NA
Width (mm) NA
General Comments:
 In reasonable condition

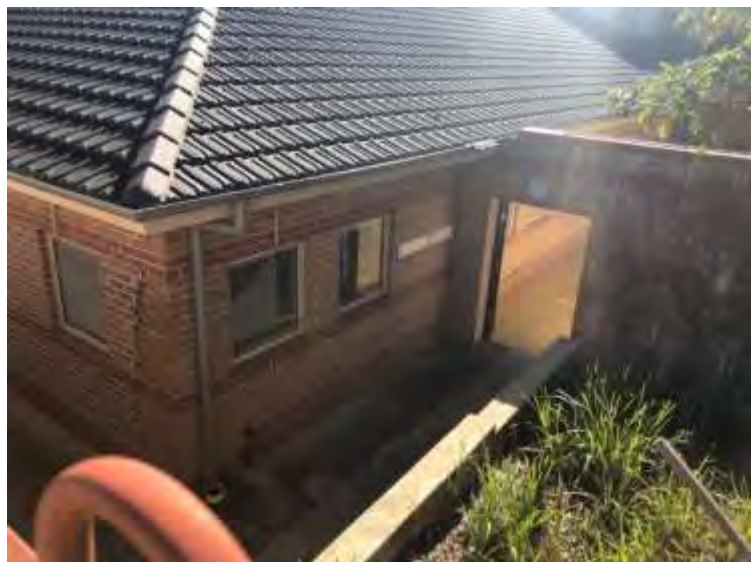
Defect ID A227
Area Type External
Location Building 14 General façade
Element General Shot
Defect Type NA
Length (mm) NA
Width (mm) NA
General Comments:
 In reasonable condition

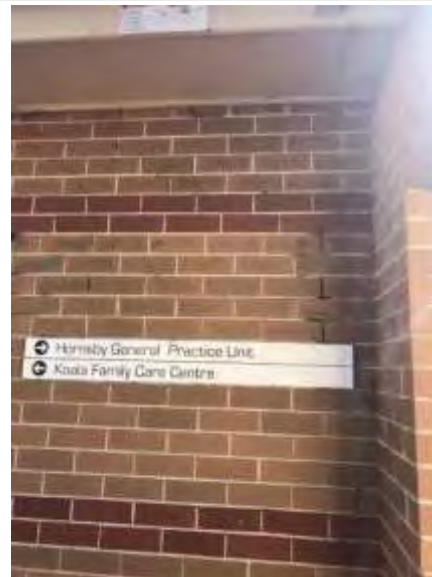
Defect ID A228

General Comments:
In reasonable condition

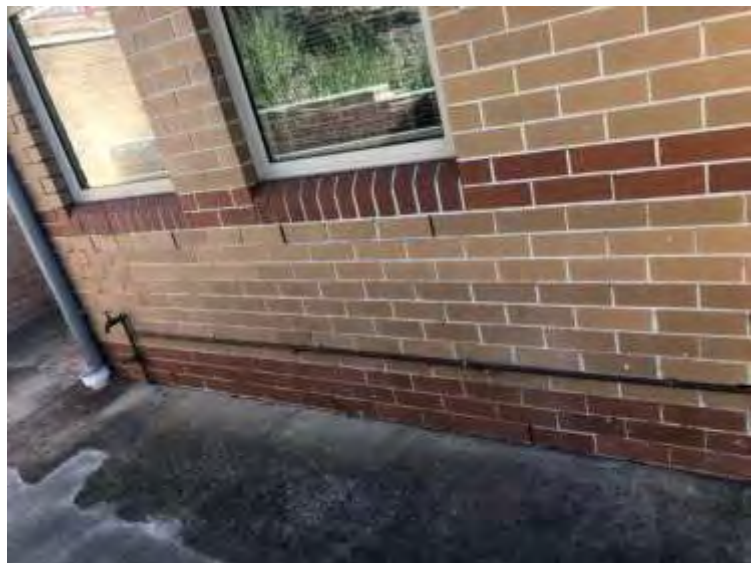
Defect ID A229

General Comments:
In reasonable condition

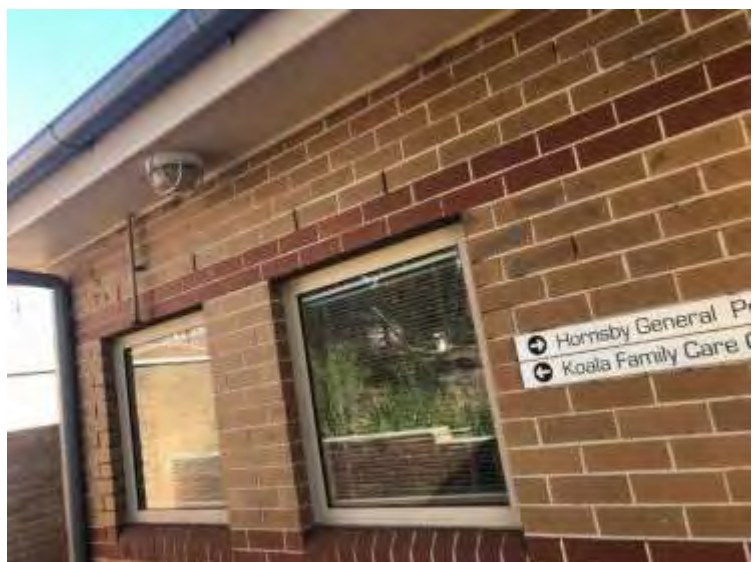
Defect ID A230

General Comments:
In reasonable condition

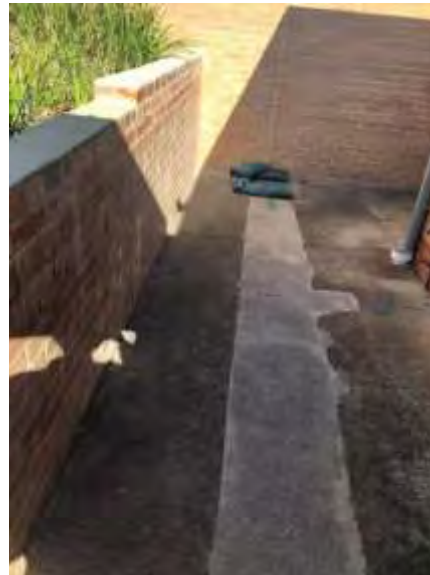
Defect ID A231
Area Type External
Location Building 14 Footpath
Element General Shot
Defect Type NA
Length (mm) NA
Width (mm) NA
General Comments:
 In reasonable condition

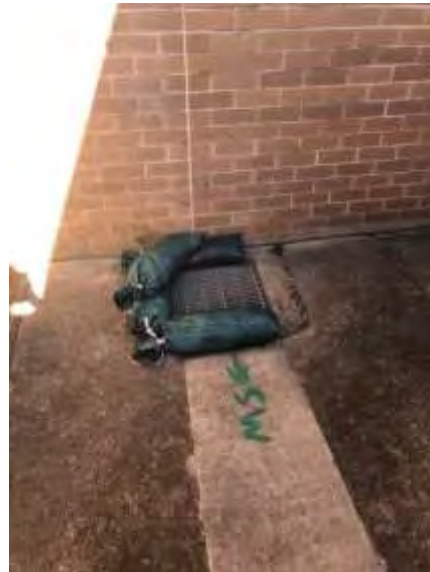
Defect ID A232
Area Type External
Location Building 14 Stormwater pit
Element General Shot
Defect Type NA
Length (mm) NA
Width (mm) NA
General Comments:
 In reasonable condition

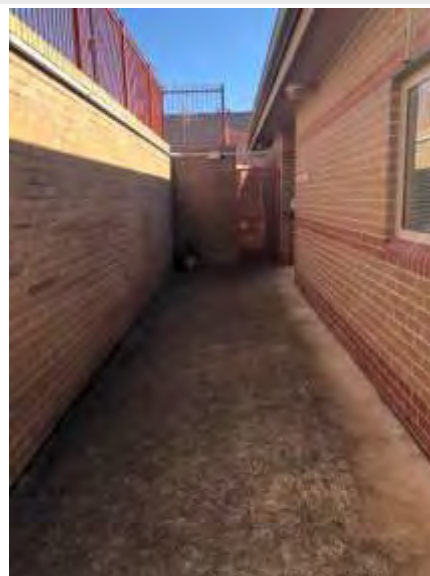
Defect ID A233
Area Type External
Location Building 14 Footpath
Element General Shot
Defect Type NA
Length (mm) NA
Width (mm) NA
General Comments:
 In reasonable condition

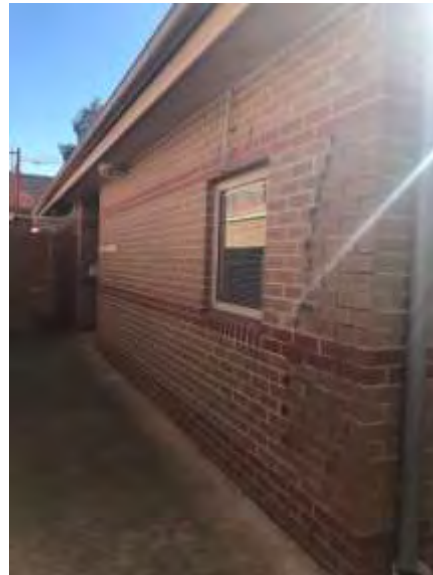
Defect ID A234
Area Type External
Location Building 14 General
façade
Element General Shot
Defect Type NA
Length (mm) NA
Width (mm) NA
General Comments:
In reasonable condition

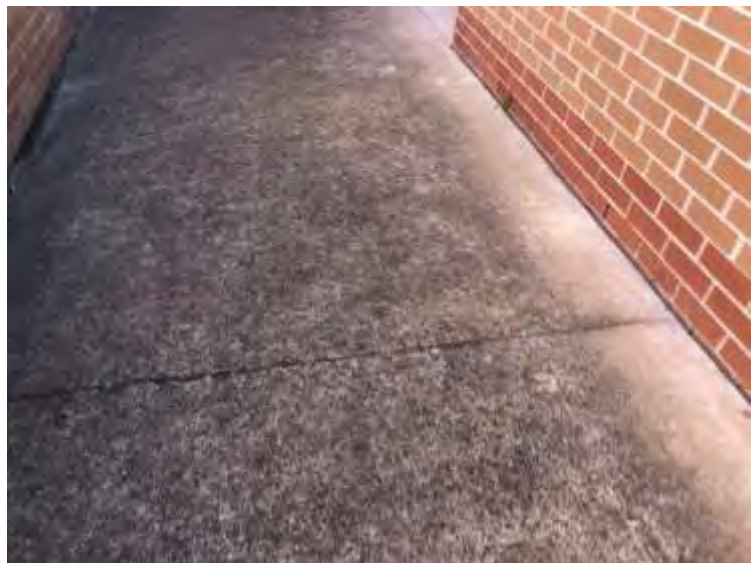
Defect ID A235
Area Type External
Location Building 14 Footpath
Element General Shot
Defect Type NA
Length (mm) NA
Width (mm) NA
General Comments:
In reasonable condition

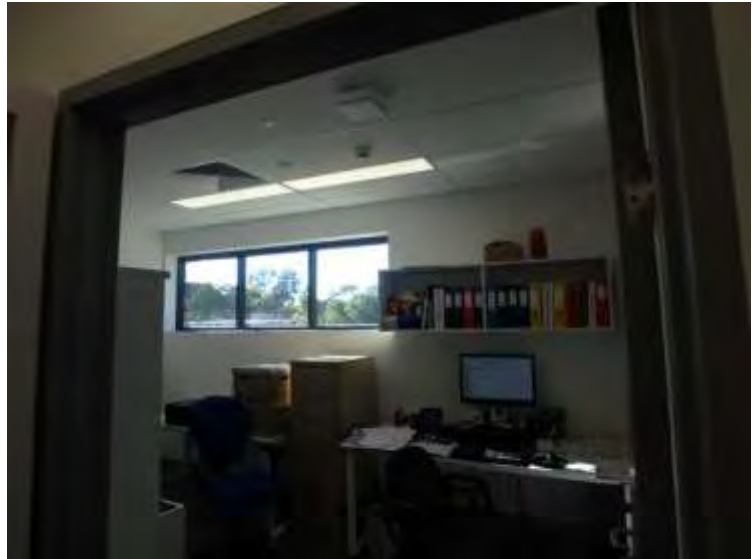
Defect ID A1
Area Type Internal
Location Engineering Office
Element General Shot
Defect Type NA
Length (mm) NA
Width (mm) NA
General Comments:
 In reasonable condition

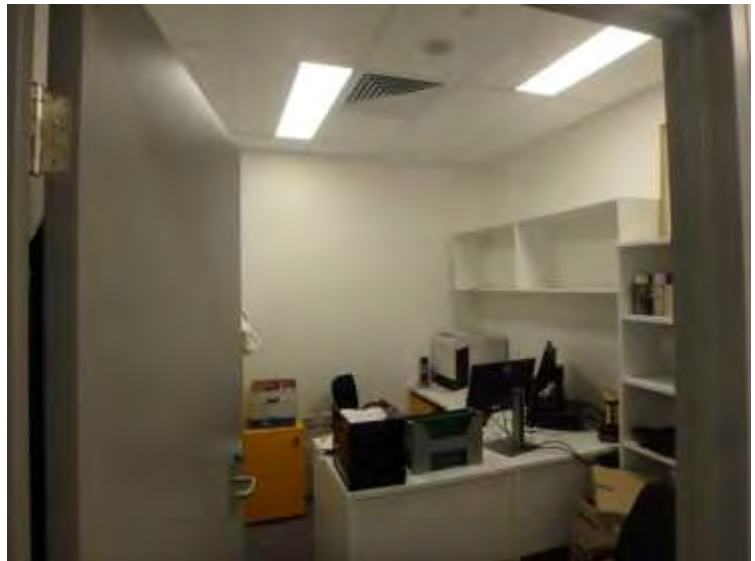
Defect ID A2
Area Type Internal
Location Engineering Office
Element General Shot
Defect Type NA
Length (mm) NA
Width (mm) NA
General Comments:
 In reasonable condition

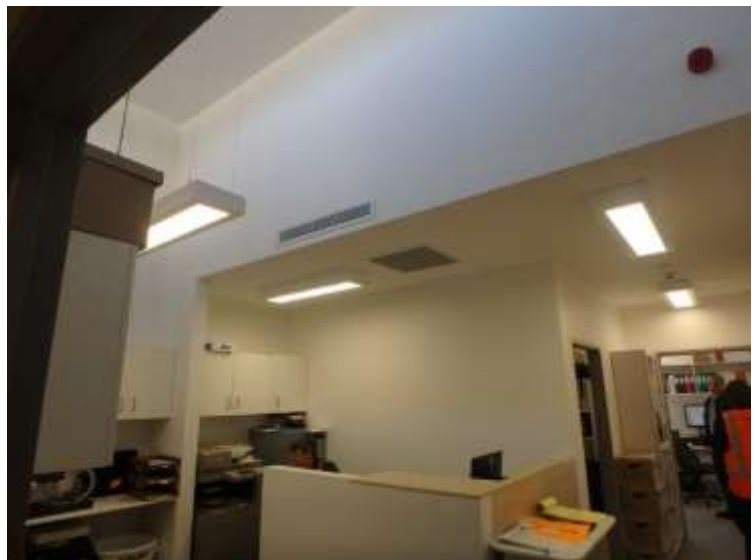
Defect ID A3
Area Type Internal
Location Engineering Reception
Element General Shot
Defect Type NA
Length (mm) NA
Width (mm) NA
General Comments:
 In reasonable condition

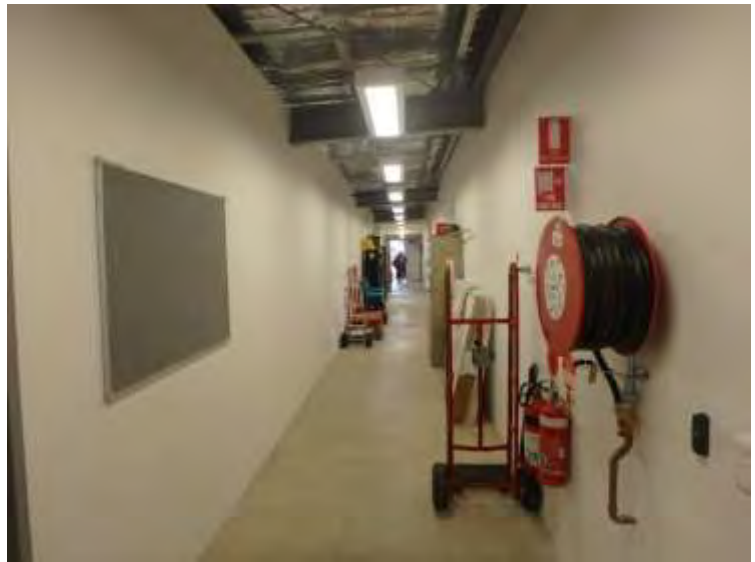
Defect ID A4
Area Type Internal
Location Engineering Hallway
Element General Shot
Defect Type NA
Length (mm) NA
Width (mm) NA
General Comments:
 In reasonable condition

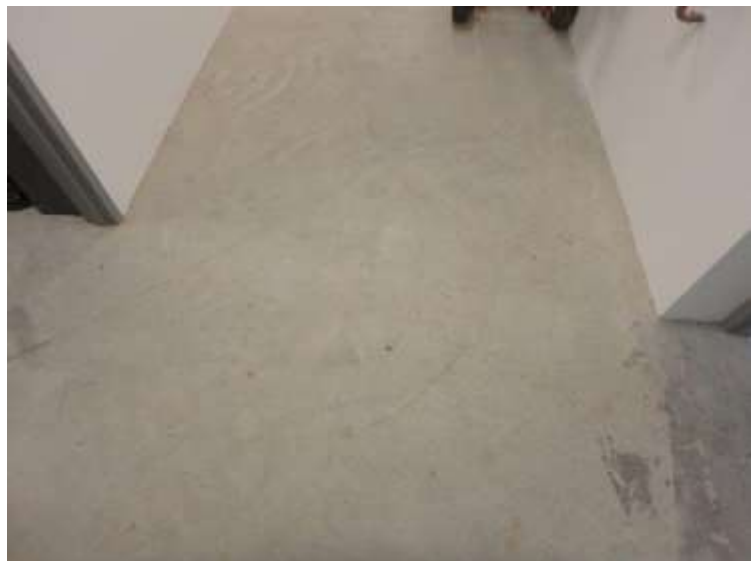
Defect ID A5
Area Type Internal
Location Engineering Hallway
Element Concrete
Defect Type Crack
Length (mm) 2000
Width (mm) 0.5
General Comments:
 Hairline cracking

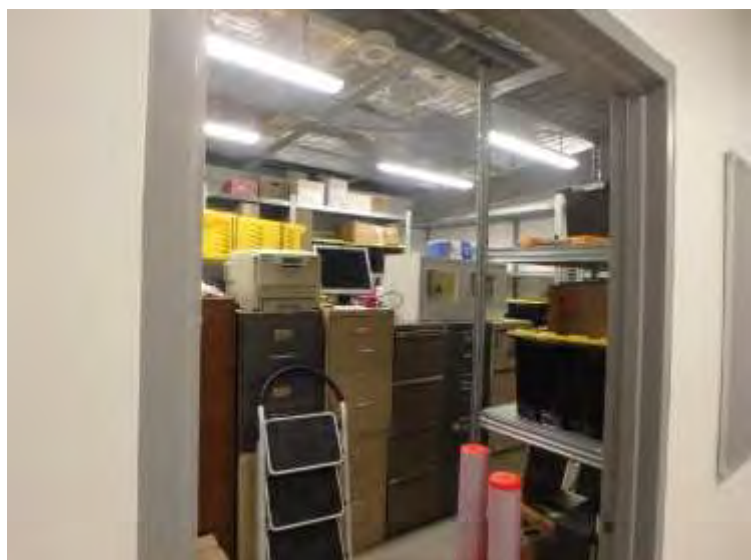
Defect ID A6
Area Type Internal
Location Engineering Storage Room
Element General Shot
Defect Type NA
Length (mm) NA
Width (mm) NA
General Comments:
 In reasonable condition

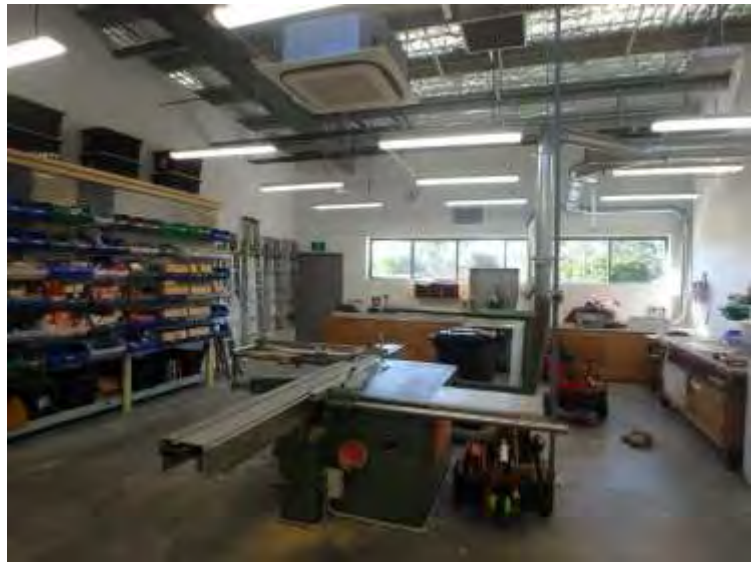
Defect ID A7
Area Type Internal
Location Engineering Workshop
Element General Shot
Defect Type NA
Length (mm) NA
Width (mm) NA
General Comments:
 In reasonable condition
