Council Assets Surrounding Hornsby Hospital

Dilapidation Report
80818469

Prepared for	Watpac Construction Pty Ltd
Project Name	Dilapidation Report
File Reference	Dilapidation Report - Hornsby Hospital Council Assets-2018-06-28.docx
Job Reference	80818469
Date	June 2018

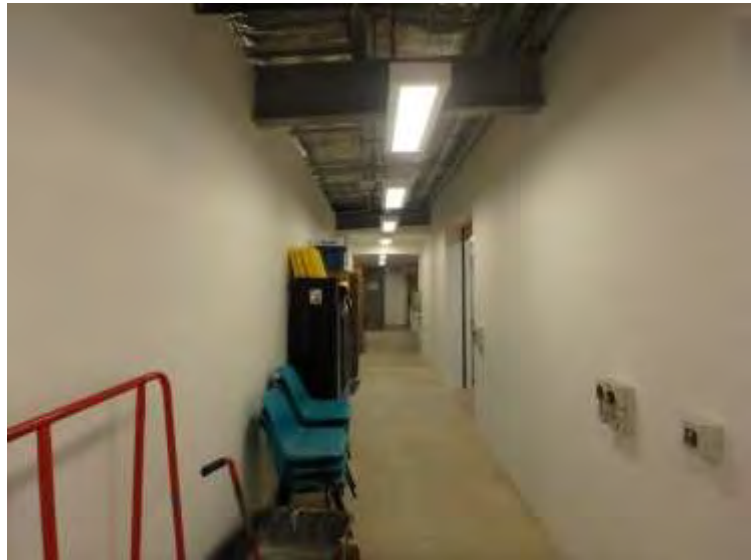
Defect ID A8
Area Type Internal
Location Engineering Hallway
Element General Shot
Defect Type NA
Length (mm) NA
Width (mm) NA
General Comments:
 In reasonable condition

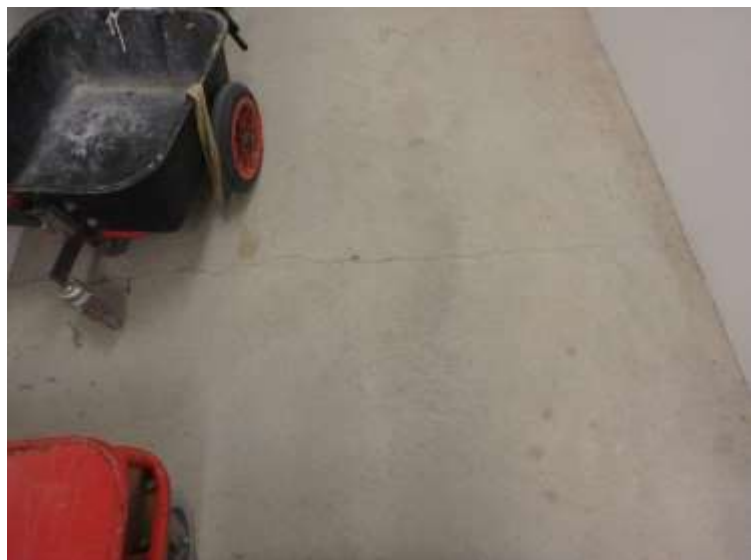
Defect ID A9
Area Type Internal
Location Engineering Hallway
Element Concrete
Defect Type Crack
Length (mm) 2000
Width (mm) 0.5
General Comments:
 Hairline cracking

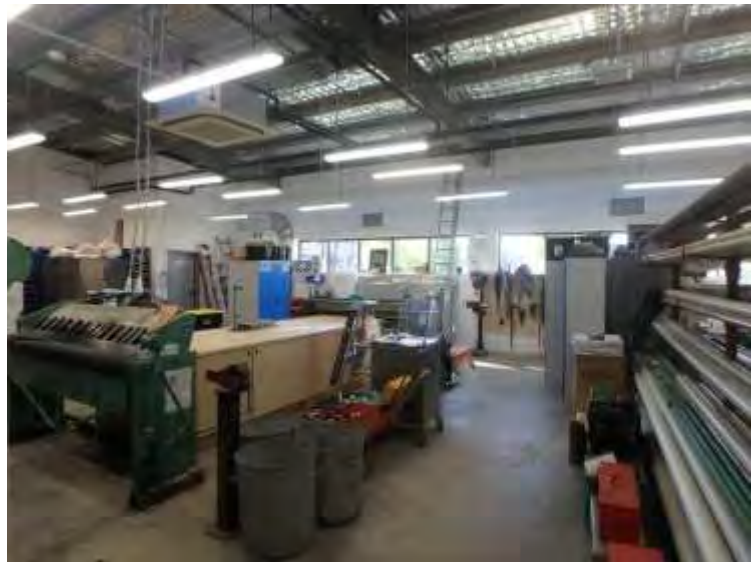
Defect ID A10
Area Type Internal
Location Engineering Plumber's Workshop
Element General Shot
Defect Type NA
Length (mm) NA
Width (mm) NA
General Comments:
 In reasonable condition

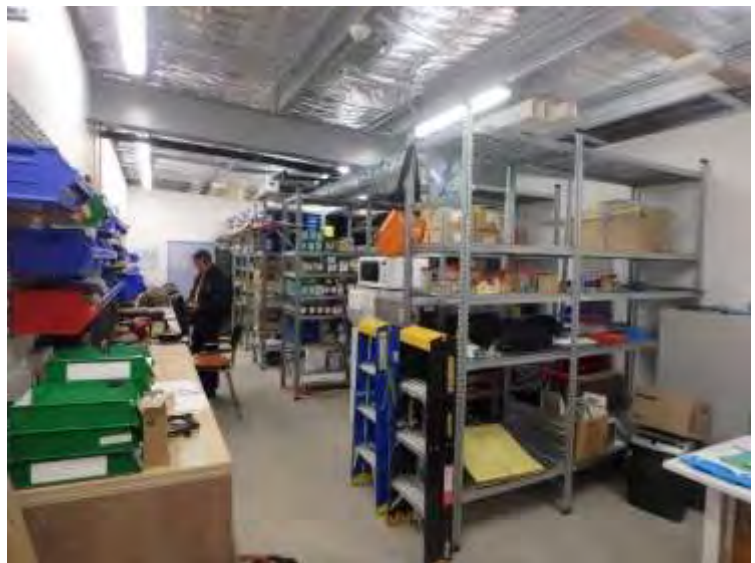
Defect ID A11
Area Type Internal
Location Engineering Electrician's Workshop
Element General Shot
Defect Type NA
Length (mm) NA
Width (mm) NA
General Comments:
 In reasonable condition

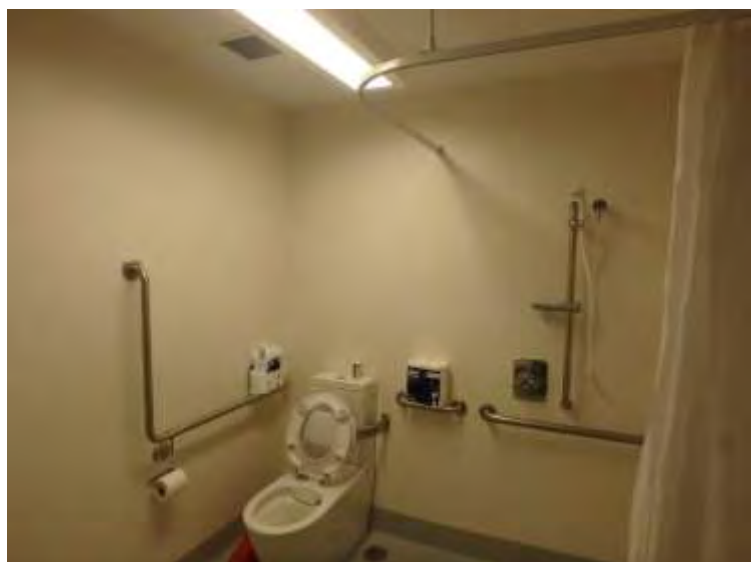
Defect ID A12
Area Type Internal
Location Engineering Unisex toilet
Element General Shot
Defect Type NA
Length (mm) NA
Width (mm) NA
General Comments:
 In reasonable condition

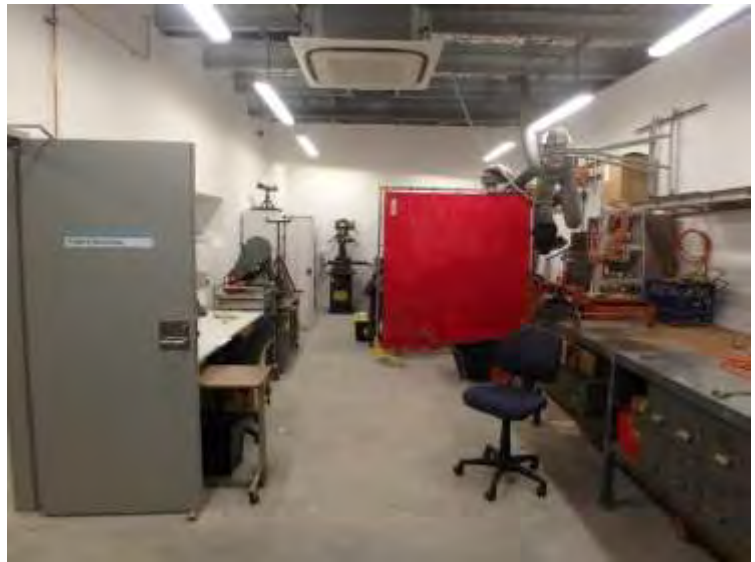
Defect ID A13
Area Type Internal
Location Engineering Fitter's Workshop
Element General Shot
Defect Type NA
Length (mm) NA
Width (mm) NA
General Comments:
 In reasonable condition

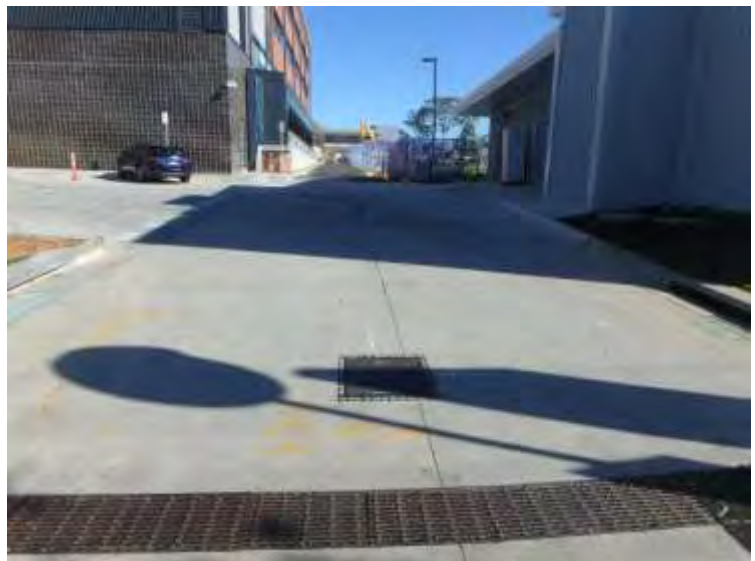
Defect ID A14
Area Type External
Location Engineering Driveway
Element General Shot
Defect Type NA
Length (mm) NA
Width (mm) NA
General Comments:
 In reasonable condition

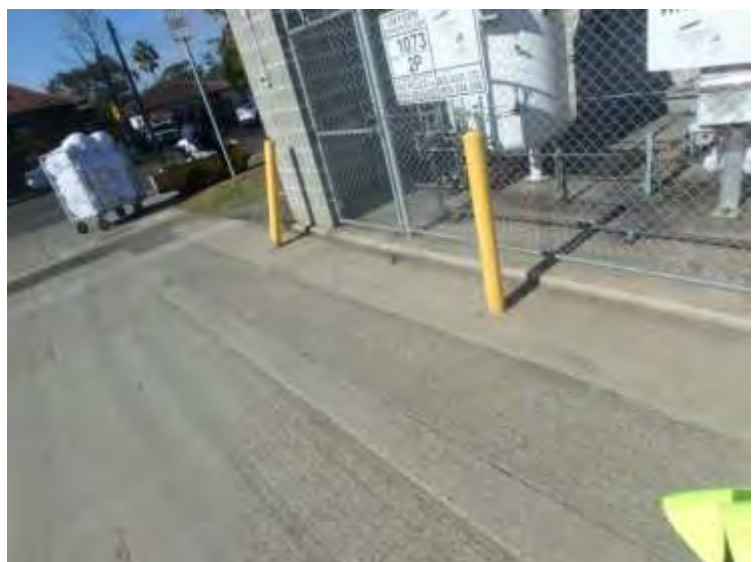
Defect ID A15
Area Type External
Location Engineering Driveway
Element General Shot
Defect Type NA
Length (mm) NA
Width (mm) NA
General Comments:
 In reasonable condition

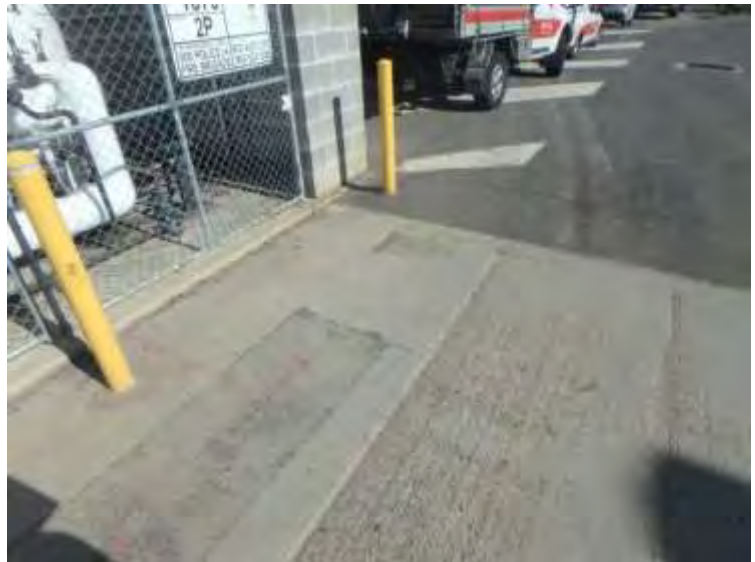
Defect ID A16
Area Type External
Location Engineering Driveway
Element General Shot
Defect Type NA
Length (mm) NA
Width (mm) NA
General Comments:
 In reasonable condition

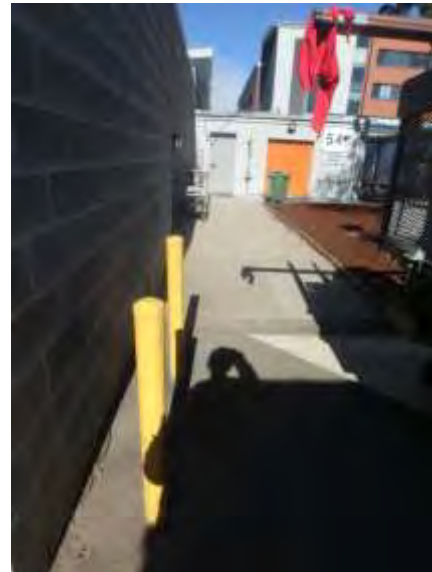
Defect ID A17
Area Type External
Location Engineering Footpath
Element General Shot
Defect Type NA
Length (mm) NA
Width (mm) NA
General Comments:
 In reasonable condition

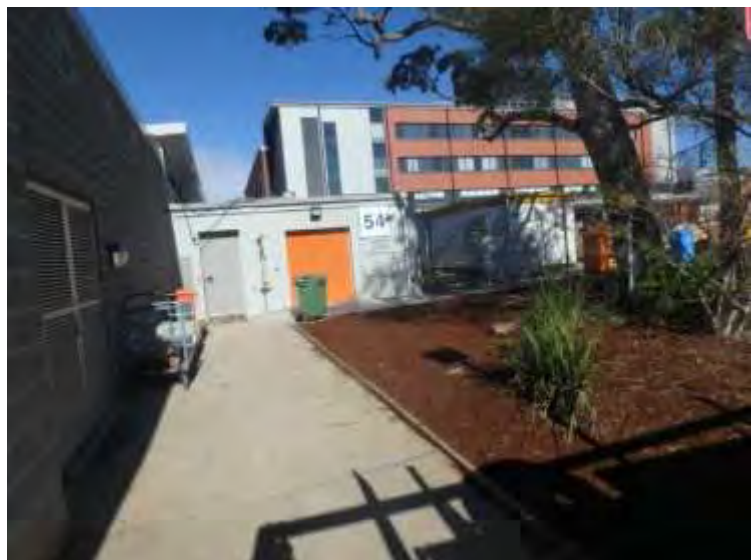
Defect ID A18
Area Type External
Location Engineering Footpath
Element General Shot
Defect Type NA
Length (mm) NA
Width (mm) NA
General Comments:
 In reasonable condition

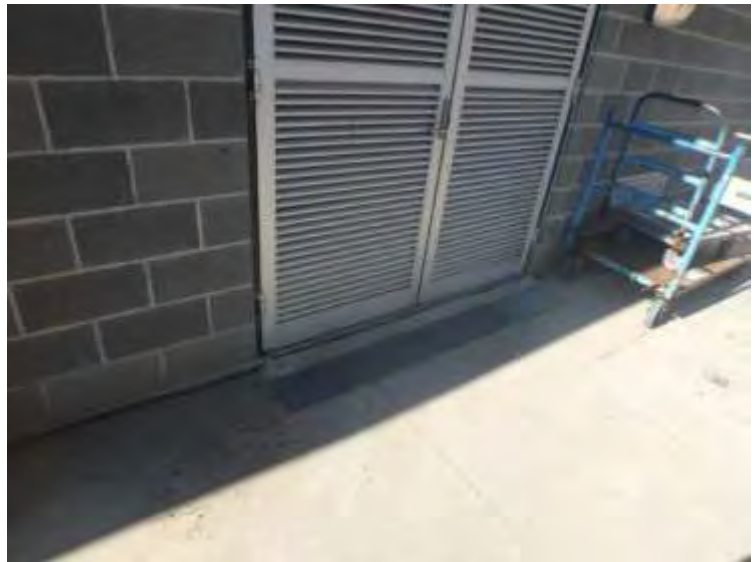
Defect ID A19
Area Type External
Location Engineering Footpath
Element General Shot
Defect Type NA
Length (mm) NA
Width (mm) NA
General Comments:
 In reasonable condition

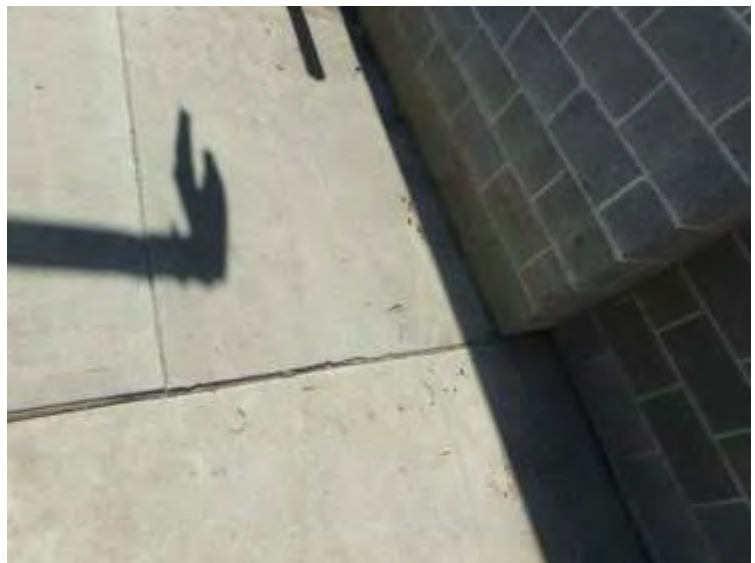
Defect ID A20
Area Type External
Location Engineering Footpath
Element General Shot
Defect Type NA
Length (mm) NA
Width (mm) NA
General Comments:
 In reasonable condition

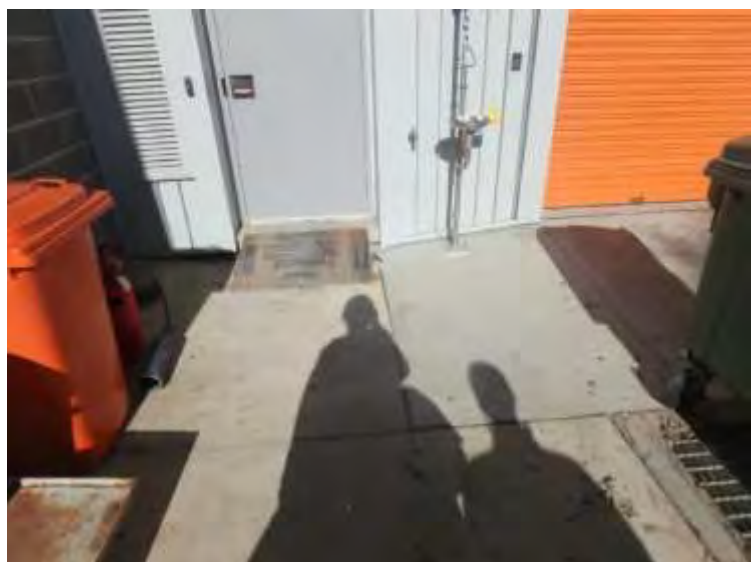
Defect ID A21
Area Type External
Location Engineering Footpath
Element General Shot
Defect Type NA
Length (mm) NA
Width (mm) NA
General Comments:
 In reasonable condition

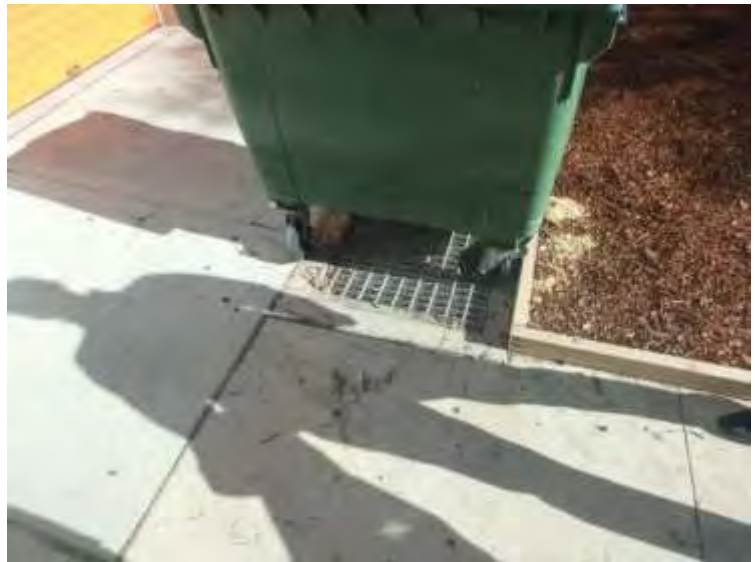
Defect ID A22
Area Type External
Location Engineering Footpath
Element General Shot
Defect Type NA
Length (mm) NA
Width (mm) NA
General Comments:
 In reasonable condition

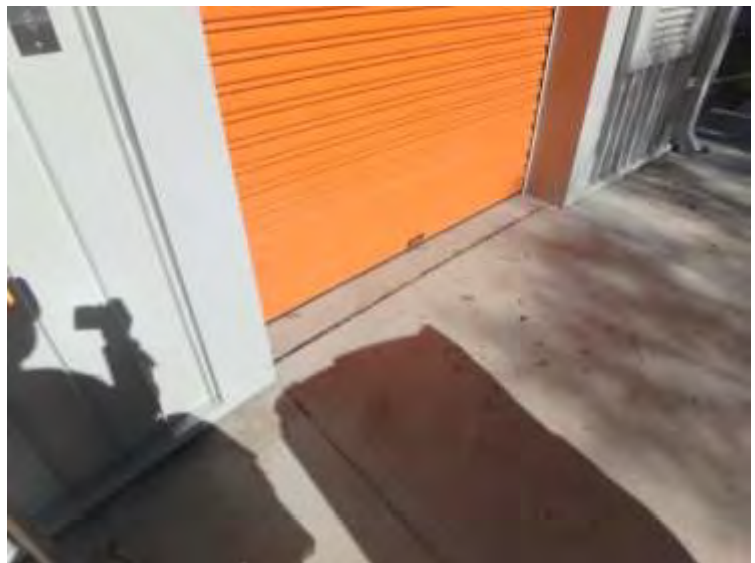
Defect ID A23
Area Type External
Location Engineering Footpath
Element General Shot
Defect Type NA
Length (mm) NA
Width (mm) NA
General Comments:
 In reasonable condition

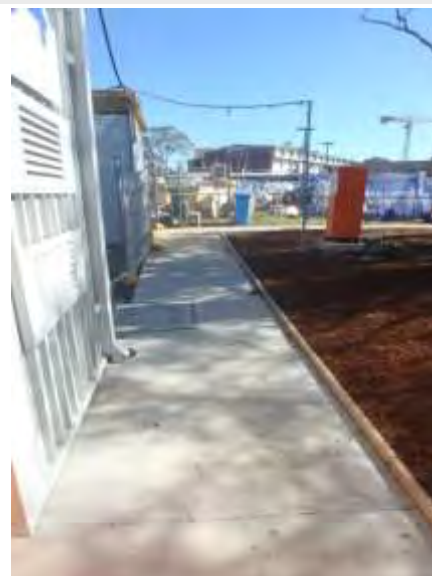
Defect ID A24
Area Type External
Location Engineering Footpath
Element General Shot
Defect Type NA
Length (mm) NA
Width (mm) NA
General Comments:
 In reasonable condition

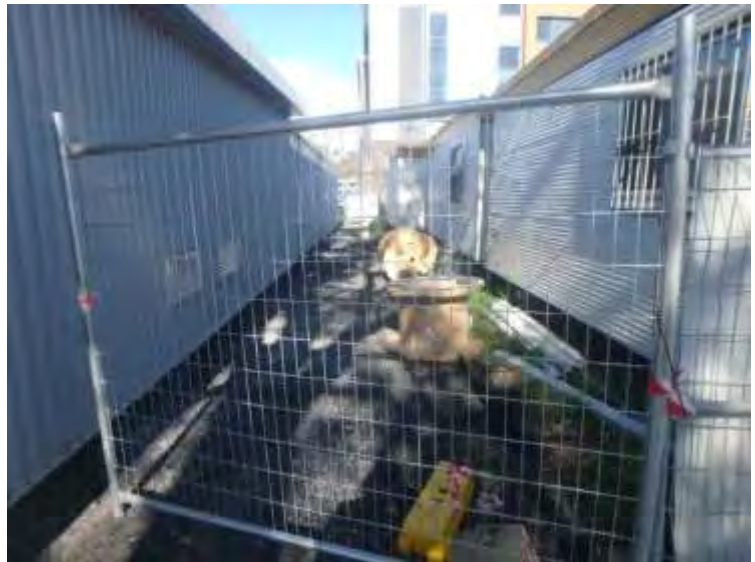
Defect ID A25
Area Type External
Location Engineering Footpath
Element General Shot
Defect Type NA
Length (mm) NA
Width (mm) NA
General Comments:
 In reasonable condition

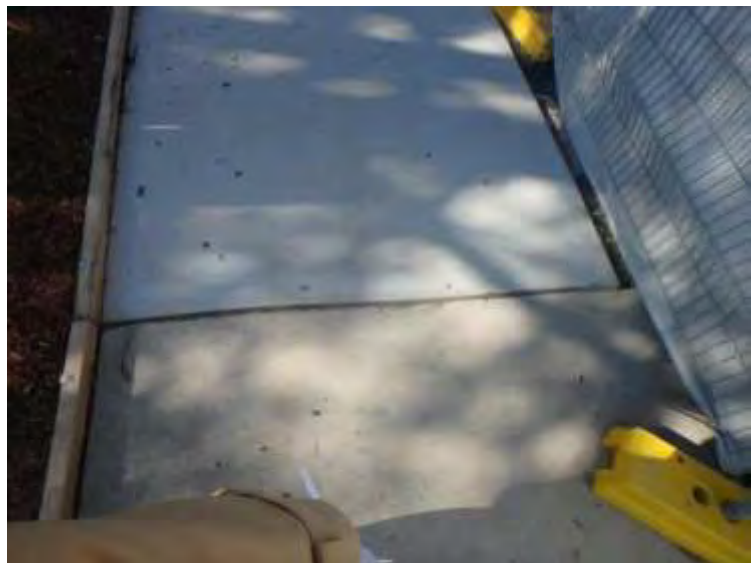
Defect ID A26
Area Type External
Location Engineering Footpath
Element General Shot
Defect Type NA
Length (mm) NA
Width (mm) NA
General Comments:
 In reasonable condition

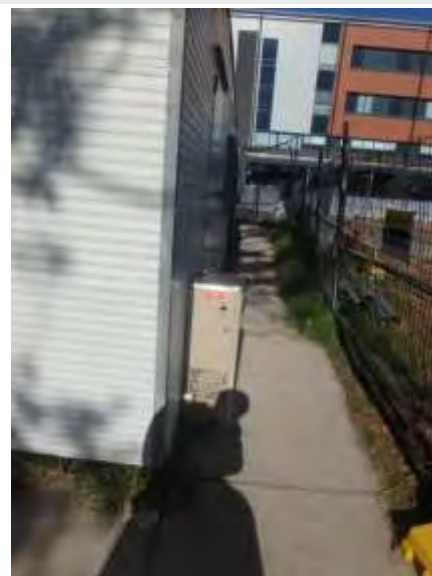
Defect ID A27
Area Type External
Location Engineering Footpath
Element General Shot
Defect Type NA
Length (mm) NA
Width (mm) NA
General Comments:
 In reasonable condition

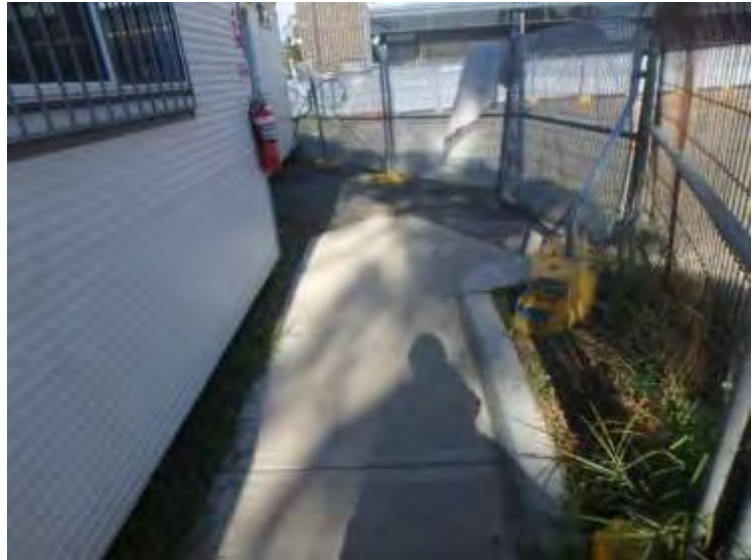
Defect ID A28
Area Type External
Location Engineering Footpath
Element General Shot
Defect Type NA
Length (mm) NA
Width (mm) NA
General Comments:
 In reasonable condition

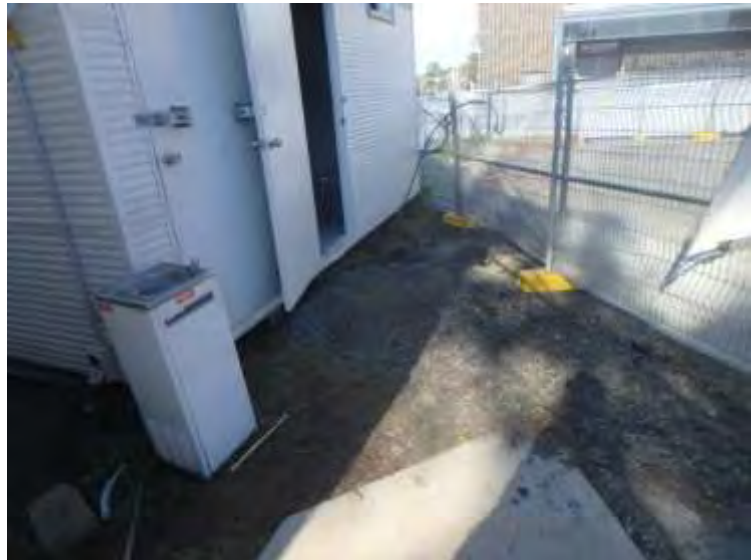
Defect ID A29
Area Type External
Location Engineering Footpath
Element General Shot
Defect Type NA
Length (mm) NA
Width (mm) NA
General Comments:
 In reasonable condition

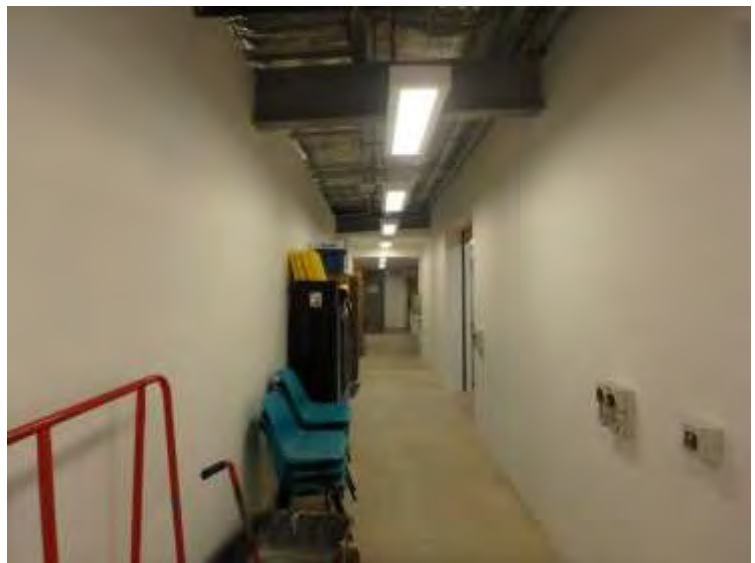
Defect ID A8
Area Type Internal
Location Engineering Hallway
Element General Shot
Defect Type NA
Length (mm) NA
Width (mm) NA
General Comments:
 In reasonable condition

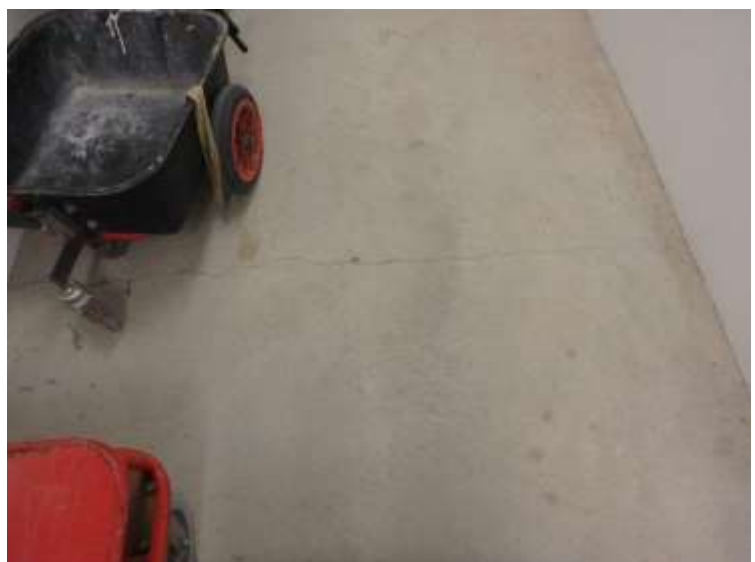
Defect ID A9
Area Type Internal
Location Engineering Hallway
Element Concrete
Defect Type Crack
Length (mm) 2000
Width (mm) 0.5
General Comments:
 Hairline cracking

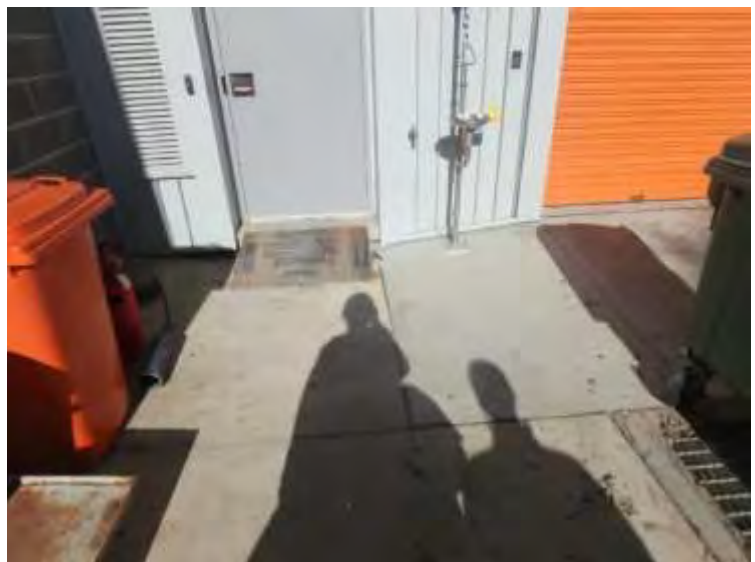
Defect ID A21
Area Type External
Location Engineering Footpath
Element General Shot
Defect Type NA
Length (mm) NA
Width (mm) NA
General Comments:
 In reasonable condition

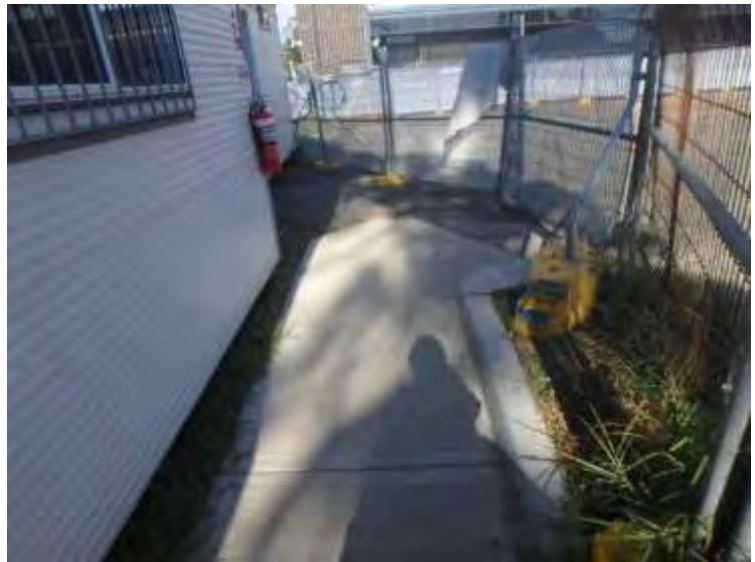
Defect ID A28
Area Type External
Location Engineering Footpath
Element General Shot
Defect Type NA
Length (mm) NA
Width (mm) NA
General Comments:
 In reasonable condition

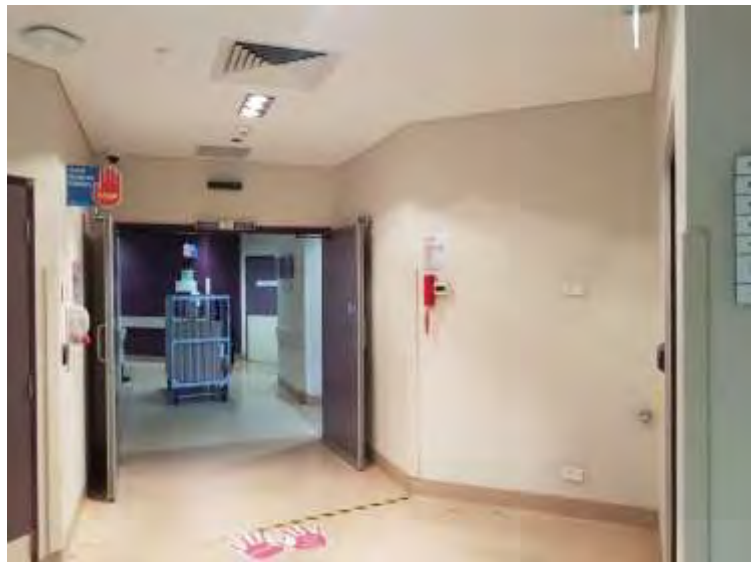
Defect ID A30
Area Type Internal
Location Hope Building Level 2
 Maternity Entrance
Element General Shot
Defect Type NA
Length (mm) NA
Width (mm) NA
General Comments:
 In reasonable condition

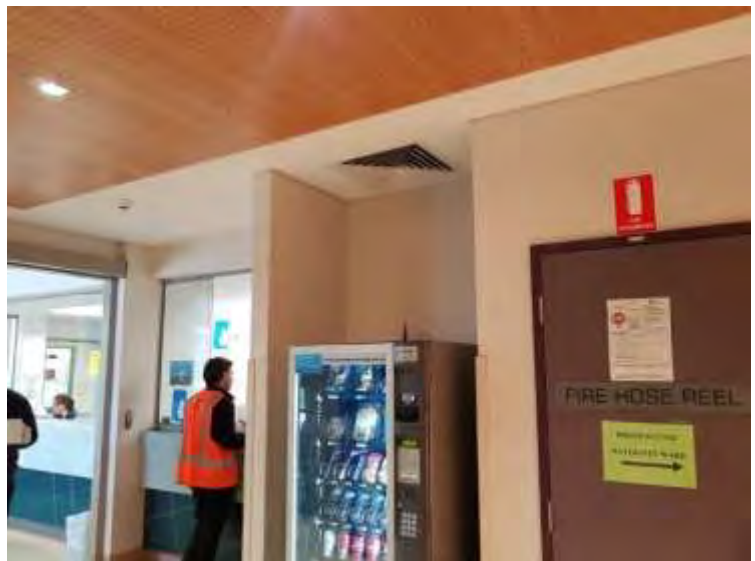
Defect ID A31
Area Type Internal
Location Hope Building Level 2
 Maternity Entrance
Element General Shot
Defect Type NA
Length (mm) NA
Width (mm) NA
General Comments:
 In reasonable condition

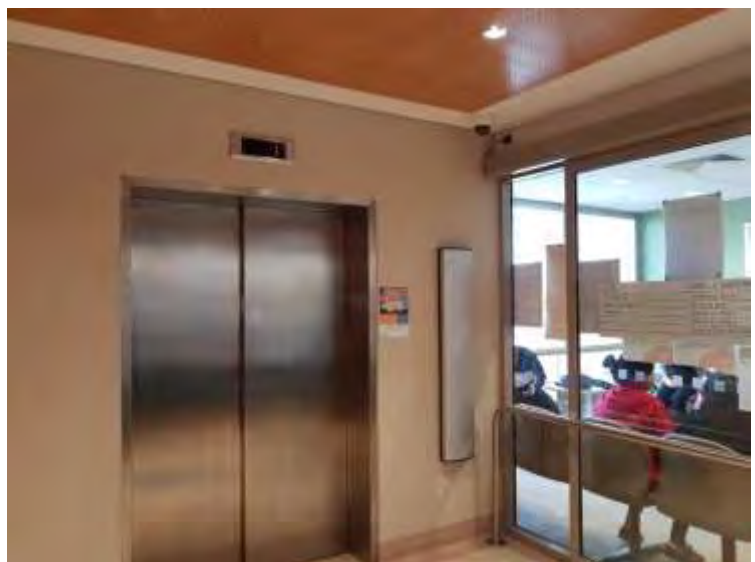
Defect ID A32
Area Type Internal
Location Hope Building Level 2
 Maternity Entrance
Element General Shot
Defect Type NA
Length (mm) NA
Width (mm) NA
General Comments:
 In reasonable condition

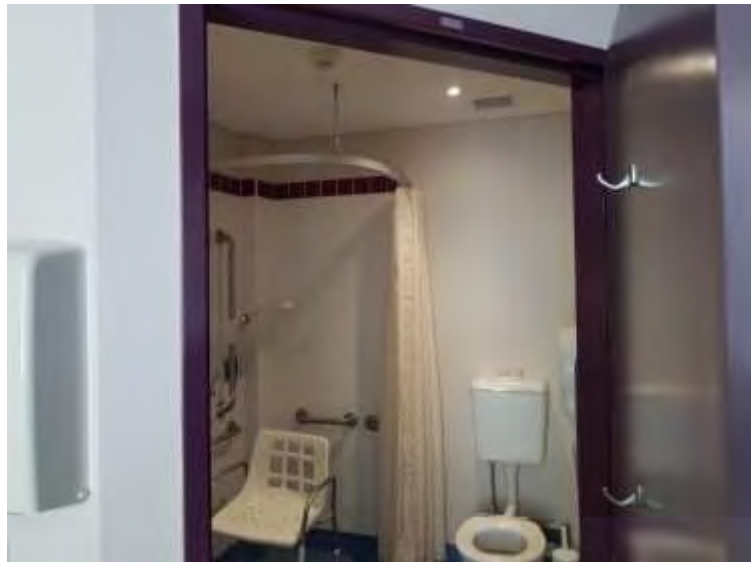
Defect ID A33
Area Type Internal
Location Hope Building Level 2
 Maternity Room 1
Element General Shot
Defect Type NA
Length (mm) NA
Width (mm) NA
General Comments:
 In reasonable condition

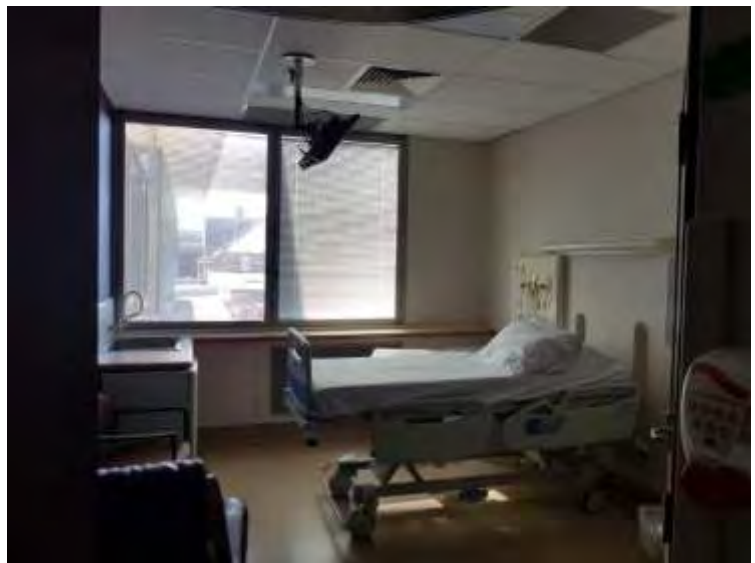
Defect ID A34
Area Type Internal
Location Hope Building Level 2
 Maternity Room 1
Element General Shot
Defect Type NA
Length (mm) NA
Width (mm) NA
General Comments:
 In reasonable condition

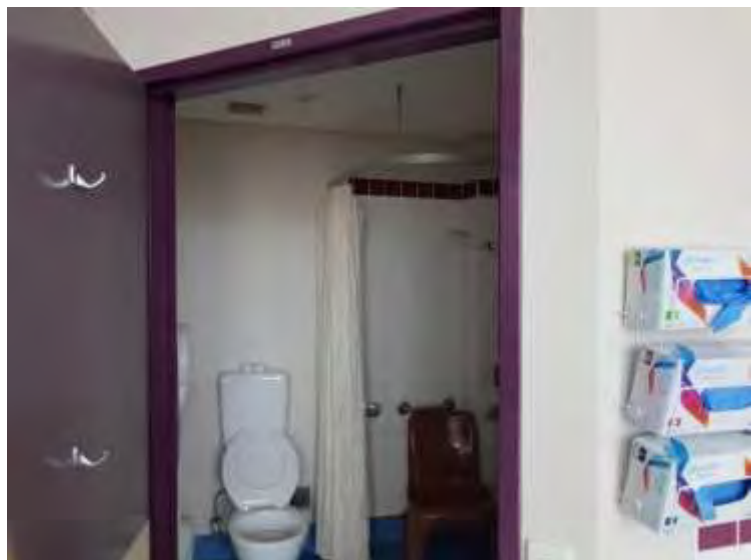
Defect ID A35
Area Type Internal
Location Hope Building Level 2
 Maternity Room 4
Element General Shot
Defect Type NA
Length (mm) NA
Width (mm) NA
General Comments:
 In reasonable condition

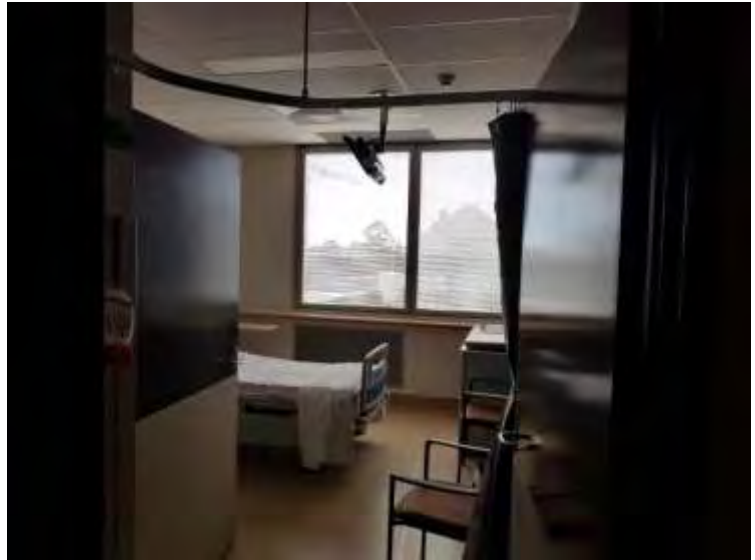
Defect ID A36

General Comments:
In reasonable condition

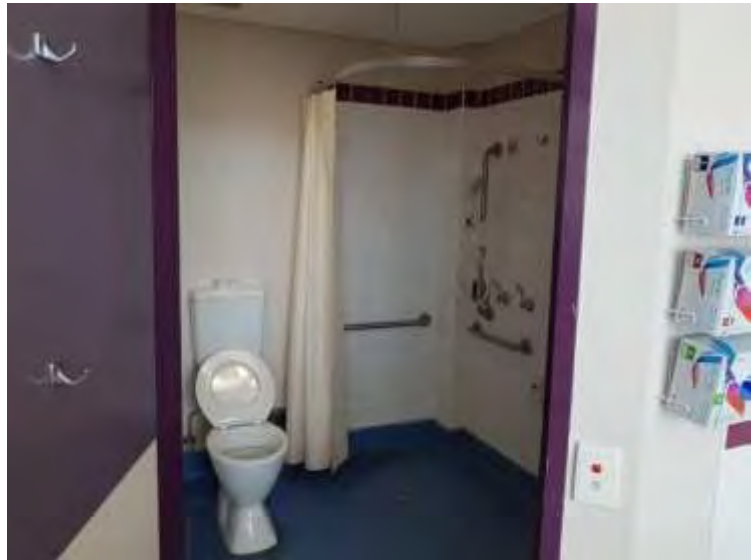
Defect ID A37

General Comments:
In reasonable condition

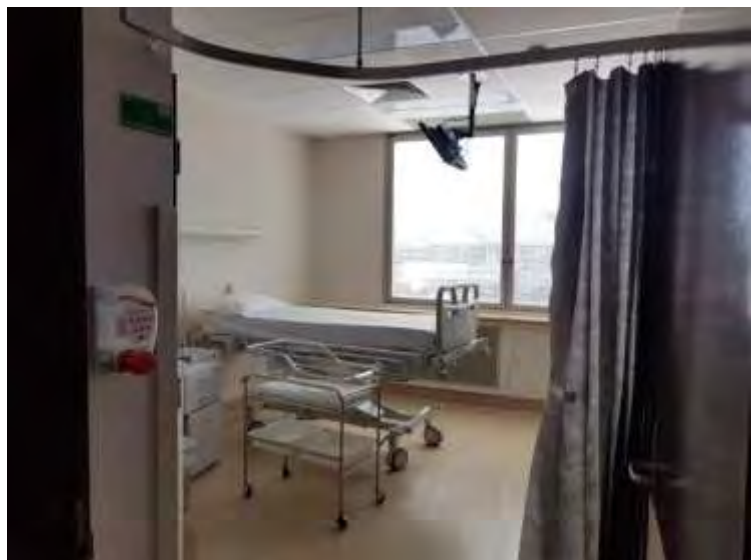
Defect ID A38

General Comments:
In reasonable condition

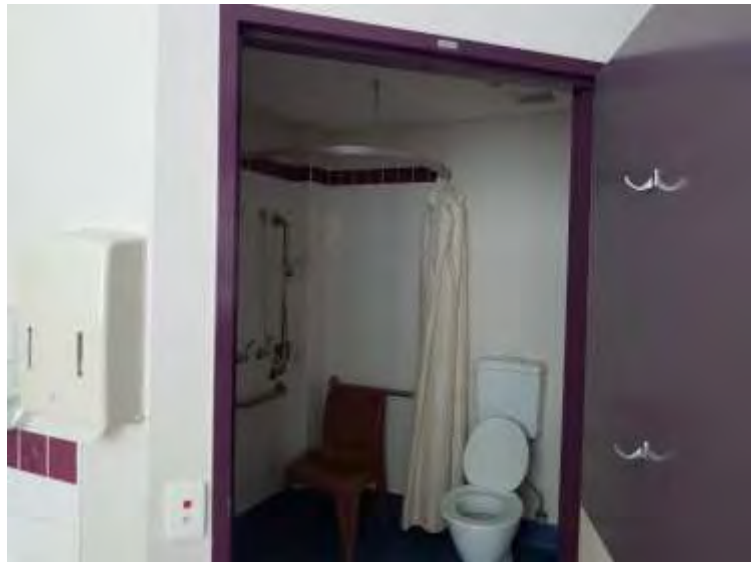
Defect ID A39
Area Type Internal
Location Hope Building Level 2
 Maternity Room 7
Element General Shot
Defect Type NA
Length (mm) NA
Width (mm) NA
General Comments:
 In reasonable condition

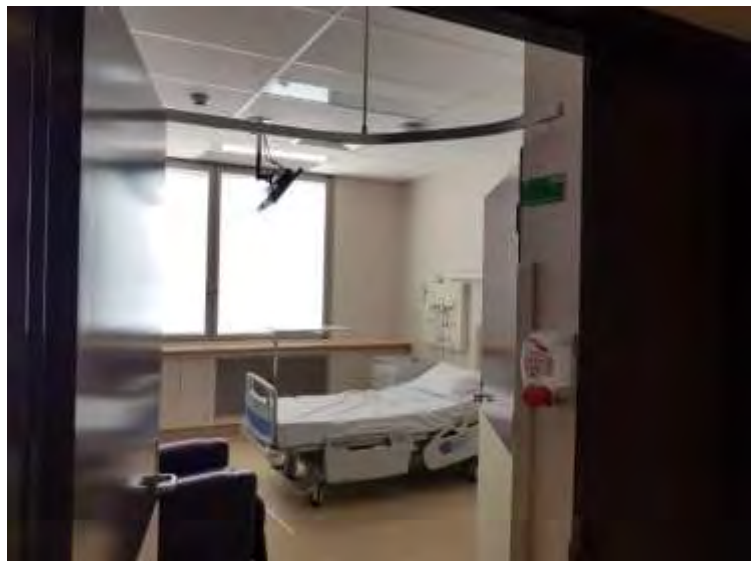
Defect ID A40
Area Type Internal
Location Hope Building Level 2
 Maternity Room 7
Element General Shot
Defect Type NA
Length (mm) NA
Width (mm) NA
General Comments:
 In reasonable condition

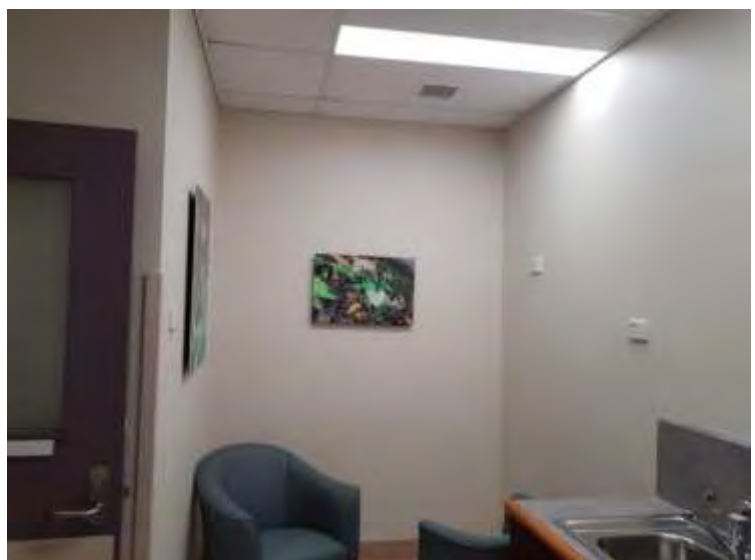
Defect ID A41
Area Type Internal
Location Hope Building Level 2
 Maternity Quiet room
Element General Shot
Defect Type NA
Length (mm) NA
Width (mm) NA
General Comments:
 In reasonable condition

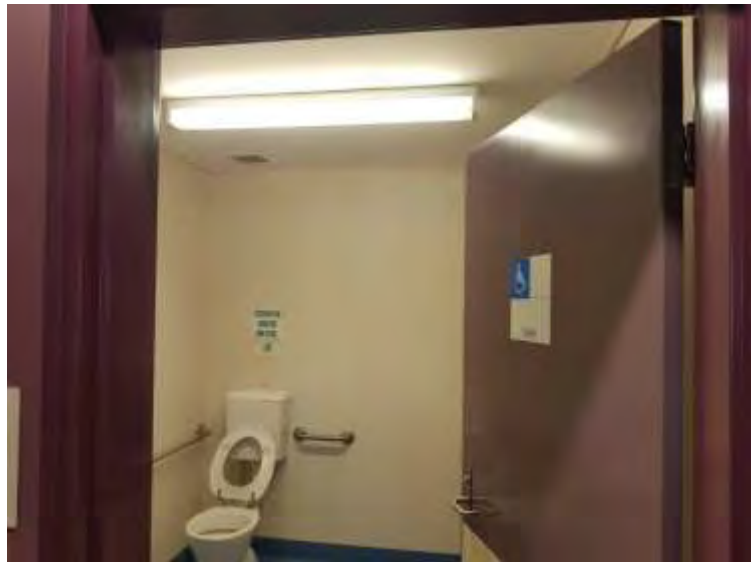
Defect ID A42
Area Type Internal
Location Hope Building Level 2
 Maternity Disabled Toilet
Element General Shot
Defect Type NA
Length (mm) NA
Width (mm) NA
General Comments:
 In reasonable condition

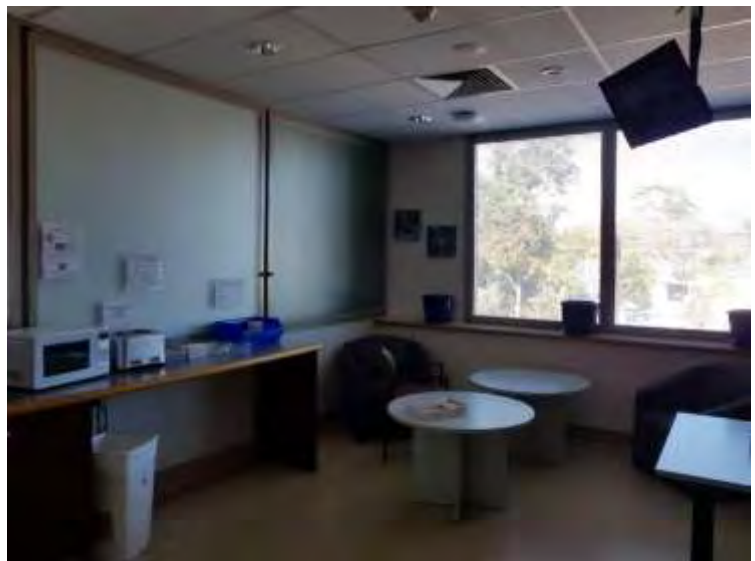
Defect ID A43
Area Type Internal
Location Hope Building Level 2
 Maternity Patient
Element General Shot
Defect Type NA
Length (mm) NA
Width (mm) NA
General Comments:
 In reasonable condition

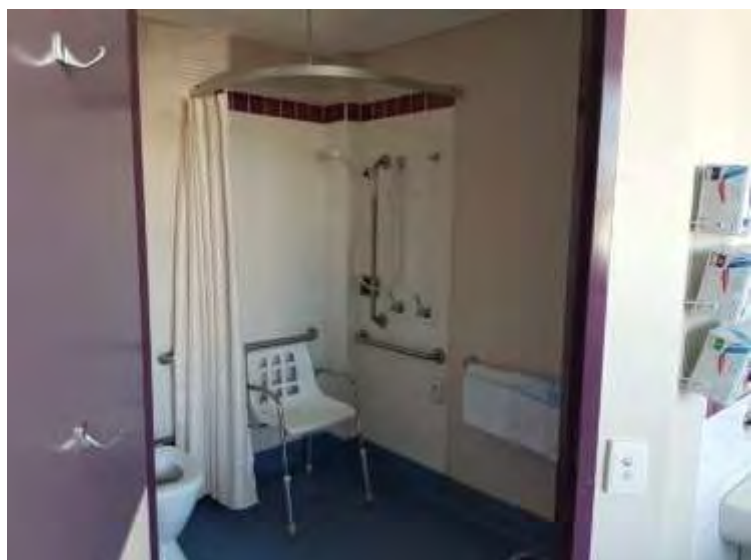
Defect ID A44
Area Type Internal
Location Hope Building Level 2
 Maternity Room 9
Element General Shot
Defect Type NA
Length (mm) NA
Width (mm) NA
General Comments:
 In reasonable condition

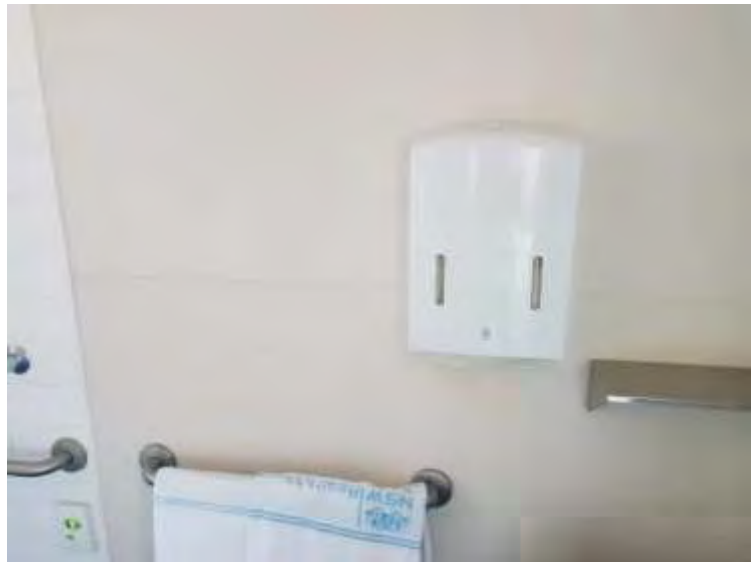
Defect ID A45
Area Type Internal
Location Hope Building Level 2
 Maternity Room 9
Element Plasterboard
Defect Type Crack
Length (mm) 4000
Width (mm) 0.5
General Comments:
 Horizontal cracking on wall

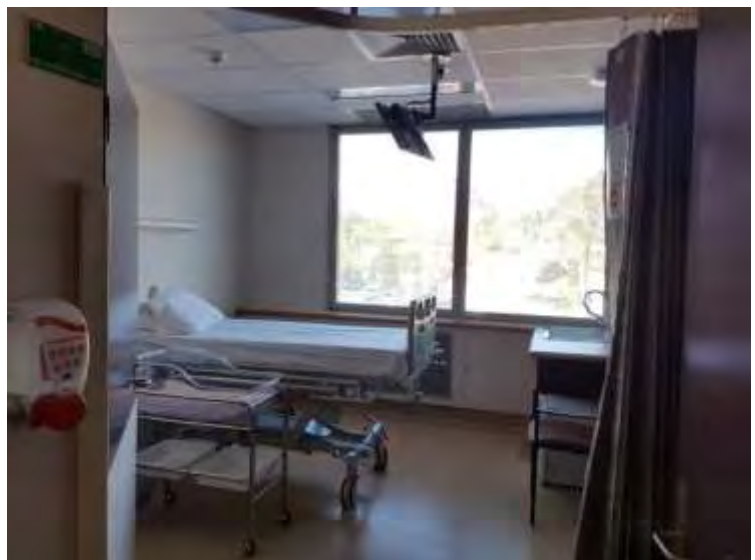
Defect ID A47
Area Type Internal
Location Hope Building Level 2
 Maternity Room 9
Element General Shot
Defect Type NA
Length (mm) NA
Width (mm) NA
General Comments:
 In reasonable condition

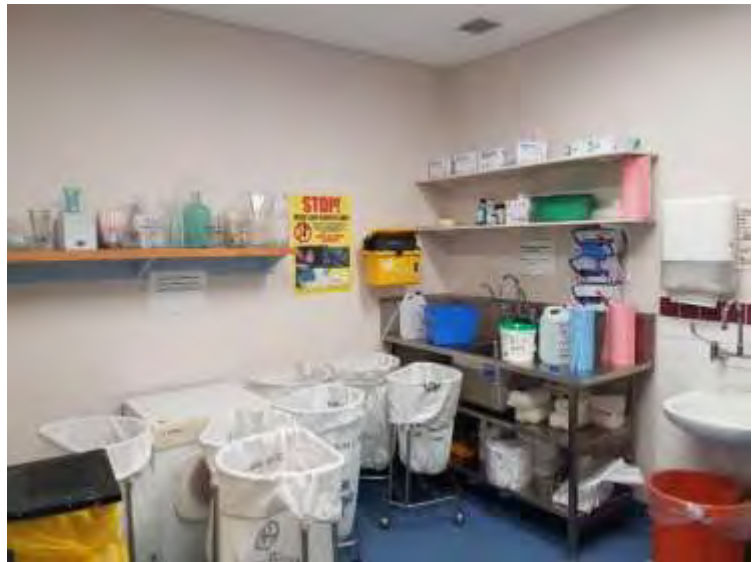
Defect ID A48
Area Type Internal
Location Hope Building Level 2
 Maternity Dirty Utility
Element General Shot
Defect Type NA
Length (mm) NA
Width (mm) NA
General Comments:
 In reasonable condition

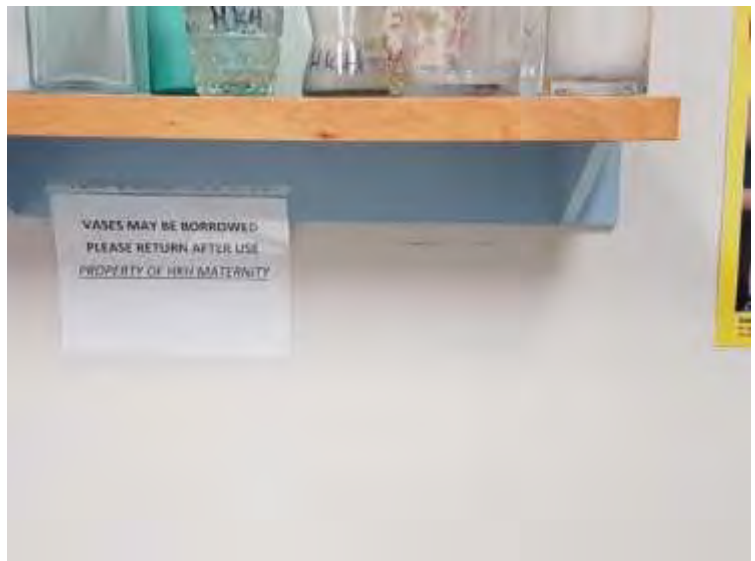
Defect ID A49
Area Type Internal
Location Hope Building Level 2
 Maternity Dirty Utility
Element Plasterboard
Defect Type Crack
Length (mm) 4000
Width (mm) <1mm
General Comments:
 Horizontal cracking on wall

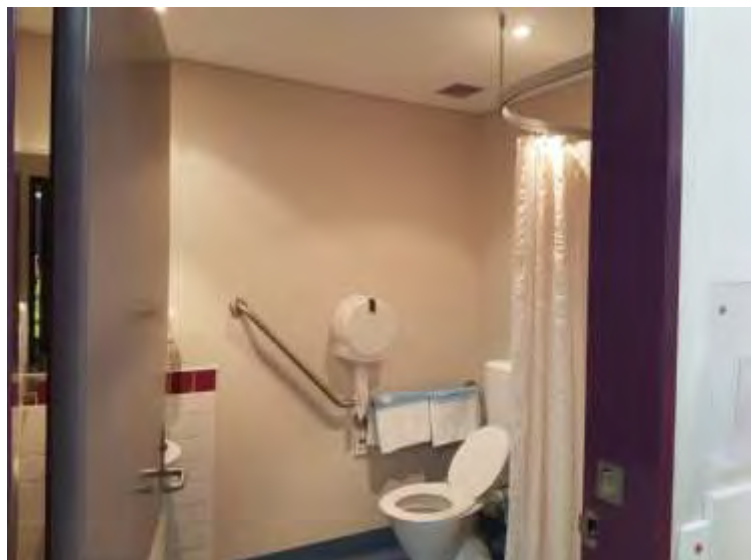
Defect ID A50
Area Type Internal
Location Hope Building Level 2
 Maternity Room 13 & 14
Element General Shot
Defect Type NA
Length (mm) NA
Width (mm) NA
General Comments:
 In reasonable condition

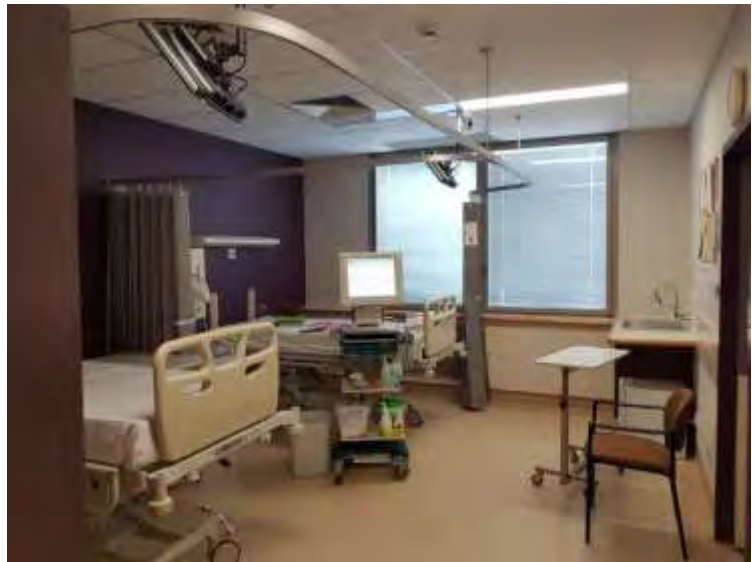
Defect ID A51
Area Type Internal
Location Hope Building Level 2
 Maternity Room 13 & 14
Element General Shot
Defect Type NA
Length (mm) NA
Width (mm) NA
General Comments:
 In reasonable condition

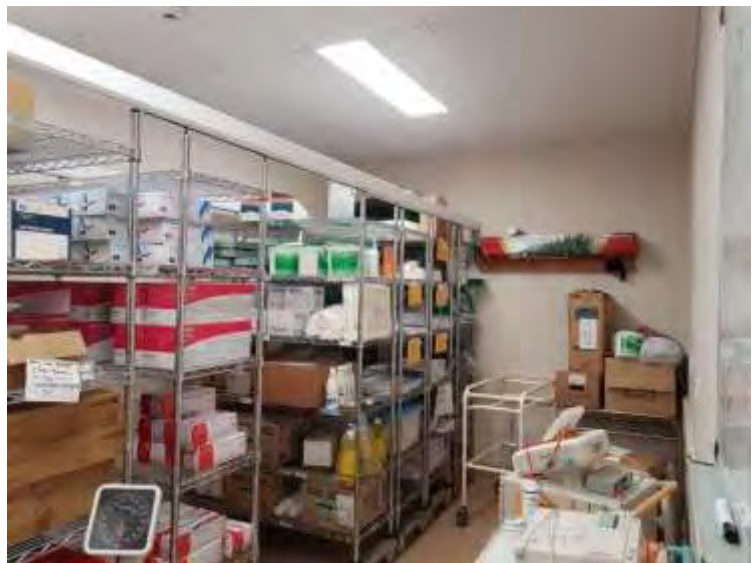
Defect ID A52
Area Type Internal
Location Hope Building Level 2
 Maternity Equipment Store
Element General Shot
Defect Type NA
Length (mm) NA
Width (mm) NA
General Comments:
 In reasonable condition

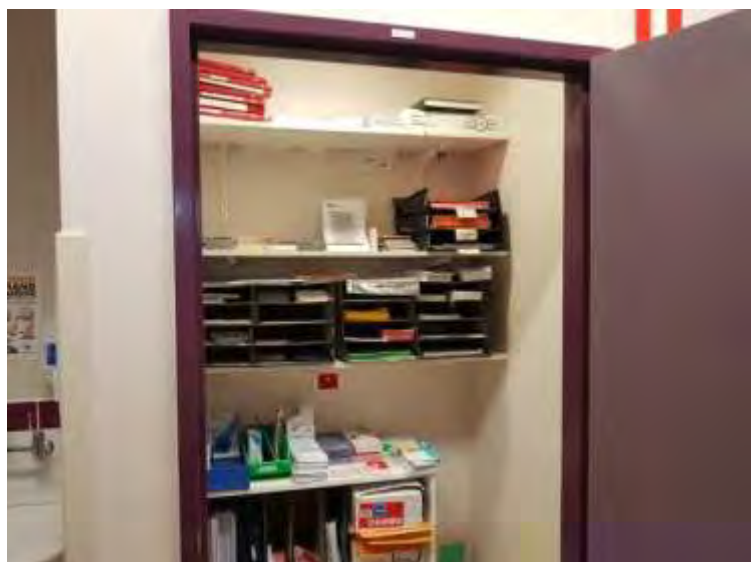
Defect ID A53
Area Type Internal
Location Hope Building Level 2
 Maternity Store room
Element General Shot
Defect Type NA
Length (mm) NA
Width (mm) NA
General Comments:
 In reasonable condition
