Council Assets Surrounding Hornsby Hospital

Dilapidation Report
80818469

Prepared for	Watpac Construction Pty Ltd
Project Name	Dilapidation Report
File Reference	Dilapidation Report - Hornsby Hospital Council Assets-2018-06-28.docx
Job Reference	80818469
Date	June 2018

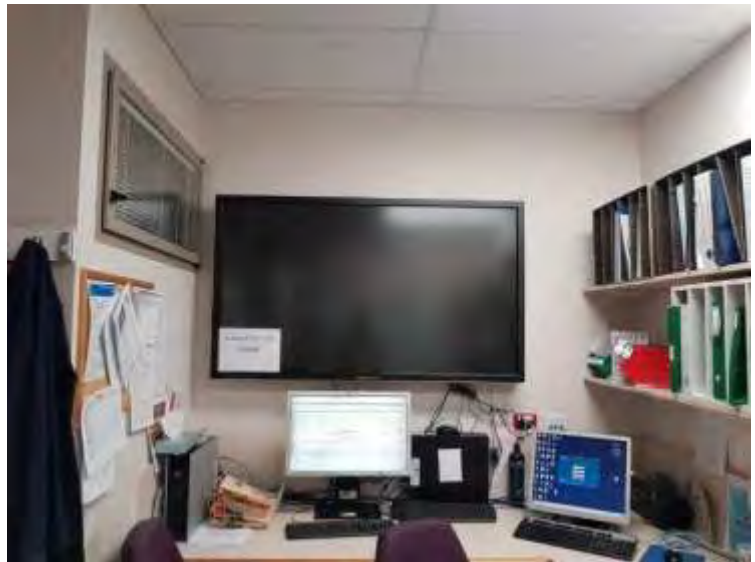
Defect ID A54
Area Type Internal
Location Hope Building Level 2
 Maternity (50.02.082)
Element General Shot
Defect Type NA
Length (mm) NA
Width (mm) NA
General Comments:
 In reasonable condition

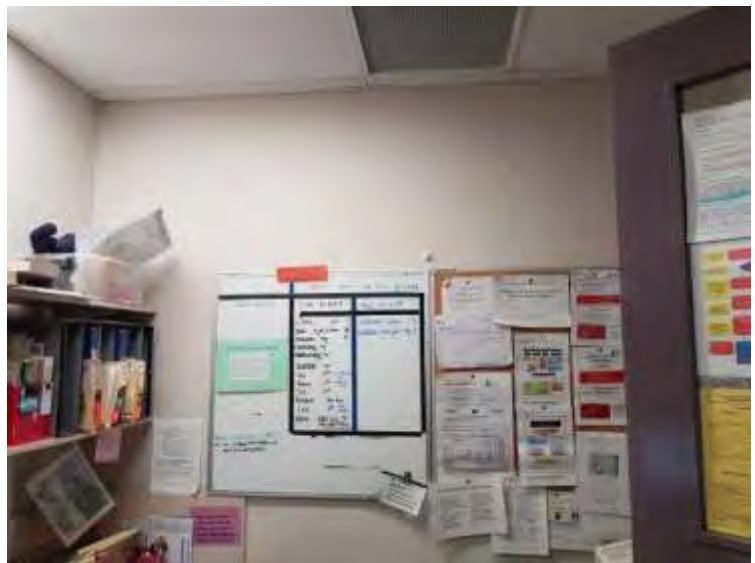
Defect ID A55
Area Type Internal
Location Hope Building Level 2
 Maternity (50.02.082)
Element General Shot
Defect Type NA
Length (mm) NA
Width (mm) NA
General Comments:
 In reasonable condition

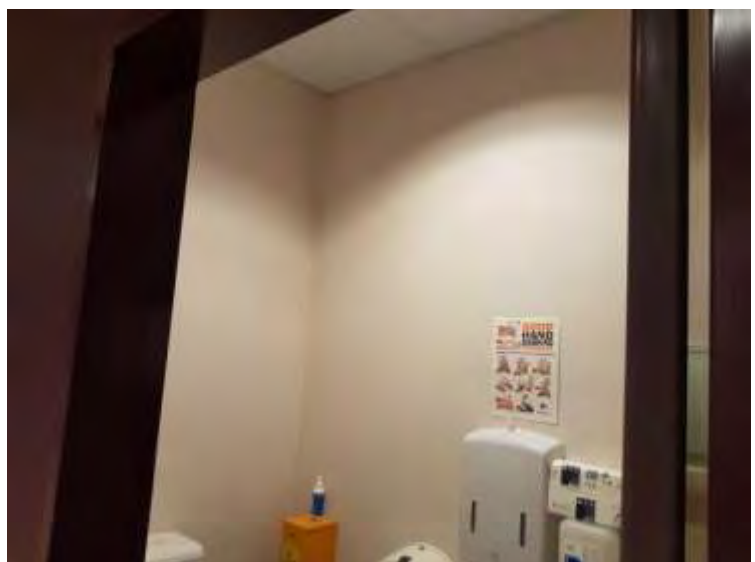
Defect ID A56
Area Type Internal
Location Hope Building Level 2
 Maternity (50.02.084)
Element General Shot
Defect Type NA
Length (mm) NA
Width (mm) NA
General Comments:
 In reasonable condition

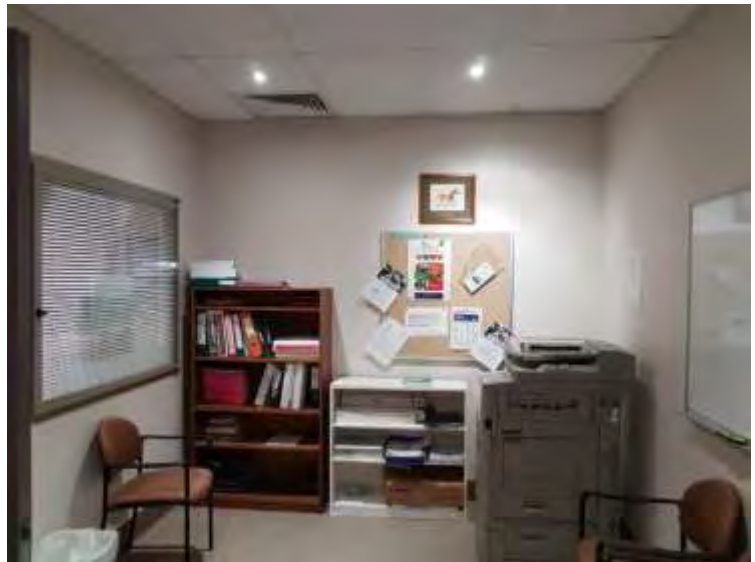
Defect ID A57
Area Type Internal
Location Hope Building Level 2
 Maternity Interview room
Element General Shot
Defect Type NA
Length (mm) NA
Width (mm) NA
General Comments:
 In reasonable condition

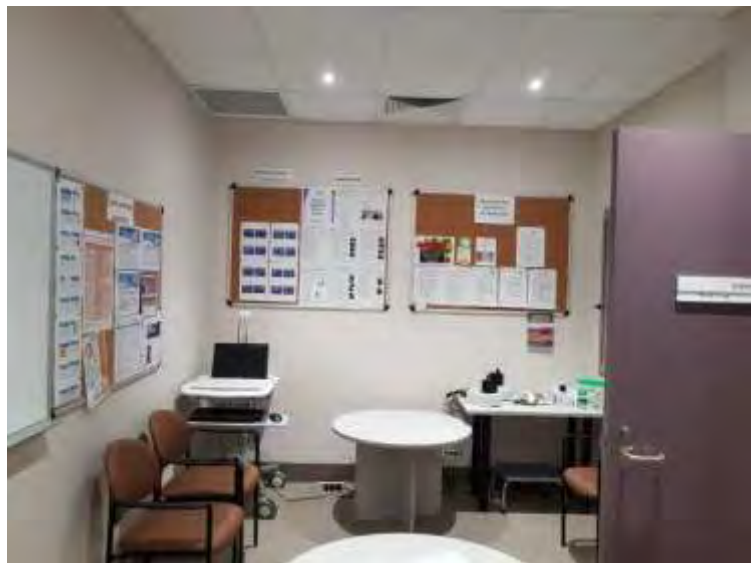
Defect ID A58
Area Type Internal
Location Hope Building Level 2
 Maternity Interview room
Element General Shot
Defect Type NA
Length (mm) NA
Width (mm) NA
General Comments:
 In reasonable condition

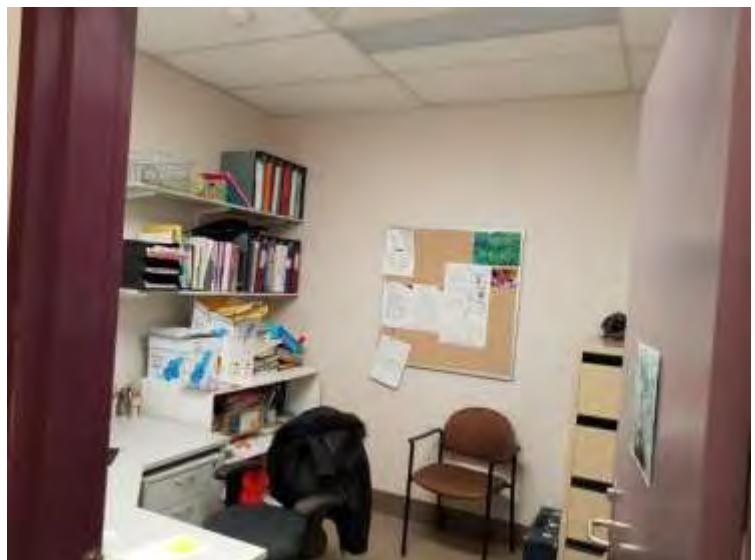
Defect ID A59
Area Type Internal
Location Hope Building Level 2
 Maternity (50.02.038)
Element General Shot
Defect Type NA
Length (mm) NA
Width (mm) NA
General Comments:
 In reasonable condition

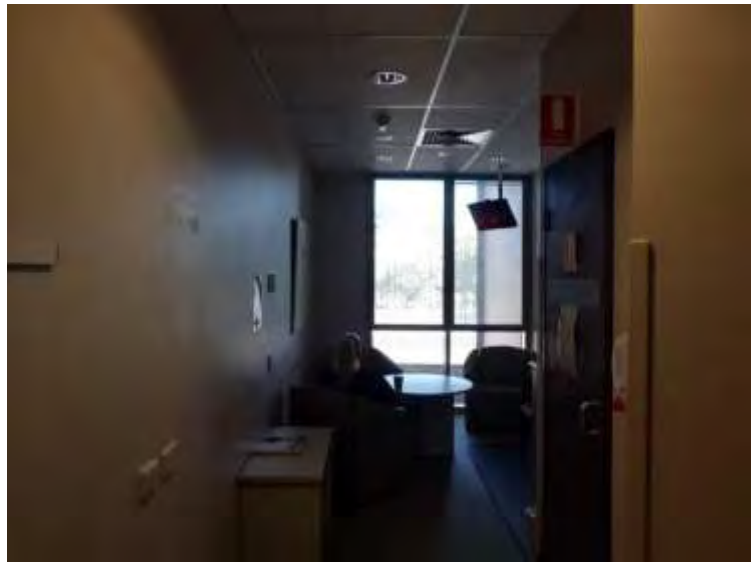
Defect ID A60
Area Type Internal
Location Hope Building Level 2
 Maternity Lounge
Element General Shot
Defect Type NA
Length (mm) NA
Width (mm) NA
General Comments:
 In reasonable condition

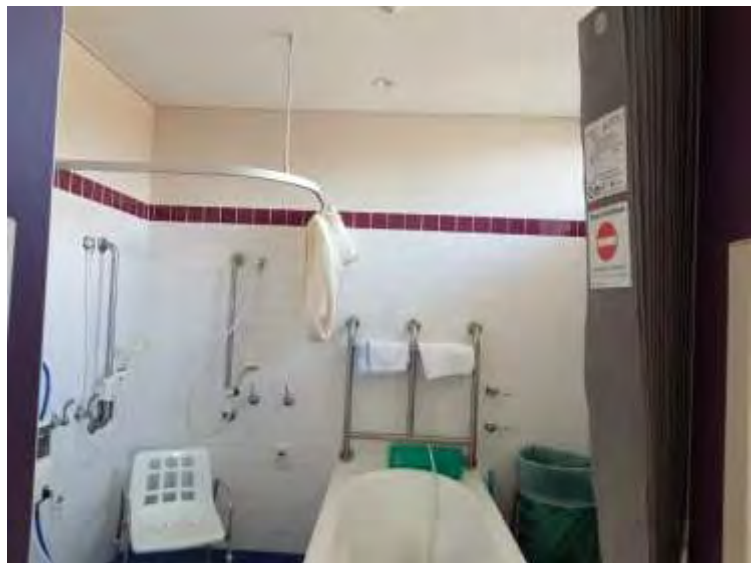
Defect ID A61
Area Type Internal
Location Hope Building Level 2
 Maternity Room 3
Element General Shot
Defect Type NA
Length (mm) NA
Width (mm) NA
General Comments:
 In reasonable condition

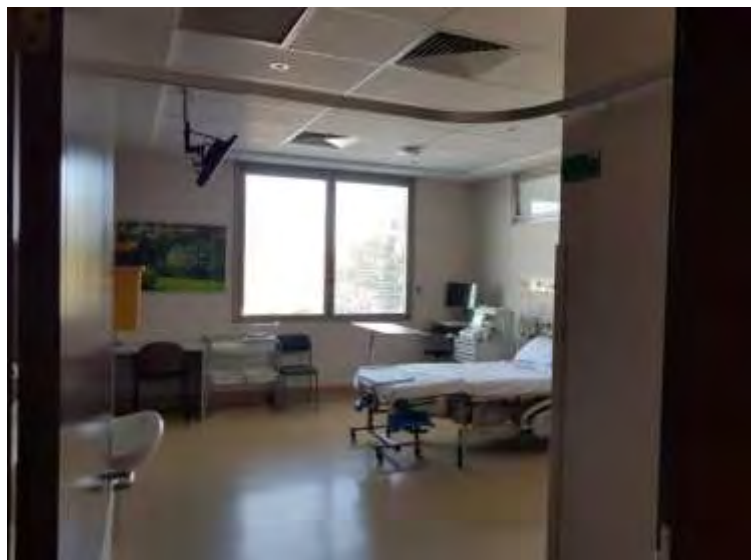
Defect ID A62
Area Type Internal
Location Hope Building Level 2
 Maternity Room 3
Element General Shot
Defect Type NA
Length (mm) NA
Width (mm) NA
General Comments:
 In reasonable condition

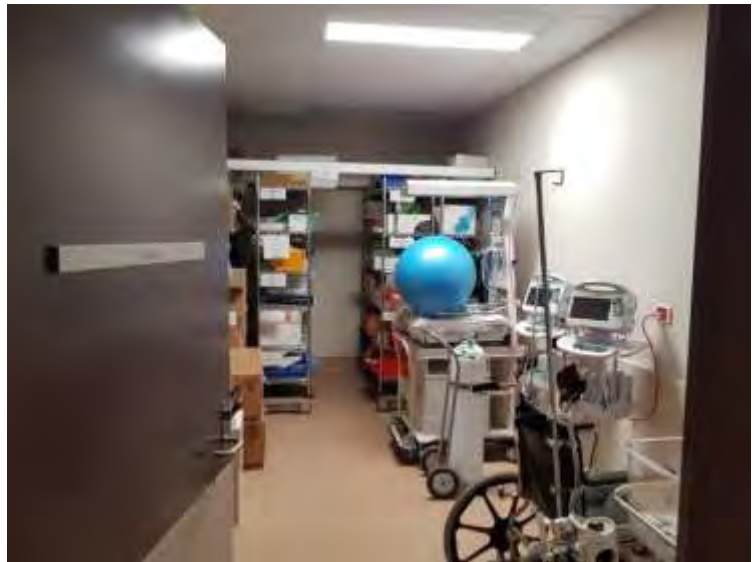
Defect ID A63
Area Type Internal
Location Hope Building Level 2
 Maternity Store
Element General Shot
Defect Type NA
Length (mm) NA
Width (mm) NA
General Comments:
 In reasonable condition

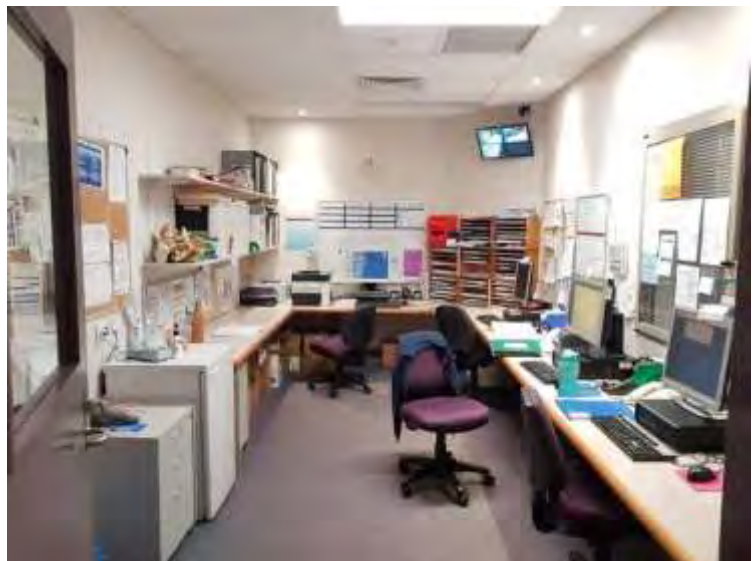
Defect ID A64
Area Type Internal
Location Hope Building Level 2
 Maternity (50.02.107)
Element General Shot
Defect Type NA
Length (mm) NA
Width (mm) NA
General Comments:
 In reasonable condition

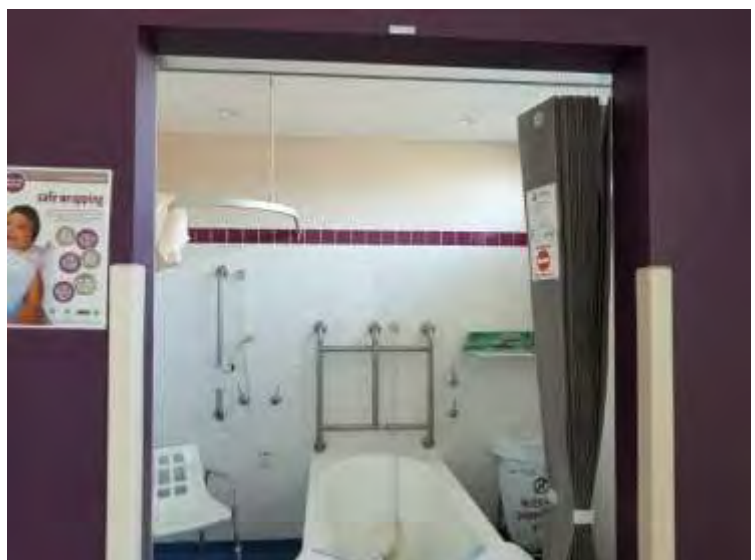
Defect ID A65
Area Type Internal
Location Hope Building Level 2
 Maternity Room 2
Element General Shot
Defect Type NA
Length (mm) NA
Width (mm) NA
General Comments:
 In reasonable condition

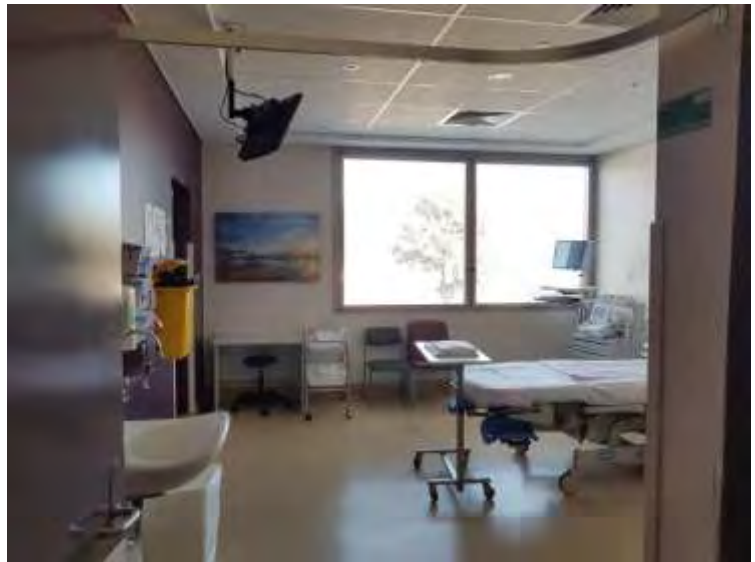
Defect ID A66

General Comments:
In reasonable condition

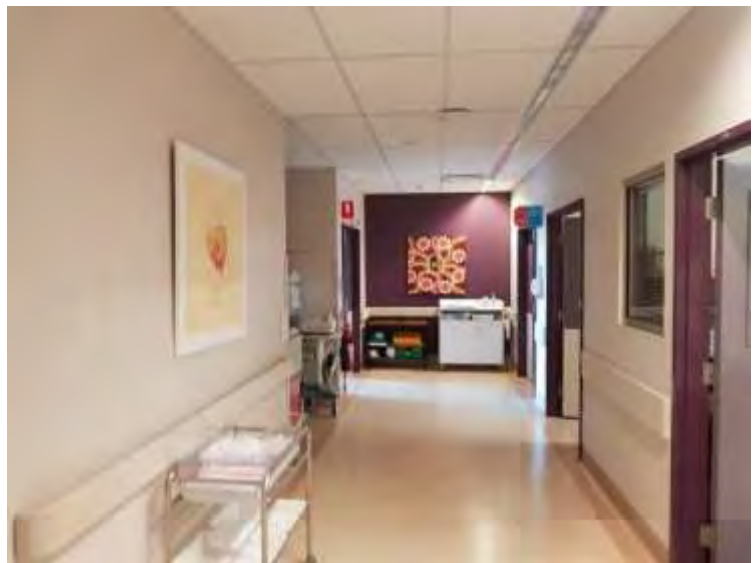
Defect ID A67

General Comments:
In reasonable condition

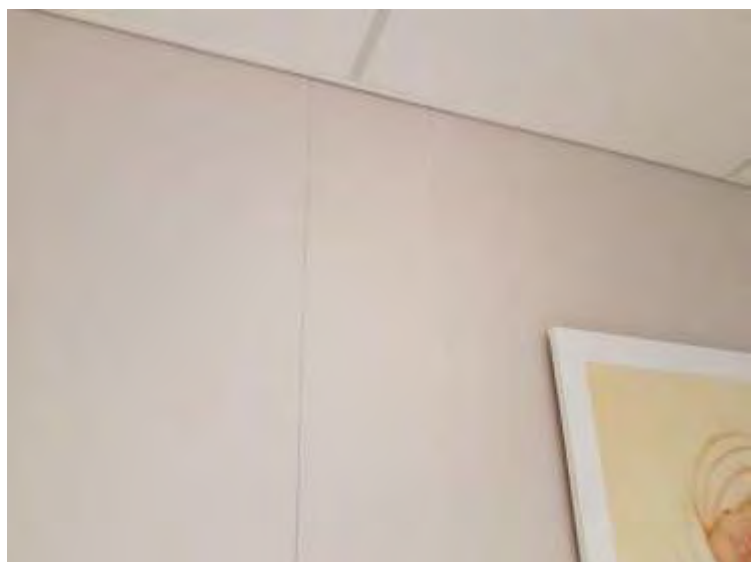
Defect ID A68

Defect Type Crack

Width (mm) 0.5

General Comments:
Vertical joint & vertical cracking on
plasterboard wall

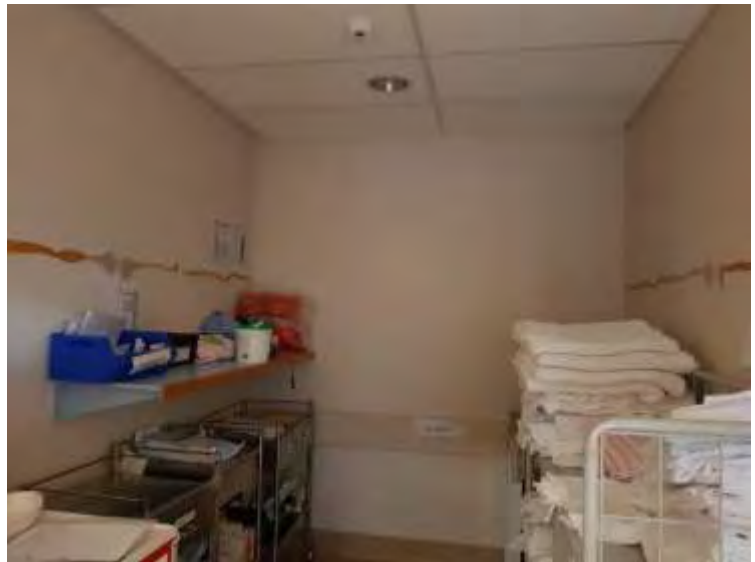
Defect ID A69
Area Type Internal
Location Hope Building Level 2
 Maternity Hallway
Element Plasterboard
Defect Type Staining
Length (mm) NA
Width (mm) NA
General Comments:
 Staining noted on plasterboard wall

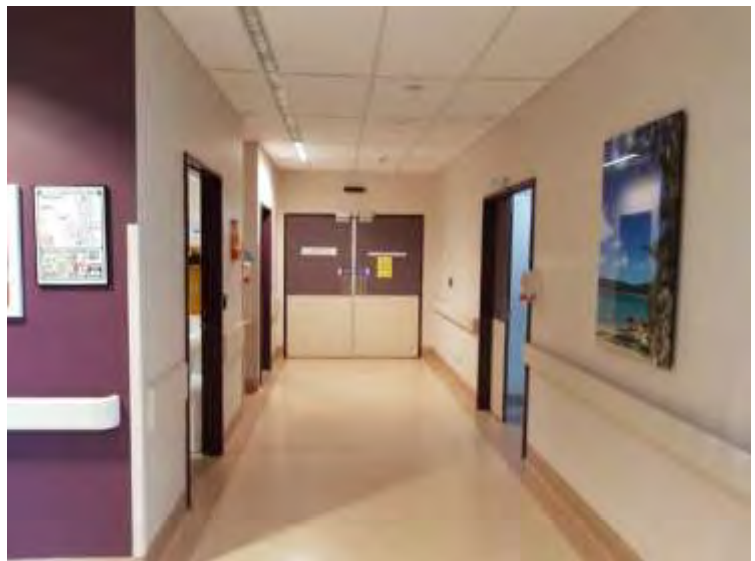
Defect ID A70
Area Type Internal
Location Hope Building Level 2
 Maternity Hallway
Element General Shot
Defect Type NA
Length (mm) NA
Width (mm) NA
General Comments:
 In reasonable condition

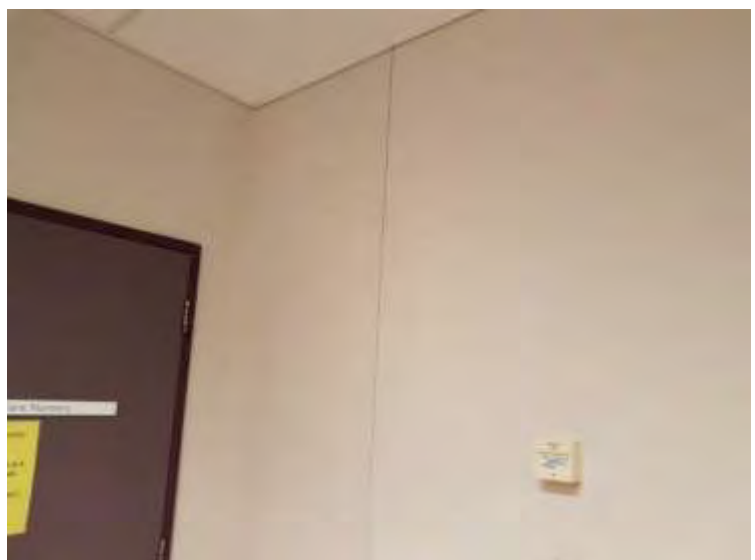
Defect ID A71
Area Type Internal
Location Hope Building Level 2
 Maternity Hallway
Element Plasterboard
Defect Type Joint
Length (mm) NA
Width (mm) NA
General Comments:
 Vertical joint on plasterboard wall

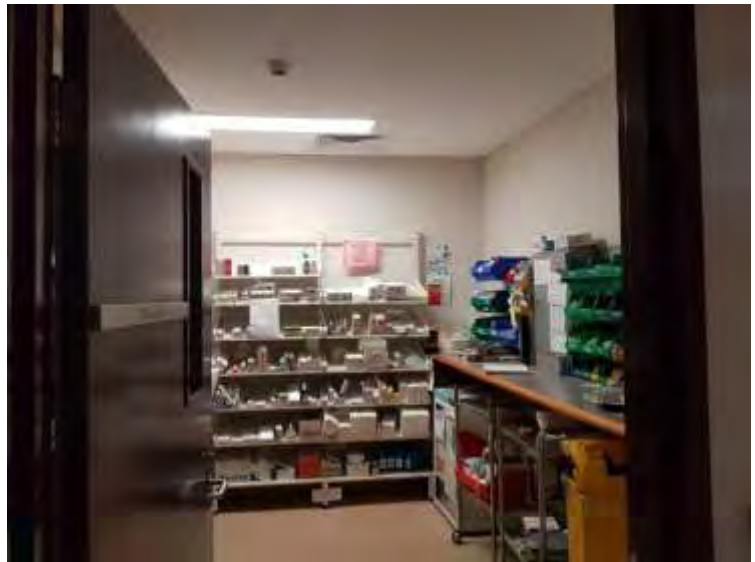
Defect ID A72
Area Type Internal
Location Hope Building Level 2
 Maternity Clean Utility
Element General Shot
Defect Type NA
Length (mm) NA
Width (mm) NA
General Comments:
 In reasonable condition

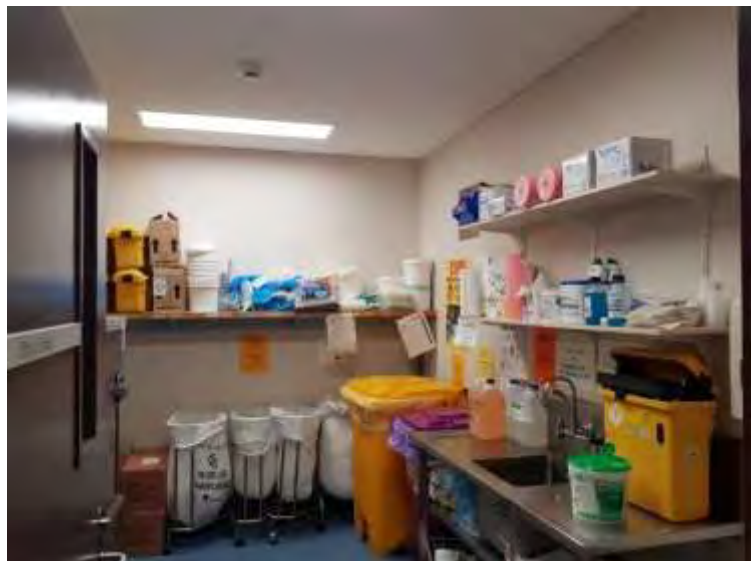
Defect ID A73
Area Type Internal
Location Hope Building Level 2
 Maternity Dirty Utility
Element General Shot
Defect Type NA
Length (mm) NA
Width (mm) NA
General Comments:
 In reasonable condition

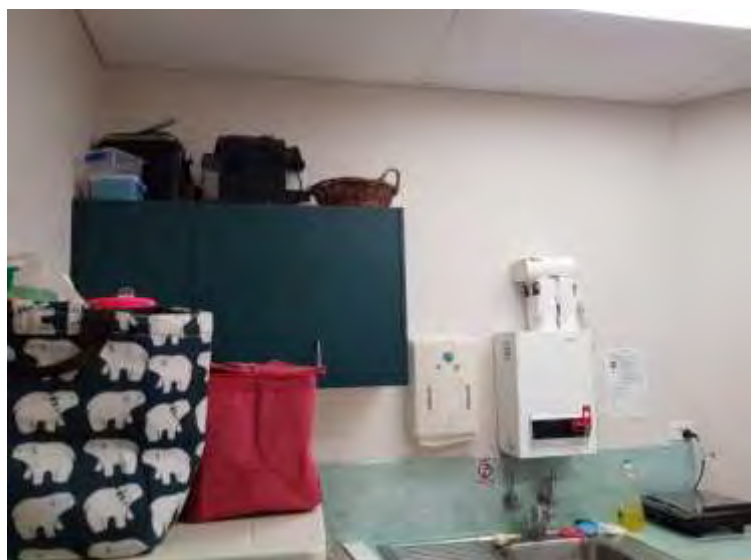
Defect ID A74
Area Type Internal
Location Hope Building Level 2
 Maternity Staff room
Element General Shot
Defect Type NA
Length (mm) NA
Width (mm) NA
General Comments:
 In reasonable condition

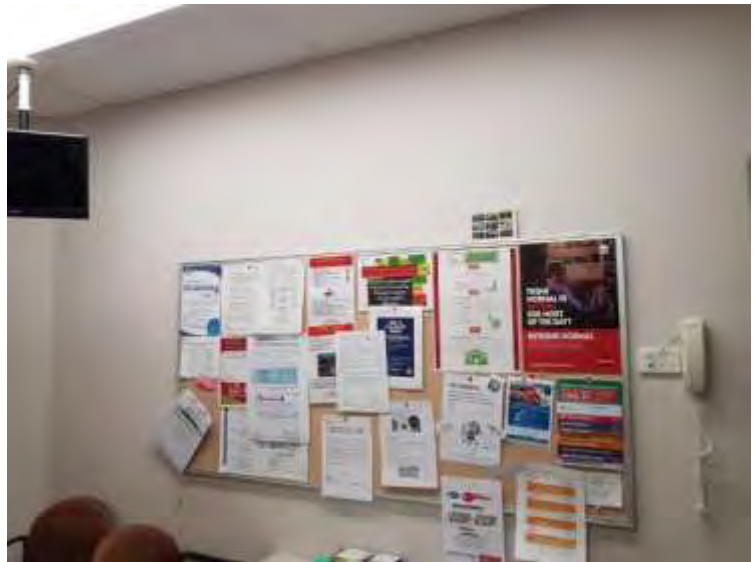
Defect ID A75
Area Type Internal
Location Hope Building Level 2
 Maternity Staff room
Element General Shot
Defect Type NA
Length (mm) NA
Width (mm) NA
General Comments:
 In reasonable condition

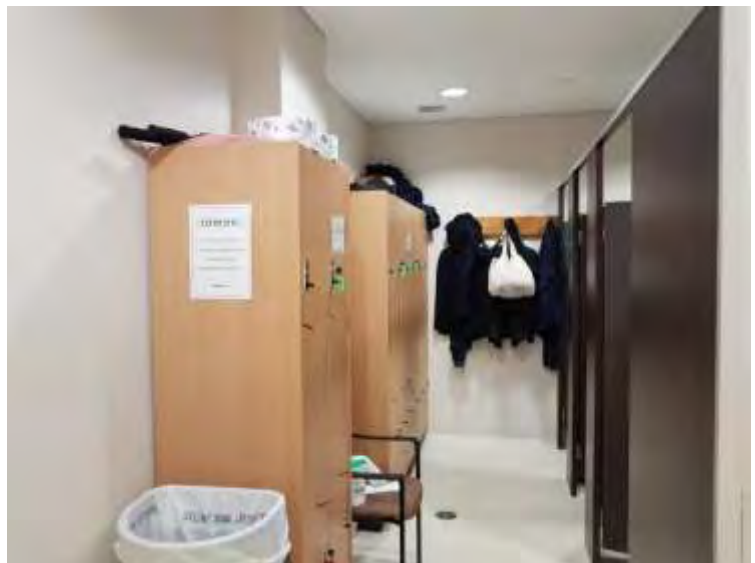
Defect ID A76
Area Type Internal
Location Hope Building Level 2
 Maternity Staff female
Element General Shot
Defect Type NA
Length (mm) NA
Width (mm) NA
General Comments:
 In reasonable condition

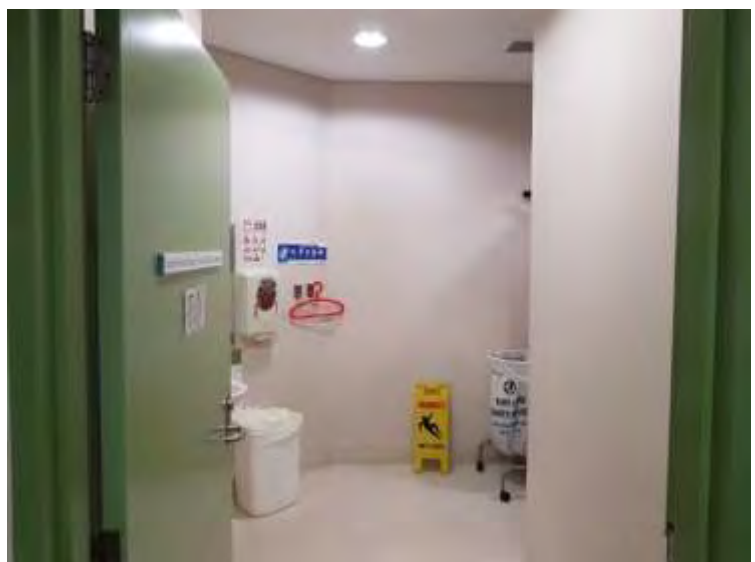
Defect ID A77
Area Type Internal
Location Hope Building Level 2
 Maternity Staff female
Element General Shot
Defect Type NA
Length (mm) NA
Width (mm) NA
General Comments:
 In reasonable condition

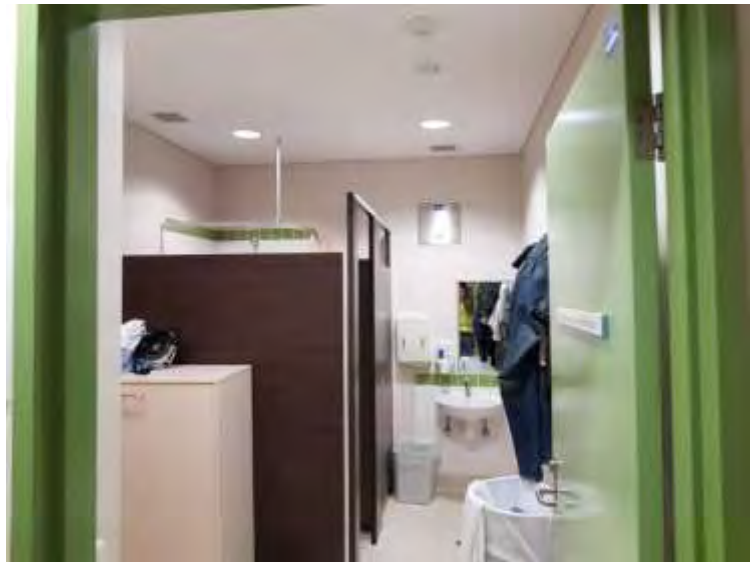
Defect ID A78

General Comments:
In reasonable condition

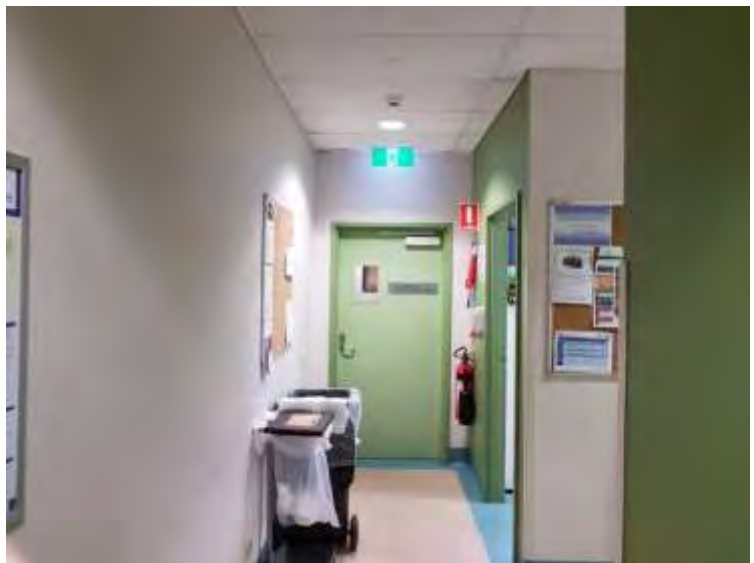
Defect ID A79

General Comments:
In reasonable condition

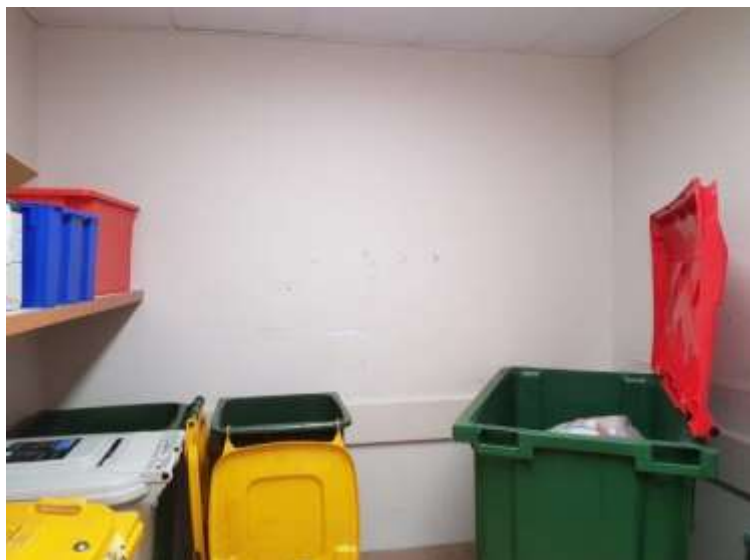
Defect ID A80

General Comments:
In reasonable condition

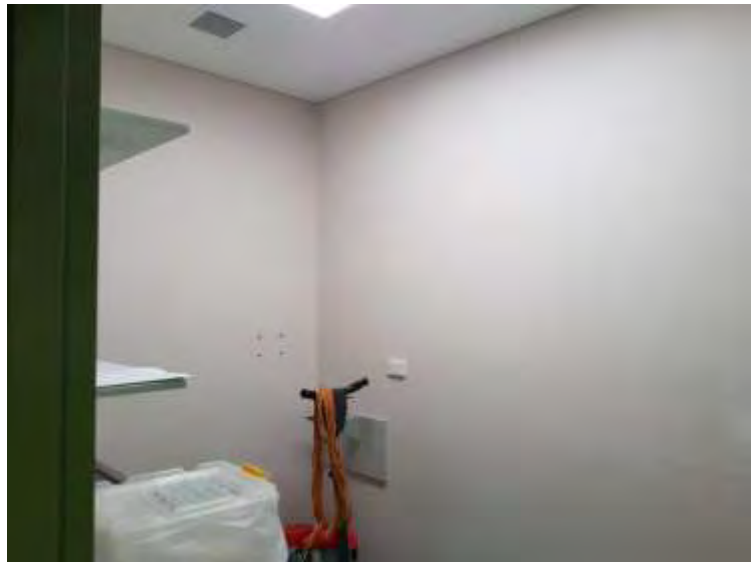
Defect ID A81
Area Type Internal
Location Hope Building Level 2
 Maternity Utility
Element General Shot
Defect Type NA
Length (mm) NA
Width (mm) NA
General Comments:
 In reasonable condition

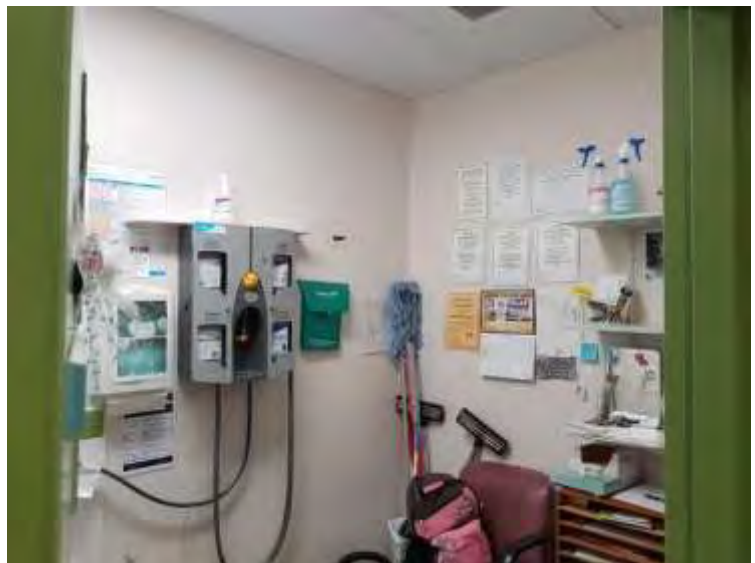
Defect ID A82
Area Type Internal
Location Hope Building Level 2
 Maternity Cleaner
Element General Shot
Defect Type NA
Length (mm) NA
Width (mm) NA
General Comments:
 In reasonable condition

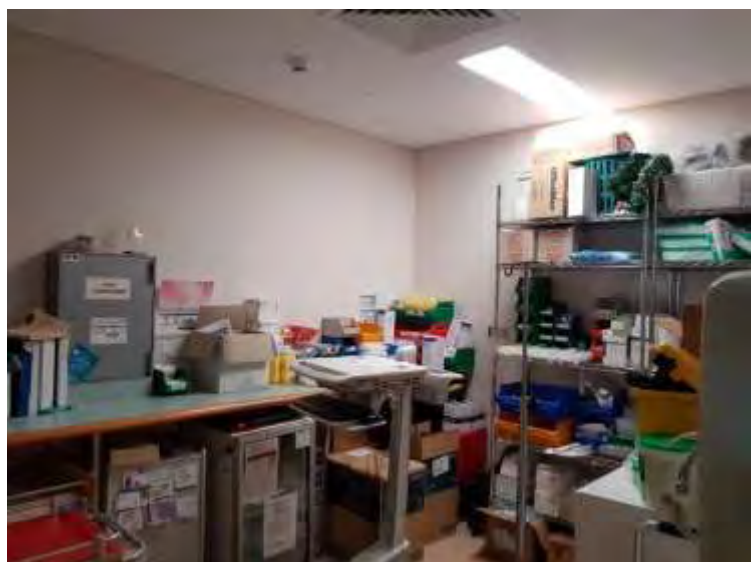
Defect ID A83
Area Type Internal
Location Hope Building Level 2
 Maternity Clean Utility
Element General Shot
Defect Type NA
Length (mm) NA
Width (mm) NA
General Comments:
 In reasonable condition

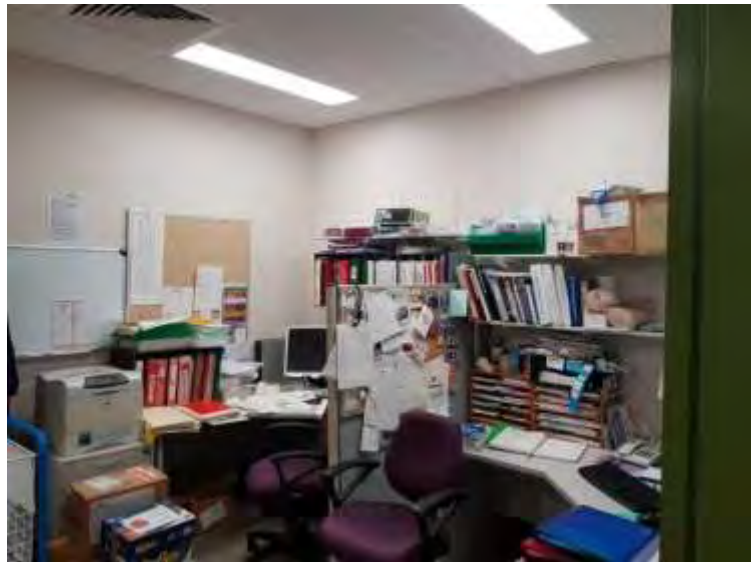
Defect ID A84
Area Type Internal
Location Hope Building Level 2
 Maternity Clinical
Element General Shot
Defect Type NA
Length (mm) NA
Width (mm) NA
General Comments:
 In reasonable condition

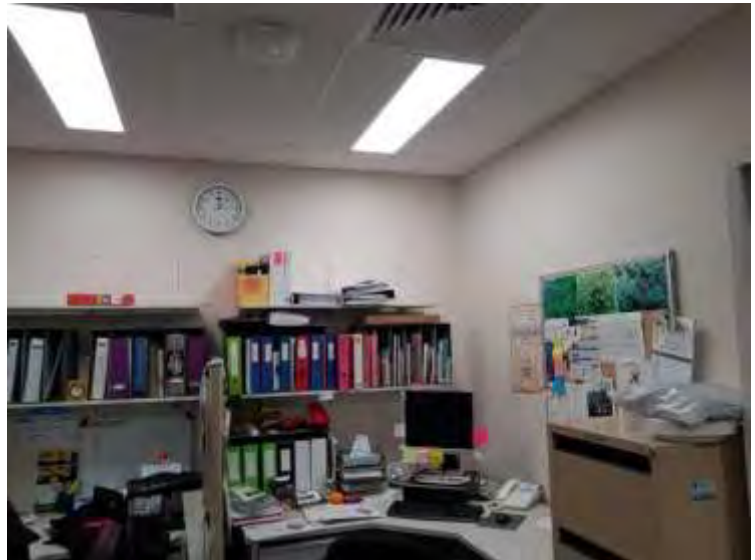
Defect ID A85
Area Type Internal
Location Hope Building Level 2
 Maternity Clinical
Element General Shot
Defect Type NA
Length (mm) NA
Width (mm) NA
General Comments:
 In reasonable condition

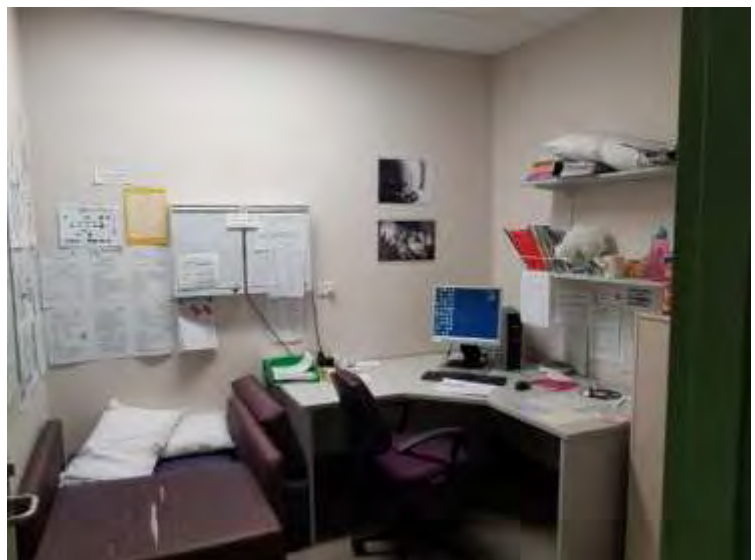
Defect ID A86
Area Type Internal
Location Hope Building Level 2
 Maternity Registrar
Element General Shot
Defect Type NA
Length (mm) NA
Width (mm) NA
General Comments:
 In reasonable condition

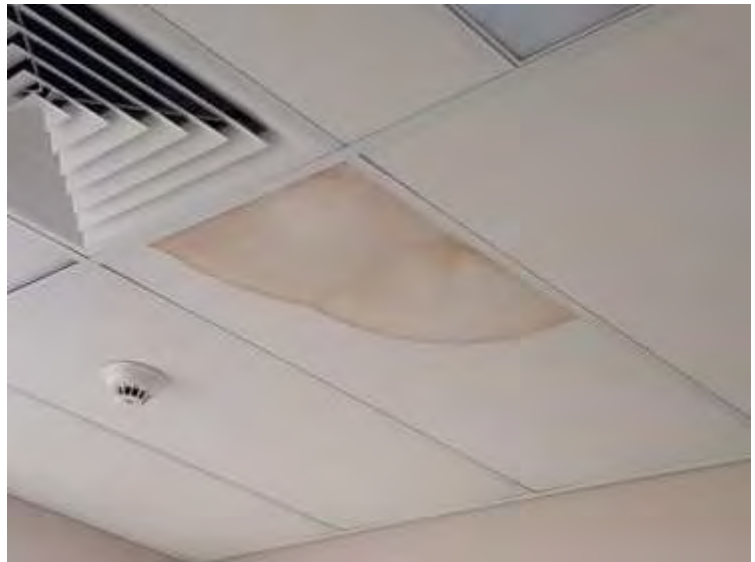
Defect ID A87
Area Type Internal
Location Hope Building Level 2
 Maternity Registrar
Element Ceiling Tile
Defect Type Staining
Length (mm) NA
Width (mm) NA
General Comments:
 Staining noted on ceiling tile

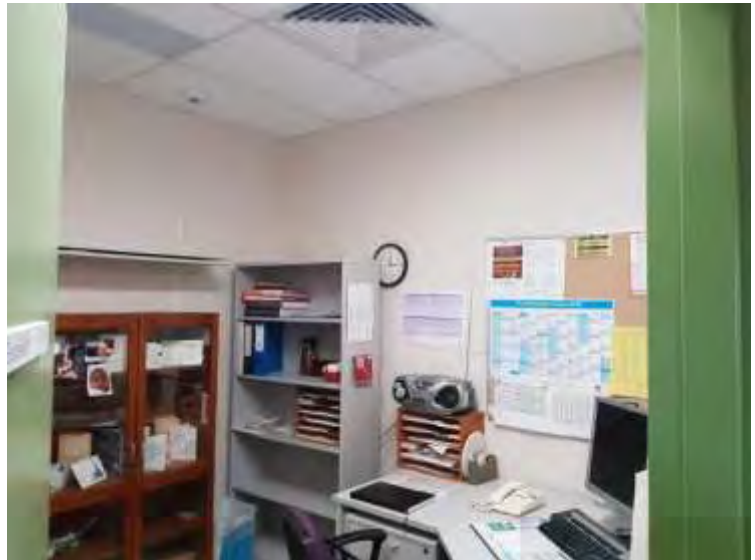
Defect ID A88
Area Type Internal
Location Hope Building Level 2
 Maternity Staff Specialist
Element General Shot
Defect Type NA
Length (mm) NA
Width (mm) NA
General Comments:
 In reasonable condition

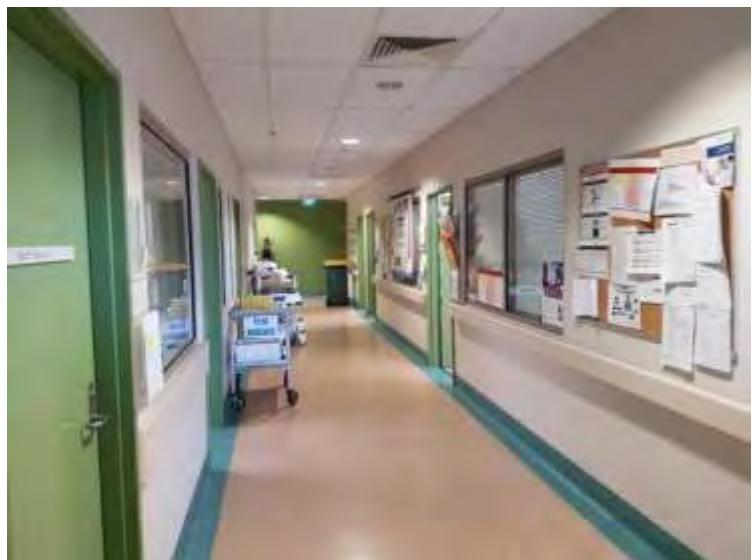
Defect ID A89
Area Type Internal
Location Hope Building Level 2
 Maternity Hallway
Element General Shot
Defect Type NA
Length (mm) NA
Width (mm) NA
General Comments:
 In reasonable condition

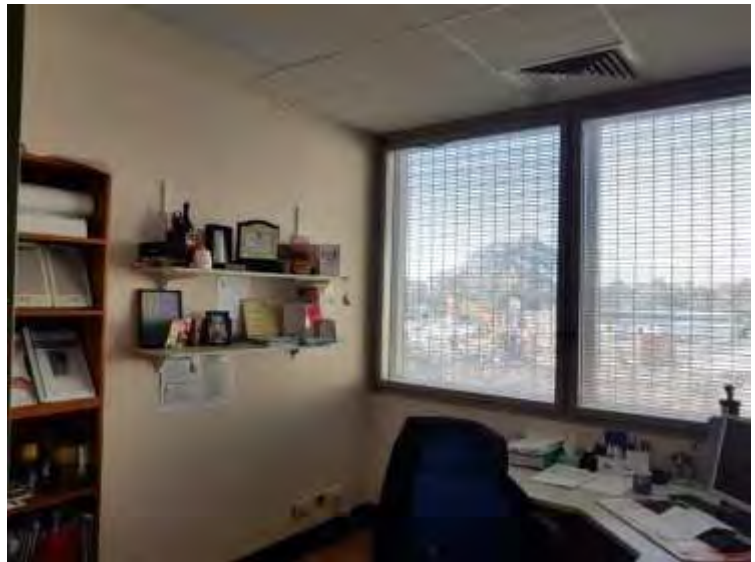
Defect ID A90
Area Type Internal
Location Hope Building Level 2
 Maternity Staff Specialist
Element General Shot
Defect Type NA
Length (mm) NA
Width (mm) NA
General Comments:
 In reasonable condition

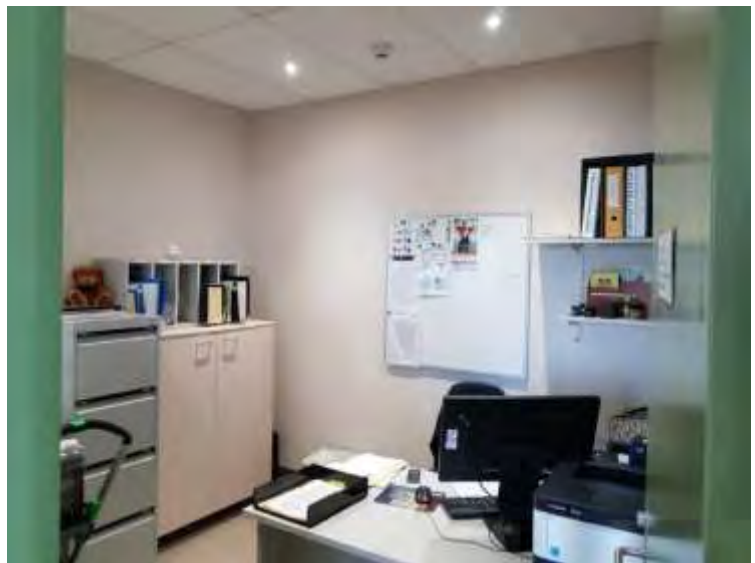
Defect ID A91
Area Type Internal
Location Hope Building Level 2
 Maternity (50.02.025)
Element General Shot
Defect Type NA
Length (mm) NA
Width (mm) NA
General Comments:
 In reasonable condition

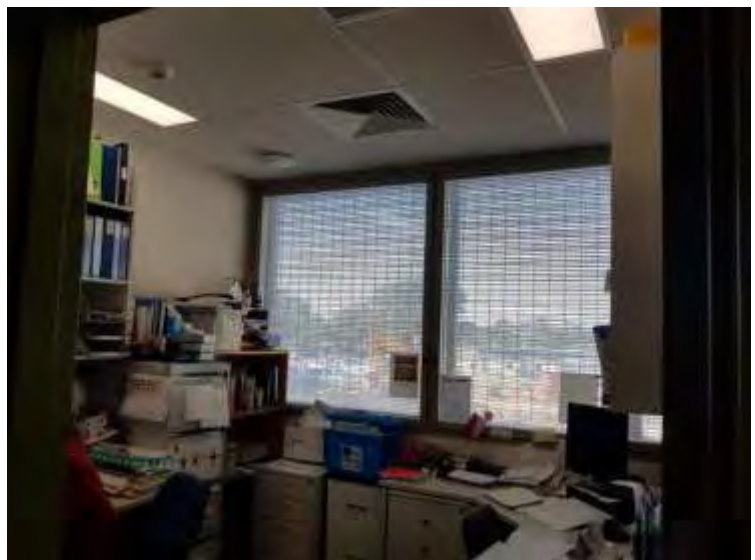
Defect ID A92
Area Type Internal
Location Hope Building Level 2
 Maternity (50.02.014)
Element General Shot
Defect Type NA
Length (mm) NA
Width (mm) NA
General Comments:
 In reasonable condition

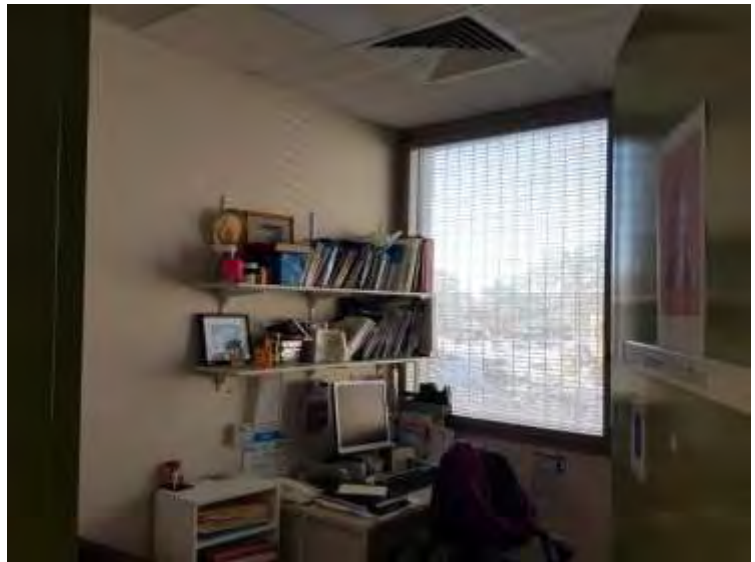
Defect ID A93
Area Type Internal
Location Hope Building Level 2
 Maternity Lactation
Element General Shot
Defect Type NA
Length (mm) NA
Width (mm) NA
General Comments:
 In reasonable condition

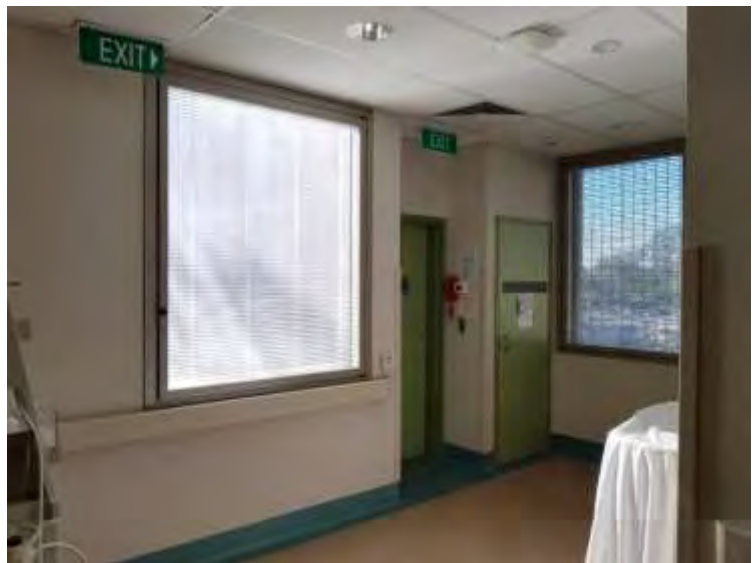
Defect ID A94
Area Type Internal
Location Hope Building Level 2
 Maternity Hallway
Element General Shot
Defect Type NA
Length (mm) NA
Width (mm) NA
General Comments:
 In reasonable condition

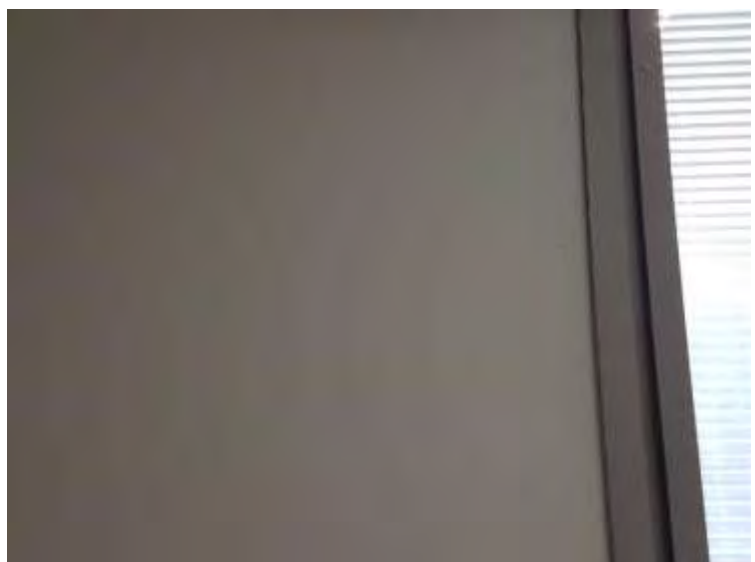
Defect ID A95
Area Type Internal
Location Hope Building Level 2
 Maternity Hallway
Element Plasterboard
Defect Type Crack
Length (mm) 2000
Width (mm) 0.5
General Comments:
 Horizontal cracking on wall adjacent to window

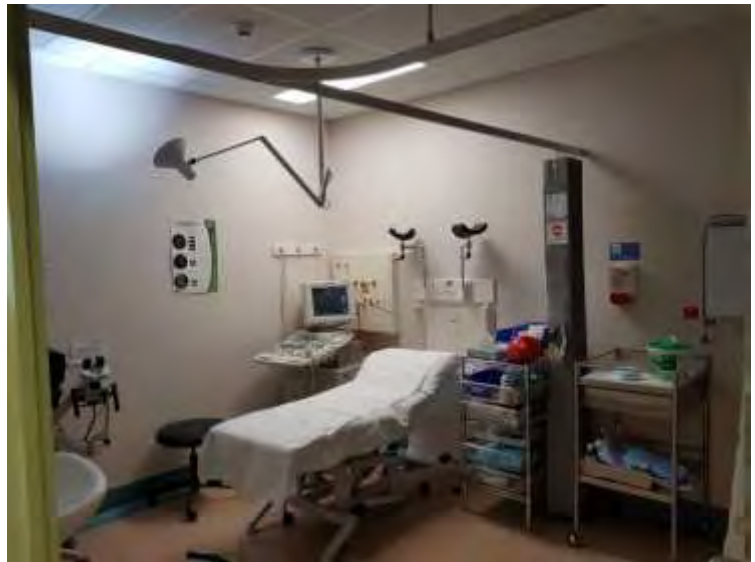
Defect ID A96
Area Type Internal
Location Hope Building Level 2
 Maternity Procedure
Element General Shot
Defect Type NA
Length (mm) NA
Width (mm) NA
General Comments:
 In reasonable condition

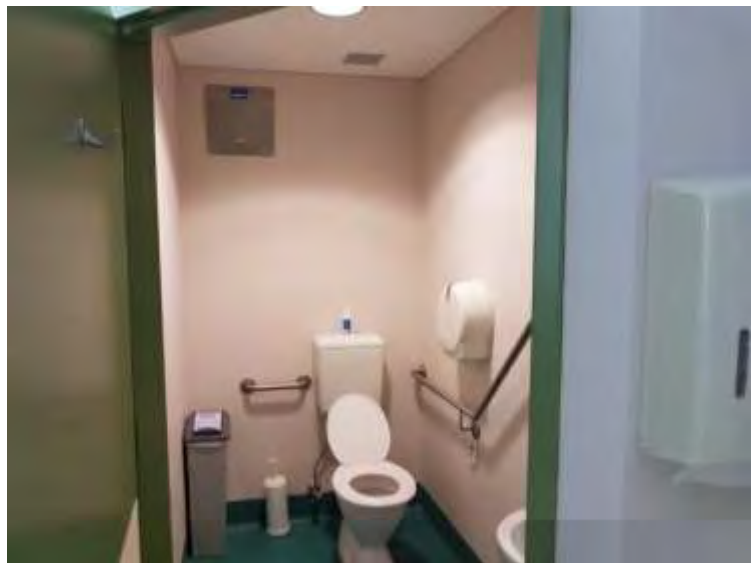
Defect ID A97
Area Type Internal
Location Hope Building Level 2
 Maternity (50.02.009)
Element General Shot
Defect Type NA
Length (mm) NA
Width (mm) NA
General Comments:
 In reasonable condition

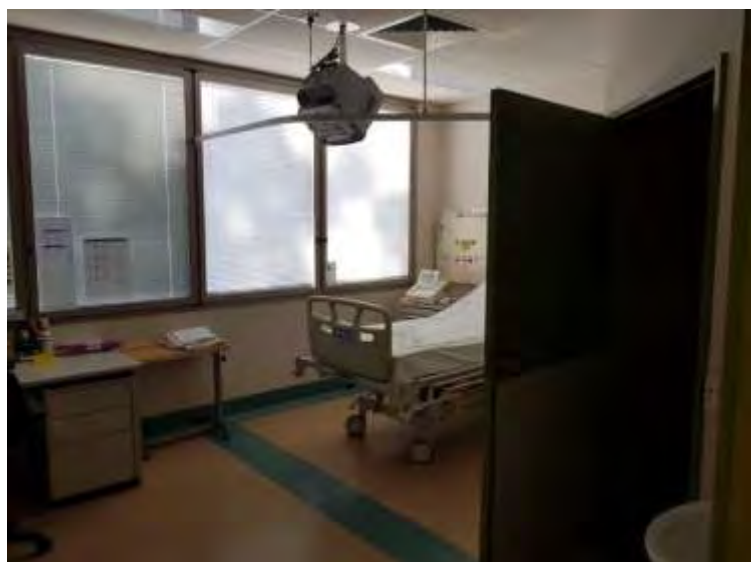
Defect ID A98
Area Type Internal
Location Hope Building Level 2
 Maternity (50.02.009)
Element General Shot
Defect Type NA
Length (mm) NA
Width (mm) NA
General Comments:
 In reasonable condition

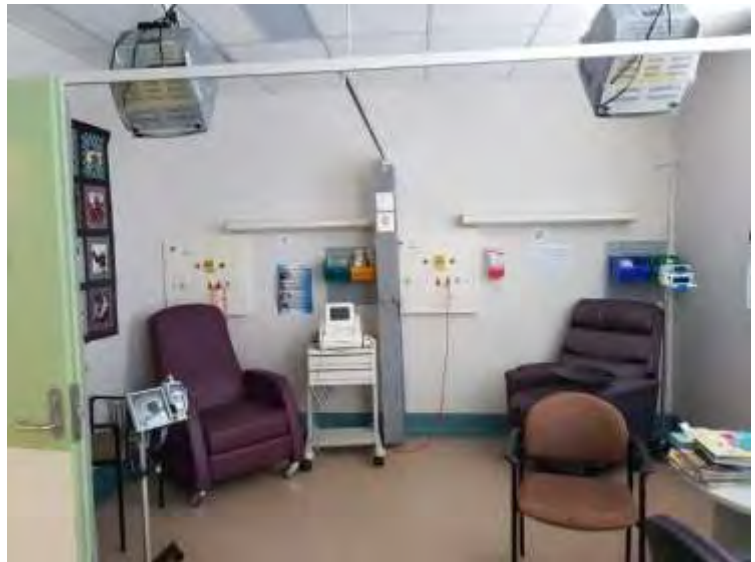
Defect ID A99
Area Type Internal
Location Hope Building Level 2
 Maternity (50.02.009)
Element General Shot
Defect Type NA
Length (mm) NA
Width (mm) NA
General Comments:
 In reasonable condition

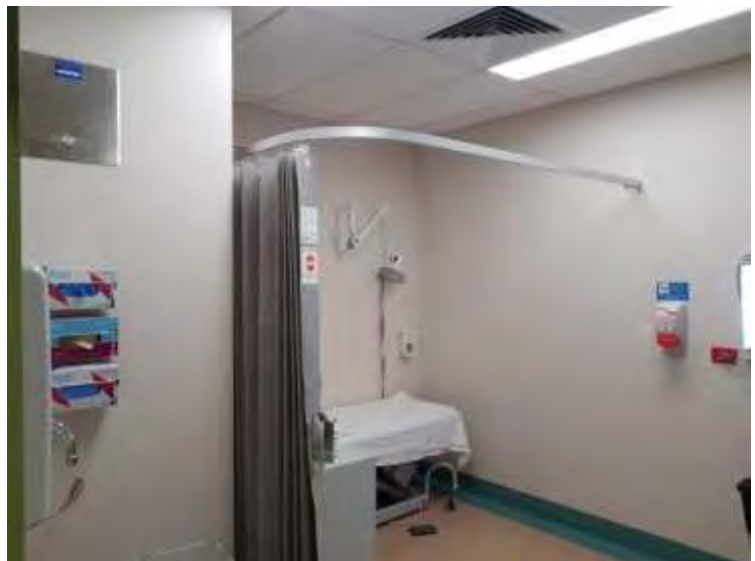
Defect ID A100
Area Type Internal
Location Hope Building Level 2
 Maternity Consultation 6
Element General Shot
Defect Type NA
Length (mm) NA
Width (mm) NA
General Comments:
 In reasonable condition

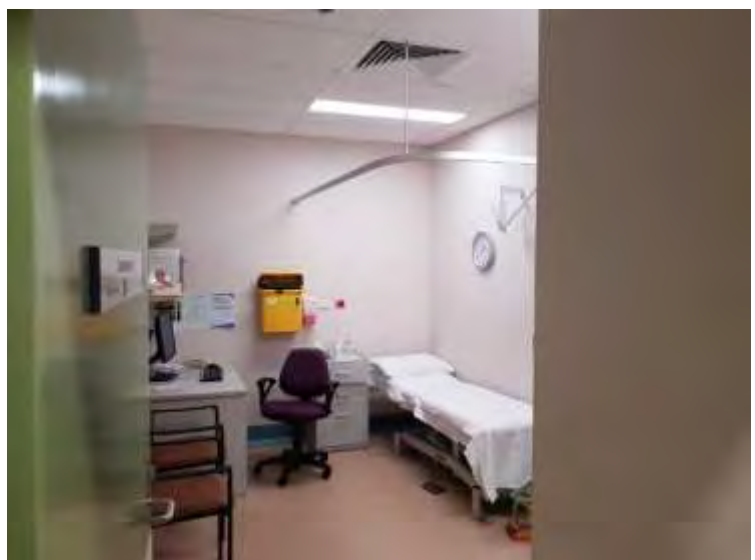
Defect ID A101
Area Type Internal
Location Hope Building Level 2
 Maternity Consultation 5
Element General Shot
Defect Type NA
Length (mm) NA
Width (mm) NA
General Comments:
 In reasonable condition
