Council Assets Surrounding Hornsby Hospital

Dilapidation Report
80818469

Prepared for	Watpac Construction Pty Ltd
Project Name	Dilapidation Report
File Reference	Dilapidation Report - Hornsby Hospital Council Assets-2018-06-28.docx
Job Reference	80818469
Date	June 2018

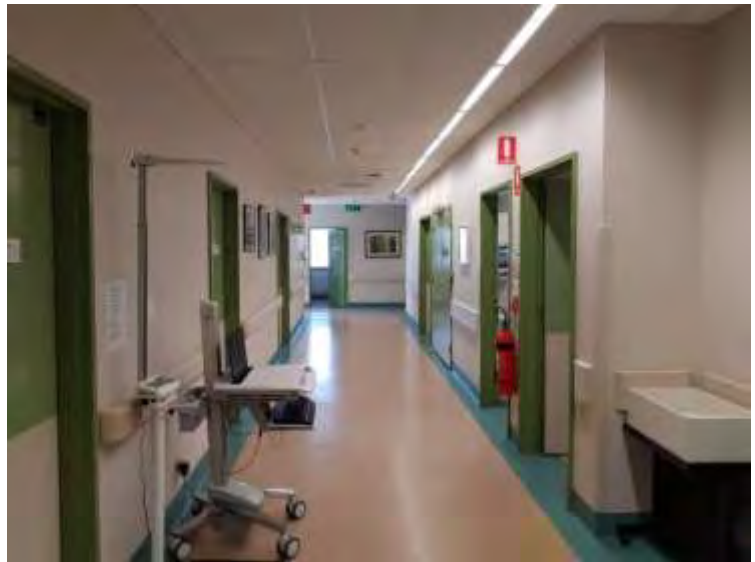
Defect ID A102
Area Type Internal
Location Hope Building Level 2
 Maternity Hallway
Element General Shot
Defect Type NA
Length (mm) NA
Width (mm) NA
General Comments:
 In reasonable condition

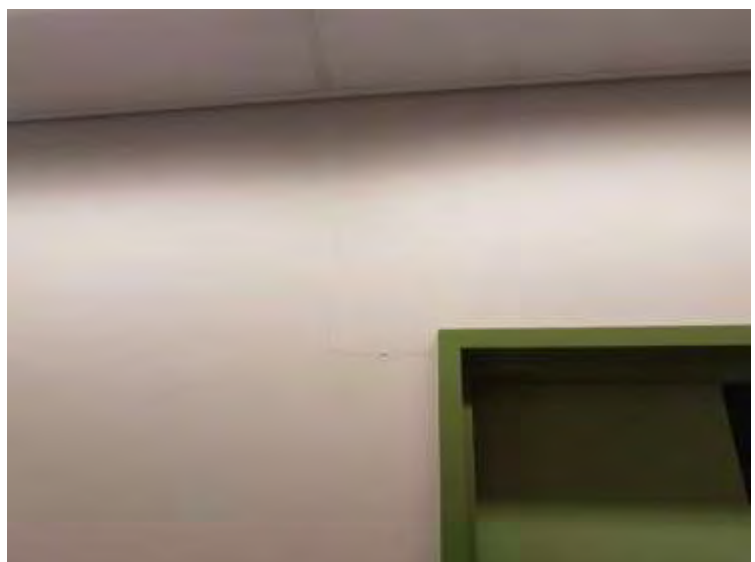
Defect ID A104
Area Type Internal
Location Hope Building Level 2
 Maternity Hallway
Element Plasterboard
Defect Type Crack
Length (mm) 600
Width (mm) 0.5
General Comments:
 Horizontal cracking noted from corner of door
 and returns up towards ceiling

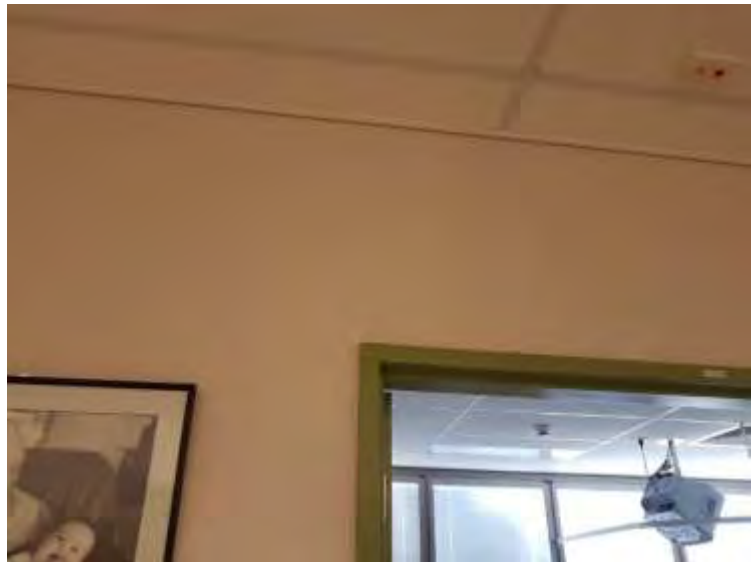
Defect ID A106
Area Type Internal
Location Hope Building Level 2
 Maternity Hallway
Element Plasterboard
Defect Type Crack
Length (mm) 500
Width (mm) 0.5
General Comments:
 Vertical cracking above door

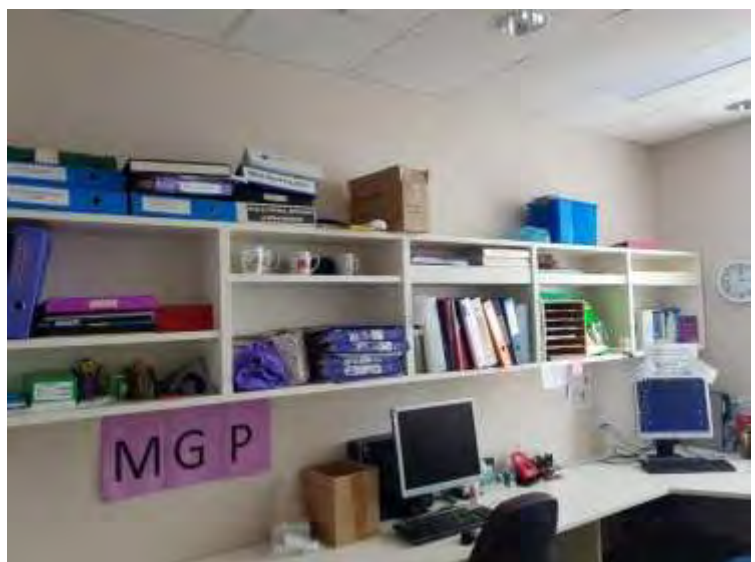
Defect ID A108
Area Type Internal
Location Hope Building Level 2
 Maternity Clinic Workroom
Element General Shot
Defect Type NA
Length (mm) NA
Width (mm) NA
General Comments:
 In reasonable condition

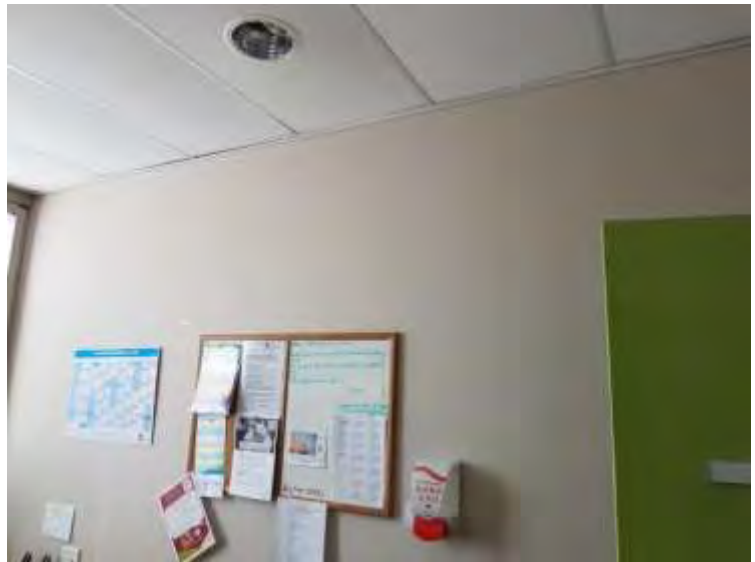
Defect ID A109
Area Type Internal
Location Hope Building Level 2
 Maternity Clinic Workroom
Element General Shot
Defect Type NA
Length (mm) NA
Width (mm) NA
General Comments:
 In reasonable condition

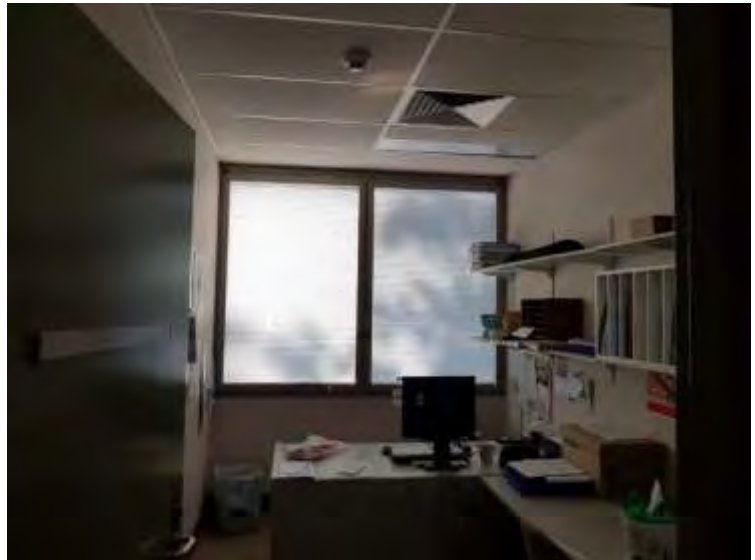
Defect ID A110
Area Type Internal
Location Hope Building Level 2
 Maternity (50.02.005)
Element General Shot
Defect Type NA
Length (mm) NA
Width (mm) NA
General Comments:
 In reasonable condition

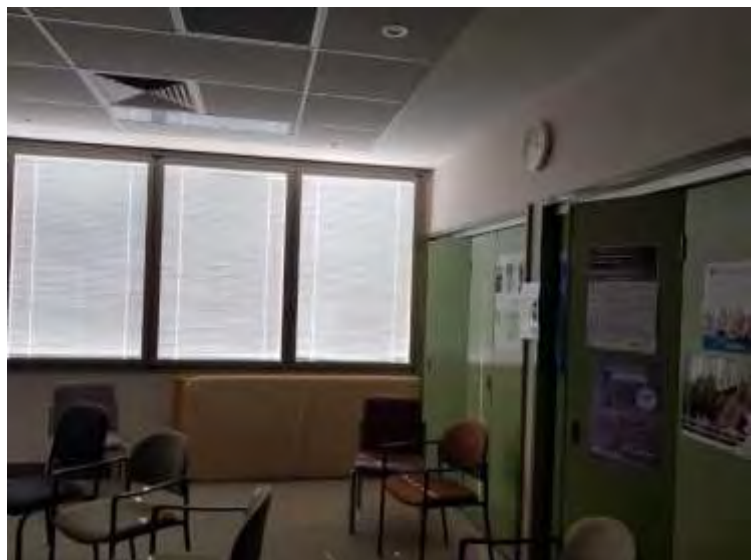
Defect ID A111
Area Type Internal
Location Hope Building Level 2
 Maternity (50.02.003)
Element General Shot
Defect Type NA
Length (mm) NA
Width (mm) NA
General Comments:
 In reasonable condition

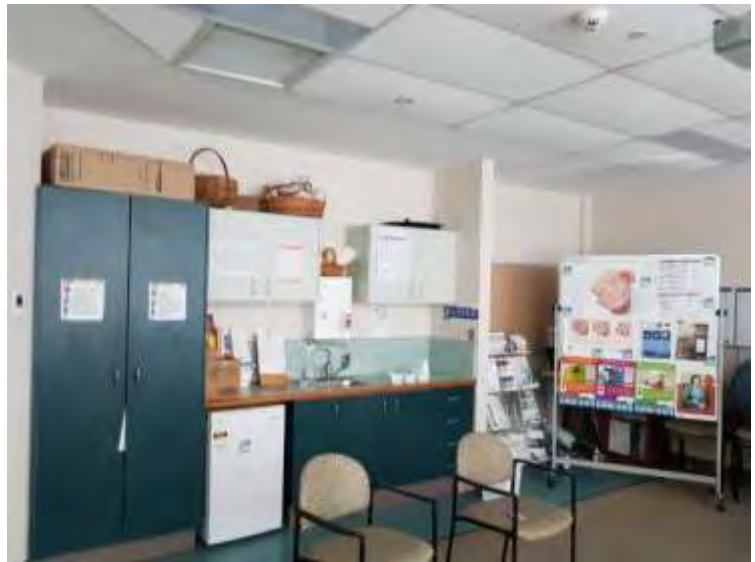
Defect ID A112

General Comments:
In reasonable condition

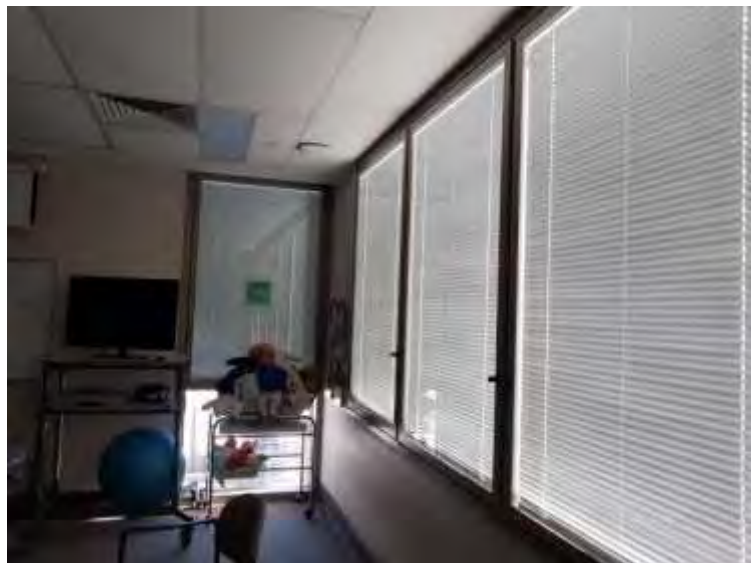
Defect ID A113

General Comments:
In reasonable condition

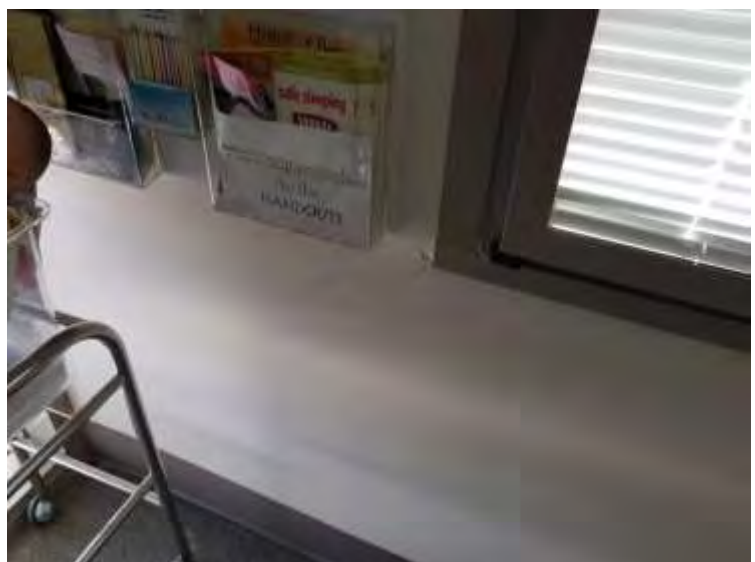
Defect ID A114

Defect Type Crack

Width (mm) 0.5

General Comments:
Diagonal cracking on wall starting at corner of window

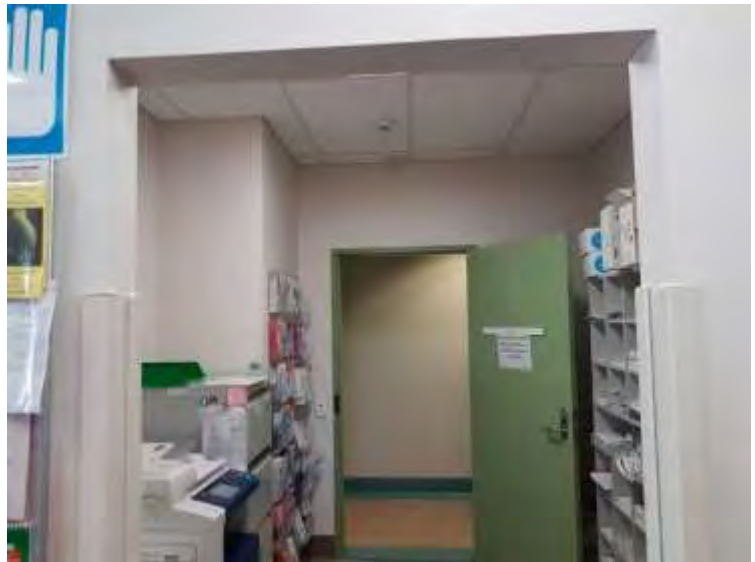
Defect ID A115

General Comments:
In reasonable condition

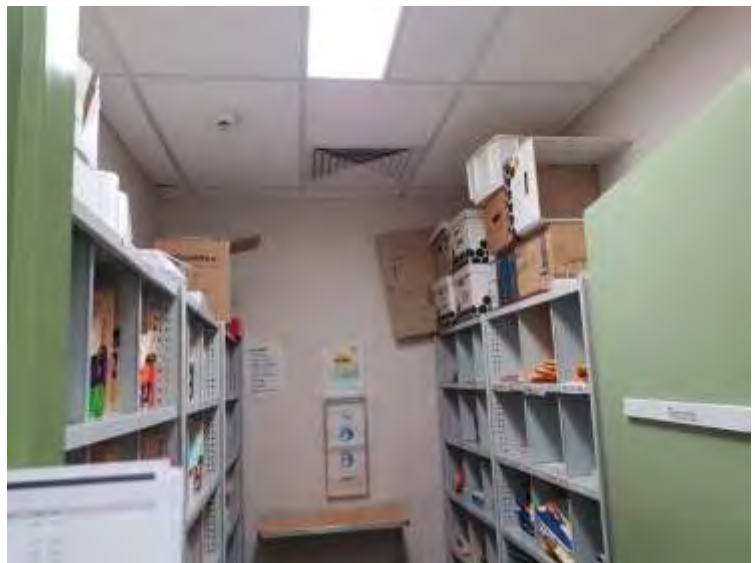
Defect ID A116

General Comments:
In reasonable condition

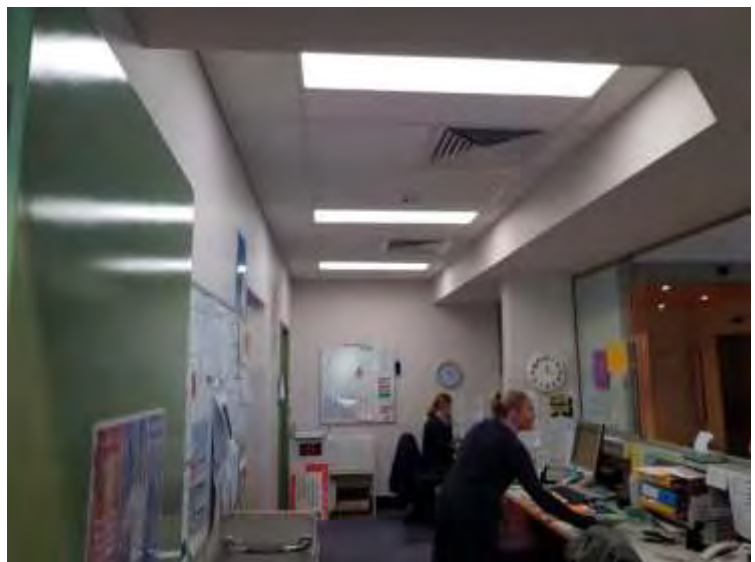
Defect ID A117

General Comments:
In reasonable condition

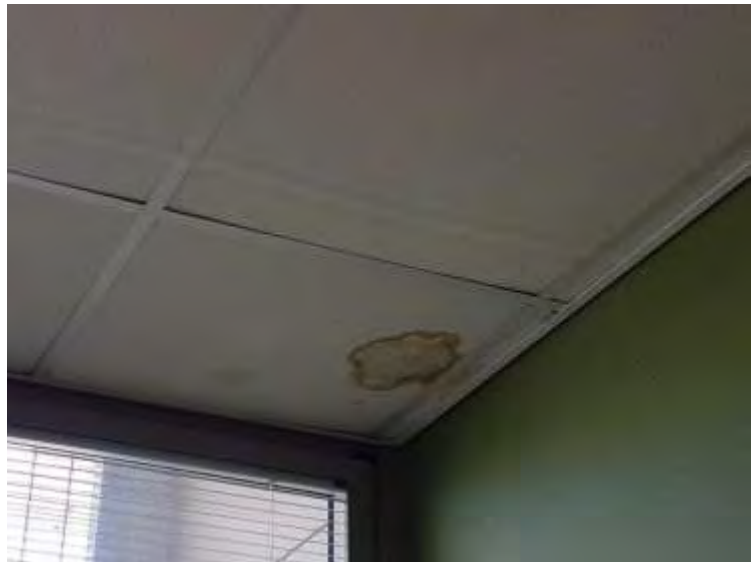
Defect ID A118
Area Type Internal
Location Hope Building Level 2
 Maternity Waiting room
Element Ceiling Tile
Defect Type Staining
Length (mm) NA
Width (mm) NA
General Comments:
 Staining noted on ceiling tile

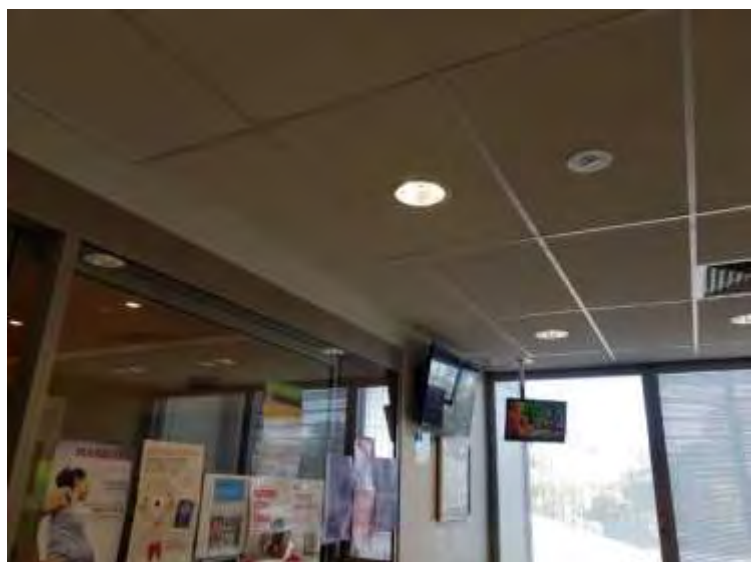
Defect ID A120
Area Type Internal
Location Hope Building Level 2
 Maternity Waiting room
Element General Shot
Defect Type NA
Length (mm) NA
Width (mm) NA
General Comments:
 In reasonable condition

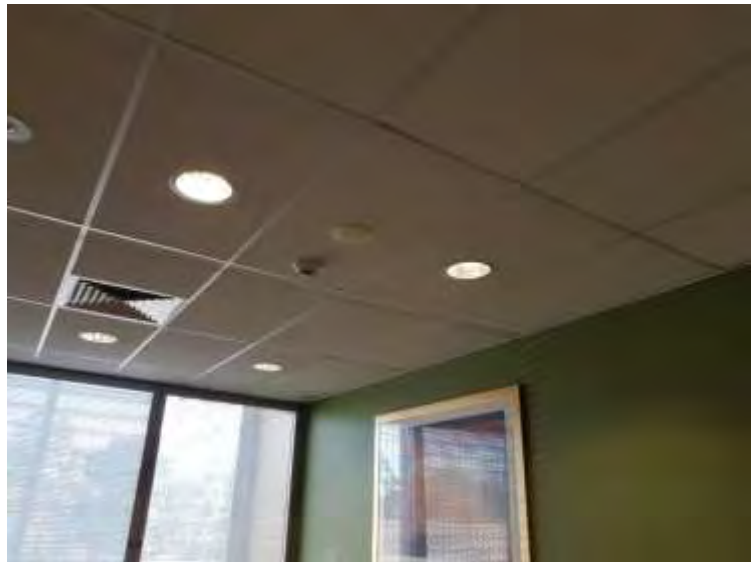
Defect ID A121
Area Type Internal
Location Hope Building Level 2
 Maternity Waiting room
Element General Shot
Defect Type NA
Length (mm) NA
Width (mm) NA
General Comments:
 In reasonable condition

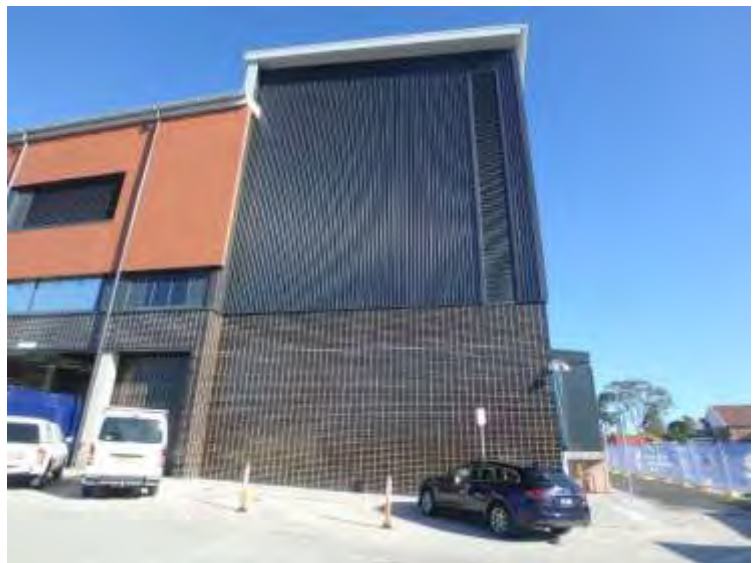
Defect ID A122
Area Type External
Location Hope Building Eastern
 Façade
Element General Shot
Defect Type NA
Length (mm) NA
Width (mm) NA
General Comments:
 In reasonable condition

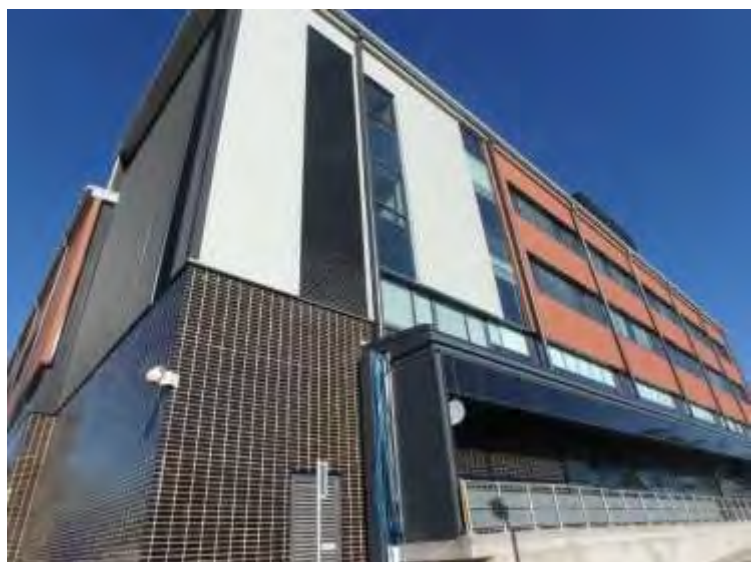
Defect ID A123
Area Type External
Location Hope Building Northern
 Façade
Element General Shot
Defect Type NA
Length (mm) NA
Width (mm) NA
General Comments:
 In reasonable condition

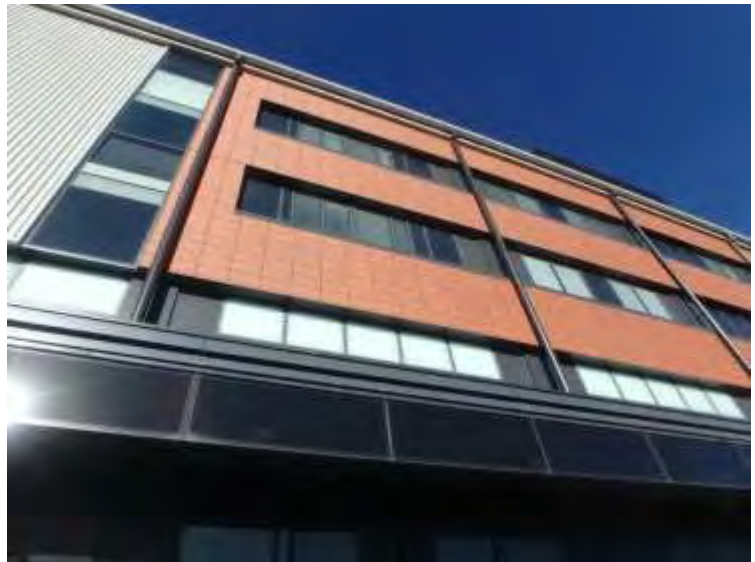
Defect ID A124
Area Type External
Location Hope Building Northern Façade
Element General Shot
Defect Type NA
Length (mm) NA
Width (mm) NA
General Comments:
 In reasonable condition

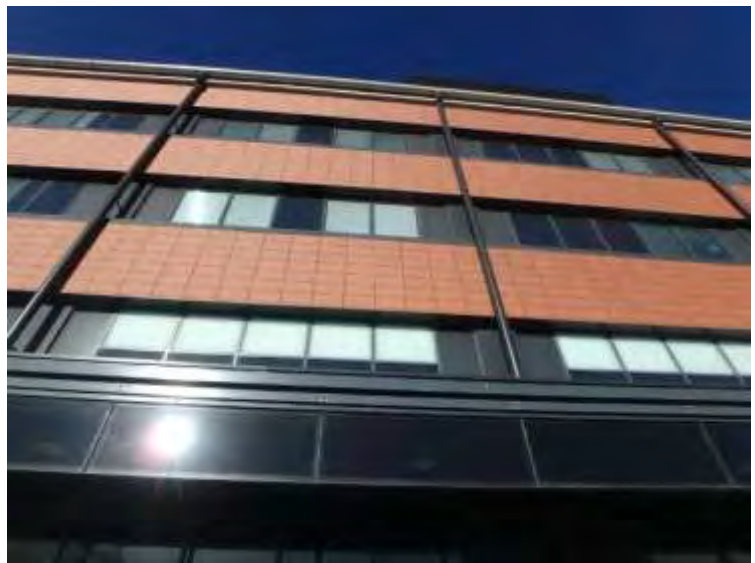
Defect ID A125
Area Type External
Location Hope Building Northern Façade
Element General Shot
Defect Type NA
Length (mm) NA
Width (mm) NA
General Comments:
 In reasonable condition

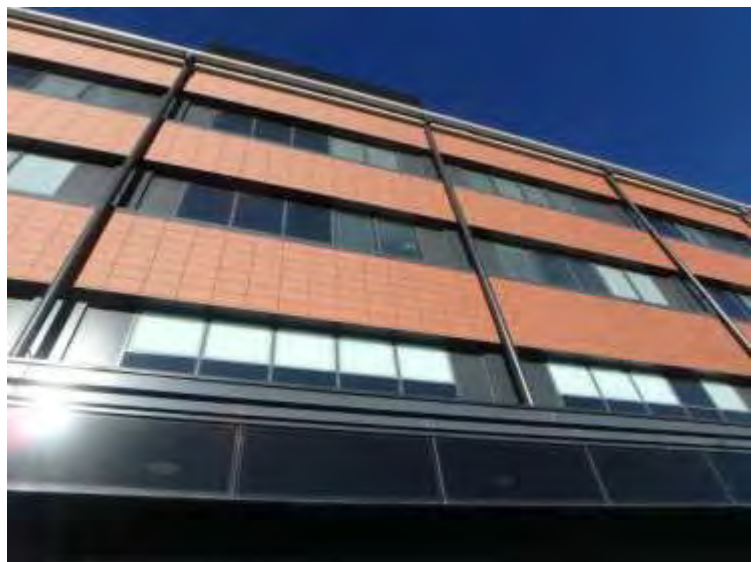
Defect ID A126
Area Type External
Location Hope Building Northern Façade
Element General Shot
Defect Type NA
Length (mm) NA
Width (mm) NA
General Comments:
 In reasonable condition

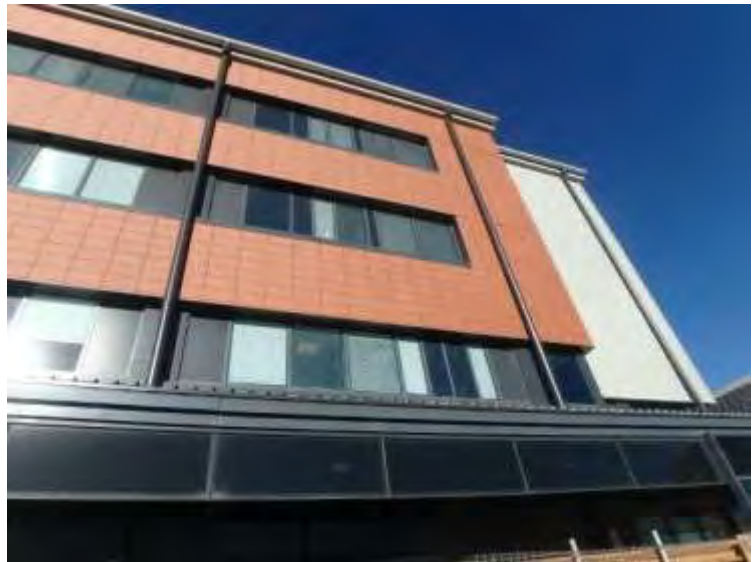
Defect ID A127
Area Type External
Location Hope Building Northern Façade
Element General Shot
Defect Type NA
Length (mm) NA
Width (mm) NA
General Comments:
 In reasonable condition

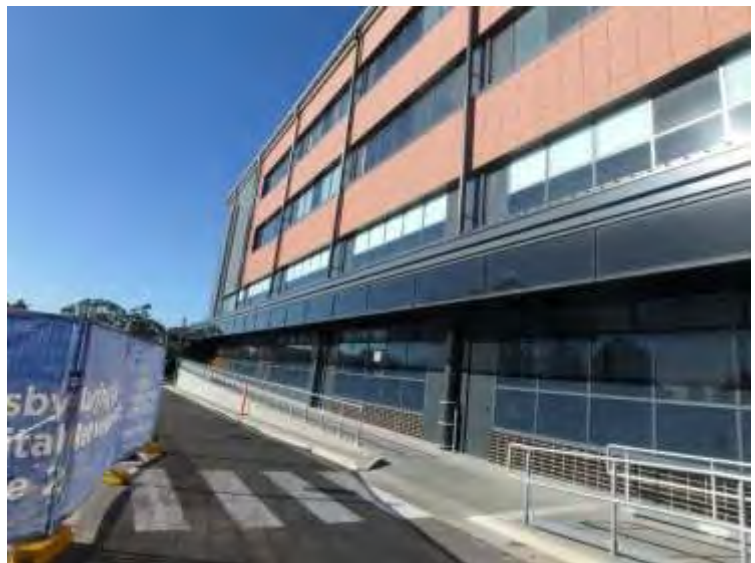
Defect ID A128
Area Type External
Location Hope Building Northern Façade
Element General Shot
Defect Type NA
Length (mm) NA
Width (mm) NA
General Comments:
 In reasonable condition

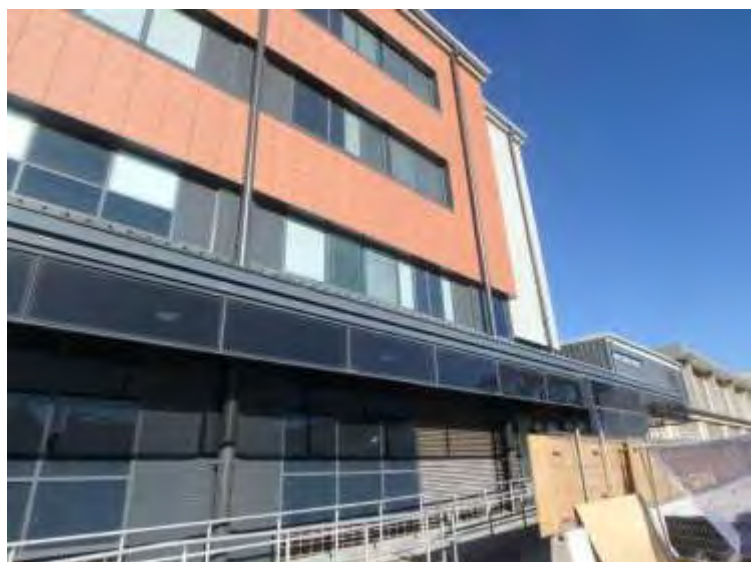
Defect ID A129
Area Type External
Location Hope Building Northern Façade
Element General Shot
Defect Type NA
Length (mm) NA
Width (mm) NA
General Comments:
 In reasonable condition

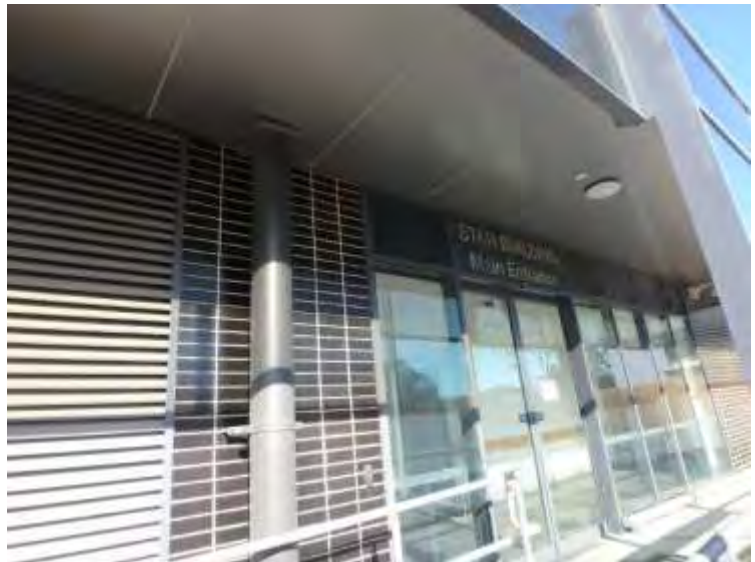
Defect ID A130

General Comments:
In reasonable condition

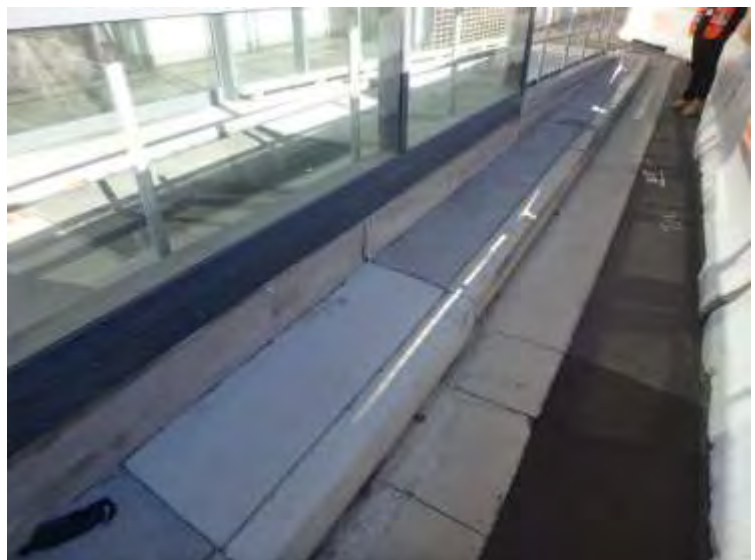
Defect ID A132

General Comments:
In reasonable condition

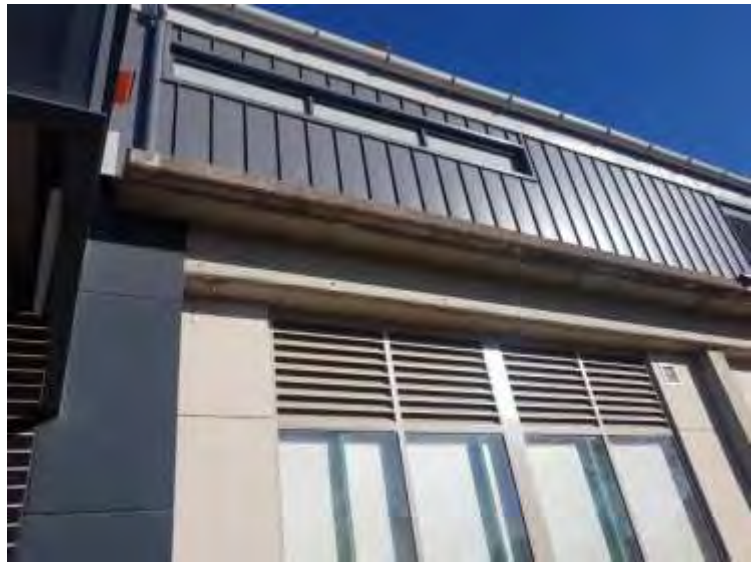
Defect ID A133
Area Type External
Location Hope Building Northern Façade
Element General Shot
Defect Type NA
Length (mm) NA
Width (mm) NA
General Comments:
 In reasonable condition

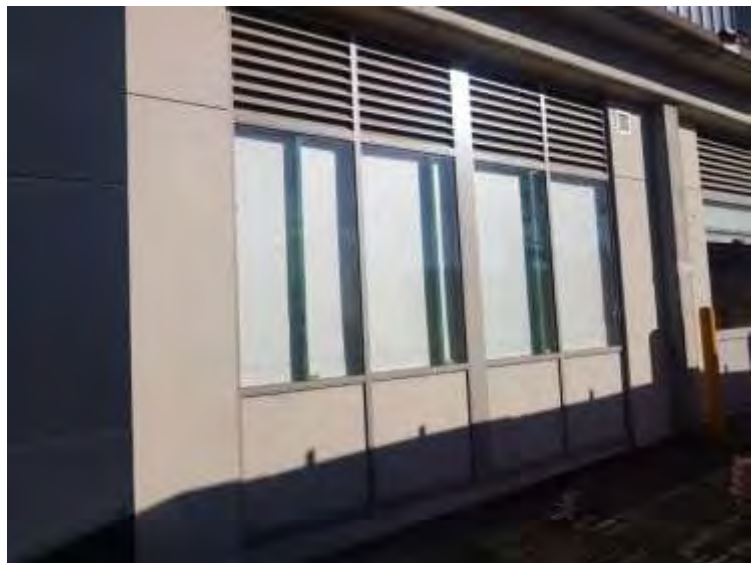
Defect ID A134
Area Type External
Location Hope Building Northern Façade
Element General Shot
Defect Type NA
Length (mm) NA
Width (mm) NA
General Comments:
 In reasonable condition

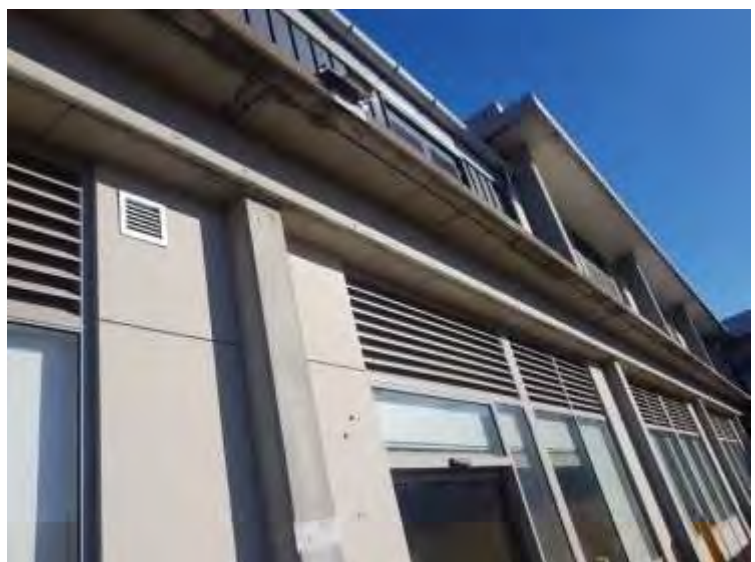
Defect ID A135
Area Type External
Location Hope Building Northern Façade
Element General Shot
Defect Type NA
Length (mm) NA
Width (mm) NA
General Comments:
 In reasonable condition

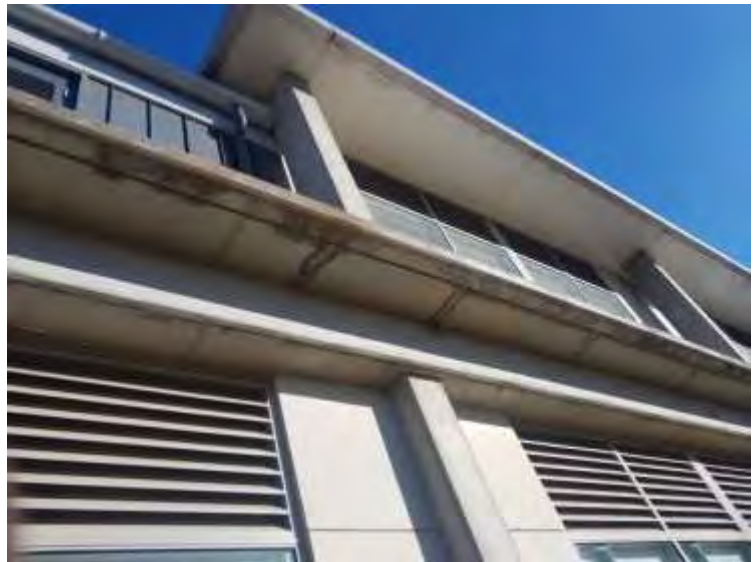
Defect ID A136
Area Type External
Location Hope Building Northern Façade
Element General Shot
Defect Type NA
Length (mm) NA
Width (mm) NA
General Comments:
 In reasonable condition

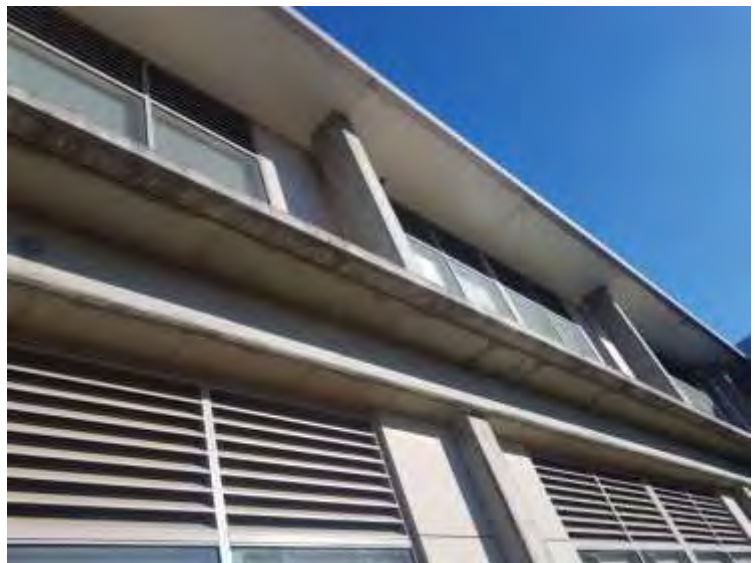
Defect ID A137
Area Type External
Location Hope Building Northern Façade
Element General Shot
Defect Type NA
Length (mm) NA
Width (mm) NA
General Comments:
 In reasonable condition

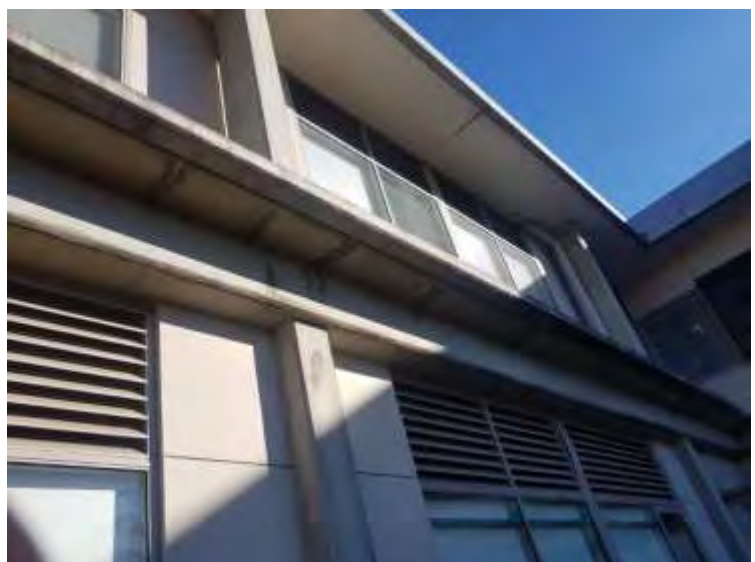
Defect ID A138
Area Type External
Location Hope Building Northern Façade
Element General Shot
Defect Type NA
Length (mm) NA
Width (mm) NA
General Comments:
 In reasonable condition

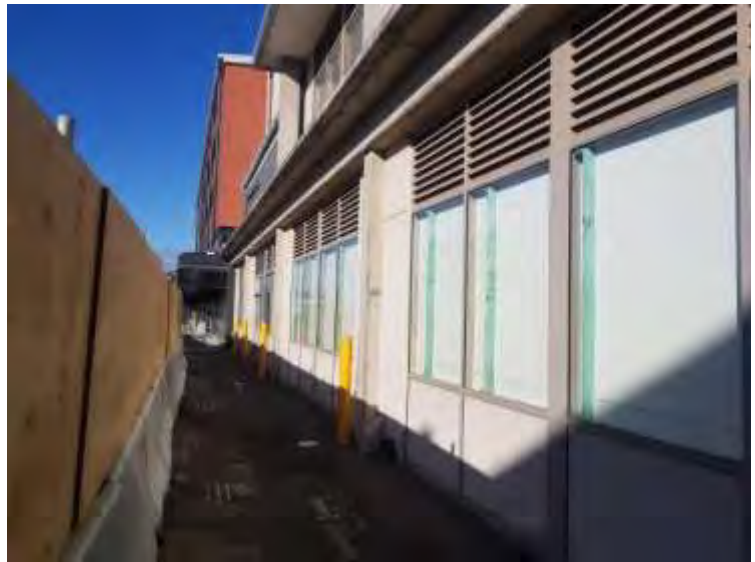
Defect ID A139
Area Type External
Location Hope Building Northern Façade
Element General Shot
Defect Type NA
Length (mm) NA
Width (mm) NA
General Comments:
 In reasonable condition

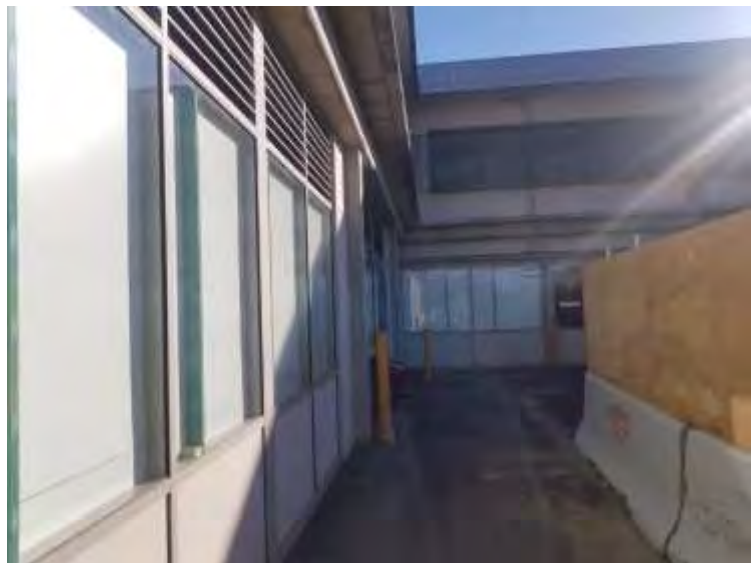
Defect ID A140
Area Type External
Location Hope Building Northern Façade
Element General Shot
Defect Type NA
Length (mm) NA
Width (mm) NA
General Comments:
 In reasonable condition

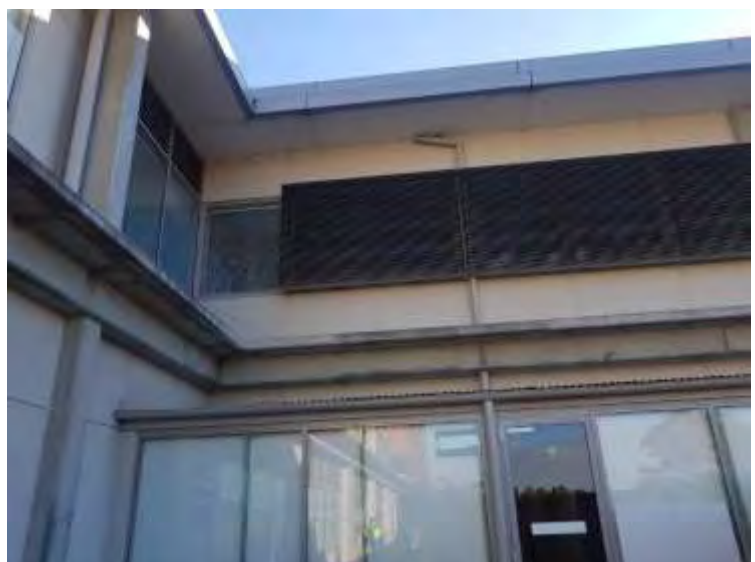
Defect ID A141
Area Type External
Location Hope Building Eastern Façade
Element General Shot
Defect Type NA
Length (mm) NA
Width (mm) NA
General Comments:
 In reasonable condition

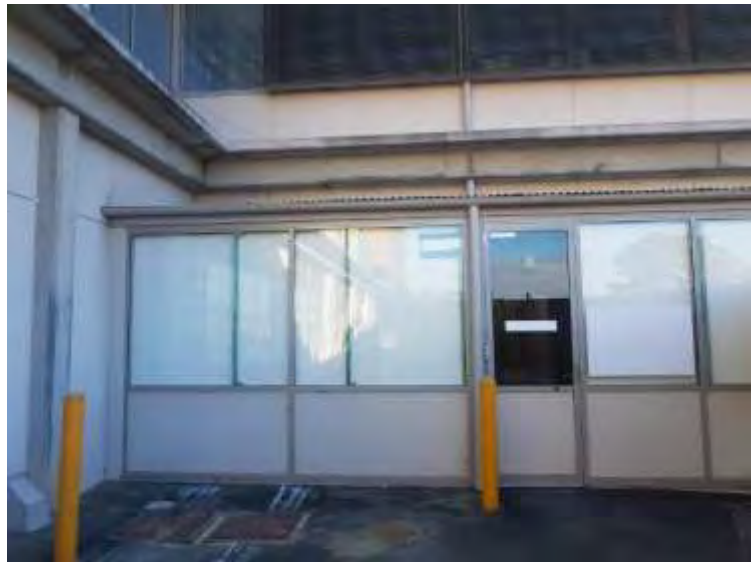
Defect ID A142
Area Type External
Location Hope Building Eastern Façade
Element General Shot
Defect Type NA
Length (mm) NA
Width (mm) NA
General Comments:
 In reasonable condition

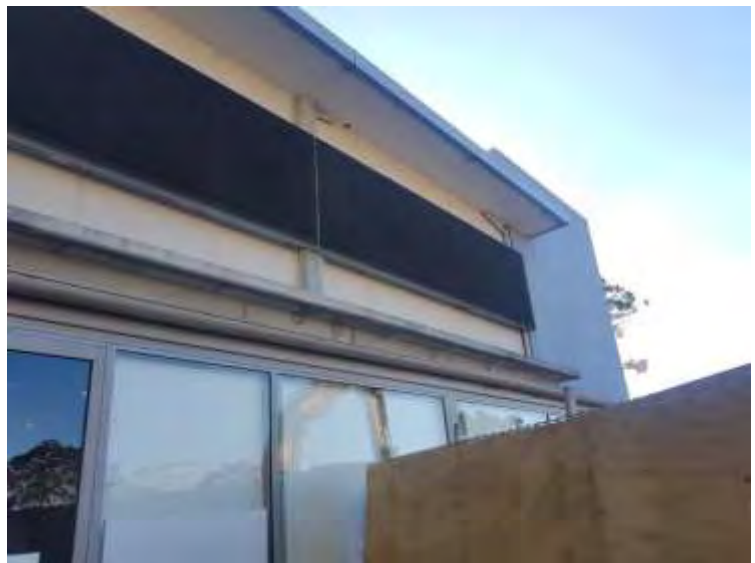
Defect ID A143
Area Type External
Location Hope Building Eastern Façade
Element General Shot
Defect Type NA
Length (mm) NA
Width (mm) NA
General Comments:
 In reasonable condition

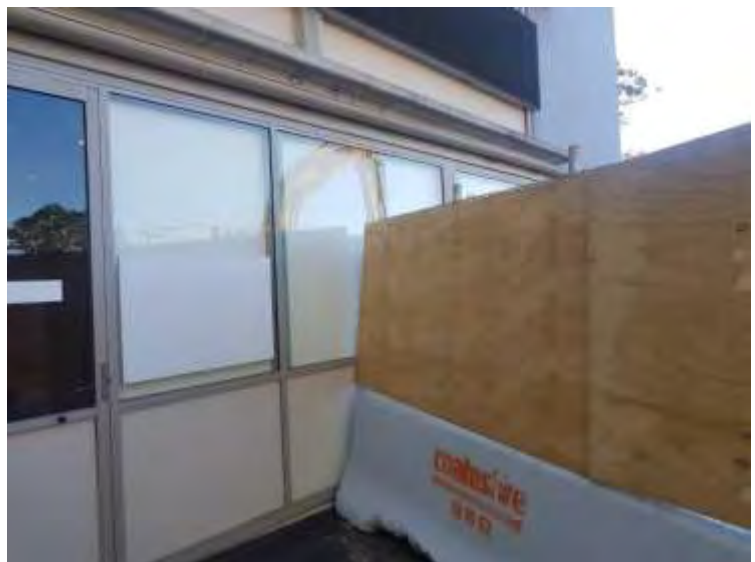
Defect ID A144
Area Type External
Location Hope Building Eastern Façade
Element General Shot
Defect Type NA
Length (mm) NA
Width (mm) NA
General Comments:
 In reasonable condition

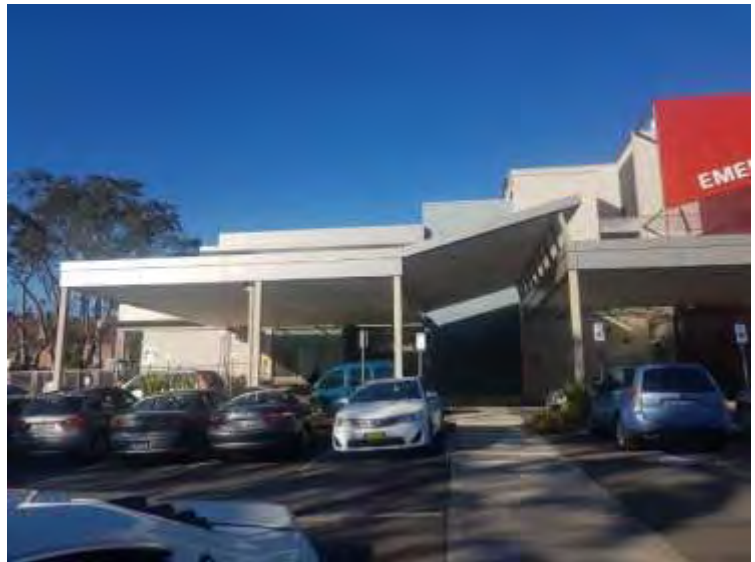
Defect ID A145
Area Type External
Location Hope Building Western Façade (Main entrance)
Element General Shot
Defect Type NA
Length (mm) NA
Width (mm) NA
General Comments:
 In reasonable condition

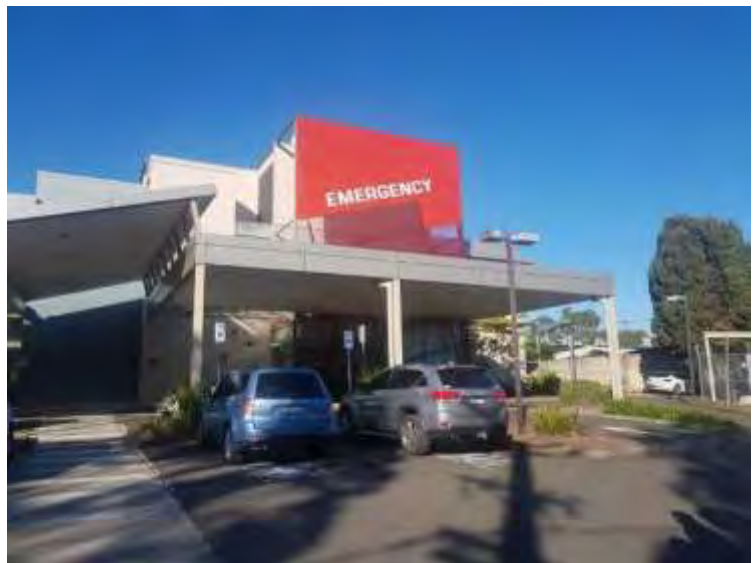
Defect ID A146
Area Type External
Location Hope Building Western Façade (Main entrance)
Element General Shot
Defect Type NA
Length (mm) NA
Width (mm) NA
General Comments:
 In reasonable condition

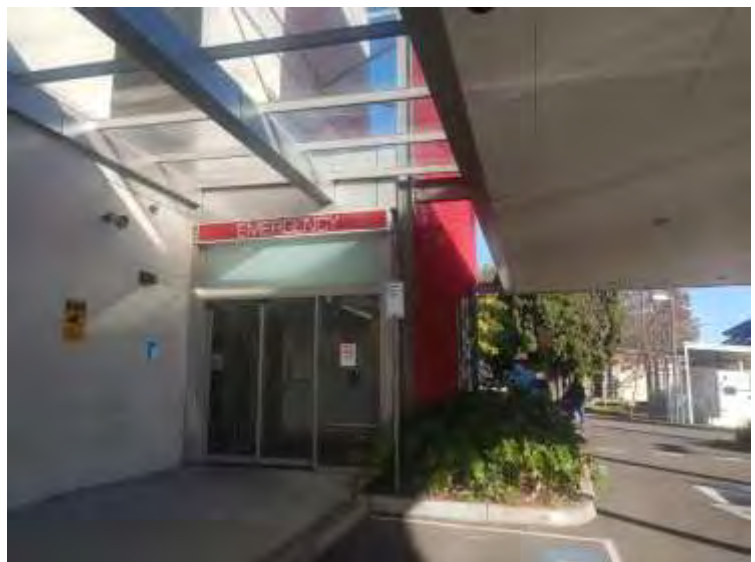
Defect ID A147
Area Type External
Location Hope Building Western Façade (Main entrance)
Element General Shot
Defect Type NA
Length (mm) NA
Width (mm) NA
General Comments:
 In reasonable condition

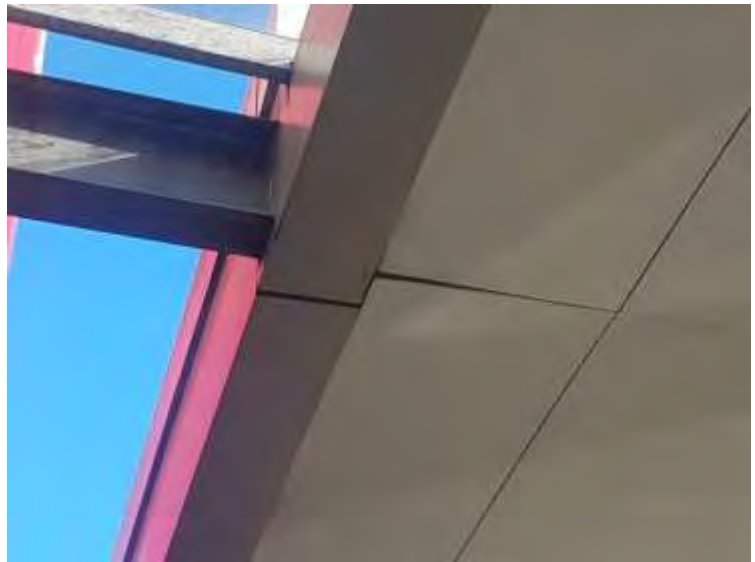
Defect ID A148
Area Type External
Location Hope Building Western Façade (Main entrance)
Element General Shot
Defect Type NA
Length (mm) NA
Width (mm) NA
General Comments:
 In reasonable condition

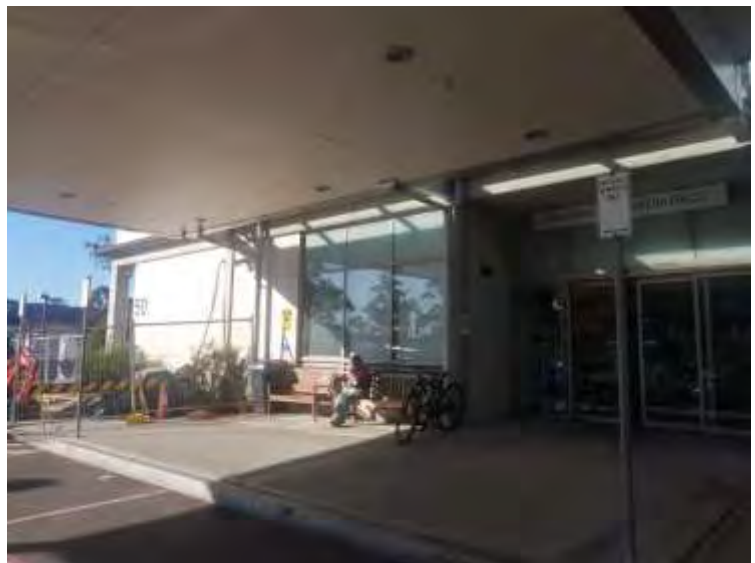
Defect ID A149
Area Type External
Location Hope Building Western Façade (Main entrance)
Element General Shot
Defect Type NA
Length (mm) NA
Width (mm) NA
General Comments:
 In reasonable condition

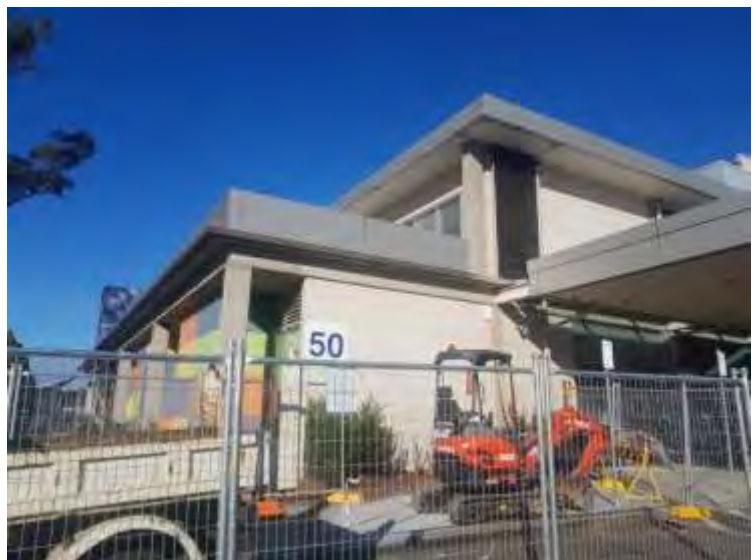
Defect ID A150
Area Type External
Location Hope Building Western Façade (Main entrance)
Element General Shot
Defect Type NA
Length (mm) NA
Width (mm) NA
General Comments:
 In reasonable condition

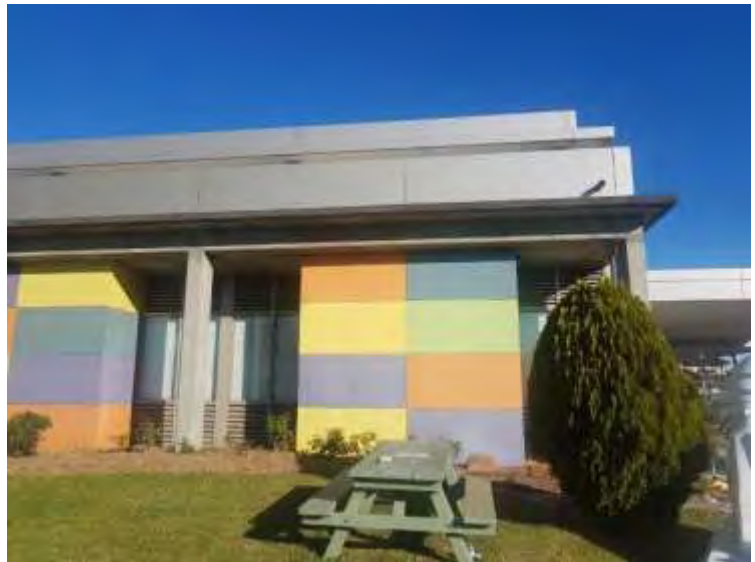
Defect ID A151
Area Type External
Location Hope Building Northern Façade (Palmerston Rd)
Element General Shot
Defect Type NA
Length (mm) NA
Width (mm) NA
General Comments:
 In reasonable condition

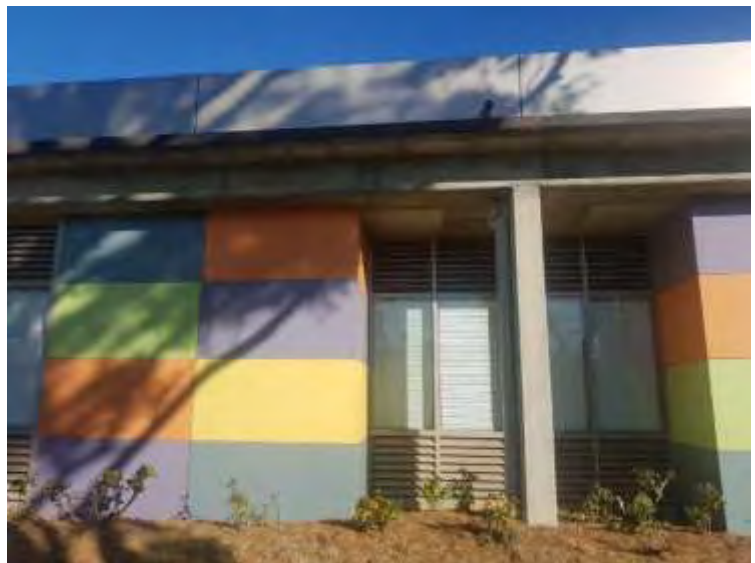
Defect ID A152
Area Type External
Location Hope Building Northern Façade (Palmerston Rd)
Element General Shot
Defect Type NA
Length (mm) NA
Width (mm) NA
General Comments:
 In reasonable condition

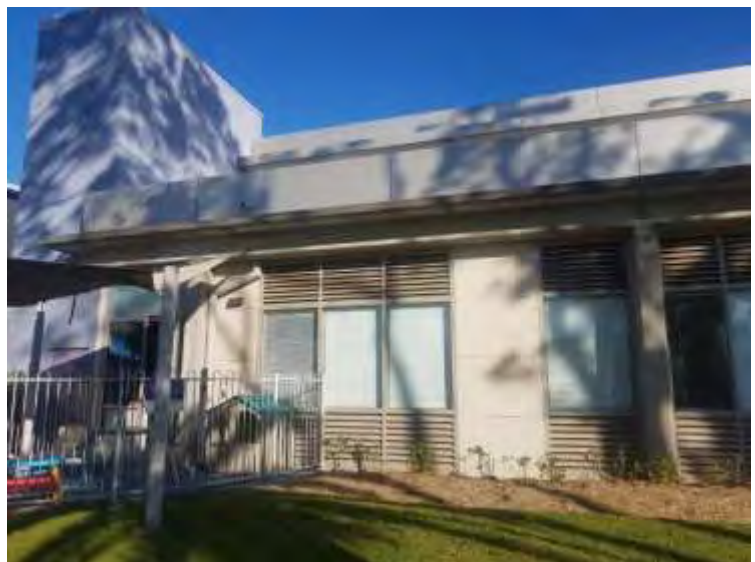
Defect ID A153
Area Type External
Location Hope Building Northern Façade (Palmerston Rd)
Element General Shot
Defect Type NA
Length (mm) NA
Width (mm) NA
General Comments:
 In reasonable condition

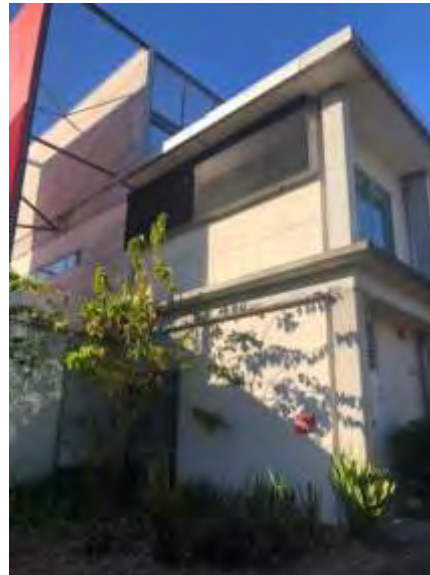
Defect ID A154
Area Type External
Location Hope Building Southern Façade
Element General Shot
Defect Type NA
Length (mm) NA
Width (mm) NA
General Comments:
 In reasonable condition

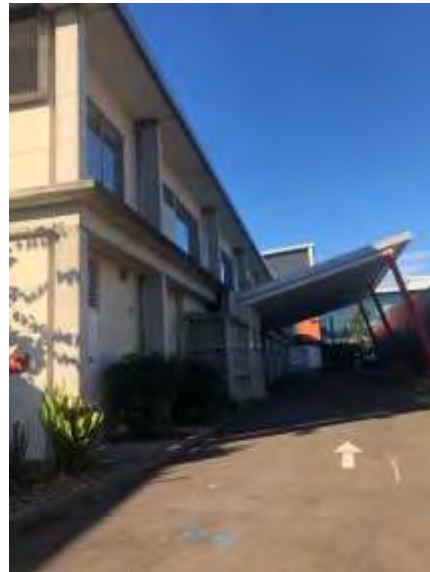
Defect ID A155
Area Type External
Location Hope Building Southern Façade
Element General Shot
Defect Type NA
Length (mm) NA
Width (mm) NA
General Comments:
 In reasonable condition
