Council Assets Surrounding Hornsby Hospital

Dilapidation Report
80818469

Prepared for	Watpac Construction Pty Ltd
Project Name	Dilapidation Report
File Reference	Dilapidation Report - Hornsby Hospital Council Assets-2018-06-28.docx
Job Reference	80818469
Date	June 2018

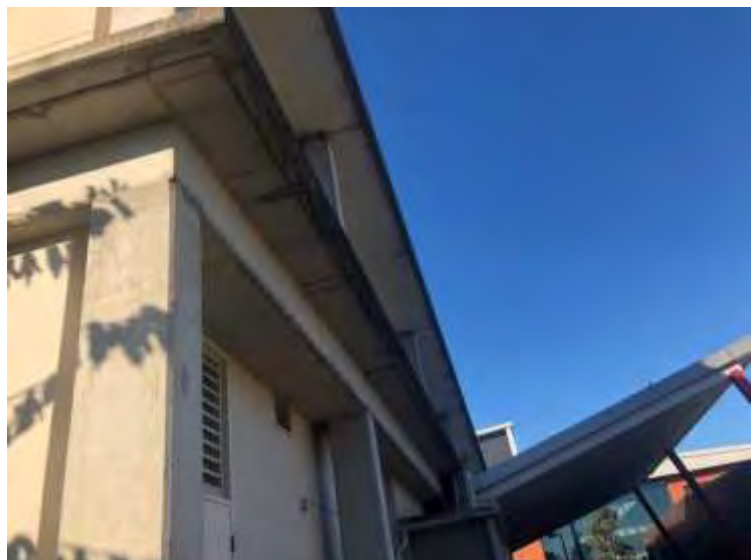
Defect ID A156
Area Type External
Location Hope Building Southern Façade
Element General Shot
Defect Type NA
Length (mm) NA
Width (mm) NA
General Comments:
 In reasonable condition

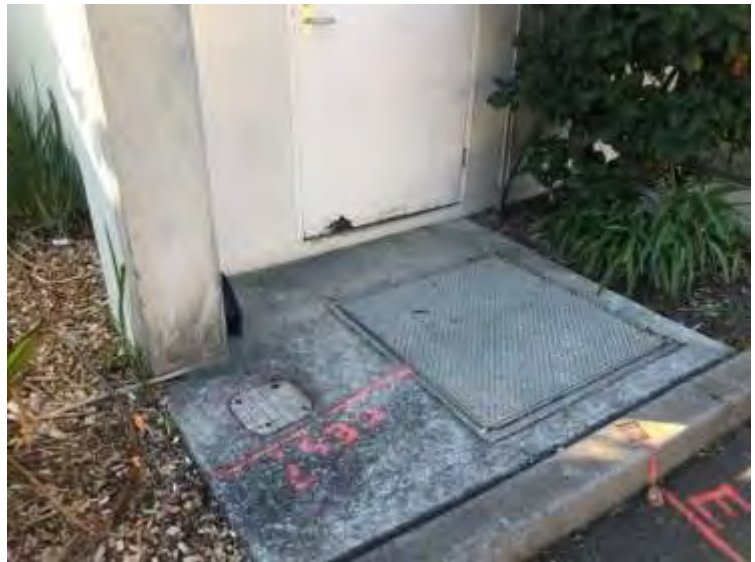
Defect ID A157
Area Type External
Location Hope Building Southern Façade
Element General Shot
Defect Type NA
Length (mm) NA
Width (mm) NA
General Comments:
 In reasonable condition

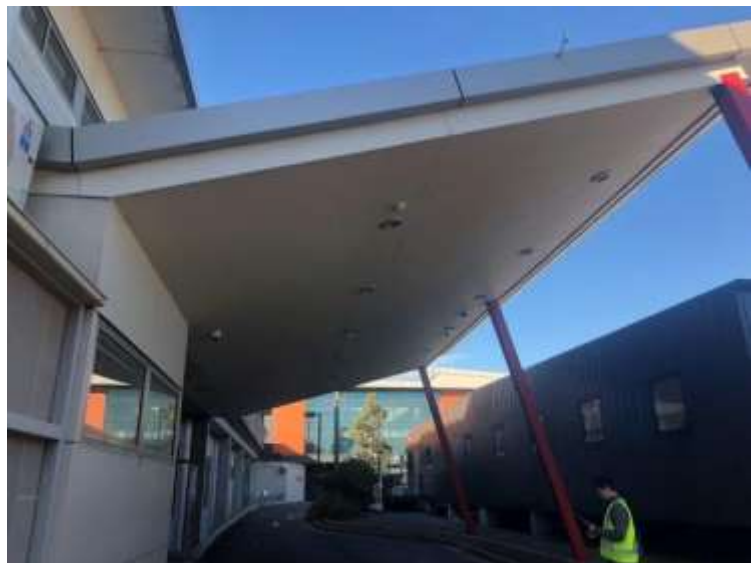
Defect ID A158
Area Type External
Location Hope Building Southern Façade
Element General Shot
Defect Type NA
Length (mm) NA
Width (mm) NA
General Comments:
 In reasonable condition

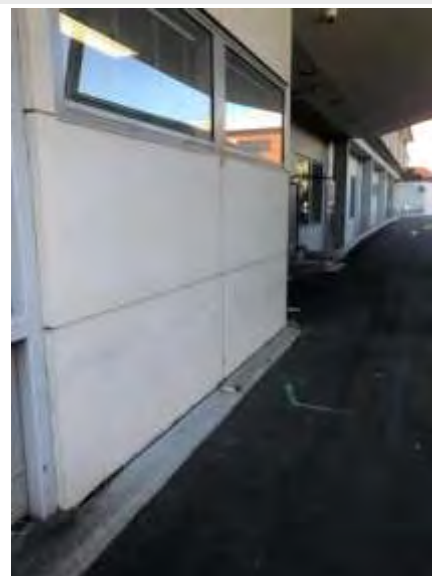
Defect ID A159
Area Type External
Location Hope Building Southern Façade
Element General Shot
Defect Type NA
Length (mm) NA
Width (mm) NA
General Comments:
 In reasonable condition

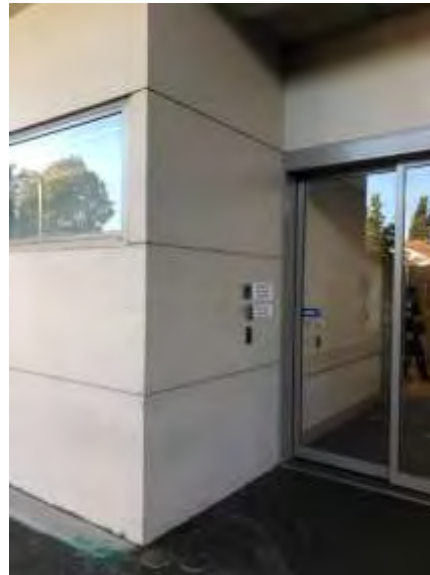
Defect ID A160

General Comments:
In reasonable condition

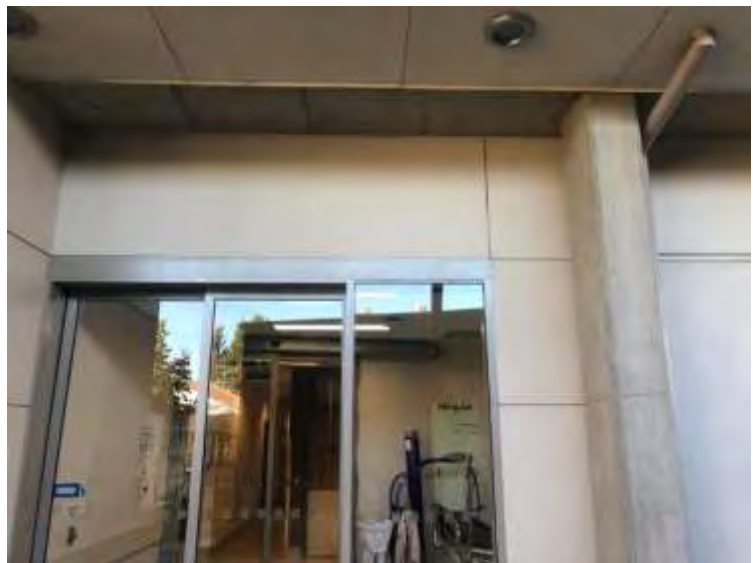
Defect ID A161

General Comments:
In reasonable condition

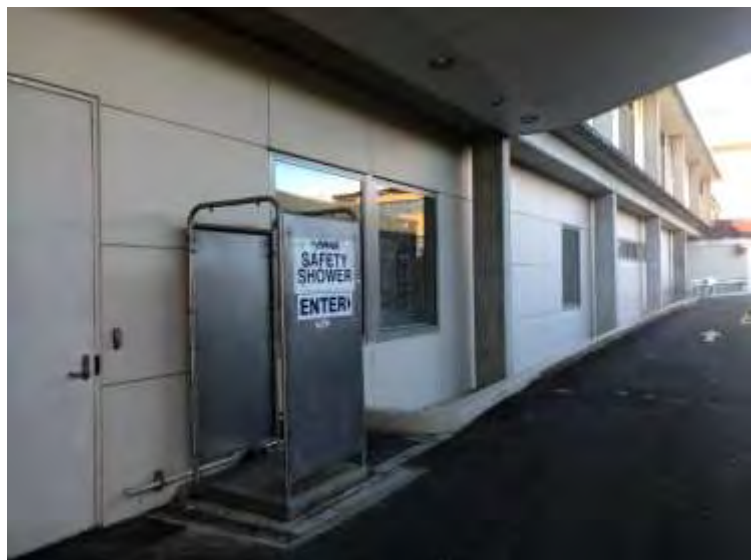
Defect ID A162

General Comments:
In reasonable condition

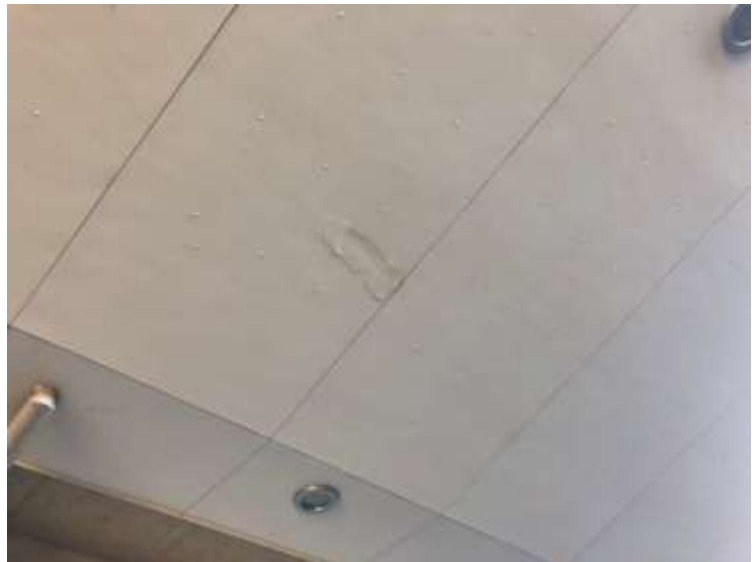
Defect ID A163
Area Type External
Location Hope Building Southern Façade
Element General Shot
Defect Type NA
Length (mm) NA
Width (mm) NA
General Comments:
 In reasonable condition

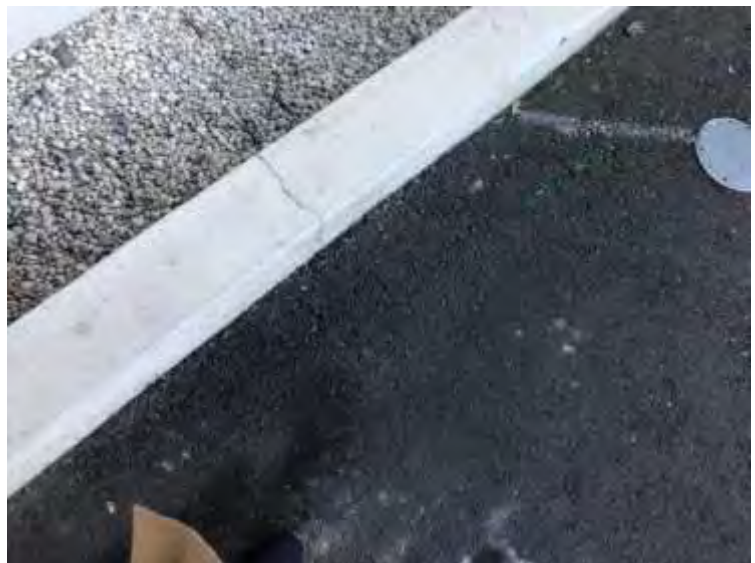
Defect ID A164
Area Type External
Location Hope Building Southern Façade
Element General Shot
Defect Type NA
Length (mm) NA
Width (mm) NA
General Comments:
 In reasonable condition

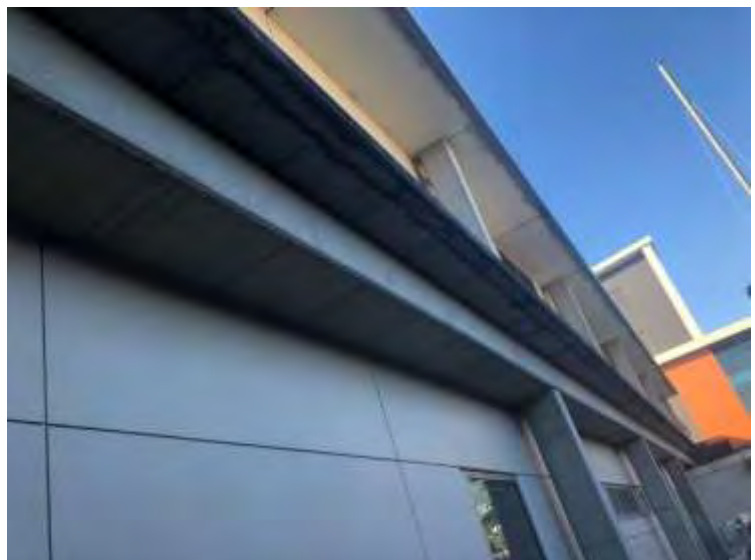
Defect ID A165
Area Type External
Location Hope Building Southern Façade
Element General Shot
Defect Type NA
Length (mm) NA
Width (mm) NA
General Comments:
 In reasonable condition

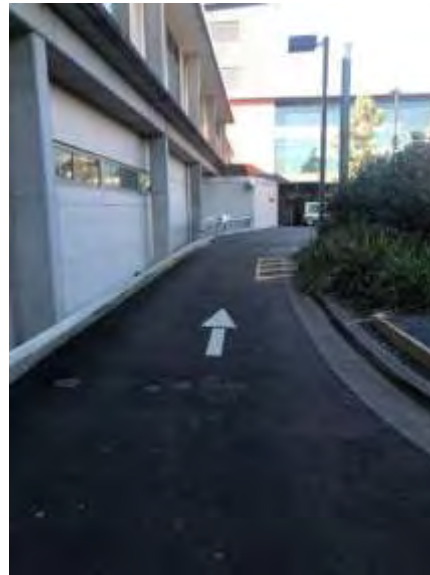
Defect ID A166
Area Type External
Location Hope Building Southern Façade
Element General Shot
Defect Type NA
Length (mm) NA
Width (mm) NA
General Comments:
 In reasonable condition

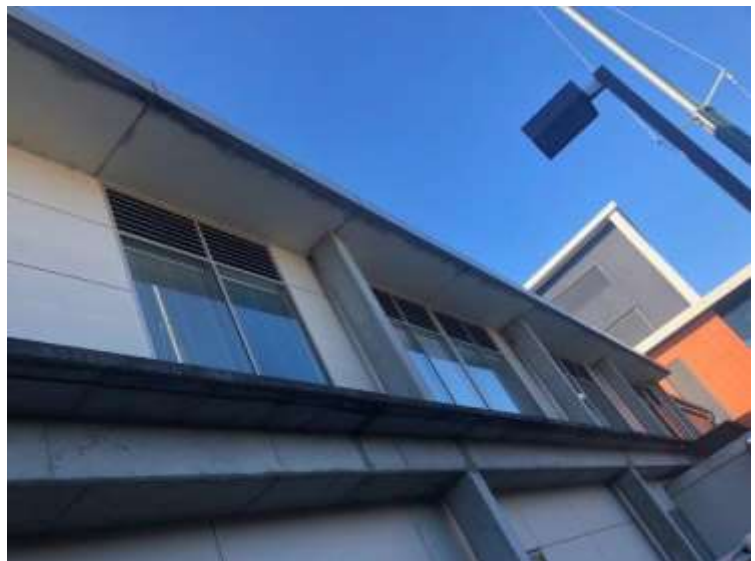
Defect ID A167
Area Type External
Location Hope Building Southern Façade
Element General Shot
Defect Type NA
Length (mm) NA
Width (mm) NA
General Comments:
 In reasonable condition

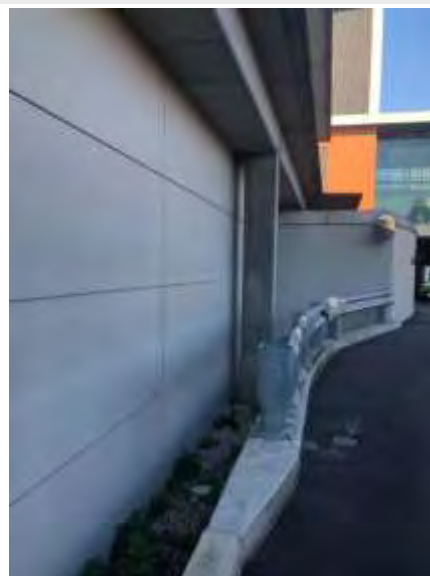
Defect ID A168
Area Type External
Location Hope Building Southern Façade
Element General Shot
Defect Type NA
Length (mm) NA
Width (mm) NA
General Comments:
 In reasonable condition

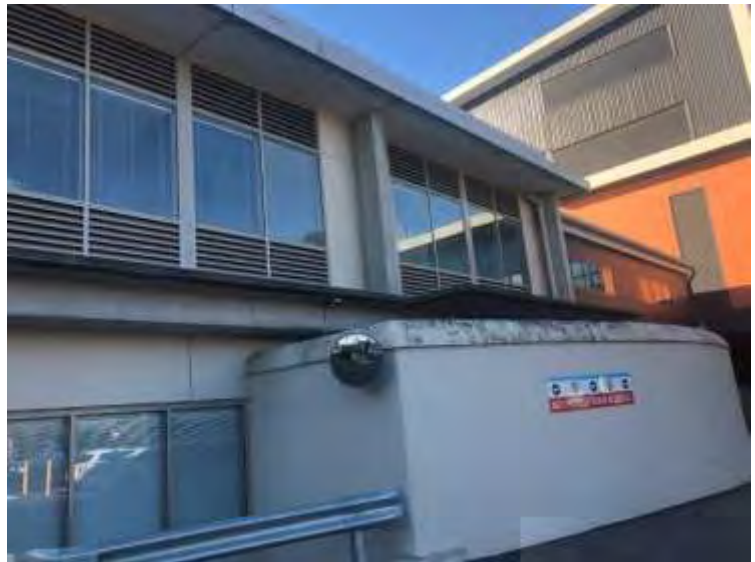
Defect ID A169
Area Type External
Location Hope Building Southern Façade
Element General Shot
Defect Type NA
Length (mm) NA
Width (mm) NA
General Comments:
 In reasonable condition

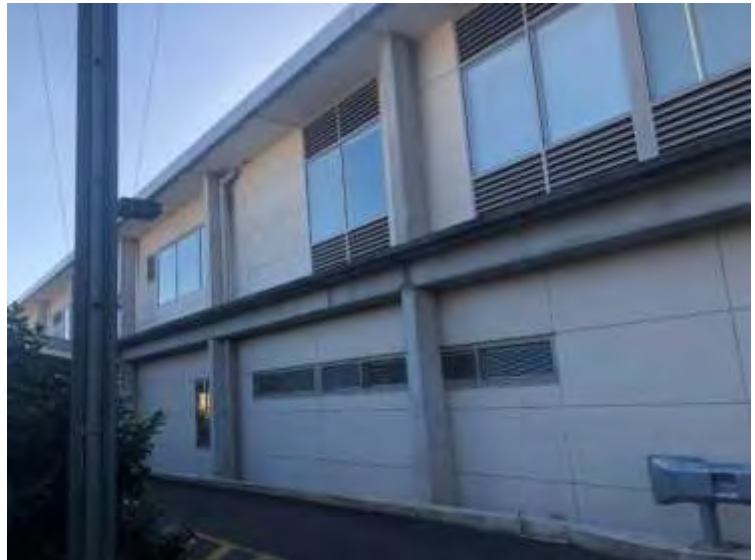
Defect ID A170
Area Type External
Location Hope Building Southern Façade
Element General Shot
Defect Type NA
Length (mm) NA
Width (mm) NA
General Comments:
 In reasonable condition

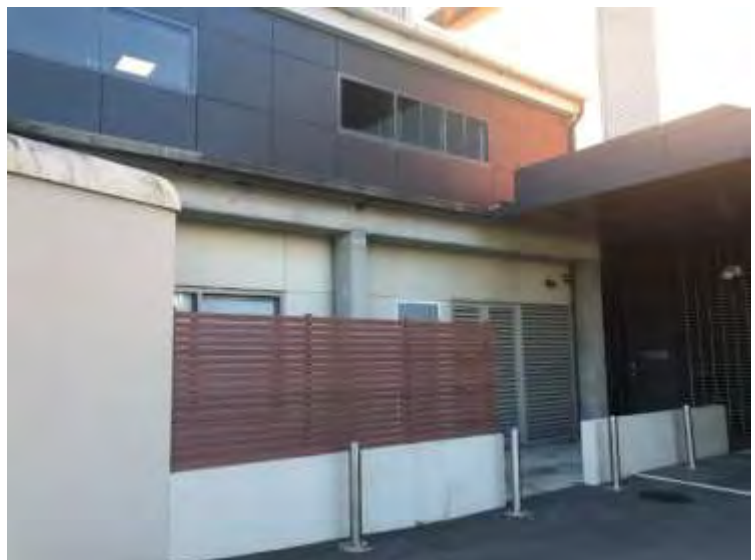
Defect ID A171
Area Type External
Location Hope Building Southern Façade
Element General Shot
Defect Type NA
Length (mm) NA
Width (mm) NA
General Comments:
 In reasonable condition

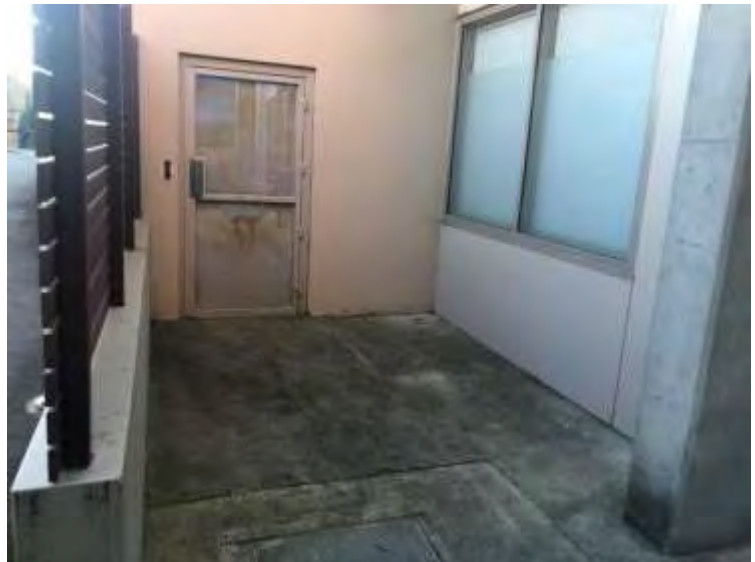
Defect ID A172
Area Type External
Location Hope Building Southern Façade
Element General Shot
Defect Type NA
Length (mm) NA
Width (mm) NA
General Comments:
 In reasonable condition

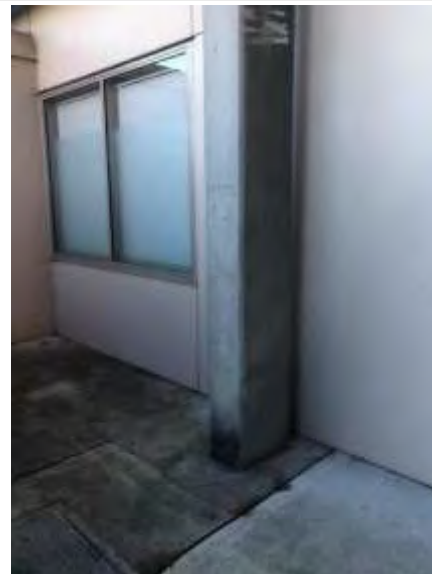
Defect ID A173
Area Type External
Location Hope Building Southern Façade
Element General Shot
Defect Type NA
Length (mm) NA
Width (mm) NA
General Comments:
 In reasonable condition

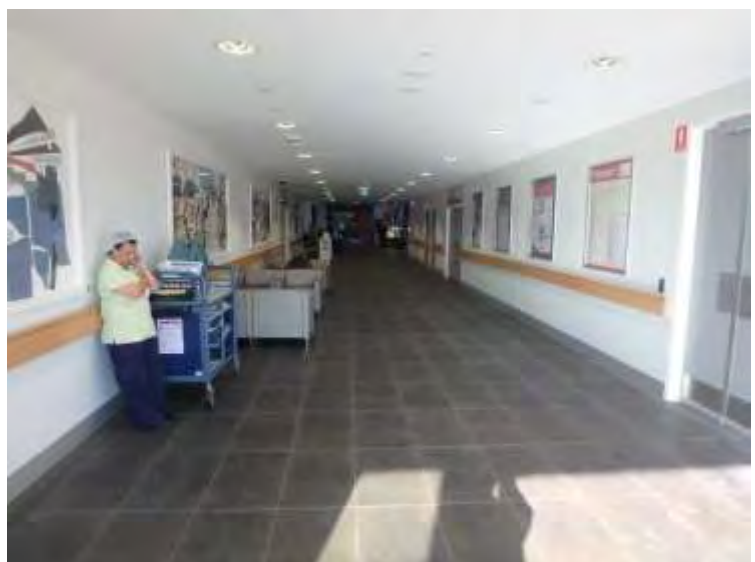
Defect ID A174
Area Type Internal
Location Hope Building Level 1 Side entrance
Element General Shot
Defect Type NA
Length (mm) NA
Width (mm) NA
General Comments:
 In reasonable condition

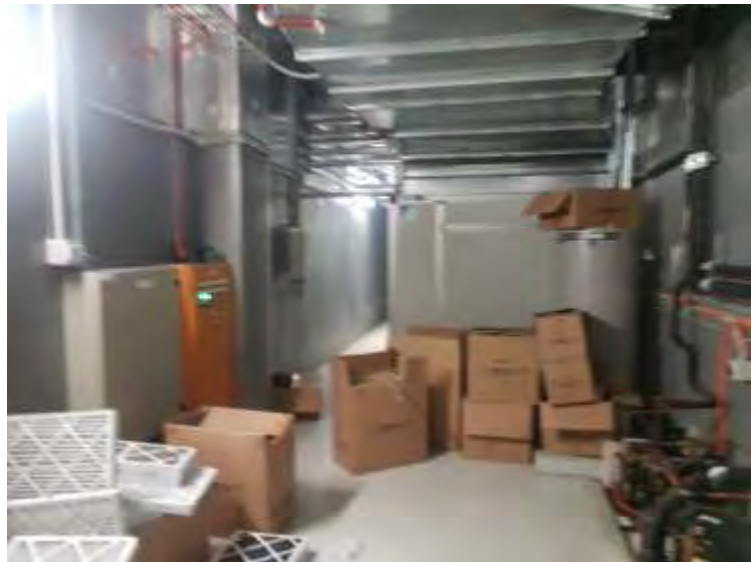
Defect ID A175
Area Type Internal
Location Hope Building Level 1
 Plant Room 1
Element General Shot
Defect Type NA
Length (mm) NA
Width (mm) NA
General Comments:
 In reasonable condition

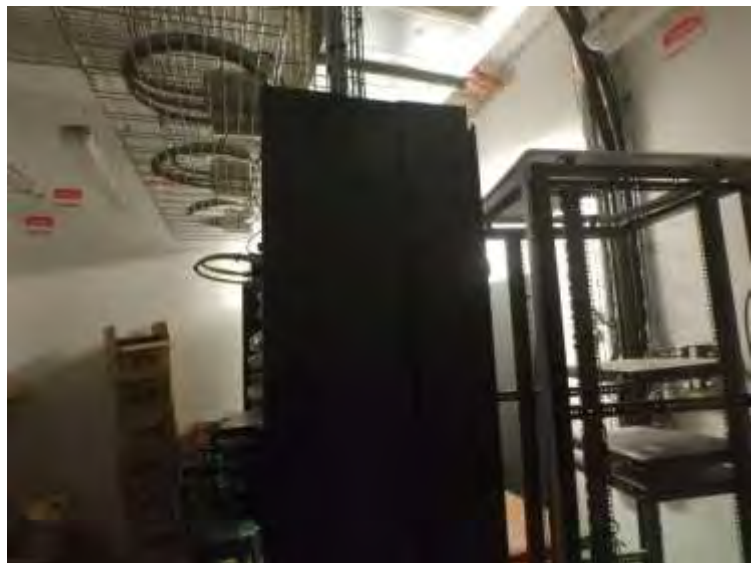
Defect ID A176
Area Type Internal
Location Hope Building Level 1
 Comms Room
Element General Shot
Defect Type NA
Length (mm) NA
Width (mm) NA
General Comments:
 In reasonable condition

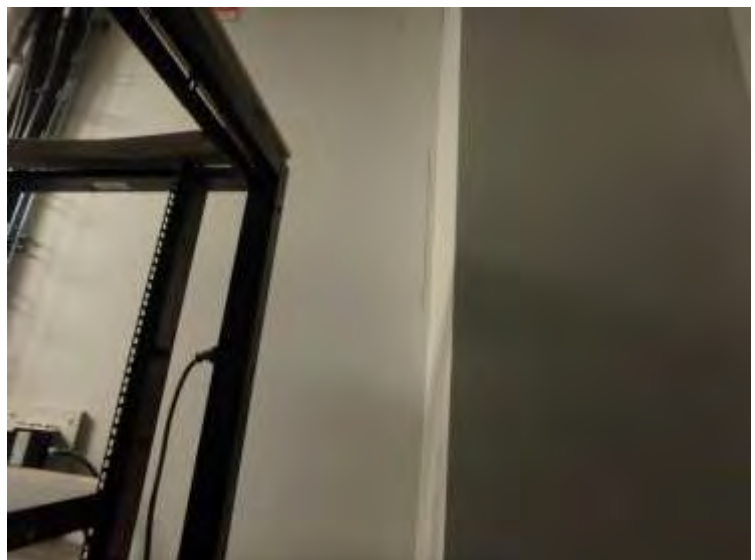
Defect ID A177
Area Type Internal
Location Hope Building Level 1
 Comms Room
Element Plasterboard
Defect Type Crack
Length (mm) 500
Width (mm) 0.5
General Comments:
 Vertical cracking to plasterboard wall

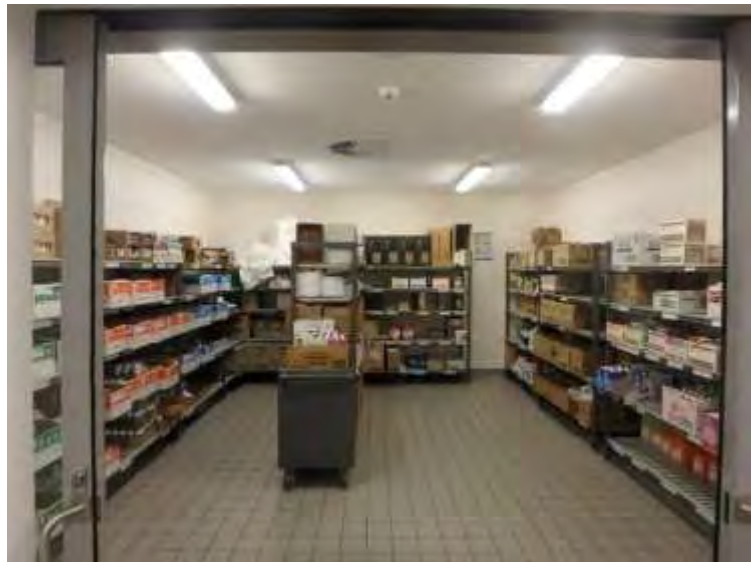
Defect ID A178
Area Type Internal
Location Hope Building Level 1
 Food Services
Element General Shot
Defect Type NA
Length (mm) NA
Width (mm) NA
General Comments:
 In reasonable condition

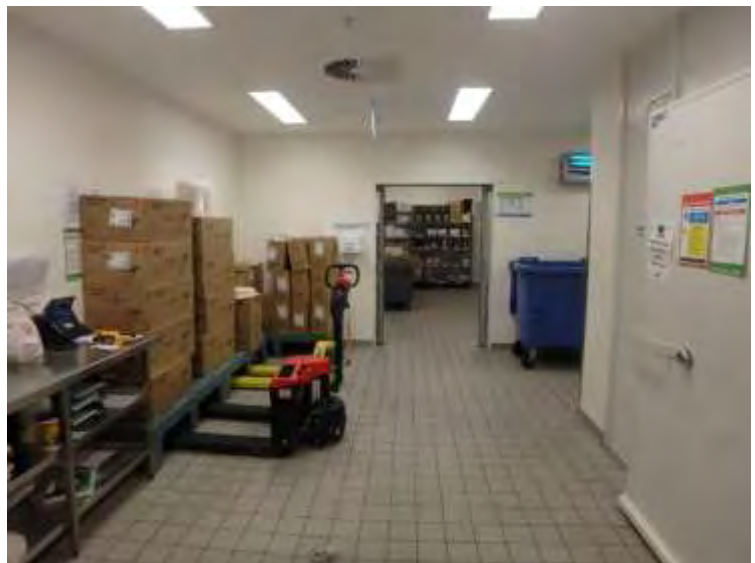
Defect ID A179
Area Type Internal
Location Hope Building Level 1
 Food Services
Element General Shot
Defect Type NA
Length (mm) NA
Width (mm) NA
General Comments:
 In reasonable condition

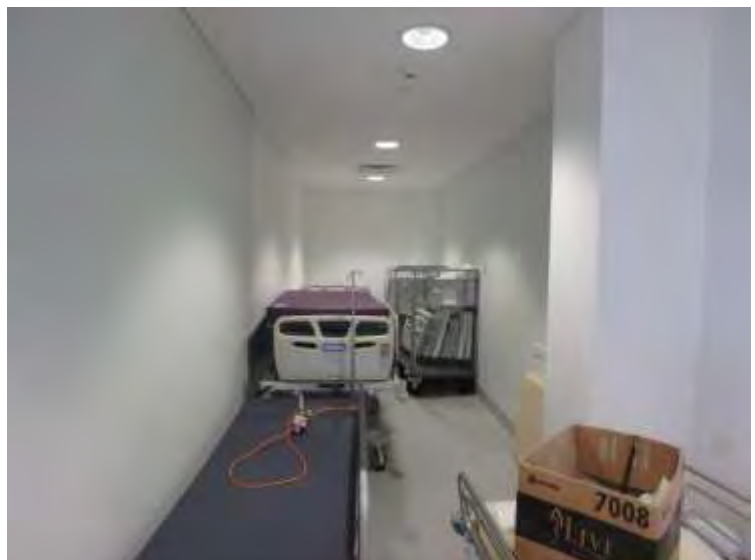
Defect ID A180
Area Type Internal
Location Hope Building Level 1
 Store room
Element General Shot
Defect Type NA
Length (mm) NA
Width (mm) NA
General Comments:
 In reasonable condition

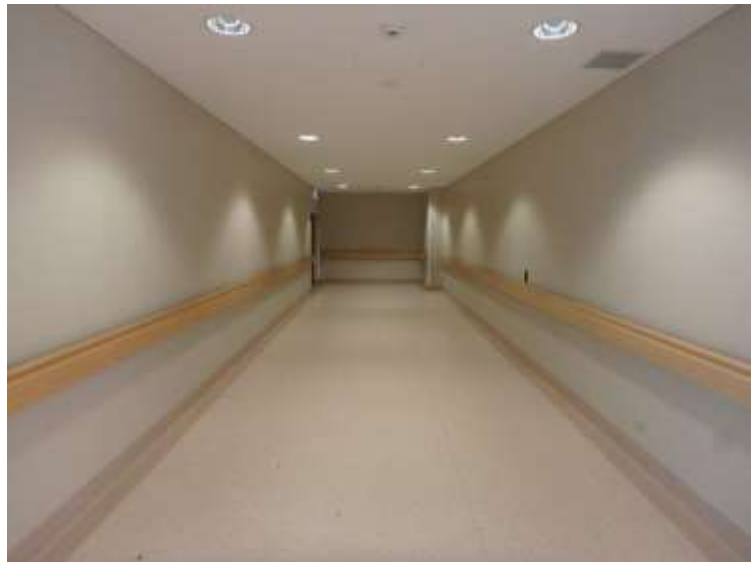
Defect ID A181

General Comments:
In reasonable condition

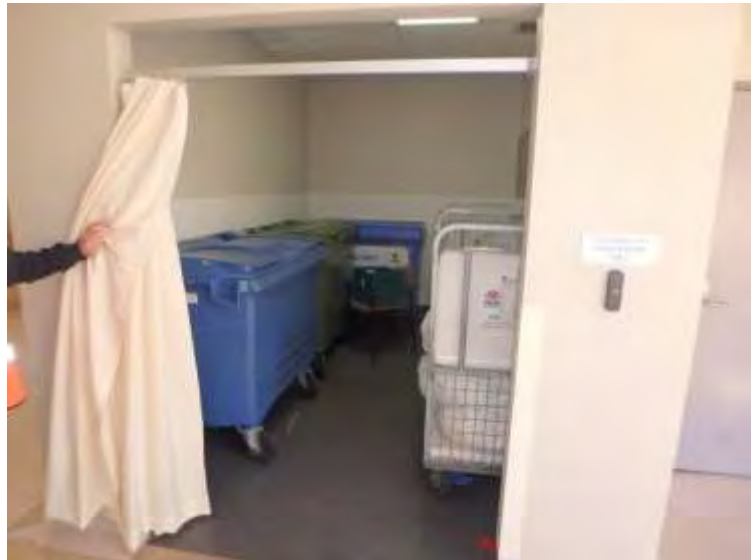
Defect ID A182

General Comments:
In reasonable condition

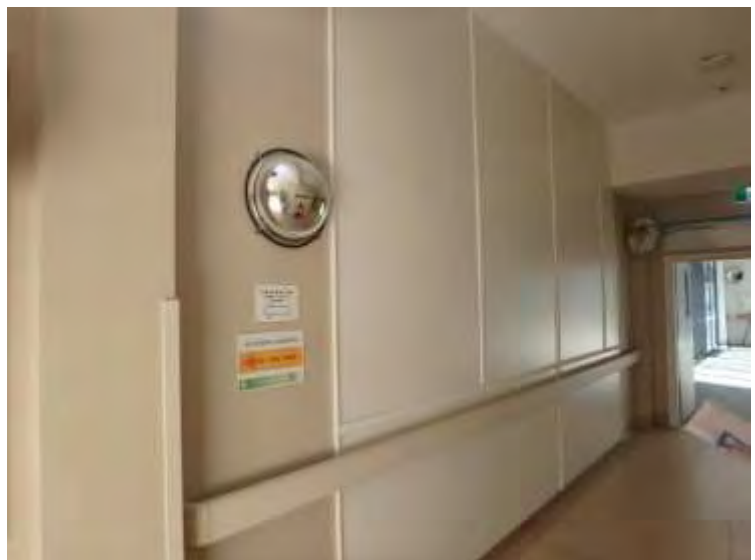
Defect ID A183

General Comments:
In reasonable condition

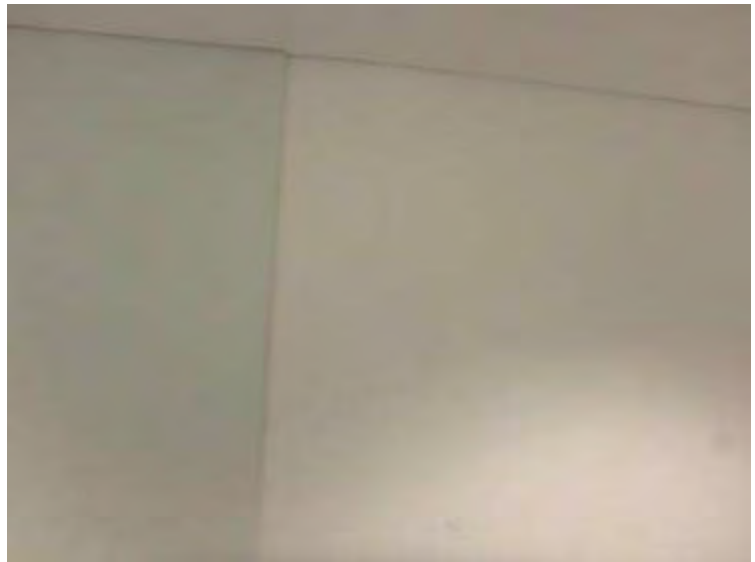
Defect ID A184
Area Type Internal
Location Hope Building Level 1
 Hallway
Element Plasterboard
Defect Type Crack
Length (mm) 1000
Width (mm) 0.5
General Comments:
 Vertical cracking to plasterboard wall

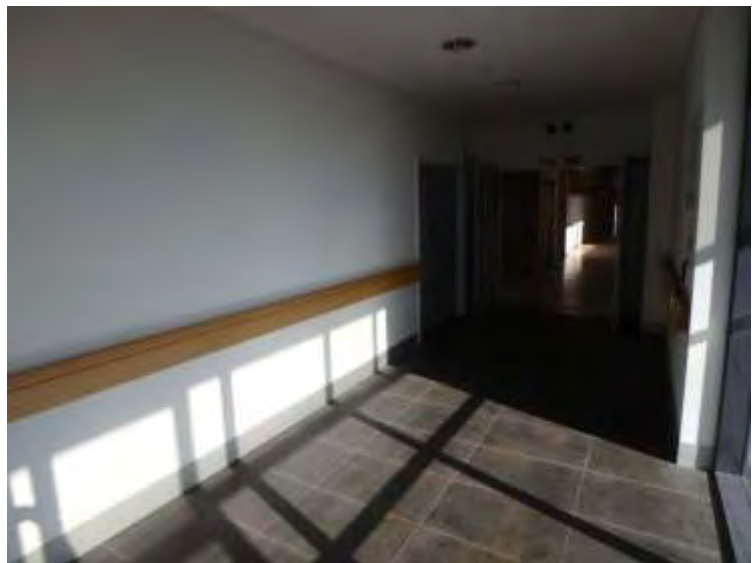
Defect ID A185
Area Type Internal
Location Hope Building Level 1
 Hallway
Element General Shot
Defect Type NA
Length (mm) NA
Width (mm) NA
General Comments:
 In reasonable condition

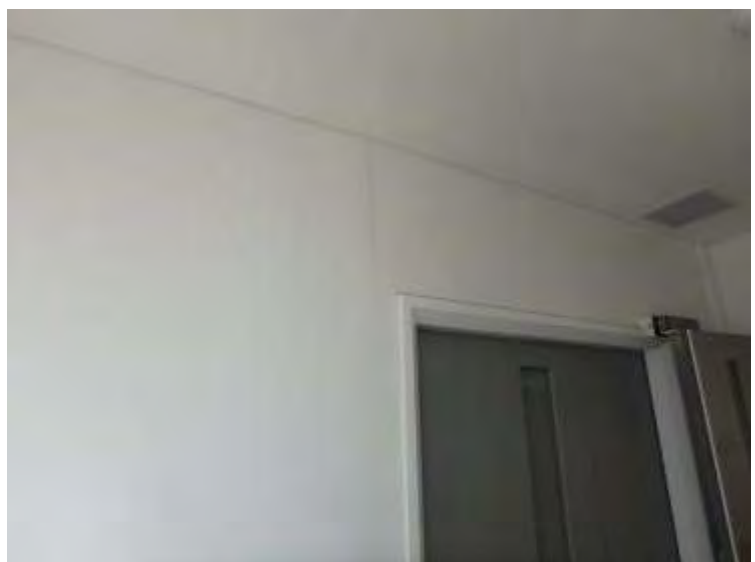
Defect ID A186
Area Type Internal
Location Hope Building Level 1
 Hallway
Element Plasterboard
Defect Type Crack
Length (mm) 500
Width (mm) 0.5
General Comments:
 Vertical cracking to plasterboard wall

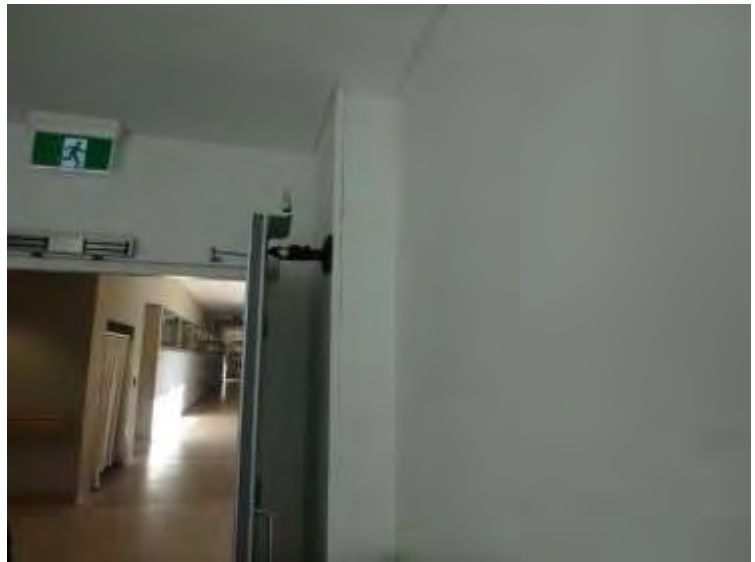
Defect ID A187
Area Type Internal
Location Hope Building Level 1
Hallway
Element Plasterboard
Defect Type Crack
Length (mm) 2000
Width (mm) 0.5
General Comments:
Vertical cracking to plasterboard wall

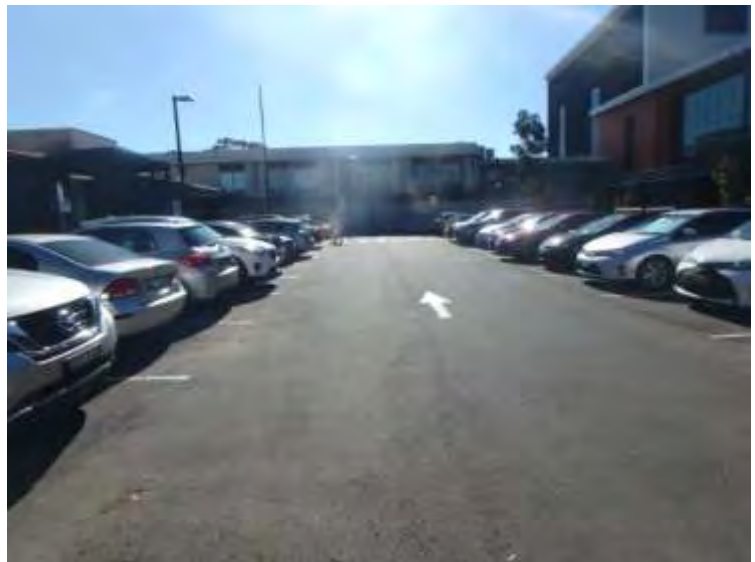
Defect ID 001
Area Type External
Location Hornsby Hospital Carpark 1
Element General shot
Defect Type N/A
Length (mm) N/A
Width (mm) N/A
General Comments:
 General shot of Carpark 1

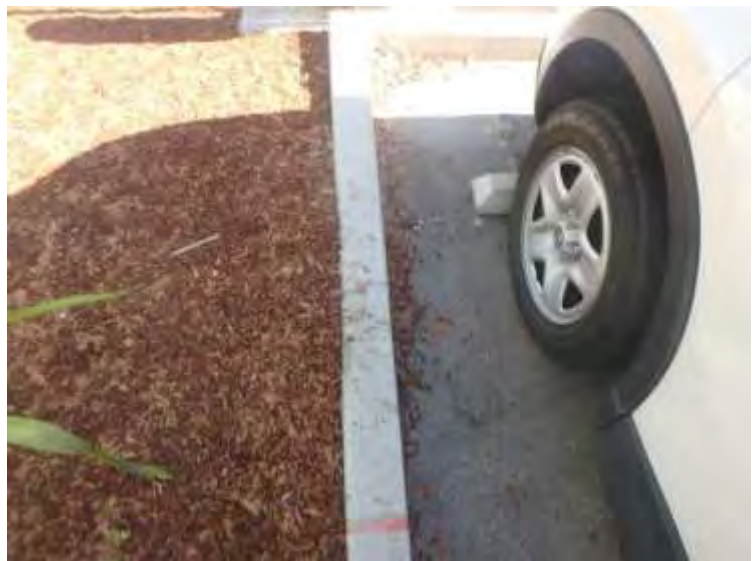
Defect ID 002
Area Type External
Location Hornsby Hospital Carpark 1
Element Kerb
Defect Type Cracking
Length (mm) Approx. 150mm
Width (mm) Approx. 1mm
General Comments:
 Cracking to concrete kerb

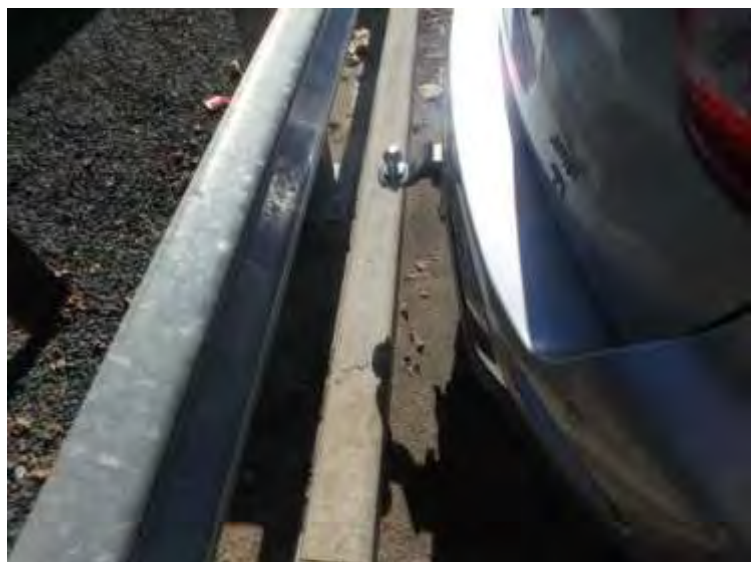
Defect ID 003
Area Type External
Location Hornsby Hospital Carpark 1
Element Kerb
Defect Type Cracking
Length (mm) Approx. 150mm
Width (mm) Approx. 2mm
General Comments:
 Cracking to concrete kerb

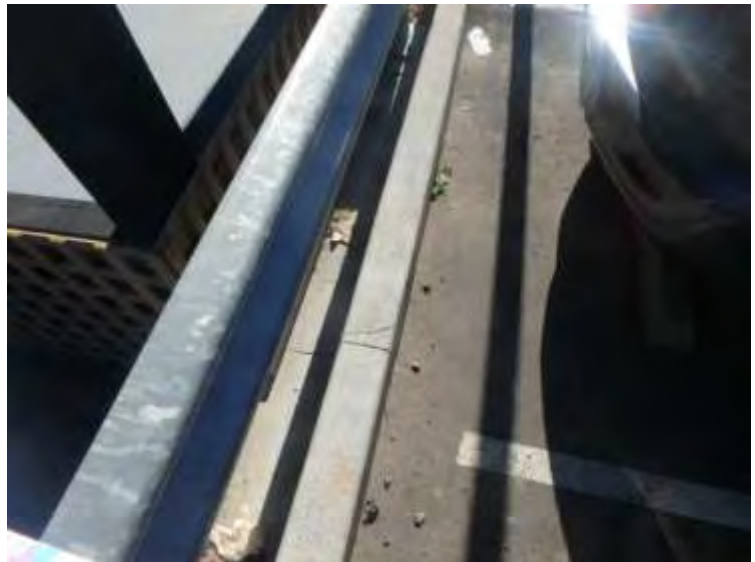
Defect ID 004
Area Type External
Location Hornsby Hospital Carpark 1
Element Kerb
Defect Type Cracking
Length (mm) Approx. 150mm
Width (mm) Approx. 1mm
General Comments:
 Cracking to concrete kerb

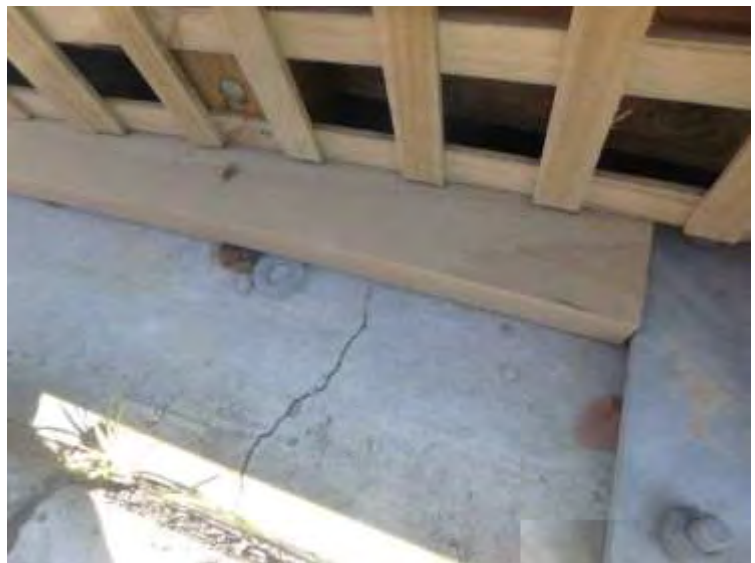
Defect ID 005
Area Type External
Location Hornsby Hospital Carpark 1
Element Slab
Defect Type Cracking
Length (mm) Approx. 300mm
Width (mm) Approx. 2mm
General Comments:
 Cracking to concrete slab adjacent to kerb

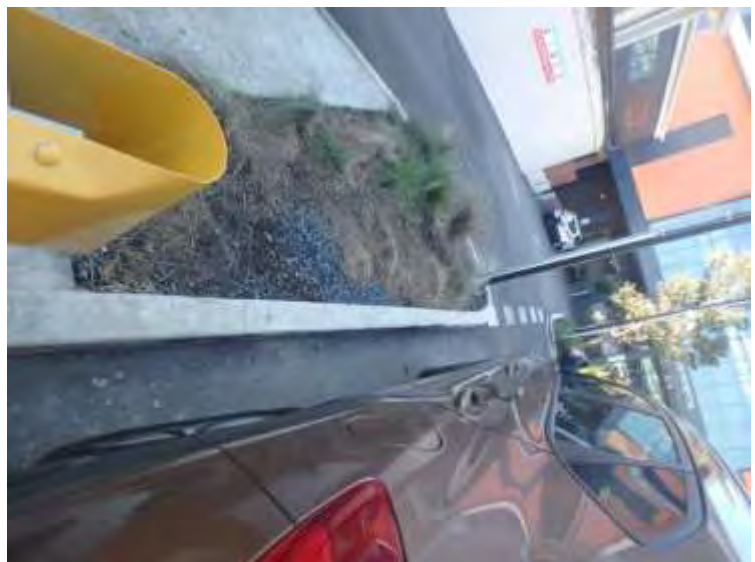
Defect ID 006
Area Type External
Location Hornsby Hospital Carpark 1
Element Kerb
Defect Type Cracking
Length (mm) Approx. 150mm
Width (mm) Approx. 1mm
General Comments:
 Cracking to concrete kerb

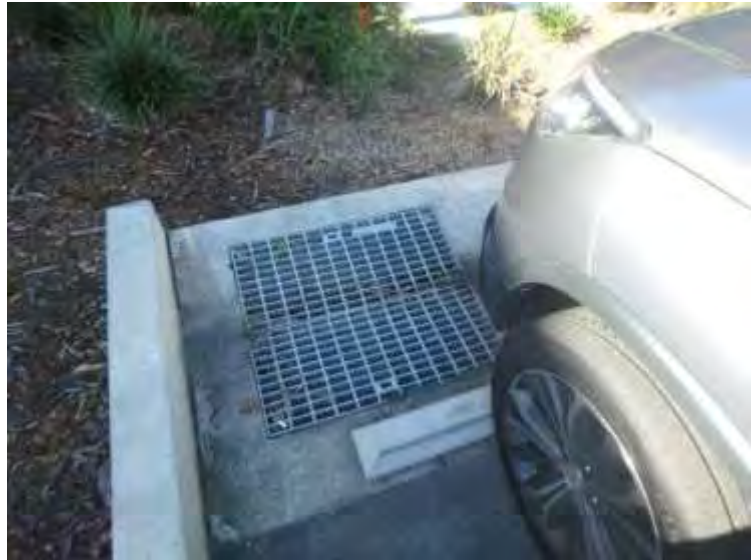
Defect ID 007
Area Type External
Location Hornsby Hospital Carpark 1
Element General shot
Defect Type N/A
Length (mm) N/A
Width (mm) N/A
General Comments:
 General shot of the stormwater pit in Carpark 1

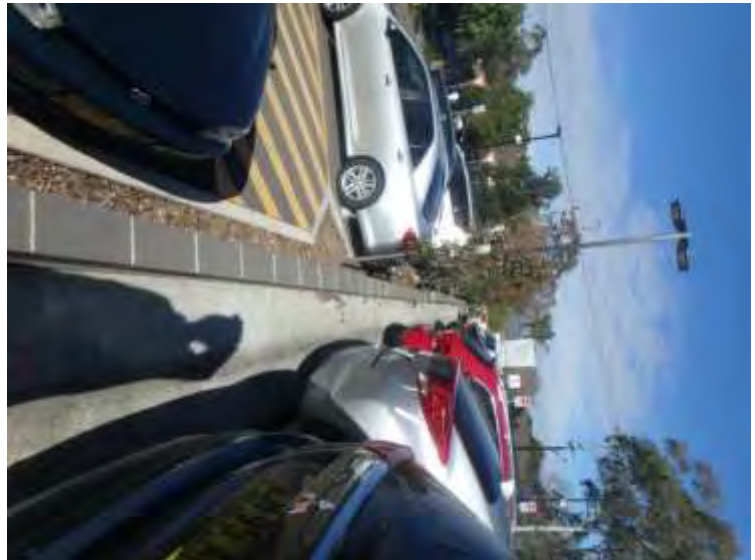
Defect ID 008
Area Type External
Location Hornsby Hospital Carpark 1
Element General shot
Defect Type N/A
Length (mm) N/A
Width (mm) N/A
General Comments:
 General shot of the tiled kerb

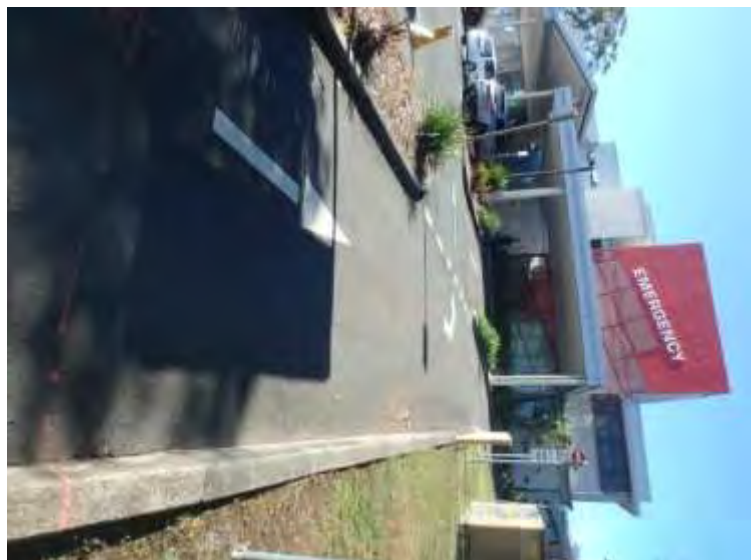
Defect ID 009
Area Type External
Location Hornsby Hospital Carpark 2
Element General shot
Defect Type N/A
Length (mm) N/A
Width (mm) N/A
General Comments:
 General shot of Carpark 2

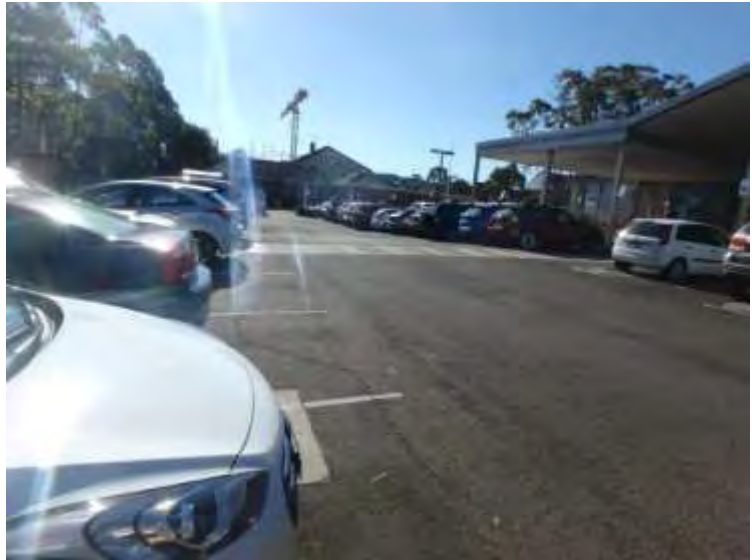
Defect ID 010
Area Type External
Location Hornsby Hospital Carpark 2
Element General shot
Defect Type N/A
Length (mm) N/A
Width (mm) N/A
General Comments:
 General shot of Carpark 2

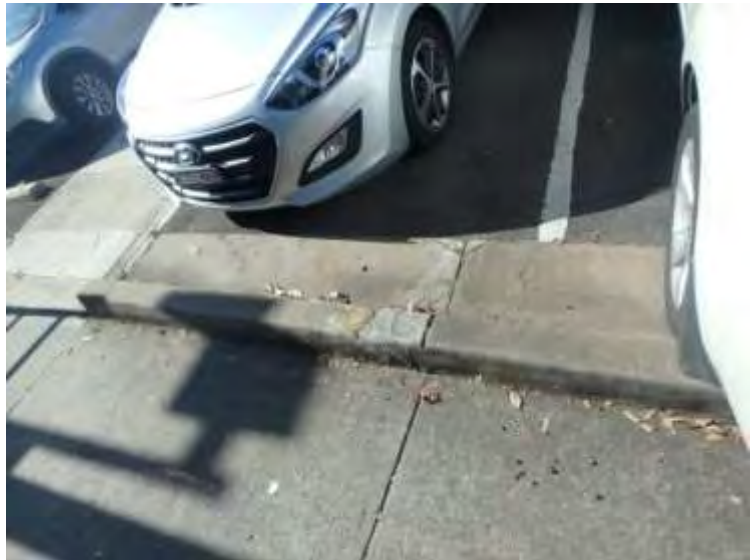
Defect ID 011
Area Type External
Location Hornsby Hospital Carpark 2
Element Kerb
Defect Type Crumbling
Length (mm) 500mm
Width (mm) 300mm
General Comments:
 Crumbling concrete kerb

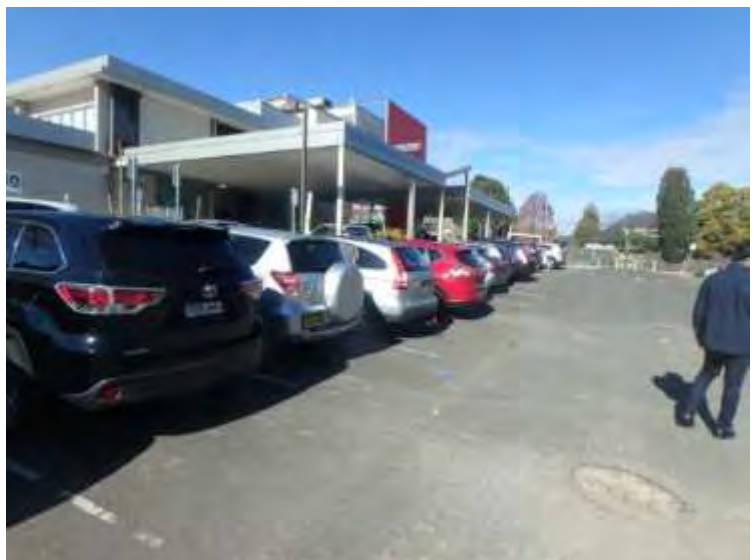
Defect ID 012
Area Type External
Location Hornsby Hospital Carpark 2
Element Driveway
Defect Type Chipped
Length (mm) 500mm
Width (mm) 500mm
General Comments:
 Chipped driveway

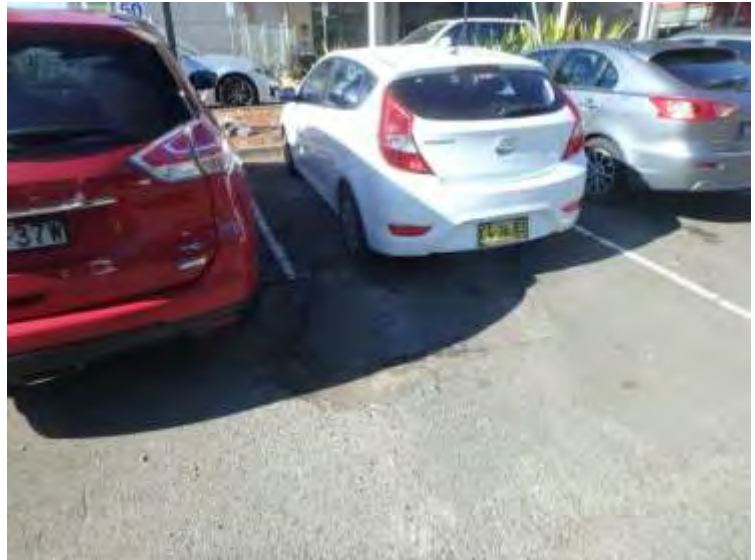
Defect ID 013
Area Type External
Location Hornsby Hospital Carpark 2
Element Driveway
Defect Type Damaged
Length (mm) Approx. 1,500mm
Width (mm) Approx. 1,000mm
General Comments:
 Damaged driveway

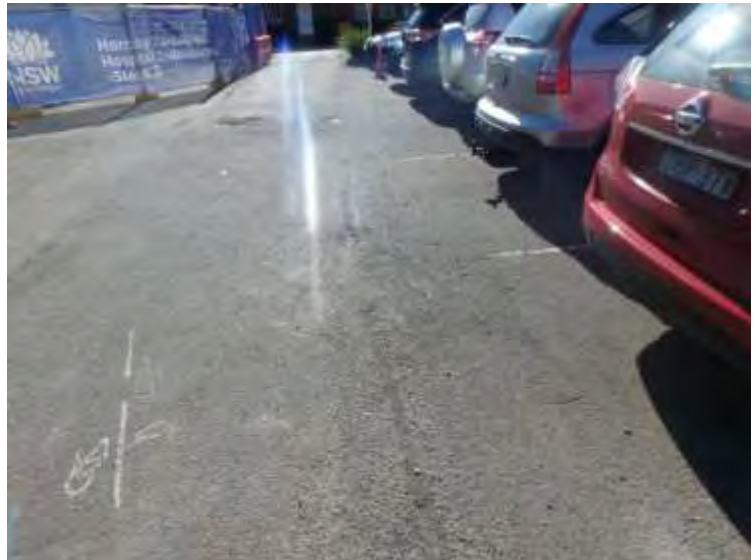
Defect ID 014
Area Type External
Location Hornsby Hospital Carpark 2
Element General Shot
Defect Type N/A
Length (mm) N/A
Width (mm) N/A
General Comments:
 General shot of carpark 2

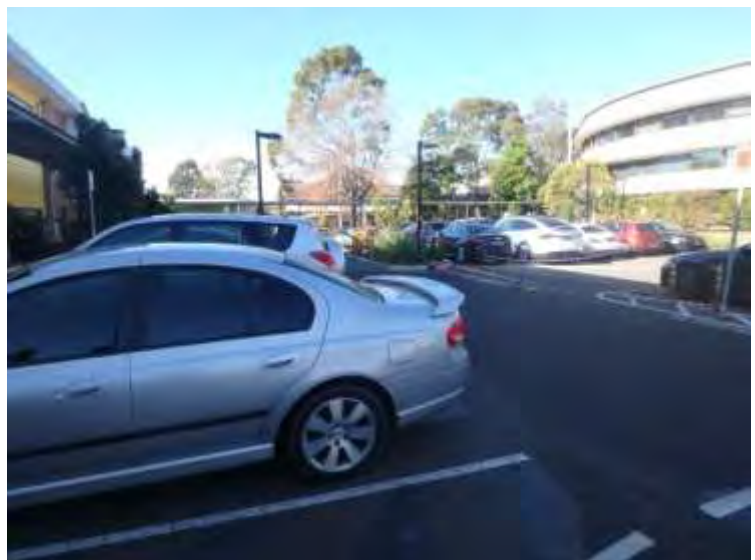
Defect ID 015
Area Type External
Location Hornsby Hospital Carpark 3
Element General Shot
Defect Type N/A
Length (mm) N/A
Width (mm) N/A
General Comments:
 General shot of Carpark 3

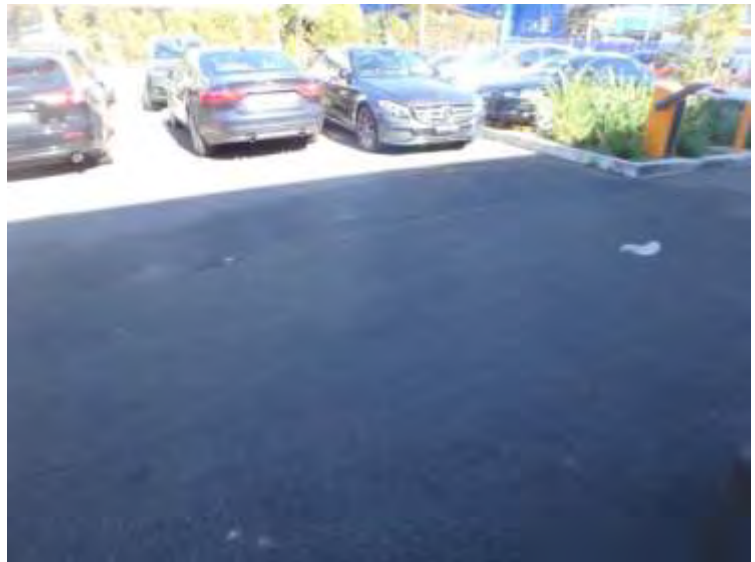
Defect ID 016
Area Type External
Location Hornsby Hospital Carpark 3
Element Driveway
Defect Type Cracking
Length (mm) Approx. 5,000mm
Width (mm) Approx. 3mm
General Comments:
 Cracking to asphalt driveway

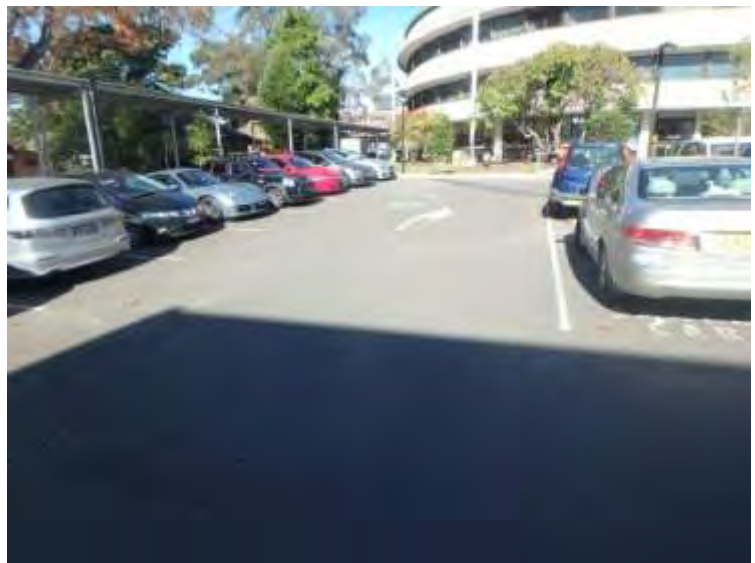
Defect ID 017
Area Type External
Location Hornsby Hospital Carpark 3
Element General Shot
Defect Type N/A
Length (mm) N/A
Width (mm) N/A
General Comments:
 General shot of Carpark 3

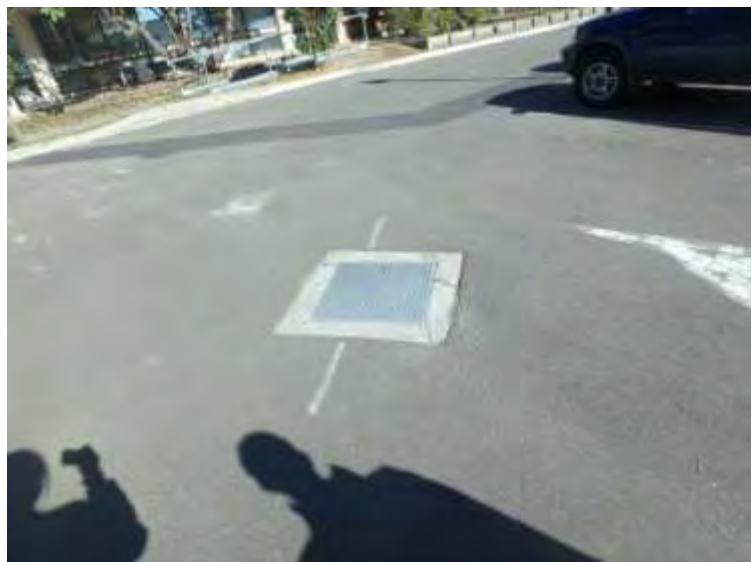
Defect ID 018
Area Type External
Location Hornsby Hospital Carpark 3
Element Driveway
Defect Type Cracking
Length (mm) Approx. 450mm in total
Width (mm) Varying
General Comments:
 Cracking to driveway surround pit
