Council Assets Surrounding Hornsby Hospital

Dilapidation Report
80818469

Prepared for	Watpac Construction Pty Ltd
Project Name	Dilapidation Report
File Reference	Dilapidation Report - Hornsby Hospital Council Assets-2018-06-28.docx
Job Reference	80818469
Date	June 2018

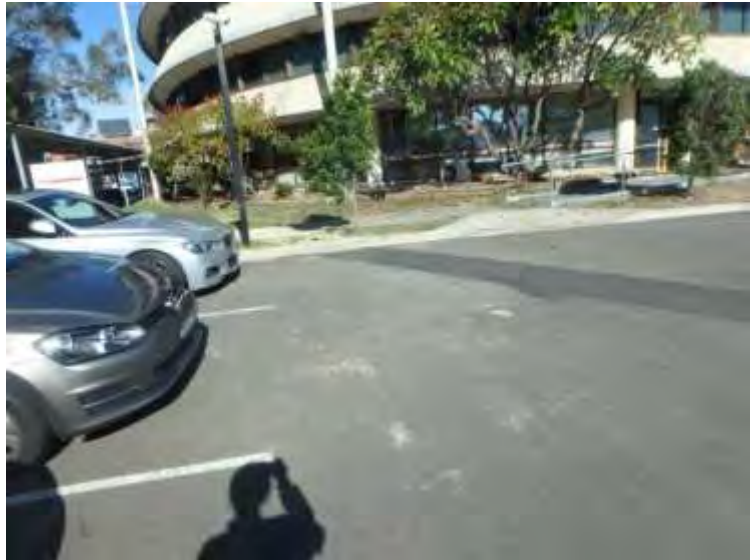
Defect ID 019
Area Type External
Location Hornsby Hospital Carpark 3
Element Driveway
Defect Type Staining
Length (mm) Approx. 4,000mm
Width (mm) Approx. 3,000mm
General Comments:
 White staining to driveway

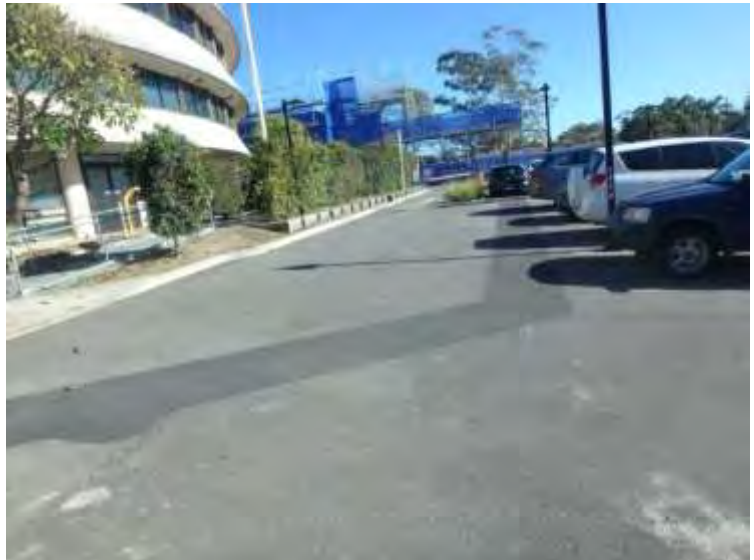
Defect ID 020
Area Type External
Location Hornsby Hospital Carpark 3
Element Driveway
Defect Type Previous repair
Length (mm) N/A
Width (mm) N/A
General Comments:
 Previous repair was noted to the driveway

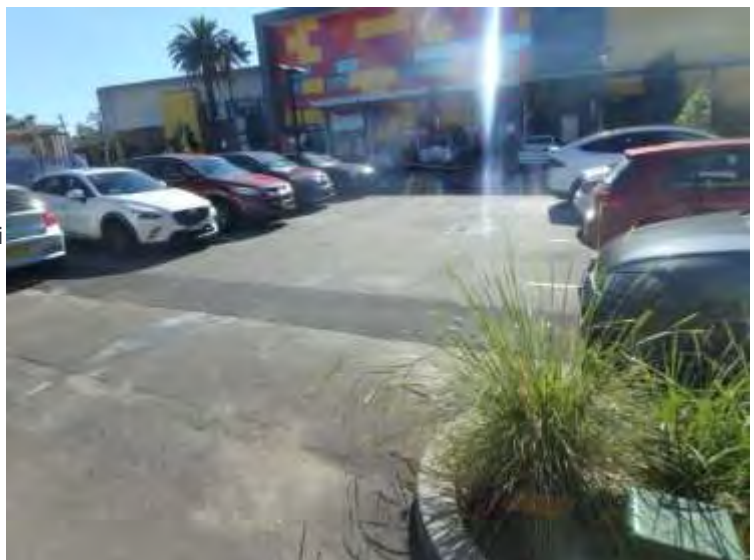
Defect ID 021
Area Type External
Location Hornsby Hospital Carpark 3
Element Driveway
Defect Type Staining and Previous repair
Length (mm) N/A
Width (mm) N/A
General Comments:
 Staining and previous repair was noted to the driveway

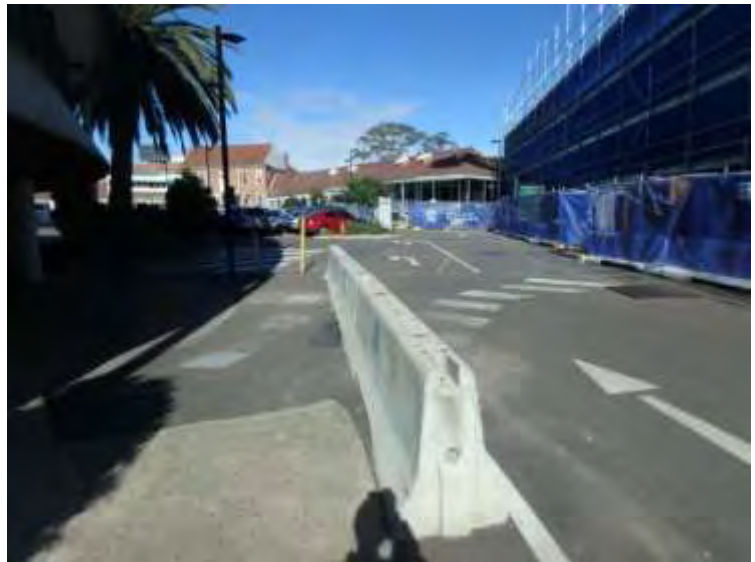
Defect ID 022
Area Type External
Location Hornsby Hospital Carpark 3
Element General Shot
Defect Type N/A
Length (mm) N/A
Width (mm) N/A
General Comments:
 General shot of Carpark 3

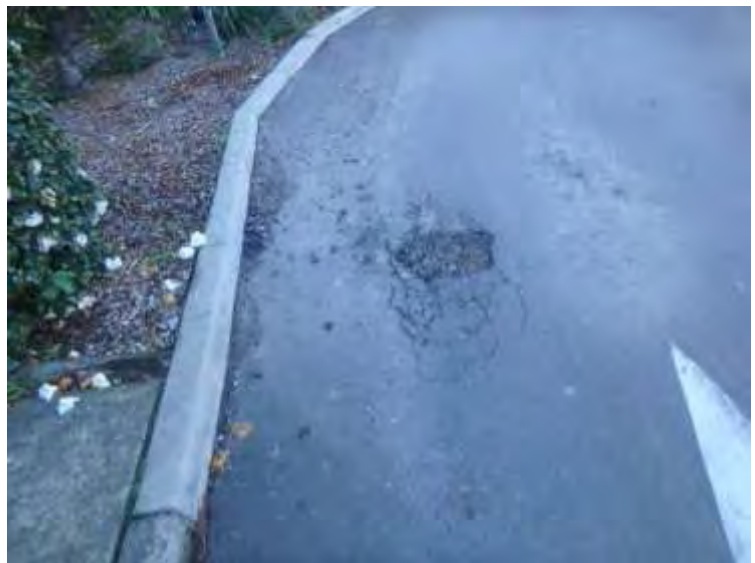
Defect ID 023
Area Type External
Location Hornsby Hospital Carpark 3
Element Driveway
Defect Type Crumbling
Length (mm) Aprox. 1,000mm
Width (mm) Approx. 500mm
General Comments:
 Crumbling driveway

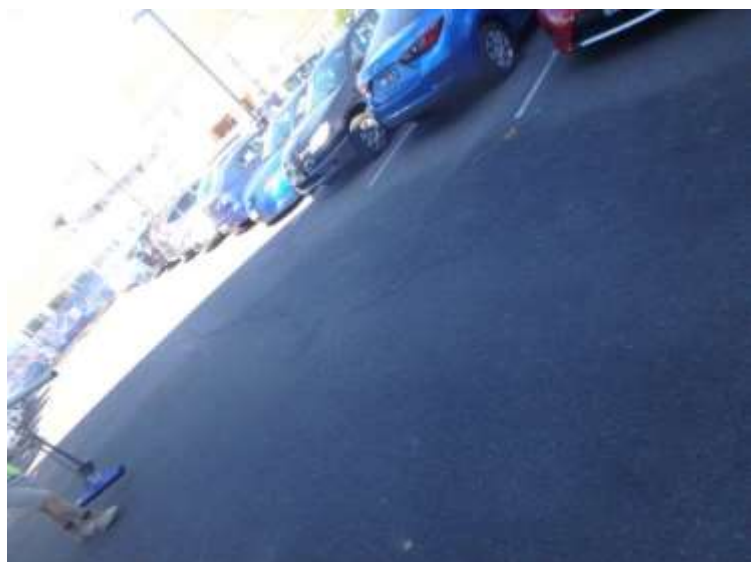
Defect ID 024
Area Type External
Location Hornsby Hospital Carpark 3
Element Driveway
Defect Type Cracking
Length (mm) Approx. 4,000mm
Width (mm) Approx. 2mm
General Comments:
 Cracking to driveway

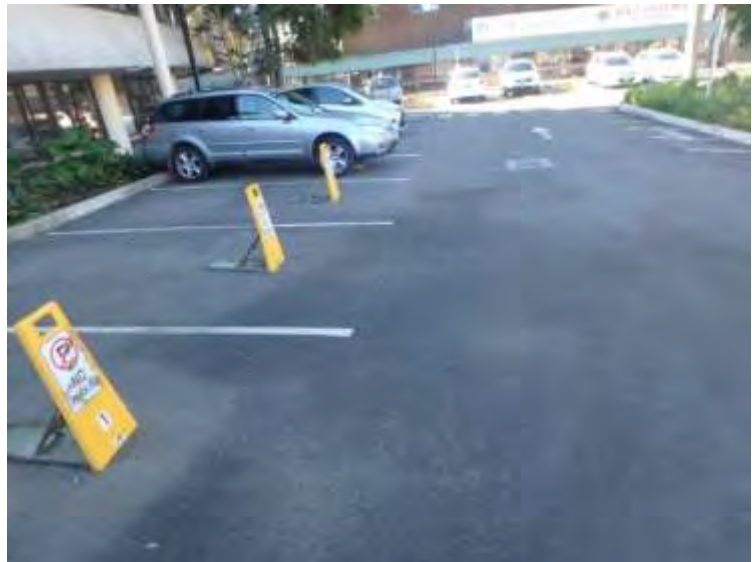
Defect ID 025
Area Type External
Location Hornsby Hospital Carpark 3
Element Driveway
Defect Type Staining
Length (mm) N/A
Width (mm) N/A
General Comments:
 Staining to driveway

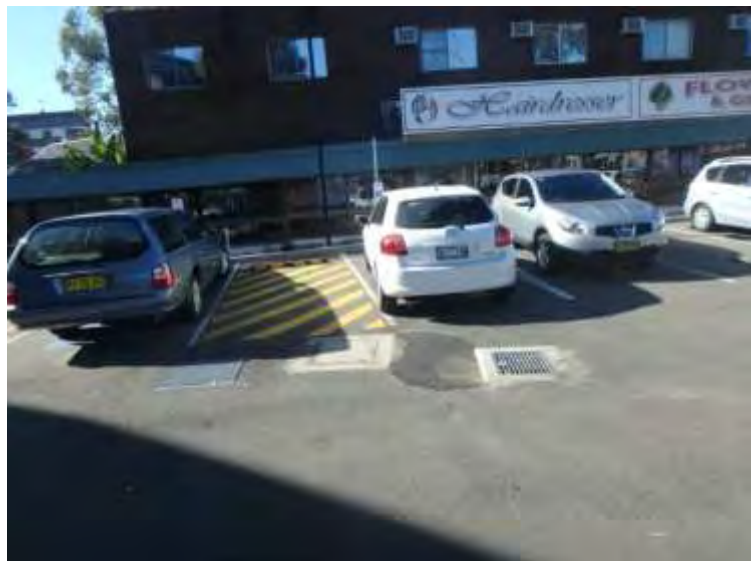
Defect ID 026
Area Type External
Location Hornsby Hospital Carpark 3
Element Driveway
Defect Type Previous repair
Length (mm) Approx. 1,000mm
Width (mm) Approx. 1,000mm
General Comments:
 Previous repair was noted to driveway, surround pit

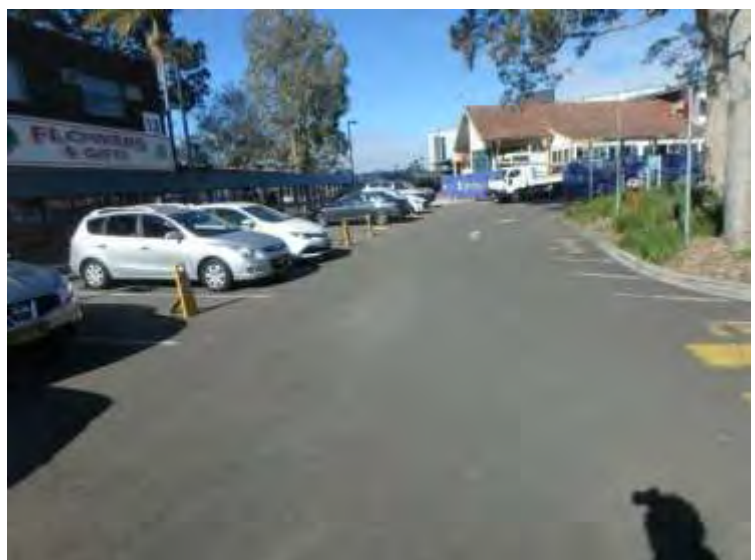
Defect ID 027
Area Type External
Location Hornsby Hospital Carpark 3
Element General Shot
Defect Type N/A
Length (mm) N/A
Width (mm) N/A
General Comments:
 General shot of Carpark 3

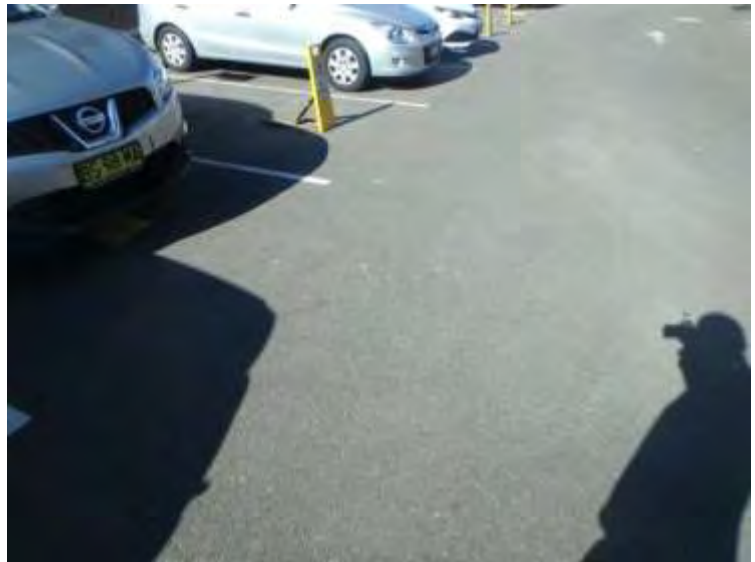
Defect ID 028
Area Type External
Location Hornsby Hospital Carpark 3
Element Driveway
Defect Type Cracking
Length (mm) Approx. 2,000mm
Width (mm) Approx. 1mm
General Comments:
 Cracking to driveway

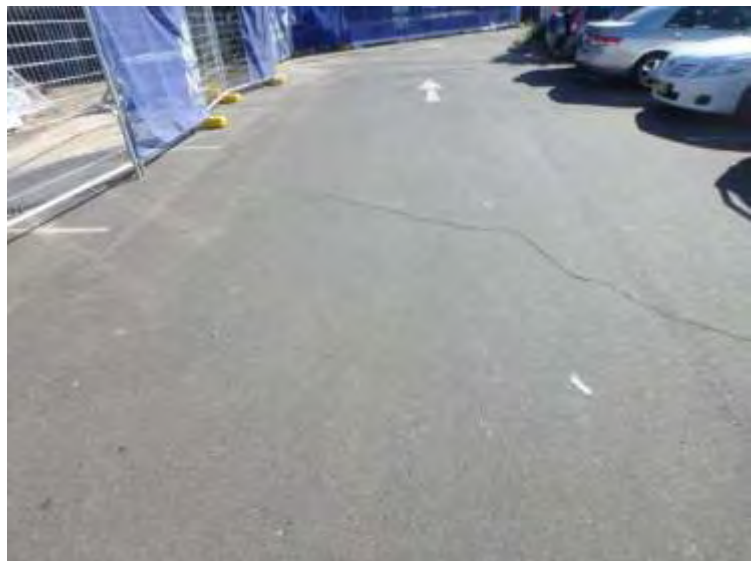
Defect ID 029
Area Type External
Location Hornsby Hospital Carpark 3
Element Driveway
Defect Type Cracking
Length (mm) Approx. 5,000mm
Width (mm) Approx. 3mm
General Comments:
 Cracking to driveway

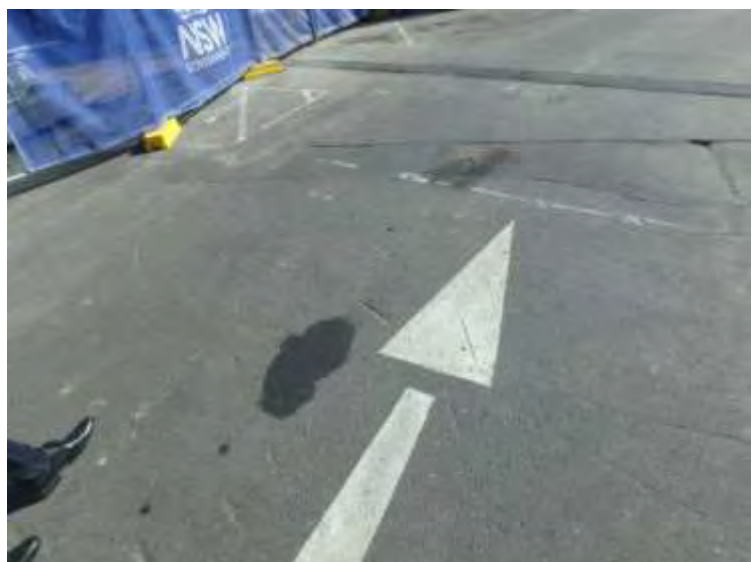
Defect ID 030
Area Type External
Location Hornsby Hospital Carpark 3
Element Driveway
Defect Type Deterioration
Length (mm) N/A
Width (mm) N/A
General Comments:
 Deteriorated driveway

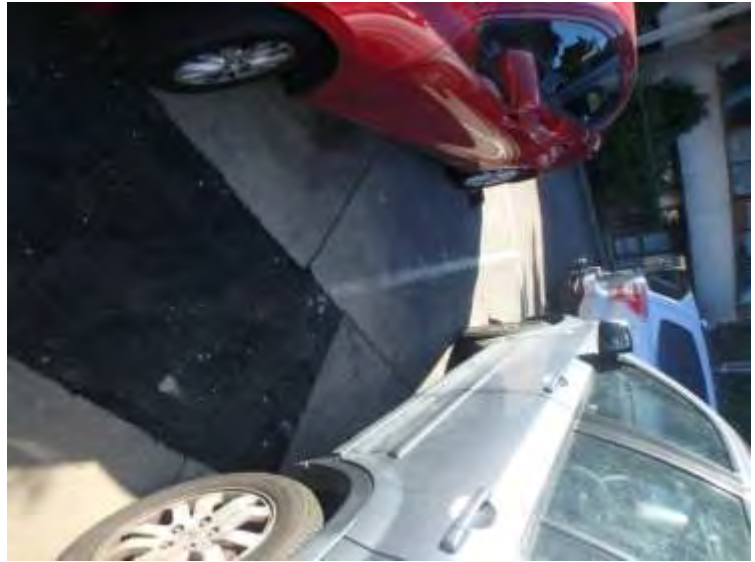
Defect ID 031
Area Type External
Location Hornsby Hospital Carpark
3
Element Driveway
Defect Type Previous repair
Length (mm) N/A
Width (mm) N/A
General Comments:
Previous repair was noted to driveway

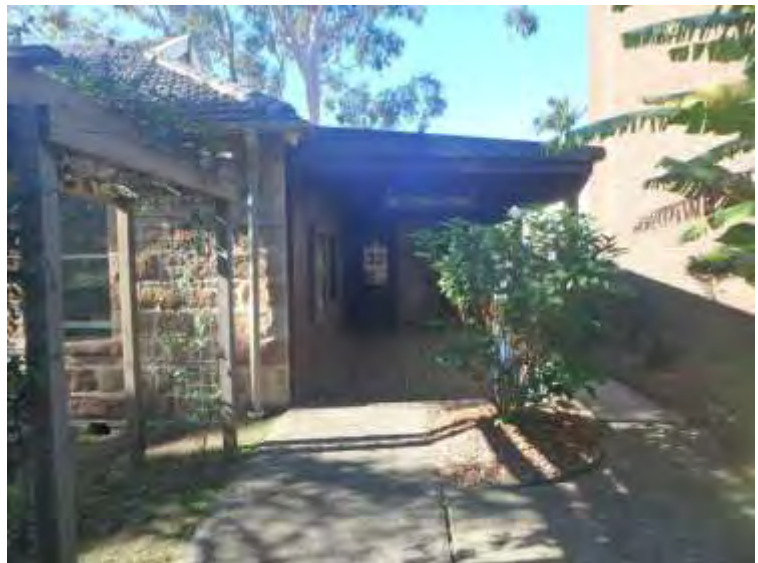
Defect ID 001
Area Type External
Location Chapel, Hornsby Hospital, NSW
Element General shot
Defect Type N/A
Length (mm) N/A
Width (mm) N/A

General Comments:
 General shot of the chapel in a easterly direction

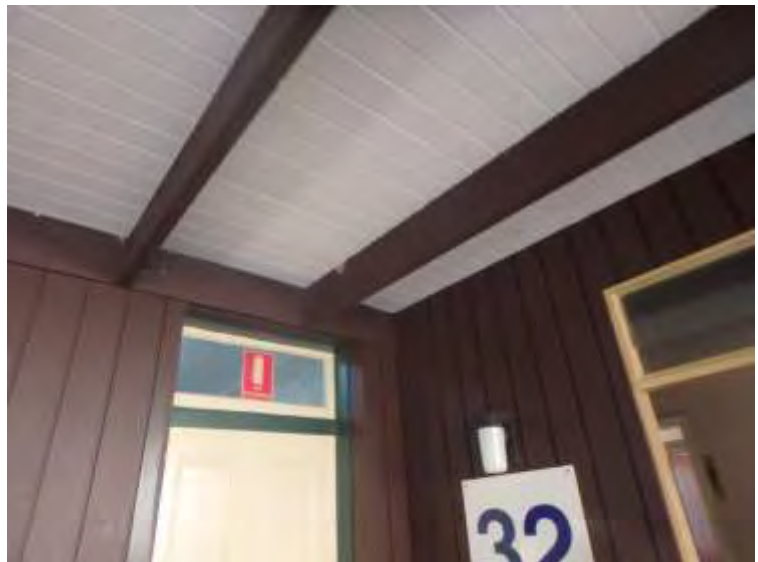
Defect ID 002
Area Type External
Location Chapel, Hornsby Hospital, NSW
Element General shot
Defect Type N/A
Length (mm) N/A
Width (mm) N/A

General Comments:
 General shot of the chapel front entry ceiling

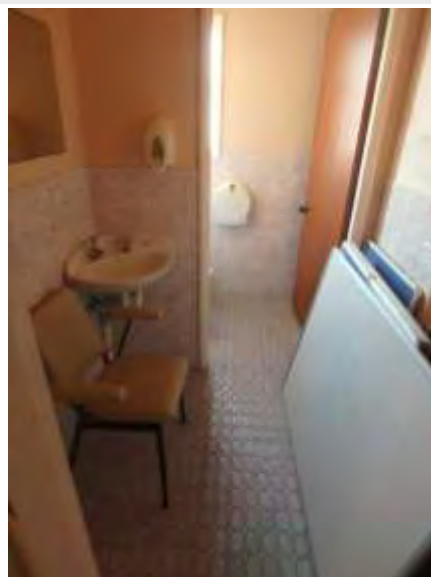
Defect ID 003
Area Type Internal
Location Chapel, Hornsby Hospital, NSW
Element General shot
Defect Type N/A
Length (mm) N/A
Width (mm) N/A

General Comments:
 General shot of femal bathroom in the chapel

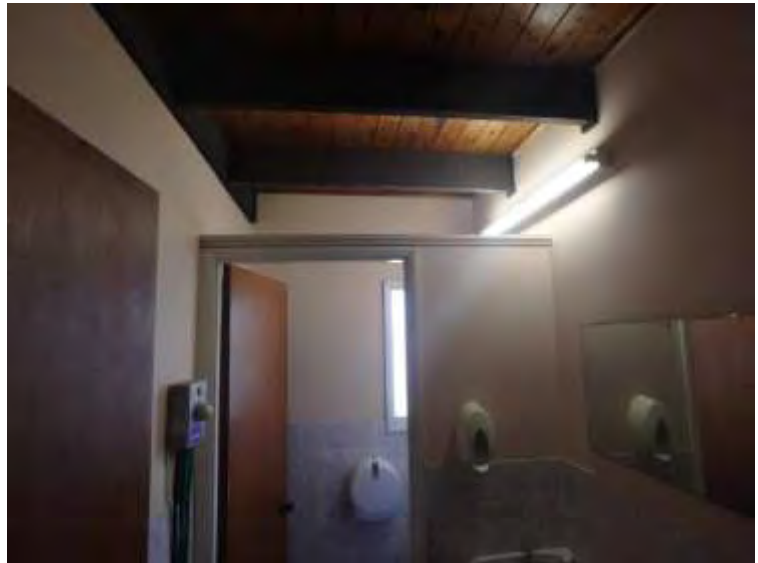
Defect ID 004
Area Type Internal
Location Chapel, Hornsby Hospital, NSW
Element General shot
Defect Type N/A
Length (mm) N/A
Width (mm) N/A

General Comments:
 General shot of male bathroom in the chapel

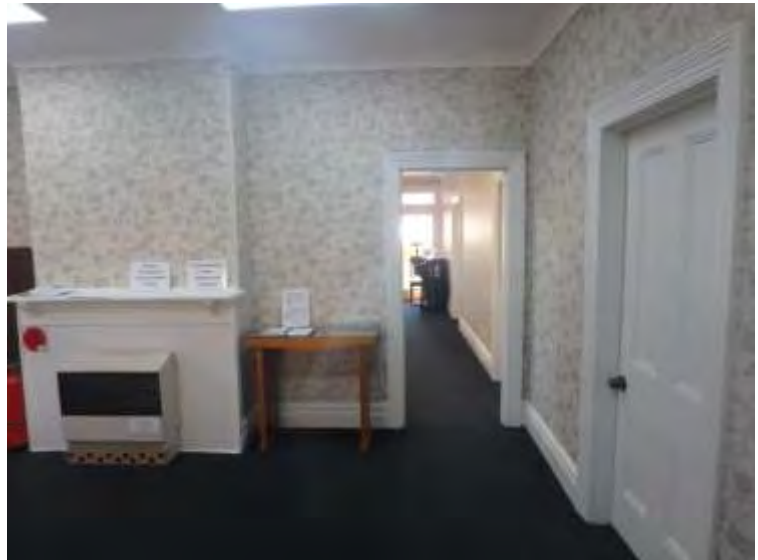
Defect ID 005
Area Type Internal
Location Chapel, Hornsby Hospital, NSW
Element General shot
Defect Type N/A
Length (mm) N/A
Width (mm) N/A

General Comments:
 General shot of the chapel internal

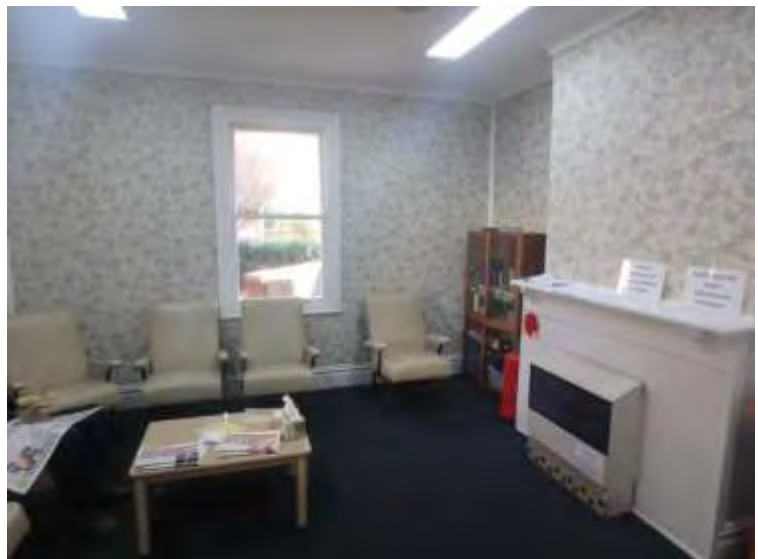
Defect ID 006
Area Type Internal
Location Chapel, Hornsby Hospital, NSW
Element General shot
Defect Type N/A
Length (mm) N/A
Width (mm) N/A

General Comments:
 General shot of the chapel internal

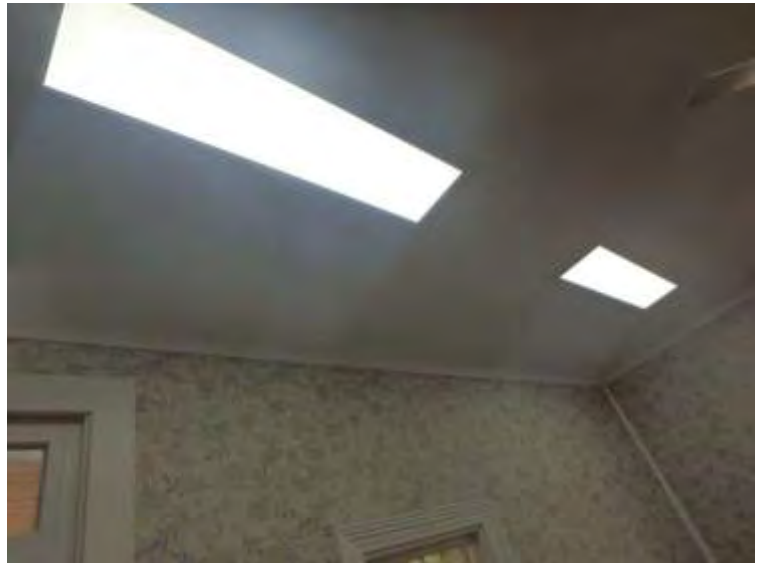
Defect ID 007
Area Type Internal
Location Chapel, Hornsby Hospital, NSW
Element General shot
Defect Type N/A
Length (mm) N/A
Width (mm) N/A

General Comments:
 General shot of the chapel internal

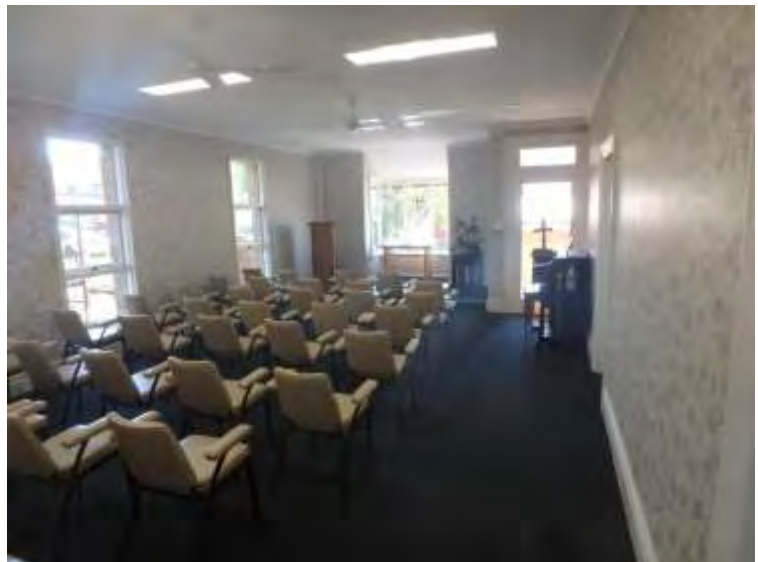
Defect ID 008
Area Type Internal
Location Chapel, Hornsby Hospital, NSW
Element General shot
Defect Type N/A
Length (mm) N/A
Width (mm) N/A

General Comments:
 General shot of the chapel internal

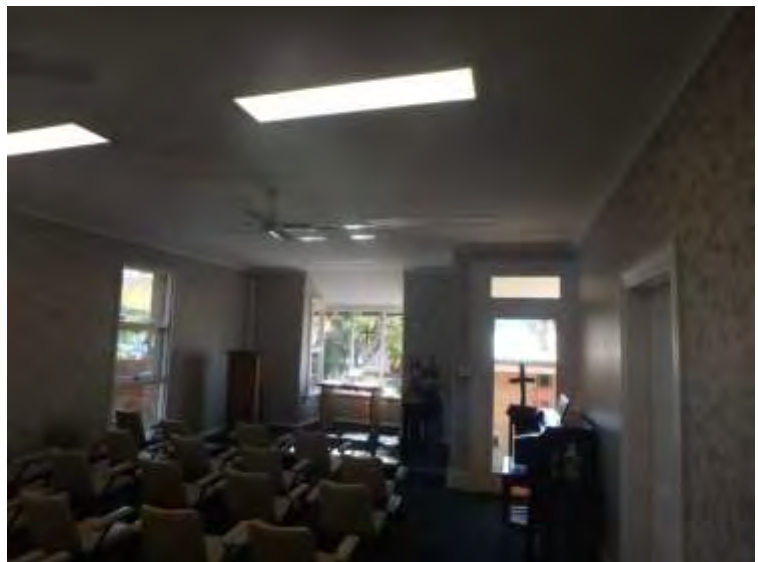
Defect ID 009
Area Type Internal
Location Chapel, Hornsby Hospital, NSW
Element General shot
Defect Type N/A
Length (mm) N/A
Width (mm) N/A

General Comments:
 General shot of the chapel internal

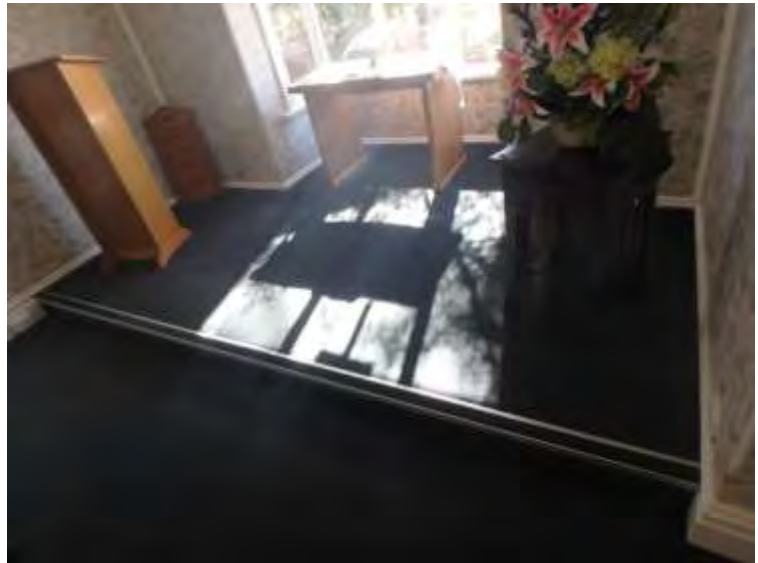
Defect ID 010
Area Type Internal
Location Chapel, Hornsby Hospital, NSW
Element General shot
Defect Type N/A
Length (mm) N/A
Width (mm) N/A

General Comments:
 General shot of the chapel internal

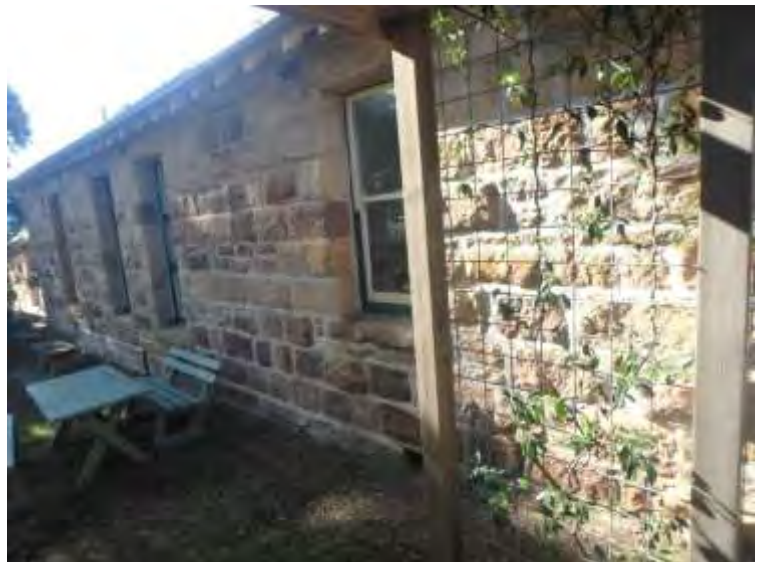
Defect ID 011
Area Type External
Location Chapel, Hornsby Hospital, NSW
Element General shot
Defect Type N/A
Length (mm) N/A
Width (mm) N/A

General Comments:
 General shot of the chapel southern façade

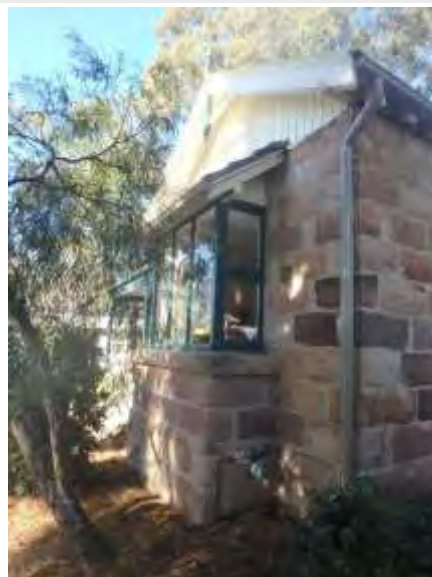
Defect ID 012
Area Type External
Location Chapel, Hornsby Hospital, NSW
Element General shot
Defect Type N/A
Length (mm) N/A
Width (mm) N/A

General Comments:
 General shot of the chapel western façade

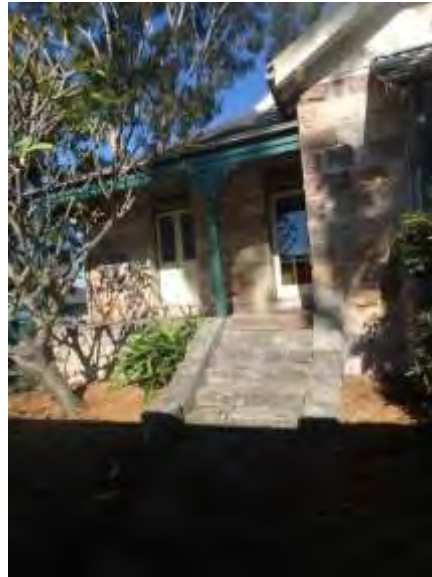
Defect ID 013

General Comments:
 General shot of the chapel western façade

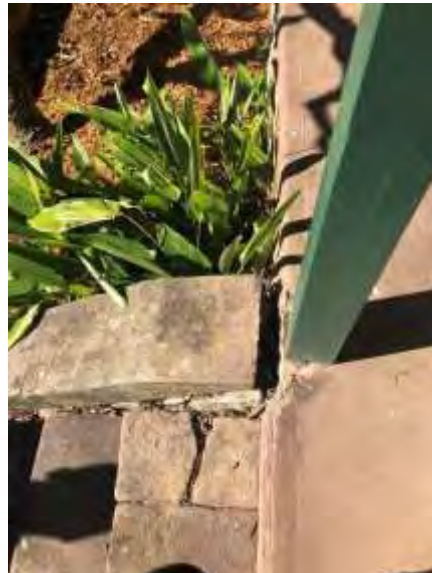
Defect ID 014

Defect Type Separation

Width (mm) 100mm

General Comments:
 Separation observed between the building and its external stair

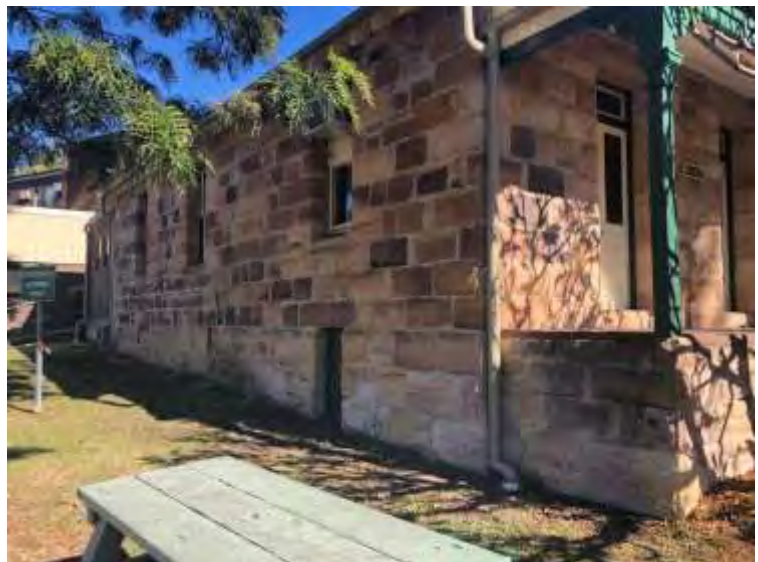
Defect ID 015

General Comments:
 General shot of the chapel northern façade

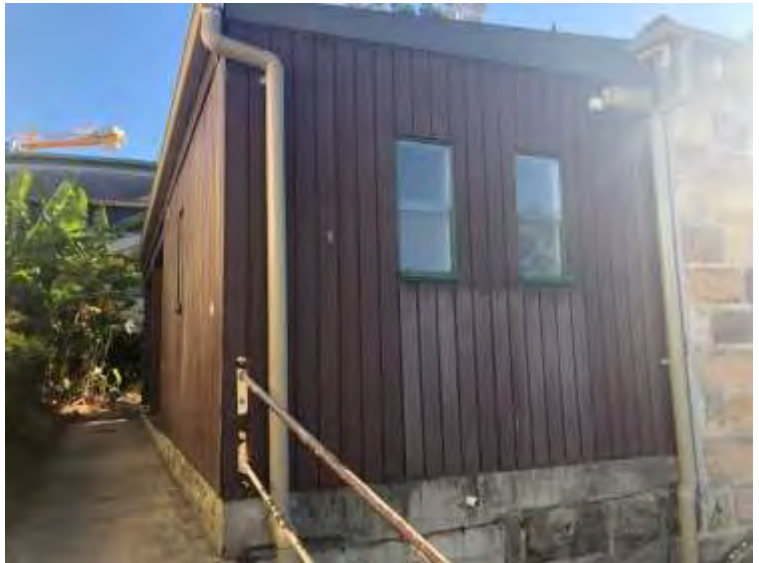
Defect ID 016
Area Type External
Location Chapel, Hornsby Hospital, NSW
Element General shot
Defect Type N/A
Length (mm) N/A
Width (mm) N/A

General Comments:
 General shot of the chapel eastern façade

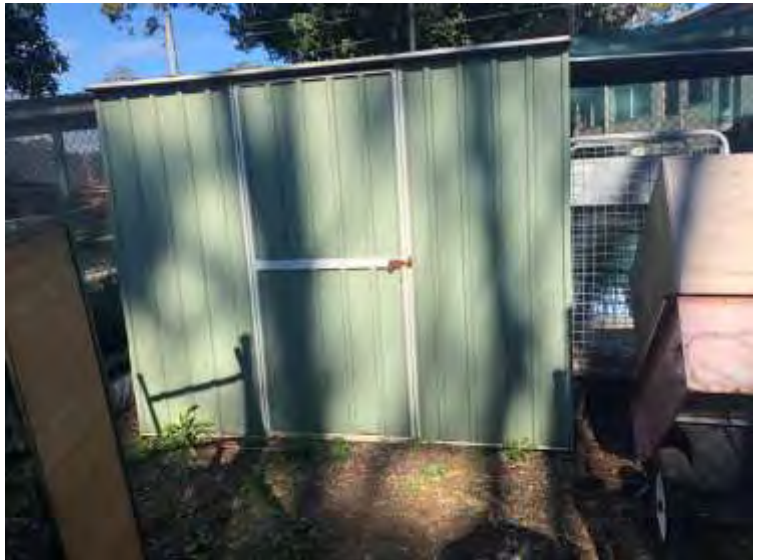
Defect ID 017
Area Type External
Location Storage Room 1, Hornsby Hospital, NSW
Element General shot
Defect Type N/A
Length (mm) N/A
Width (mm) N/A

General Comments:
 General shot of storage room 1 (refer Appendix B for location)

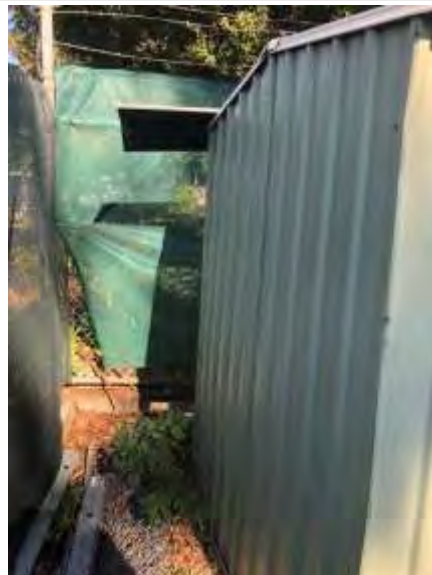
Defect ID 018
Area Type External
Location Storage Room 1, Hornsby Hospital, NSW
Element General shot
Defect Type N/A
Length (mm) N/A
Width (mm) N/A

General Comments:
 General shot of storage room 1 (refer Appendix B for location)

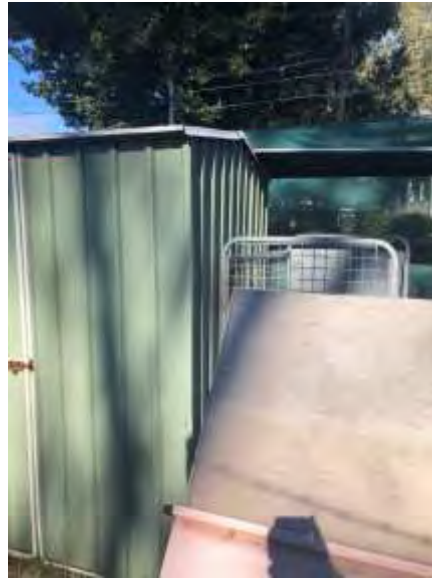
Defect ID 019
Area Type External
Location Storage Room 1, Hornsby
Hospital, NSW
Element General shot
Defect Type N/A
Length (mm) N/A
Width (mm) N/A

General shot of storage room 1 (refer
Appendix B for location)

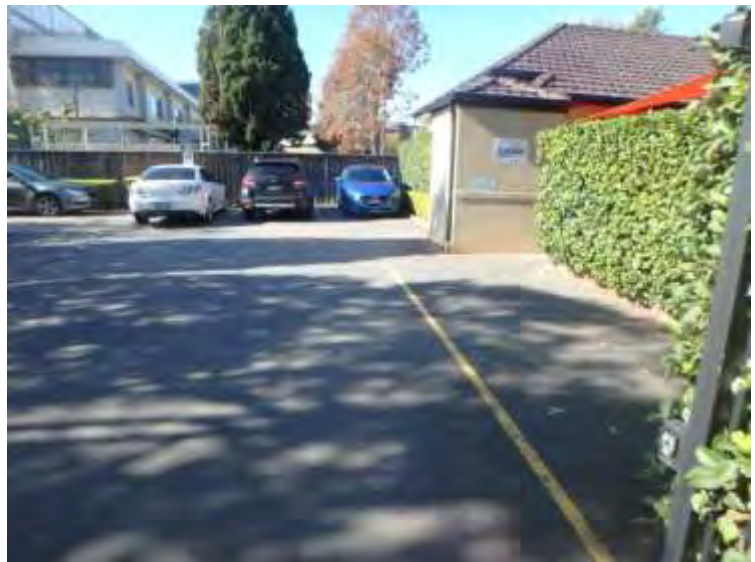
Defect ID A174
Area Type External
Location Kindergarten Parking
Element General Shot
Defect Type NA
Length (mm) NA
Width (mm) NA
General Comments:
 In reasonable condition

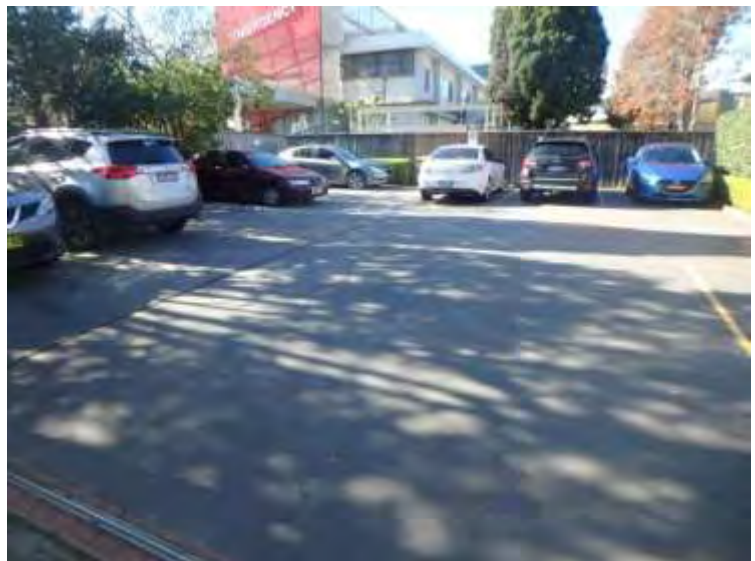
Defect ID A175
Area Type External
Location Kindergarten Parking
Element General Shot
Defect Type NA
Length (mm) NA
Width (mm) NA
General Comments:
 In reasonable condition

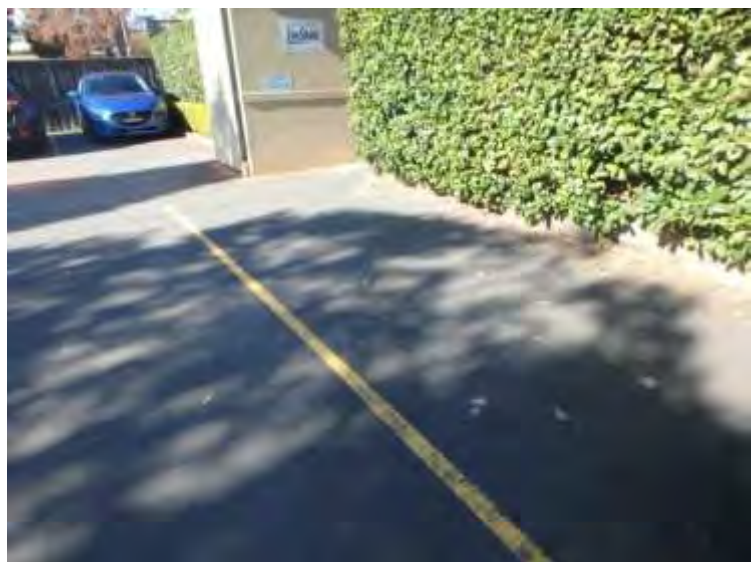
Defect ID A176
Area Type External
Location Kindergarten Parking
Element Bitumen pavement
Defect Type Crack
Length (mm) NA
Width (mm) NA
General Comments:
 Typical cracking on bitumen paving

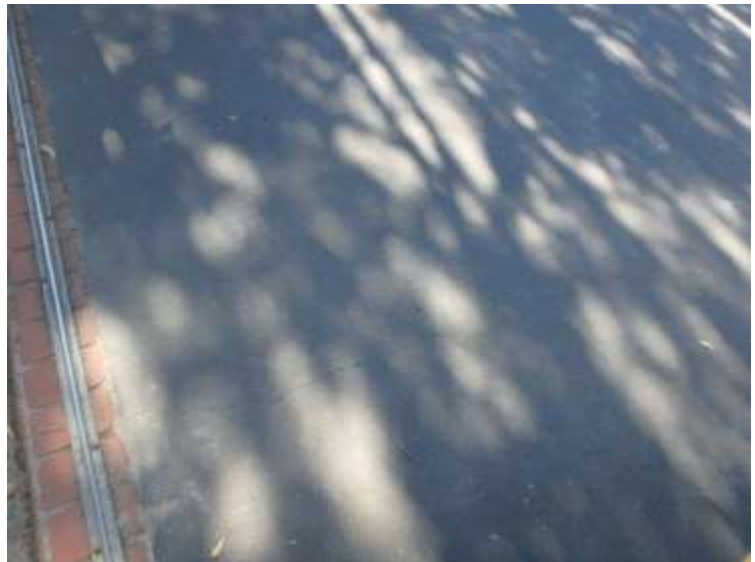
Defect ID A177
Area Type External
Location Kindergarten Parking
Element Bitumen pavement
Defect Type Crack
Length (mm) NA
Width (mm) NA
General Comments:
 Typical cracking on bitumen paving

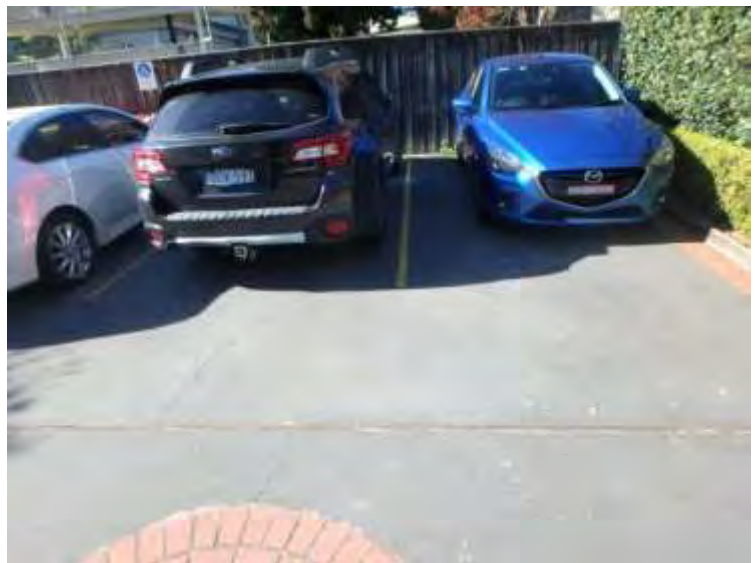
Defect ID A178
Area Type External
Location Kindergarten Parking
Element Bitumen pavement
Defect Type Crack
Length (mm) NA
Width (mm) NA
General Comments:
 Typical cracking on bitumen paving

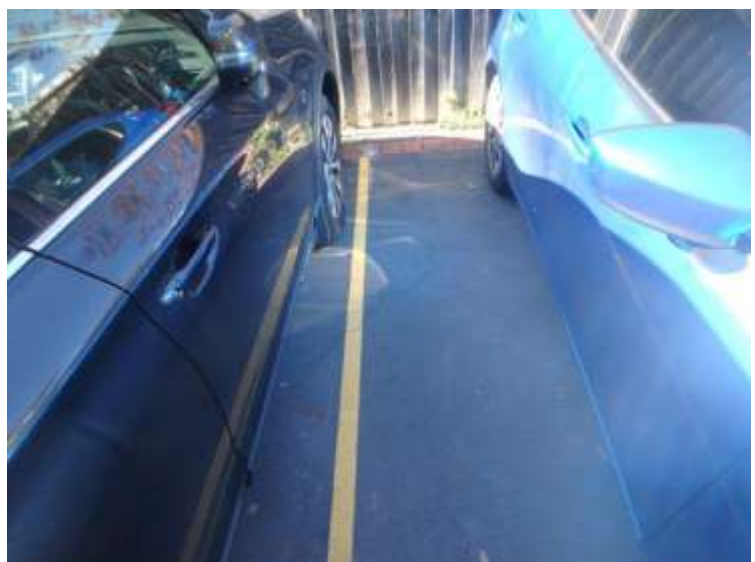
Defect ID A179
Area Type External
Location Kindergarten Parking
Element Bitumen pavement
Defect Type Crack
Length (mm) NA
Width (mm) NA
General Comments:
 Typical cracking on bitumen paving

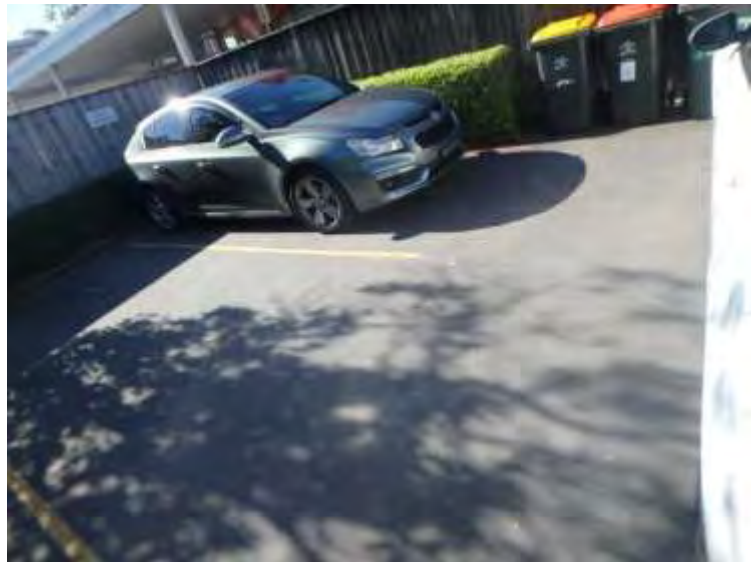
Defect ID A180
Area Type External
Location Kindergarten Parking
Element Bitumen pavement
Defect Type Crack
Length (mm) NA
Width (mm) NA
General Comments:
 Typical cracking on bitumen paving

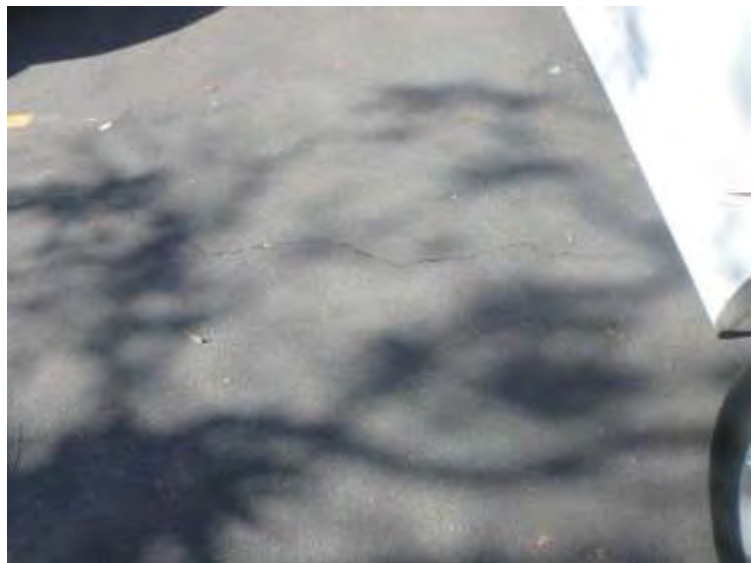
Defect ID A181
Area Type External
Location Kindergarten Parking
Element Bitumen pavement
Defect Type Crack
Length (mm) NA
Width (mm) NA
General Comments:
 Typical cracking on bitumen paving

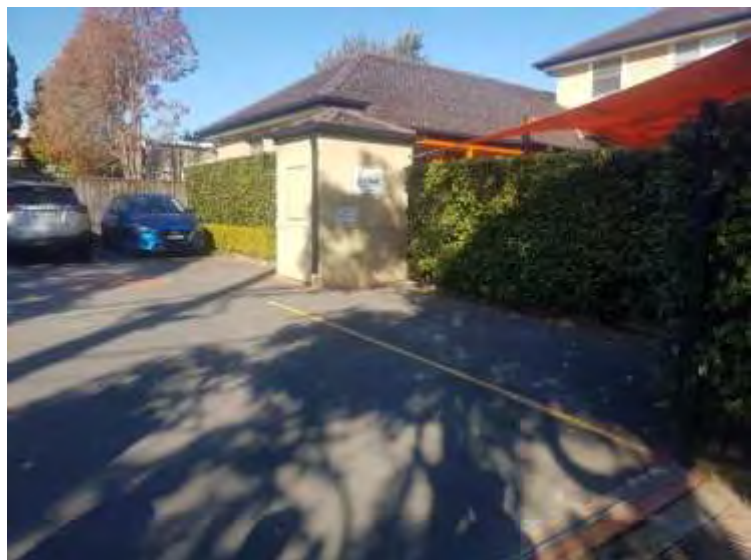
Defect ID A182
Area Type External
Location Kindergarten Entrance
Element General Shot
Defect Type NA
Length (mm) NA
Width (mm) NA
General Comments:
 In reasonable condition

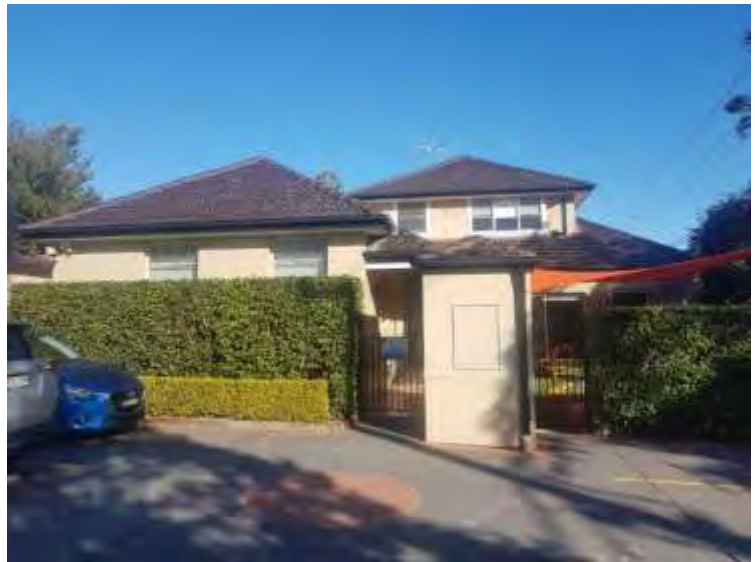
Defect ID A183

General Comments:
In reasonable condition

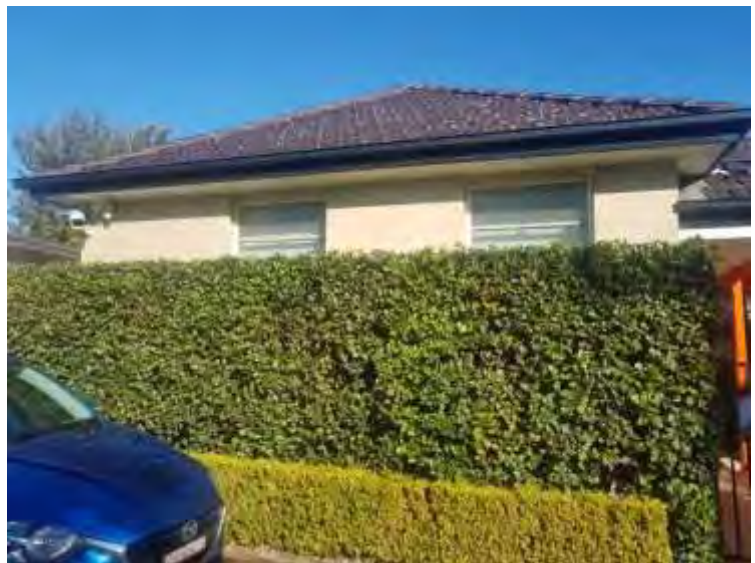
Defect ID A184

General Comments:
In reasonable condition

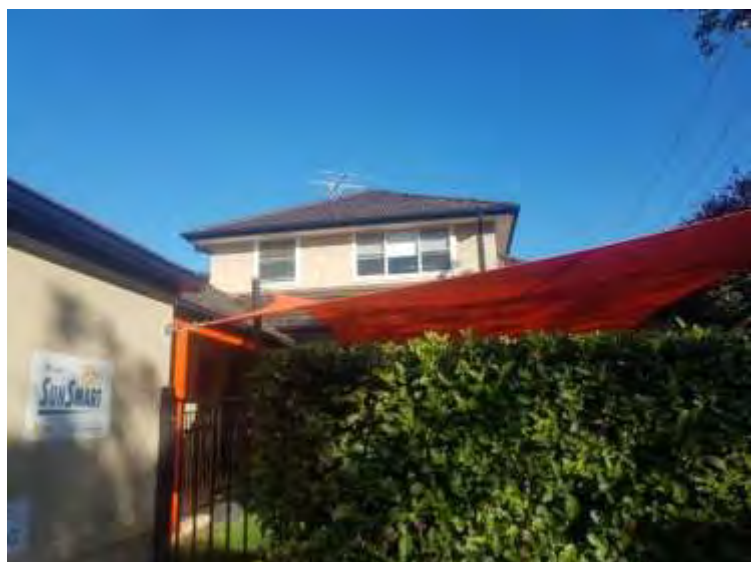
Defect ID A185

General Comments:
In reasonable condition

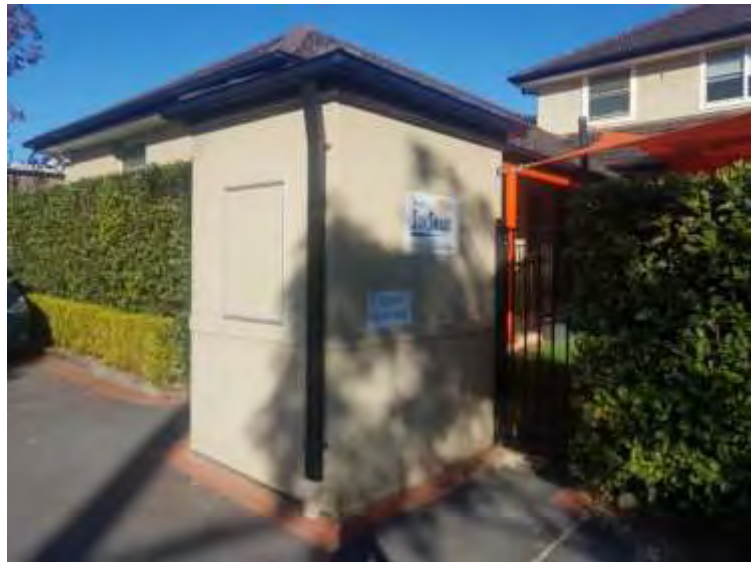
Defect ID A186
Area Type External
Location Kindergarten Northen Façade
Element General Shot
Defect Type NA
Length (mm) NA
Width (mm) NA
General Comments:
 In reasonable condition

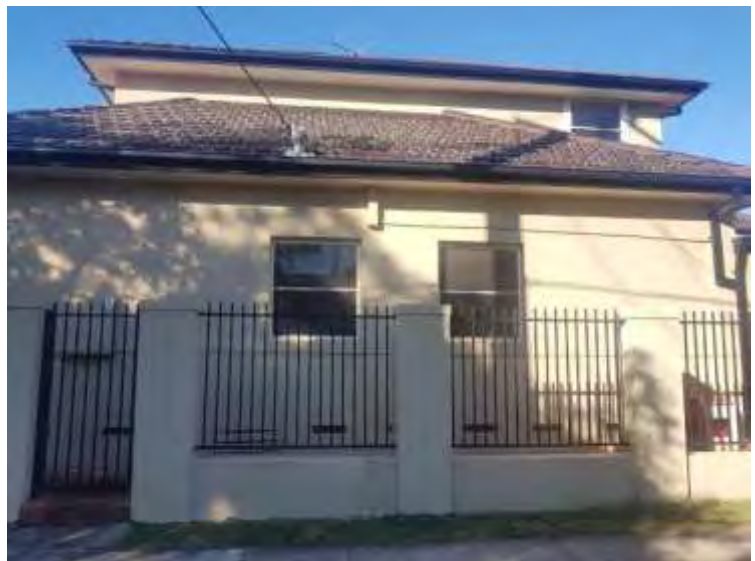
Defect ID A187
Area Type External
Location Kindergarten Western Façade
Element General Shot
Defect Type NA
Length (mm) NA
Width (mm) NA
General Comments:
 In reasonable condition

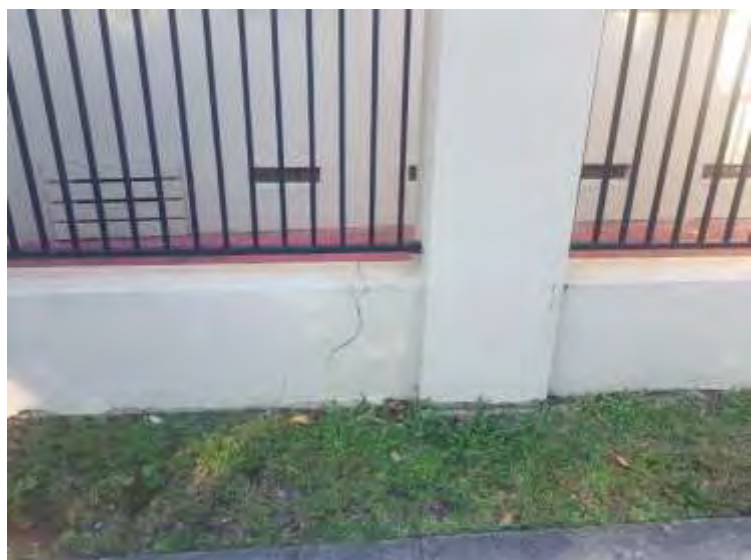
- Minor cracking on boundary brick fence.
- Typical cracking on bitumen pavement.

Defect ID A188
Area Type External
Location Kindergarten Western Façade Brick fence
Element Brick
Defect Type Crack
Length (mm) 300
Width (mm) 0.5
General Comments:
 Diagonal cracking to brick fence

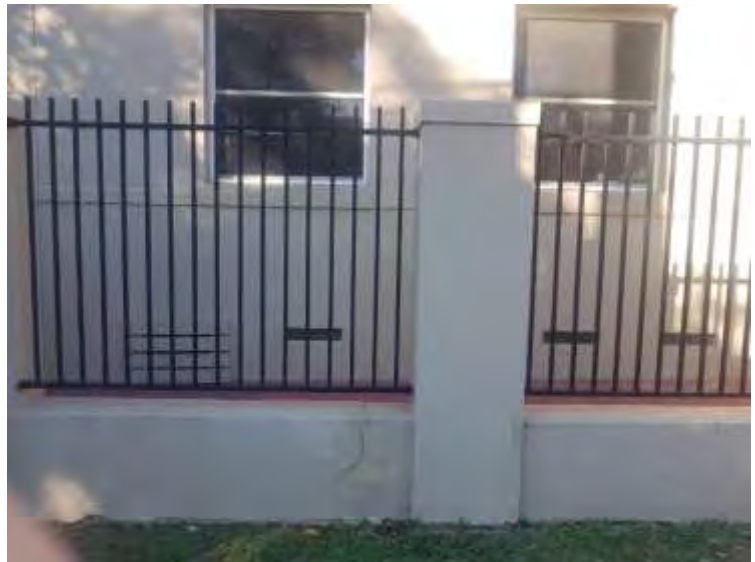
Defect ID A189

General Comments:
In reasonable condition

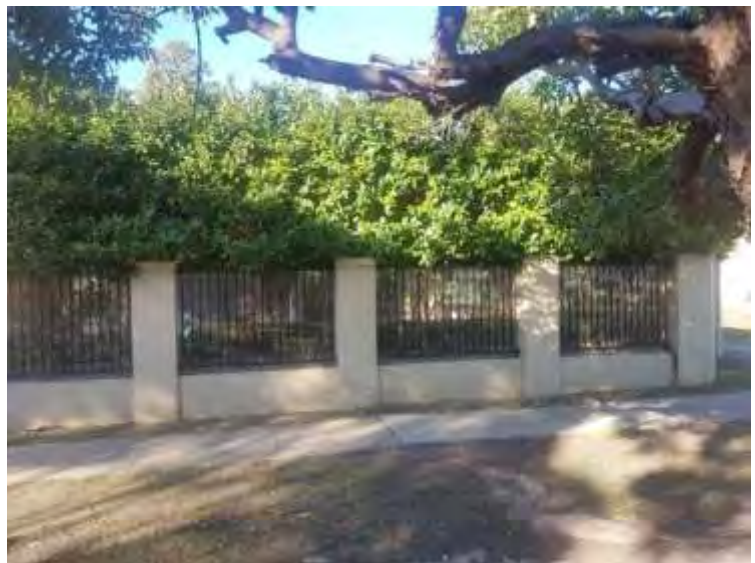
Defect ID A190

General Comments:
In reasonable condition

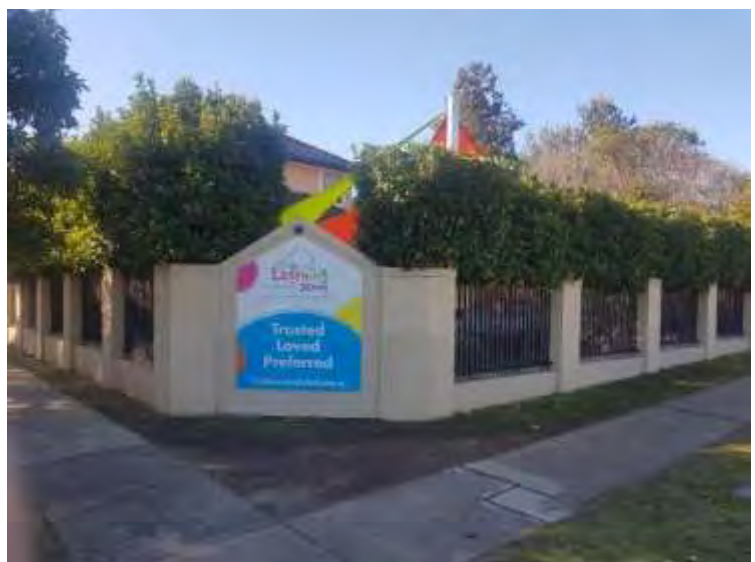
Defect ID A191

General Comments:
In reasonable condition
