Council Assets Surrounding Hornsby Hospital

Dilapidation Report
80818469

Prepared for	Watpac Construction Pty Ltd
Project Name	Dilapidation Report
File Reference	Dilapidation Report - Hornsby Hospital Council Assets-2018-06-28.docx
Job Reference	80818469
Date	June 2018

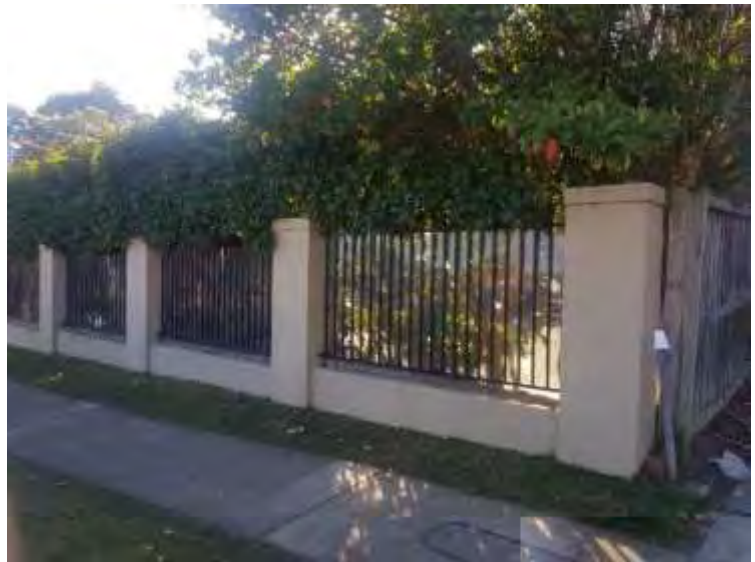
Defect ID A192
Area Type External
Location Kindergarten Southern Boundary Fence
Element General Shot
Defect Type NA
Length (mm) NA
Width (mm) NA
General Comments:
 In reasonable condition

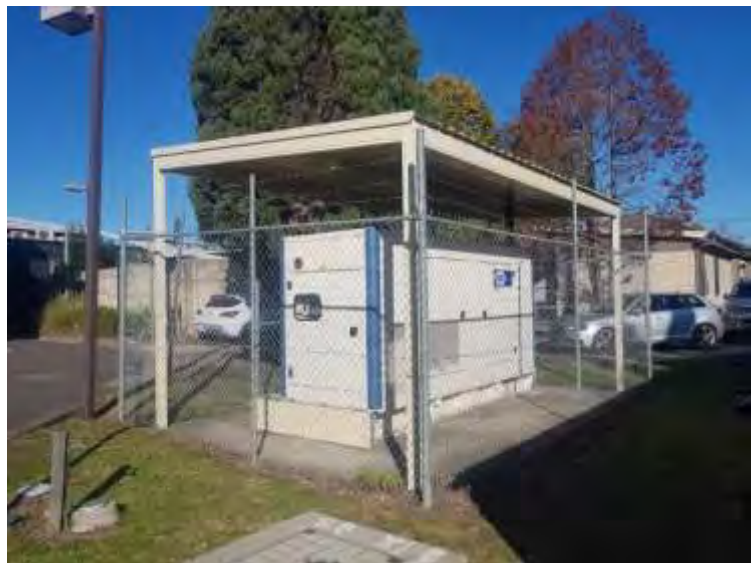
Defect ID A194
Area Type External
Location Substation
Element General Shot
Defect Type NA
Length (mm) NA
Width (mm) NA
General Comments:
 In reasonable condition

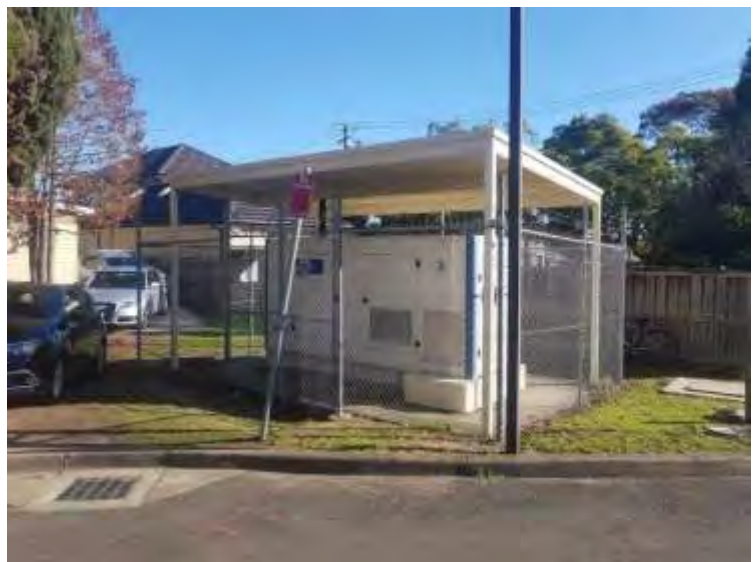
Defect ID A195
Area Type External
Location Substation
Element General Shot
Defect Type NA
Length (mm) NA
Width (mm) NA
General Comments:
 In reasonable condition

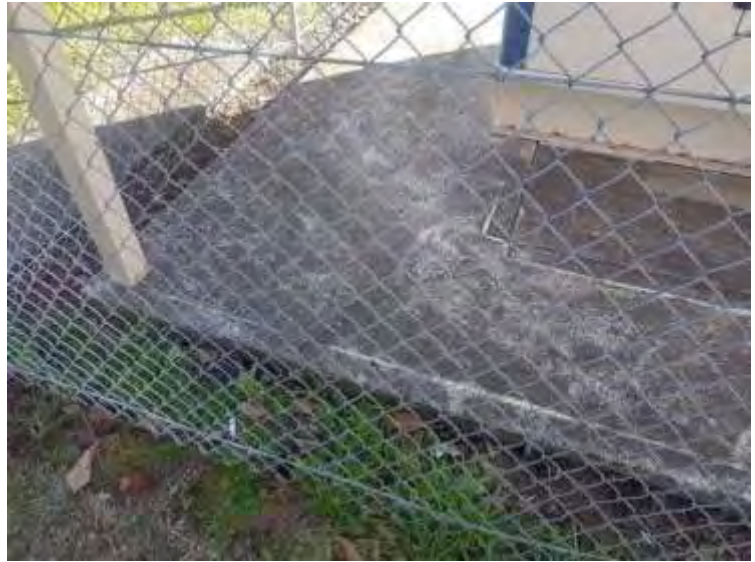
Defect ID A196
Area Type External
Location Substation Pavement
Element Concrete
Defect Type Crack
Length (mm) NA
Width (mm) NA
General Comments:
 Typical cracking on concrete pavement

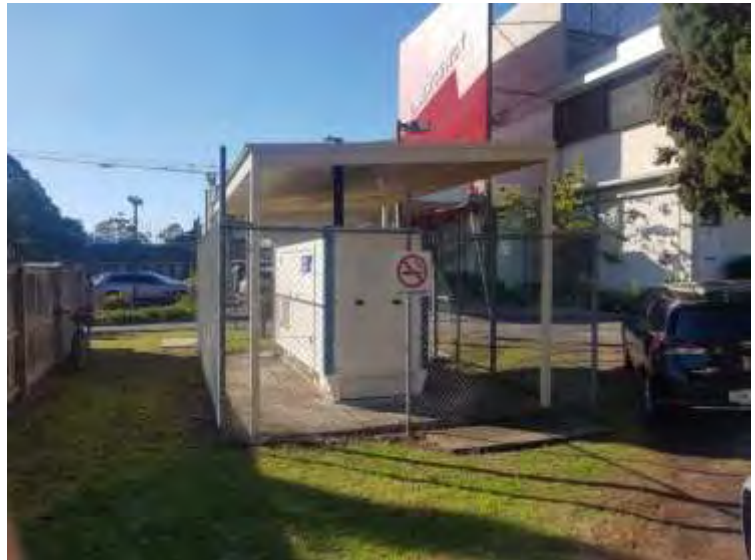
Defect ID A197
Area Type External
Location Substation
Element General Shot
Defect Type NA
Length (mm) NA
Width (mm) NA
General Comments:
 In reasonable condition
