**Royal Prince Alfred Hospital Redevelopment (RPAH  
Redevelopment)**

**Construction Noise and Vibration Monitoring Report 2**

| Document Title | Construction Noise and Vibration Monitoring |

| Revision | Date | Document Reference | Prepared By | Checked By | Approved By |
|---|---|---|---|---|---|
| 0 | 30/01/2024 | 20230239.17/3001A/R0/LA | LA | | AW |

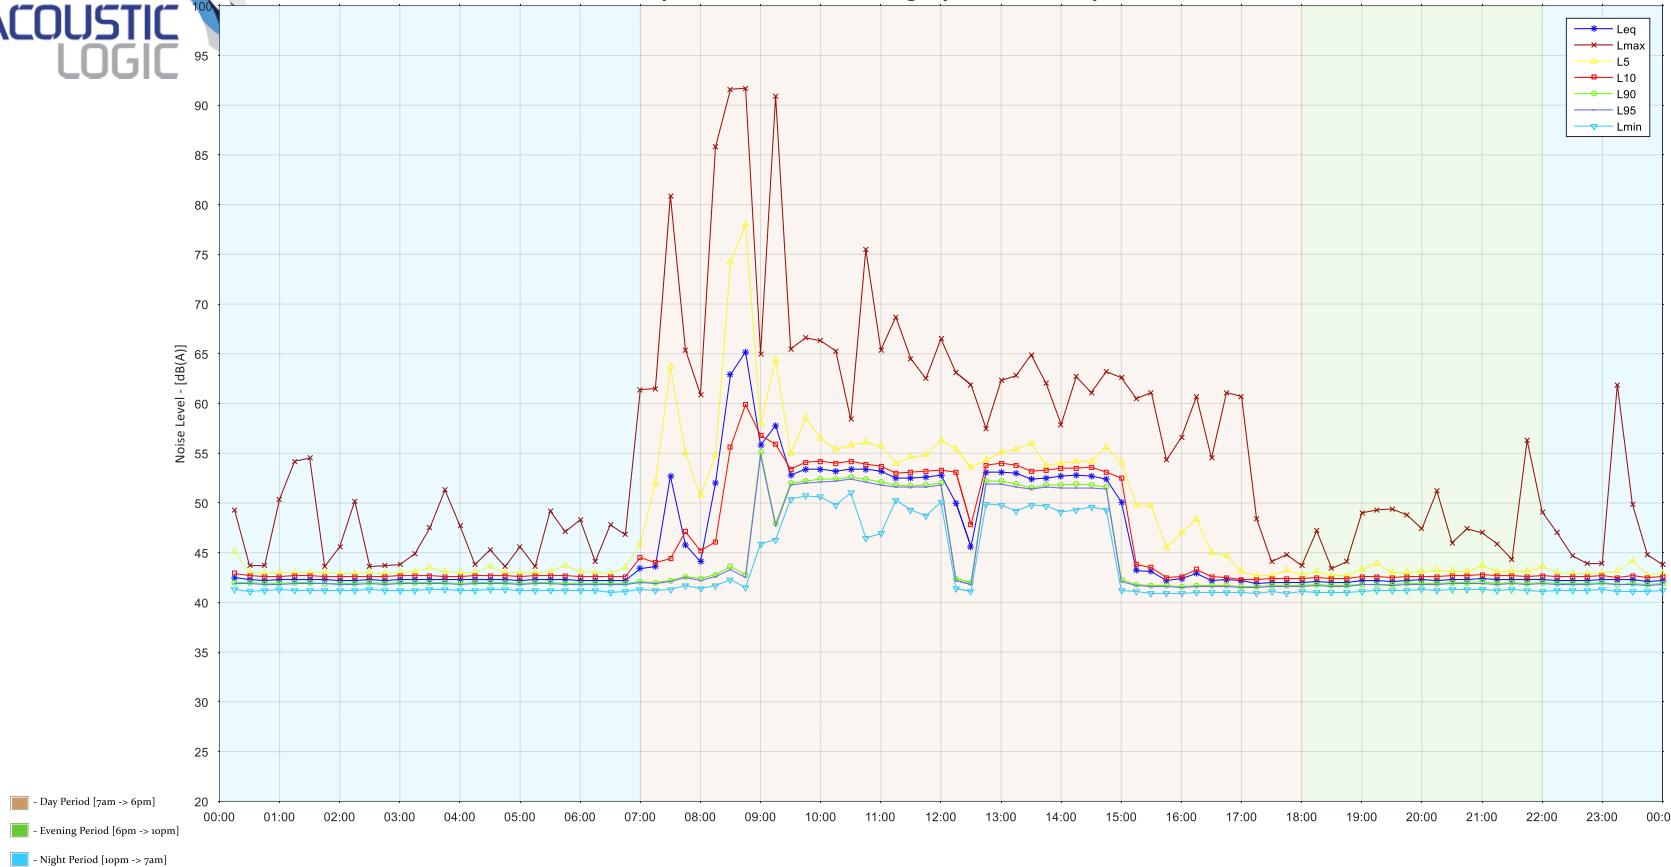
Centenary Institute - Level 4 Surgery Room: Friday 15 December, 2023

- One exceedance of the noise management levels for animal behavioural, holding and breeding spaces is observed within the monitoring period on 15/12/2023, however this exceedance is followed by a continuous and steady increase of the existing ambient noise profile of the space , and is therefore indicative of operational activity / set-up of the surgery room, rather than construction activity.
