Multi-Storey Carpark, Liverpool Hospital

Fortnightly Noise and Vibration Monitoring Report #1

Project ID	20200931.7
Document Title	Fortnightly Noise and Vibration Monitoring Report
Attention To	ADCO Constructions Pty Ltd

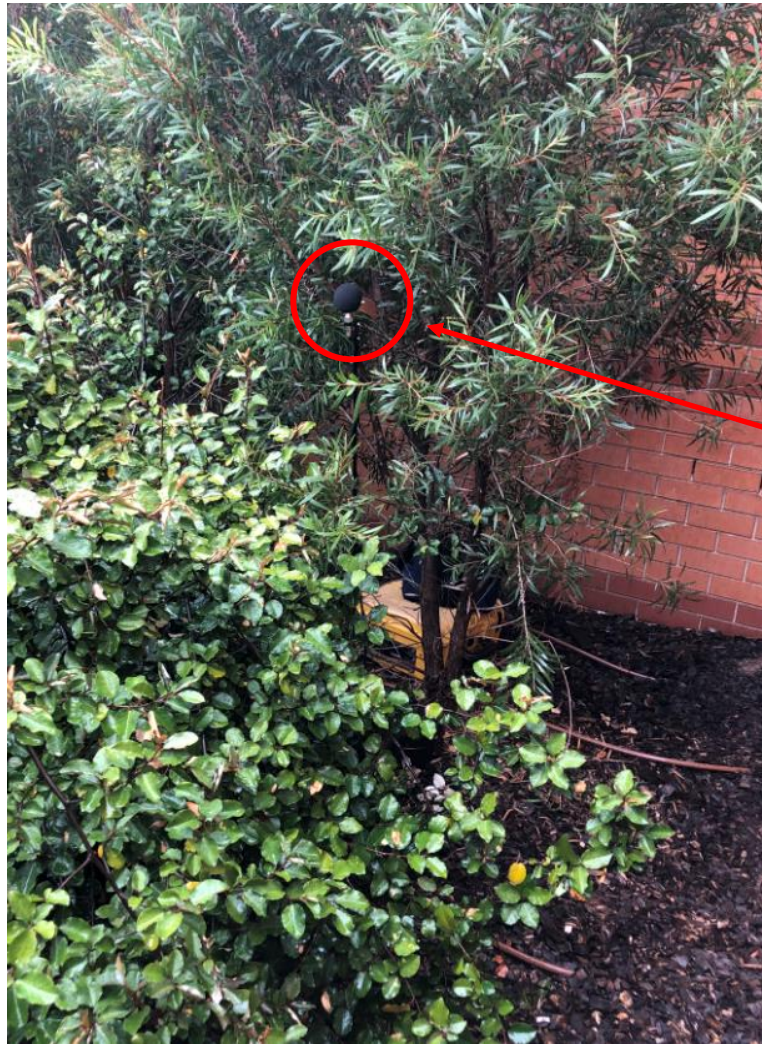
Figure 2: Noise Monitor installed within Brain Injury Unit Garden Bed

- **Noise Monitoring Location:** Located along the northern façade of the Brain Injury Unit (facing the construction site) situated within a small garden bed.
- **Vibration Monitor Location 1:** Located along the northern façade of the Brain Injury Unit (facing the construction site) situated within a small garden bed with the geophone of the monitoring station positioned in the ground against the façade.

Microphone of Noise Monitoring Station

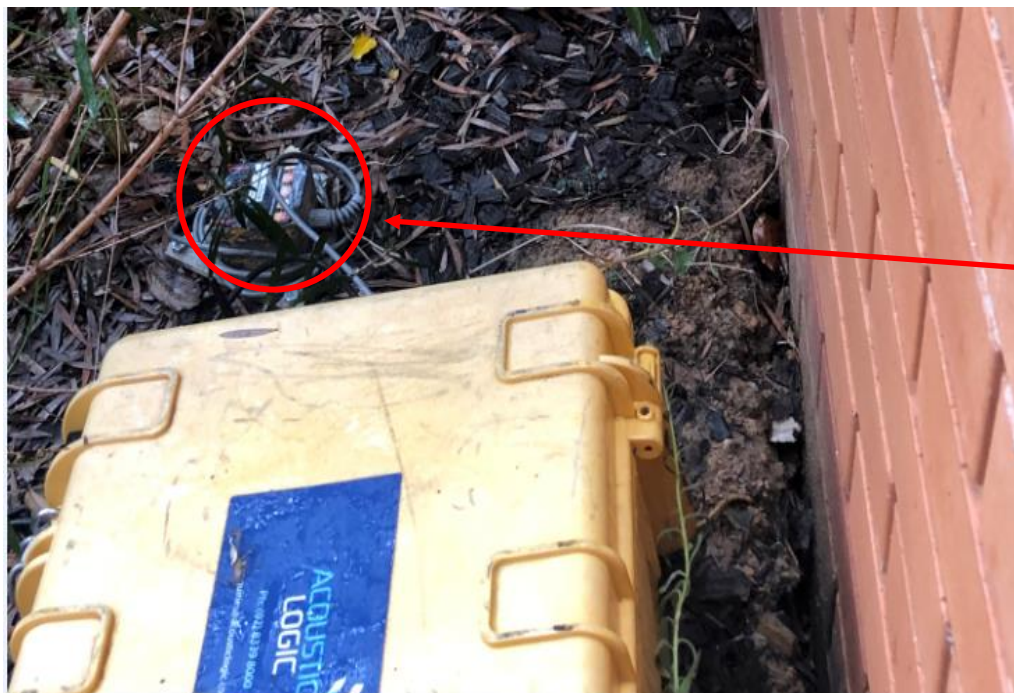
Figure 3: Vibration Monitor installed within Brain Injury Unit Garden Bed

Geophone of Vibration Monitoring Station

It is noted that during the monitoring period, the geophone was mounted in the soil of a garden bed in front of the Brain Injury Unit due to the approval to fix the geophone to the façade wall of the Brain Injury Unit was not available at this time.

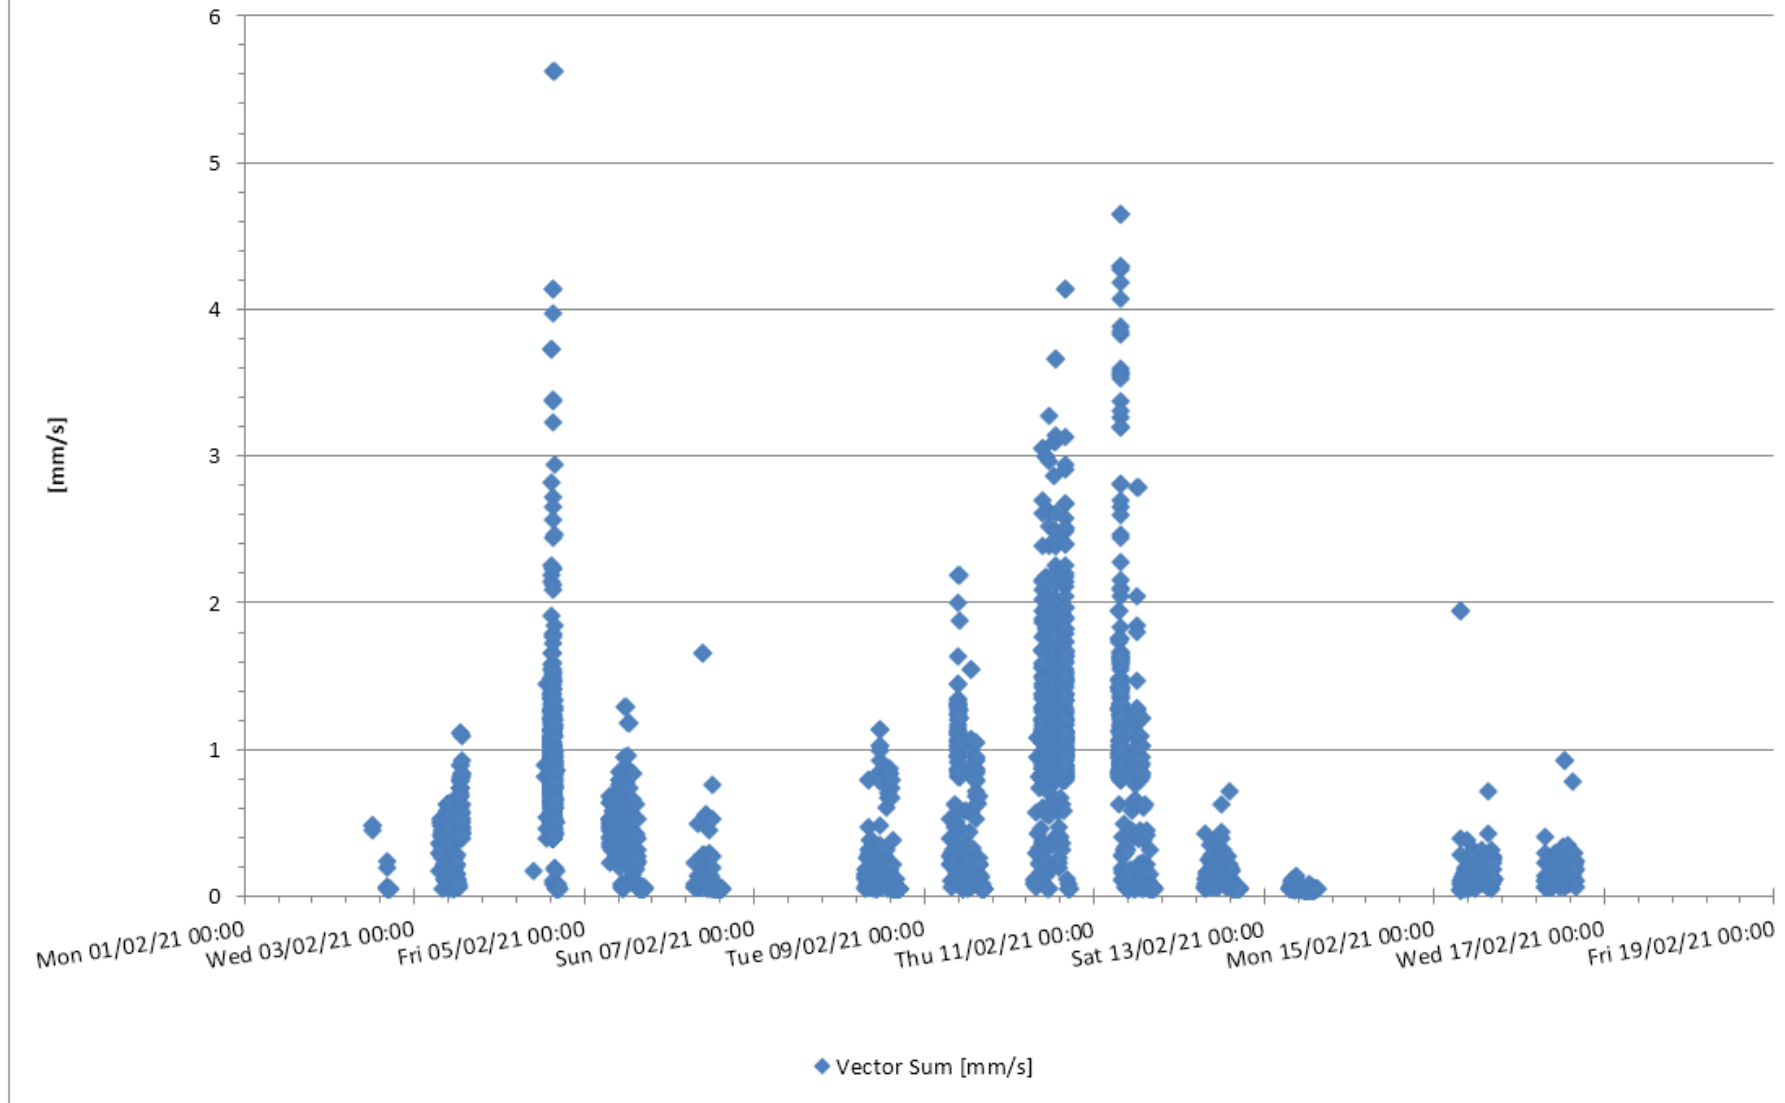
M7395 20200931_7 @ Liverpool MSCP Brain Injuries Unit - Compliance

The vibration monitoring data is presented in table 4 below and has been graphed and attached in Appendix B of this report. The measured vibration levels and frequencies of each event have been reviewed against the requirements of section 3.2 of this report and are presented and discussed below.

Vibration Monitor Location	Date	Maximum Measured Vibration Level PPV (mm/s)	Time (24hr)	Target Vibration Limit* PPV (mm/s)	Complies?	DIN 4150 Building Damage Vibration Criteria* PPV (mm/s)	Complies?
Liverpool Hospital, Brain Injury Unit	Tuesday, 2 nd February 2021	0.48	12:19	<0.56	Yes	<20	Yes
	Wednesday, 3 rd February 2021	1.11	13:12		No		Yes
	Thursday, 4 th February 2021	5.62	15:25		No		Yes
	Friday, 5 th February 2021	1.29	11:30		No		Yes
	Saturday, 6 th February 2021	1.65	09:14		No		Yes
	Monday, 8 th February 2021	1.14	11:24		No		Yes
	Tuesday, 9 th February 2021	2.19	09:43		No		Yes
	Wednesday, 10 th February 2021	4.14	15:53		No		Yes
	Thursday, 11 th February 2021	4.65	07:30		No		Yes
	Friday, 12 th February 2021	0.71	14:00		No		Yes

*We note that the 0.56mm/s PPV is the vibration management trigger level for humans' comfort and that 20mm/s PPV is the vibration criteria based on German Standard DIN 4150 for building damage. Given this, exceedances of the 0.56mm/s PPV would not result in damage to the building structure.

During the monitoring period, it is noted that generally the noise and vibration generation from construction activities being undertaken at the Stage 1 Multi-Storey Car Park project site is above the recommended noise and vibration limits established in sections 2.2 and 3.2 of this report. However; as discussed above, exceedances of the humans' comfort vibration limit would not result in damage to the building structure as the vibration levels measured during the monitoring period are below the DIN-4150 vibration criteria.

In addition, it is recommended to review the '*Ameliorative Measures*' detailed in the '*Stage 1 – Construction Noise and Vibration Management Plan*' (Ref: 20200931.1/0412A/R3/SN) dated 4/12/2020 prepared by this office for ongoing construction works to be undertaken at the project site.
