Multi-Storey Carpark, Liverpool Hospital

Fortnightly Noise and Vibration Monitoring Report #2

Project ID	20200931.7
Document Title	Fortnightly Noise and Vibration Monitoring Report
Attention To	ADCO Constructions Pty Ltd

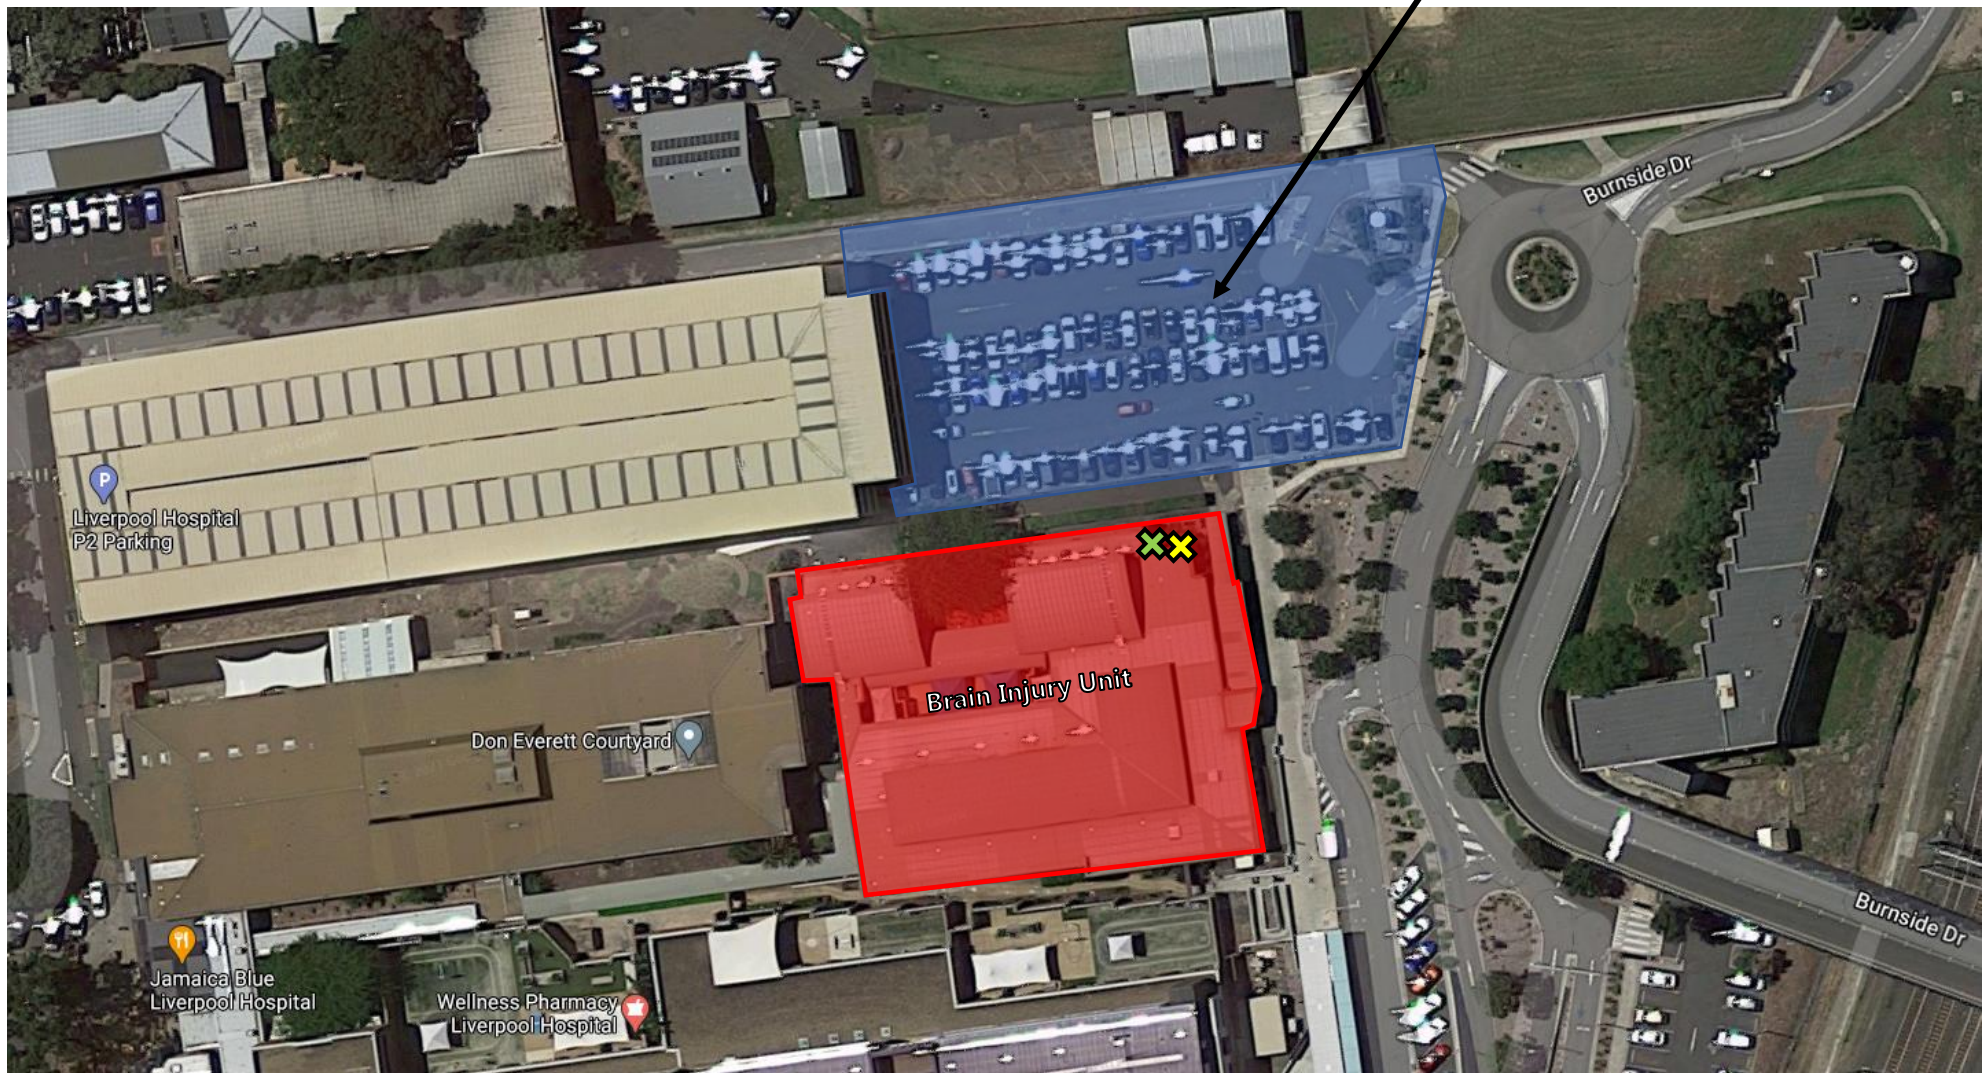
Figure 1: Aerial site map & monitoring locations

- **Noise Monitoring Location:** Located along the northern façade of the Brain Injury Unit (facing the construction site) situated within a small garden bed.
- **Vibration Monitor Location 1:** Located along the northern façade of the Brain Injury Unit (facing the construction site) with the geophone mounted directly to the façade of the building structure.

✕ = Noise Monitor Location

✕ = Vibration Monitor Location

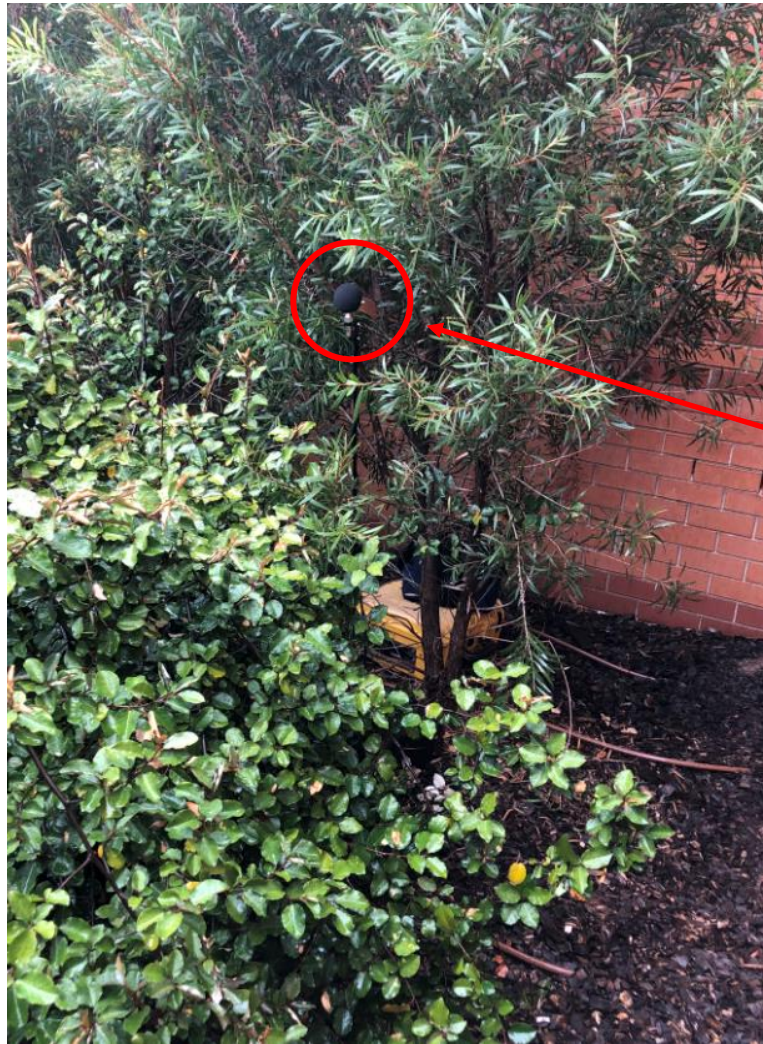
Figure 2: Noise Monitor installed within Brain Injury Unit Garden Bed

Microphone of Noise Monitoring Station

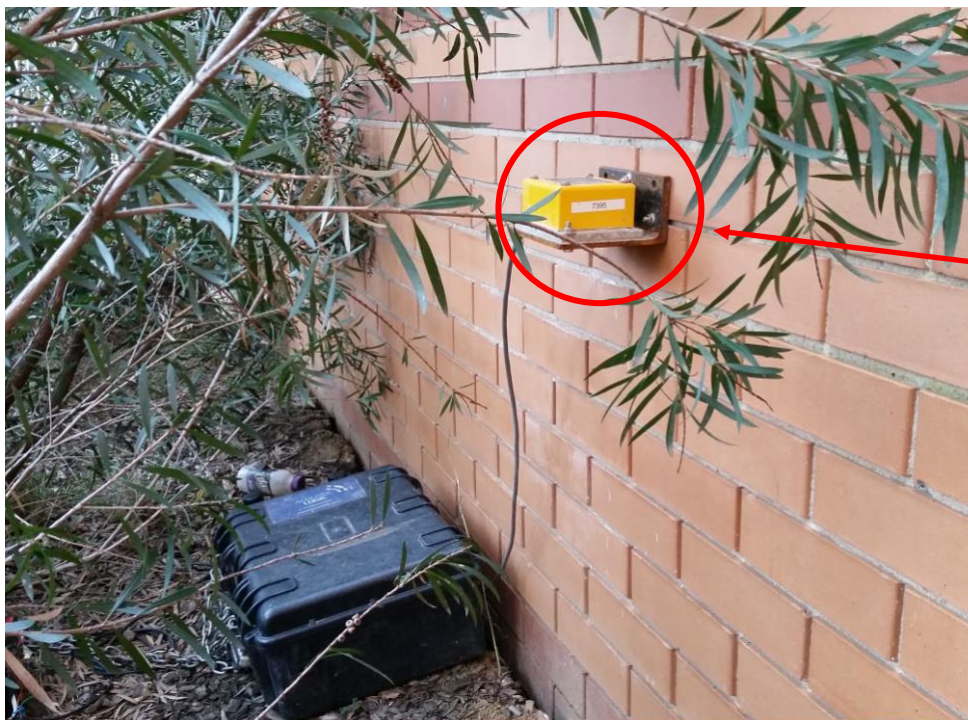
Figure 3: Vibration Monitor installed along Brain Injury Unit Facade

Geophone of Vibration Monitoring Station

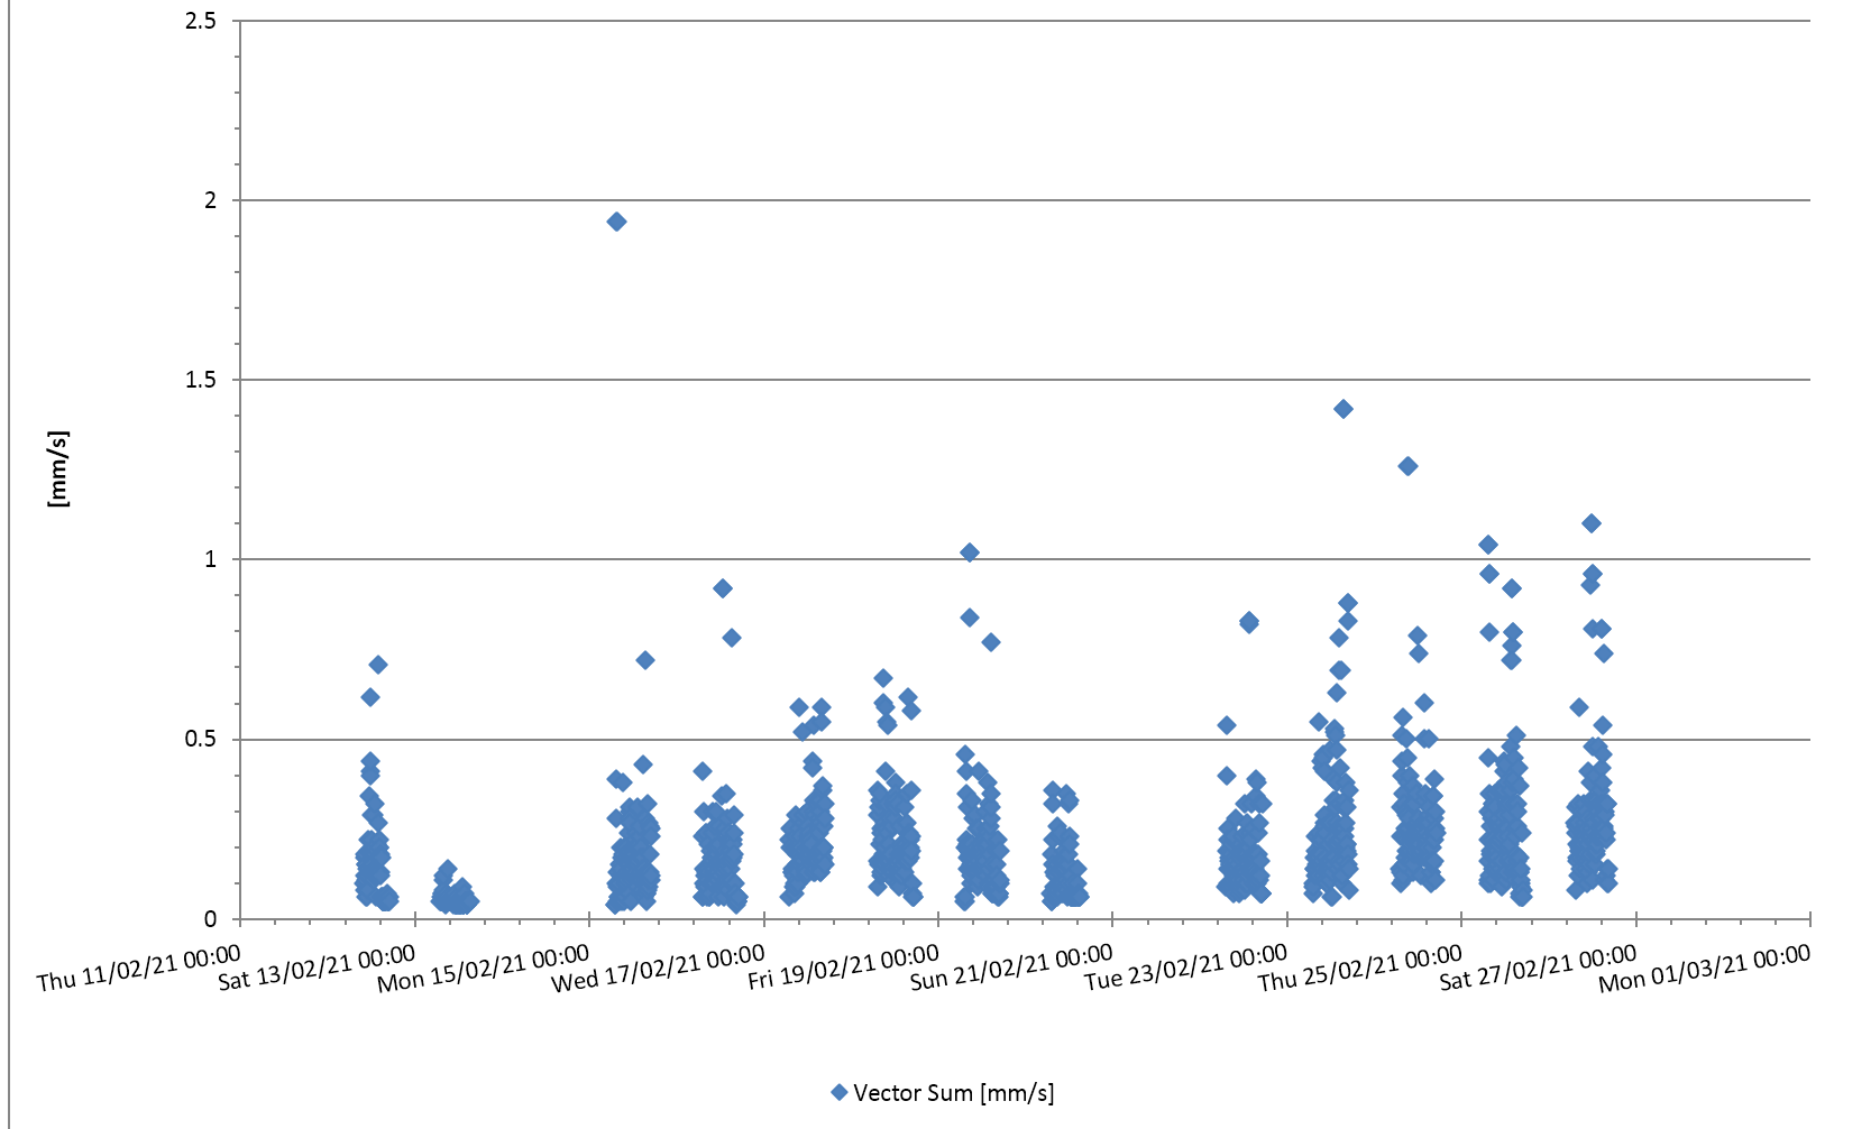
M7395 20200931_7 @ Liverpool MSCP Brain Injuries Unit - Compliance

Vibration Monitor Location	Date	Maximum Measured Vibration Level PPV (mm/s)	Time (24hr)	Target Vibration Limit* PPV (mm/s)	Complies?	DIN 4150 Building Damage Vibration Criteria* PPV (mm/s)	Complies?
Liverpool Hospital, Brain Injury Unit	Friday, 12 th February 2021	0.71	14:00	<0.56	No	<20	Yes
	Saturday, 13 th February 2021	0.14	09:05		Yes		Yes
	Monday, 15 th February 2021	1.94	07:27		No		Yes
	Tuesday, 16 th February 2021	0.92	12:28		No		Yes
	Wednesday, 17 th February 2021	0.59	09:45		No		Yes
	Thursday, 18 th February 2021	0.67	08:45		No		Yes
	Friday, 19 th February 2021	1.02	08:29		No		Yes
	Saturday, 20 th February 2021	0.36	07:30		Yes		Yes
	Monday, 22 nd February 2021	0.82	13:34		No		Yes
	Tuesday, 23 rd February 2021	1.42	15:21		No		Yes
	Wednesday, 24 th February 2021	1.26	09:10		No		Yes
	Thursday, 25 th February 2021	1.04	07:33		No		Yes
	Friday, 26 th February 2021	1.1	11:39		No		Yes

*We note that the 0.56mm/s PPV is the vibration management level for humans' comfort and that 20mm/s PPV is the vibration criteria based on German Standard DIN 4150 for building damage. Given this, exceedances of the 0.56mm/s PPV would not result in damage to the building structure.

In addition, it is recommended to review the '*Ameliorative Measures*' detailed in the '*Stage 1 – Construction Noise and Vibration Management Plan*' (Ref: 20200931.1/0412A/R3/SN) dated 4/12/2020 prepared by this office for ongoing construction works to be undertaken at the project site.
