Health Infrastructure NSW
Westmead PSB and MSCP
Construction Noise Monitoring

Noise monitoring report
2022-08-01 to 2022-08-31

**Vibration Monitoring - KR - Animal
House - August 2022**

**Vibration Monitoring - CHW - L1 Lab -
August 2022**

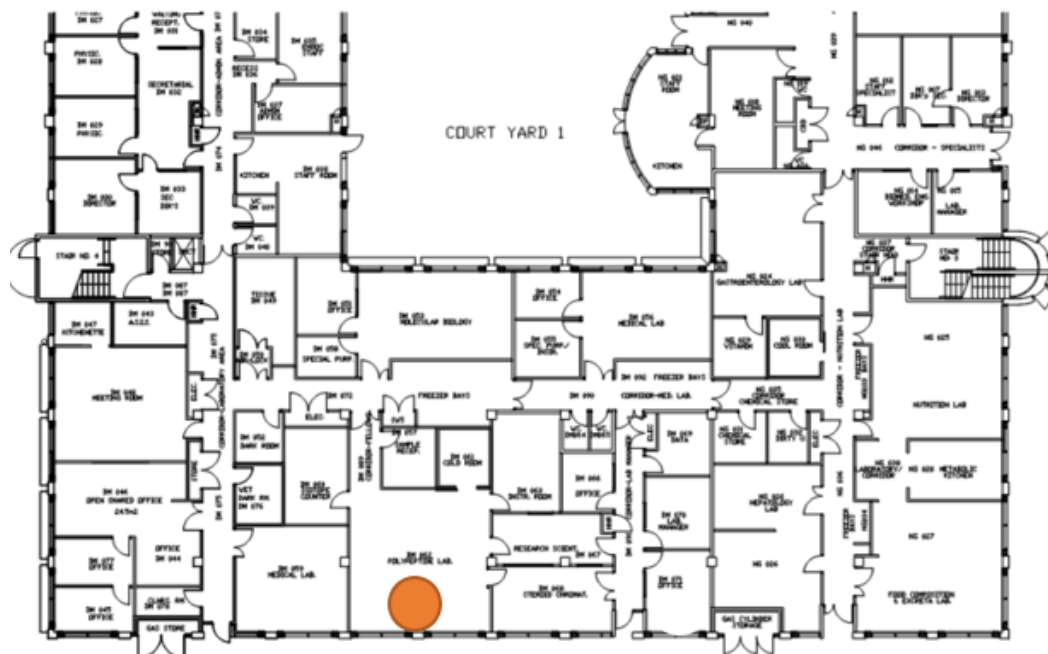
Figure 2: CHW - L1 Lab vibration monitor location shown in orange

The location of this monitor is shown below in Figure 2.

Monitoring at this location utilises a GeoSIG GMSplus with a GeoSIG VE-11 geophone. The calibration certificate for the geophone is included in Appendix A.
