Westmead PSB and MSCP Construction Noise Monitoring

Noise monitoring report 2022-05-01 to 2022-05-31

Vibration Monitoring - KR - Animal House - May 2022

Vibration Monitoring - CHW - L1 Lab - May 2022

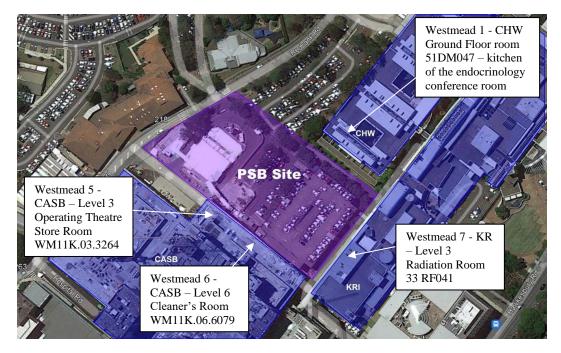
Figure 1: PSB noise monitoring locations.

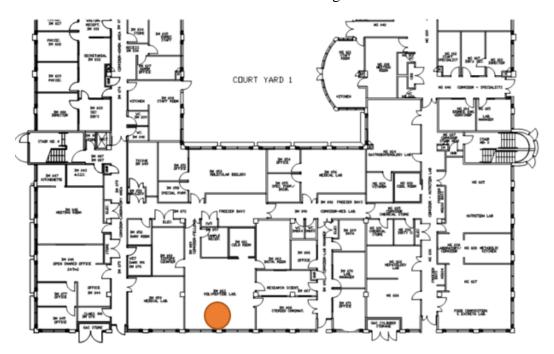
Figure 2: CHW - L1 Lab vibration monitor location shown in orange

Monitoring at this location utilises a GeoSIG GMSplus with a GeoSIG VE-11 geophone. The calibration certificate for the geophone is included in Appendix A.
