NOISE AND VIBRATION MONITORING REPORT FEBRUARY 2024

LIVERPOOL HEALTH AND ACADEMIC PRECINCT

LENDLEASE BUILDING PTY LTD

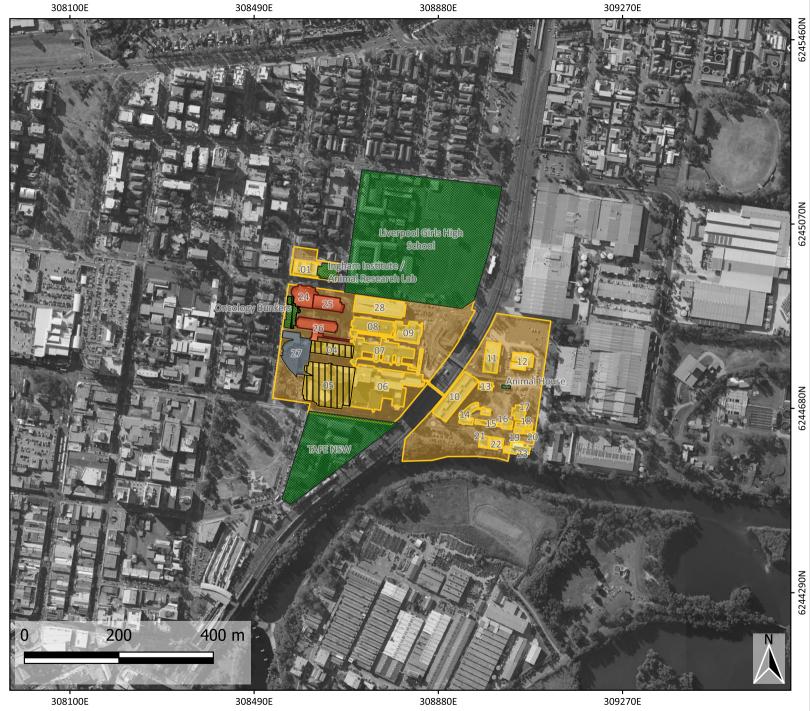
Title:	Site Location and Regional Context
Project ID:	PRJ-000719
Project Location:	Liverpool Health and Academic Precinct Elizabeth and Goulburn Street, Liverpool NSW 2170
Figure Number:	01
Client:	Lendlease Construction Pty Ltd
Map Scale:	1:8,000
CRS:	GDA2020 / MGA zone 56
Source:	SixMaps
Prepared By:	Brendon Phan
Reviewed By:	Scott Bamford
Date:	05/07/2023
Revision:	V1
