RE: Dust Monitoring – July 2023

**Stage 3 St. George Hospital,
16 Kensington Street,
Kogarah**

Monitoring Period:
30 June 2023 to 06 July 2023

DUST MONITORING REPORT

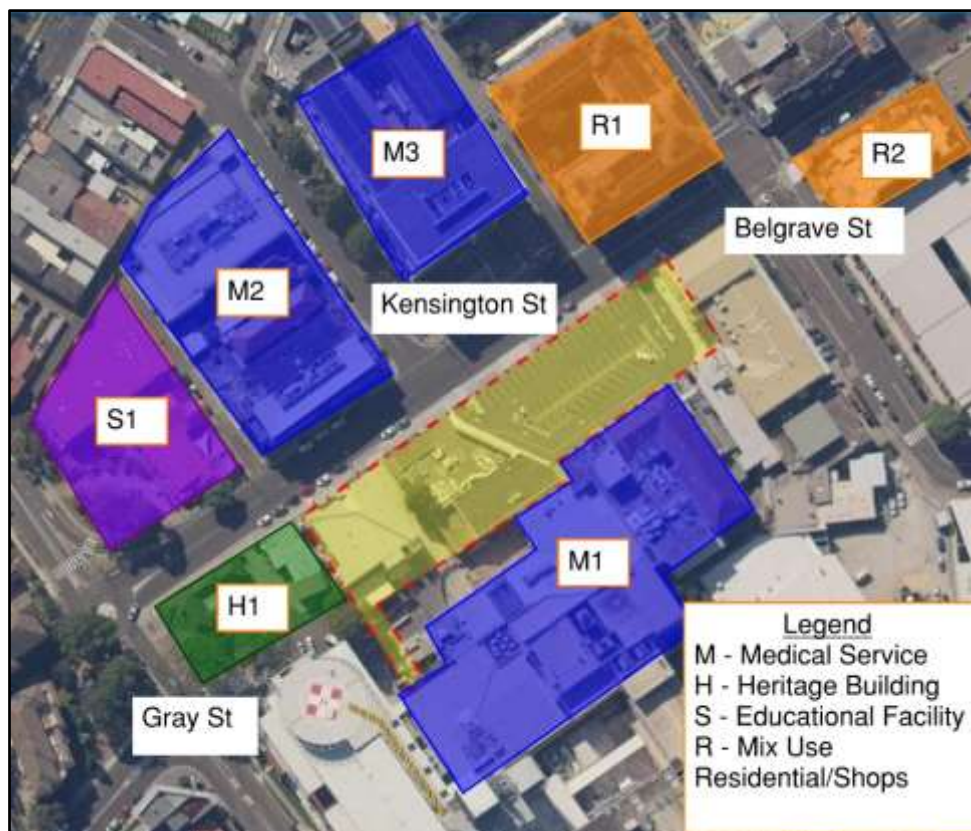
Figure 1 Site plan

The nearest dust sensitive receivers are identified in Figure 1 and listed below:

- ❖ M1, Medical Facility on the Southern boundary of the site.
- ❖ M2, Medical Facility on the Norther boundary of the site along Kensington St.
- ❖ M3, Medical Facility on the Norther boundary of the site along Kensington St.
- ❖ H1, Fire Station (heritage) on the Western side of the boundary.
- ❖ SW, Sydney Water asset along the Northern boundary of the site along Kensington St

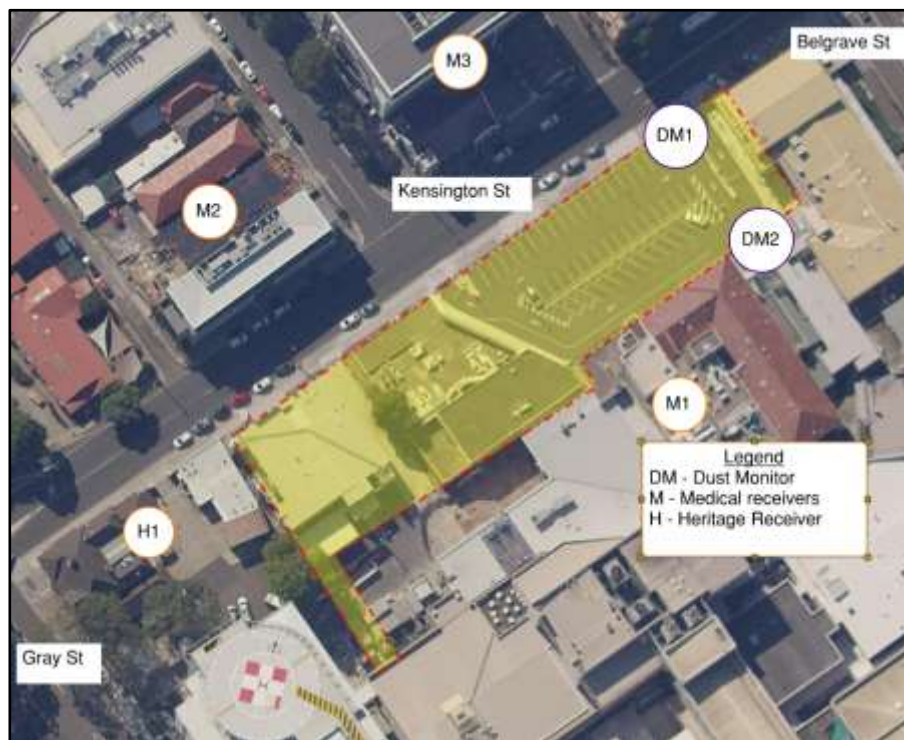
Figure 3 Site setup

Monitor 1 and Monitor 2 are on a solar stand in accordance with the manufacturer's recommendations. The monitor was (re)located to be as close to the operating plant as possible, site setup is shown in Figure 3 below. Each device was set to continuous daily monitoring mode at 15-minute intervals recording pollutant particles as PM_{2.5} and PM₁₀.

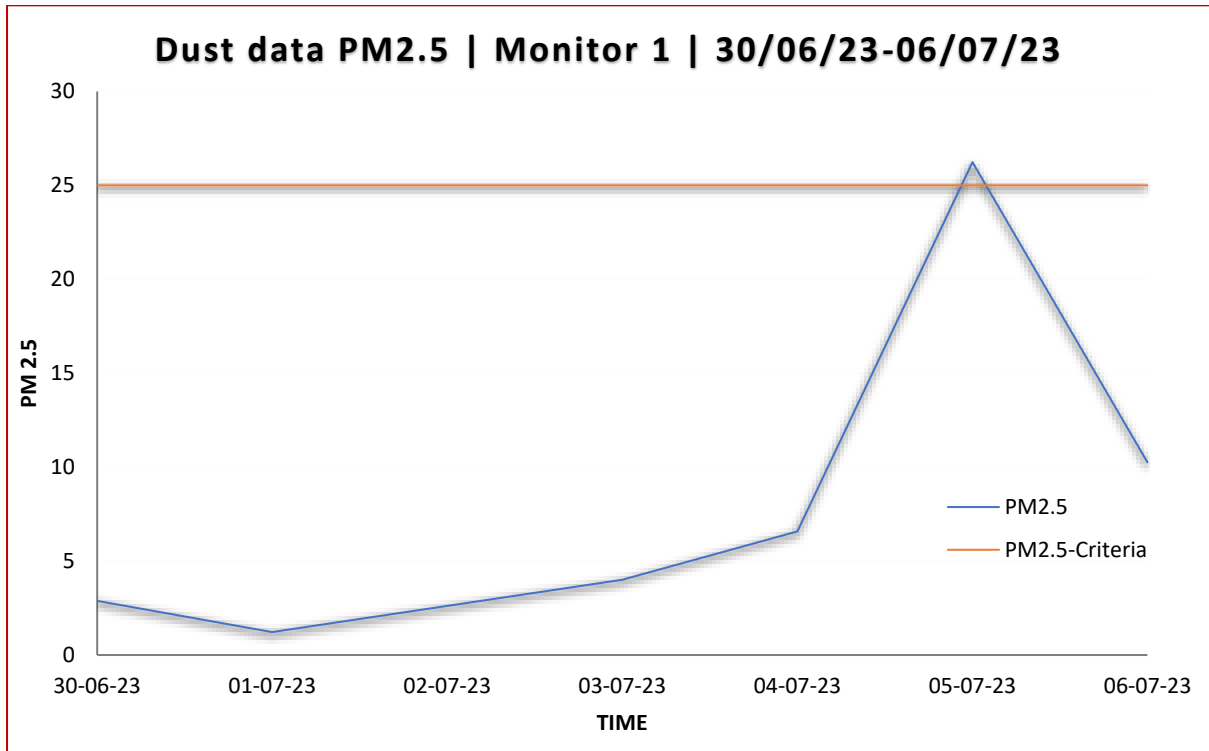
Appendix 1 – Dust Monitoring Data

As can be seen from the previous section and the graphs below, the daily average PM_{2.5} and PM₁₀ concentrations were found to be within the criteria except on two occasions from Monitor 1 on 05/07/2023 to 06/07/2023 for the PM₁₀ concentration.

- ❖ Minimise works that generates dust during extreme weather conditions such as windy days, hot

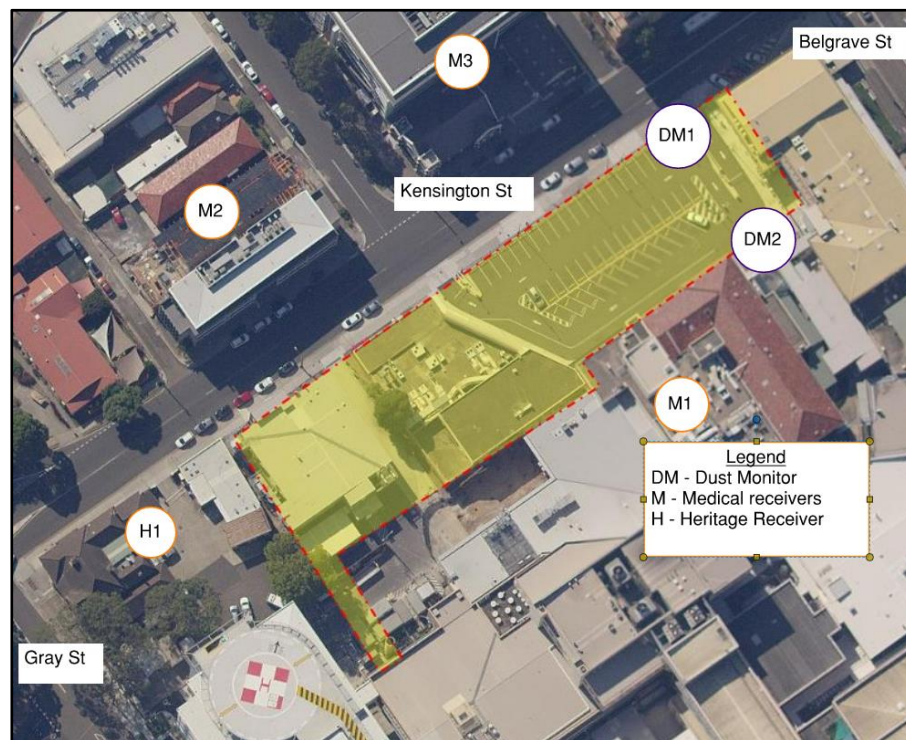
Figure 3 Site setup

Monitor 1 and Monitor 2 are on a solar stand in accordance with the manufacturer's recommendations. The monitor was (re)located to be as close to the operating plant as possible, site setup is shown in Figure 3 below. Each device was set to continuous daily monitoring mode at 15-minute intervals recording pollutant particles as PM_{2.5} and PM₁₀.

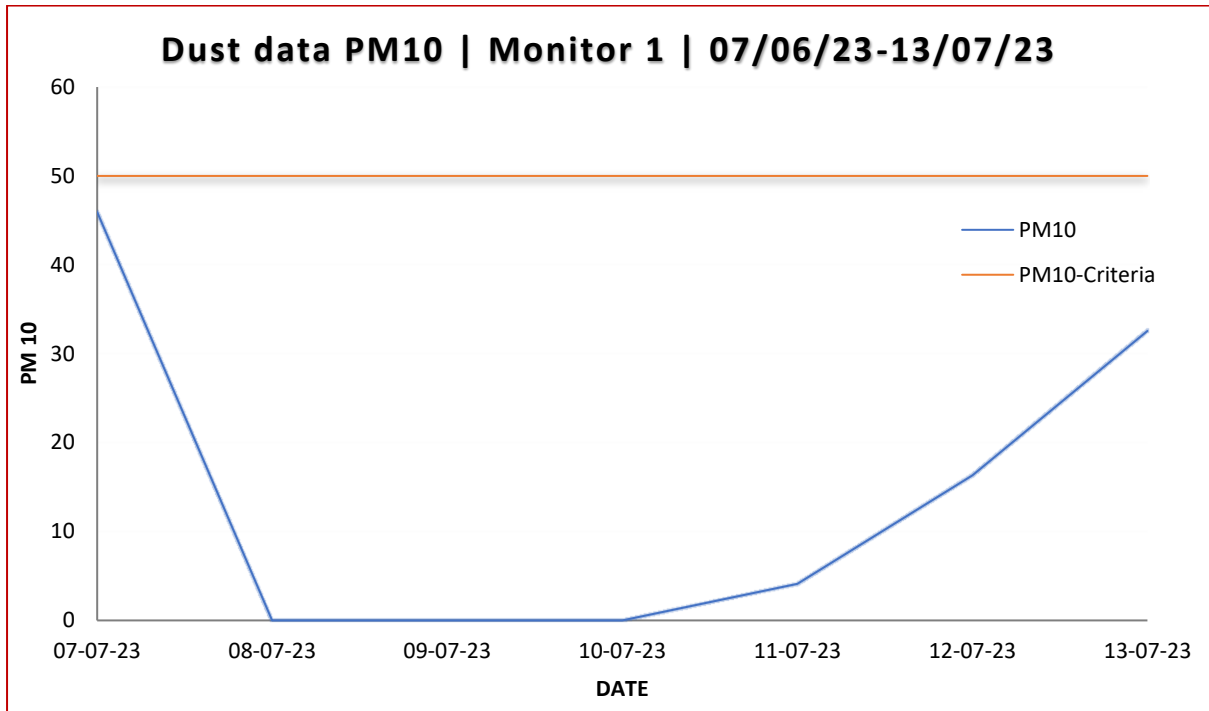
Appendix 1 – Dust Monitoring Data

As can be seen from the previous section and the graphs below, the daily average PM_{2.5} and PM₁₀ concentrations were found to be within the criteria set for this site. Data on 08/07/2023 to 10/07/2023 for Monitor 1 were not collected due to low battery.

- ❖ Minimise works that generates dust during extreme weather conditions such as windy days, hot and dry days.
- ❖ Spray water during excavation works as well as on stockpiles.
- ❖ Dampen and/or cover stockpiles.
- ❖ Cover vehicle loads when leaving/entering the site.
- ❖ Reduce the vehicle speed when operating on site.
- ❖ Remove any mud and/or dust stuck on vehicles prior to leaving the site.
- ❖ Typical issues covered in a consultation program include a public contact point for handling complaints
- ❖ Early notification of proposed operations and any significant change to operations

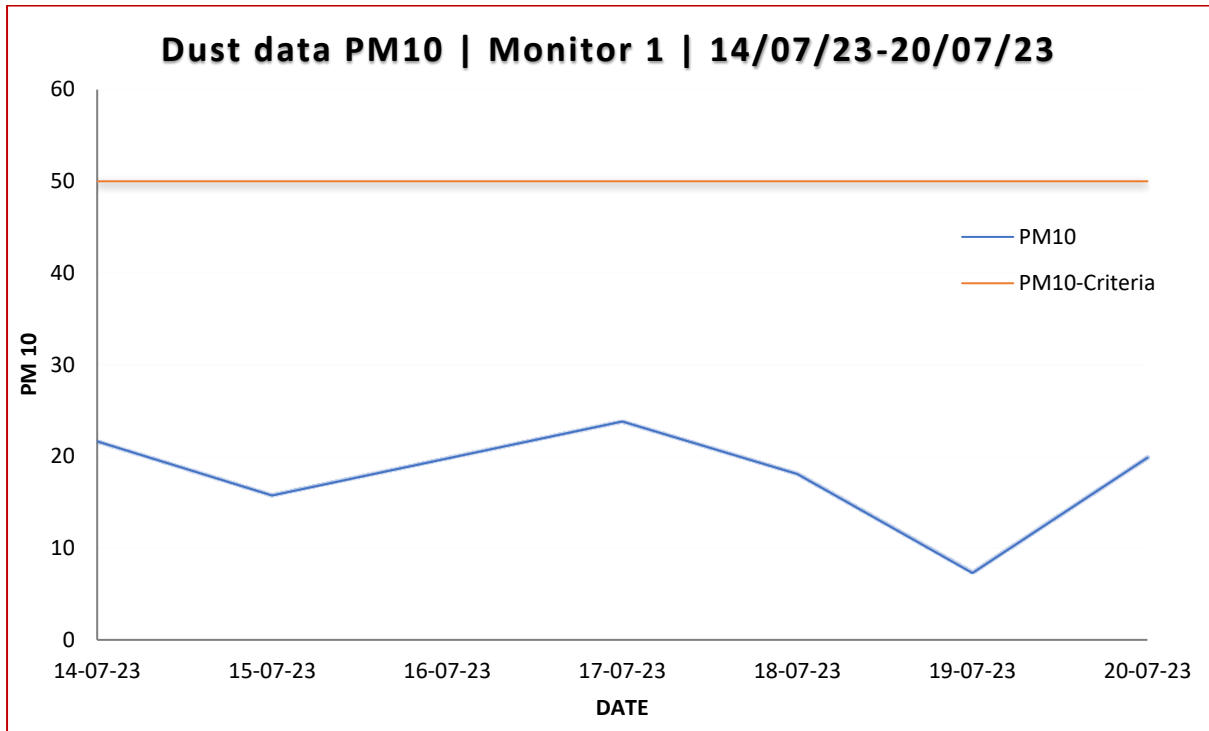
Appendix 1 – Dust Monitoring Data

As can be seen from the previous section and the graphs below, the daily average PM_{2.5} and PM₁₀ concentrations were found to be within criteria set for this site. Data for 19/07/2023 Monitor 2 was not collected due to low battery.

- ❖ Minimise works that generates dust during extreme weather conditions such as windy days, hot and dry days.
- ❖ Spray water during excavation works as well as on stockpiles.
- ❖ Dampen and/or cover stockpiles.
- ❖ Cover vehicle loads when leaving/entering the site.
- ❖ Reduce the vehicle speed when operating on site.
- ❖ Remove any mud and/or dust stuck on vehicles prior to leaving the site.
- ❖ Typical issues covered in a consultation program include a public contact point for handling complaints
- ❖ Early notification of proposed operations and any significant change to operations

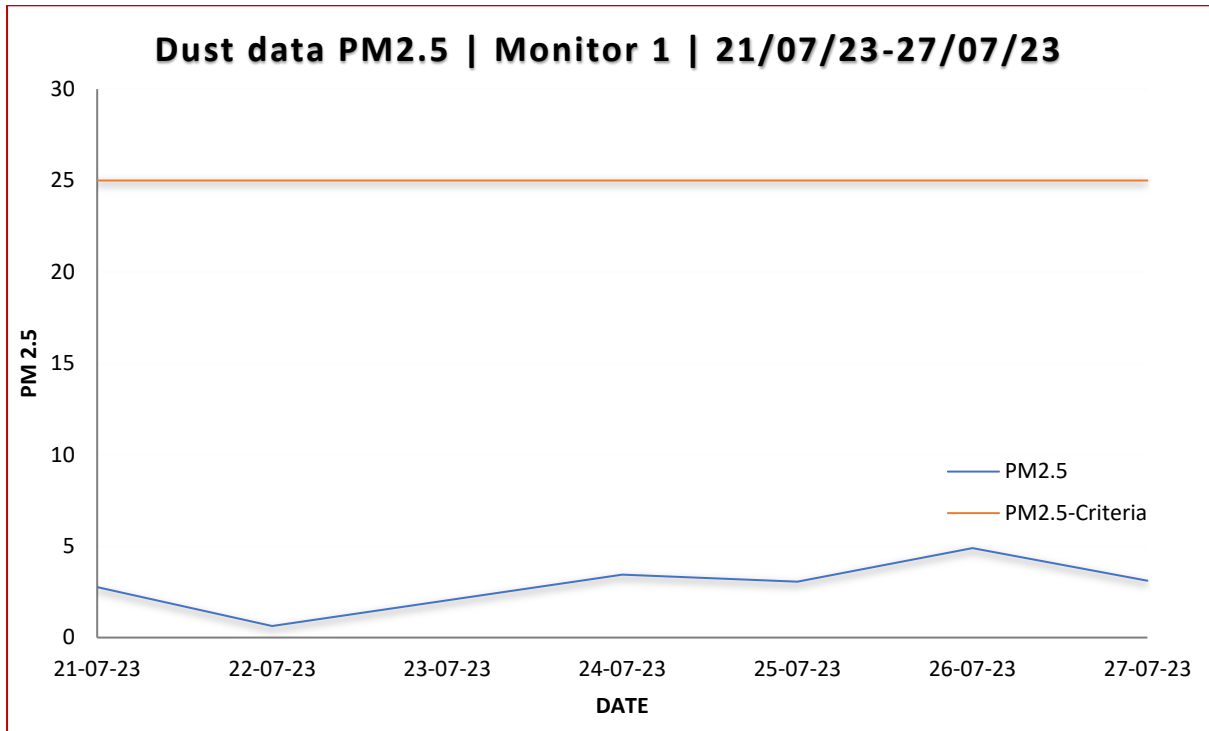
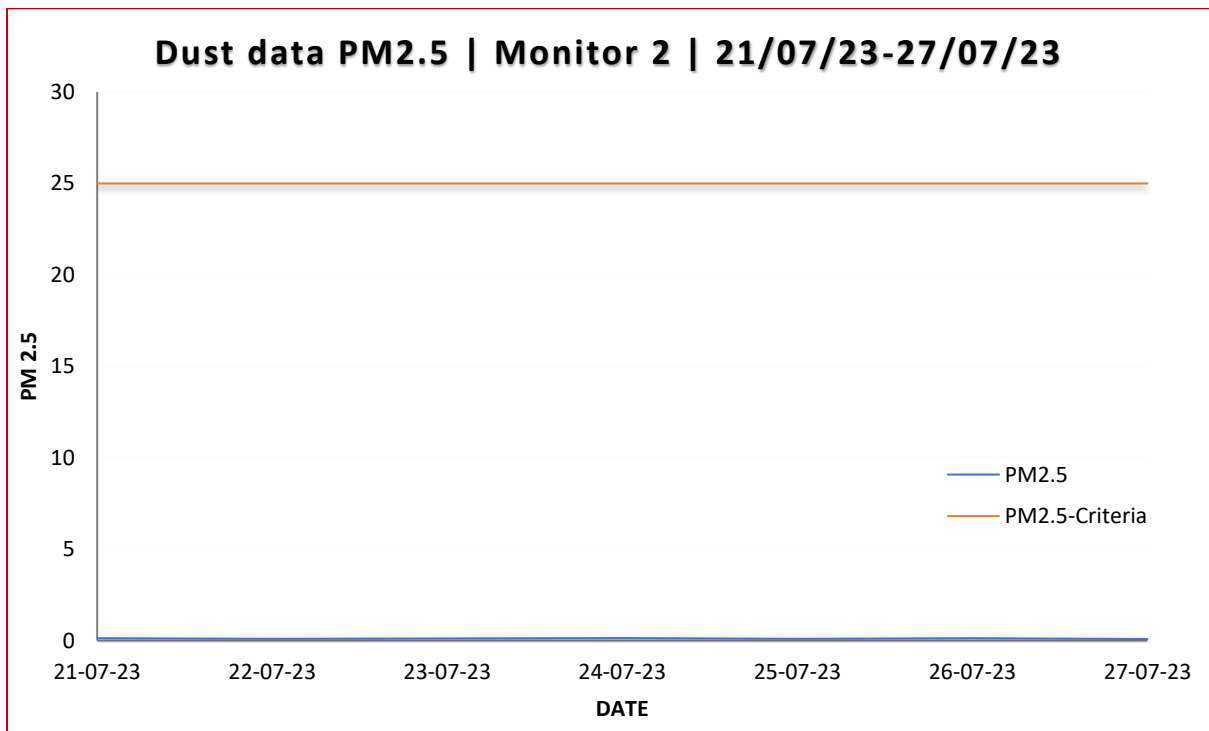
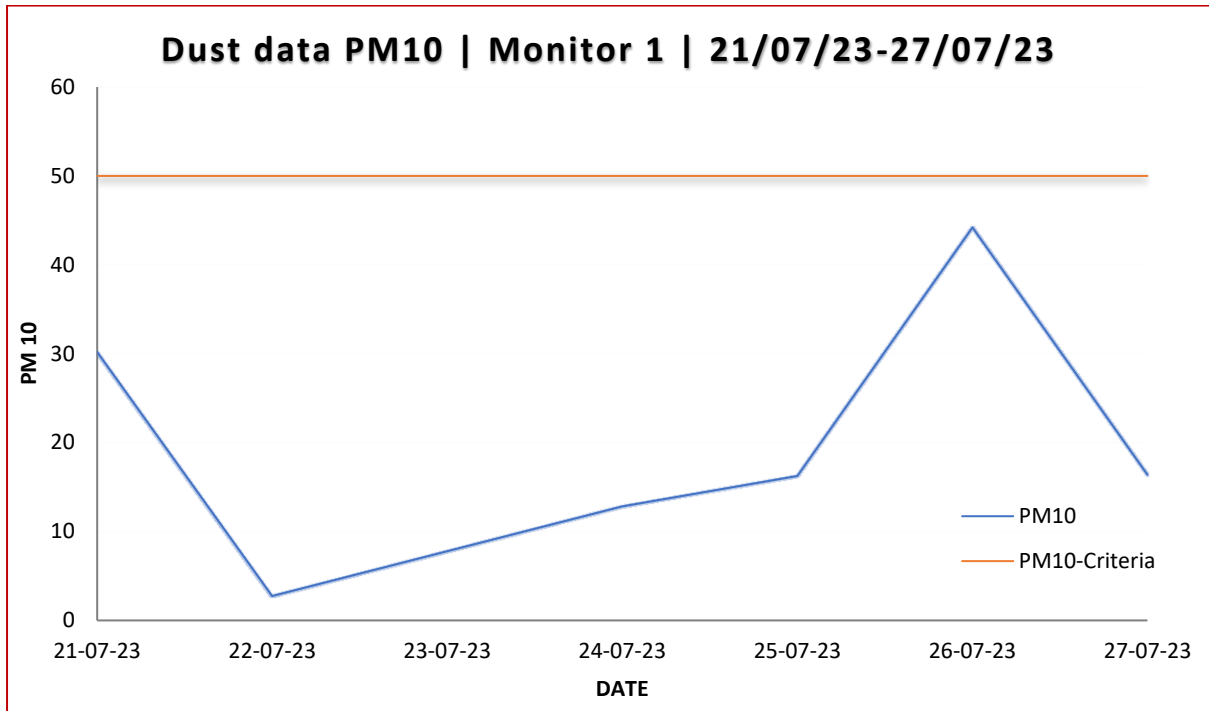
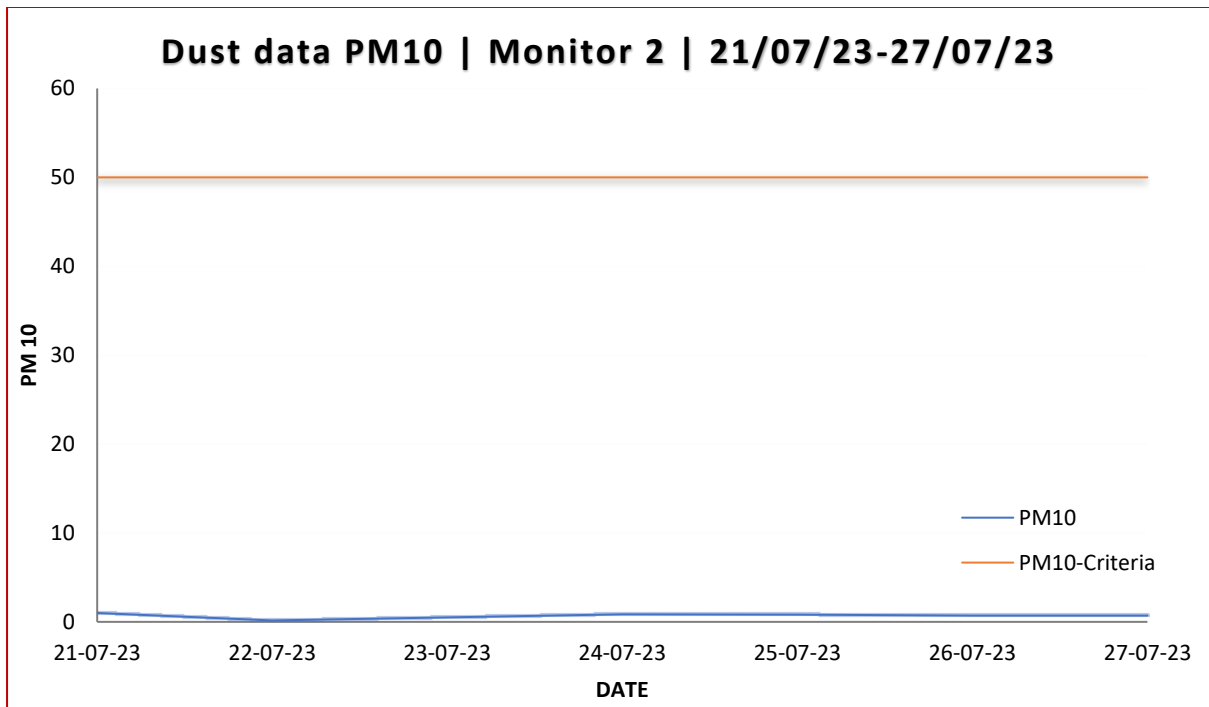
Appendix 1 – Dust Monitoring Data

As can be seen from the previous section and the graphs below, the daily average PM_{2.5} and PM₁₀ concentrations were found to be within criteria set for this site.
