RE: Dust Monitoring - October 2023

DUST MONITORING REPORT

Stage 3 St. George Hospital, 16 Kensington Street, Kogarah

Monitoring Period: 29 September 2023 to 05 October 2023 Client: MOITS PTY LTD

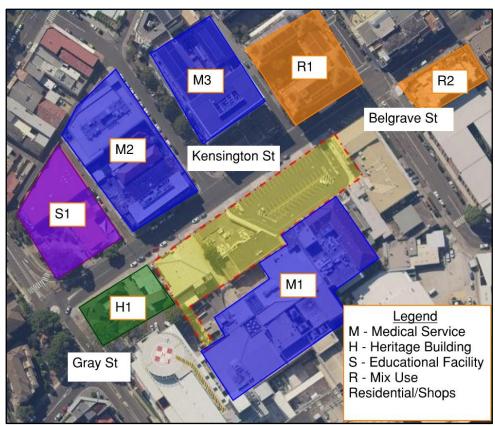
Figure 1 Site plan

The nearest dust sensitive receivers are identified in Figure 1 and listed below:

- ❖ M1, Medical Facility on the Southern boundary of the site.
- M2, Medical Facility on the Norther boundary of the site along Kensington St.
- M3, Medical Facility on the Norther boundary of the site along Kensington St.
- + H1, Fire Station (heritage) on the Western side of the boundary.
- SW, Sydney Water asset along the Northern boundary of the site along Kensington St

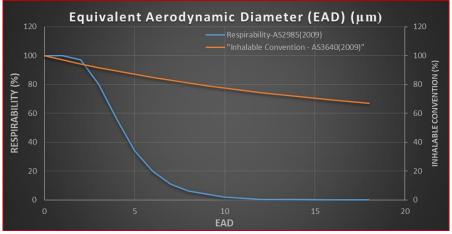
Figure 2 Site setup

Figure 2 represents a summary of the extracted equivalent particle aerodynamic diameter (EAD) in relation to their respirability and inhalable convention and their corresponding percentage in accordance with AS2985-2009 and AS3640-2009

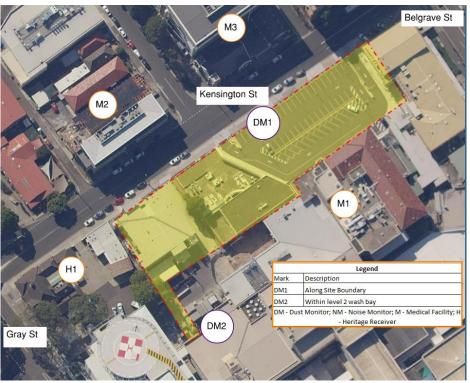
Figure 3 Site setup

Monitor 1 and Monitor 2 are on a solar stand in accordance with the manufacturer's recommendations. The monitor was (re)located to be as close to the operating plant as possible, site setup is shown in Figure 3 below. Each device was set to continuous daily monitoring mode at 15-minute intervals recording pollutant particles as PM_{2.5} and PM₁₀.

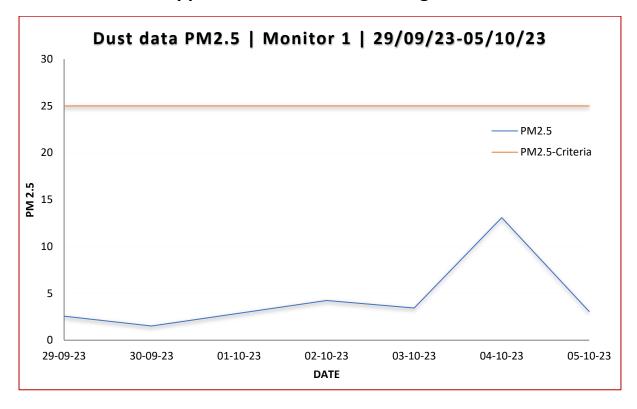
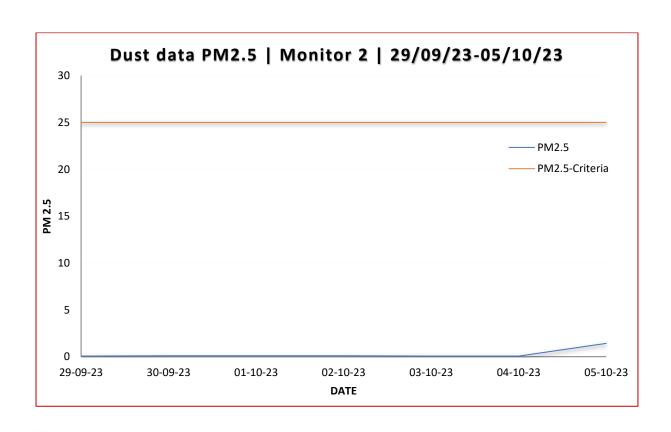
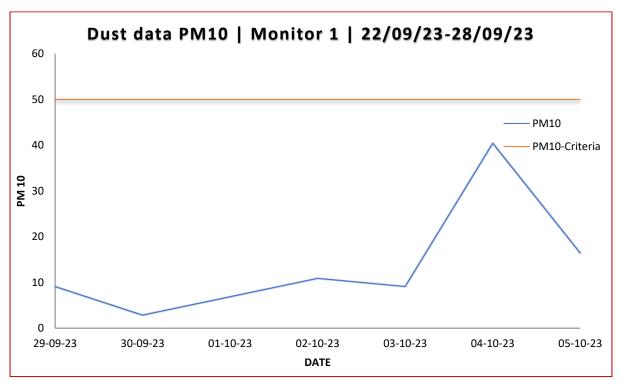
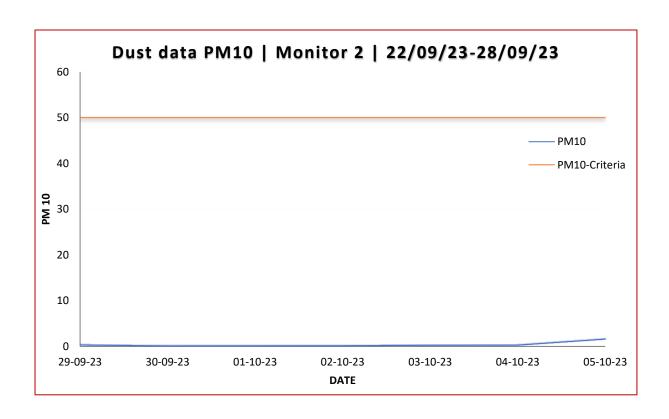
Appendix 1 – Dust Monitoring Data

As can be seen from the previous section and the graphs below, the daily average $PM_{2.5}$ and PM_{10} concentrations were found to be within criteria set for this site.

- Minimise works that generates dust during extreme weather conditions such as windy days, hot and dry days.
- Spray water during excavation works as well as on stockpiles.
- Dampen and/or cover stockpiles.
- Cover vehicle loads when leaving/entering the site.
- * Reduce the vehicle speed when operating on site.
- Remove any mud and/or dust stuck on vehicles prior to leaving the site.
- ❖ Typical issues covered in a consultation program include a public contact point for handling complaints
- **Second Second S**

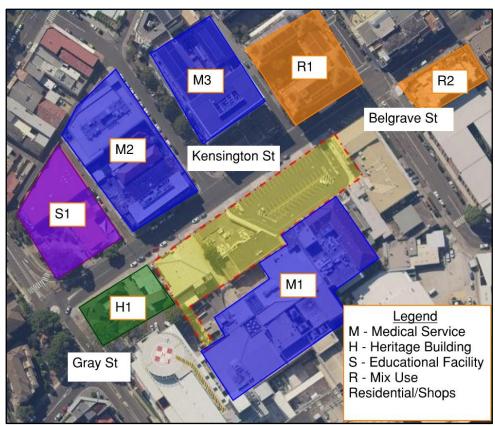
Figure 1 Site plan

The nearest dust sensitive receivers are identified in Figure 1 and listed below:

- M1, Medical Facility on the Southern boundary of the site.
- M2, Medical Facility on the Norther boundary of the site along Kensington St.
- M3, Medical Facility on the Norther boundary of the site along Kensington St.
- + H1, Fire Station (heritage) on the Western side of the boundary.
- SW, Sydney Water asset along the Northern boundary of the site along Kensington St

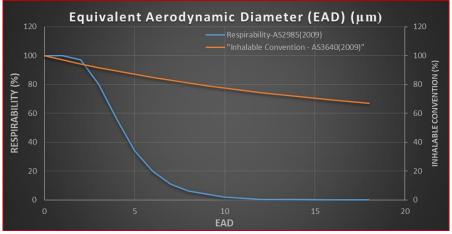
Figure 2 Site setup

Figure 2 represents a summary of the extracted equivalent particle aerodynamic diameter (EAD) in relation to their respirability and inhalable convention and their corresponding percentage in accordance with AS2985-2009 and AS3640-2009

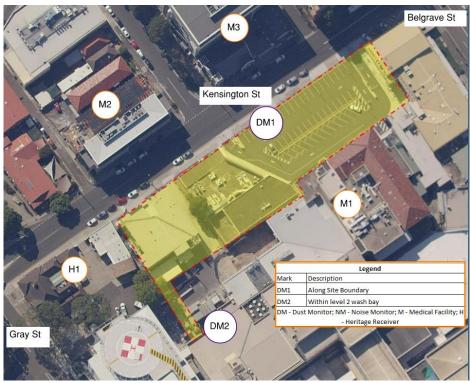
Figure 3 Site setup

Monitor 1 and Monitor 2 are on a solar stand in accordance with the manufacturer's recommendations. The monitor was (re)located to be as close to the operating plant as possible, site setup is shown in Figure 3 below. Each device was set to continuous daily monitoring mode at 15-minute intervals recording pollutant particles as PM_{2.5} and PM₁₀.

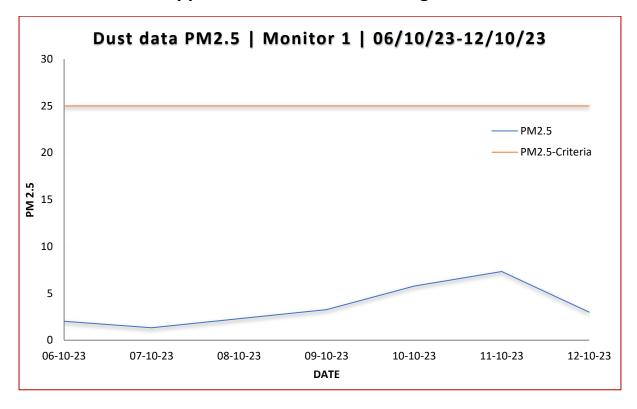
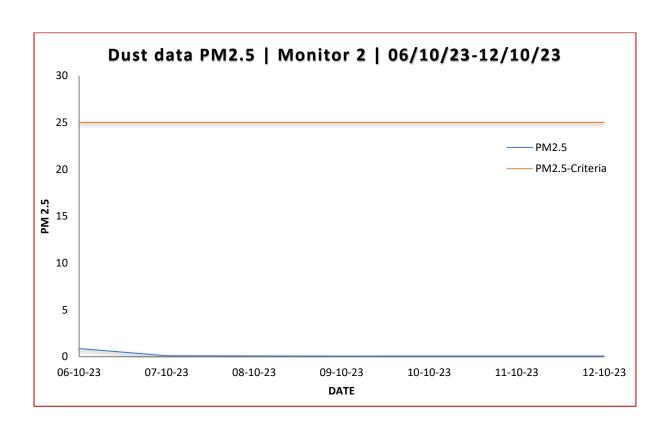
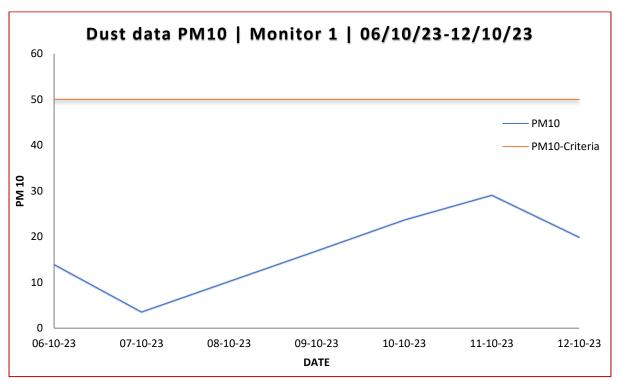
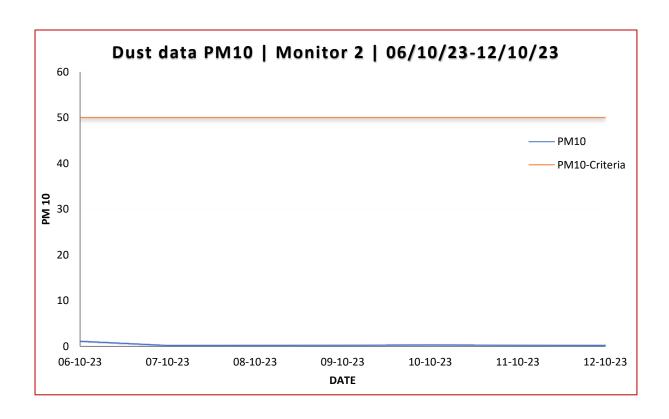
Appendix 1 – Dust Monitoring Data

As can be seen from the previous section and the graphs below, the daily average $PM_{2.5}$ and PM_{10} concentrations were found to be within criteria set for this site.

- Minimise works that generates dust during extreme weather conditions such as windy days, hot and dry days.
- Spray water during excavation works as well as on stockpiles.
- Dampen and/or cover stockpiles.
- Cover vehicle loads when leaving/entering the site.
- Reduce the vehicle speed when operating on site.
- Remove any mud and/or dust stuck on vehicles prior to leaving the site.
- ❖ Typical issues covered in a consultation program include a public contact point for handling complaints
- **Second Second S**

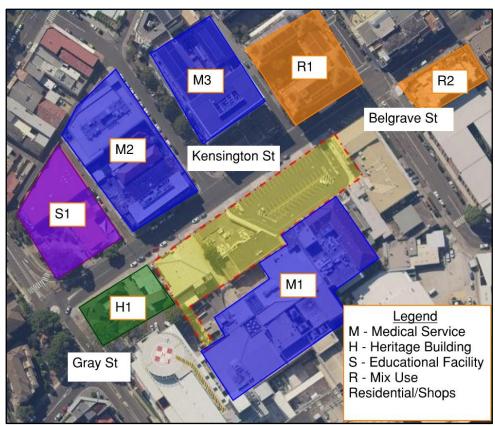
Figure 1 Site plan

The nearest dust sensitive receivers are identified in Figure 1 and listed below:

- ❖ M1, Medical Facility on the Southern boundary of the site.
- M2, Medical Facility on the Norther boundary of the site along Kensington St.
- M3, Medical Facility on the Norther boundary of the site along Kensington St.
- + H1, Fire Station (heritage) on the Western side of the boundary.
- SW, Sydney Water asset along the Northern boundary of the site along Kensington St

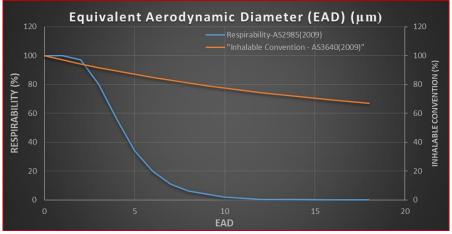
Figure 2 Site setup

Figure 2 represents a summary of the extracted equivalent particle aerodynamic diameter (EAD) in relation to their respirability and inhalable convention and their corresponding percentage in accordance with AS2985-2009 and AS3640-2009

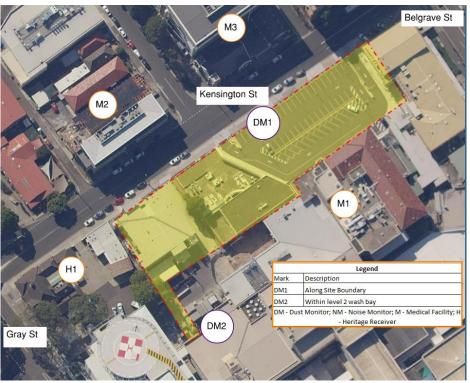
Figure 3 Site setup

Monitor 1 and Monitor 2 are on a solar stand in accordance with the manufacturer's recommendations. The monitor was (re)located to be as close to the operating plant as possible, site setup is shown in Figure 3 below. Each device was set to continuous daily monitoring mode at 15-minute intervals recording pollutant particles as PM_{2.5} and PM₁₀.

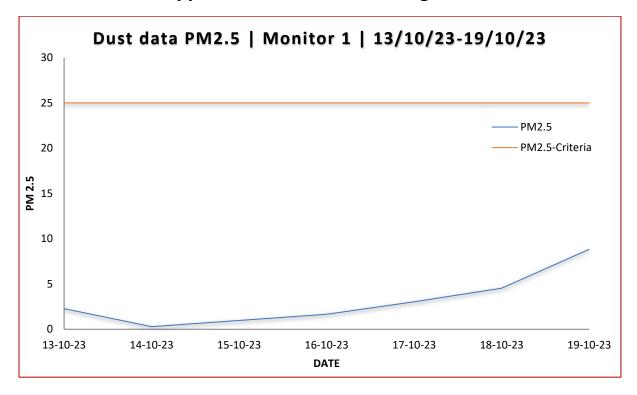
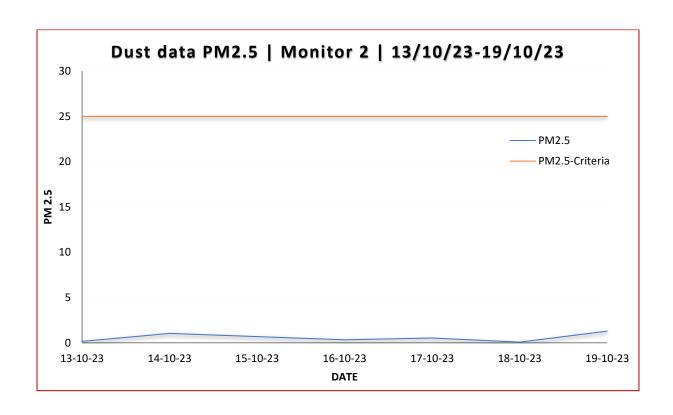
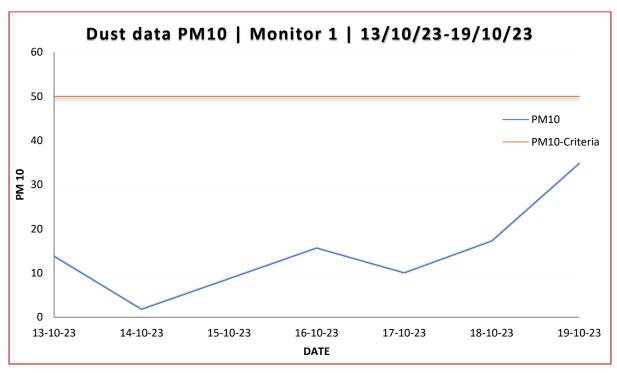
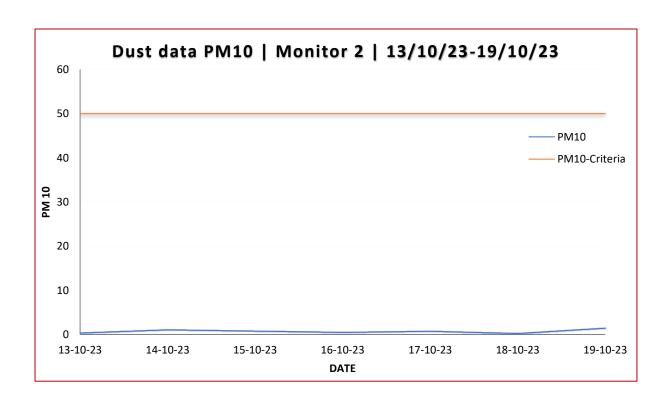
Appendix 1 – Dust Monitoring Data

As can be seen from the previous section and the graphs below, the daily average $PM_{2.5}$ and PM_{10} concentrations were found to be within criteria set for this site.

- Minimise works that generates dust during extreme weather conditions such as windy days, hot and dry days.
- Spray water during excavation works as well as on stockpiles.
- Dampen and/or cover stockpiles.
- Cover vehicle loads when leaving/entering the site.
- * Reduce the vehicle speed when operating on site.
- Remove any mud and/or dust stuck on vehicles prior to leaving the site.
- ❖ Typical issues covered in a consultation program include a public contact point for handling complaints
- **Second Second S**

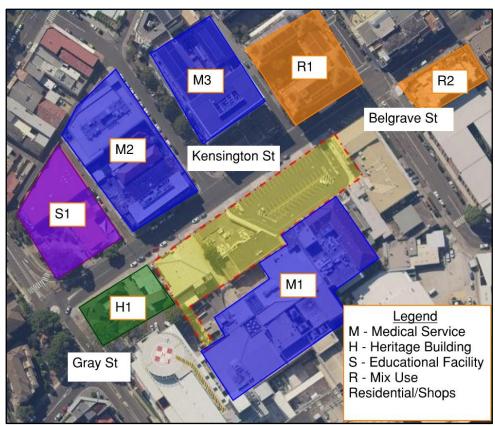
Figure 1 Site plan

The nearest dust sensitive receivers are identified in Figure 1 and listed below:

- ❖ M1, Medical Facility on the Southern boundary of the site.
- M2, Medical Facility on the Norther boundary of the site along Kensington St.
- M3, Medical Facility on the Norther boundary of the site along Kensington St.
- + H1, Fire Station (heritage) on the Western side of the boundary.
- SW, Sydney Water asset along the Northern boundary of the site along Kensington St

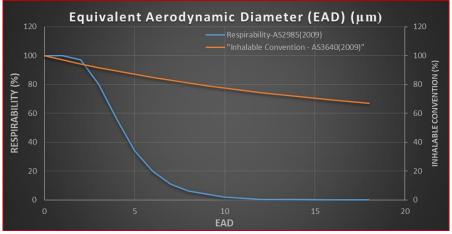
Figure 2 Site setup

Figure 2 represents a summary of the extracted equivalent particle aerodynamic diameter (EAD) in relation to their respirability and inhalable convention and their corresponding percentage in accordance with AS2985-2009 and AS3640-2009

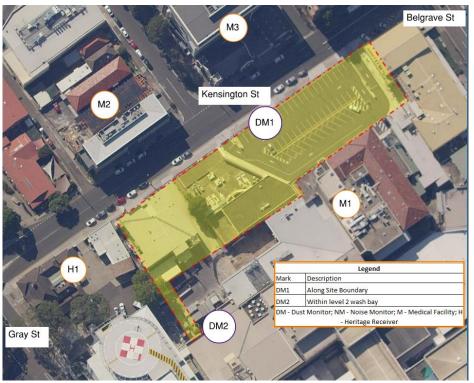
Figure 3 Site setup

Monitor 1 and Monitor 2 are on a solar stand in accordance with the manufacturer's recommendations. The monitor was (re)located to be as close to the operating plant as possible, site setup is shown in Figure 3 below. Each device was set to continuous daily monitoring mode at 15-minute intervals recording pollutant particles as PM_{2.5} and PM₁₀.

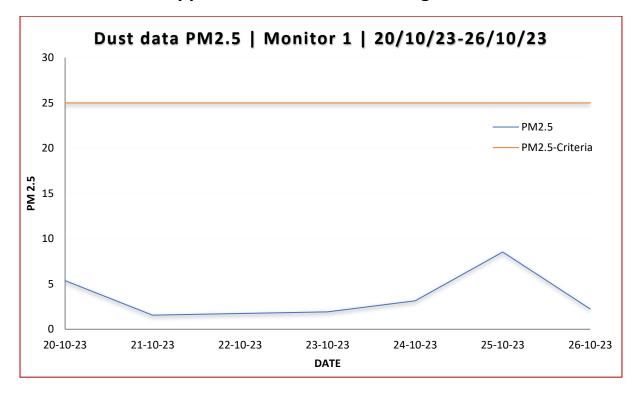
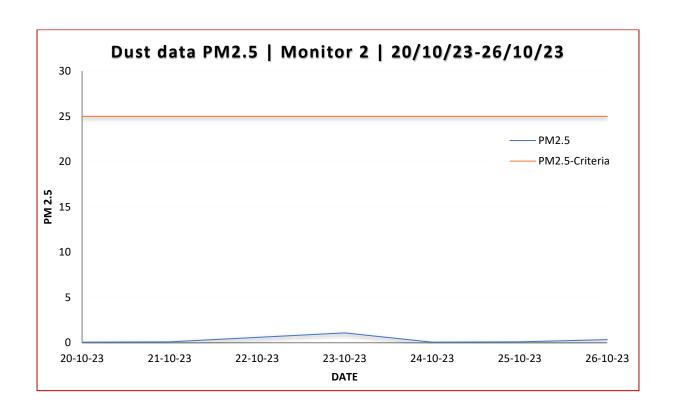
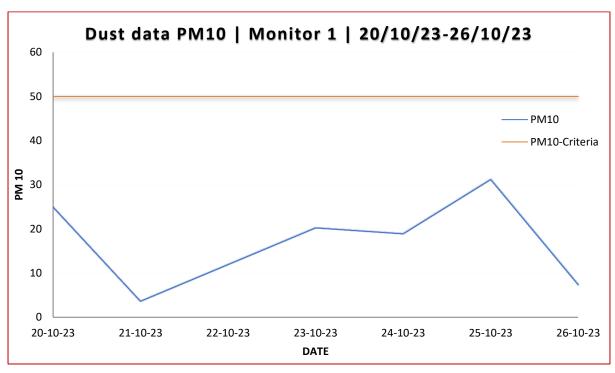
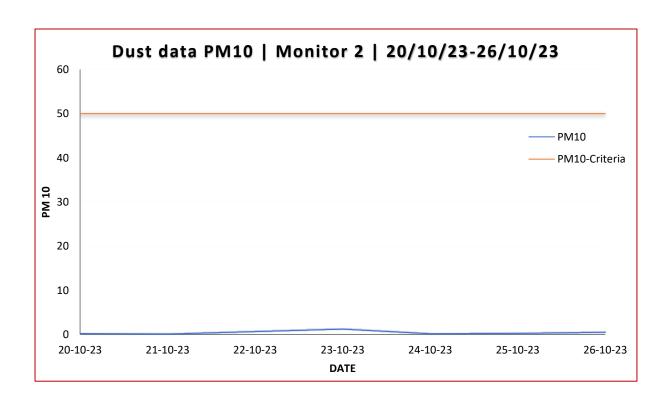
Appendix 1 – Dust Monitoring Data

As can be seen from the previous section and the graphs below, the daily average $PM_{2.5}$ and PM_{10} concentrations were found to be within criteria set for this site.

- Minimise works that generates dust during extreme weather conditions such as windy days, hot and dry days.
- Spray water during excavation works as well as on stockpiles.
- Dampen and/or cover stockpiles.
- Cover vehicle loads when leaving/entering the site.
- * Reduce the vehicle speed when operating on site.
- Remove any mud and/or dust stuck on vehicles prior to leaving the site.
- ❖ Typical issues covered in a consultation program include a public contact point for handling complaints
- **Second Second S**
