Health Infrastructure NSW
Westmead PSB and MSCP
Construction Noise Monitoring

Noise monitoring report
2023-01-01 to 2023-01-31

Westmead VVMF Construction Noise Monitoring

Noise monitoring report 2024-01-01 to 2024-01-31

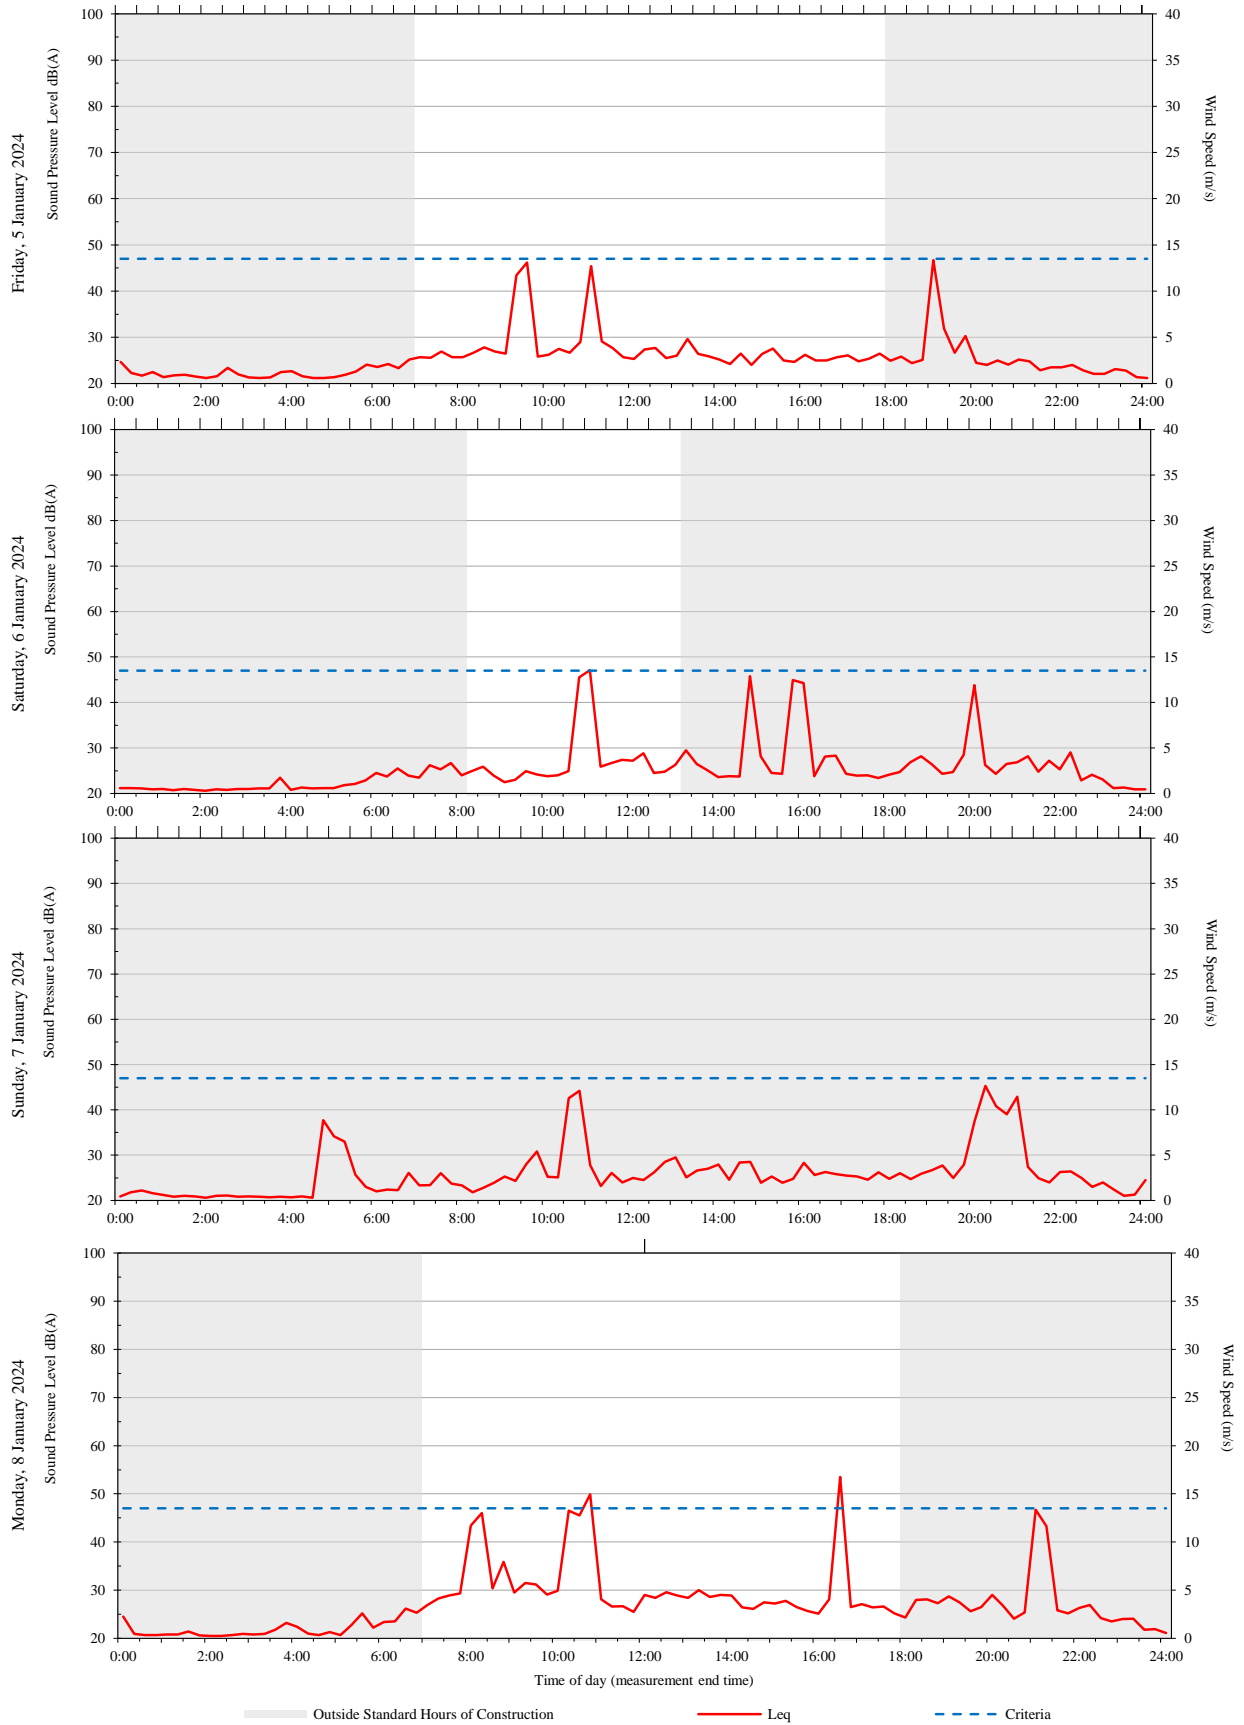
A6 RMH Level 1 Store Room 101 (Westmead 3)

Unattended monitoring: RMH Level 1 Store Room 101 (Internal)

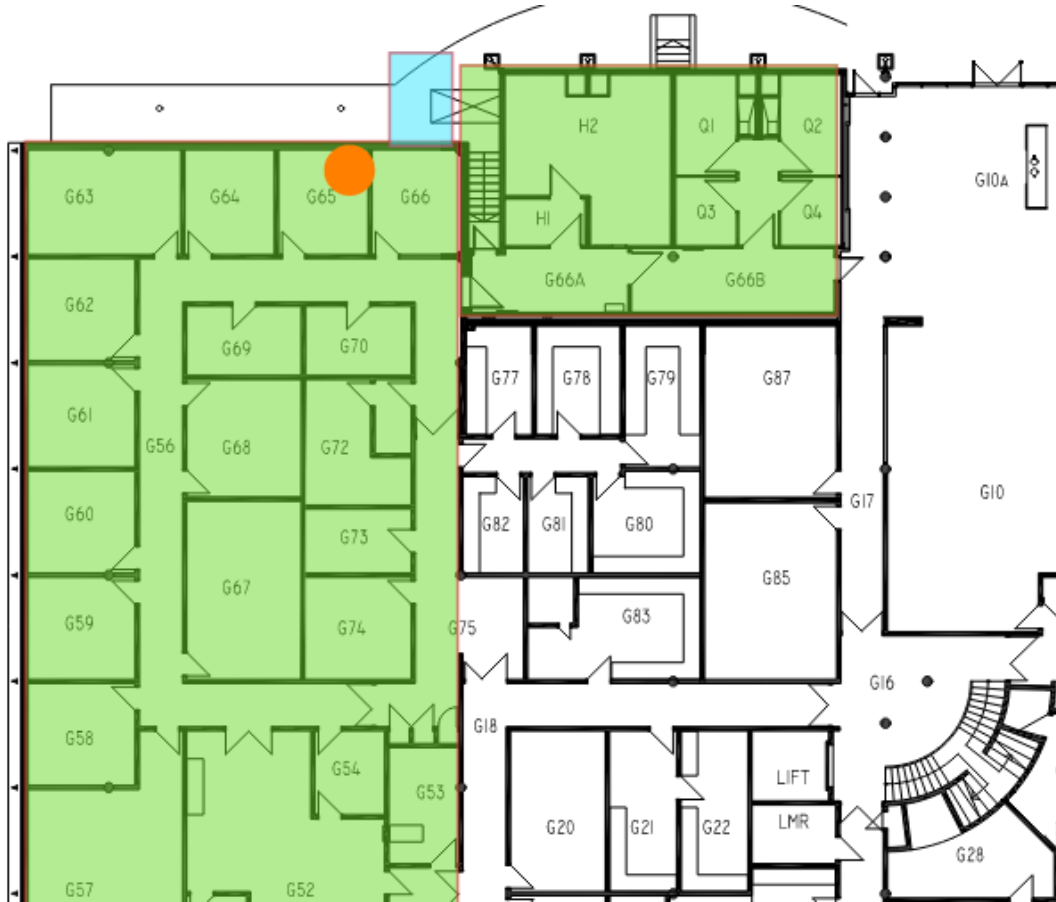
Figure 3: CMRI Animal Holding Facility vibration monitor location

Monitoring at this location utilises a GeoSIG GMSplus with a GeoSIG VE-11 geophone. The calibration certificate for the geophone is included in Appendix A.

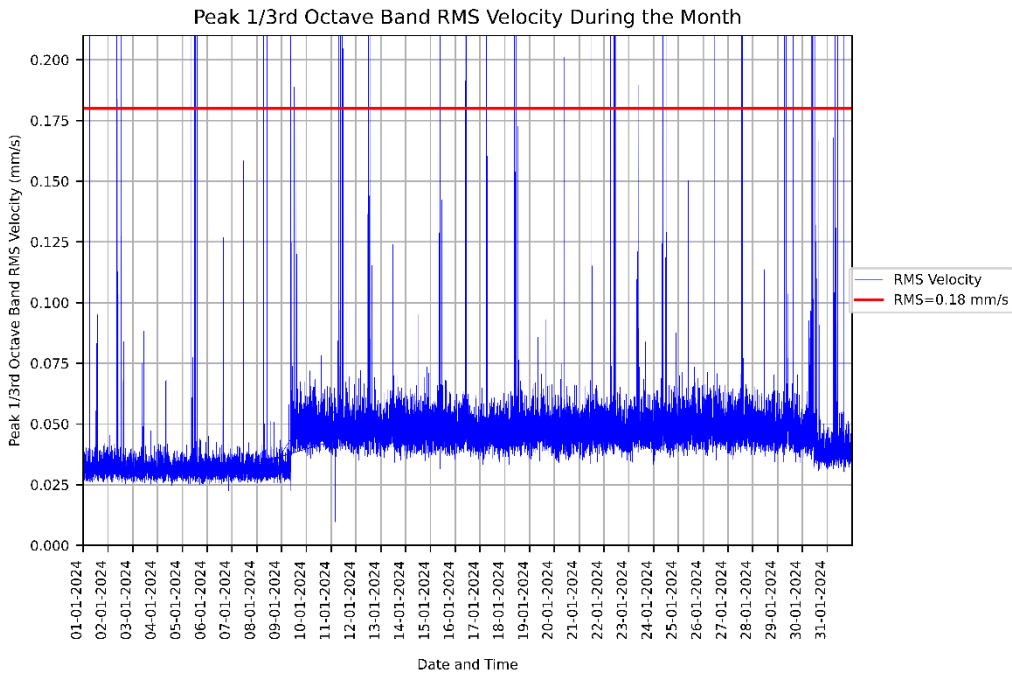
Figure 1: Measured RMSV vibration levels for 01/01/2024 to 31/01/2024 at the WIMR - BSF Mice Holding Room - Rack.

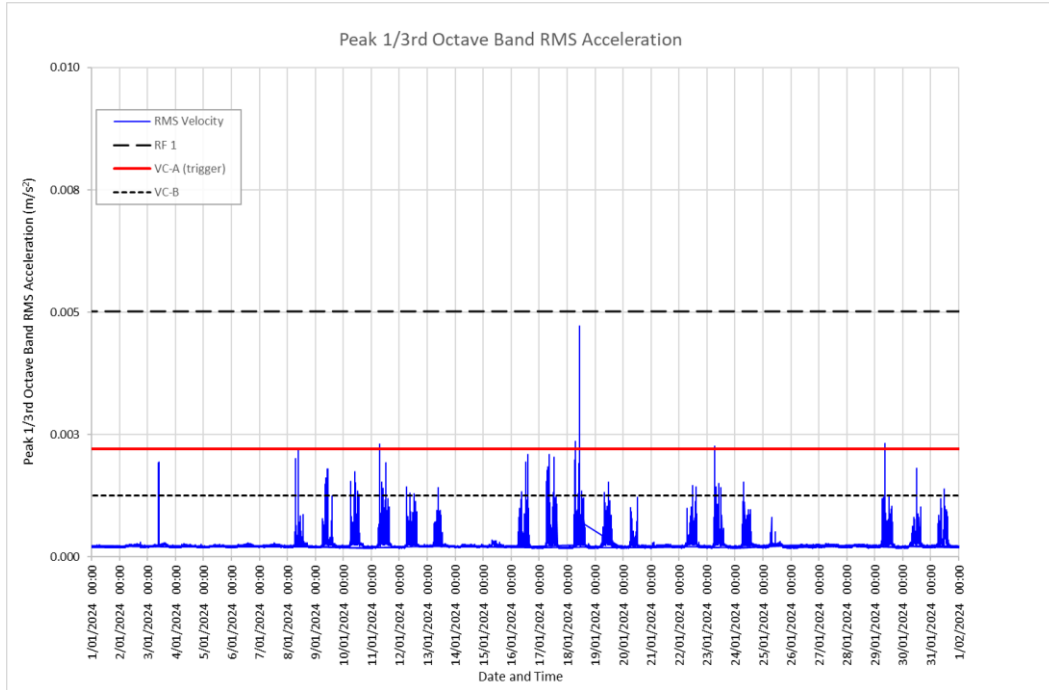
Figure 3 below shows the vibration levels (RMS acceleration) recorded between 01/01/2024 and 31/01/2024. The recorded data is shown in blue, while the limit of 0.0025 m/s^2 (VC-A) is shown in red.

Figure 3: Measured RMS acceleration vibration levels for 01/01/2024 to 31/01/2024 at KR – L4.

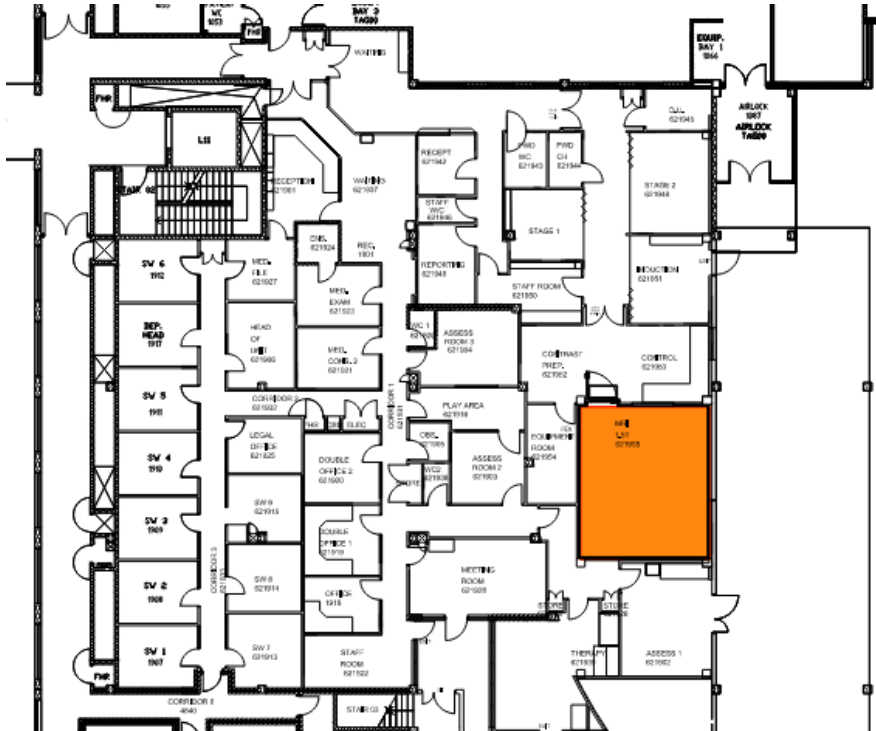
Figure 3: SCHN - 1.5t MRI vibration monitor location

Monitoring at this location utilises a GeoSIG GMSplus with a GeoSIG VE-11 geophone. The calibration certificate for the geophone is included in Appendix A.
