Health Infrastructure NSW  
**Westmead PSB and MSCP**  
**Construction Noise Monitoring**

Noise monitoring report  
2023-06-01 to 2023-06-30

# **Children's Hospital Westmead**

**Vibration Monitoring - WIMR - BSF  
Mice Holding Room - Rack - June 2023**

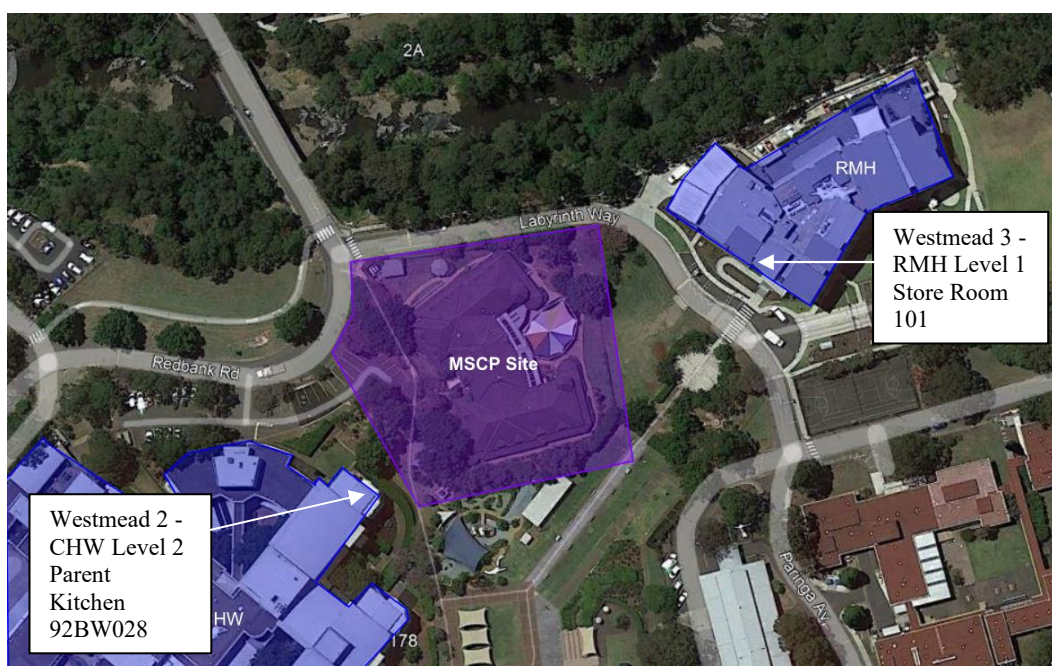
Figure 2: MSCP noise monitoring locations.

Acoustic Research Labs Ngara noise loggers have been installed in the locations shown in Figure 1 and Figure 2 below.

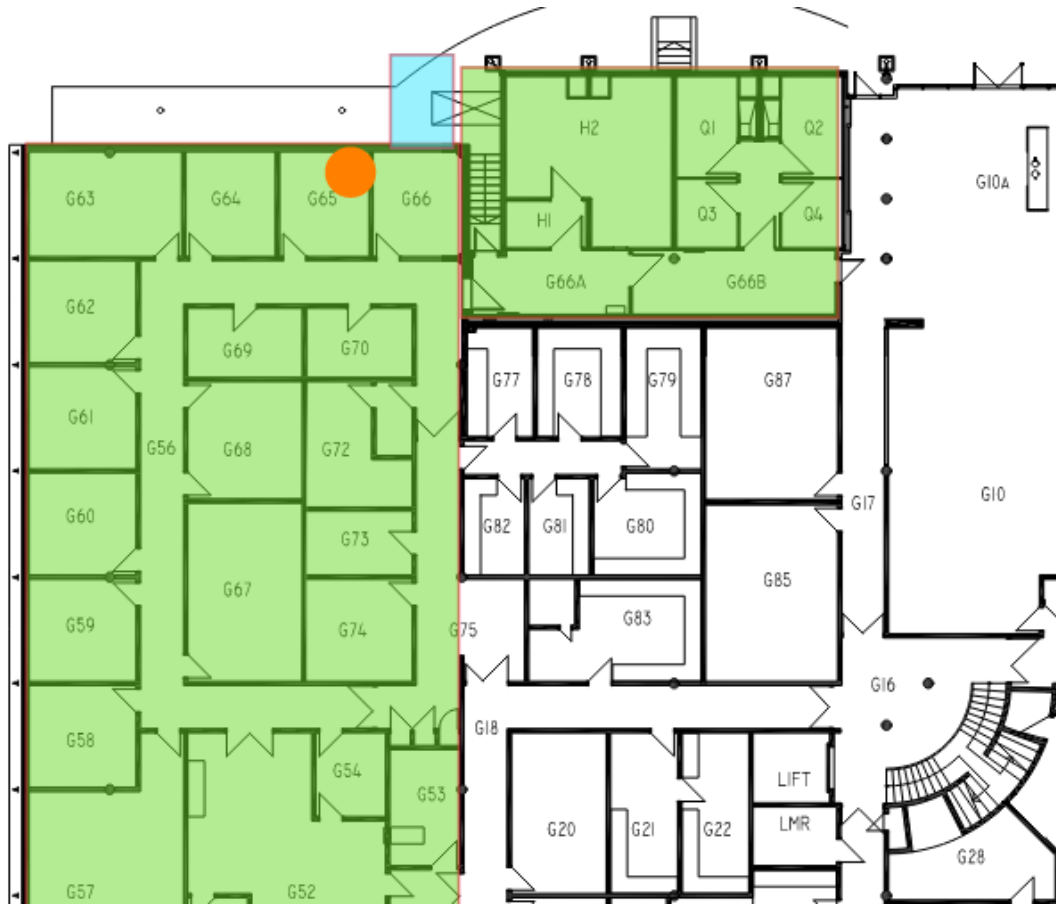
Figure 3: CMRI Animal Holding Facility vibration monitor location

Monitoring at this location utilises a GeoSIG GMSplus with a GeoSIG VE-11 geophone. The calibration certificate for the geophone is included in Appendix A.
