Health Infrastructure NSW
Westmead PSB and MSCP
Construction Noise Monitoring

Noise monitoring report
2023-08-01 to 2023-08-31

AC21

v1 | 13 September 2023

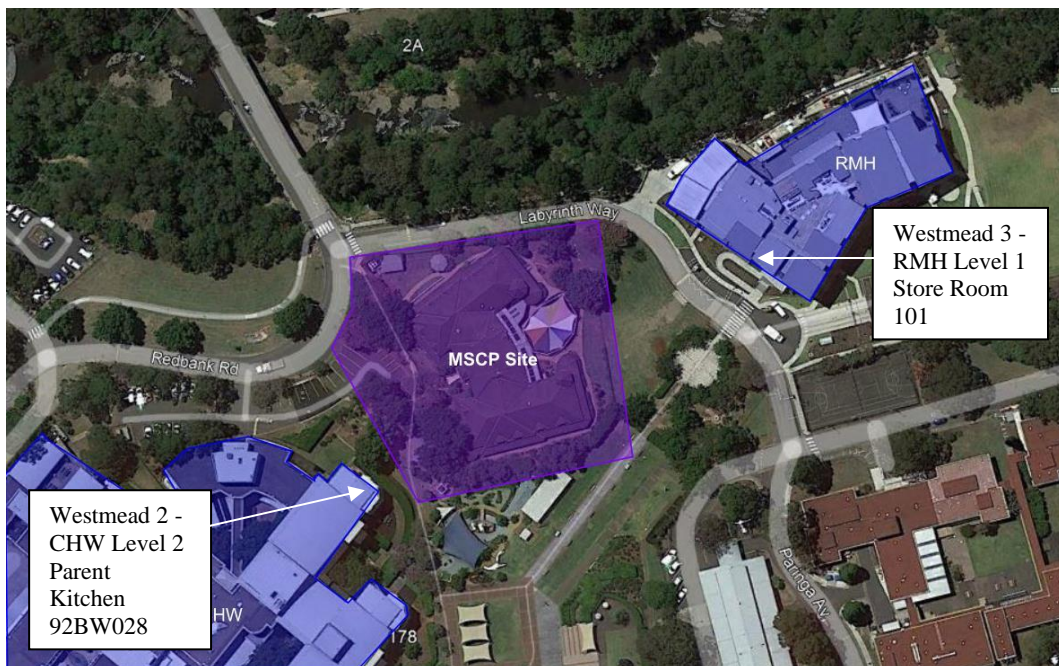
Figure 1: PSB noise monitoring locations.

Acoustic Research Labs Ngara noise loggers have been installed in the locations shown in Figure 1 and Figure 2 below.

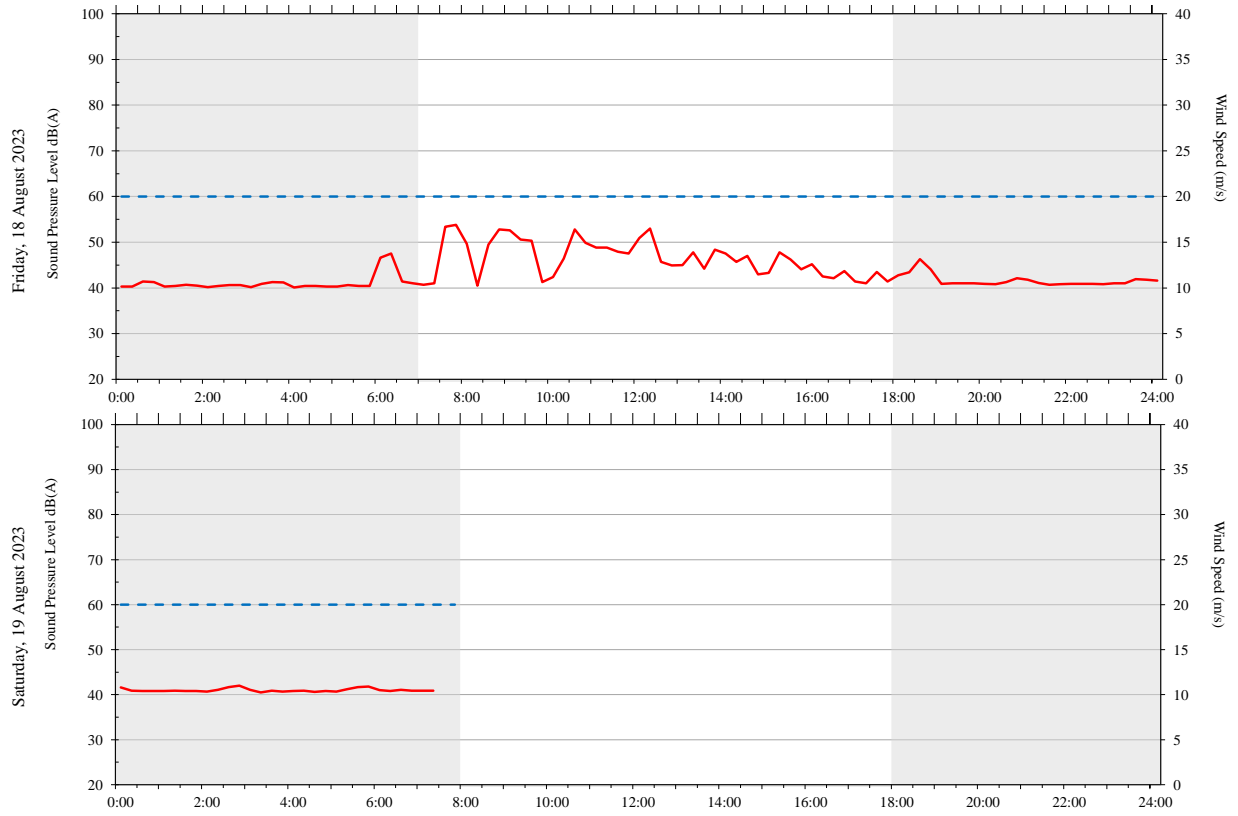
A1 CHW Ground Floor room 51DM047 (Westmead 1)

Unattended monitoring: CHW Ground Floor room 51DM047 (Internal)

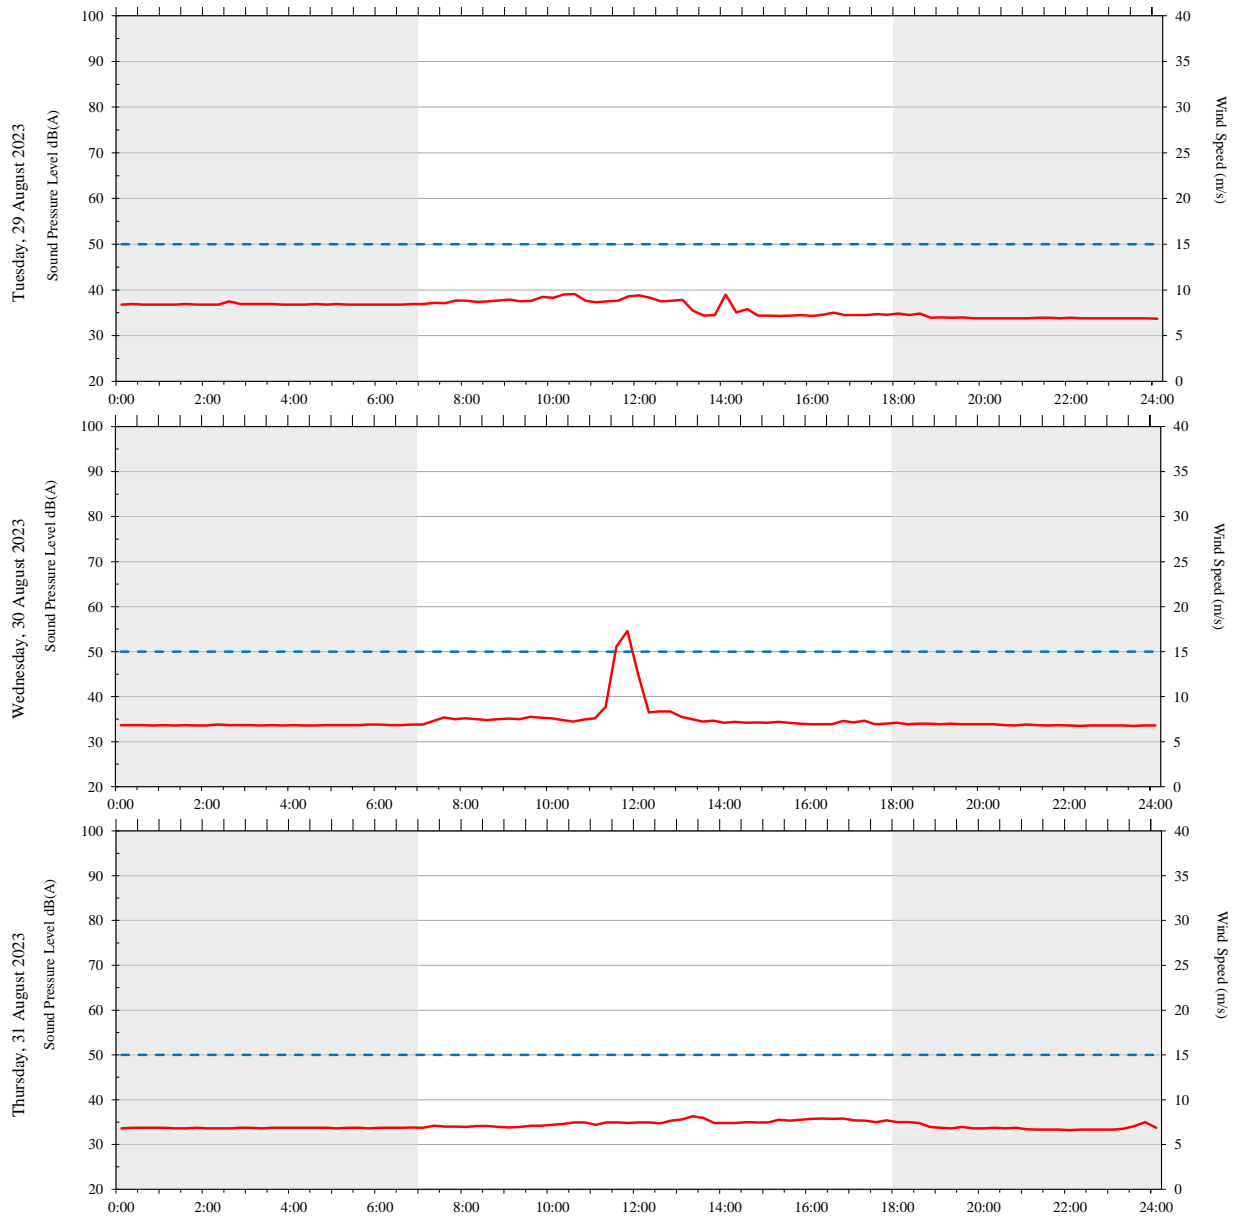
A2 CASB Level 3 Operating Theatre Store Room WM11K.03.3264 (Westmead 5)

Outside Standard Hours of Construction Leq Criteria
