Health Infrastructure NSW
Westmead PSB and MSCP
Construction Noise Monitoring

Noise monitoring report
2023-12-01 to 2023-12-31

Westmead VVMF Construction Noise Monitoring

Noise monitoring report 2023-12-01 to 2023-12-31

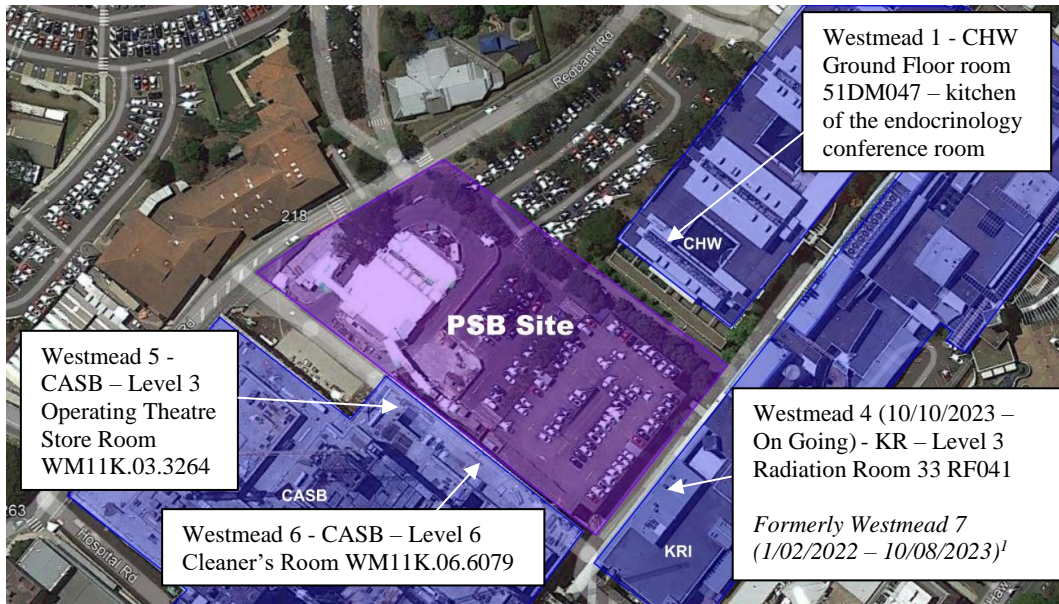
Figure 1: PSB noise monitoring locations.

Acoustic Research Labs Ngara noise loggers are installed in the locations shown in Figure 1 and Figure 2 below.

Note 1: Westmead 7 noise logger was temporarily repurposed for another project on the 10/8/2023. See Section 2.1.

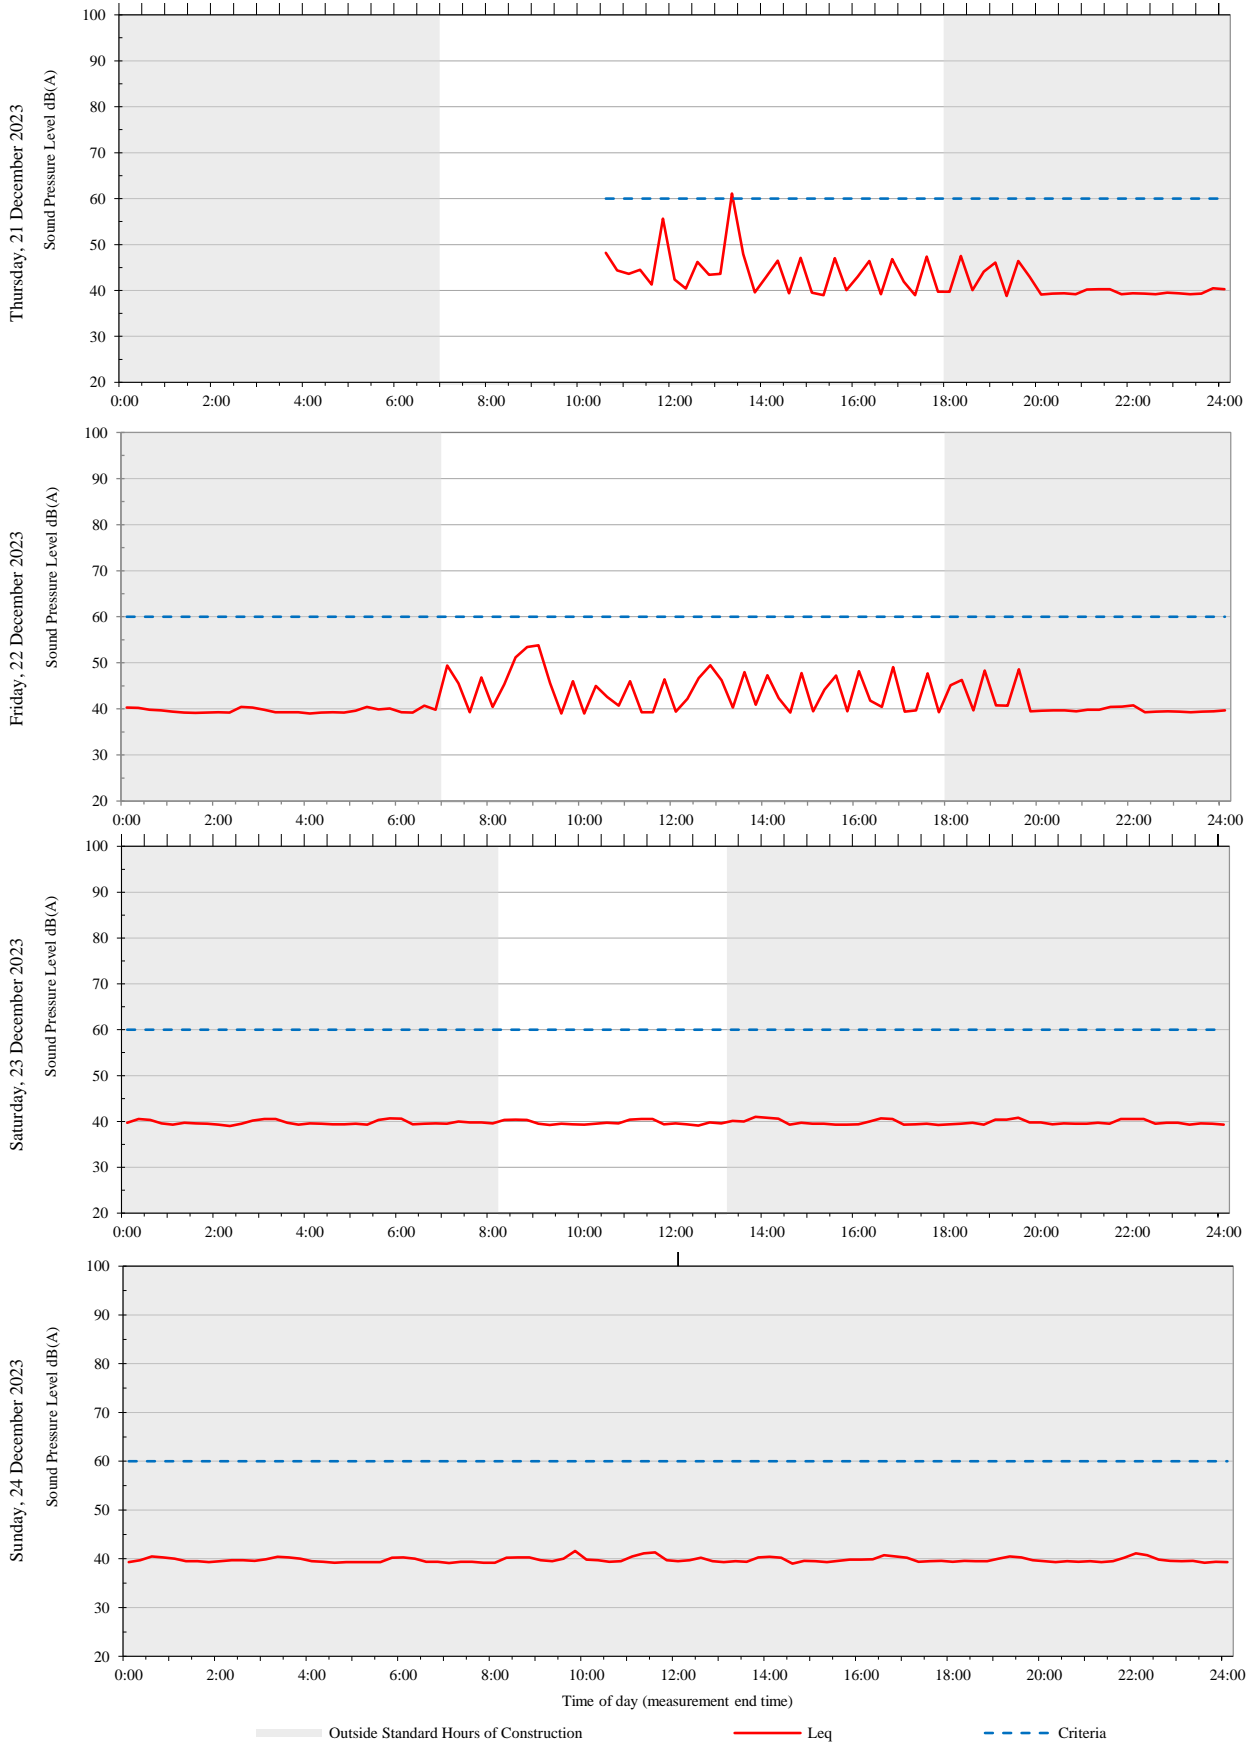
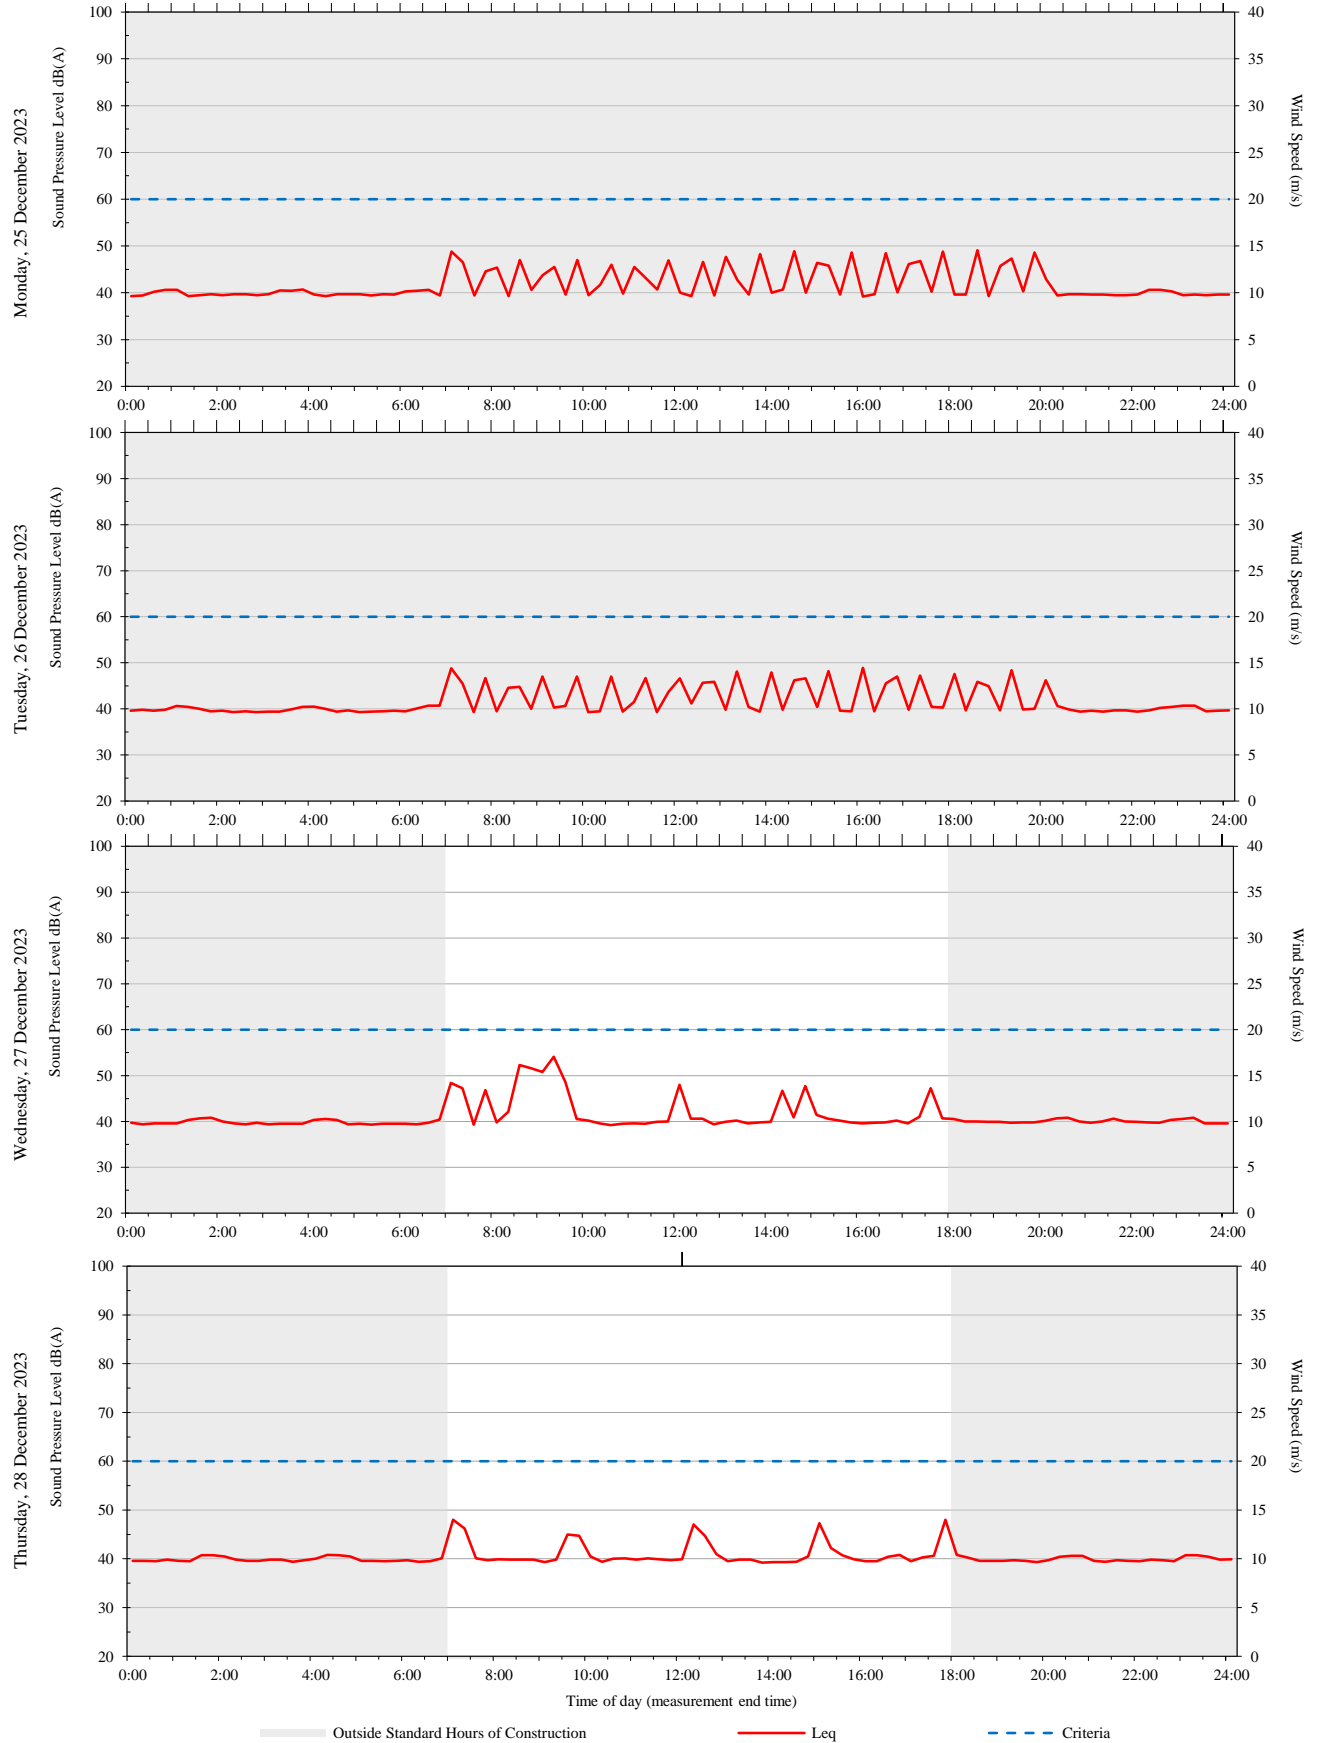
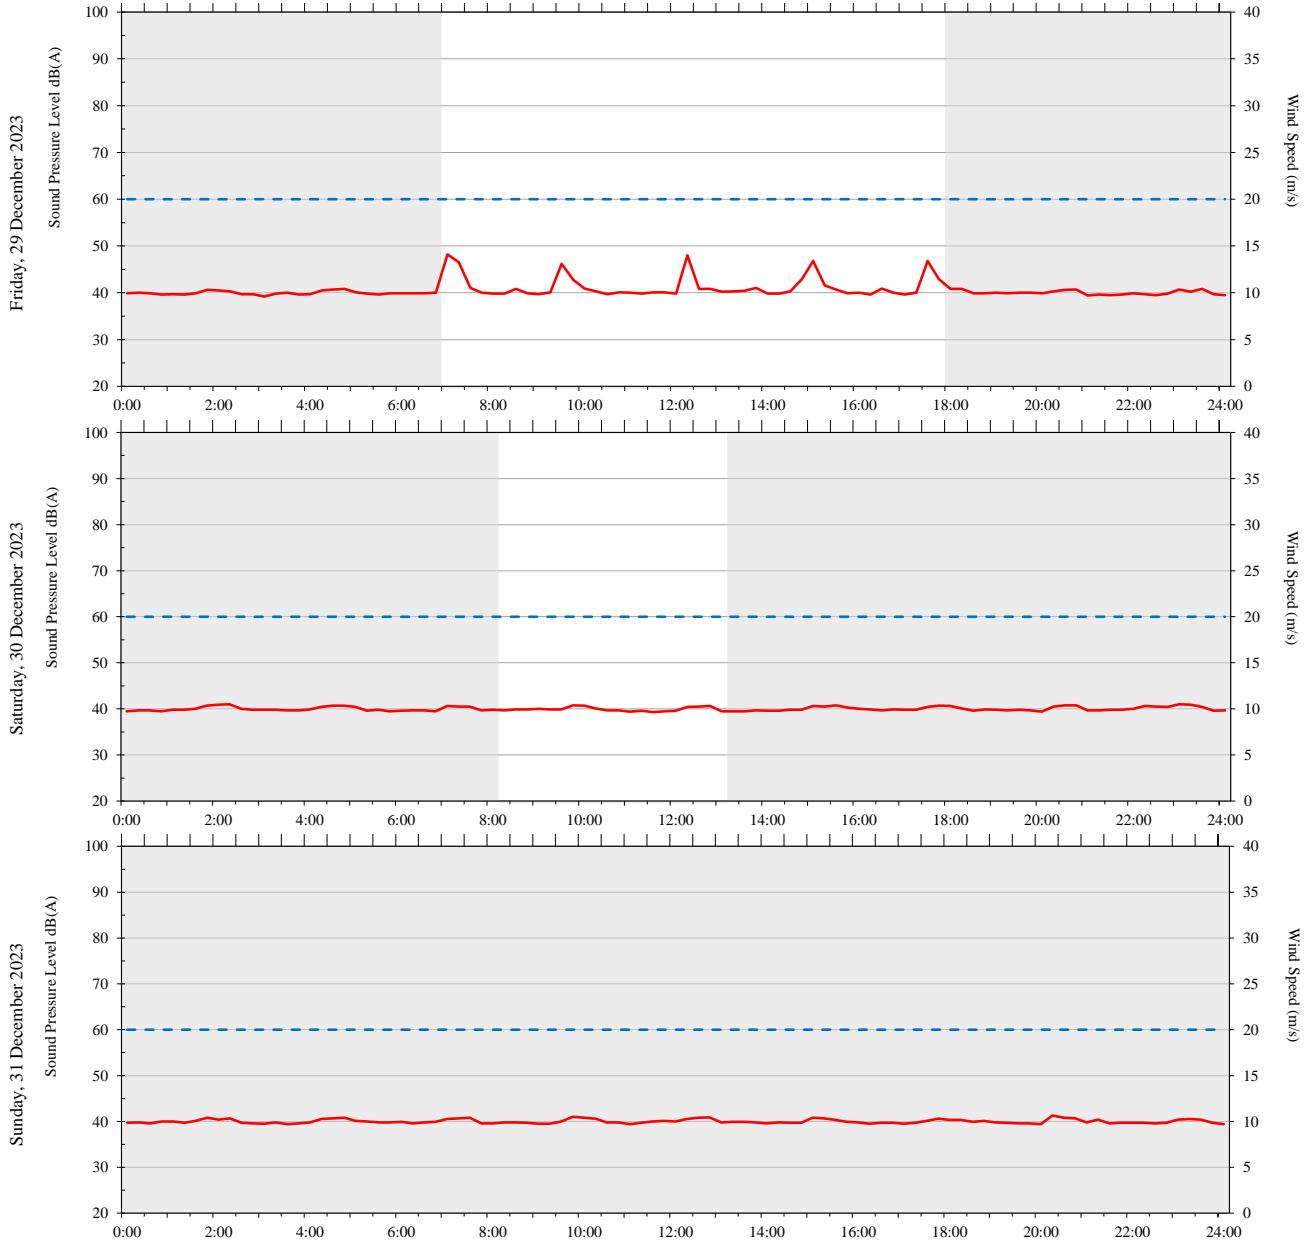
A1 CHW Ground Floor room 51DM047 (Westmead 1)

Unattended monitoring: CHW Ground Floor room 51DM047 (Internal)

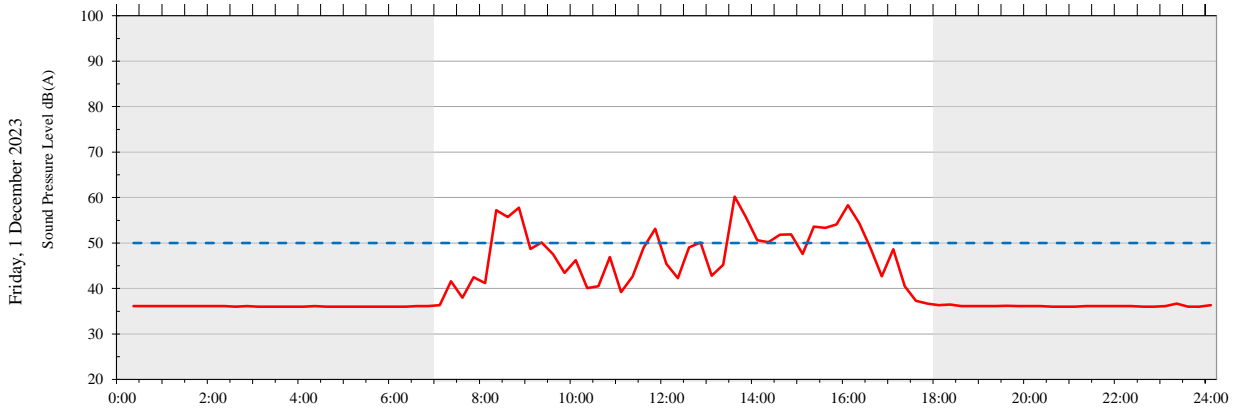
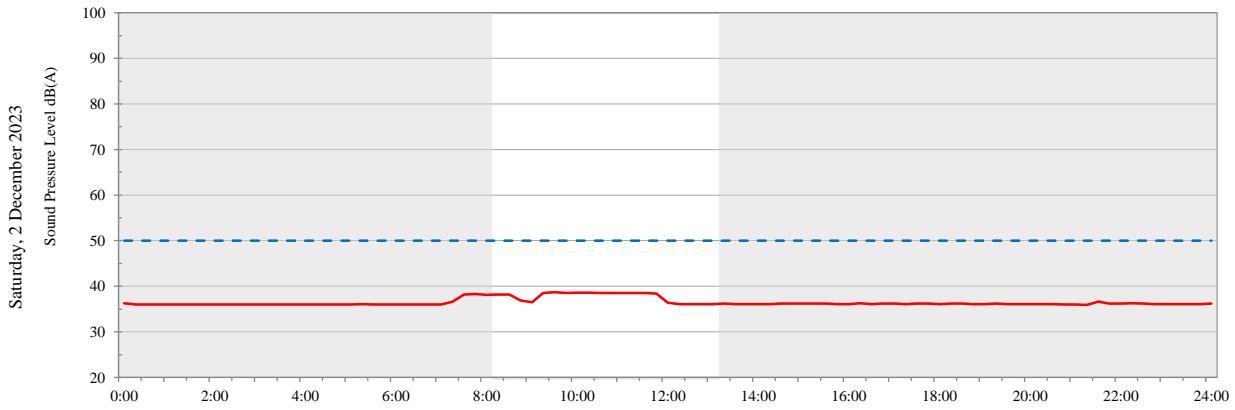
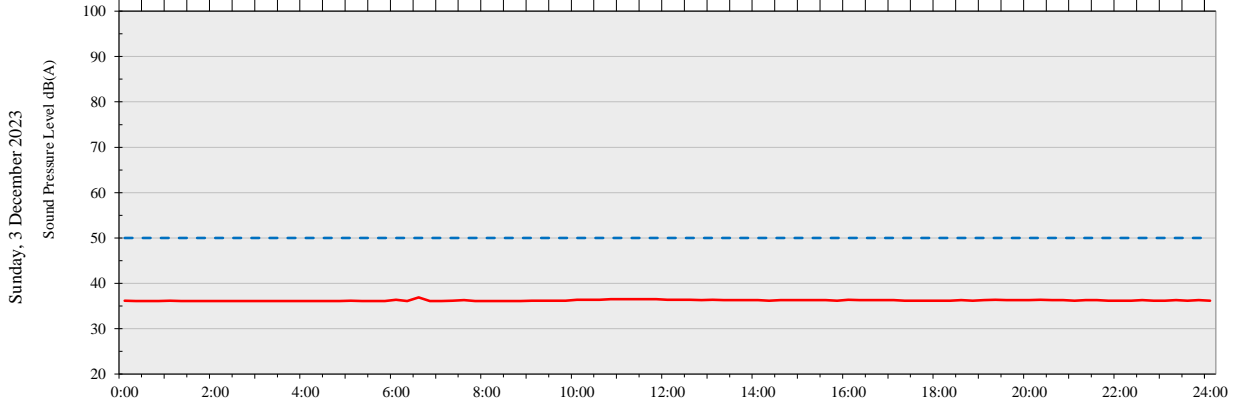
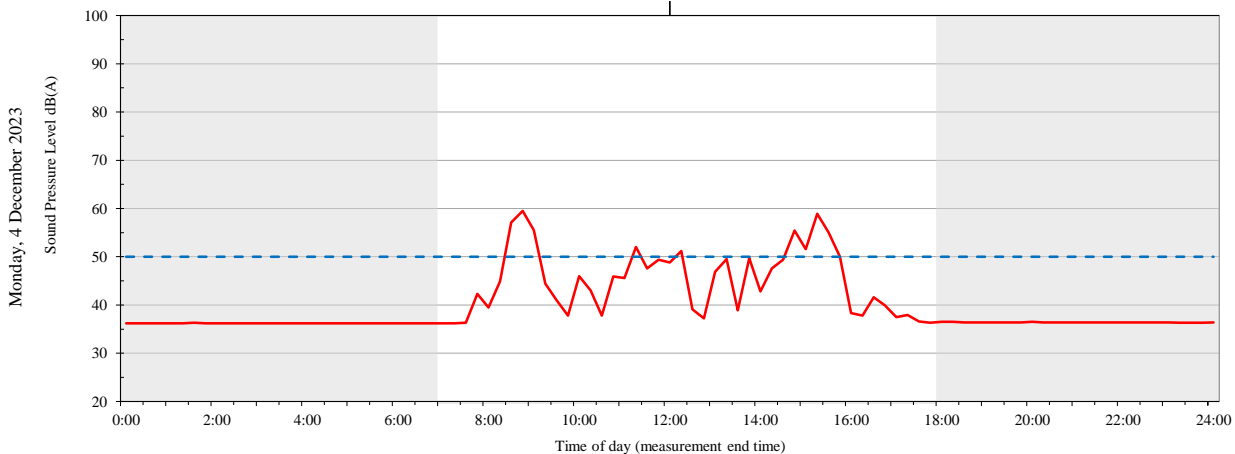
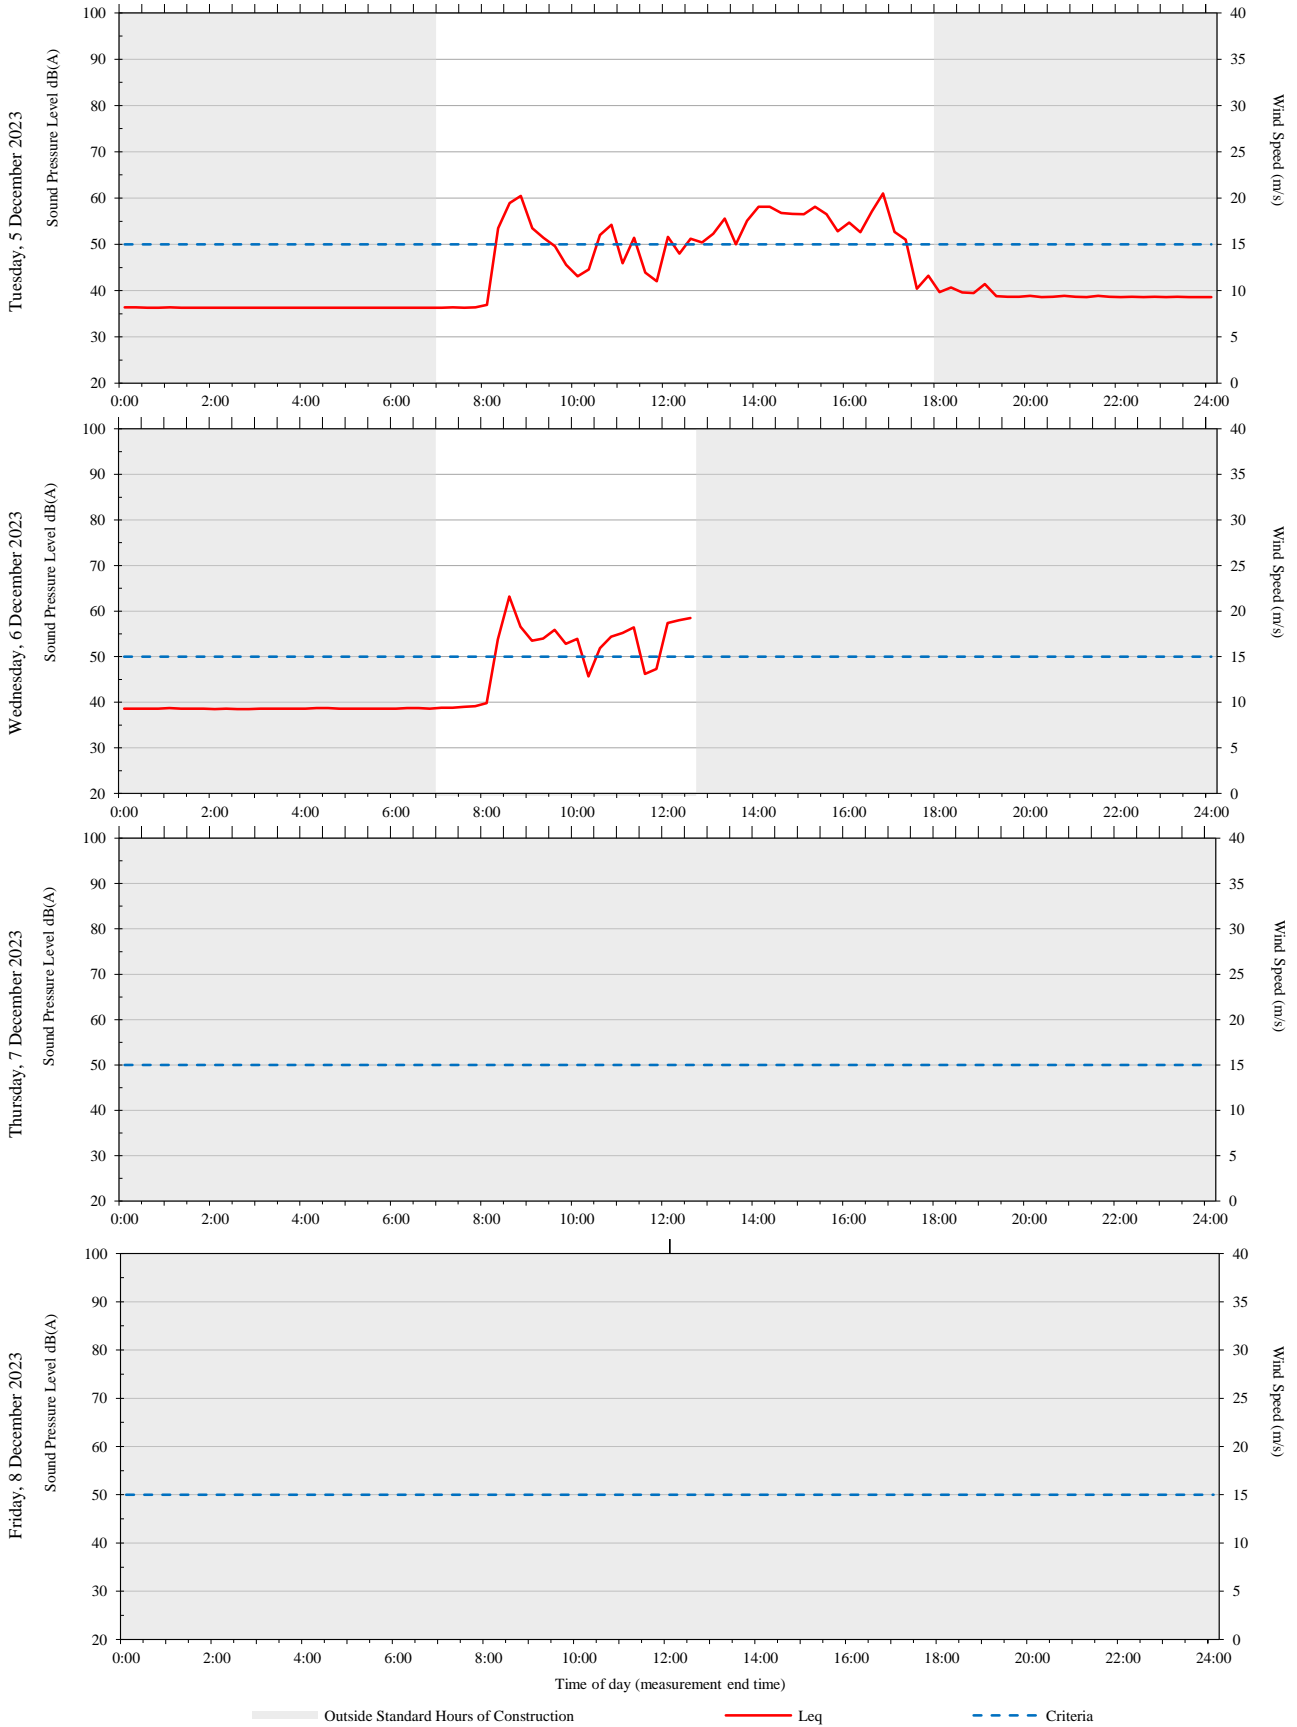
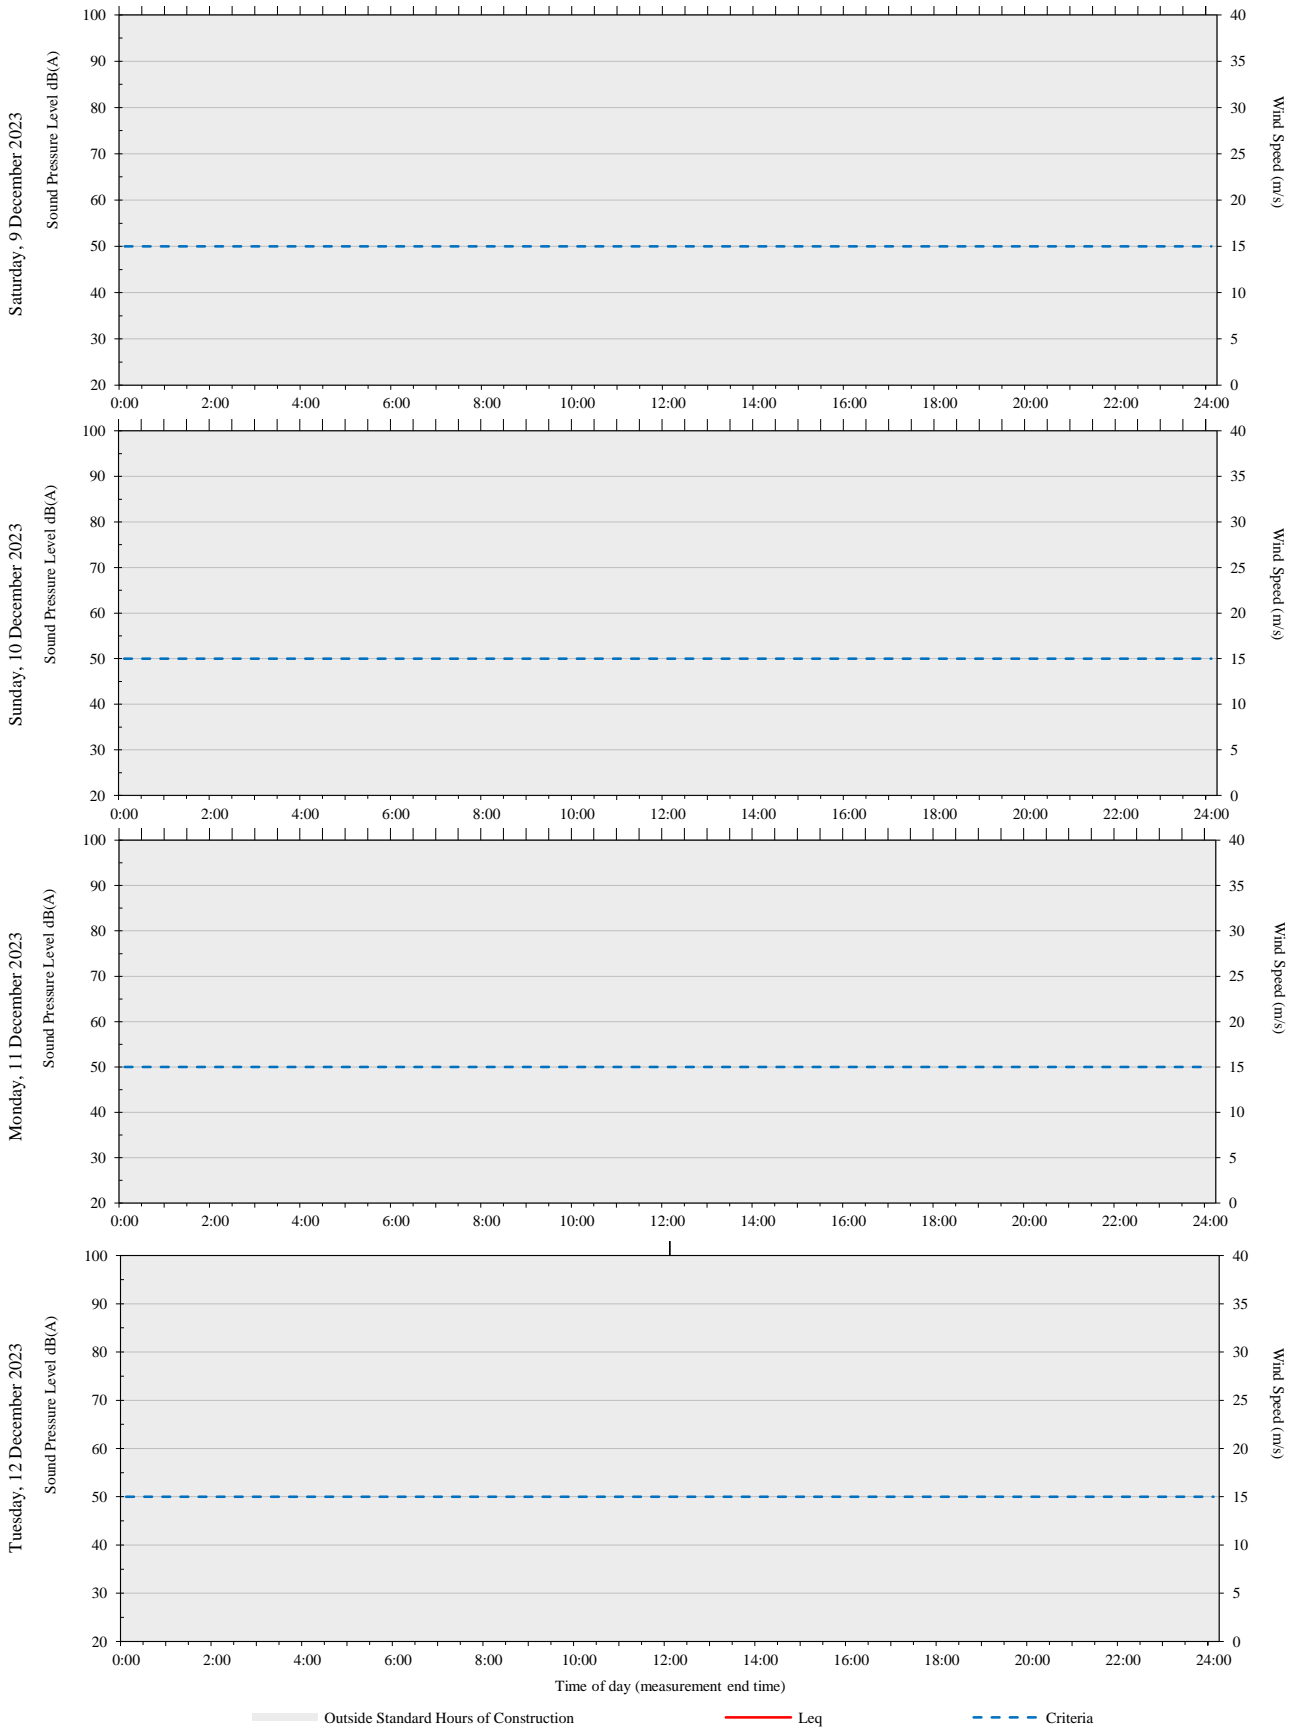
A2 CASB Level 3 Operating Theatre Store Room WM11K.03.3264 (Westmead 5)

Outside Standard Hours of Construction Leq Criteria
