Health Infrastructure NSW
Westmead PSB and MSCP
Construction Noise Monitoring

Noise monitoring report
2023-12-01 to 2023-12-31

Westmead VVMF Construction Noise Monitoring

Noise monitoring report 2023-12-01 to 2023-12-31

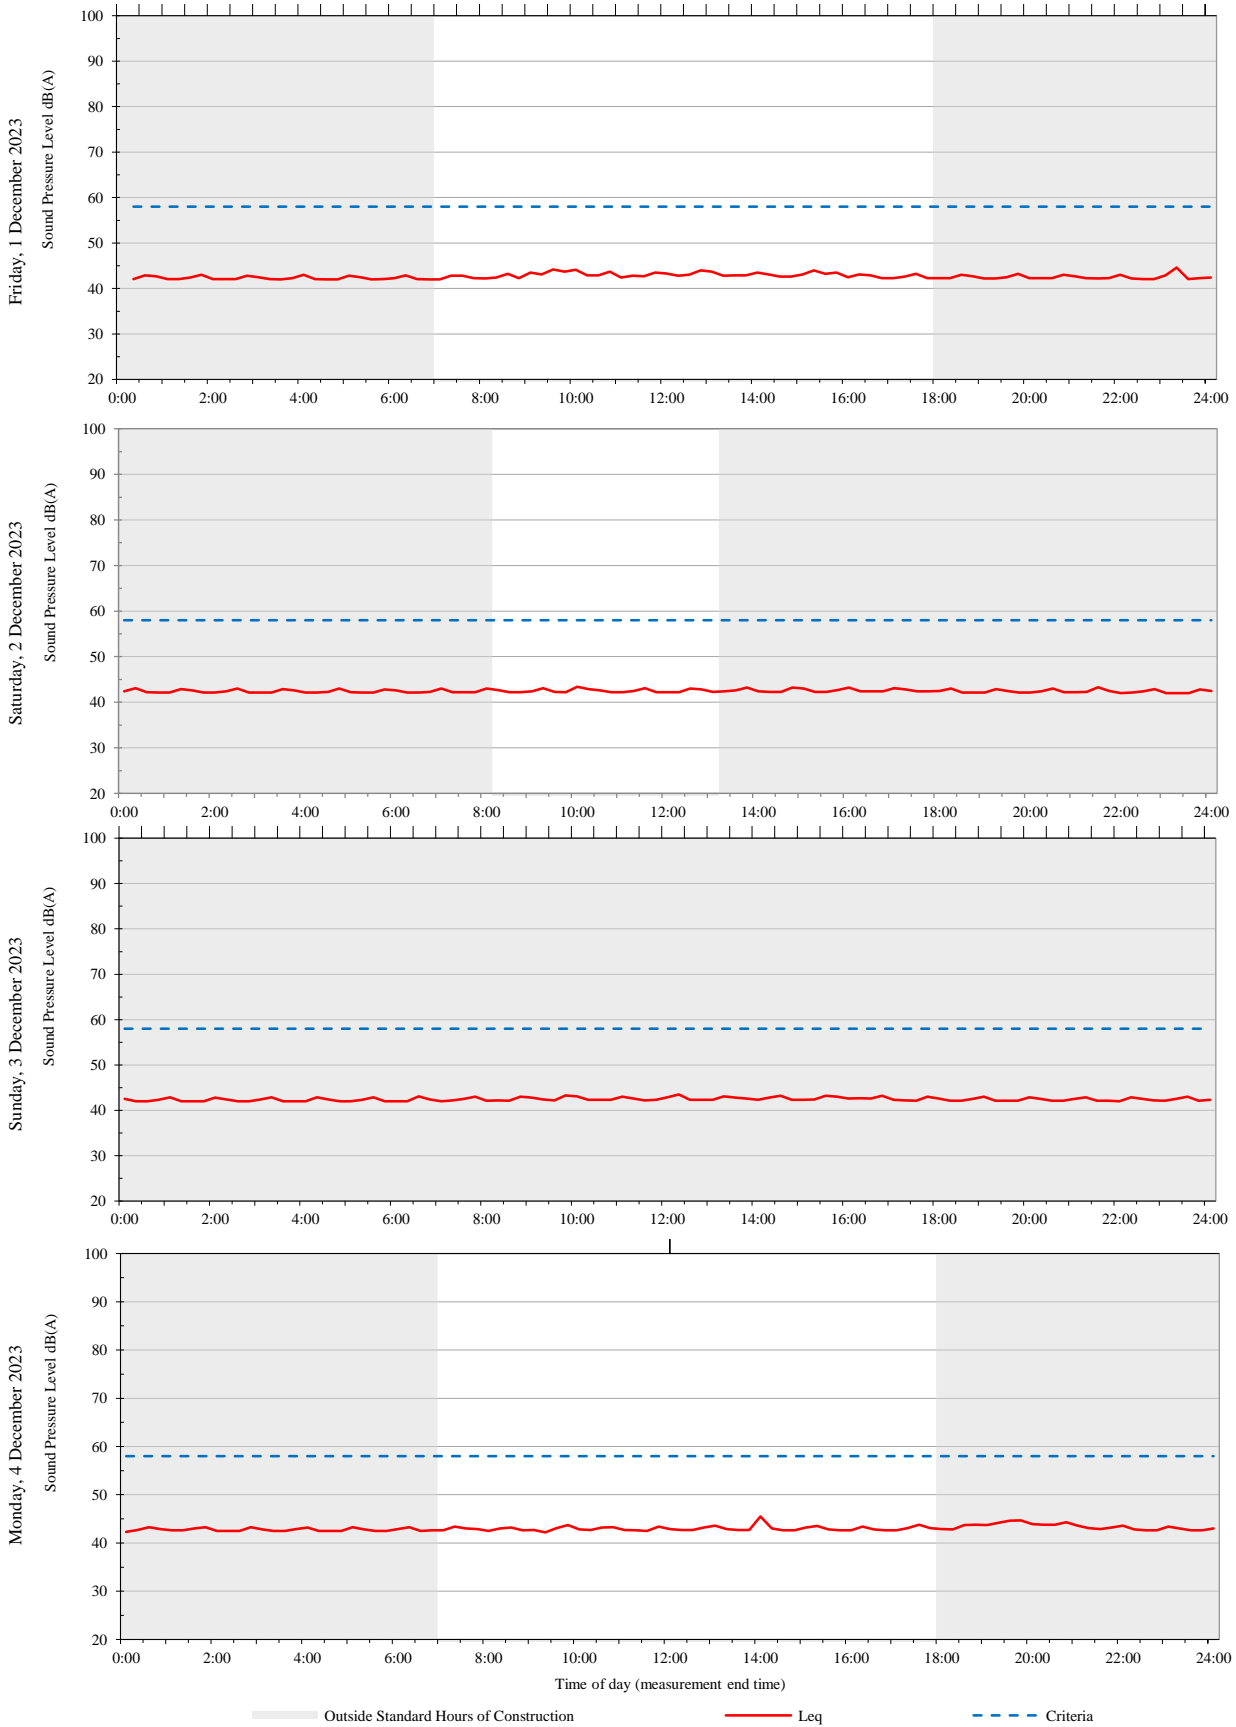
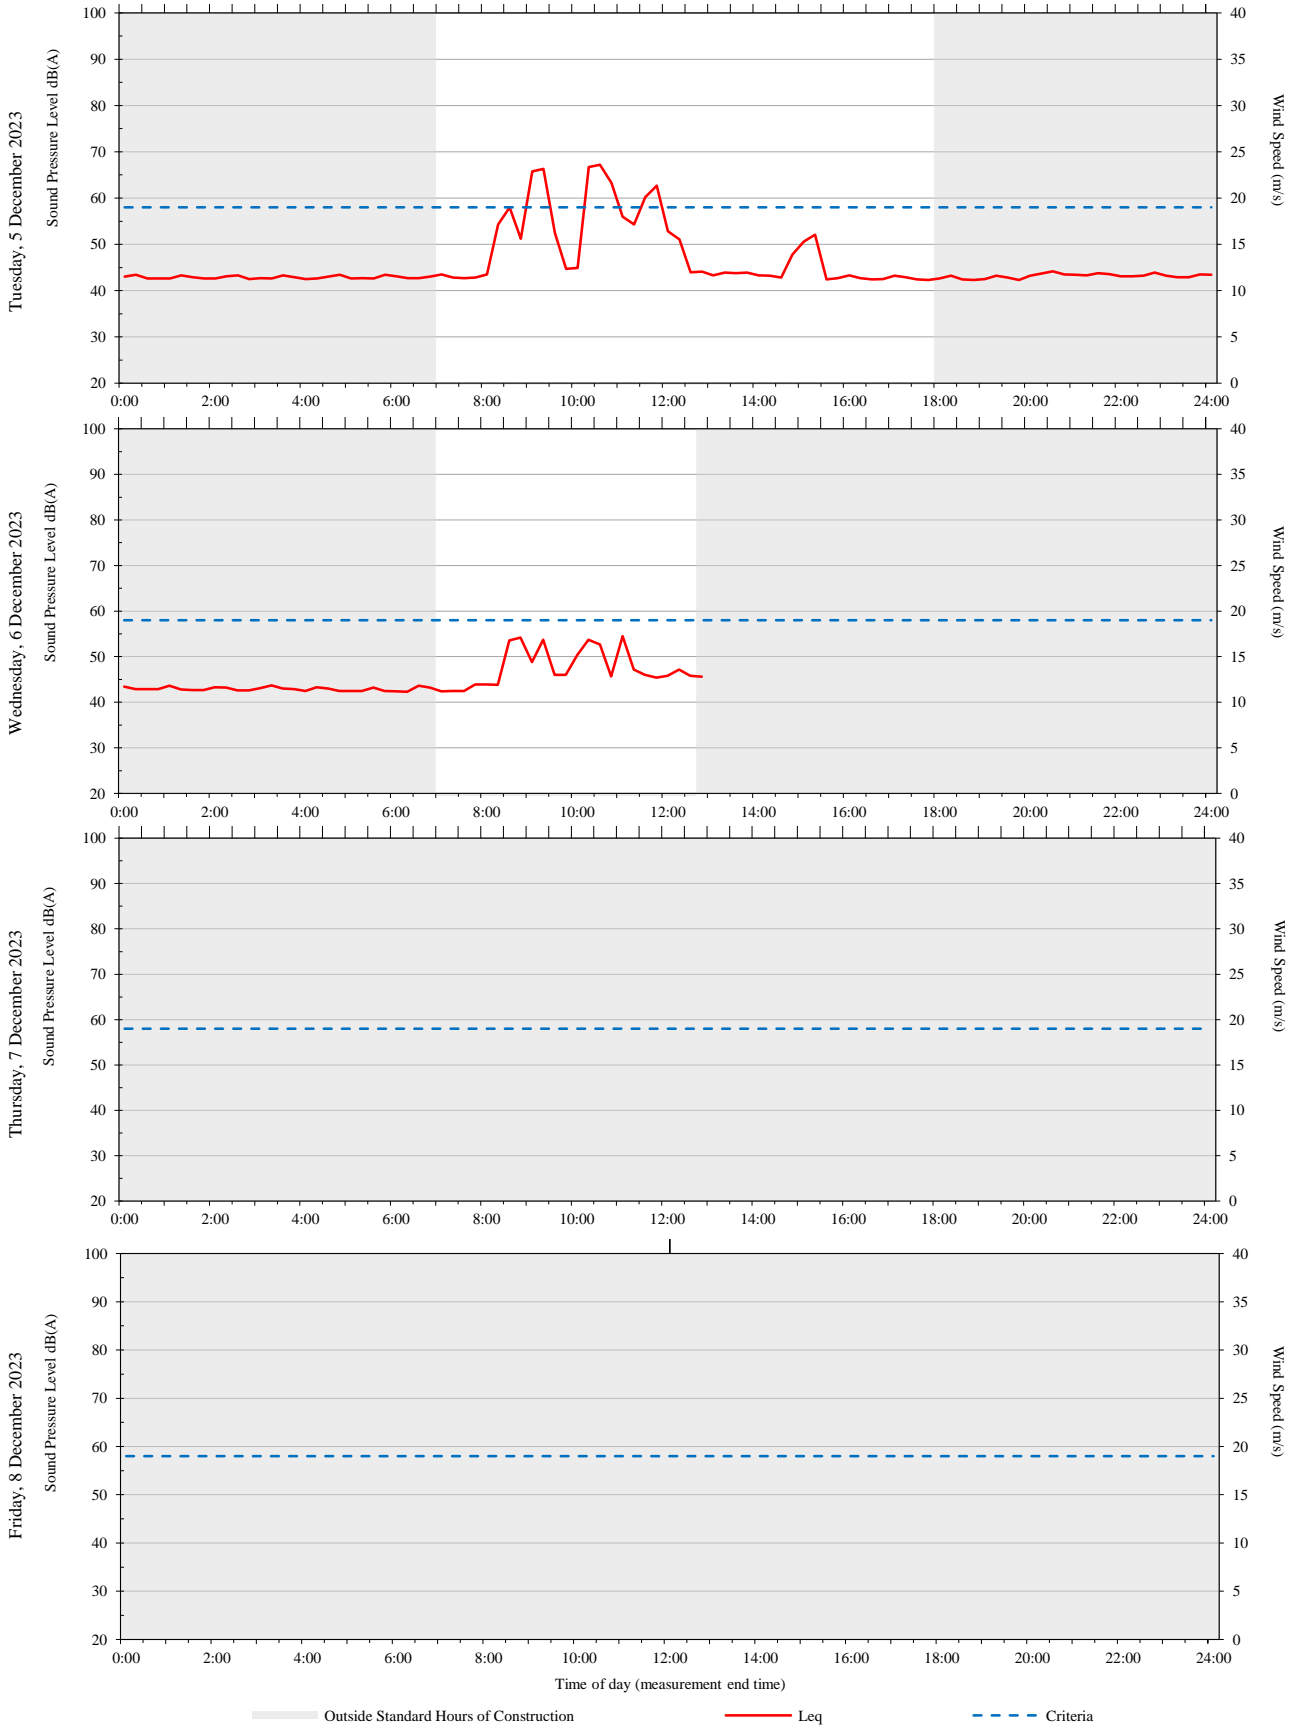
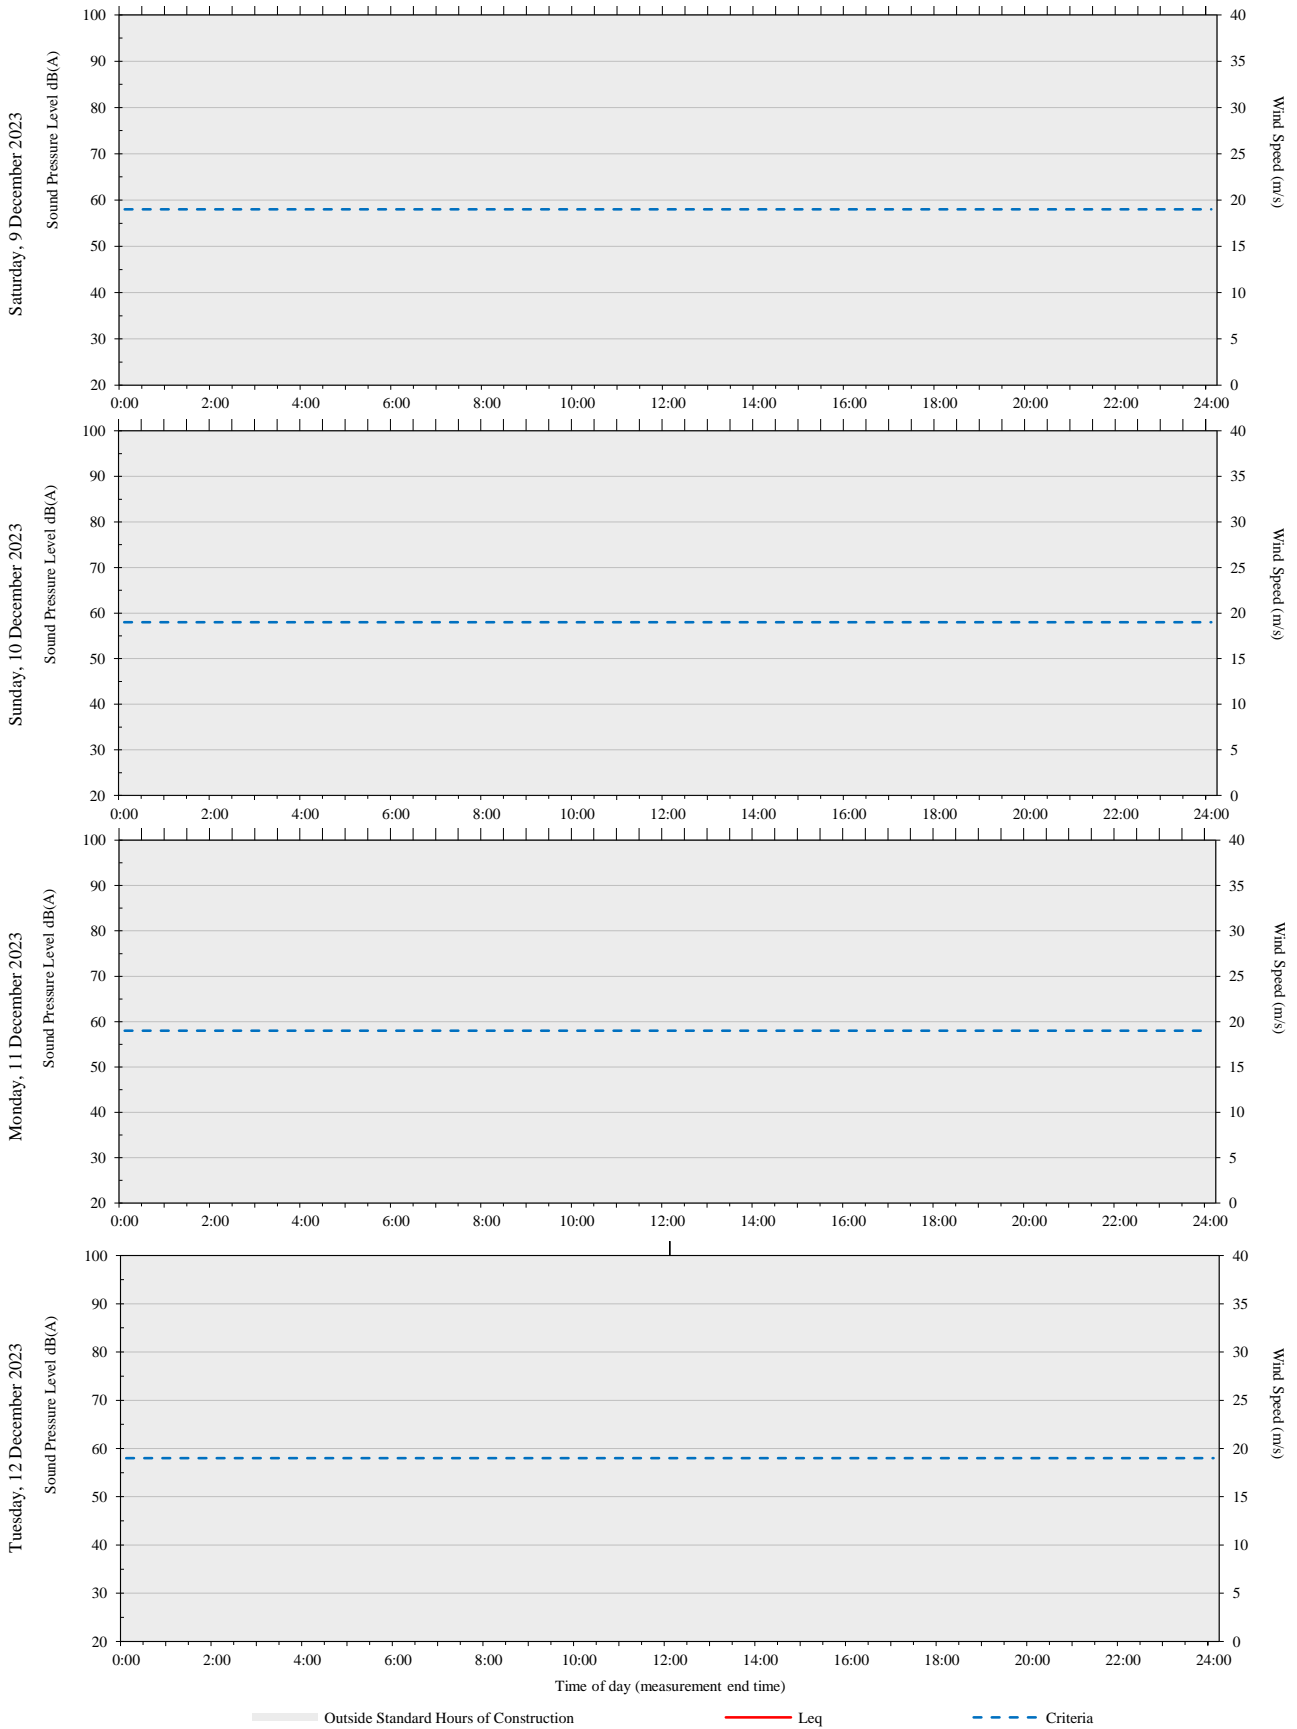
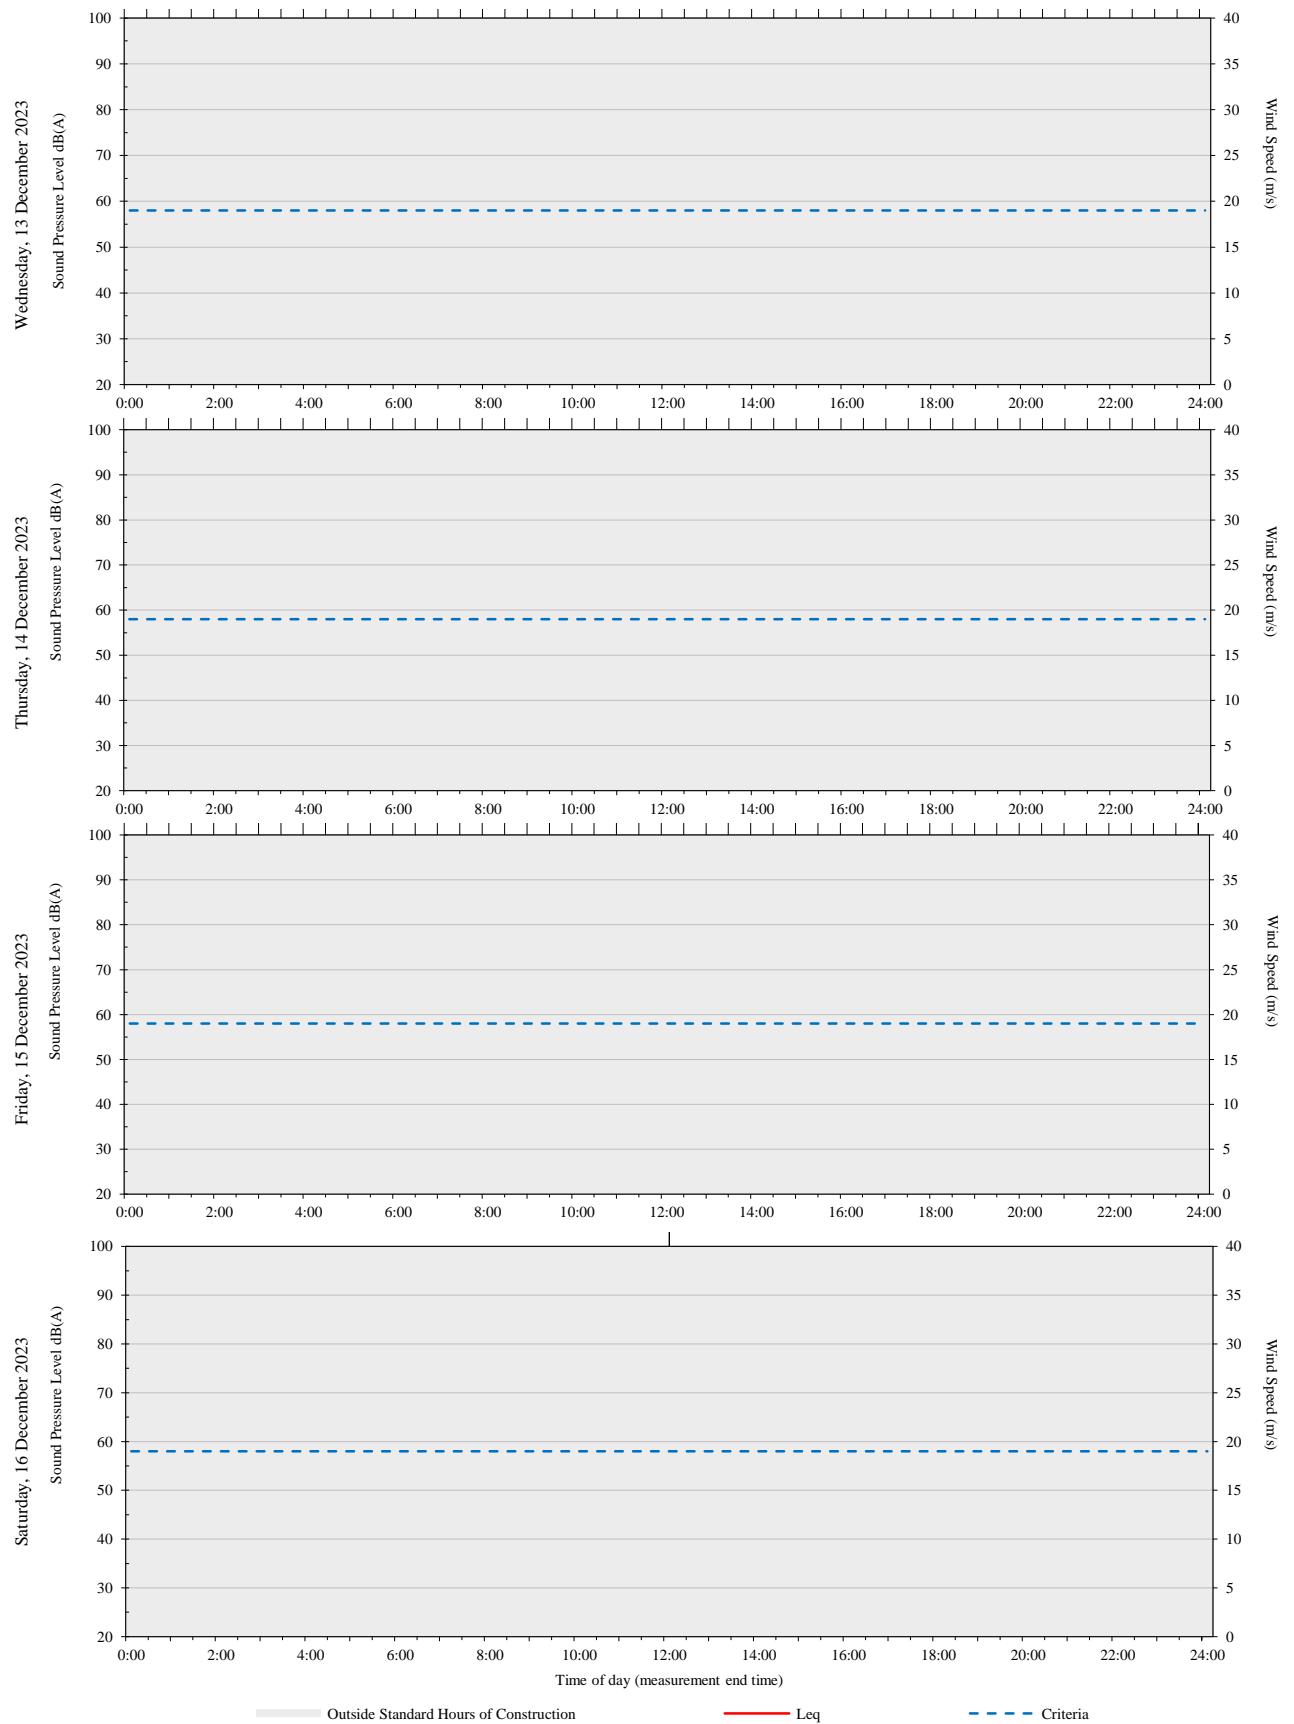
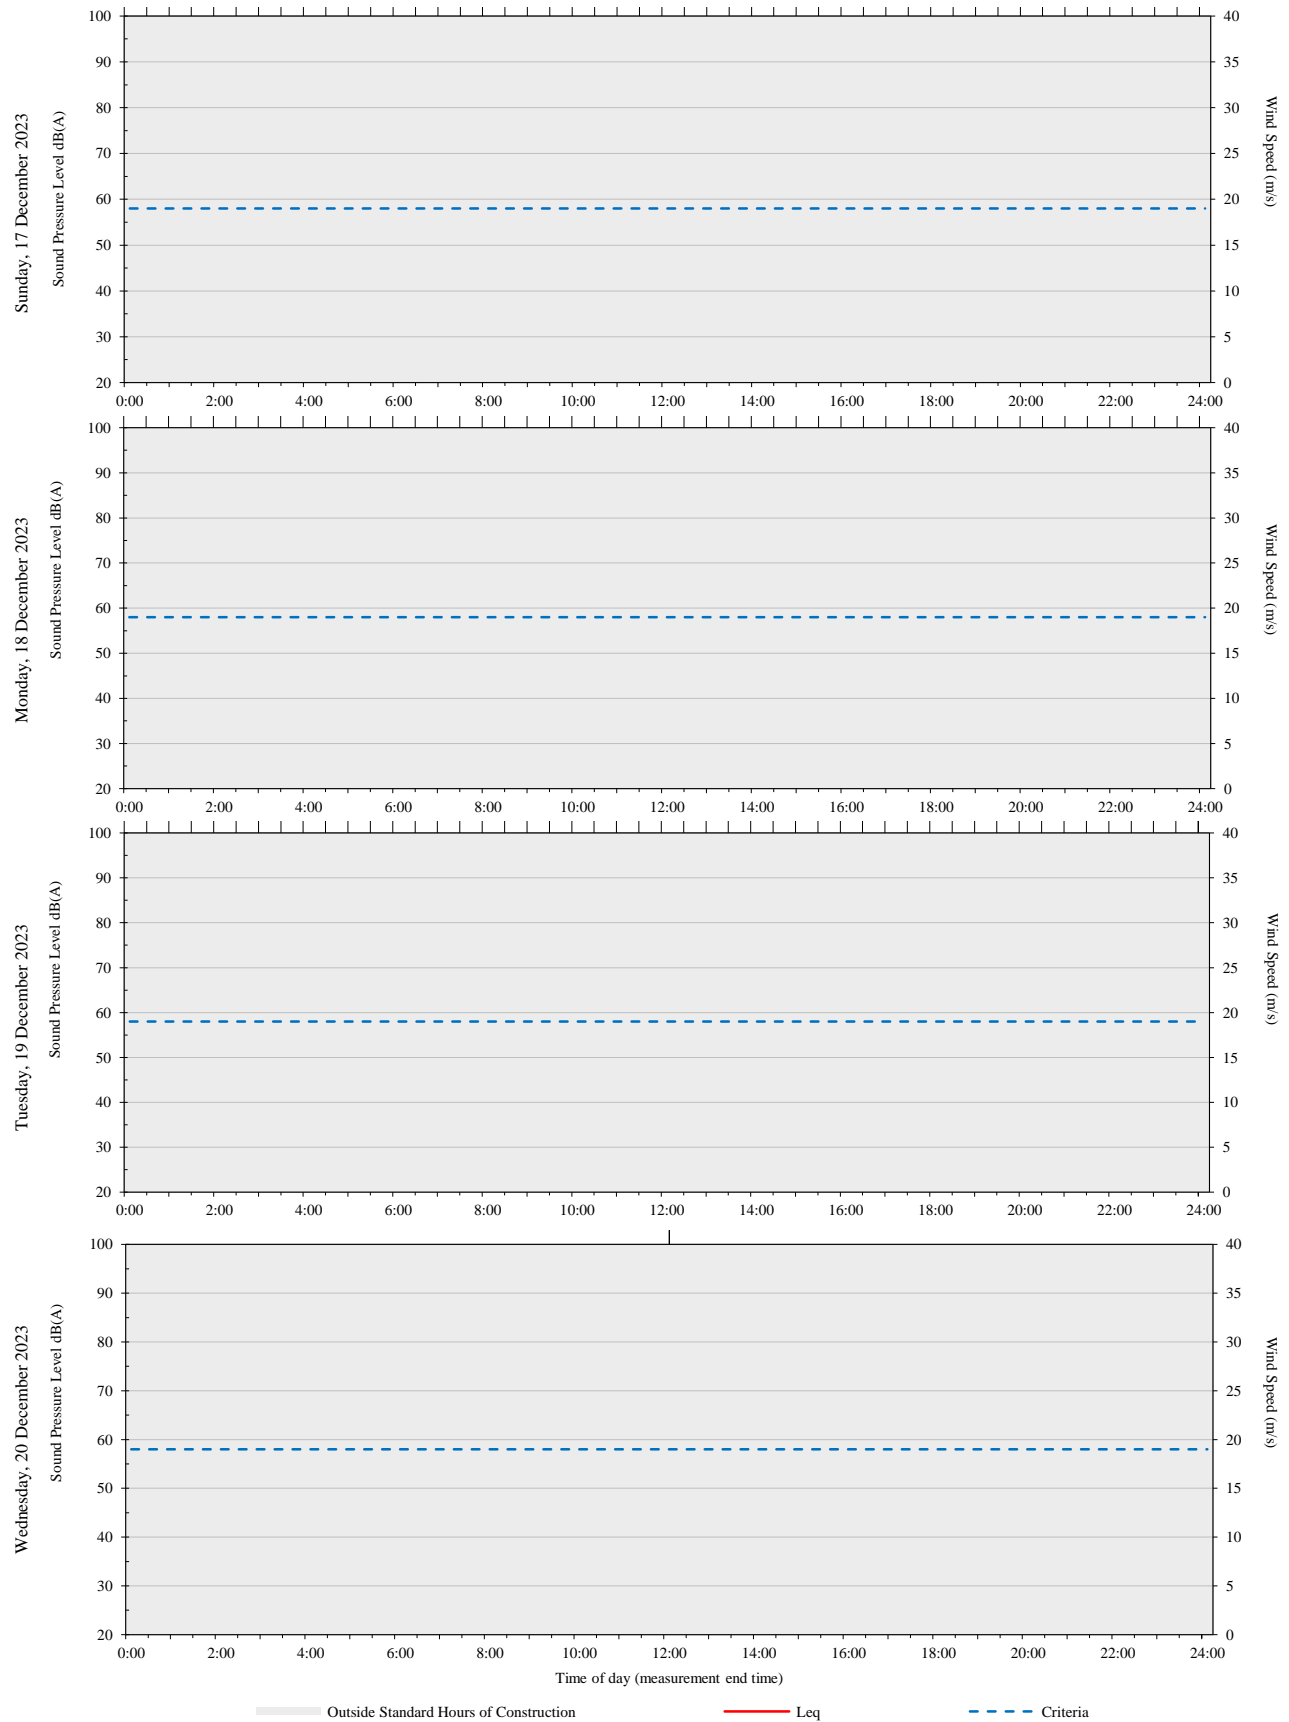
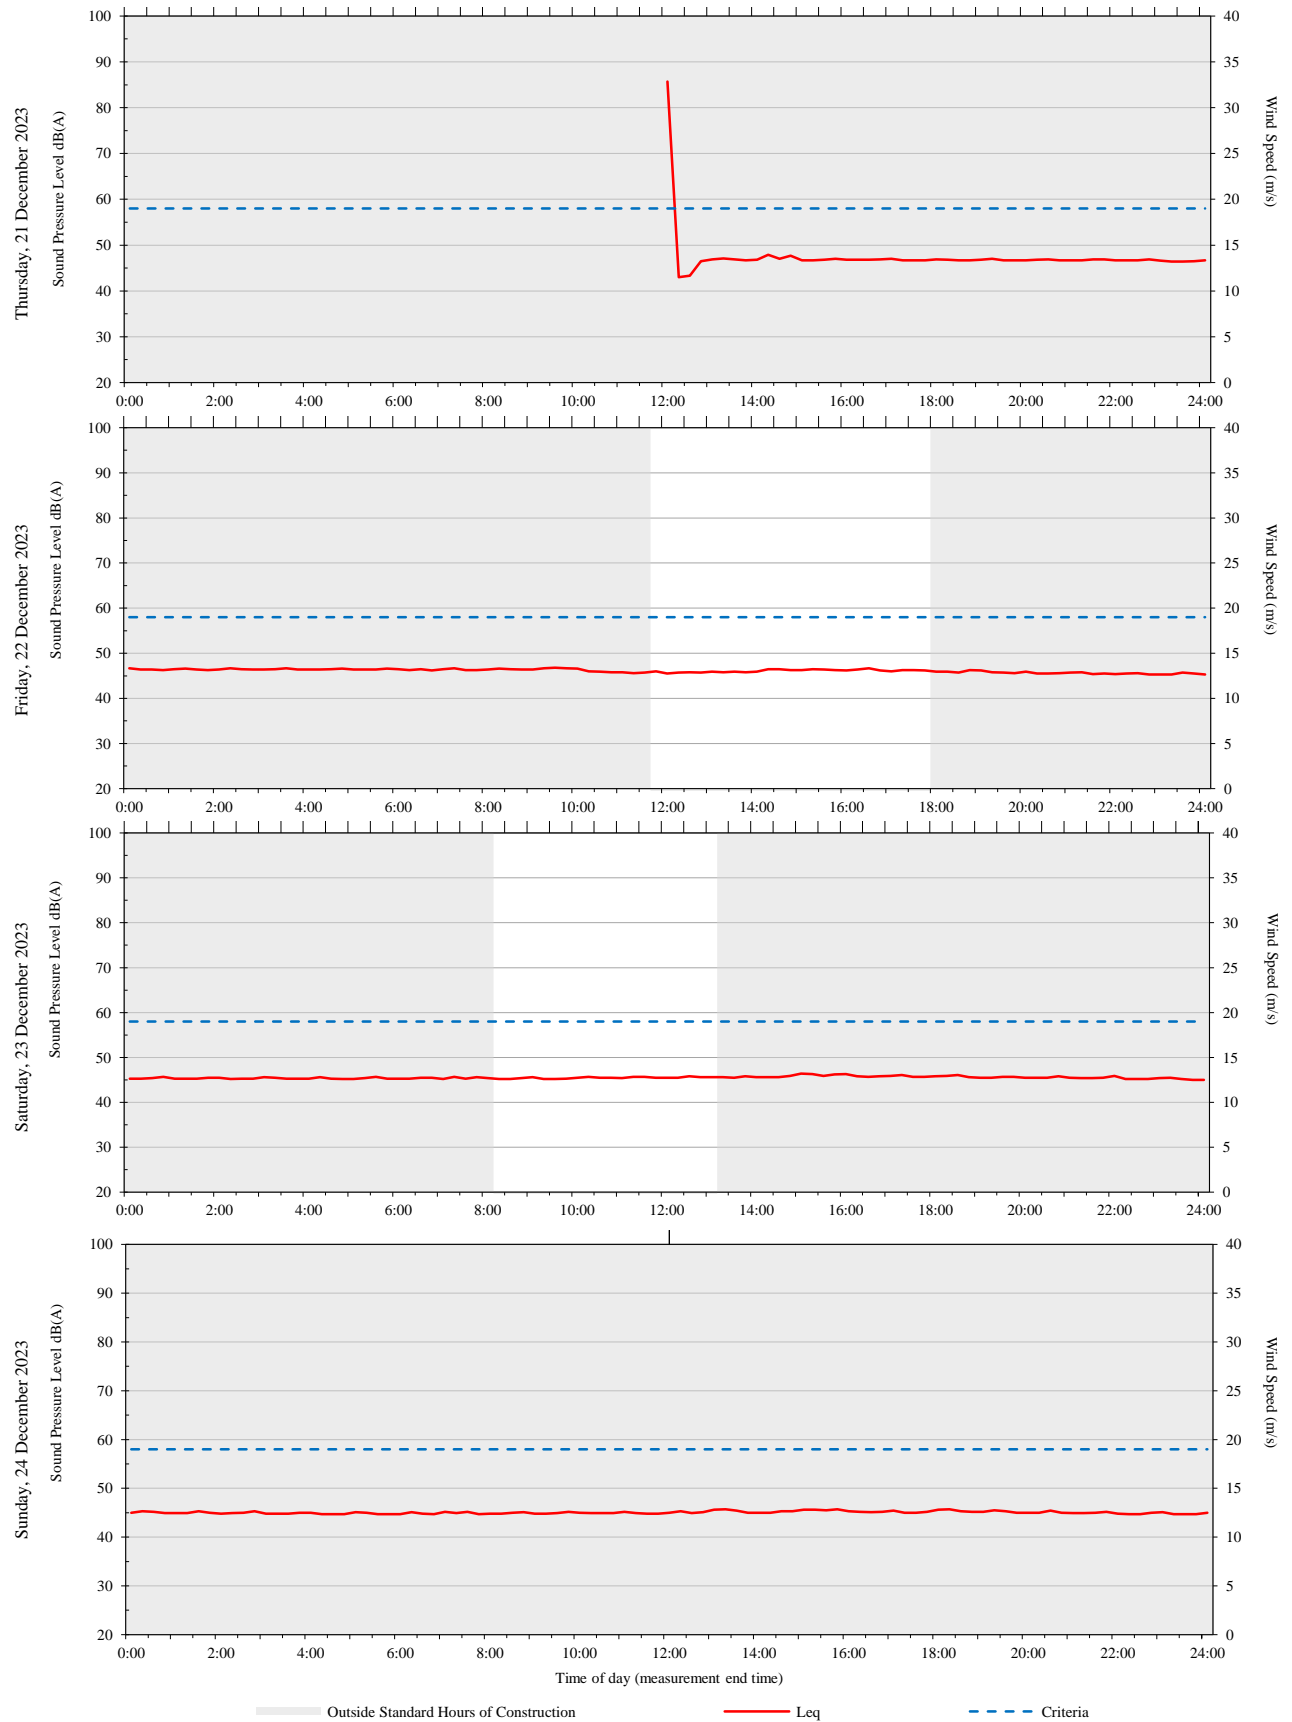
A4 KR Level 3 Radiation Room 33 RF041 (Westmead 4)

Unattended monitoring: KR Level 3 Radiation Room 33 RF041 (Internal)
