Health Infrastructure NSW
Westmead PSB and MSCP
Construction Noise Monitoring

Noise monitoring report
2023-12-01 to 2023-12-31

Westmead VVMF Construction Noise Monitoring

Noise monitoring report 2023-12-01 to 2023-12-31

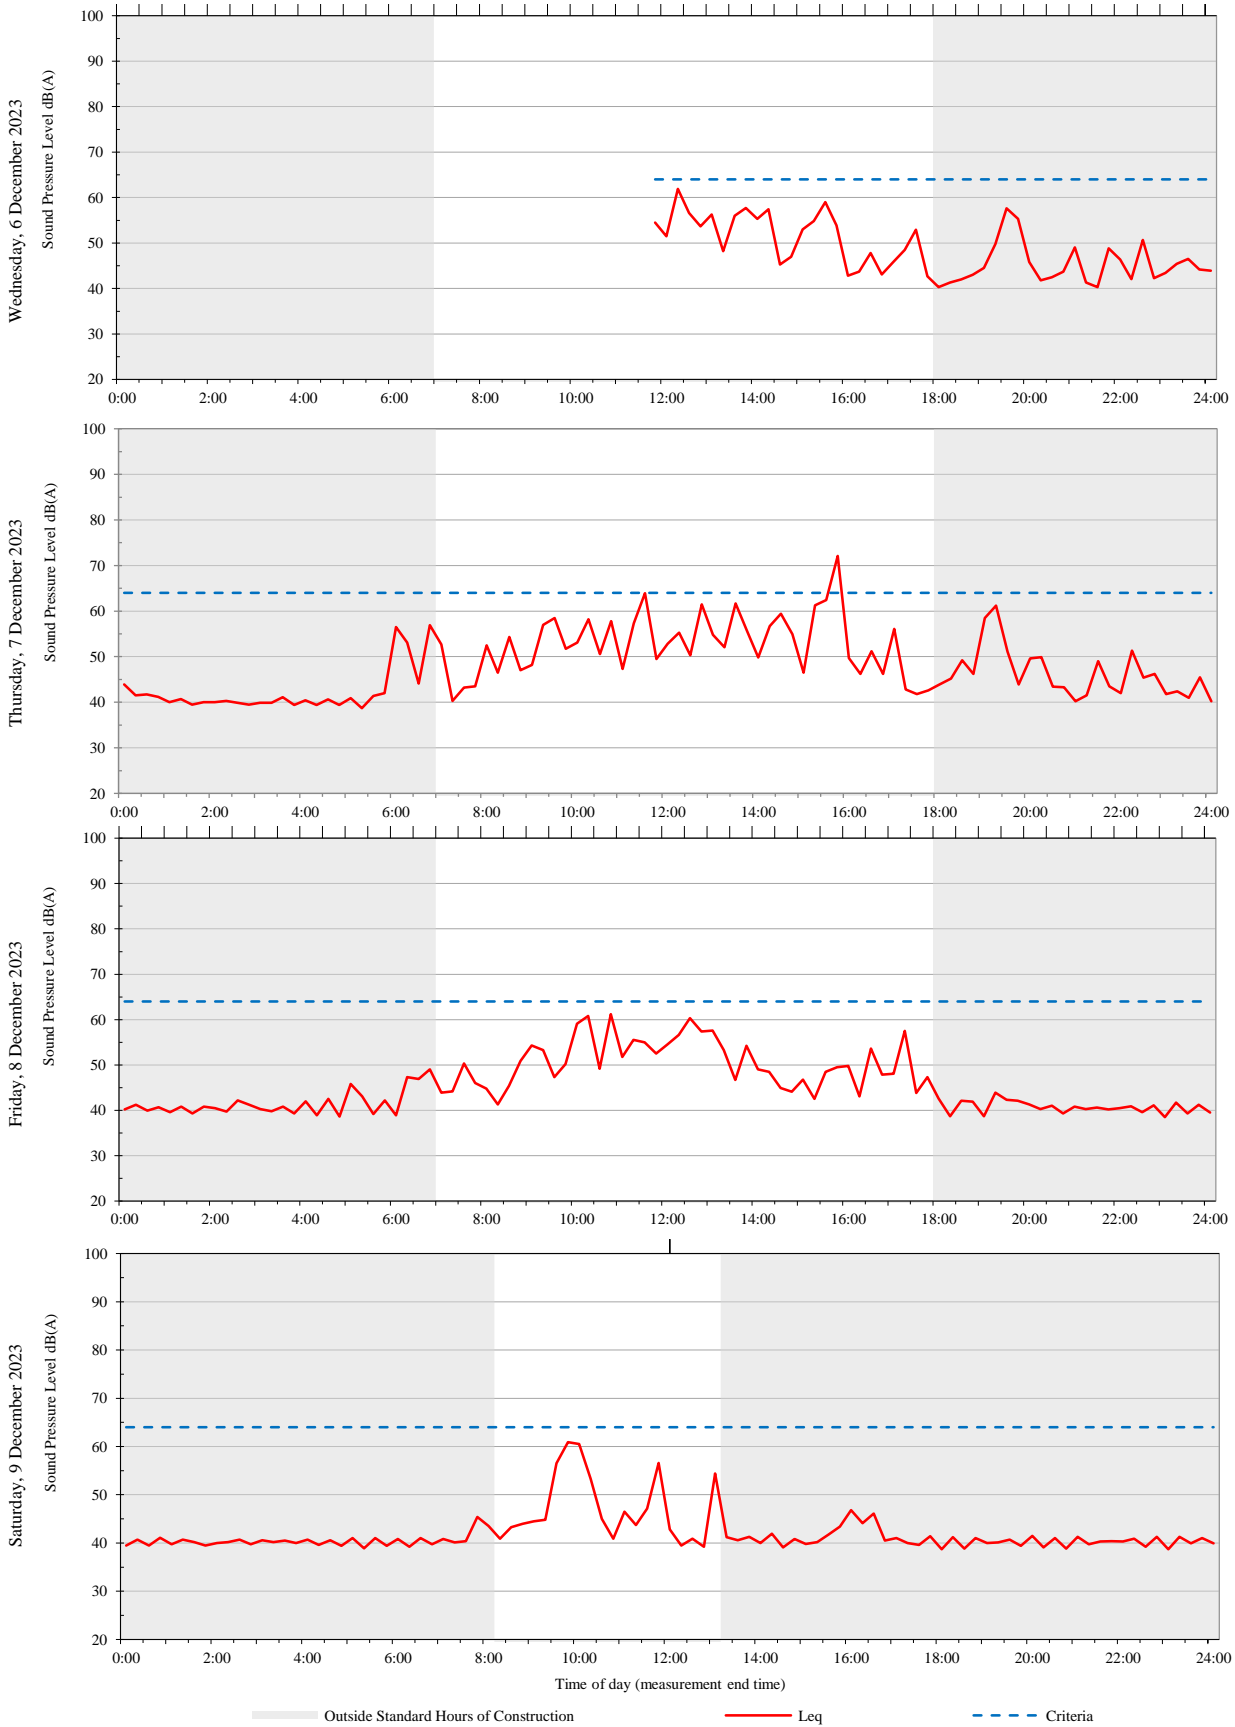
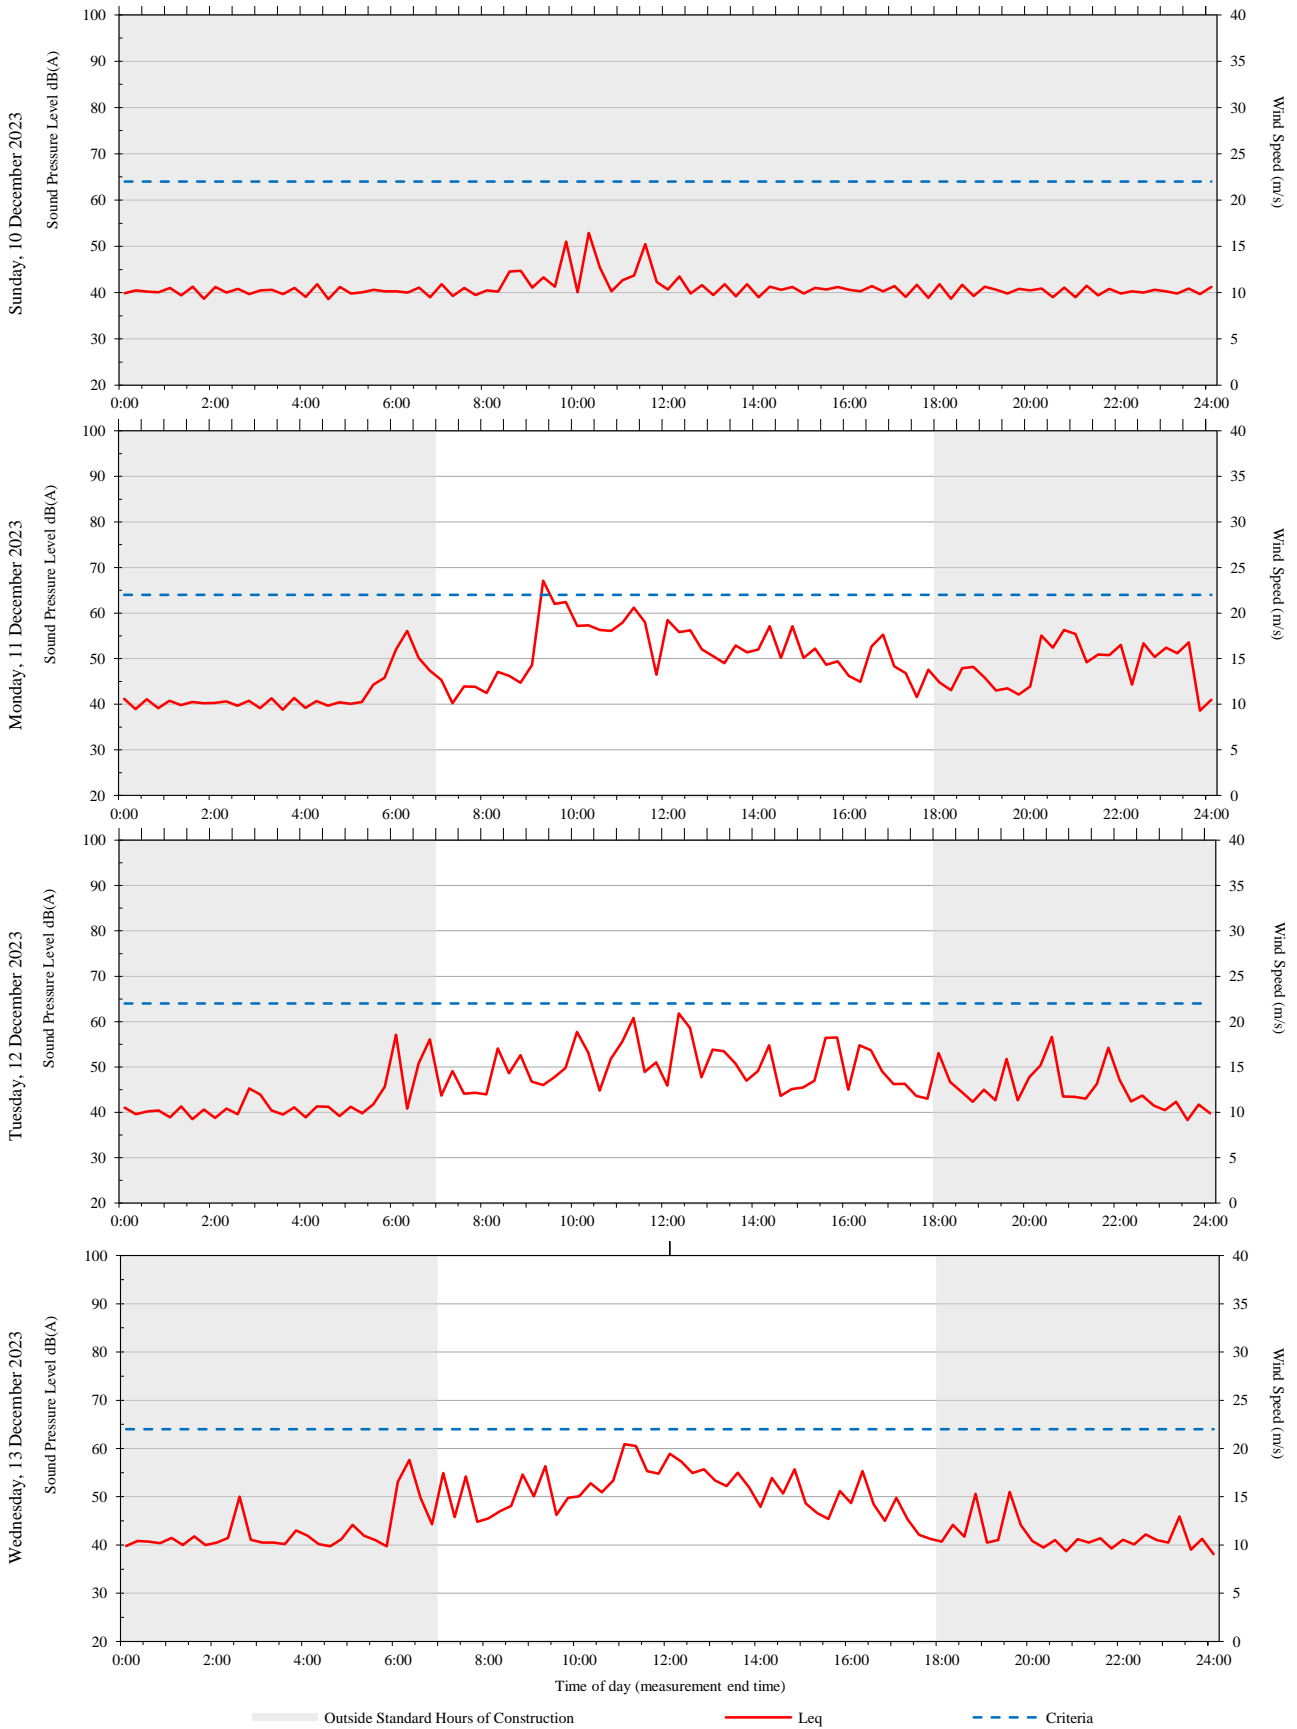
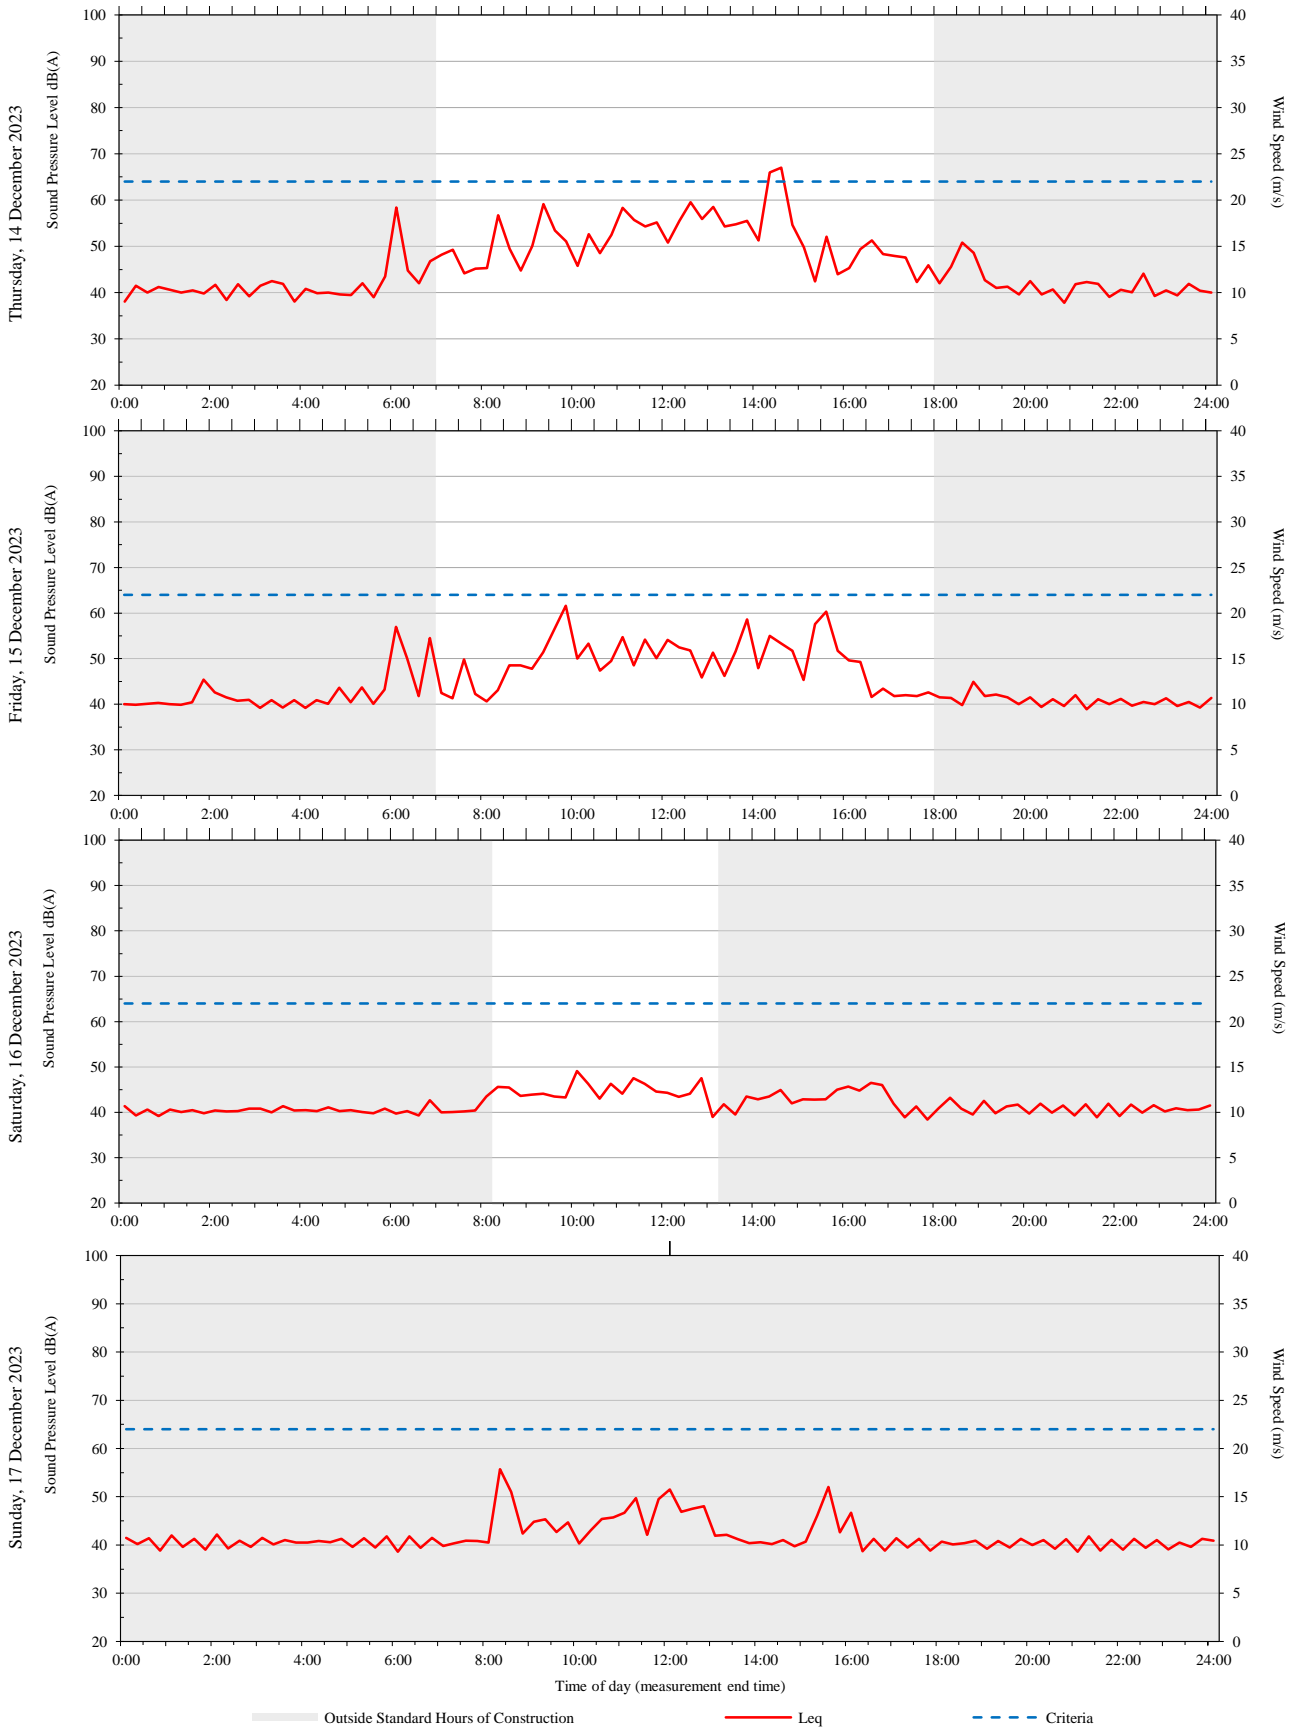
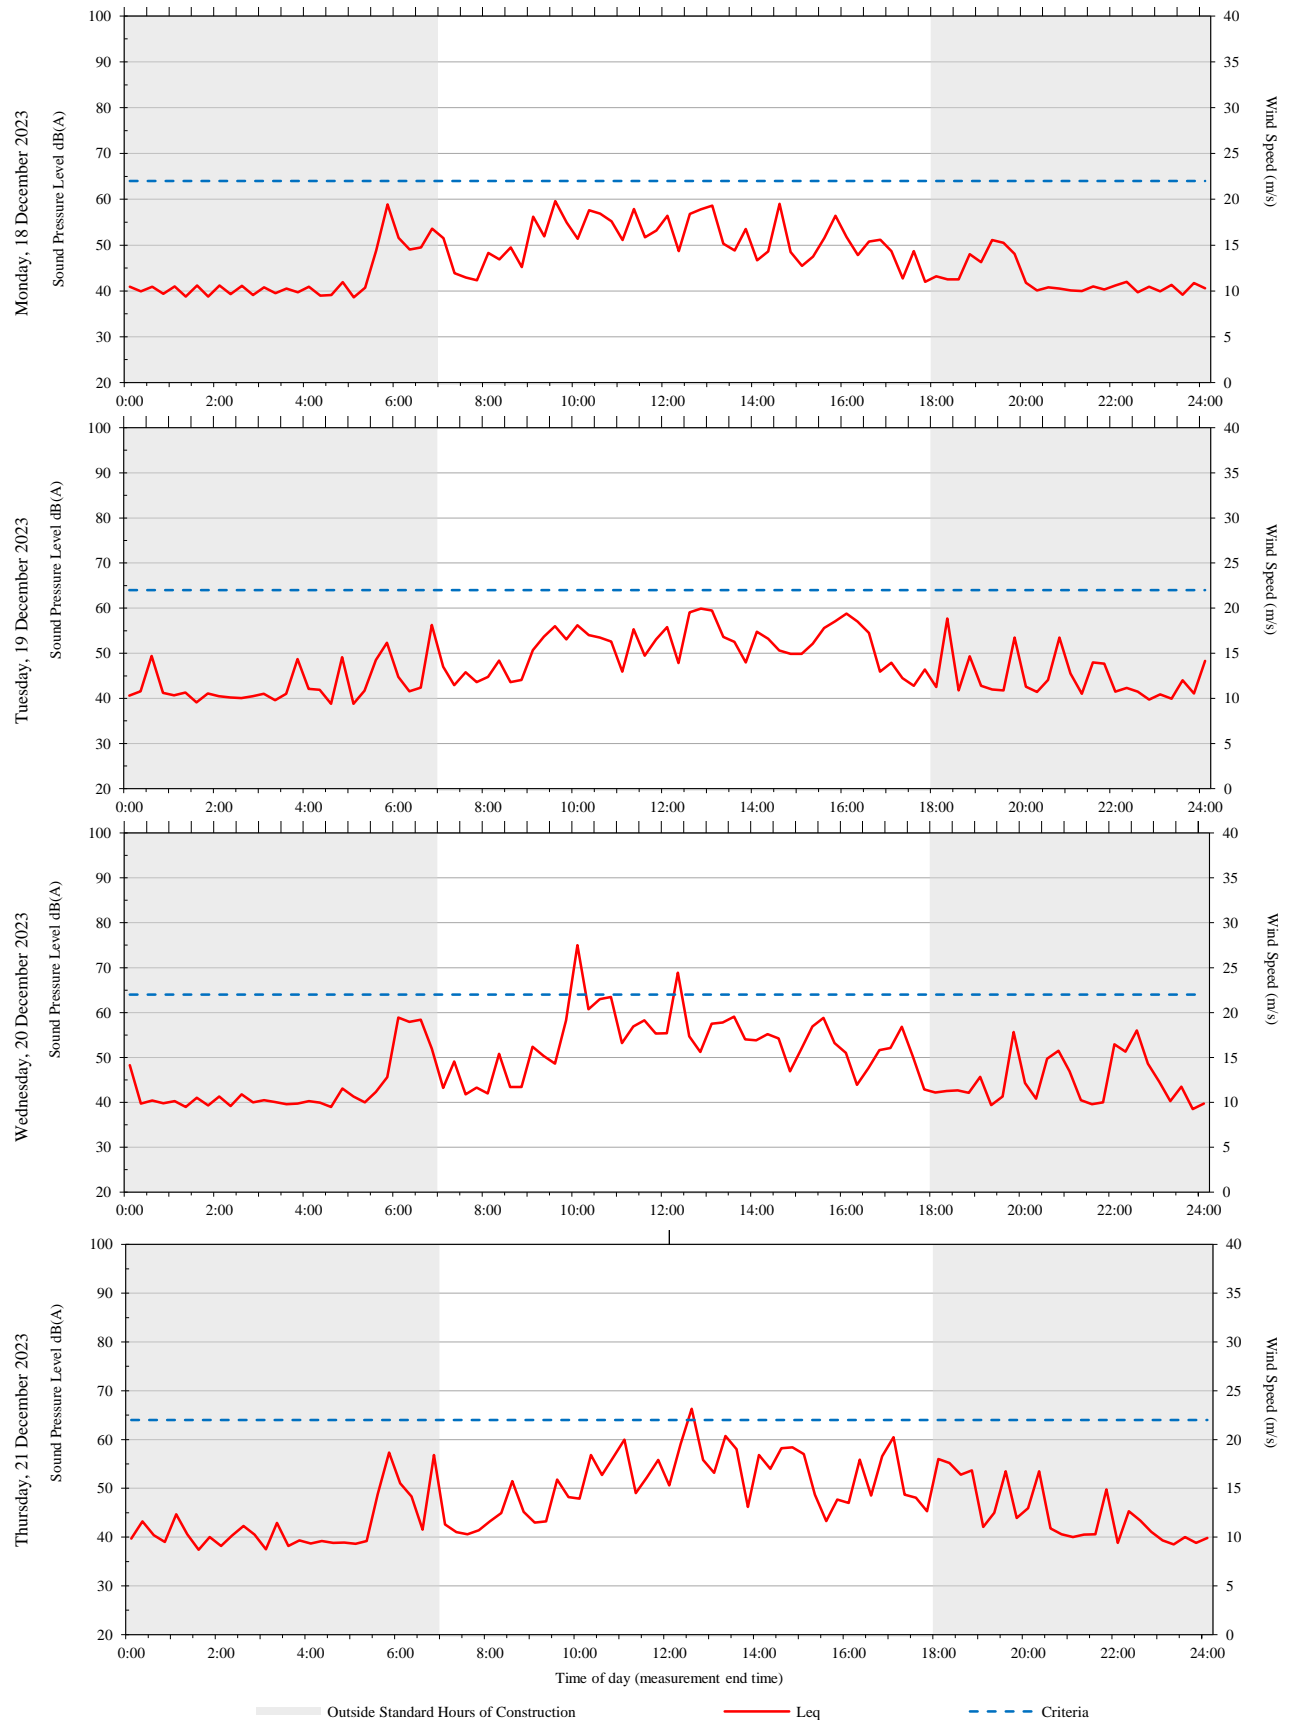
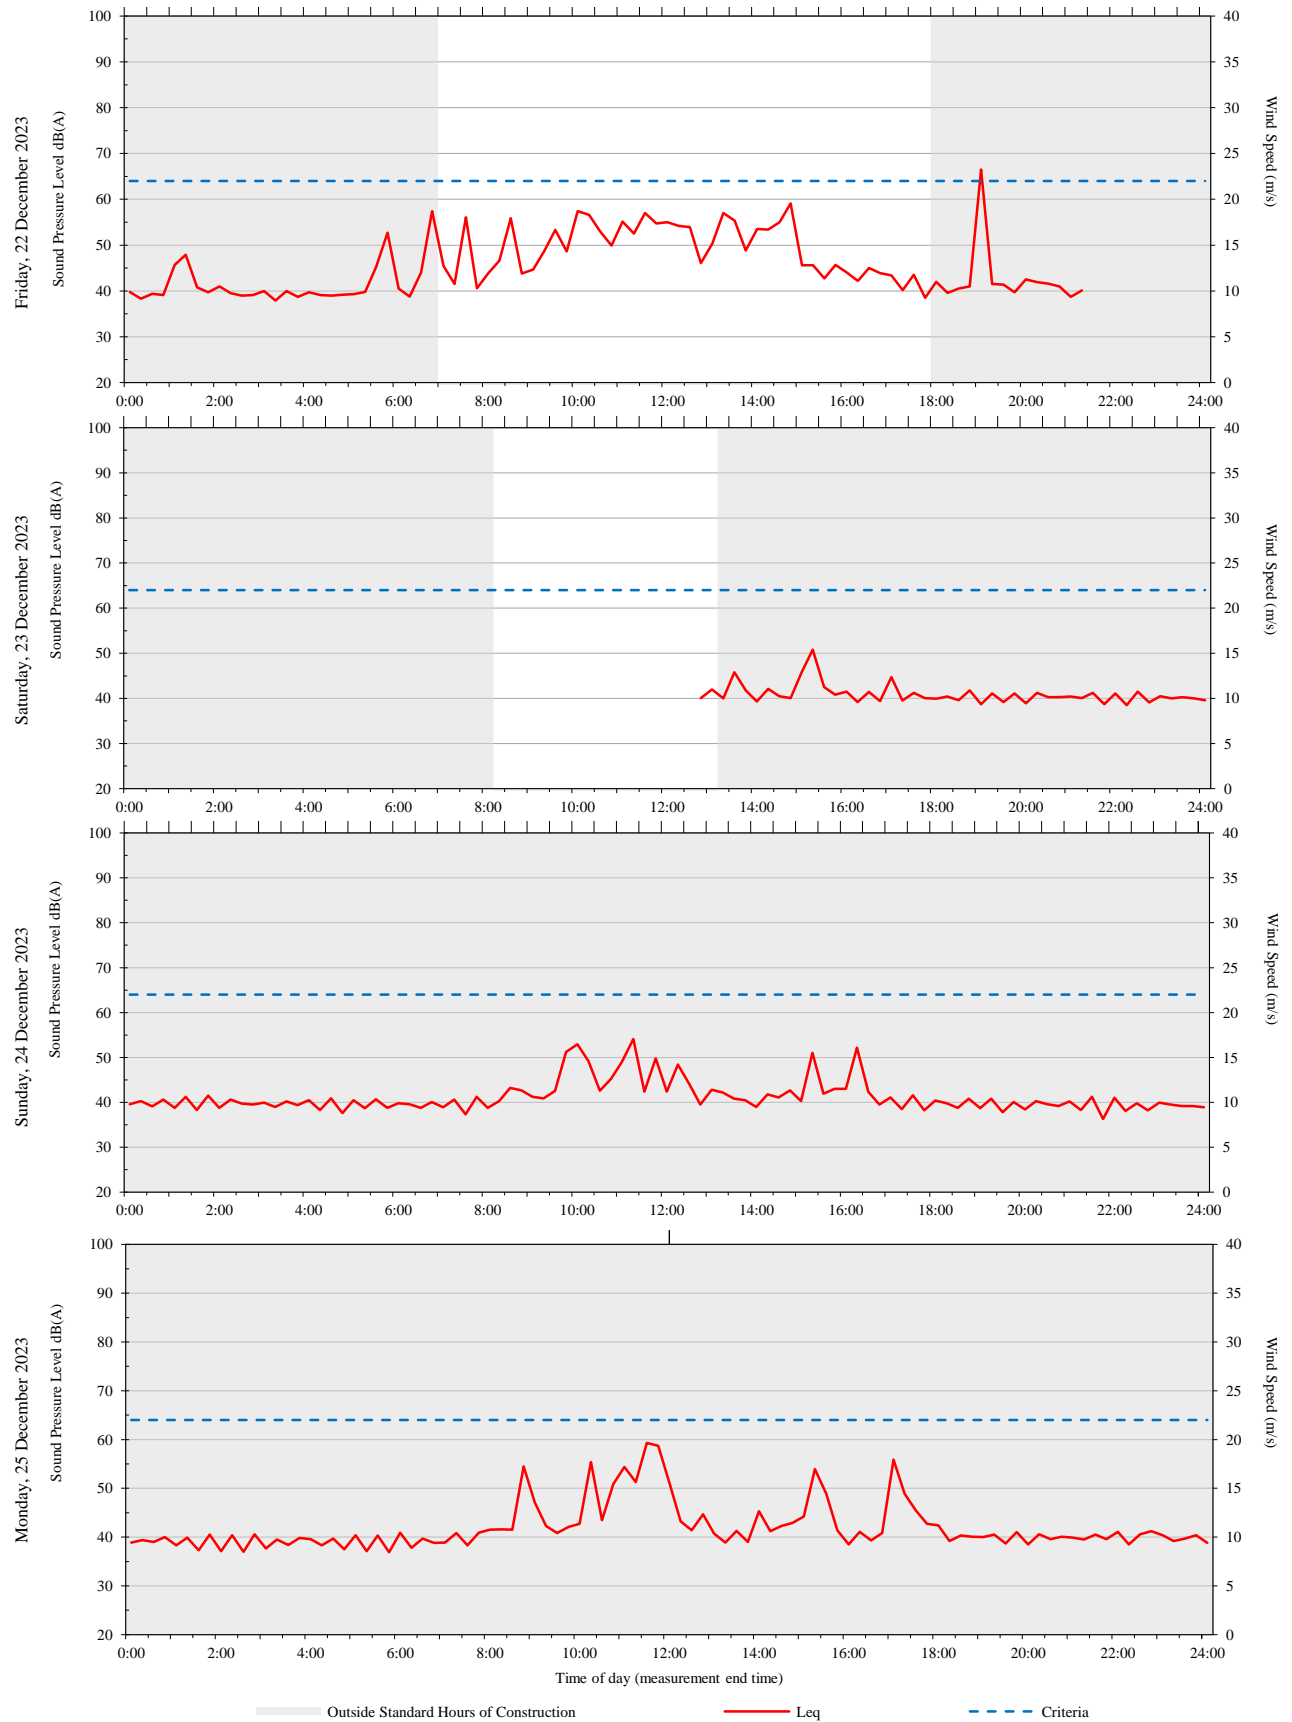
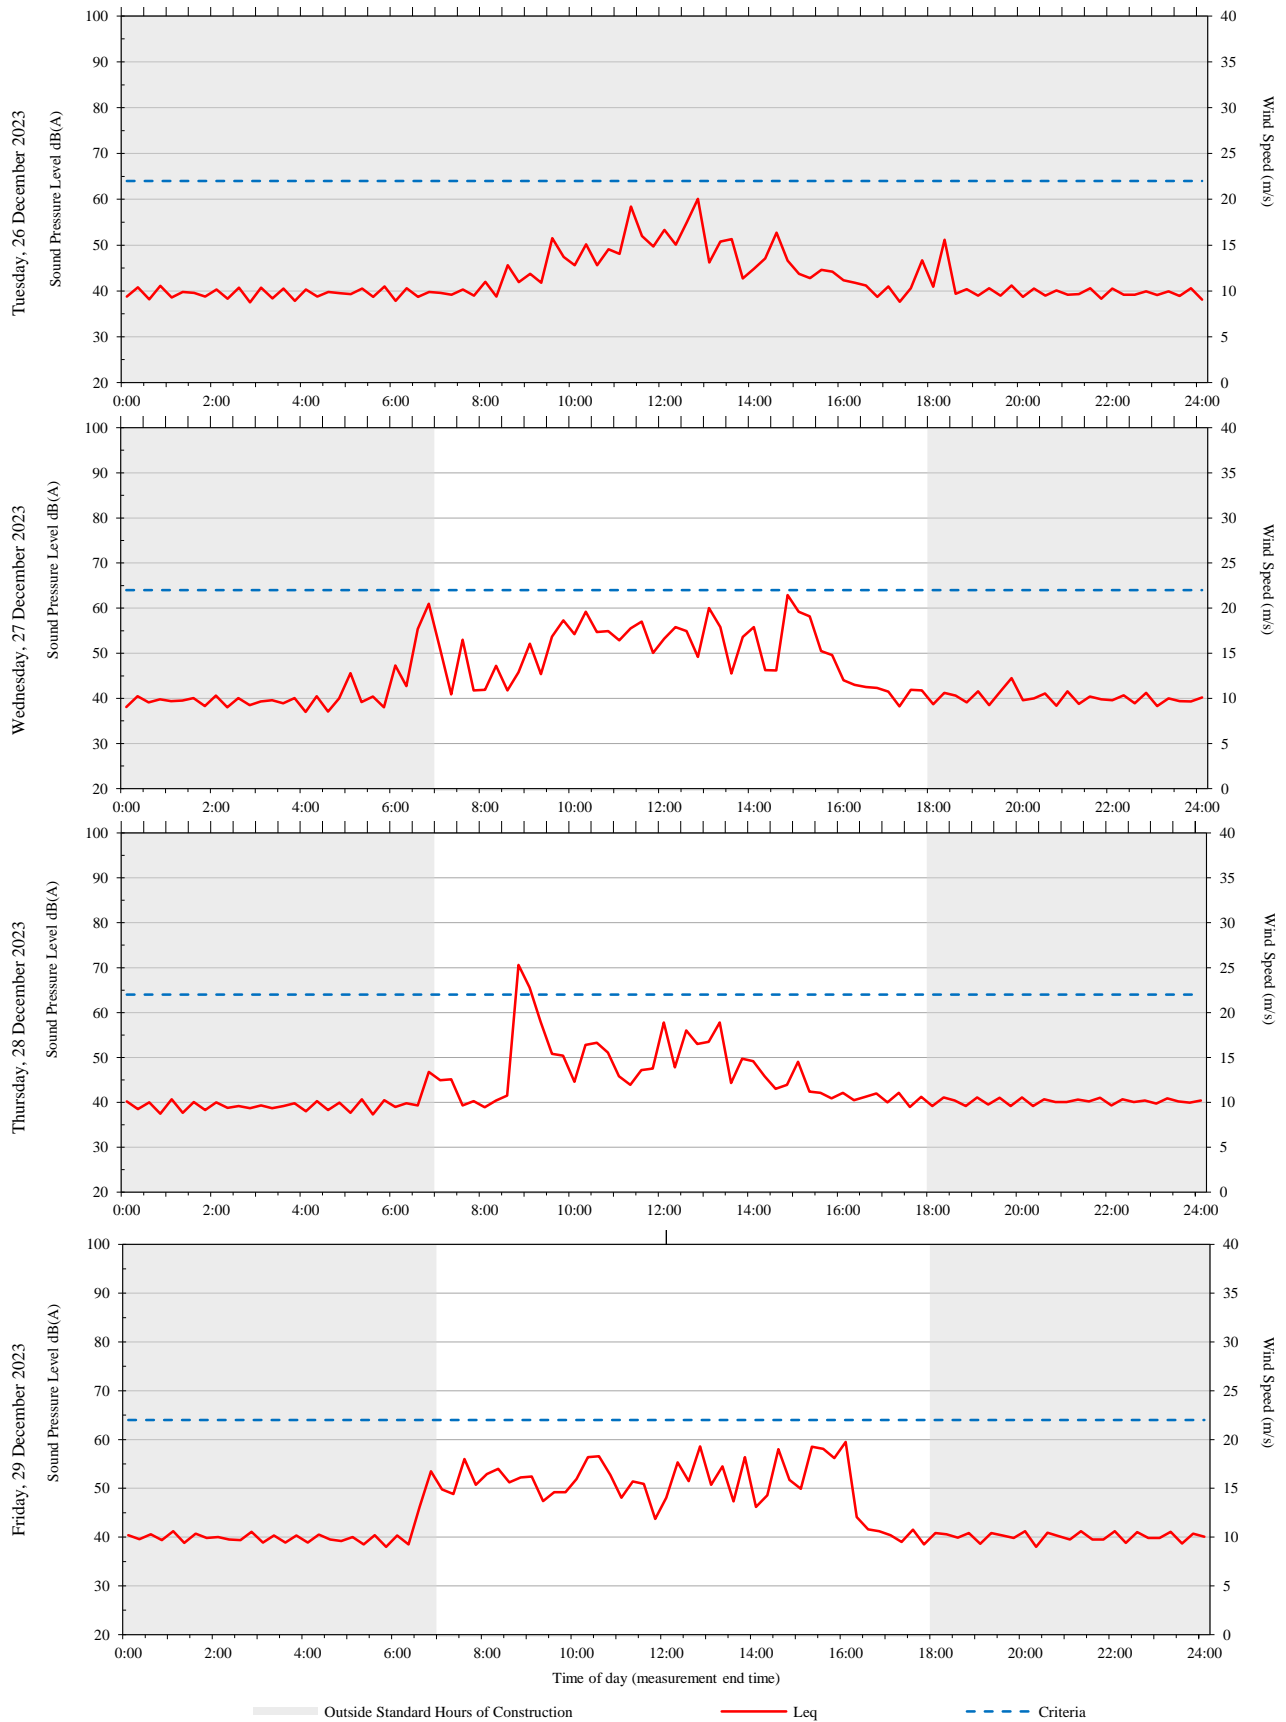
A5 CHW Level 2 Parent Kitchen 92BW025 (facing MSCP site) (Westmead 2)

Unattended monitoring: CHW Level 2 Parent Kitchen 92BW025 (Internal)

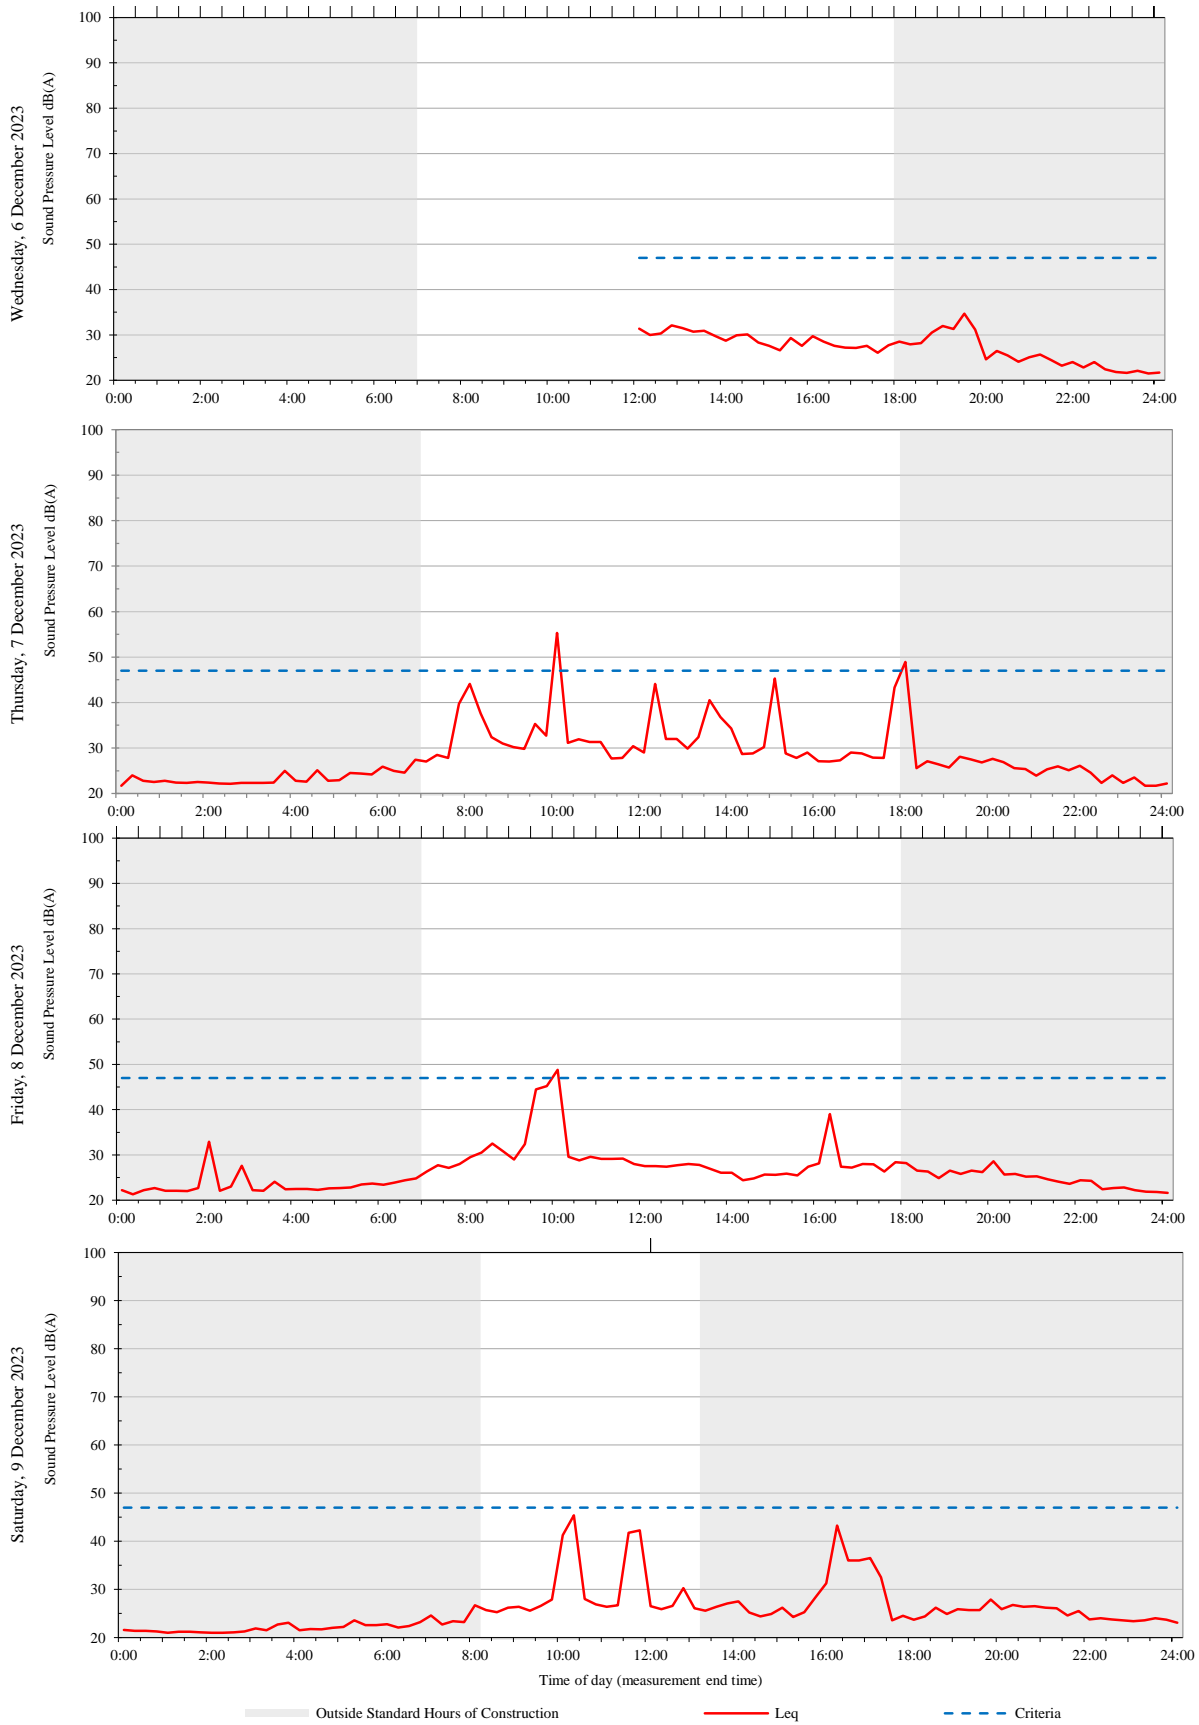
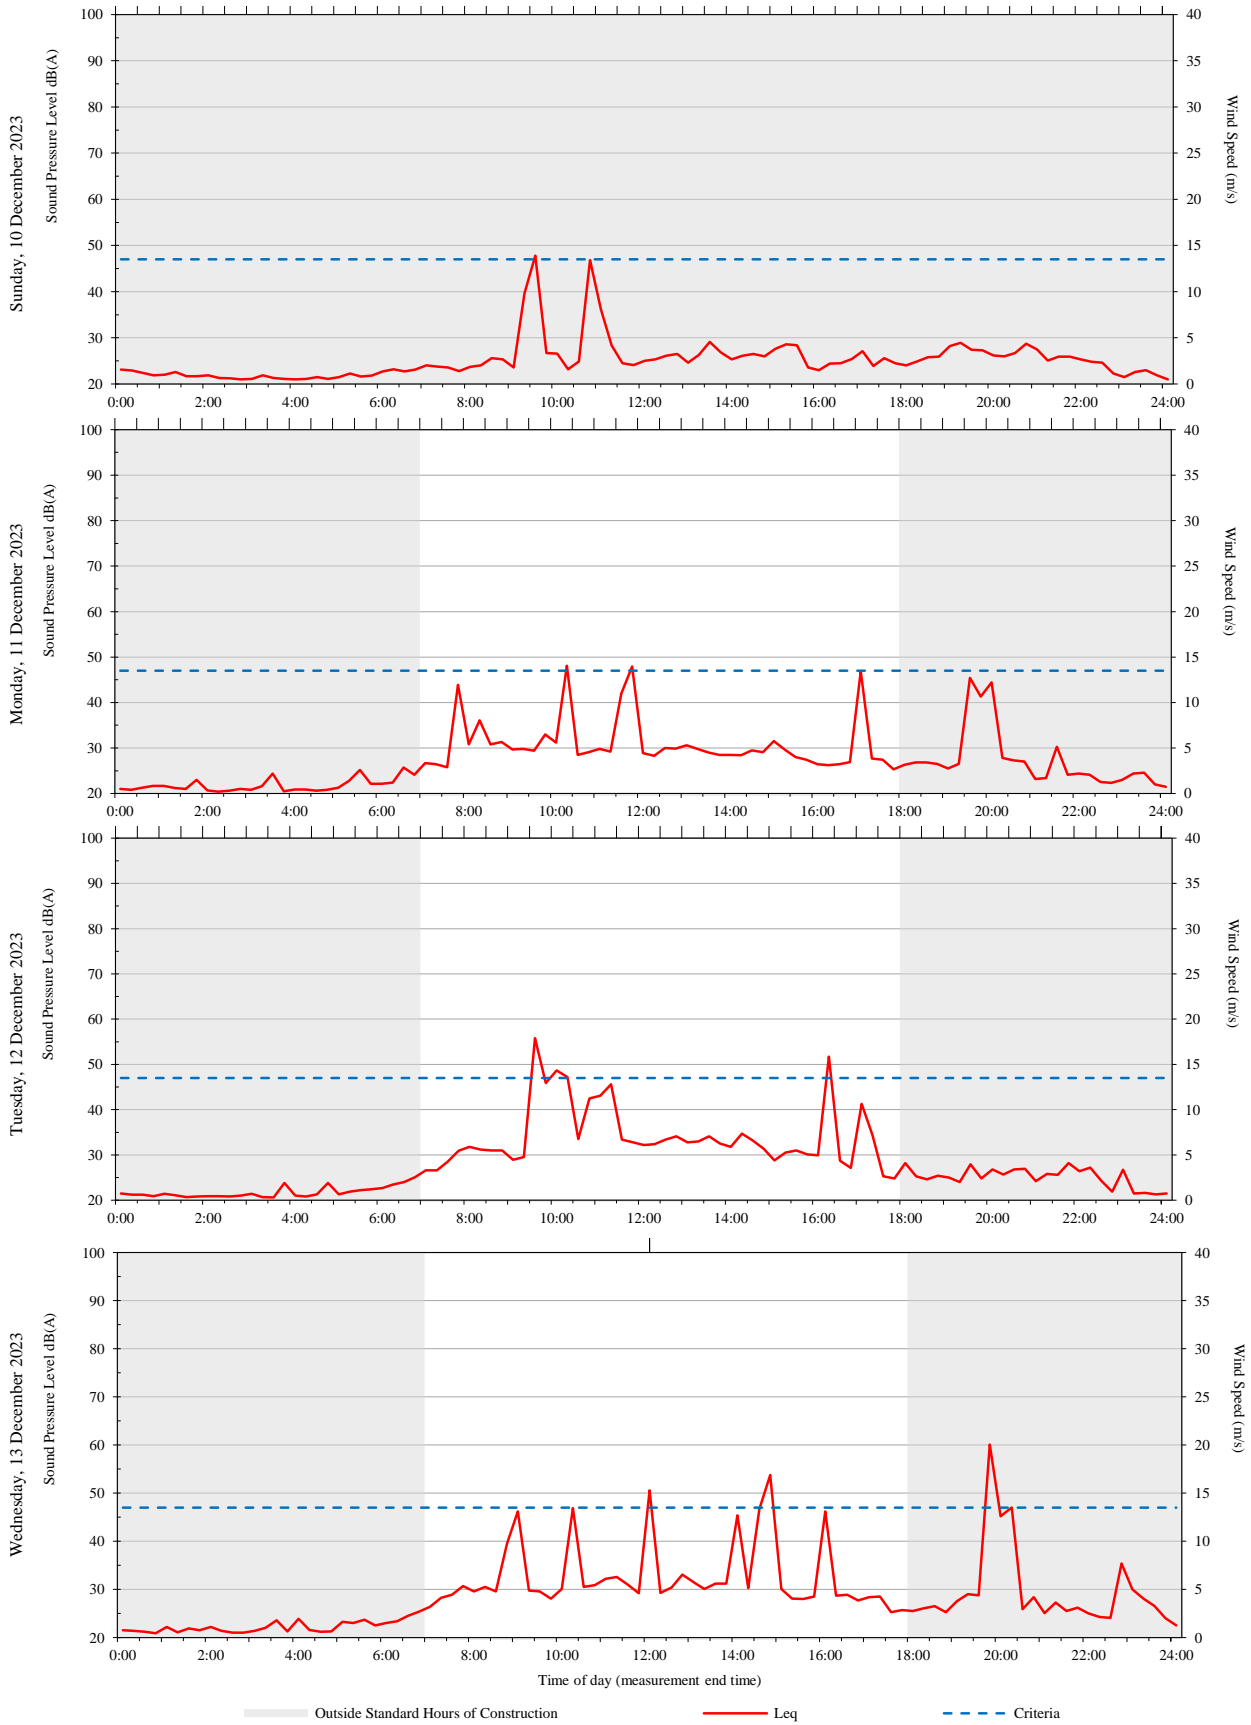
A6 RMH Level 1 Store Room 101 (Westmead 3)

Unattended monitoring: RMH Level 1 Store Room 101 (Internal)

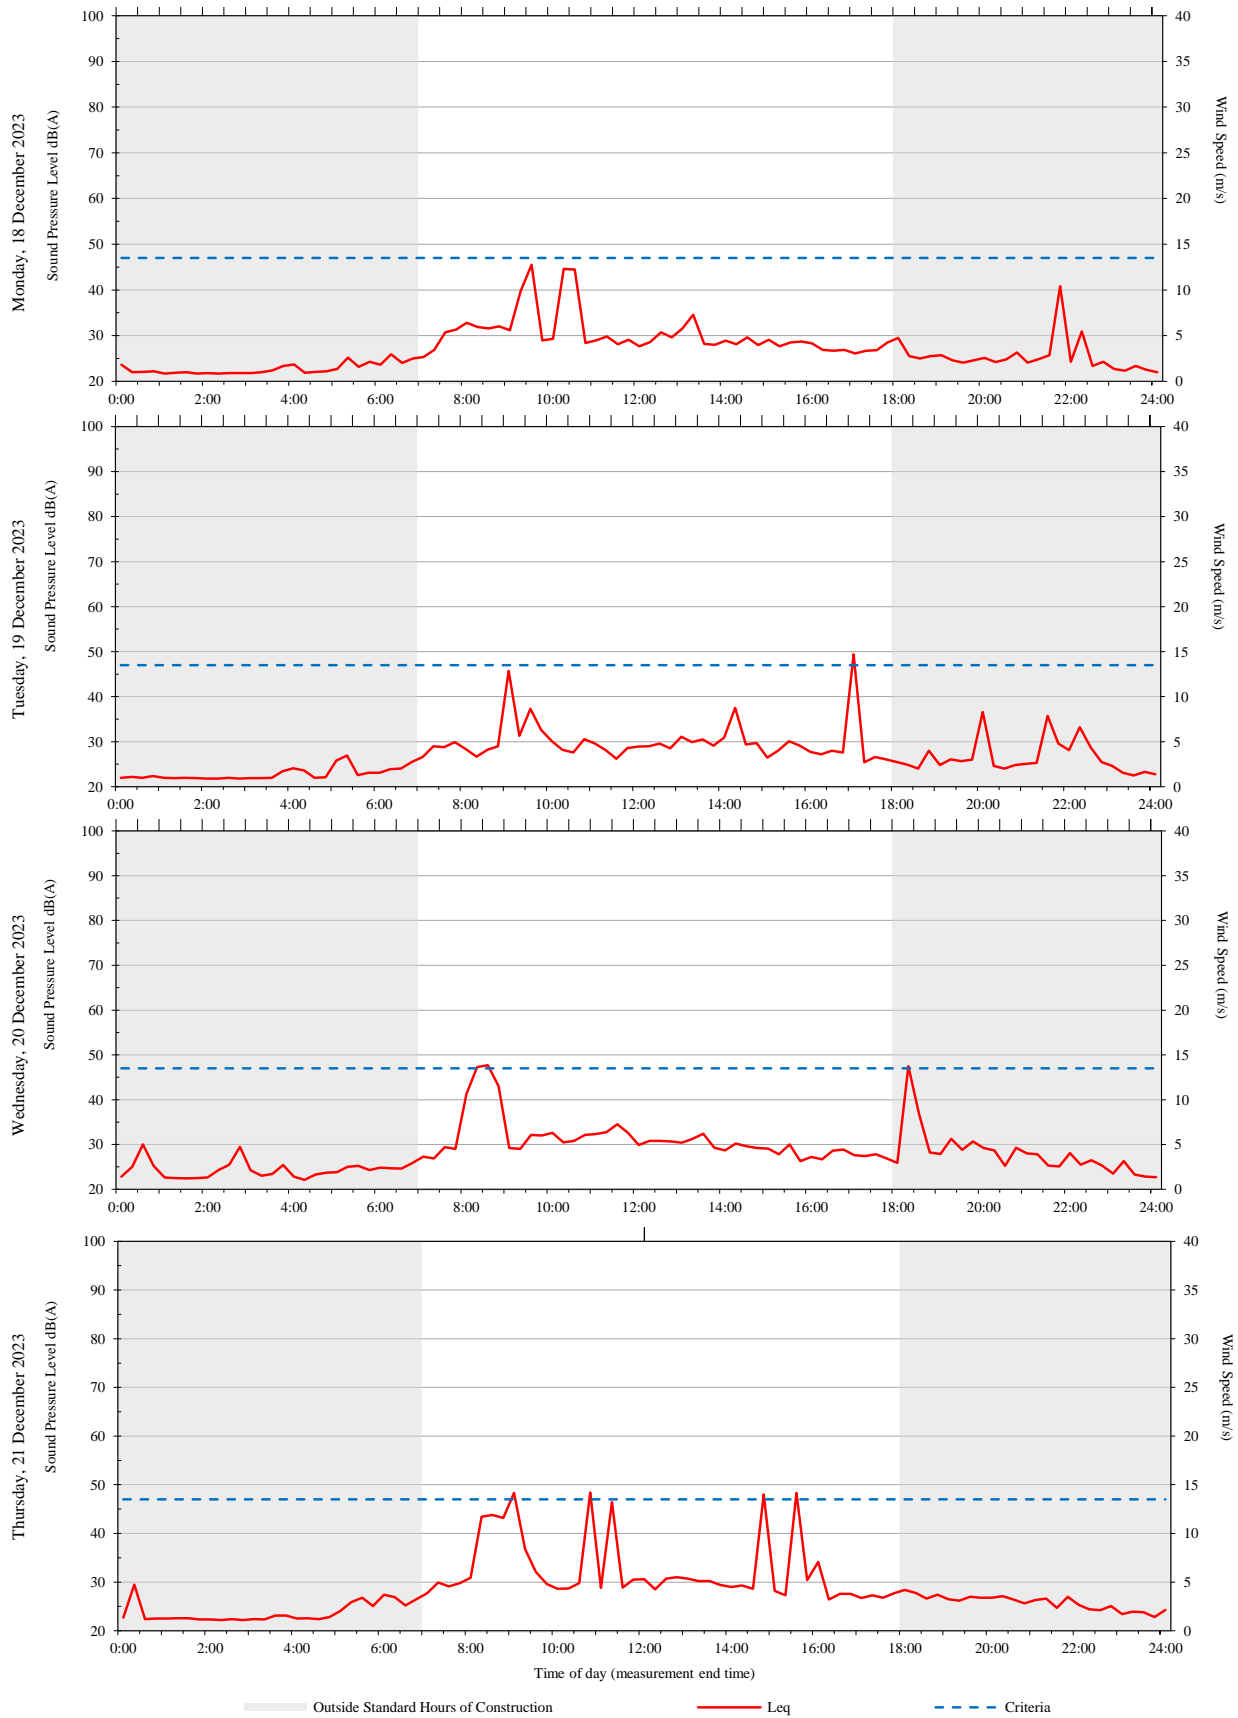
Unattended monitoring: RMH Level 1 Store Room 101 (Internal)

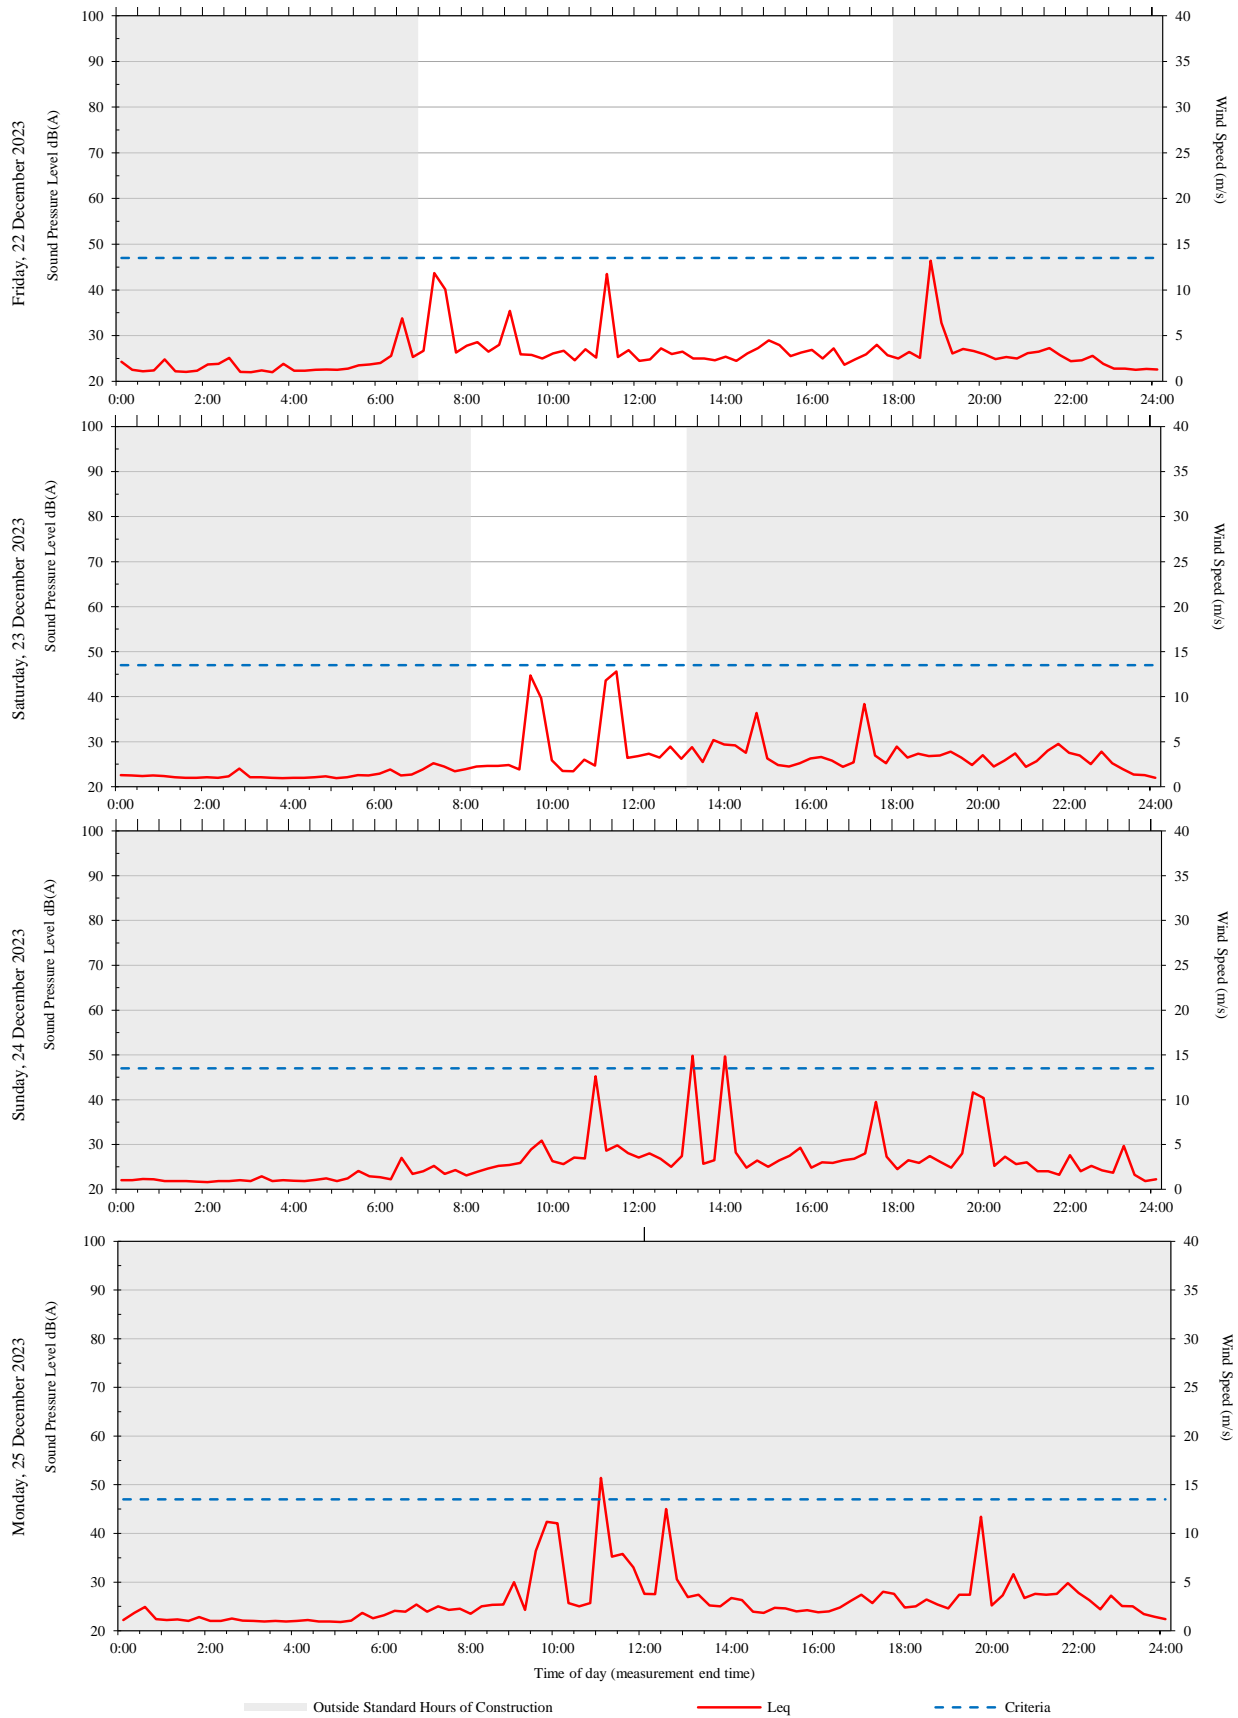
Unattended monitoring: RMH Level 1 Store Room 101 (Internal)
