Health Infrastructure NSW
Westmead PSB and MSCP
Construction Noise Monitoring

Noise monitoring report
2023-12-01 to 2023-12-31

Westmead VVMF Construction Noise Monitoring

Noise monitoring report 2023-12-01 to 2023-12-31

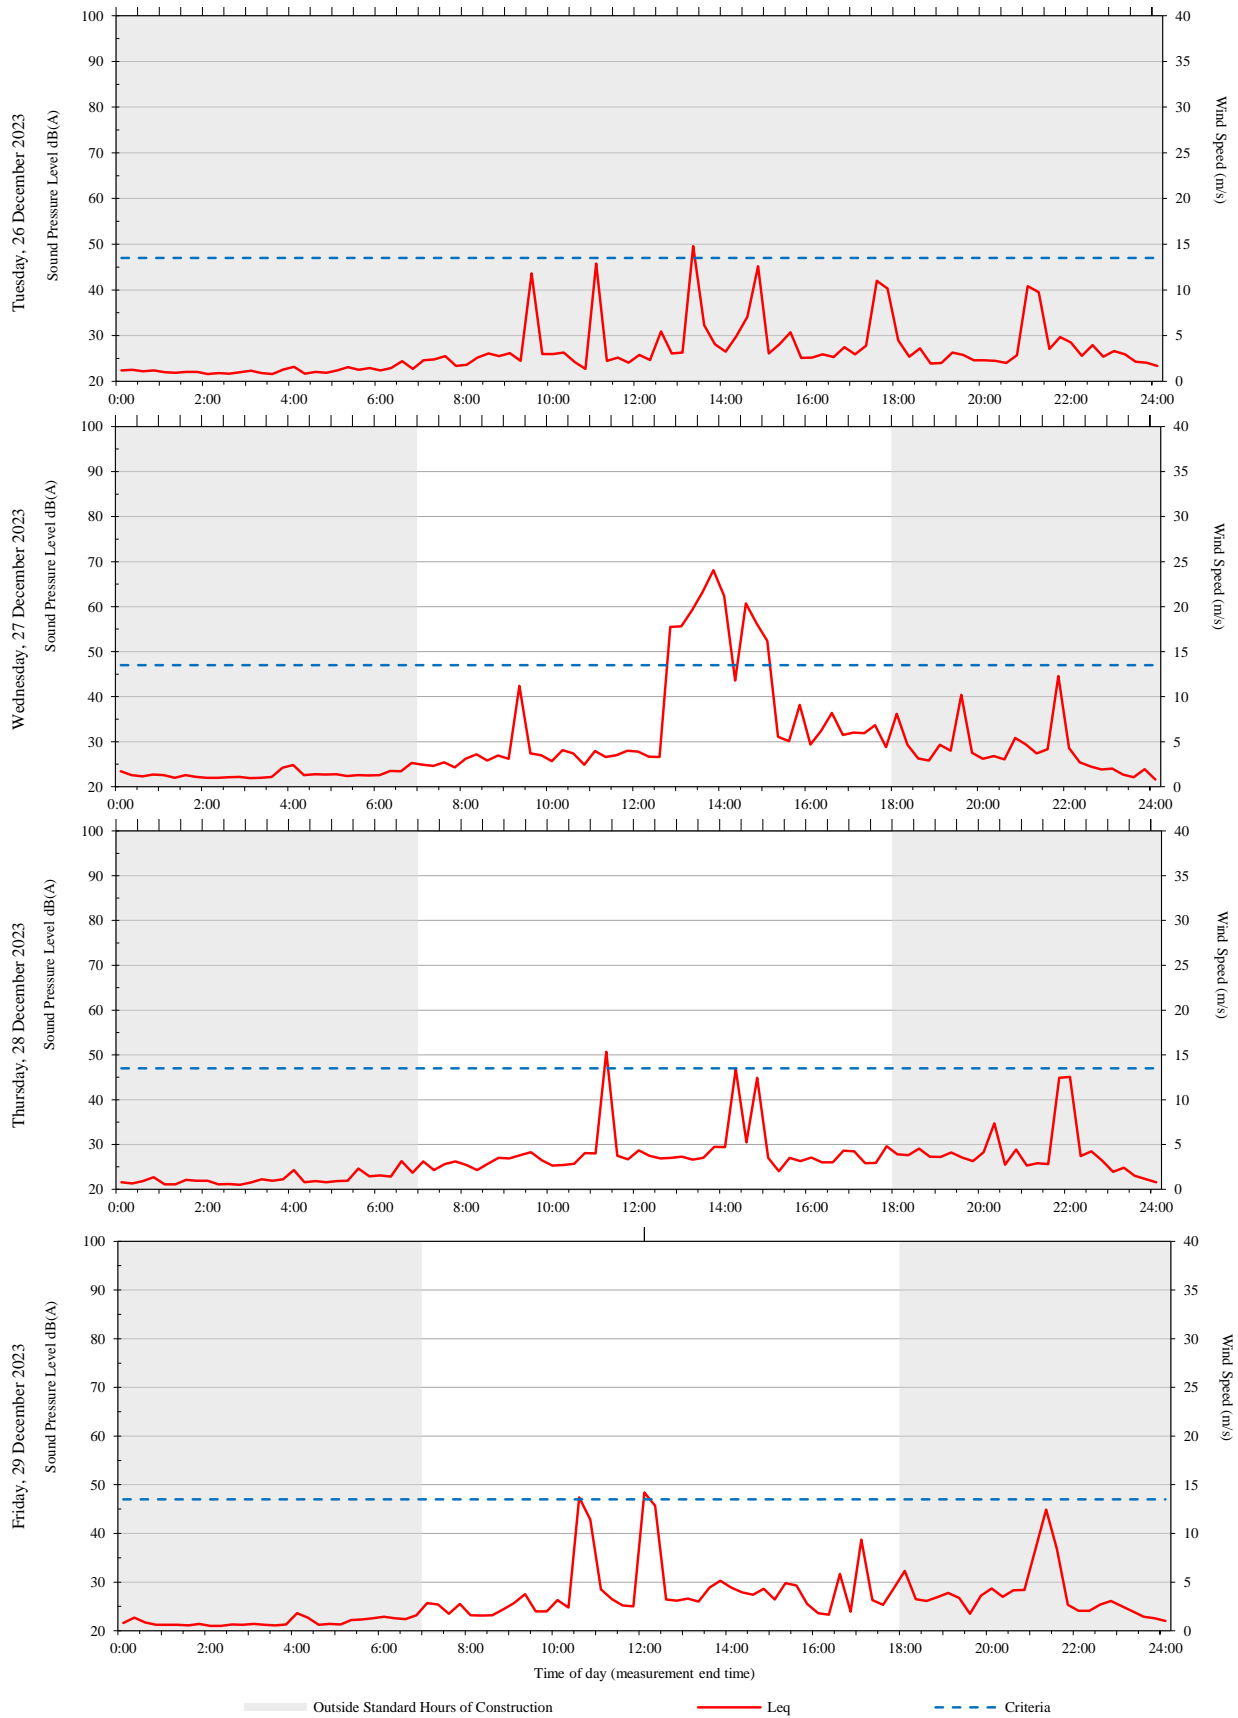
Unattended monitoring: RMH Level 1 Store Room 101 (Internal)

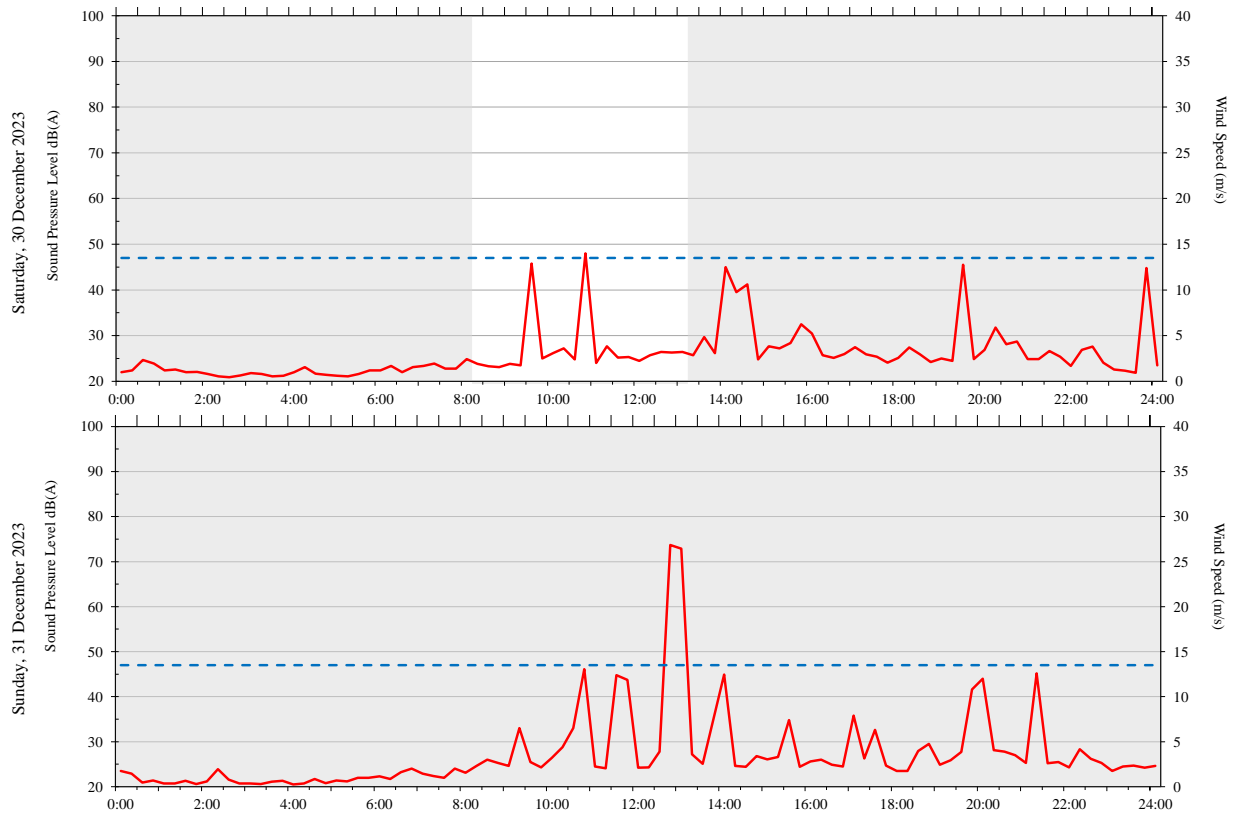
Unattended monitoring: RMH Level 1 Store Room 101 (Internal)

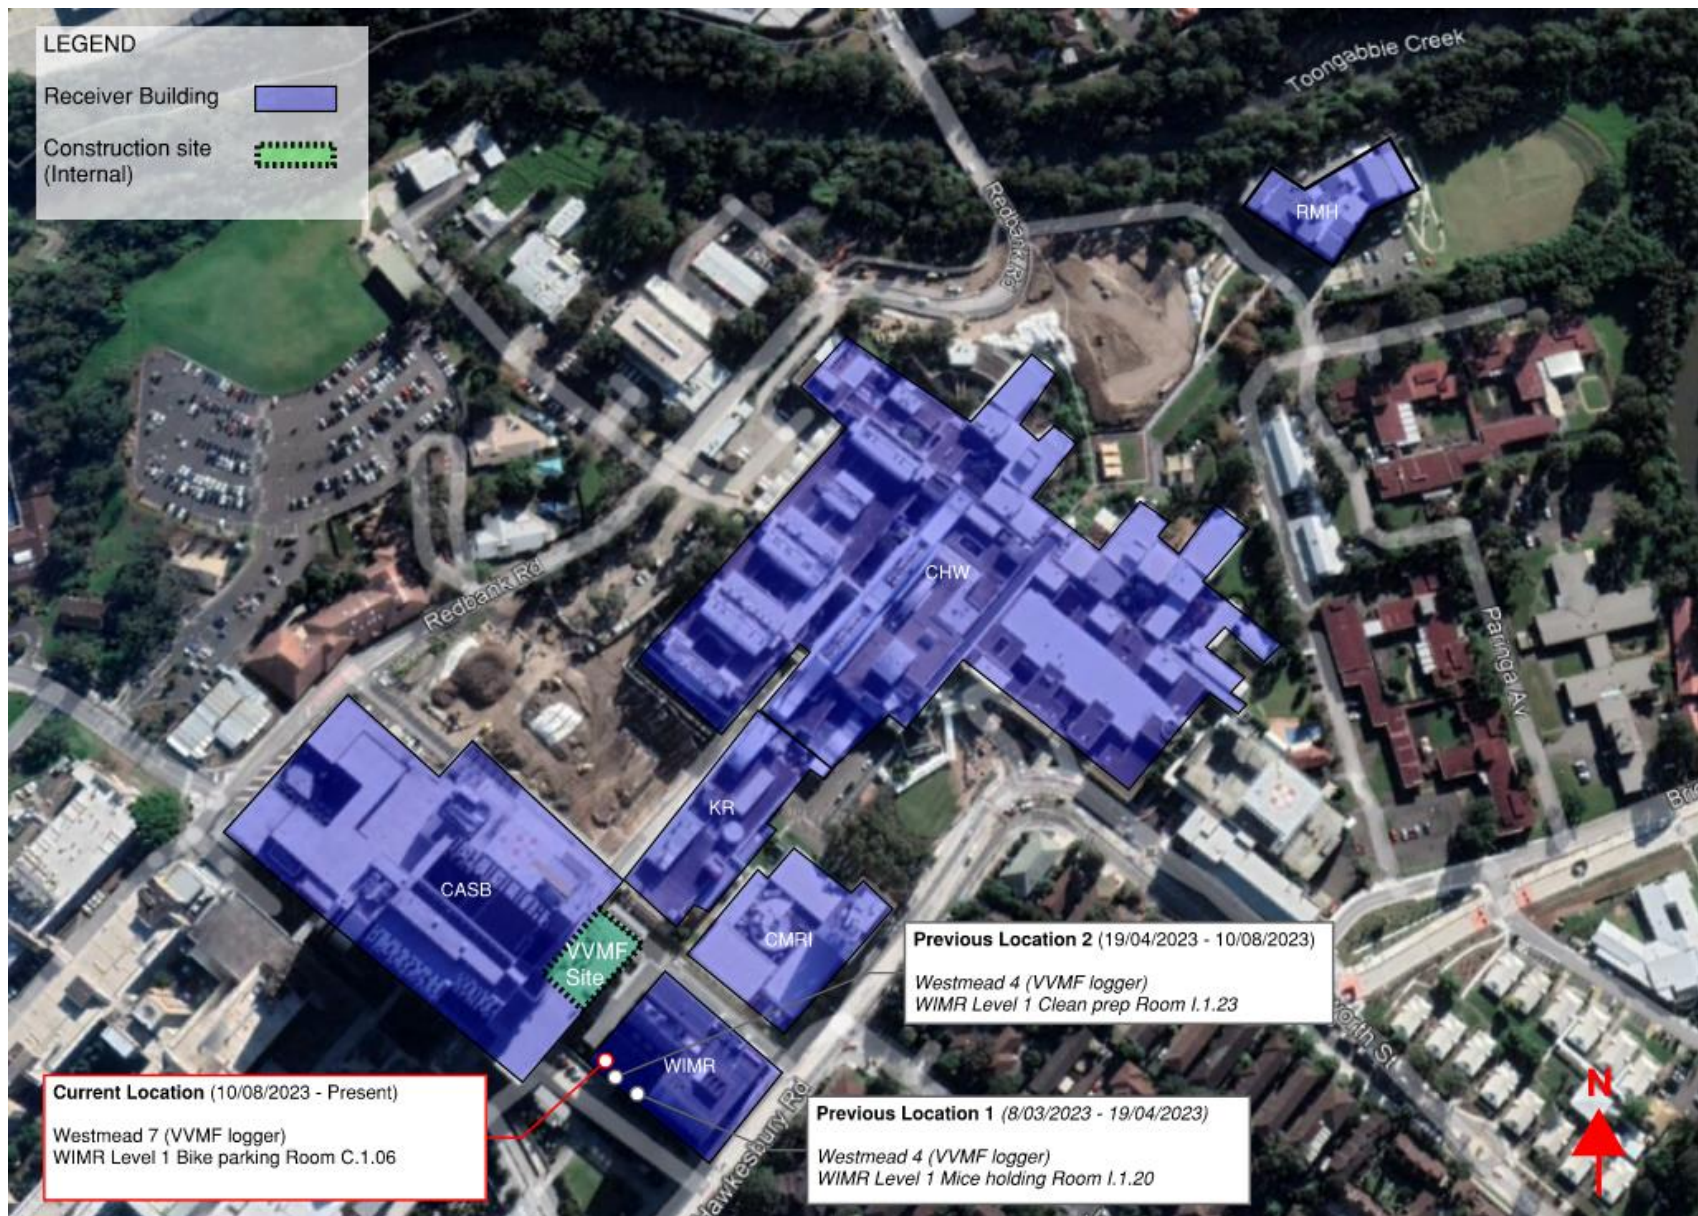
Figure 1: VVMF noise monitoring locations

One Acoustic Research Labs Ngara noise logger is installed at the location shown in Figure 1 below.

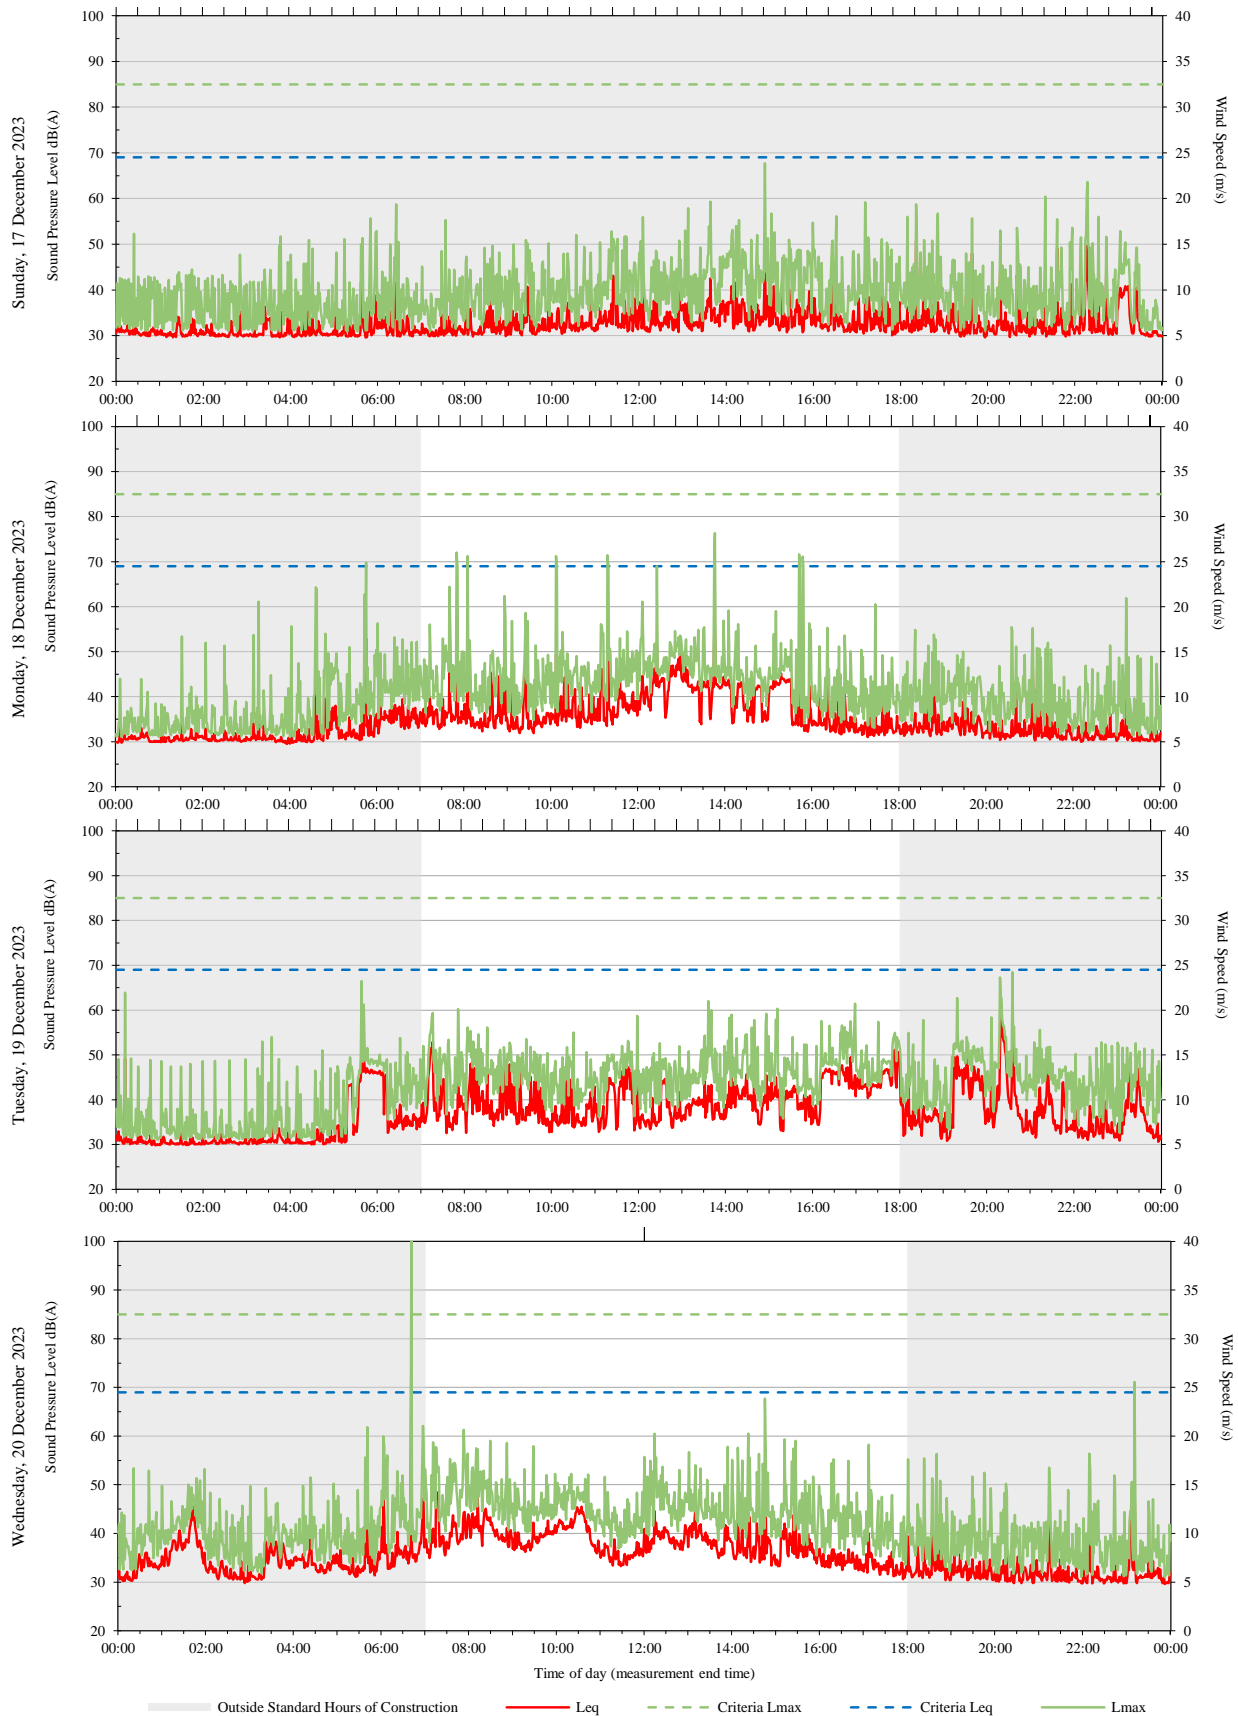
Unattended monitoring: WIMR Level 1 Bike Parking room (C.1.06) (Internal)

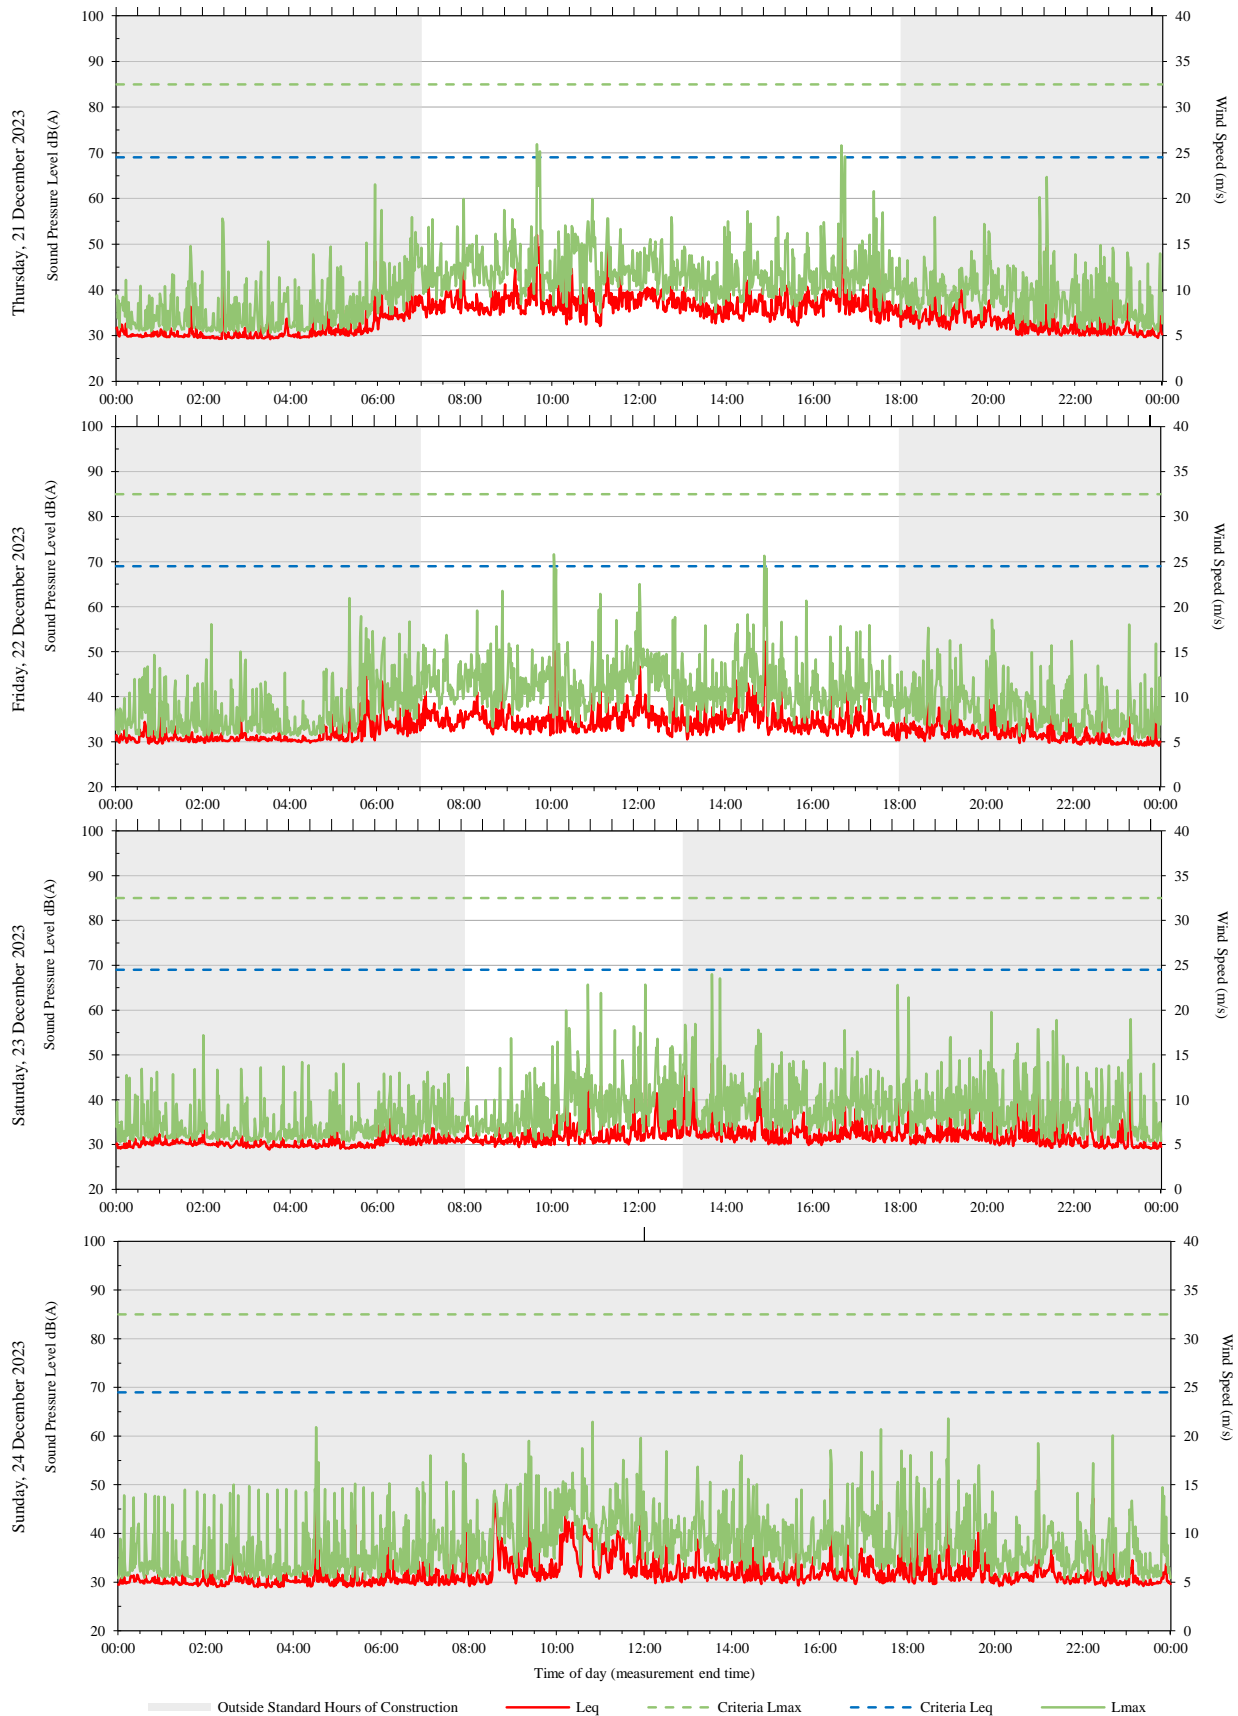
Unattended monitoring: WIMR Level 1 Bike Parking room (C.1.06) (Internal)

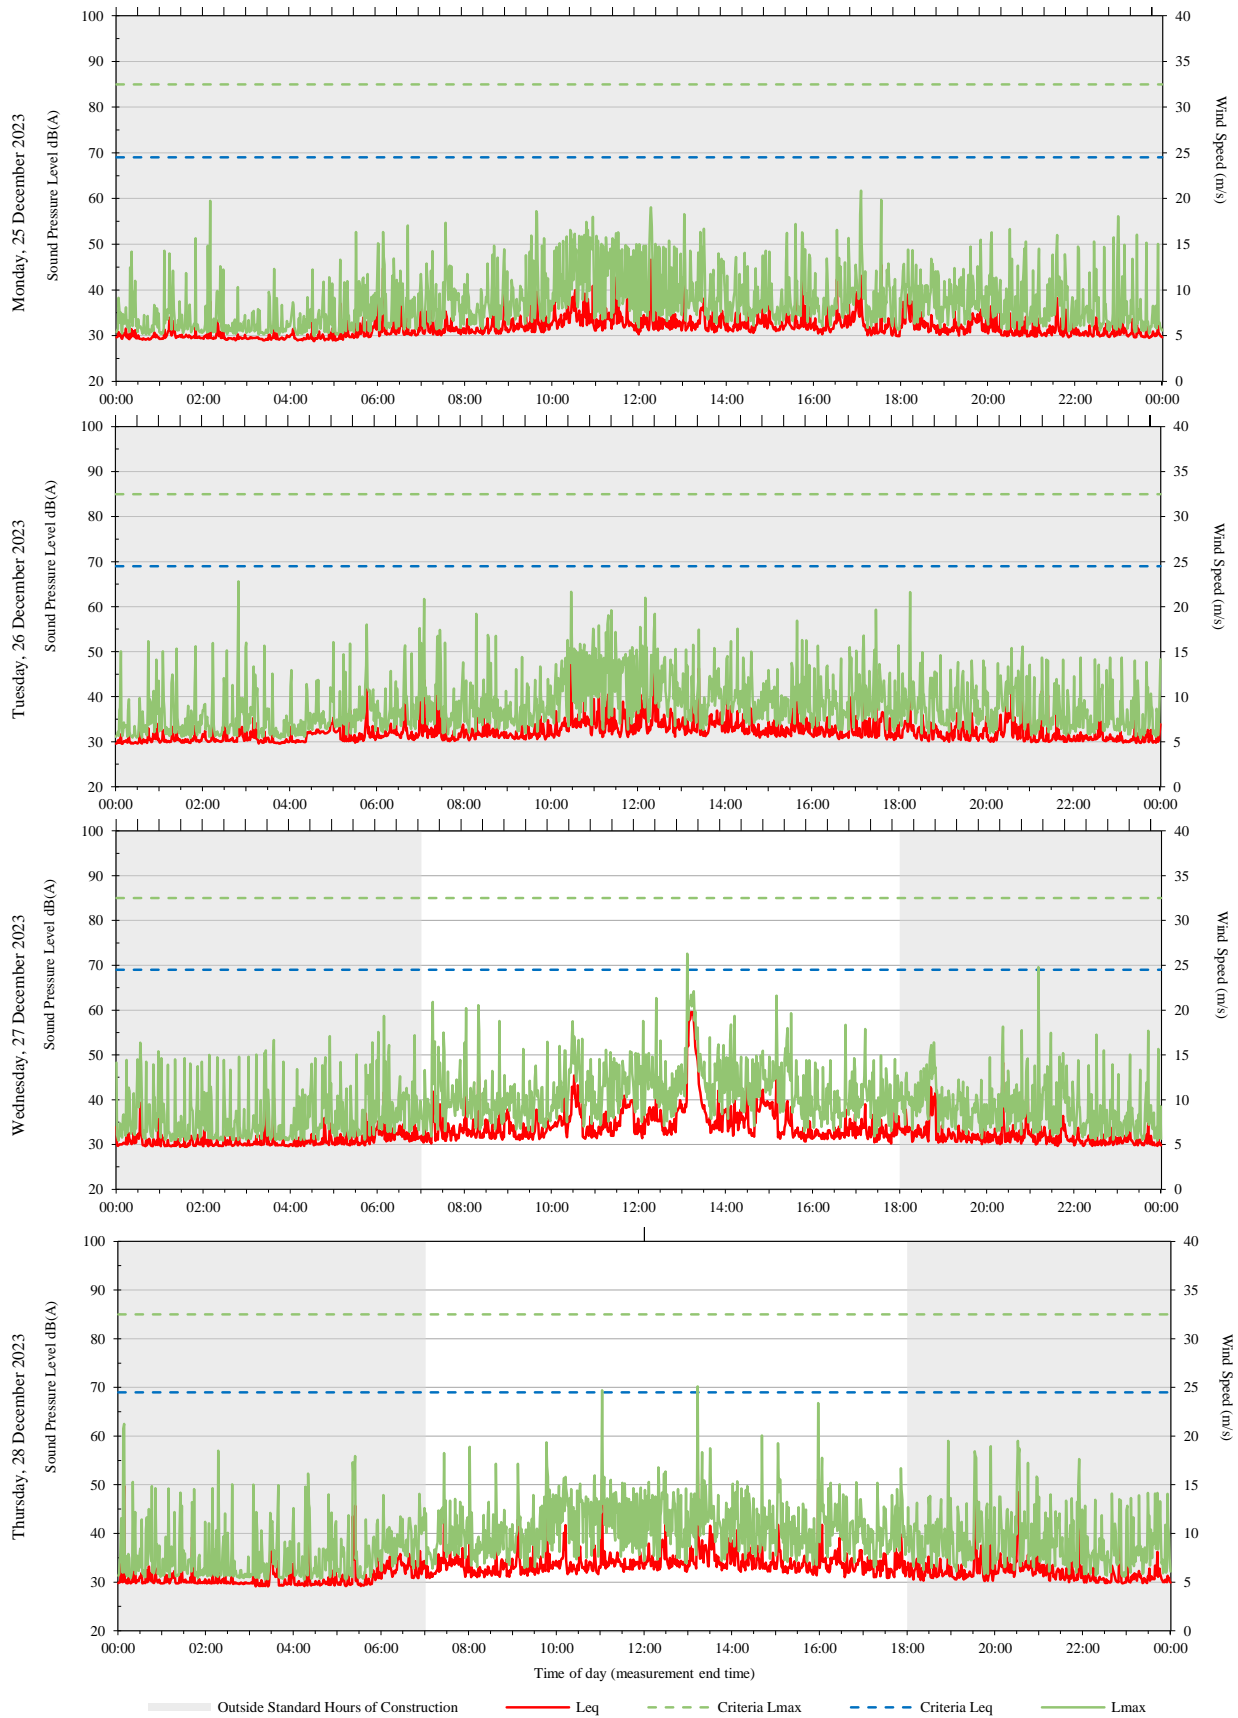
Unattended monitoring: WIMR Level 1 Bike Parking room (C.1.06) (Internal)

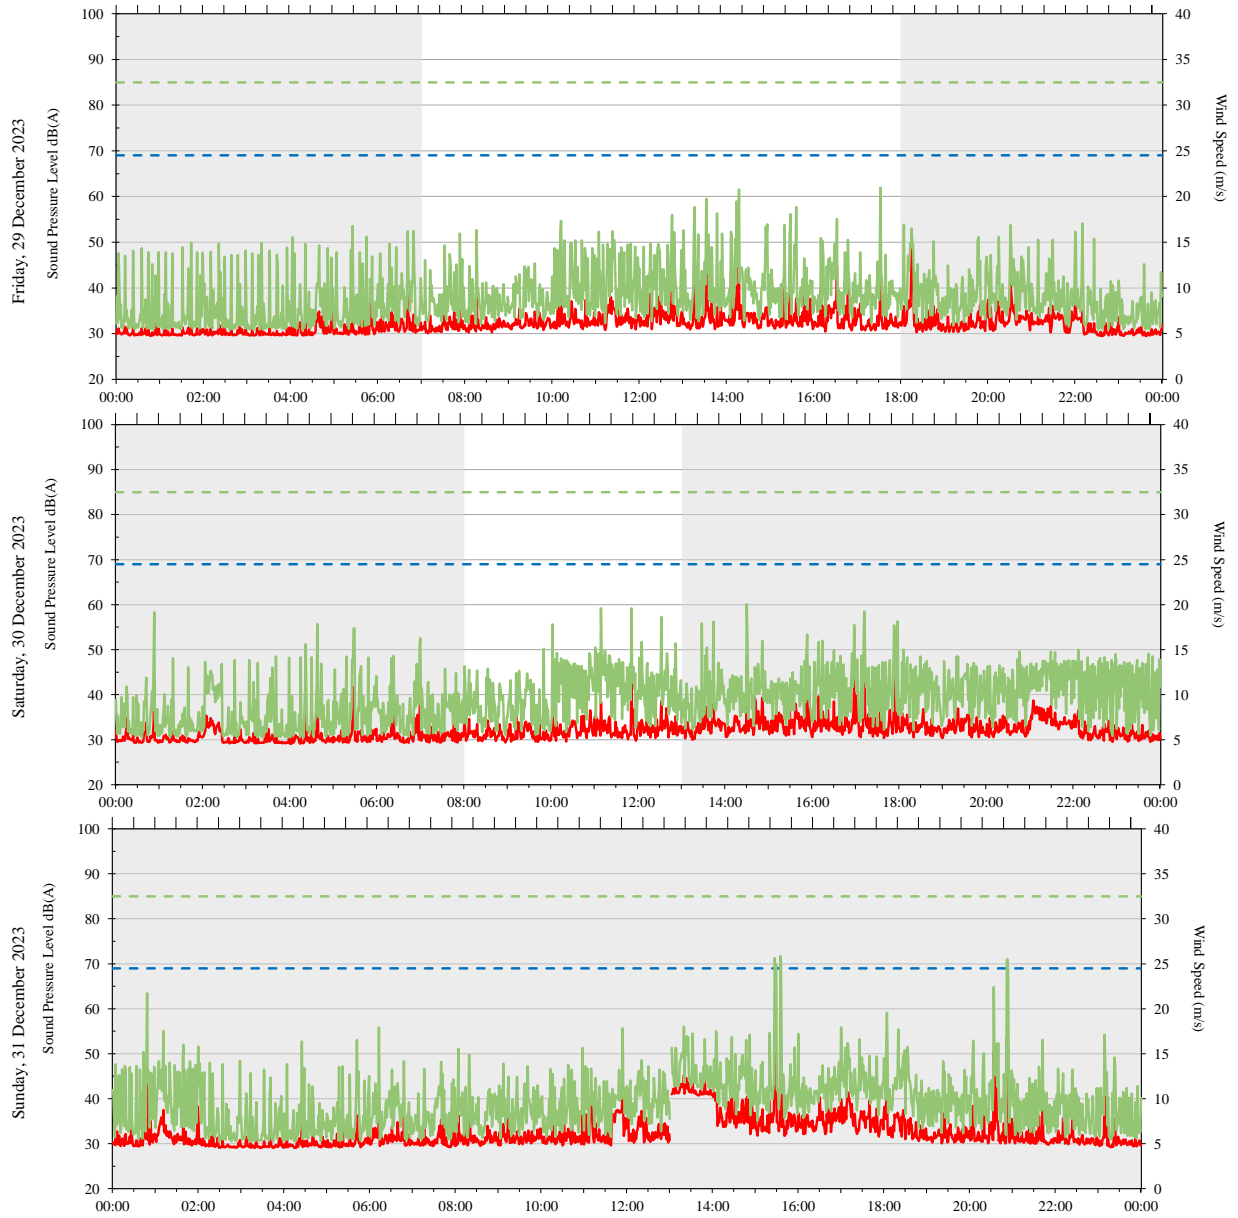
Unattended monitoring: WIMR Level 1 Bike Parking room (C.1.06) (Internal)

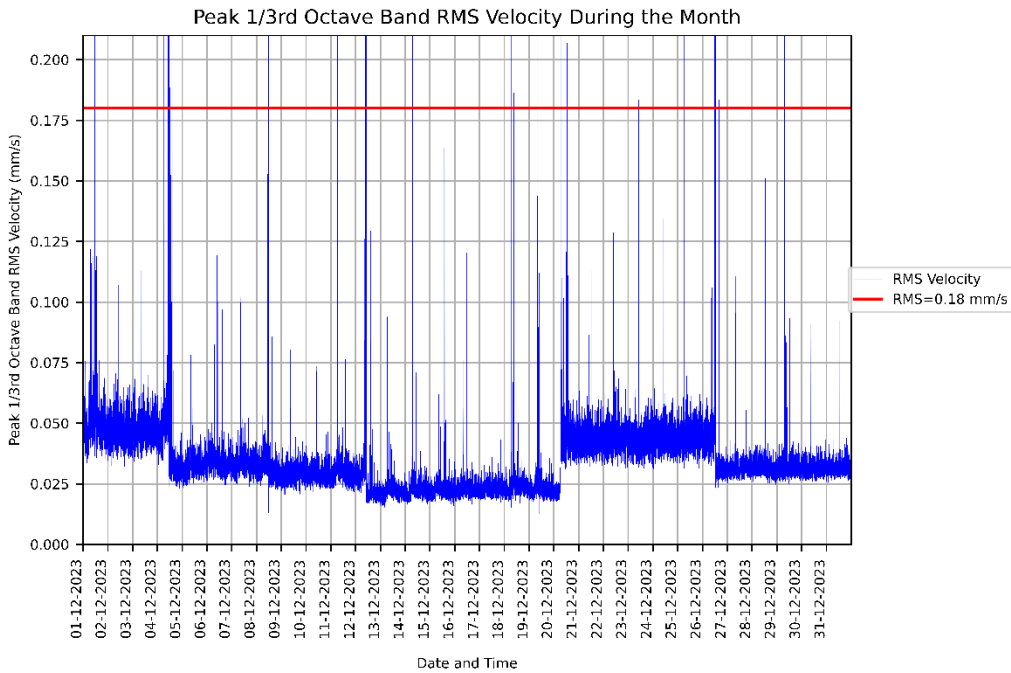
This report summarises the vibration monitoring data recorded at WIMR - BSF Mice Holding Room - Rack, over one month – from 01/12/2023 to 31/12/2023. Graphs in this report show the recorded data in blue, and exceedance trigger levels in red.

Figure 1: Measured RMSV vibration levels for 01/12/2023 to 31/12/2023 at the WIMR - BSF Mice Holding Room - Rack.

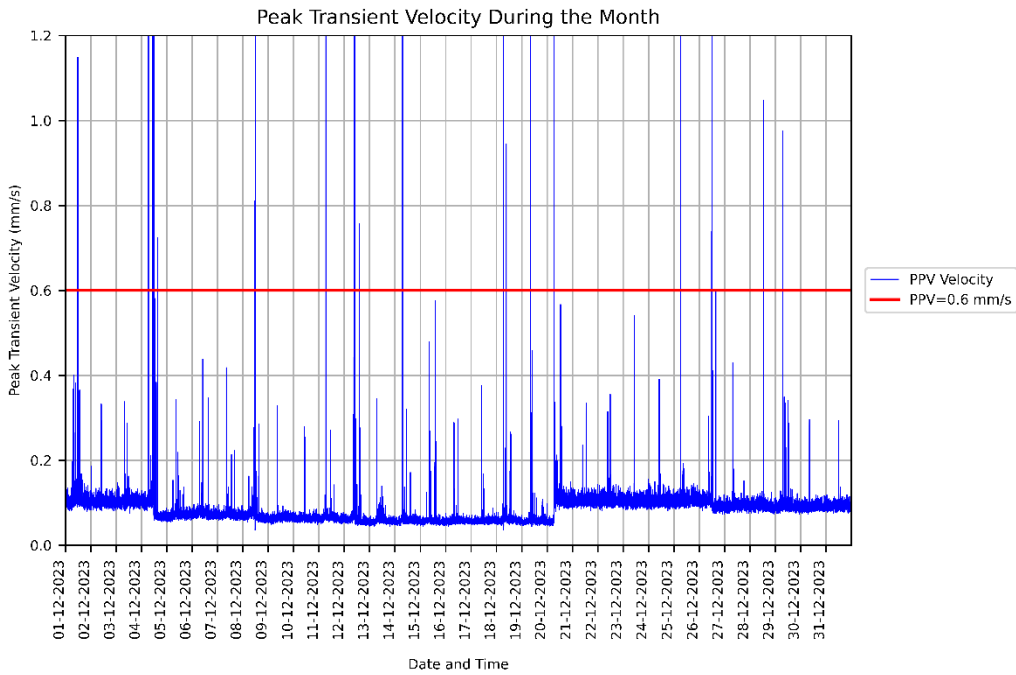
Figure 2: Measured vibration levels for 01/12/2023 to 31/12/2023 at the WIMR - BSF Mice Holding Room - Rack.

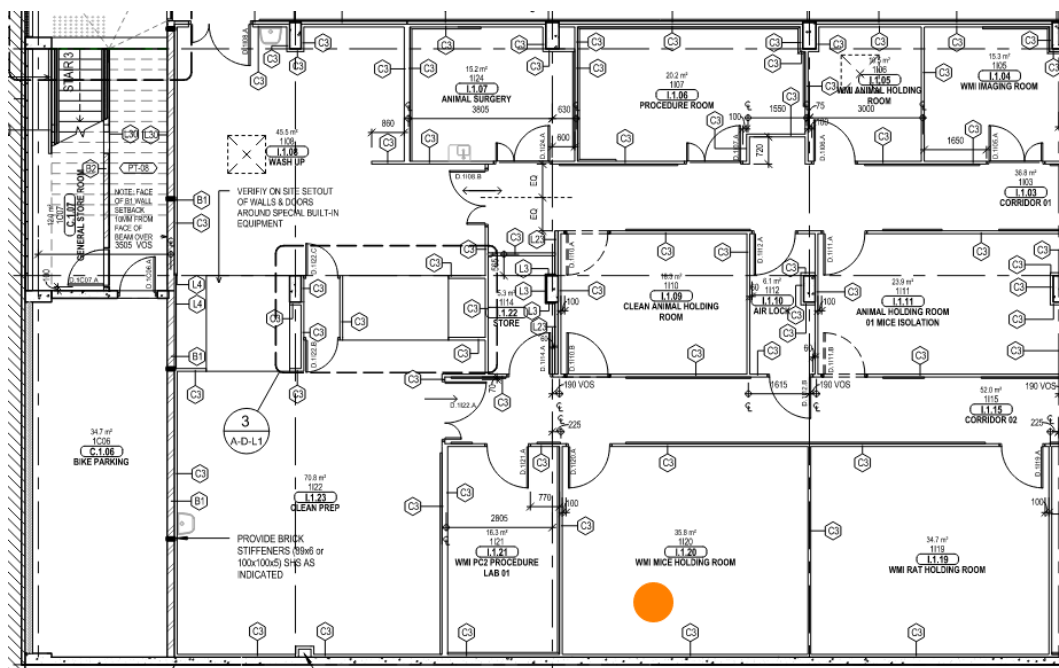
Figure 3: WIMR - BSF Mice Holding Room - Rack vibration monitor location

Monitoring at this location utilises a GeoSIG GMSplus with a GeoSIG VE-11 geophone. The calibration certificate for the geophone is included in Appendix A.

The location of this monitor is shown below in Figure 3.

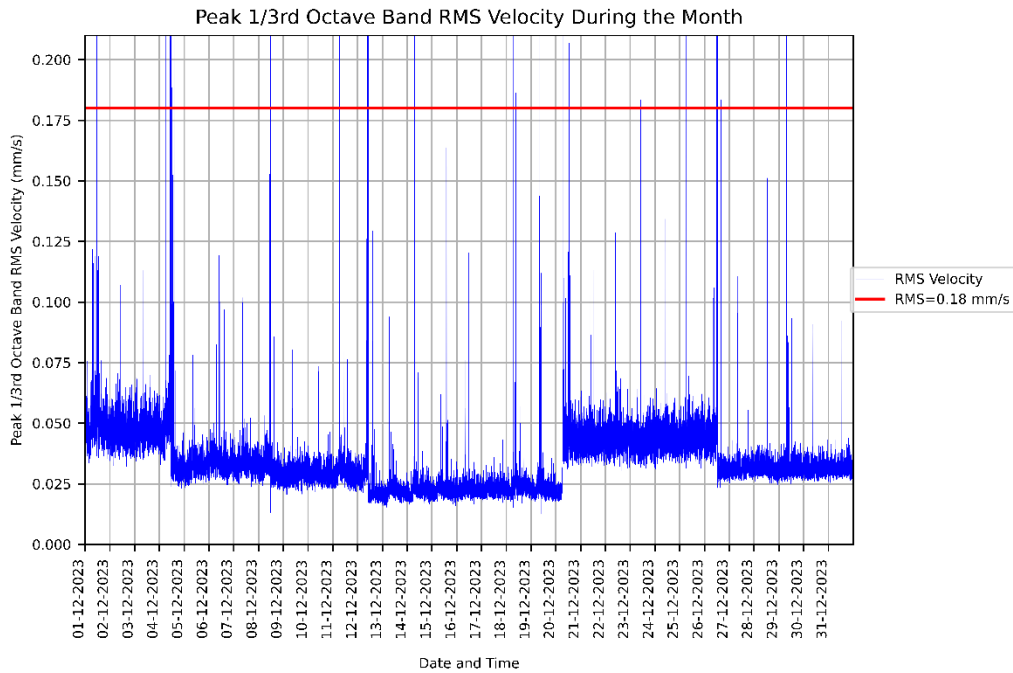
Figure 4 below shows the vibration levels (RMS velocity) recorded between 01/12/2023 and 31/12/2023. The recorded data is shown in blue, while the limit of 0.18mm/s (V_{RMS}) is shown in red.

Figure 4: Measured RMSV vibration levels for 01/12/2023 to 31/12/2023 at the WIMR - BSF Mice Holding Room - Rack.

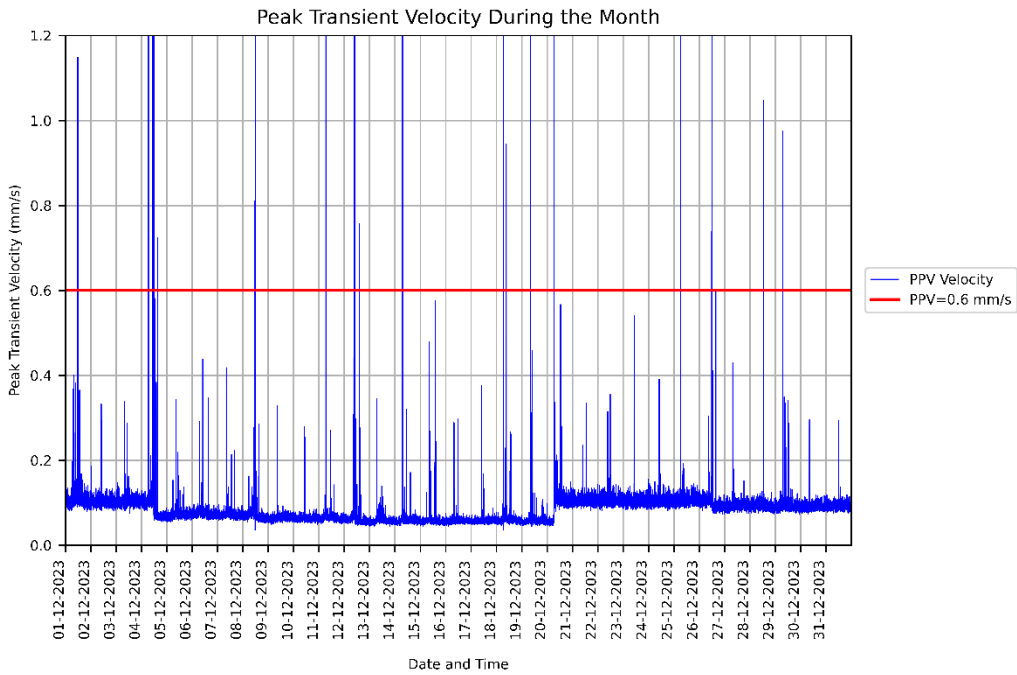
Figure 5 below shows the peak particle vibration levels (PPV velocity) recorded between 01/12/2023 and 31/12/2023. The recorded data is shown in blue, while the limit of 0.6mm/s (V_{PPV}) is shown in red.

Figure 5: Measured PPV vibration levels for 01/12/2023 to 31/12/2023 at the WIMR - BSF Mice Holding Room - Rack.

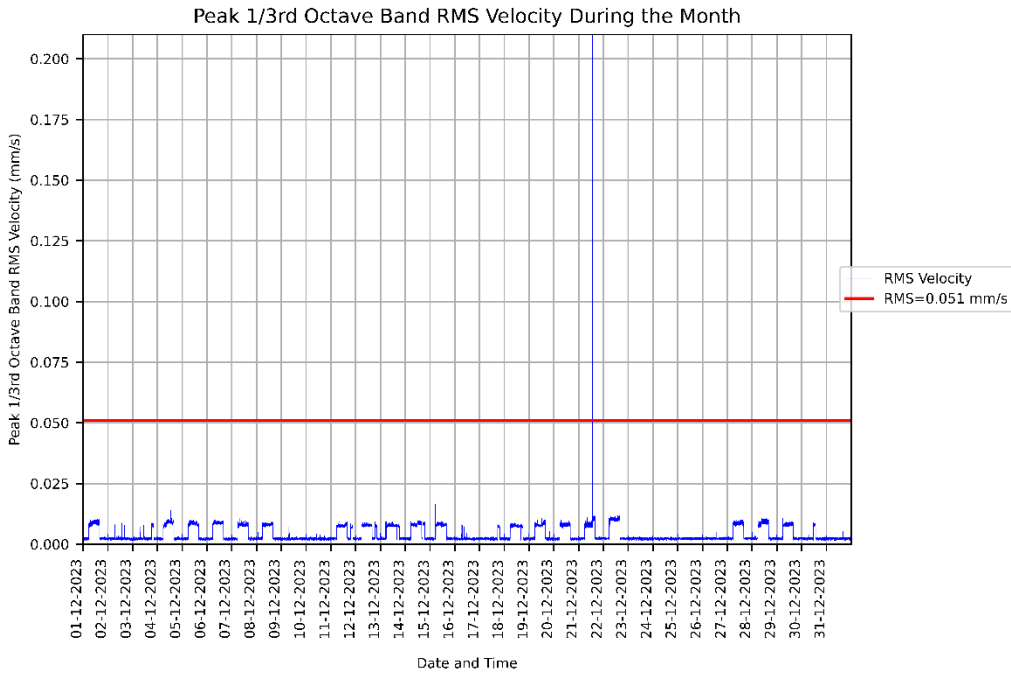
This report summarises the vibration monitoring data recorded at CMRI Animal Holding Facility, over one month – from 01/12/2023 to 31/12/2023. Graphs in this report show the recorded data in blue, and exceedance trigger levels in red.

Figure 1: Measured RMSV vibration levels for 01/12/2023 to 31/12/2023 at the CMRI Animal Holding Facility.

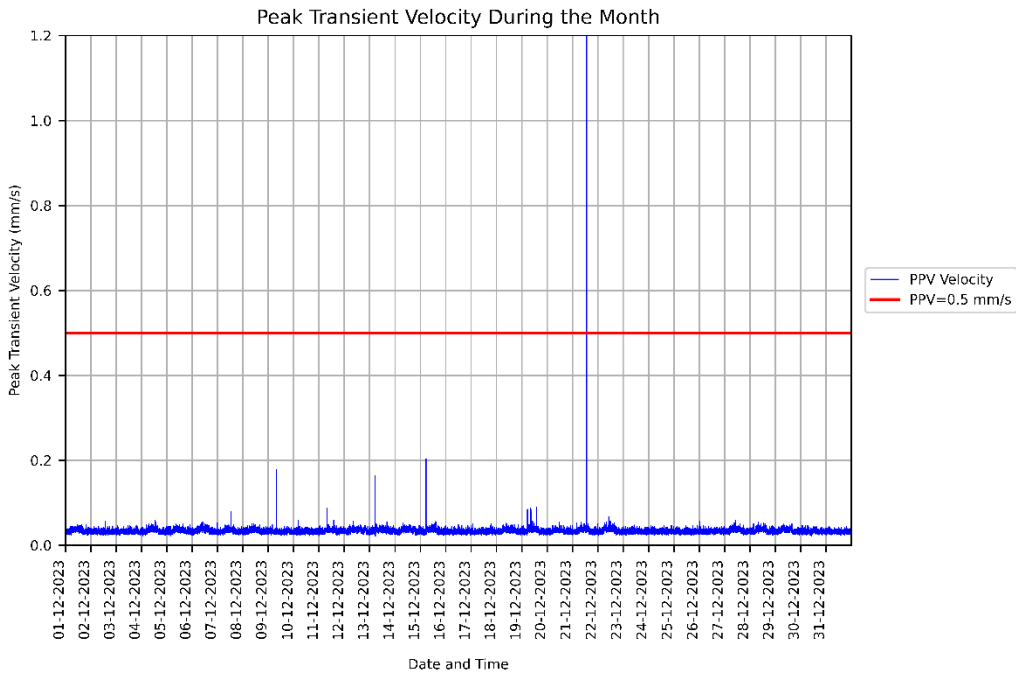
Figure 2: Measured vibration levels for 01/12/2023 to 31/12/2023 at the CMRI Animal Holding Facility.

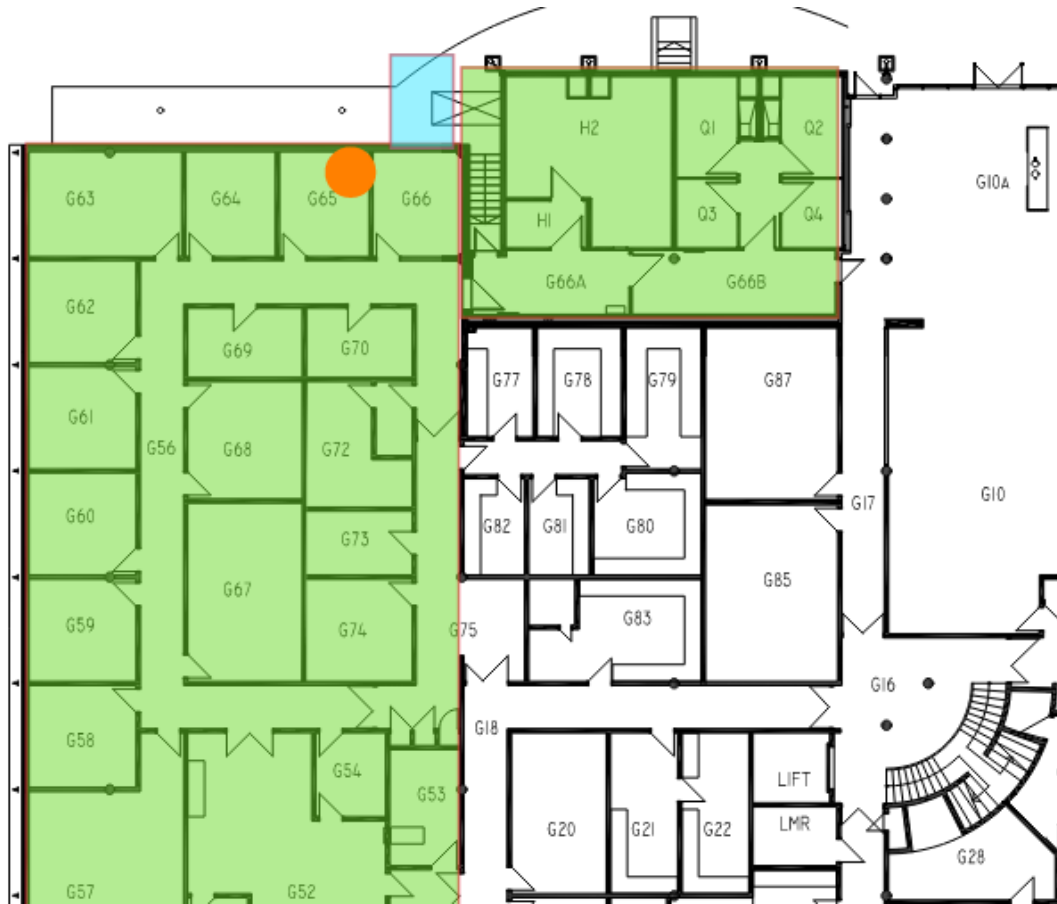
Figure 3: CMRI Animal Holding Facility vibration monitor location

Monitoring at this location utilises a GeoSIG GMSplus with a GeoSIG VE-11 geophone. The calibration certificate for the geophone is included in Appendix A.

The location of this monitor is shown below in Figure 3.

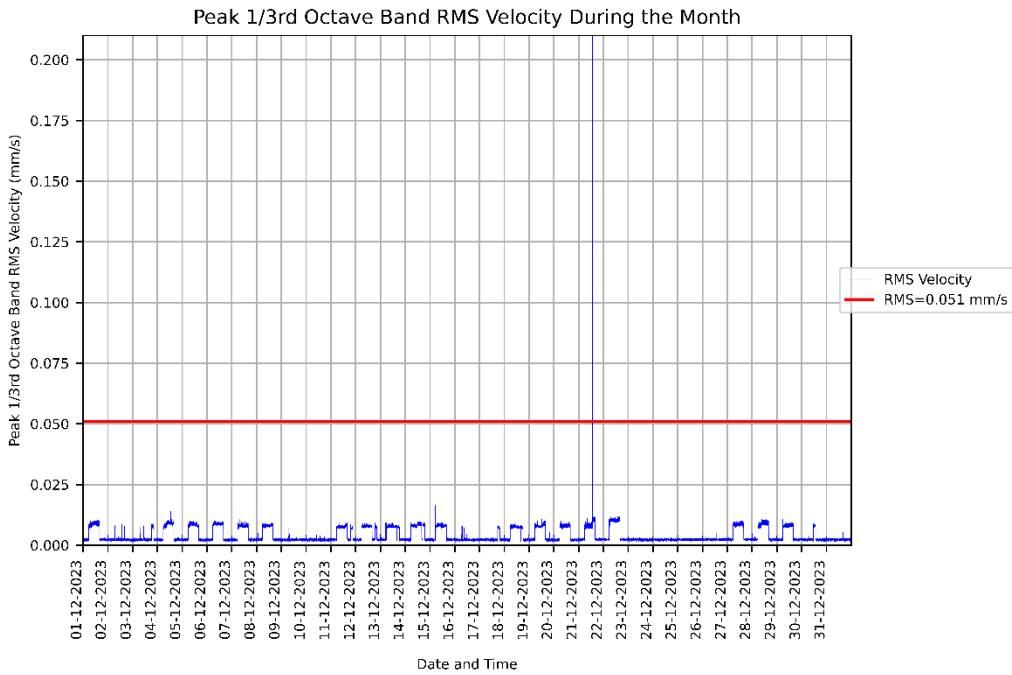
Figure 4 below shows the vibration levels (RMS velocity) recorded between 01/12/2023 and 31/12/2023. The recorded data is shown in blue, while the limit of 0.051mm/s (V_{RMS}) is shown in red.

Figure 4: Measured RMSV vibration levels for 01/12/2023 to 31/12/2023 at the CMRI Animal Holding Facility.

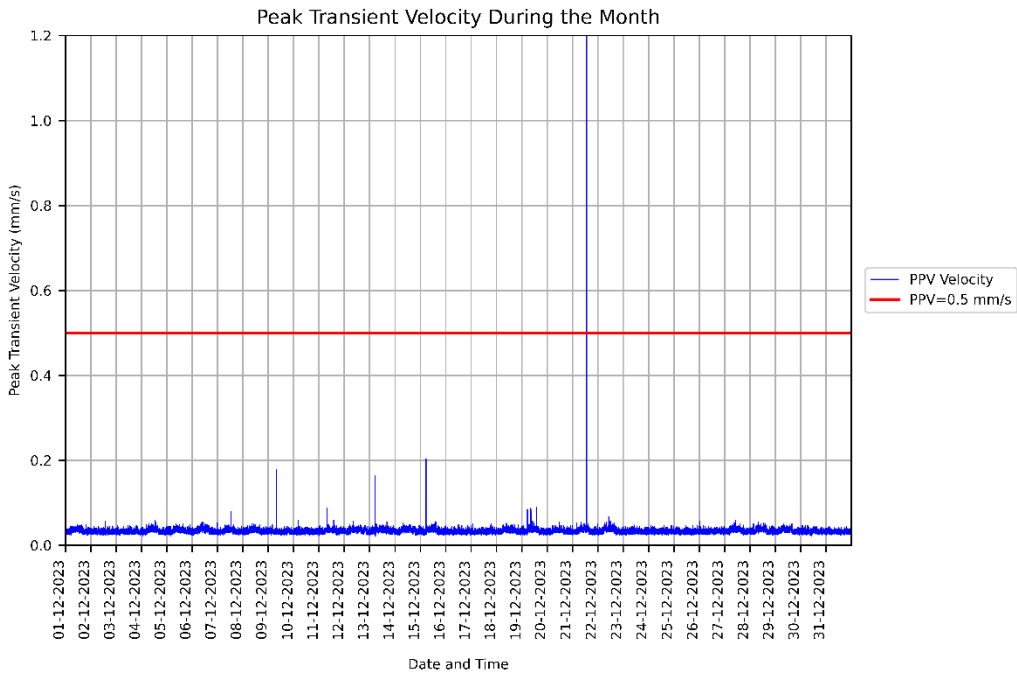
Figure 5 below shows the peak particle vibration levels (PPV velocity) recorded between 01/12/2023 and 31/12/2023. The recorded data is shown in blue, while the limit of 0.5mm/s (V_{PPV}) is shown in red.

Figure 5: Measured PPV vibration levels for 01/12/2023 to 31/12/2023 at the CMRI Animal Holding Facility.

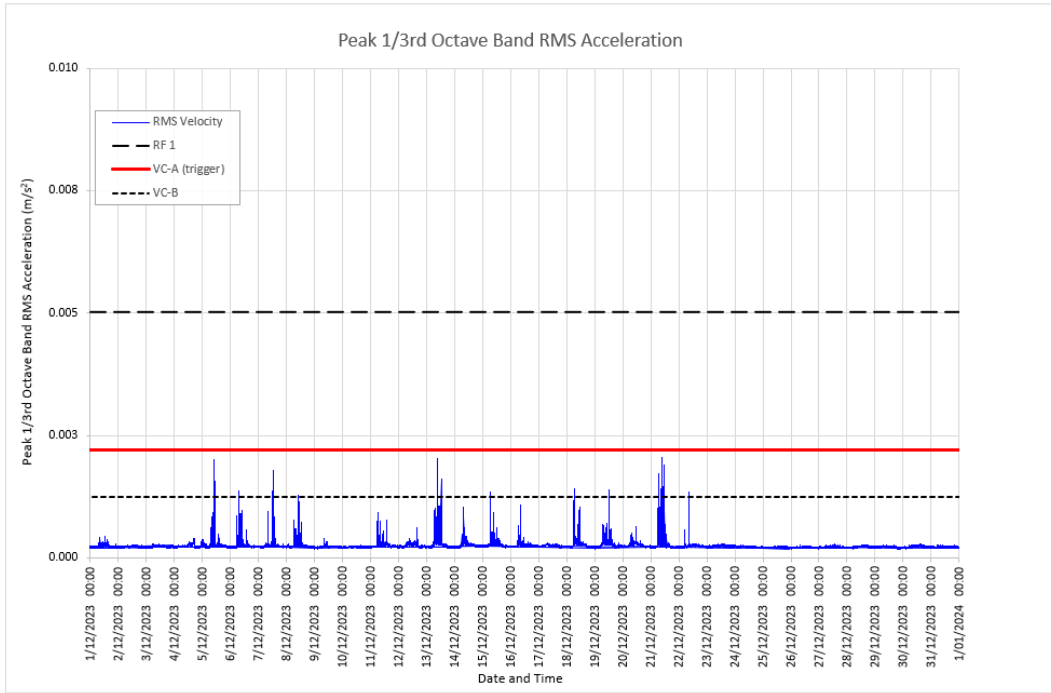
Figure 1: Measured RMS acceleration vibration levels at the KR L4.

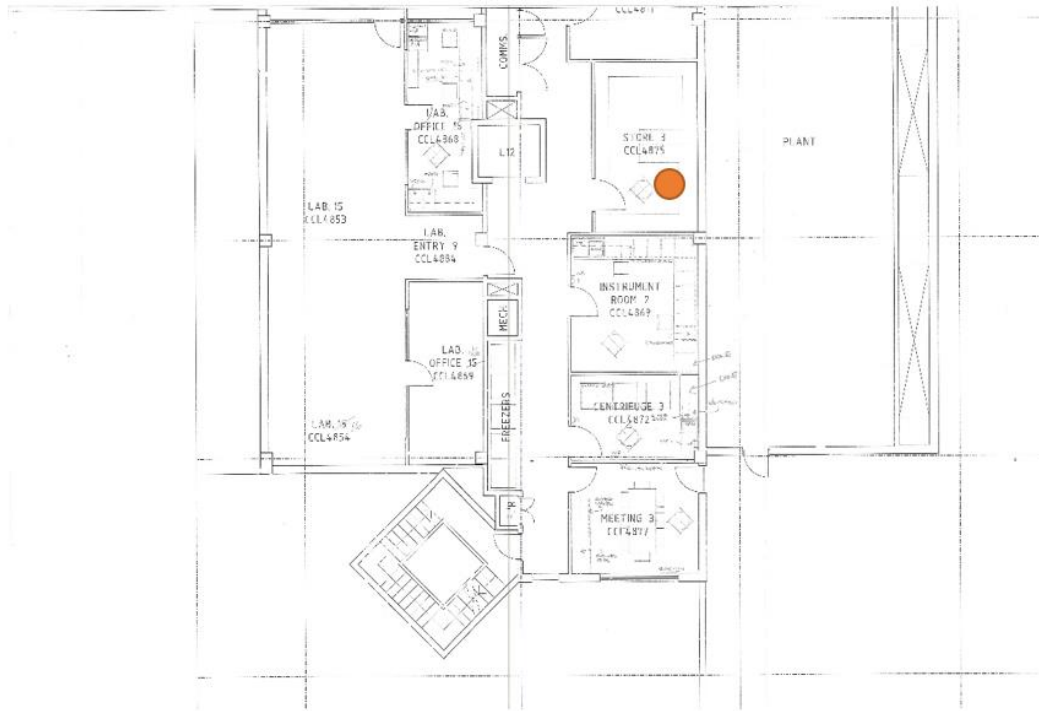
Figure 2: KR – L4 vibration monitor location

Monitoring at this location utilises a SVAN 958AG (SN 59827) with a triaxial accelerometer (SA207B).

The location of this monitor is shown below in Figure 2.
