Health Infrastructure NSW
Westmead PSB and MSCP
Construction Noise Monitoring

Noise monitoring report
2023-12-01 to 2023-12-31

Westmead VVMF Construction Noise Monitoring

Noise monitoring report 2023-12-01 to 2023-12-31

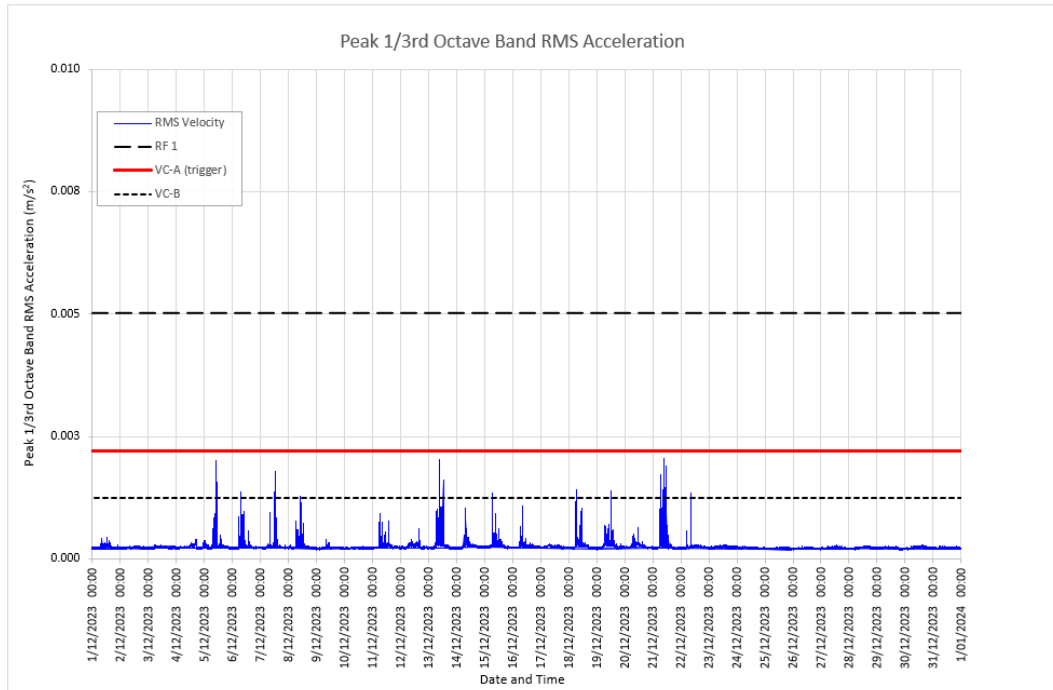
Figure 3 below shows the vibration levels (RMS acceleration) recorded between 01/12/2023 and 31/12/2023. The recorded data is shown in blue, while the limit of 0.0025 m/s^2 (VC-A) is shown in red.

Figure 3: Measured RMS acceleration vibration levels for 01/12/2023 to 31/12/2023 at KR – L4.

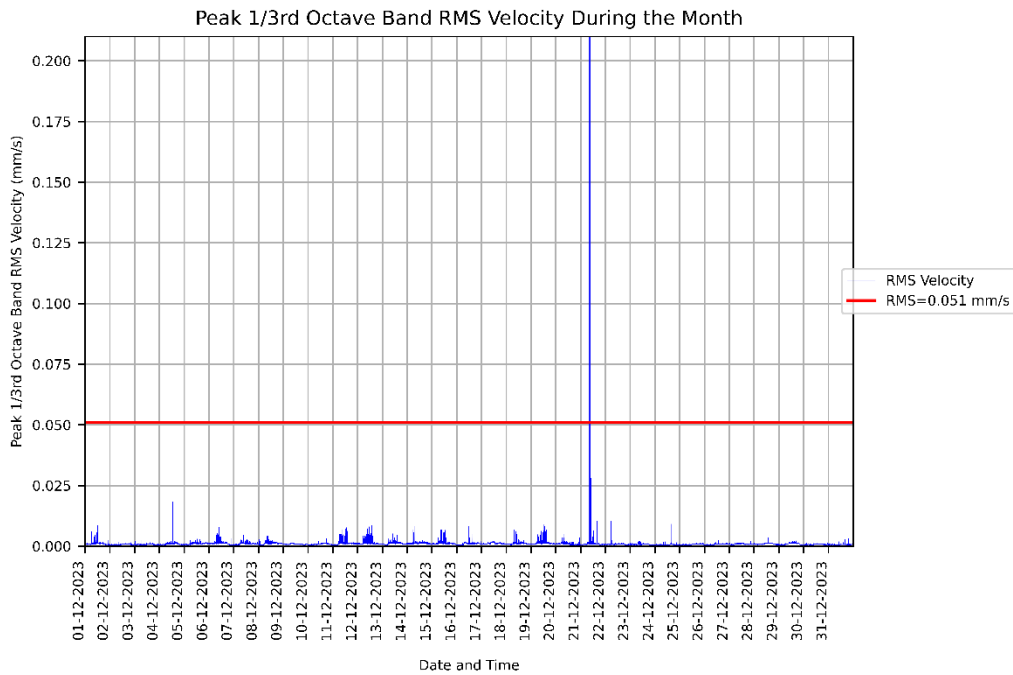
Measurements on 22 December 2023 should be ignored. During this period calibrations were undertaken that required excitation of the monitor.

Figure 1: Measured RMSV vibration levels for 01/12/2023 to 31/12/2023 at the SCHN - 1.5t MRI.

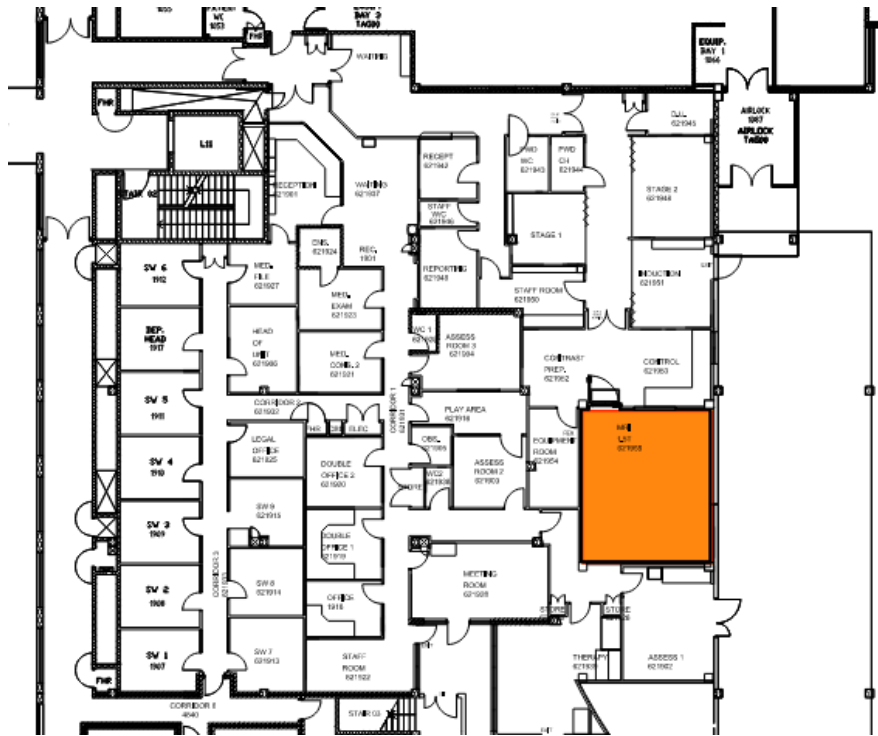
Figure 3: SCHN - 1.5t MRI vibration monitor location

Monitoring at this location utilises a GeoSIG GMSplus with a GeoSIG VE-11 geophone. The calibration certificate for the geophone is included in Appendix A.

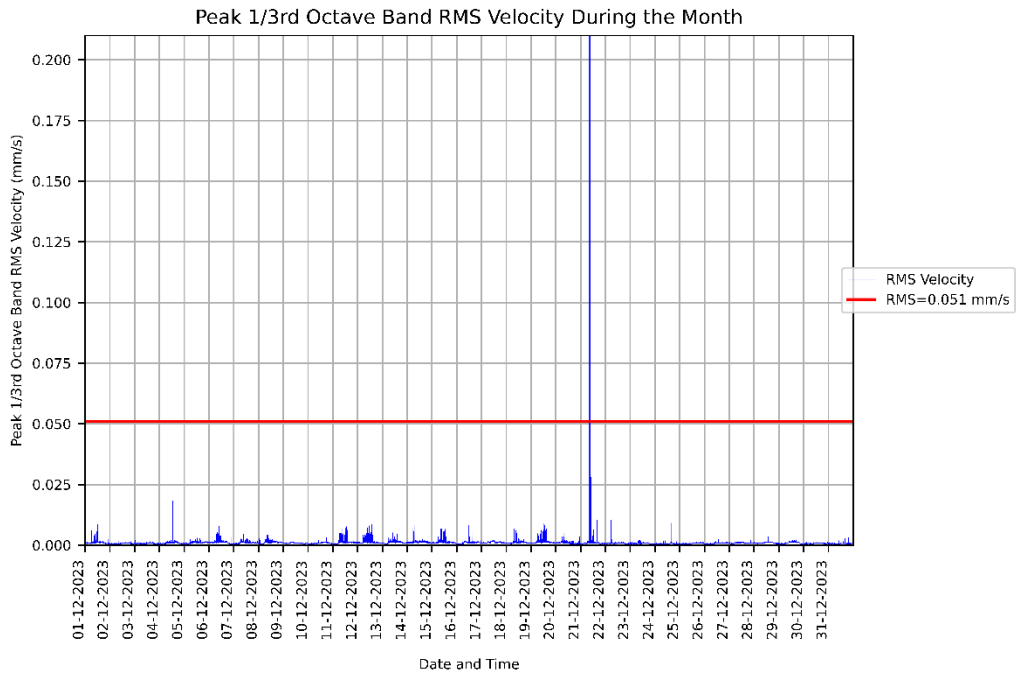
Figure 4 below shows the vibration levels (RMS velocity) recorded between 01/12/2023 and 31/12/2023. The recorded data is shown in blue, while the limit of 0.051mm/s (V_{RMS}) is shown in red.

Measurements on 22 December 2023 should be ignored. During this period calibrations were undertaken that required excitation of the monitor.

Figure 4: Measured RMSV vibration levels for 01/12/2023 to 31/12/2023 at the SCHN - 1.5t MRI.

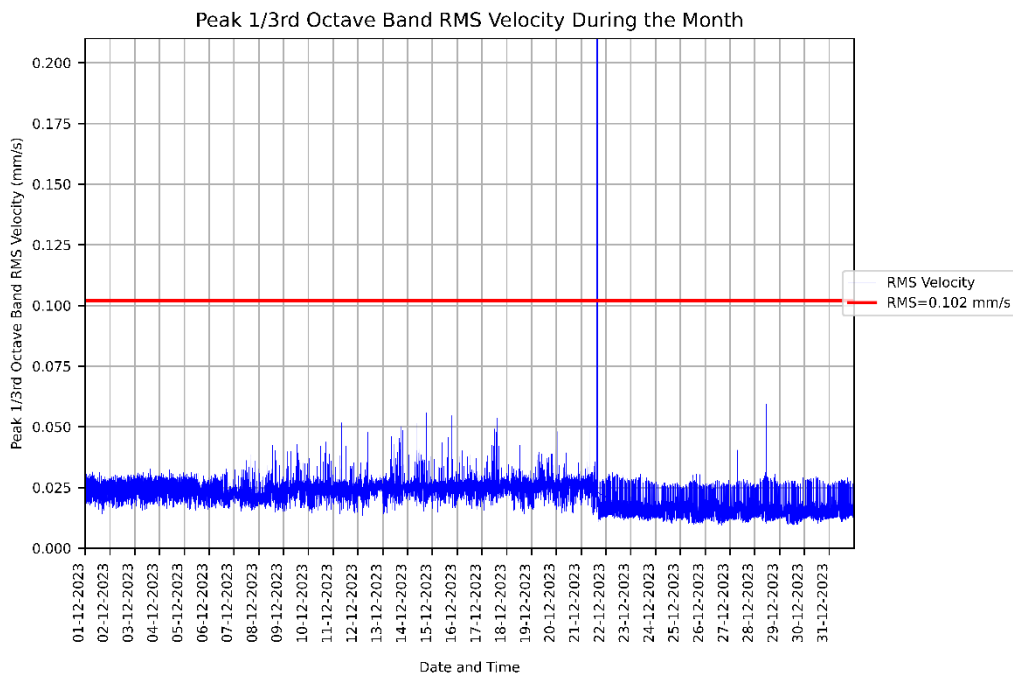
Measurements on 22 December 2023 should be ignored. During this period calibrations were undertaken that required excitation of the monitor. After this period, the vibration monitor was relocated to the Multi-Equipment Room 3 on Level 3 in KR, hence the slight shift in vibration magnitudes.

Figure 1: Measured RMSV vibration levels for 01/12/2023 to 31/12/2023 at the KR - Gait Lab.

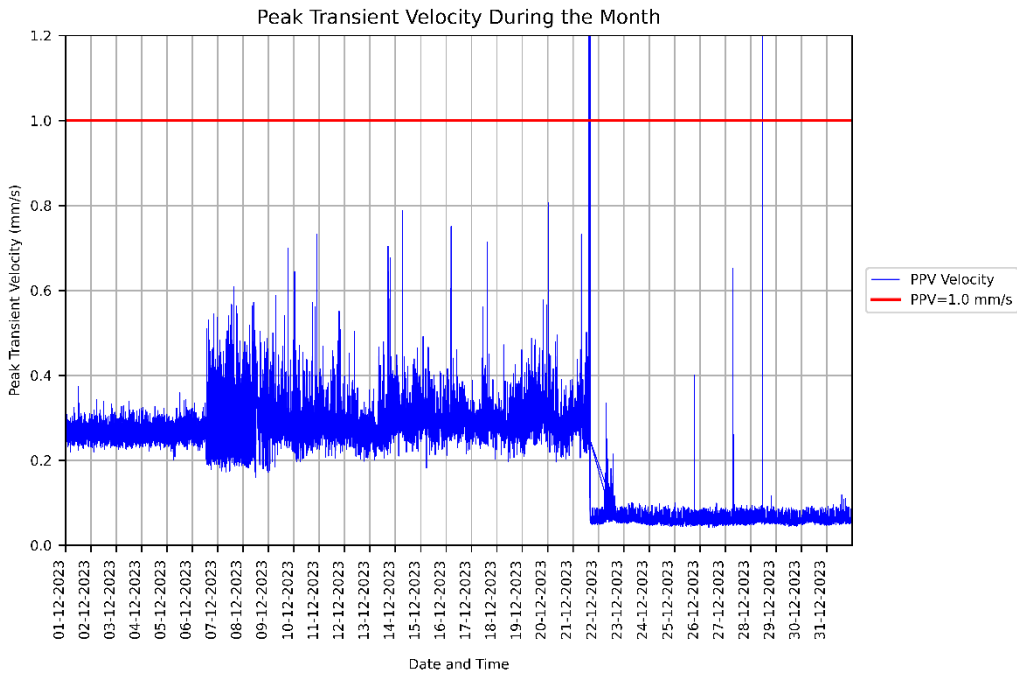
Figure 2: Measured vibration levels for 01/12/2023 to 31/12/2023 at the KR - Gait Lab.

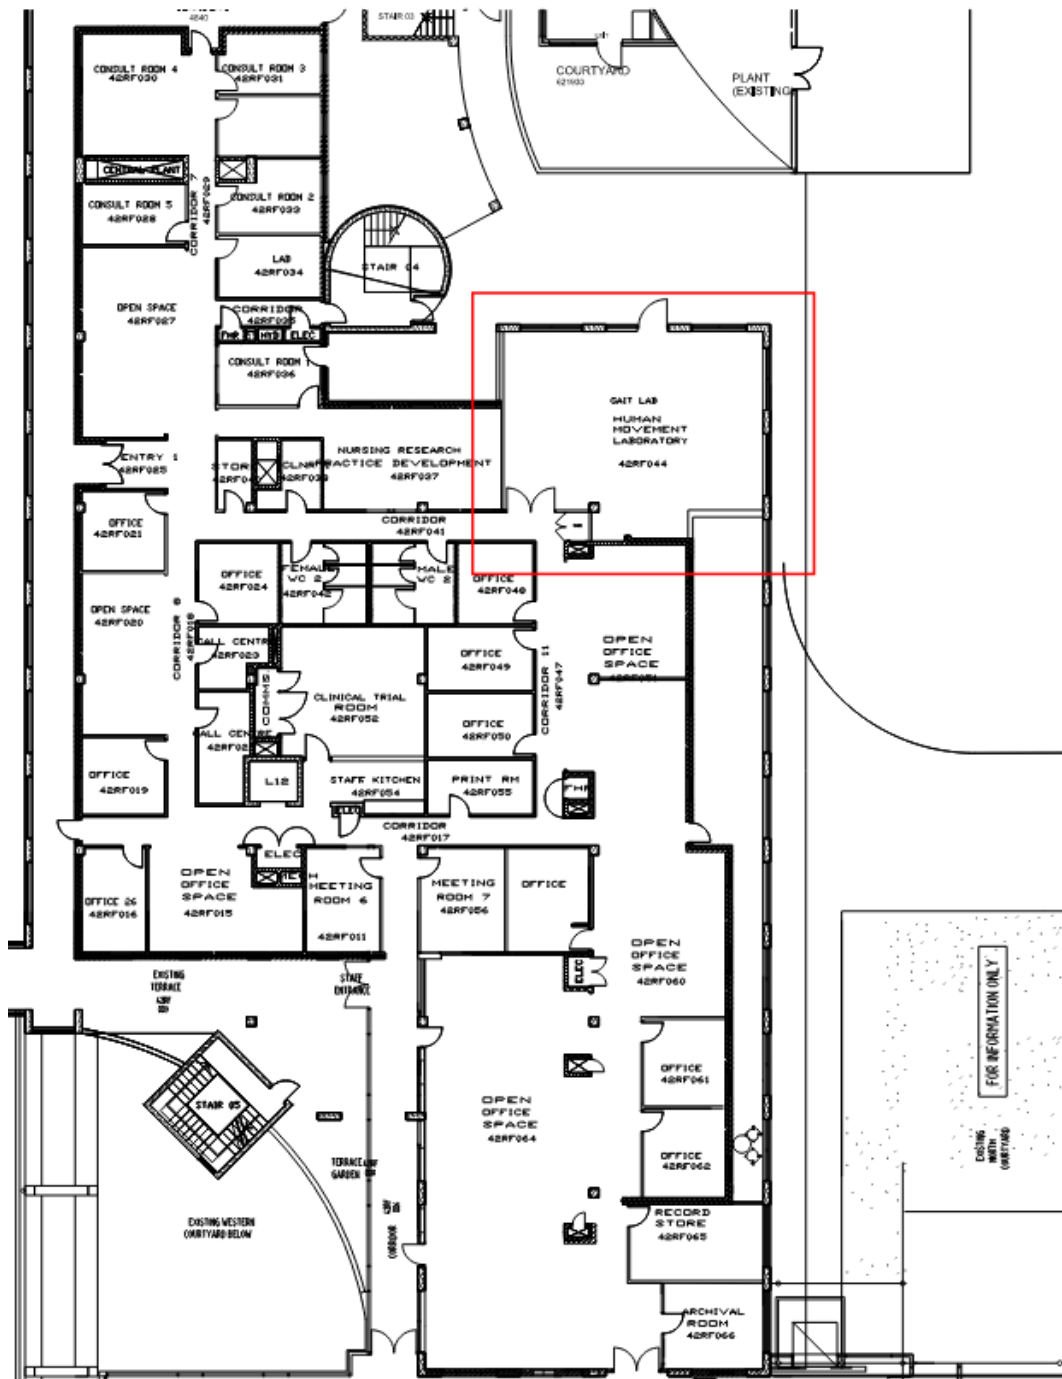
Figure 3: KR - Gait Lab vibration monitor location

Monitoring at this location utilises a GeoSIG GMSplus with a GeoSIG VE-11 geophone. The calibration certificate for the geophone is included in Appendix A.

The location of this monitor is shown below in Figure 3.

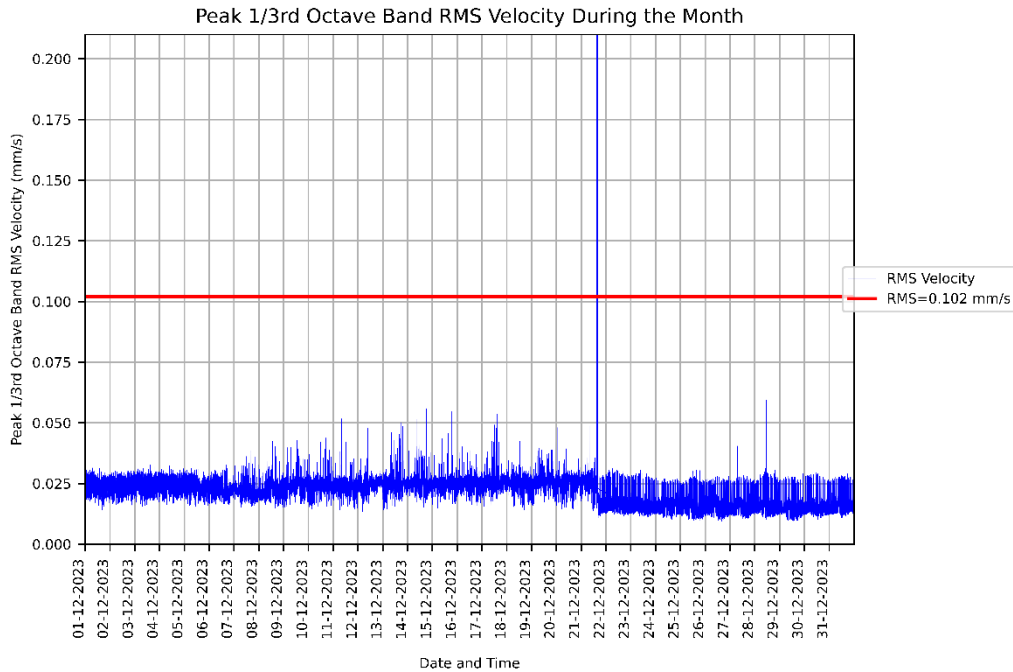
Figure 4 below shows the vibration levels (RMS velocity) recorded between 01/12/2023 and 31/12/2023. The recorded data is shown in blue, while the limit of 0.102mm/s (V_{RMS}) is shown in red.

Measurements on 22 December 2023 should be ignored. During this period calibrations were undertaken that required excitation of the monitor. After this period, the vibration monitor was relocated to the Multi-Equipment Room 3 on Level 3 in KR, hence the slight shift in vibration magnitudes.

Figure 4: Measured RMSV vibration levels for 01/12/2023 to 31/12/2023 at the KR - Gait Lab.

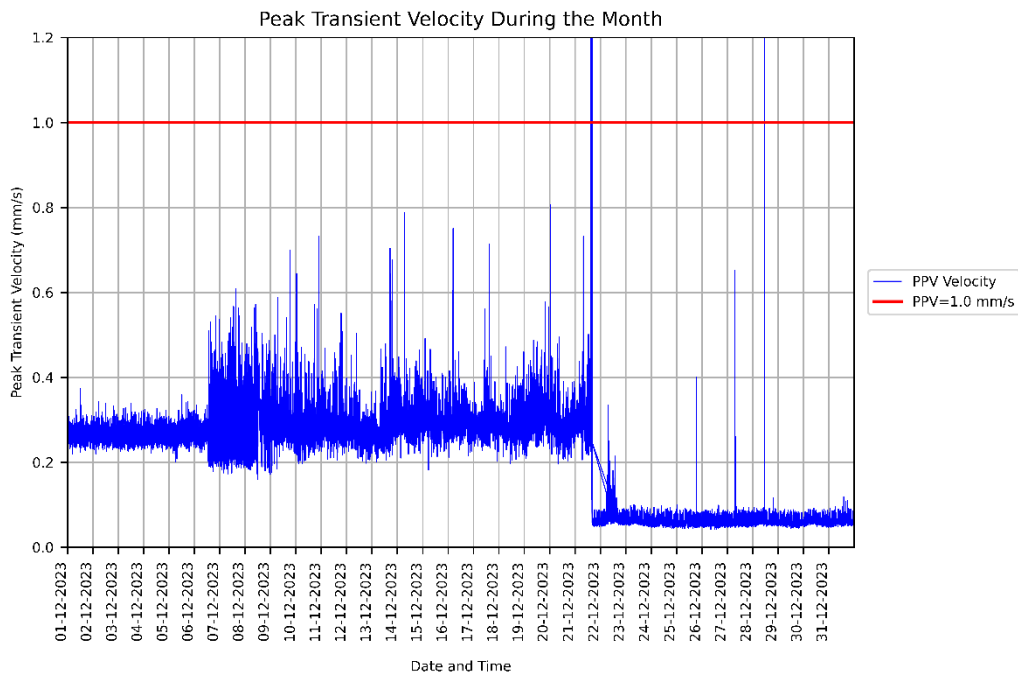
Figure 5 below shows the peak particle vibration levels (PPV velocity) recorded between 01/12/2023 and 31/12/2023. The recorded data is shown in blue, while the limit of 1.0mm/s (V_{PPV}) is shown in red.

Figure 5: Measured PPV vibration levels for 01/12/2023 to 31/12/2023 at the KR - Gait Lab.

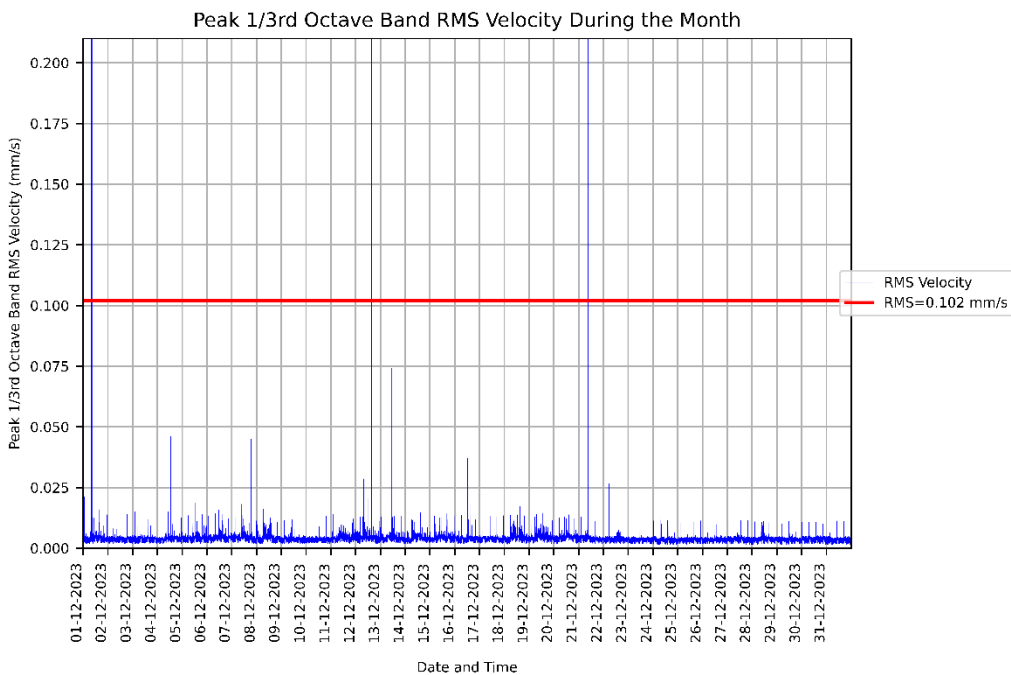
Measurements on 22 December 2023 should be ignored. During this period calibrations were undertaken that required excitation of the monitor.

Figure 1: Measured RMSV vibration levels for 01/12/2023 to 31/12/2023 at the SCHN L1 Endocrinology Lab.

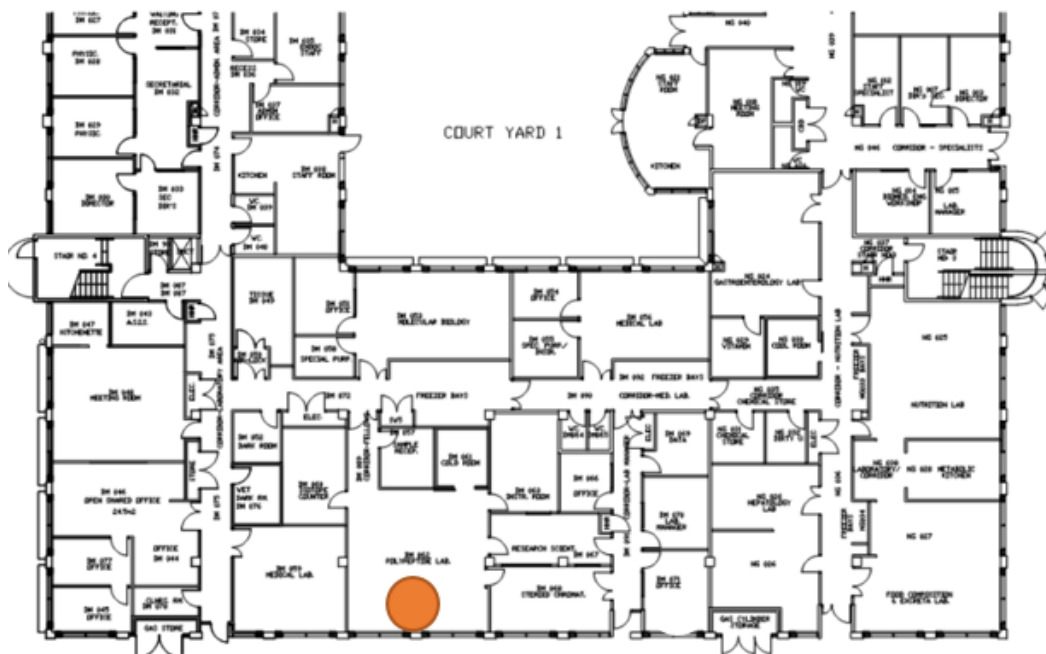
Figure 3: SCHN L1 Endocrinology Lab vibration monitor location shown in orange

Monitoring at this location utilises a GeoSIG GMSplus with a GeoSIG VE-11 geophone. The calibration certificate for the geophone is included in Appendix A.

The location of this monitor is shown below in Figure 3.

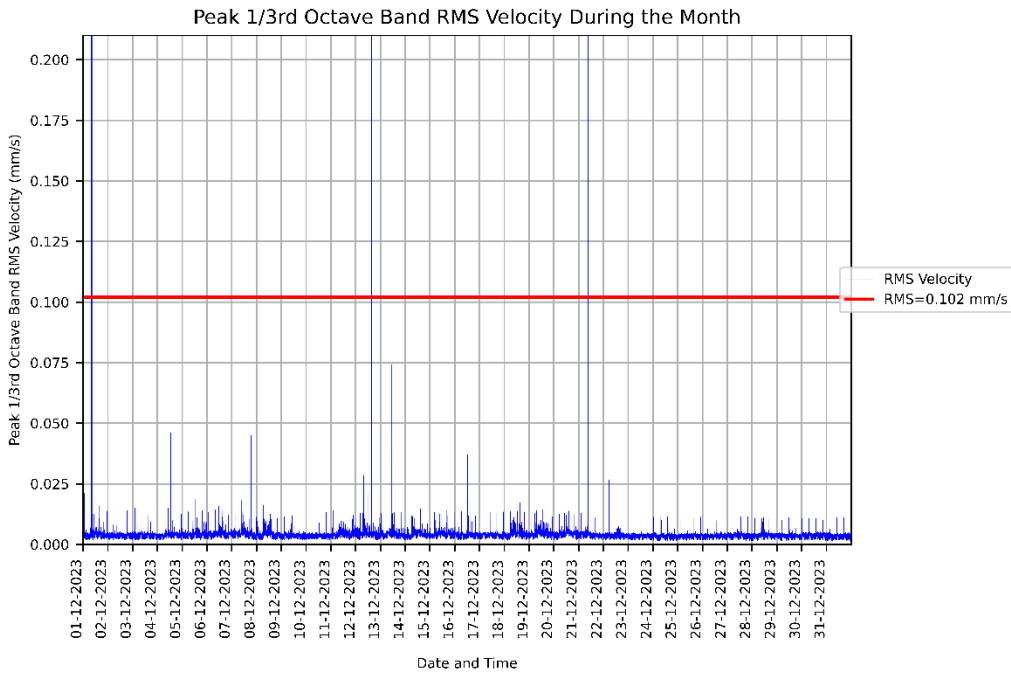
Figure 4 below shows the vibration levels (RMS velocity) recorded between 01/12/2023 and 31/12/2023. The recorded data is shown in blue, while the limit of 0.102mm/s (V_{RMS}) is shown in red.

Measurements on 22 December 2023 should be ignored. During this period calibrations were undertaken that required excitation of the monitor.

Figure 4: Measured RMSV vibration levels for 01/12/2023 to 31/12/2023 at the SCHN L1 Endocrinology Lab.

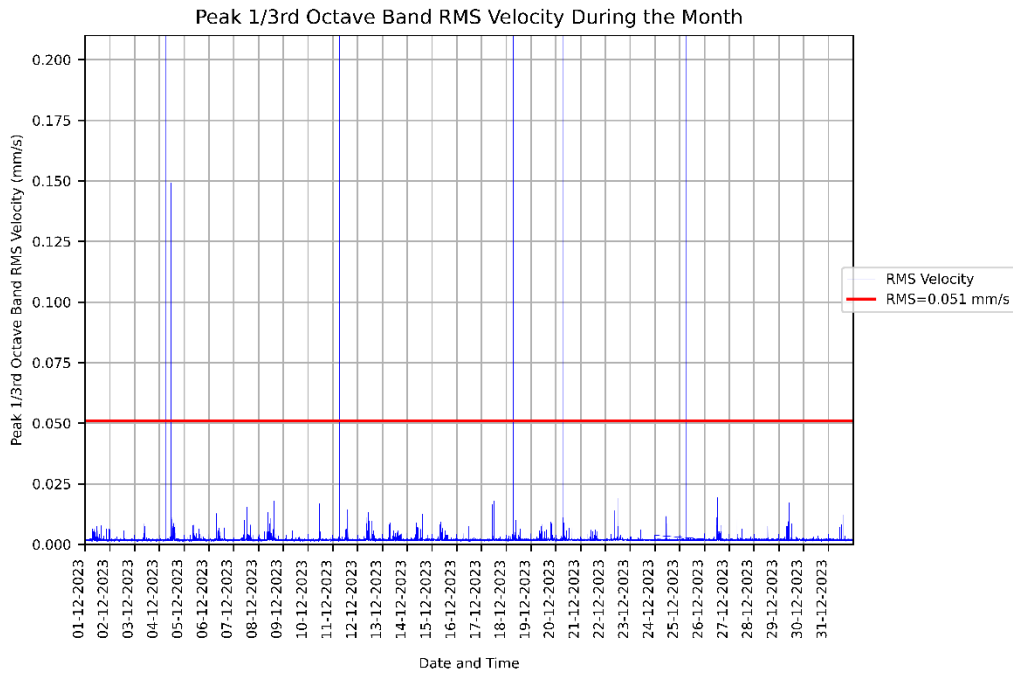
This report summarises the vibration monitoring data recorded at WIMR - BSF Mice Holding Room - Floor, over one month – from 01/12/2023 to 31/12/2023. Graphs in this report show the recorded data in blue, and exceedance trigger levels in red.

Figure 1: Measured RMSV vibration levels for 01/12/2023 to 31/12/2023 at the WIMR - BSF Mice Holding Room - Floor.

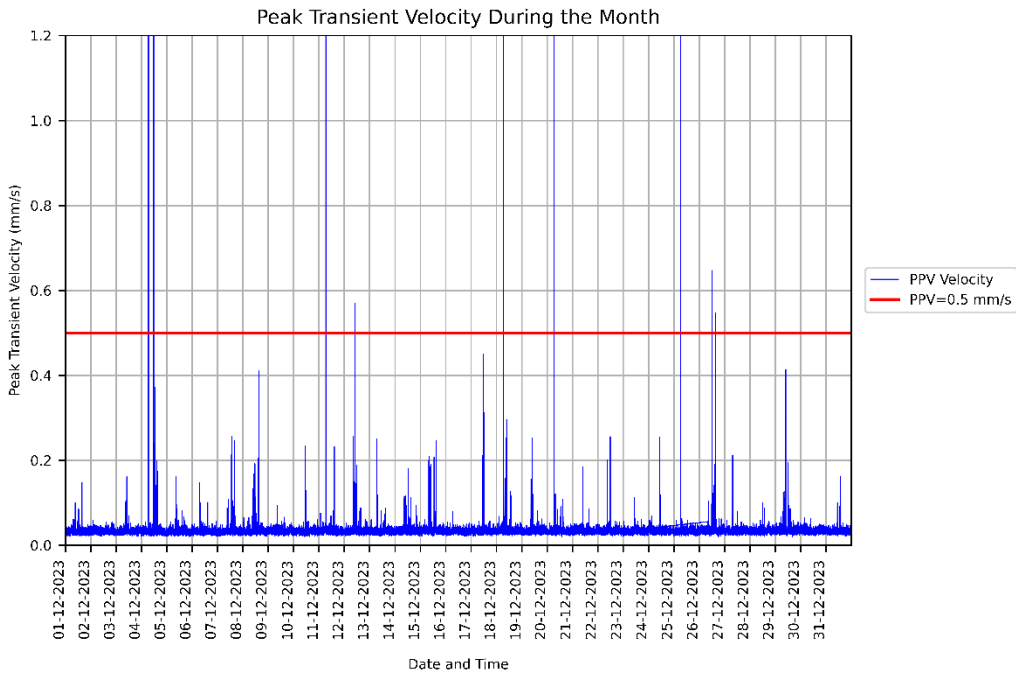
Figure 2: Measured vibration levels for 01/12/2023 to 31/12/2023 at the WIMR - BSF Mice Holding Room - Floor.

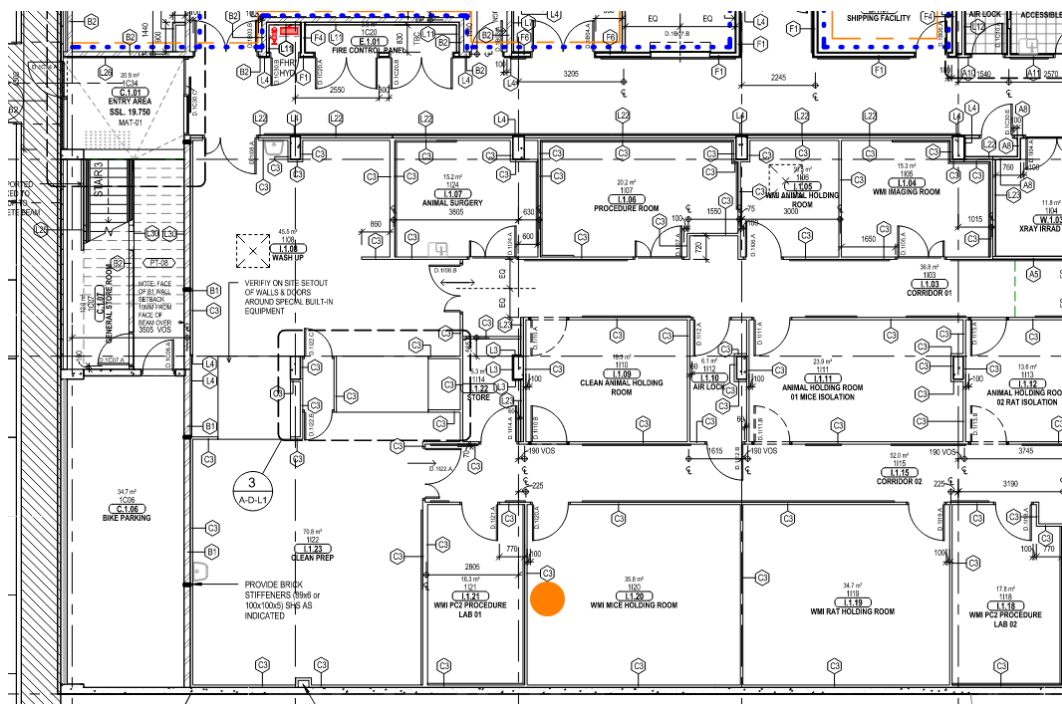
Figure 3: WIMR - BSF Mice Holding Room - Floor vibration monitor location

Monitoring at this location utilises a GeoSIG GMSplus with a GeoSIG VE-11 geophone. The calibration certificate for the geophone is included in Appendix A.

The location of this monitor is shown below in Figure 3.

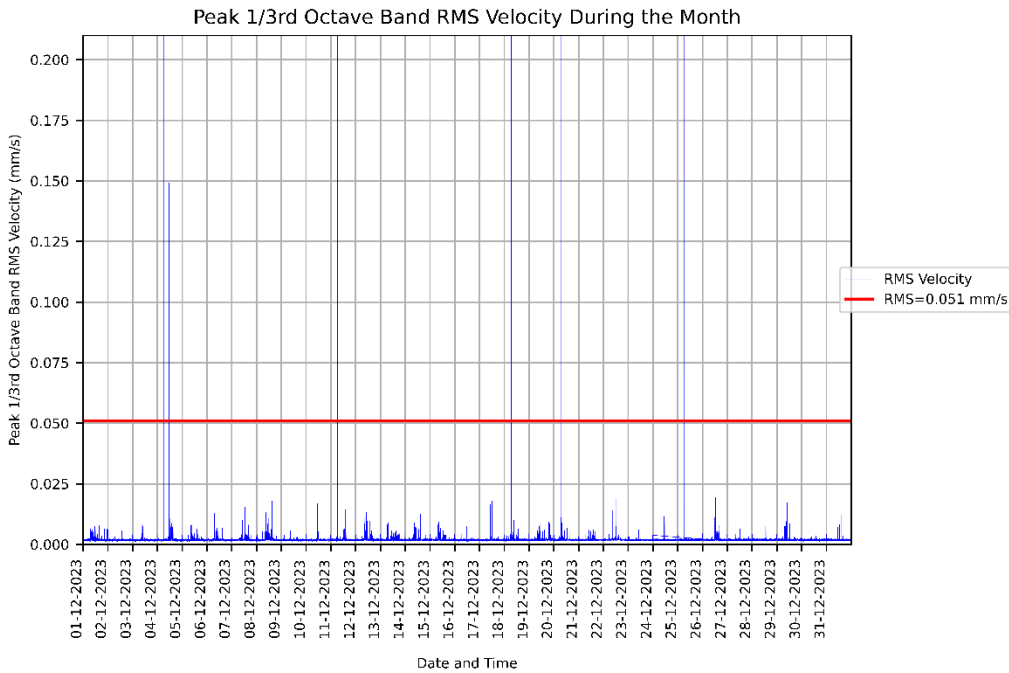
Figure 4 below shows the vibration levels (RMS velocity) recorded between 01/12/2023 and 31/12/2023. The recorded data is shown in blue, while the limit of 0.051mm/s (V_{RMS}) is shown in red.

Figure 4: Measured RMSV vibration levels for 01/12/2023 to 31/12/2023 at the WIMR - BSF Mice Holding Room - Floor.

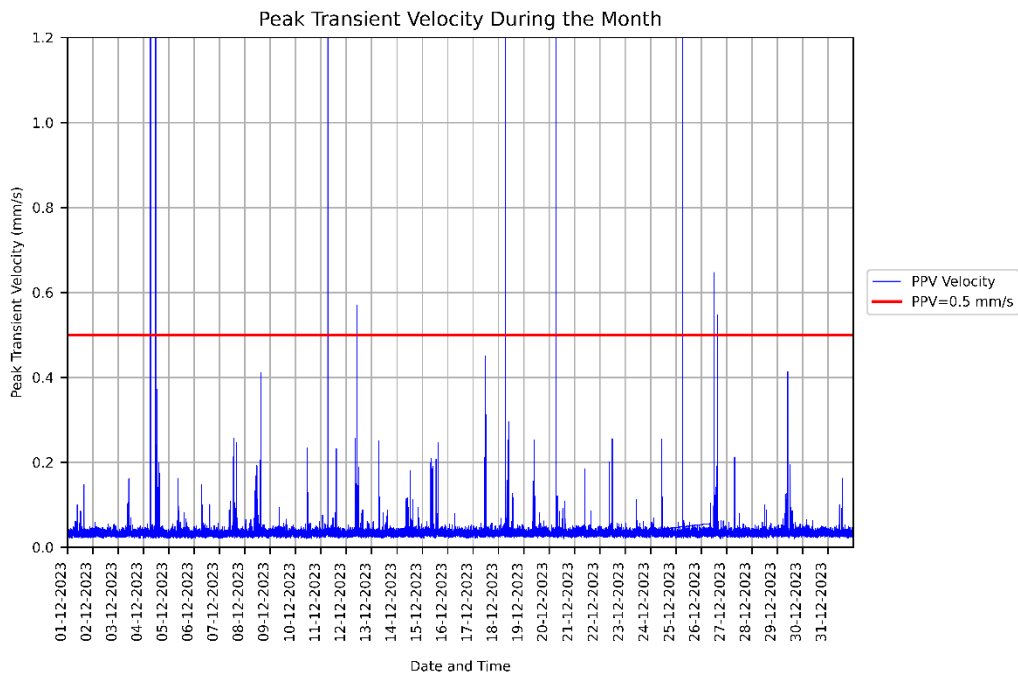
Figure 5 below shows the peak particle vibration levels (PPV velocity) recorded between 01/12/2023 and 31/12/2023. The recorded data is shown in blue, while the limit of 0.5mm/s (V_{PPV}) is shown in red.

Figure 5: Measured PPV vibration levels for 01/12/2023 to 31/12/2023 at the WIMR - BSF Mice Holding Room - Floor.

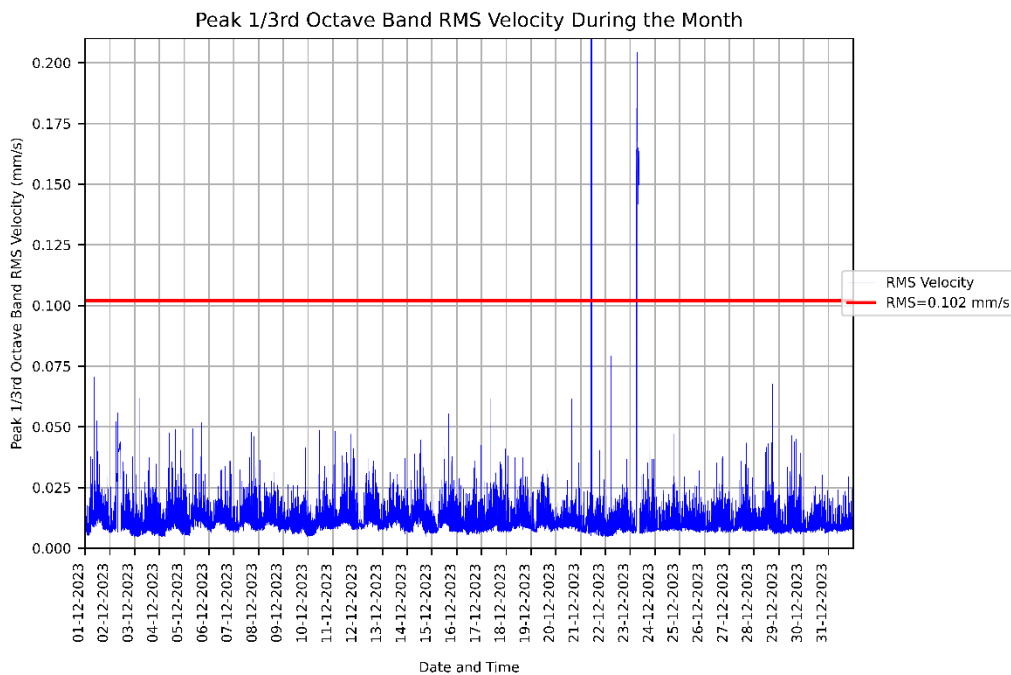
Measurements on 22 December 2023 should be ignored. During this period calibrations were undertaken that required excitation of the monitor.

Figure 1: Measured RMSV vibration levels for 01/12/2023 to 31/12/2023 at the CASB level 3 Surgical Suite.

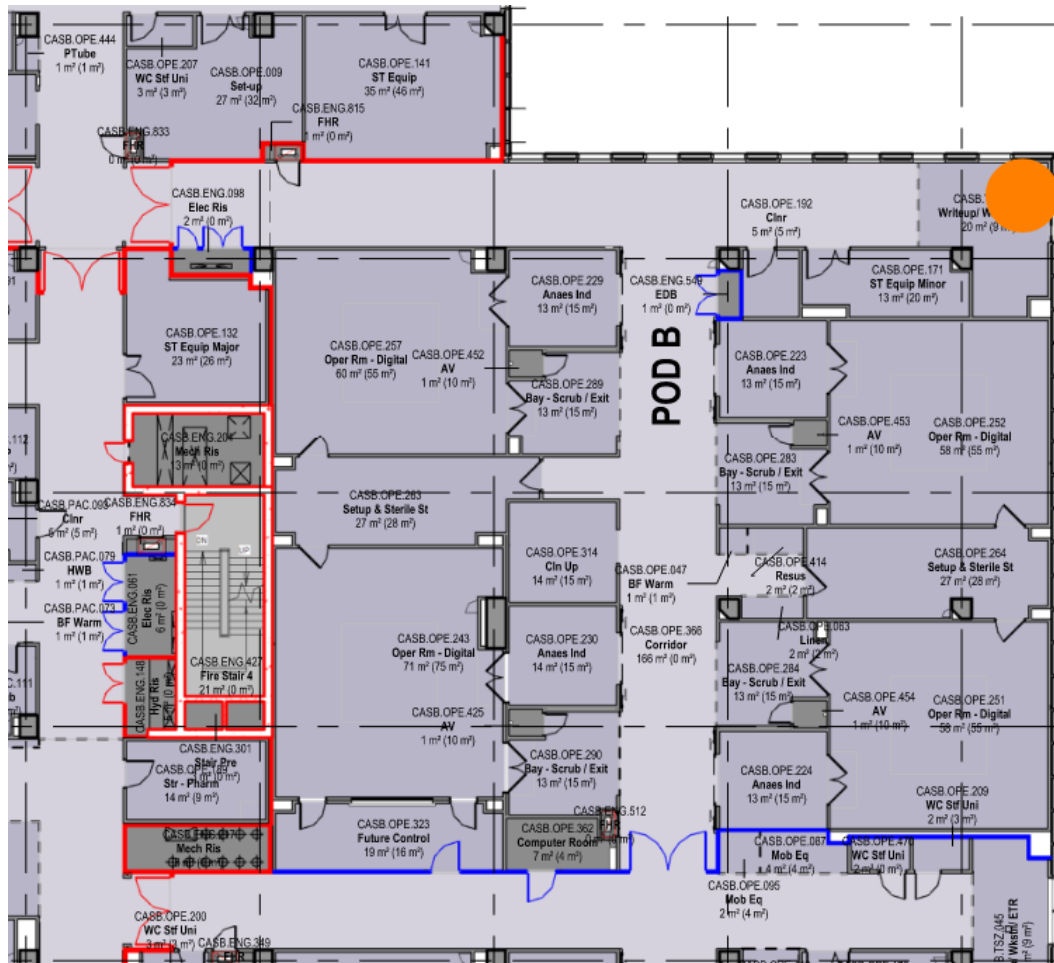
Figure 3: CASB level 3 Surgical Suite vibration monitor location

Monitoring at this location utilises a GeoSIG GMSplus with a GeoSIG VE-11 geophone. The calibration certificate for the geophone is included in Appendix A.

The location of this monitor is shown below in Figure 3.

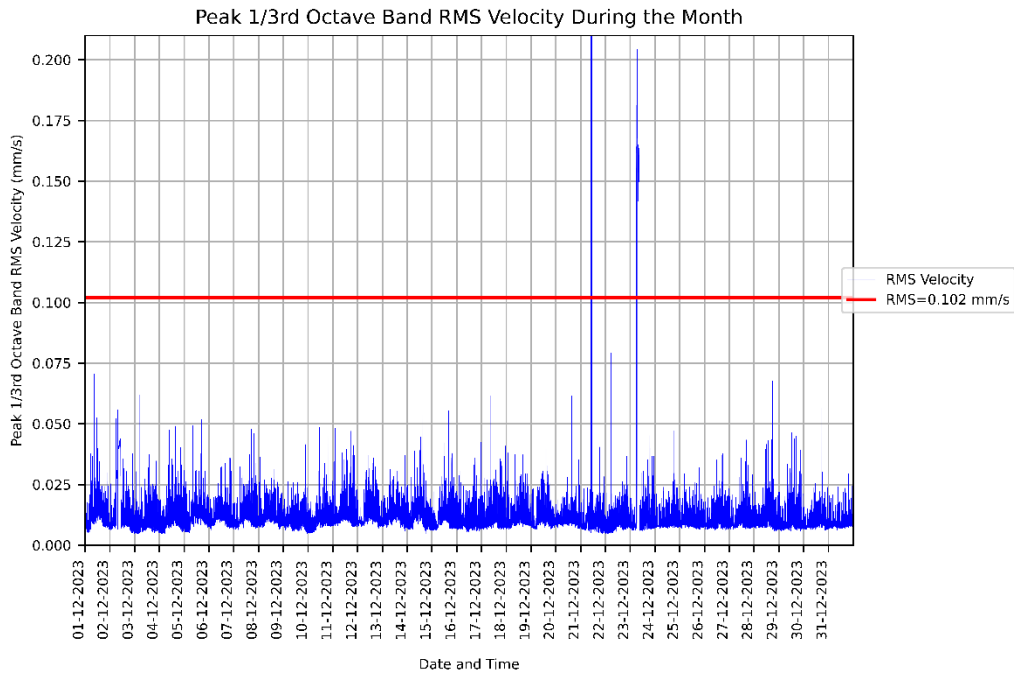
Figure 4 below shows the vibration levels (RMS velocity) recorded between 01/12/2023 and 31/12/2023. The recorded data is shown in blue, while the limit of 0.102mm/s (V_{RMS}) is shown in red.

Figure 4: Measured RMSV vibration levels for 01/12/2023 to 31/12/2023 at the CASB level 3 Surgical Suite.
