PROPERTY CONDITION SURVEY - COMMERCIAL/INDUSTRIAL

AD2696A

Mears and Church Street
MUDGEES NSW 2850

145 Church Street
MUDGEES NSW 2850

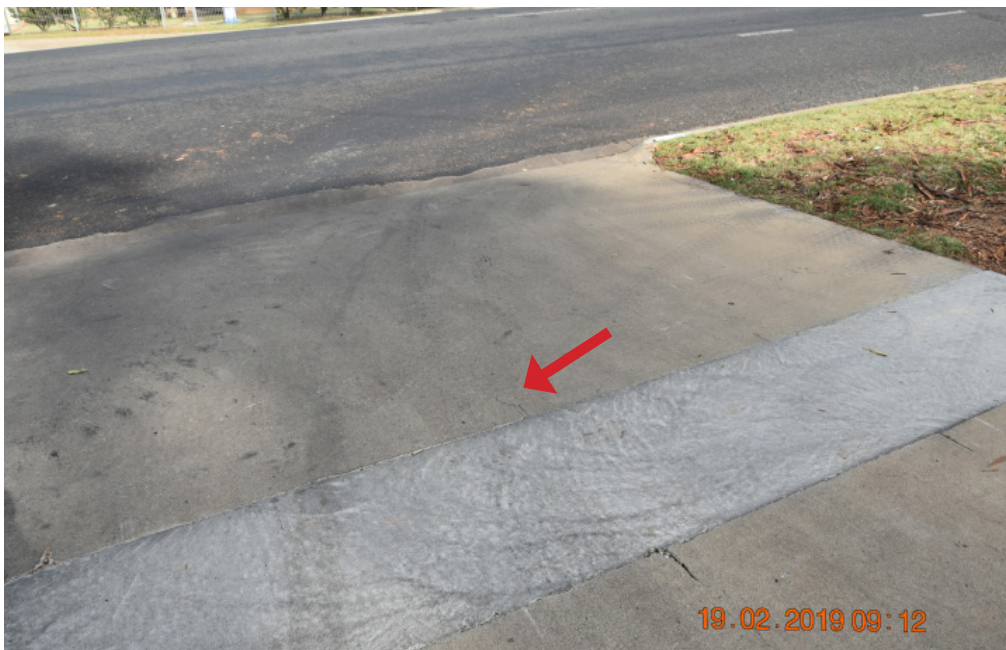
Figure: 0002

General view of the entrance driveway to the medical centre. Showing cracking.

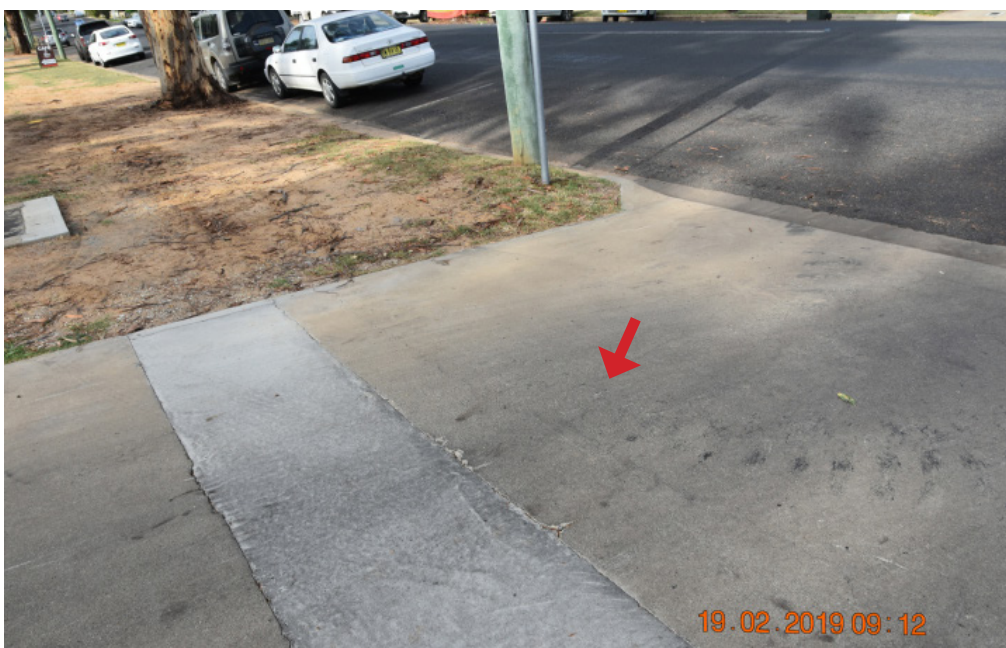
Figure: 0003

General view of the entrance driveway to the medical centre. Showing cracking.

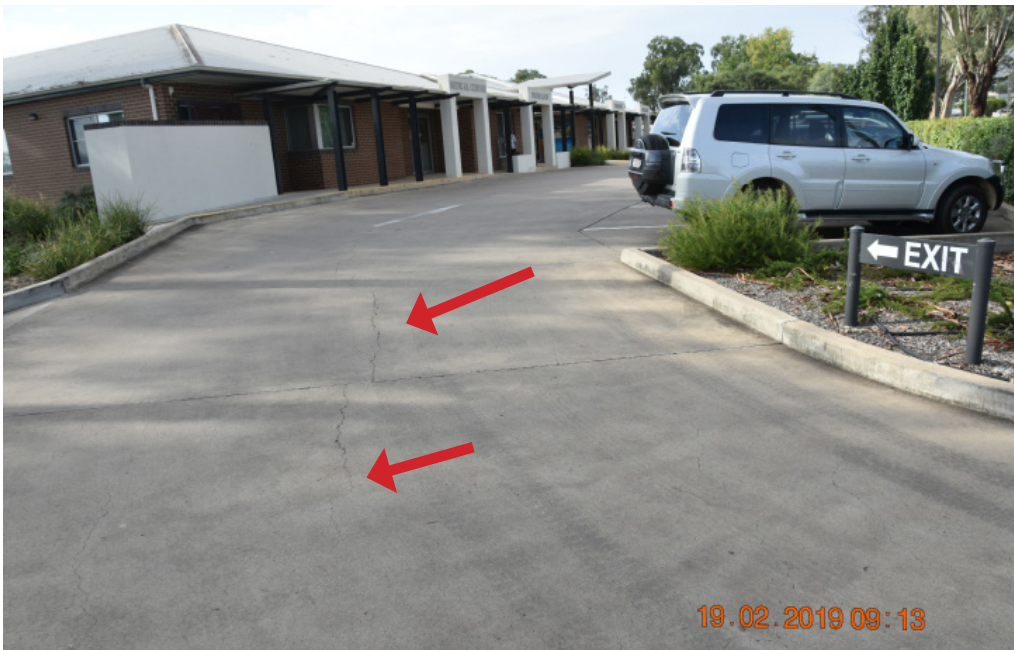
Figure: 0008

General view of the entrance driveway. Showing cracking.

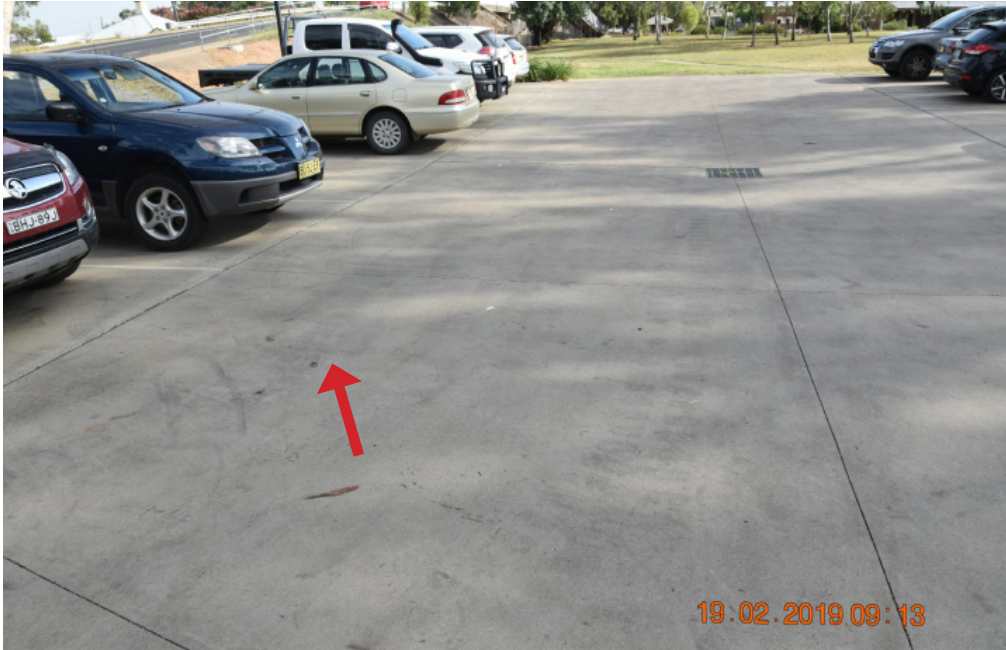
Figure: 0013

- Cracking in the north carpark. See photo 13-16, 18
- Cracking in the west carpark. See photo 21, 22, 58-60
- Cracking in the west carpark, looking south from the pedestrian crosswalk. See photo 23

General view of the north carpark. Showing cracking.

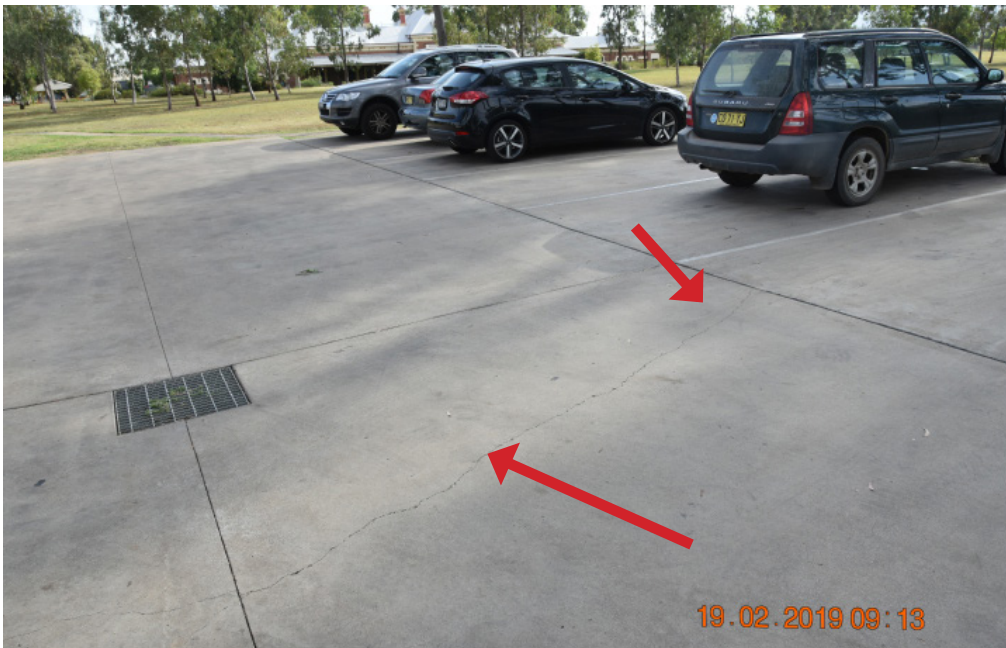
Figure: 0014

General view of the north carpark. Showing cracking.

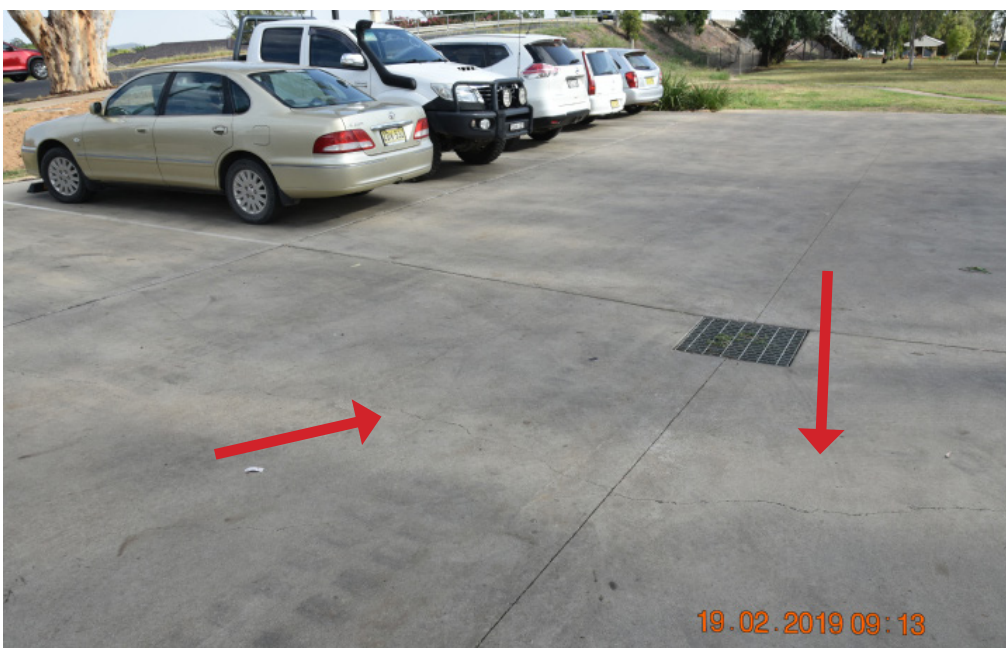
Figure: 0015

General view of the north carpark. Showing cracking.

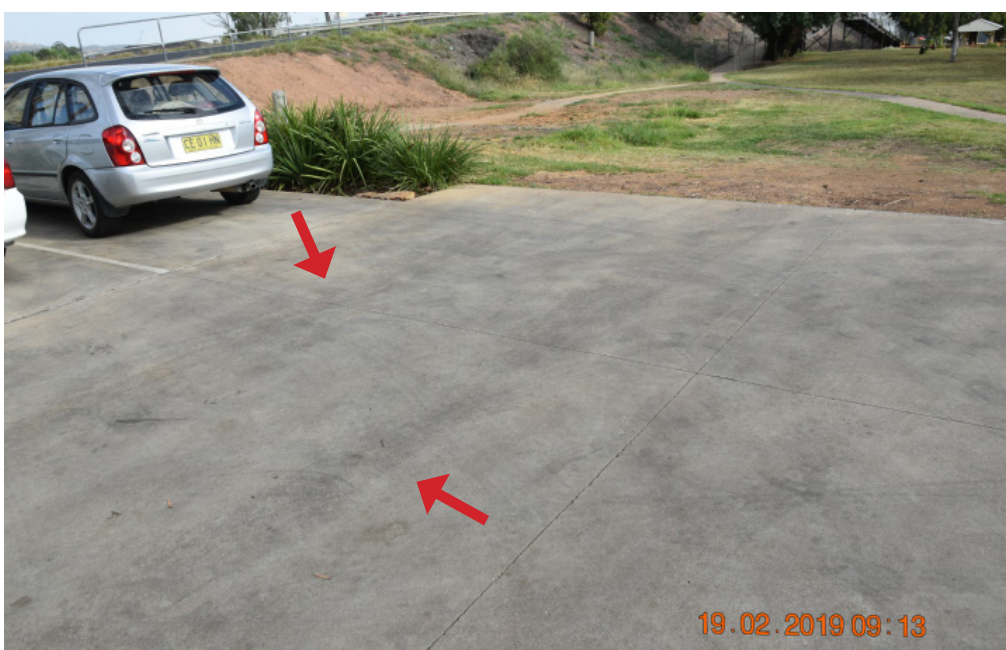
Figure: 0018

General view of the north carpark. Showing cracking.

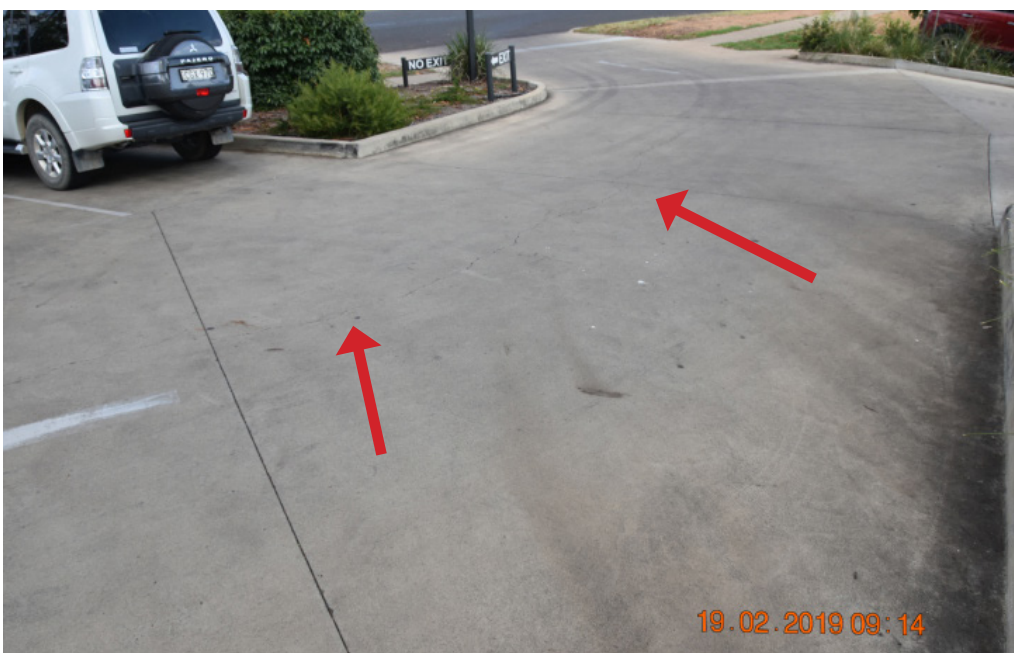
Figure: 0021

General view of the west carpark. Showing cracking.

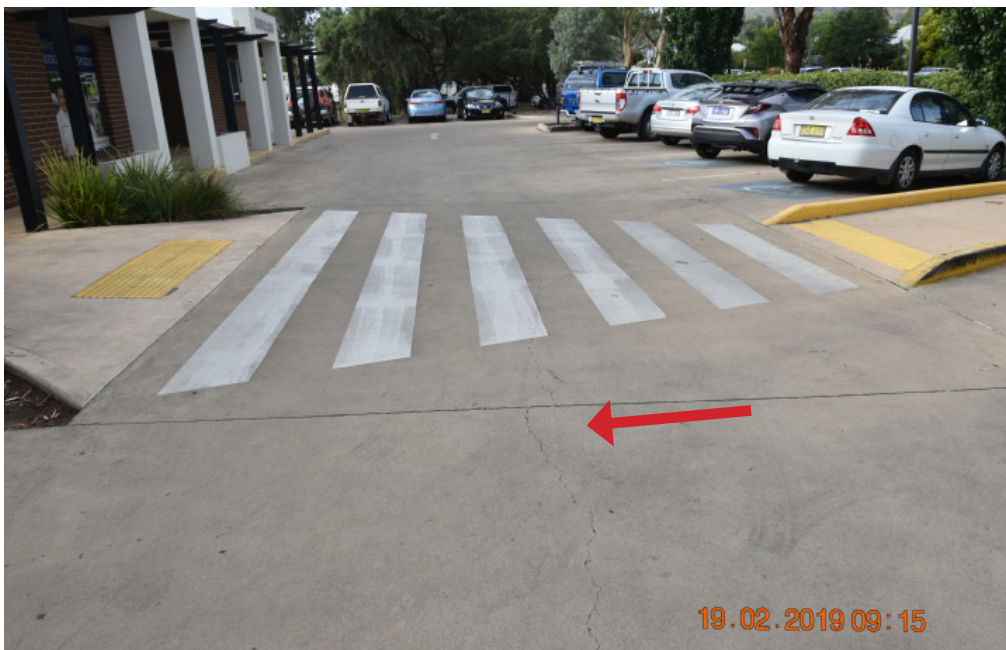
Figure: 0023

General view of the west carpark, looking south from the pedestrian crosswalk. Showing cracking.

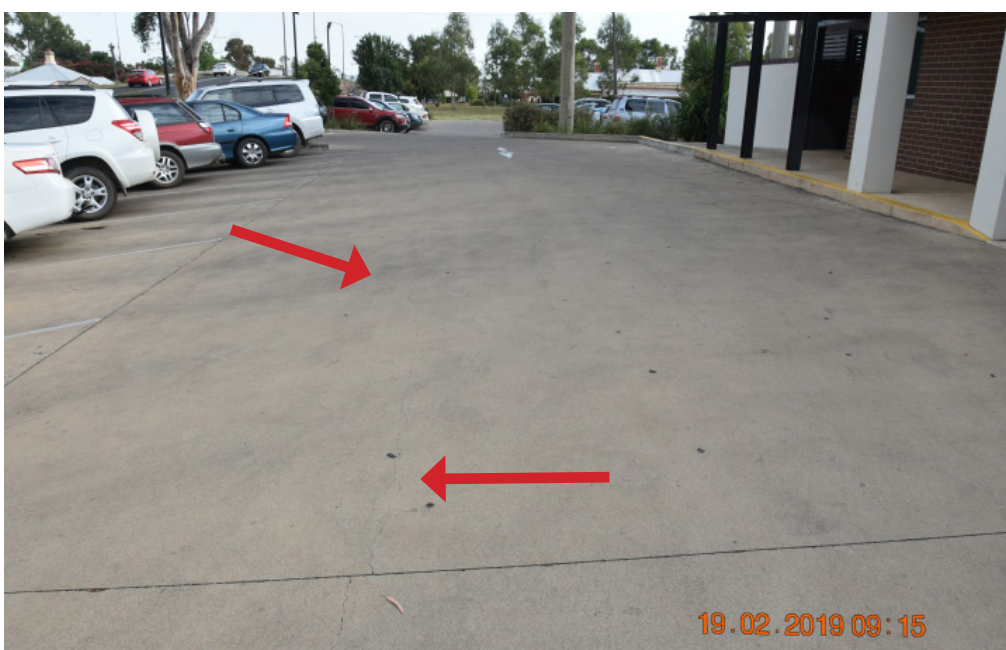
Figure: 0024

- Cracking in the west carpark, looking north from the pedestrian crosswalk. See photo 24
- Cracking in the west carpark, outside radiology. See photo 68

General view of the west carpark, looking north from the pedestrian crosswalk. Showing cracking.

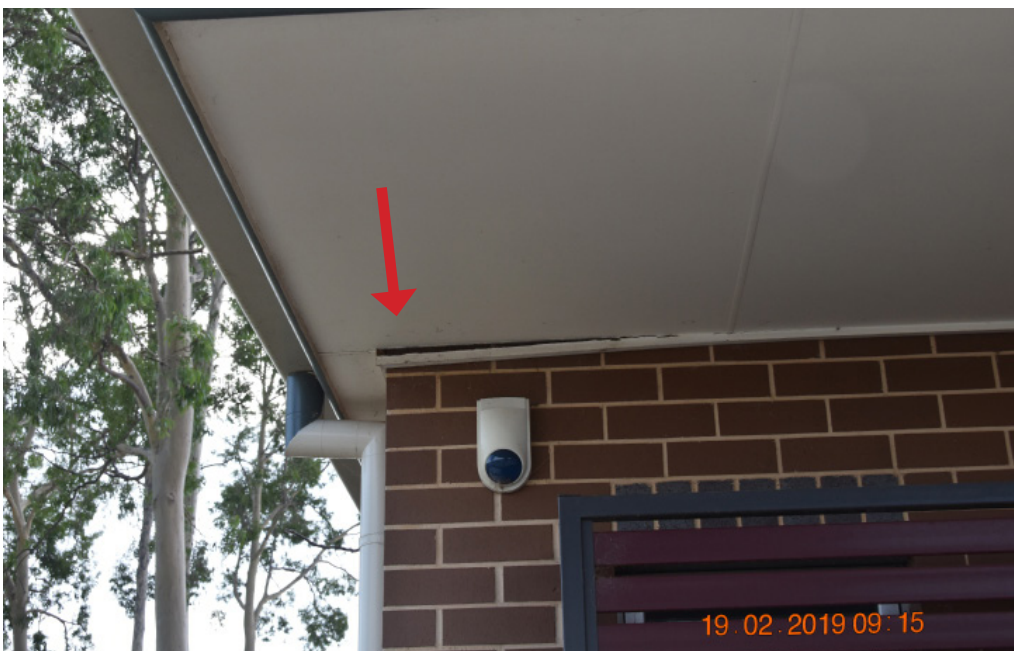
Figure: 0027

- Detachment of the wooden strip on the west wall of the medical centre, north side. See photo 27
- Fine cracking in the second column from the north on the west side of the medical centre. See photo 34
- Cracking in the underside of the awning on the north side of the pharmacy. See photo 51
- Cracking in the underside of the sail shade outside the main entrance to the medical centre. See photo 43
- Fine cracking in the column on the west side of the medical centre, outside radiology. See photo 65
- Minor damage in the gutter on the north side of the medical centre, near the east corner. See photo 198
- Slight stepped cracking in the west wall of the hospital, at approximately 30 metres from the south driveway. See photo 295

Detachment of the wooden strip on the west wall of the medical centre, north side.

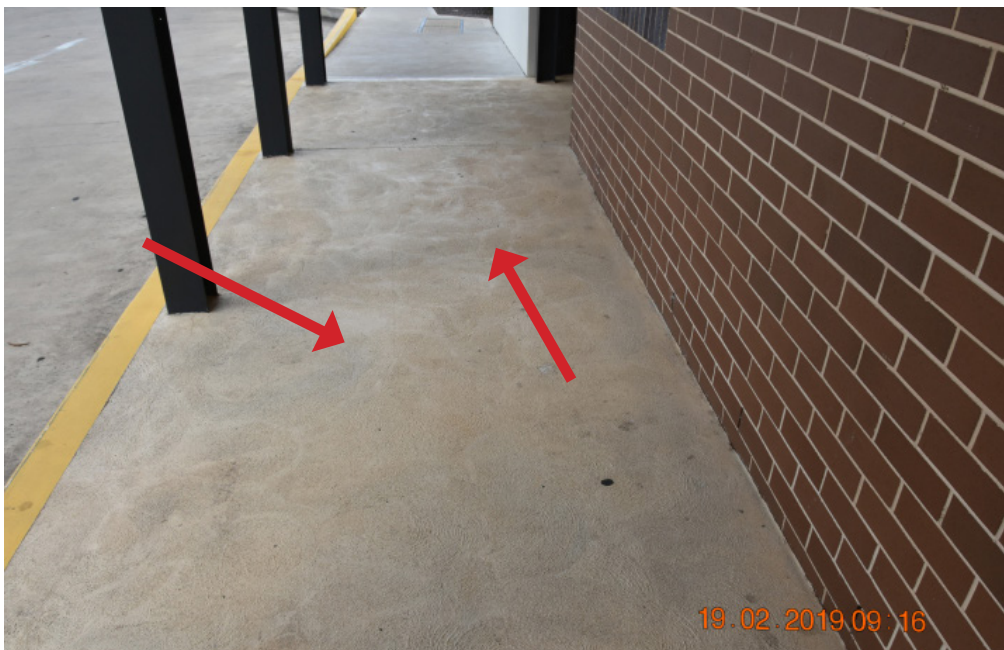
Figure: 0032

Paving on the west side of the medical centre, looking north. Showing fine crack-ing.

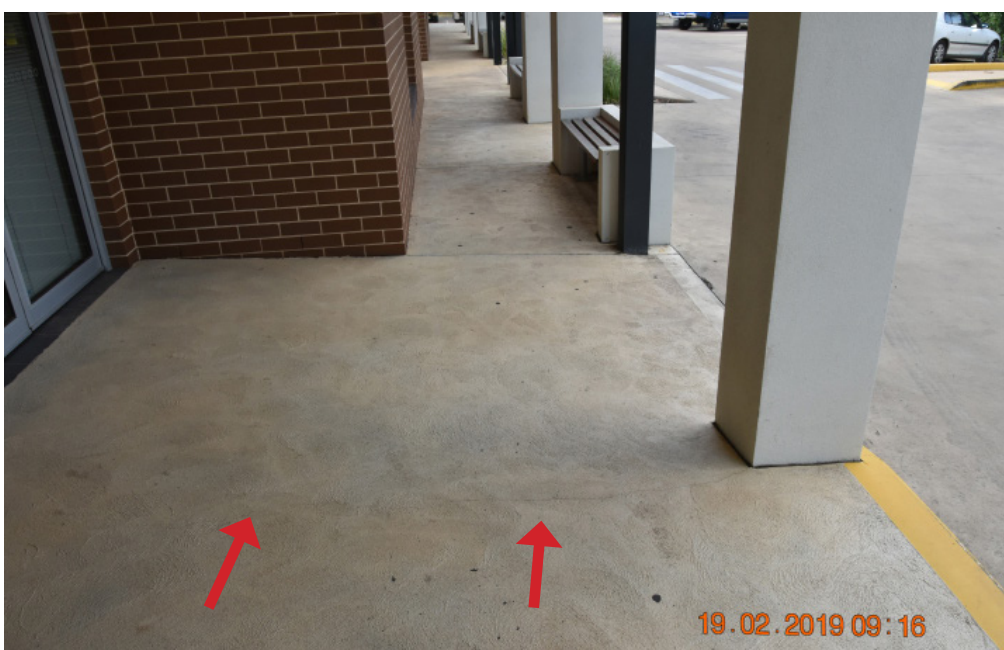
Figure: 0033

Paving on the west side of the medical centre, looking south. Showing fine crack-ing.

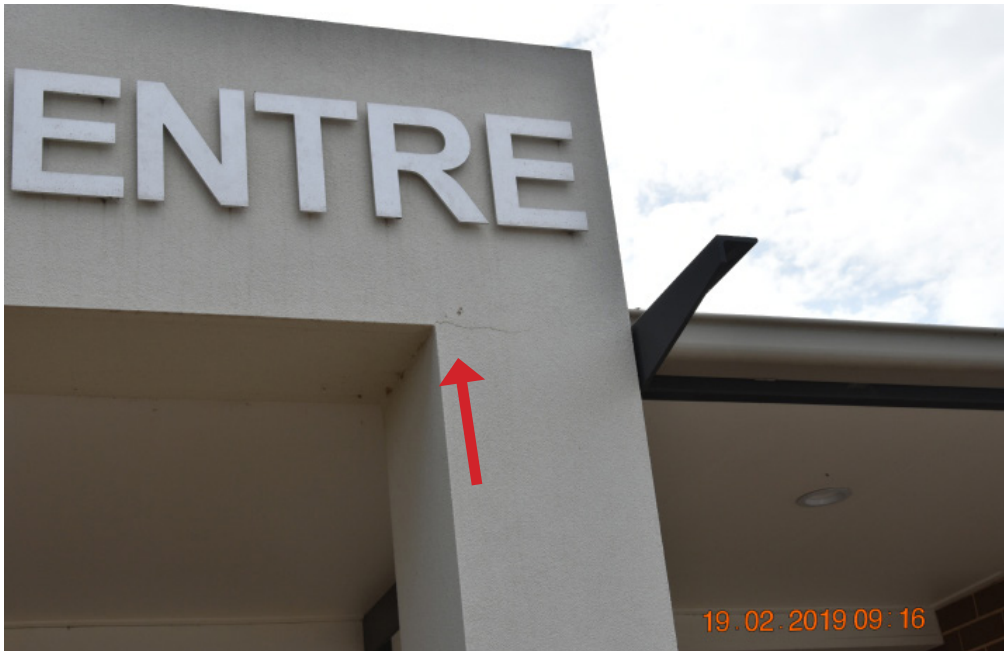
Figure: 0034

Fine cracking in the second column from the north on the west side of the medical centre.

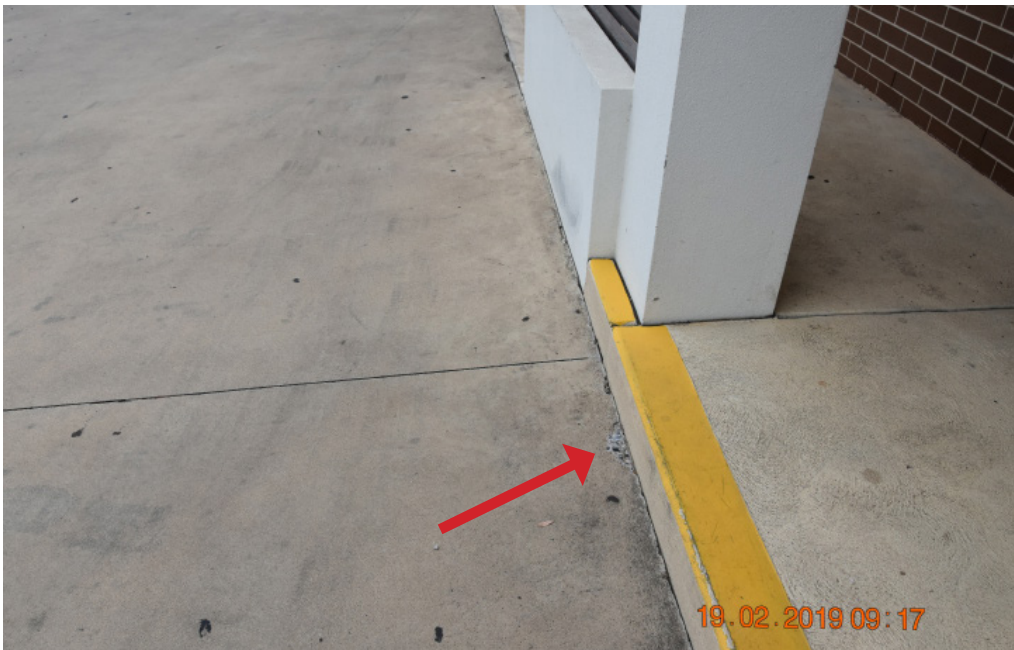
Figure: 0038

Chipping in the paving on the west side of the medical centre.

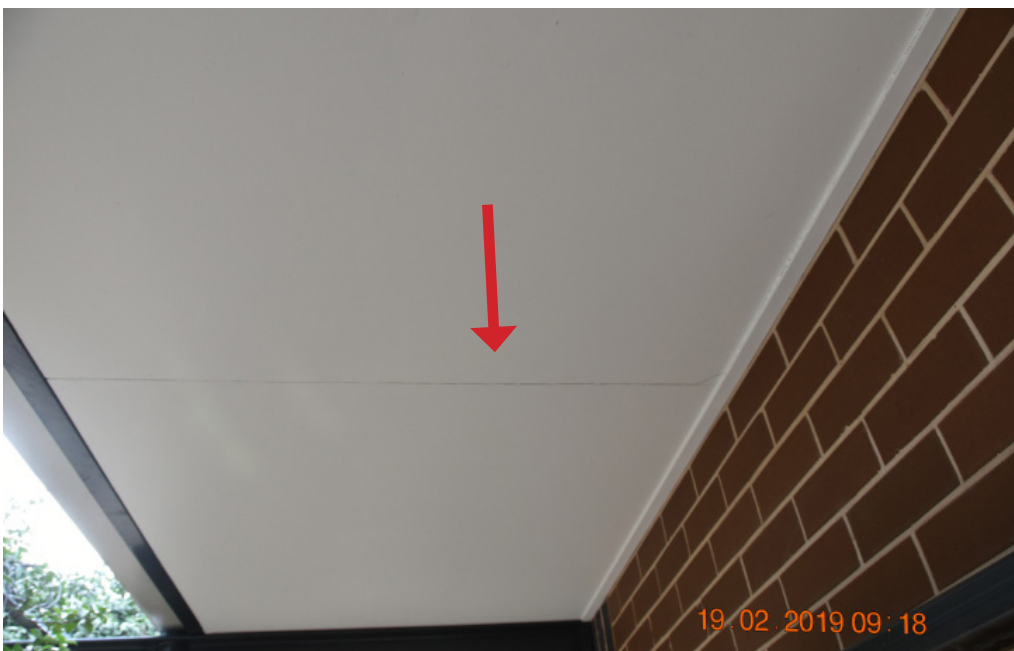
Figure: 0051

Cracking in the underside of the awning on the north side of the pharmacy.

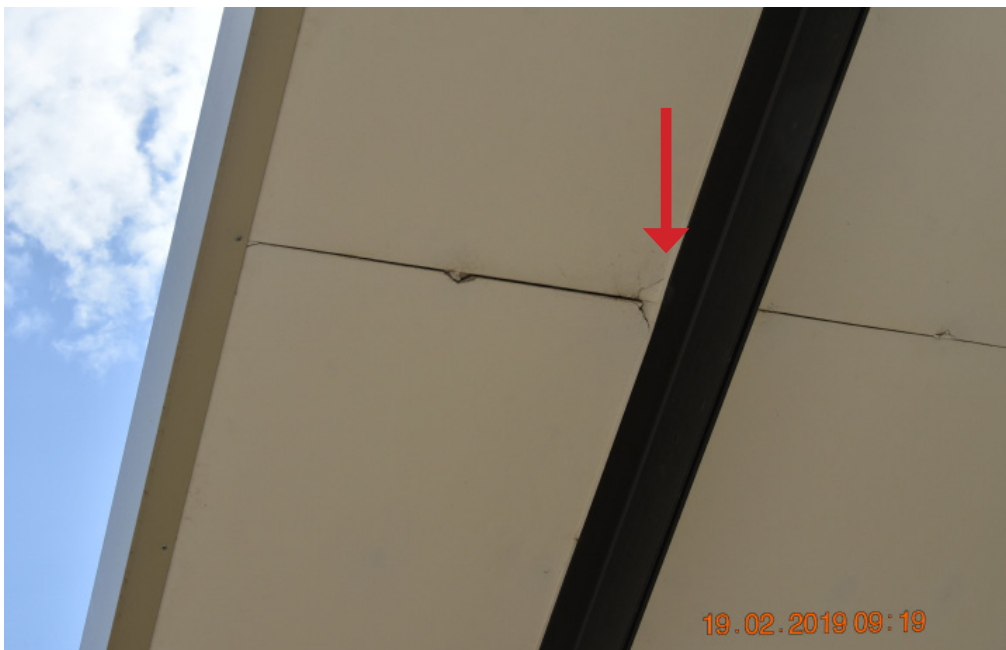
Figure: 0053

Cracking in the underside of the sail shade outside the main entrance to the medical centre.

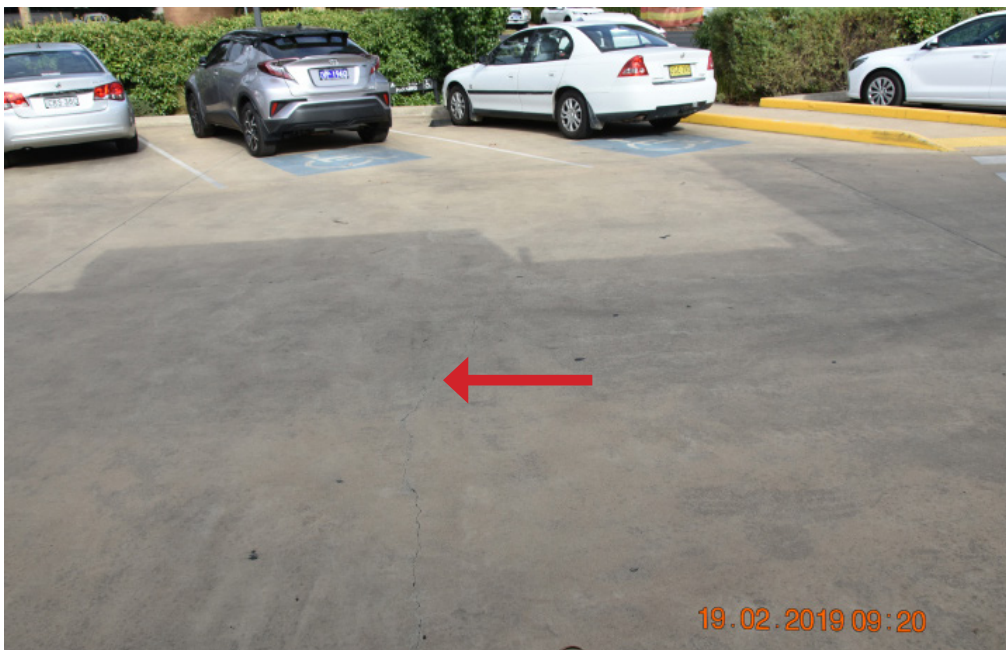
Figure: 0059

General view of the west carpark. Showing cracking.

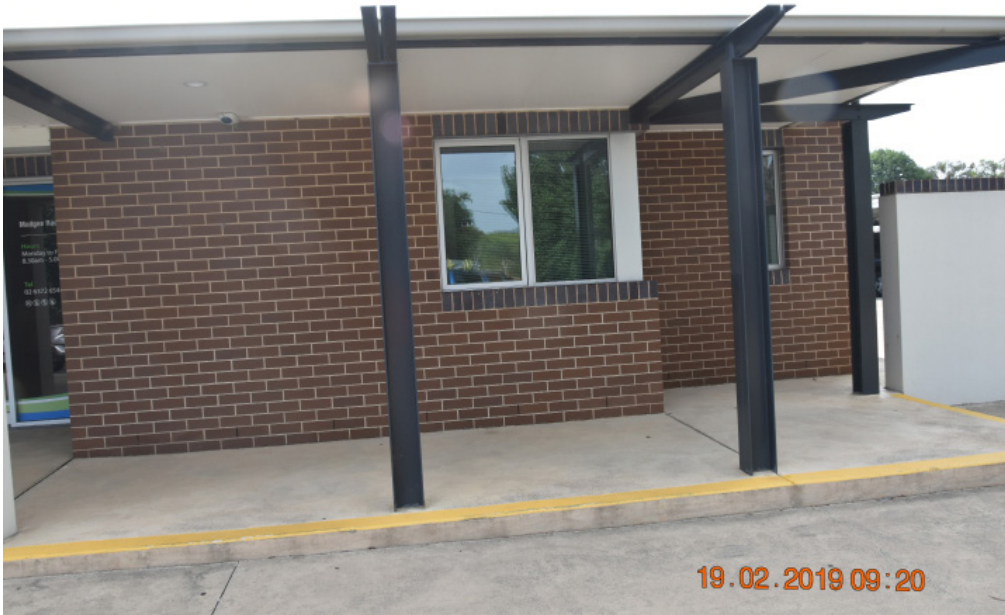
Figure: 0065

Fine cracking in the column on the west side of the medical centre, outside radiology.

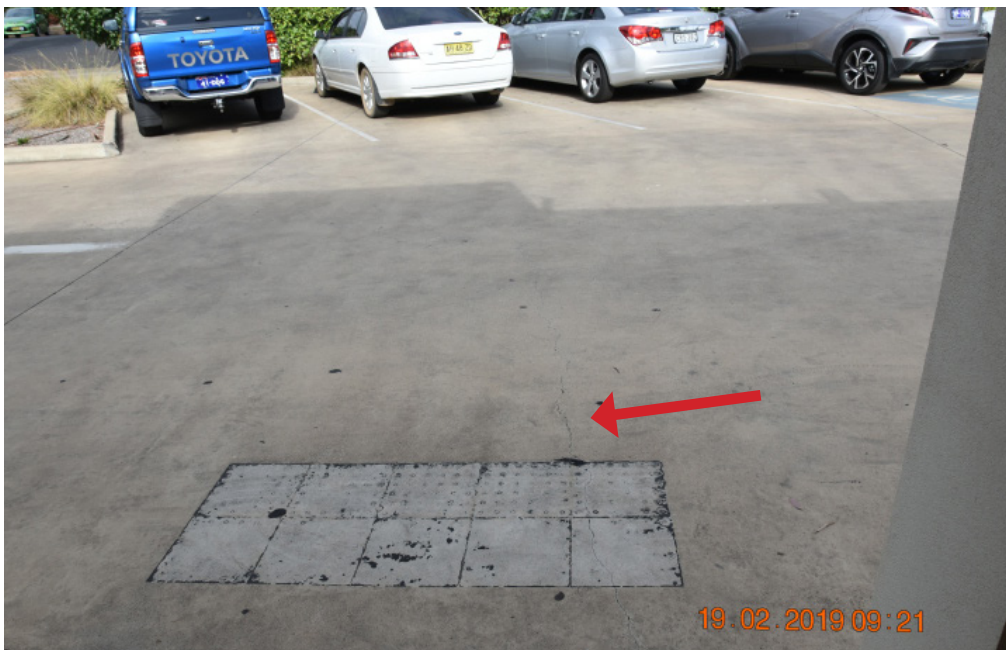
Figure: 0068

Cracking in the west carpark, outside radiology.

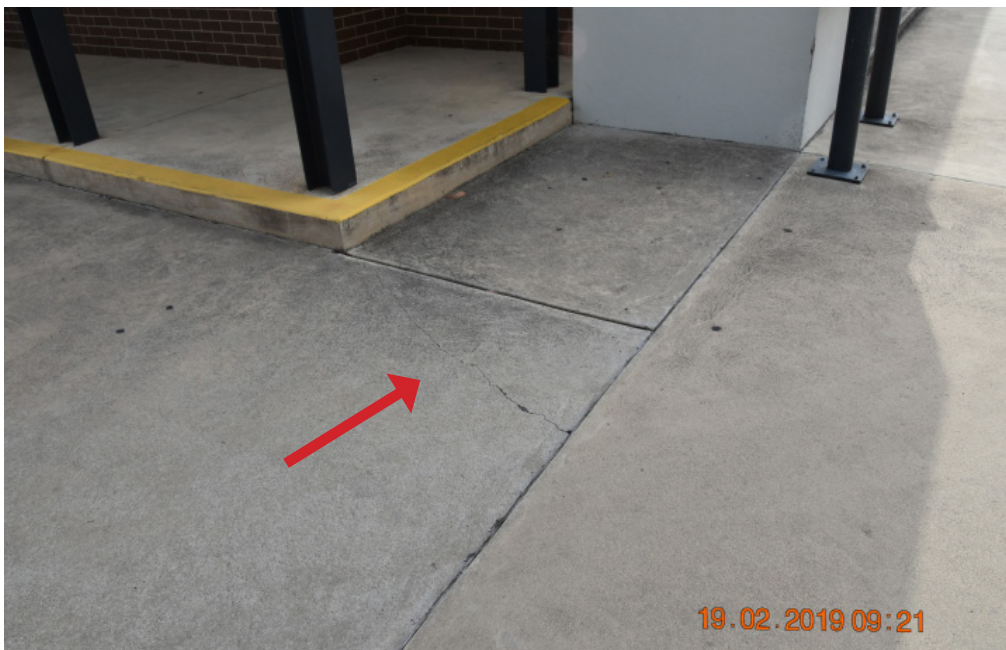
Figure: 0071

Cracking in the paving near the south-west corner of the medical centre.

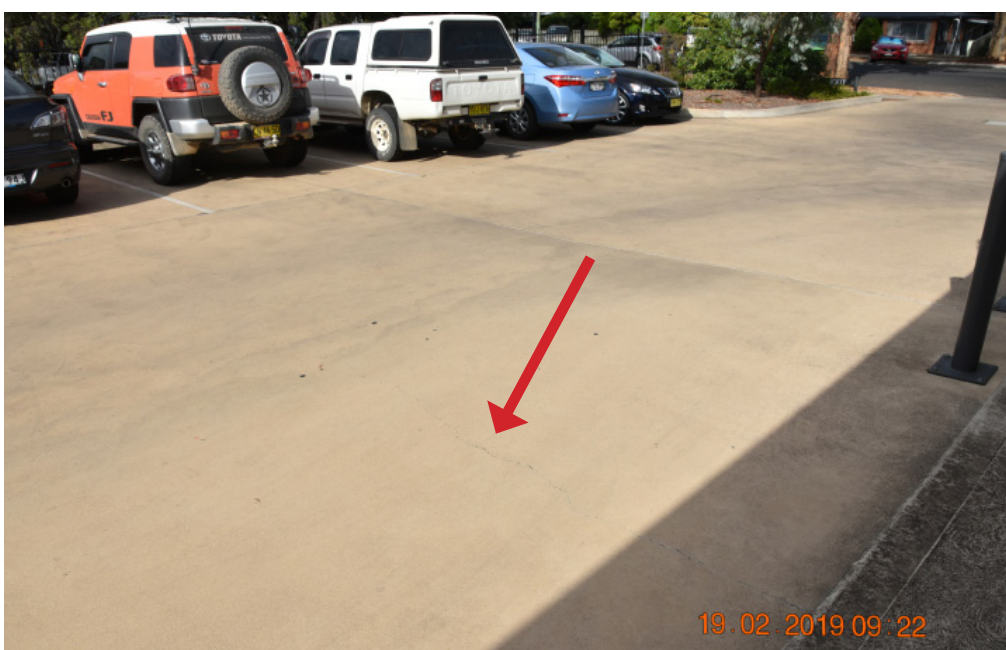
Figure: 0078

General view of the south carpark. Showing cracking.

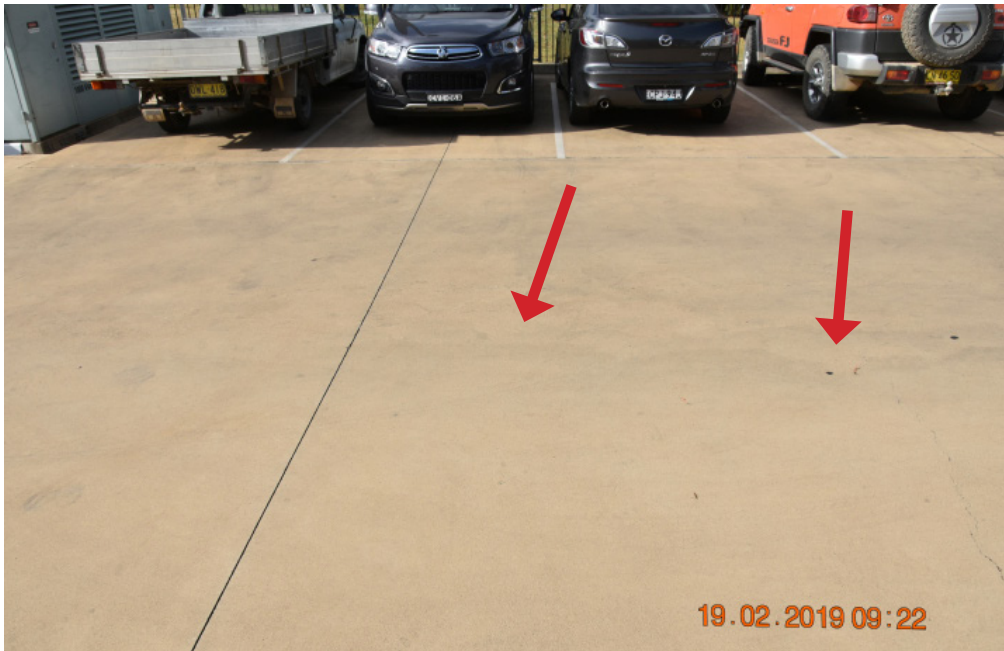
Figure: 0079

General view of the south carpark. Showing cracking.

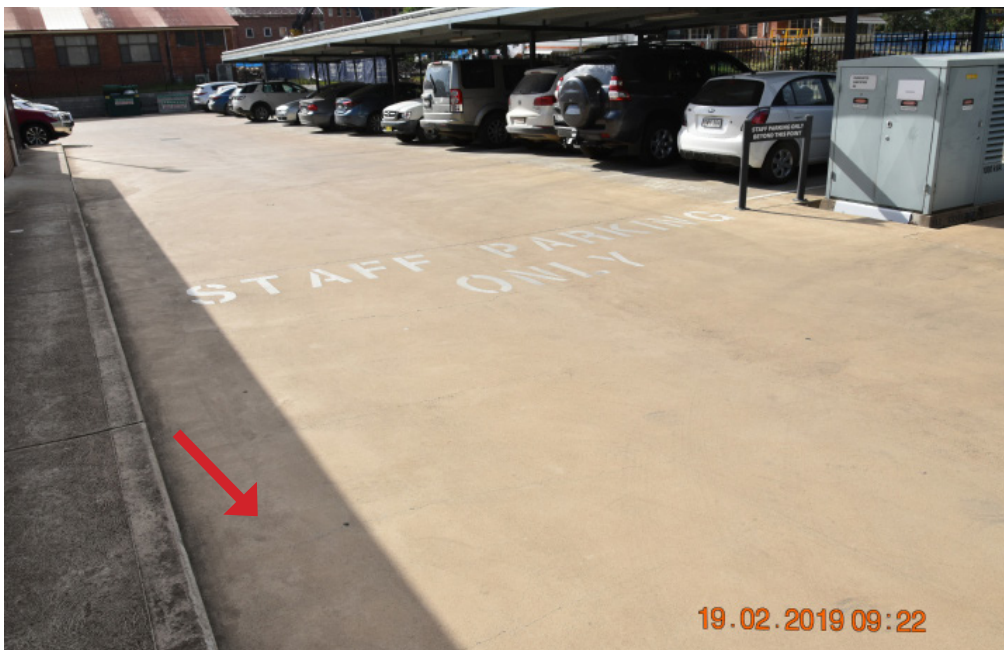
Figure: 0080

General view of the south carpark. Showing cracking.

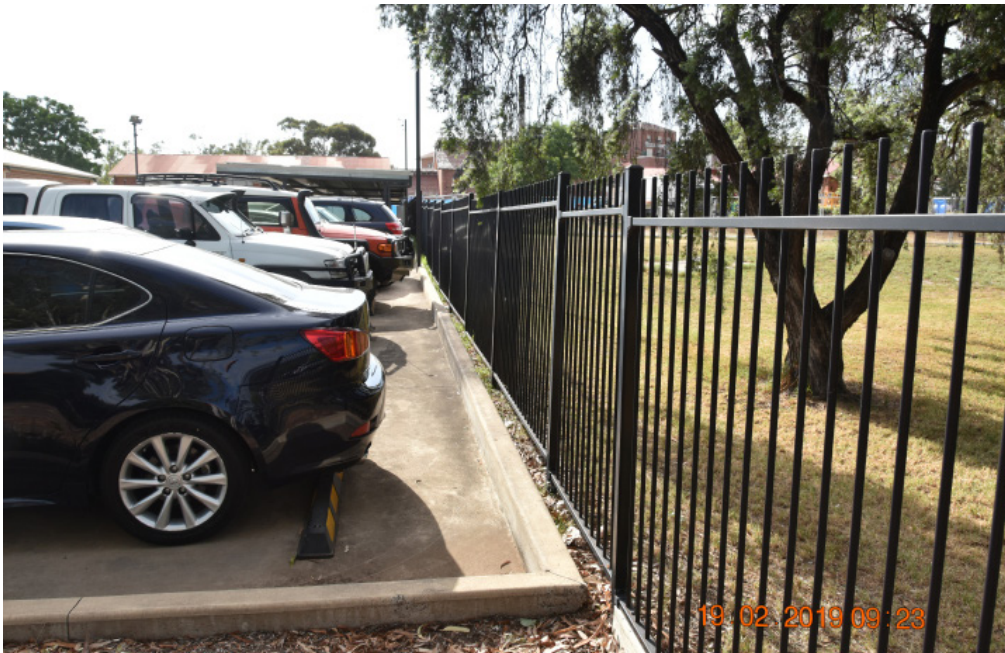
Figure: 0086

Cracking in the kerb on the south side of the south carpark, adjacent to the west parking space.

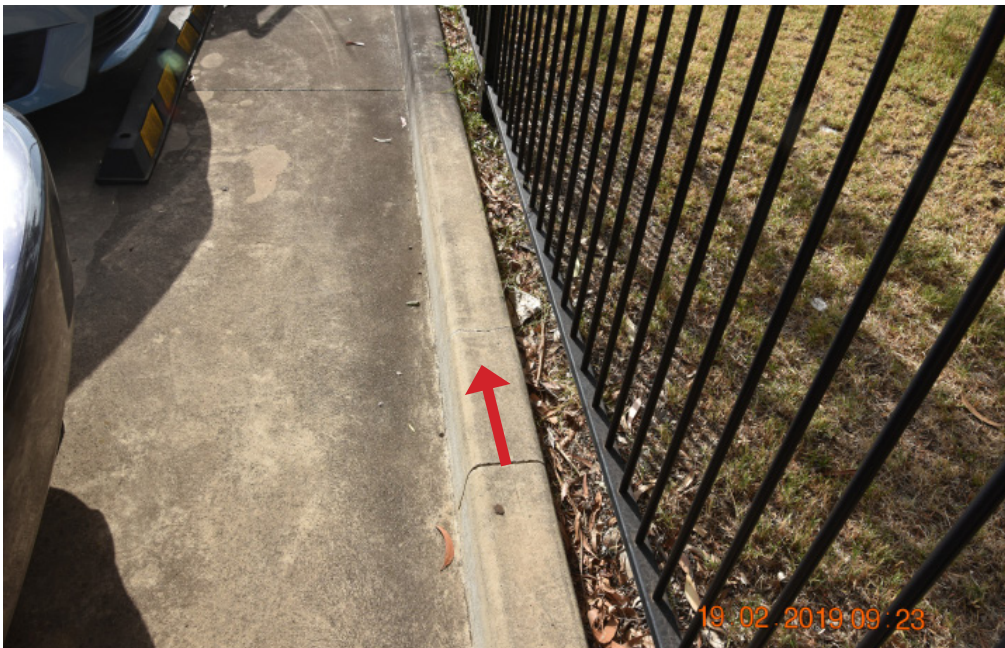
Figure: 0087

Cracking in the kerb on the south side of the south carpark, adjacent to the third parking space from the west.

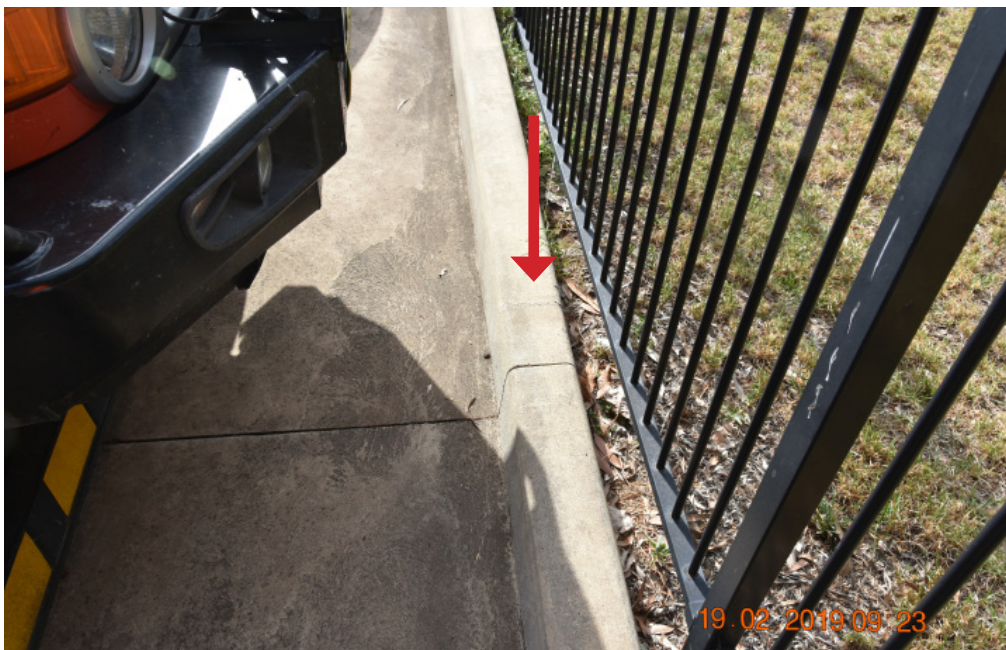
Figure: 0089

Cracking in the kerb on the south side of the south carpark, adjacent to the fourth parking space from the west.

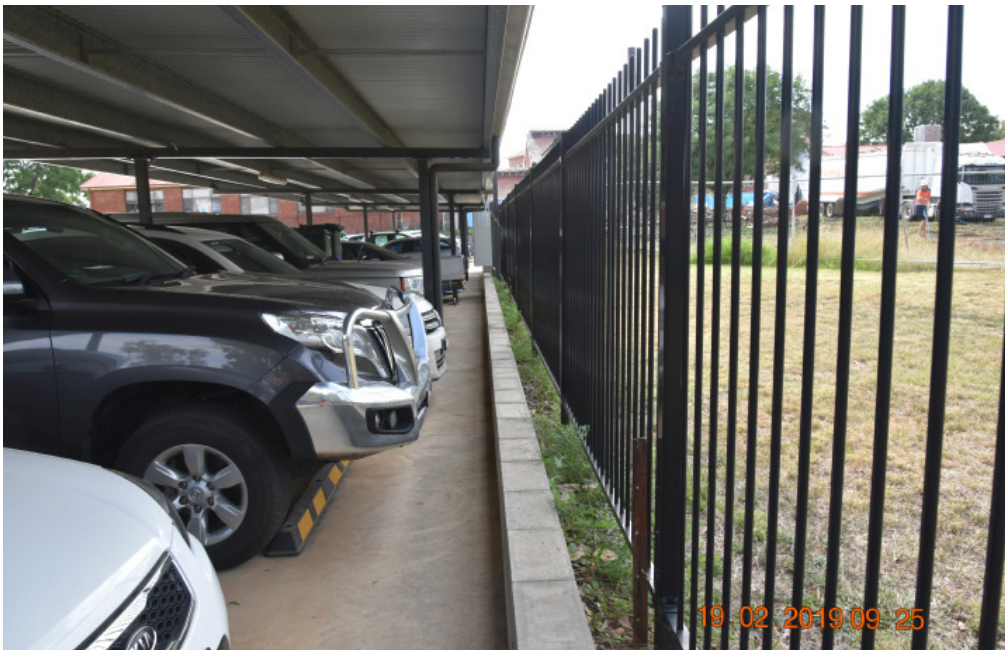
Figure: 0099

South boundary fence, looking west from the substation.

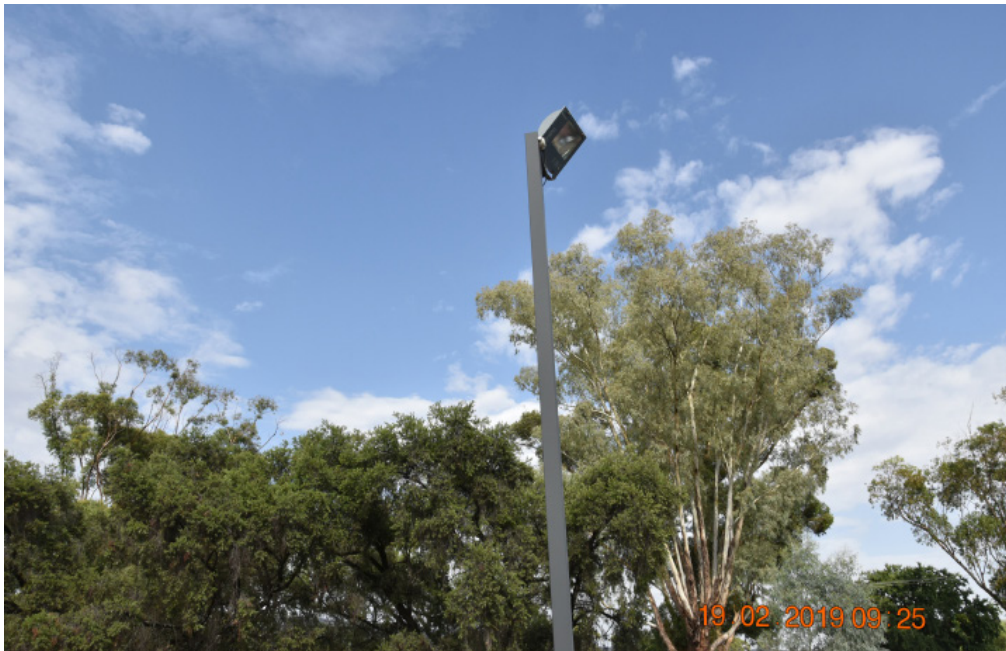
Figure: 0100

Light pole on the south side of the medical centre.

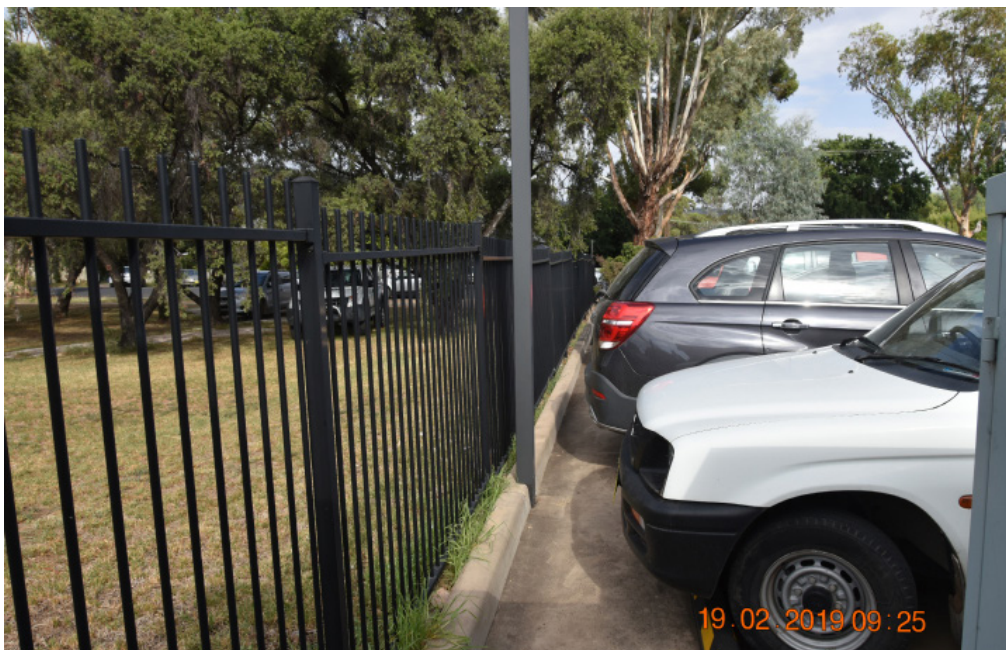
Figure: 0101

Light pole on the south side of the medical centre.

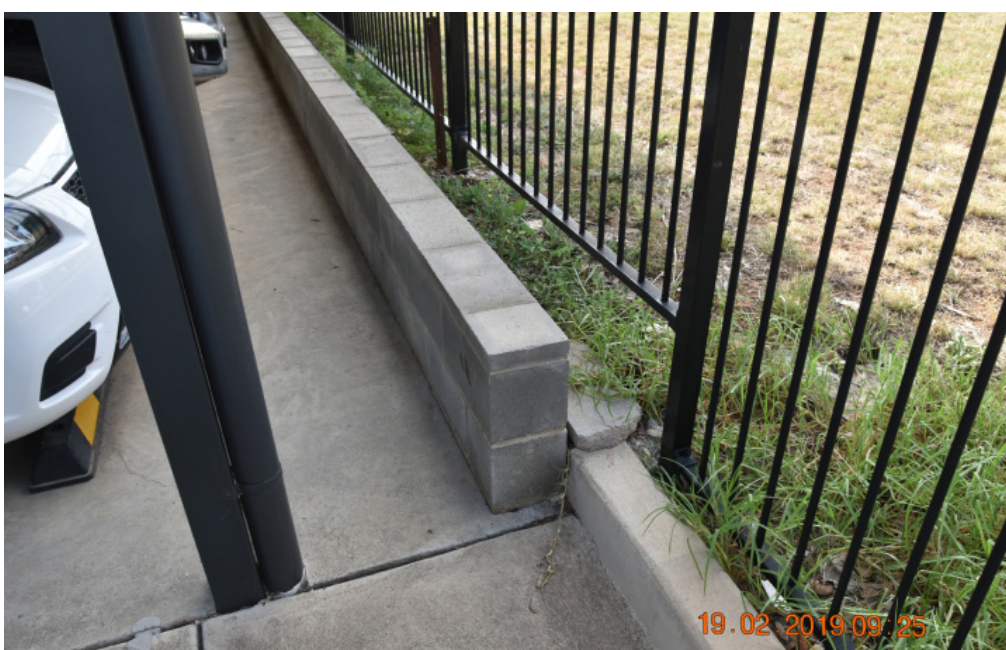
Figure: 0102

Retaining wall on the south side of the south carpark, adjacent to the carport.

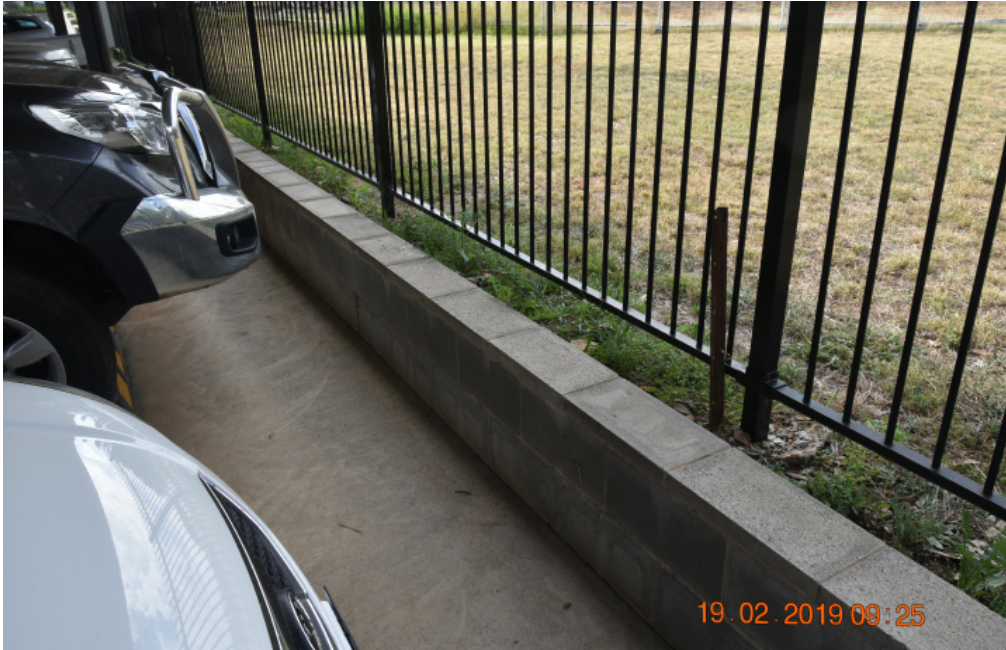
Figure: 0103

Retaining wall on the south side of the south carpark, adjacent to the carport.

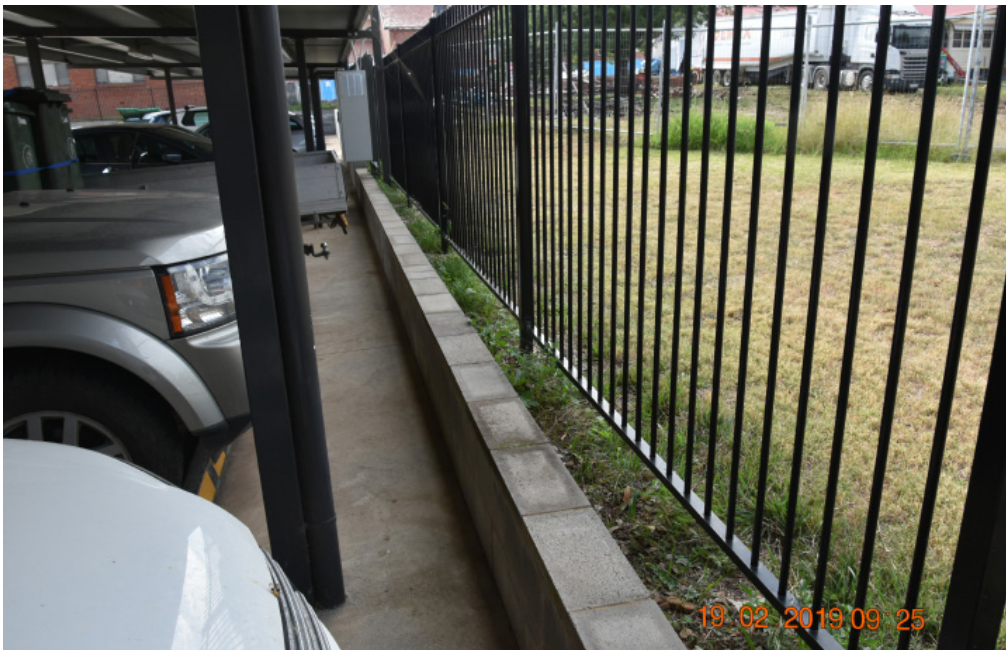
Figure: 0104

Retaining wall on the south side of the south carpark, adjacent to the carport.

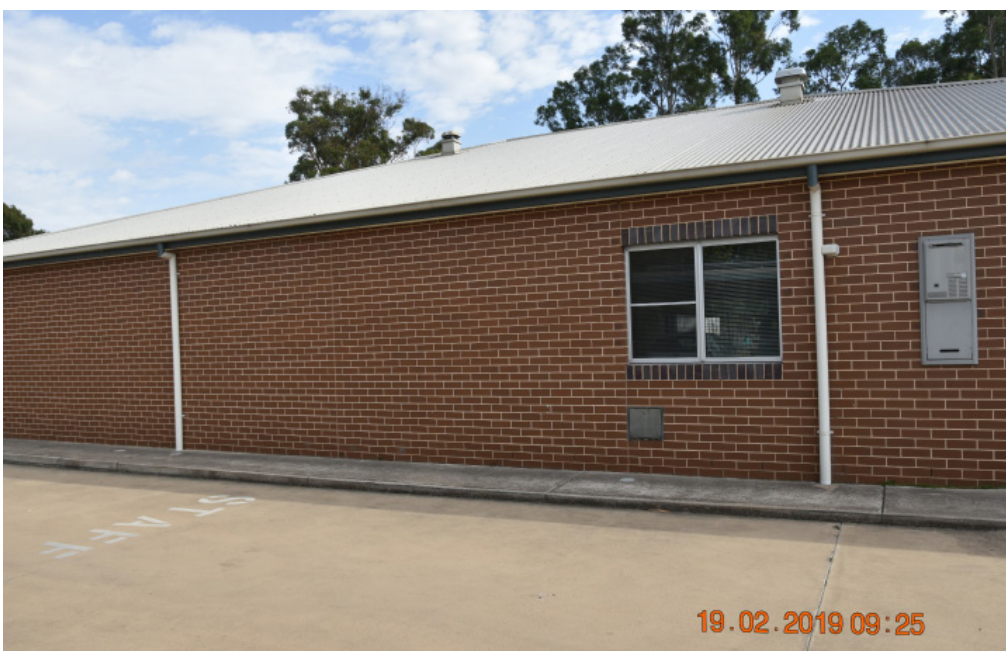
Figure: 0105

South wall of the medical centre.
