PROPERTY CONDITION SURVEY - COMMERCIAL/INDUSTRIAL

AD2696A

Mears and Church Street
MUDGEES NSW 2850

145 Church Street
MUDGEES NSW 2850

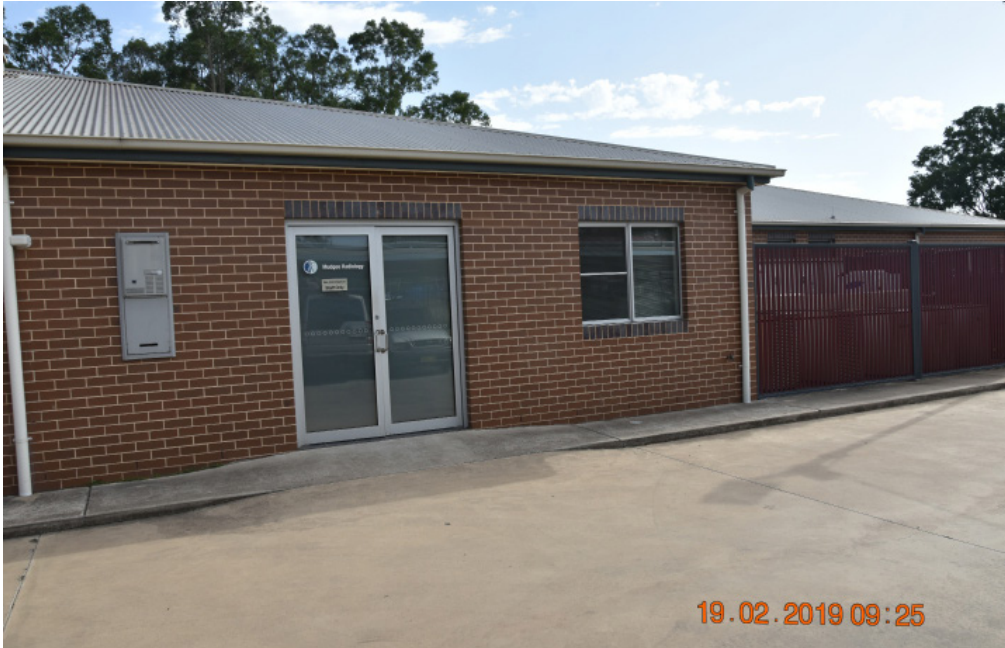
Figure: 0106

South wall of the medical centre.

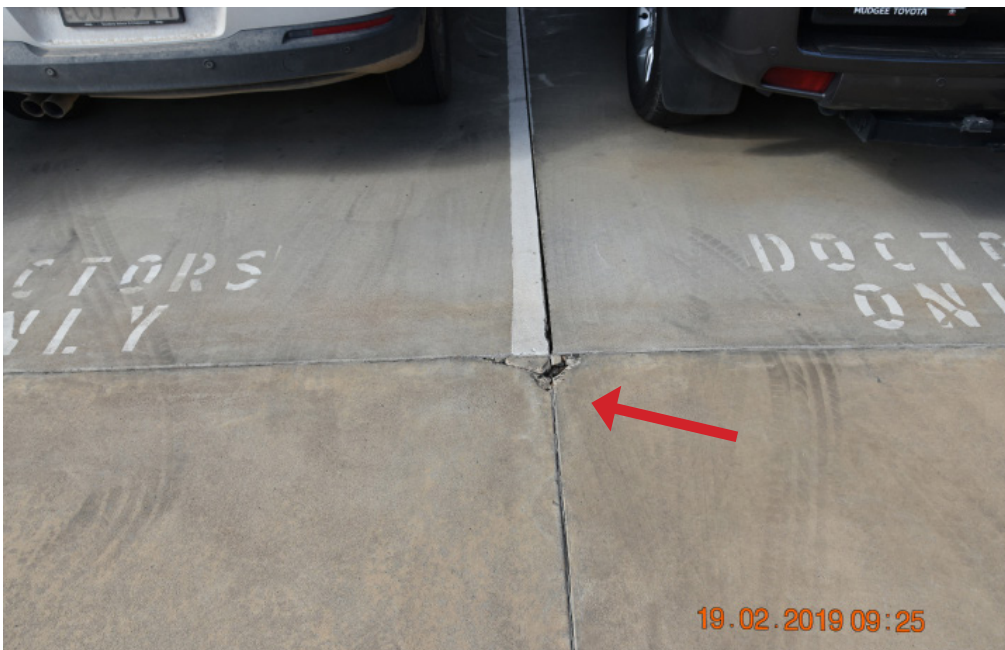
Figure: 0107

Chipping in the in the second doctors only parking space from the west on the south carpark.

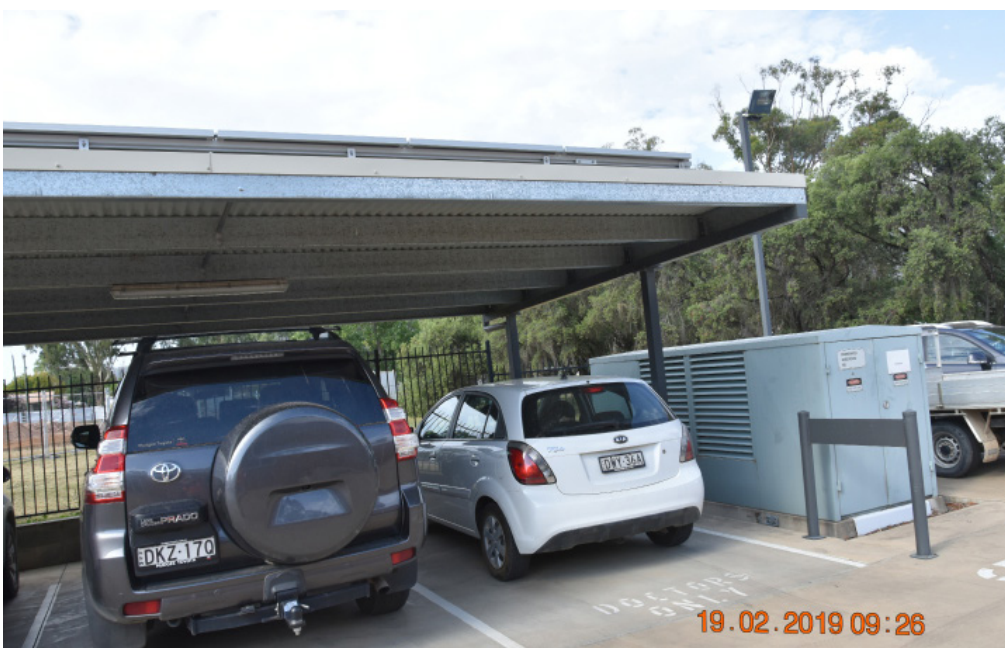
Figure: 0108

General view of the doctors only parking spaces.

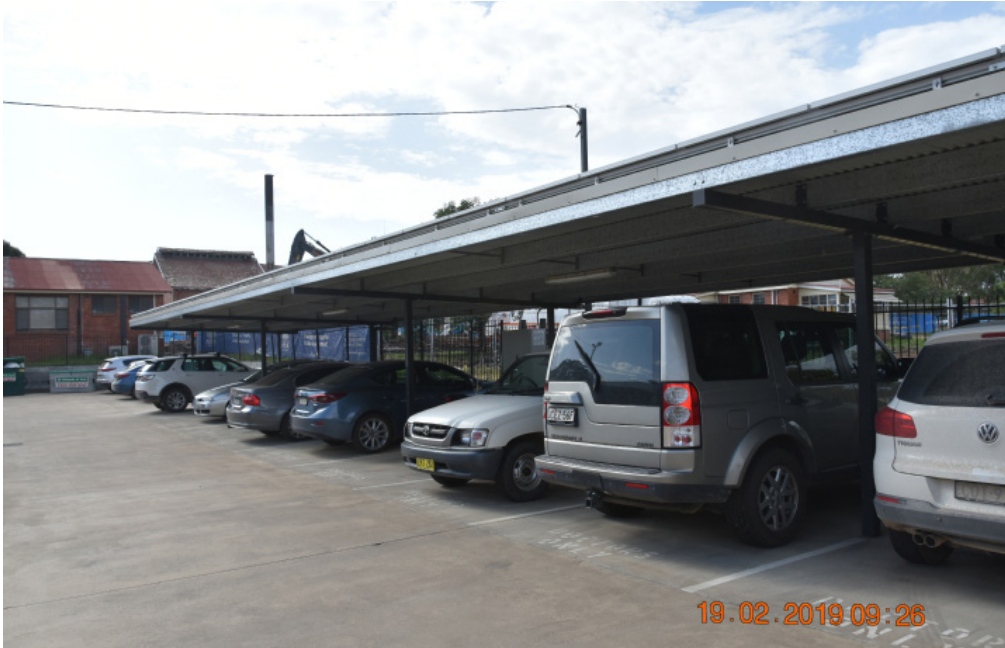
Figure: 0110

General view of the south carpark, looking west from the doctors only parking spaces. Showing cracking.

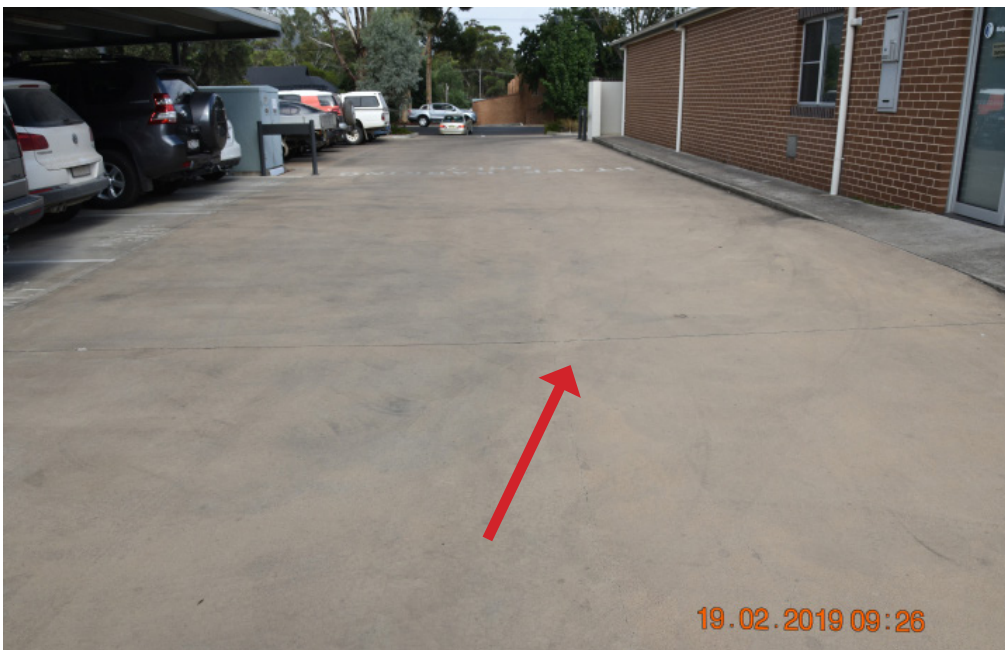
Figure: 0111

General view of the south carpark, looking east from the doctors only parking spaces. Showing cracking.

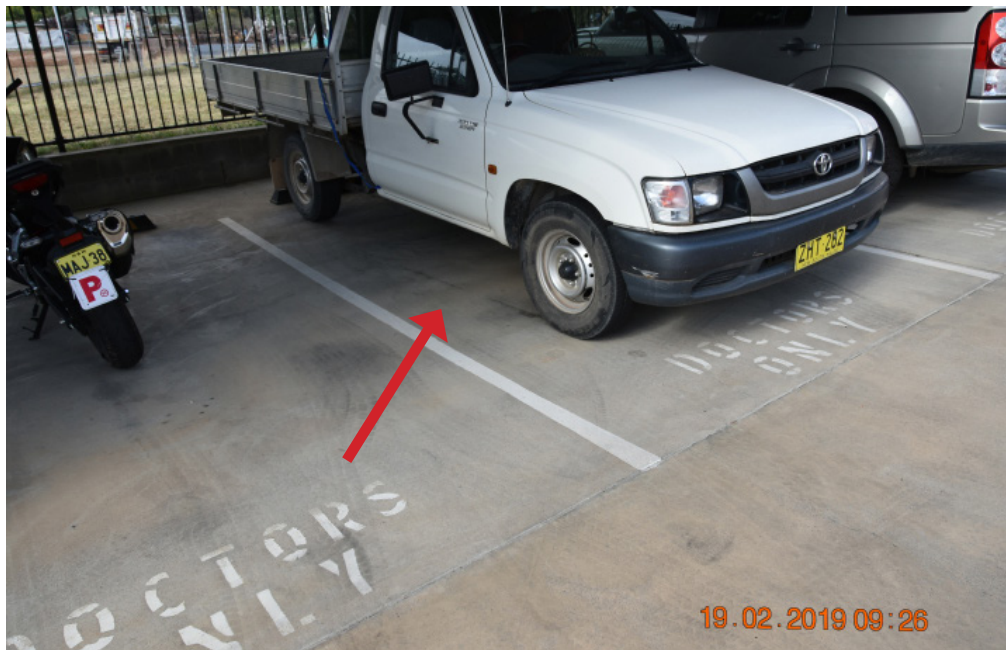
Figure: 0112

Cracking in the doctors only parking spaces.

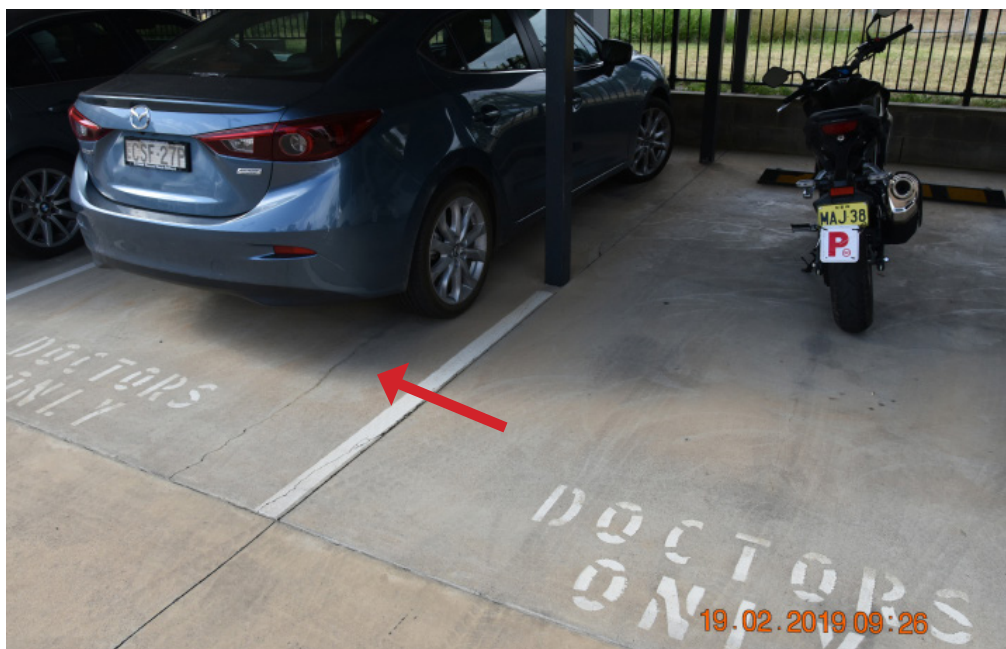
Figure: 0113

Cracking in the doctors only parking spaces.

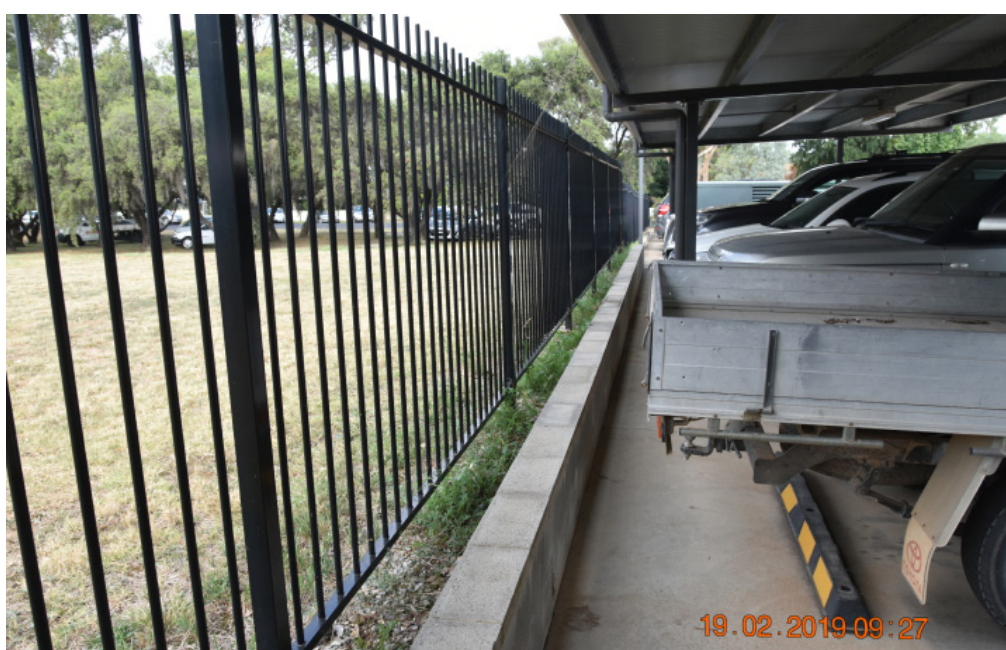
Figure: 0114

South boundary fence, looking west from the doctors only parking spaces.

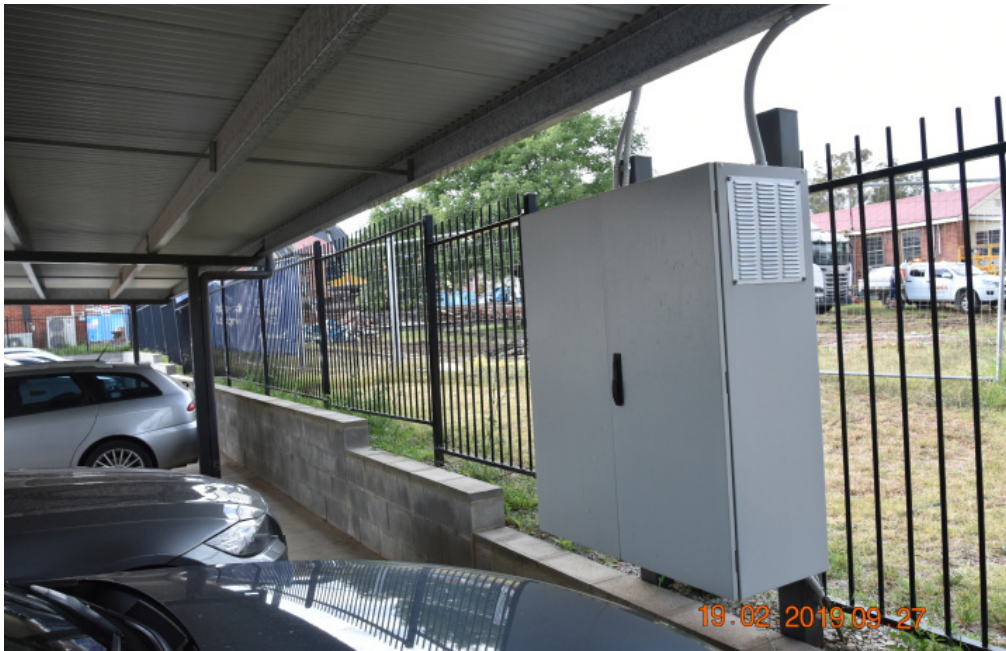
Figure: 0115

South boundary fence, looking east from the doctors only parking spaces.

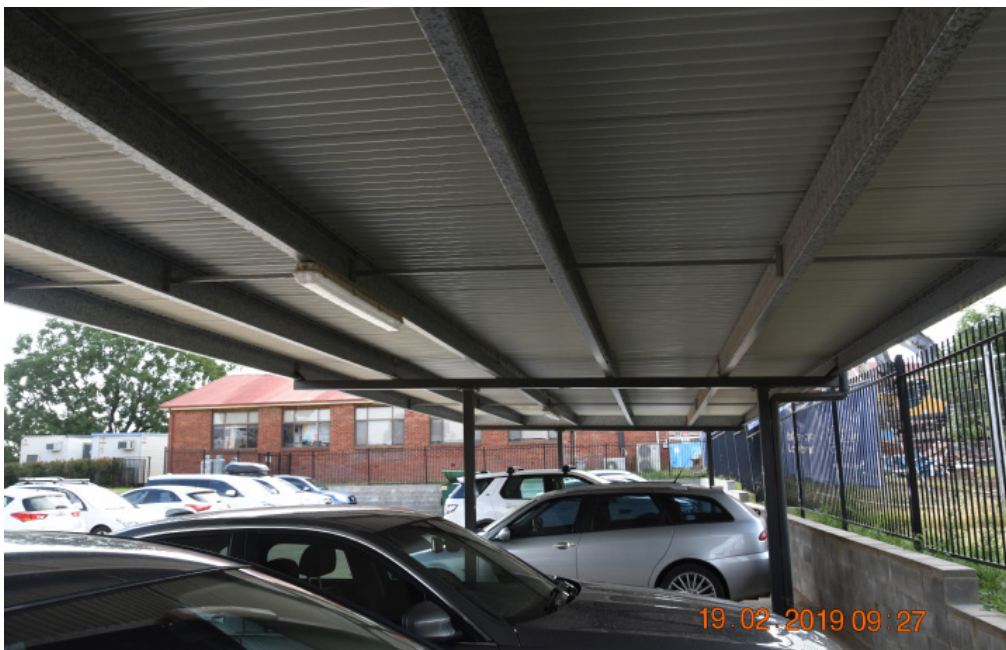
Figure: 0116

Underside of the carport on the south carpark.

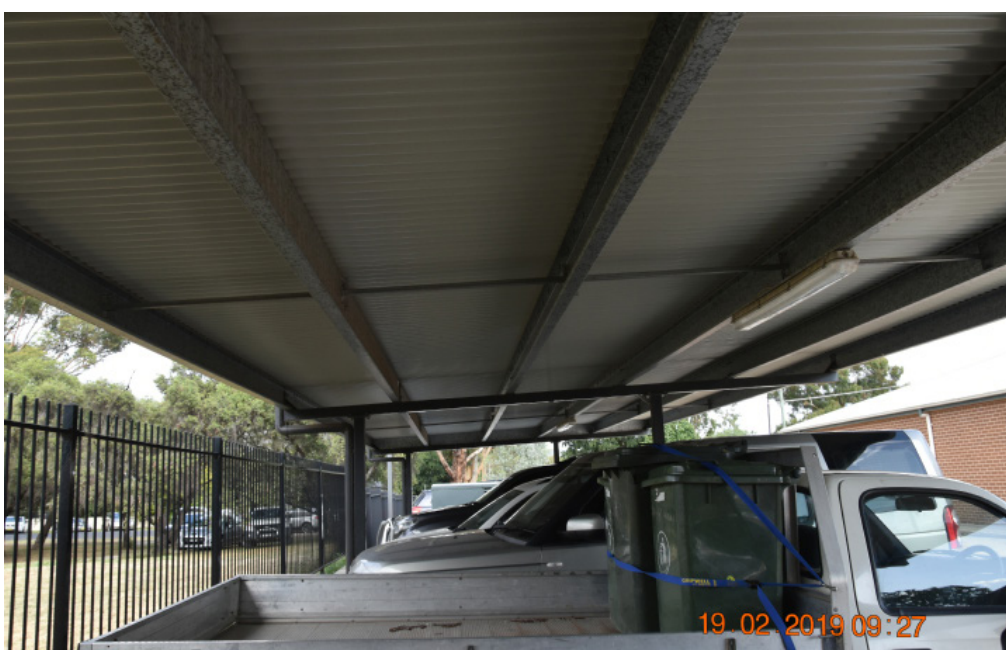
Figure: 0117

Underside of the carport on the south carpark.

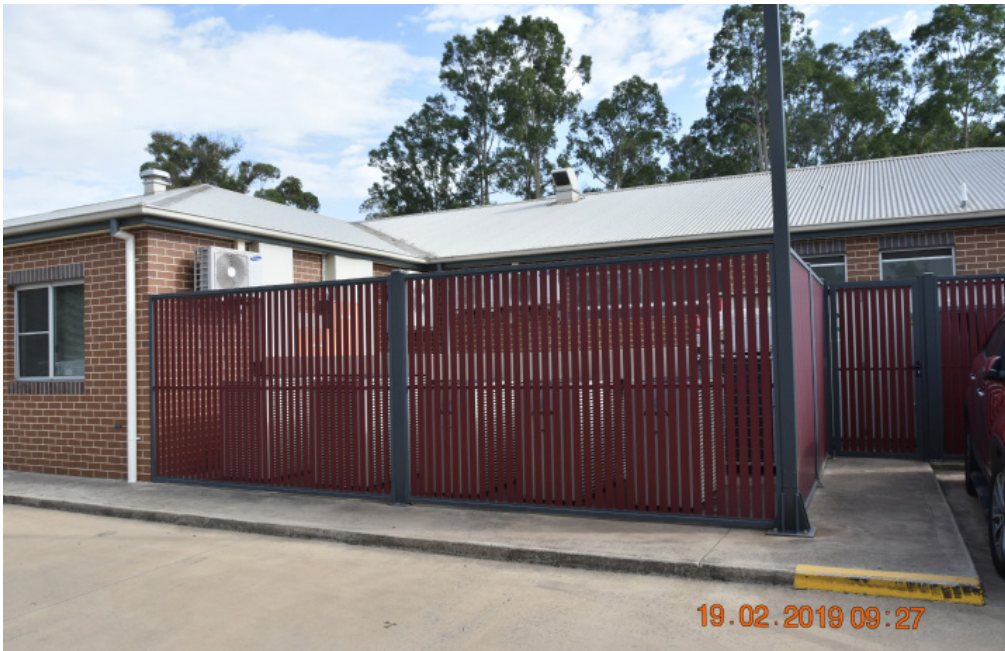
Figure: 0119

Fence near the southeast corner of the medical centre.

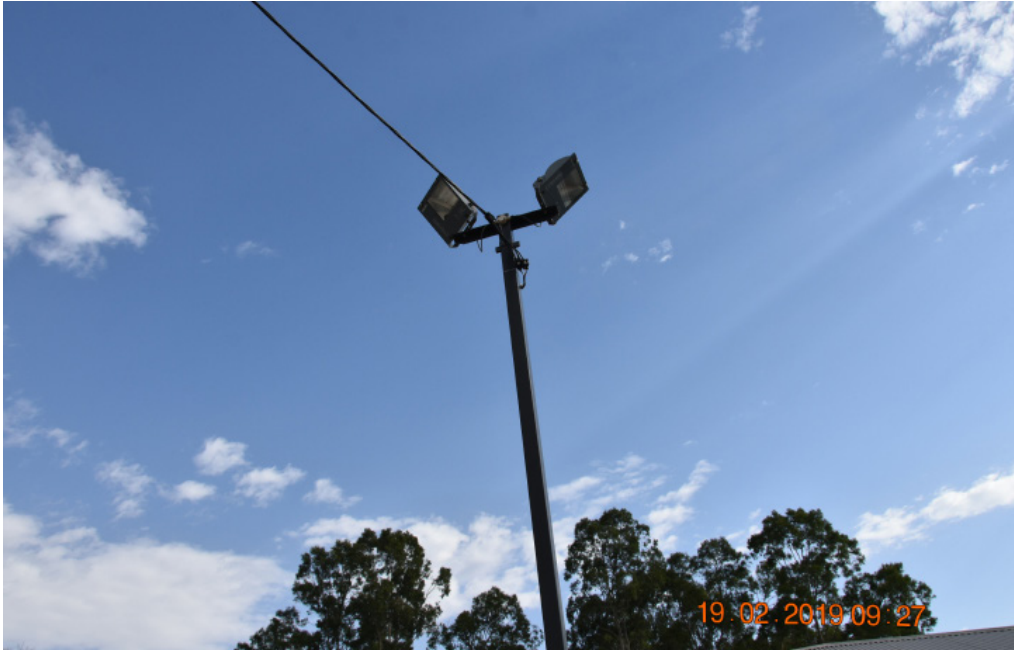
Figure: 0121

Light pole near the southeast corner of the medical centre.

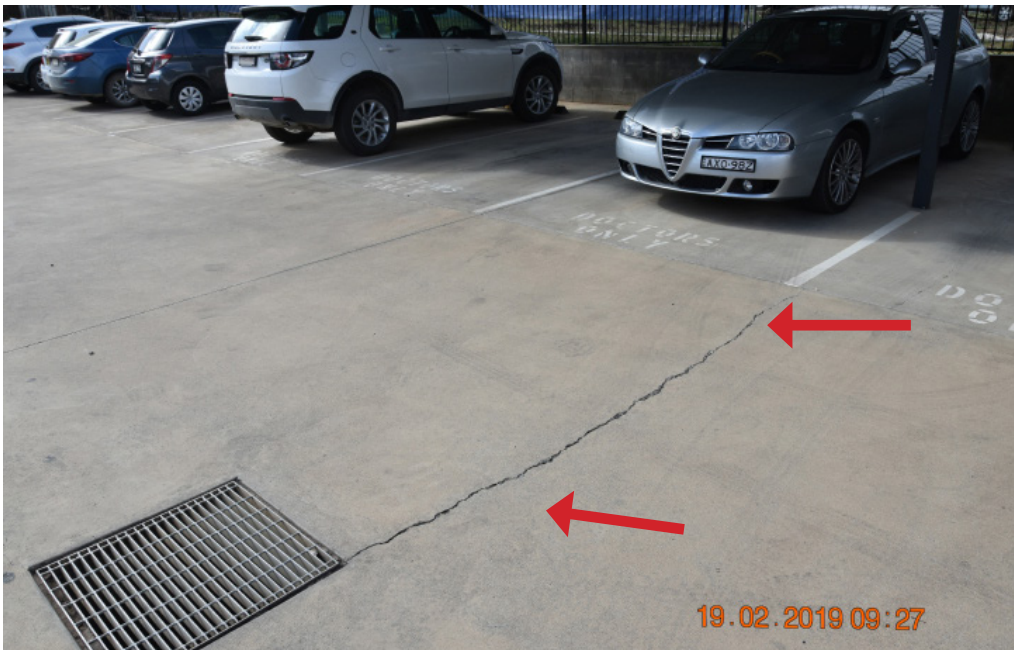
Figure: 0122

Wide cracking in the south carpark, near the southeast corner of the medical centre.

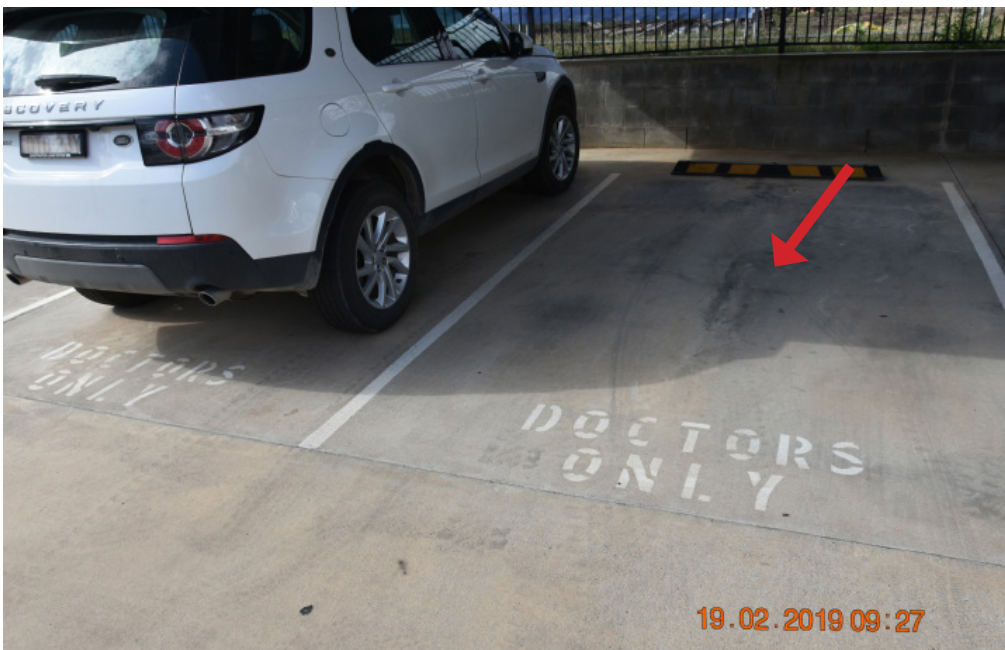
Figure: 0126

South boundary fence, looking from the east doctors only parking space.

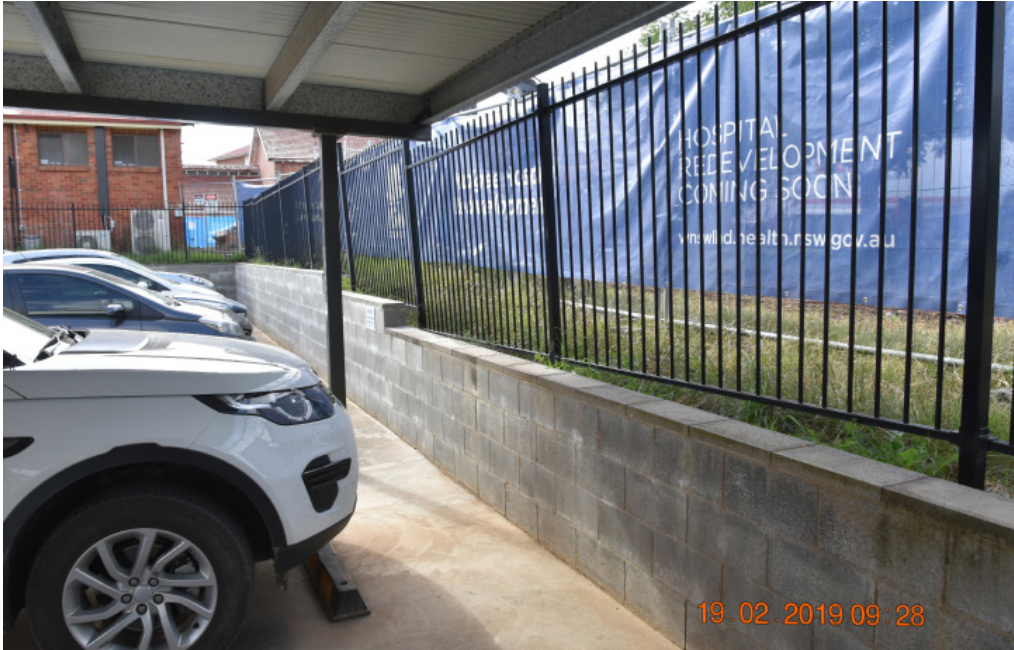
Figure: 0127

South boundary fence, looking from the east doctors only parking space.

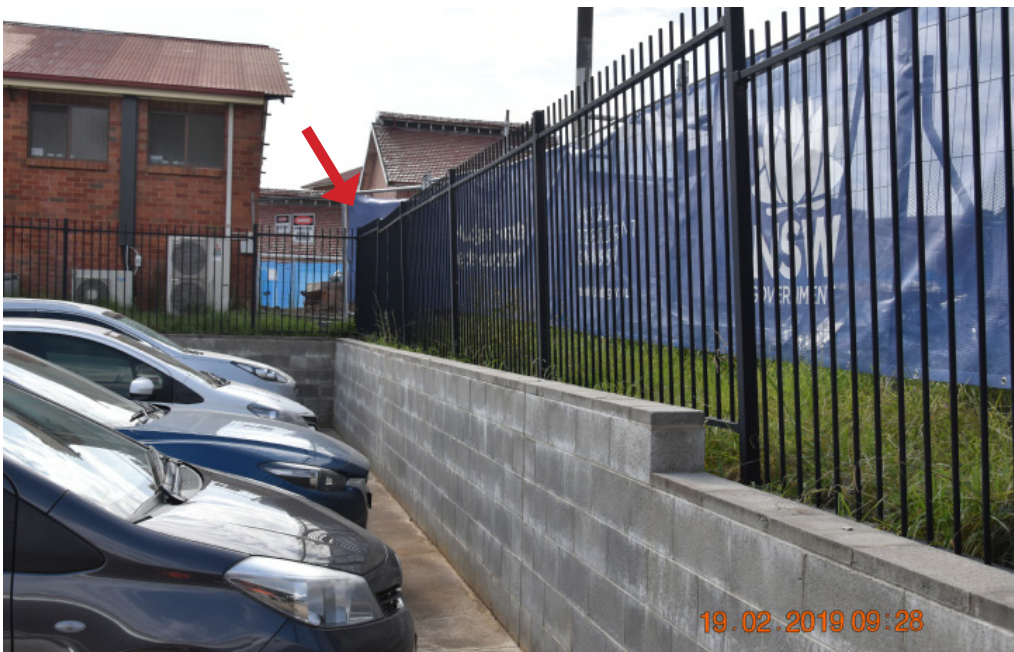
Figure: 0128

South boundary fence, east side. Showing leaning.

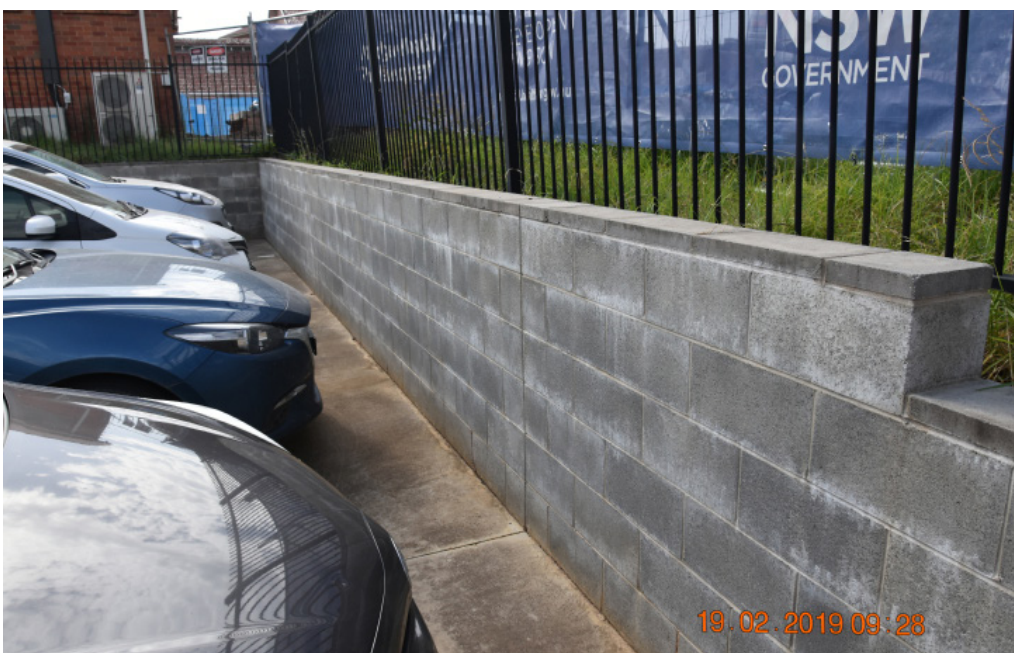
Figure: 0129

Retaining wall on the south side of the south carpark, east side.

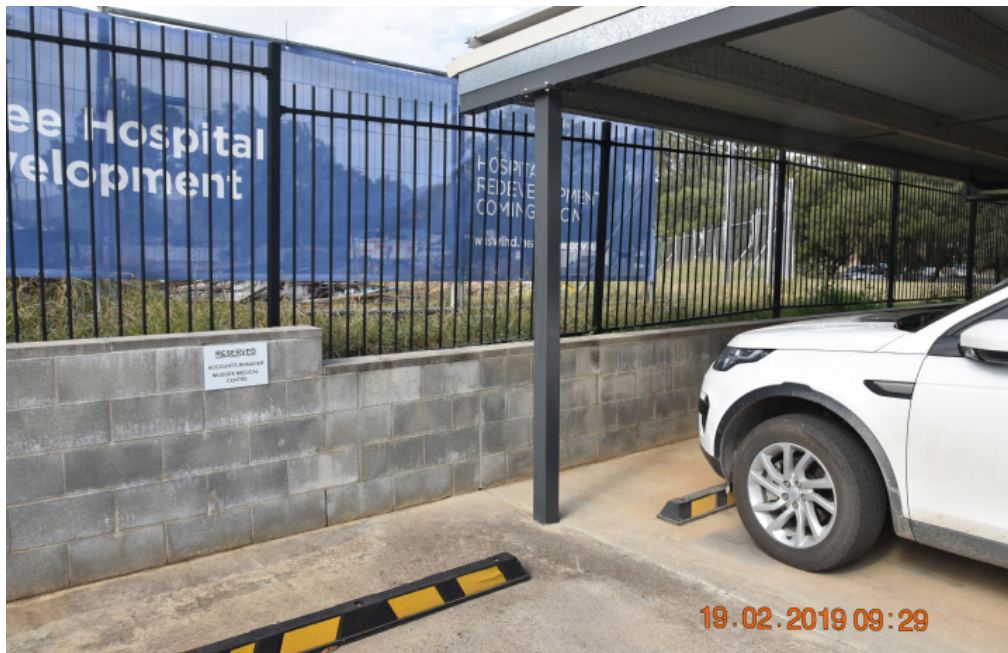
Figure: 0130

Retaining wall on the south side of the south carpark, adjacent to the doctors only parking spaces.

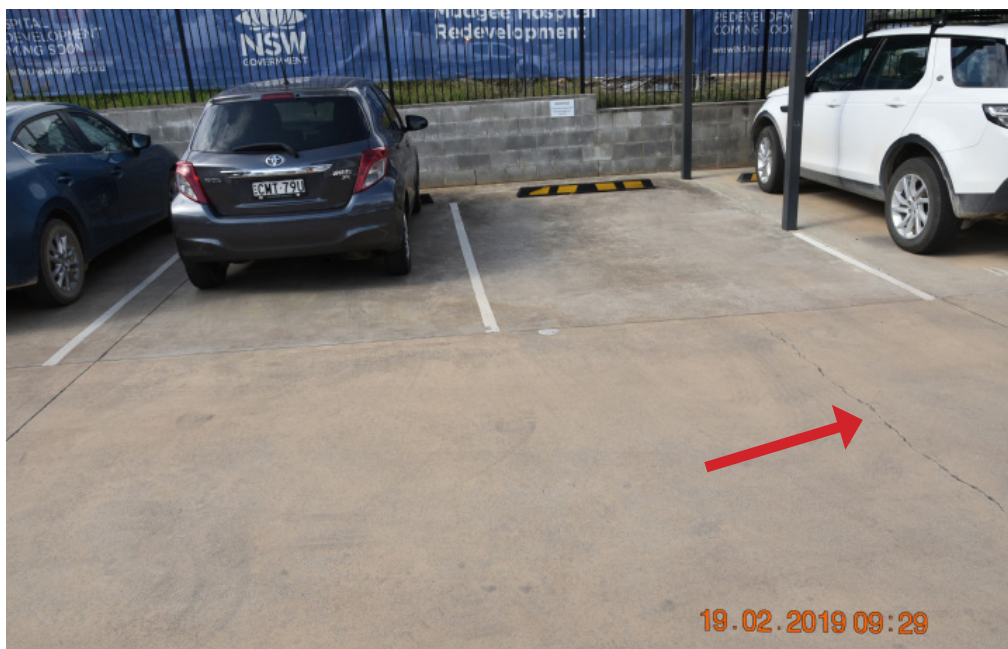
Figure: 0131

General view of the south carpark, east side. Showing cracking.

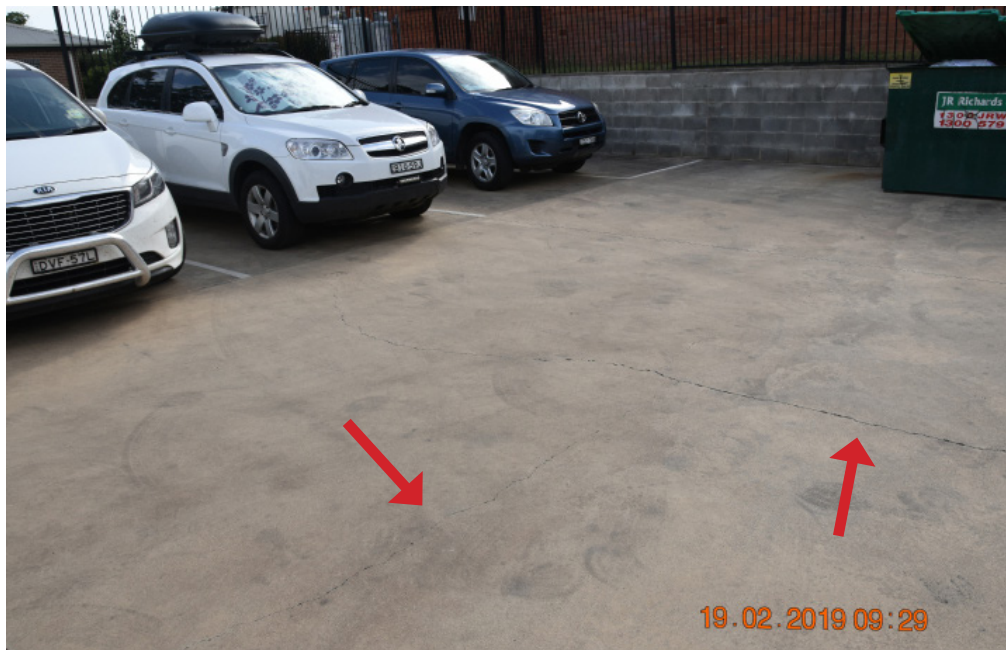
Figure: 0133

General view of the south carpark, east side. Showing cracking.

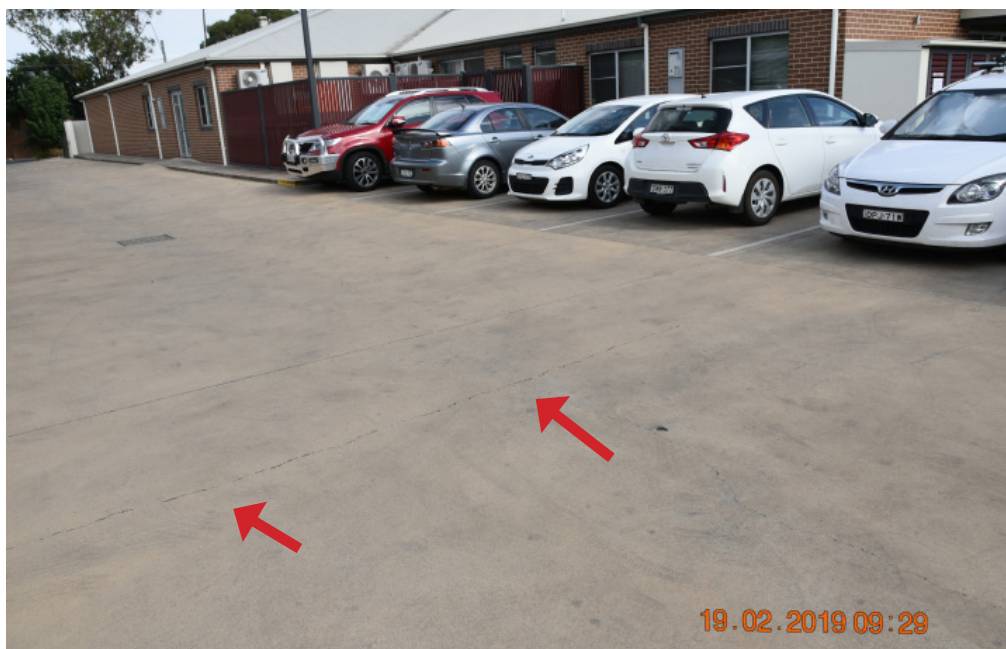
Figure: 0134

General view of the south carpark, east side. Showing cracking.

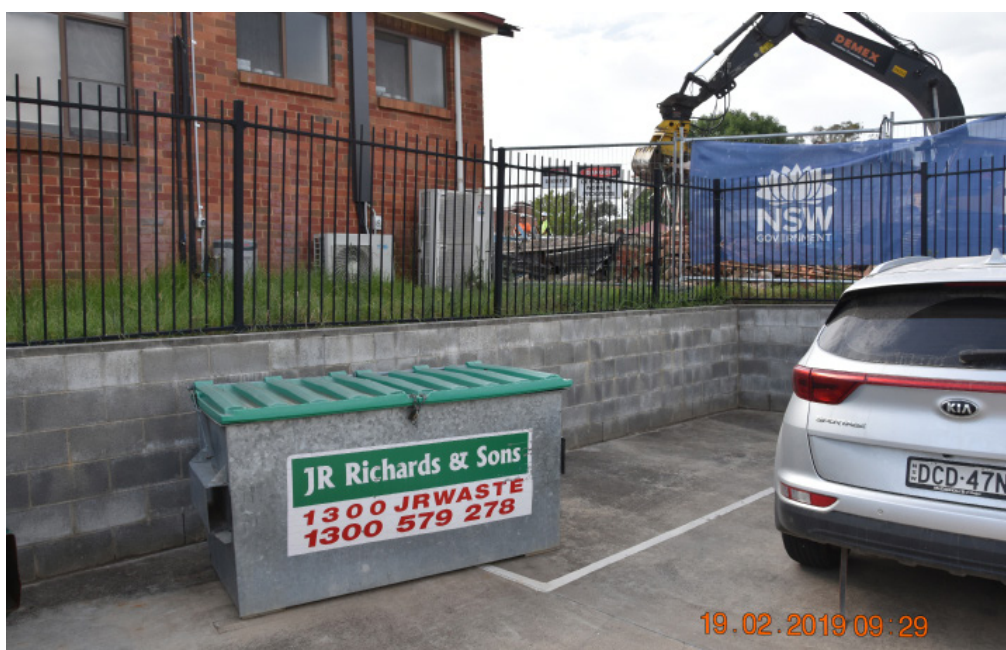
Figure: 0135

Fence on the east side of the medical centre.

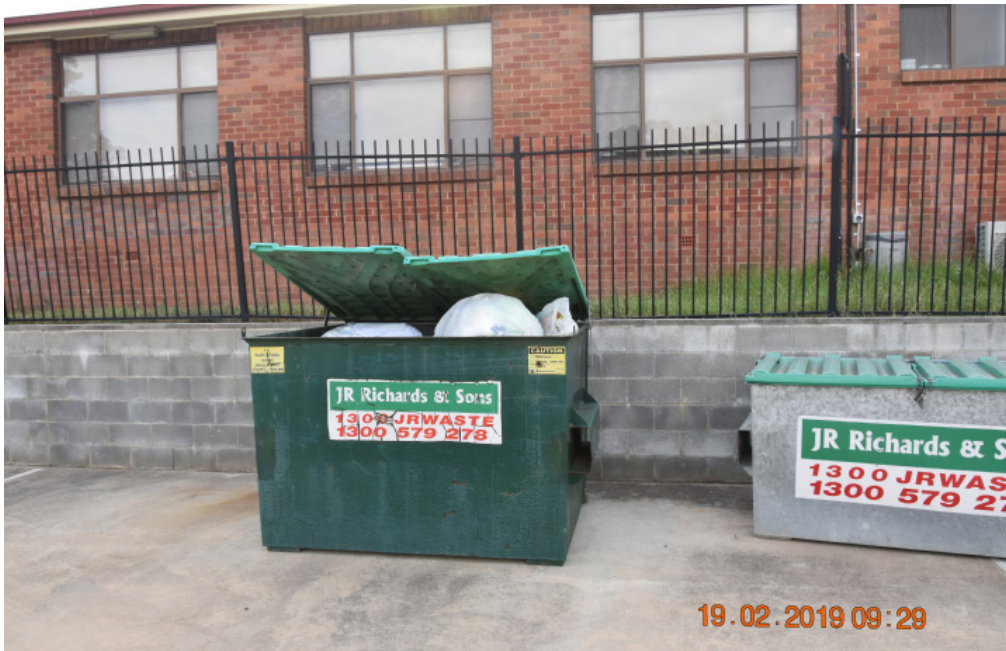
Figure: 0136

Fence on the east side of the medical centre.

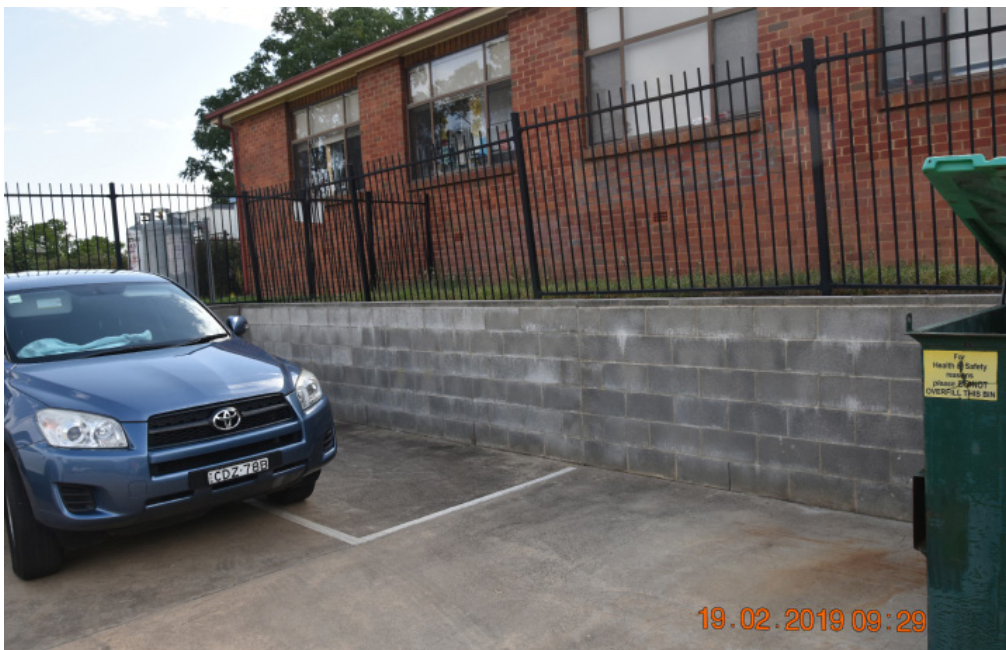
Figure: 0137

Fence on the east side of the medical centre.

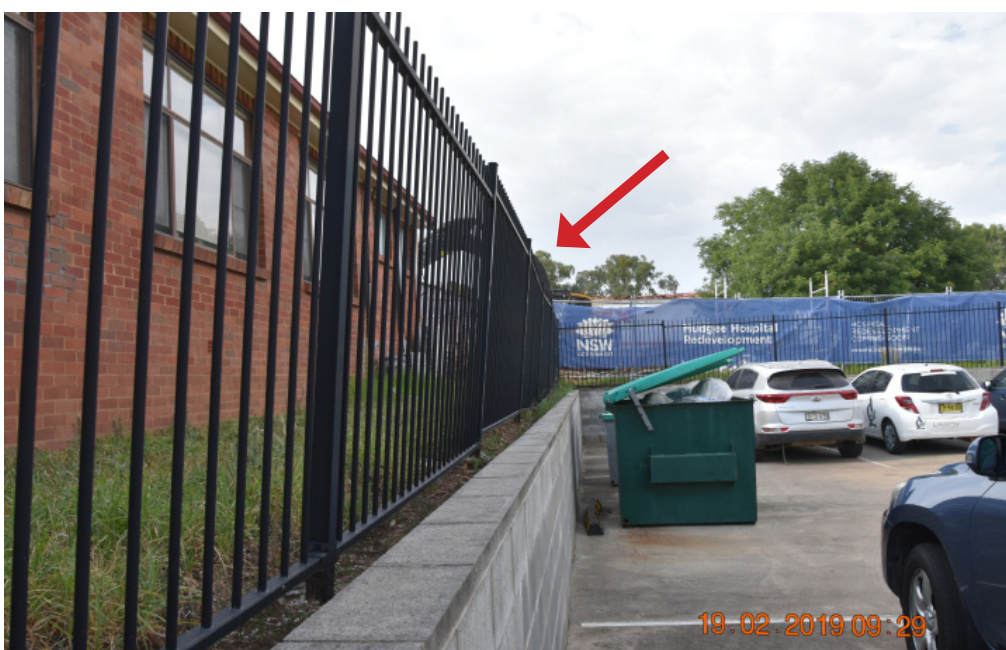
Figure: 0138

Leaning in the east boundary fence, south side of the medical centre.

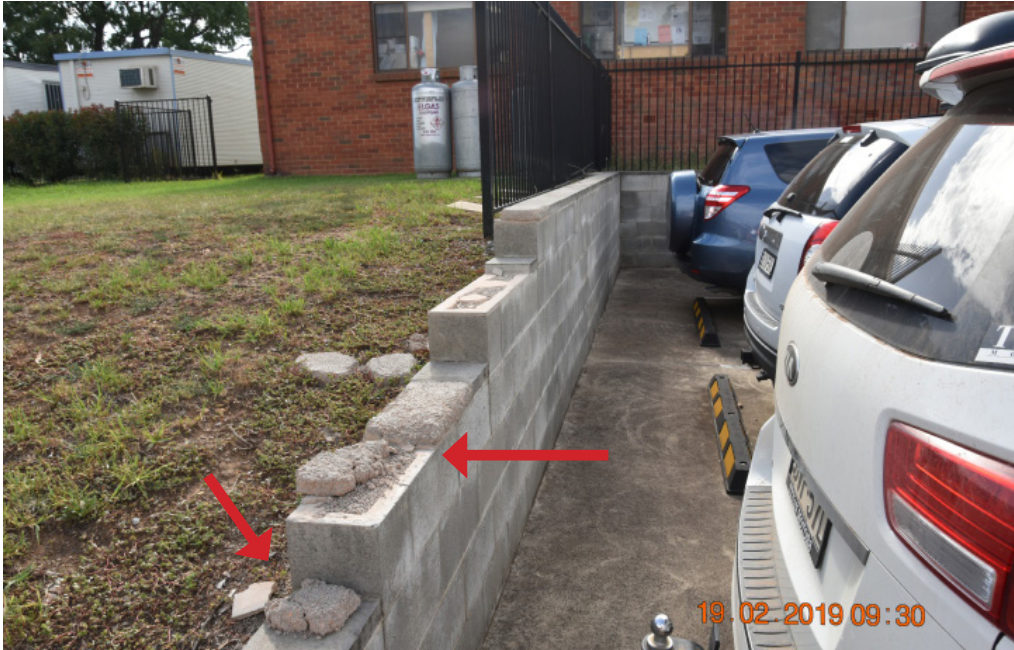
Figure: 0139

Retaining wall on the north side of the doctors only parking spaces on the south carpark. Showing damage.

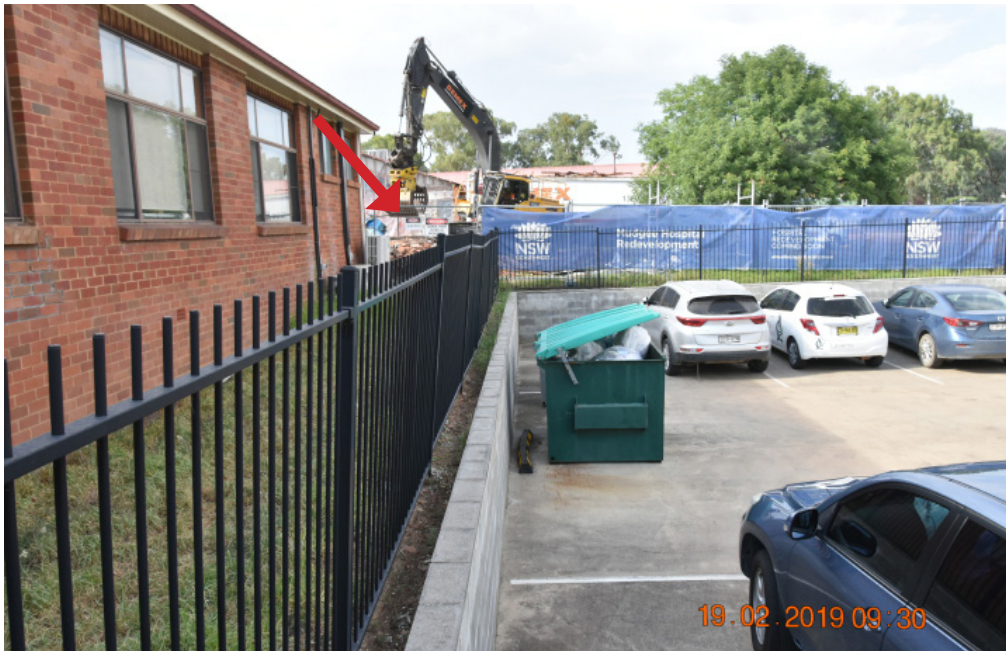
Figure: 0141

Fence on the north side of the doctors only parking spaces.

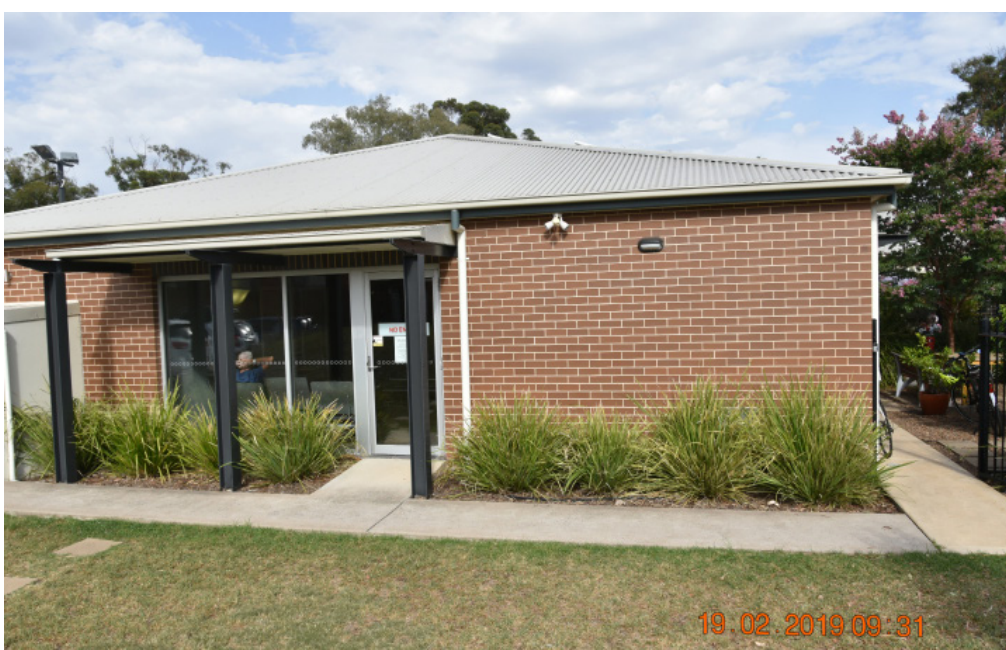
Figure: 0143

East wall of the medical centre.

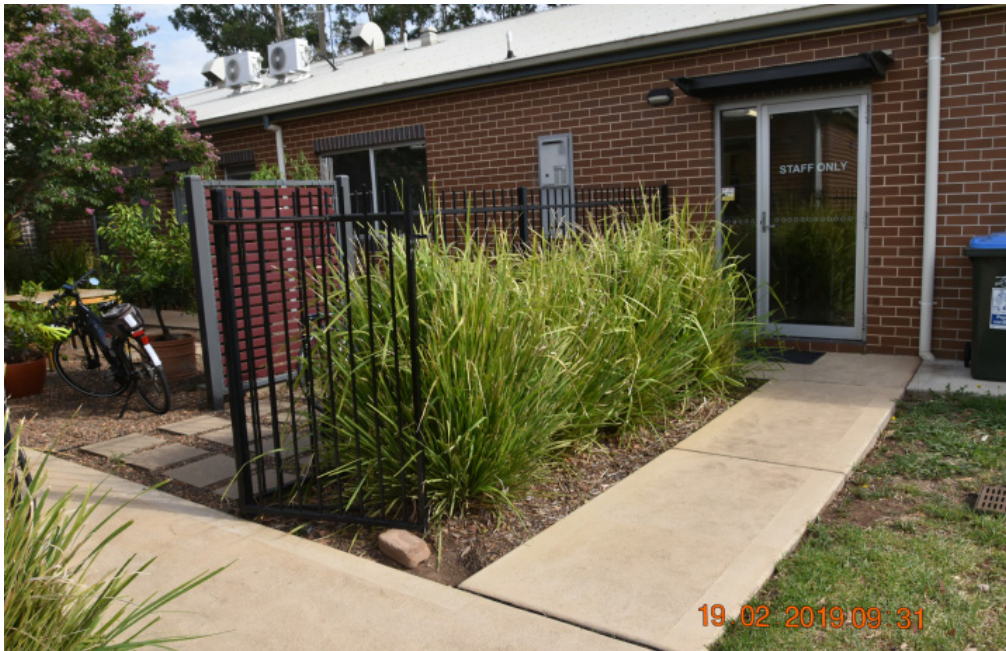
Figure: 0144

East wall of the medical centre.

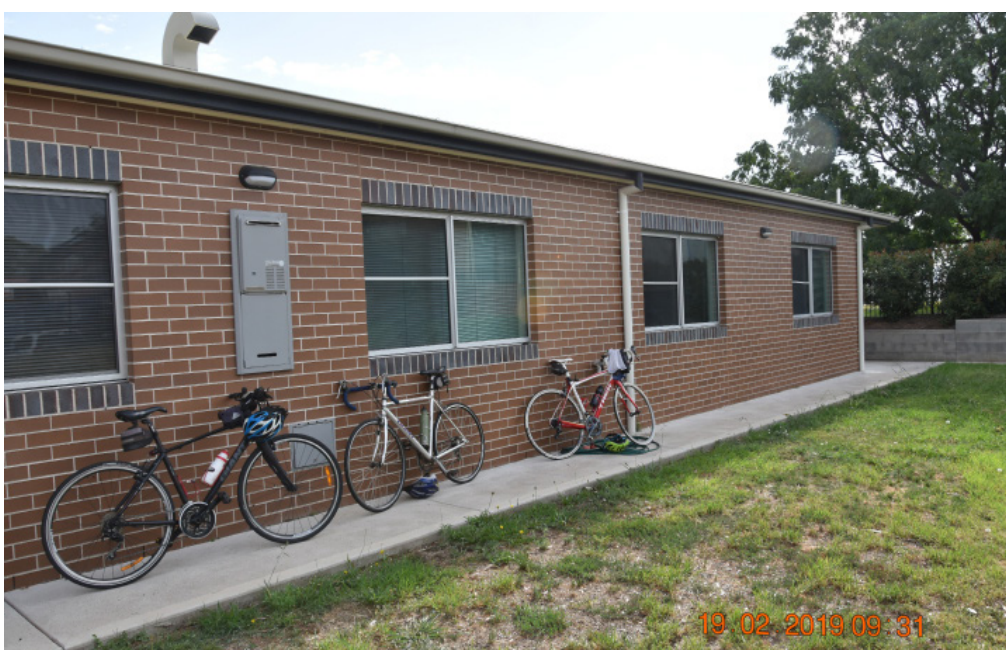
Figure: 0146

South wall of the medical centre.

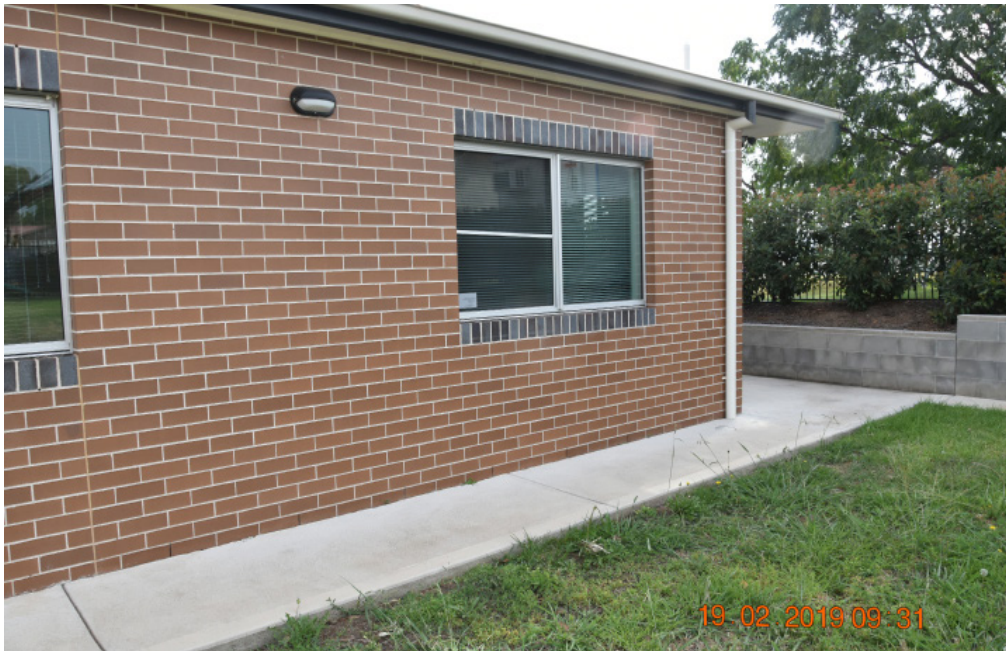
Figure: 0147

South wall of the medical centre.

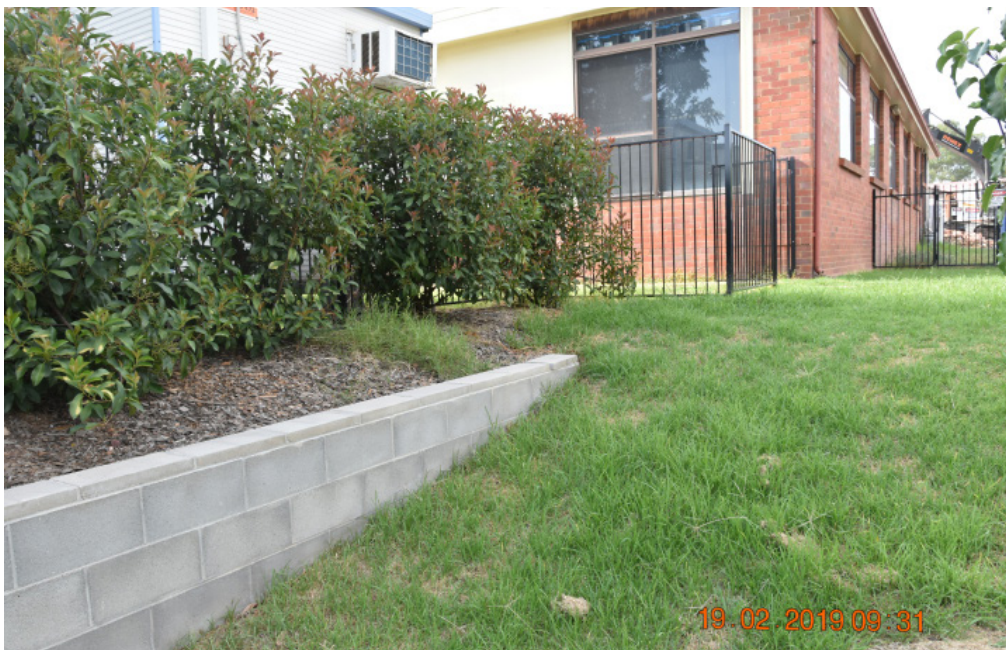
Figure: 0148

South wall of the medical centre.

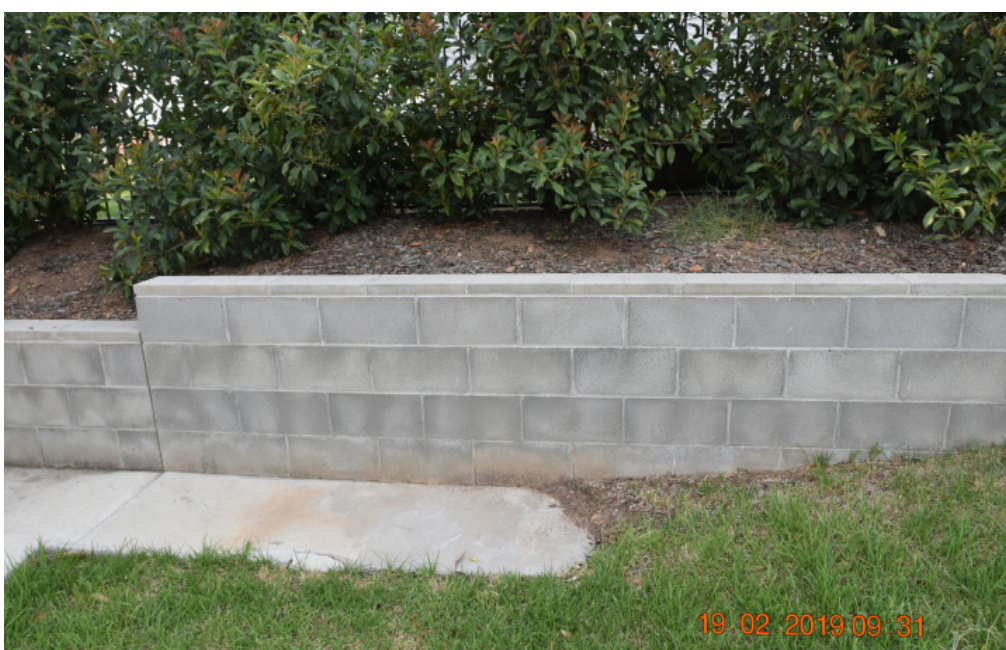
Figure: 0149

Retaining wall on the east side of the medical centre.
