PROPERTY CONDITION SURVEY - COMMERCIAL/INDUSTRIAL

AD2696A

Mears and Church Street
MUDGEES NSW 2850

145 Church Street
MUDGEES NSW 2850

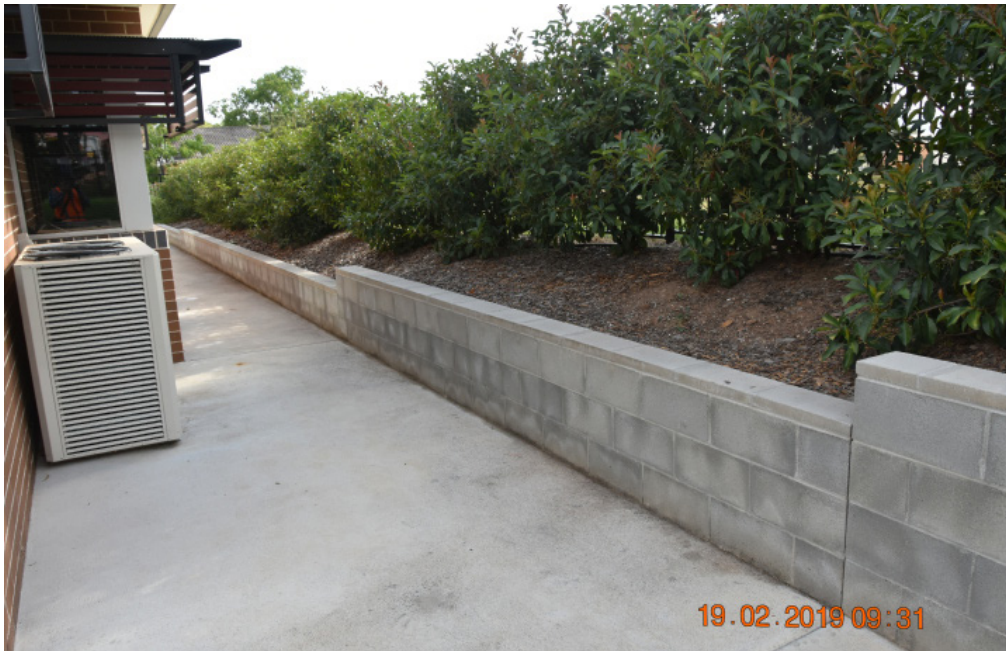
Figure: 0150

Retaining wall on the east side of the medical centre.

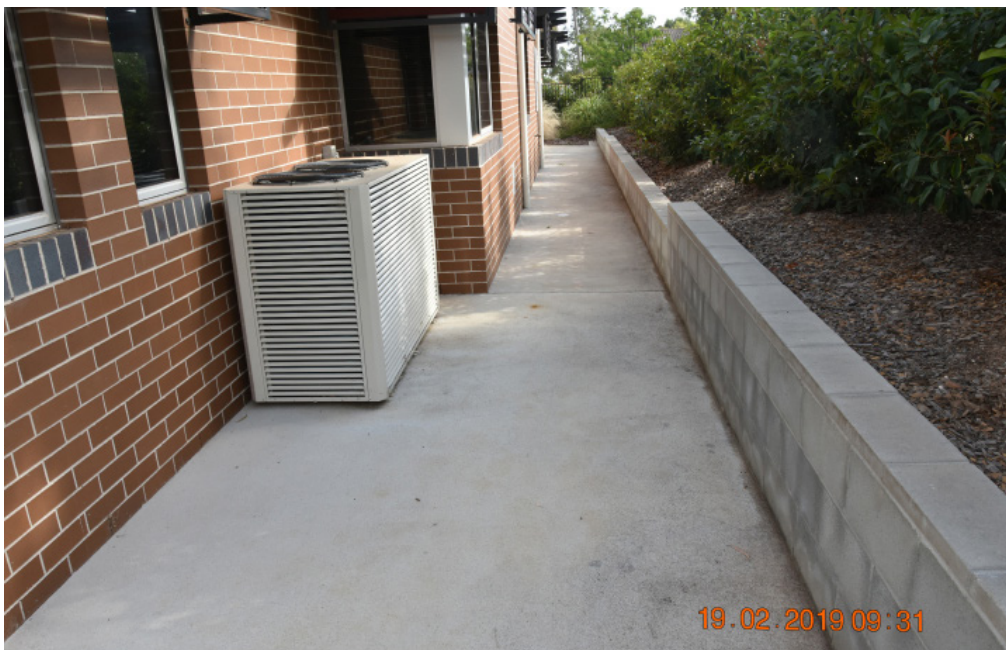
Figure: 0151

Retaining wall on the east side of the medical centre.

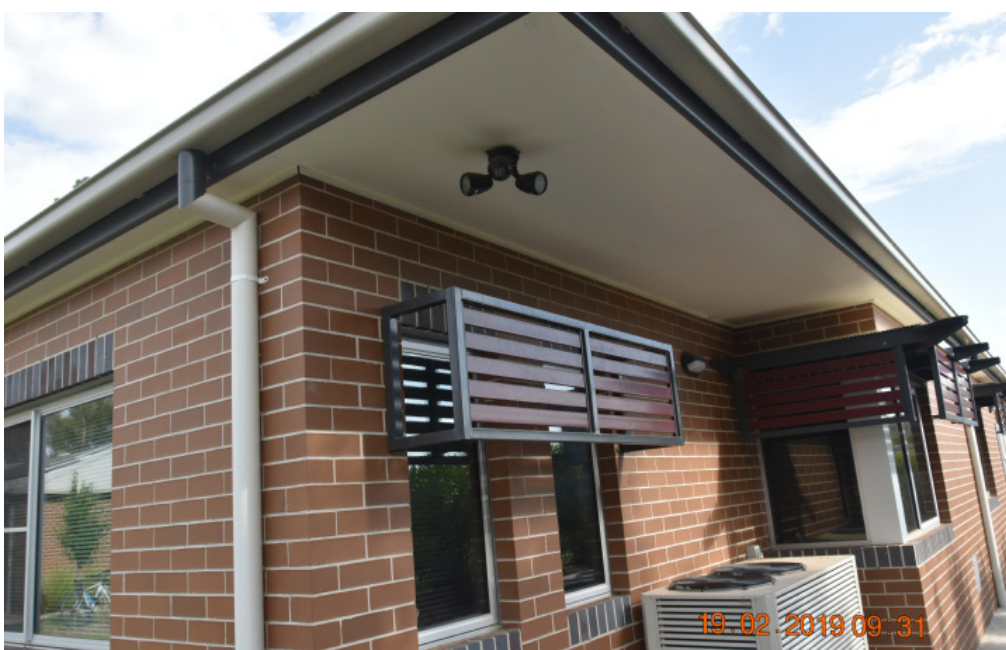
Figure: 0152

Pathway on the east side of the medical centre.

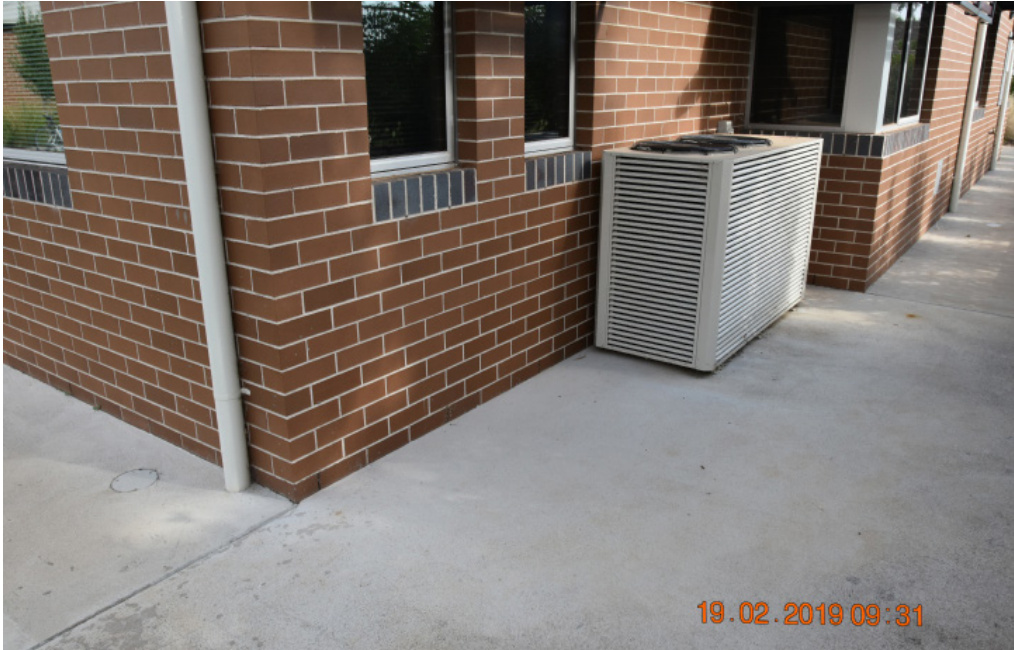
Figure: 0153

East wall of the medical centre.

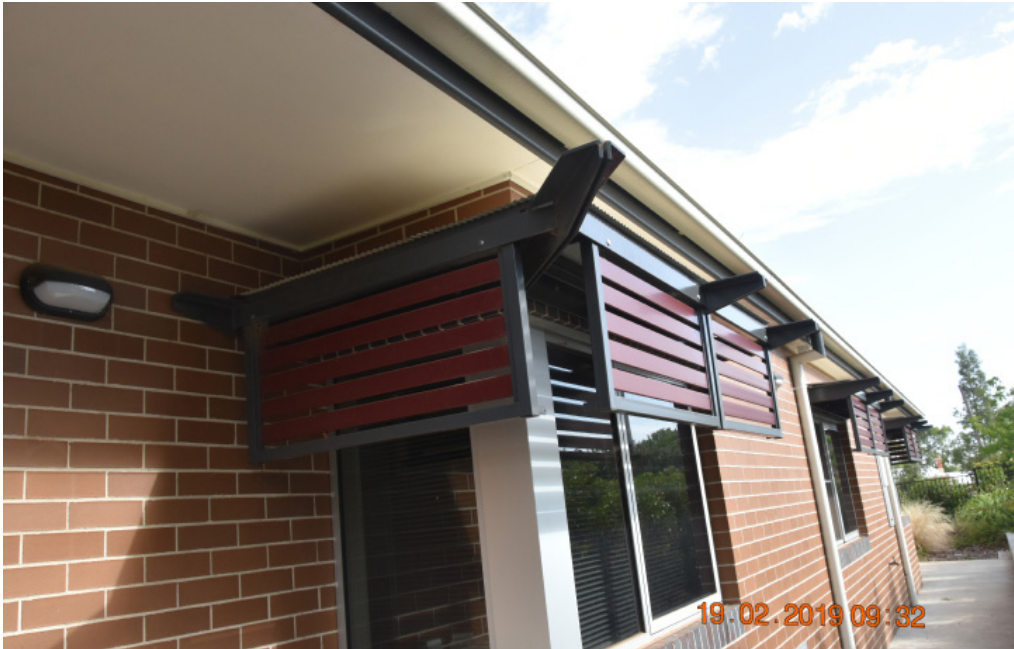
Figure: 0154

East wall of the medical centre.

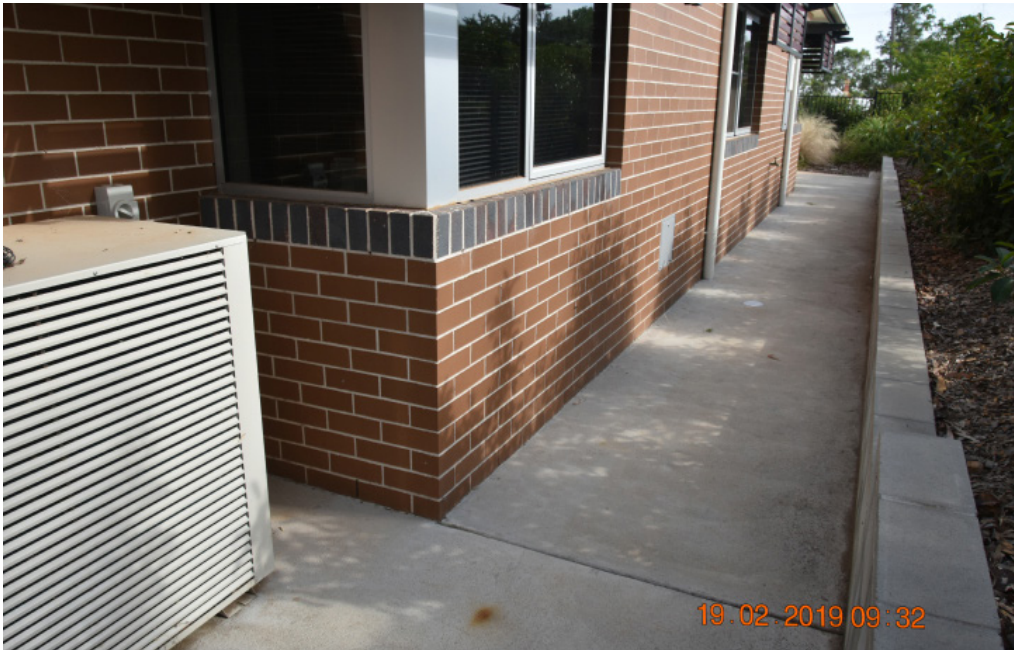
Figure: 0155

East wall of the medical centre.

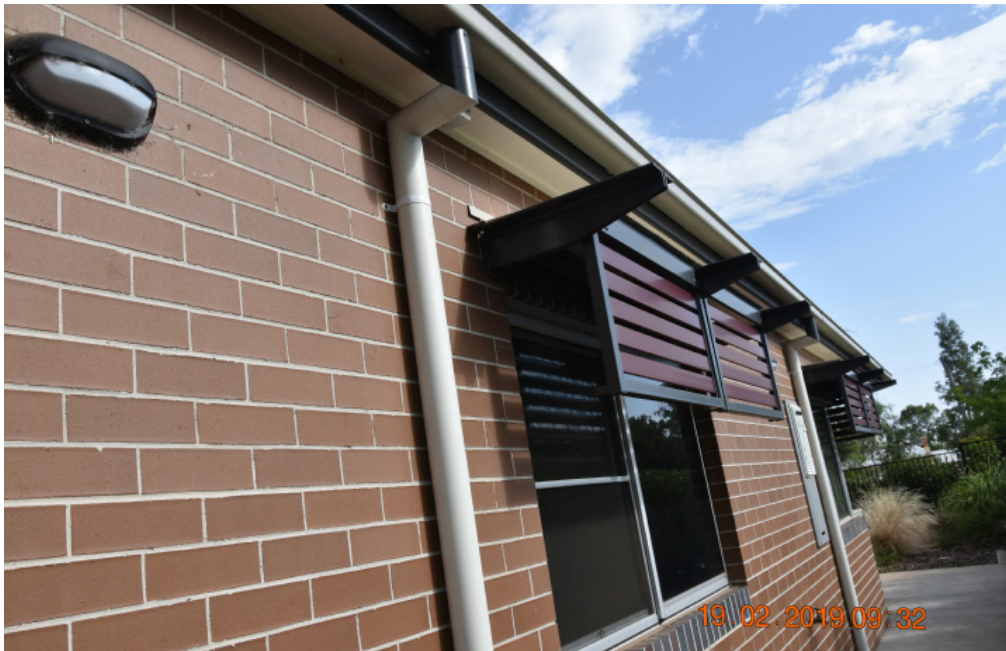
Figure: 0156

East wall of the medical centre.

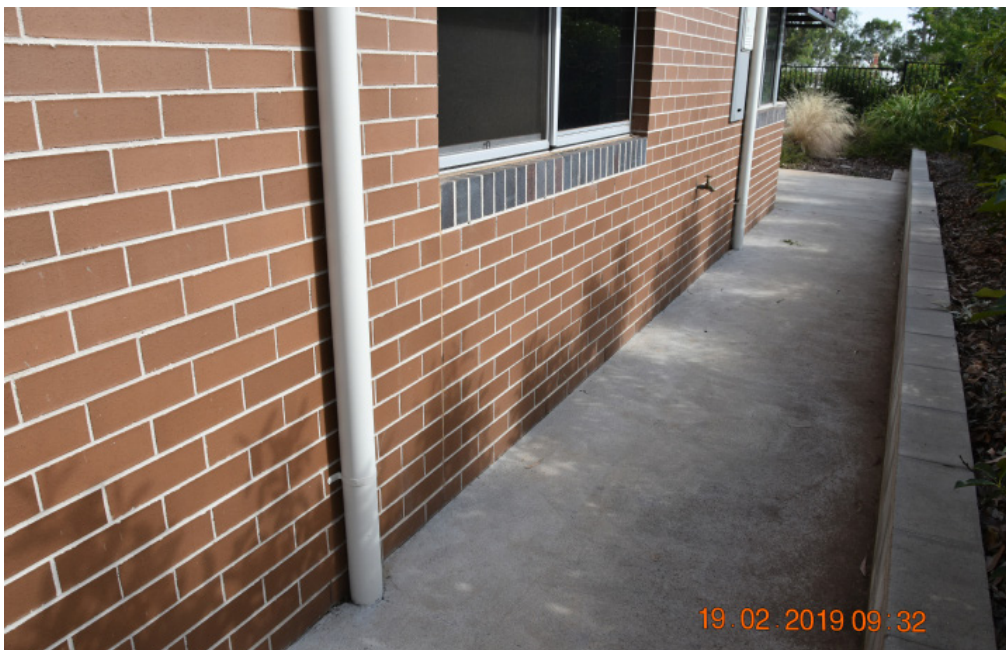
Figure: 0157

East wall of the medical centre.

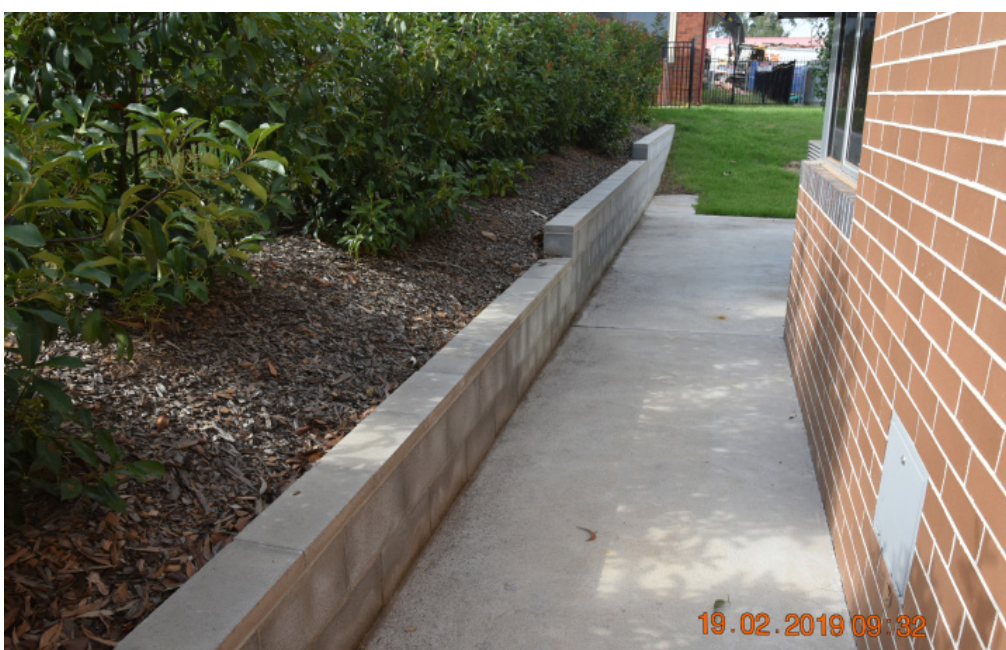
Figure: 0158

East wall of the medical centre.

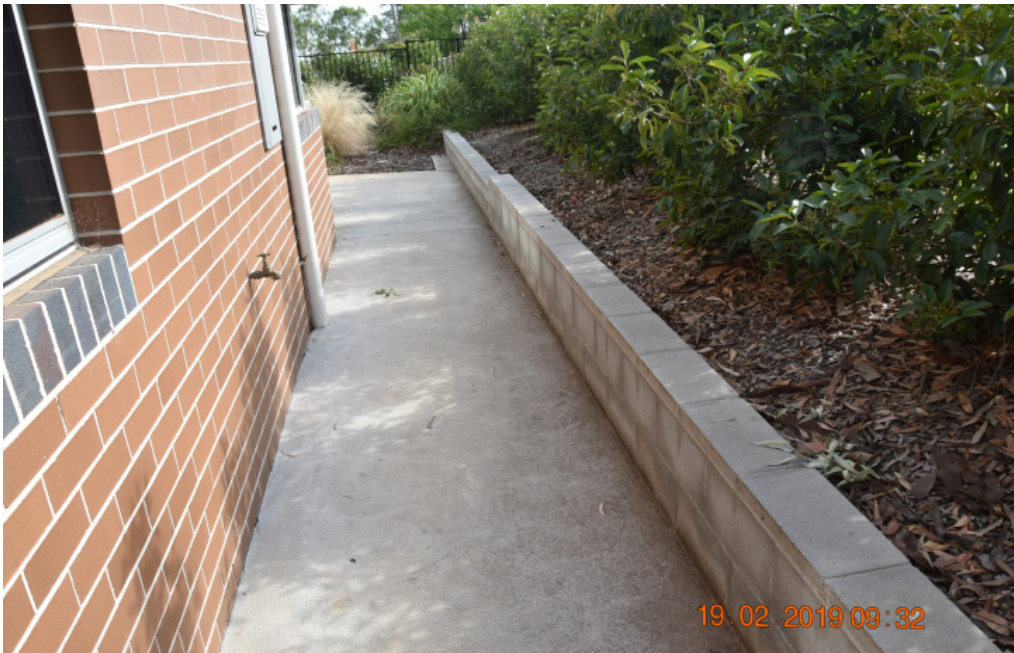
Figure: 0159

Pathway on the east side of the medical centre.

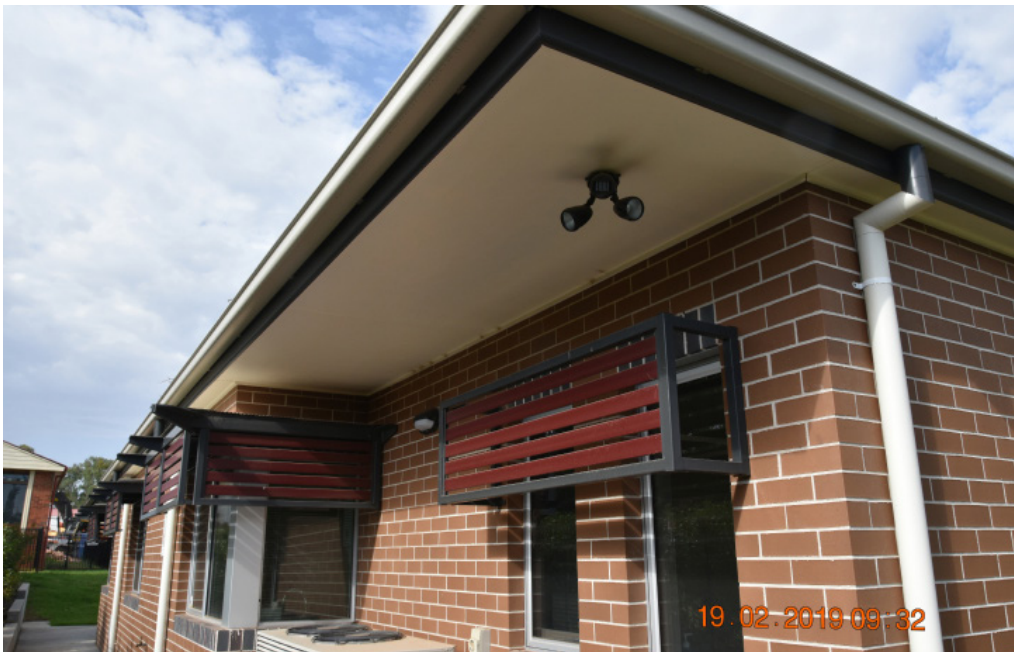
Figure: 0160

Pathway on the east side of the medical centre.

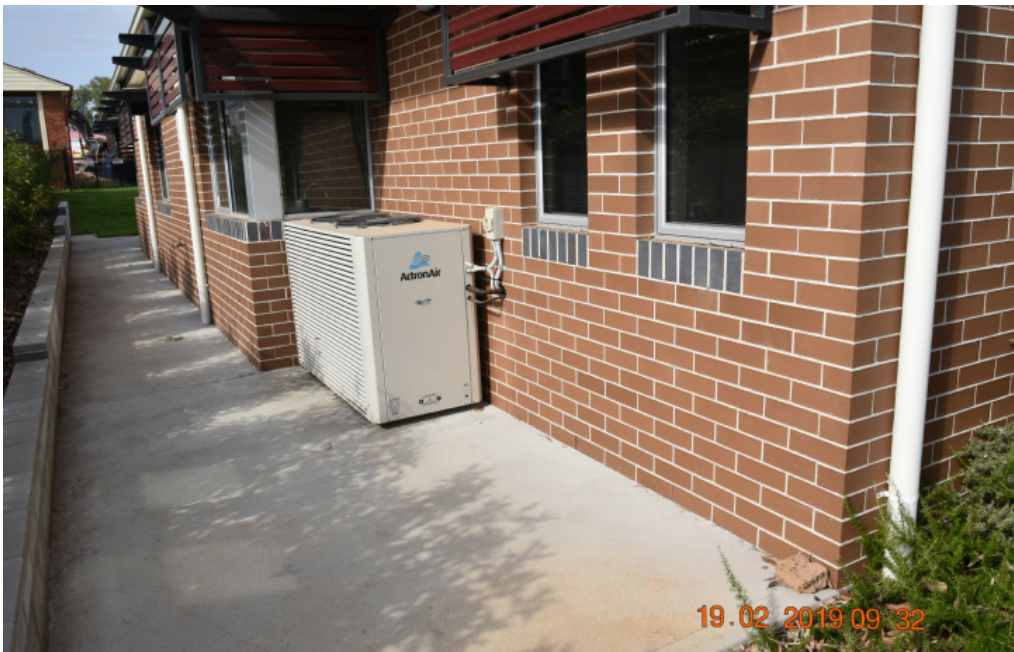
Figure: 0161

East wall of the medical centre, looking from the north.

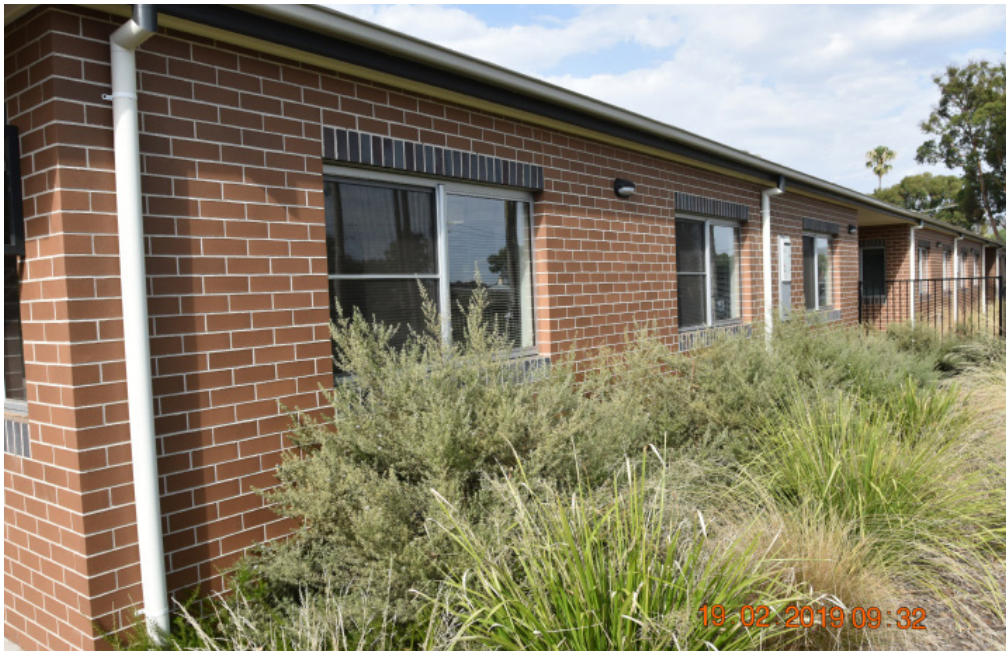
Figure: 0162

East wall of the medical centre, looking from the north.

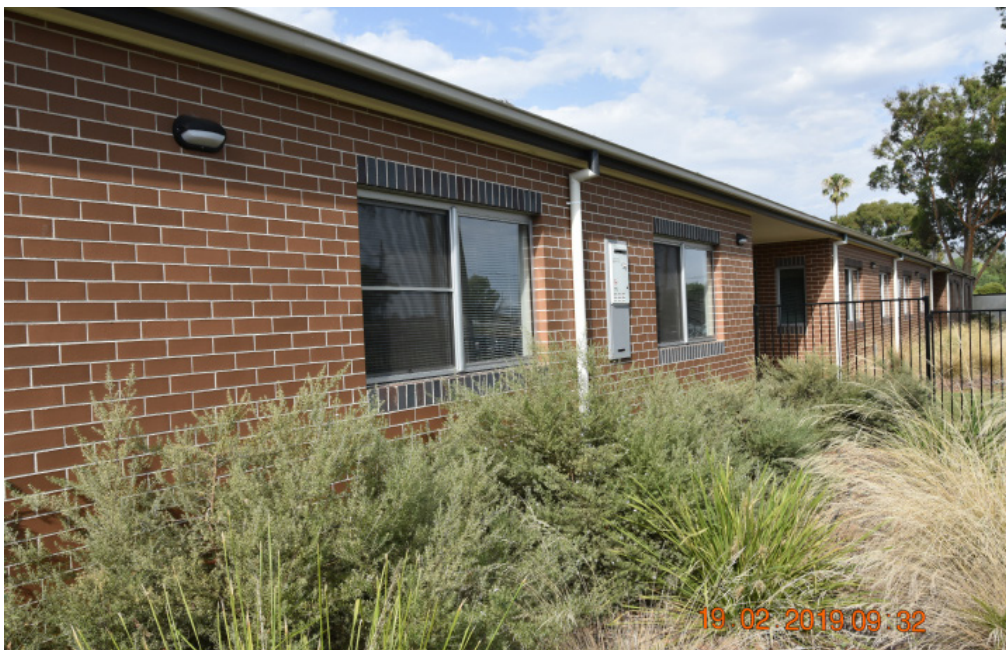
Figure: 0163

North wall of the medical centre.

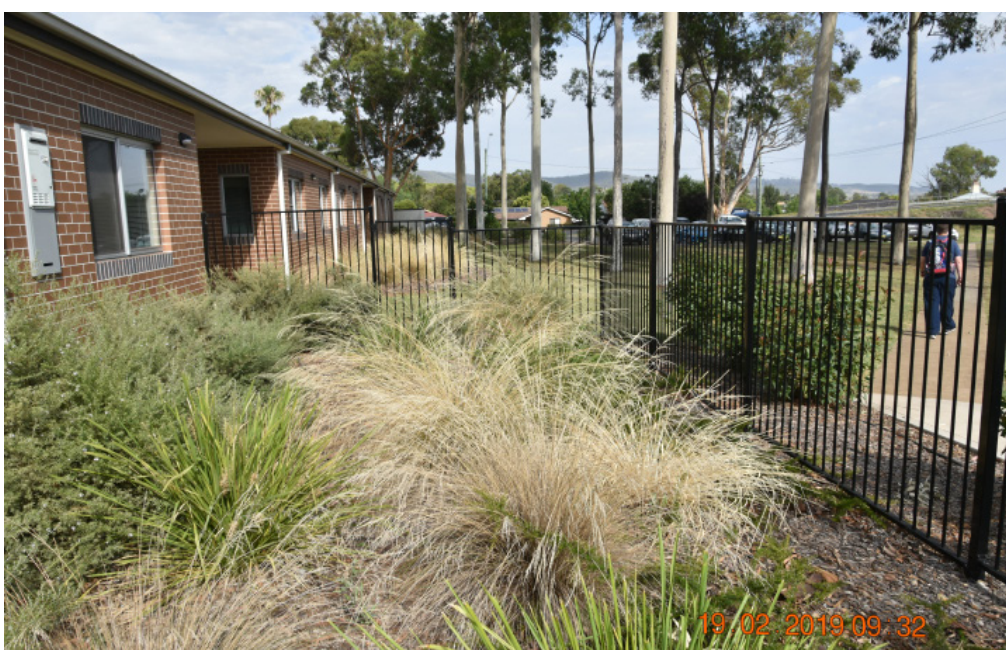
Figure: 0164

North wall of the medical centre.

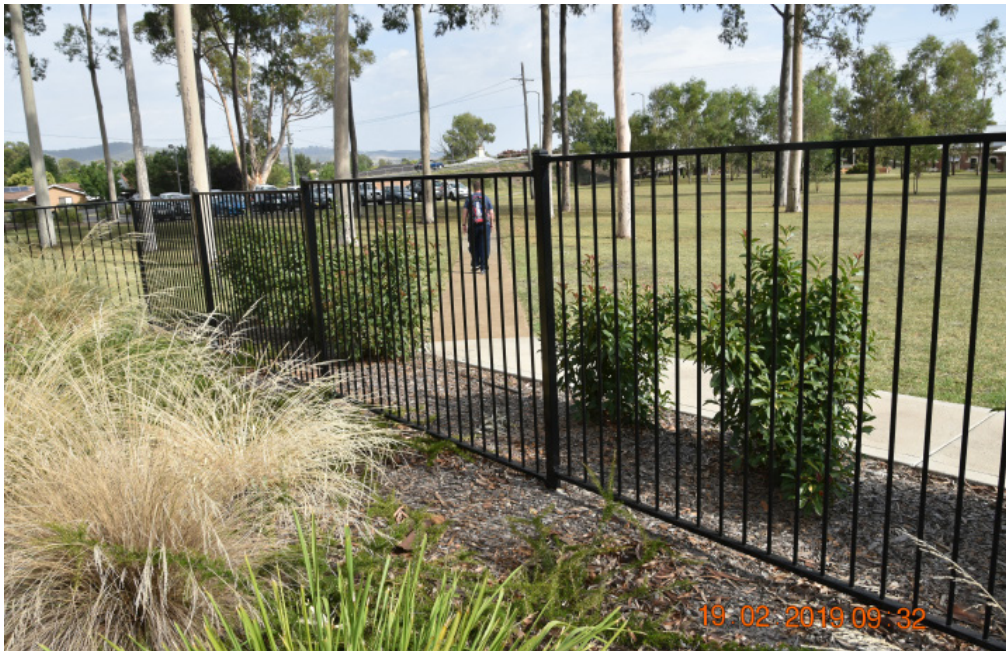
Figure: 0165

Fence on the north side of the medical centre.

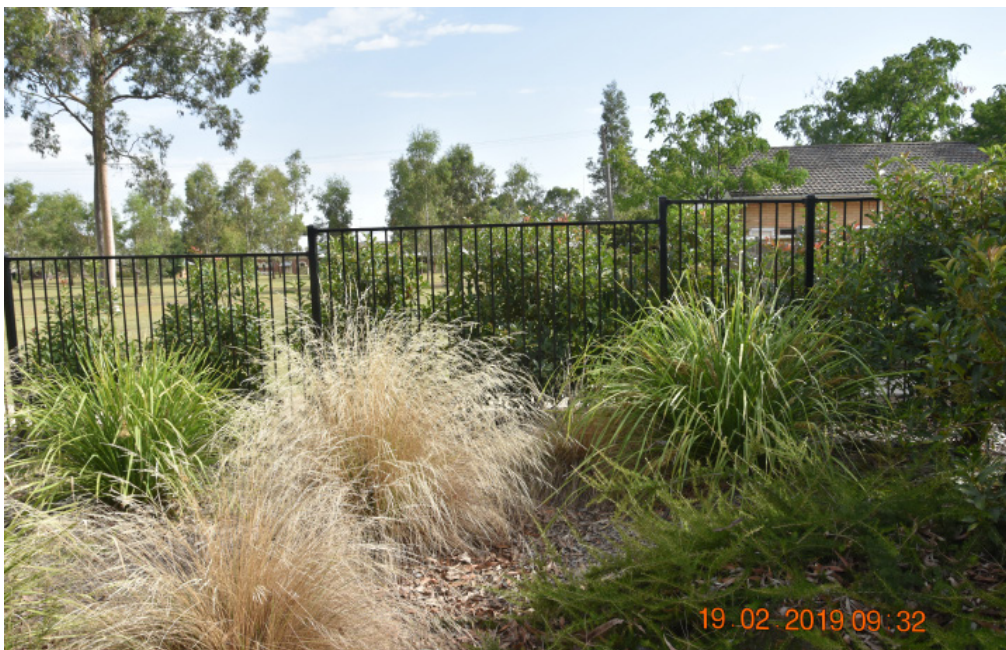
Figure: 0166

Fence on the north side of the medical centre.

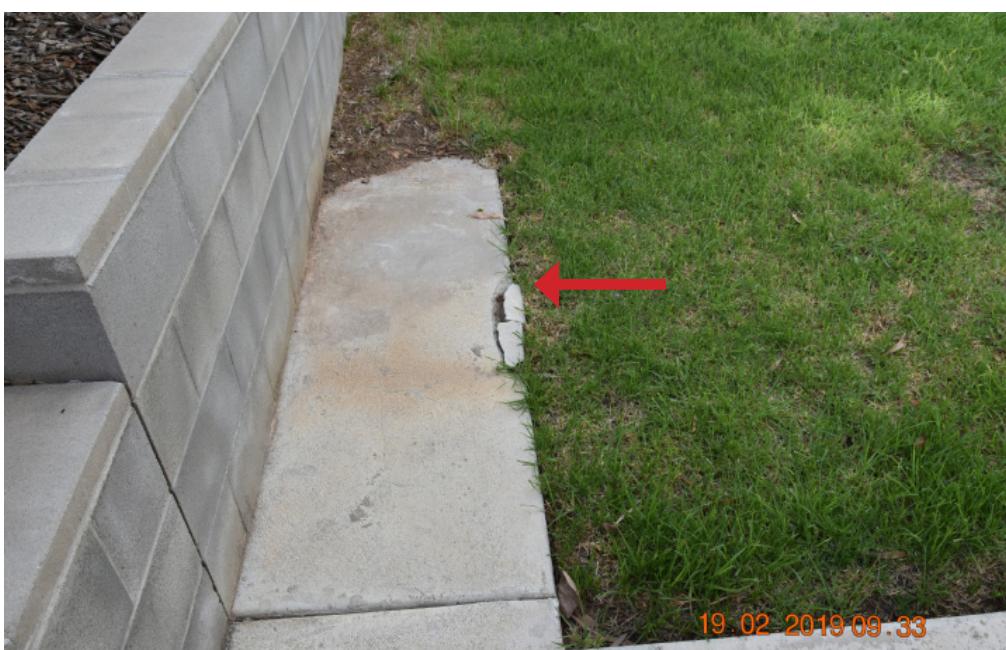
Figure: 0167

Fence on the north side of the medical centre.

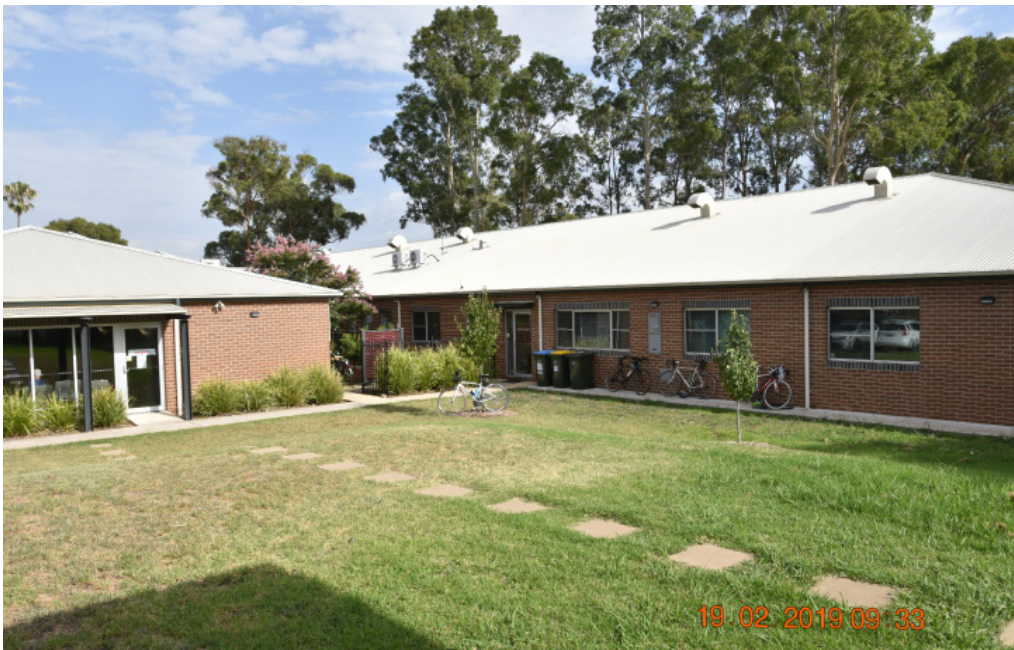
Figure: 0169

General view of the medical centre, looking from the east.

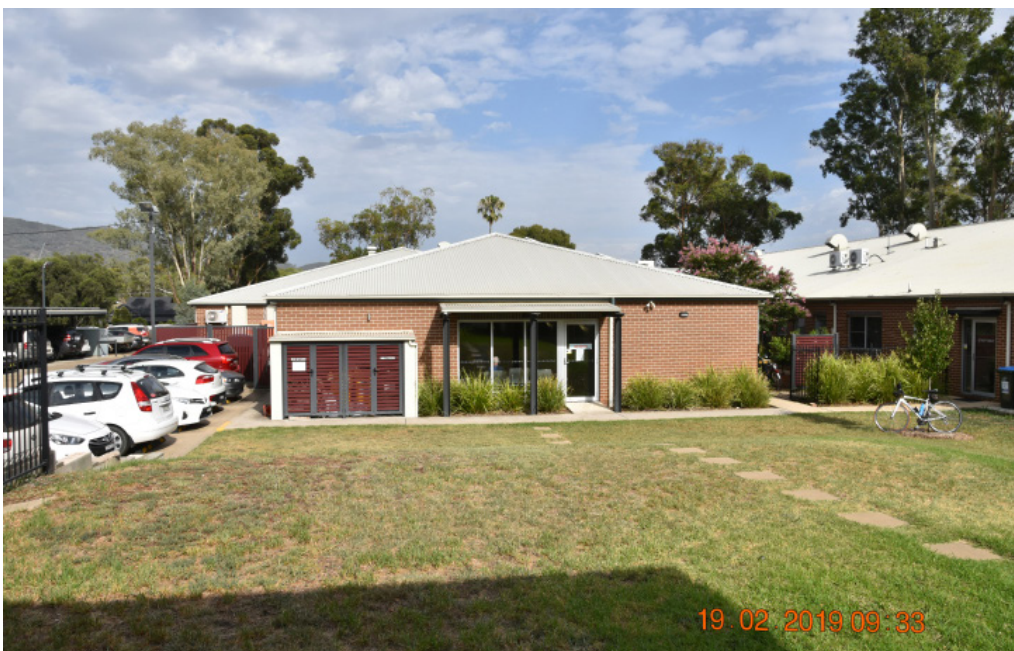
Figure: 0170

General view of the medical centre, looking from the east.

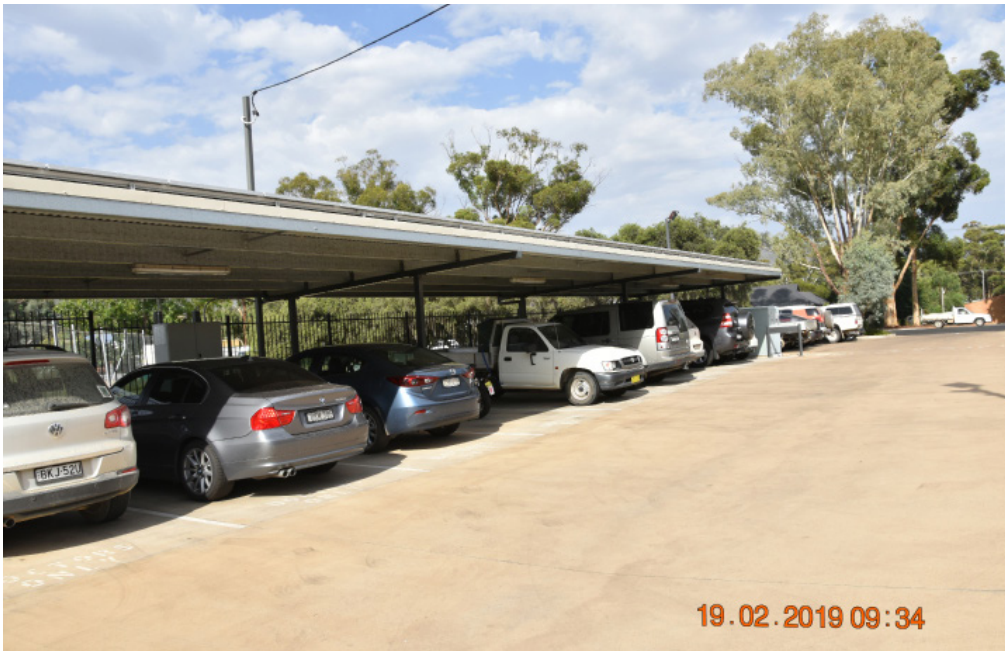
Figure: 0172

General view of the doctors only parking spaces.

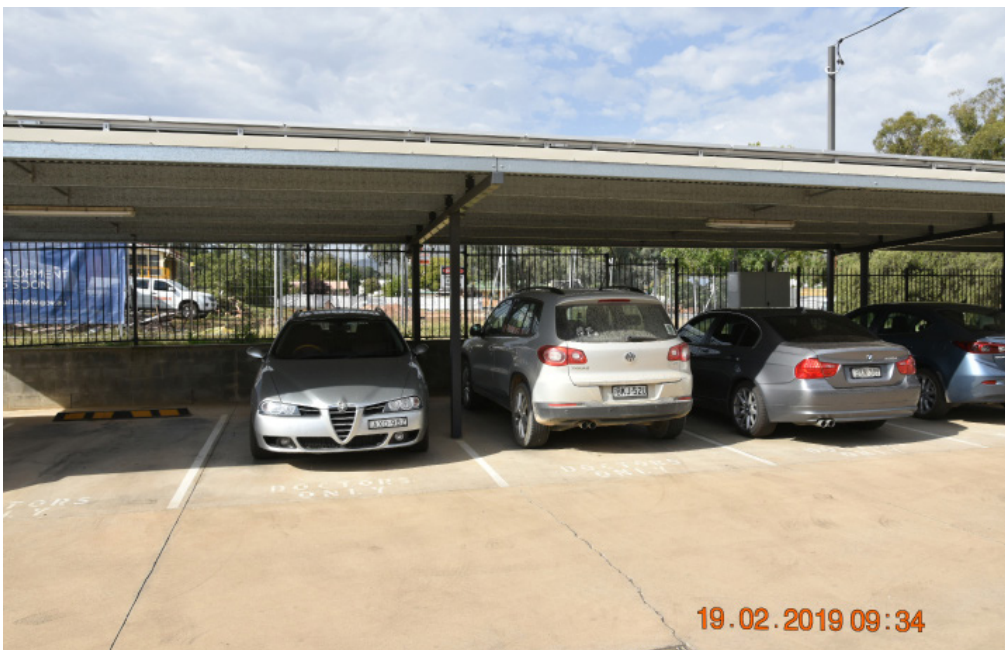
Figure: 0173

General view of the doctors only parking spaces.

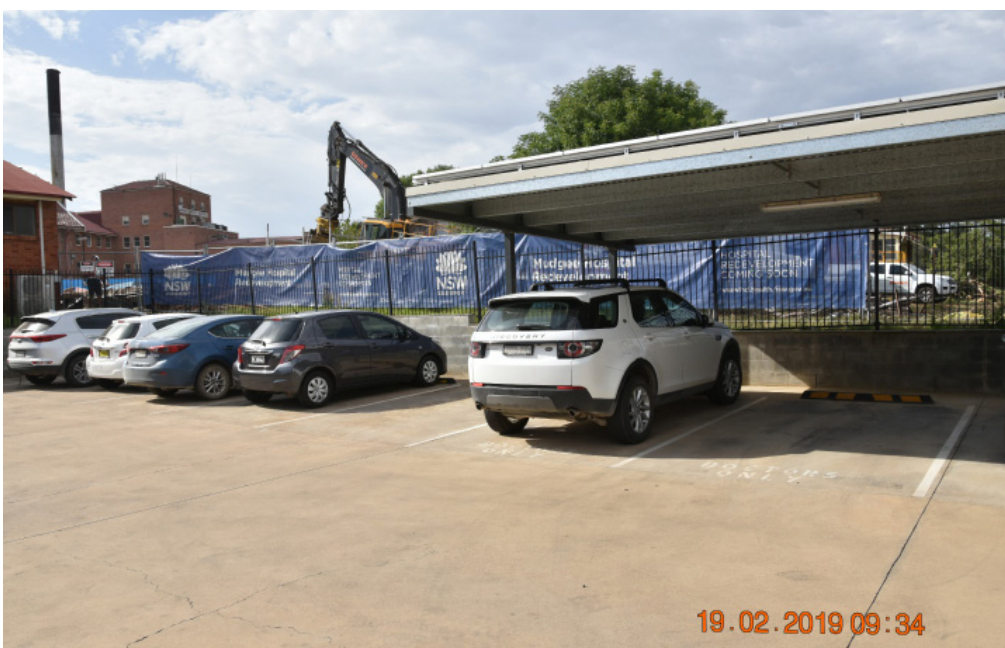
Figure: 0174

General view of the doctors only parking spaces.

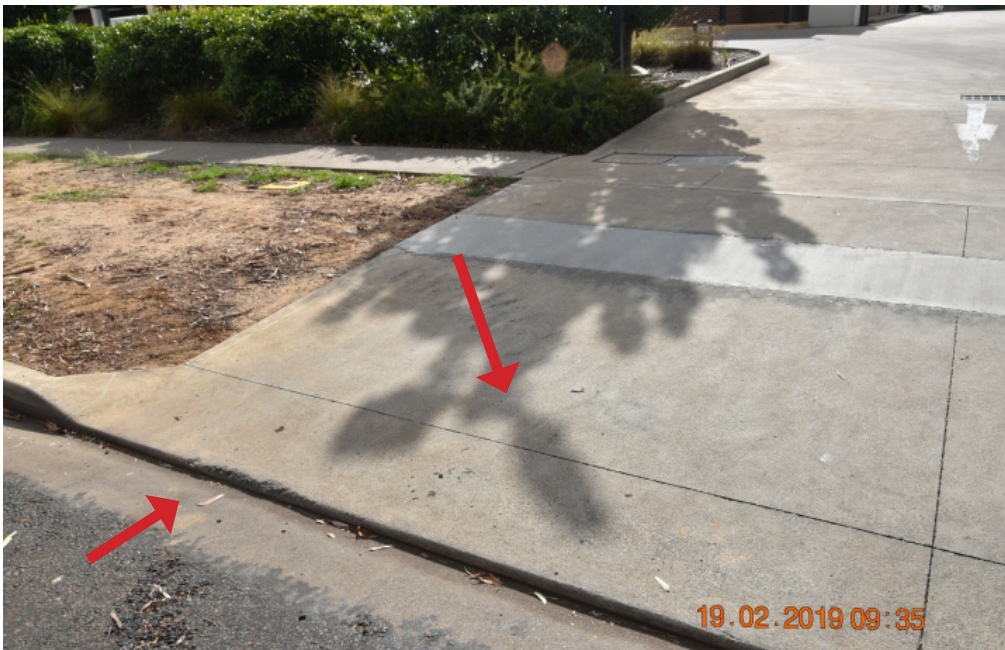
Figure: 0175

General view of the exit driveway. Showing chipping in the crossover.

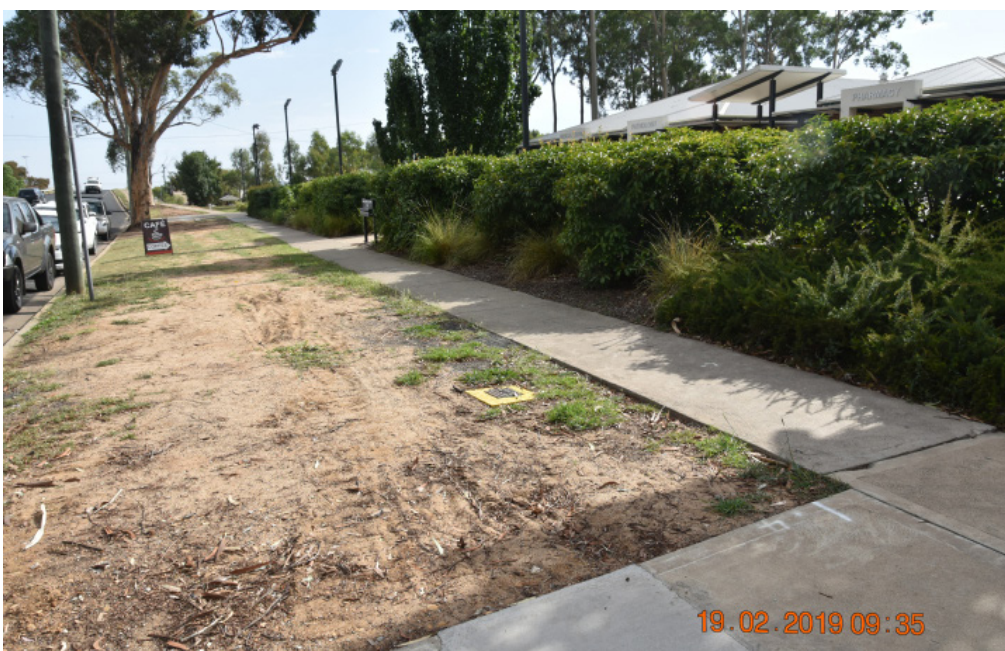
Figure: 0176

General view of the exit driveway. Showing chipping in the crossover and cracking in the driveway.

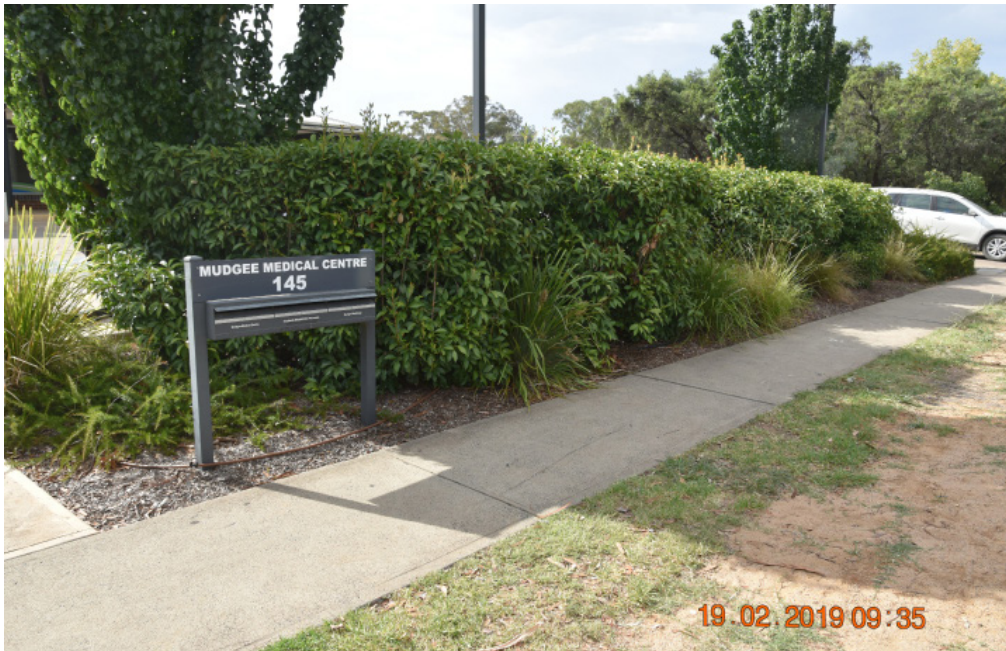
Figure: 0177

Footpath and nature strip outside the medical centre.

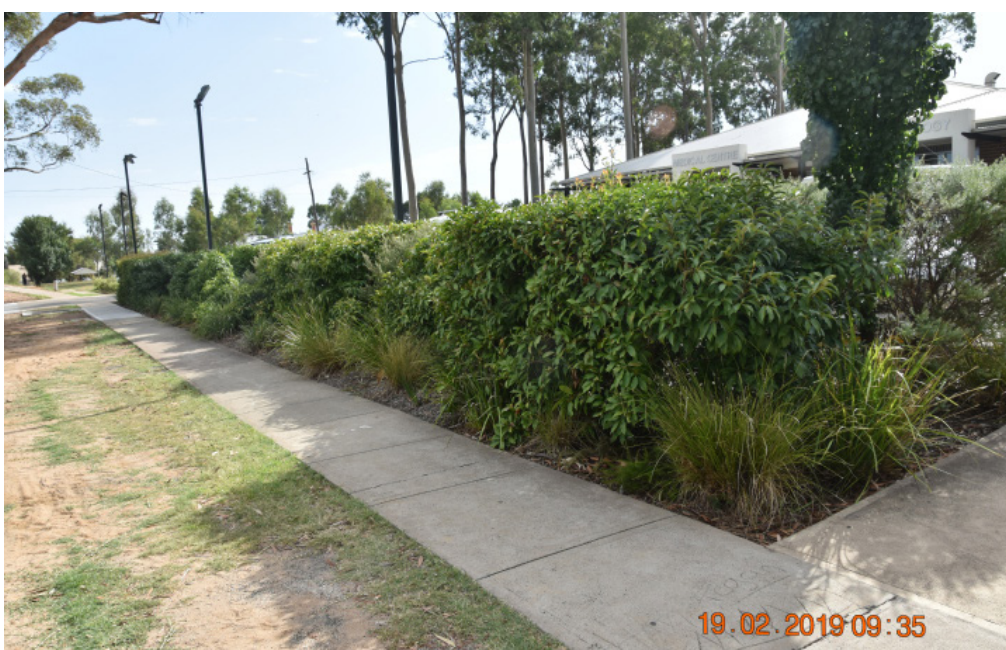
Figure: 0179

Pathway to the pedestrian crosswalk on the west side of the medical centre.

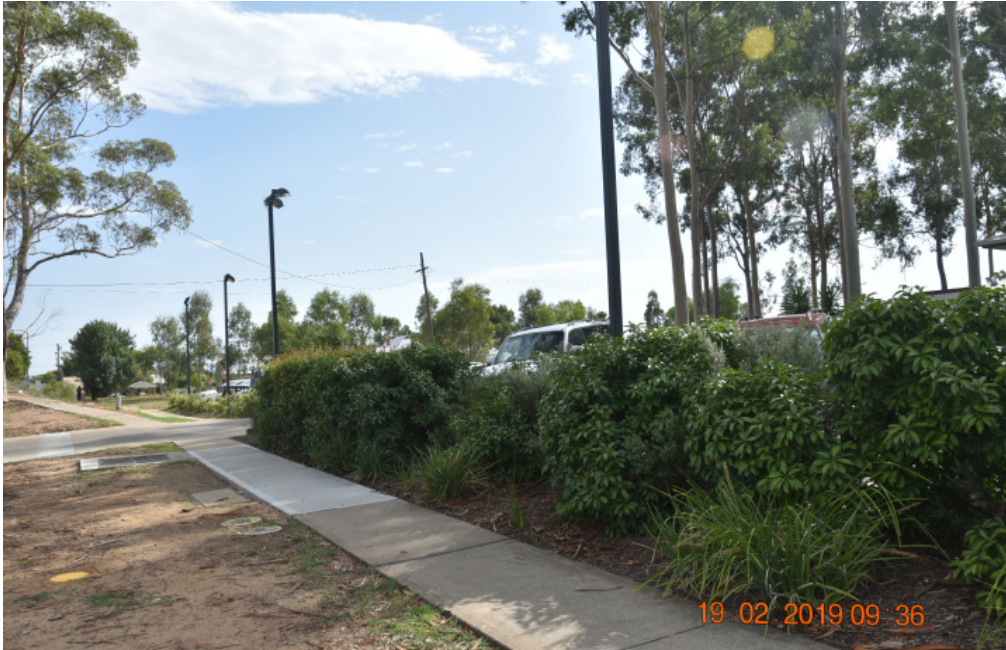
Figure: 0180

General view of the garden bed on the west side of the medical centre.

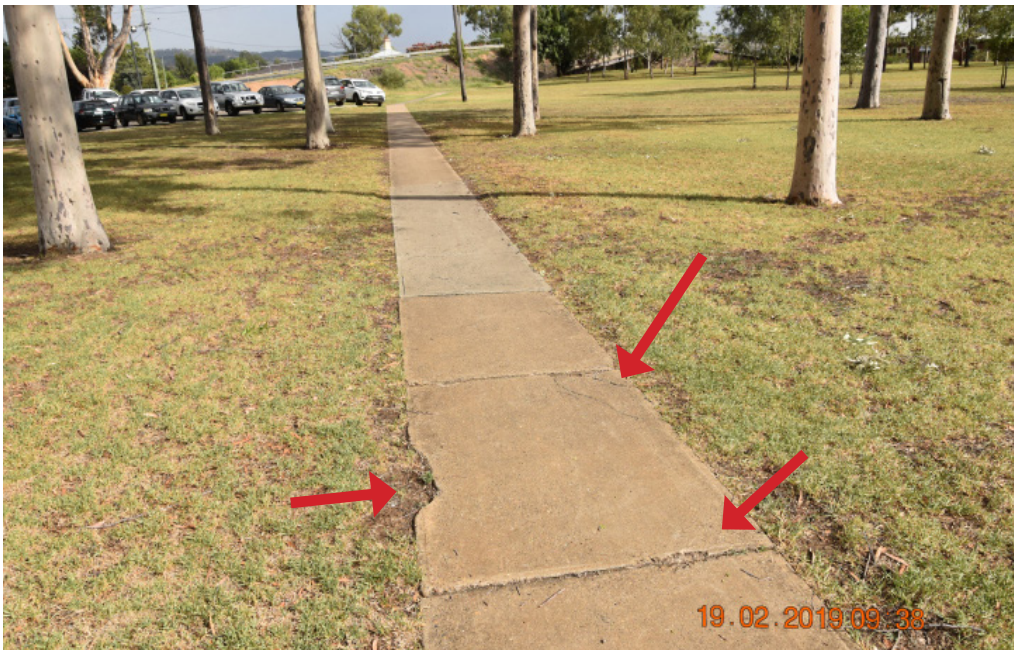
Figure: 0200

Pathway on the north side of the medical centre, near the east corner. Showing cracking and chipping.

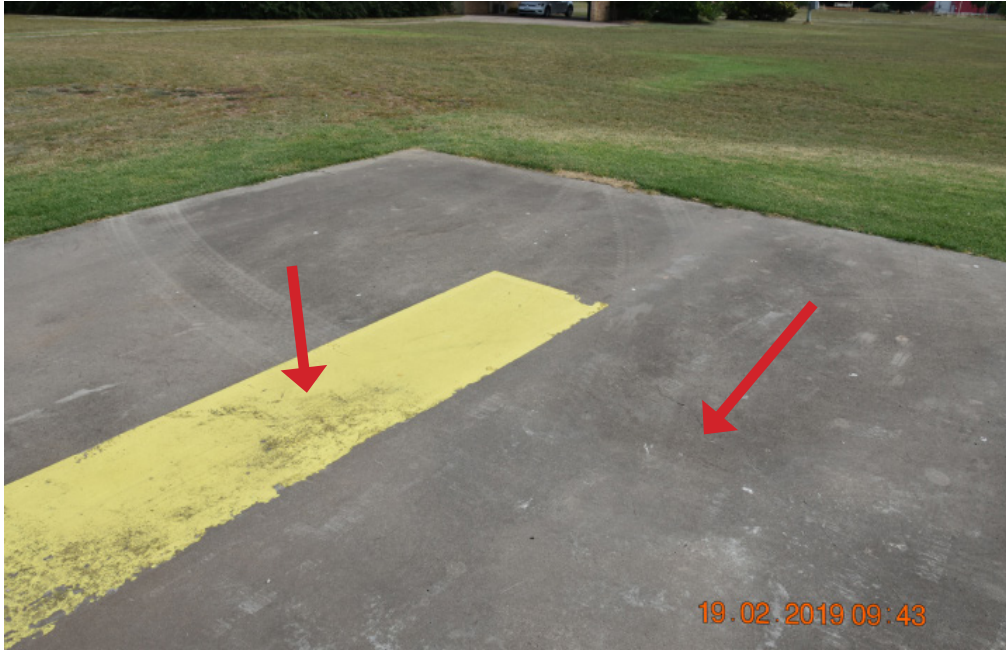
Figure: 0214

General view of the helipad. Showing cracking.

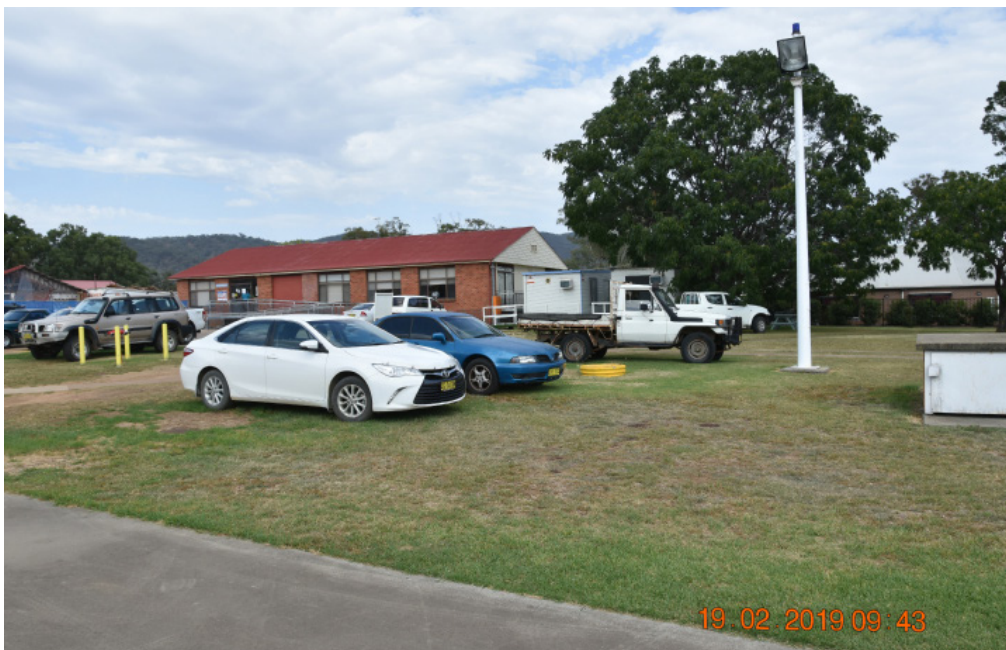
Figure: 0215

General view of the grass area on the west side of the helipad.

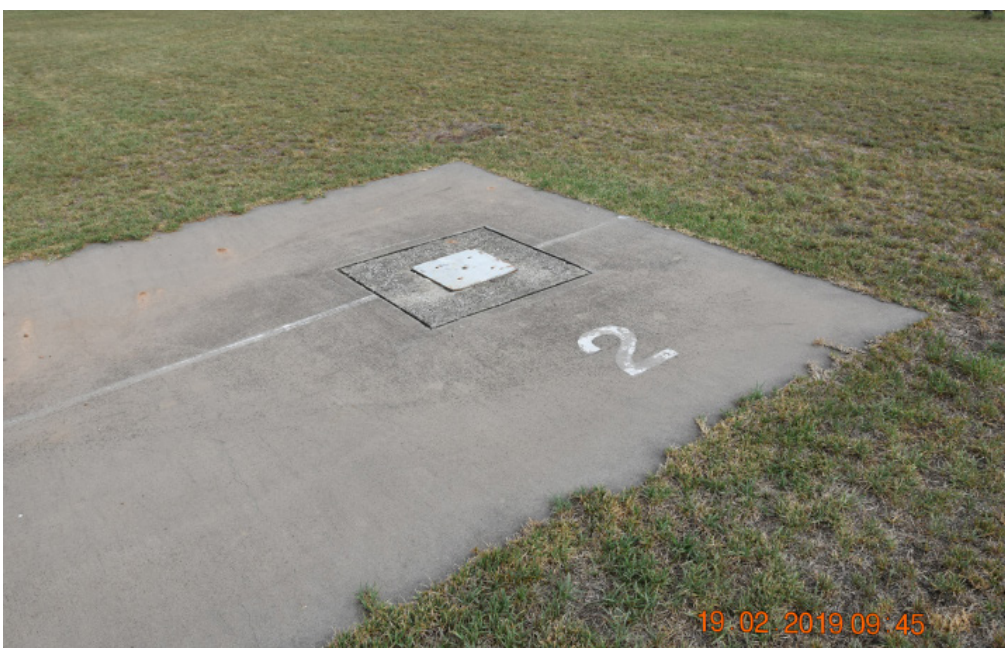
Figure: 0225

Concrete slab on the north side of the helipad.

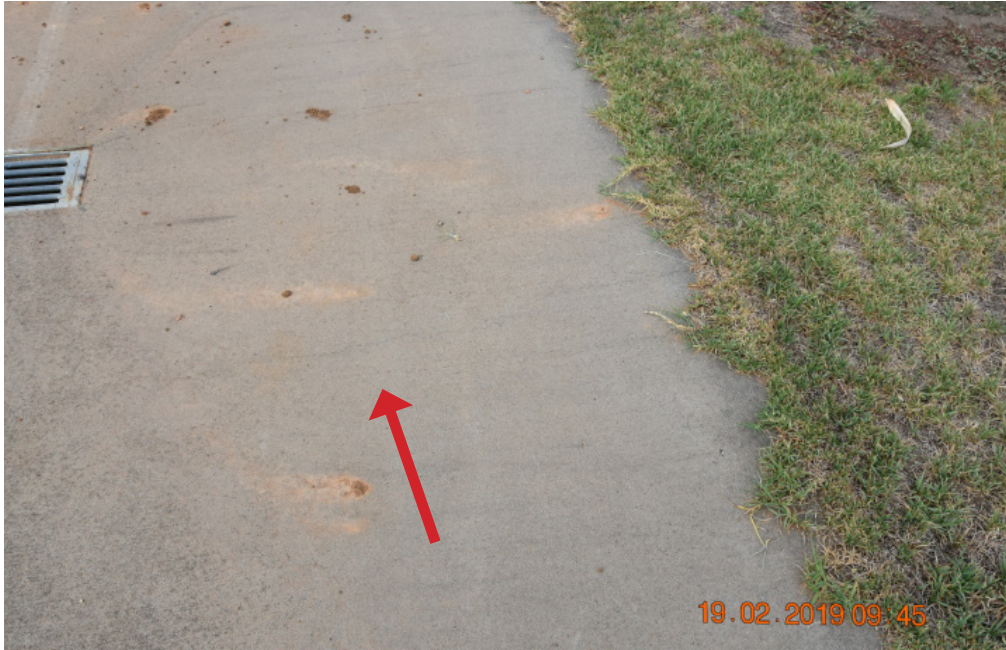
Figure: 0226

Fine cracking in the concrete slab on the north side of the helipad.

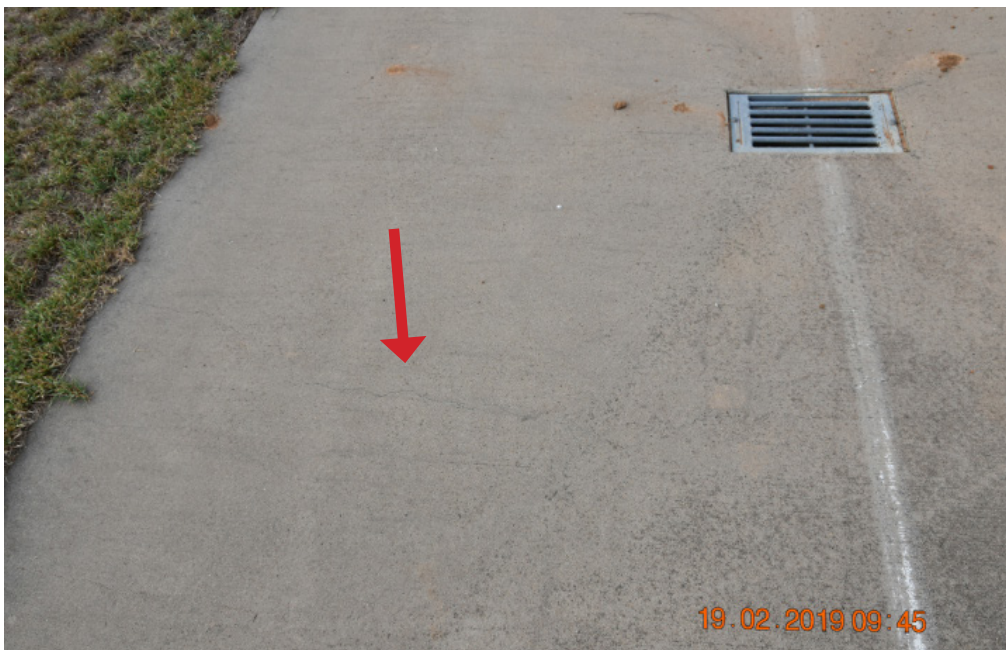
Figure: 0227

Fine cracking in the concrete slab on the north side of the helipad.
